**An Archaeological Standing Building Survey.  
Cherry Hill Farm,  
Silverdale, Newcastle under Lyme  
Staffordshire.**

**On Behalf of Rossisle Development Co Ltd**

**October 2014**

**ABRS Project No 2014-CHSS**

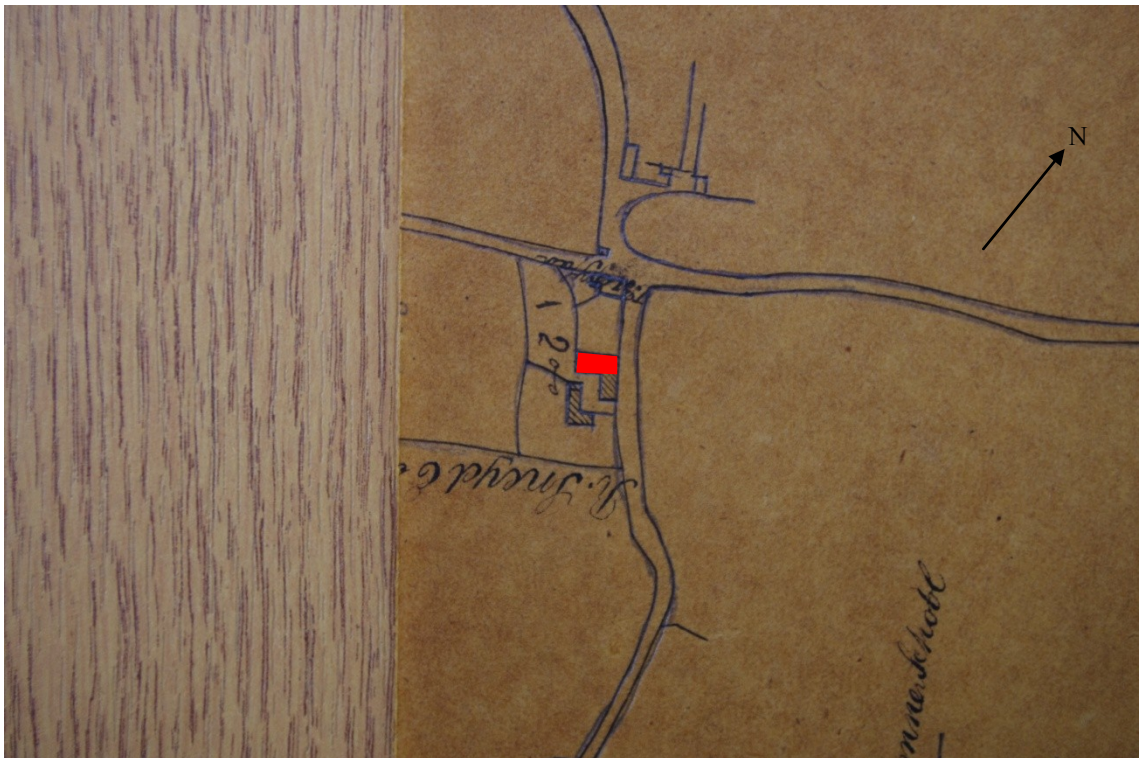
**Figure 2**

Map of Lands in Knutton Bought by Ralph Sneyd in 1841  
(Showing Recorded Building in Red)

deposited by Knight & Sons (the Sneyd Family solicitors) indicate that an estate in Knutton was bought from a Thomas Fletcher Fenton Boughey in 1841. With the conveyance there is a sketched map showing the buildings of the current Cherry Hill Farm (*Figure 2*). The accompanying map key records that the un-named buildings labelled as 2 were occupied by Charles Whalley. It is described as consisting of a “*house, buildings, gardens and fold yards*”, in all 3 roods, 24 perchs (a rood is approximately  $\frac{1}{4}$  of an acre). Whites Directory and Gazetteer of Staffordshire, 1834 lists a Charles Walley [sic] suggesting he had tenanted the farm for some time prior to its sale.

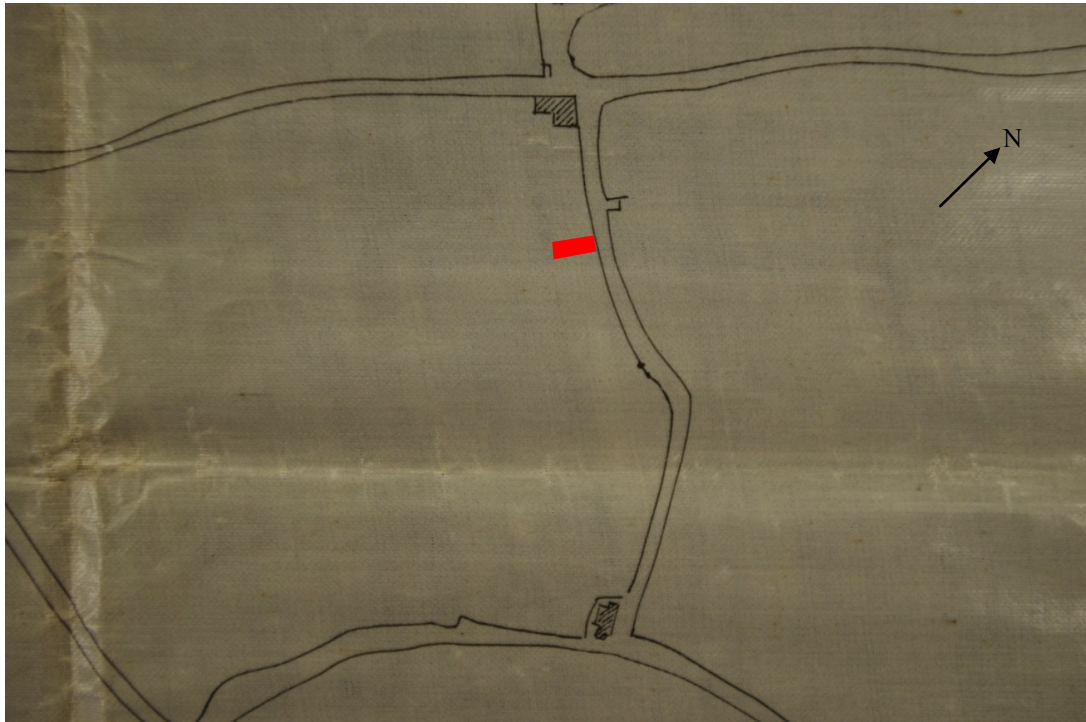
**Figure 3**  
1839 Knutton Tithe Map

The map included with the 1841 conveyance appears to be a tracing of the Knutton Tithe Map drawn in 1839 (SRO Ref D593/H/3/404 (*Figure 3*)). The map clearly records the alignment of Cherry Hill Lane, as well as the cross roads with Church Lane, the map, however does not contain any detail of buildings of Cherry Hill Farm, it is likely, therefore that the farm was not liable for tithe at the time.

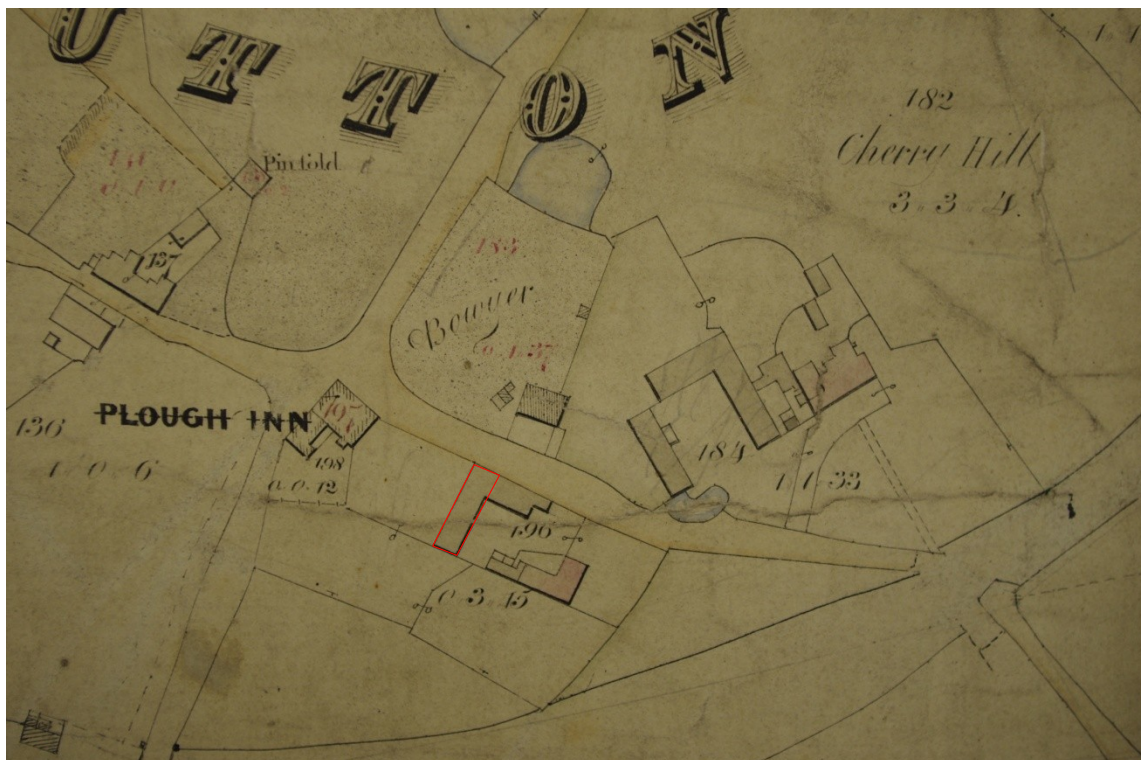
**Figure 4**  
Map of The Knutton Estate in the Parish of Wostanton 1848.

In 1848 Ralph Sneyd commissioned a map of the Knutton Estate (*Figure 4*). The map drawn by J. Myatt clearly records the buildings of the current Cherry Hill Farm. The buildings are almost certainly those subject to this historic building recording.

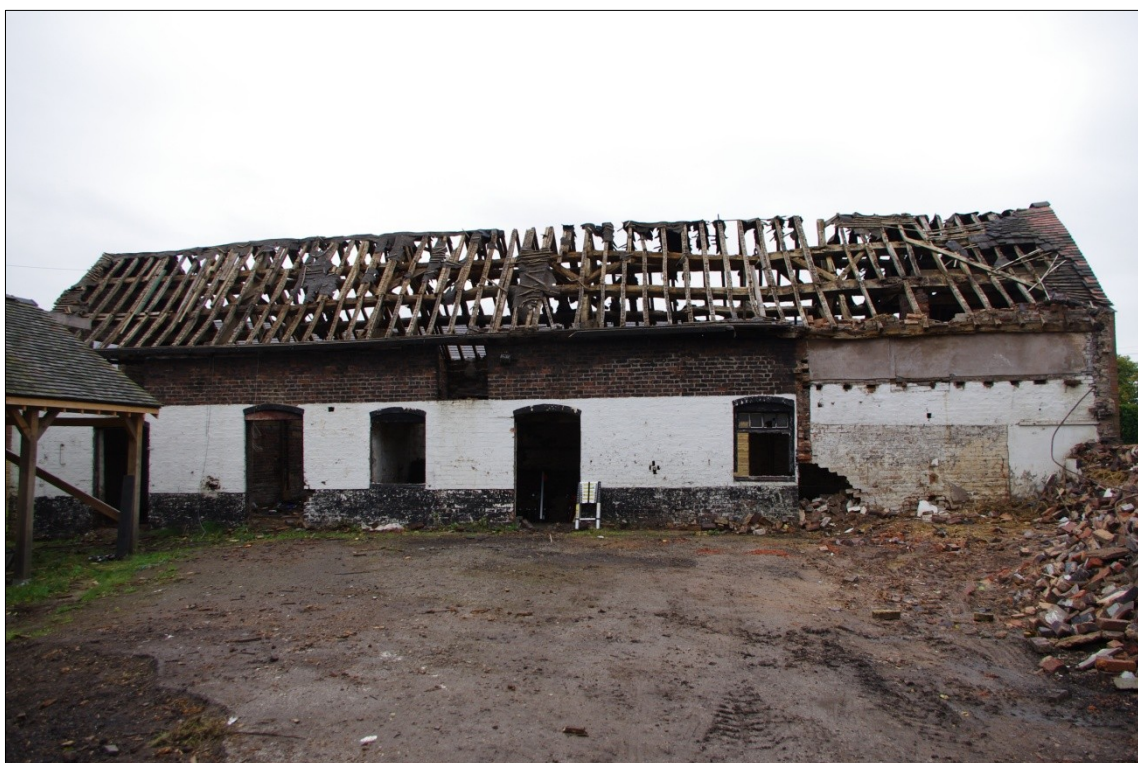
**Figure 7**  
Principal Elevation (looking North West).

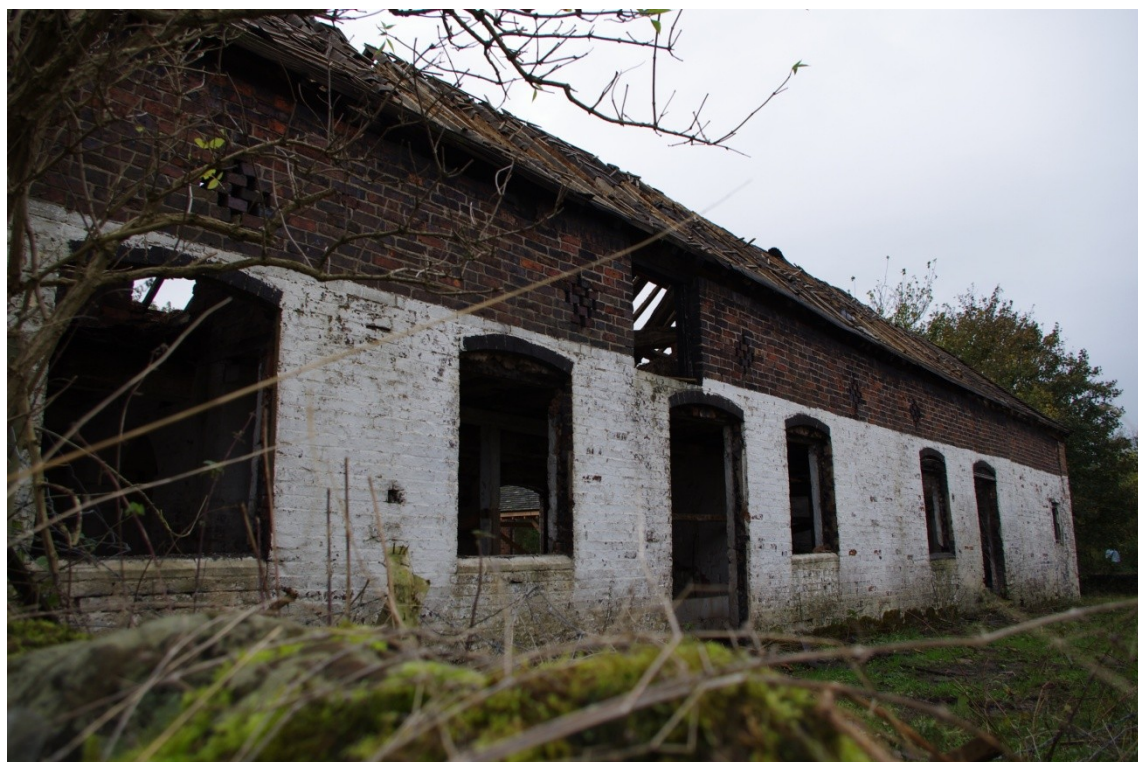
**Figure 8**  
Rear Elevation (Oblique View looking South).

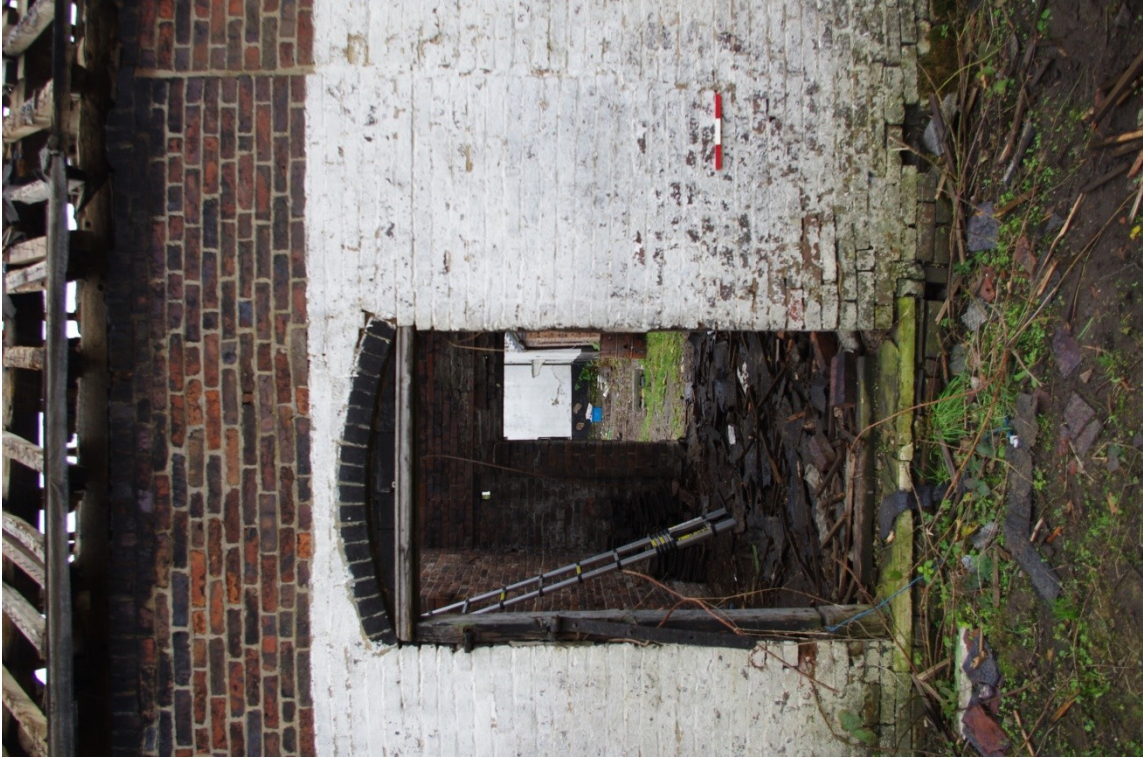
**Figure 9** Straight Joint Visible in Brickwork at South Western End of Rear Elevation.

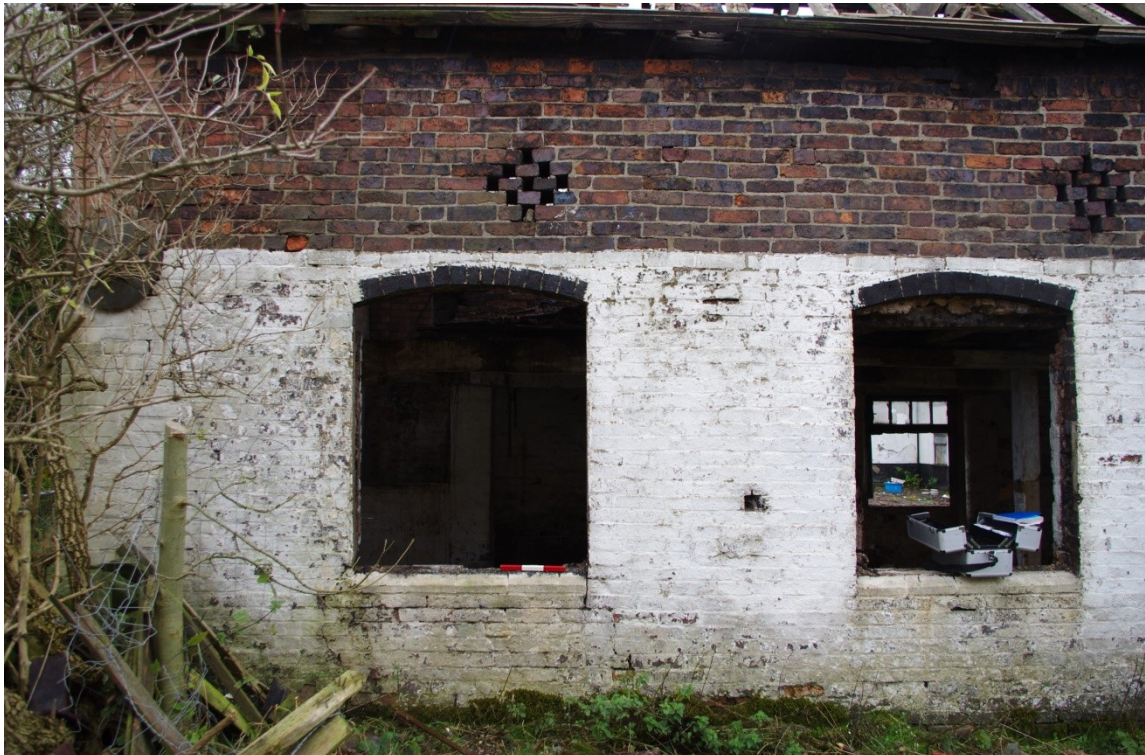
**Figure 10**  
Straight Joint & Partially Blocked Door at North Eastern End of Rear Elevation.

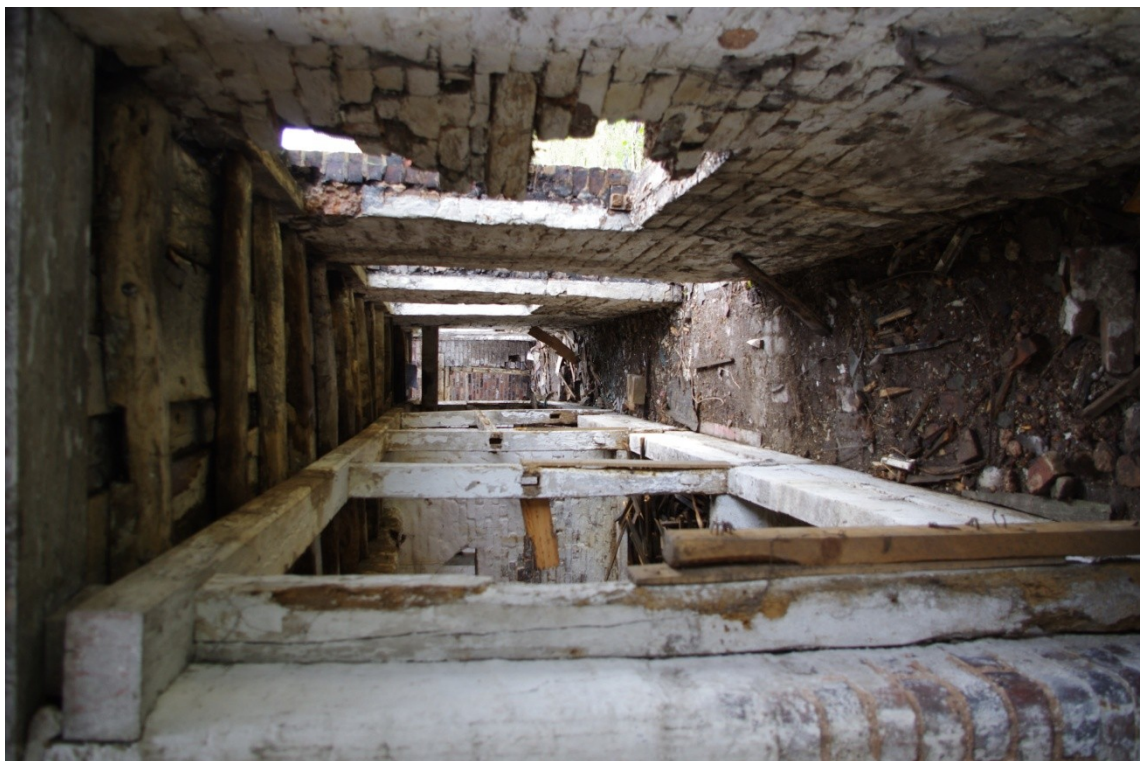
Internally the building consists of five bays; the three north easternmost bays (C, D & E) are cattle stalls and a loose box on the gable. Interestingly, there is a feeding passage along the rear of the stalls (*Figure 11*). In the 19th century feeding passages were incorporated into cow hovels allowing farmers to lay feed directly at the cows head speeding up the feeding and reducing waste because the farmer no longer needed to push pass the beasts from behind with the danger of dropped feed being fouled in the dung and are regarded as innovative. In this case the feed passage has been largely re-built in modern breeze blocks, but the remains of the brick-built troughs and tether bars (*Figure 13*) confirm the stalls and the feed passage are in their original location. The floors of the central stalls are a modern concrete slab, the drain channel and dung passage is apparently original brick. The cross walls at each end of

Figure 11 Feeding Passage.

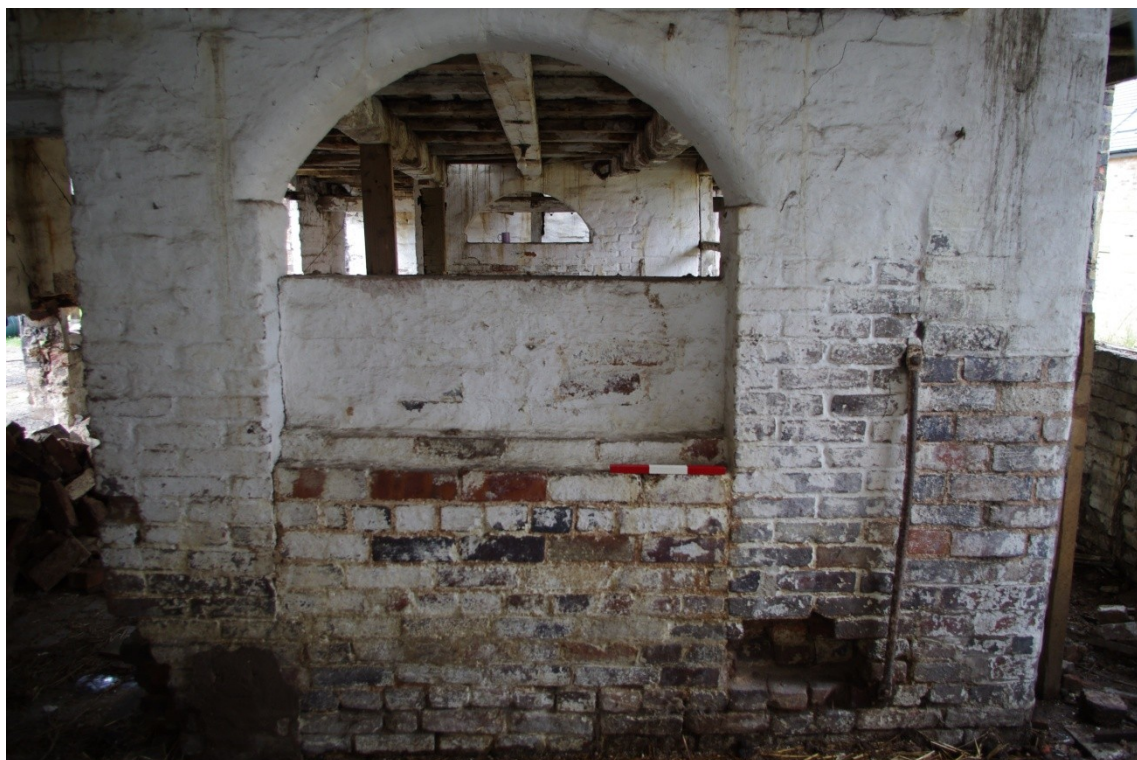
the stalls are brick-built with central arched openings, there is extensive evidence of alteration to both these cross walls, including reducing the size of the opening on at least two separate occasions (*Figure 12*).

Figure 12  
Cross Wall Between D & E Showing Multiple Building Phases.

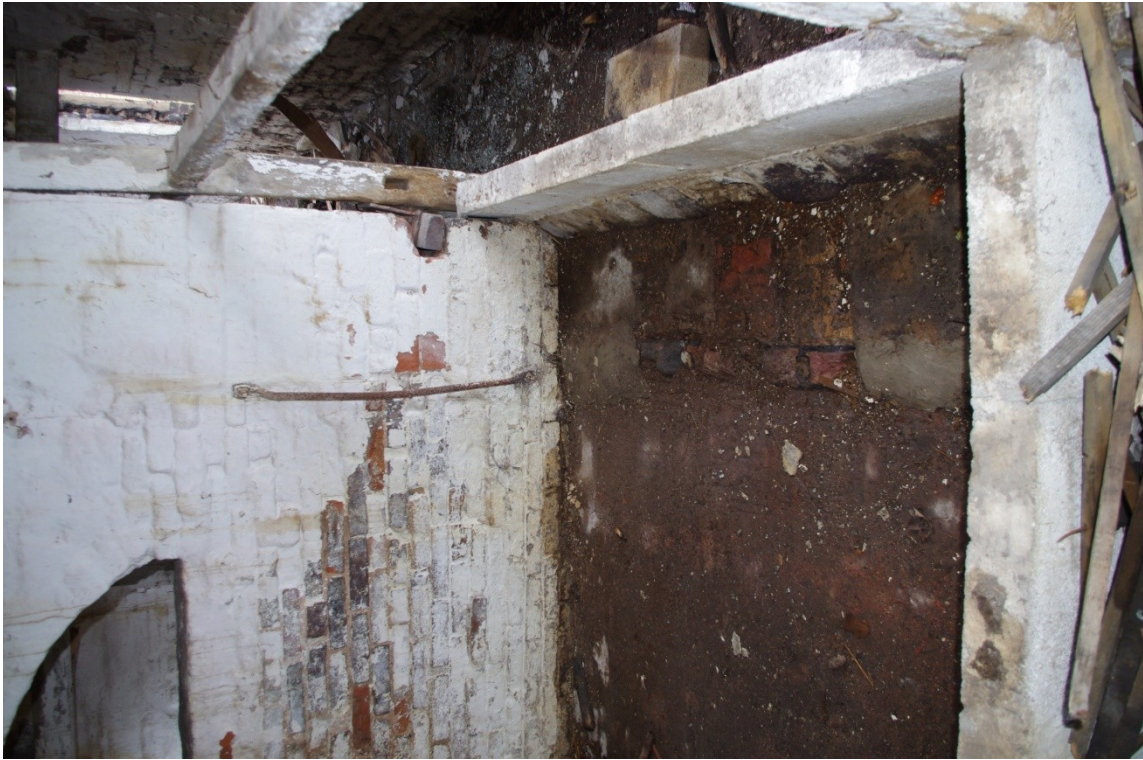
Figure 13 Outline Remains of Trough  
& Tether Bar B.

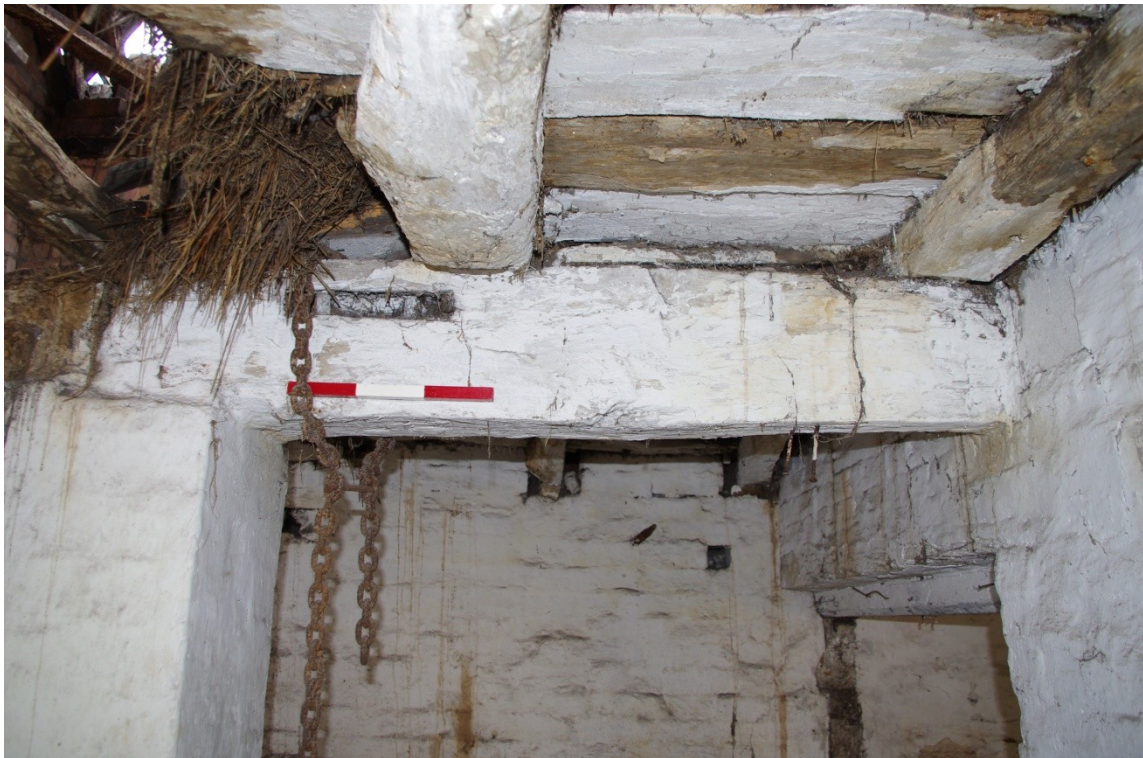
There is a loft above the central and north eastern stalls. The ceiling is carried on joists with two large bridging beams, the joists and the bridging beams show extensive evidence of re-use (*Figure 14*). Lofts over cattle stalls were common; this allowed hay and fodder to be stored close to the beasts, hay lofts, however fell out of favour in the later part of the 19th century when agricultural theory argued for “airy” cow houses on health and hygiene grounds.

Figure 14  
Re-used Bridging Beam E.

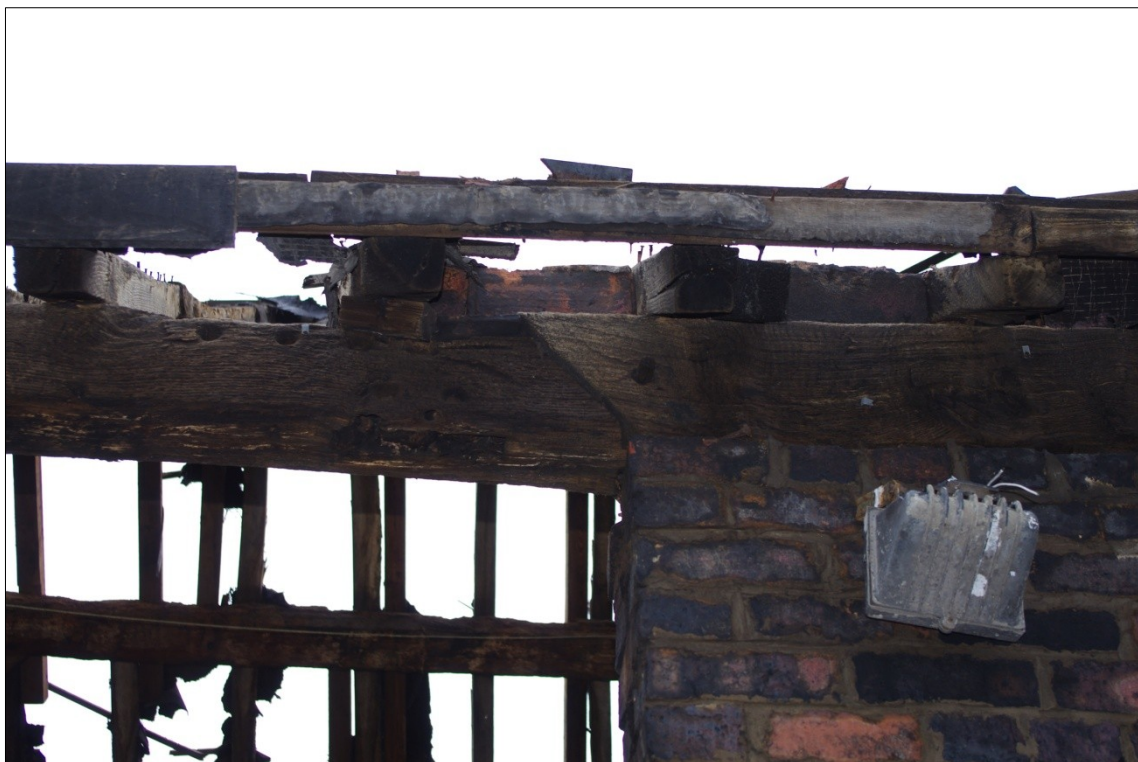
Both the wall plates consist of a number of lengths of timber with both scarfed joints (*Figure 15*) and straight joints, the number of open mortise and peg holes suggest the timbers are re-used. In places the wall plate and the long walls are out of alignment indicating significant historical structural movement. There a number of straight joints visible in the original brickwork, including two full height joints on the rear elevation (*Figures 9 & 10*), the brickwork each side of these joints appears to be contemporary, so the origin of the joints is unclear. The south westernmost joint may correspond with the separate bays recorded by earlier cartographic sources (*Fig. 4*); however, the joint cannot be seen in the principal elevation. There is also evidence that the north easternmost window on the ground floor has been inserted into a blocked door way, so despite its uniform appearance, the building has a potentially more complex history.

**Figure 15**  
Scarfed Joint & Empty Peg Holes on Principal Elevation Wall Plate.

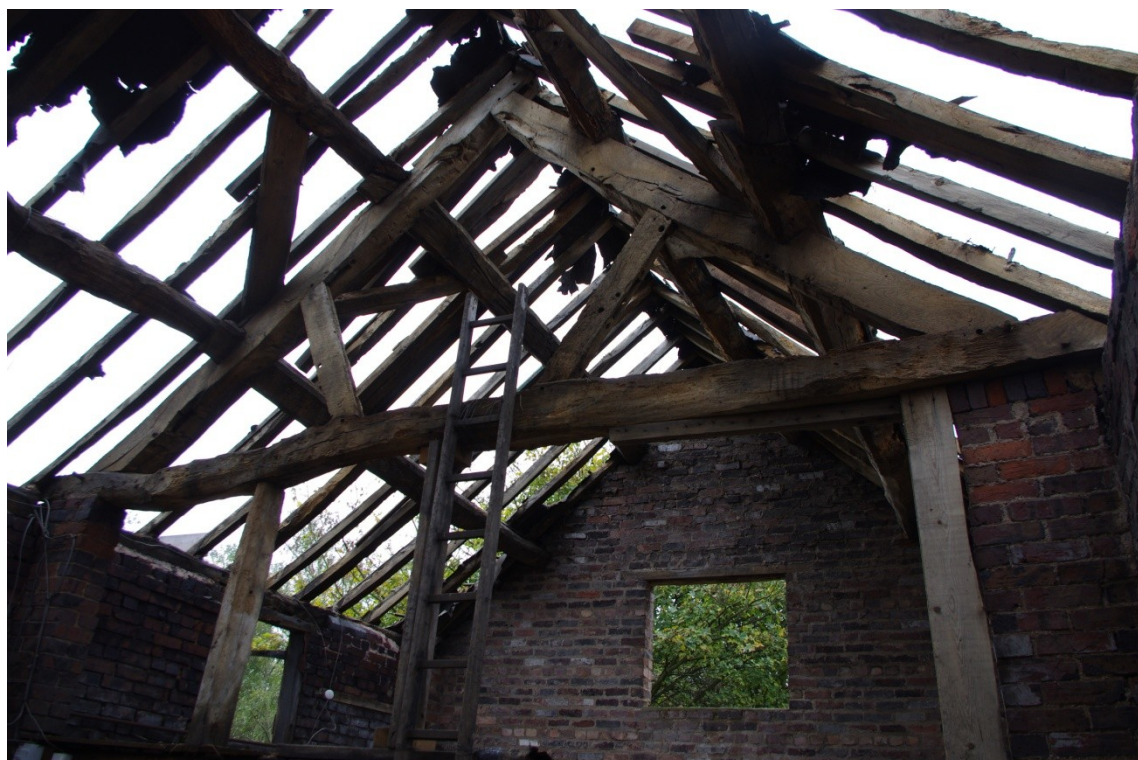
The roof is carried on four trusses (numbered for this record 01 – 04 south west – north east). Trusses 01 to 03 are simple A frame trusses with angled struts (*Figures 16 & 21*). Again, as with all the structural timber within the building there is extensive evidence of re-use. A study of Post Medieval roof trusses in Staffordshire (Peters, Vernacular Architecture 1988) suggests the use of such trusses originated in the 16th century, but had all but disappeared by the middle of the 19th century, suggesting a tentative, if broad date for the building. However, the Truss 04 (*Figure 17*) is of a different design, it is a king post truss with twin raking struts; Peters, again suggests a date for the use of multiple struts to before 1820, however, this example with both struts on the king post does not exactly match those in Peters’ study group, so once again the exact date is un-sure. Truss 04 does appear to show less evidence of re-used timbers, and may therefore be the original truss, while 01 to 03 are later replacements. The condition of the roof and ceiling prevented a more detailed examination of the truss.

**Figure 16**  
Truss 01.

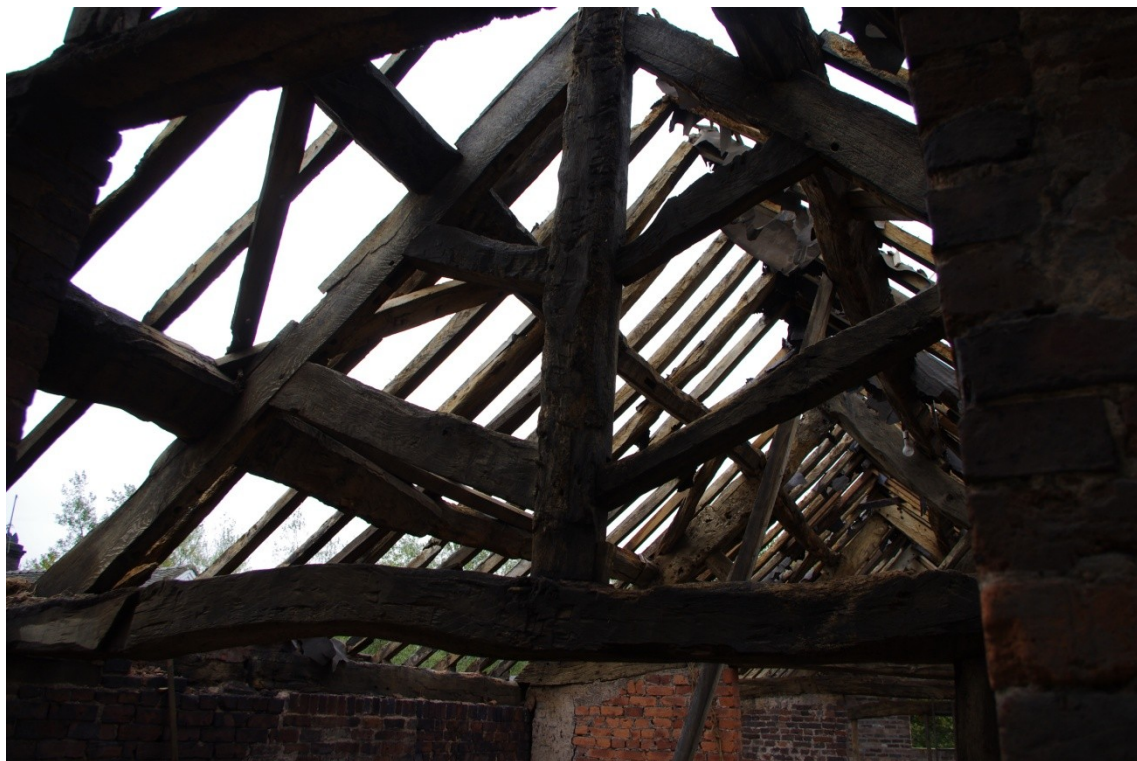
**Figure 17**  
Truss 04.

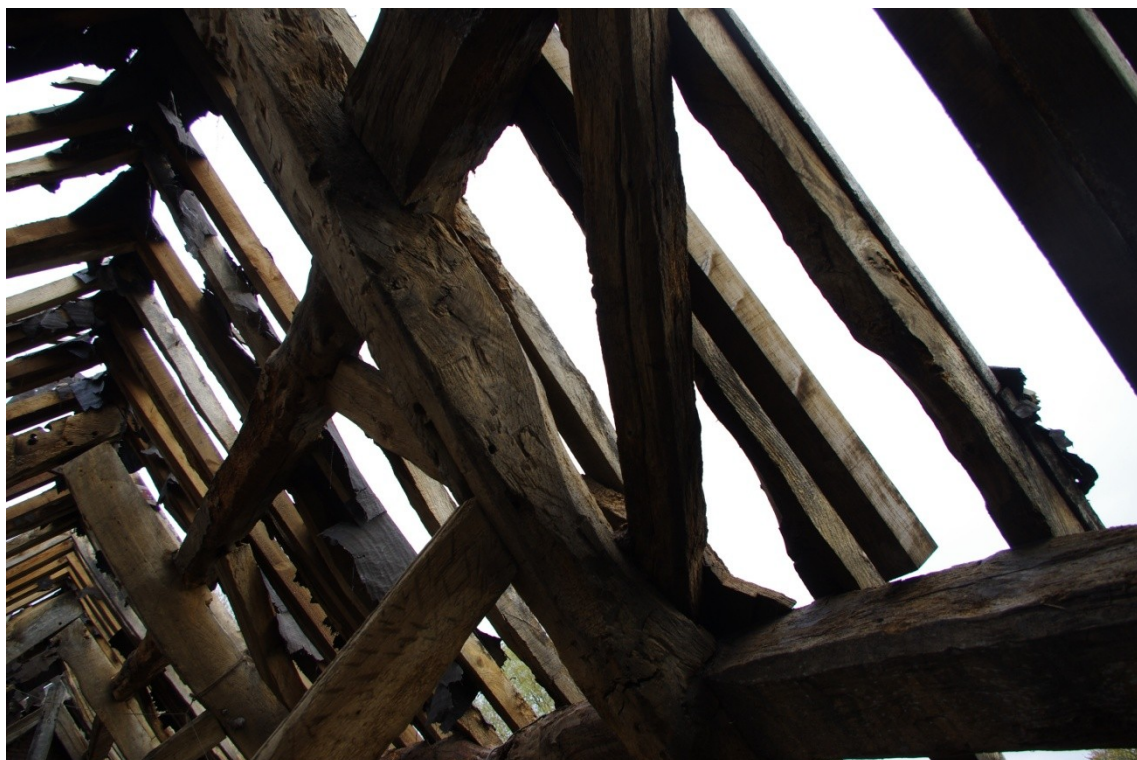
upper purlin (*Figure 18*), the joints between the wind braces, trusses and purlins appear to vary, but again the condition of the roof prevented a more detailed examination.

**Figure 18**  
Wind Brace.
