## **An Archaeological Standing Building Survey. The George Hotel, Melton Mowbray, Leicestershire. (NGR SK 75123 19185)**

**On Behalf of Queensbridge Homes Ltd**

ABRS Report No 2014-GHML

**May 2014**

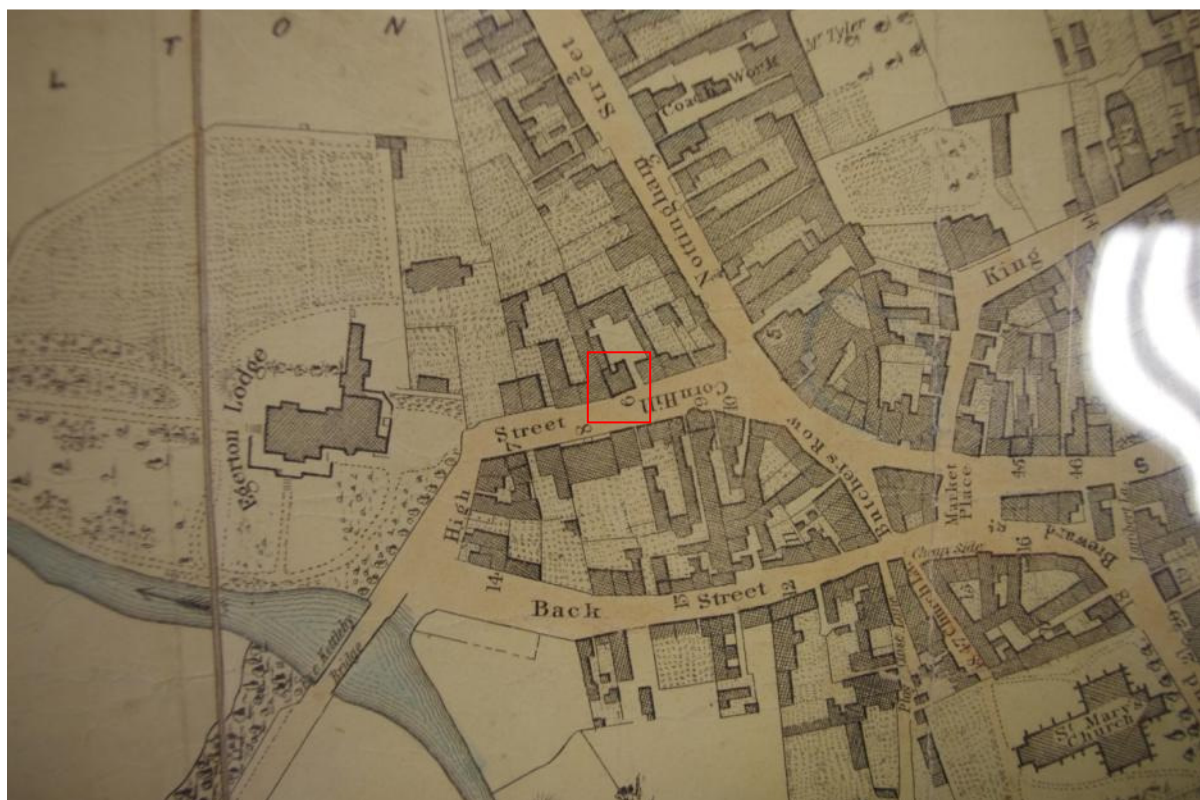
**Figure 2**  
John Wood's Plan of Melton Mowbray (1839).

Wood's Plan clearly records the George Hotel as fronting High Street to the south, the outline of the inn is drawn in a thicker line (as are all the other inns & taverns on the map). The George occupies the south westernmost corner of the current plot, to the east is an alley leading to a yard surrounded by a range of outbuildings, it is unclear whether these buildings belong to the George Hotel, however, it is likely that these buildings are stabling and store rooms for the inn. Also it is unclear as to whether the building immediately to the east of the alley is part of the George or a separate building all together. It is clear, however, that the carriage arch has yet to be built.

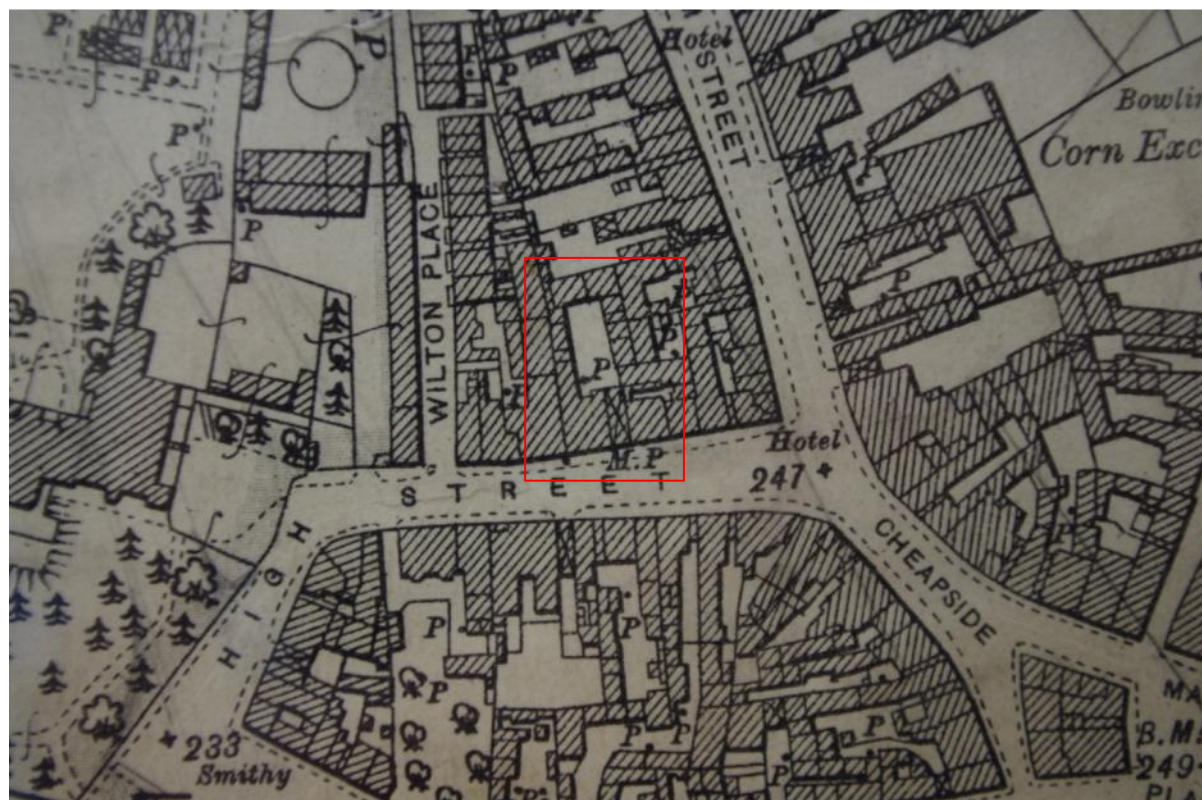
**Figure 4**  
Second Edition Ordnance Survey XX.5 (1904).  
1:2500

By 1904 the hotel had again changed hands and was now kept by William Henry Sampey, the hotel is now simply described as “*The George Hotel*”, the hotel is no longer a posting house. Also in 1904 the second edition Ordnance Survey was published (ROLLR Ref XX.5 (*Figure 4*)). The hotel itself remains largely as it was recorded by the first edition, with only limited changes, most notably the unusual range of four outbuildings to the north east of the coach arch appear to have been replaced by a single range.

The outbuildings to the north have also undergone some change, the northernmost east – west range is now, once again a single building, but at least part of the smaller building to the west

recorded in figure 3 still remains. The north – south aligned ranges can, based upon their appearance in figure 4, be identified with certainty as stabling.

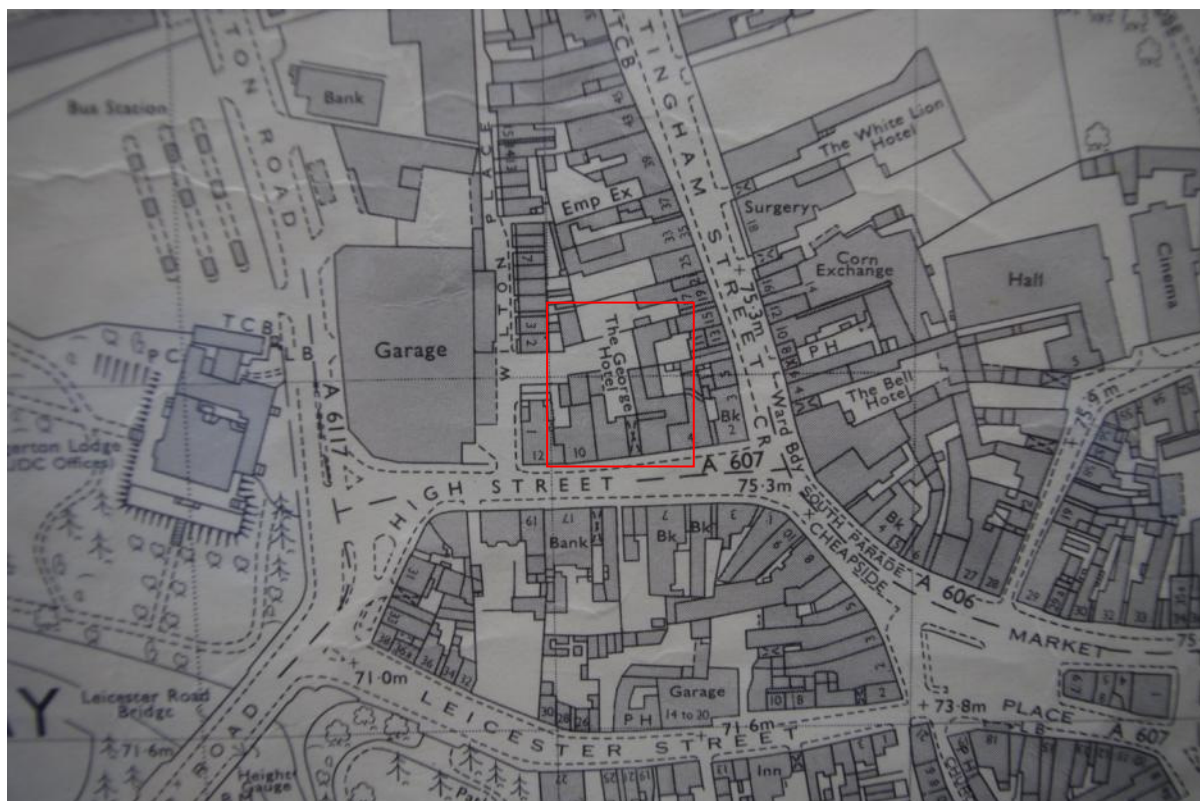
**Figure 5**  
Third Edition Ordnance Survey XX.5 (1930).  
1:2500

The third edition Ordnance Survey published in 1930 (ROLLR Ref XX.5 (*Figure 5*)) records the hotel largely as it currently stands. Again, the only significant alterations have occurred to the rear outbuildings. At least one bay of the westernmost north – south range has been demolished creating access to Wilton Place, probably reflecting the growth of motor cars rendering the carriage arch obsolete as a vehicle entrance. This has also created a single isolated building in the north westernmost corner of the plot. The easternmost north – south range has also been significantly truncated, leaving at most two bays of the original buildings.

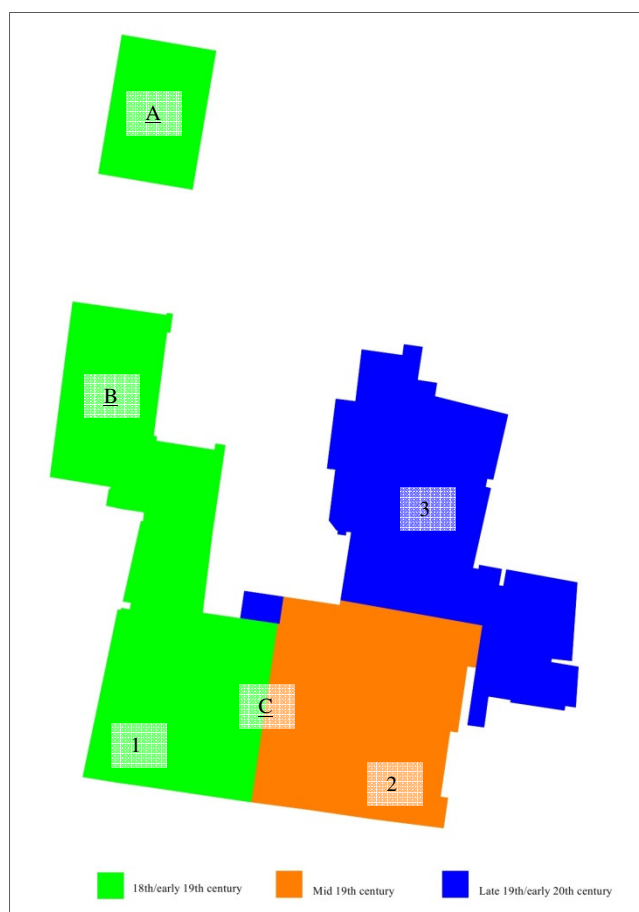
**Figure 7**  
Principal Phases & Divisions.  
(Not to Scale)

Building C is the main body of the George Hotel and consists of three distinct elements; C1, the westernmost bay, C2, the easternmost bay and C3, the north westernmost wing, to the rear of C2 (*Figure 7*).

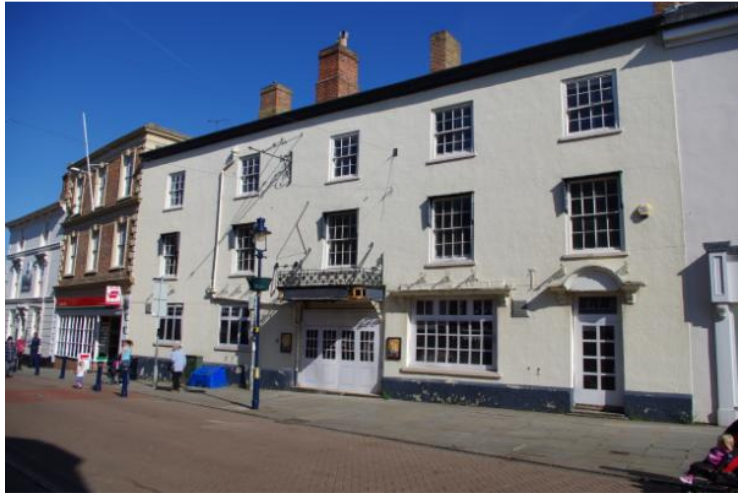
**Figure 8**  
High Street Elevation (Looking North West).

Externally the principal High Street elevation is rendered with a pediment and a rendered plinth (*Figures 8 & 40*). The rear elevations are all painted brick. The roofs are Welsh slate with a number of hips; there are also a number of brick-built chimneys including two large chimneys above C1. There is a central carriage arch over which there is a modern, although not un-attractive canopy (*Figure 13*). To the right is a pedestrian door with an attractive arched hood carried on simple geometric consoles, a design common to the mid 18th century. The door itself was concealed by security shutters, but its height suggests the presence of an over-door light or fanlight. The large ground floor window between the carriage arch and door also has a flat hood with the same consoles. The windows of the western bay contain no such flourishes and may reflect the origin of the two bays as separate buildings as shown in figure 2.

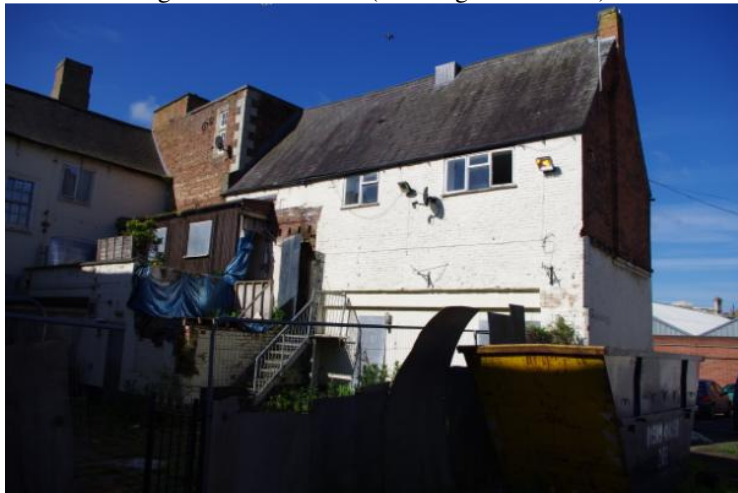
**Figure 10**  
East Facing Elevation (Looking South West).

The east facing long elevation is painted brick and is much altered (*Figures 10 & 43*), the ground floor is open fronted, the lintel is a steel rolled steel joist (RSJ), confirming the opening is a later insertion, probably added in the mid 20th century as cars were replacing horse drawn vehicles and the hotel offered garaging. The first floor has two inserted window openings, probably enlargements of earlier windows with modern timber casement windows. The brickwork is 9 ½ x 2 ¼ x 4 inch handmade bricks laid in an English Garden Wall Bond (one course of header bricks to four courses of stretcher bricks). There are two probable bridging beams visible in the external walls as well as repaired brickwork suggesting the location of other removed bridging beams.

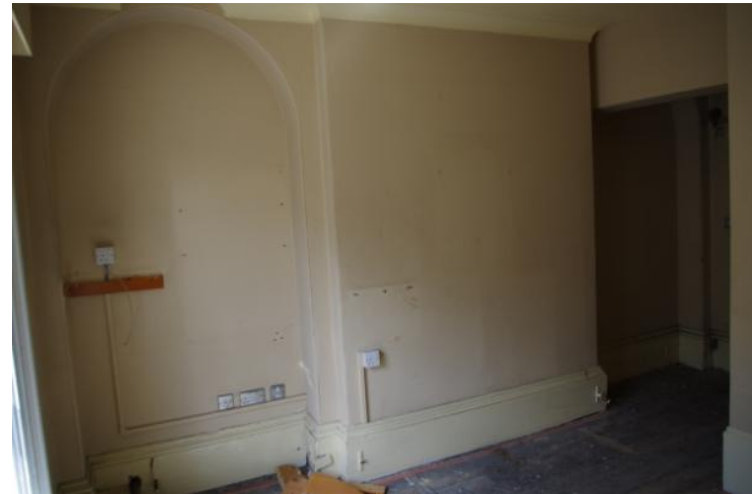
**Figure 21**  
Higher Status Room, First Floor East.

The frontage rooms appear to be the main residential rooms and were originally finished to a high standard with arched alcoves, deep skirting boards (*Figure 21*) and large fireplaces (now blocked). The broomhandle beading on the chimney breast indicates the finish is original. The frontage windows are recessed eight over eight sash windows. Interestingly, there is no evidence of a fire in the westernmost frontage room, although there is an adjacent chimney in the west wall. Immediately to the north there is another room, the southern and eastern walls are modern studwork indicating this room has been re-modelled in order to accommodate the corridor to the more recent rear wing. The room does however contain a chimney breast indicating there was originally a domestic room here.

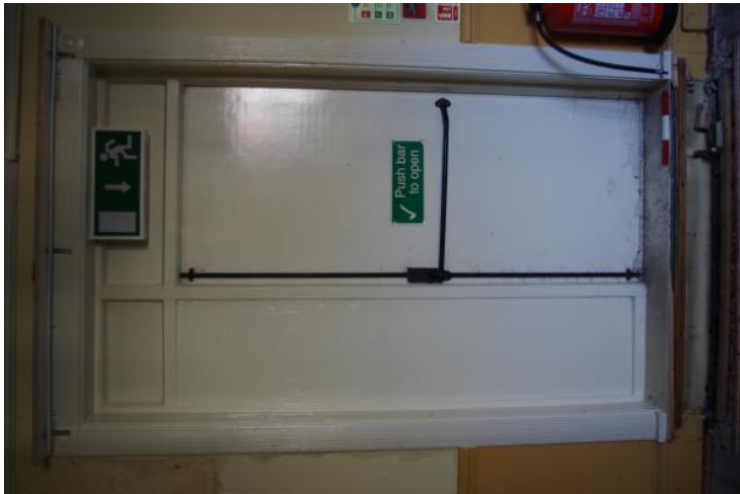
**Figure 24**  
Early 19th Century Door Case.

Potentially early 19th century features include the door on the south wall (currently the modern fire escape). The door case is wide with corner squares of concentric rings (*Figure 24*); such a design was common in the early 19th century and was frequently used in entrance halls of first floor landings (Hall). There are also two eight over eight sash windows (one on the north wall & the second on the west gable), both of which have the same moulded surround and corner squares the eastern window case has retained the plain square block at its base (*Figures 25 & 26*). An external examination of both windows reveal that both have flush sash boxes (*Figure 28*), although not accurate flush sash boxes are normally considered to be early 19th century, this along with the apparently early 19th century window case suggests a tentative date for both the windows and the bay as a whole.

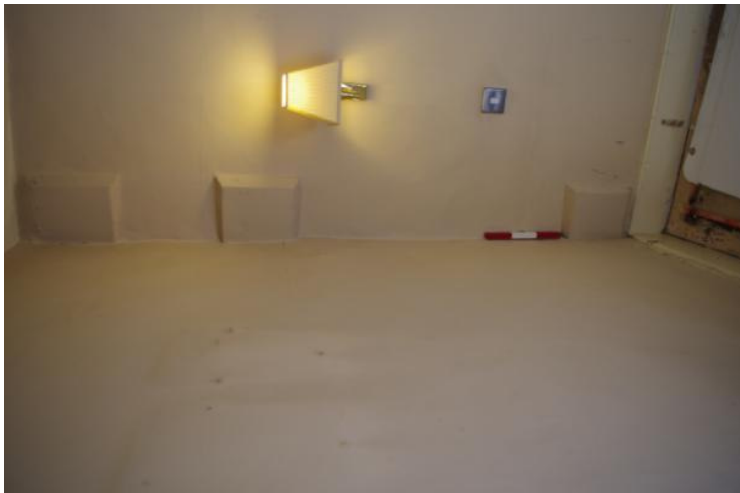
**Figure 30**  
C1 Exposed Quoins in South Westernmost Room, Second Floor.

There are two underdrawn beams visible in the westernmost frontage room, it is likely that at least one of which is a tie beam for a roof truss, being only 1350mm apart, it would be unlikely that both are tie beams. The floors are gypsum, no doubt reflecting the lower status of these second floor rooms. The frontage windows are recessed six over six sash windows, the thickness of the glazing bars suggests a mid 19th century date; the windows were probably added when the hotel was, according to cartographic sources enlarged in the mid 19th century. Further evidence of which could be seen with the exposed quoins in the south

west corner (*Figure 30*). The quoins were originally external features of number 10 High Street, the presence of the quoins inside the George indicates the second floor was most likely a later edition after number 10 was built.

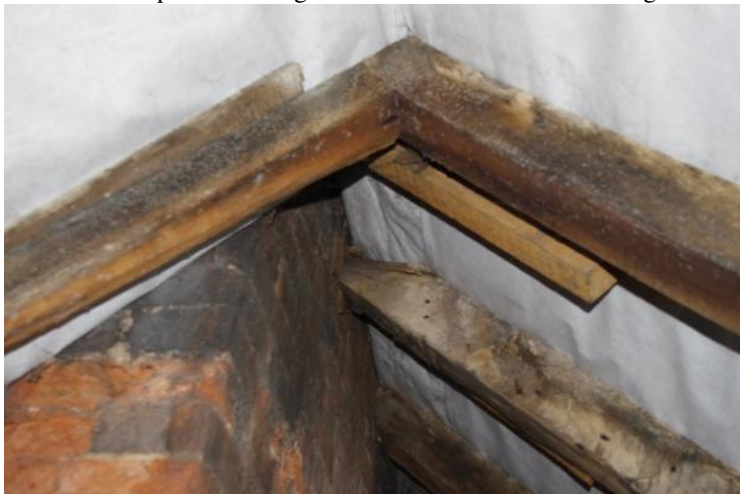
**Figure 34**  
C2 Coupled Rafters.

There was only limited access to the attic space available, the roof appeared to be a simple construction of coupled rafters (*Figures 33 & 34*). The uniformity of the rafters suggests the roof is a more recent element of the building, probably mid 19th century in date.

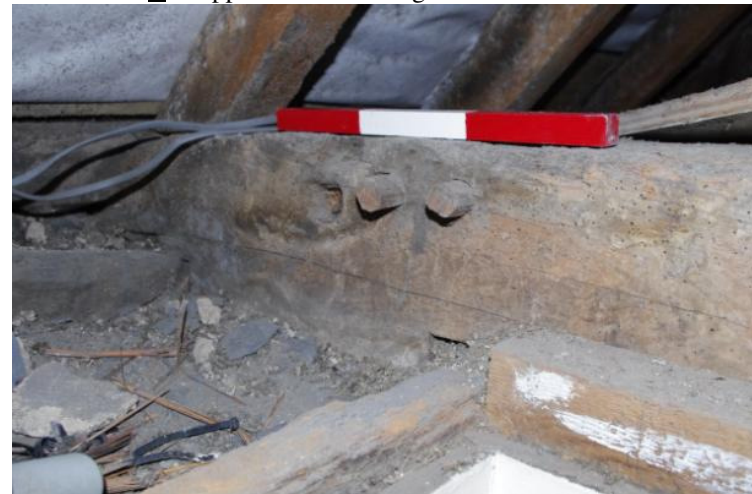
**Figure 35**  
C2 Original Tie Beam Showing Empty Mortise.

Again there was limited access to the attic space. The roof was again uniform coupled rafters. There was however a single earlier tie beam still *in-situ*, the empty mortise for a principal rafter (*Figure 35*) confirms this was originally a tie pie for a truss, and most likely part of the original roof structure.
