**An Archaeological Standing Building Survey.
14 Dean Street,
Brewood
Staffordshire.**

**Planning Permission No
14/00257/LBC**

ABRS Project No 2015-DSBS

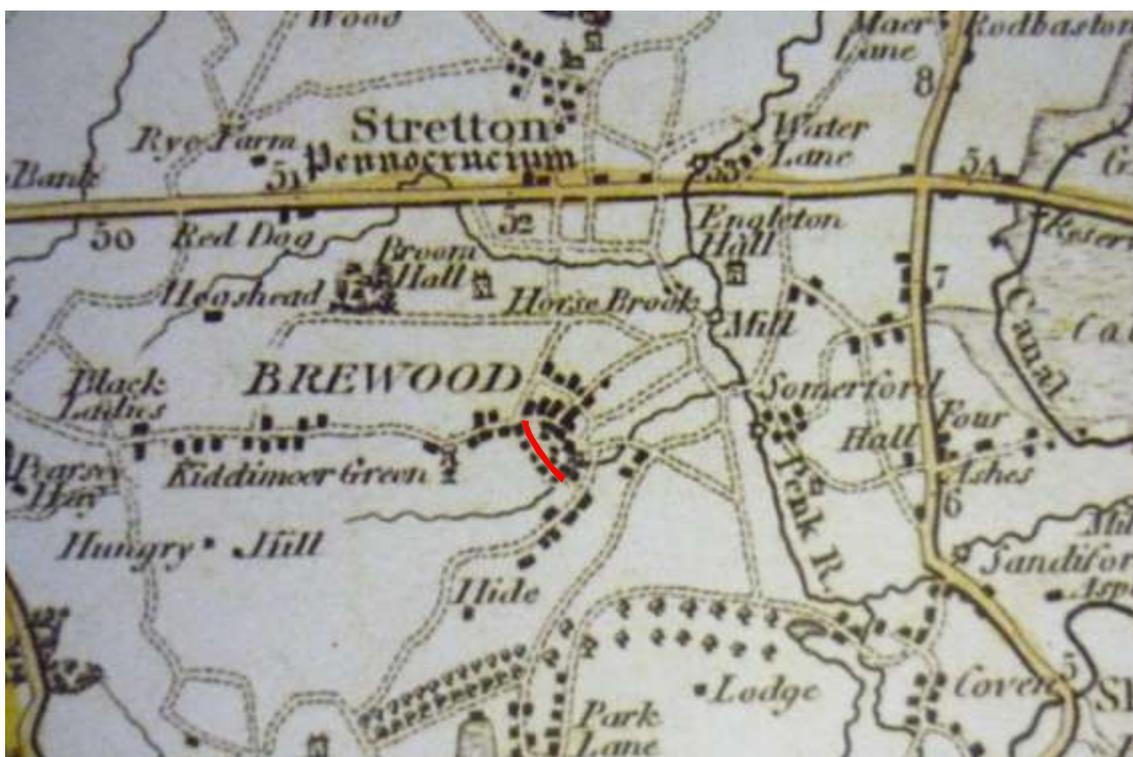
Figure 2

William Yates's County Map of Staffordshire (1798)
Probable Alignment of Dean Street in Red.

Staffordshire was well documented by early cartographers, both Kips (1607-10) and John Speed (again 1610) record Brewood, but in no significant detail, only the town's location and the presence of the church are recorded. Yates's county map of 1798 (*Figure 2*) is the first to record the town in detail and the probable alignment of Dean Street or a predecessor.

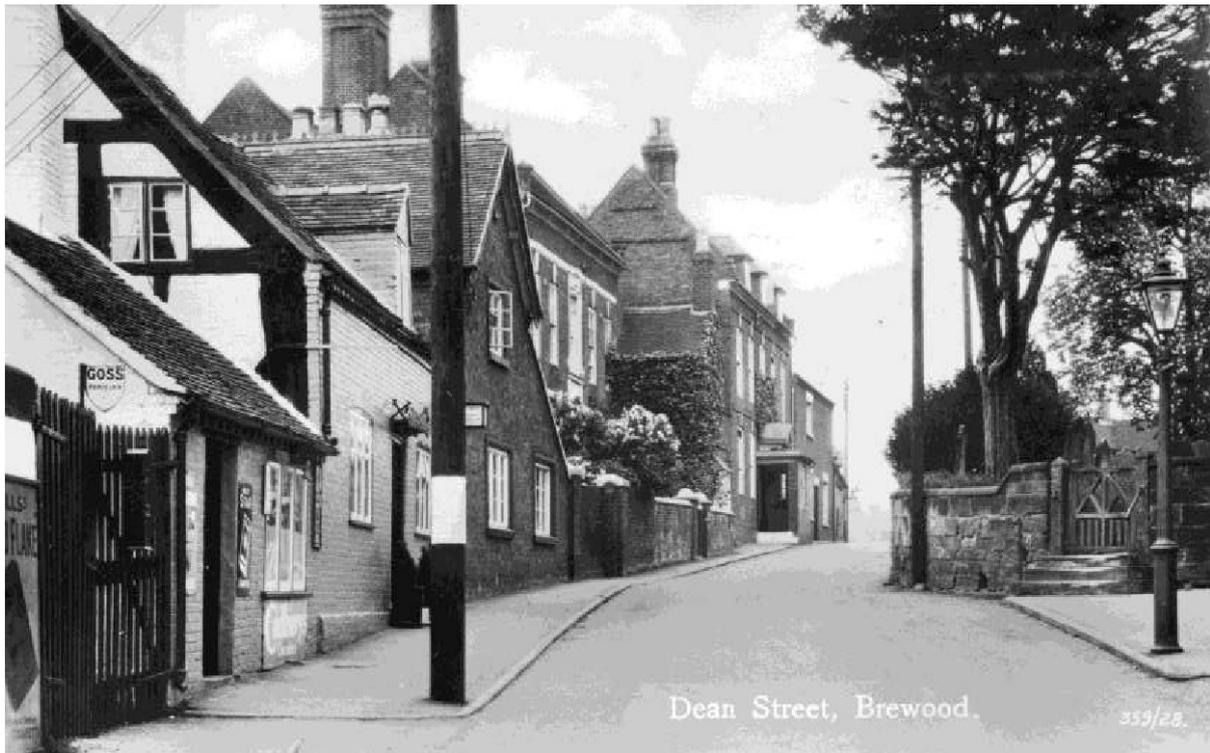
Figure 6

Mid 20th Century Photograph of Dean Street, 14 Dean Street to Left.

The photograph is likely to be mid 20th century in date and shows the building in some detail; the gable timber frame is visible as is the brick frontage. The south easternmost single storey extension can also be seen. Unlike the current layout, there is a door on the Dean Street frontage as well as a single window, it is likely, therefore than significant re-building of the extension has occurred since the photograph was taken.

A moulded stone, most likely a rose or leaf motif was also recovered from the principal elevation (*Figure 9*). There is no evidence of the stone apparent in *Figure 6*, so it is likely that the stone was inserted during the later 1950-60s re-building of this elevation. It is possible that the stone is a relic of the site's past as a stone yard.

Following the removal of the roof tiles and felt the rafters were exposed, the front slope was made up of two sets of rafters, the shallower rafters being the later reflecting the change in roof line seen in historic photographs (*Figure 6*). The rafters themselves were mixed and showed evidence of re-use. A closer examination of the rafters revealed at least two separate styles of incised Roman numeral carpenters marks (*Figure 19*). This clear stylistic difference would suggest that the rafters have come either from two separate sources or from two

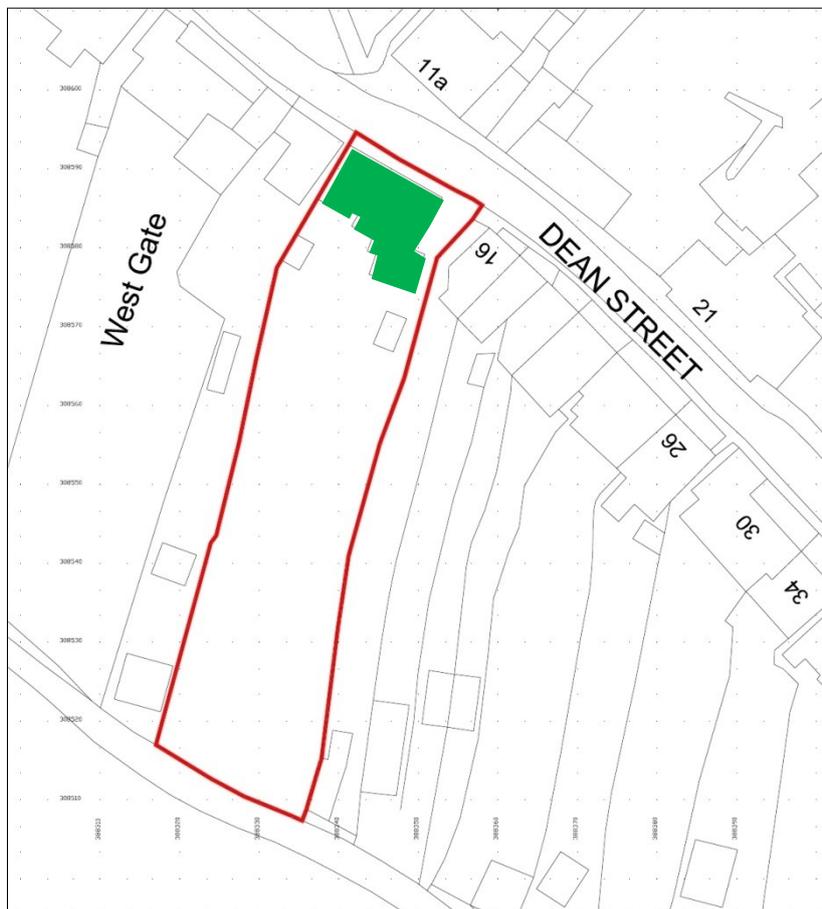
Figure 7
Plan of the proposed development area & Recorded Building in Green.
(Provided by client. Not to Scale).

Orientation: The building subject to this historic building recording is approximately “L” shape in plan, the long axis is orientated north west – south east and the short axis is orientated north east – south west (*Figures 7 & 22*), the principal elevation is that facing Dean Street to the north east. Where the terms ‘left’, ‘right’, ‘front’ and ‘back’ etc are used in the report, this is in relation to this principal elevation as viewed from the north east. For the purposes of this historic building recording a letter prefix is added for significant partitions where required.

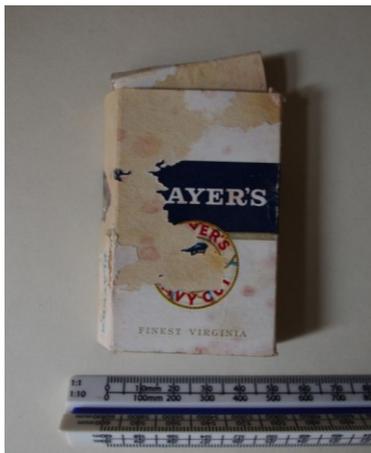
Figure 8

Cigarette Packet Recovered from Cavity on Principal Elevation, c. 1950-60s.

The single storey frontage bay consisted of a single room open to the roof level with access to the historic bay via an inserted door and stair, the floor being approximately 500mm lower. The roof was carried on purlins, extensive paint coverage concealed any detail and again modern decor concealed any historical features. Demolition of this bay was monitored and two cigarette packets dating to the 1950s or '60s recovered from within the cavity of the principal elevation (*Figure 8*). The packets, along with the straight joint visible on the south east gable (*Figure 12*) confirmed that the principal elevation was re-built in the latter half of the 20th century.

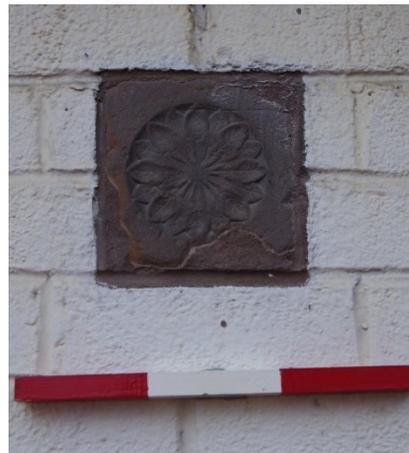
Figure 9

Moulded Stone on Principal Elevation, Unknown Date.

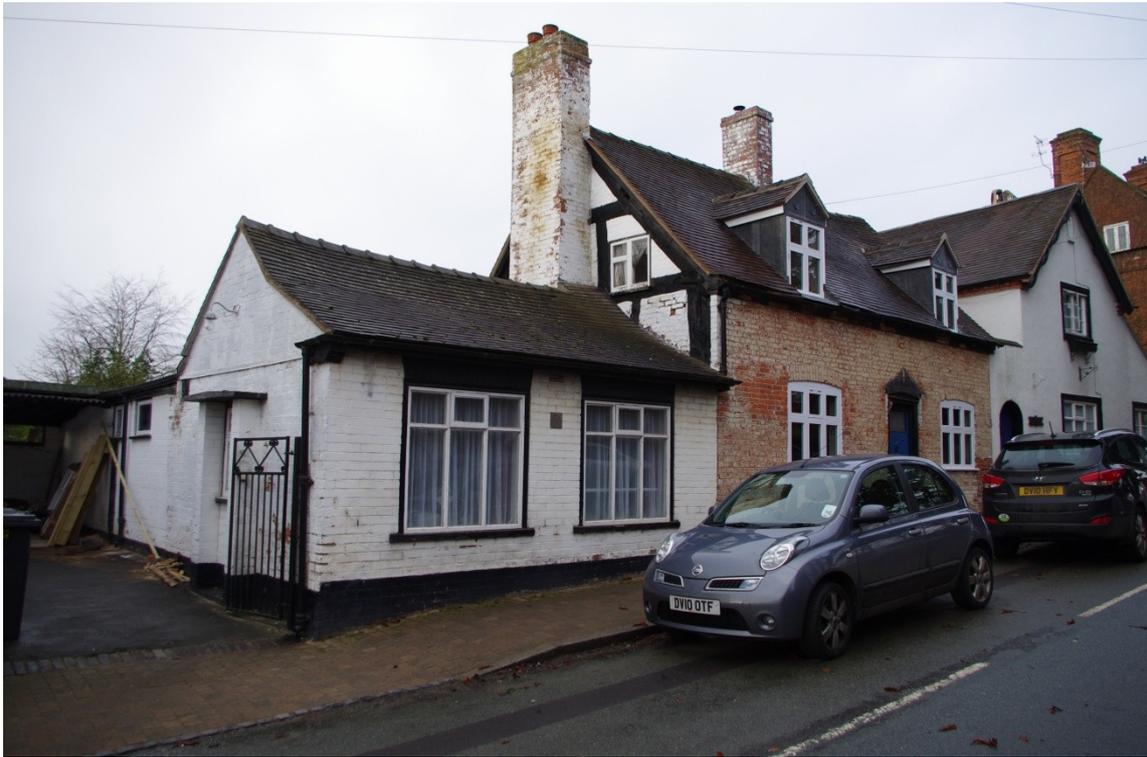
Figure 10
Principal Elevation (looking West - North West).

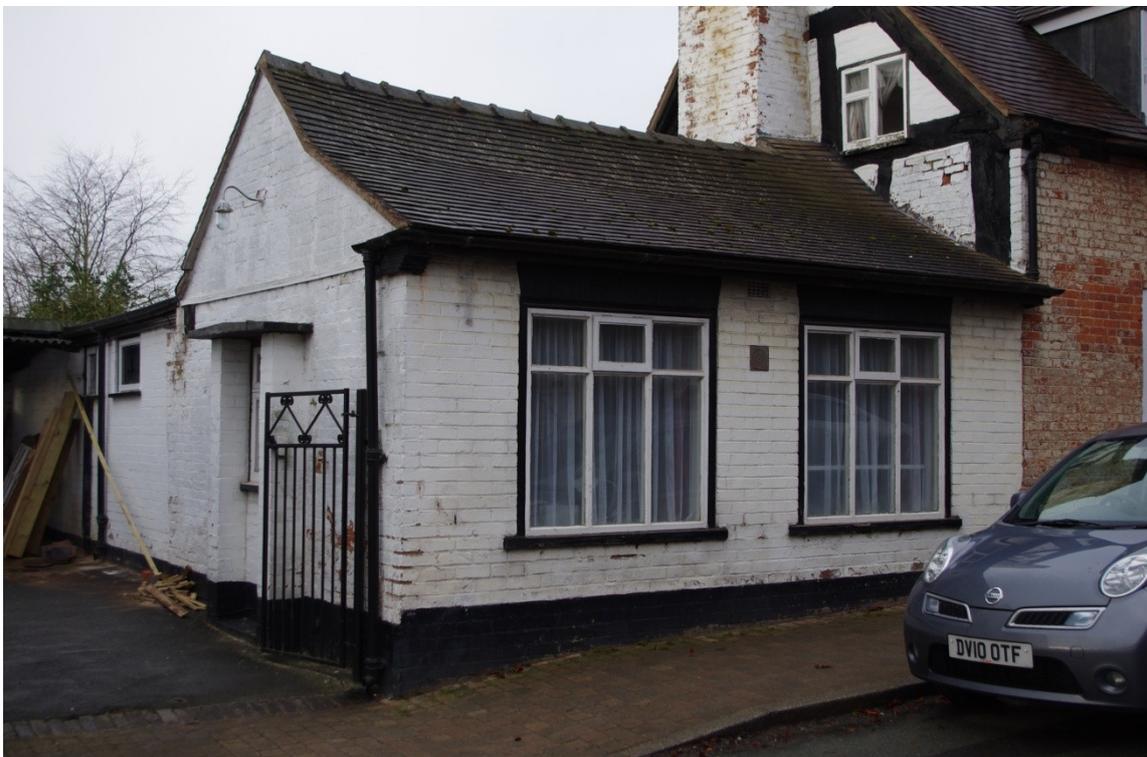
Figure 11
Principal Elevation of 19th Century Extension (looking West - South South).

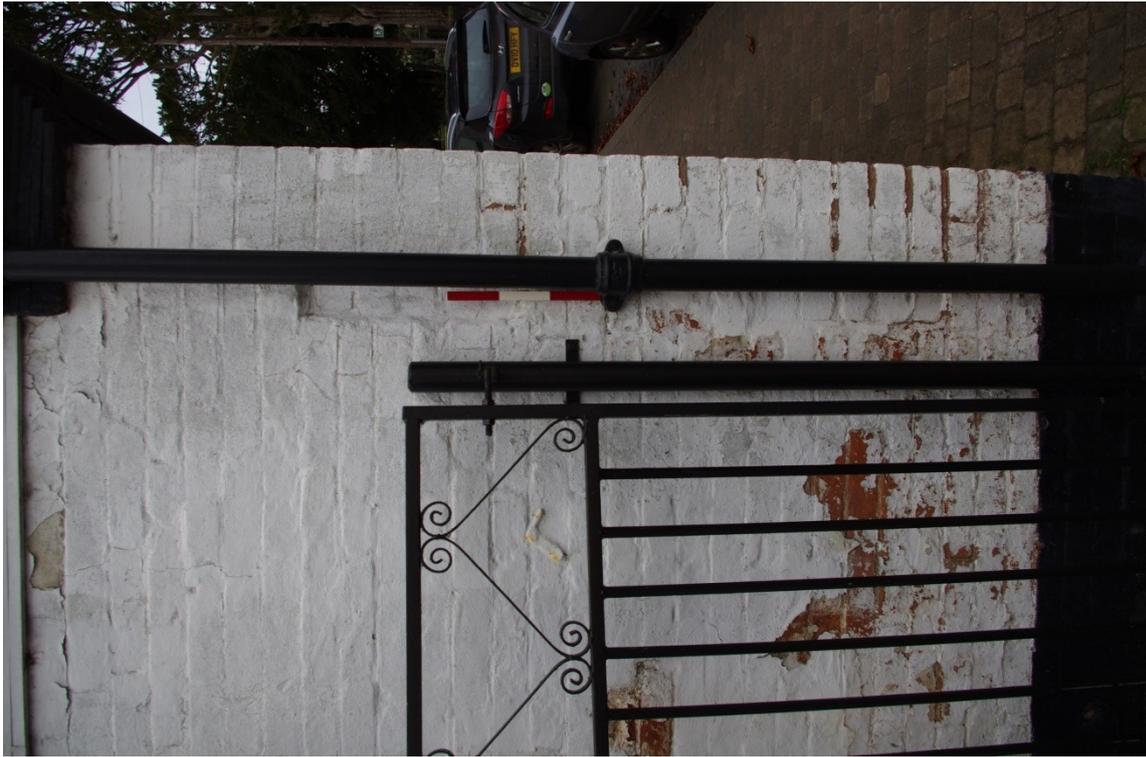
Figure 12 Straight Joint Visible in Brickwork at South East Corner Showing Evidence of Re-building.

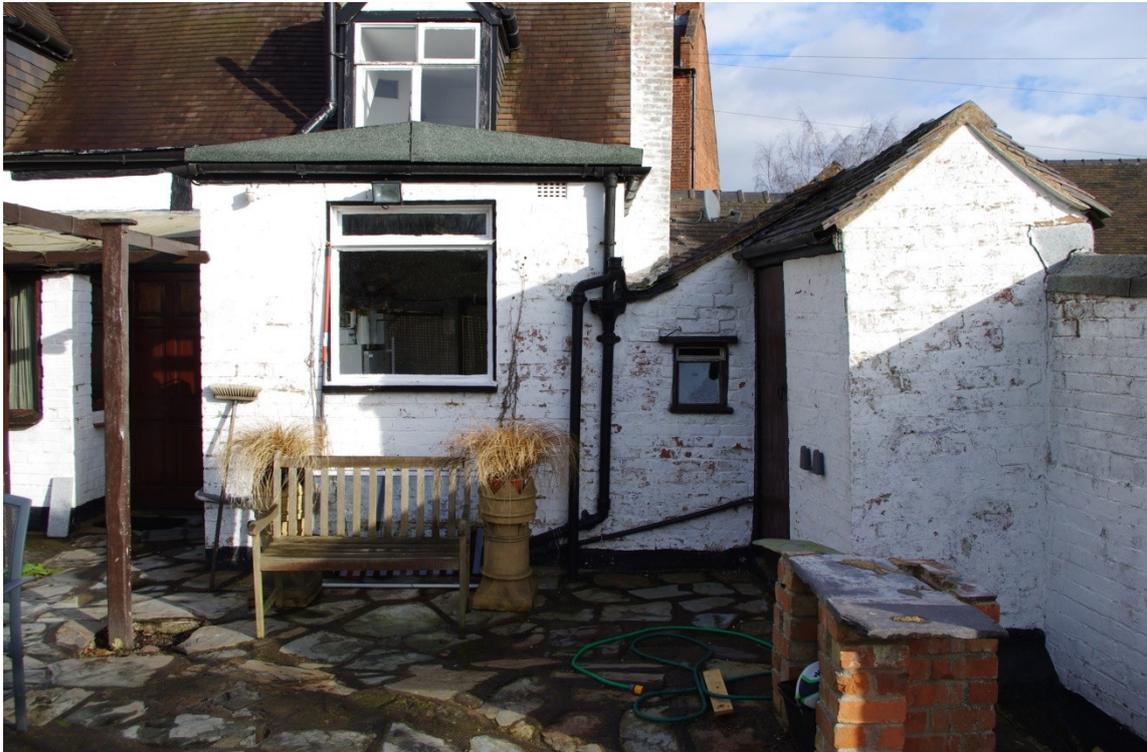
The later extensions, approved for demolition were recorded by photographic survey and demolition of the south easternmost extension was monitored. The extensive modern decor meant that establishing a chronology was extremely difficult. The majority of the exposed brickwork was late 19th century in date. The quality of the brickwork as well as visible straight joints would seem to suggest that C may be the earliest element of the extensions (*Figure 13*).

Figure 13
Rear Elevation Showing C (Right of Centre with Small Window), Potentially the Earliest Extension.

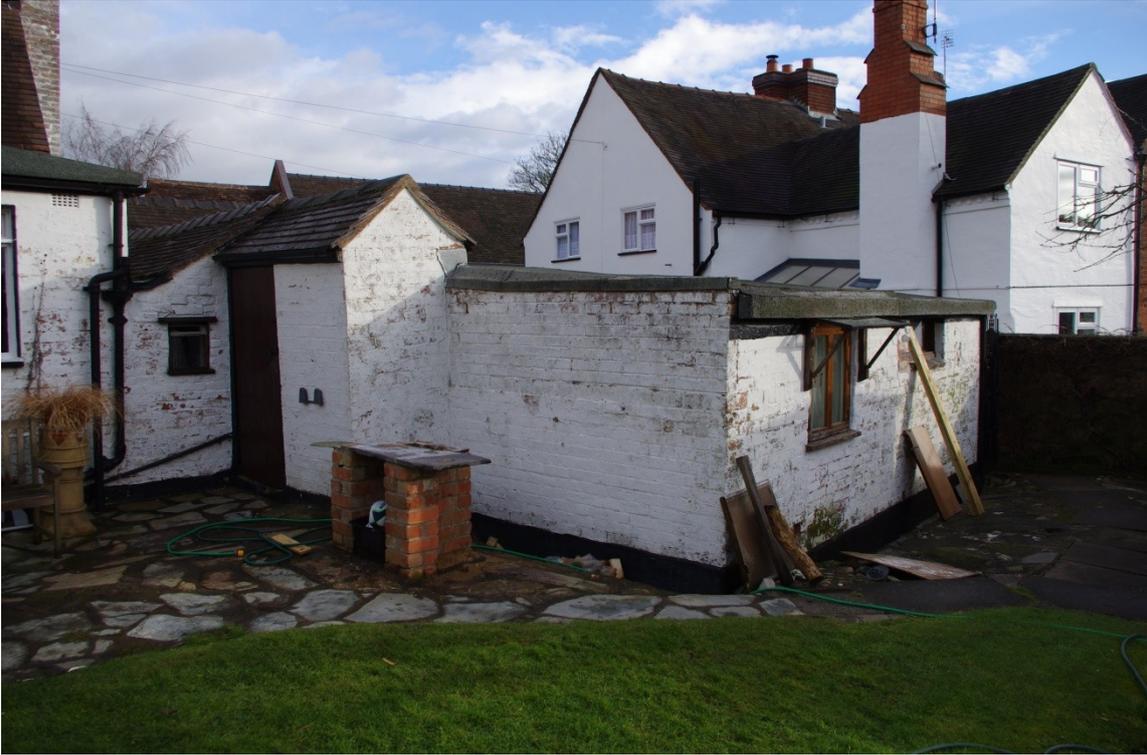
Figure 14
Rear Elevation, Most Recent Extensions, General View (looking East).

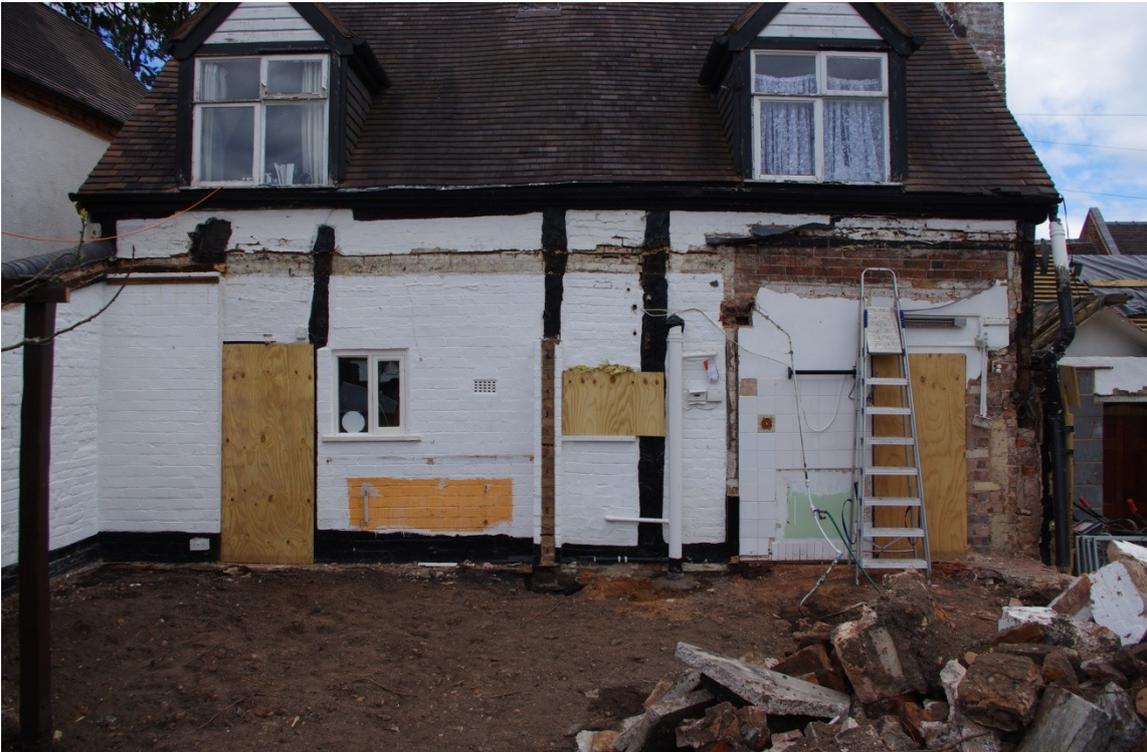
The two complete studs, as well as the partial studs (*Figures 15 & 22*) are interesting, as they appear to be the remains of a close stud timber frame. Close studding became fashionable in the early 15th century, becoming the most desirable and expensive building style from the 16th century onwards. Although fragmentary, the studs revealed on the rear elevation suggest the building was originally close studded, the studs then being lost during successive phases of re-building as indicated by the cartographic sources. Close studding fell out of favour in the late 16th century as a result of both the change in styles and tastes and a shortage of suitable building oak. It is possible; therefore that the close studs give tentative support to the listing date. Further evidence of the 16th century date are the exposed joists at the southern end of the elevation. The dimensions of the joists, the width being slightly greater than the depth, suggests an earlier 16th century date rather than late, as from the late 16th century it became more common for joists to be laid on edge.

Figure 15
Rear Elevation Following Demolition Showing Close Studding.

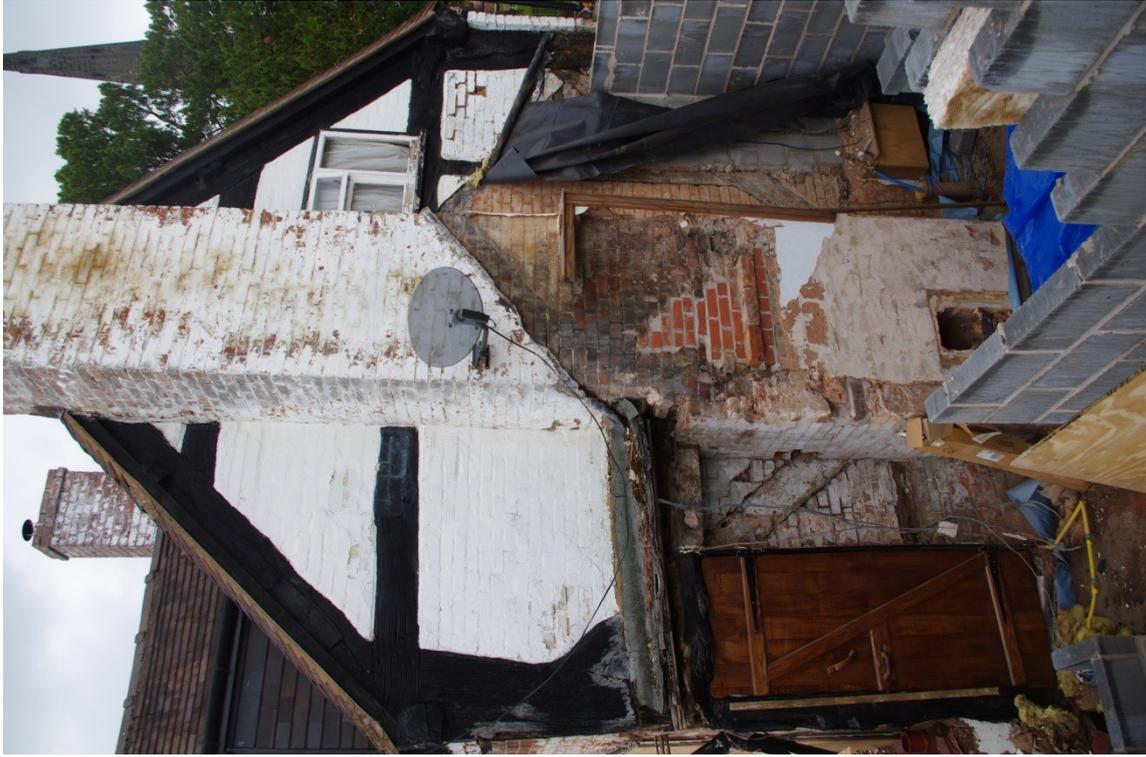
The demolition of the south easternmost extensions revealed the timber frame of the south easternmost gable (*Figures 16 & 24*). Unfortunately, a very large, late 19th century brick-built chimney, along with two inserted doorways have had a significant impact upon the gable frame, leaving little of diagnostic value. The gable frame consists of two corner posts, both badly degraded, what is possibly an early or original sill, a tie beam, a collar beam and two down braces, one of which is slightly concave (*Figures 17 & 18*). There is also a single stud, although this is likely to be later.

Figure 16 South East Facing Gable Following Demolition (looking North West).

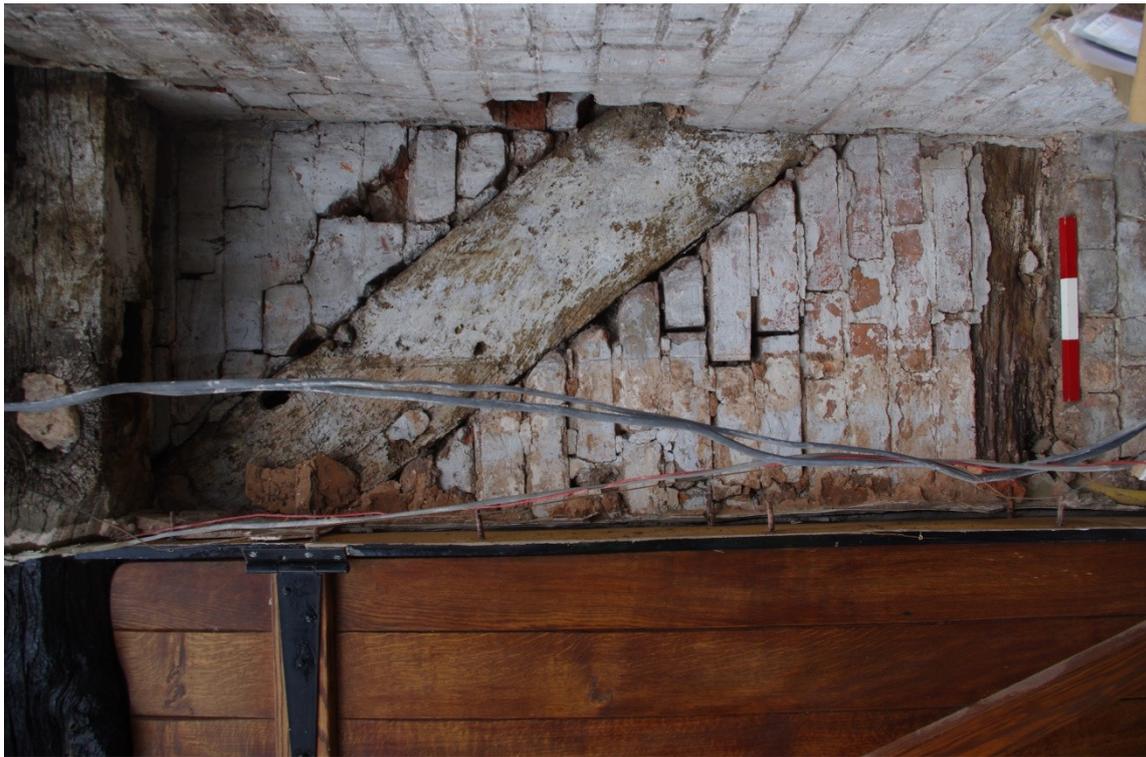
Figure 17 Rearmost Down Brace on South East Facing Gable.

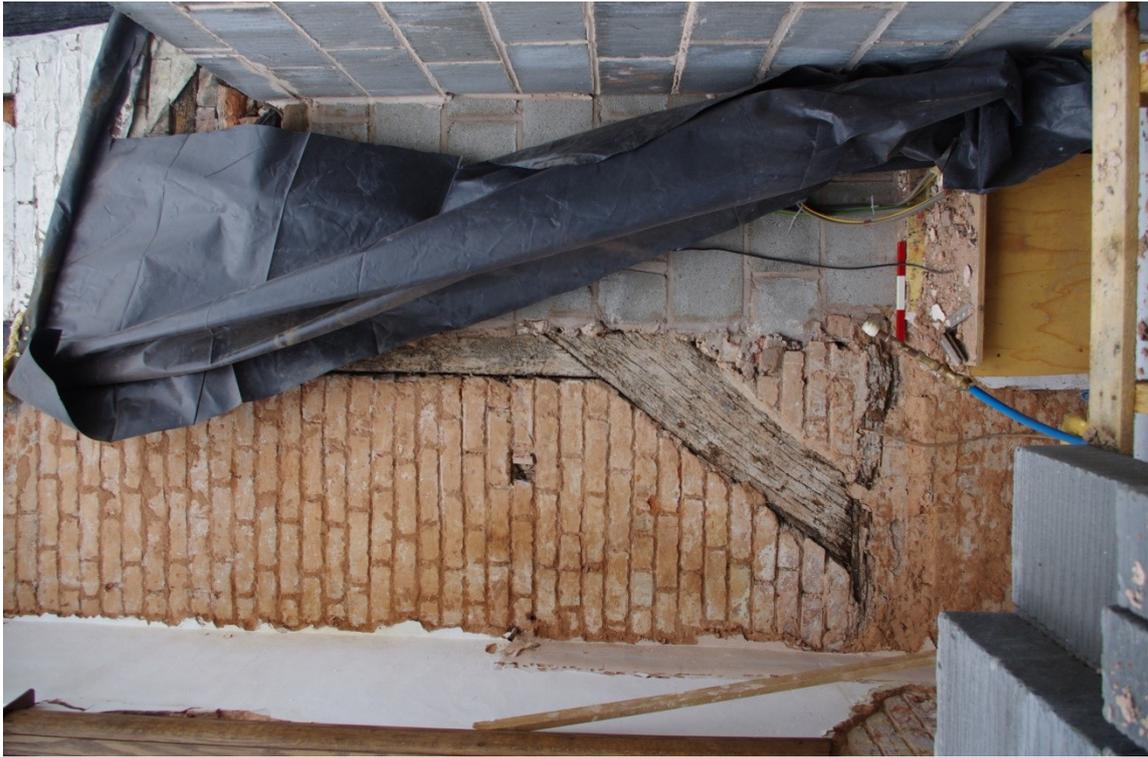
Figure 18 Front Down Brace on South East Facing Gable.

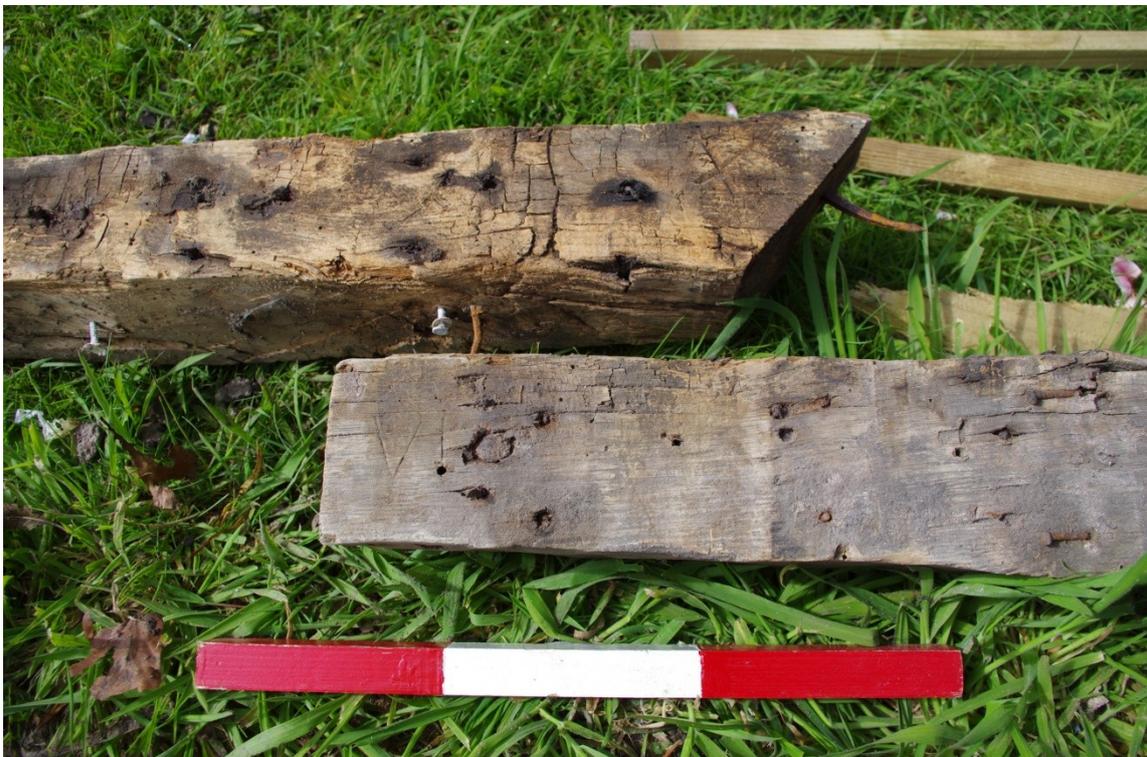
Figure 19
Inscribed Carpenters Marks Showing Different Styles on Rafters Recovered from 19th Century Extension.

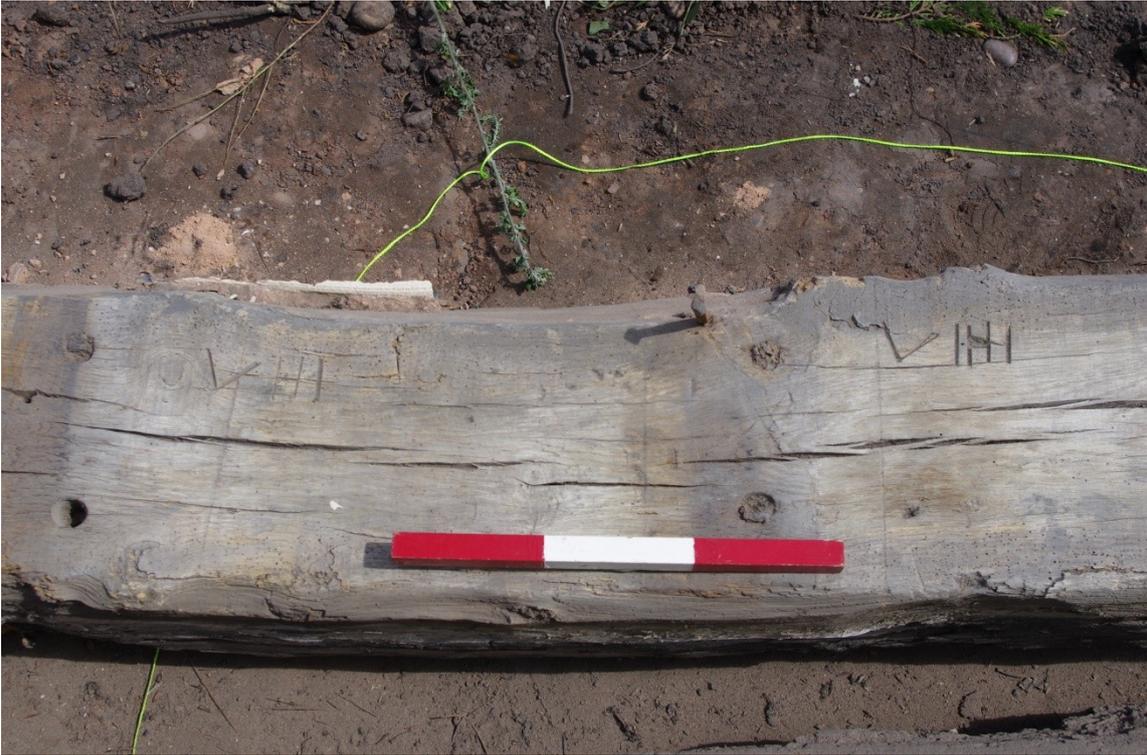
Figure 20

The upper faces of the purlins were also examined and recorded following removal. The frontage purlin contained an extensive series of inscribed carpenters marks (*Figure 20*). The location of the marks, adjacent to open peg holes suggests the purlin was originally a bridging beam. The numbers 3 to 12 in Roman numerals are inscribed on the beam, suggesting it may have originated from a large building. Interestingly the ghost outlines of the joists visible on the beam do not align with the open peg holes, suggesting the beam has been re-used on at least two occasions before being its current use as a purlin.

Inscribed Carpenters Marks, Peg Holes and Ghost Joists on Purlin Recovered from 19th Century Extension.

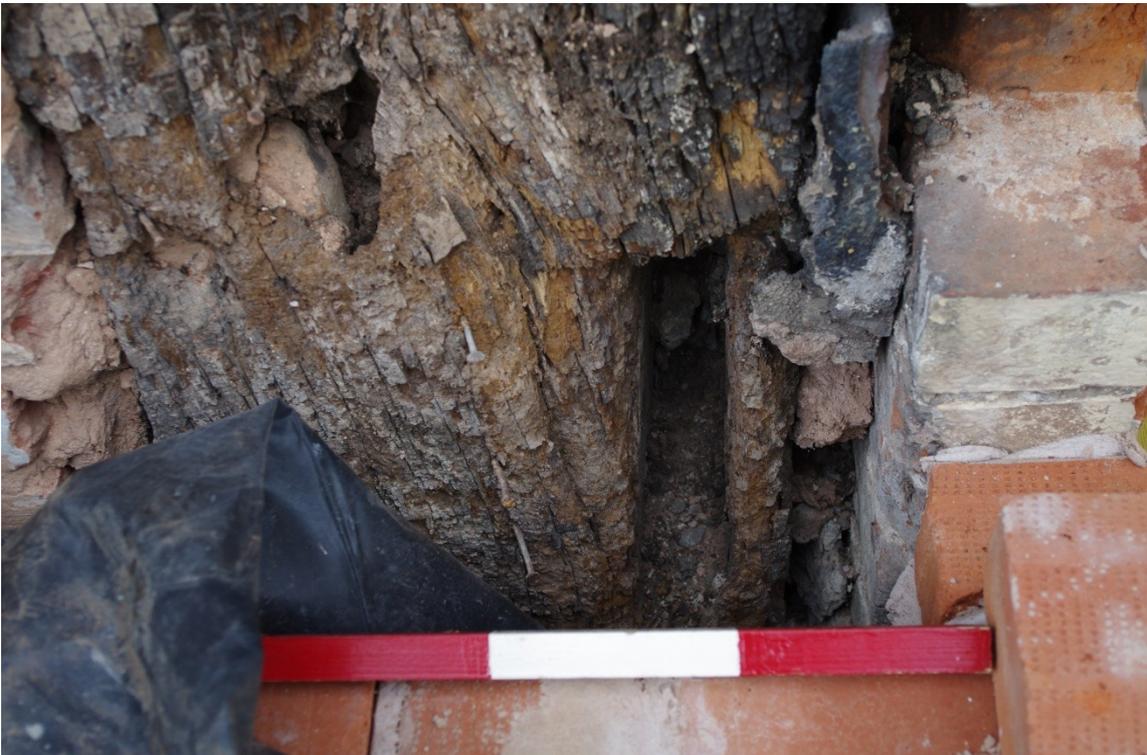
Figure 21

Both of the corner posts are jowled and the south easternmost post has an open mortice (*Figure 21*), suggesting there may have been further framing attached here, there was no evidence of motices on the other corner post.

Open Mortice on South Easternmost Corner Post.

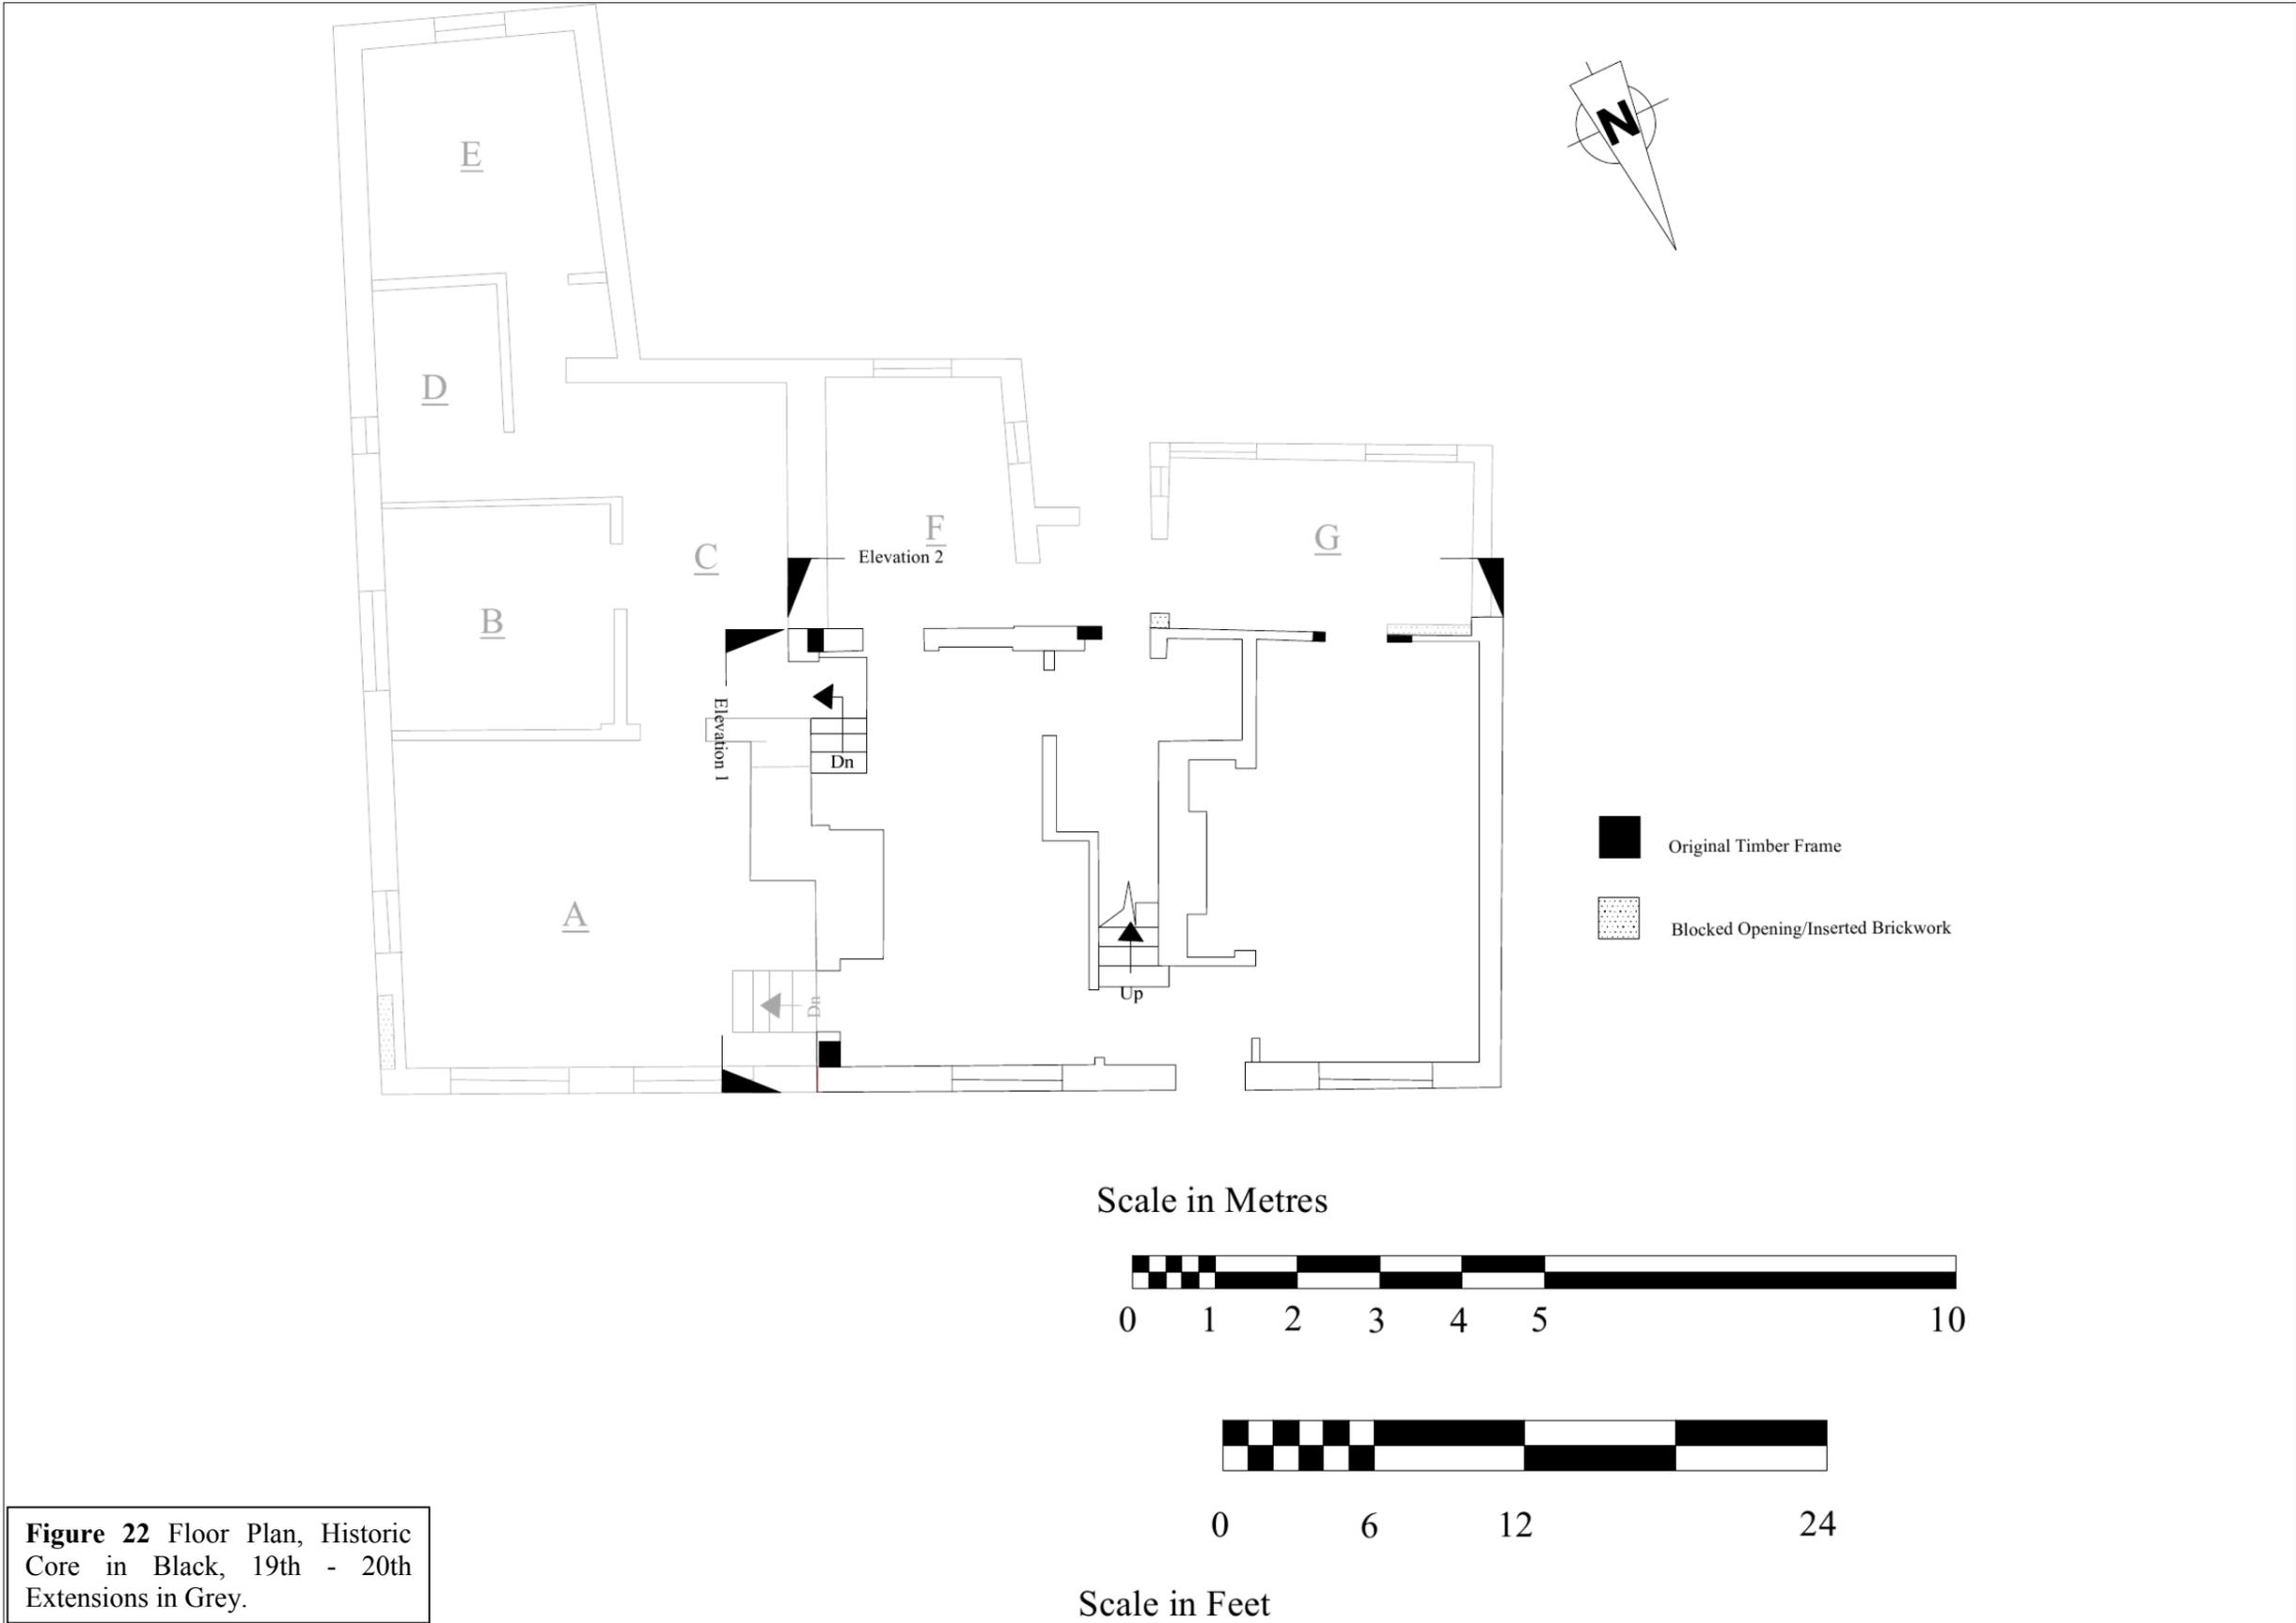
The historic core of the building was only recorded externally as part of this historic building recording, concentrating on those areas exposed by the demolition of the later extensions. The historic building is largely brick-built with limited remains of timber framing, most notably on the south east facing elevation. The principal elevation has a late 19th or early 20th century brick skin and will be un-affected by the proposed works. Demolition of the rear extensions exposed a number of sections of concealed timber framing (*Figures 15, 22 & 23*). The exposed sections consisted of two complete studs, a further three partial studs and a single rail. Part of the south easternmost corner post was also exposed. Three floor joists were also exposed sat atop the rail (*Figure 22*). The brick-nogging is mixed, but the brick dimensions indicate it is likely to be late in date.

Figure 22 Floor Plan, Historic Core in Black, 19th - 20th Extensions in Grey.
