**An Archaeological Standing Building Survey.
Erdeswick House
Sandon
Staffordshire.**

Erdeswick House

Coach House

August 2015

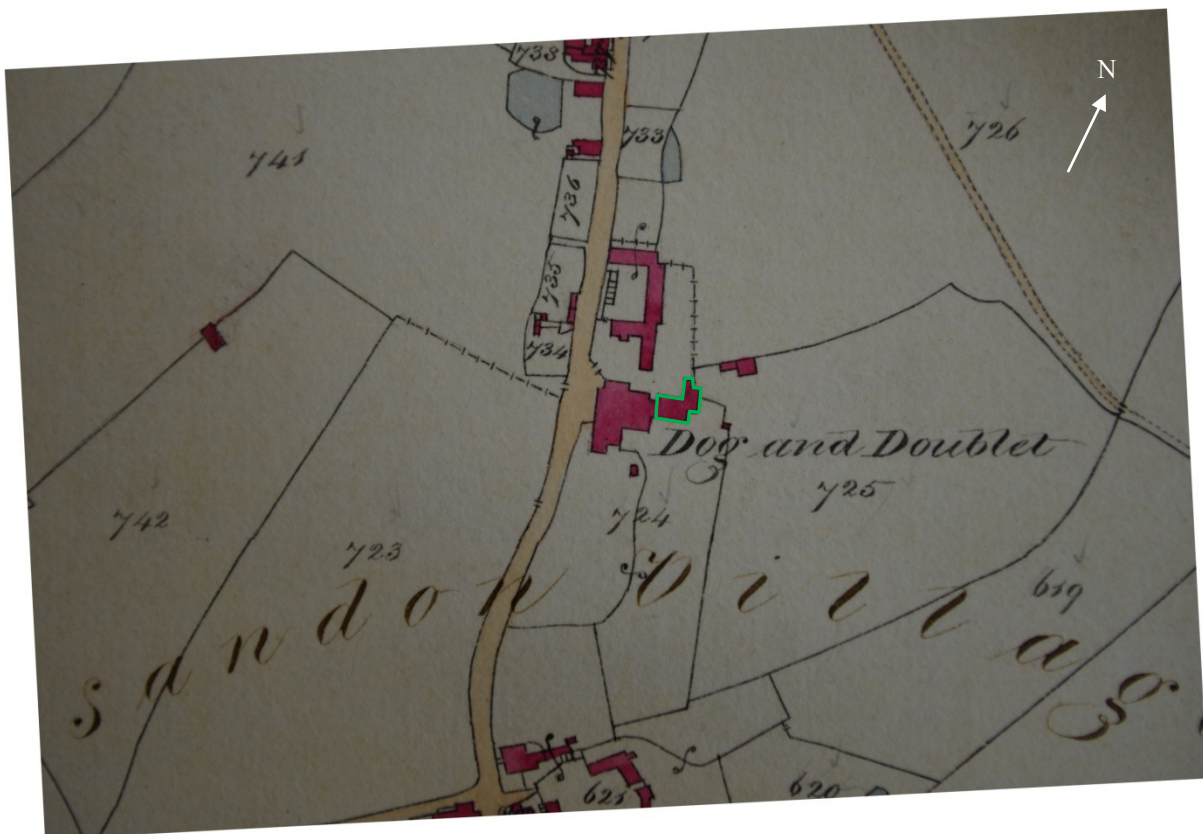
Figure 3
Sandon Tithe Map 1838.
(Lichfield Record Office Ref B/A/15)

The 1838 Tithe Map (LRO Ref B/A/15 (*Figure 3*)) records the village of Sandon in significant detail. The building is clearly identified as the Dog and Doublet and described in the attached apportionment as an "...inn with offices, coach houses, stables and yard farm buildings with fold yard and rick yard Bowling Green and pleasure ground and garden". The adjacent field, numbered as 724 is identified as "Dog Croft"; the name suggests it has some association with the inn. The Dog & Doublet is owned by the Earl of Harrowby and occupied by John Pritchard.

The tithe map records that the Dog & Doublet consists of a single building consisting of two principal ranges, one fronting the turnpike and a second perpendicular range, including the current coach house to the rear. The north – south aligned range of the coach house subject

to this historic building recording appears to differ in both plan form and location to the current range, extending further to the north and being apparently narrower. It is possible, therefore that this element is earlier and no longer surviving on site.

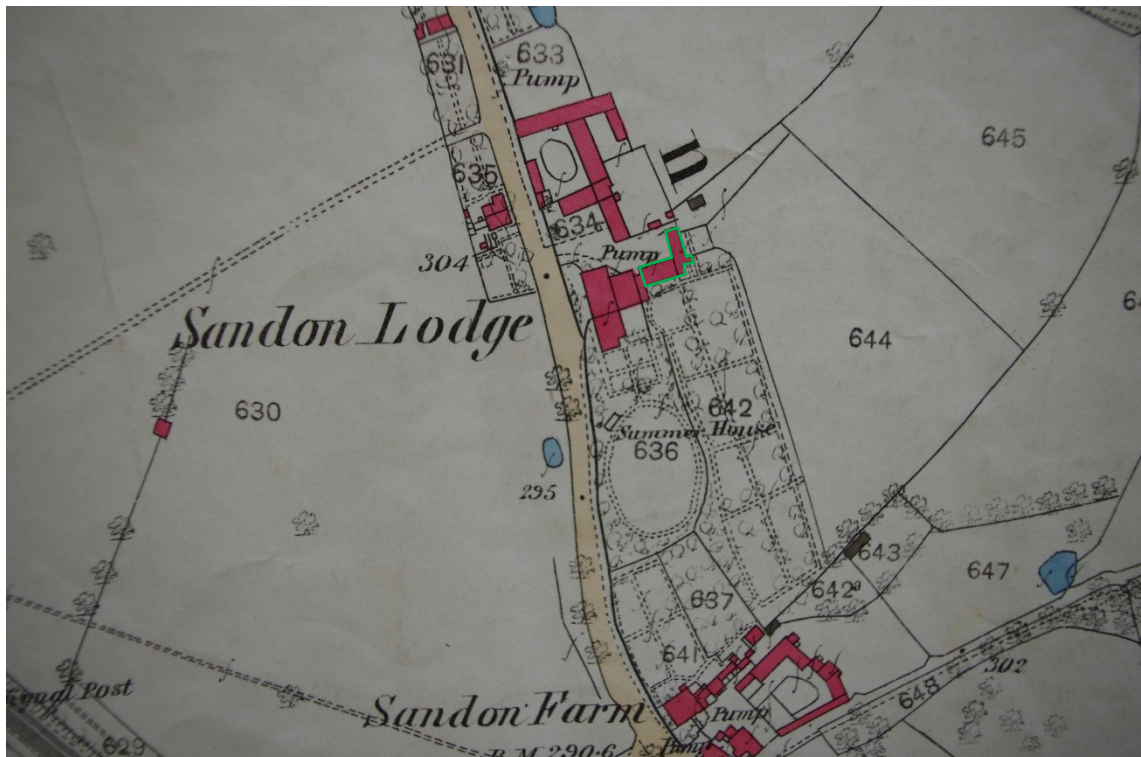
Figure 4
First Edition Ordnance Survey (1881)
Sheet XXX.12

At the time of the first edition Sandon Lodge had long since ceased to be a coaching inn and this is reflected in the extensive and elaborate formal gardens laid out to the south of the house, possibly a remnant of the time the house served as the Earls’ residence. The gardens suggest a house of some status following the Earl’s departure. Interestingly, there appears to be a property boundary between the southern and northern bays of the building, suggesting the two were separate at the time. The second edition Ordnance Survey was published in 1901, the building is identical in plan form. The gardens to the south are somewhat less grand, suggesting the house had lost some of its earlier status.

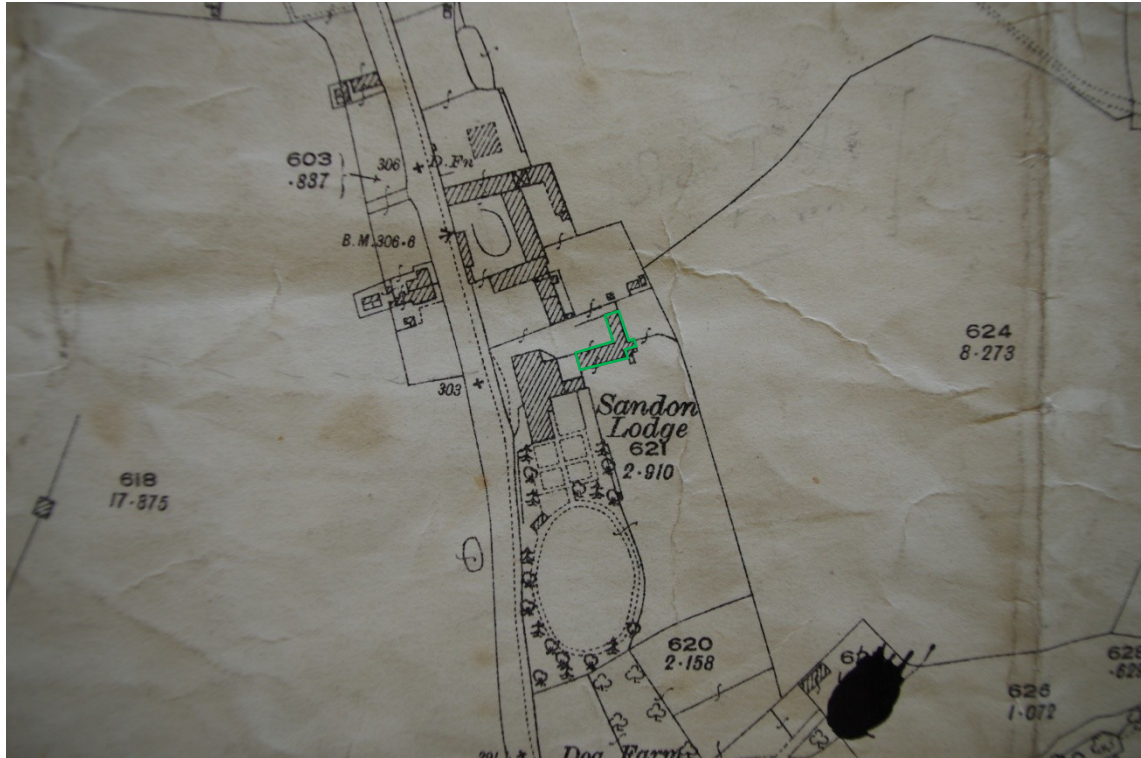
Figure 5
Third Edition Ordnance Survey (1924)
Sheet XXX.12

By the time the third edition Ordnance Survey was published in 1924 (SRO Ref XXX.12 (*Figure 5*)) Sandon Lodge and the coach house had undergone significant alteration. The coach house is now a free standing building with the bay joining it to the house having been

demolished sometime between 1901 and 1924. Unlike the previous editions, there appears to be a small outshoot on the south facing elevation of the easternmost bay, the outshot has the appearance of pigsty, which were common throughout the era. The formal gardens are still recorded to the south of the house and there appears to be a more established property boundary between Sandon Lodge and Stonebench Farm to the north.

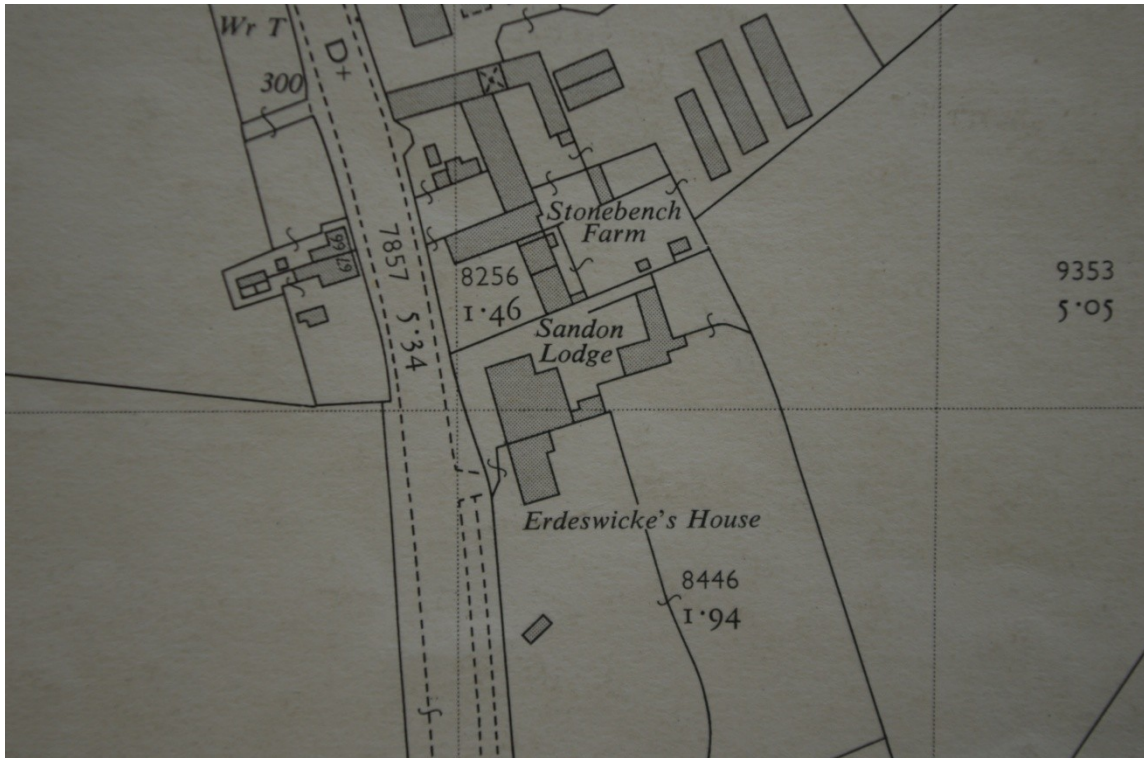
Figure 6
1960 Ordnance Survey
SJ 9429 & SJ 9529

By the 1960s Sandon Lodge and the coach house had again undergone alterations. The 1960 Ordnance Survey (SRO Ref SJ9429 & SJ9529 (*Figure 6*)) records the coach house as it currently stands. The east – west aligned bay has been further reduced in size as a result of further demolition at the western end and the small outshoot seen in Fig. 5 is also no longer recorded.

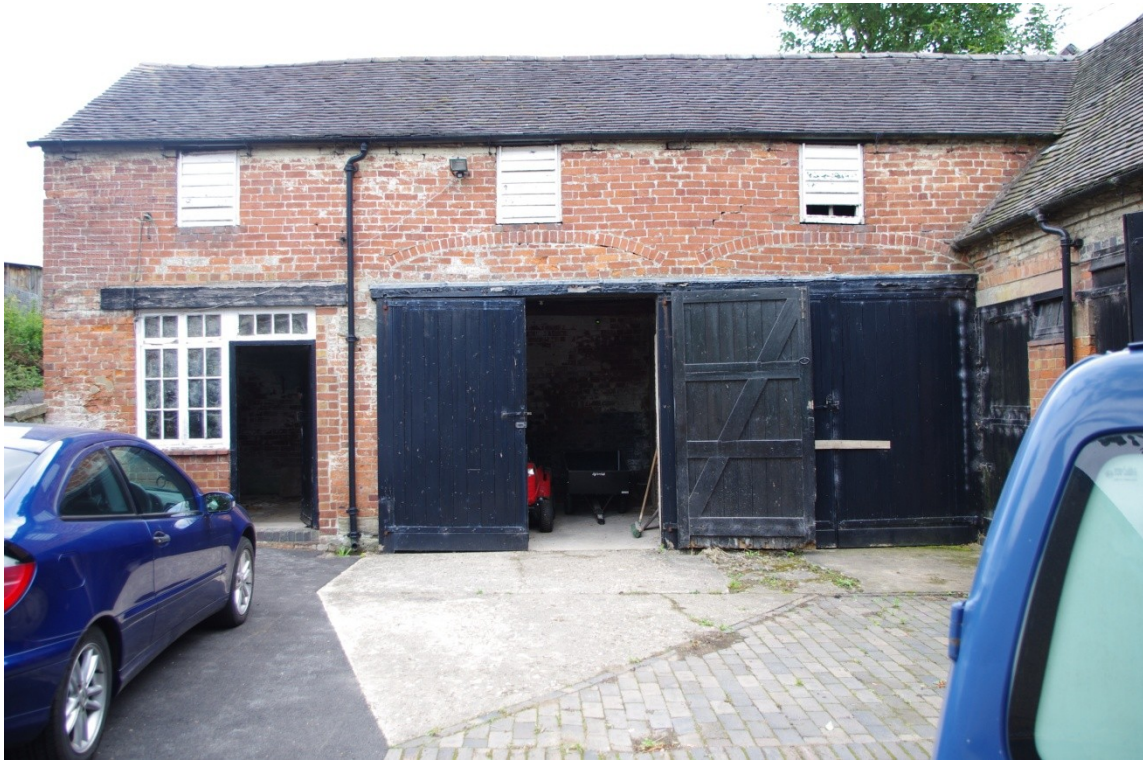
Figure 8
Principal Elevation A, B & C (looking West - North West).

Abutting the north easternmost corner of D is the second range, consisting of three bays, A, B, and C (*Figure 23*). The range is brick-built, the bricks themselves are 10 x 2 ½ x 5 inch handmade red bricks laid in no discernible bond. The dimensions suggest a pre 19th century date for the building. There are three partially blocked carriage arches on the principal elevation (*Figure 8*), the northernmost being nearly completely blocked with a pedestrian door and inserted window (*Figure 16*). The southernmost arch has been blocked internally in the modern era and the central arch is still open. Above each arch are louvered loft windows. There is a partially blocked loft door, now a window opening on the northern gable. The rear elevation appears to be constructed of more modern brick (brick dimensions 9 x 3 x 4 ½ inch). There is also a blocked opening visible externally on the rear wall of A. There is a loft door on the rear elevation of H which, as a result of the difference in ground level, is only some 500mm above the current ground level (*Figure 12*).

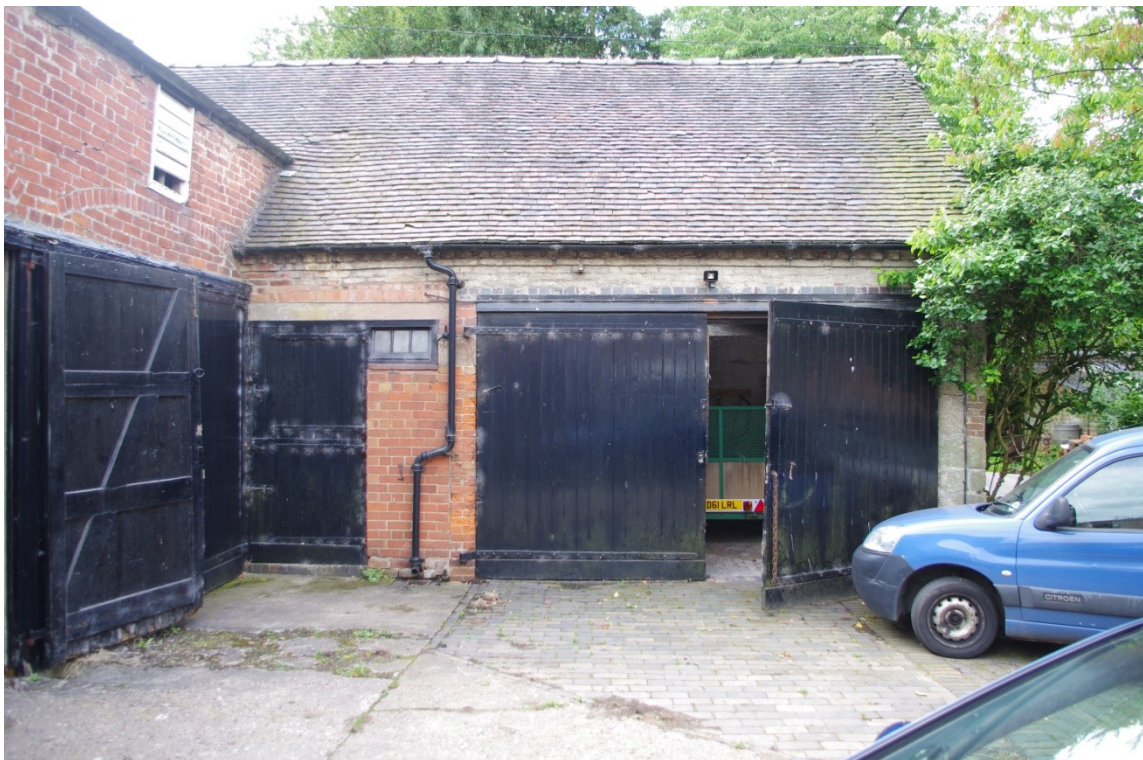
Figure 9
Principal Elevation D (looking South - South East).

The principal elevation, facing north is largely modern and consists of one large coach door and a smaller pedestrian door (*Figure 9*). The dimensions of the coach door suggests it may have been modified in order to accommodate a car and serve as a garage. The smaller pedestrian door shows clear evidence of in-fill (*Figures 9 & 23*), indicating it too was originally a large carriage door, further evidence of which is the pintle in C which confirms the original opening.

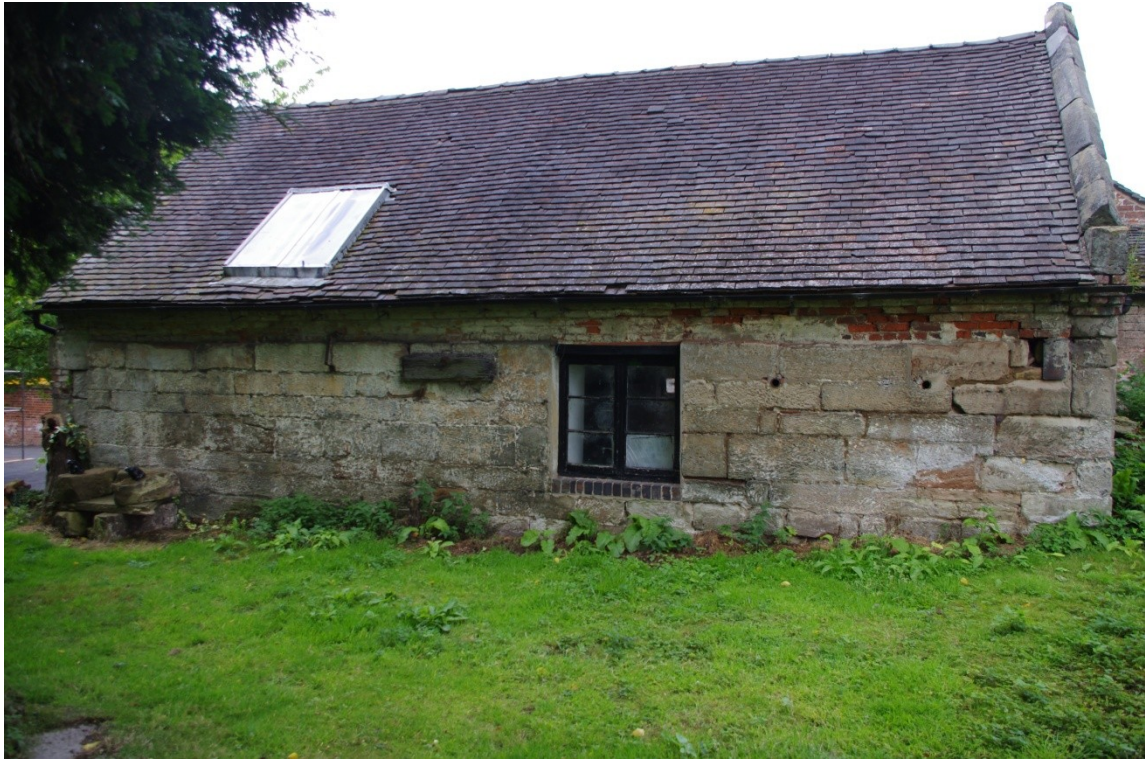
Figure 10
Rear Elevation D (looking North – North West).

Both the southern long elevation and eastern gable of D are built of local sandstone. The blocks are well finished, laid in courses, but not of ashlar quality and bedded in lime mortar. There are three courses of 9 x 2 ½ x 4 inch handmade red bricks immediately below the eaves on the long elevation (*Figure 10*), suggesting the roof level has been altered at some point. On the southern slope of the eastern gable there is a surviving coped abutment, the copingstones are moulded and well finished (*Figure 15*). The northern face is coped with blue bricks. Also on the eastern gable is a partially blocked doorway.

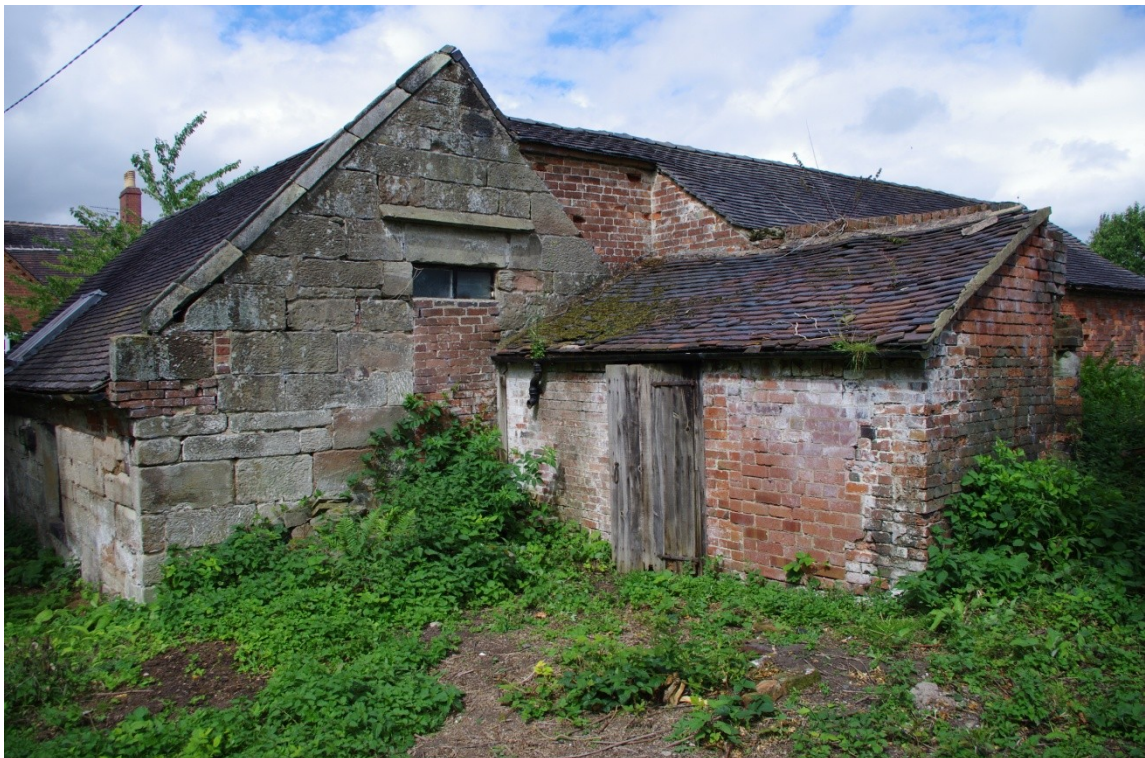
Figure 11
East Facing Gable D (left) and Principal Elevation E (looking West – North West).

The final, lesser range, E projects from the eastern gable of D. It is a single storey, brick-built lean to under a plain tile roof (*Figure 11*). There is a single door on the principal elevation and a window on the rear elevation as well as evidence of a second blocked opening

on the principal elevation. Internally there is a cross wall and door creating two un-equal bays and the roof is carried on a single purlin. It is likely that the range was originally a pigsty with the smaller bay serving as a privy, a common arrangement.

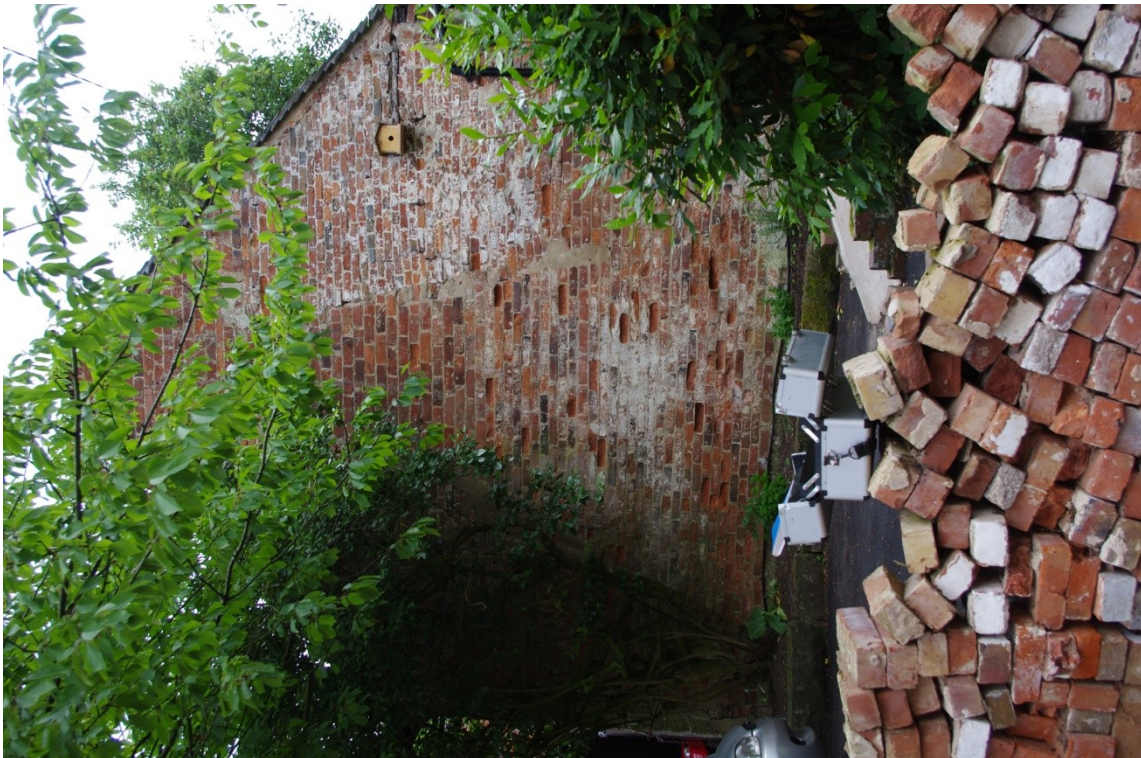
The westernmost gable presents a much more complicated elevation, hinting at the history of this part of the coach house as should on historic maps (*Figs. 3 & 4*). On the south westernmost corner a straight joint is visible in the stonework as well as quoins indicating the presence of a lost bay (*Figure 14*). The straight joint and quoins indicate the current bay (D) post dates the lost bay. The westernmost gable itself is brick-built, there are a number of different phases visible within the brickwork, including the outline of a substantial chimney (*Figure 13*). To the north is a flat arch, although there is no clear evidence for the opening below the arch.

Figure 13 Outline of In-Filled
Chimney in West Facing Gable of D.

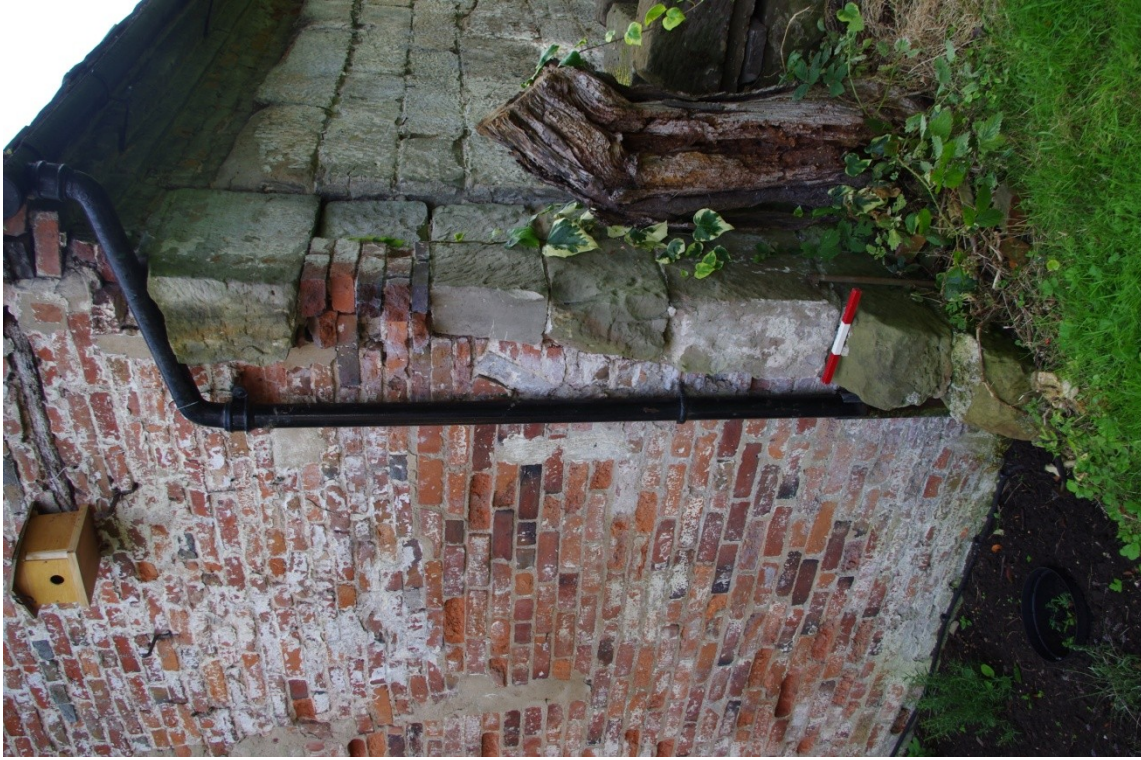
Figure 14 Quoins & Straight Joint Visible in West Facing Gable and South Facing Long Elevation of D Indicating Location of Demolished Bay.

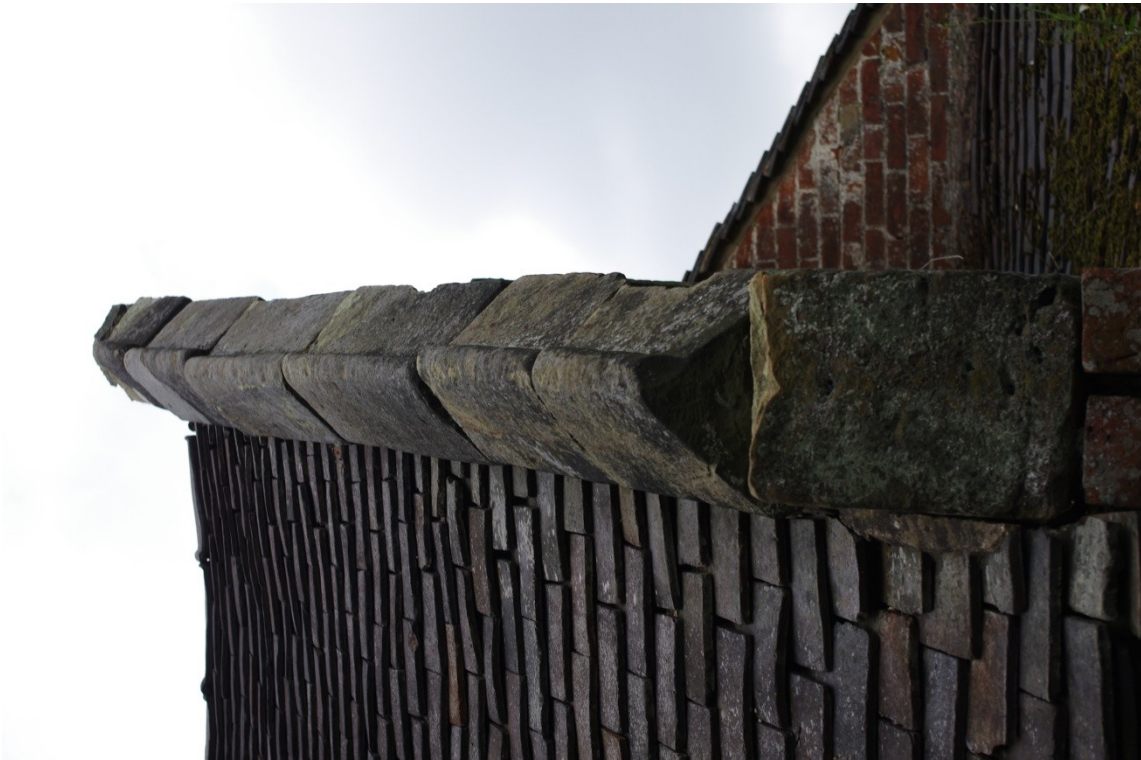
Figure 15 Moulded Stone Coped Abutment on East Facing Gable of D.

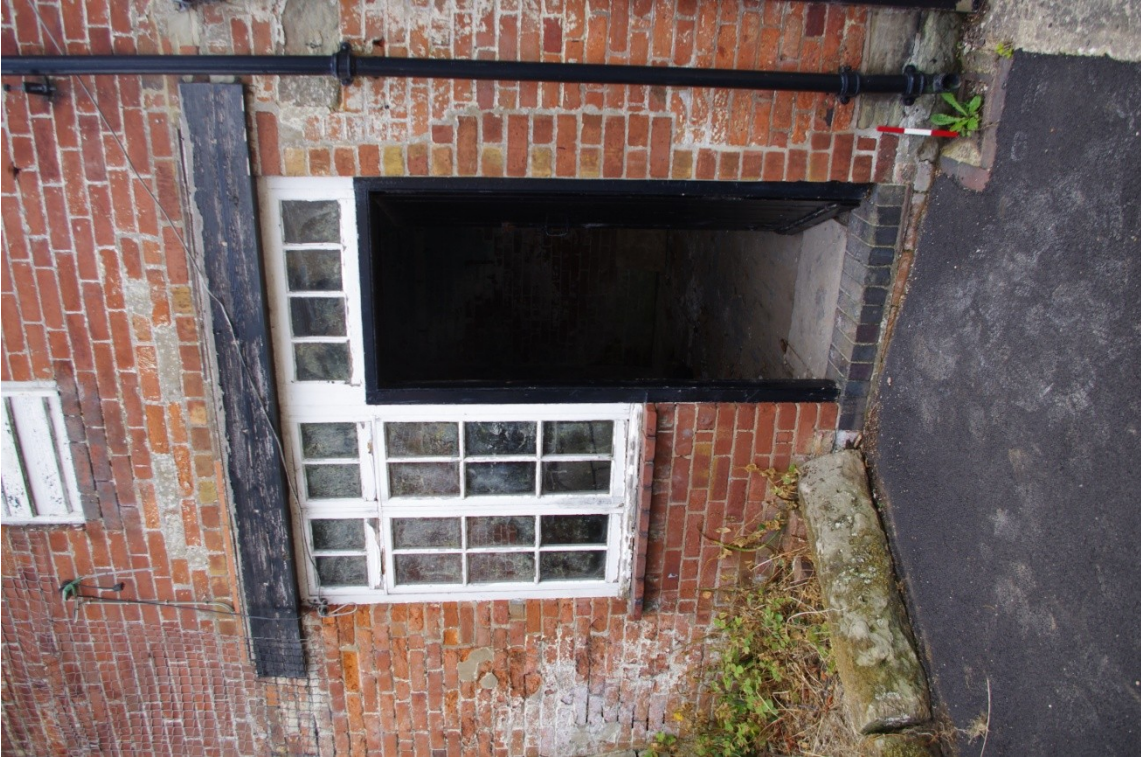
Figure 16 Partly Blocked Carriage Door on Principal Elevation of A.

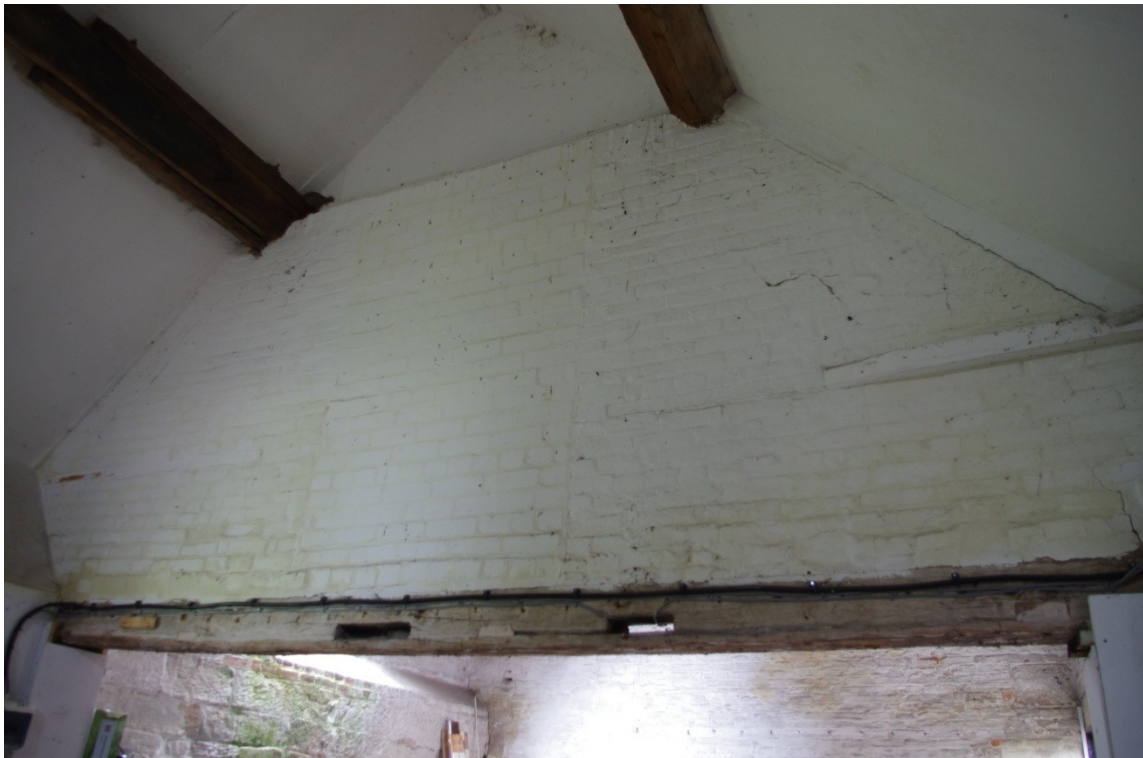
Internally, D consists of two equal bays. There is a brick-built wall carried by the tie beam within the attic space. There is a blocked opening in this wall (*Figure 17*) which suggests the wall may have originally been full height and divided the range in to two separate bays and that there was originally a first floor. The eastern end is rendered while the western end is exposed stone, this suggests a potentially more domestic use for the eastern end or it was used for a carriage of some status. The latter is more likely given the history of Erdeswick House as the temporary residence of the Earl.

Figure 17
Brick-Built Wall & Blocked Opening Carried on Tie Beam in D (looking South West).

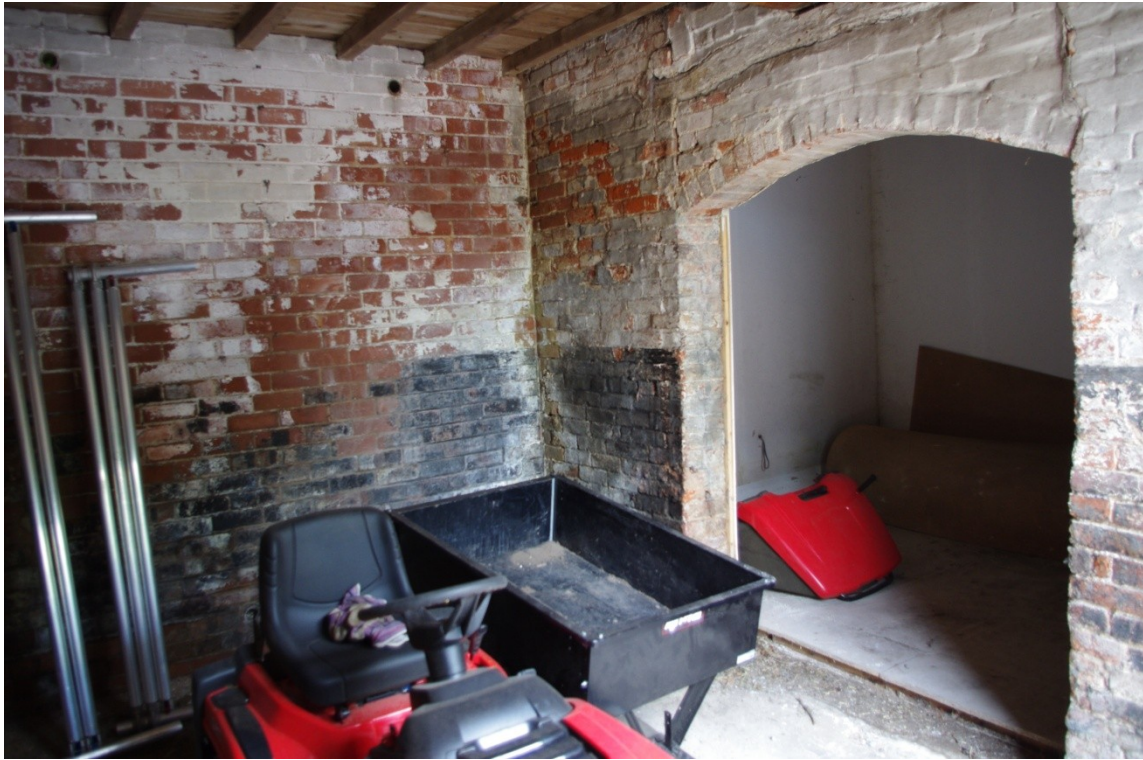
Figure 18

Dividing B and C is a brick-built cross wall, the bricks appear early and the wall is likely to be original, there is central opening in the wall with a lowered flat brick arch, above with is the original timber lintel (*Figure 18*). The final bay, C has been extensively modernised with dry lined walls and hardboard flooring, leaving little of historical significance exposed. The ceiling is carried on a substantial roughly finished oak bridging beam.

B, Internal View Showing Partly Blocked Opening (Right) & Newer Brick-Built Rear Wall (Left) (looking South East).

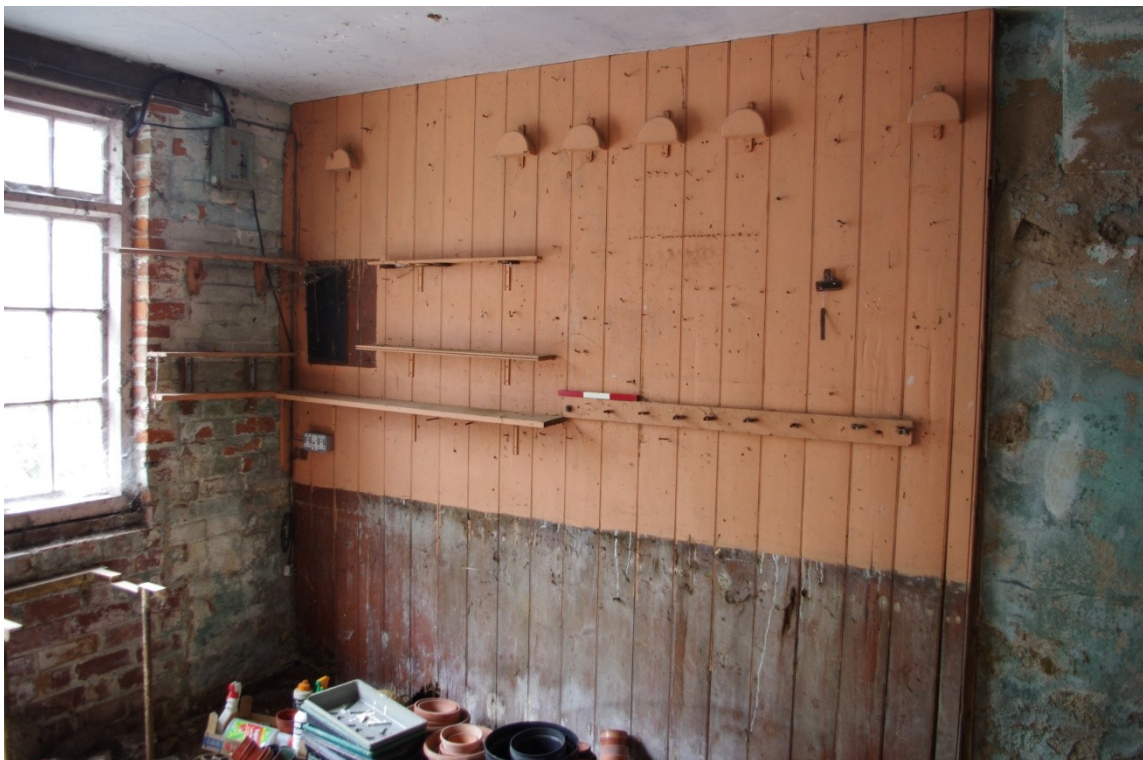
Figure 19

Internally, the range consists of three principal bays. The northernmost bay, A consists of a single room with ladder access to the loft above, part of the northernmost wall has tongued and grooved panelling and a saddle tree and tack hooks (*Figure 19*), confirming the coach house history of the building, the remainder of this northern wall is rendered, other walls are painted brick. There appears to be a straight joint between the rear wall and the cross wall and the rear wall appears to be more modern brick (brick dimensions 9 x 3 x 4 ¼ inch), it is likely, therefore that the rear wall has a more recent internal brick skin. Interestingly, there is a small area of parquet flooring remaining adjacent to the door (*Figure 20*), it is unclear whether this is original, and if original, it suggests a coach house of some status. The central bay, B is largely bare, again with painted brick walls, the northern cross wall is built on stone footing (*Figure 21*) and there is modern poured concrete floor. The ceiling is carried on a substantial oak bridging beam.

A Showing Panelling & Tack Hooks on Northernmost Wall (looking North – North West).

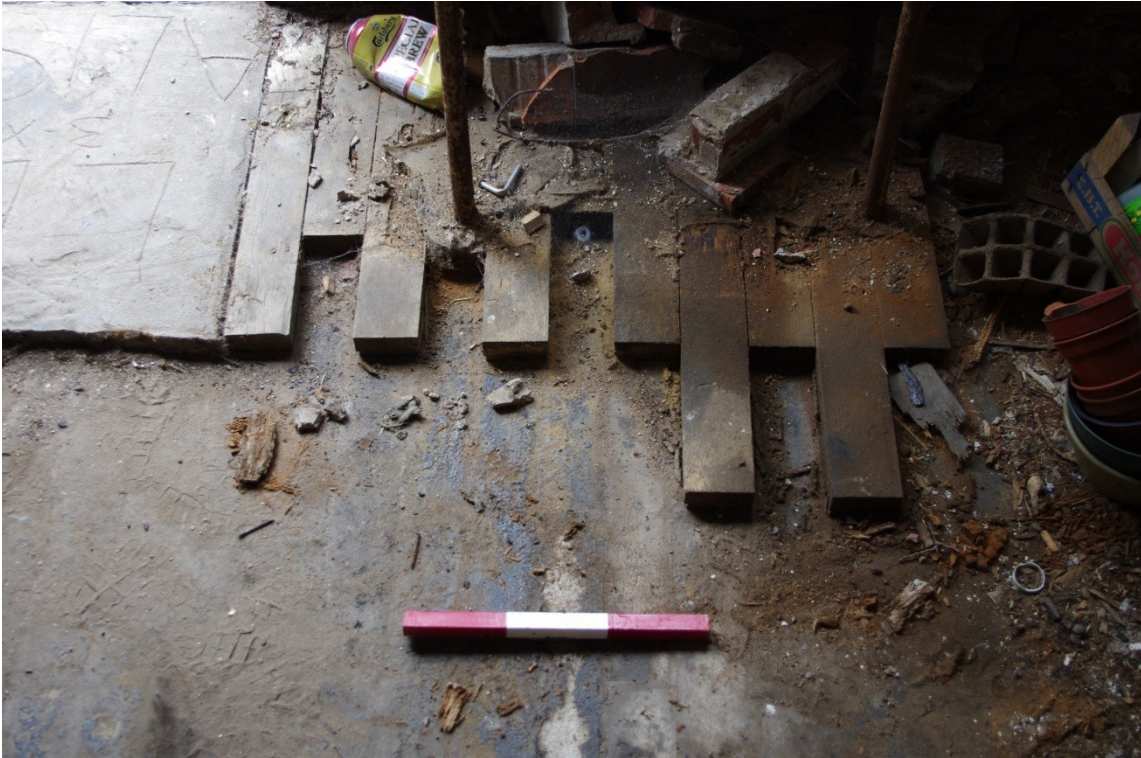
Figure 20

A Limited Remains of Parquet Floor Adjacent to Doorway.

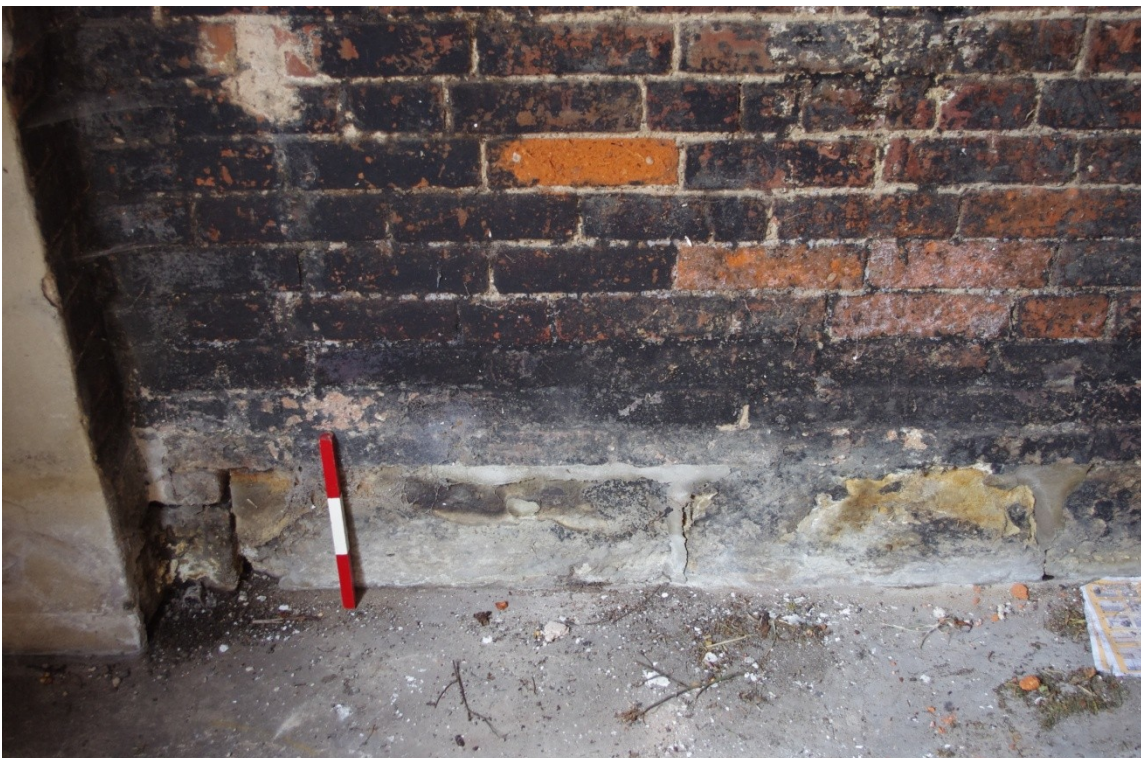
Figure 21

B Limited View of Stone-Built Footing.

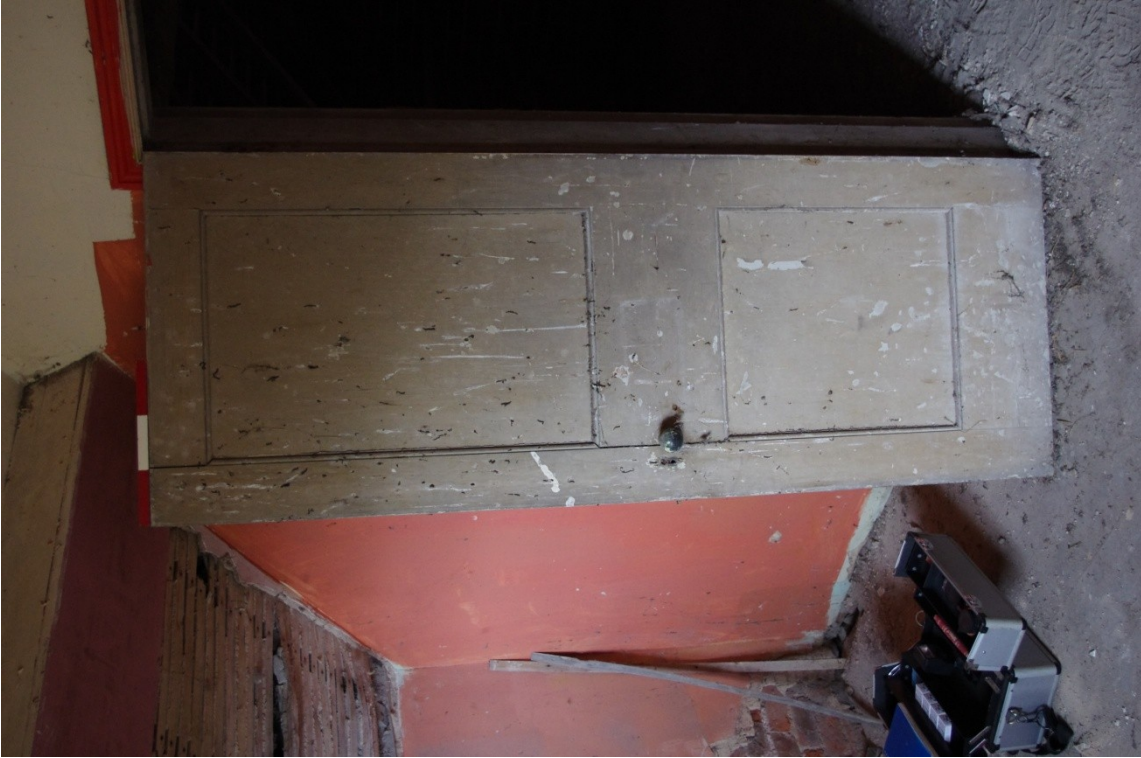
Figure 22 Early 19th Century Door in
E.
