**A Photographic Survey.
Hartshill Institute (Former)
287 Hartshill Road
Hartshill
Stoke-on-Trent
(NGR SJ 86624 45788)**

**Planning Permission No
SOT/57854/57855**

ABRS Project No 2015-HIHS

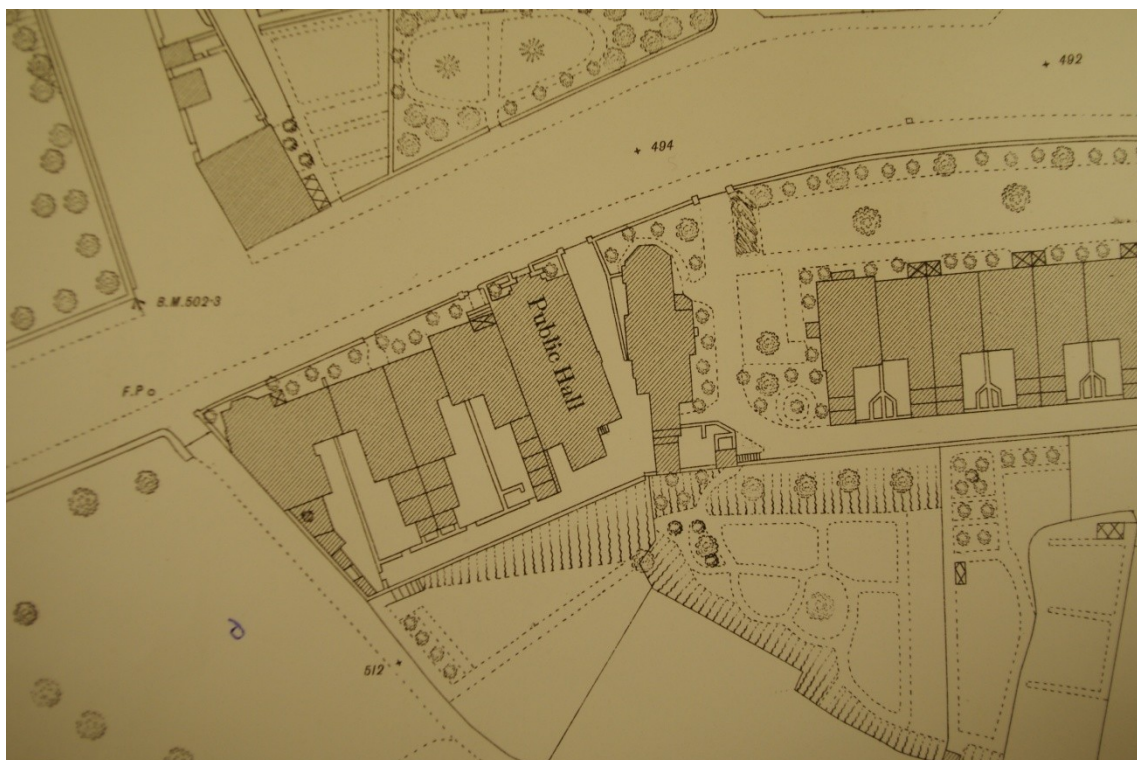
Figure 4
Stoke-on-Trent Ordnance Survey 1:500 plan 1878.
(SoTCA Ref XVIII.1.16)

A historical map regression confirms that the building plan remained largely unaltered during the 20th century. The only significant alteration is the addition of two small outshoot extensions to the south elevation. Viewing the Stoke on Trent Ordnance Survey 1:500 plan of 1878 and the later 1:500 plan of 1951 (SoTCA Ref XVIII.1.16 (*Figure 4*) & SoTCA Ref SJ8645 NE (*Figure 5*)) indicates this extension dates to the 20th century. The straight joint in the brickwork of the south easternmost extension is still apparent. Less apparent changes observed during the recording include the forward paired shafts on the porch being replaced with concrete shafts and an additional brick skin at ground level on the principal elevation.
