**An Archaeological Standing Building Survey.  
Redmorlea Farm  
Waterhouses  
Staffordshire**

**On Behalf of HLW Developments Ltd**

**July 2016**

**ABRS Project No 2016-RFWS**

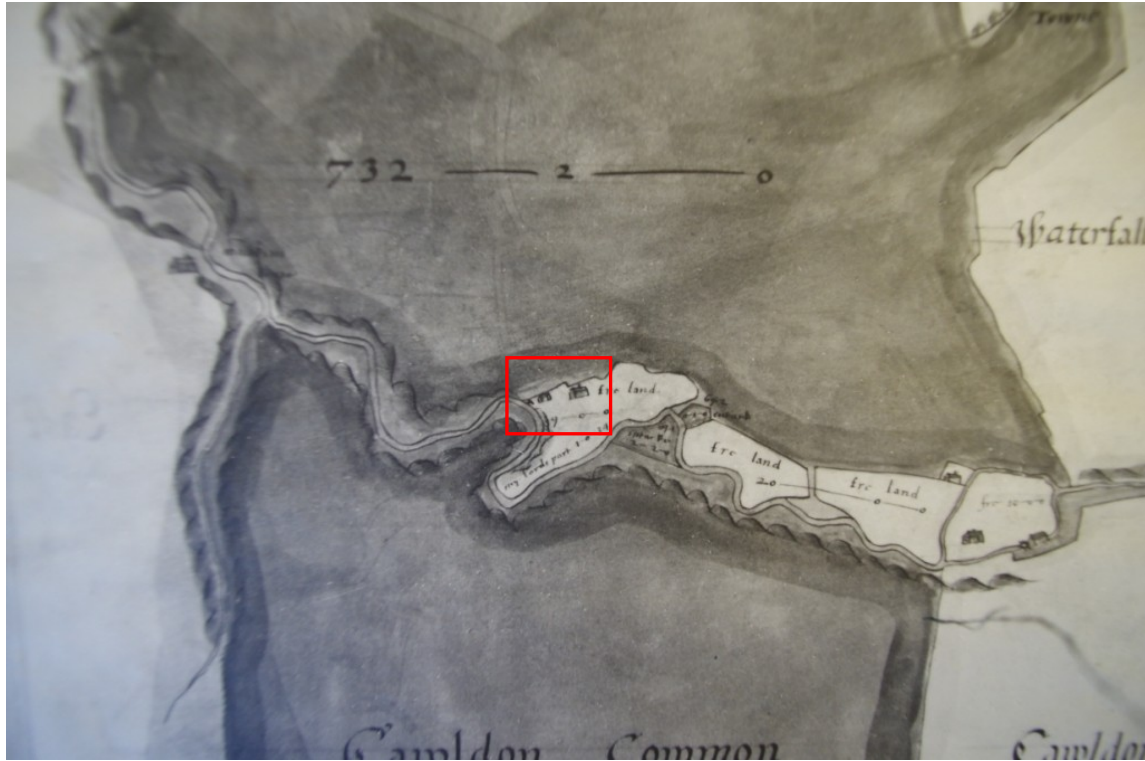
**Figure 2**

approximately the same location as the current building. The building is recorded as having a single, off centre stack, the current Redmorlea Farmhouse has a similar arrangement. It is likely, therefore that this building is Redmorlea Farm. To the north west of the house is a “U” shaped structure, possibly representing another building, possibly a threshing barn, with its large, central threshing doors.

William Senior's Map of the Earl of Newcastle's Land (1631).

In 1631 the Earl of Newcastle commissioned William Senior to record and map his holdings in Staffordshire, including the lands in and around Waterfall. The map, “*Waterfall and Caudon in the Countie of Stafford Belonging to the Right Honble W<sup>m</sup> Earle of Newcastle*” (SRO Ref 476/1/5/1 (*Figure 2*)) is the first available and to some degree accurate record of the area and includes the proposed development area. Using the location of Caudon Mill (right foreground Fig. 2), which is recorded by modern maps it is possible, by following the course of the River Hamps to locate Redmorlea Farm. Senior’s map records a building in

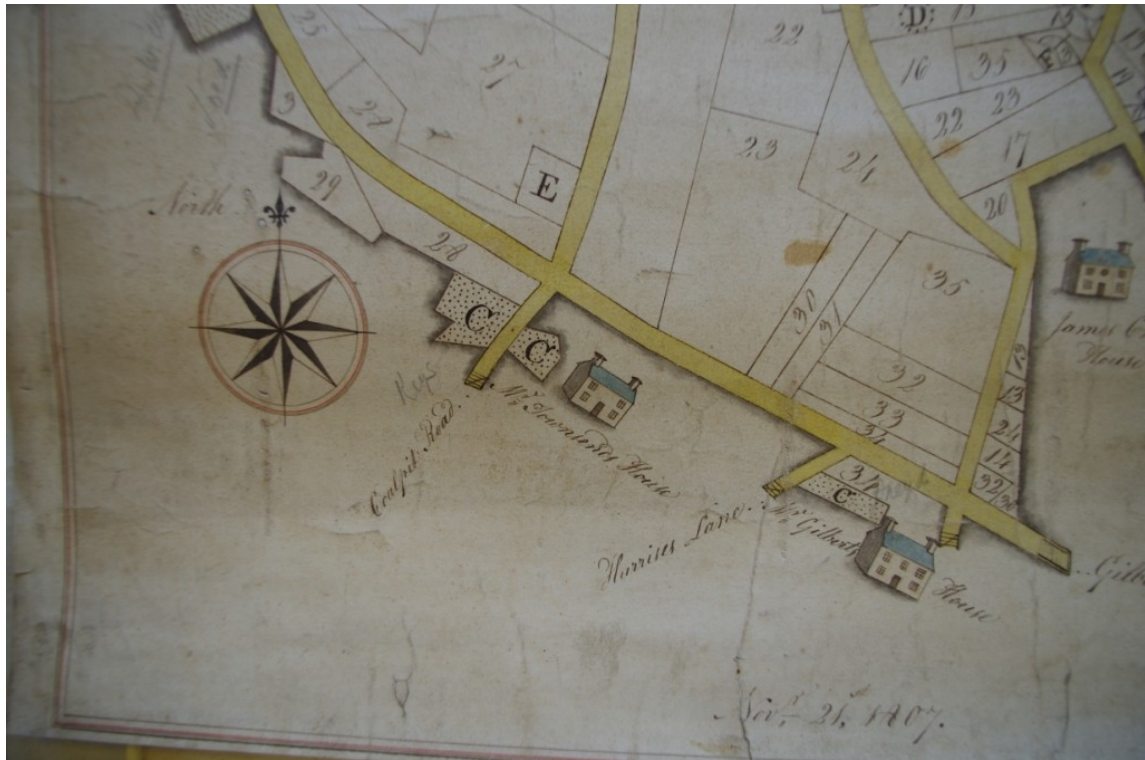
**Figure 3**  
Waterfall Enclosure Map (1807).

In 1807 Waterfall Common was, by Act of Parliament enclosed. The enclosure map (SRO Ref D424/M/1 (*Figure 3*)) drawn in November the same year records the common in detail. Redmorlea Farm, was, at the time however beyond the southernmost boundary of the common. The map does however record Mr Townsends House occupying approximately the same site as Redmorlea Farm. Although the representation of the house within the map does not match the previous representation or the current farmhouse it is likely that Mr Townsend's House is Redmorlea Farm. There is no further detail recorded by the map, however the individual representation of the dwelling suggests it was a house of some status as was Mr Townsend. Background information indicates the Townsend Family were well established in the parish with John Townsend being the incumbent of St James & St Bartholomew's between 1757 and 1780. Indeed, land immediately to the west of Mr Townsend's house is recorded as being church land, suggesting that the two are related. In 1890 a stained glass window was installed in the Church by Miss Townsend in memory of her mother, the family remained in the parish until at least the turn of the 20th century.

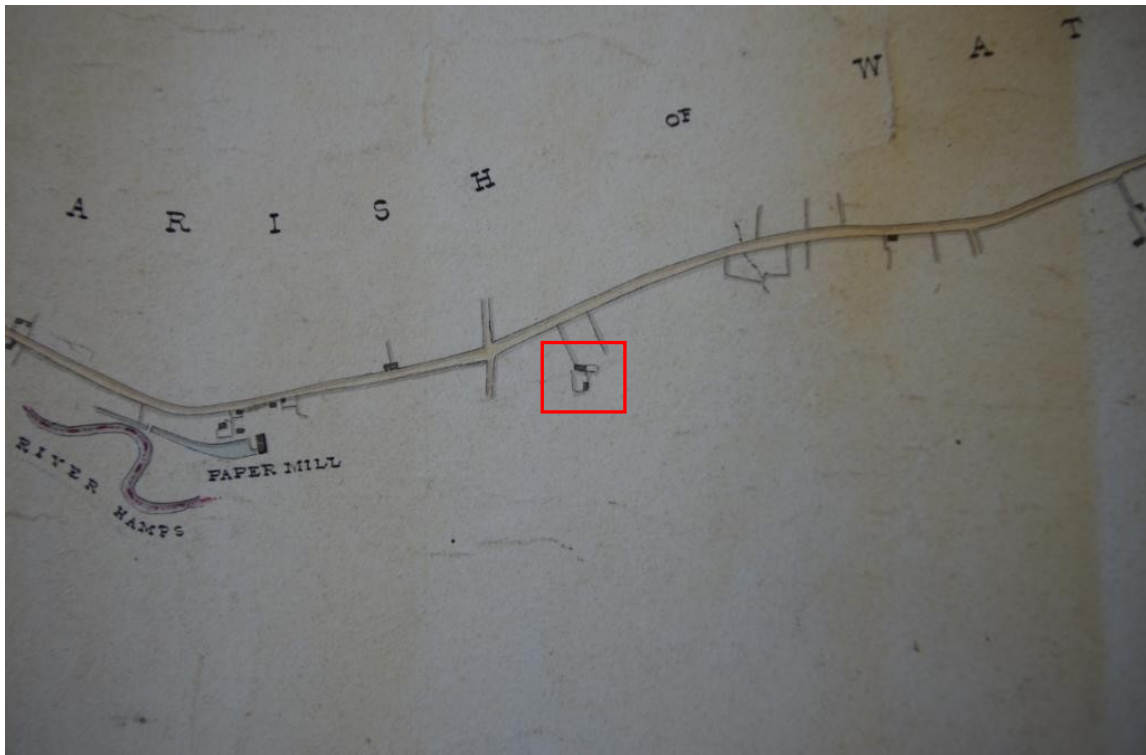
**Figure 4**  
Ashbourne and Leek Turnpike Road Plan of Present Road and Proposed Deviations Between Hanging Bridge and New Street (1828).

Immediately to the north of Redmorlea Farm is the alignment of the Ashbourne and Leek Turnpike, built 1763-4, linking Ashbourne with Hanging Bridge. In 1828 plans were drawn to improve and straighten the road between Hanging Bridge and New Street (SRO Ref D423/M/8/4 (*Figure 4*)). The map records the alignment of the road, junctions and key buildings, including Redmorlea Farm. Although not identified by name and not including the farmhouse the map is the first representation of the outbuildings associated with the farm. There are two linear buildings, one aligned north – south and a larger east –west building.

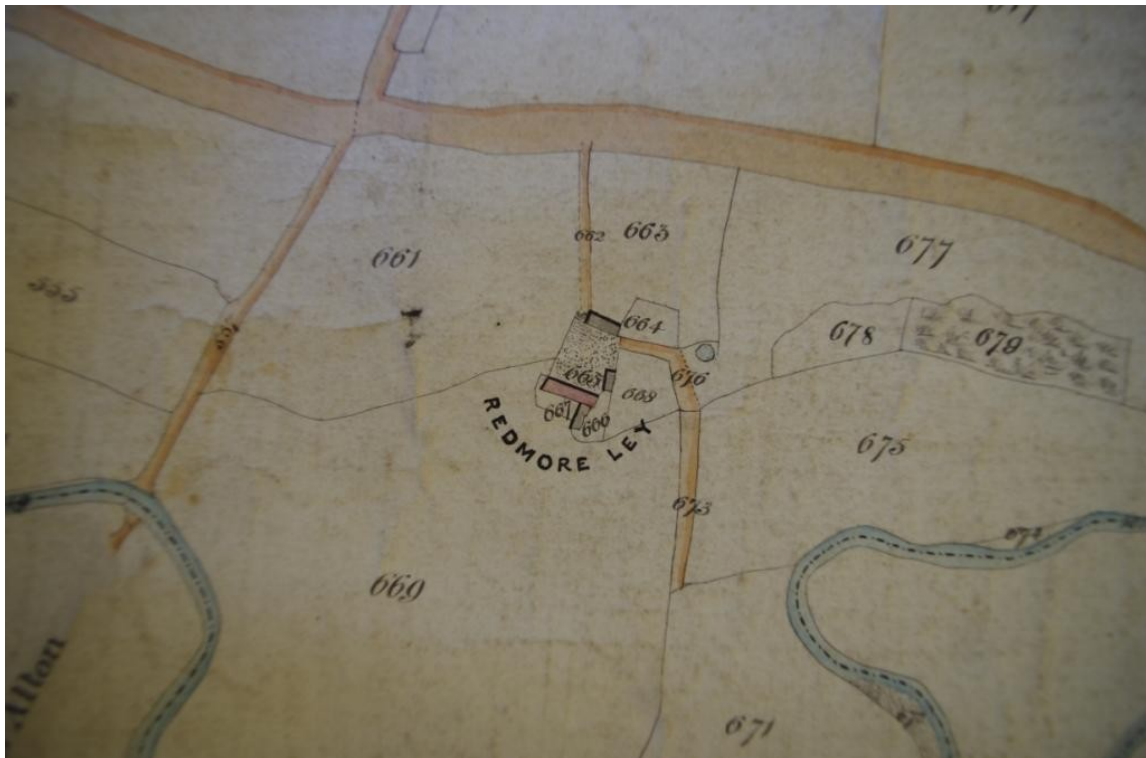
**Figure 5**  
Plan of the Parish of Waterfall (1846).

Redmorlea Farmhouse is coloured red and outbuildings coloured grey as was common practice. The buildings are the same recorded by the Turnpike Map situated around a yard. The accompanying key identifies the yard (no. 665) as a milking yard [and] barn; this suggests the farm was a dairy farm. There is another yard (no. 666) to the south east of the house as well as a stackyard to the north east of the northernmost outbuilding/barn. No. 668 to the east is described as garden and no. 663, the field between the barn and the road is identified as Calf Croft, again evidence of the pastoral nature of the farm.

In 1846 a *Plan of the Parish of Waterfall* (SRO Ref D5133/6/11A (*Figure 5*)) was drawn to accompany the parish tithe. The map is the first modern, detailed representation of Redmorlea, labelled as Redmore Ley by the cartographer.

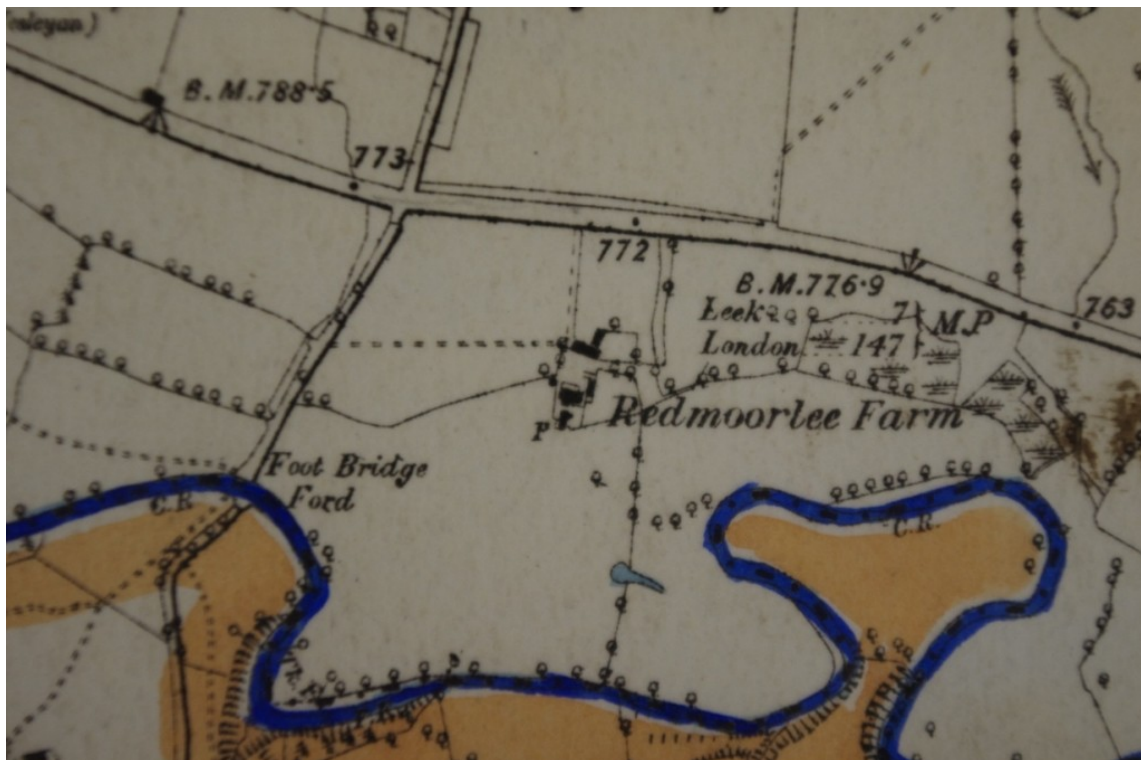
**Figure 6**  
First Edition Ordnance Survey (1888).  
(14.NW 1:10560)

The first edition Ordnance Survey of the Staffordshire Moorlands was published in 1888 (Figure 6). Identified as Redmoorlee (the adopted and standard OS spelling) the farm is recorded in detail, as with earlier maps there are a collection of outbuildings around a yard to the north of the farmhouse, the footprint of which has been altered since pervious maps. The northernmost barn has a north facing outshot facing a probably fold yard to the east, it is likely that this outshot is a shelter shed for cattle. To the west of the yard is a small square outbuilding and there is also a liner building to the south of the farmhouse.

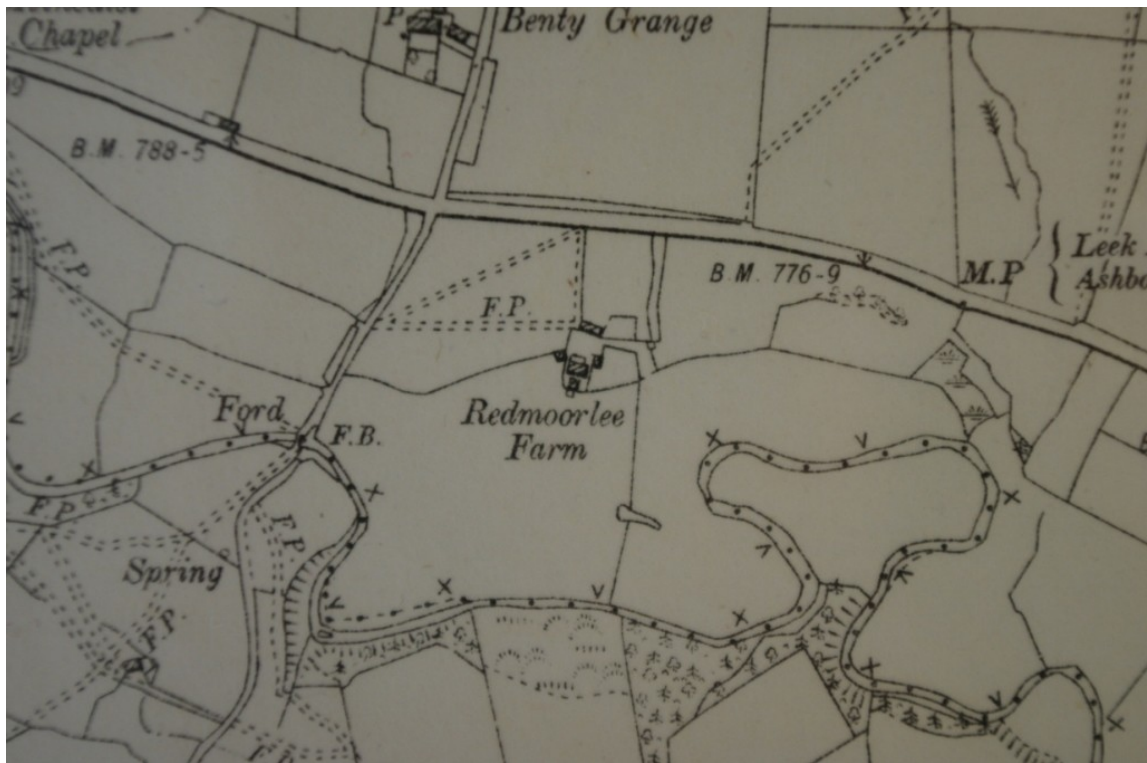
**Figure 7**  
Second Edition Ordnance Survey (1900).  
(14.NW 1:10560)

The second edition Ordnance Survey published in 1900 (*Figure 7*) records the majority of the farm as it was recorded by the first edition map, the only significant difference is the outshot to the northernmost barn is no longer recorded, indicating that it was demolished sometime in the 1890s. Kelly's Directory of 1912 lists a Chas. Mycock – farmer of Redmore Lea Farm, Charles was one four Mycocks in the Parish, all of whom were farmers. Charles was again listed in 1928. By 1940 there is no mention of Redmorlea, the Mycock Family are still strongly represented with Endor Mycock at Gib Farm and Geo. Mycock at Back-o'-the-Brook Farm.

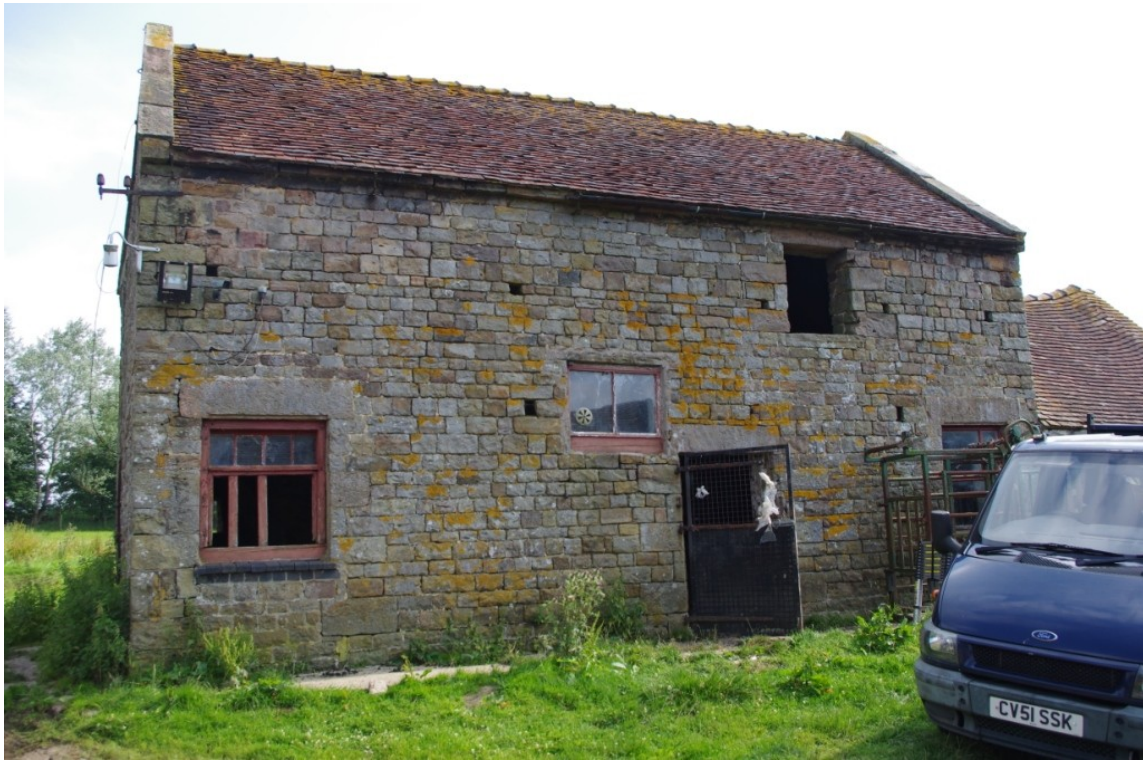
**Figure 11**  
Building 01 Principal Elevation, General View (Looking North East).

Building 01 is a linear building forming the northern range of the farmyard (*Figures 9 & 10*). The building is built of coursed squared local gritstone under a plain tile roof (*Figure 11*) with parapet gables and gritstone kneelers. There are corner quoins and tooled window and door heads. Window and door reveals are also quoined.

The building consists of two phases, A to the west and B to the east. A is two storey, B is single storey, there is a straight joint visible between the two indicating B is a later extension. There are a number of openings on the principal elevation of A including a central door with attractive and well finished quoins and head (*Figure 12*). There are two windows towards the gable ends and an off centre window, the gable windows with hit and miss vents. The off centre window is at an awkward height and is poorly finished and is likely to be a later insertion. A closer inspection of the windows indicate these are inserted into partially blocked doorways (*Figure 13*) indicating there were originally three doors on this principal elevation. This arrangement of three doors on the principal elevation is a common feature of 18th century cowhouses, but went out of favour in the 19th century.

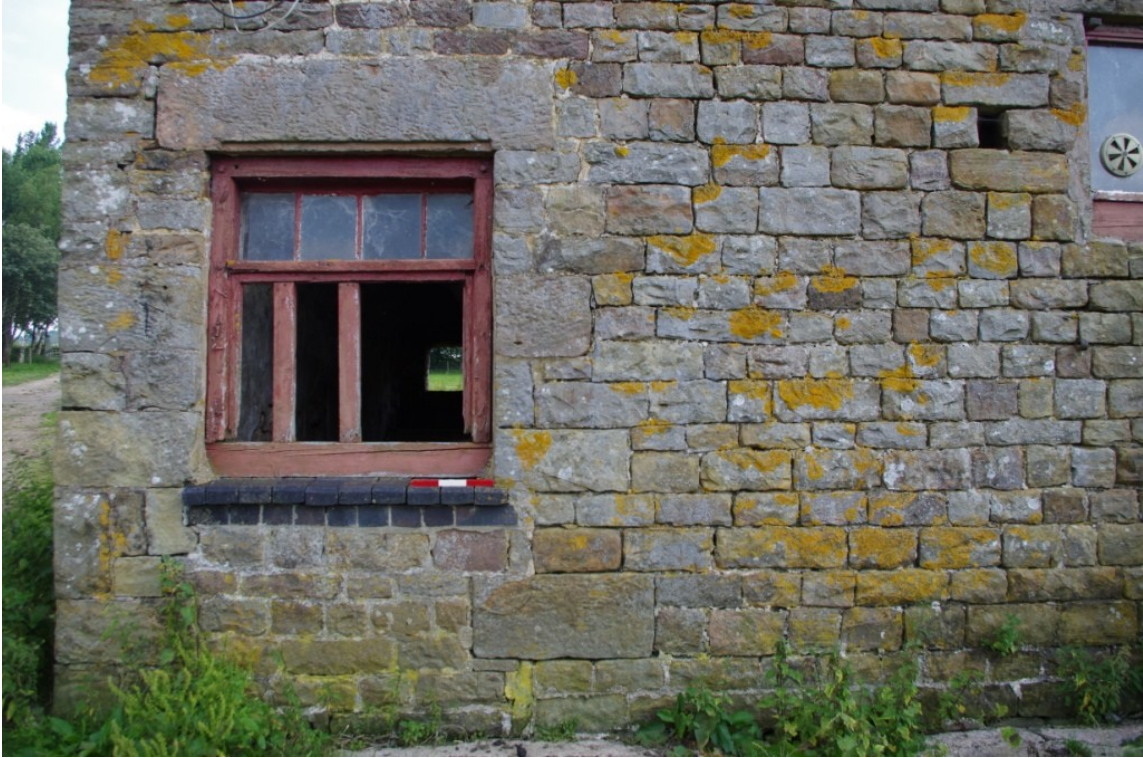
**Figure 13**  
Building 01 Window Inserted into Blocked Doorway, Principal Elevation.

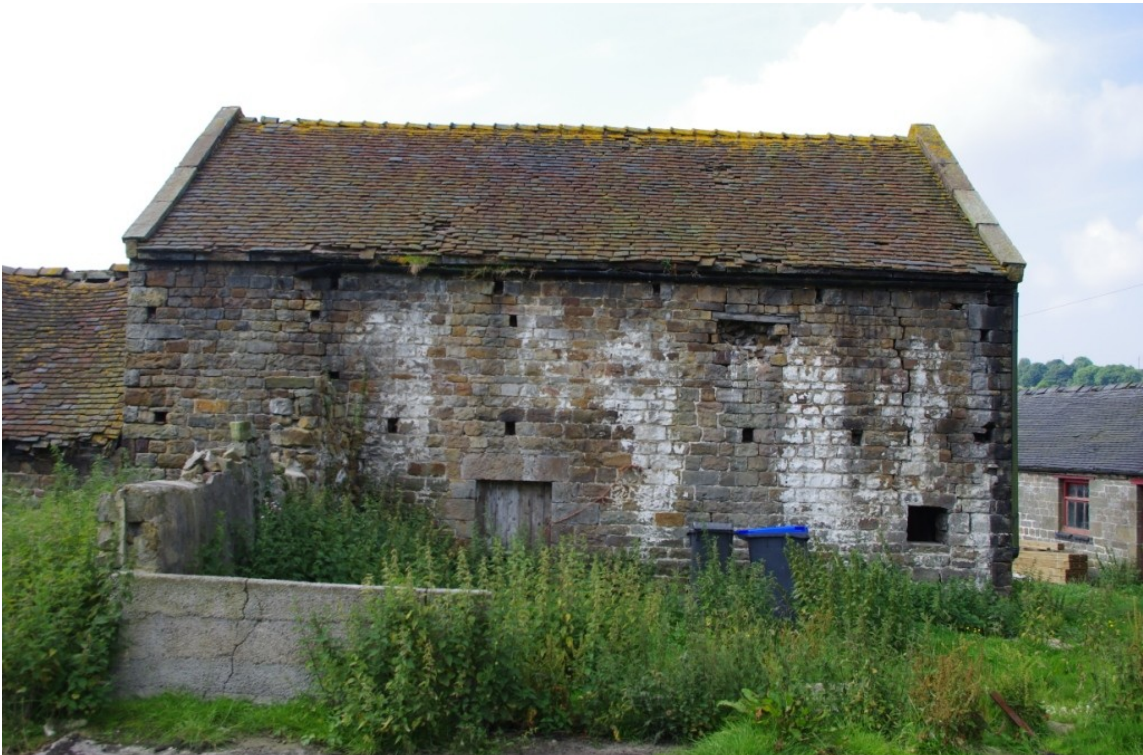
The rear elevation (*Figure 14*) consists of a single central door, in line with that on the principal elevation and two low level windows. The tooled heads and quoined reveals indicate they are original. There is a single loft window, again poorly finished with a timber lintel, likely to be a later insertion. There is a projecting wall and the remains of lime washing, evidence of at least one of the two former buildings visible here on earlier maps.

**Figure 14**  
Building 01 Rear Elevation (Looking South-South West).

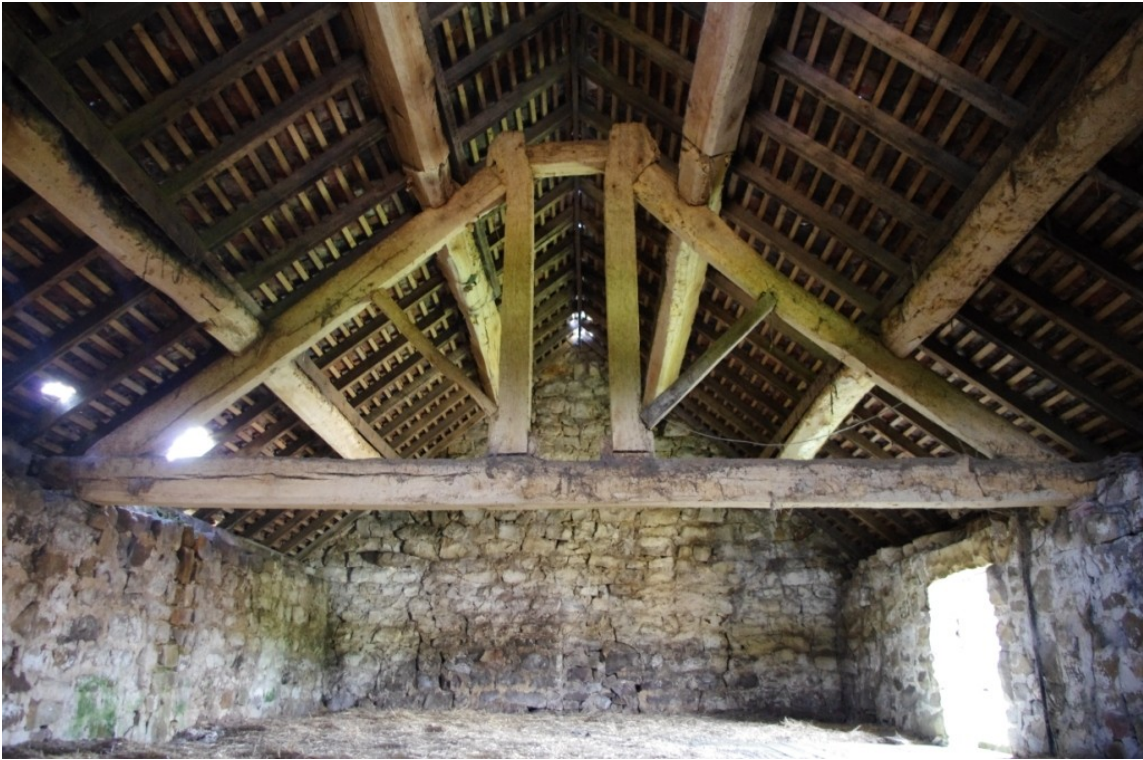
The roof structure of A consists of paired oak purlins carried on a single truss. The truss is unusual in design consisting of close set Queen Posts with raking struts (*Figure 15*). The exact reason for this design is unclear, where storage is required up to roof level a Queen Post truss is used, which also allows a wider roof span. The closeness of these two queen posts negates any space gained. Peters (*Vernacular Architecture* (Vol 19, 1988)) suggests that queen post trusses only arrived in Staffordshire in the years immediately preceding 1820. The article also quotes “various nineteenth century writers, including the Enclosure Commissioners” advocating the use of king-post trusses for buildings of up to thirty feet span and queen-post trusses only for wider span. This building at only 4650mm (c.15 foot) wide does not fit into that wider span category. It can only be assumed that the building was re-roofed, potentially by a carpenter who had not yet seen a true Queen Post truss created this truss. The loft space is exceptionally tall, allowing a large floor storage area, which again confuses the origins of the roof structure. The height of the loft supports the possibility that the roof has been replaced and raised.

**Figure 15**  
Building 01A Roof Truss.

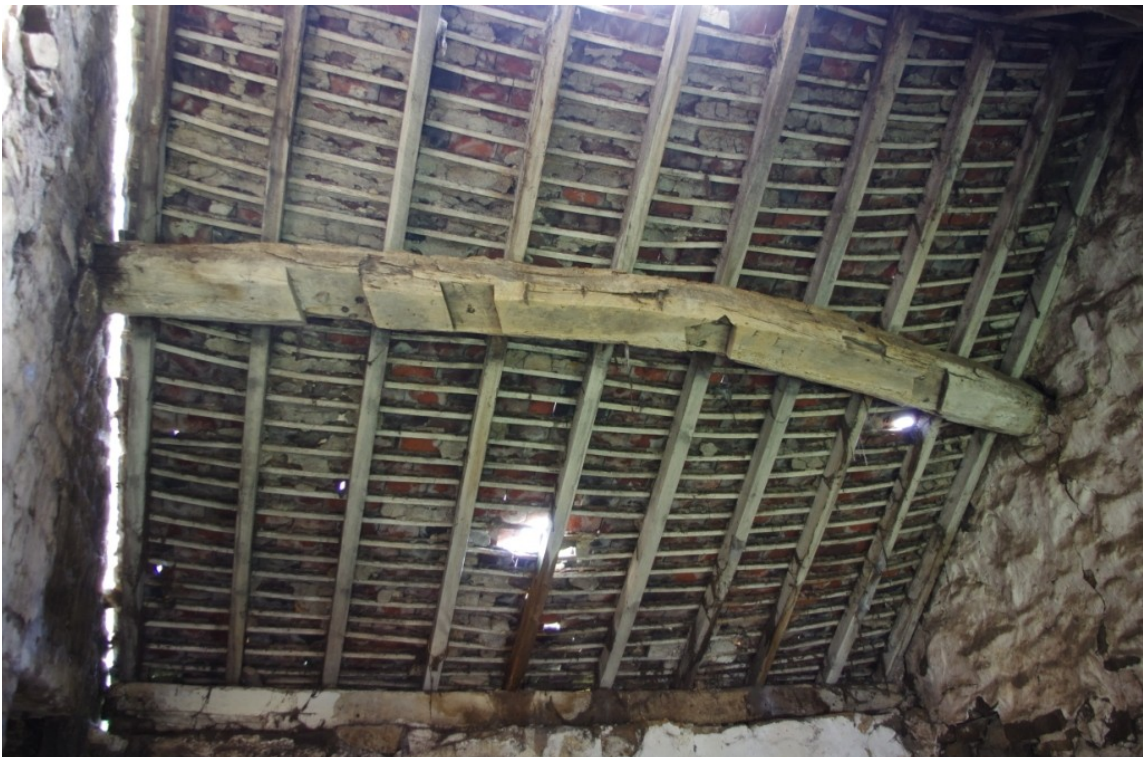
The roof structure of B although simpler in nature is equally interesting, the roof consists of two purlins, both of which are re-used timbers. The northernmost appears to be cruck blade

with a number of open mortices indicating re-use (*Figure 16*), at least two of the mortices indicate the original location of tie beam and collar, there are a further two, originally lower mortices as well as evidence of a probable wind brace. The southernmost purlin (*Figure 17*) is also re-used, this time a probable principal rafter or bay post with an open collar mortice and wind brace, or rail mortice and brace. Although much weathered there is also evidence of jointing on its eastern end although this is difficult to characterise.

**Figure 16**  
Building 01B, Possible Cruck Blade Re-used as a Purlin.

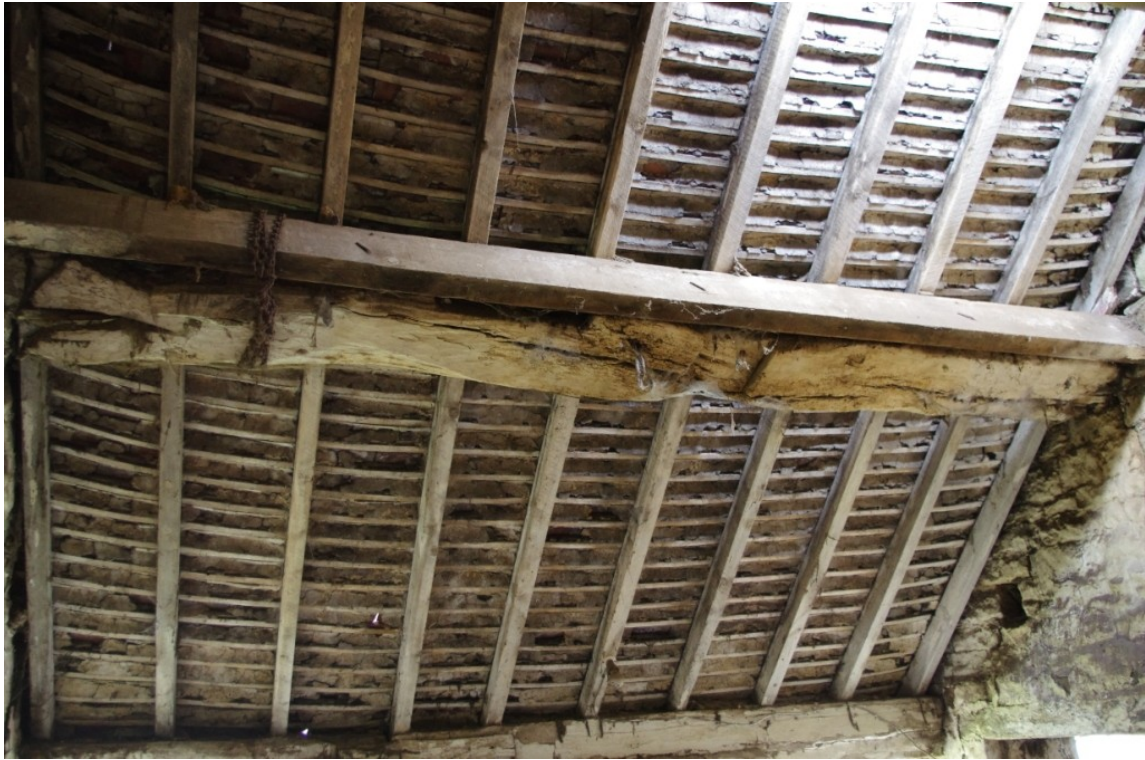
**Figure 17**  
Building 01B, Bay Post Re-used as Purlin.

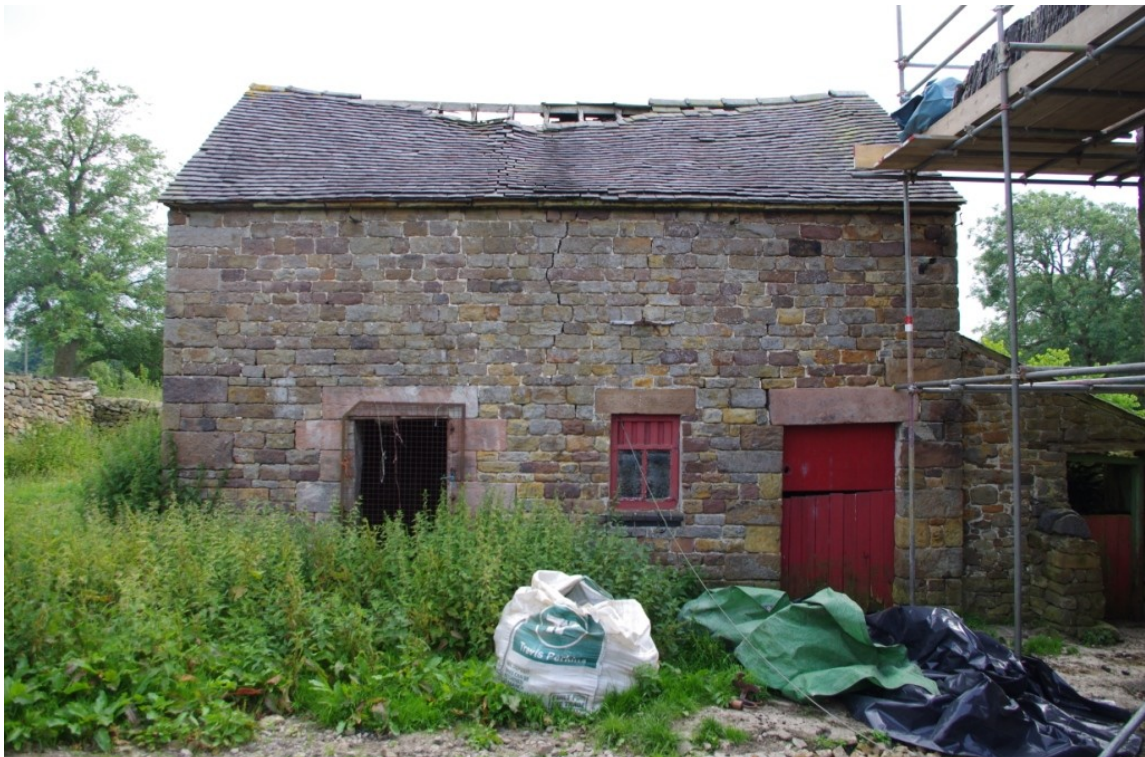
Building 02 forms the eastern range of the yard (*Figures 9 & 10*); it is a two storey building, again in coursed squared local gritstone under a plain tile roof (*Figure 18*). There is a poor quality rubble-built lean to on the southernmost gable, clearly later in date.

**Figure 18**  
Building 02 Principal Elevation, General View (Looking East-South East).

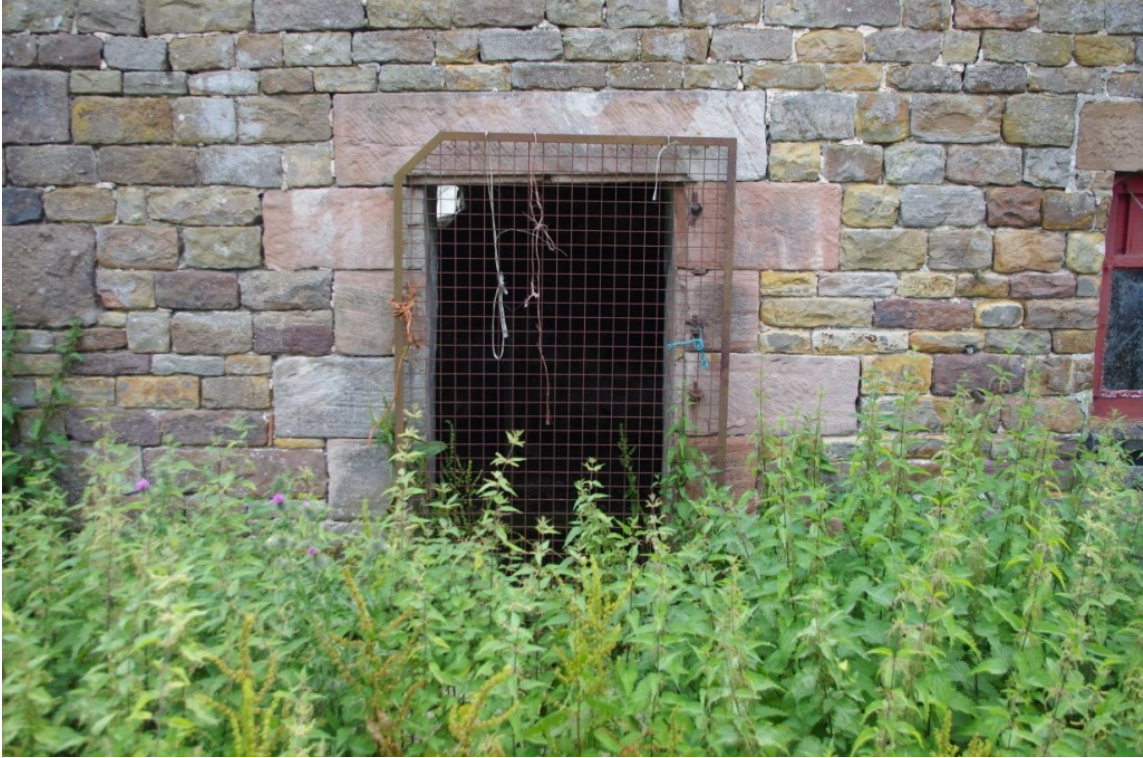
**Figure 19**  
Building 02, Well Finished Quoins on Northernmost Door, Principal Elevation.

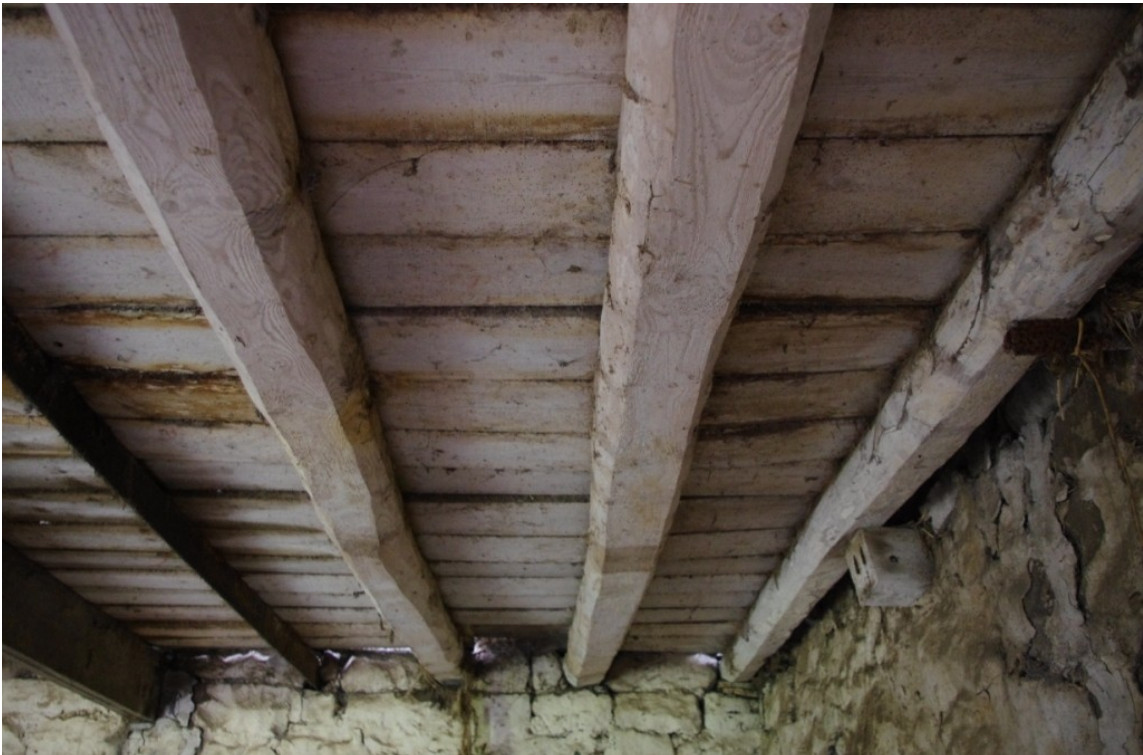
Internally, the ground floor consists of a single bay with 20th century concrete stalls along the rear wall with tethering for eight beasts in four double stalls. The low ceiling, indicative of a pre-19th century cowhouse is carried on a variety of joists, interestingly some running back to front (southern end) and others running side to side (northern end). There is also an inserted rolled steel joist (RSJ) supporting the failing timber structure. Some of these joists are also interesting for their dimensions, their width being noticeably greater than the depth (*Figure 20*). Joists of these dimensions were a common feature in early 16th century houses, this suggests that the joists are either re-used, or that the building may have 16th century, domestic origins.

**Figure 20**  
Building 02A, Flattened Joists.

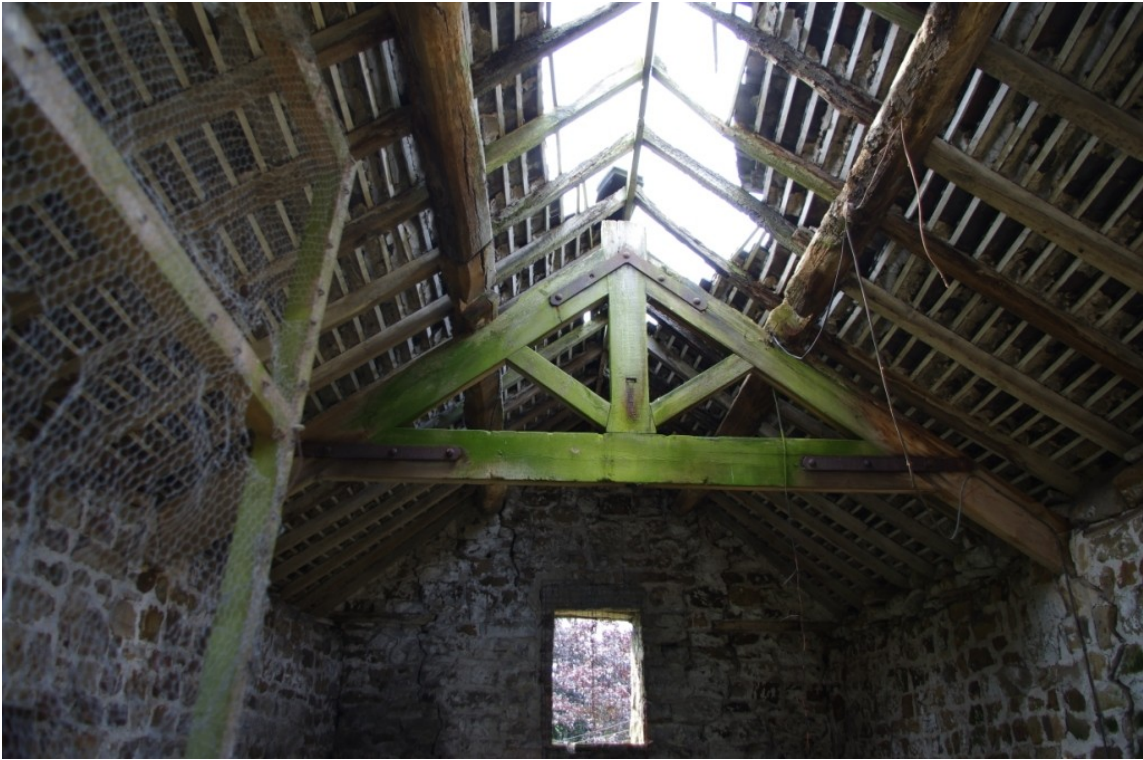
Access to the loft is via the gable loft door, unfortunately the precarious condition of the floor prevented a detailed examination. The roof is carried on two hardwood purlins supported by a later deal king post truss with raking struts (*Figure 21*). The truss has a bolted heel and iron straps, suggesting it is likely to be late 19th or even early 20th century in date, clearly not original. Further evidence of which are the matching open mortices on the underside of the purlins (*Figure 22*) indicating the location of a lost, original truss. The size of the loft would have originally allowed the storage of a significant amount of feed, suggesting the farm, at

**Figure 21**  
Building 02(A) Roof Truss.

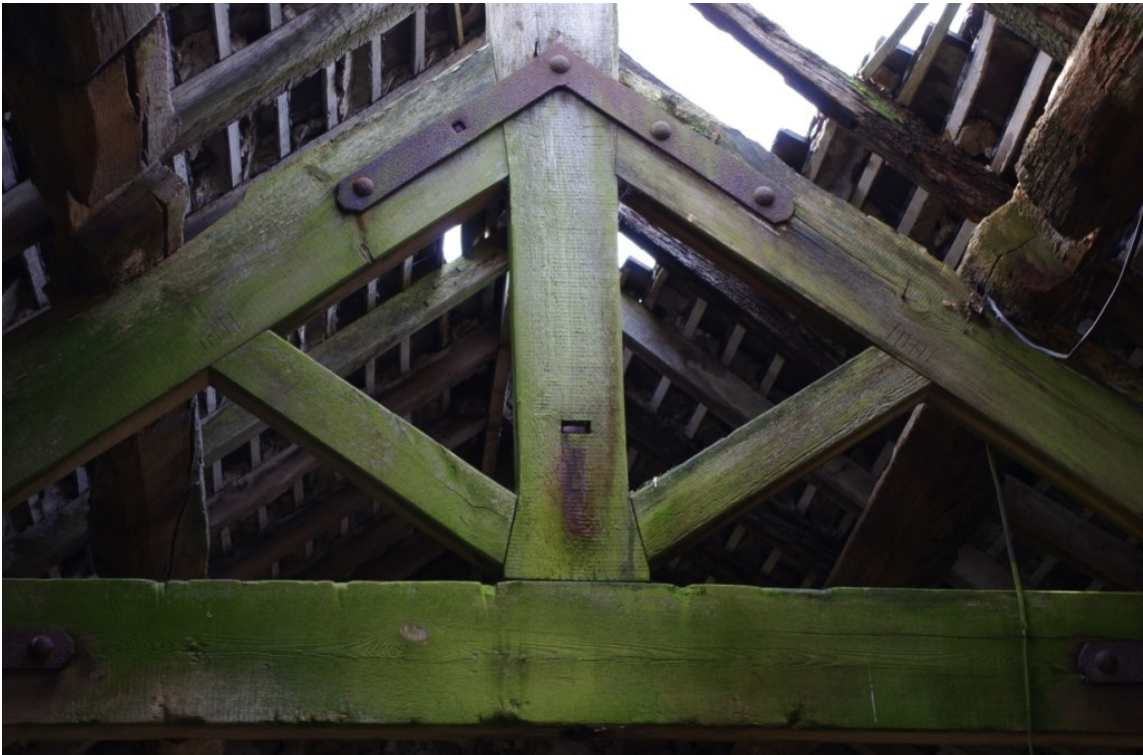
**Figure 22**  
Building 02A Open Mortise on Underside of Purlins Indicating Position of Original Truss.

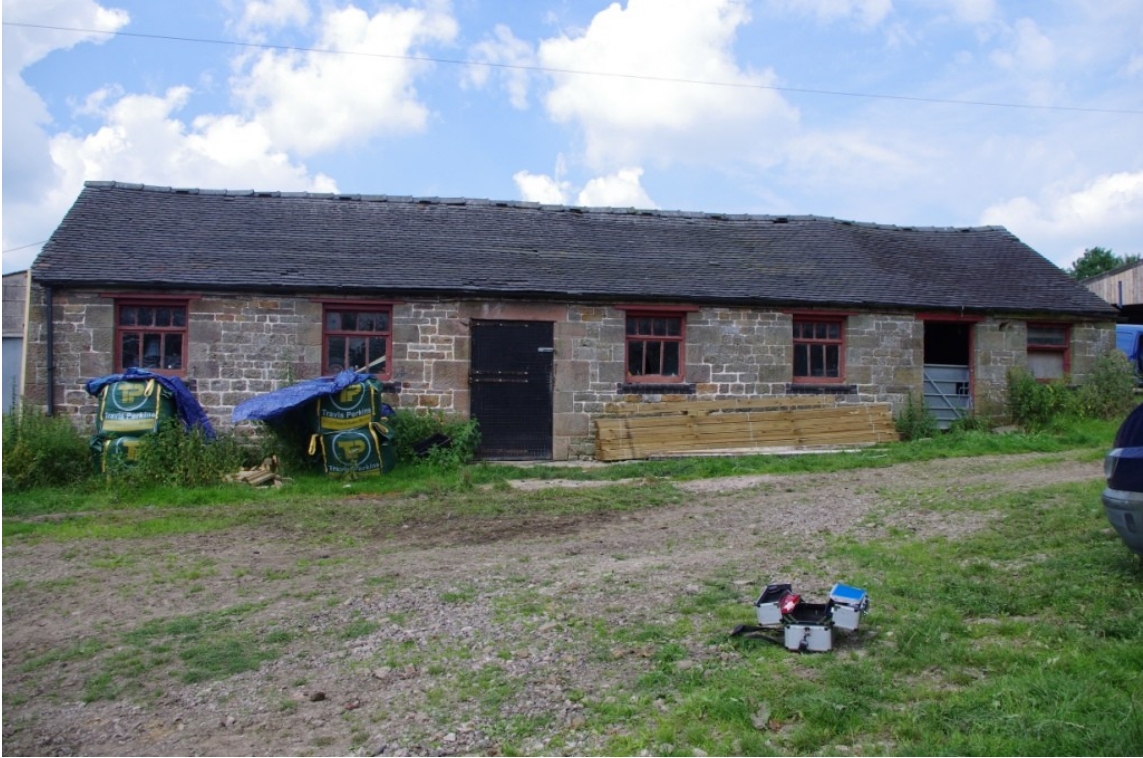
Building 03 is aligned north – south and forms the westernmost range of the yard (*Figures 9 & 10*). Cartographic sources indicate it is the latest of the principal farm buildings, dating to the early 20th century. The building is single storey in coursed squared local gritstone under a plain tile roof with substantial well finished quoined door and window reveals (*Figure 23*). There is a modern breeze-block built extension on the south gable.

**Figure 23**  
Building 03 Principal Elevation, General View (Looking West-North West).

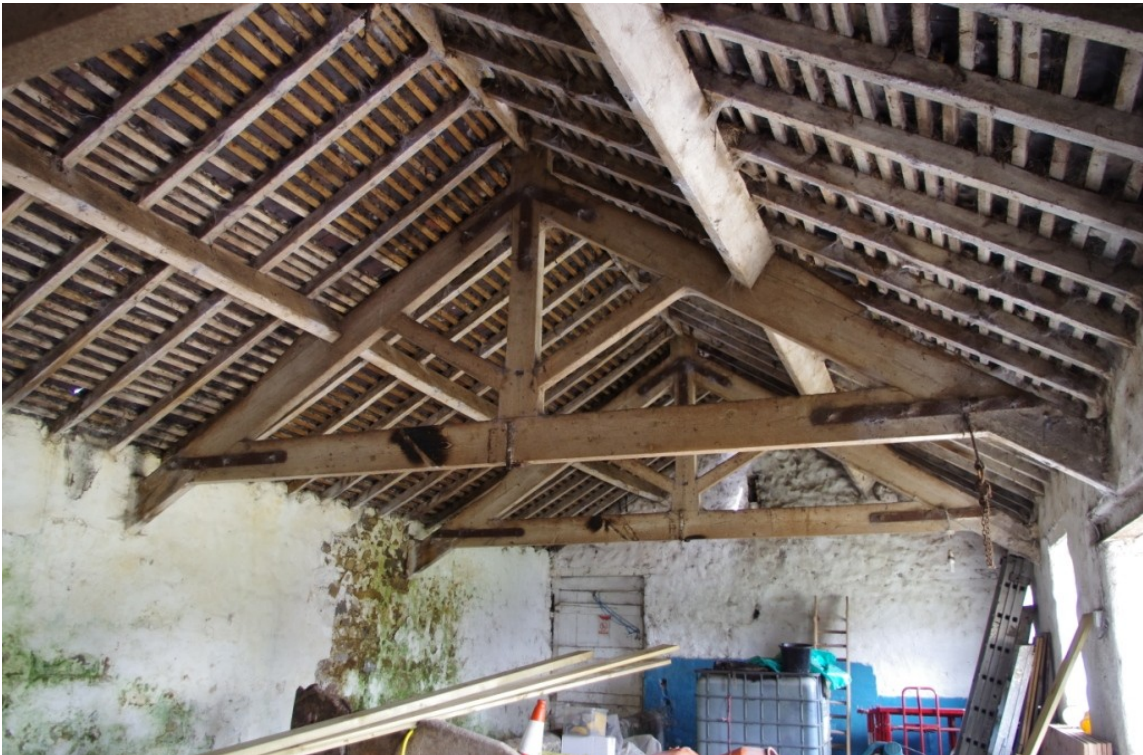
The roof is carried on three deal king post trusses with raking struts (*Figure 24*). The trusses have bolted heel posts and iron straps, identical to the truss in building 02, it is likely, therefore that building 02 was re-roofed at the same time as the construction of building 03.

**Figure 24**  
Building 03 Roof Truss.

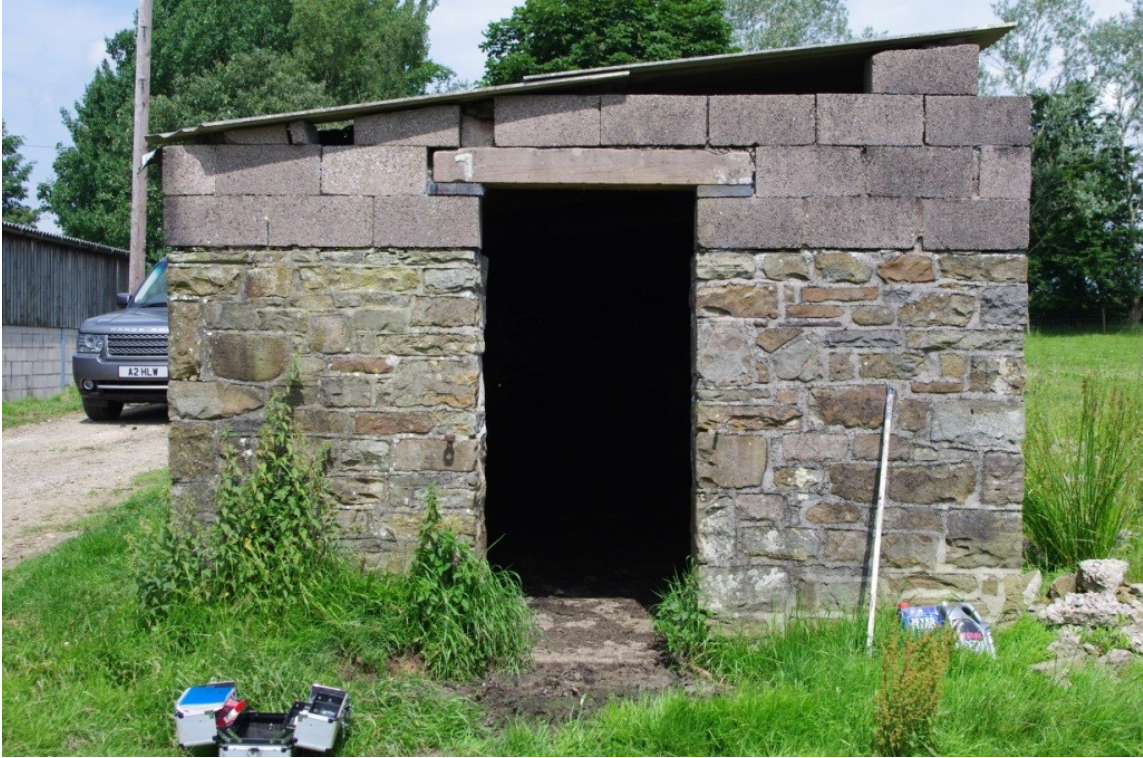
Building 04 is the final recorded building, located to the north of the farmyard (*Figure 10*). The rectangular rubble and block-built building has a mono-pitched corrugated asbestos cement sheet roof (*Figure 25*).

Cartographic evidence indicates the building dates to the mid to late 20th century. The average quality of the stonework along with modern materials and cement mortar pointing supports this evidence.

**Figure 25**  
Building 04 General View of Southern Gable (Looking North).
