**An Archaeological Standing Building Survey.
Tansor Grange,
Tansor,
Northamptonshire.**

**Planning Permission No
14/01620/FUL**

ABRS Project No 2014-TGWN

An Archaeological Standing Building Survey of Tansor Grange (outbuildings), Tansor Wold Road, Tansor, Northamptonshire (NGR TL 07039 90273).

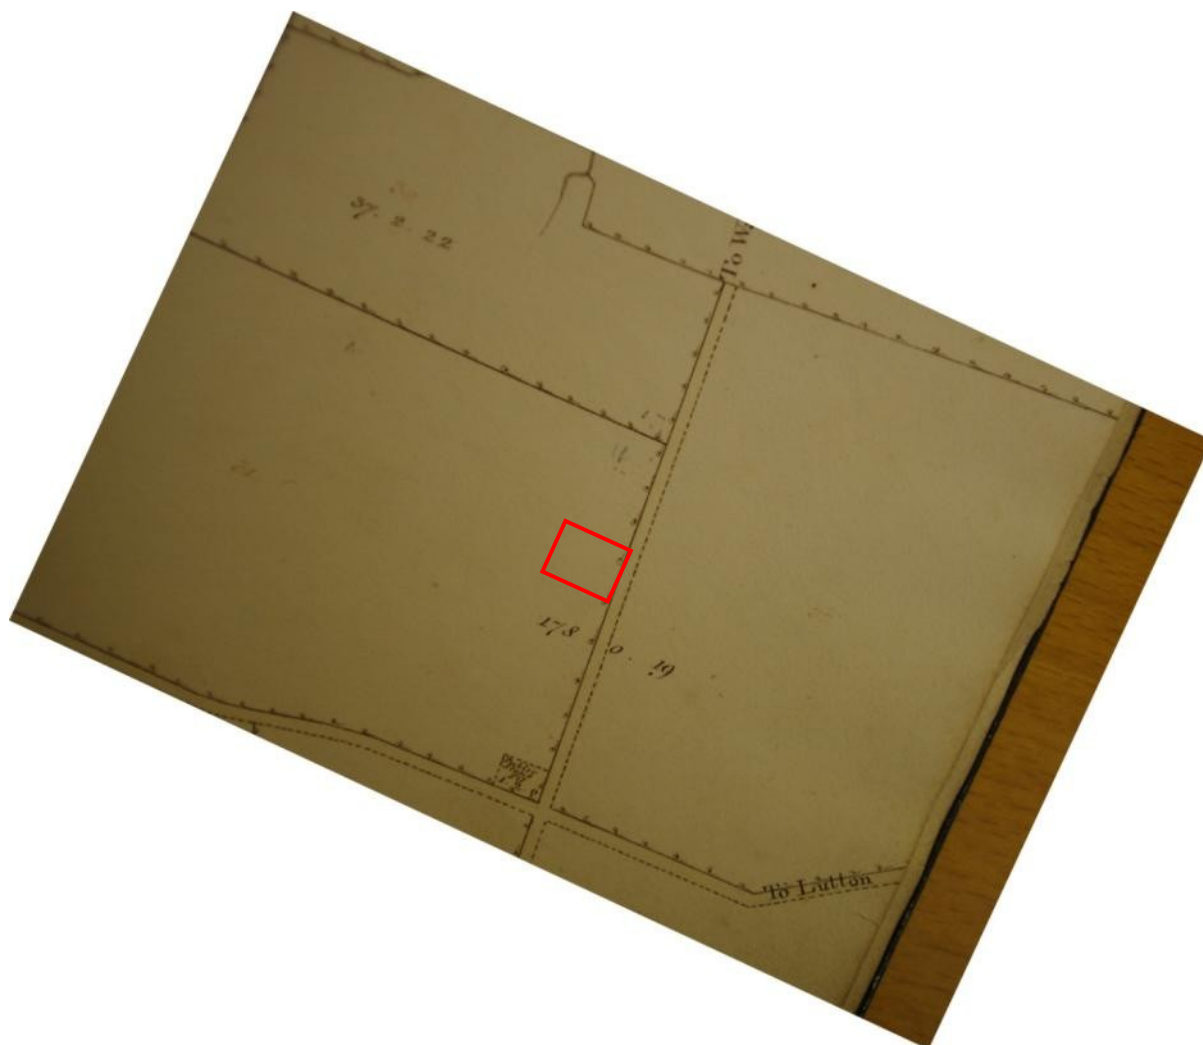
Figure 3

A Proportionate Valuation of the Messuages, Cottages & Lands in the Parish of Tansor 1830.
(Approximate Area of Tansor Grange Highlighted)

In 1830 “*A Proportionate Valuation of the Messuages, Cottages & Lands in the Parish of Tansor*” was made, with an accompanying map (*Figure 3*); the map appears to have been based upon the existing Inclosure Map and again contains no record of the buildings within the proposed development area, identified as 31. The accompanying valuation, however does record the farm and its buildings; the farm is owned by the Rev. C.A Wheelwright and was

tenanted by William Pitts. It is described as “Farm House, Buildings, Yard, Garden and Land”. Based upon these two pieces of information it is likely that Tansor Grange is an ‘Enclosure Farm’, built specifically on a virgin site following the Parish Enclosure. The farm however is not identified by name.

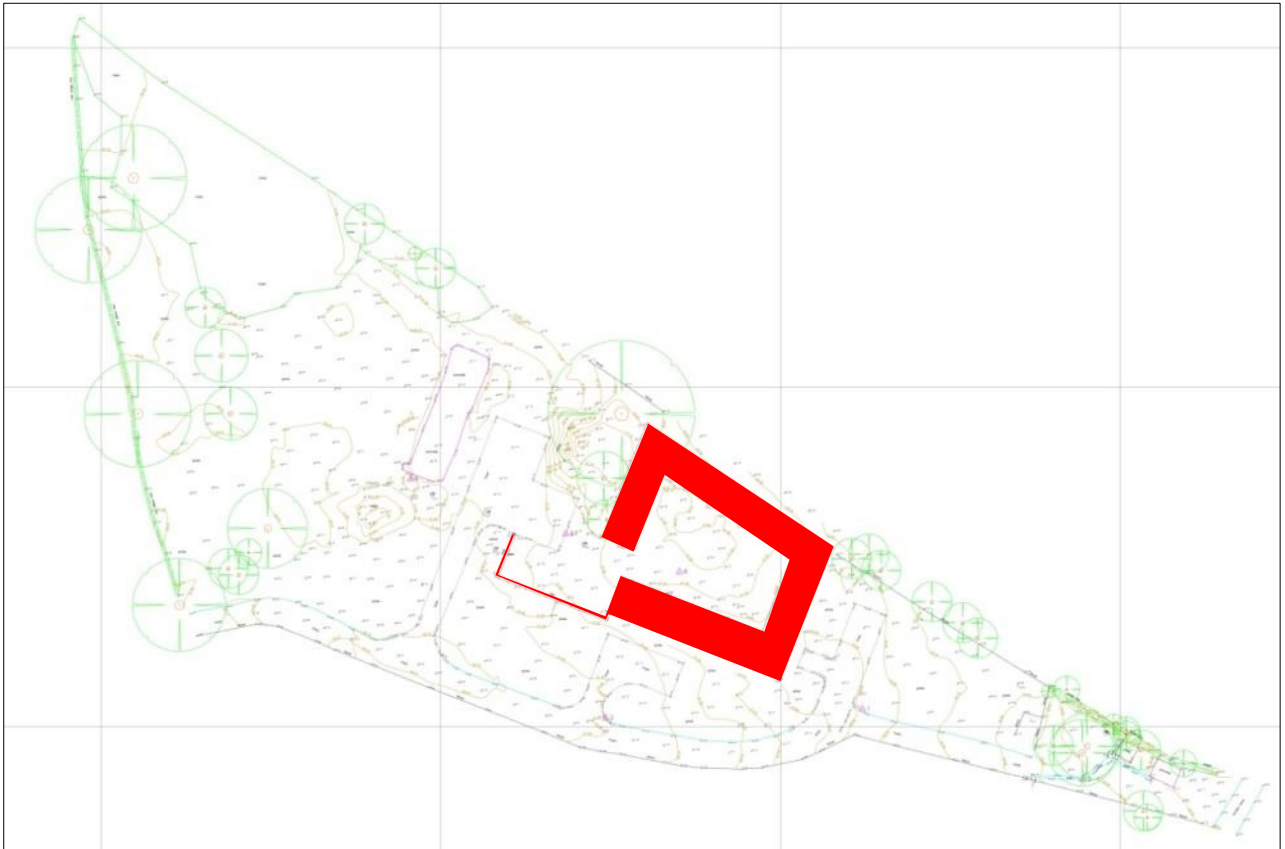
Figure 5
Plan of the proposed development area & Recorded Buildings in Red.
(Provided by client. Not to Scale).

Orientation: The building group subject to this historic building recording consists of two ‘L’ shaped ranges enclosing a central yard. The long axis is orientated west-north west – east-south east, the shorter axis is orientated north east – south west (*Figures 5 & 21*); for ease of description this is taken hereafter to be north to south and east to west with the principal elevations facing the central yard. Where the terms ‘left’, ‘right’, ‘front’ and ‘back’ etc are used in the report, this is in relation to these principal elevations as viewed from the yard. For the purposes of this historic building recording a letter prefix has been allocated to each building and a number suffix added for significant partitions where required.

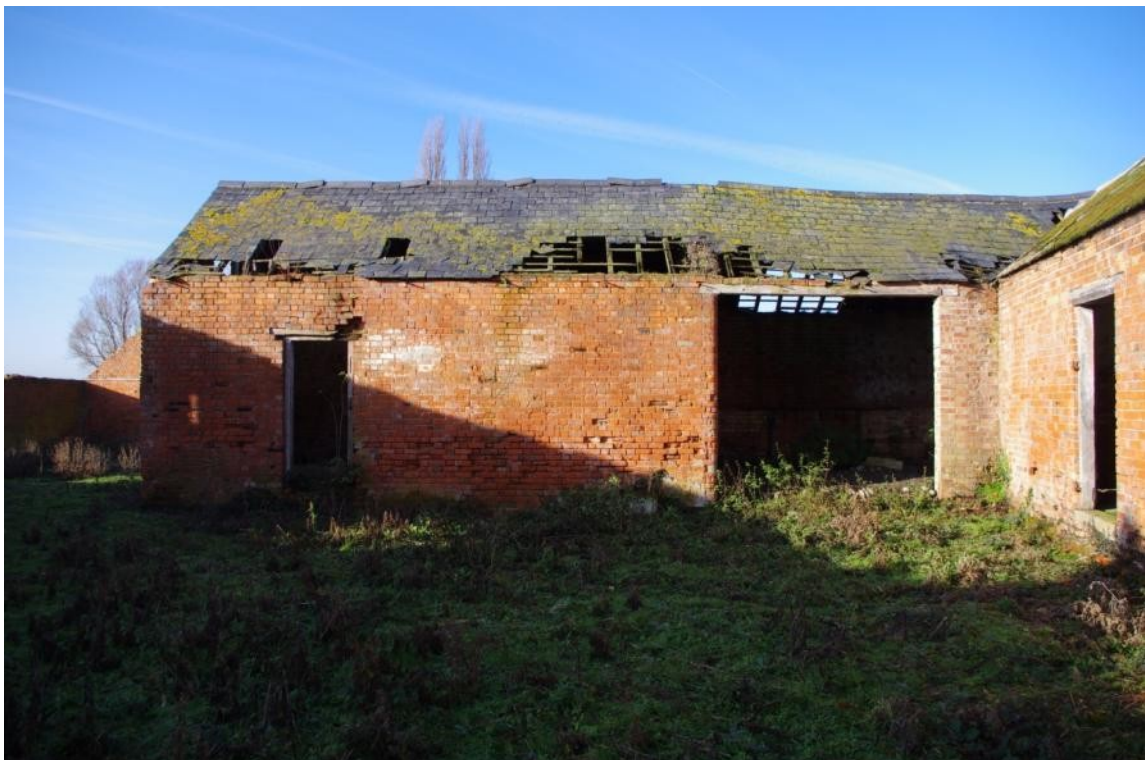
Figure 7
Building B Principal Elevation (looking West – North West).

Building B is located abutting the westernmost end of building A, aligned approximately north to south. There is no clear joint between the two, and it is likely that they are contemporary; however the unusual angle between the two (*Figure 21*) raises a doubt over this. The building again consists of three bays, the largest being the northernmost bay (1). Both bricks and bond are identical to A but the roof is clad in Welsh Slate.

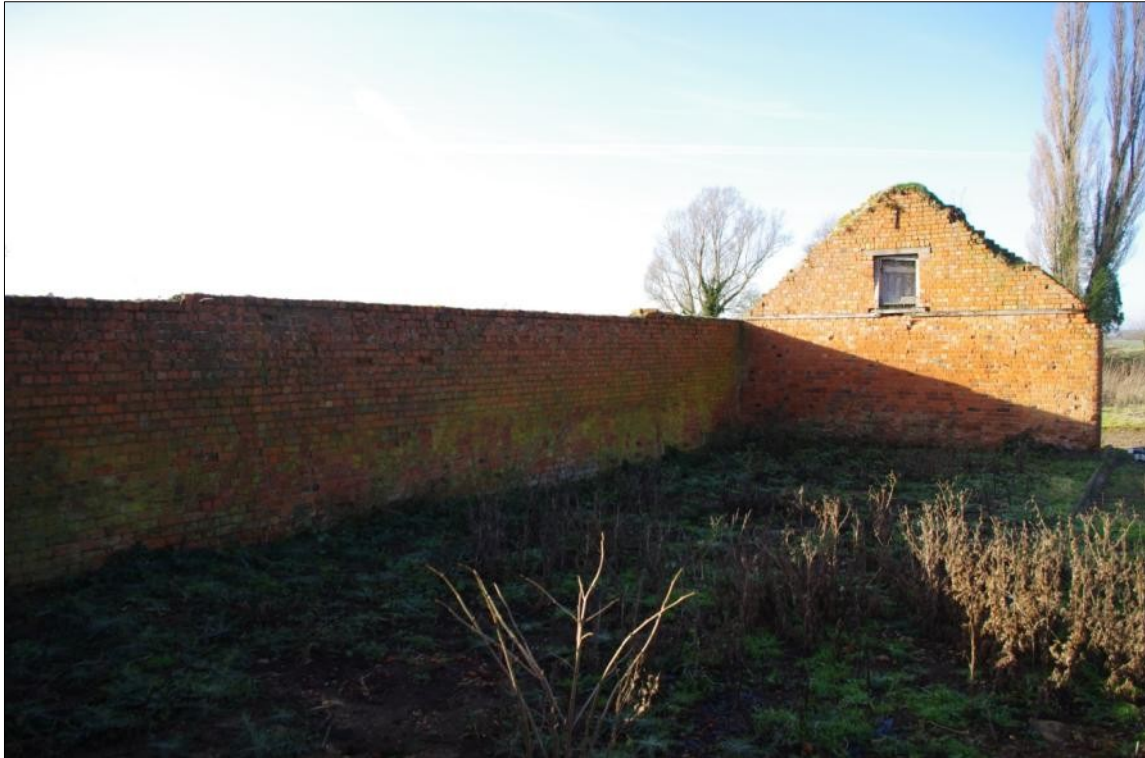
Figure 8
Building C General View (looking West – South West).

Building C is largely derelict and only the westernmost gable and rear (southern) wall remains, the easternmost gable is the gable of building D, to the east. There is a clear straight joint in the brickwork indicating that D pre-dates C. The remaining walls are red brick-built and the gable wall indicates the building originally had a pitched roof. The bricks themselves are 3 x 9 x 4 inch laid in a Dutch bond (alternate courses of header and stretcher bricks) with lime mortar cement. There is a pitching hole on the west gable (*Figure 8*), but no further indication as to the original plan form or use of the building. The height of the gable indicates that the building was unlikely to have been a barn, and in all likelihood was another stock rearing shed, possibly an open fronted cow hovel, this appears to be indicated on the second edition Ordnance Survey (*Figure 4*) and explains the lack of any evidence of a front (north) wall.

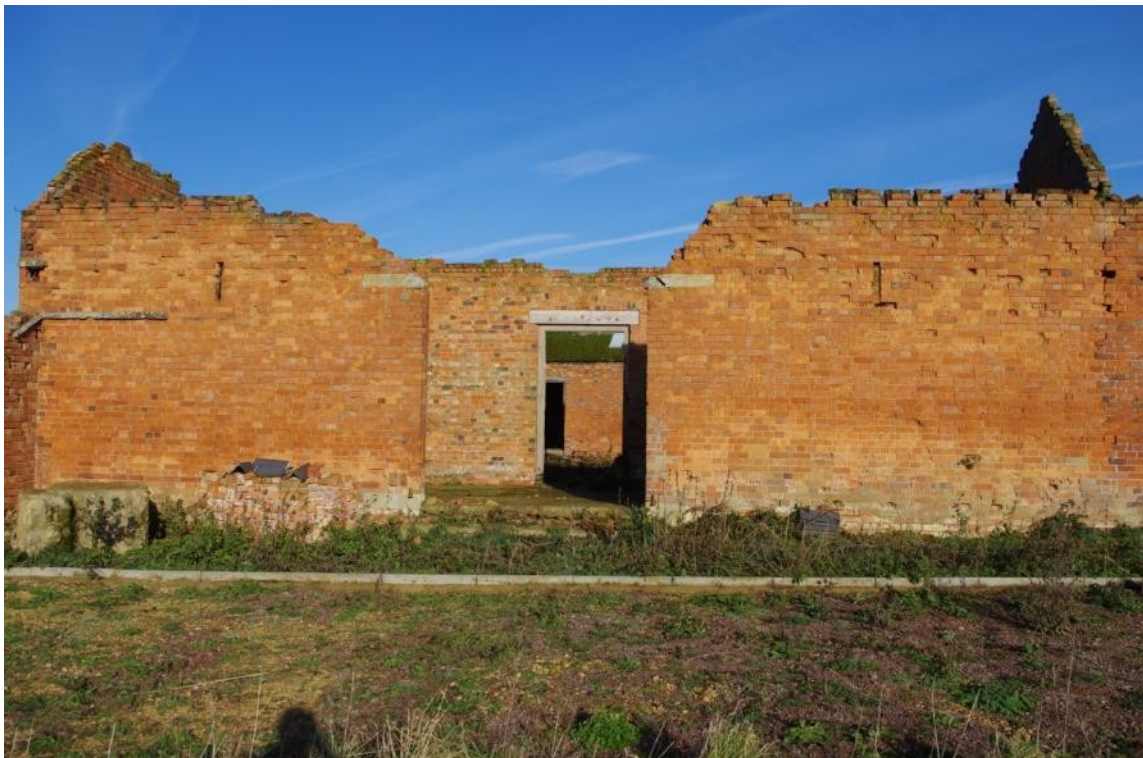
Figure 9
Building D South Facing Elevation (looking North East).

There is an opening on each of the long elevations, the southernmost is the larger of the two and appears to have originally been a threshing or cart door (*Figure 9*), and there are sandstone hinge pads as well as cast iron pintles. The northernmost door, opening into the yard is smaller with flat cambered brick arch head over. Given the apparent pastoral nature of the buildings it is likely that the building was originally a feed store, feed entered the large southern door and was distributed to the livestock in the yard through the smaller northern door.

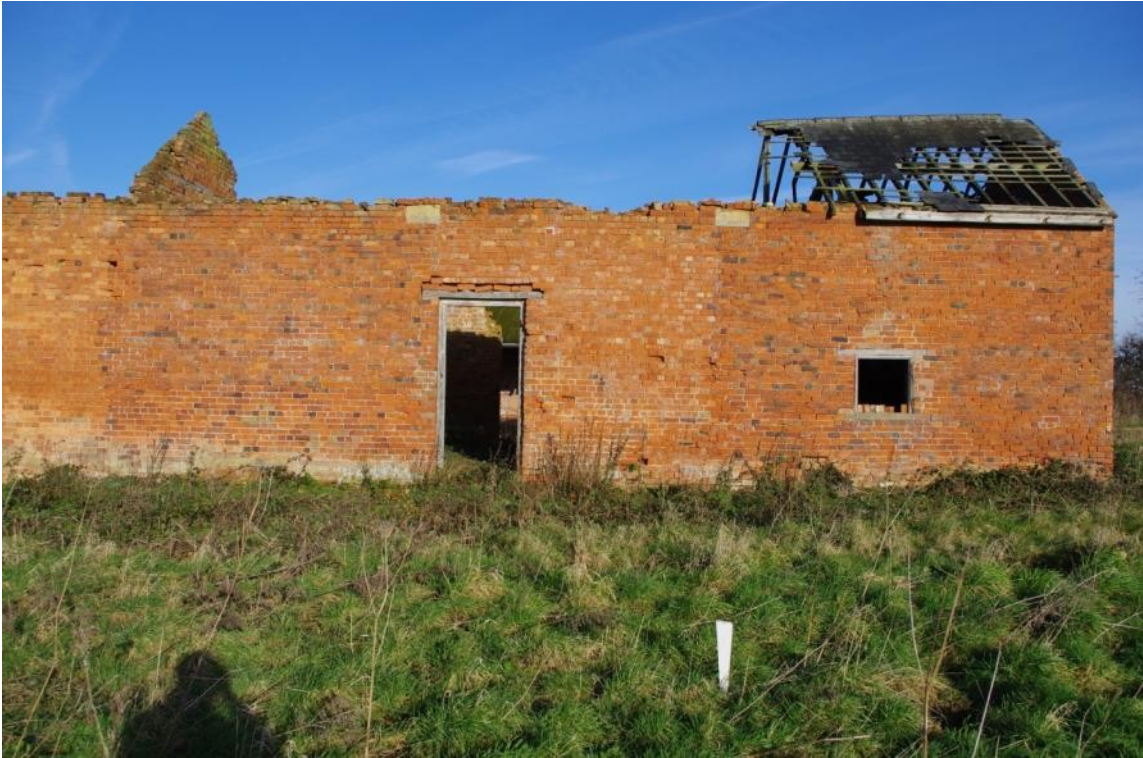
Figure 10
Building E South Facing Elevation Showing Blocked Threshing/Cart Door (looking North East).

The door has been reduced in size with brick infill, the sandstone hinge pads, however can still be seen giving an indication of the original dimensions of the door (*Figure 10*), there is a smaller door on the northern elevation giving access to the yard, in all likelihood the building had a similar function to D. There is a small window opening on the southern elevation to the east of the door as well as a loft door on the east facing gable (*Figure 11*).

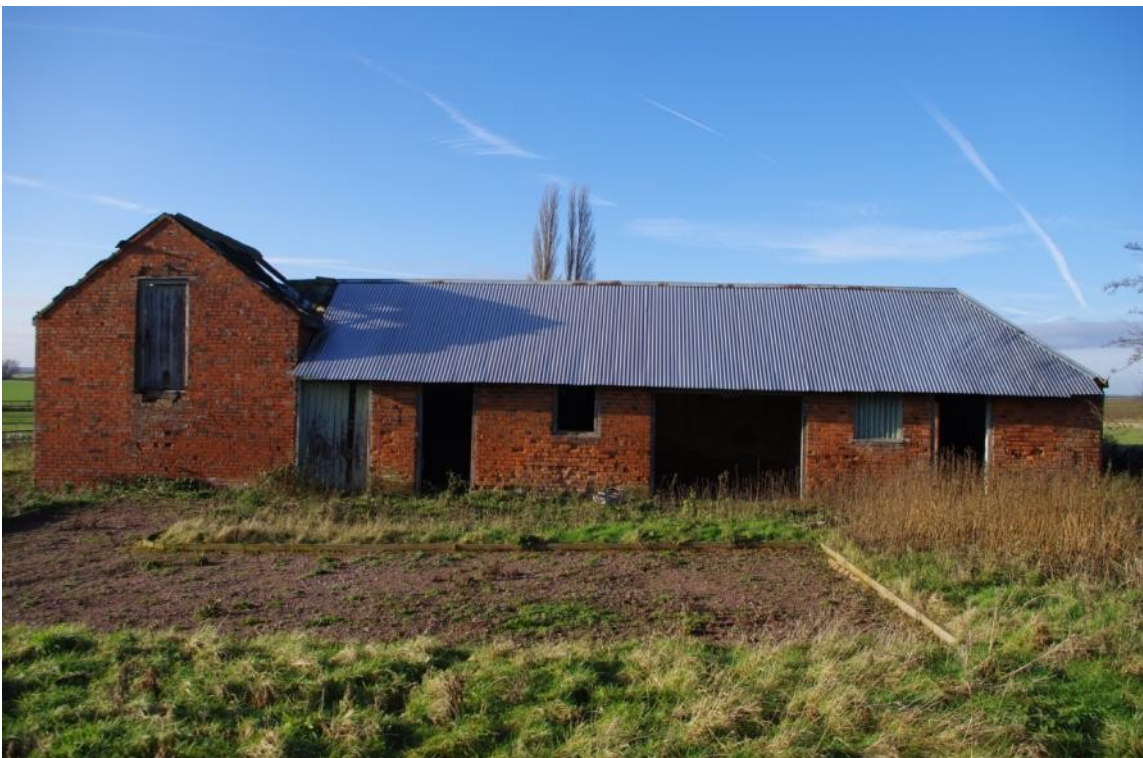
Figure 11
Building E Principal Elevation (looking West – North West).

Building F is the final recorded building and closes the easternmost end of the yard, unlike the previous buildings; its principal elevation is undoubtedly facing the Grange to the east, with its 'back' to the yard (*Figures 11 & 21*). The red brick-built building consists of three bays with a cross passage to the south between it and building E. The bricks themselves are 2 ¾ x 9 x 4 inch laid in a double Flemish bond (alternate header bricks and stretcher bricks in *each* course) in lime mortar, the roof is clad in corrugated tinned sheets.

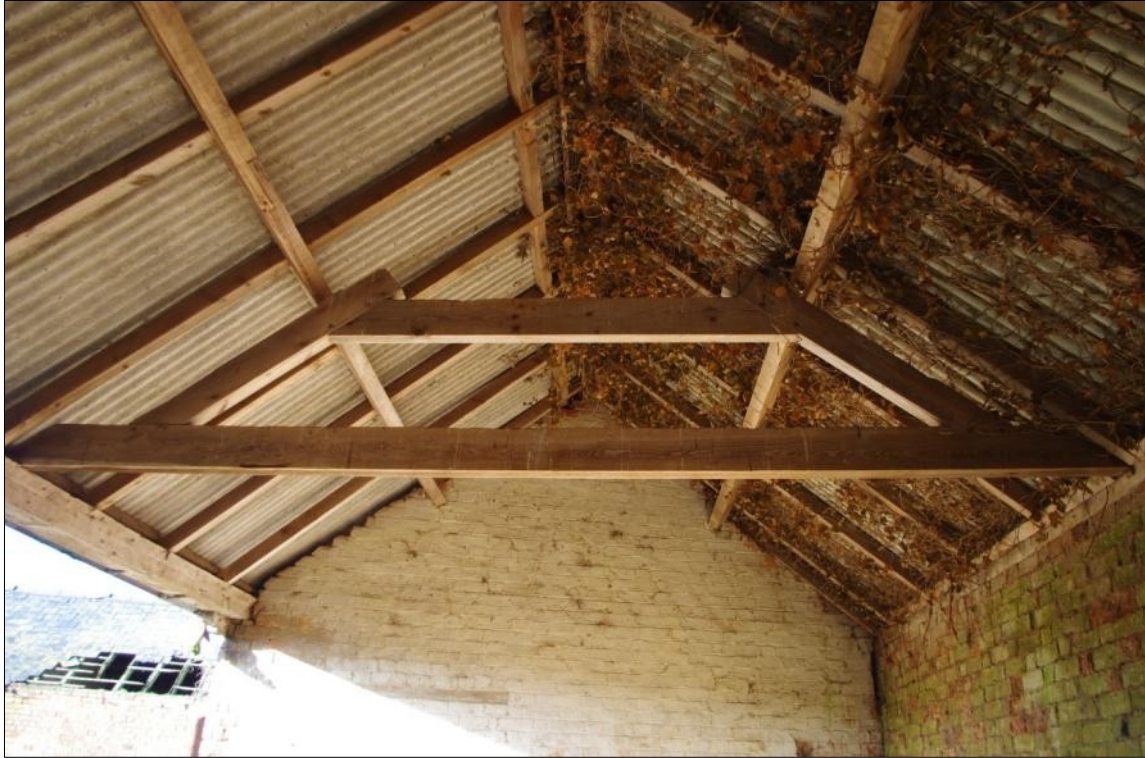
Figure 12
Building A Truncated Principal Rafter Truss.

Both of these western bays have brick floors. The roof is carried on five truncated principal rafter trusses (*Figures 12 & 21*), all in deal carrying paired purlins. Interestingly, despite the apparent age the trusses are pegged. The corrugated asbestos cement sheet roof is almost certainly not original. There is a small opening roughly inserted into the principal elevation of (3) at ground level, it is likely this opening was added after the building ceased being used for cattle rearing and was, in all likelihood used to keep poultry, hence the small ground level opening.

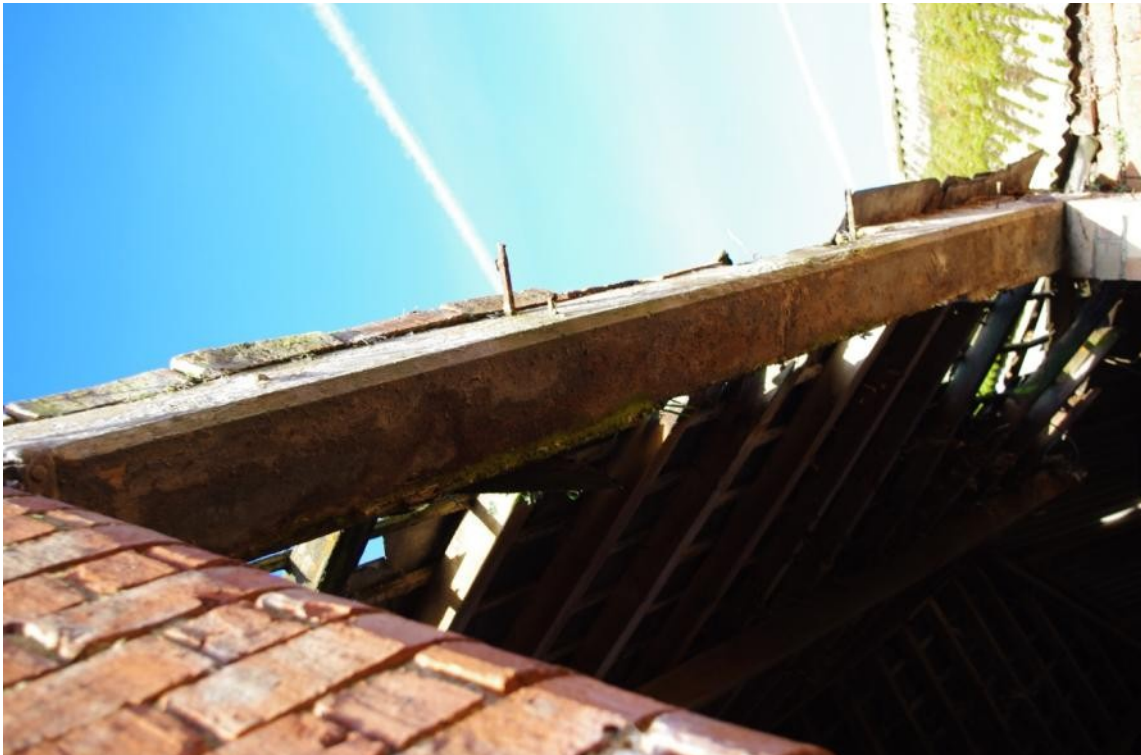
Figure 15 Building B Chamfered and Stopped Lintel.

The northernmost bay (1) is largely open fronted, the lintel, like the post discussed earlier is chamfered with run out stops (*Figure 15*), again an extravagant touch for an agricultural building. Internally, there is a brick-built manger along the rear (west) wall with tethering for 8 or 16 beasts. The floor is pitched stone (*Figure 14*) and the roof is carried on paired purlins, in deal. To the south is a smaller central bay (2) with no external access, the bay has a brick floor and saddle trees on each gable wall, probably a tack or feed store. The southernmost bay, (3) again has a brick floor and external access on both the principal elevation and the southernmost gable, as well as access to (2). The gable door has the same chamfered and stopped head seen previously, confirming that this was as design rather than simple re-use of an existing chamfered door frame. Once again there is a roughly inserted opening at ground level in the rear elevation (*Figure 16*), like A(1), discussed above it is likely that this bay was also used for poultry keeping when not longer used for stock rearing.

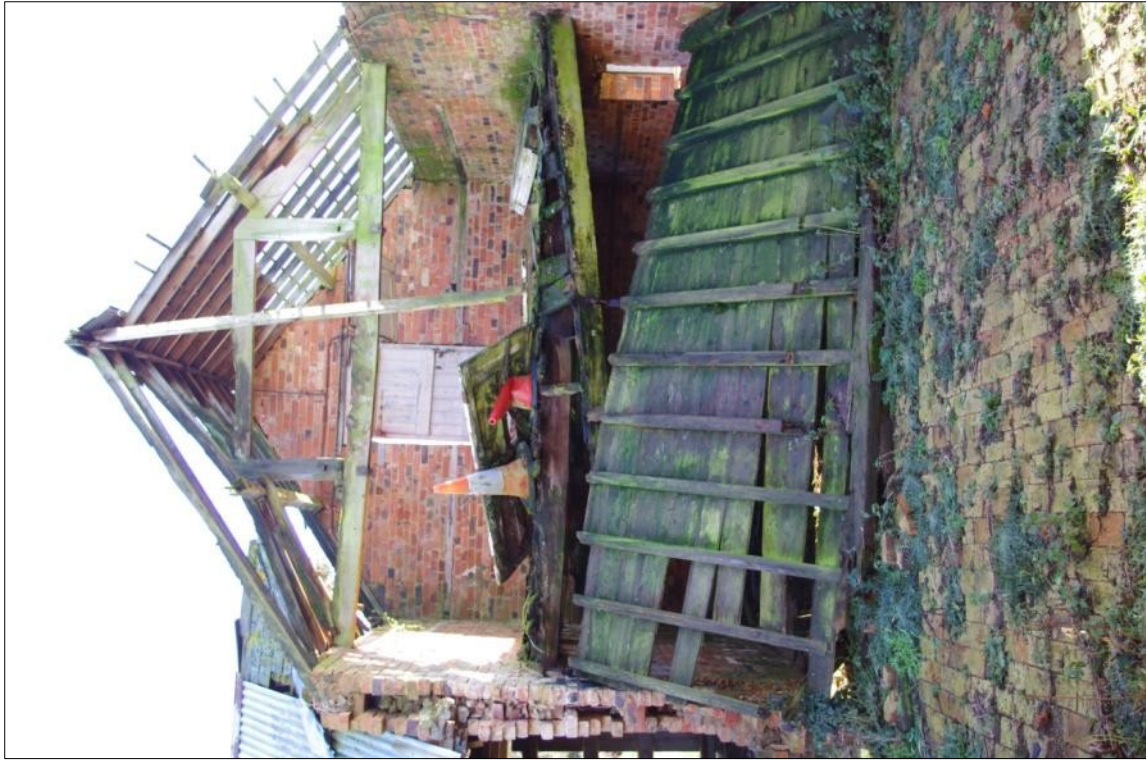
Figure 18 Building E Queen Post Truss & Remains of Loft Over Easternmost Bay.

There are the limited and precarious remains of the roof structure as well as a loft over the easternmost bay. There is a single remaining Queen Post truss with stirrup straps carrying paired purlins (*Figure 18*). The loft is also timber-built and originally separated from the central bay by a timber screen (now collapsed outwards); the only apparent access to this loft was via the loft door on the east gable.

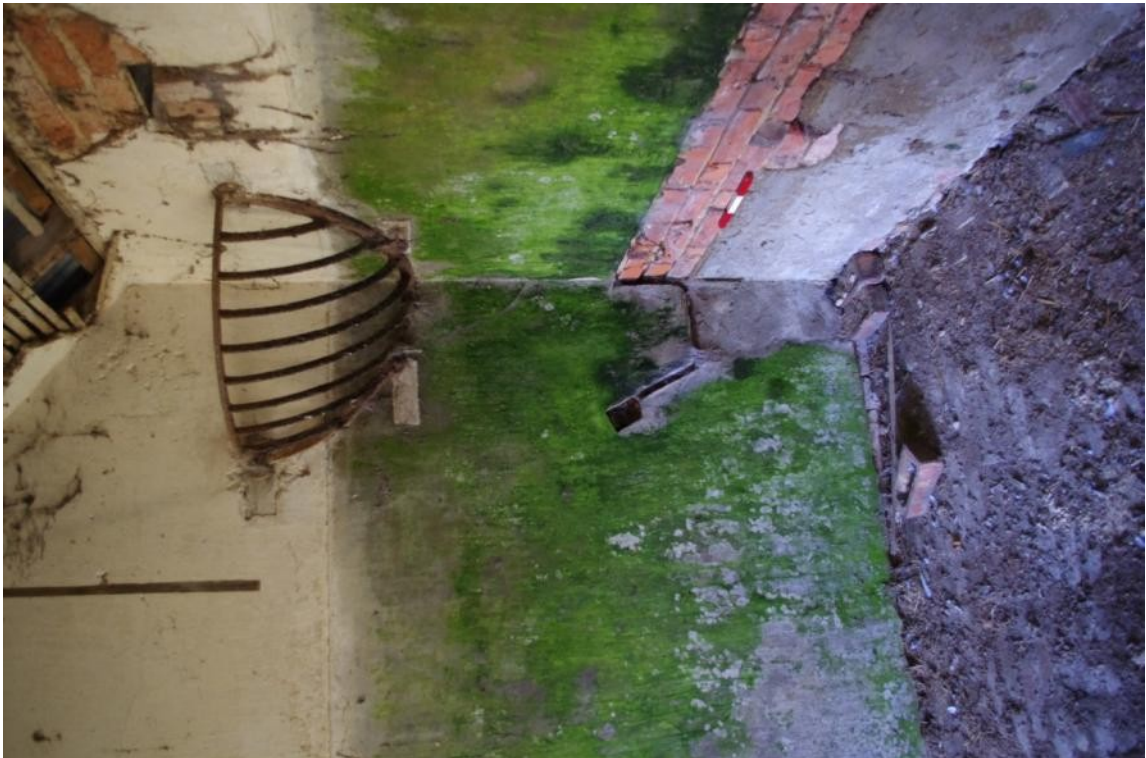
Figure 19 Building E (1) Rendered Finish, Outline of Manger & Hay Rack.

The southernmost bay, (1) has a single door on the east facing elevation at the southern end of the bay, internally there is brick floor with a central covered drain (now damaged and exposed) and the outline remains of two stalls visible on the rear (west) wall, there is also a single corner hay rack in the south west corner (*Figure 19*), it is likely that there was originally a second in the opposite corner. Unlike the previous buildings, this bay has painted lime mortar rendered walls as well as a plaster and lath ceiling. These both indicate the bay was originally stabling for two horses, its aspect, facing the Grange, not the yard indicates the horses stabled here were riding or carriage horses, not working horses and were kept separate from the working farm. To the north is (2) also rendered and painted, there is a large carriage door on the eastern elevation, again facing the Grange. Internally, there is a modern poured concrete floor and a saddle tree on the south wall (*Figure 20*); in all likelihood this bay was originally a carriage house for the Grange, as opposed to a cart shed for the farm.

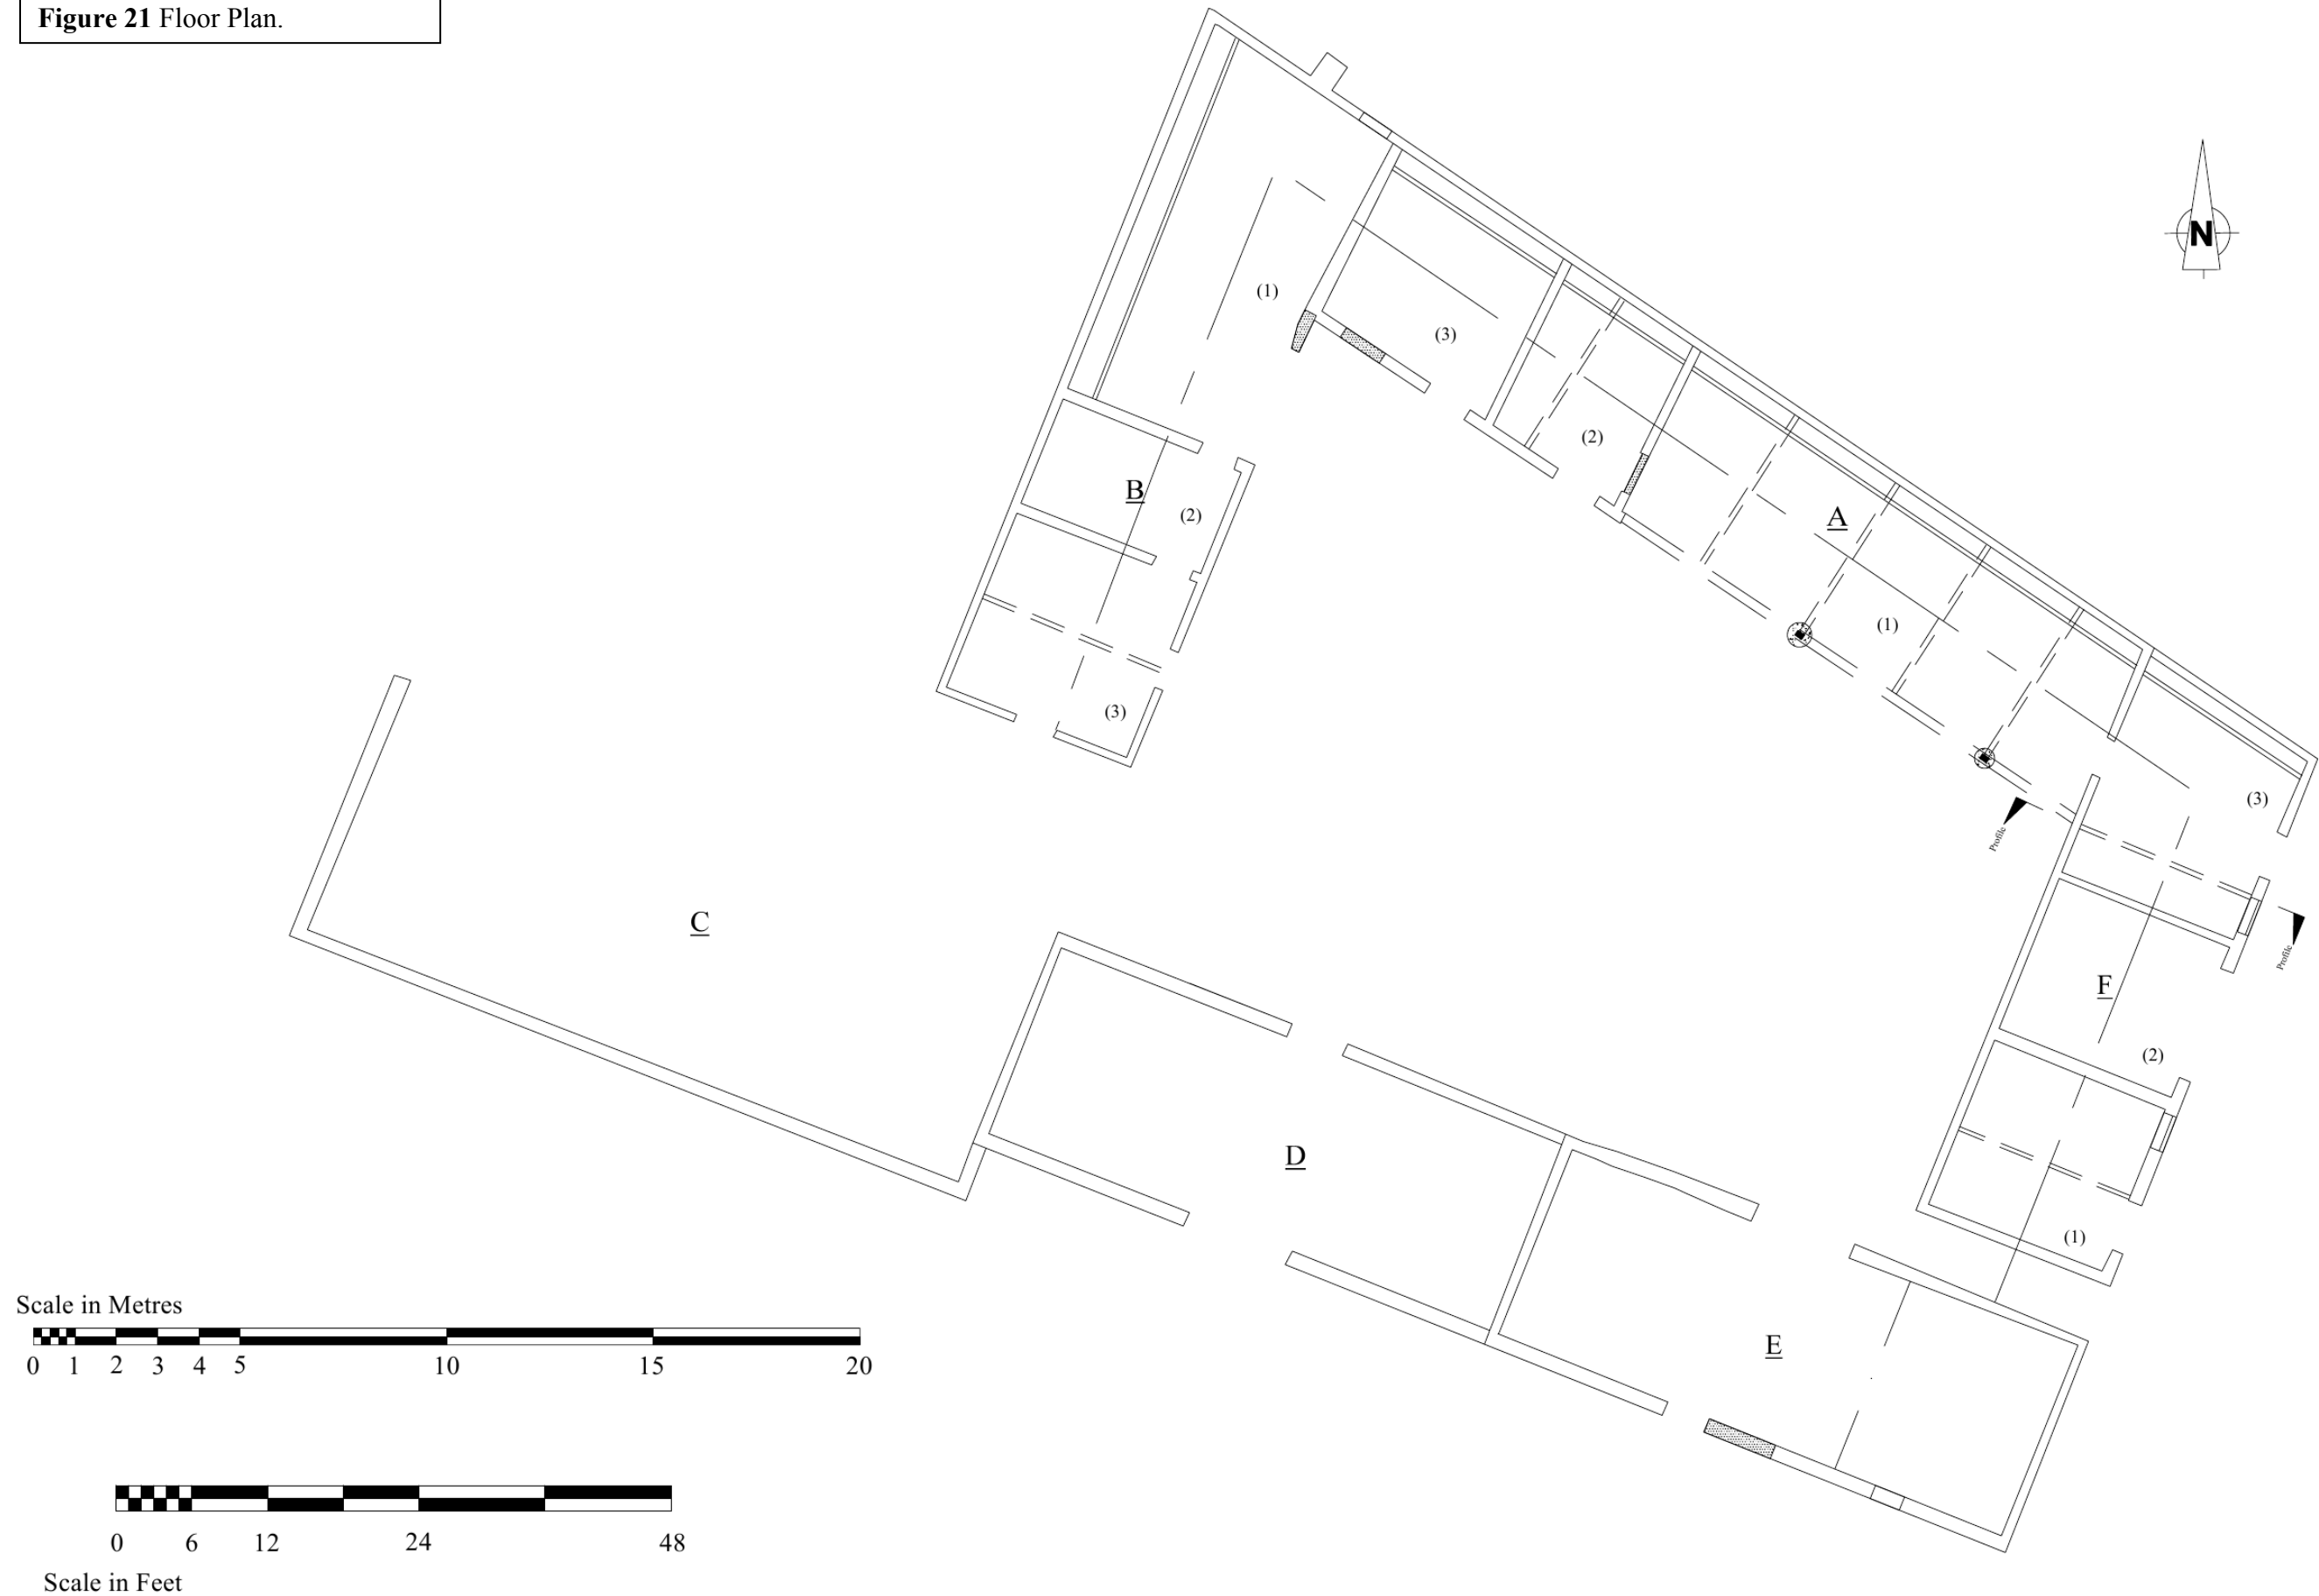
Figure 21 Floor Plan.

Building A forms the northernmost range of the yard (*Figure 21*) the range consists of three bays fronting the yard to the south, the largest (1) is an open fronted 3 bay structure, almost certainly a cow hovel. The building is brick-built under a corrugated asbestos cement sheet roof; the bricks themselves are 3 x 9 x 4 ¼ inch laid in a double Flemish bond (alternate header bricks and stretcher bricks in *each* course). The wall plate of the open front is carried on two oak post sat atop sandstone staddle stones, largely encased in modern concrete, unusually for a farm building the posts are chamfered with run out stops (*Figure 13*), an extravagant finish for a cow hovel. Internally there is a brick-built manger along the rear (north) wall, a number of original tether rings remain attached to the manger and there is space for 8 or 16 beasts (if tethered singularly or in pairs). To the west are two loose boxes (2) and (3), both have brick-built mangers on the rear wall and a single door on the principal elevation, one of which, (2) has a chamfered and stopped head. There is a blocked opening to the west of the current opening of (3); this appears to have been carried out early in the building's history as the bricks are very similar in appearance to those used for the walls. There is also a blocked opening between (2) and (1); this opening appears to have only recently been blocked, the infill being the ubiquitous 20th century Fletton brick.
