**An Archaeological Standing Building Survey.  
12 Harbidges Lane  
Long Buckby  
Northamptonshire**

**December 2016**

**ABRS Project No 2016-HLBN**

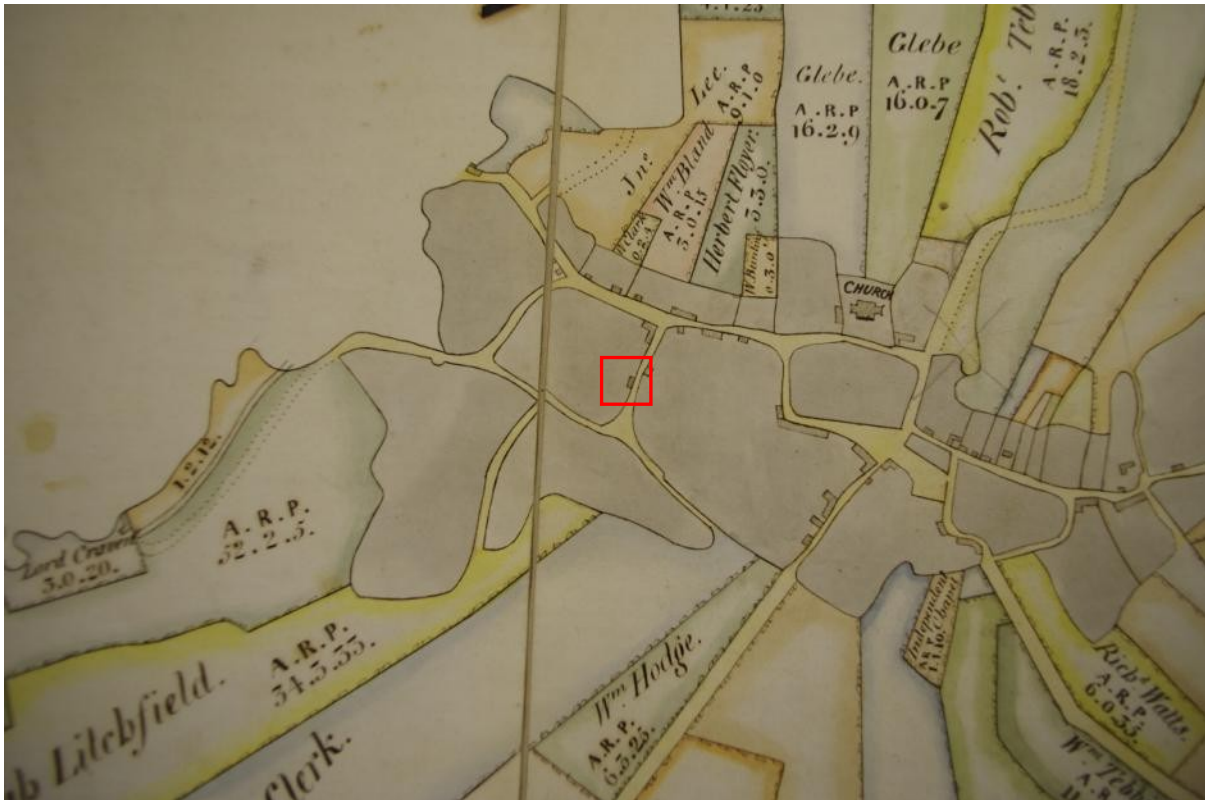
**Figure 2**  
1844 Copy of 1765 Enclosure Map.

One of the earliest available maps showing the proposed development area is an 1844 copy of the 1765 enclosure map (*Figure 2*). The village core is clearly identifiable, as is the unnamed Harbidges Lane. A building, likely to be 10-12 Harbidges lane is recorded in the approximate location of the proposed development area; however it does not match the current footprint of 10-12 Harbidges Lane, which is “L” shaped, with the northernmost range being gable on to the street. There is no indication of any outbuildings to indicate the recorded buildings were standing at the time of enclosure.

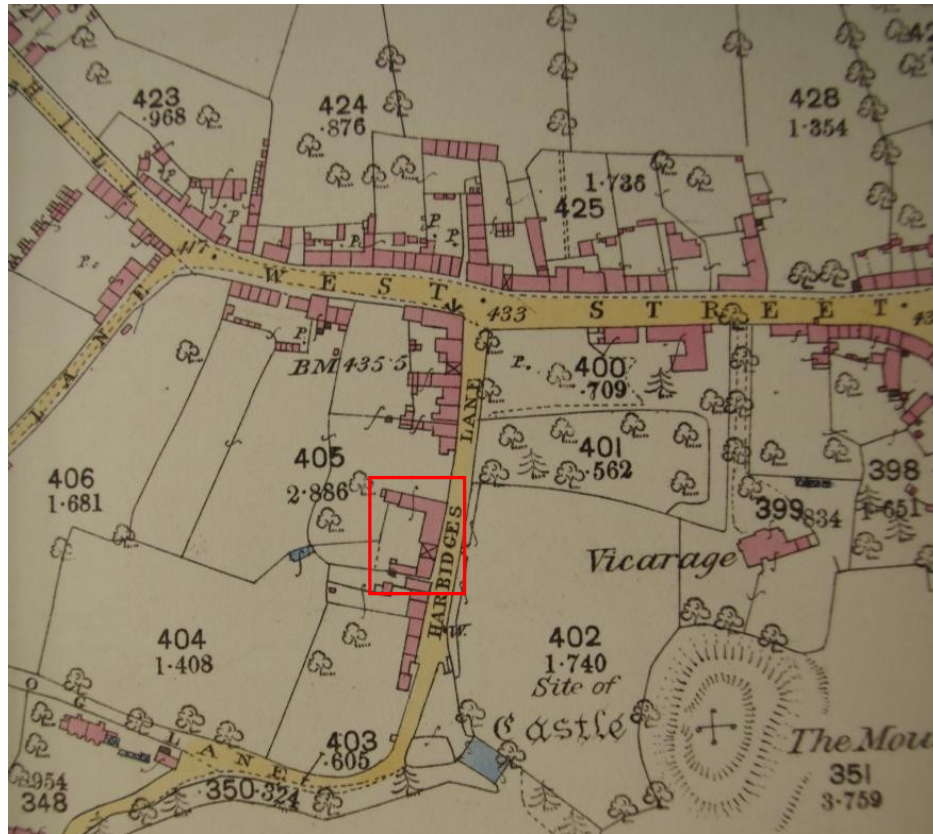
**Figure 3**  
First Edition Ordnance Survey (1885).

The first edition Ordnance Survey (*Figure 3*) recording Long Buckby was surveyed and published in 1885. The map is the first to clearly record outbuildings to the south of the proposed development area, potentially including those subject to this historic building recording. The map shows a covered entrance between 10-12 Harbidges Lane and an “L” shaped building to the south, which has a small projecting bay at its west end. This covered entrance is confirmed by an early 20th century photograph of the building when it was in use as a pub called The Engine Inn (*Figure 4*), evidence of the covered entrance can just be seen in the top left had corner.

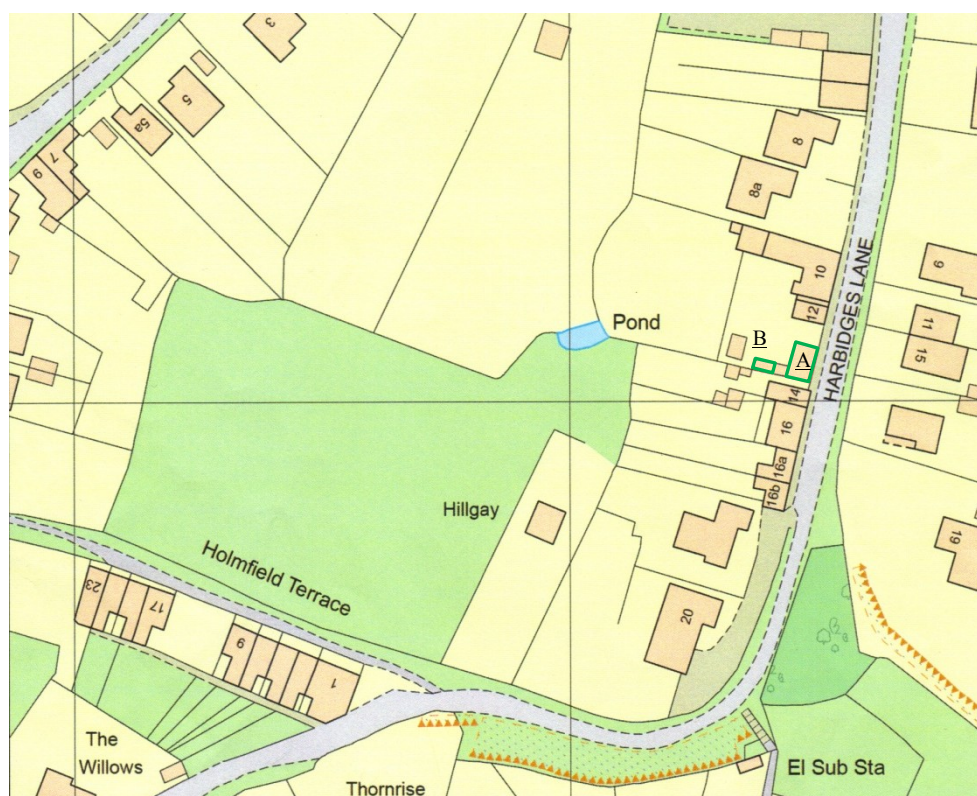
**Figure 5**  
Plan of the Proposed Development, Recorded Buildings in Green.

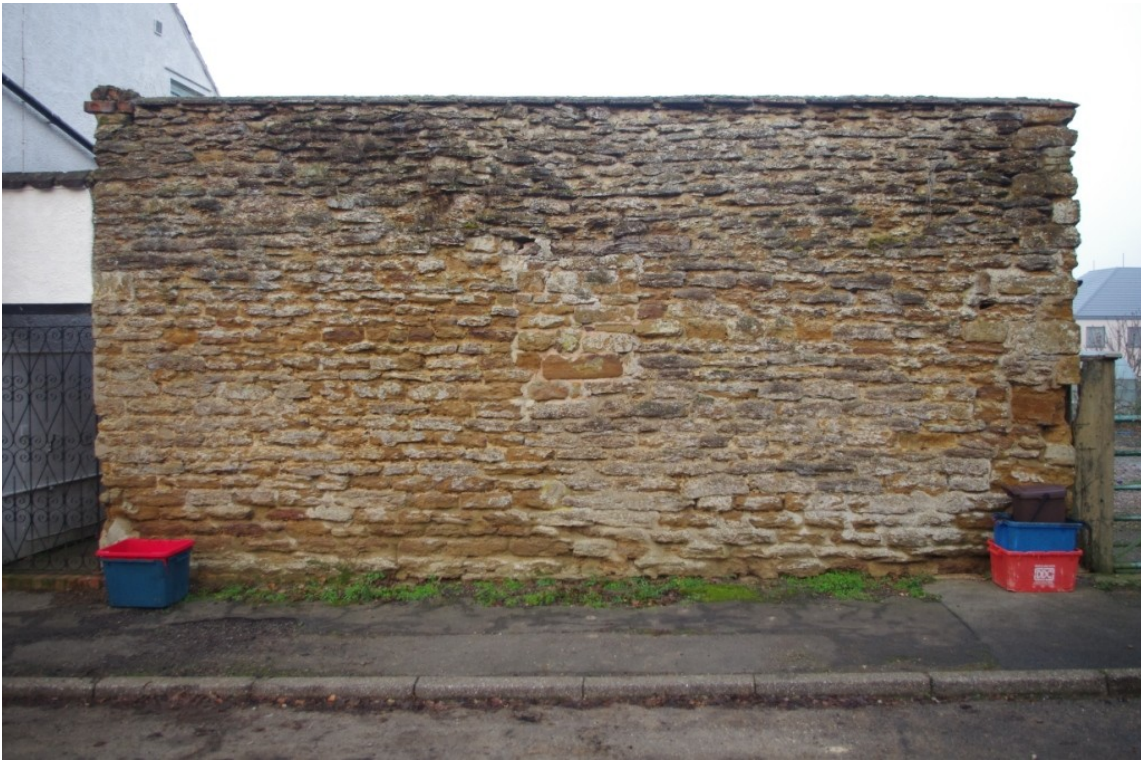
Building A occupies the south easternmost corner of the proposed development area, fronting Harbidges Lane (*Figure 17*). The building is single storey under a lean to roof of corrugated asbestos cement sheets. It is largely built of coursed local stone rubble (*Figure 6*) with some brickwork. There is clear quoinwork on the north easternmost corner, suggesting this may be retained from an earlier building (*Figure 7*), there is no evidence of similar quoinwork on the south east corner, suggesting this part has been extensively rebuilt. The southern wall has been raised with the addition of 13 courses of red bricks.

**Figure 6**  
Building A Harbidges Lane Elevation (Looking West - North West).

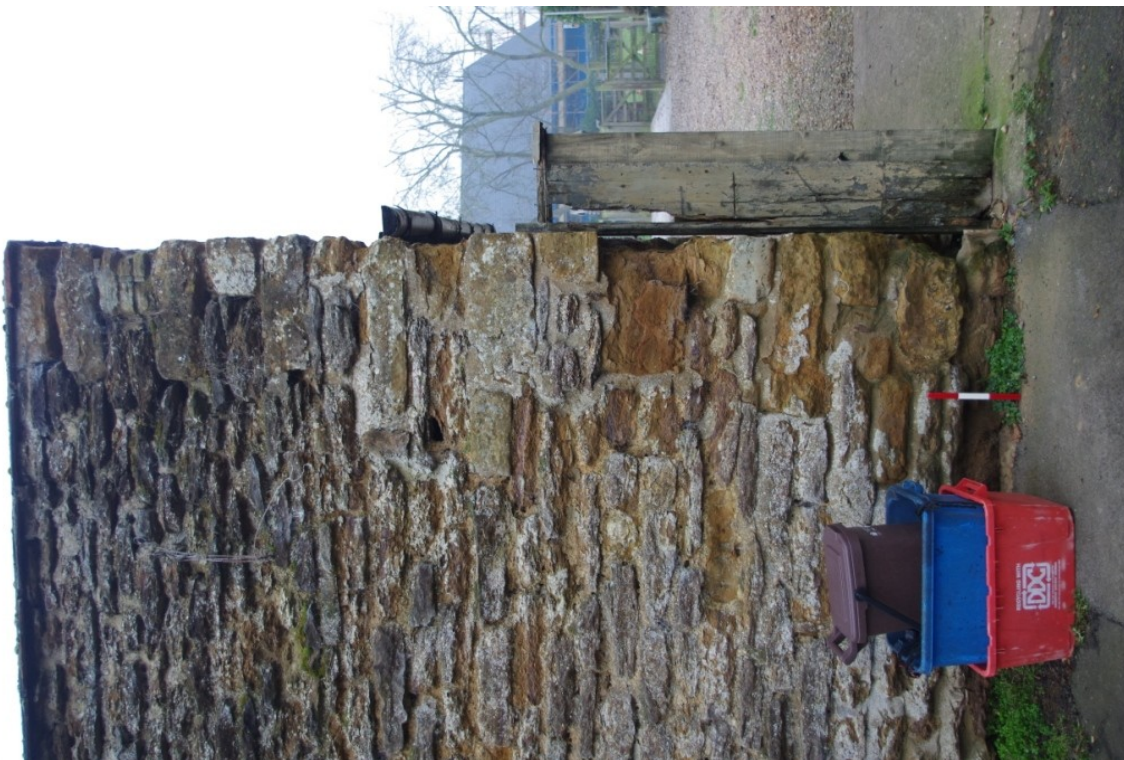
**Figure 7**  
Building A Quoinwork on North East  
Corner.

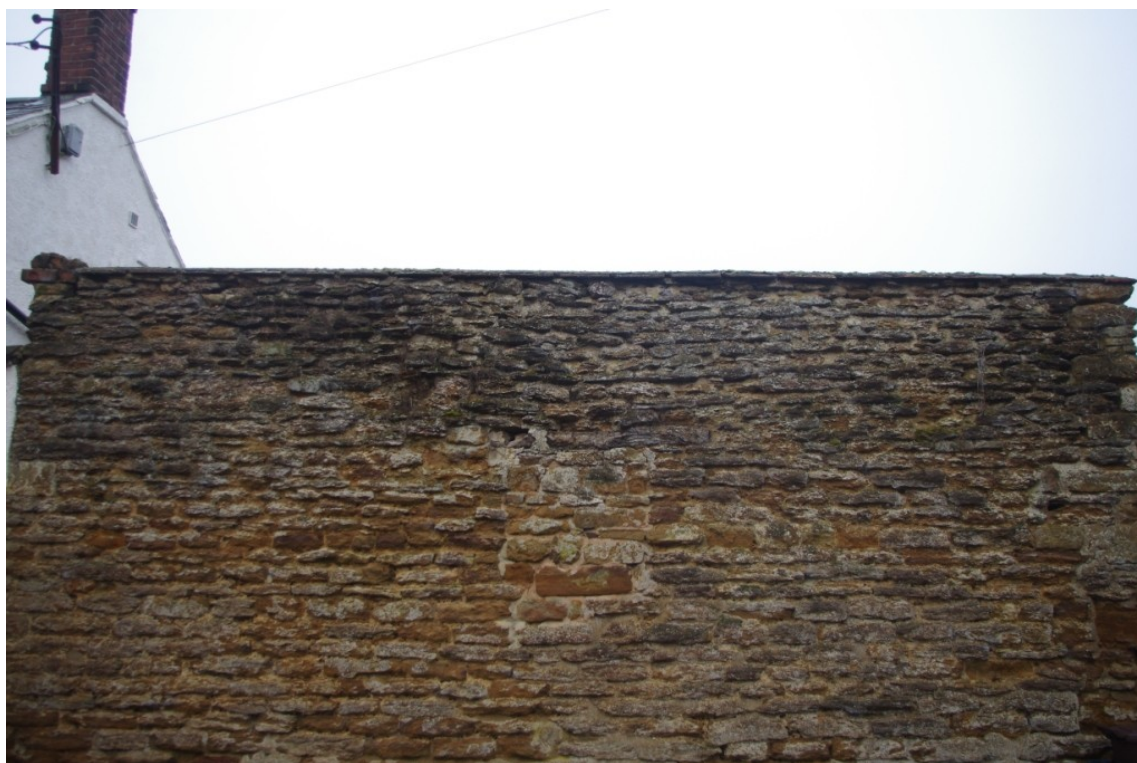
There is evidence of a blocked window towards the centre of the Harbidges Lane elevation, above which are the remains of a timber lintel (*Figure 8*). There is clear evidence that the upper part of this elevation has been rebuilt with between 6 and 9 courses of poorly laid rubble in cement mortar (*Figure 8*).

**Figure 8**  
Building A Harbidges Lane Elevation Showing Replaced Upper Courses & Blocked Window.

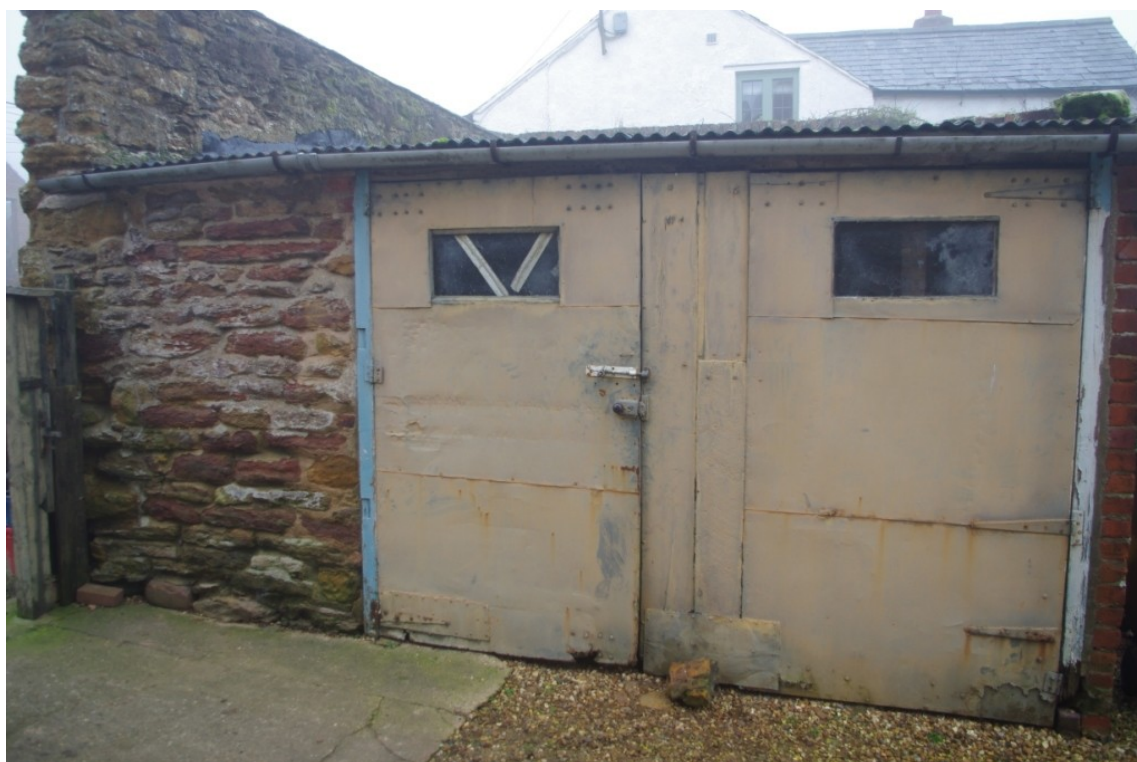
The north facing wall consists largely of a 20th century double door. The straight joint between the north and east walls indicate the two are not contemporary, it is likely that the northern wall is a later build. A number of the stones show clear signs of burning (fire reddened stones (*Figure 9*)), such burning is not seen elsewhere on the building, further evidence that this wall is later, potentially using salvaged stone.

**Figure 9**  
Building A North Facing Elevation Showing Door & Fire Reddened Stones (Left).

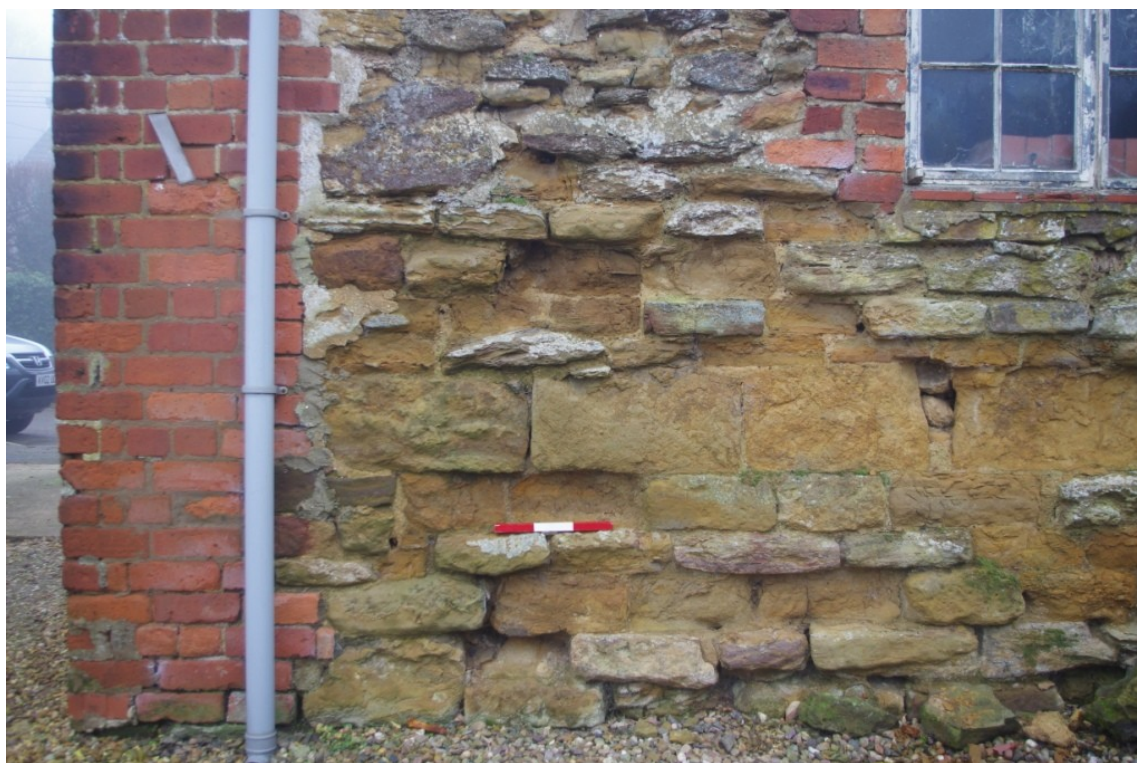
The westernmost wall contains evidence of a number of potential building phases. The lowest courses in the north western corner consist of a single course of ashlar-like blocks, similar to that seen in 10-12 Harbidges Lane (*Figure 10*). It is possible, therefore that this area is a remnant of the earlier building. The remainder of the stonework within the elevation consists of coursed local rubble, similar to that seen on the Harbidges Lane elevation. The elevation also contains a centrally placed Crittal style casement window, which is likely to be mid 20th century in date and confirms the 1951 construction date. The window is within a brick-built reveal. There are also up to 13 courses of red bricks in cement mortar up to eaves height.

**Figure 10**  
Building A Ashlar Blocks & Narrow Courses on West Facing Elevation.

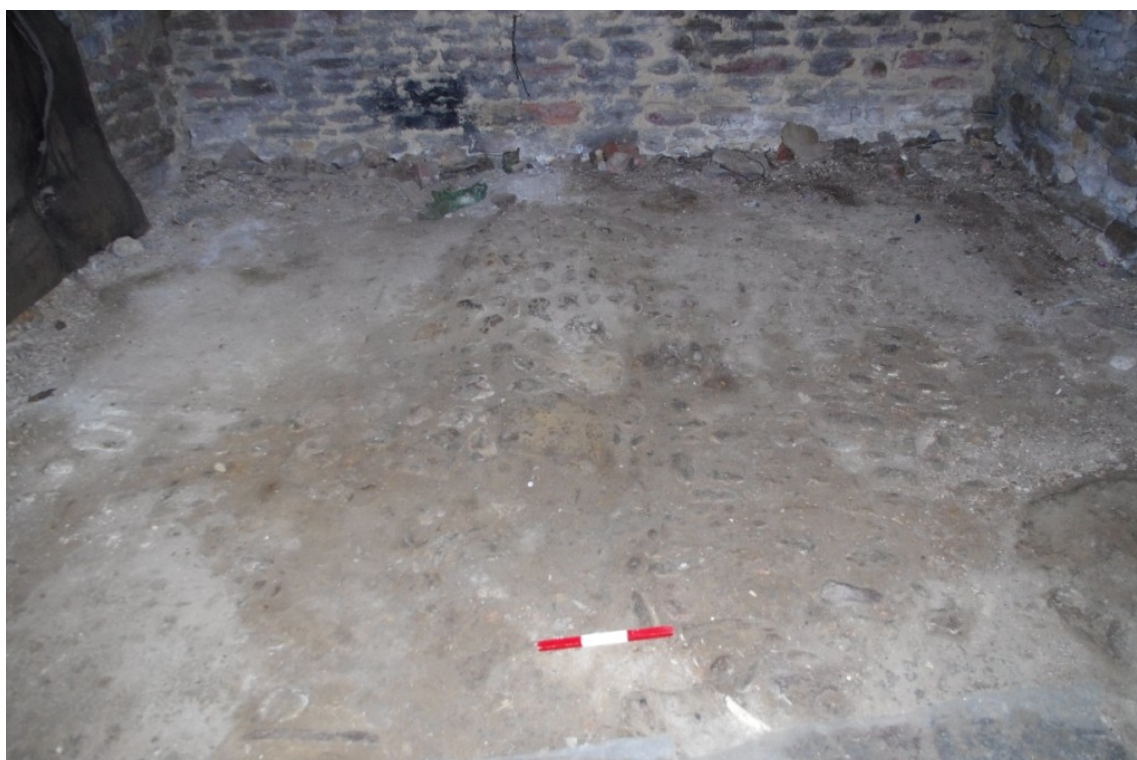
Internally, the building contains nothing of architectural or historical significance. The roof is carried on modern deal purlins, there are isolated areas of pitched stone flooring (*Figure 11*).

**Figure 11**  
Building A Pitched Stone Floor.

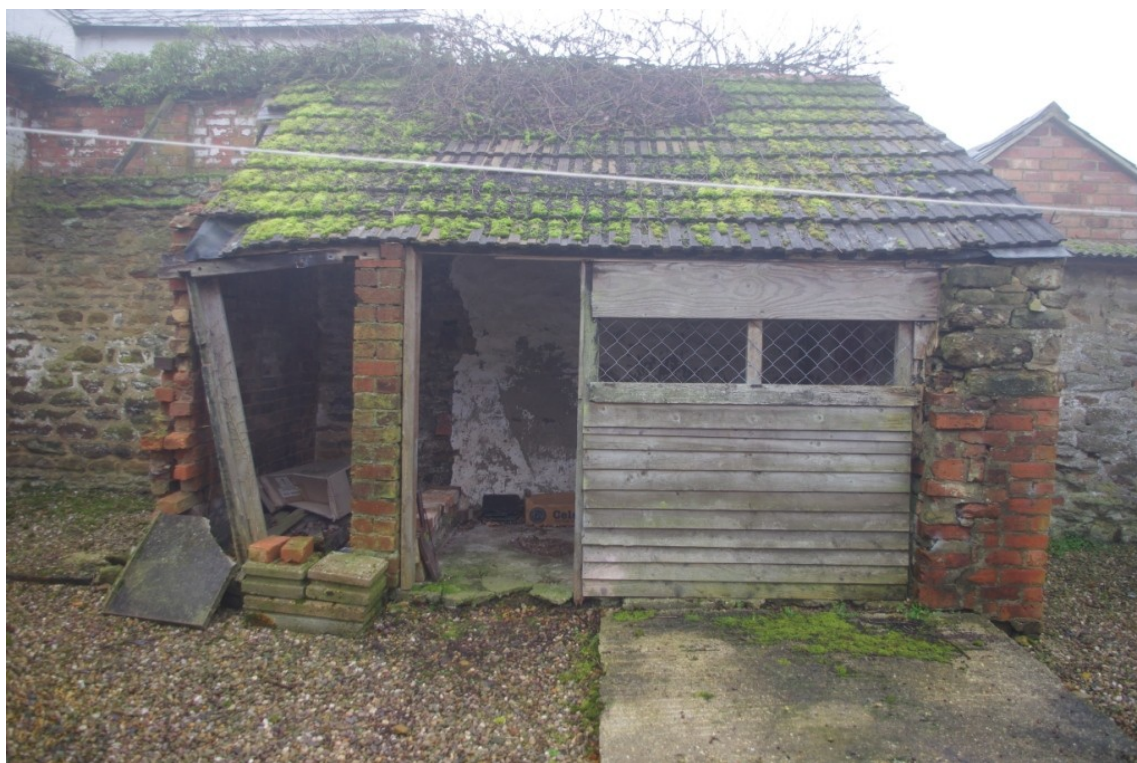
**Figure 12**  
Building B North Facing Elevation, General View (Looking South).

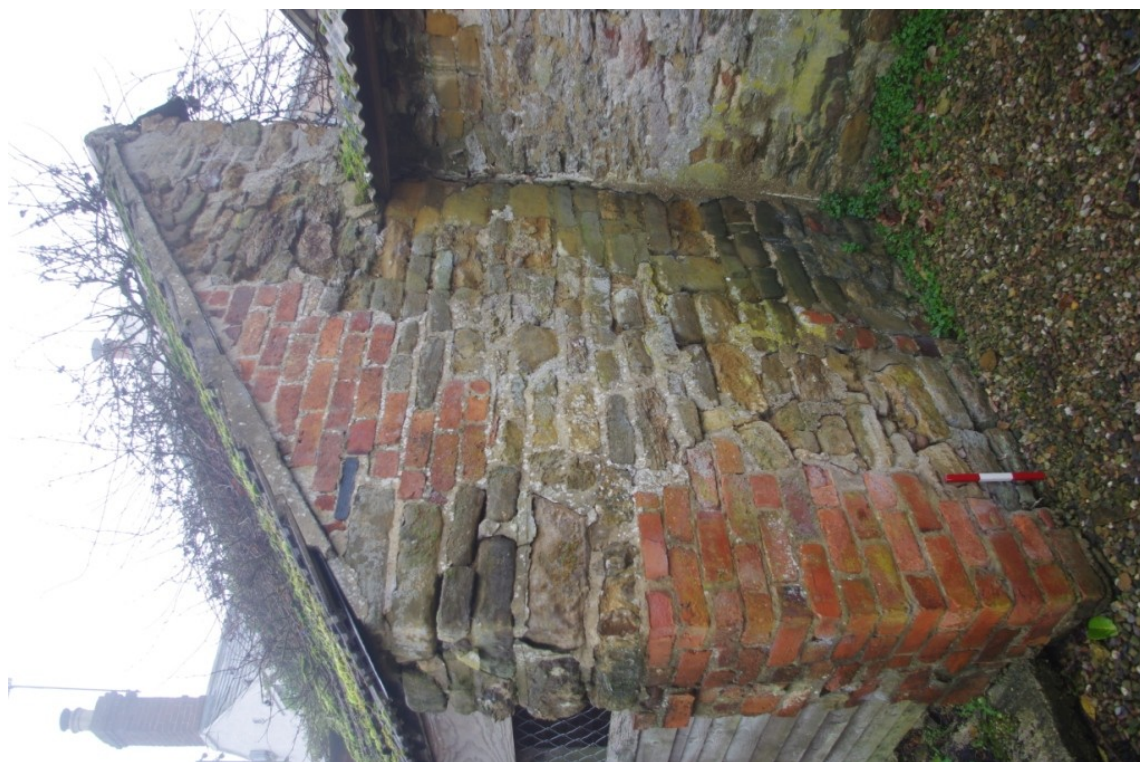
**Figure 13**  
Building B West Facing Gable.

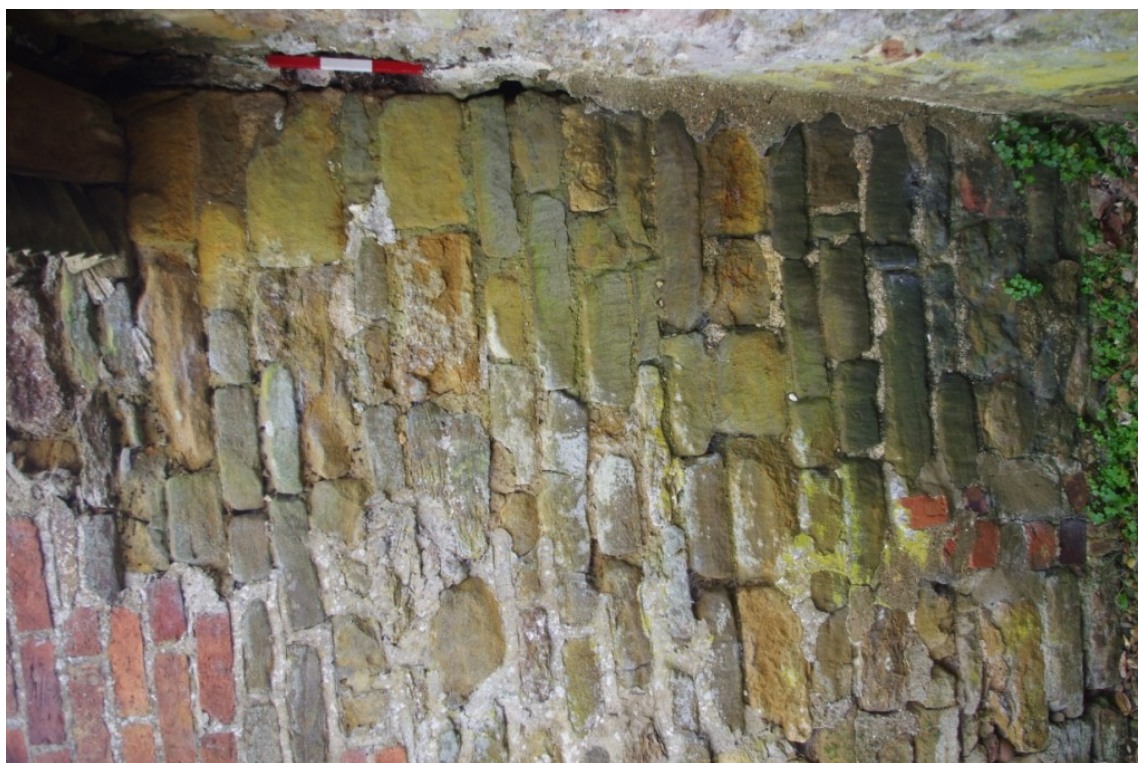
**Figure 14**  
Building B Quoined South West  
Corner.

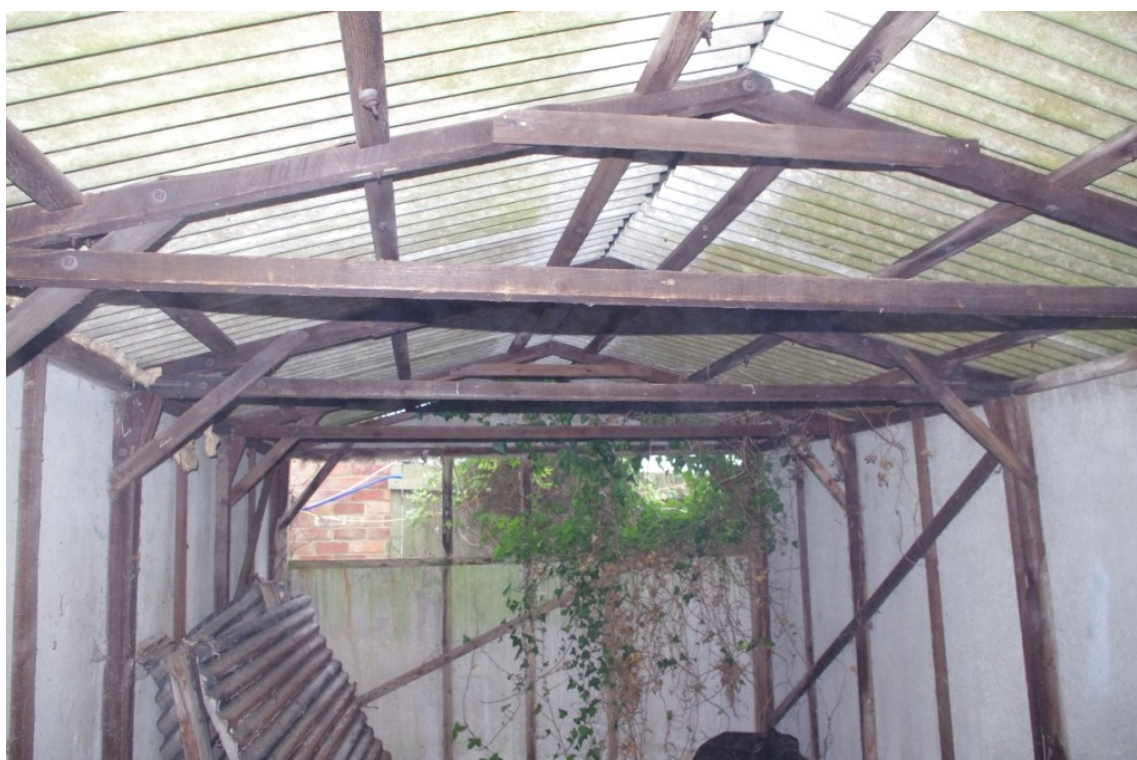
Within the proposed development area and also scheduled for demolition is a single asbestos cement garage. This type of garage was common in the mid to late 20th century and sold in kit form for self assembly. However, this example is of a different design of flat asbestos sheets cladding a deal frame (*Figure 15*) and is likely to have been built from scratch.

**Figure 15**  
Internal Garage Frame.

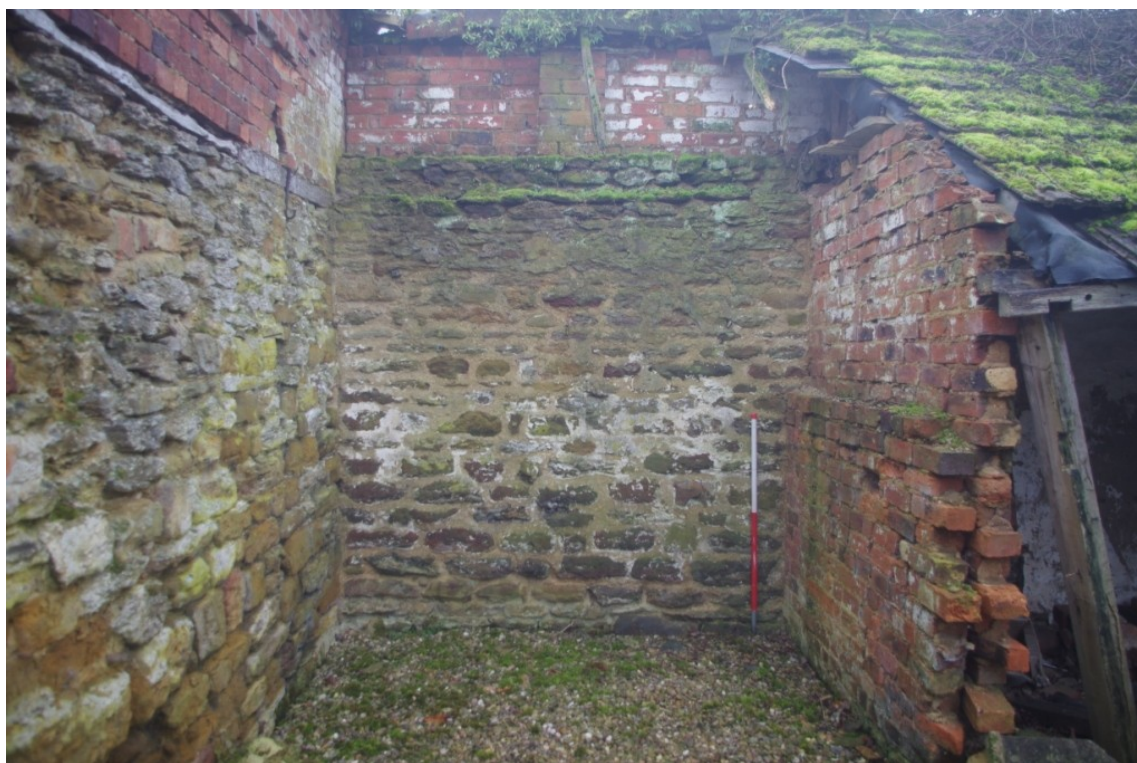
The southern boundary wall also forms the south wall of buildings A and B. The wall is largely stone built, but has been raised with 13 courses of red brick (*Figure 16*). The stonework is largely identical to that described previously. There is potential evidence of a later skin added to the north facing elevation between A and B which confuses the relationship between the boundary wall and the west wall of A and prevents the establishment of clear phasing here.

**Figure 16**  
Boundary Wall Showing Upper Brick Courses.
