**An Archaeological Standing Building Survey.
Barn Farm
Bromley Wood
Abbots Bromley
Staffordshire**

An Archaeological Standing Building Survey.

March 2017

ABRS Project No 2017-BFAS

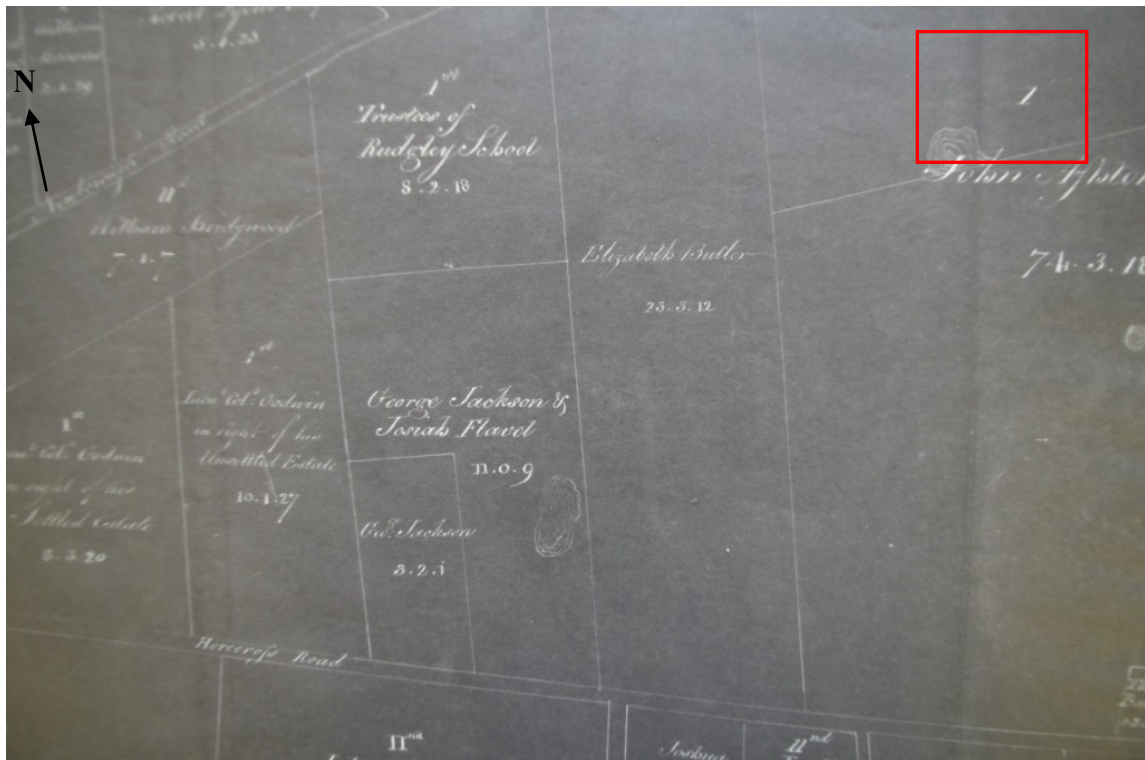
Figure 2
Abbots Bromley Enclosure Map (1799).
(Approximate Location of Barn Farm)

Abbots Bromley was enclosed in 1799 and an enclosure map produced (SRO Ref 382/1-3 (Figure 2)). The map records the area of Barn Farm, but does not record any standing buildings. The area of Barn Farm is recorded as large, largely rectangular fields, laid out perpendicular to the principal road alignments, a classic enclosure landscape.

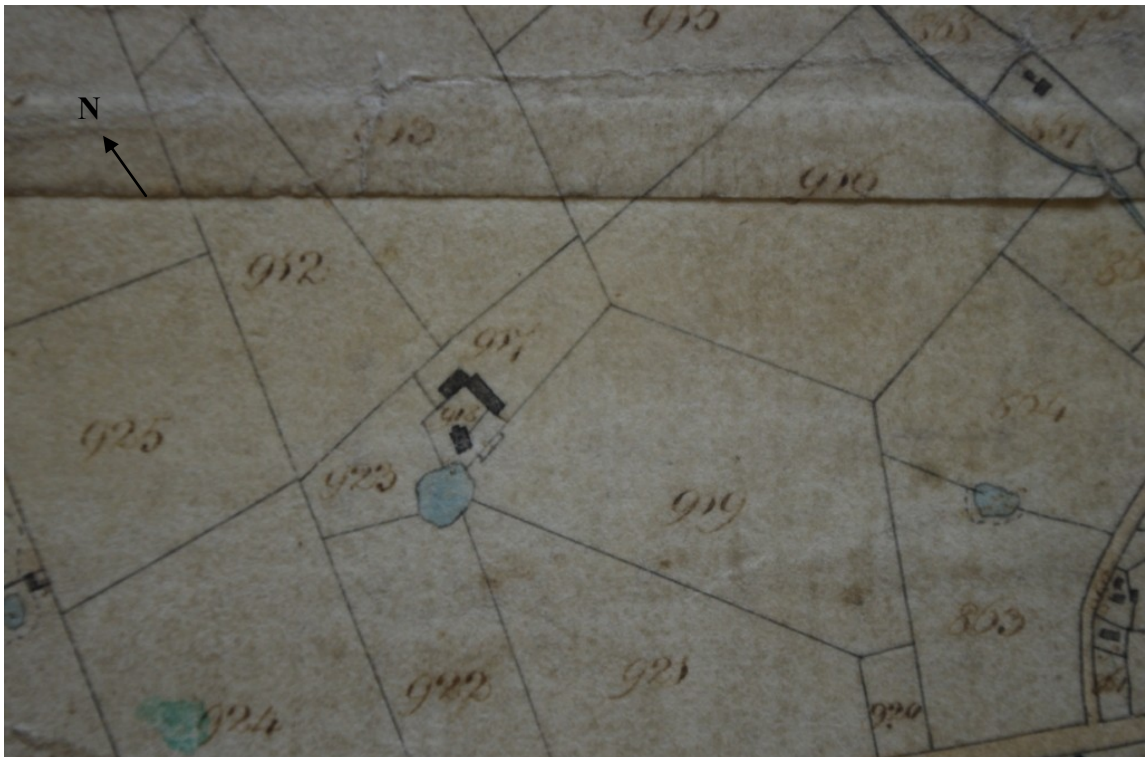
Figure 4
Abbots Bromley Tithe Map (1846).

In 1846 a *Plan of The Township of Abbots Bromley & Bromley Hurst, Parish of Abbots Bromley in County of Staffordshire* (SRO Ref D3924/3/3 (*Figure 4*)) was produced to accompany the tithe award. The map does not contain the same level of detail as the earlier Parish map, but Barn Farm is clearly identifiable, and by 1846 a farmhouse has been constructed. The accompanying apportionment identifies the landowner as Thomas Brooks and that the farm was occupied by Charles Glover. Parcel 918 is identified as house, buildings, yard & garden. The surrounding fields are also identified as pasture (no.s 921 & 922), meadows (no.s 917 & 923) and arable (919). The fields are also named, Long Lands (919) and Far Field (921 & 923) give an idea of the now lost pre-enclosure field names.

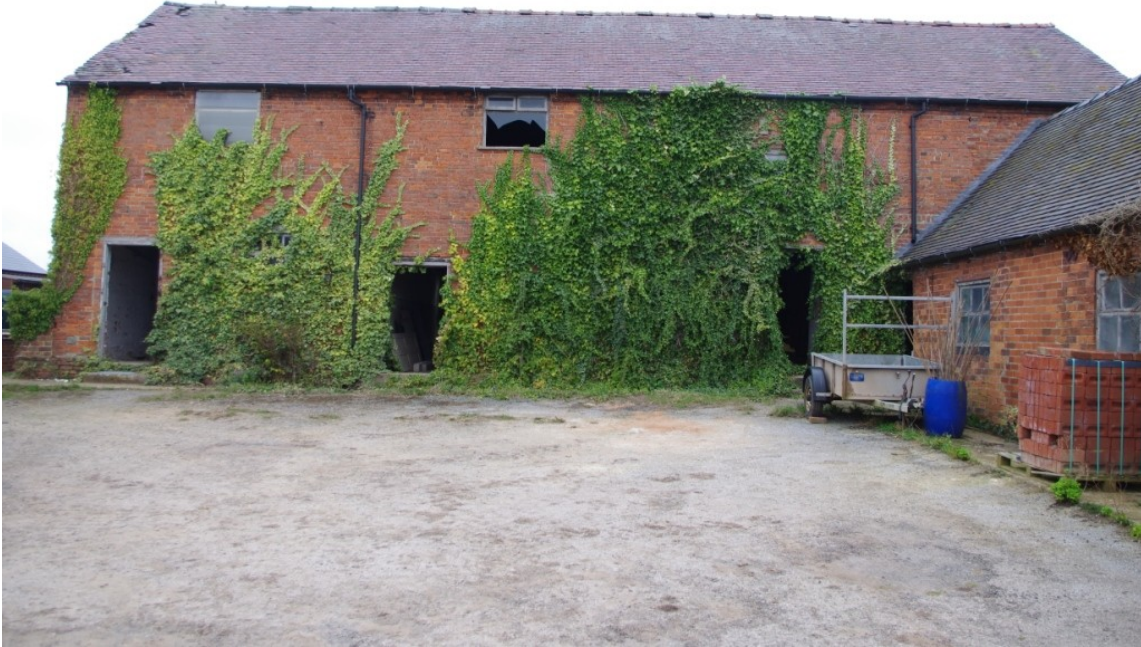
Figure 7
Building A Principal Elevation (Looking North).

Building A is a linear building of three bays, but originally four built of local handmade red bricks (brick dimensions 9 inch x 2 ½ inch x 4 ¼ inch) laid in a largely stretcher bond with lime mortar under a plain tile roof (*Figure 7*). Both long elevations are largely concealed by ivy growth, the west facing gable has modern granite dust render and evidence of a now lost external stair (*Figure 8*). The east facing gable is largely concealed by the later cart shed (Building C). There is evidence of a blocked threshing door on the principal elevation of (3), the brick infill appears early, suggesting this was an early modification to the building. There is a stone key stone at the top of the arch. The corresponding door on the north facing elevation has also been largely blocked, but in this instance with timber and a cart door has been retained, offset to the east (*Figure 9*). There are a multitude of openings on each

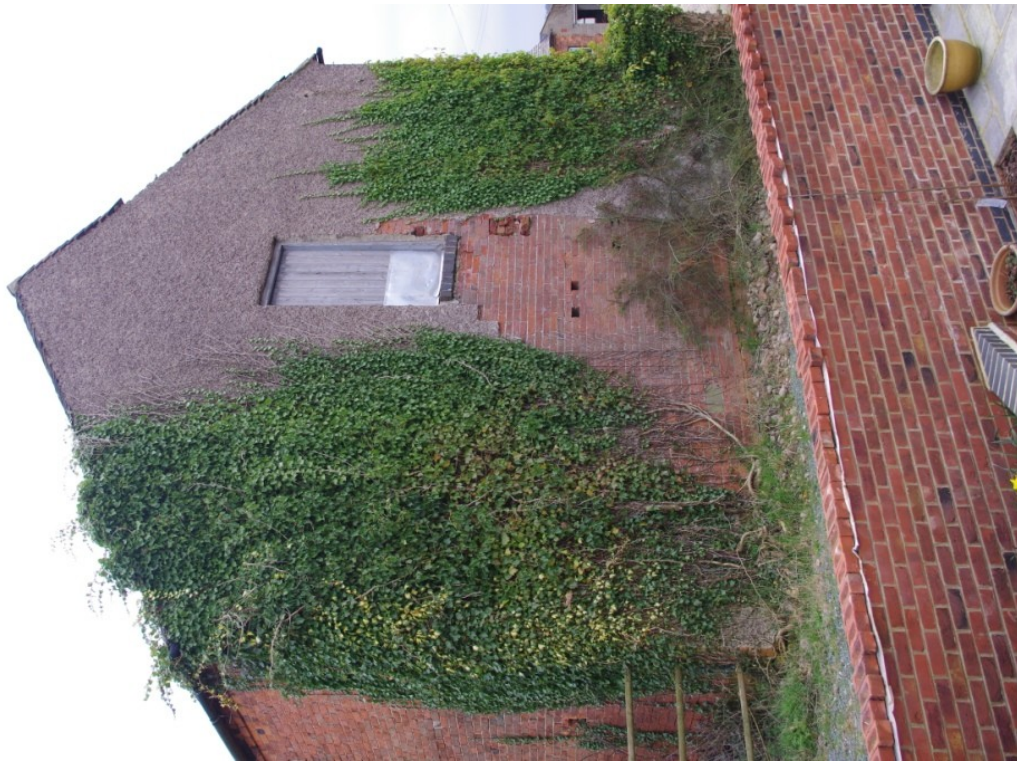
Figure 8
Building A West Facing Gable
Showing Evidence of Lost Stair.

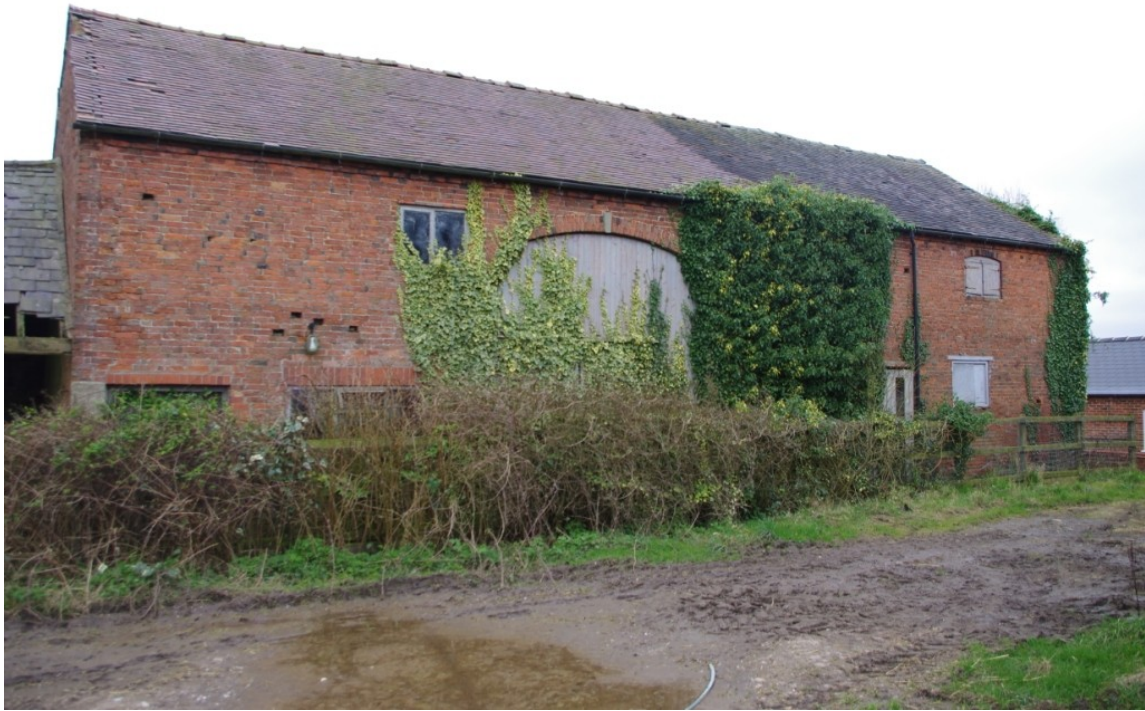
Figure 9
Building A North Facing Elevation (Looking South-South West).

elevation, it is likely that those under arched heads may be earlier and those under flat heads may be later alterations.

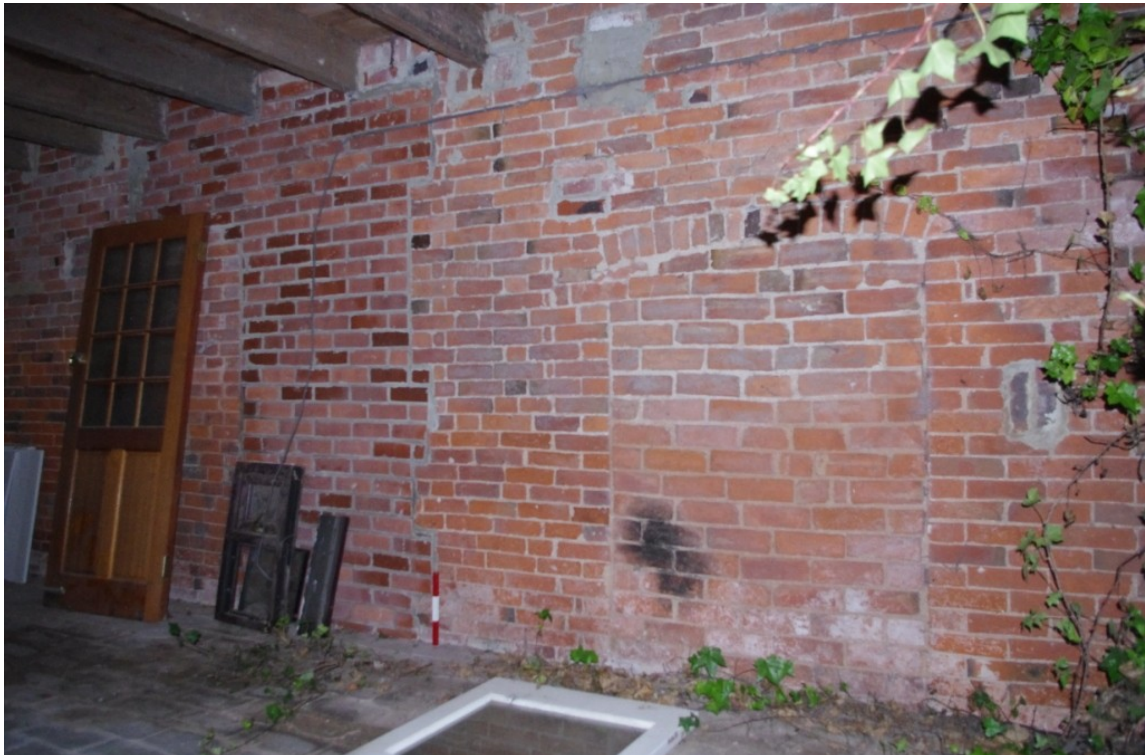
Figure 10
Building A(3) Blocked Openings in West Facing Wall.

Internally, the building is divided into three bays, all appear to be original. There is a blue brick threshing floor in bay (3) as well as original candle niches adjacent to the threshing doors. There are two blocked openings on the eastern wall (*Figure 10*) indicating this easternmost bay was originally part of A. The use of modern bricks in the northernmost opening indicates this was blocked recently. The original purpose of the southern opening is unclear due to its unusually low height.

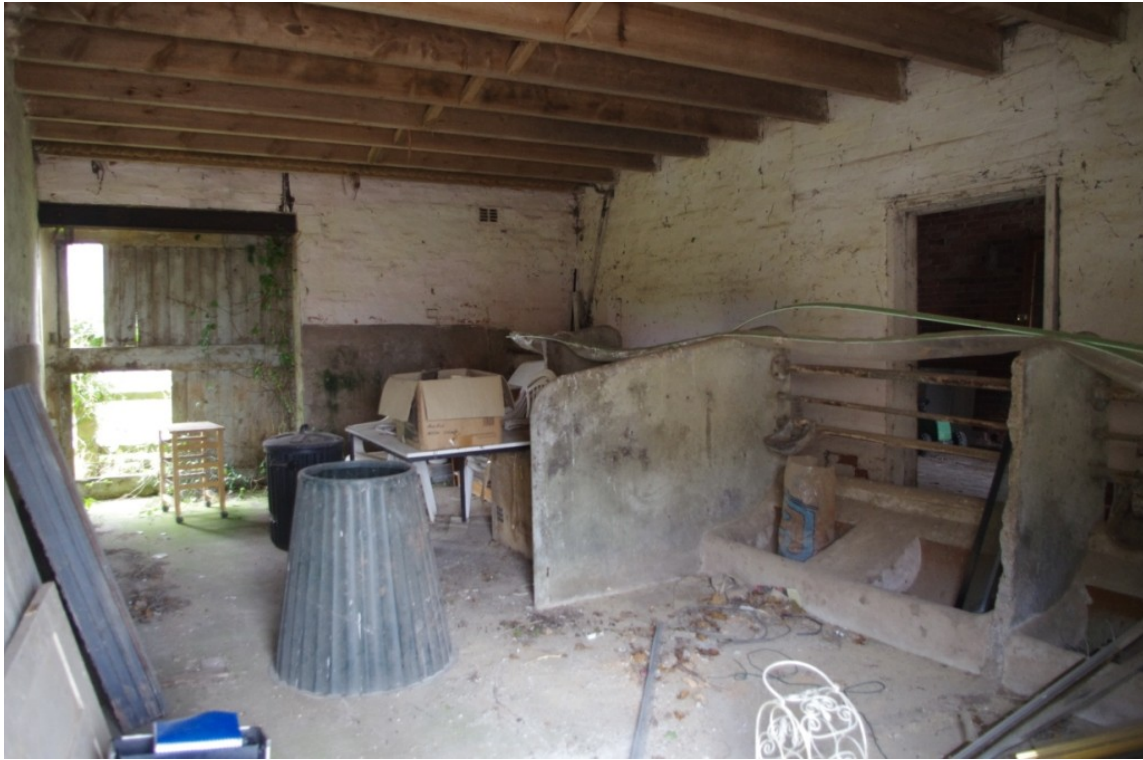
Figure 11
Building A(2) Concrete Stalls & Feed Passage on East Wall.

(2) has four double stalls along the east wall (*Figure 11*), an opening has been inserted into the wall between (2) and (3) in order to provide access to a feed passage. The use of concrete indicates the stalls are 20th century in date as early 20th century legislation encouraged the use of more hygienic concrete for cattle stalls. The ceiling is carried on deal rafters, apparently 20th century in date.

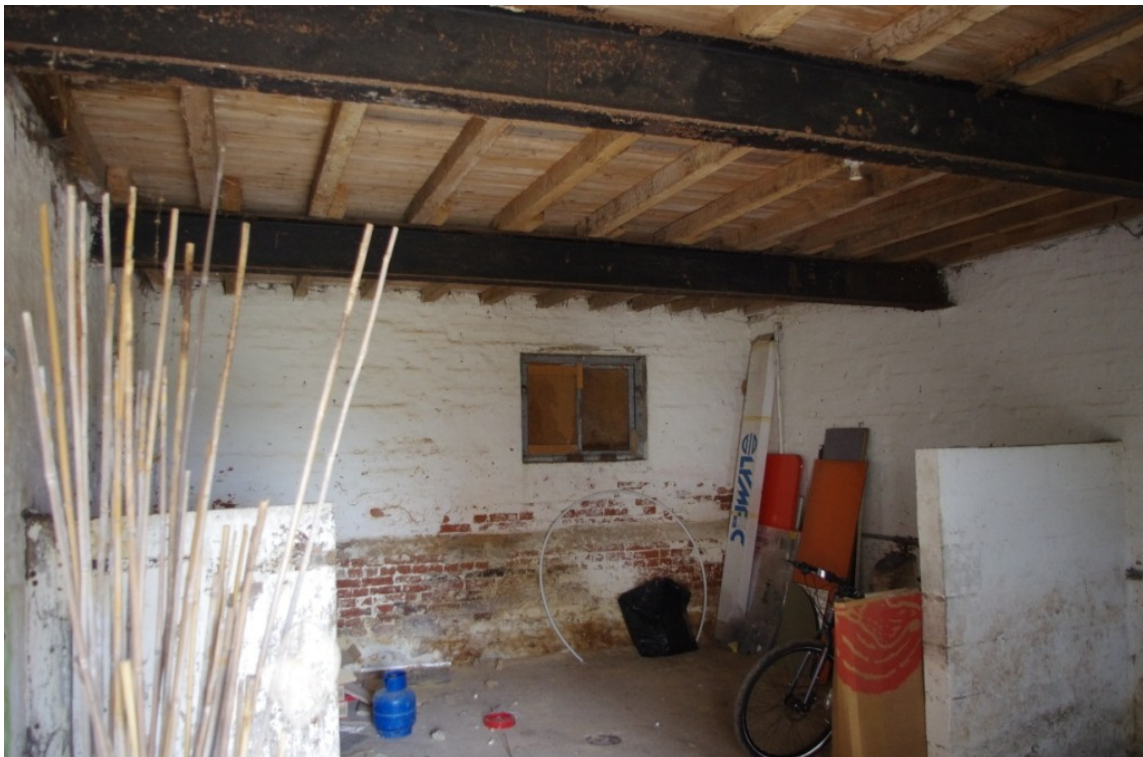
Figure 12
Building A(1) General View & RSJ Bridging Beams (Looking North-North East).

There is no indication of the original use of (1), the floor is modern concrete and the door is a modern replacement, the ceiling is identical to that seen in (2), however there are an additional two rolled steel joist (RSJ) bridging beams (*Figure 12*). One of which is stamped DORMAN LONG IRON AND STEEL MIDDLESBROUGH ENGLAND, a prolific steel maker during the early 20th century.

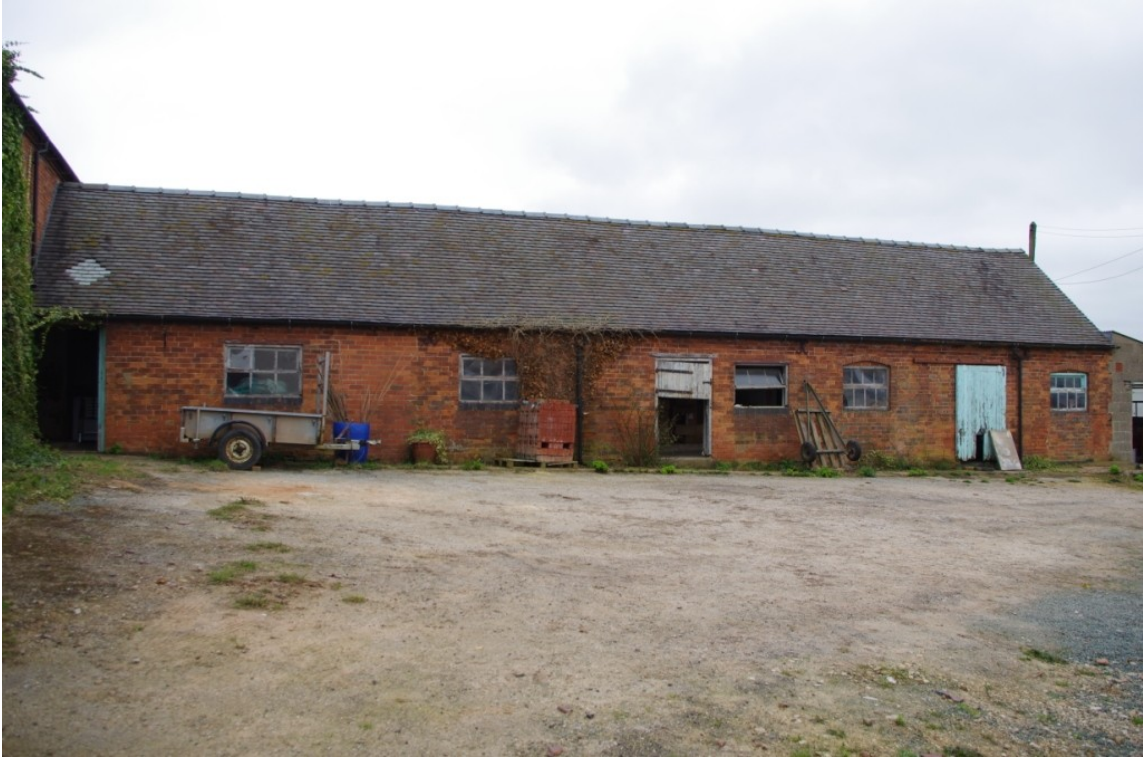
Figure 13
Building B Principal Elevation (Looking East).

Building B is aligned north – south abutting the south face of A at its eastern end (*Figure 17*). The building is again brick-built under a plain tile roof (*Figure 13*). There is a clear difference between the bricks used on the principal and east facing elevations, this confirms earlier cartographic sources (Fig. 3) that B was originally open fronted. The bricks on the rear elevation measure 9 inch x 2 ½ inch x 4 inch, suggesting a pre 1850 construction date, those on the principal elevation are a more standardised size of 9 inch x 3 inch x 4 inch suggesting a post 1850 date. There is a modern extension in concrete blocks abutting the southernmost gable.

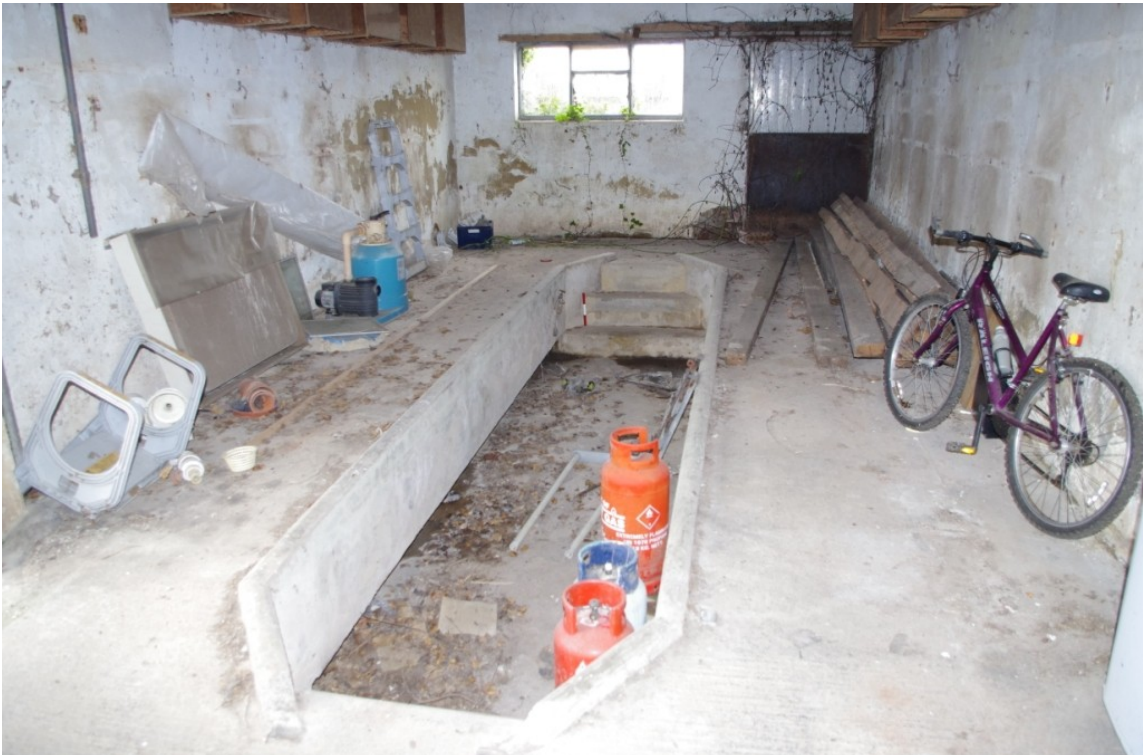
Figure 14
Building B(1) Sunken Milking Floor (Looking North West).

Internally, the building is divided into four principal bays. The northernmost bay, (1) was originally part of A and now houses a sunken milking floor (*Figure 14*), the wall is carried on a rolled steel joist (RSJ) lintel; again confirming this is not an original opening. There are a further two RSJ bridging beams in (1), again stamped with the Dorman Long name, suggesting they may be contemporary to those seen in A(1).

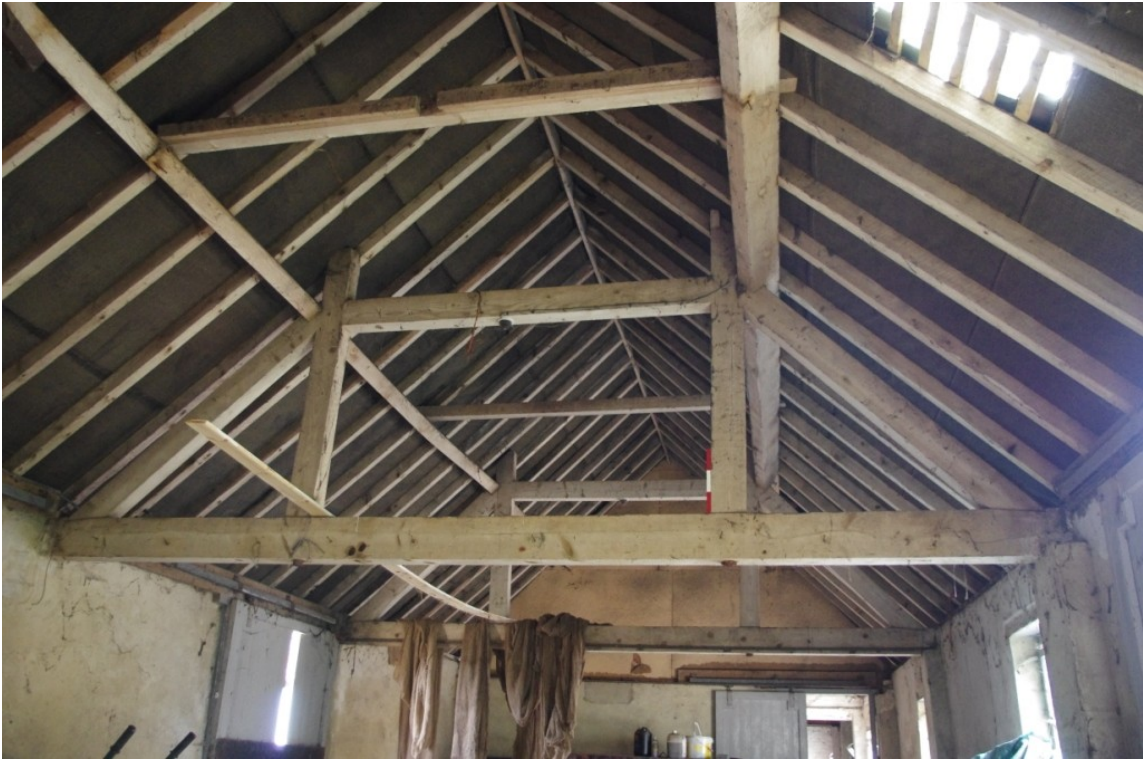
Figure 15
Building B(2) Queen Post Truss.

The roof is carried on five Queen post trusses (*Figure 15*). Peters (*Vernacular Architecture* (Vol 19, 1988)) suggests that queen post trusses only arrived in Staffordshire in the years immediately preceding 1820, which provides a tentative date, broadly supported by cartographic sources for the construction of the building. However, both cartographic sources and physical evidence indicates the building has been extensively re-modelled, so it would be impossible to state categorically whether the roof is original, or later.

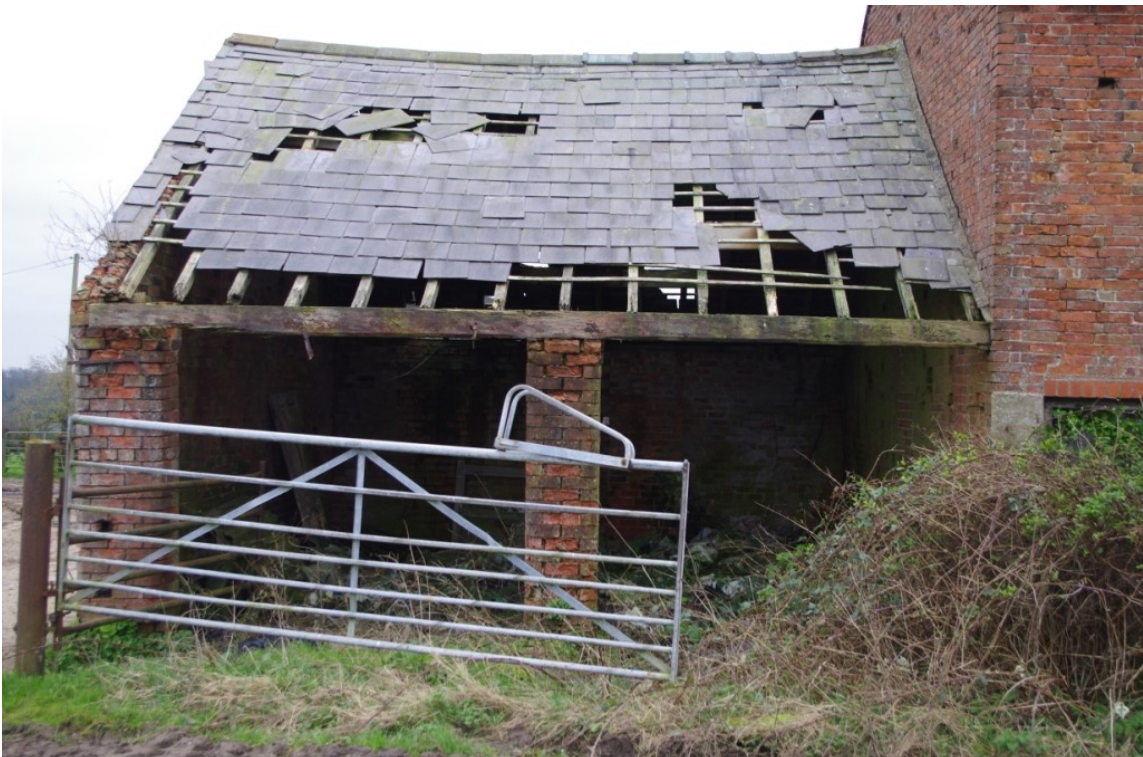
Figure 16
Building C Principal Elevation (Looking South).

Building C is an open fronted cart shed abutting the east facing gable of building A (*Figure 17*). The two bay building is brick-built (brick dimension 9 inch x 3 inch x 4 inch) under a Welsh Slate roof (*Figure 16*). The central brick column is built with attractive cant brick reveals.

Cartographic evidence indicates the cart shed is a later edition, first appearing on the first edition Ordnance Survey, the brick dimensions support a later 19th century construction date, as does the Welsh Slate roof. Cart sheds were commonly built with openings facing away from the farmyard, with the intention that animals were less likely to enter the building from the yards and damage either themselves or the machinery.
