**An Archaeological Standing Building Survey.  
Carriage Houses  
St James's Yard  
Derby**

**(NGR SK 35167 36256)**

**On Behalf of Trigpoint Conservation &  
Planning**

**April 2017**

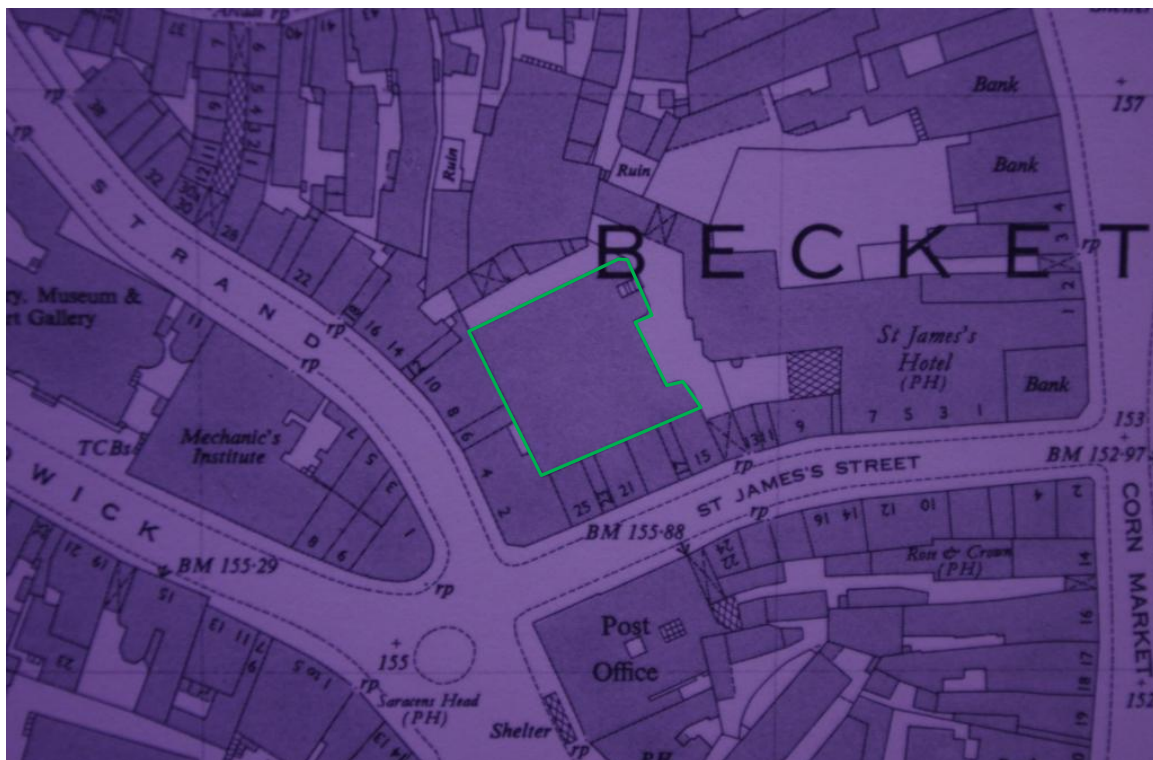
**Figure 4**  
1967 Edition Ordnance Survey.  
(SK 3536)

It is unclear how long C.A Newton remained at the site, post war mapping including the 1967 Ordnance Survey (DRO Ref SK3536 (*Figure 4*)) show no significant alterations to the

buildings; a number of the lesser buildings to the north of St James's Yard are recorded as ruins, suggesting that the site as a whole was becoming run down.

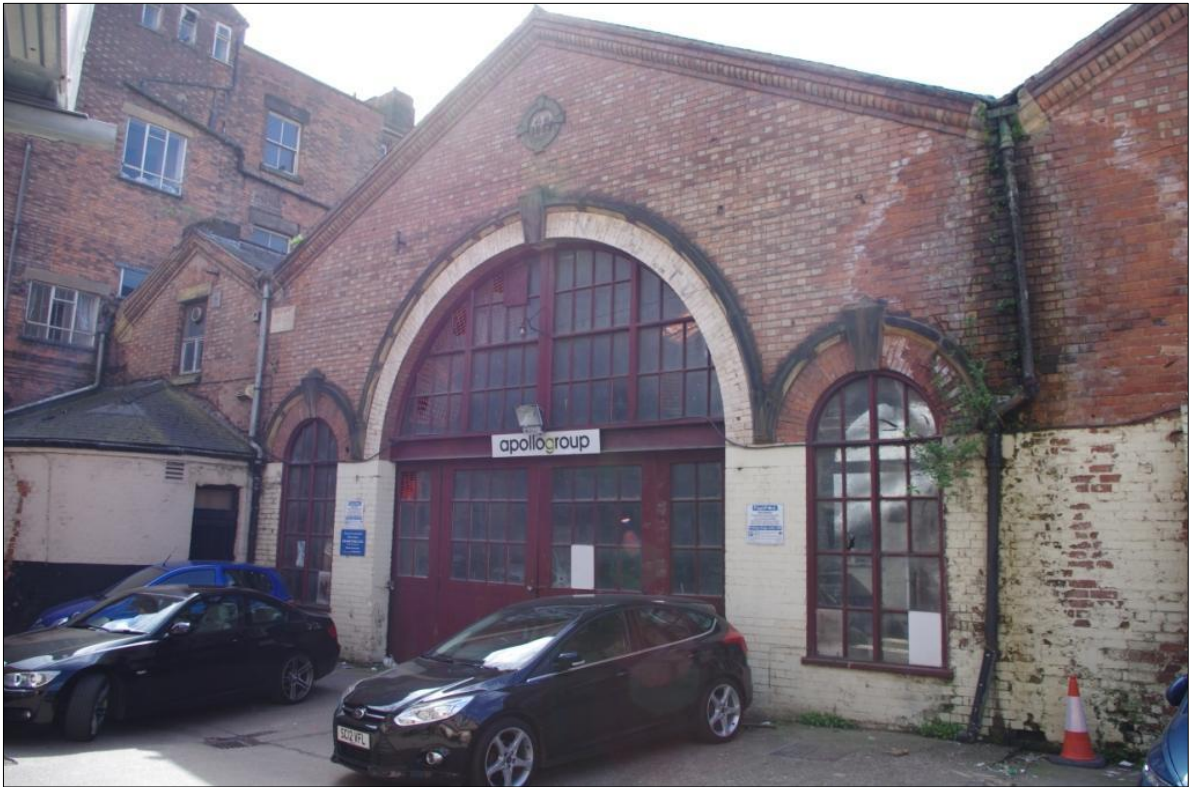
The principal gables are by far the most striking feature of the building, especially (1), which consists of a wide Serlian or triple arch gable (*Figure 6*), almost Palladian in appearance. Each of the arches is brick-built with sandstone label moulds and key stones. Over the central, glazed arch, which is finished in painted cream brickwork is a date stone inscribed 1867 in a sandstone oculus (*Figure 7*), the date supports the documentary evidence for the building's construction. There is faint traces of lettering on the painted arch, the letter N and abbreviation Ltd can be made out, probably originally spelling C.A Newton Ltd. Each gable is finished with bull nosed brick corbelling, the outer gables and central valley are finished with worked sandstone kneelers following the bull nosed finish of the bricks. All, in all attractive and well-finished elevations, reflecting the status of the hotel, even in its ancillary buildings. There is evidence of two lost pitched rooflines abutting the eastern gable of (2) (*Figure 8*), these are likely the remnants of the two bays seen here on earlier maps. The southernmost was originally heated as indicated by the blocked fireplace now visible on the external wall.

**Figure 6**  
(1) Principal Elevation (Looking South West).

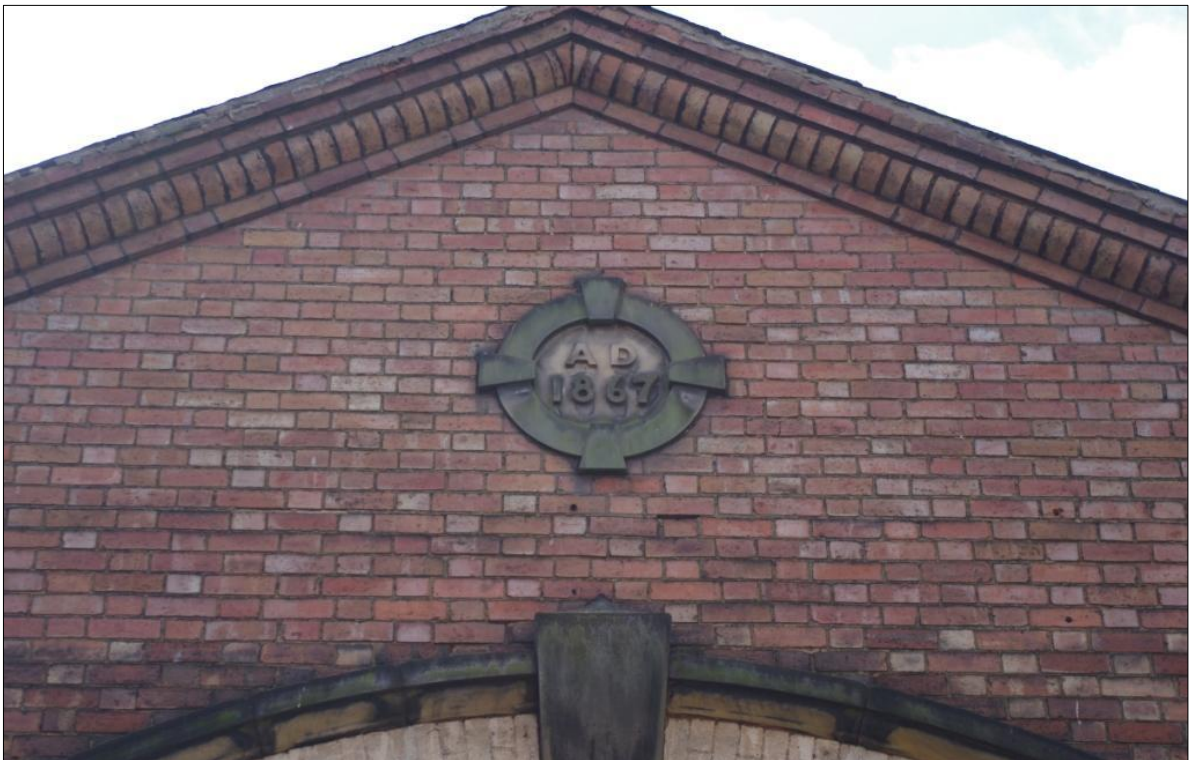
**Figure 7**  
(1) Date Stone on Principal Elevation.

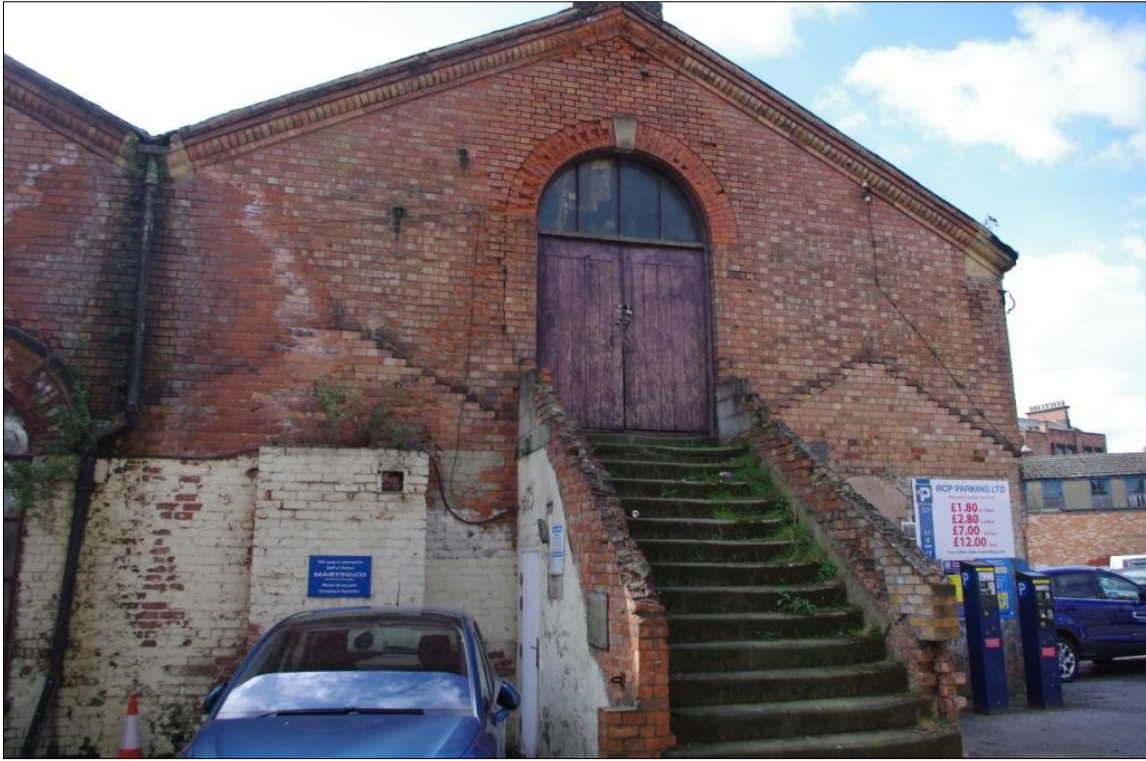
(2) Principal Elevation Showing Outline of Lost Buildings (Looking West – North West).

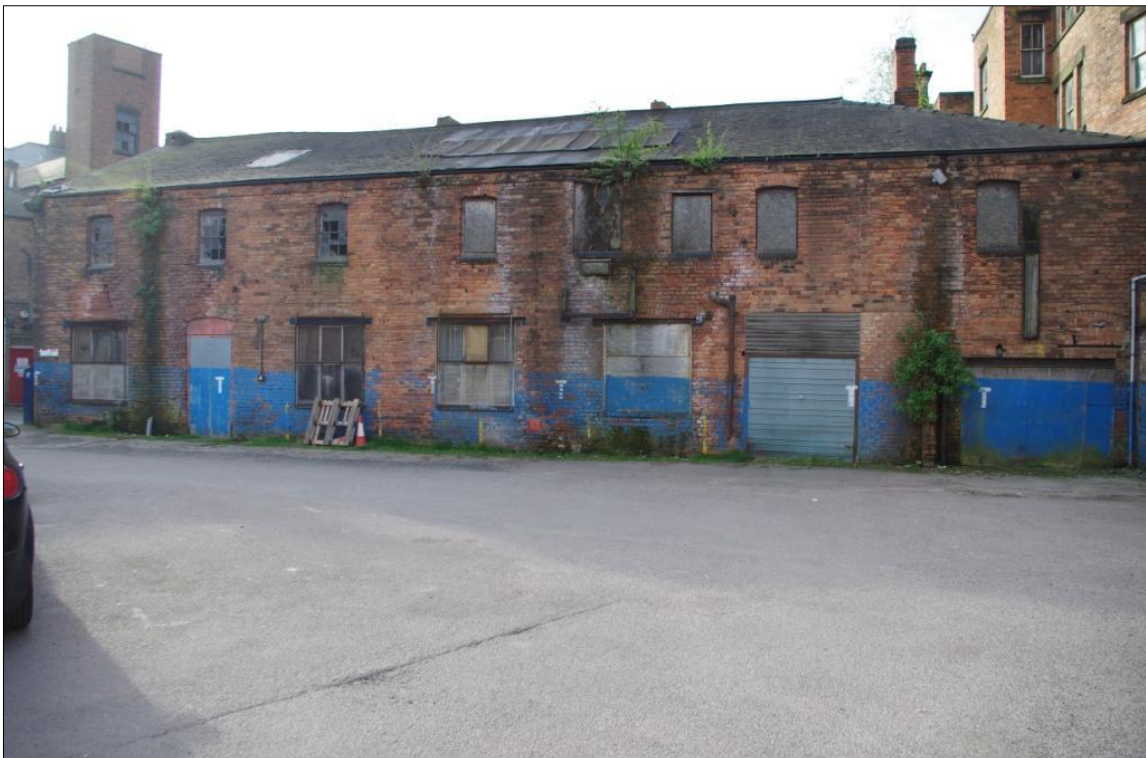
**Figure 9**

The north facing long elevation is much more utilitarian in appearance, reflecting its lower status (*Figure 9*). All of the openings show evidence of alteration and change, but originally consisted of windows under flat cambered brick arches and blue, cant brick sills, the original size of the ground floor windows suggests internal light was required. The first floor windows are more standard in size and the timber built six over six vertical sashes may be original, the size of the windows bars appear to be Victorian in date. At the far west end of this elevation, two large and un-attractive vehicle openings have been crudely inserted, probably during the building's post hotel use. The use of the ubiquitous Fletton Brick would suggest this alteration was undertaken after World War II.

(2) North West Facing Elevation (Looking South – South East).

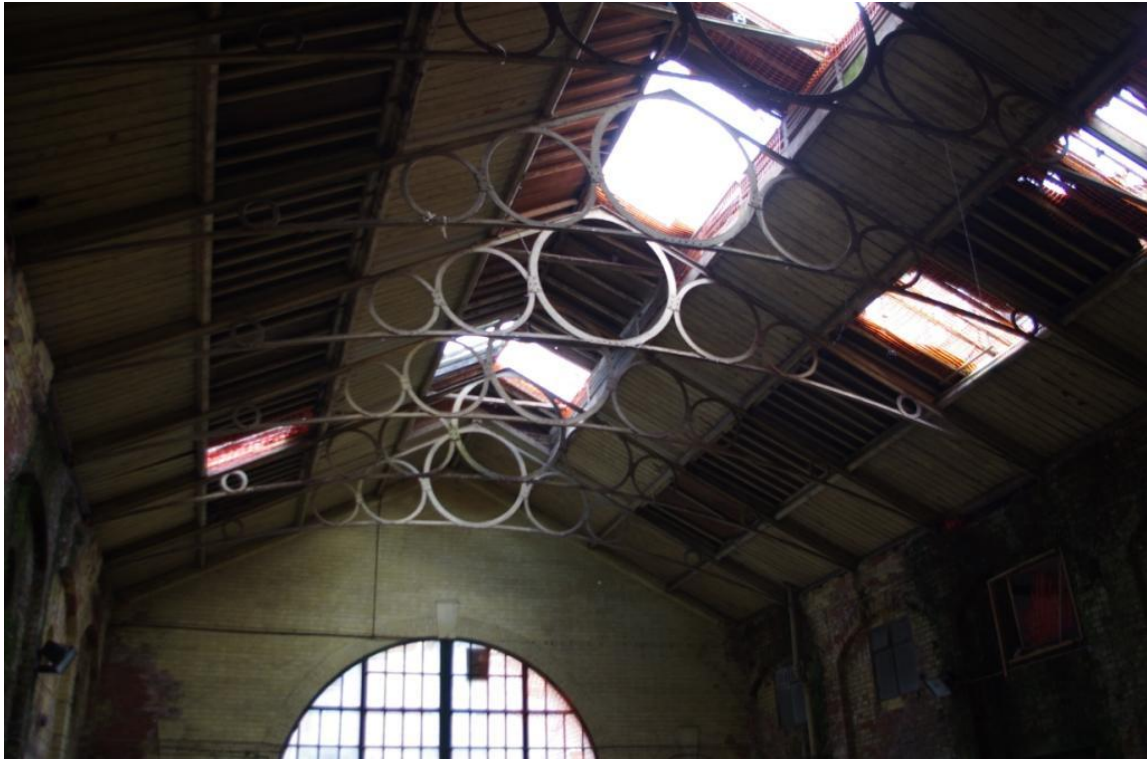
Internally, the building remains divided into three principal ranges, the central range, (1) being the largest. The interior of (1) consists of eight bays, the roof is carried on attractive iron trusses with hoops of diminishing diameter between the principal and tie beam (*Figure 10*) creating an aesthetically pleasing roof with its lantern and skylights. The hoops and elegantly curved tie beam complement the triple arched principal gable creating an extremely attractive and high roof for an ancillary building. There are a further three round headed slim windows on the west gable, which also retains some of the original signage associated with C.A Newton (*Figure 11*). There are further blind arches along the south wall, some with iron-framed 32 light windows at ground level and smaller, timber casement windows at first floor level. It is unclear whether these openings are original or later alterations. Those on the north wall retain early timber and glazed partitions, one of which contains a door with a numbered plaque above (*Figure 12*). A limited view of the north wall from within (2) shows a partial arch (*Figure 13*) which suggests these large glazed openings are a later modification. The arches on the north wall contain blind pitching holes; it appears that these are a decorative flourish rather than original blocked pitching holes. The floor is paved with blue setts, reflecting the origin of the building as a carriage house.

**Figure 10**  
(1) Diminishing Hoop Cast Iron Truss.

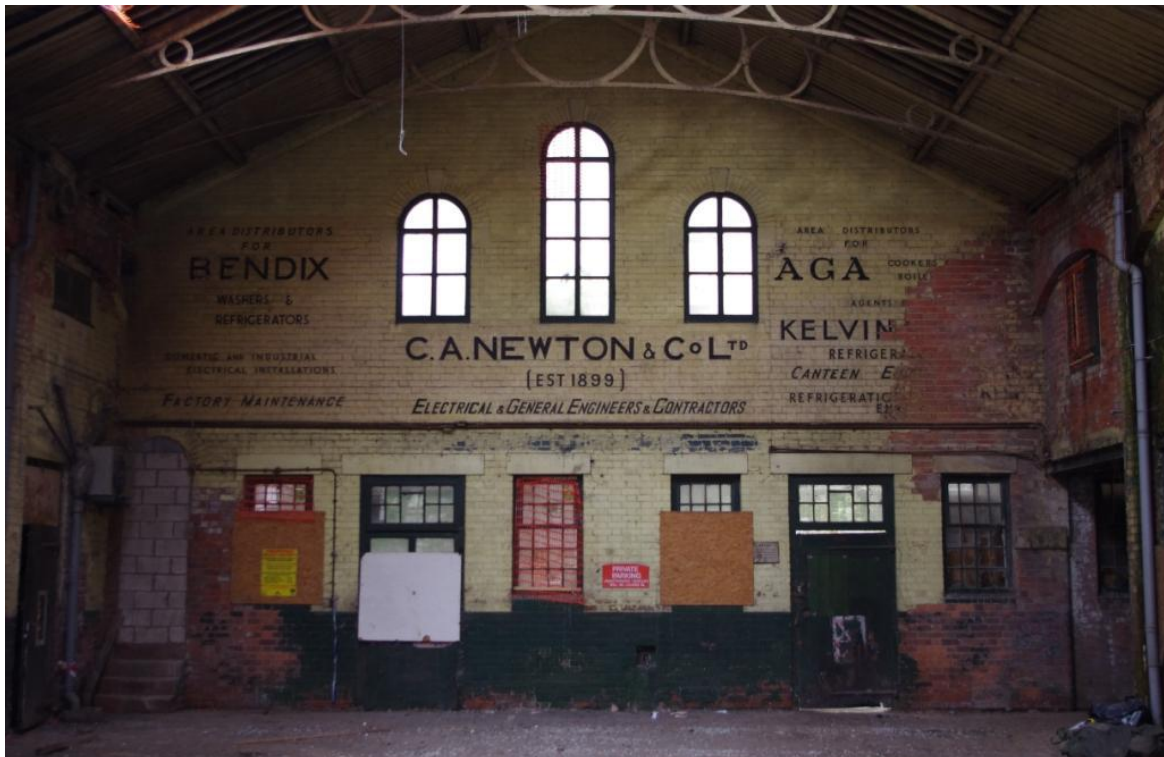
**Figure 11**  
(1) East Facing Gable, Internal with Signage & Windows.

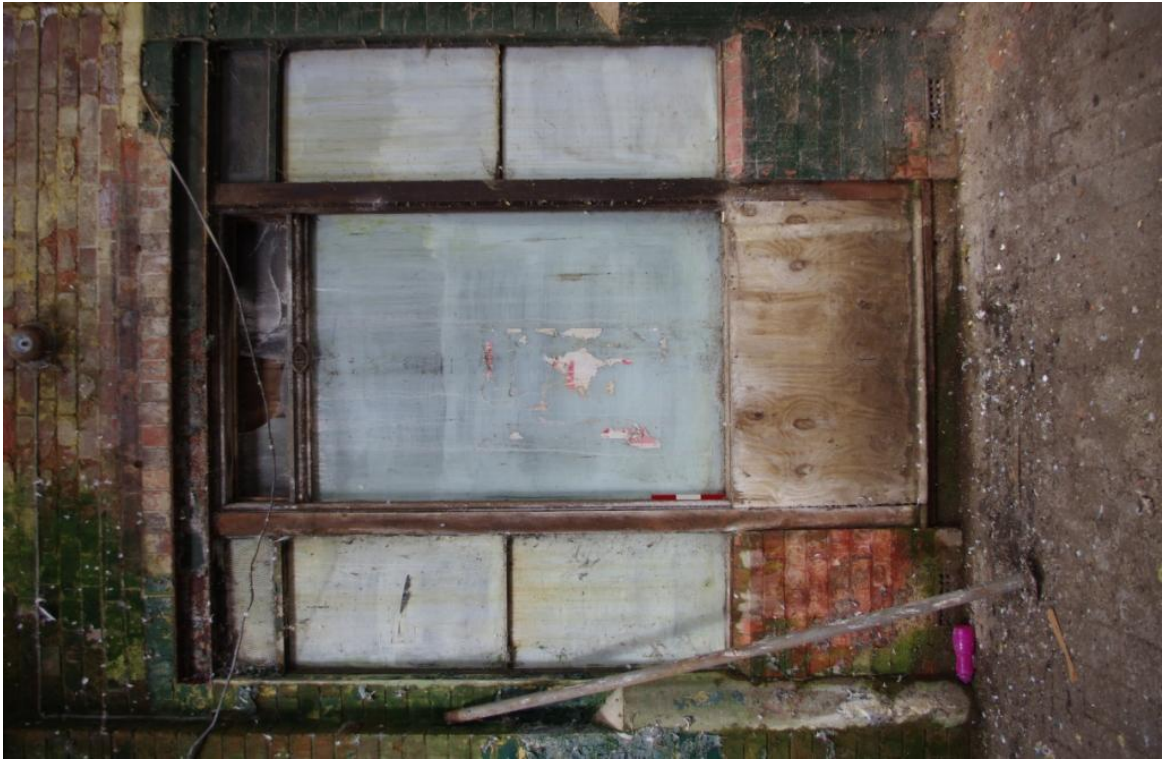
**Figure 12**  
(1) Early Glazed Opening on North Wall (Looking North).

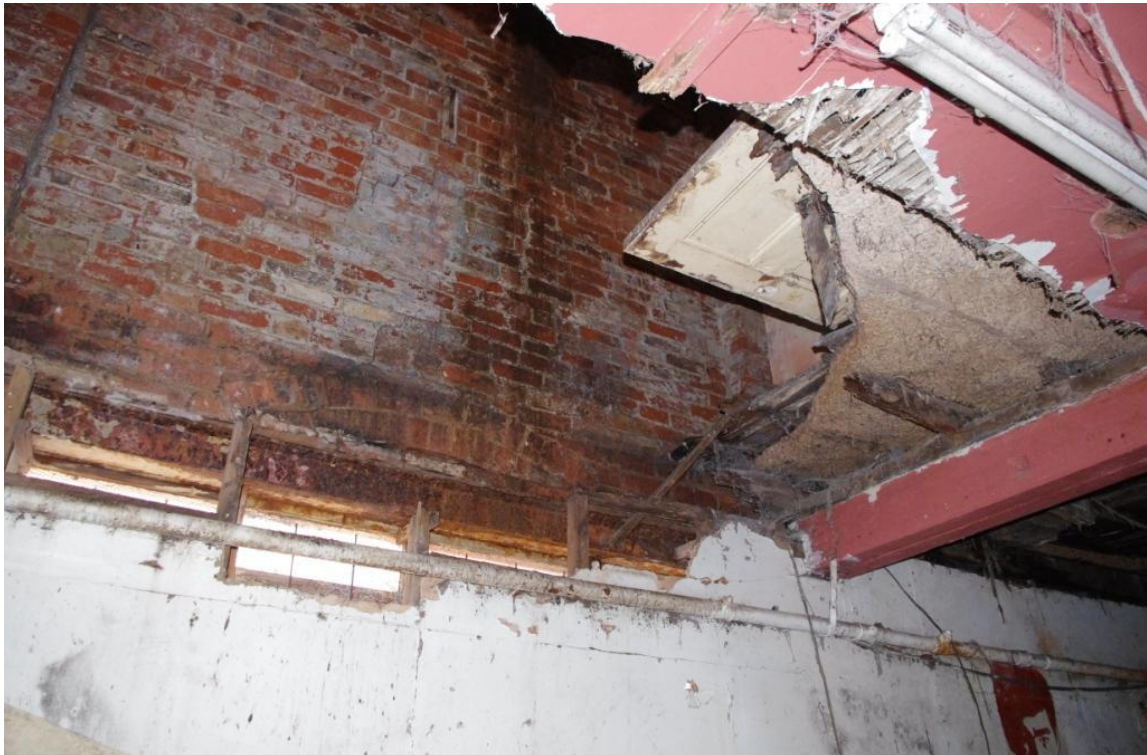
**Figure 13**  
(2) Limited View of Arch on South Wall (Looking South).

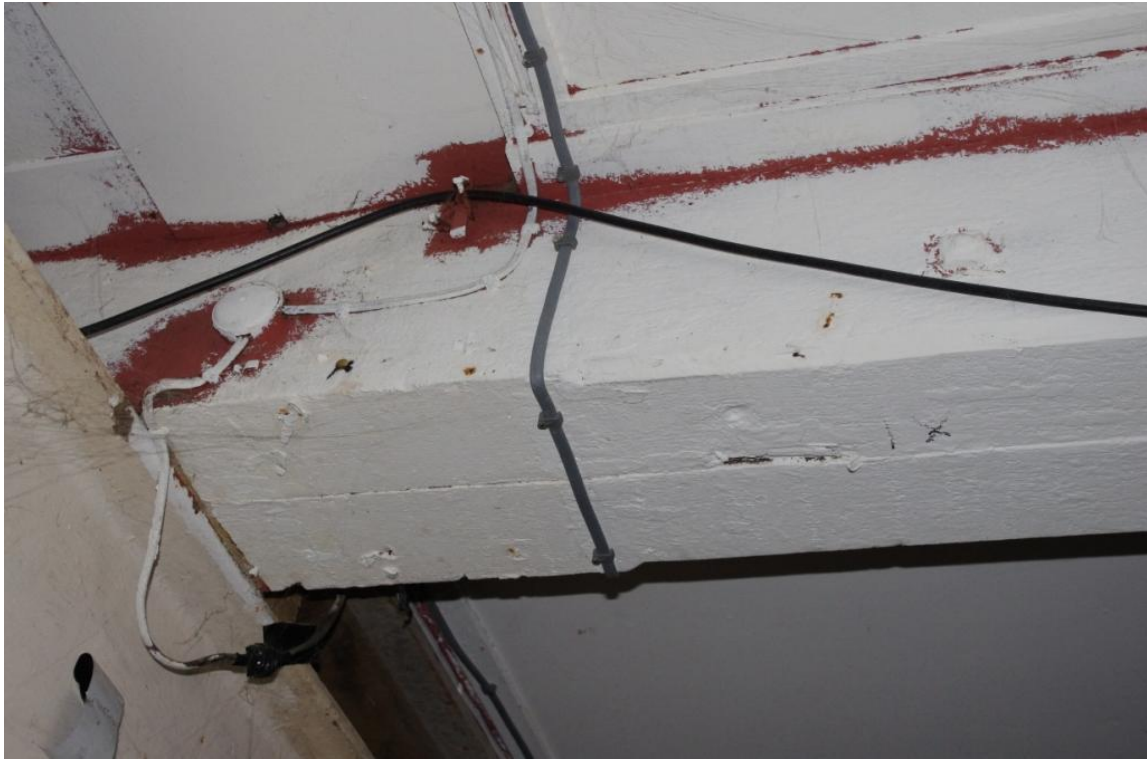
**Figure 14**  
(2) Chamfered & Stopped Joist.

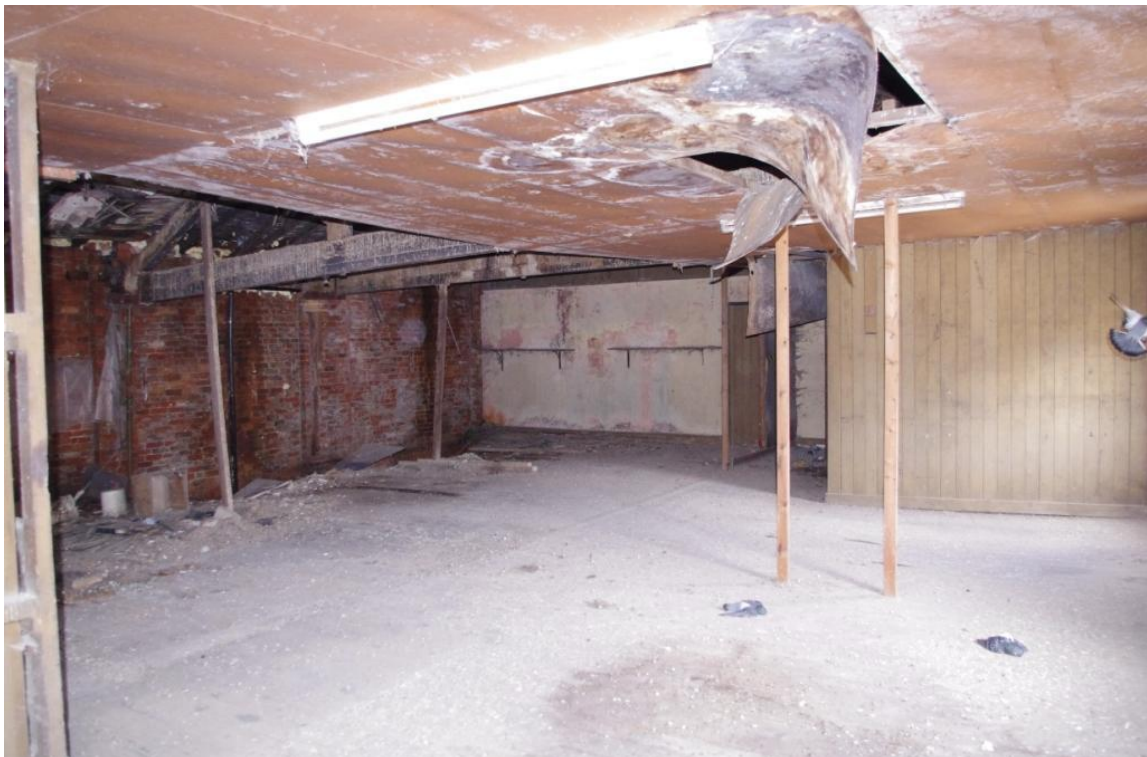
The first floor is divided into two principal bays by a plaster and lath cross wall, the easternmost bay (A) is largely open (*Figure 15*), the westernmost bay (B) consists of a number of rooms off a central corridor, most of which were inaccessible due to the condition of the floor. The roof is carried on Queen Post trusses in deal (*Figure 16*), some of the roof is underdrawn and the floor is exposed floorboards. Queen Post trusses are used where storage is required up to roof level, and allow for a wider roof span. There is a partition wall in the north west corner of A creating a small, irregular shaped room, C, there is extensive, early looking racking on the walls, as well as a 19th century four panel door, suggesting that this is an early, if not original partition and room. The partition wall is bare tongued and grooved timber; the general finish of this floor reflects the original, utilitarian origins of the building. It is likely that this floor was originally used as a hayloft; therefore, it was unlikely to have been well finished.

**Figure 15**  
(2) A General View (Looking South West).

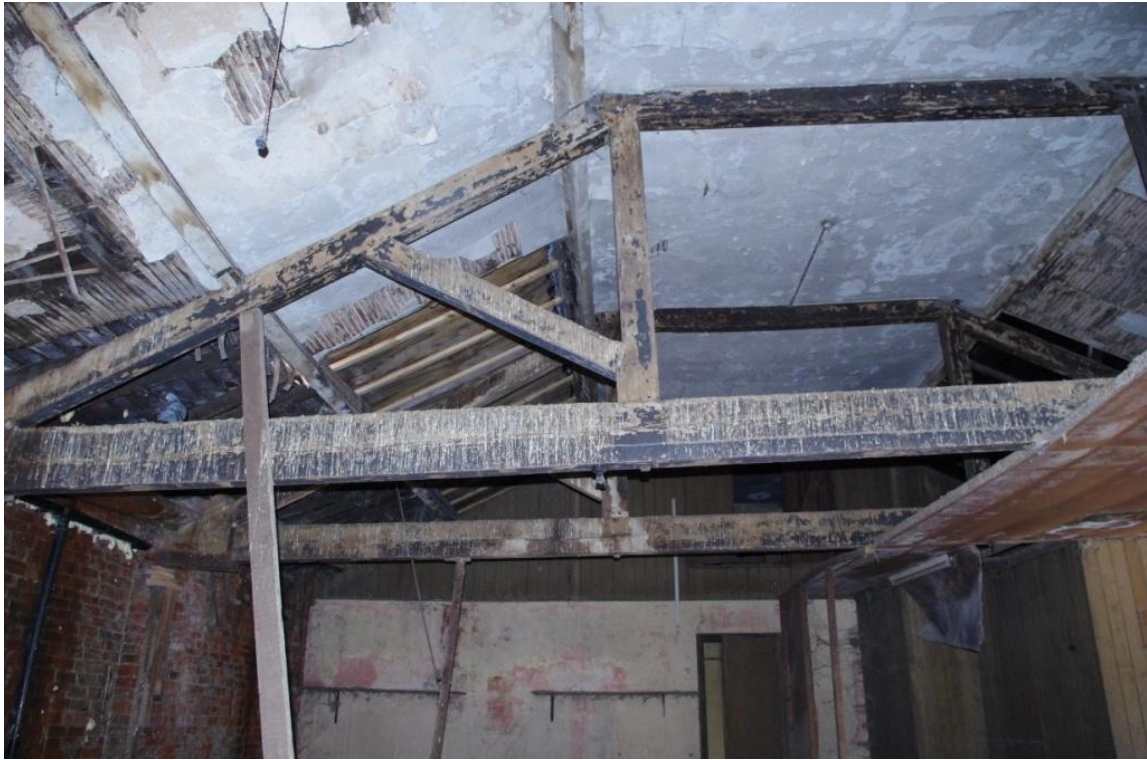
**Figure 16**  
(2) Queen Post Roof Truss.

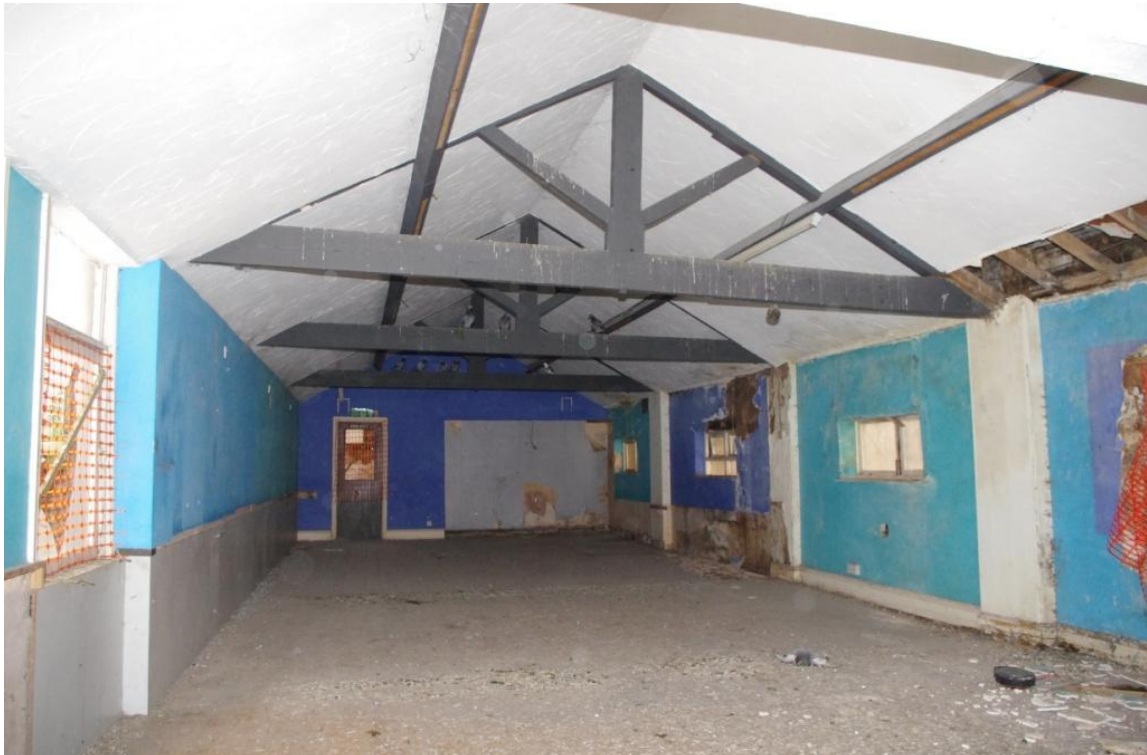
**Figure 17**  
(3) First Floor, General View & King Post Roof Truss (Looking West).

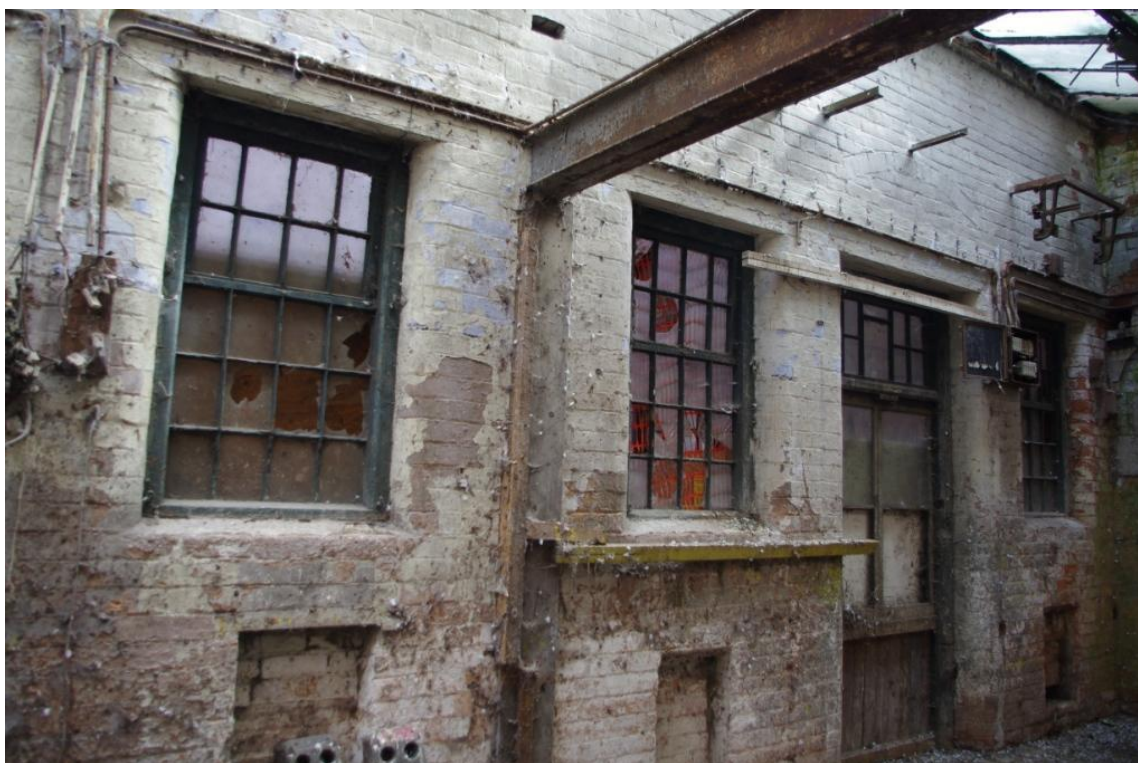
**Figure 18**

To the west of (1) and (2) is a full width, narrow bay, (4). There is a limited lean-to roof covering the eastern end of the bay, but the lack of a full width roof suggests this bay was originally open. Further evidence of which are the number of openings, both in use and blocked on the wall between (1) and (4) (*Figure 18*), the blocked openings, mirror those recorded elsewhere with flat cambered brick arches, while those openings which remain in use have flat heads and bull nosed reveals (*Figure 18*). It is possible that these openings are later.

Interestingly, there is the remains of a mounting for an in-line drive shaft in the south west corner of the east wall (*Figure 18*). It is unlikely that the hotel would have had use for such machinery, so it is likely that this shaft is later, perhaps added under the ownership of Newton. It is possible, therefore that some degree of small-scale manufacture or repair was carried out on site.

(4) West-South West Facing Wall Showing Flat Heads, Blocked Arch & Line Shaft.
