**An Archaeological Standing Building Survey.
The Wheat Barn
Duck End Farm
Duck End
Wilstead
Bedfordshire**

May 2017

ABRS Project No 2017-DEWB

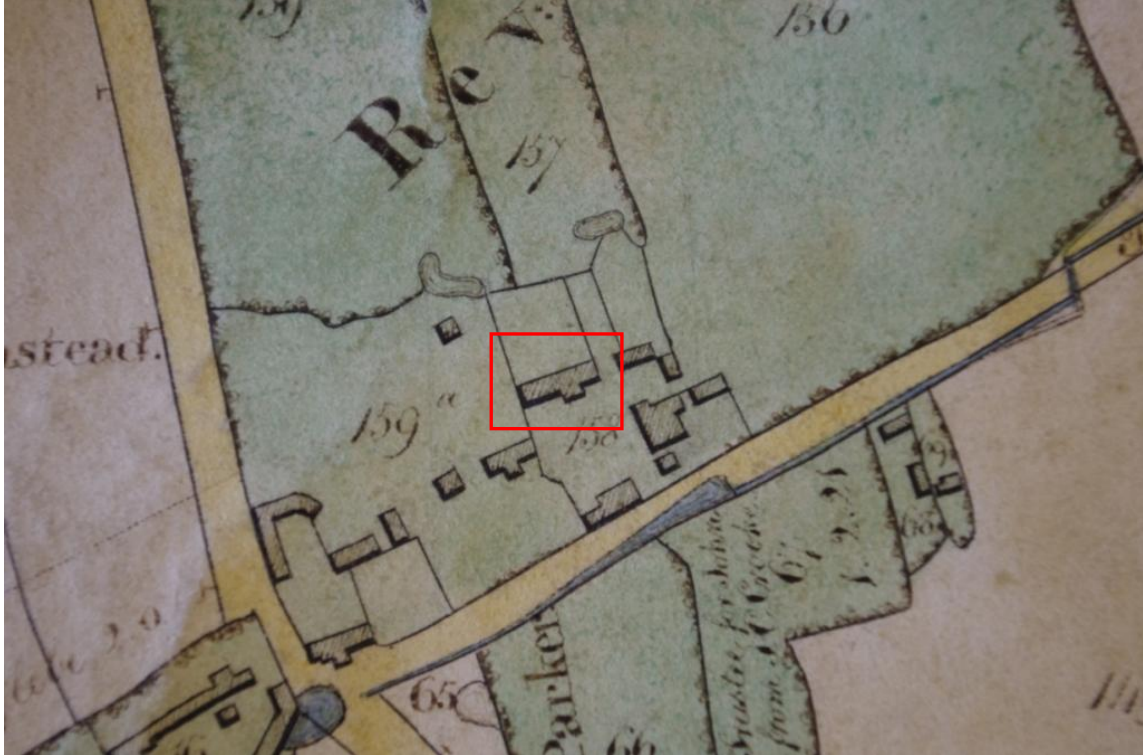
Figure 2
Wilhampstead Parish Map (1809).

The earliest map of the Parish including the proposed development area is *A map of the parish of Wilhampstead* by Thomas Lilburne from 1809 (BA&RS Ref MA36 (Figure 2)). Duck End Farm is identified as number 158 and belongs to the Rev. Thomas Hind & Wife. The area is coloured green, however there is no key to indicate the reason. Written on the map is the description that the area was known as... “*Mill Field (Part of) 1st Allotment of Open Field*”. The general arrangement of the fields, perpendicular to the road would suggest that they are enclosure fields. The barn subject to this recording is clearly visible and identifiable and appears to be almost identical in plan to as it currently stands.

The map also records the estate of Samuel Whitbread as laying largely in the south east of the Parish which gives an indication of the likely location of Westcotes Manor.

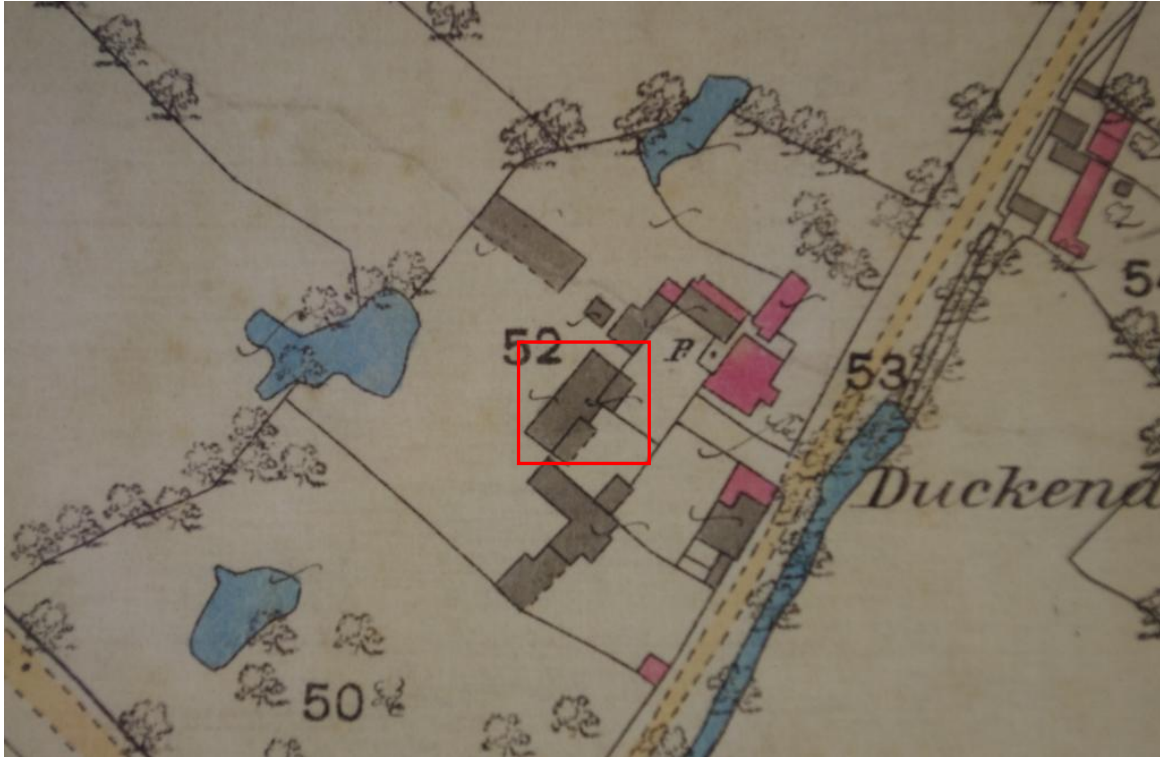
Figure 3
First Edition Ordnance Survey (1883).
(Sheet XVI.16)

The first edition Ordnance Survey was published in 1883 (BA&RS Ref XVI.16 (*Figure 3*)). The recorded building is again clearly visible, part of a large and somewhat congested farm complex, with at least 6 domestic dwellings along with 9 agricultural buildings, suggesting that at the time the farm was a major concern.

The recorded building has apparently been extended to the south east with the addition of two lean to buildings each side of the threshing door. The south westernmost appears to be open-fronted and within its own fold yard, suggesting it was, at the time used for animal husbandry, probably an open-fronted shelter shed. There is a second open-fronted shed to the north, both of which suggest the farm was then a mixed farm. Farming records held by BA&RS from between 1892 and 1923 confirm this with extensive livestock records including, sheep and cattle. The farm was still producing wheat and barley.

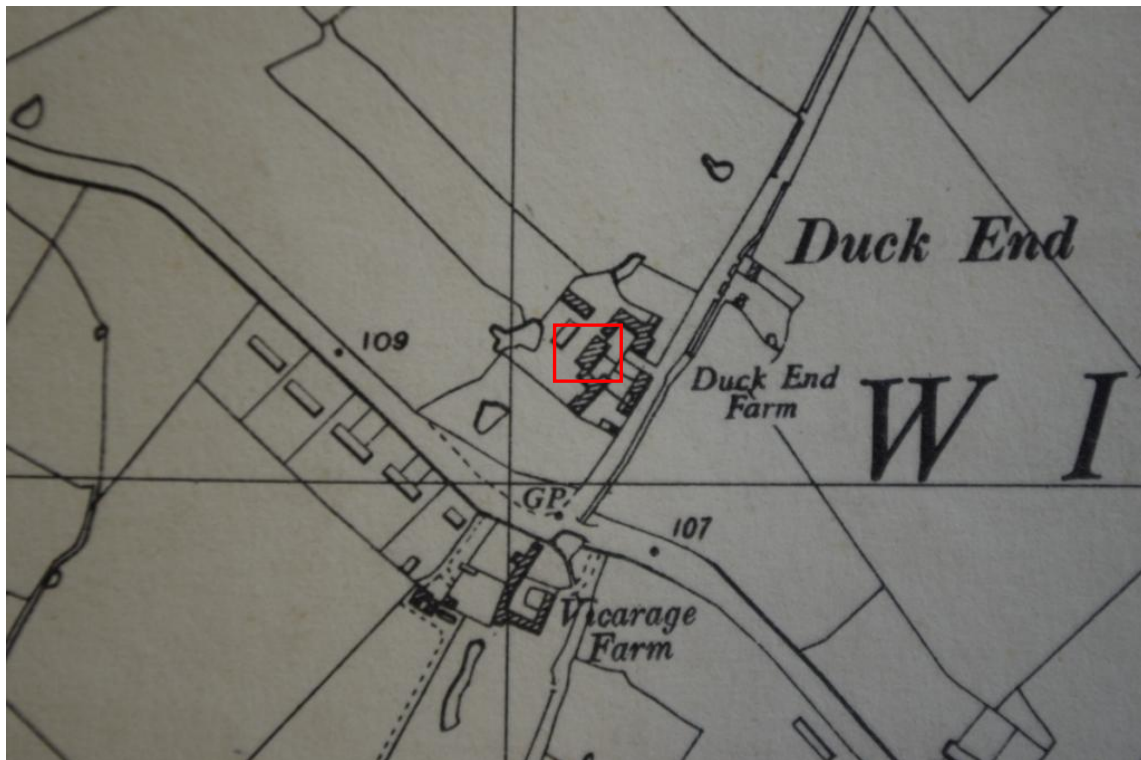
Figure 5
1960 Edition Ordnance Survey (1:10560).
(TL24 SE)

(BA&RS Ref TL23 SE (*Figure 5*)) is the first to record the building to the north west of the building. Viewing online versions which cannot be re-produced for copyright reasons indicate that this building was not constructed until the 1950s.

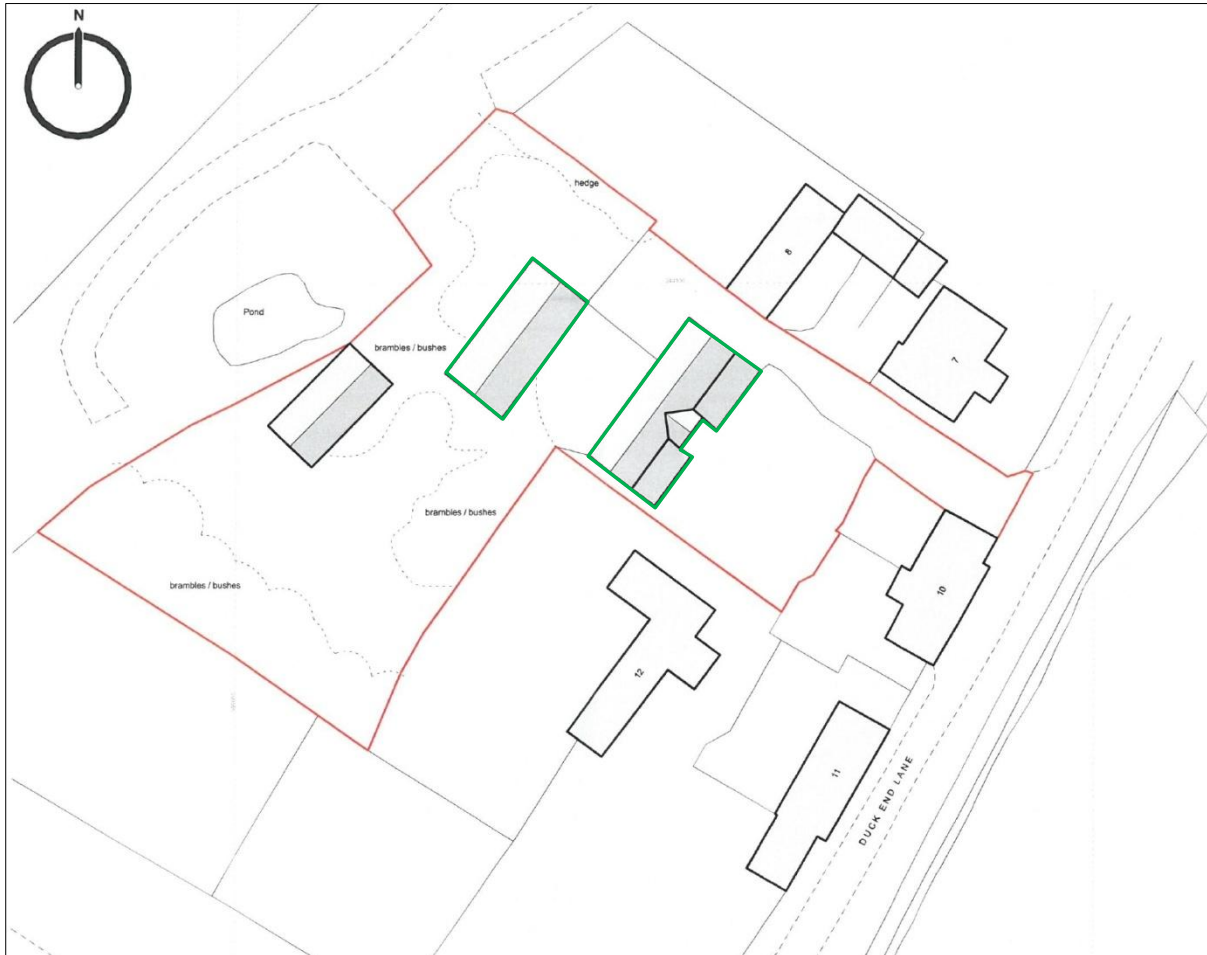
Figure 6
Plan of the Proposed Development Area in Red, Recorded Buildings in Green.
(Provided by client. Not to Scale).

Orientation: There are two buildings subject to this historic building recording. The buildings are linear in plan; the long axis is orientated north east –south west (*Figures 6, 22, & 24*), the principal elevation of Building A faces to the south east and Building B to the north east. Where the terms ‘left’, ‘right’, ‘front’ and ‘back’ etc are used in the report, this is in relation to these principal elevations as viewed from the south east and north east. For the

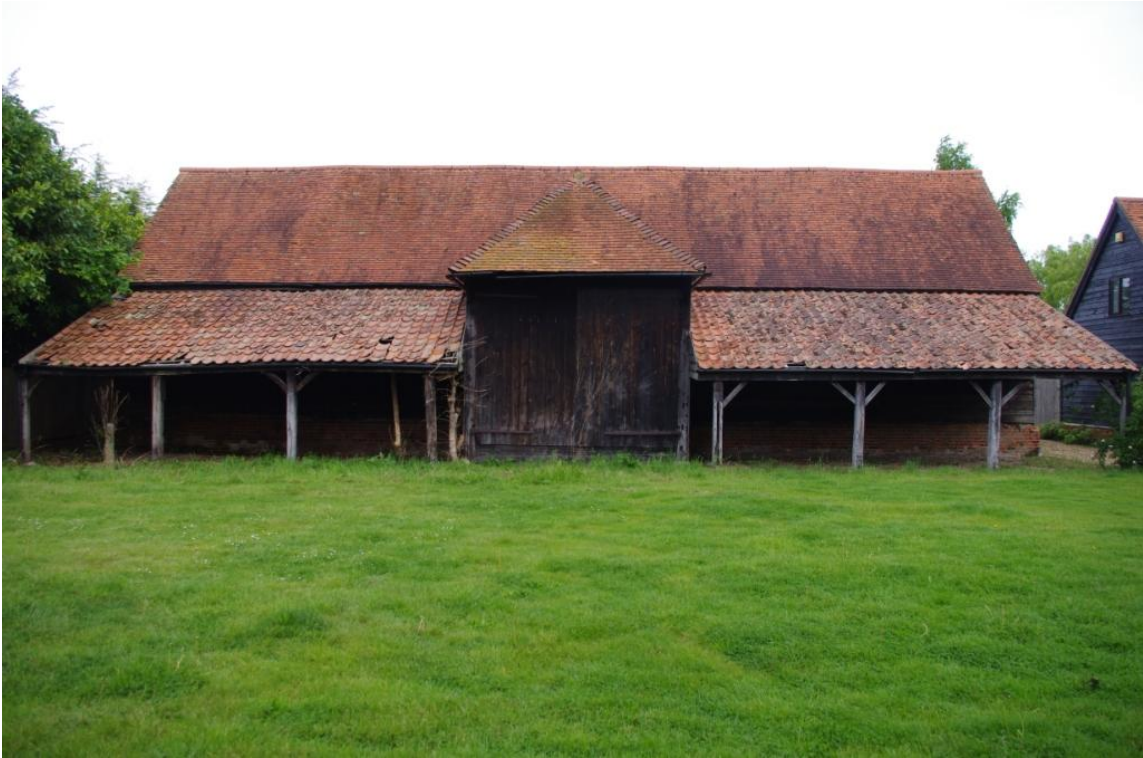
Figure 7
Principal Elevation (Looking North West).

There are central threshing doors on each long elevation, those on the principal elevation are in a projecting hipped porch (*Figure 7*). The hipped porch provided additional protection to the threshing floor from driving rain or snow and some argue allowed late delivered carts to be left under cover over night before being unloaded. The north west facing, rear elevation has two pitching doors at first floor level, the south westernmost having a cat hole (*Figure 8*), suggesting it may be, if not original, early. The large threshing doors, although early looking may not be original, they do however finish some 18inches (c.450mm) above the ground, a common feature on barns which ensured the doors cleared the manure in the yard and kept free roaming pigs off the threshing floor. The latch is decorated with a Saltire (*Figure 9*). Such symbols originated as Apotropaic, or ritual marks, commonly known as witches marks in the 17th century, their intention was to ward off evil and as such they were located near doors, windows and chimneys and were common in the 17th century, but persisted as decorative features on door latches for many generations. However, it is likely that some degree of symbolic meaning was retained into the early to mid 19th century when this latch was likely to have been made, especially on agricultural buildings where superstition persisted in the protection of livestock and the storage of crops. A Suffolk Blacksmith interviewed in the 20th century described the symbol as the cross of St. Andrew between the jambs of the door or window barring the way to any evil spirits (Hall). The latch on the south easternmost pitching door, which retains a cat hole, which may, therefore be original is similarly decorated.

Abutting the principal elevation are two, timber-built open fronted shelter sheds (*Figure 7*). Cartographic evidence indicates these are later additions. Never the less, both are interesting additions to the building reflecting the change from arable farming to mixed farming including livestock rearing. Both are constructed in deal, but some effort has been made in the finishing with attractive concave braces (*Figure 10*) and chamfered and stopped posts, an un-necessary flourish on a shelter shed. The concave braces are limited to the south westernmost shed, those on the north easternmost shed are straight, hinting that these may have been replaced.

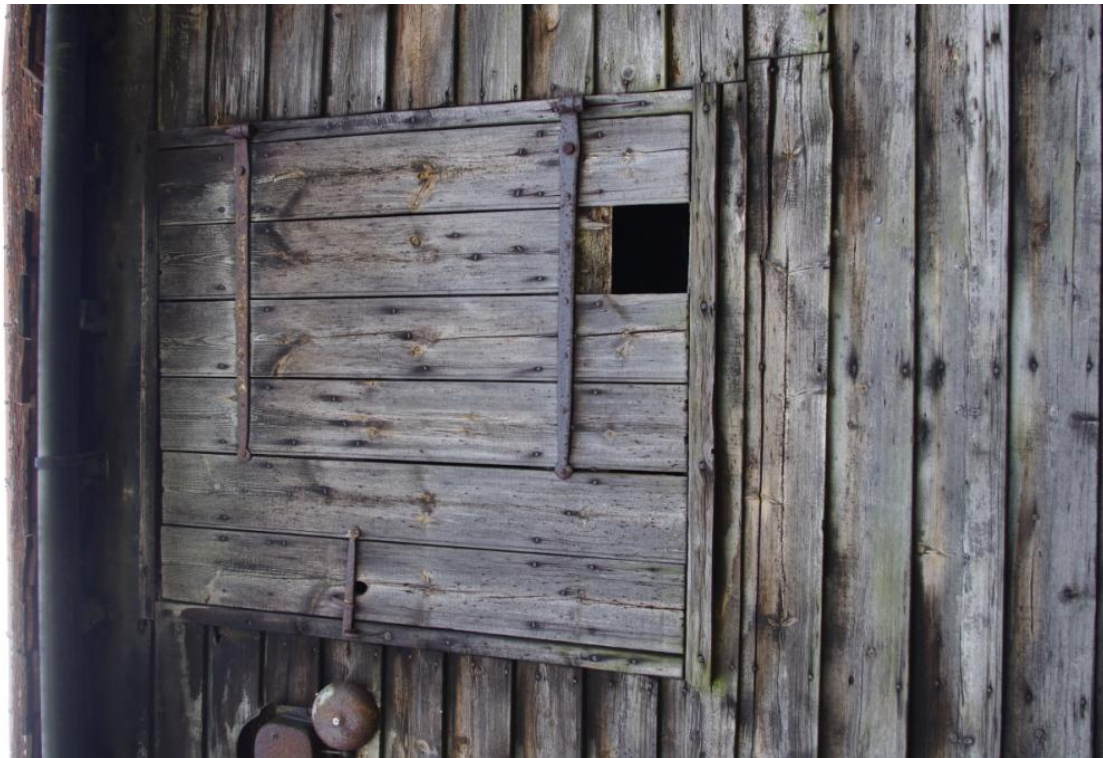
Figure 8
Original Pitching Door inc' Cat Hole &
Hinges on North West Facing
Elevation.

The pitching doors have a mix of strap hinges, those on the south easternmost door are a matching pair, which again suggests it may be original and appear to be mid 18th century in style (*Figure 8*). The top hinge of the north easternmost door is of a similar design, the lower hinge, however is of an apparently earlier design and probably re-used.

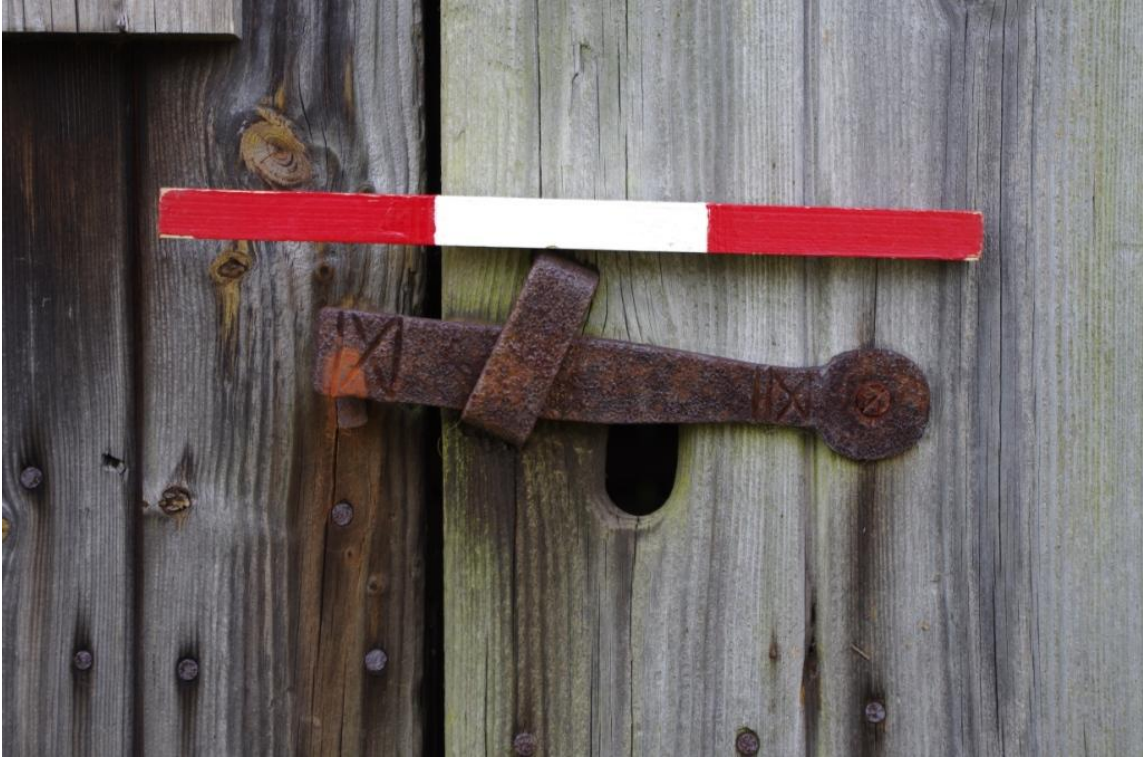
Figure 9
Saltire Decorated Latch on North West Facing Threshing Door.

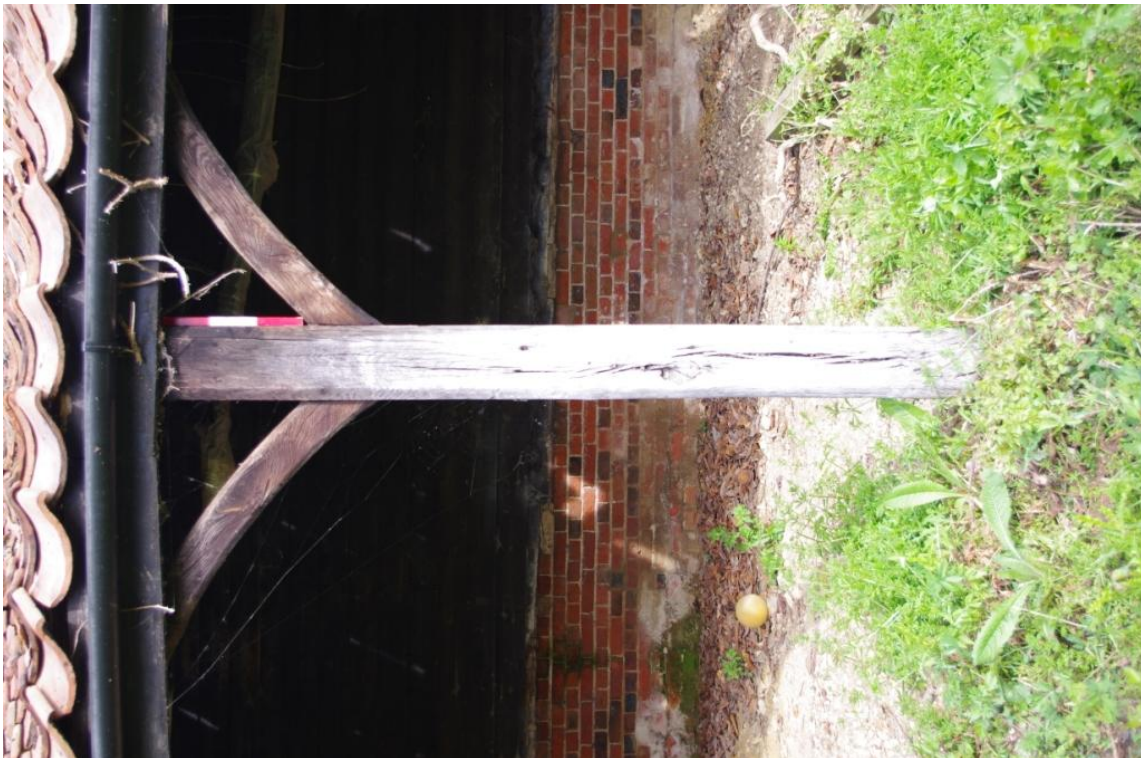
Figure 10
Concave Braces on Shelter Shed, South
East Facing Elevation.

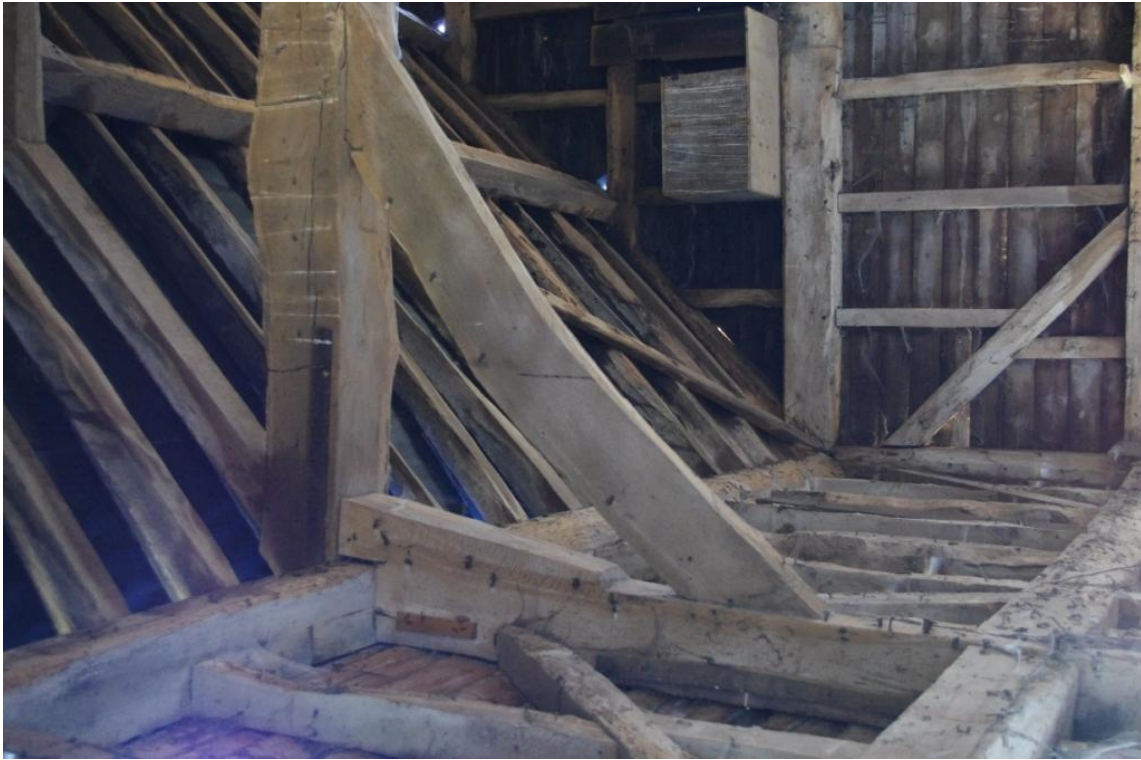
Figure 11
Concave Brace Between Bay Post &
Tie Beam.

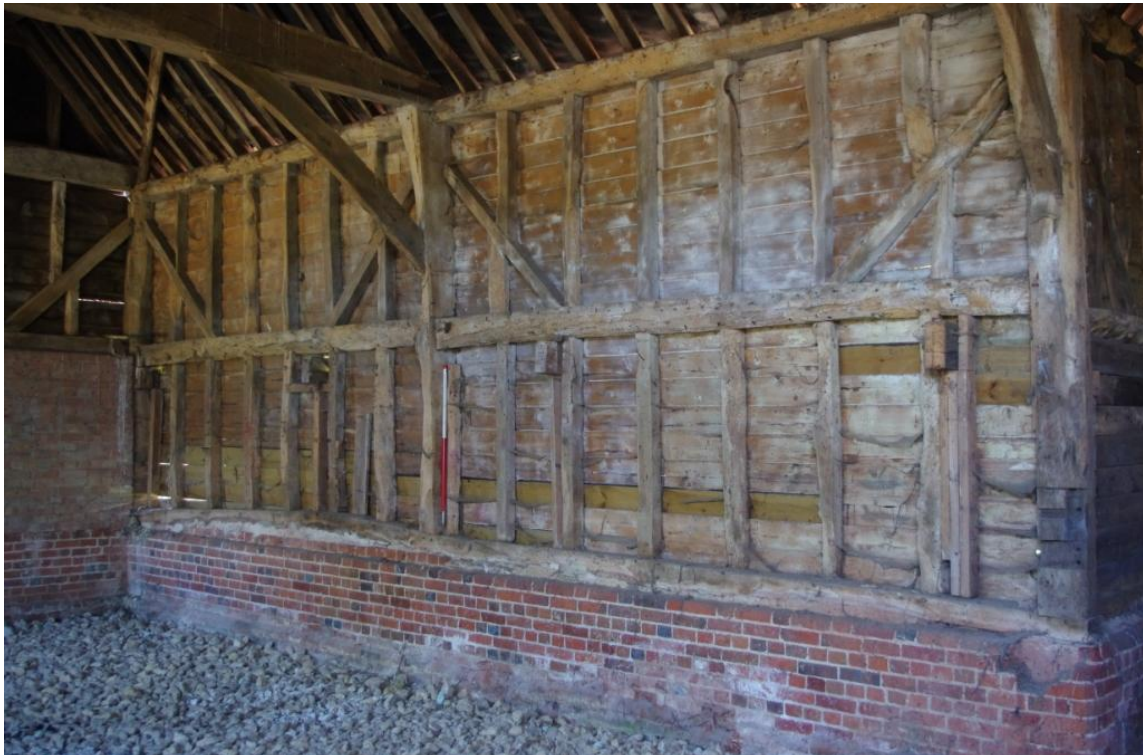
Figure 12
Wall Studding, Internal Wall (Looking East).

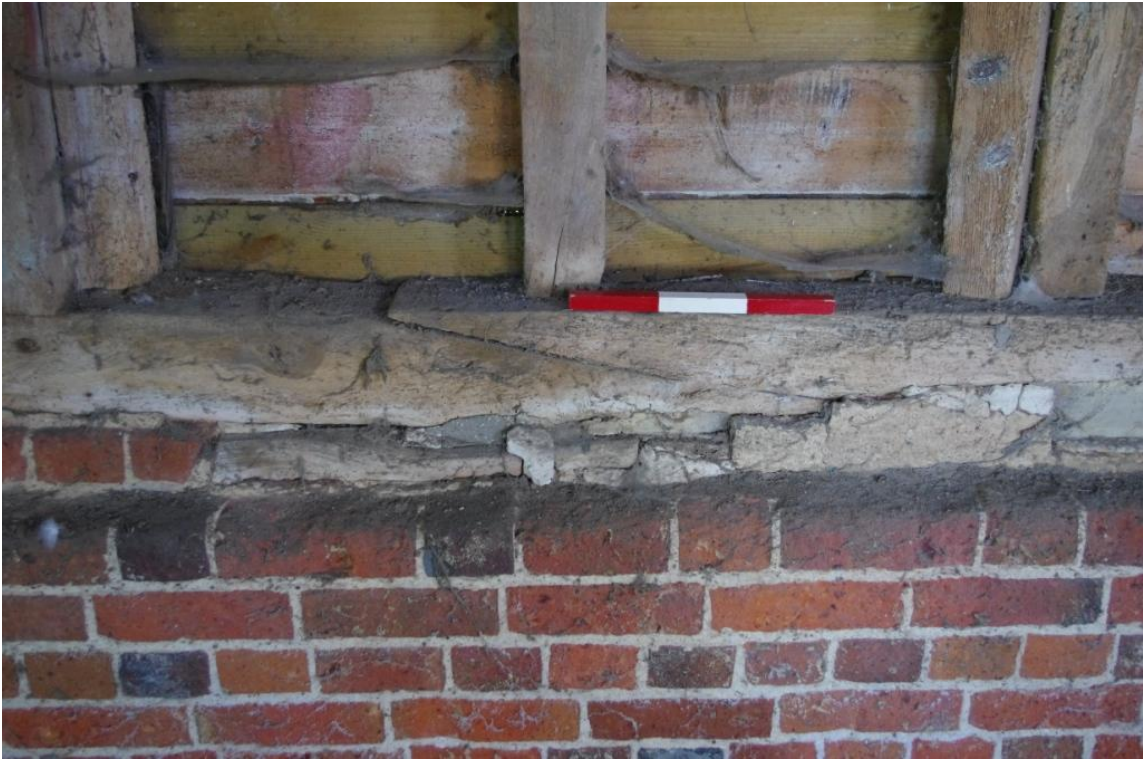
Figure 13
Scare Joint on Sill Beam, Internal View.

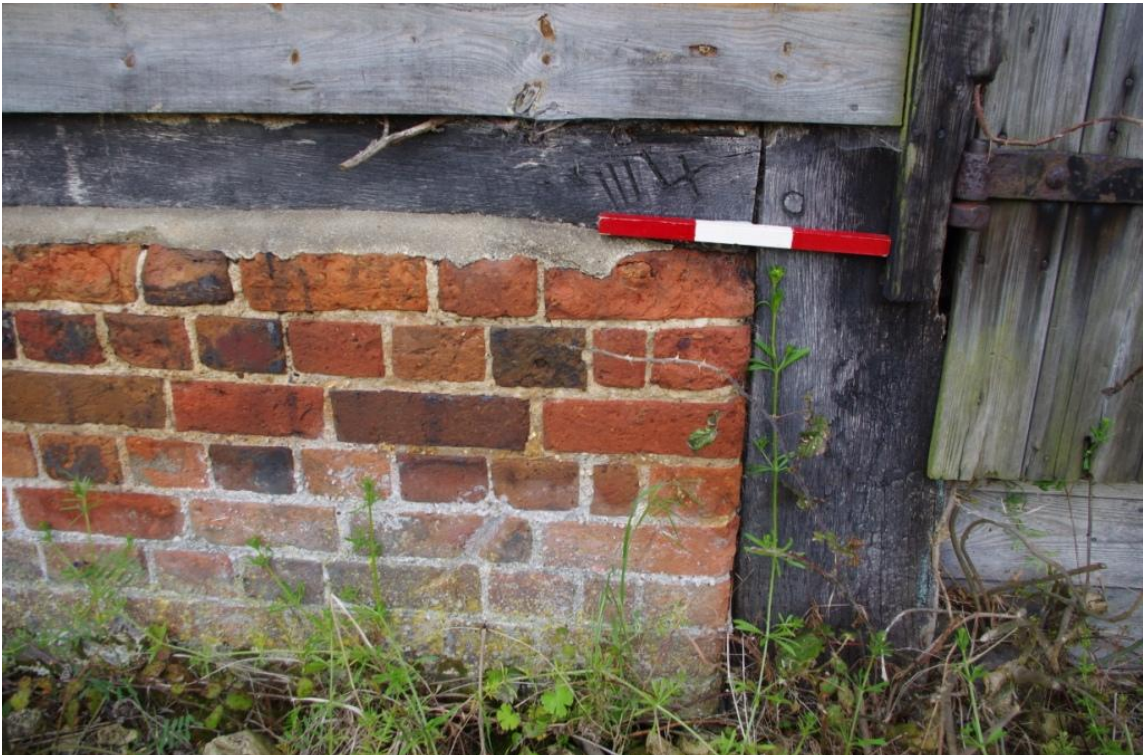
Figure 14
Assembly Marks on Sill Beam, External View.

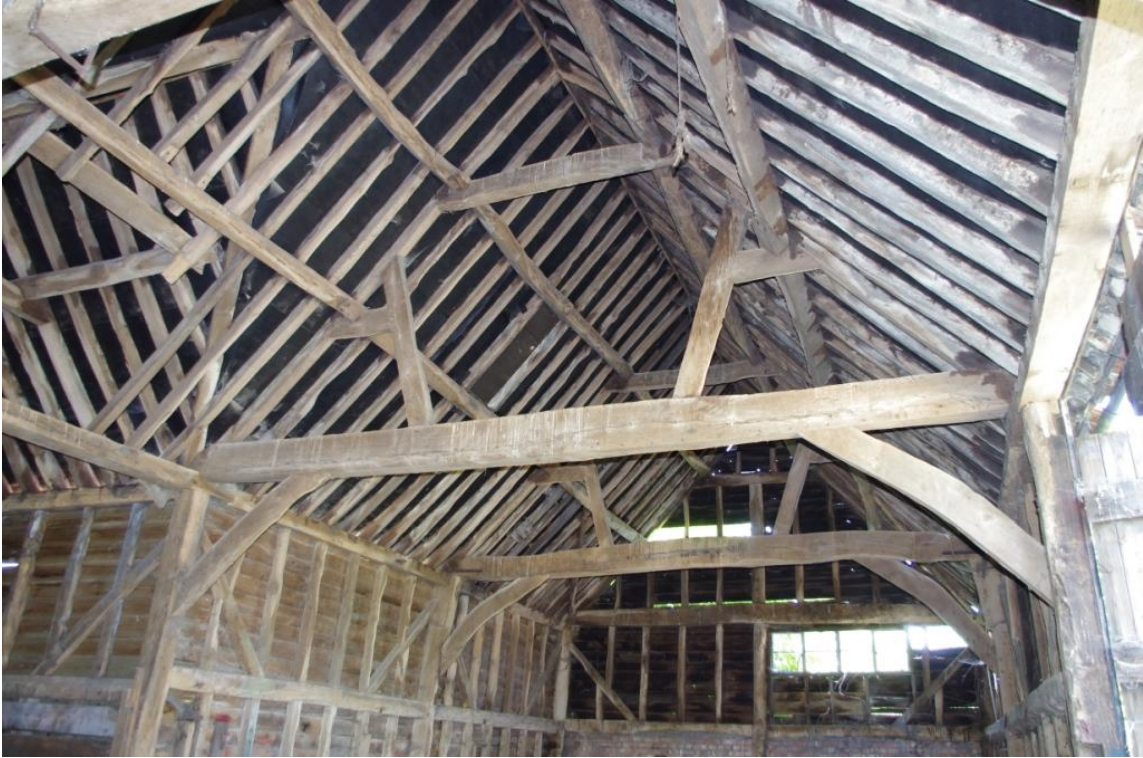
Figure 15
Truss, General View (Looking South West).

The roof is carried on four trusses, the trusses consist of raked queen struts holding an interrupted collar beam, there is also an upper collar (*Figure 15*). The trusses are all pegged and there are iron straps between the tie beams and wall plate, it is unclear whether these are original, or a later repair. The purlins are clasped between the collar and rafter (*Figure 16*). With earlier clasped purlins, the principal rafter tended to diminish, there is no evidence of this here, which again suggests a later construction date. As with the wall frames, there are extensive incised Roman numeral assembly marks on the trusses (*Figure 17*). There is a ridge plank at the apex of the common rafters, the use of a ridge plank as opposed to a ridge beam again suggests a later, rather than earlier construction date.

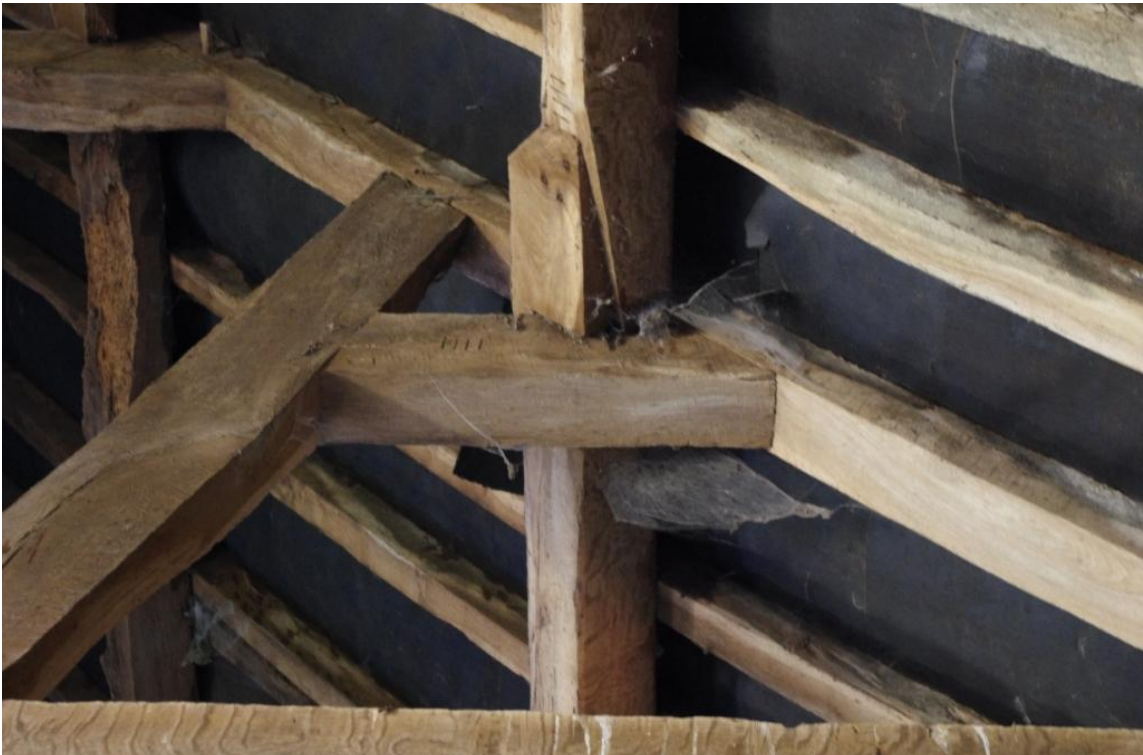
Figure 16
Interrupted Collar Beam & Clasped Purlin.

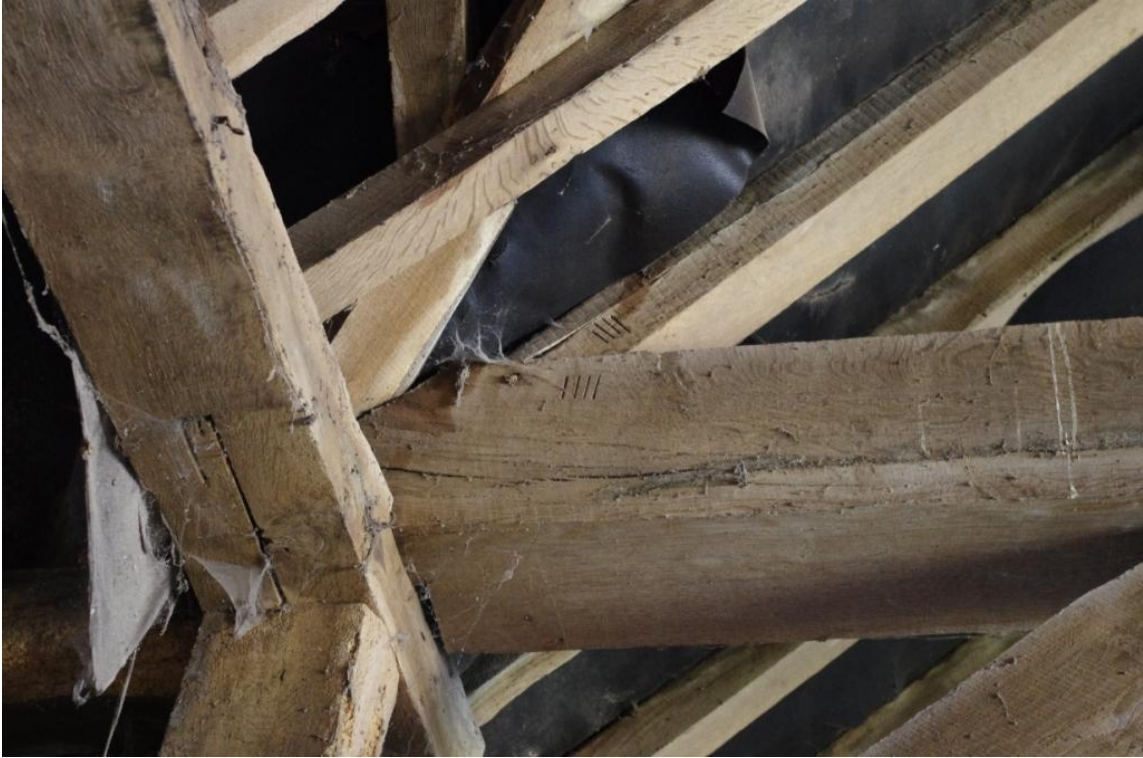
Figure 17
Assembly Marks on Truss.

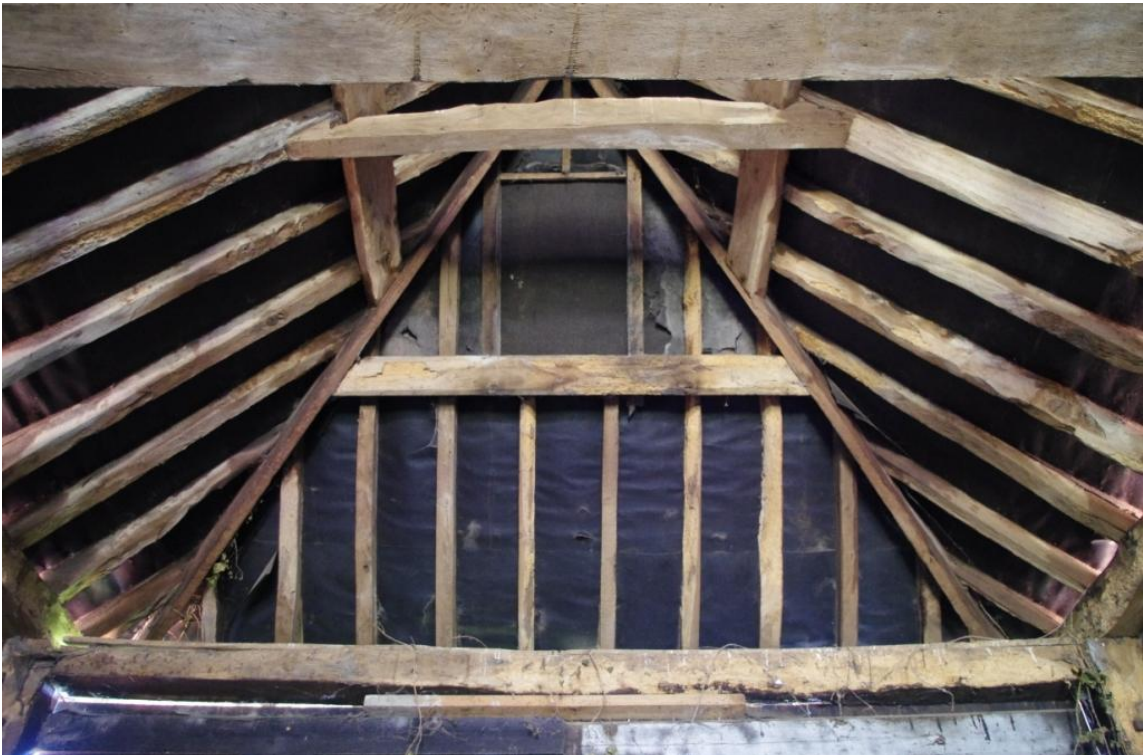
Figure 18
Clasped Purlin & Possible Pitching Door in Hipped Porch.

The roof of the porch is similarly constructed to the main roof, the same clasped purlins (*Figure 18*) confirm the porch is almost certainly original. There is also possible evidence of blocked roof light, or even a pitching hole on the hipped roof.

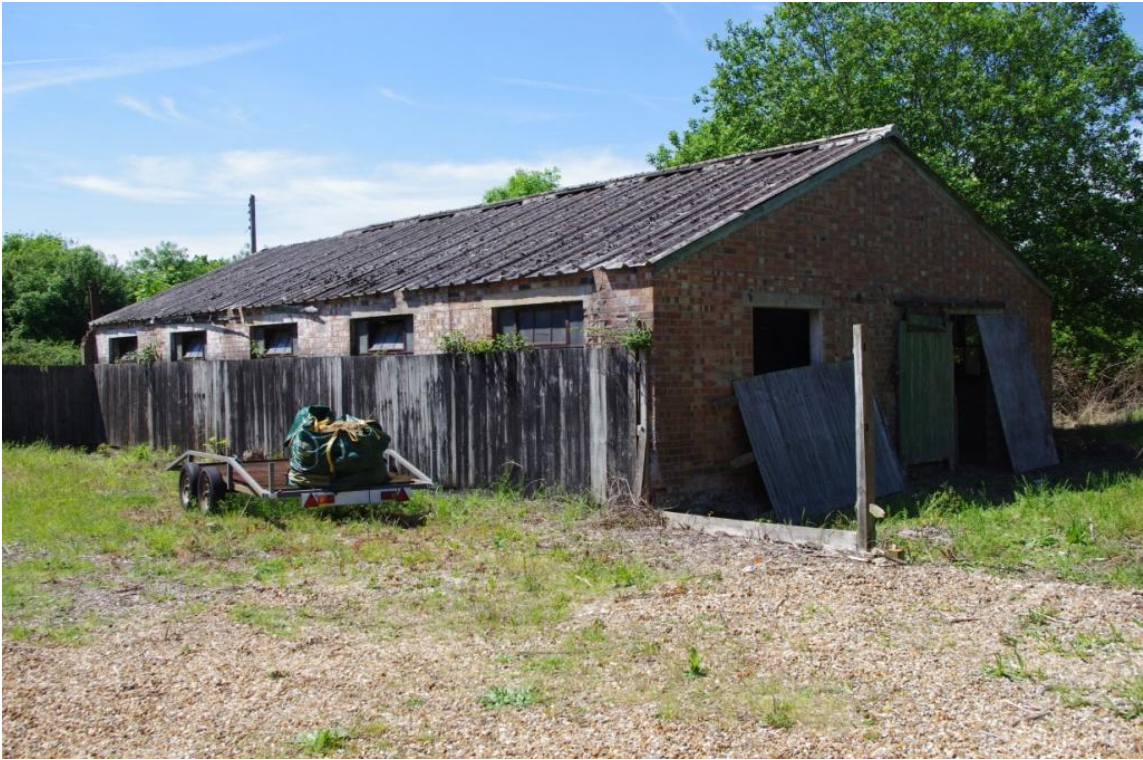
Figure 19
Building B, General View (Looking West – South West).

Building B is located some 10 metres north west of building A. The building is brick-built under a corrugated asbestos cement roof (*Figure 19*). The bricks are mid 20th century Fletton Bricks. There is a single timber sliding door on the north east facing gable, off set to the right as well as a single central door on the south west facing gable. There are 10 light steel framed windows on each long elevation as well as another window opening (minus frame) on the north east facing gable.

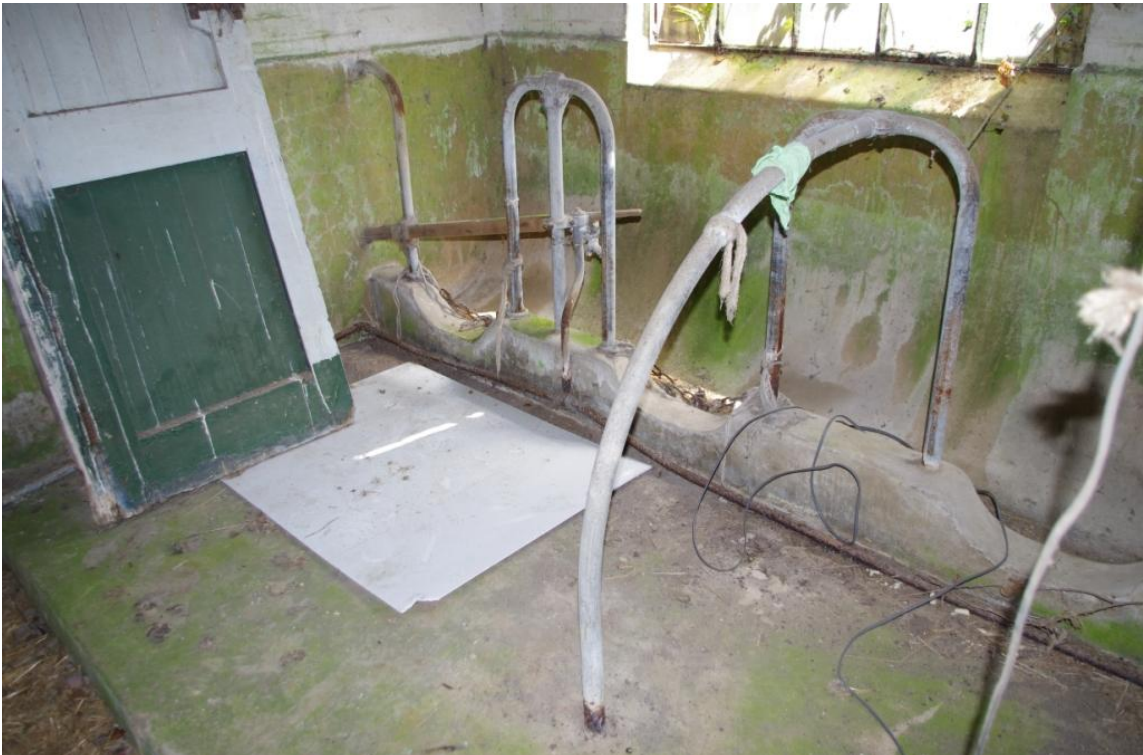
Figure 20
Building B Concrete & Steel Stalls.

Internally, the building is divided into two unequal bays (*Figure 24*). The largest being the south westernmost bay. This bay has concrete and steel stalls along each long elevation (*Figure 20*) and a central, sunken milking floor. The north easternmost bay is divided into two rooms, there is no evidence of original form or function, but in all likelihood the two are ancillary rooms associated with the milking parlour to the south west.

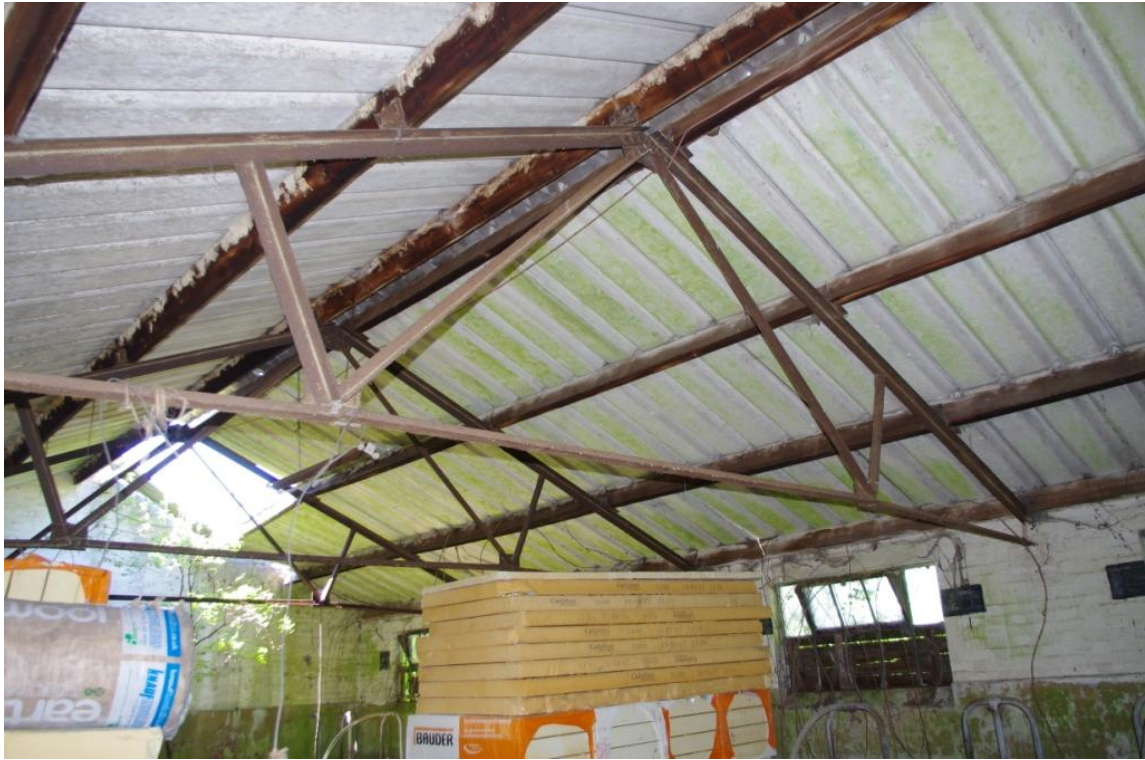
Figure 21
Building B Roof Trusses.

The roof is carried on three angled steel fan trusses which appear to be slightly too wide for the building (*Figure 21*).
