**An Archaeological Standing Building Survey.  
Claybrooke Mill  
Claybrooke Magna  
Leicestershire**

**November 2017**

**ABRS Project No 2017-CMCL**

**Planning Permission No  
17/01258/FUL**

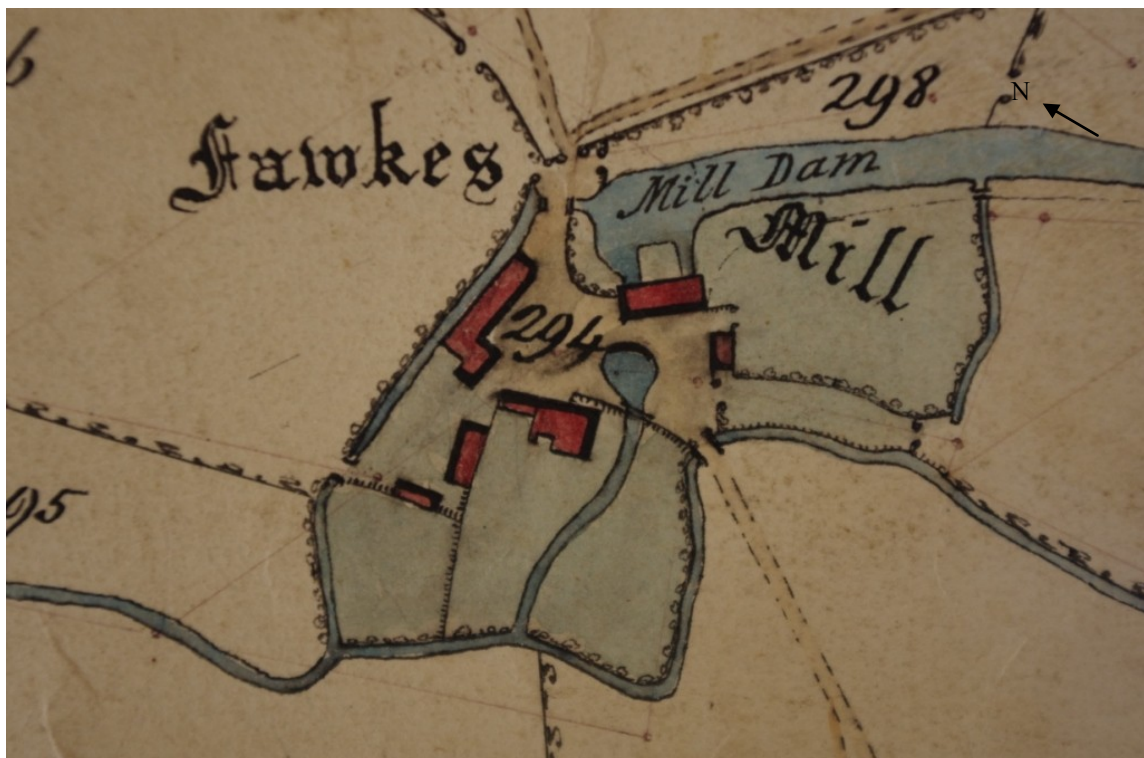
**Figure 3**  
A Plan of the Parish of Claybrooke Magna and Claybrooke Parva (1839).

In 1839 “A Plan of the Parish of Claybrooke Magna and Claybrooke Parva” was produced for the Parish tithe (ROLLR Ref 4D69/8 (*Figure 3*)). It is the first map which records the mill complex in detail, interestingly the Mill is identified as Fawkes Mill, suggesting that it may have been in the Fawkes Family for a number of generations at that time. A mid 19th century trade directory supplied by Mr & Mrs Eales records that the interest accrued upon a £20 bequest left by John Fowke in 1829 be divided equally between the poor of the Parish and the Sunday School. This suggests the Fowkes Family were well established in the village and apparently a Family of some means. The Mill remained within the Fowkes/Fawkes Family throughout the remainder of the 19th century. Wrights Directory of Leicestershire published in 1894 lists Mrs Mary Ann Fawkes as a private resident, and a Arthur Tyers as a grazier and miller, suggesting a possibly widowed Mary had sold the mill to Mr Tyers, as confirmed by a sales catalogue dated July 27th 1893, which also confirms that Arthur Tyers was the sitting tenant at the time of the sale. The Mill remained with the Tyers until at least 1941.

The recorded building is clearly visible on the Parish Plan of 1839 to the north of the mill, identifiable by the angled south east corner. This unusual alignment indicates that this trackway crossing the mill site pre-dates the 18th century mill complex and is likely to be of some antiquity. The 1893 sales catalogue describes the mill as consisting of dwelling house, stables, barn, cow shed and wagon hovels, piggeries and other outbuildings.

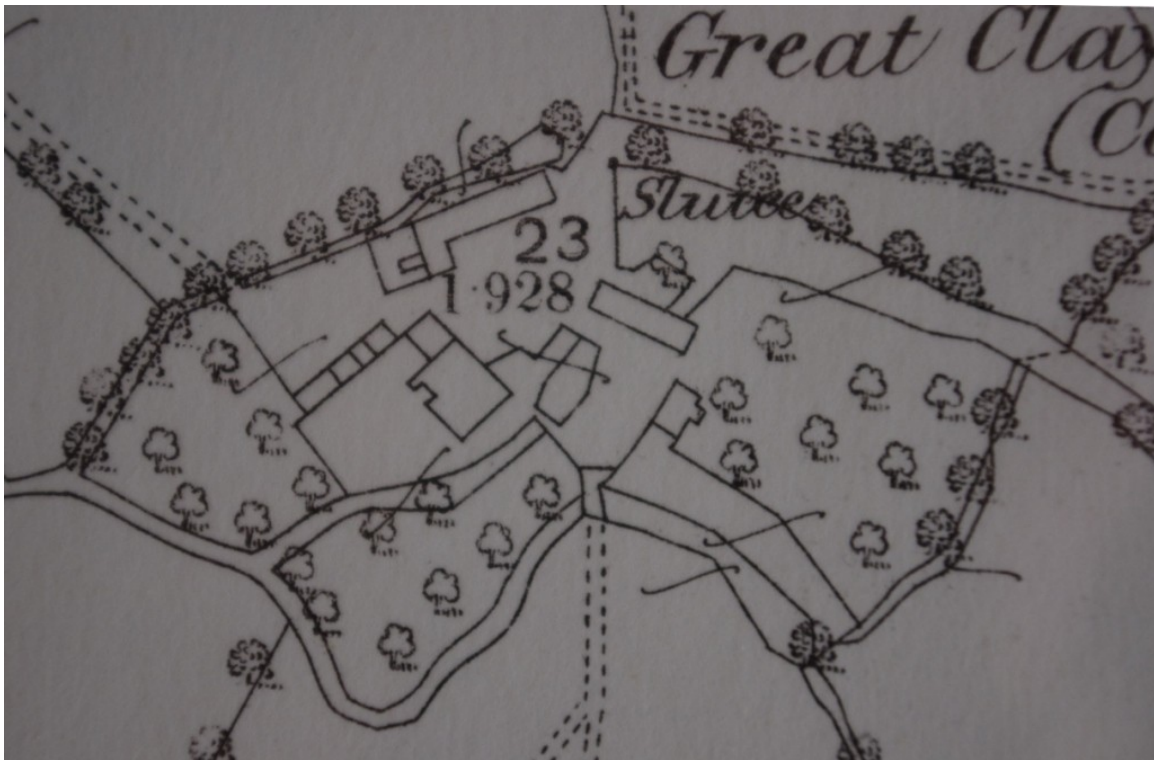
**Figure 4**  
First Edition Ordnance Survey (1887).

The first edition Ordnance Survey was published in 1887 (ROLLR Ref XLVIII.3 (*Figure 4*)), it is the first modern representation of Claybrooke Magna Mill. The Mill is clearly identified as a corn mill. The recorded building is the largest on the site and is almost identical to the footprint of the building recorded in 1839, the only difference being an outshoot on the south

west facing gable into a probable fold yard. Interestingly, the tell-tale south east angle is not recorded, this is most likely as a result of an error in the mapping.

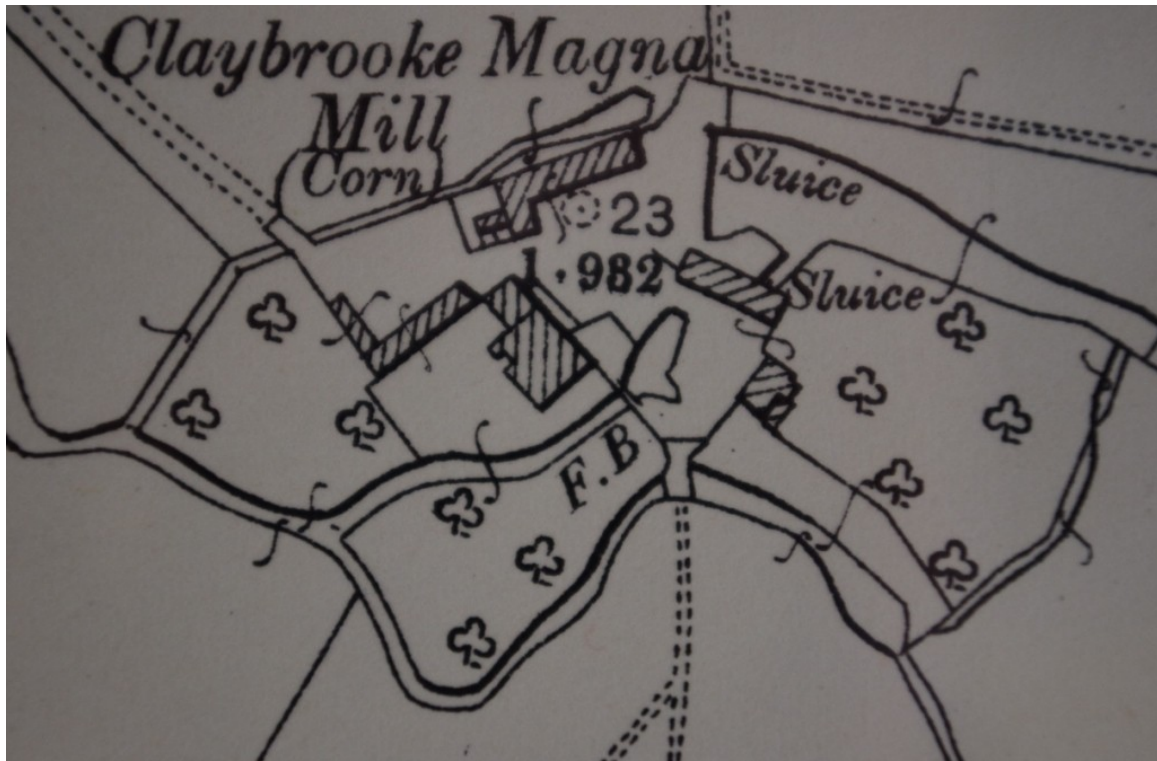
**Figure 5**  
Second Edition Ordnance Survey (1903).

The second edition Ordnance Survey was published 1903 (ROLLR Ref XLVIII.3 (*Figure 5*)), it shows the recorded building largely as it stood in 1887, the only difference being the outshoot on the south west gable is now clearly identifiable as a pigsty. There is also a rick stand to the south of the building, suggesting that as well as being a mill, the site was also a working farm.

To the south of C is D, another single storey bay under a lean to roof. There are at least two phases of brickwork visible on the south west corner of D indicating re-building work (*Figure 15*). The lower courses are the likely remains of the pigsty seen here on the second edition Ordnance Survey (*Fig. 5*). Further evidence that D is later and was originally an open yard can be seen in the corbels on the easternmost wall, originally an external feature (*Figure 16*). There is also evidence of a blocked opening on the east wall of D, originally providing cross passage through B(1). There is a stub wall projecting from the westernmost wall, which again may be a remnant of the earlier pigsty.

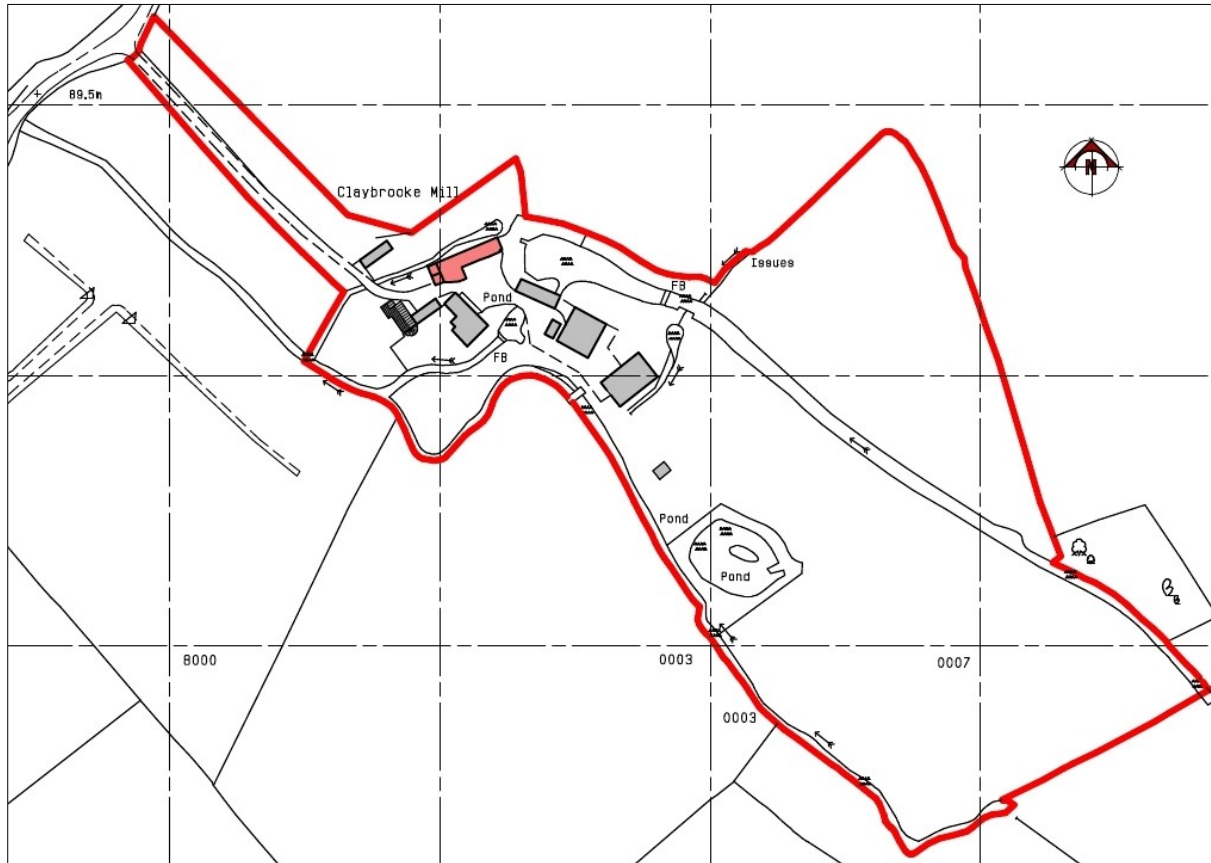
**Figure 6**  
Plan of the Proposed Development Area, Recorded Building in Red.  
(Provided by client. Not to Scale).

*Orientation:* The building subject to this historic building recording is linear in plan, orientated west-south west – east-north east (*Figures 6 & 17*) for ease of description this is taken hereafter to be east to west. The principal elevation faces south. Where the terms ‘left’, ‘right’, ‘front’ and ‘back’ etc are used in the report, this is in relation to this principal elevation, as viewed from the south. For the purposes of this historic building a number suffix has been added for significant partitions where required.

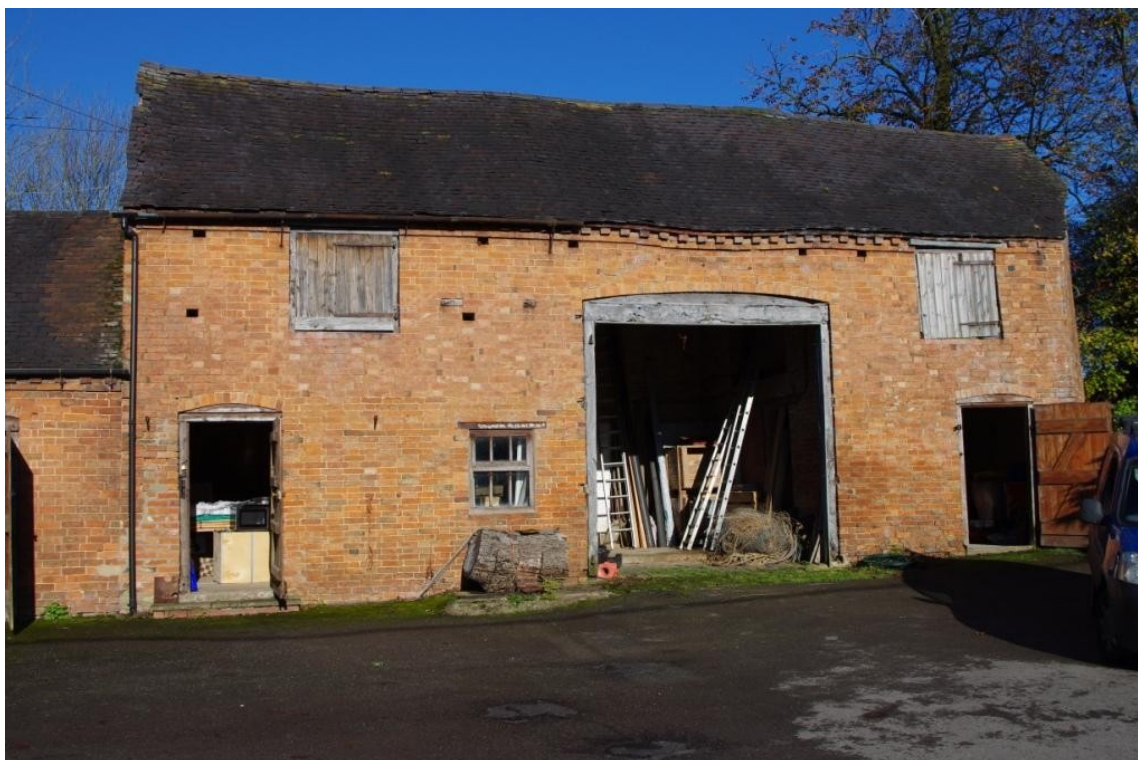
**Figure 7**  
Building A Principal Elevation (Looking North – North West).

The building is linear in plan aligned east – west (*Figure 17*), forming the northern end of the mill complex. The building is brick-built under a plain tile roof. The building consists of five distinct phases, with clear straight joints between each indicating different construction dates. The easternmost part is the largest element, consisting of a three bay barn, A with a central door on the south facing elevation (*Figure 7*), there is no corresponding door on the north facing elevation, which abuts the mill race (*Figure 8*), this lack of second door suggests the building was never used for threshing and was a fodder barn. The rear elevation also has a brick-built revetment, the blue bricks, measuring 9inch x 3inch x 4 ¼inch suggests this is a later modification, there is limited evidence of an earlier, stone-built footing or revetment visible in places (*Figure 9*). There are at least two clear phases of brickwork visible within the principal elevation (*Figure 10*), the lower courses consist of 9inch x 2 ½inch x 4 ½inch handmade red bricks laid in a Flemish Garden Wall bond (three stretcher bricks to one header brick in each course) in lime mortar. These brick dimensions suggest a pre early 19th century construction date for the building, confirming the cartographic sources. The upper courses, however are 9inch x 3inch x 4 ½inch, again laid in a Flemish Garden Wall bond, these dimensions suggest these upper courses are likely to be post 1830s in date, indicating that the building has been repaired, or indeed, largely re-built in the later 19th century.

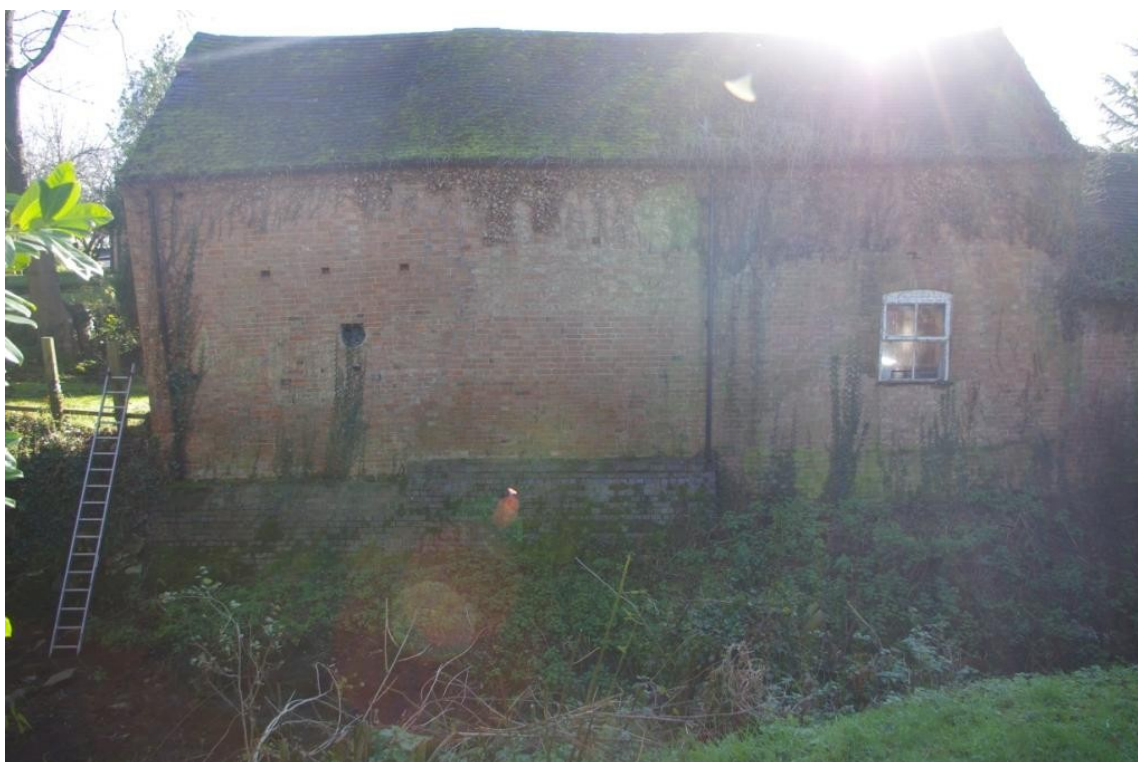
**Figure 8**  
Building A Rear Elevation (Looking South – South East).

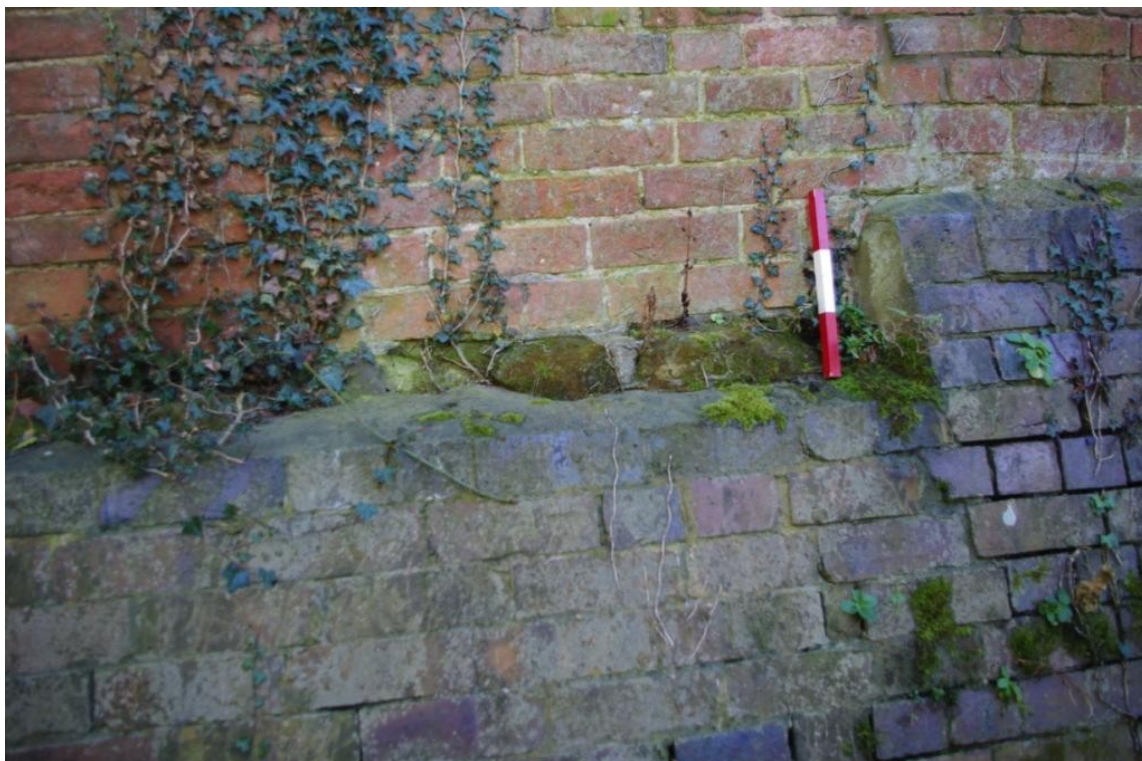
**Figure 9**  
Building A Blue Brick Revetment & Earlier Stone Footing.

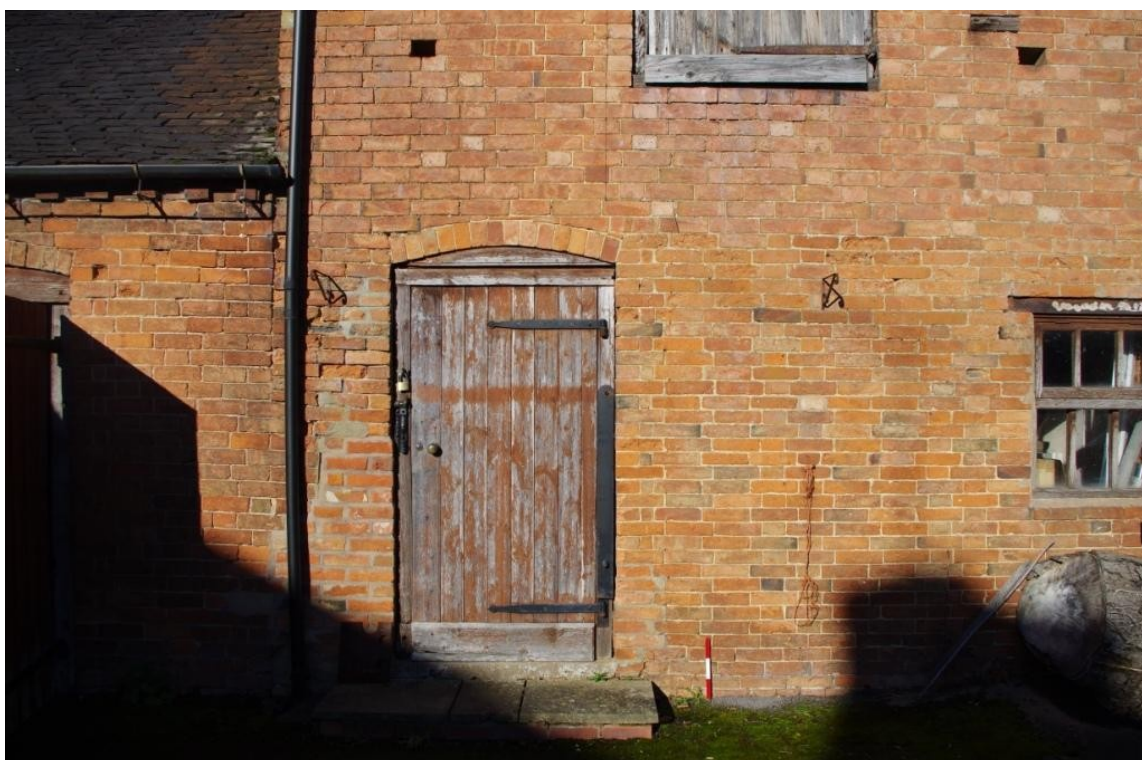
**Figure 10**  
Building A Multiple Brickwork Phases on Principal Elevation.

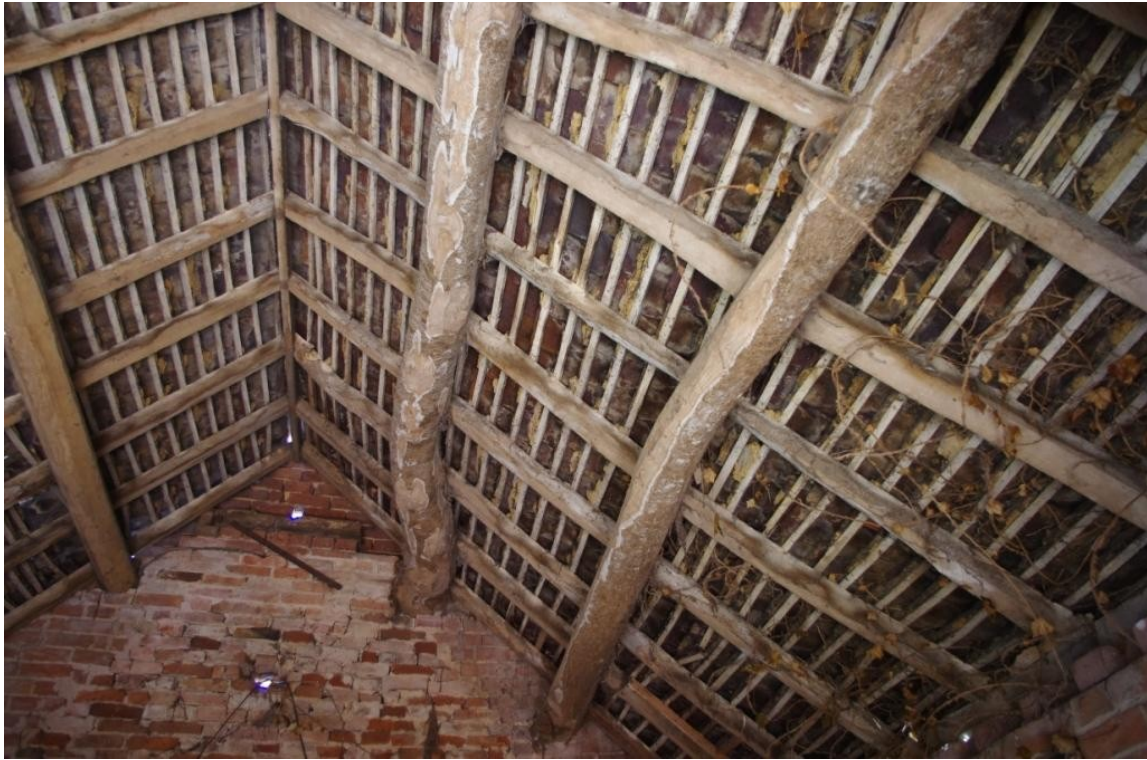
**Figure 11**  
Building A Purlins.

Internally, A consists of three bays; neither cross wall is tied into the long elevations, suggesting they may be later. There are first floors over both end bays, (1) and (3), with pitching doors on the principal elevation; the central bay, (2) is open to the roof. The roof is carried on paired purlins in oak, all of which are only roughly finished (*Figure 11*). There is little evidence of the original form and function of each bay, however this is a common arrangement with animal housing each side of central fodder store, it is likely that (1) and (3) were originally stabling. The pitching doors on the principal elevation, as well as a third, blocked pitching door on the west facing gable confirm the gable bays were, in all likelihood for fodder storage.

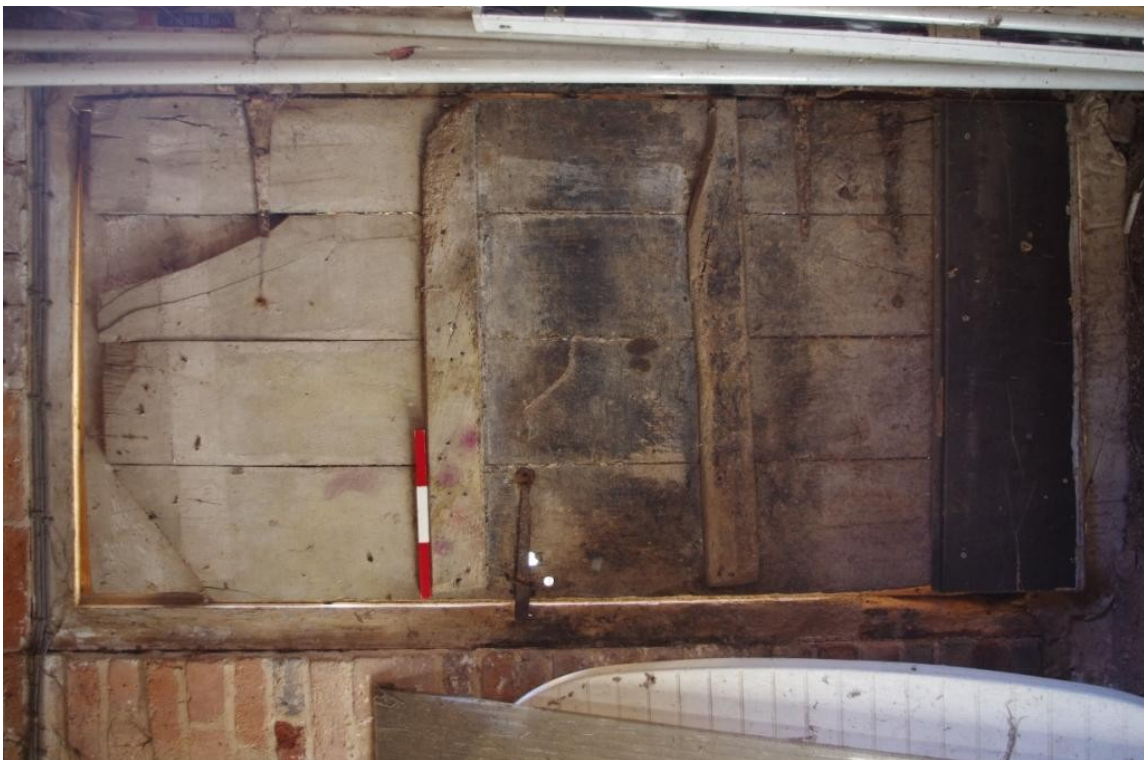
Internally, B is divided into two bays, there is no evidence the two were ever connected, there is however an opening between B(2) and A, this opening contains an early looking plank door (*Figure 12*). The remainder of the doors throughout the building and windows are 20th century, although there are apparently some re-used 19th century hinges and Suffolk latches. There is a second door on the west gable of B(2) with approximately 600mm change in ground level with C, to the west. Along the rear wall of B(2) is a brick-built manger, the floor is a mix of brick pavers and an area of small cobbles (*Figure 13*), this, along with the central gully confirms B(2) was originally for animal housing, possibly a cow shed. There is no clear indication of the original form or function of B(1), although it is likely that it too was a cow shed.

**Figure 12**  
Building B(2) Early Looking Plank  
Door.

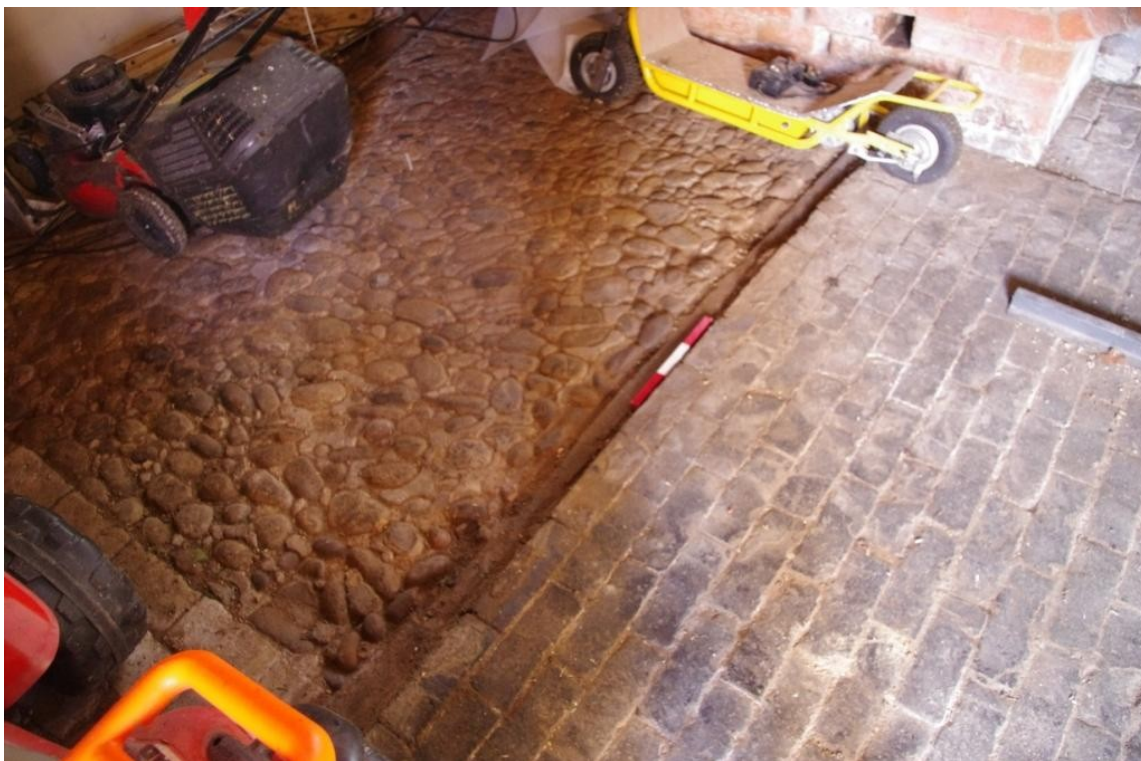
**Figure 13**  
Building B(2) Floor.

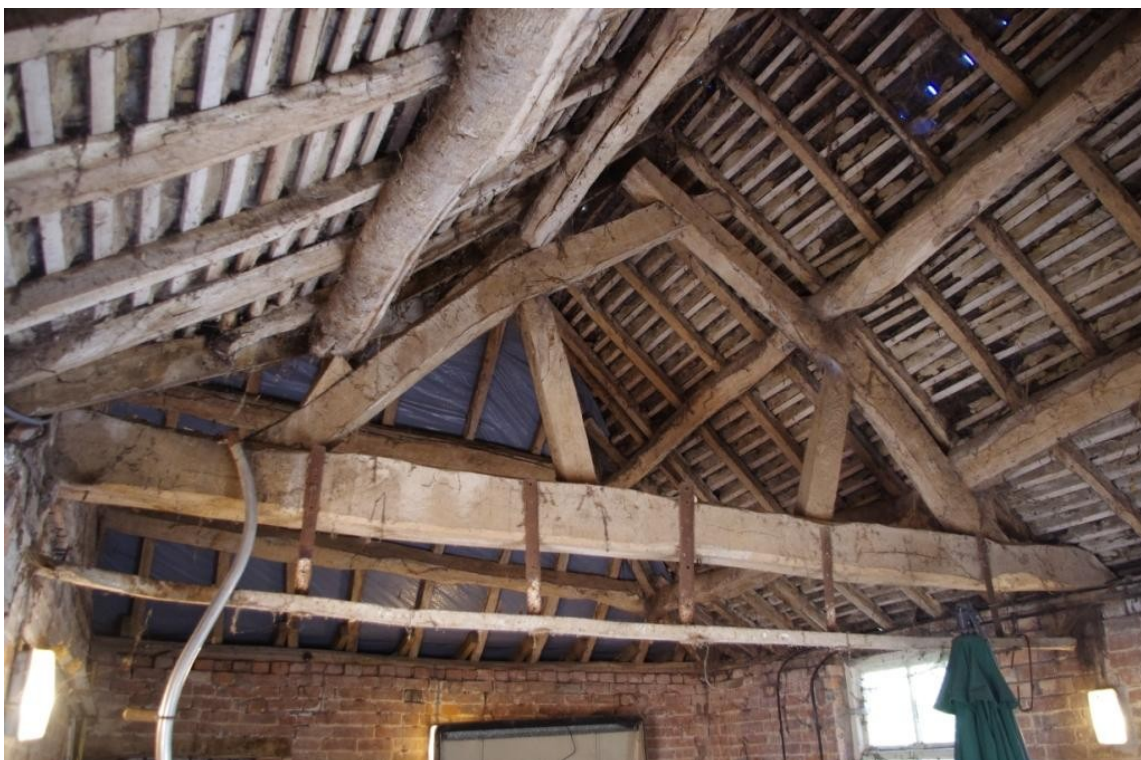
The roof is carried on paired oak purlins, again only roughly finished. There is a single hardwood A frame truss with raking struts over B(2) (*Figure 14*). The crudity of the finish

would suggest an early date, or potentially re-used, however, this is impossible to confirm. There is no truss within B(1), the paired purlins are carried by the cross wall.

**Figure 14**  
Building B(2) Roof Truss.

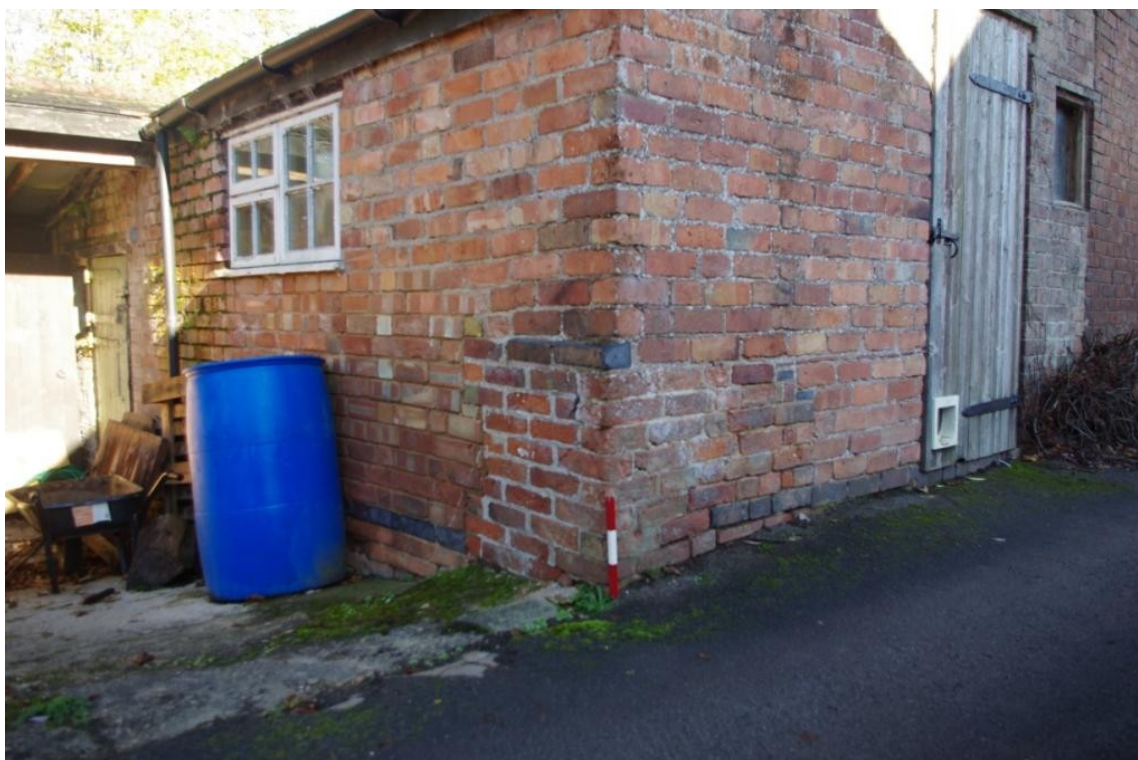
**Figure 15**  
Building D Multiple Brickwork Phases on South & West Facing Elevations.

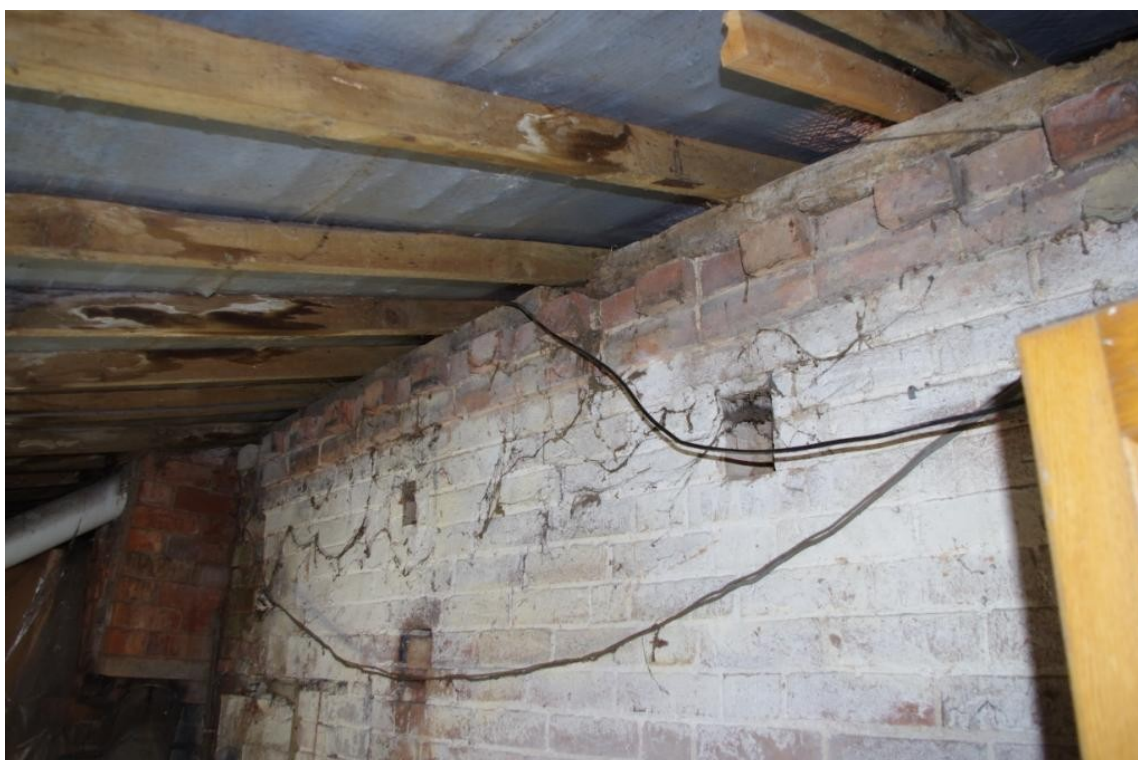
**Figure 16**  
Building D Corbelling on Easternmost Wall.
