## **An Archaeological Standing Building Survey The Crown Inn Cheadle Staffordshire**

ABRS Report No 2017-CMCS

**October 2017**

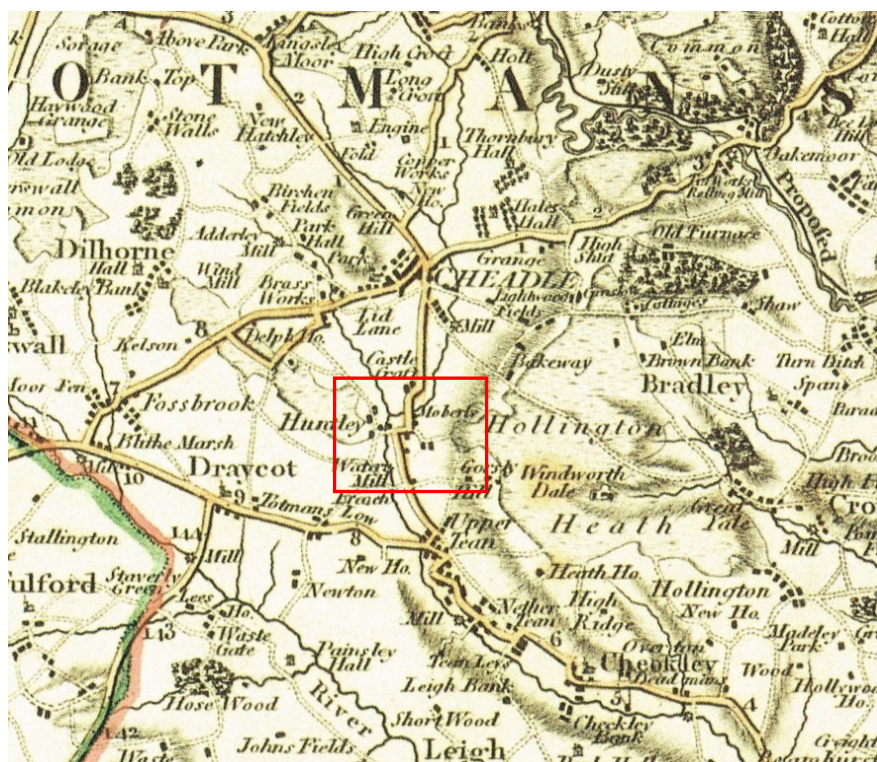
**Figure 2**  
William Yates's County Map of Staffordshire (1798).

The hamlet of Mobberley is located within the modern parish of Cheadle, south of Cheadle, straddling the Uttoxeter road. The settlement has Saxon origins and is recorded in the Domesday Book as *Celle* and was held by Robert of Stafford. Historically, the hamlet consisted of a few scattered dwellings, farmsteads and an inn – The Crown Inn. In 1847 the hamlet became part of the ecclesiastical parish of Freehay, the earliest known documentary reference to the hamlet dates to late 16th century. Yates's Map of 1798 (*Figure 2*) records the principal thoroughfares and a number of buildings within the hamlet, Tean Road is shown as a substantial road, the present alignment of Freehay Road is only recorded as trackway, using these alignments it is possible to suggest that the building now known as the Crown Inn was recorded in 1798.

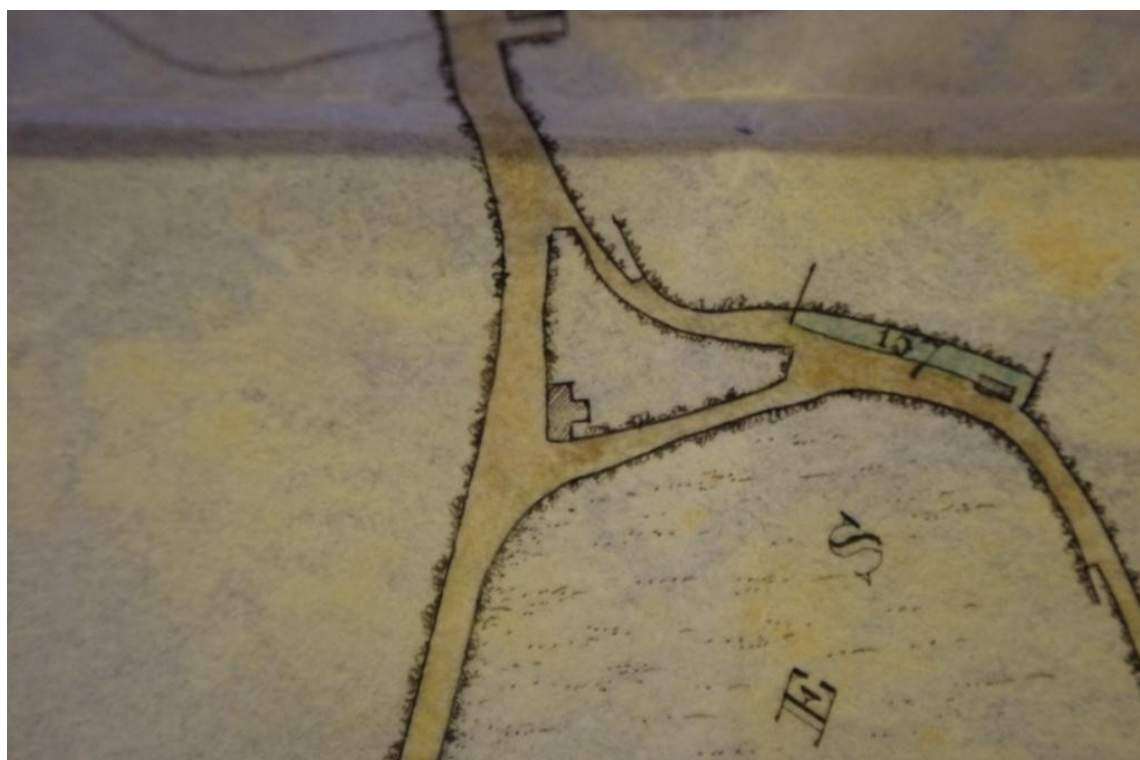
**Figure 3**  
Plan of Allotments on the Little Common and Draycott Commons in the Parish Cheadle, 1831 (Plan II).

The Parish was enclosed in the early 19th century, with a map produced in 1831 (SRO Ref Q/RDC/72 (*Figure 3*)). Although not clear from the award, the parcel on which the Crown Inn stands appears to be "Old Enclosure" and therefore, there is no further information about the site. The building, now the Crown Inn is, however clearly recorded as a "T" shaped building fronting Tean Road in the south westernmost angle of the triangular plot.

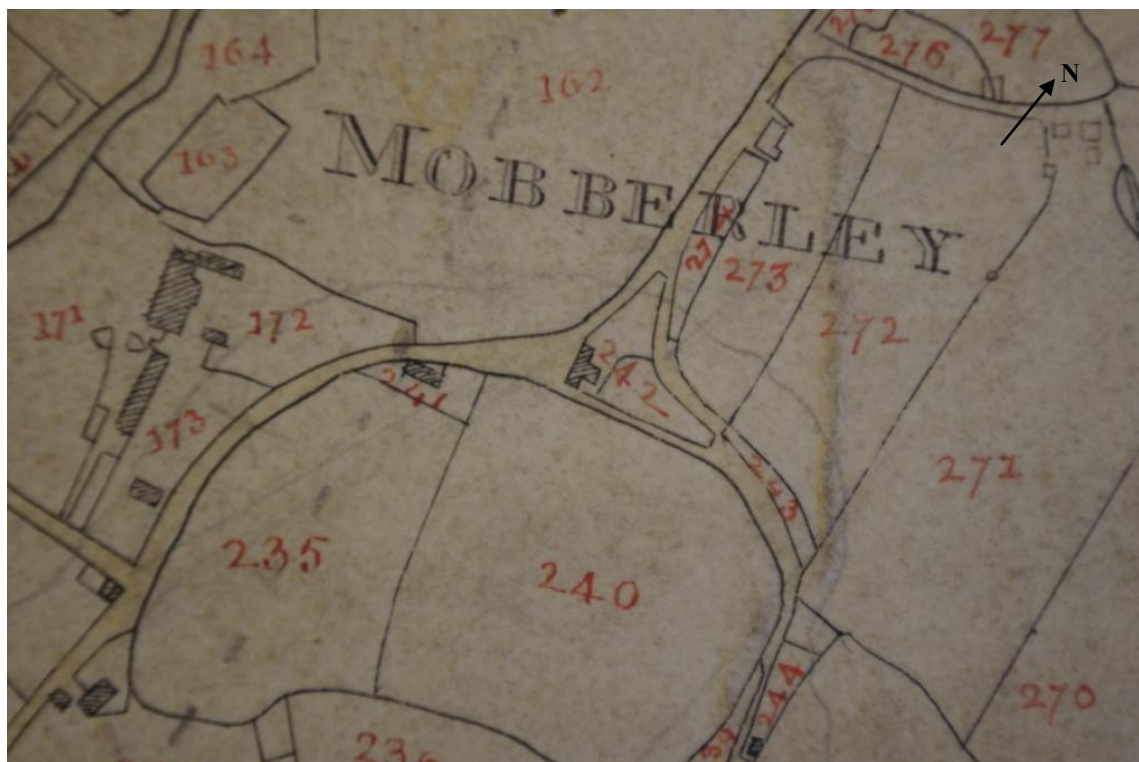
**Figure 4**

Plan of Area Showing Dairy House, Hazel Wall, Both Hall, Park Hall and Mobberley (Undated).

An undated map (SRO Ref D1176/A/3/17 (*Figure 4*)) shows the Crown Inn similar to how it is recorded by the enclosure map, the only significant difference being the alignment of Tean Road, which appears to meander more. The triangular plot is also shown as divided in two, this may suggest that the building may, at the time have been two separate dwellings, although, there is no way to confirm this.

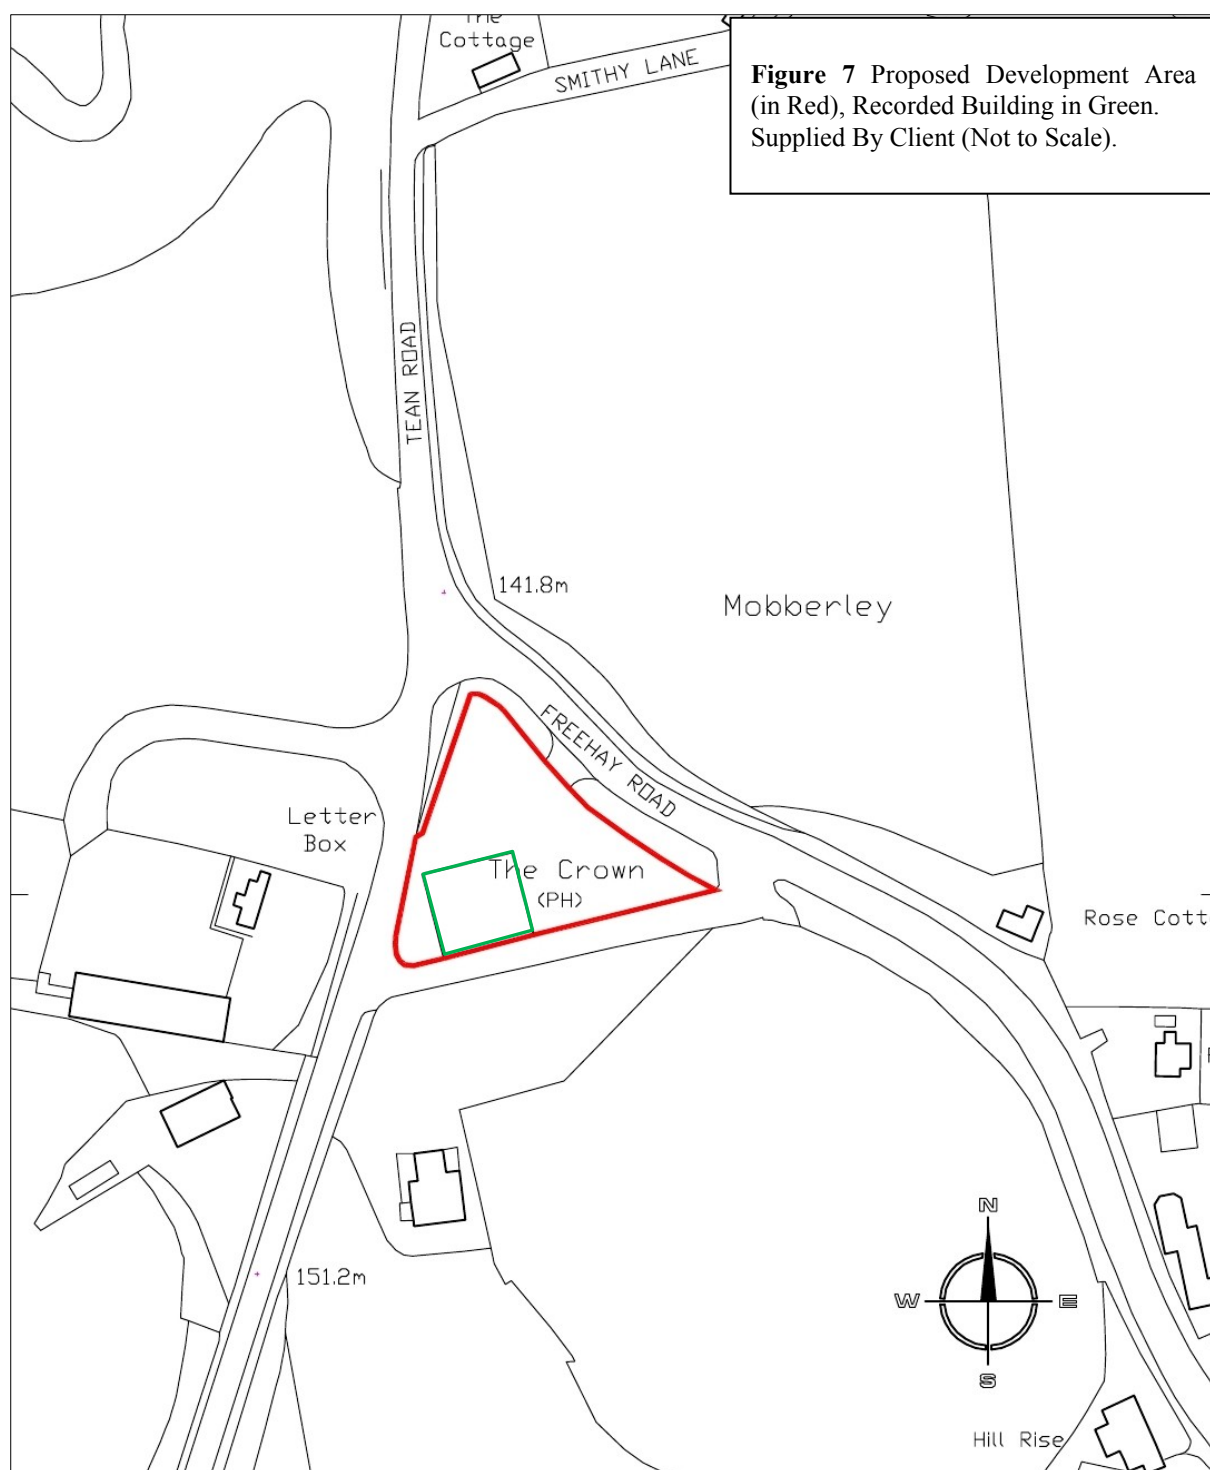
The Crown Inn is rectangular in plan occupying the south westernmost corner of a triangular plot of land, fronting Tean Road (*Figures 7 & 16*). The building has a two storey principal elevation with gabled dormers (*Figure 8*) and an extensive rear range under a flat roof. The building is rough rendered in a mix of modern cement mortar and older cement mortar, the pitched roof is plain tiles (largely missing). Windows and doors are a mix of uPVC and modern timber casement windows.

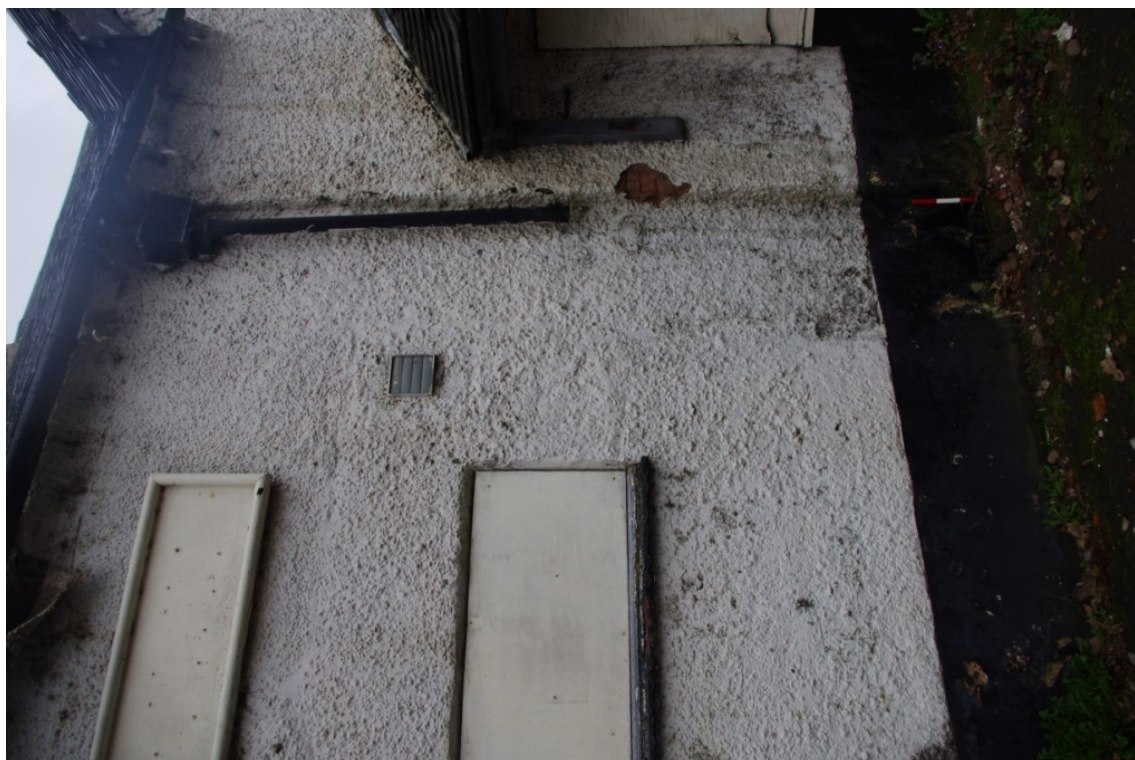
**Figure 9**  
Stepped Joint Between (1) (Right) &  
(2) (Left).

There are at least four separate phases visible from the outside of the building, the principal elevation consists of two linear bays, (1) to the south and (2) to the north both fronting Tean Road, (1) being the larger of the two. The step between (1) and (2) (*Figure 9*) suggests the two are not contemporary, possibly confirmed by the off centre stack which may indicate the original gable wall. There is a parapet on the southern gable and probable evidence of corbelling on the principal elevation, now rendered. External corbels can be seen on the rear elevation (*Figure 10*).

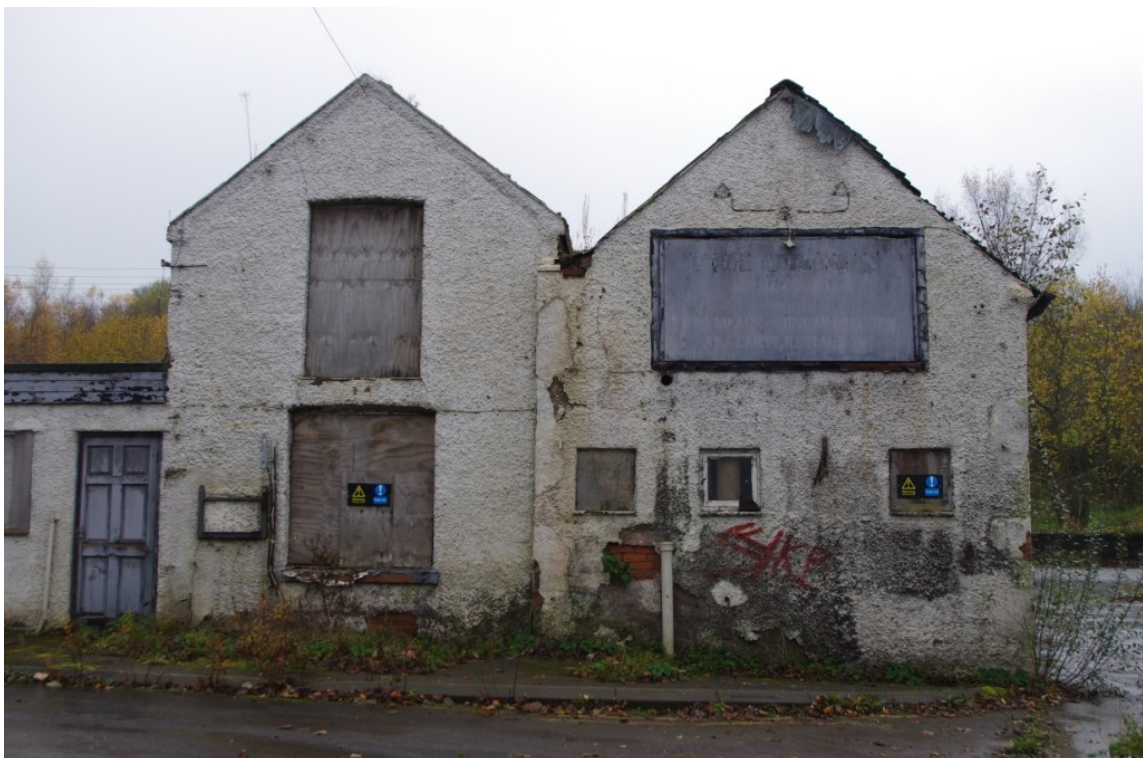
**Figure 11**  
North Facing Gable (Looking South).

This northern bay is a double pile with a second range, (4) to the east of the frontage range (*Figure 11*). Again, there is a stepped joint between (2) and (4), suggesting the two are not contemporary, this is confirmed by exposed brickwork, bricks within (4) measure 9inch x 3inch, suggesting a later 19th century construction date which is confirmed by cartographic sources. There is also a straight joint visible on the rear elevation (*Figure 12*) as well as a possible cellar entrance on the northern wall.

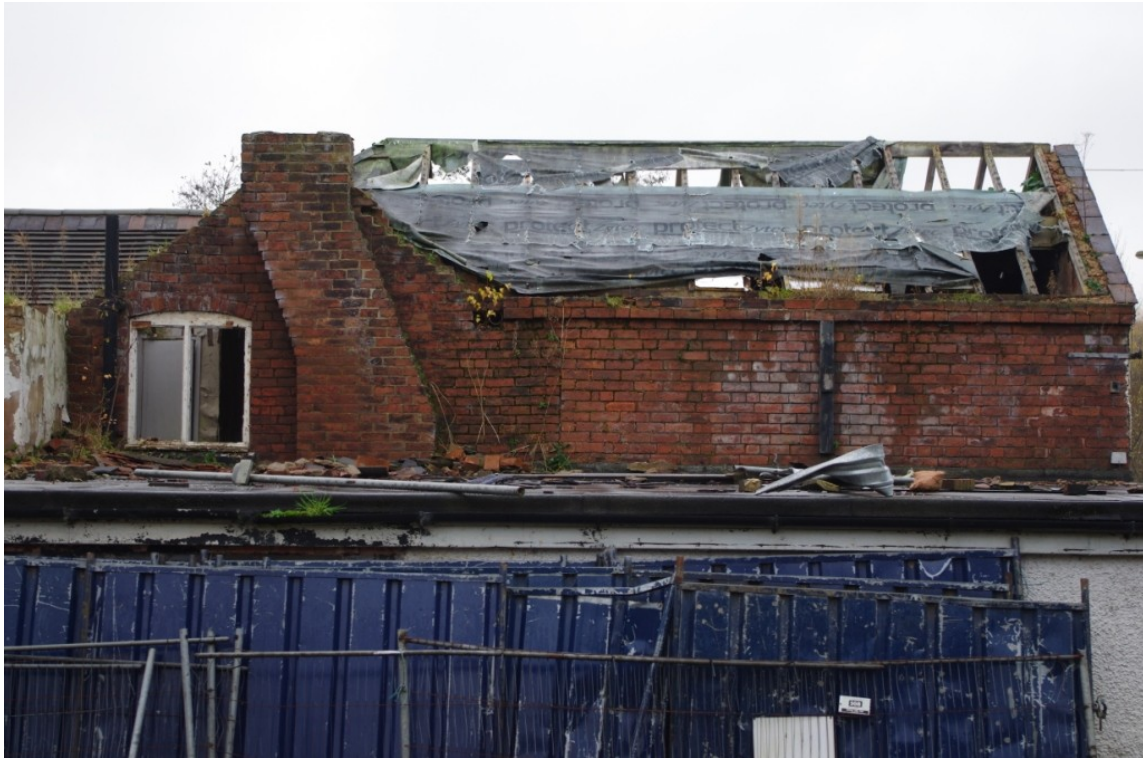
There are two remaining fireplaces within the building, which again give an indication of original floor plan. One is located at the northern end of (1), in what was originally the gable wall (*Figure 15*), the second at the eastern end of (3), in what was originally another gable wall. This chimney has an external breast, which suggests it may be a later addition (*Figure 12*).

**Figure 12**  
Rear Elevation of (3) (Left) & (4) (Right) Showing Straight Joint & Chimney Breast.

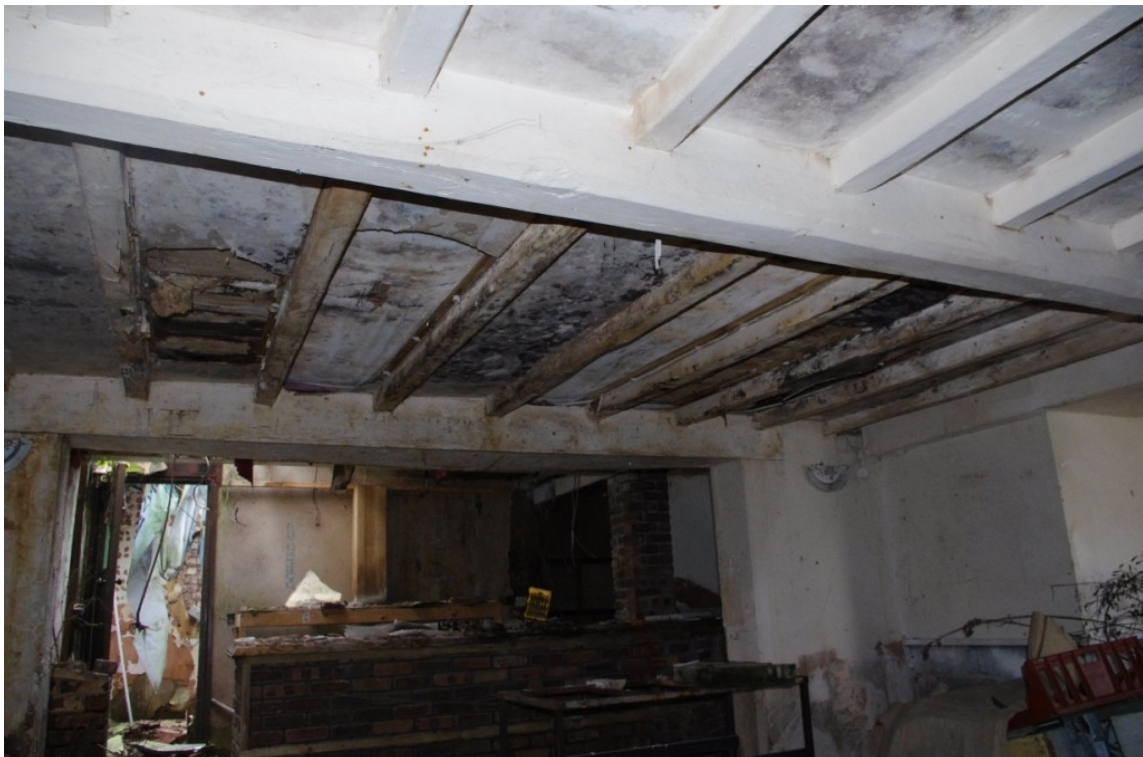
The frontage range, (1) is likely to be the earliest part of the building and consisted of two bays, elements of which can still be seen. There are original east – west joists carried on a chamfered and stopped bridging beam (*Figure 13*), the stop is missing on the southernmost beam, but the northernmost beam retains a simple run out stop (*Figure 14*), which is unfortunately difficult to date, but could potentially be as early as the early 18th century. There are further exposed joists visible in (3), in this case the joists are aligned north – south. The scattling suggests these joists are deal and therefore likely to be mid to late 19th century in date.

**Figure 13**  
(1) Joists & Bridging Beam.

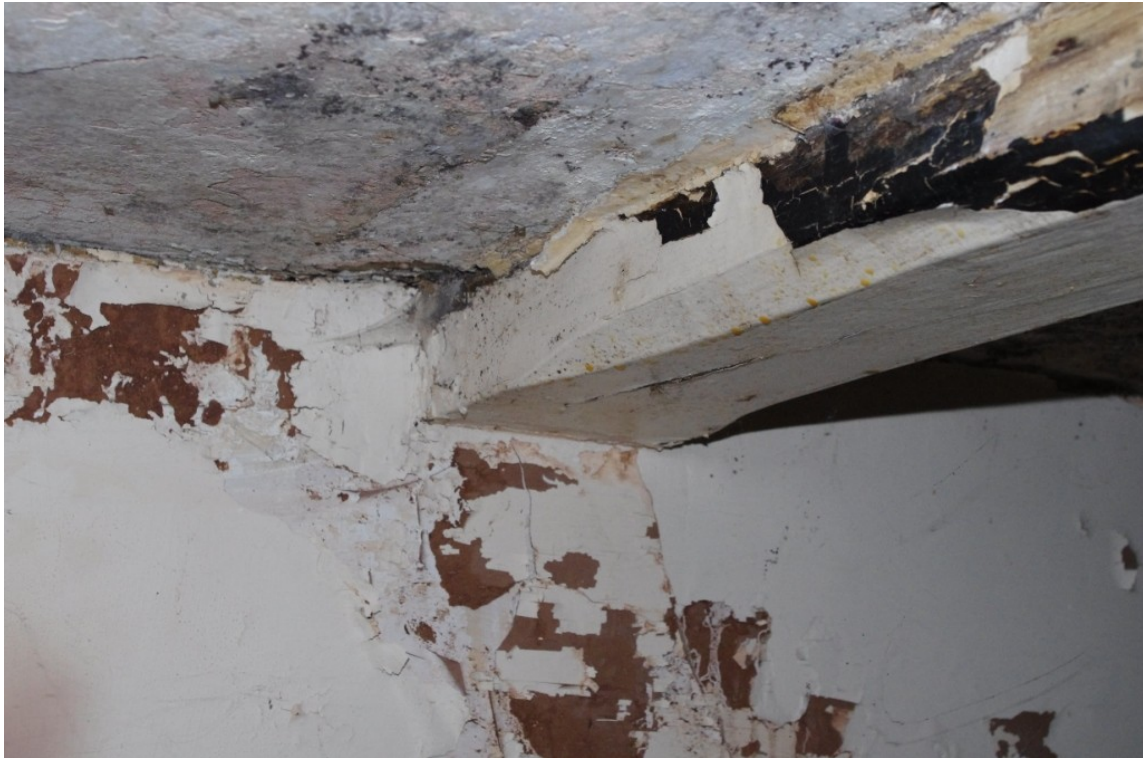
**Figure 14**  
(2) Run Out Stop on Bridging Beam (Looking North East).

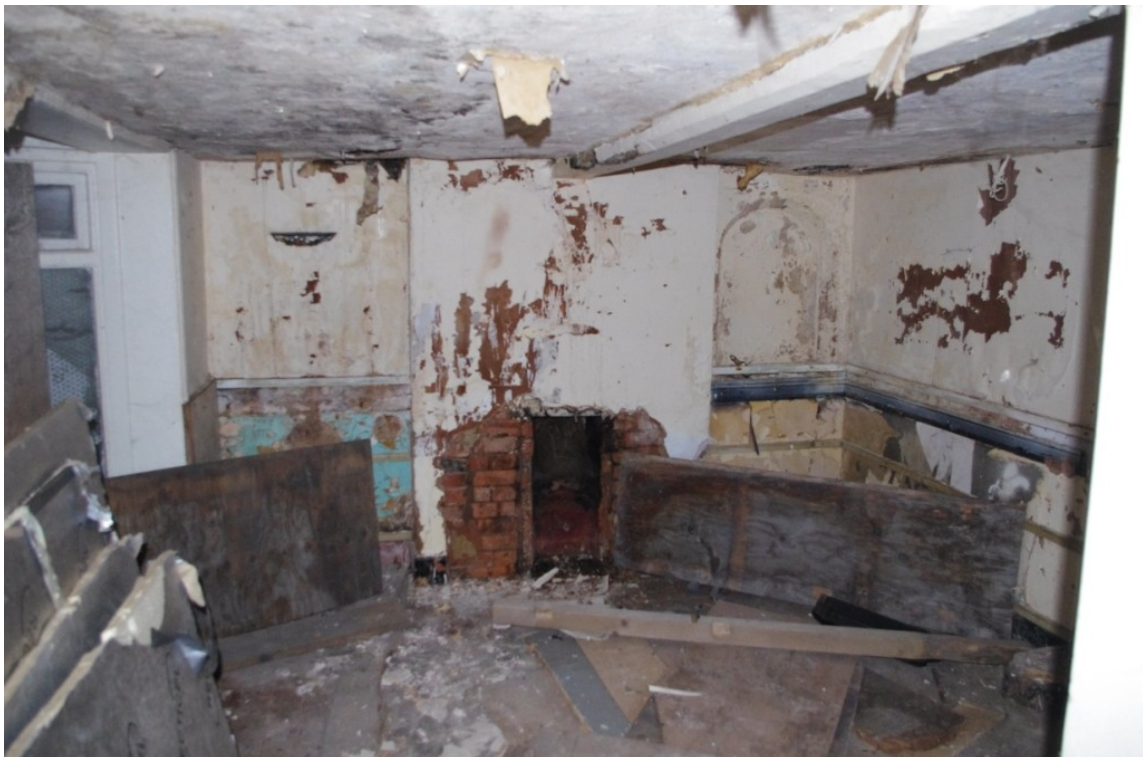
**Figure 15**  
(2) Fireplace in Original Gable Wall.
