**An Archaeological Standing Building Survey
The Woodman Inn
Old Hall Street
Hanley
Stoke on Trent**

December 2017

**Planning Application No
SOT61357/FUL**

ABRS Project No 2017-WPHS

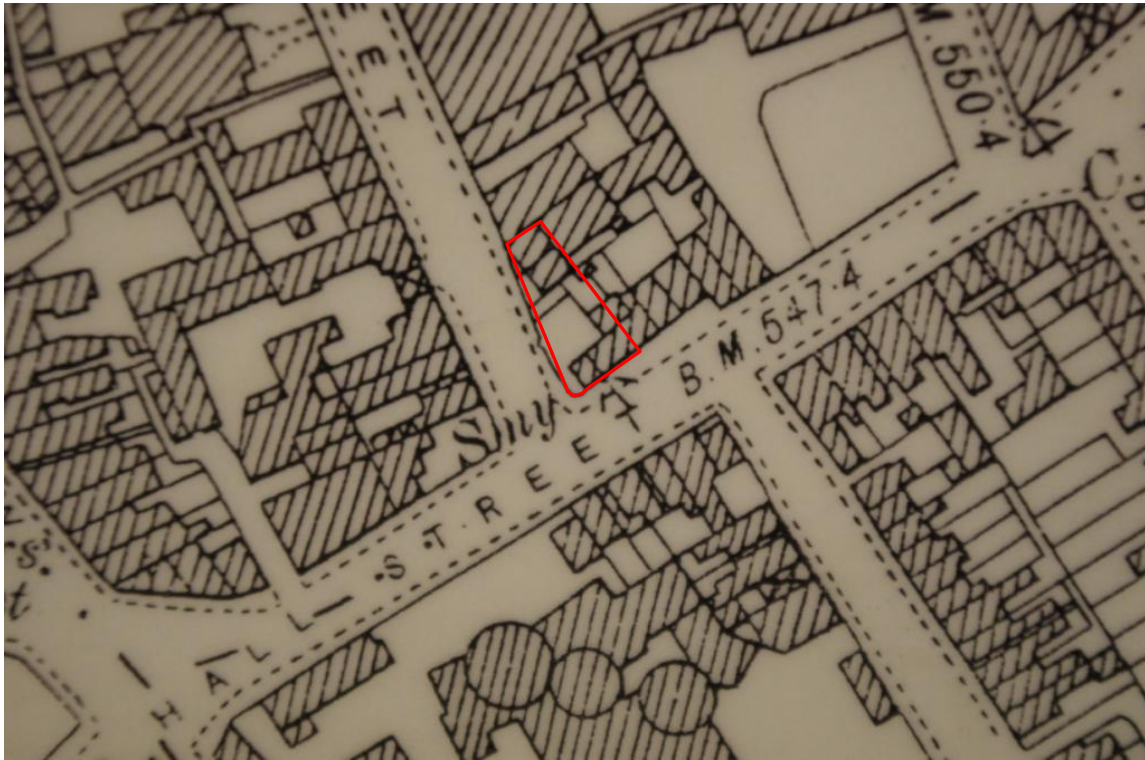
Figure 2
Second Edition Ordnance Survey, 1903.
(Sheet XII.13)

The second edition Ordnance Survey published in 1903 (SoTCA Ref XII.13 (*Figure 2*)) gives an indication of the layout of Hanley during these early clearances. The corner plot on Old Hall Street and New Street (now Goodson Street) is clearly visible and there are a number of buildings fronting Old Hall Street, none of which match the current footprint of the Woodman. Fronting New Street is an empty plot, possibly part of the slum clearance preparation for the construction of the Woodman. During the late 19th and early 20th centuries a number of local authorities adopted a policy of encouraging breweries to surrender licences on the, then vast numbers, of smaller pubs in return for the granting of licences to new-build pubs in the developing suburbs or larger, purpose-built pubs in the city centres. Local authorities were happier with the policy of larger, but fewer. It is likely that it was a similar arrangement which brought about The Woodman Inn.

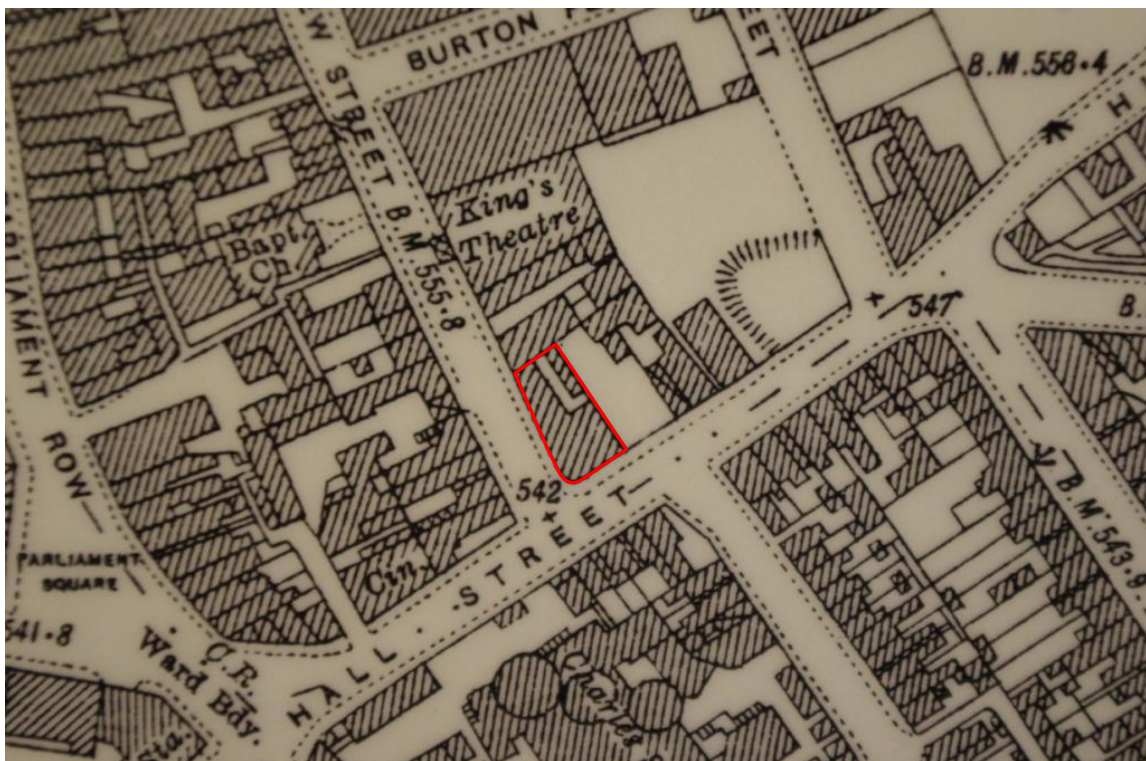
Figure 3
1925 Edition Ordnance Survey.
(Sheet XII.13)

The earliest cartographic reference to the Woodman is the 1925 edition Ordnance Survey (SoTCA Ref XII.13 (*Figure 3*)) which records the outline of the pub, but does not identify it as such or by name. The first map where the pub is identified by name is the 1950 edition Ordnance Survey (SoTCA Ref SJ8847 NE (*Figure 4*)). The pub is exactly as recorded in 1925, an approximate “L” shape with a small yard to the north east containing a small outbuilding, in all probability the toilets. The suffix (BH) is included on the site, suggesting the pub was, at the time still recorded as a Beer House.

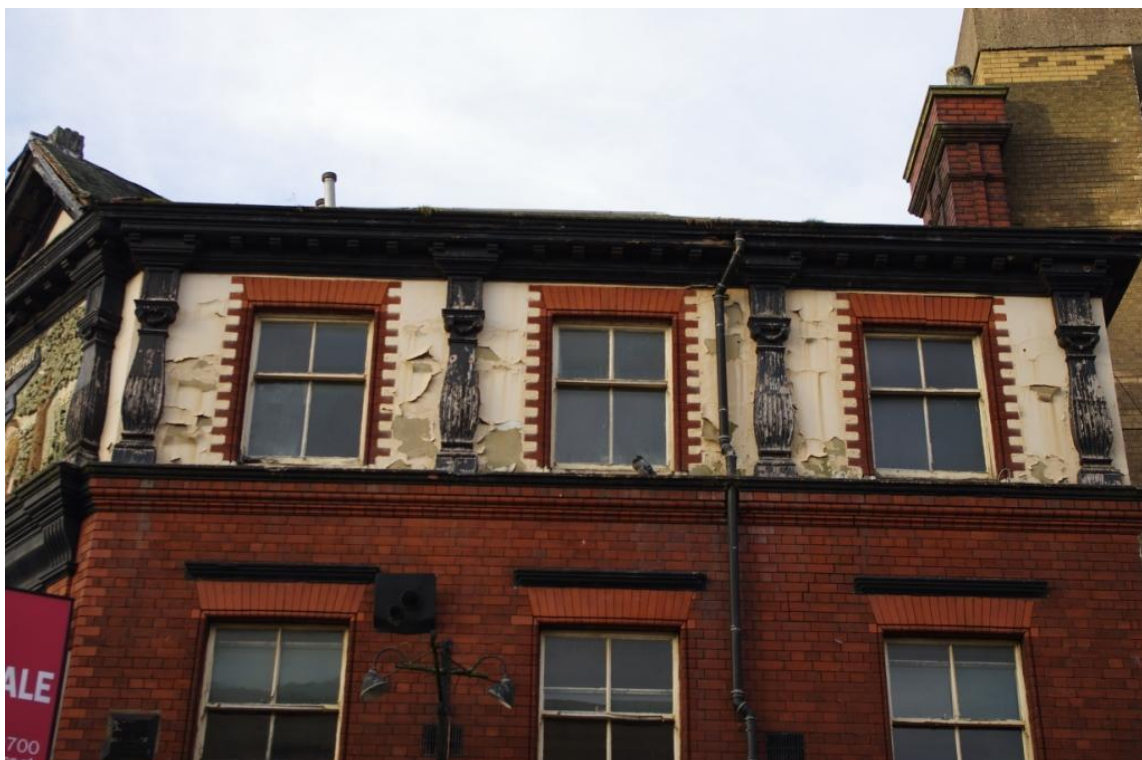
Figure 6
Second Floor, Old Hall Street Elevation (Looking North).

The Woodman Inn is approximately rectangular in plan occupying the corner plot of Old Hall Street and Goodson Street (*Figure 5*). The building is three storeys under a hipped plain tile roof with a single storey rear extension under a modern flat roof. The building is brick-built, brick dimensions of 9inch x 3inch x 4inch support the early 20th century construction date indicated by cartographic sources. The second floor is smooth rendered with a gable dormer on the south west angle, there is exposed brick detailing surrounding the windows, not unlike some early 18th century Queen Anne-style buildings. The second floor also contains decorative pilasters (*Figure 6*) as well as an ornate relief depicting a Woodsman in traditional attire on the gable dormer (*Figure 7*) and deep cornice. Windows are timber two over two sashes.

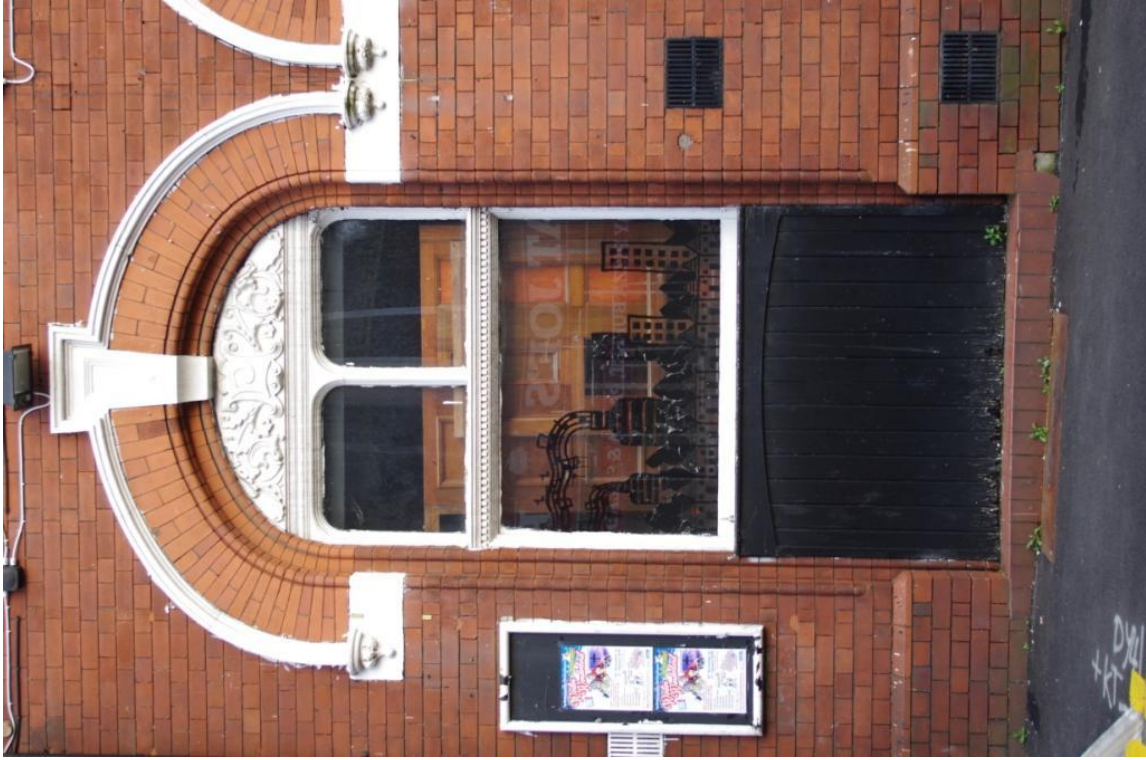
Figure 8
Ground Floor Window, Old Hall Street
Frontage.

The ground and first floors are finished in exposed brick laid in an English Bond (alternating courses of headers and stretchers); the first floor windows are finished with moulded brick reveals, gauged-brick flat arches and painted, possibly stone sills and label moulding above. The ground floor, arched windows are recessed with finely rubbed brick voussoirs and moulded relief over the window (*Figure 8*). Although painted, given the age of the building it is likely that these features may be terracotta.

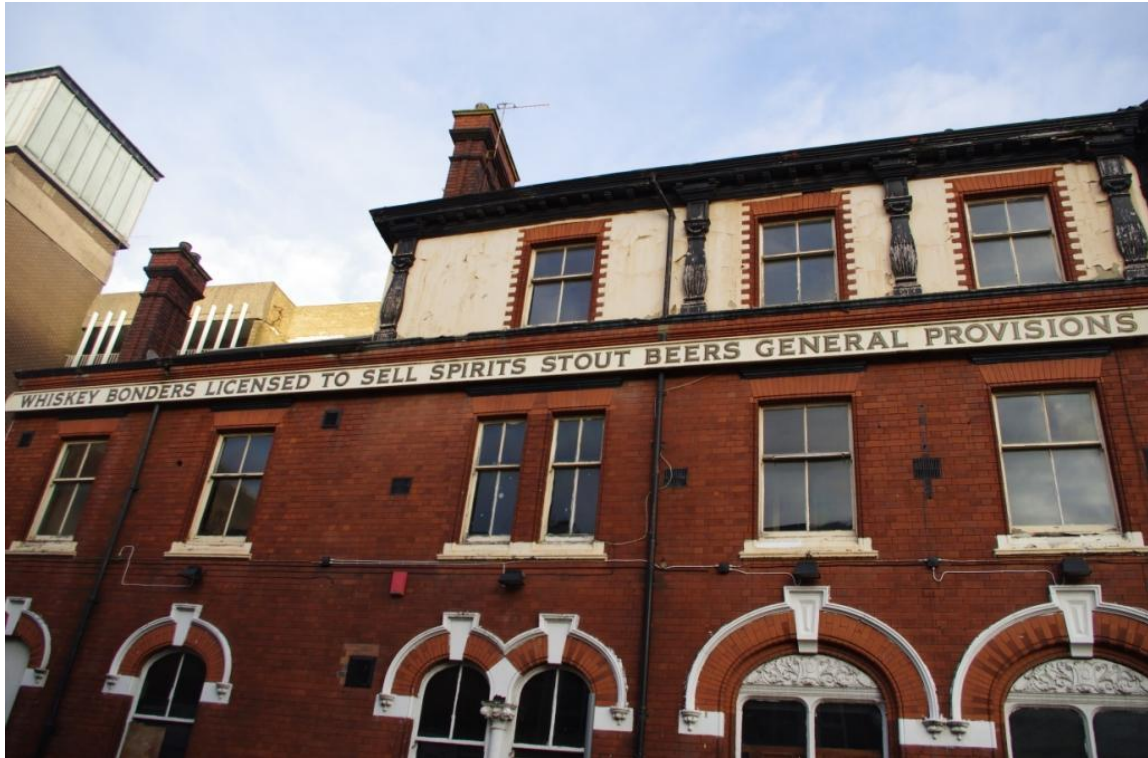
Figure 10
Signage on Goodson Street Elevation (Looking North East).

The west facing elevation interestingly retains some original signage describing the pub as “Whiskey Bonders Licensed To Sell Spirits Stout Beers General Provisions” (*Figure 10*). This further complicates the historical status of the pub; Whiskey Bonders are merchants licensed to age whiskey in a bonded warehouse for at least four years before bottling and selling. This, along with the use of the term “provisions” again hints at a more retail orientated business, rather than a pure public house. It is possible that this apparent ambiguity is the reason the pub remained largely un-named in directories until 1940.

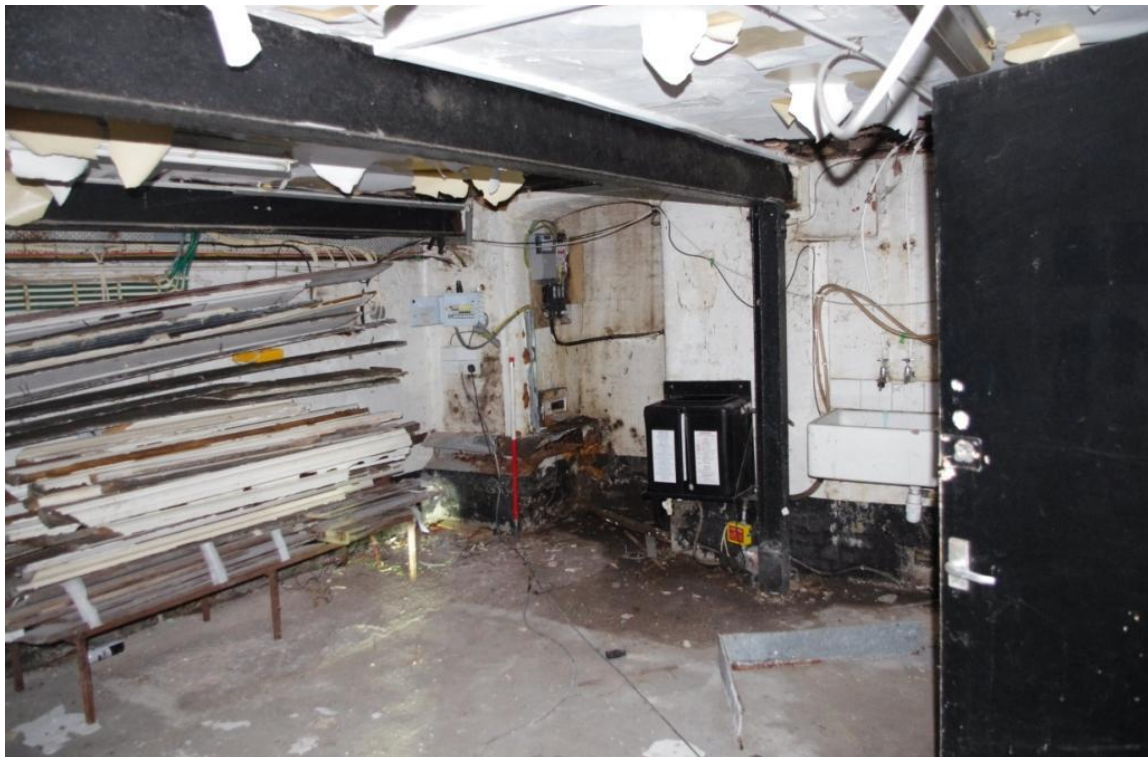
Figure 11
Cellar (B), General View (Looking East).

There is an extensive range of cellarage at the southern end of the building (*Figure 16*), its size may reflect the status of the pub as a whiskey bonder. The cellars are brick-built with rolled steel joist (RSJ) carrying the ground floor above and a modern poured concrete slab floor (*Figure 11*). The large southernmost area, (A) has been subdivided with an inserted north – south wall of modern concrete blocks. To the north of (A) is (B), a small bay with a chute from Goodson Street, in all likelihood a coal bunker as the opening is too small for barrels. The northernmost area, (C) is separated from (A) by the stone-built central stair and a possibly original large timber plank and batten door (*Figure 12*), wide enough, potentially to manoeuvre large kegs, potential evidence of the bonded use of the building. In the north easternmost corner of (C) is a modern keg lift. There is a blocked opening on the northern wall, which may hint at further cellars beyond (*Figure 16*).

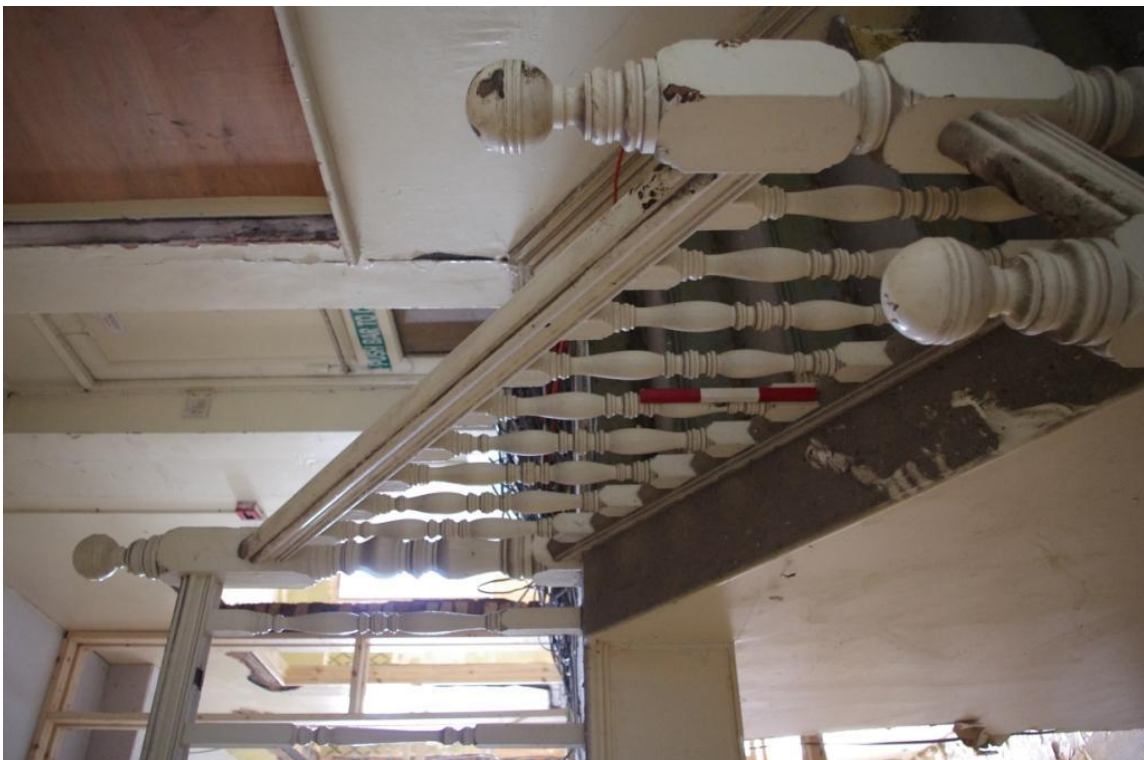
Figure 13
Stair Detail, Second Floor (Looking
West).

Access to the upper floors is via an original timber-built dog leg stair with open landing. The stairs, despite being on the second floor, and potentially in an area of reduced status are finished to reasonable standard for the era with turned newel post and balusters (*Figure 13*). Some of the stair is enclosed, probably as a result of modern fire regulations. The first floor (*Figure 18*) consists of two principal bays, again aligned north – south and east – west. There are extensive historical and modern stud-built partitions which cause a significant degree of confusion in establishing the original layout of the floor. Principally, the first floor consists of two bays, further subdivided into 6 rooms, with the location of the fireplaces providing a likely indication of an original plan form. There is a chimney on the northern gable in (D), which along with the wall thickness with (E), to the south suggests (D) is an original, albeit small room. There is a second chimney serving both (E) and (F), the crudely inserted door opening to the east of the chimney breast indicates these were originally separate rooms. There is evidence of a blocked door on the southern wall of (F) indicating it was originally accessed off the hallway. (F) is also finished with a deep plaster ceiling cornice (*Figure 14*), perhaps reflecting a higher status of this room.
