**An Archaeological Standing Building Survey
Trimpley Farm
Trimpley
Bewdley
Worcestershire**

June 2018

ABRS Project No 2018-TFTW

**An Archaeological Standing Building Survey, Trimpley Farm, (Threshing Barn Only),
Trimpley, Bewdley, Worcestershire (NGR SO 79294 78439).**

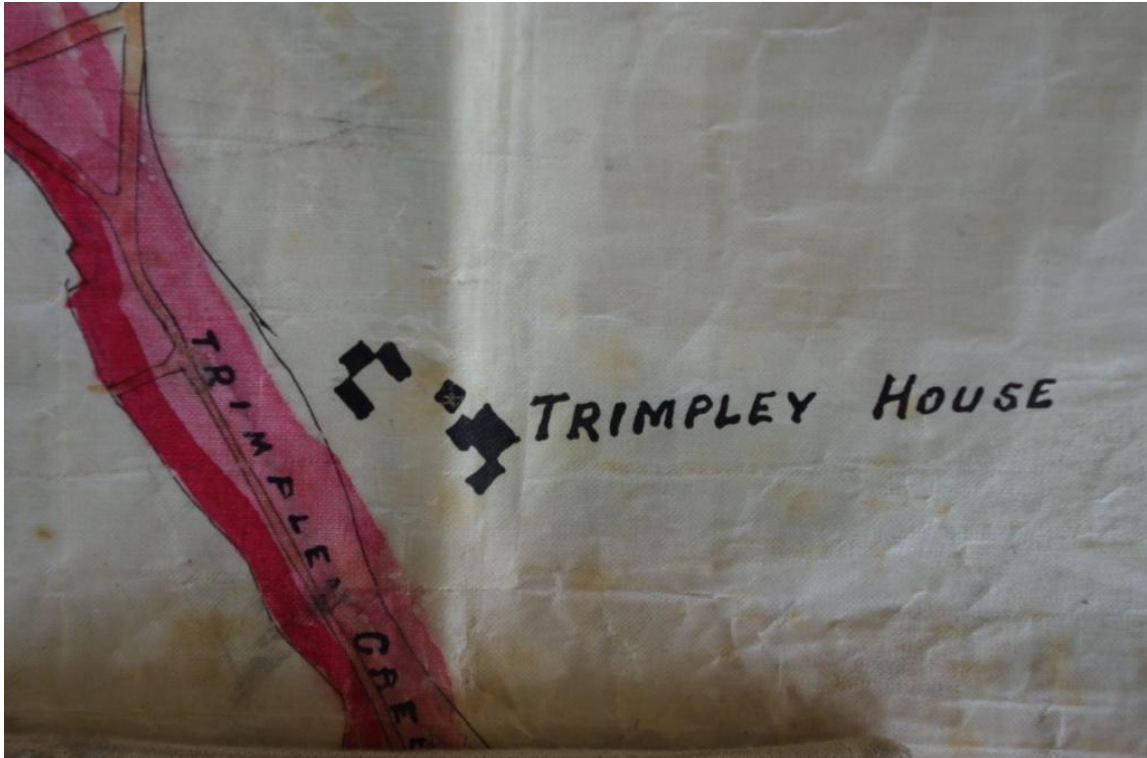
Figure 3
A Plan of the Parish of Kidderminster (1867).

A Plan of the Parish of Kidderminster produced in 1867 (WA&AS Ref 5403/21 (*Figure 3*)) provides another early representation of proposed development area, it lacks the detail of the earlier map, but again Trimpley House and its associated outbuildings are clearly identified.

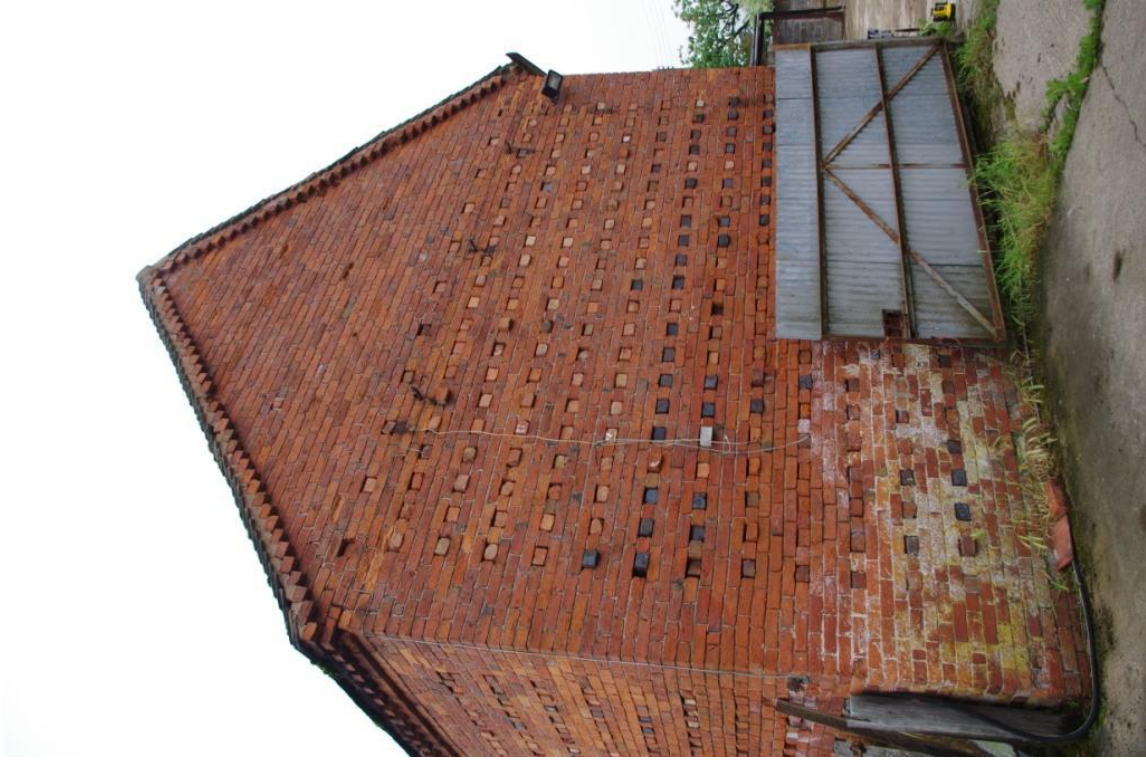
Figure 8
South West Facing Gable (Looking East).

course (*Figure 8*). The extent of ventilation suggests this bay, at least was for hay, rather than grain, as hay required greater ventilation during storage. There is a single course of missing brick vents on each long elevation of the easternmost bay just below the eaves.

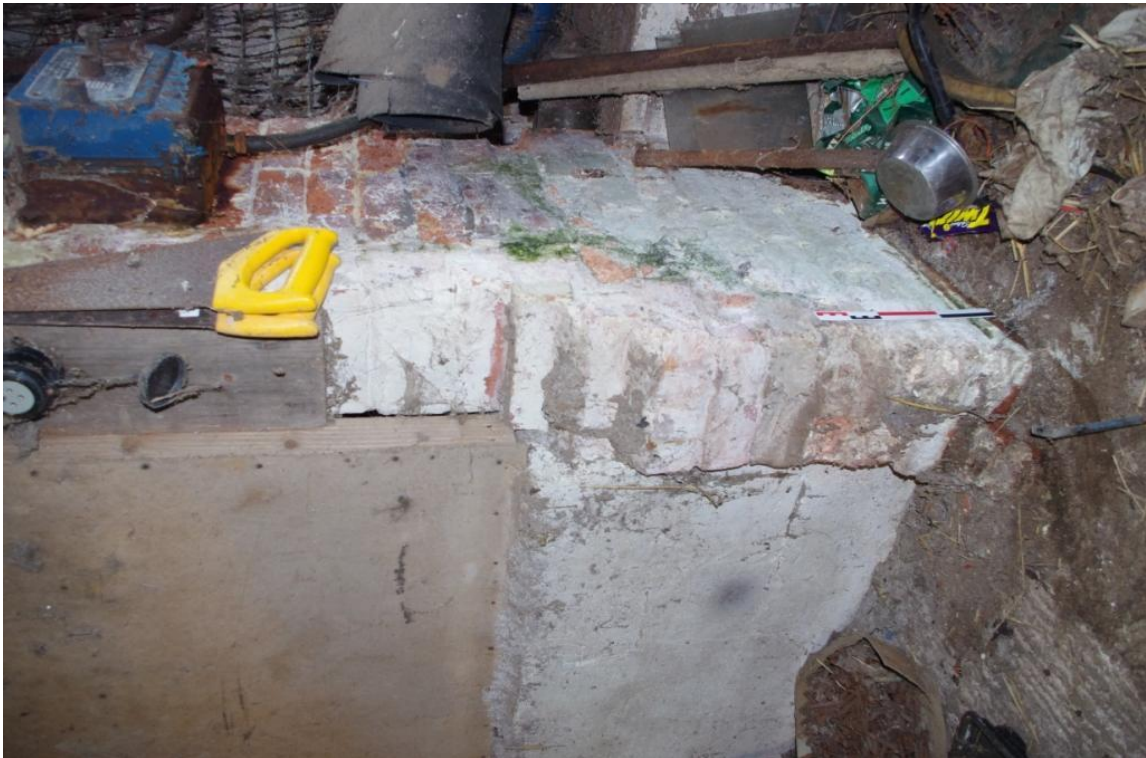
Figure 9
Remnant of Sleeper Wall on Principal Elevation, Internal (Looking East - South East).

Internally, as expected the barn consists of a large open area sub-divided by wall stubs into three bays. The wall stubs show evidence of lost sleeper walls at ground level separating the central threshing floor from each of the storage bays (*Figure 9*). There are openings in each of the projecting wall stubs on the south east elevation, one of which retains an early plank door, in oak, possibly indicating the location of corn holes, a mid 18th century development. The corn hole was designed to hold the mixed grain and chaff after flail threshing until enough had been collected to make winnowing worthwhile. These internal features appear to contradict the external appearance of the barn with its extensive ventilation as a fodder barn. It is possible, therefore that the barn may have been a mixed use barn.

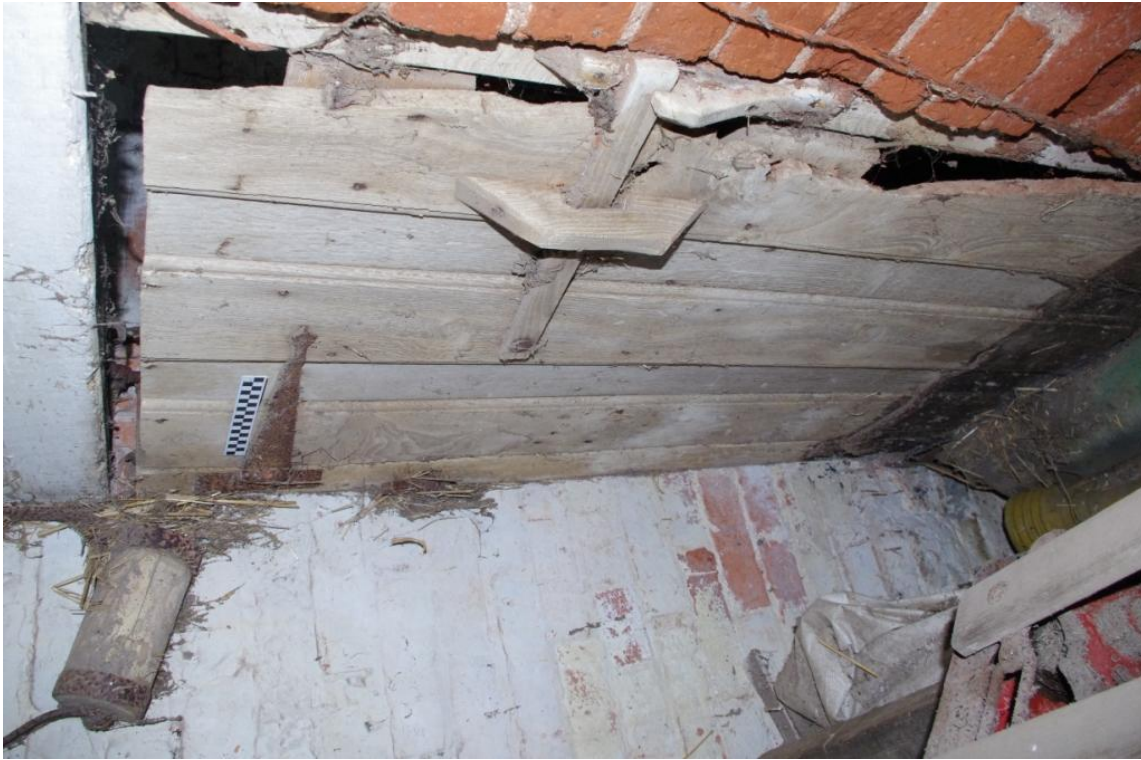
Figure 10
Potentially 17th Century Door to Corn
Hole.

The corn hole door itself is an interesting design, with a thinner central plank (*Figure 10*); this design originated in the last quarter of the 17th century, suggesting a tentative date for the door. It is more than likely that the door is re-used, the arrowhead strap hinges are also stylistically 17th century in appearance, but they are clearly re-used having been attached to the outer face of the door and bent to fit the rebated planks (*Figure 11*).

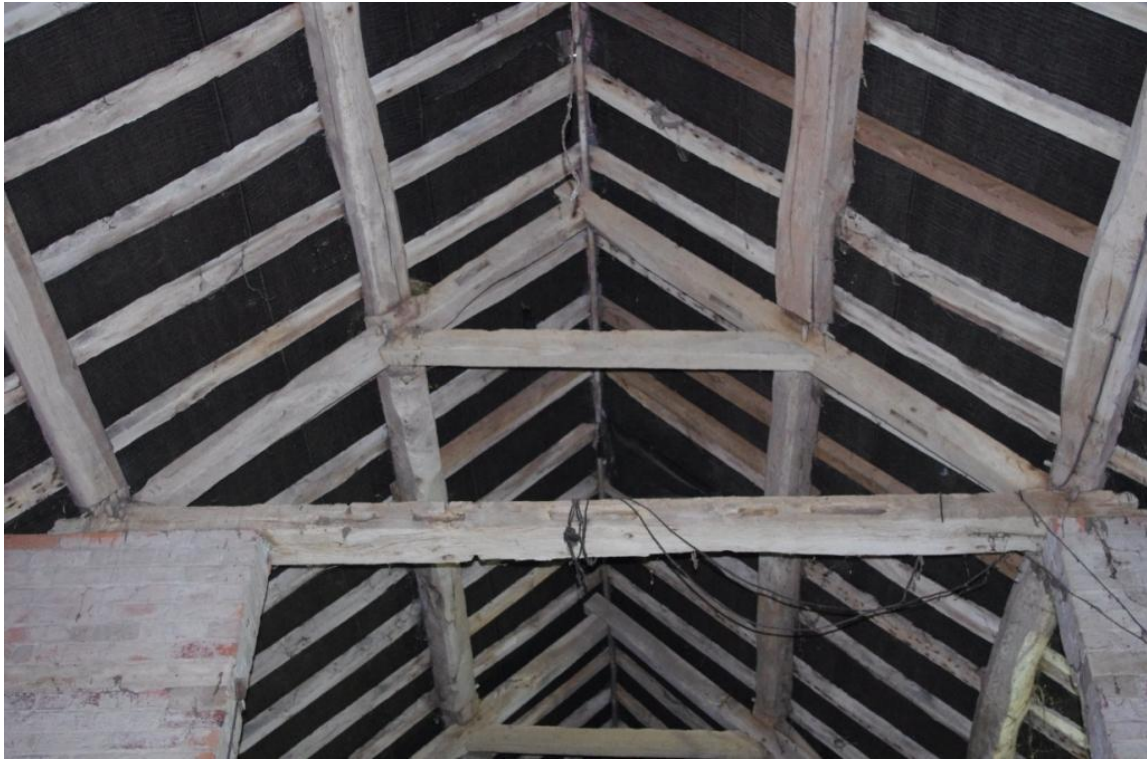
Figure 12
Truss 02 (Looking South West).

The roof is carried on four hardwood trusses carrying butt purlins supported by brick piers. Trusses 01 and 04, the gable trusses match, as do trusses 02 and 03 over the threshing floor. Both types are a simple A frame with a collar beam (*Figure 12*), trusses 01 and 04 have additional raking struts between the tie beam and the principal rafter (*Figure 13*). Trusses 02 and 03 show extensive evidence of re-used timber with open mortices on the tie beam and on the principal rafters (*Figure 12*), the lack of any evidence of re-used timbers on trusses 01 and 04 may suggest trusses 02 and 03 may be later replacements using reclaimed timbers.
