An Archaeological Standing Building Survey 95 New Road Kidderminster Worcestershire

ABRS Report No 2018-NSKW_v1

An Archaeological Standing Building Survey

ABRS Project No 2018-NSKW

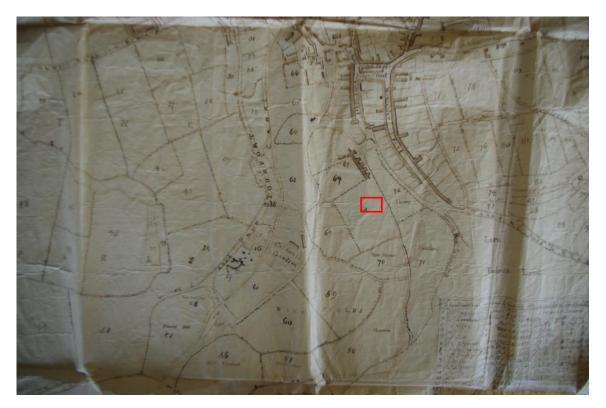
Figure 2 John Doharty jnr's Map of 1753.

In around 1160, Henry II granted the Manor to his steward, *Manasser Biset*, and by the early 13th century the town had both a fair and a market. The industrial potential of the River Stour led to the growth of a textile industry, in around 1540 John Leland noted that Kidderminster "*standeth most by clothing*". The textile industry grew and evolved and carpet manufacture emerged during the 18th century, in 1772 the Staffordshire and Worcestershire Canal opened and brought more traffic and trade and by the 19th century carpet production became the major industry of the town and resulted in a growth in population and redevelopment of the town. Prior to this the town was relatively compact and centred on the High Street, to the north of the New Road as illustrated by John Doharty jnr's map of 1753 (WA&AS Ref BA 3676(xxix) (*Figure 2*)). The site later occupied by the Corn Exchange Inn is shown as an un-developed open field.

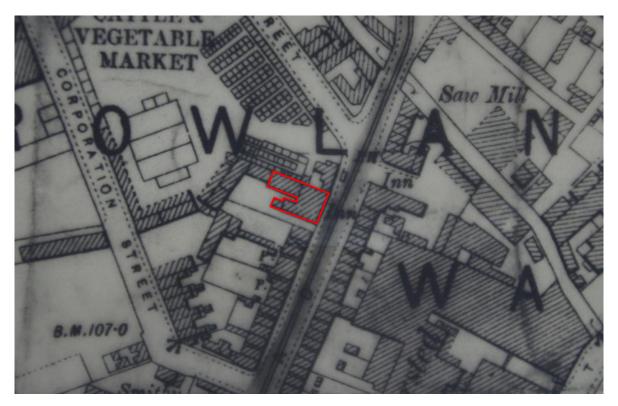
Figure 5 Second Edition Ordnance Survey 1903. (Sheet VIII.15)

The first edition Ordnance Survey was published in 1885 (*Figure 4*), it is the first modern and clear representation of New Road. The Corn Exchange Inn is not identified by name but the building is recorded as an Inn. The map appears to show the Inn only occupied the north easternmost bay of the building, with a clear boundary between the two bays. The map also records what appear to be ancillary buildings; common to Inns and a yard to the rear. Kelly's Directory published in 1884 records that Inn was kept by Mrs Louisa Bennett. By the time of the second edition was published in 1902 the Inn is shown as occupying the whole of the plot (*Figure 5*).

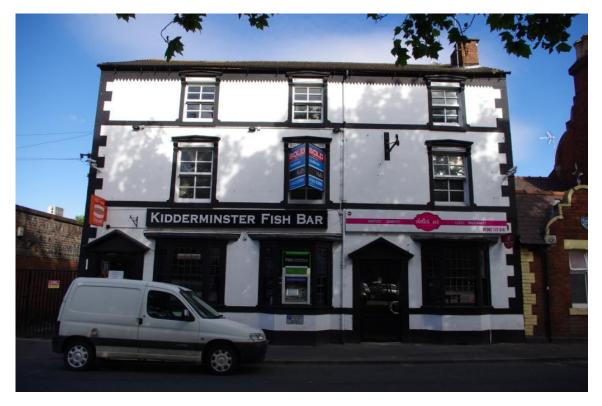
Figure 7 Principal Elevation (Looking West – North West).

The principal elevation is two asymmetrical bays, reflecting the first edition Ordnance Survey (*Fig.4*), on the ground floor are three projecting bay windows with single light sash windows, with apparently modern leading. The sash horns appear to be late 19th or potentially early 20th century in date, but are likely to be modern replacements. Following the repeal of duty on glass and the window tax bay windows blossomed during the late 19th century. Both of the ground floor doors have modern pediment door heads and pilaster surrounds. The 2015 planning application indicated that previously the southernmost door had a "*semi-circular arch*" and this was replaced by the pediment to match the "*triangular arch*" over the northern door. The windows on the first and second floors are clearly modern top hinged casement windows, the proportions of both the lights and overly large glazing bars detract from the decorative hood and reveals and the overall appearance of this important principal elevation.

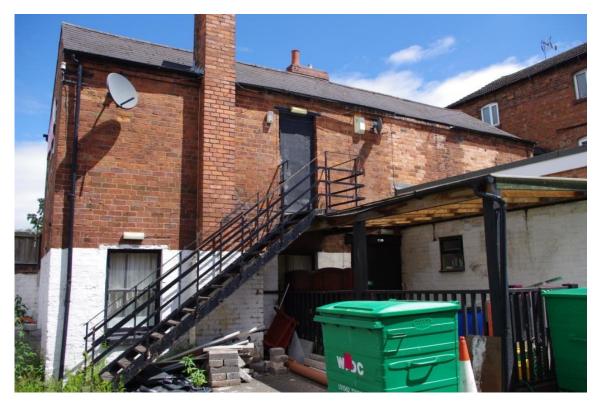
Figure 8 South – South West Facing Rear Elevation of \underline{B} (Looking North – North East).

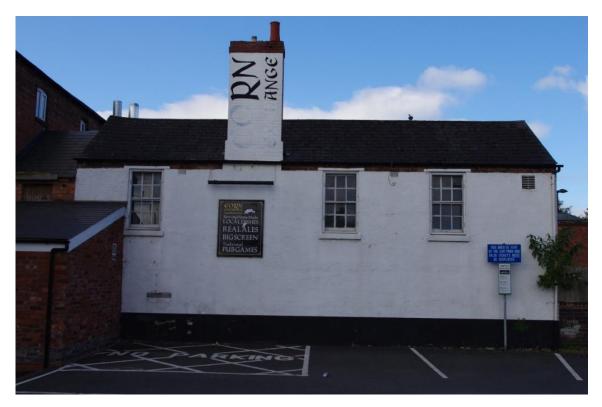
Figure 9 North – North East Facing Elevation of <u>B</u> (Looking South – South West).

There is a single gable chimney on <u>A</u>, on the northernmost gable. There is a chimney on each of the long elevations of <u>B</u>. That on the north facing elevation appears to be especially large (*Figures 9 & 18*), the chimney on the south is smaller and has been enlarged with the addition of an external pier, potentially to repair weathered brickwork.

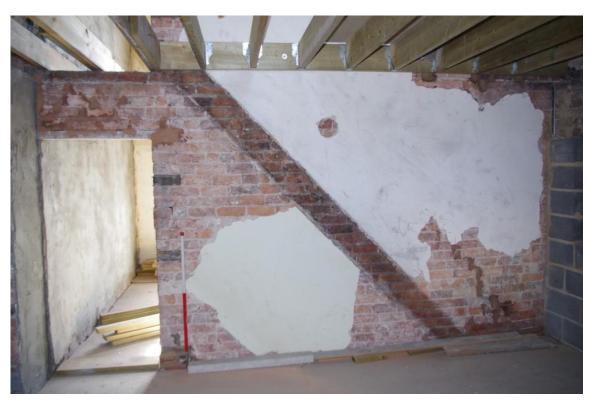
Figure 10 <u>A</u>(05) Outline of Stair Stringer on West – North West Facing Wall (Looking East – South East).

<u>A</u> consists of two principal bays, there are internal chimney breasts on the northern gable of (02) and (03) and a single chimney breast on the northern wall of (05), it is likely that there was also a chimney breast in (01), although there is no longer any evidence of this. <u>A</u> is further divided longitudinally by an original brick-built wall creating what would have originally been four principal rooms (*Figure 18*). There is the outline of a stair stringer raising south to north on the west facing wall of (05) (*Figure 10*), this gives an indication as to the location of the original first to second floor staircase, there is, however no sign of the original ground to first floor stair. The current stair is modern.

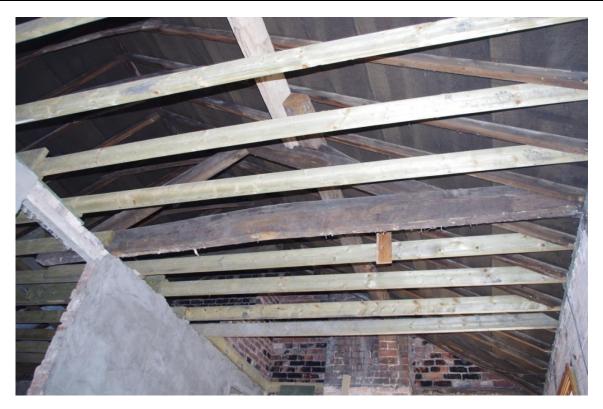
Figure 11 <u>A</u> Partial Roof Truss.

The roof structure has also been largely exposed by the recent works, again the structure is largely built of deal. The roof was originally carried on a single King post truss with raking struts, this however has been largely truncated leaving only the front principal rafter, half the tie beam and a single strut (*Figure 11*). Interestingly, the front purlins appear to be earlier oak beams, some with open mortice indicate probable re-use (*Figures 12 & 13*). The rear

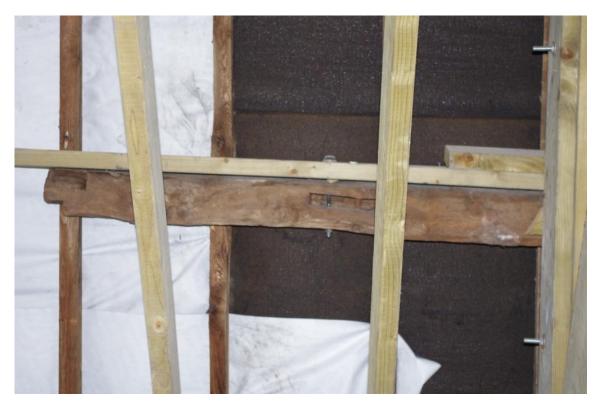
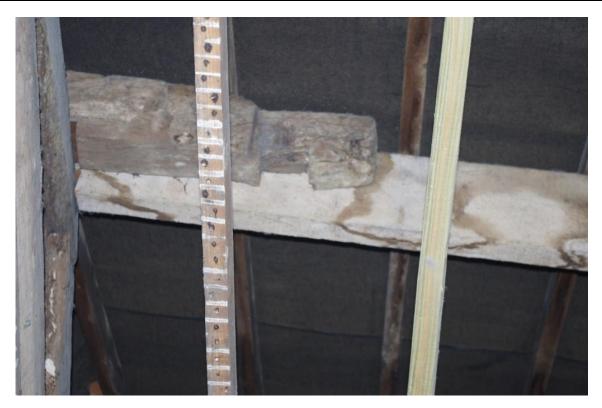
Figure 12 <u>A</u> Re-used Purlin on Front Roof.

Figure 13 <u>A</u> Re-used Purlin on Front Roof.

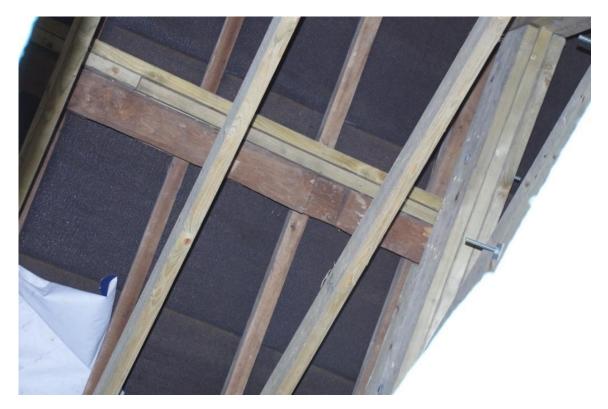
Figure 14 <u>A</u> Original Trenched Purlin on Rear Roof.

purlin is clearly trenched to take the now missing principal rafter (*Figure 14*) which confirms it is contemporary with the roof, the front purlins are without a doubt salvaged and re-used. The first floor of <u>B</u> consists of one large bay, (07) and a smaller room, (06). The removed render in (06) has exposed the straight joint between <u>A</u> and <u>B</u>, confirming the two are not contemporary. As seen externally, there is a large chimney breast on the northern wall and a smaller chimney breast on the southern wall (*Figure 15*); the presence of two fireplaces suggests the space was originally divided into two un-equal bays. The proximity of the door to the southernmost chimney suggests this door is a later insertion. Unlike <u>A</u>, <u>B</u> has retained early, if not original windows on the north facing elevation. The windows are six over six sash windows with late 19th century sash horns with an architrave surround.

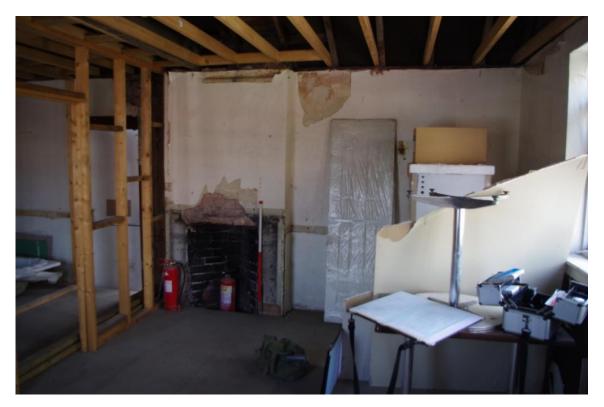
Figure 15 <u>B</u>(07) Smaller Chimney Breast (Looking South – South West).

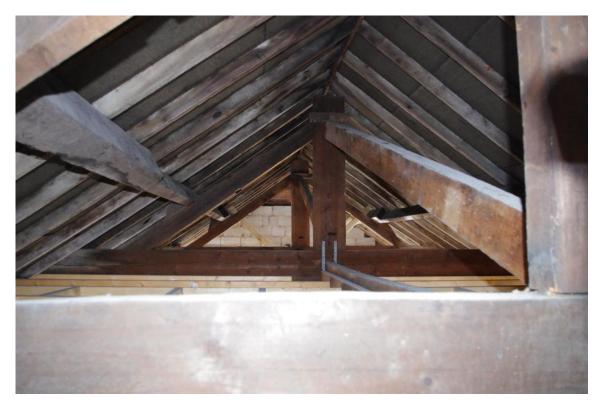
Figure 16 <u>B</u> King Post Truss (Looking West – North West).

The roof structure is again exposed, the roof is carried on three King post trusses (*Figure 16*) with common purlins, again all in deal. There are a number of rase or shipping marks visible on some of the timbers (*Figure 17*). These marks would be scored into the timber using a rase knife either immediately after purchase or during shipping. Both Arabic and Roman numerals are known to have been used. Once the timbers have been cut interpreting such marks is extremely difficult as they no longer complete. The marks are likely to represent ownership, order numbers, shipping information or other such information.

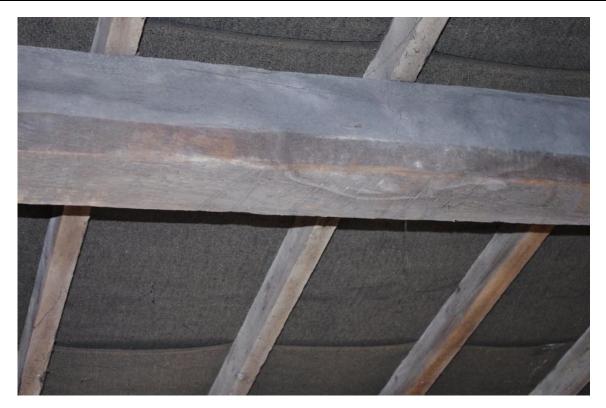
Figure 17 <u>B(</u>07) Rase Marked Purlin.

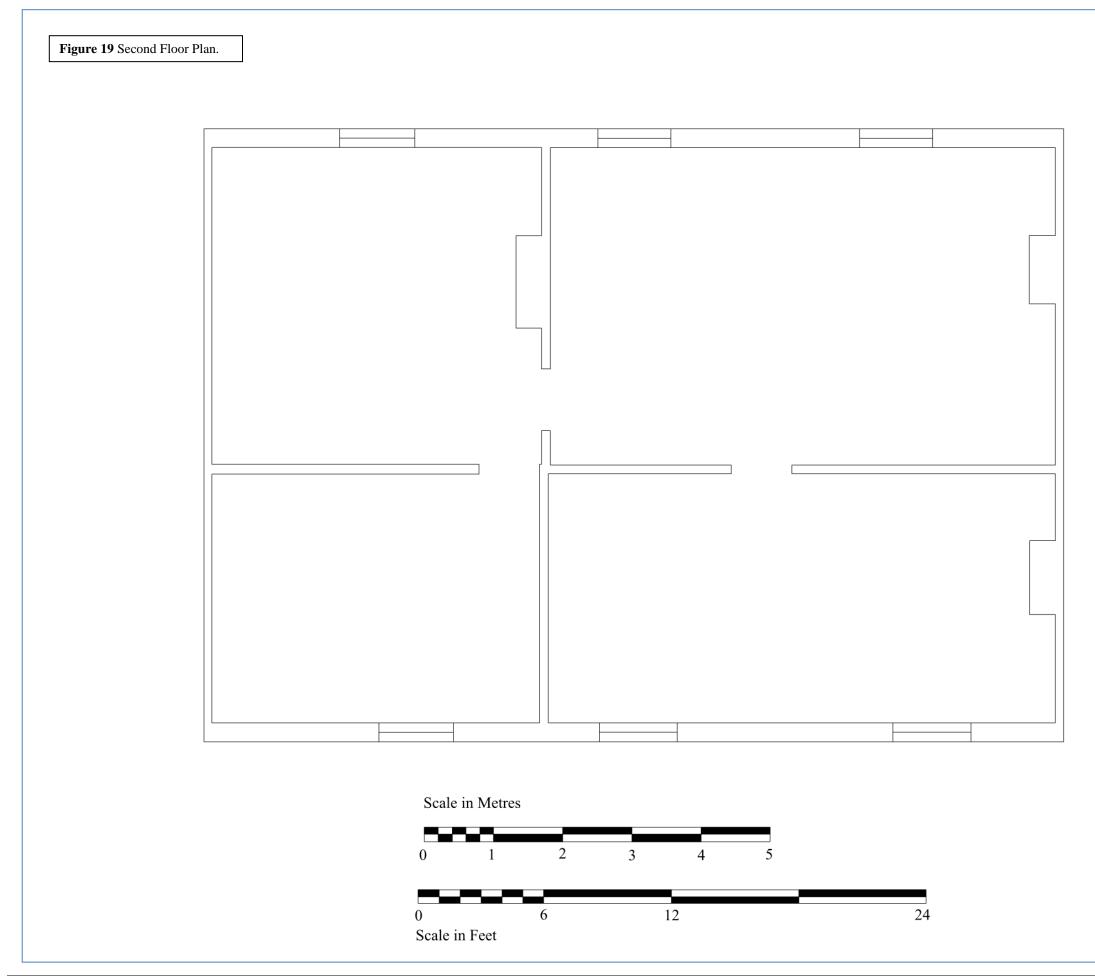
The second floor is largely inaccessible due to the removal of the floor, the exposed ceiling joists were all deal and of standard 4inch x 3inch, again physical evidence supporting the mid to late 19th century construction date. The second floor plan (*Figure 19*) mirrors that of the first floor.
