**An Archaeological Standing Building Survey  
Norris Hill Farm  
Blackfordby Lane  
Moir  
Leicestershire**

**November 2018**

**ABRS Project No 2018-NHBL**

**An Archaeological Standing Building Survey of Outbuildings at Norris Hill Farm,  
Blackfordby Lane, Moira, Leicestershire (NGR SK 32481 17380).**

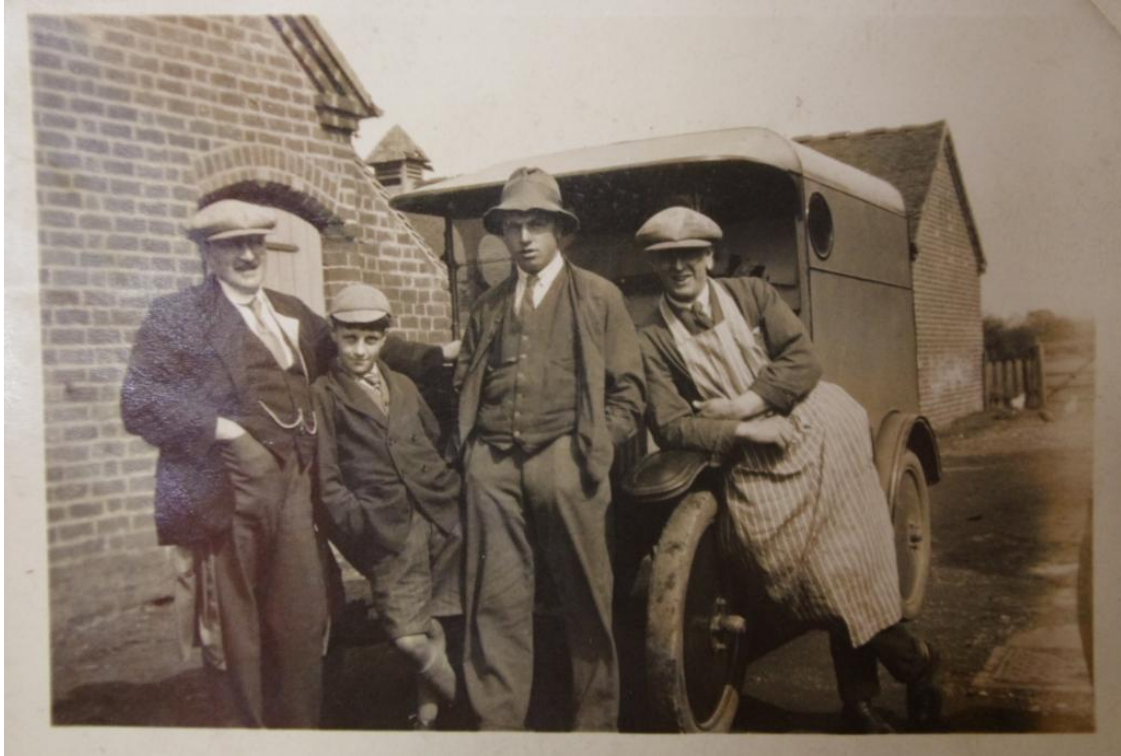
**Figure 6**

A photograph taken during the 1930s (*Figure 6*) gives a glimpse of the buildings and shows a dovecote on one of the buildings. The farm has remained with the Massey Family since. Mapping shows no significant changes to the buildings throughout the remainder of the 20th century, larger scale farm buildings are constructed to the north west and some minor extensions added to the traditional buildings. Mr Massey Snr went on to purchase Norris Hill House, reuniting the two properties; Norris Hill Hall was then demolished during World War II.

Early/Mid 20th Century Photograph of George Massey Snr (centre) Showing Farm Buildings in Background.

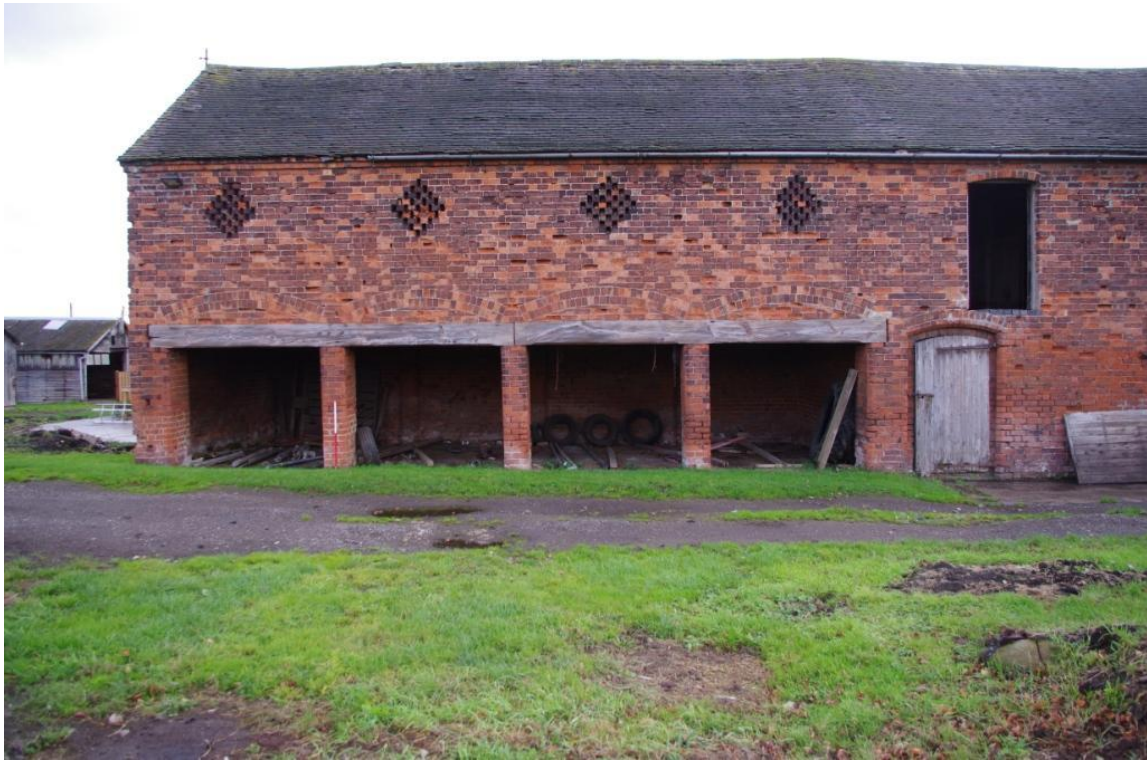
**Figure 8**  
(6), West – North West Facing Elevation (Looking East – South East).

The building is “E”-shaped in plan, the long axis is aligned north – south while the shorter axis are east – west, forming two foldyards to the west (*Figure 22*). The building is brick-built under a plain tile roofs and is a single phase, brick dimensions, although not always accurate of 9inch x 3inch x 4 ½inch supports the cartographic evidence of a mid 19th century construction date. The large north – south range consists of two principal bays, the northernmost being two storey, a large granary over a 4 bay wagon hovel, (6) (*Figure 8*). It

is common for the openings of a wagon hovel to face away from the farmyard, the intention being that animals were less likely to enter the building from the yards and damage either themselves or the machinery. The openings are carried on timber bressumers, above which are brick relieving arches. The first floor granary has diamond shaped missing brick ventilation and there are pitching doors on the west facing long elevation and on the north facing gable. There is also a hanging door on the west facing elevation, the foot of which interferes with the arch of the door below suggesting it may be a later enlargement of a pitching door. The first floor is gypsum and lathe laid on deal joists to the north and timber floorboards to the south, it is unclear whether this is by design or as the result of repair and replacement. The roof is carried on deal King post trusses with raking struts (*Figure 9*), the King post being an iron rod is almost certain to post date the 1860s, which again supports the cartographic evidence.

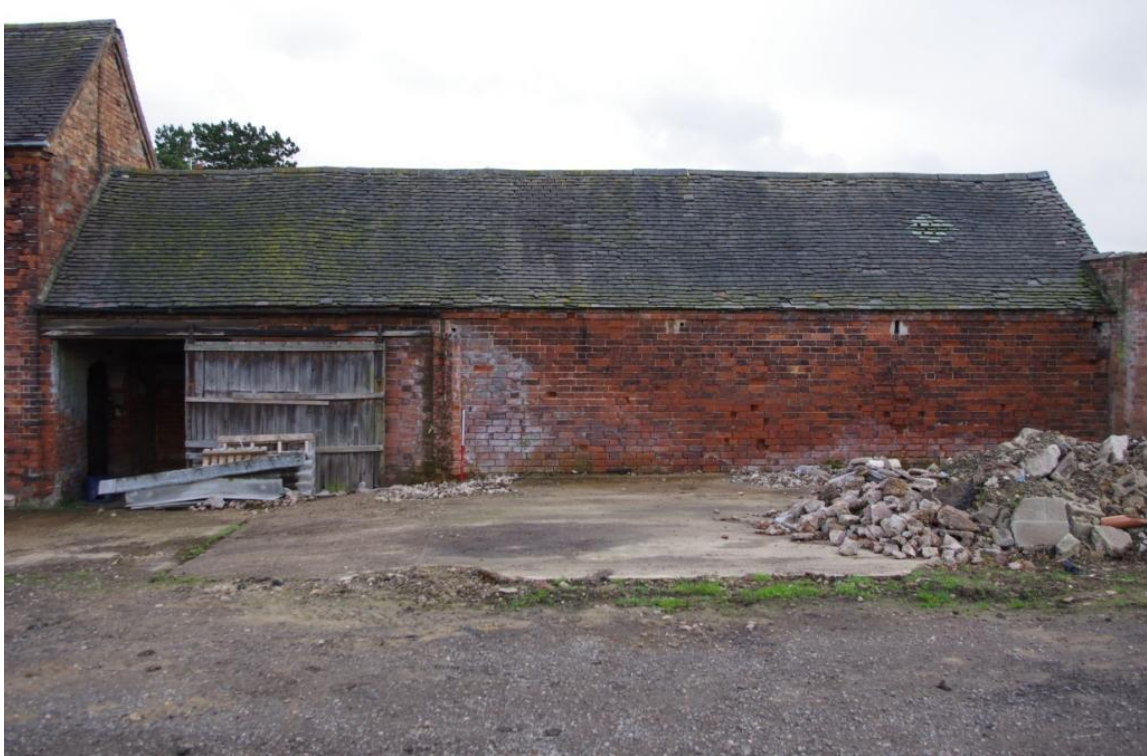
**Figure 10**  
(1) & (2) West – North West Facing Elevation (Looking East – South East).

The southern range, (1) and (2) is a single storey cowshed (*Figure 10*) with standing for 16 beasts with slate stalls, there is standing for a single animal at the southern end used for training young heifers to milk. There is a feeding passage along the rear wall, feeding passages were seen as a significant advance in agricultural practice in the mid to late 19th century introduced to speed up feeding and prevent wastage with feed being fouled in animal dung. The feeding passage being clearly incorporated into the building supports the cartographic sources that the buildings are mid 19th century in date and followed up to date practices. Further evidence of this is the roof over (1) and (2); the roof is carried on two deal King post trusses with raking struts, the King post being an iron bar.

The building has remained largely unaltered with the exception of openings between (2), (3) and (4) being blocked. There is also a blocked opening on the southernmost gable of (1); it is unclear whether this is an original opening, or a later insertion to provide access to the recently demolished modern building beyond.

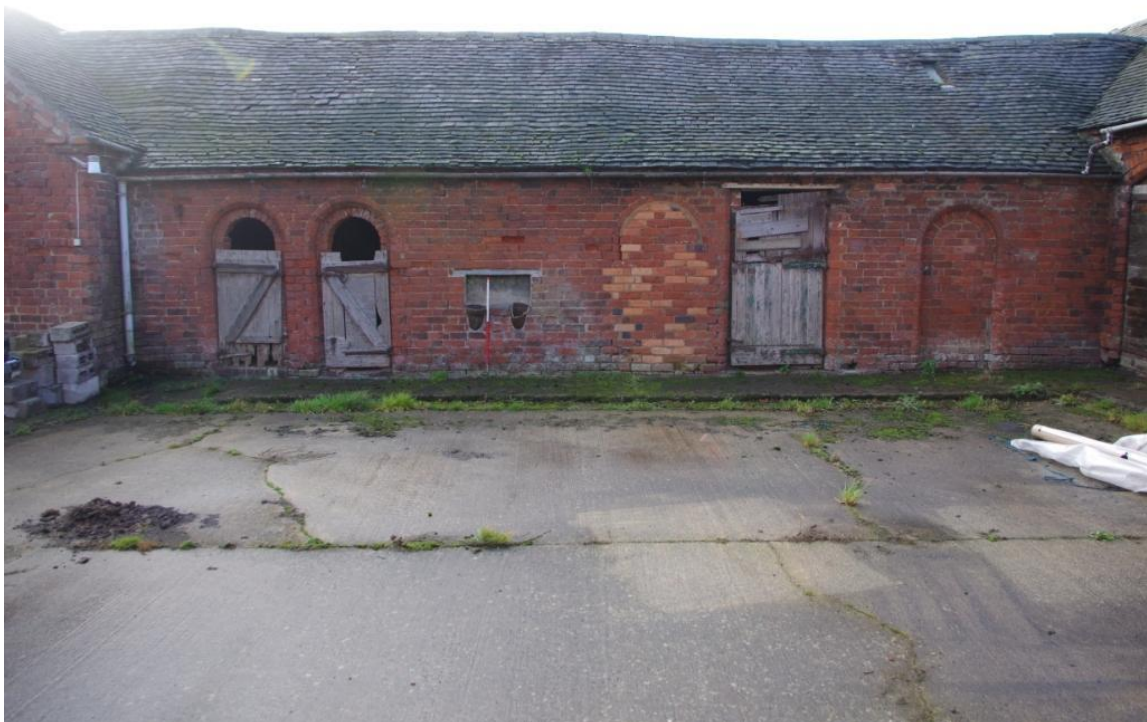
**Figure 11**  
B(20), (21) & (22), North – North East Facing Elevation (Looking South – South West).

There is a range projecting from the east elevation of (1), again single storey and forming the southern range of a foldyard. The north facing elevation has a number of attractively finished two centred arched doors (*Figure 11*), the doors are unusually narrow, with cant brick reveals and the range may have originally been for calves. The two westernmost doors have been blocked and replaced by a larger central (to the bay) door. Internally, the range originally consisted of one large bay, (22) and a loose box, (20) to the east, a second loose box was then added to the west, reducing the original size of (22). There is further evidence of alteration work with the use of steel tubing for stalls along the eastern and western walls, the use of steel is almost certain to be 20th century in date. The roof is again carried on deal King post trusses with an iron King post.

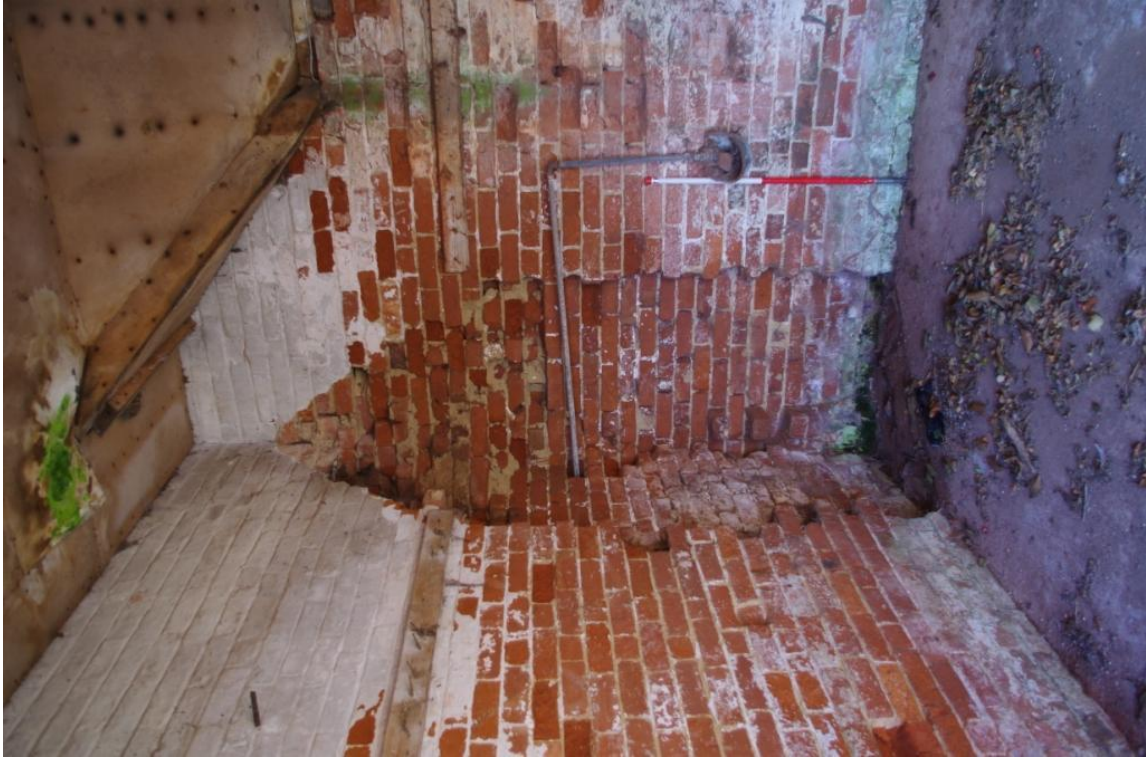
**Figure 12**  
(16), Outline of Kiln/Furnace Structure  
in South West Corner.

At the east end of this range is a perpendicular range of four rooms, (16), (17), (18) and (19), (16), (18) and (19) being the most interesting of the four. (16), the north retains the outline of a kiln or forge in the south west corner (*Figure 12*), the exact origin of which is unclear but may have originally been a copper for heating and mixing feed. The insertion of a water trough indicates the space was most recently used as animal housing. To the south is (18) and (19), (19) consists of a low room with (18) to the east and extending over (*Figure 13*). This arrangement was common with poultry being kept over a pig sty, there is, however no physical or cartographic evidence of the pig sty, so it is possible that the rooms served another purpose.

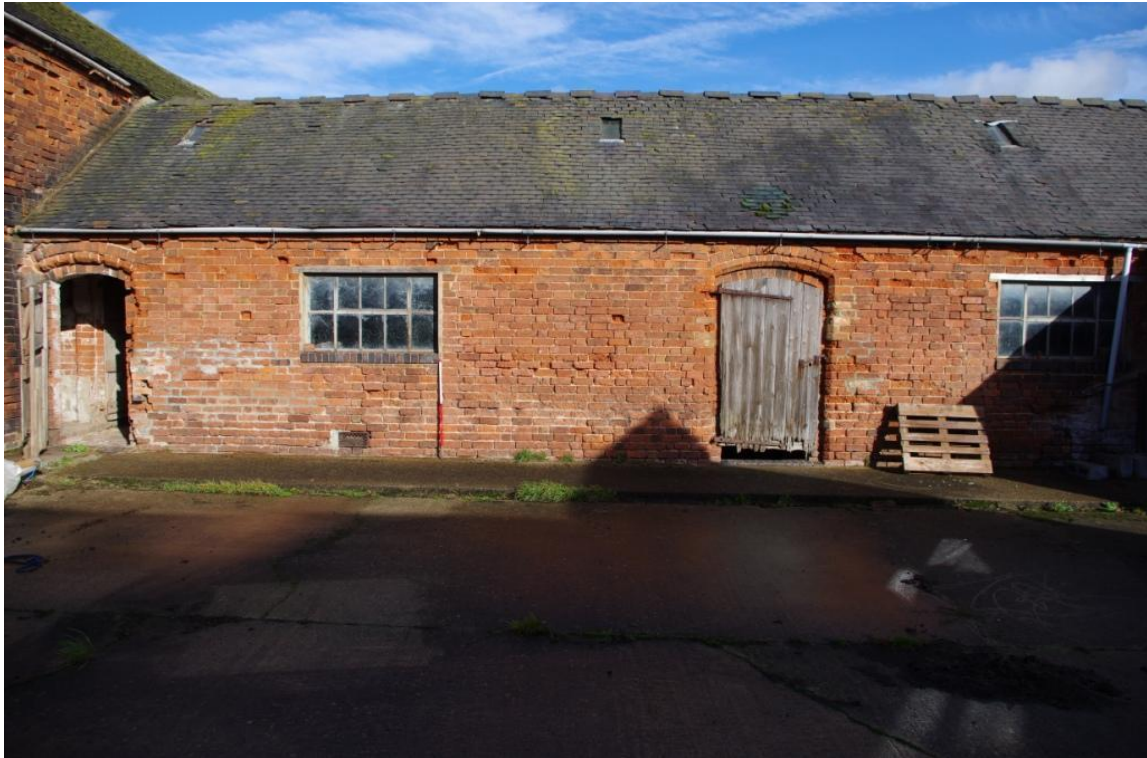
**Figure 14**  
(15) South – South West Facing Elevation (Looking North – North East).

(15) forms the northern range of the foldyard, with two doors on the south facing elevation (*Figure 14*) and a further two doors on the east facing gable, one of which is a six panel door salvaged from the demolition of Norris Hill Hall (*Figure 15*). Internally, the range has standing for 14 beasts in 7 double stalls, again in slate with brick and ceramic mangers (*Figure 16*). The use of concrete, slate, brick and ceramics in cow sheds was compulsory following the Milk and Dairies Act of 1926 in order to prevent the spread of TB and other diseases, the surfaces allowed easier and more through disinfection. A feeding passage runs along the northernmost wall (*Figure 17*).

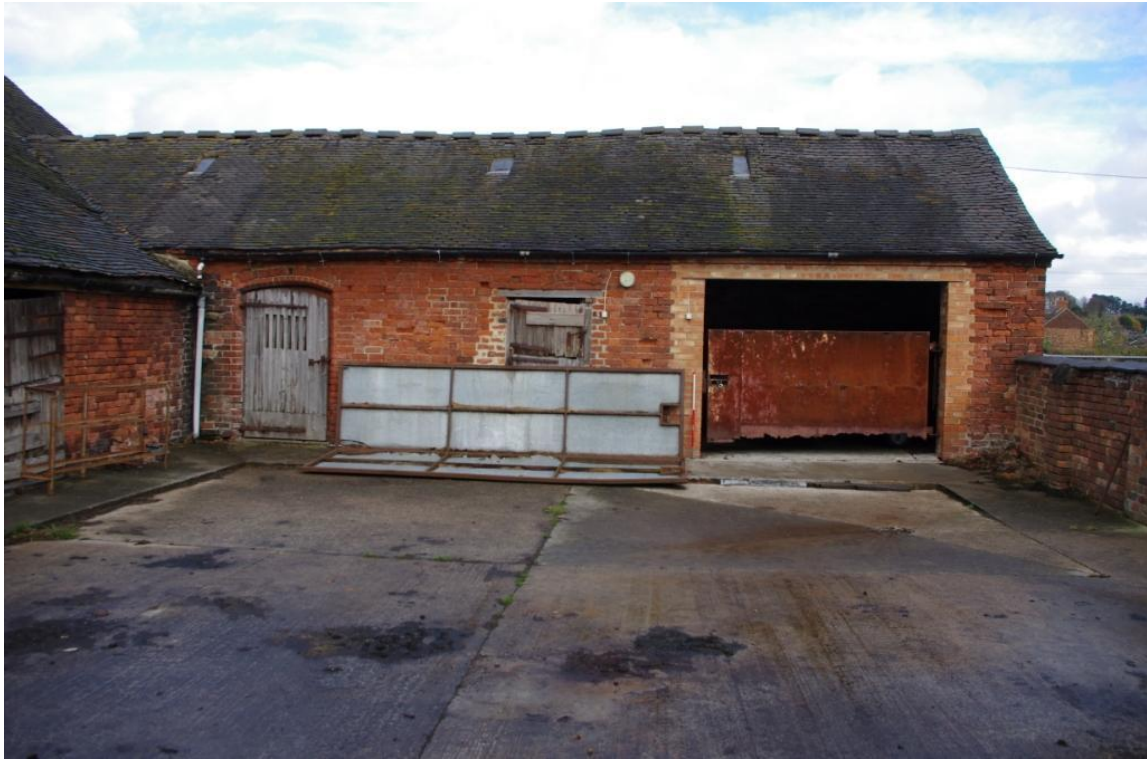
**Figure 18**  
(7), (8) & (9), South – South West Facing Elevation (Looking North – North East).

(7), (8), and (9) form the northernmost foldyard. (7), (8) and (9) were originally stabling with doors on the south facing elevation (*Figure 18*), a large double door has been inserted into (9) and the central door altered with a modern insert, the original flat cambered brick arch survives in the brickwork above. The westernmost door, potentially of oak is original and finished to a high standard with hit and miss ventilation bars and chamfered hole for the latch (*Figure 19*), with a cant brick reveal such details confirm the range as stabling, as stables were frequently finished to higher standard than other farm buildings.

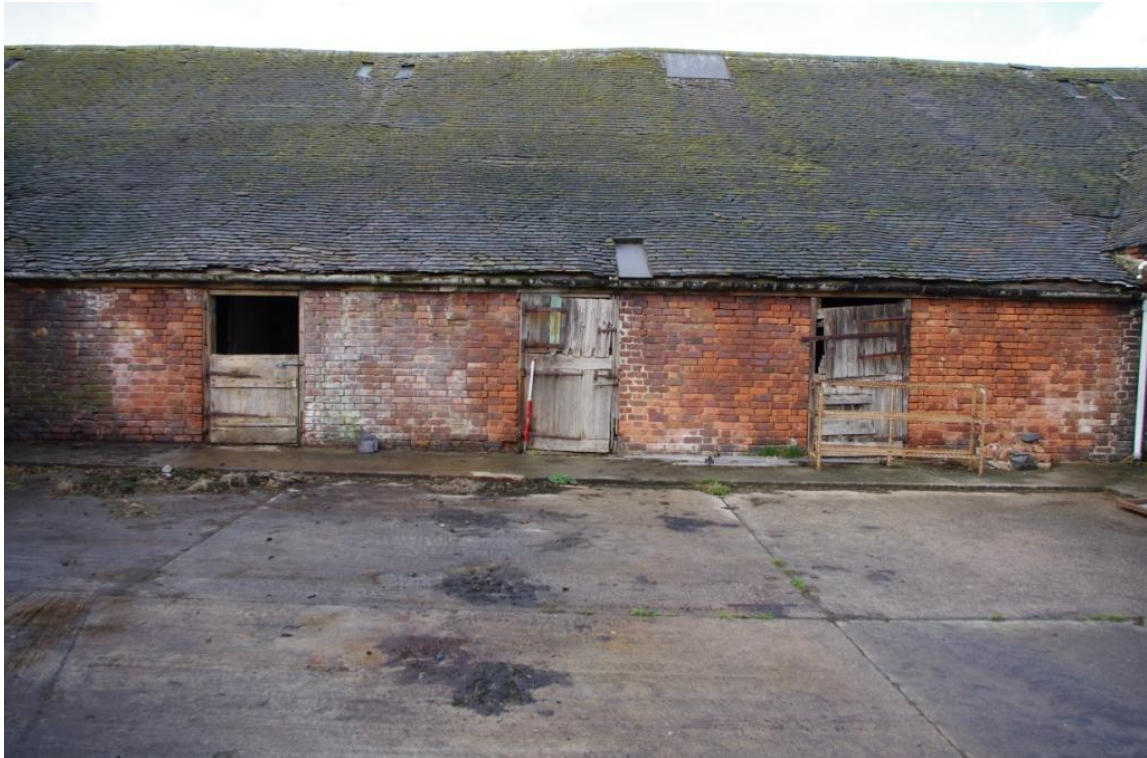
**Figure 20**  
(10), (11), (12) & (13), East – South East Facing Elevation (Looking West – North West).

Forming the western range of the foldyard is a lean to building abutting the east face of (3), (4), (5) and (6). The lean to is, according to cartographic sources original to the building, there, is, however a straight joint visible in the brickwork of the east facing elevation indicating this is later (*Figure 20*). It is likely that the lean to was originally a shelter shed for the fold yard. Internally, the lean to is divided into four bays with a feeding passage, (14) between the bays and north – south range, there are attractively finished arched feeding holes (*Figure 21*) between the bays and (14), some of which are blocked; the feeding passage also accesses the stables to the north. The small sizes of these current bays suggest the lean to may have been used as calf pens.
