**An Archaeological Standing Building Survey
Westacott Farm
Crediton
Devon**

**Planning Application No
18/01830/FULL**

**An Archaeological Standing Building Survey, Westacott Farm (Outbuildings),
Crediton, Devon, (NGR SX 84238 97627).**

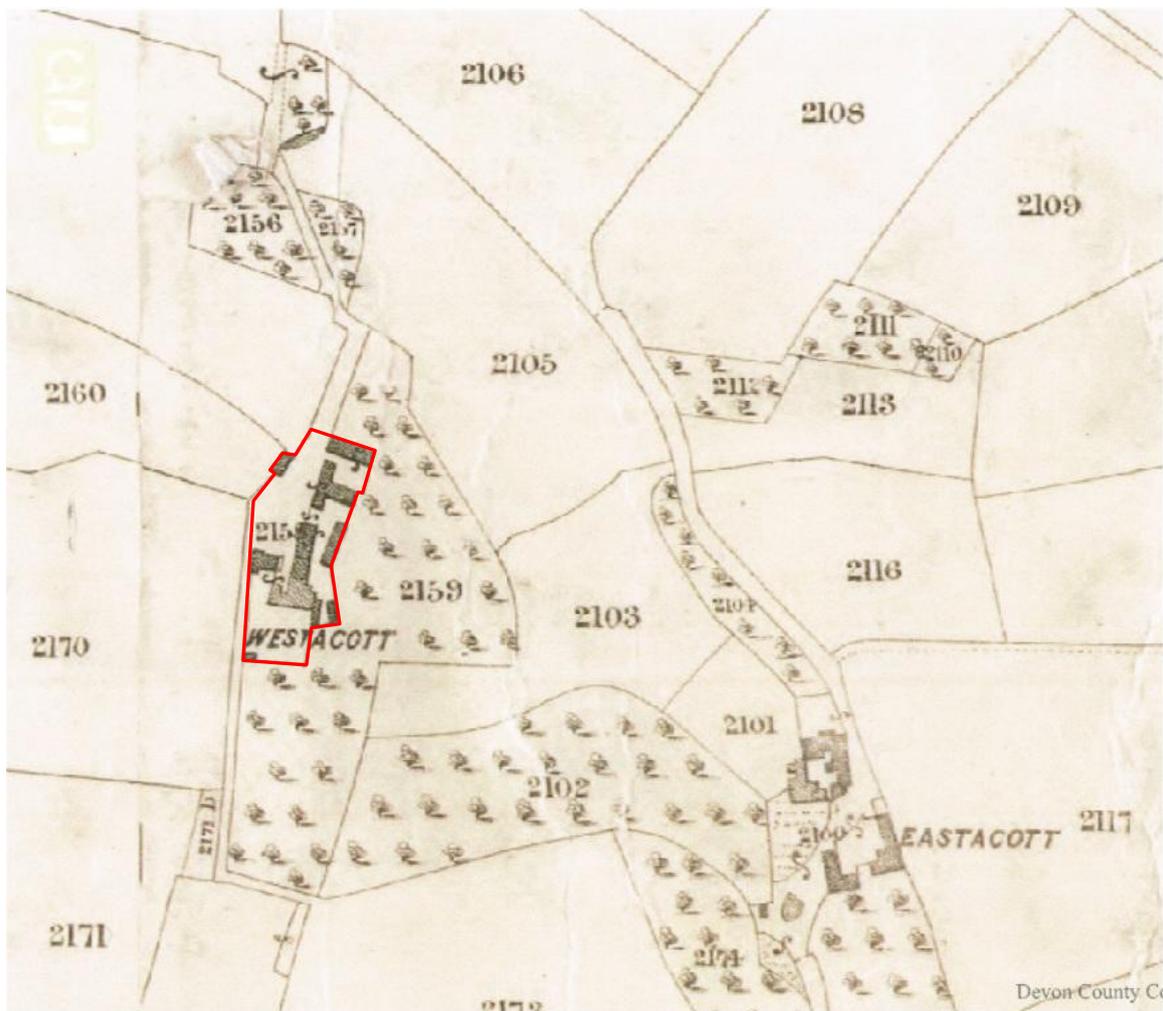
Figure 2
A Plan of the Parish of Crediton in the County of Devon (1841).

The earliest available cartographic reference to the proposed development area is “A *Plan of the Parish of Crediton in the County of Devon (Part II)*” drawn in 1841 for the church tithe (Figure 2). Westacott Farm is clearly recorded and identified by name, the accompanying

apportionment identifies 2158 as Homestead and Lane and 2159 as Court Orchard. The farm is owned by John Yarde of the Westacott Estate and occupied by John Rowe, other sources describe it as the Trobridge Estate. John Yarde (1799-1871) was the Conservative MP for South Devon between 1835 and 1858, upon his retirement in 1858 he was created Baron Churston, of Churston Ferrers and Lupton and in 1860 changed the family name to Yarde-Buller. John Rowe's occupancy of the farm is confirmed by Whites History, Gazetteer and Directory of the County of Devon published in 1850 which also records John Rowe.

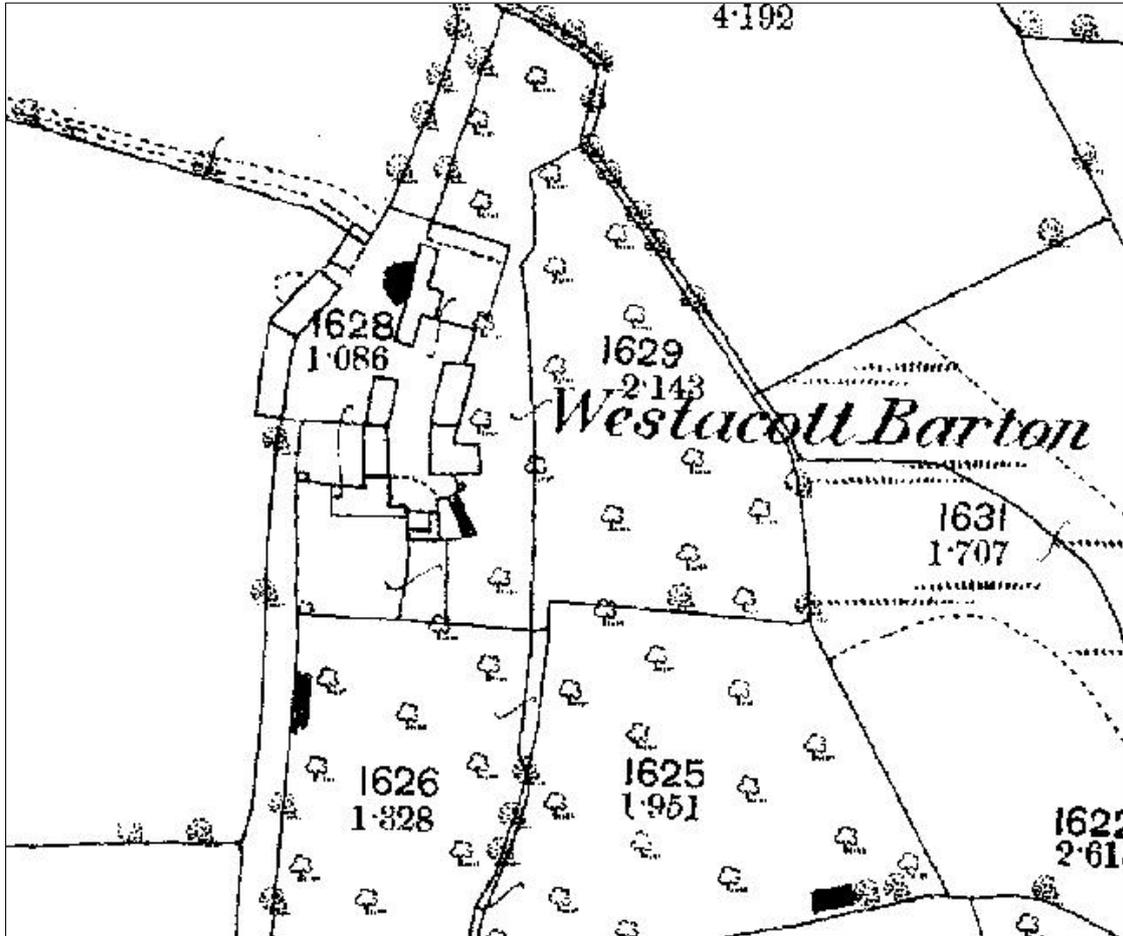
Figure 3
First Edition Ordnance Survey (1889).

The plan records Westacott as a linear farmstead, the differentiation in shading would suggest that a farmhouse was located at the southernmost end of the farmstead. Neither the plan, nor the apportionment give any indication as to the nature and use of the buildings, but the description of Orchard Close would suggest the likely presence of an apple loft, cider mill and most likely other commonly found agricultural buildings.

In 1857 Billings Directory & Gazetteer of the County of Devon lists Henry James of Westacott Barton, Kelly's Post Office Directory published in 1883 lists Edward James, likely a descendent of Henry, who remained at the farm until at least 1893. The first edition Ordnance Survey, the first modern map of the proposed development area and the parish in general was published in 1889; the online version (*Figure 3*) lacks the colour detail of a published version but does record some significant alterations to the farmstead and potentially interesting features. To the west and north west two buildings have been built, the

northernmost having what appears to be a horse engine house on the west facing elevation. The small building immediately to the north appears to be open fronted, as does a larger building to the north east, these are most likely linhays or open fronted shelter sheds, or in the case of the smaller shed a cart shed.

There is a second, semi circular structure abutting the “T” shaped building recorded in 1841, which itself is on a reduced footprint. The semi-circular structure is shaded, which may suggest, following Ordnance Survey conventions that it is of timber or iron construction. The easternmost building appears to have been extended to the south and occupying a larger footprint than it did in 1841, suggesting it may have been extended or re-built, most likely under the direction of the James Family.

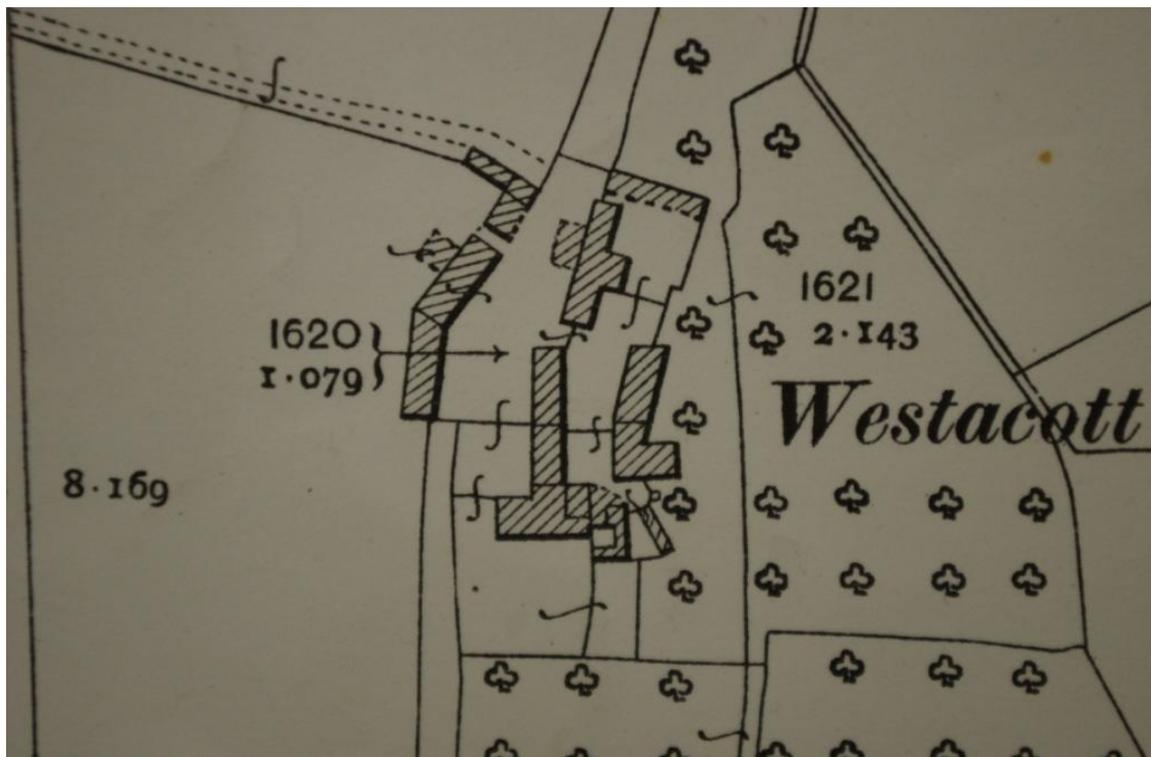
Figure 4
Second Edition Ordnance Survey (1905).

The second edition Ordnance Survey was published in 1905 (DA&LS Ref LXVII.11 (*Figure 4*)), the map is clearer than the online version of the first edition, and shows a number of features and changes to the farmstead. The two semi circular structures have been replaced

by square structures, the westernmost remaining open sided while the other appears to be open to the north. The north easternmost open fronted building is confirmed as an open fronted shelter shed with a fold yard to the south.

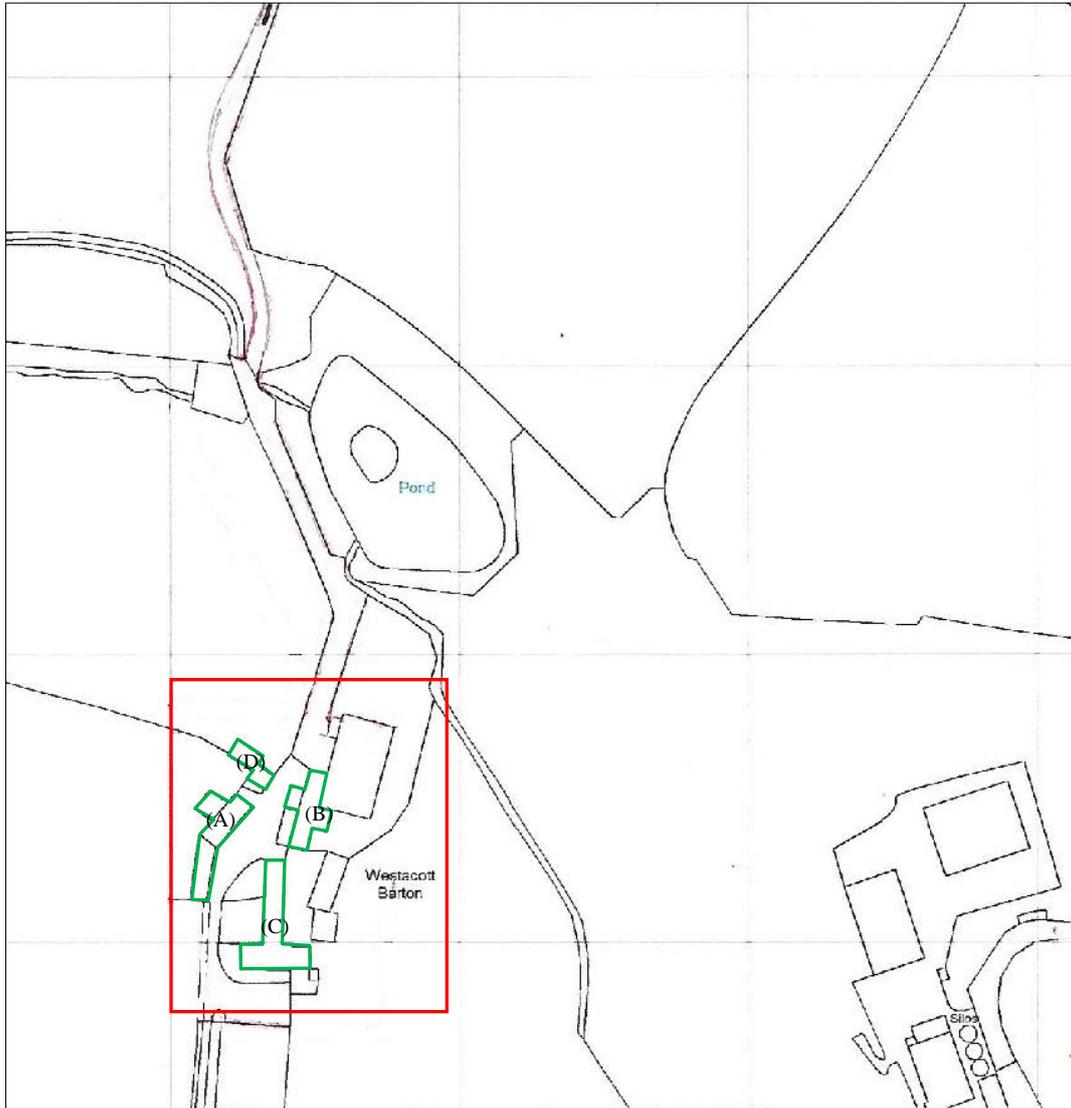
Figure 5
Proposed Development Area, in Red, Recorded Buildings in Green.
Supplied By Client (1:1250).

Orientation: There are four buildings subject to this historic building recording, all are linear in plan, with the long axis aligned north-north east – south-south west (*Figure 5*), for ease of description this is taken hereafter to be north to south. The principal elevations are those facing the yard. Where the terms ‘left’, ‘right’, ‘front’ and ‘back’ etc are used in the report, this is in relation to these principal elevations, as viewed from the yard. For the purposes of this historic building recording a letter affix has been allocated to identify each building and a number suffix added for significant partitions where required.

Building D is located to the north east of building A (*Figure 5*). The building survives only as two cob walls under a lean to roof in corrugated tinned steel sheets (*Figure 22*). The apparently unstable roof structure prevented further recording, but there appeared to be a manger along the northernmost wall, suggesting the building may have originated as a shelter shed. There is a second lean to corner to corner with the north westernmost corner of the cob wall; it too is in a too dilapidated condition to record.

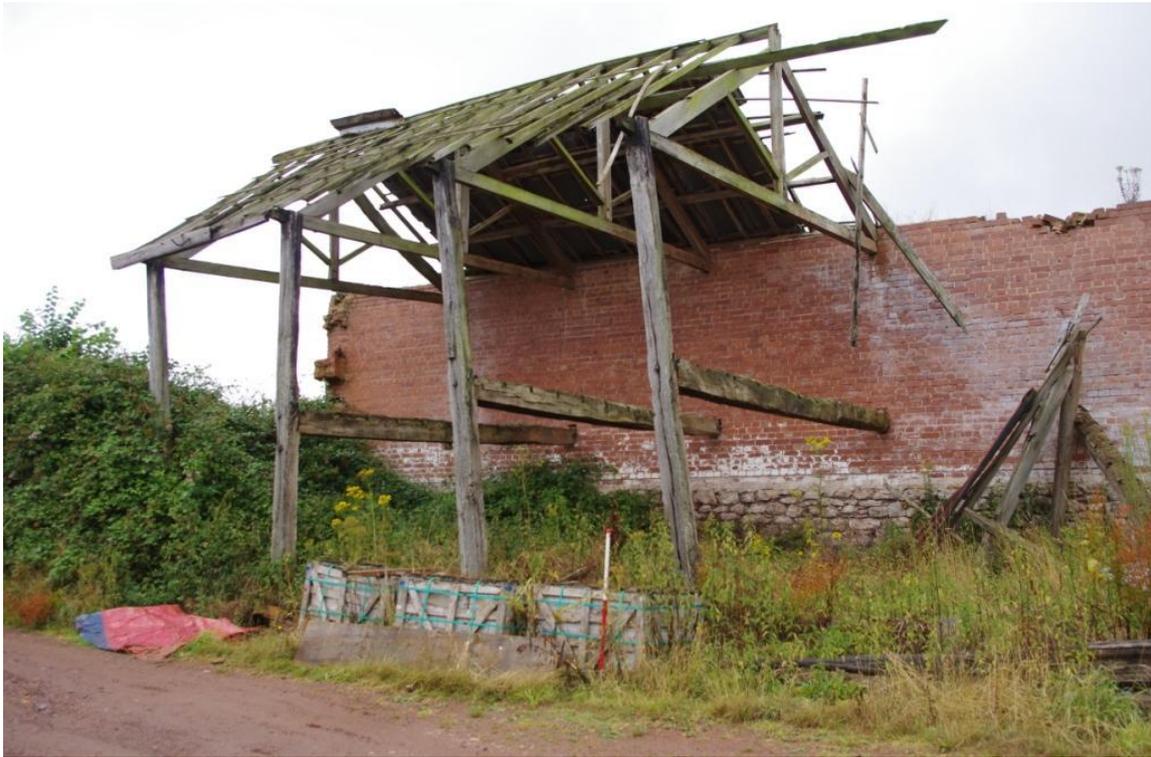
Building A forms the westernmost range of the former farmstead (*Figure 23*), it is a linear range consisting of three principal elements, the southernmost range being ruinous consists only of the rear brick and stone-built wall and four cross frames and trusses (*Figure 6*). The condition of the range prevented a detailed examination and record, but from the remains it is possible to assume the range may have originally been a linhay, a two-storied open fronted cattle building with hay-loft above. The use of deal for the trusses, which are also bolted suggests a mid to late 19th century construction date, this is supported by cartographic sources which indicates the range post dates 1841.

Figure 6
Building A Ruined Southernmost Range (Looking South West).

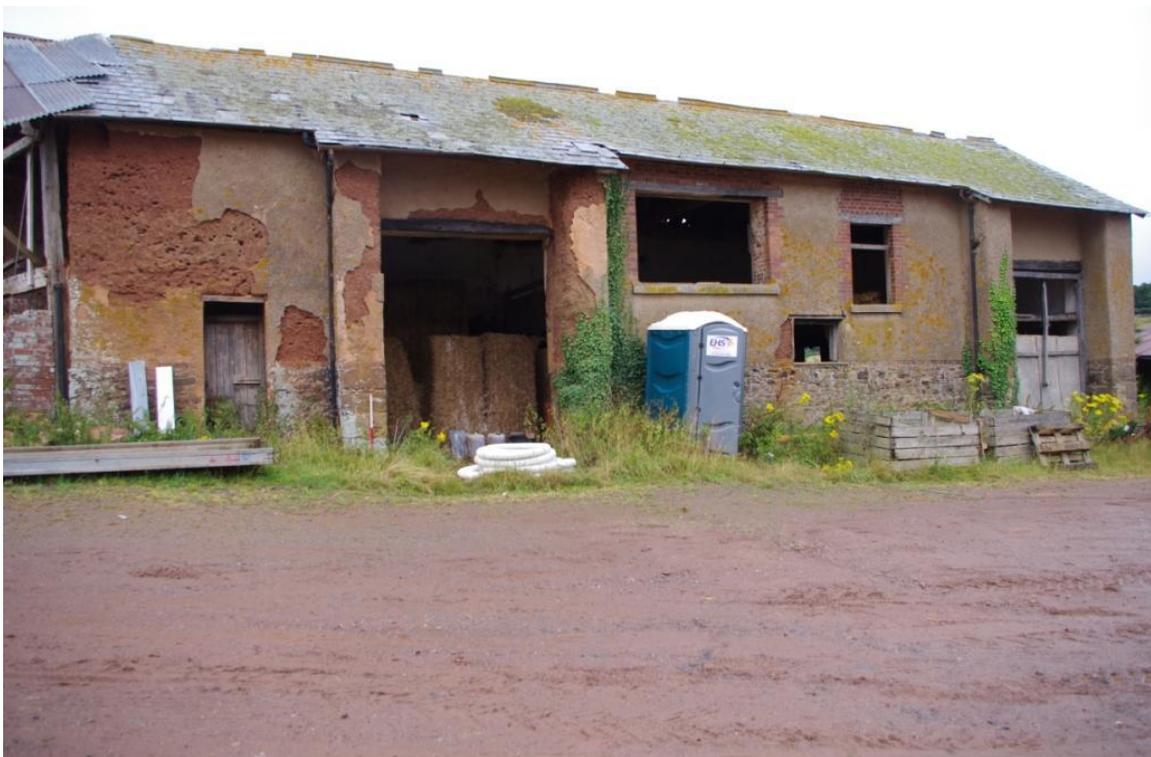
On the principal elevation there is a large off centre threshing door flanked by cob buttresses, and a second, slightly lower threshing door to the north, this arrangement is mirrored on the rear elevation, which itself is largely concealed by an additional bay and vegetation. There is a small pedestrian door adjacent to the south gable.

Figure 7
Building A Principal Elevation (Looking North – North West).

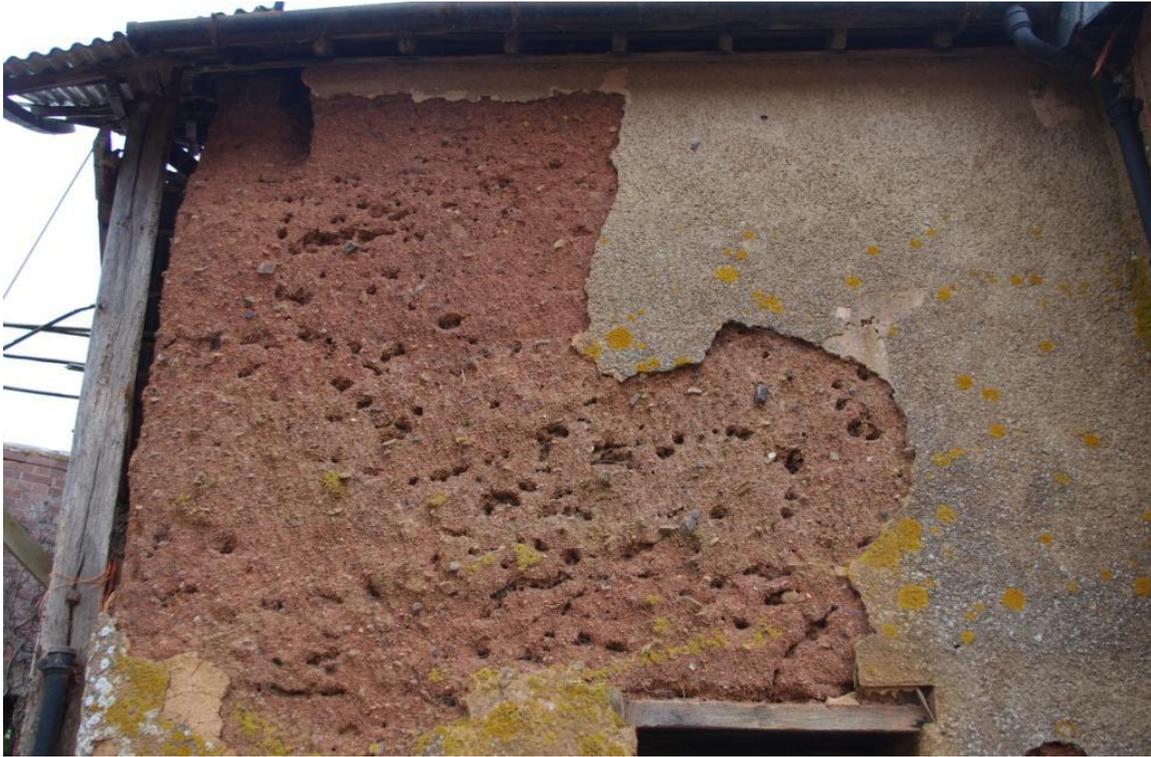
Figure 8
Building A Principal Elevation, Showing Banding in Cob (Looking North West).

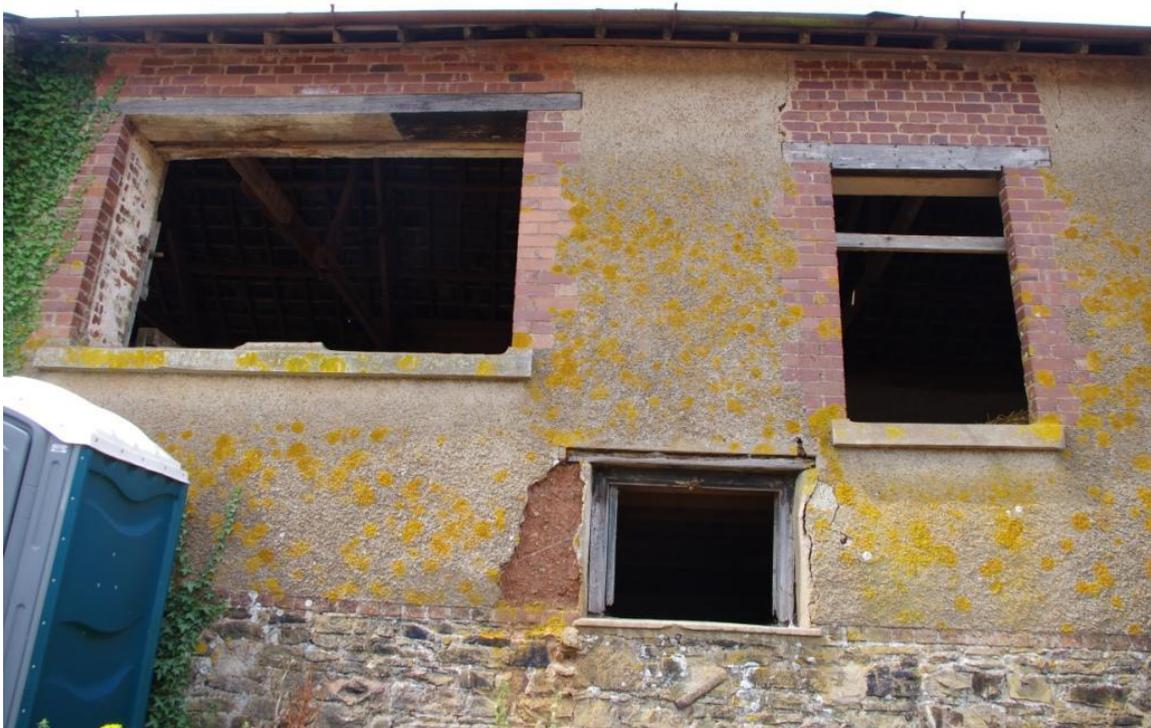
There are three openings on the principal elevation, only one, on the ground floor being potentially original. The two first floor openings with their brick reveals and flat timber lintels are undoubtedly later insertions (*Figure 9*), both openings have well finished concrete sills, the larger having the outline of a central mullion. It is unclear as to why these openings were added, but the brick reveals appear to be clearly mid to late 20th century in date giving an indication as to when the openings were inserted.

Figure 9
Building A Inserted First Floor Openings on Principal Elevation (Looking North West).

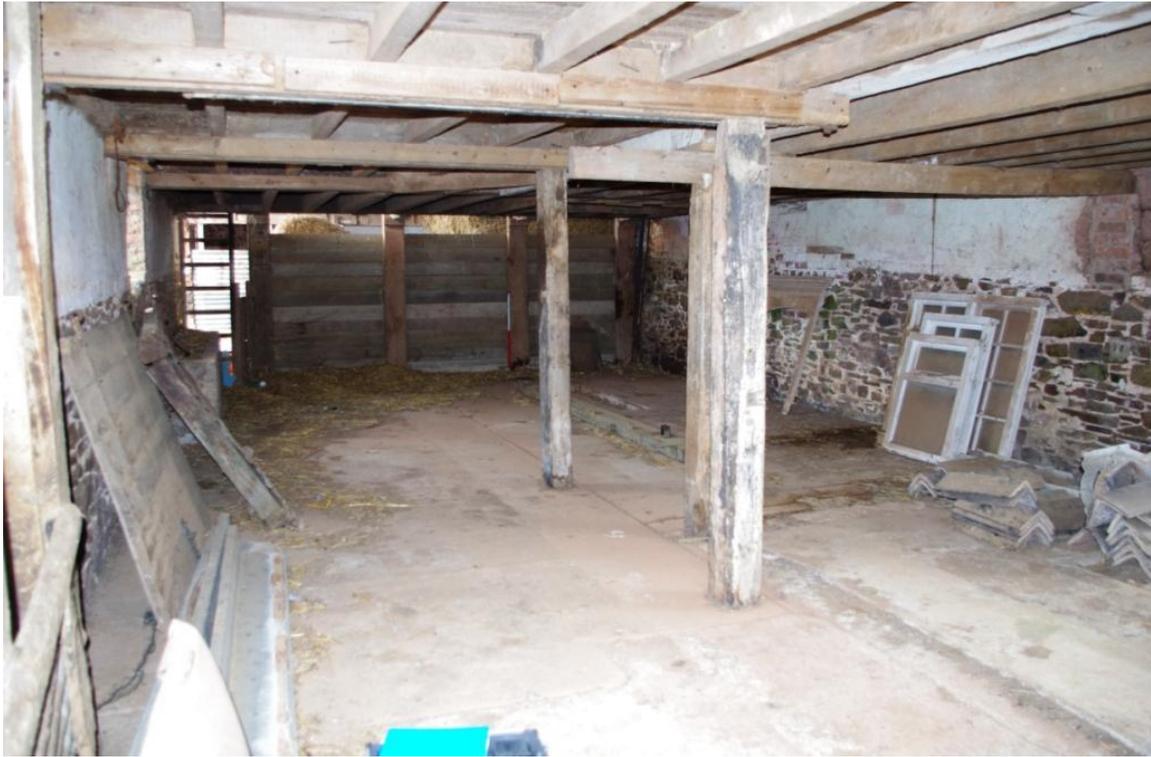
Internally, the range consists of three bays (*Figure 24*), the two southernmost bays, (3) and (4) are clearly modern insertions, indicating that the range was originally a single bay, confirming it as a threshing or fodder barn. (3) and (4) are open to the roof, while there is a first floor above (2), this floor is not convincingly original and the use of rolled steel joists (RSJ) as bridging beams would appear to support this. There is no indication as to the most recent use of (2) beyond a short concrete manger against the principal elevation (*Figure 10*).

Figure 10
A(2) General View, Internal (Looking South West).

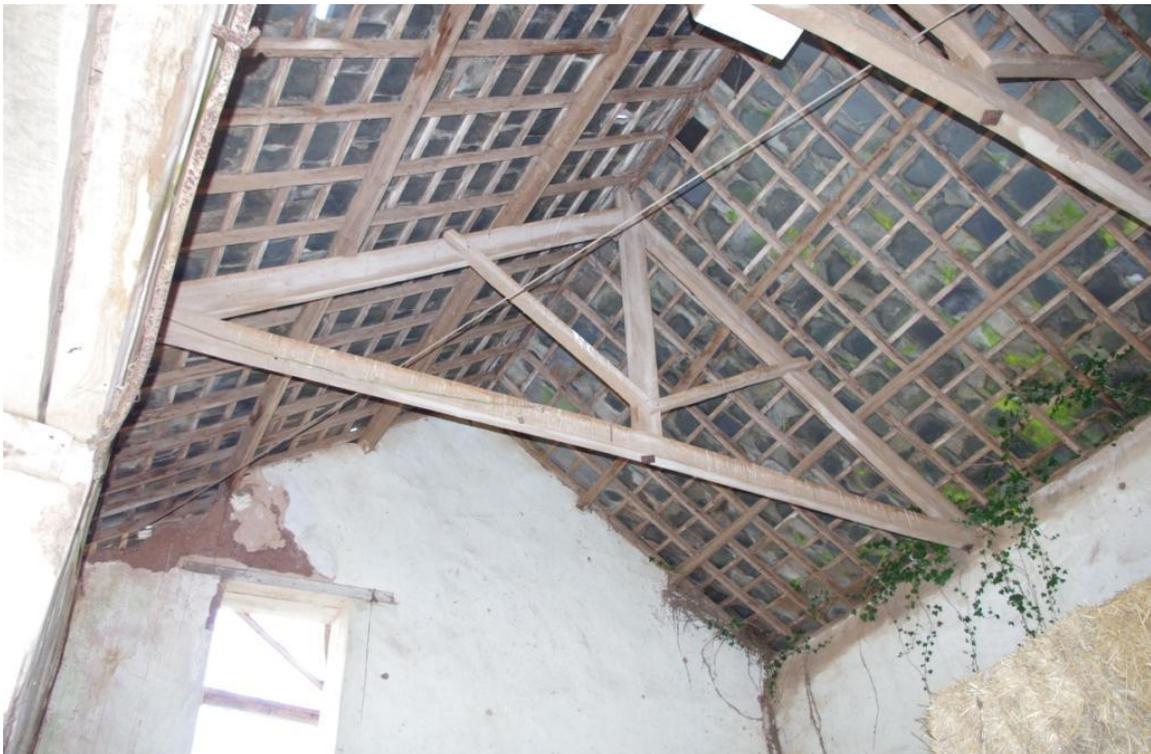
Access to the first floor is via a timber ladder. The roof is carried on five King post trusses with raking struts. The trusses are somewhat naive in their finish with a straight King post bolted at the heel and the raking struts being finished with half lap joint and nailed to the King post (*Figure 11*). King post trusses have a wide date span, but examples such as these, bolted at the heel tend to be exclusively post 1860s in date, a date which is supported by cartographic sources. The forward raking struts on the four northernmost trusses have been removed for some unknown purpose.

Figure 11
A(4) King Post Truss (Looking South West).

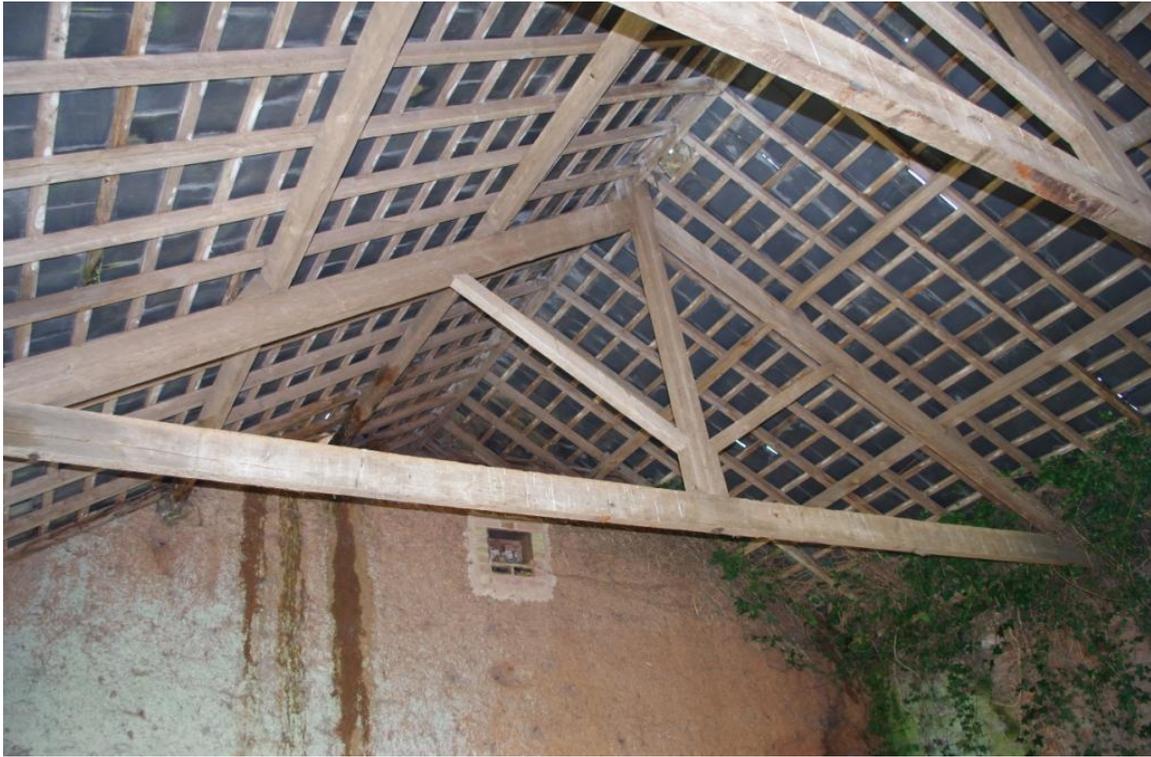
Abutting the rear elevation is (1), an open fronted bay (*Figure 24*), the west facing wall is modern concrete blocks while the south facing wall, although ruinous is of 19th century brick, the rubble sleeper wall suggests it may have originally been cob. The roof is again carried on King post trusses, but in this case better finished (*Figure 12*), this would suggest the two are not contemporary, this is supported by cartographic sources which suggest there was originally a horse engine here, likely replaced by the current building.

The roof of (1) is clad in Welsh slate which is identical in appearance to that used on the main range, which conflicts somewhat with the assumption that the roof on the main range is original. It is possible therefore that both ranges have been re-roofed.

Figure 12
A(1) King Post Truss (Looking East – South East).

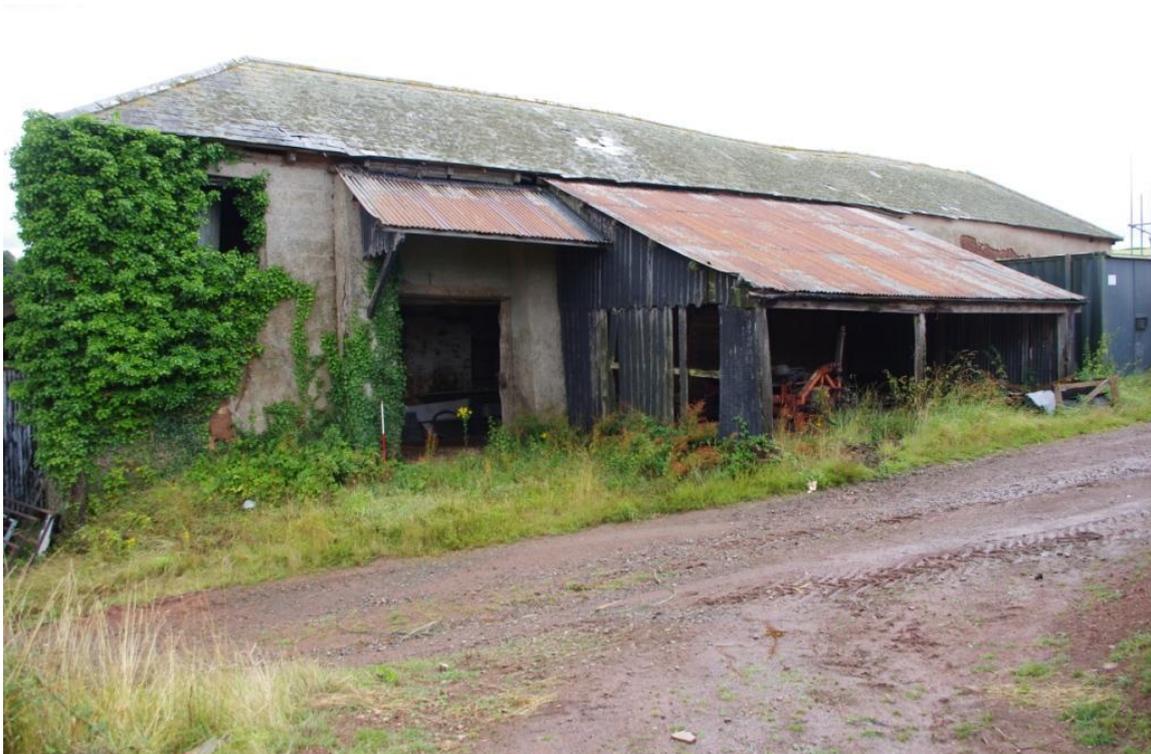
Building B is located to the east of building A and on a similar alignment. The building is again largely cob built under a hipped roof clad in Welsh slate (*Figure 13*). The building occupies the same footprint as a building recorded on the 1841 tithe map, so could potentially be the earliest building remaining within the farmstead. The building has undergone significant repair and alteration, the south facing gable, although rendered has clearly been re-built in modern concrete blocks (*Figure 14*). The north facing gable, as well as part of the east facing long elevation is built of local rubble stone (*Figure 15*), it is unclear whether this a later repair or part of the original structure to strengthen the down slope part of the building as the stone used is identical to that used for the sleeper walls elsewhere within the building.

Figure 13
B Principal Elevation (Looking South – South East).

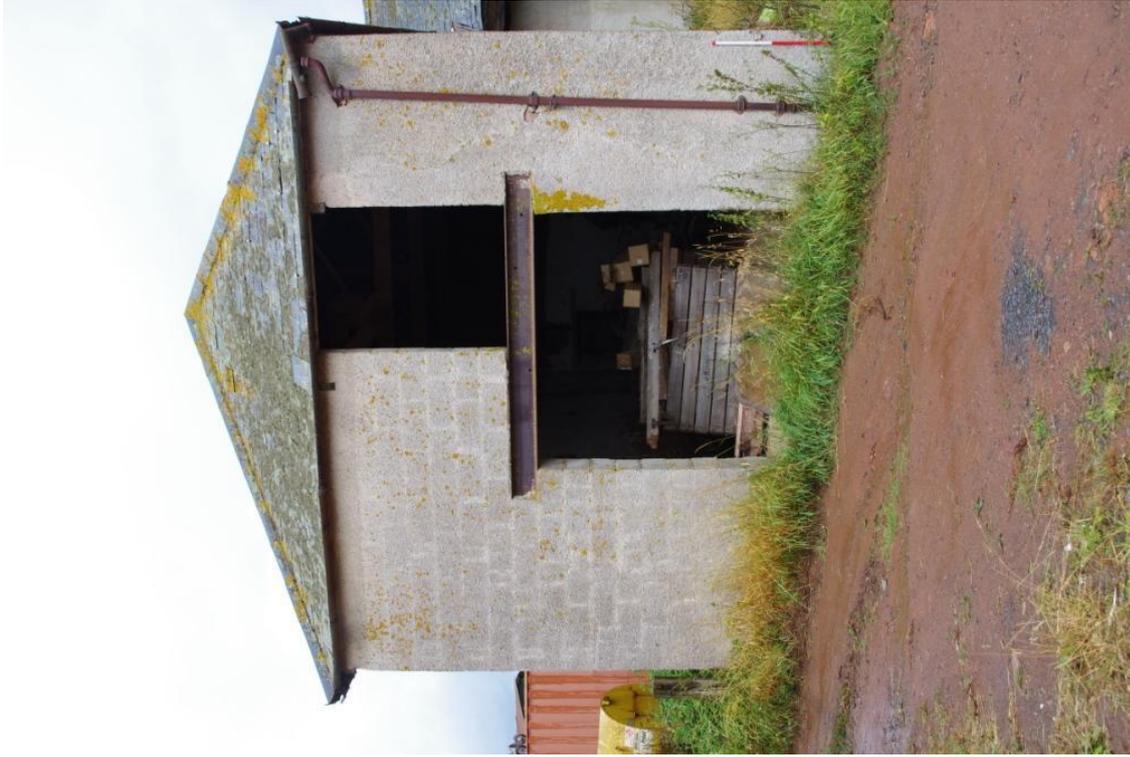
Figure 14
B South – South West Facing Gable
(Looking North).

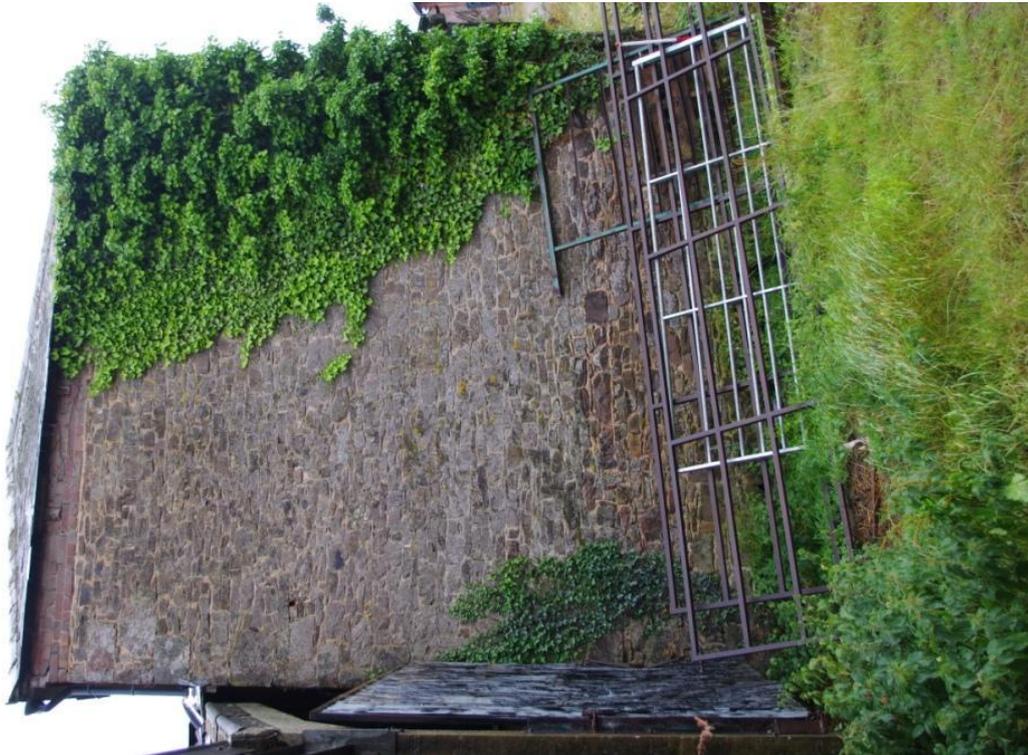
Figure 15
B North – North East Facing Gable
(Looking South – South West).

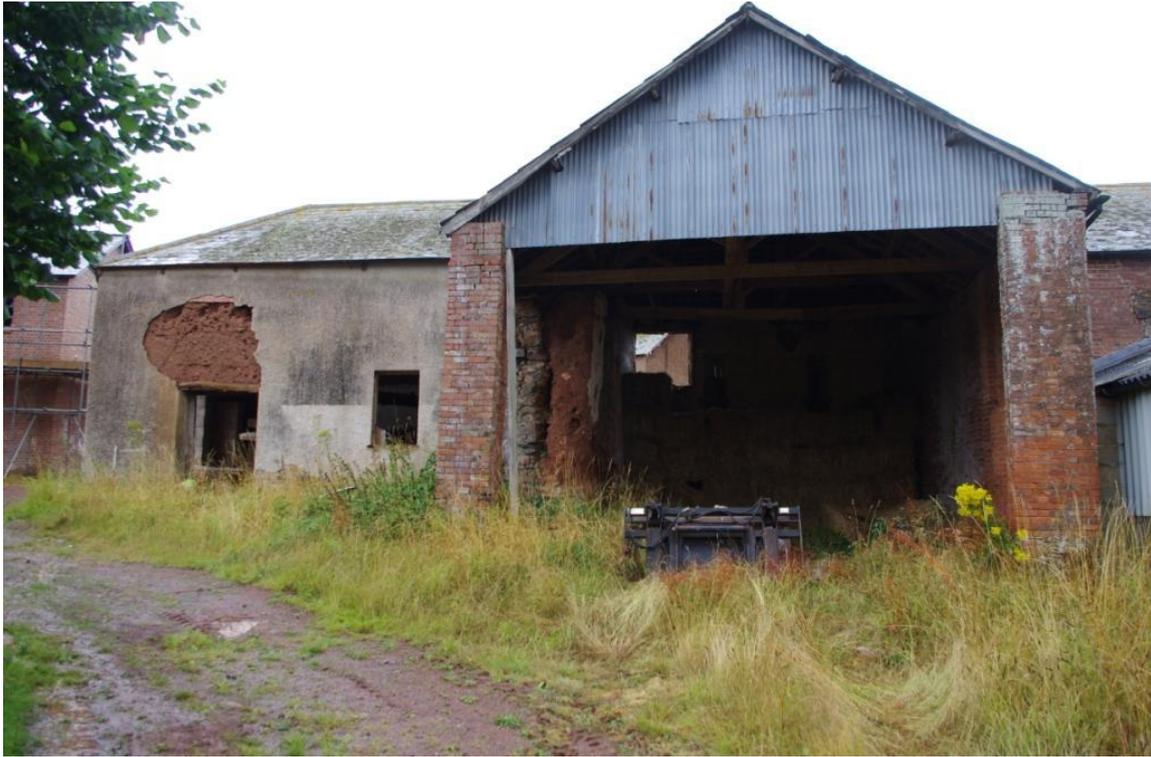
On the east facing elevation is a short, largely open sided projecting bay, (2) (*Figure 16*). According to the 1841 map this was originally a larger bay, but it was partially demolished prior to the publication of the 1889 Ordnance Survey. A short section of cob wall survives on the south, the northern wall is brick-built, and the two phases of brick work suggests the westernmost part is later.

Figure 16
B(2) East – South East Facing Elevation (Looking West).

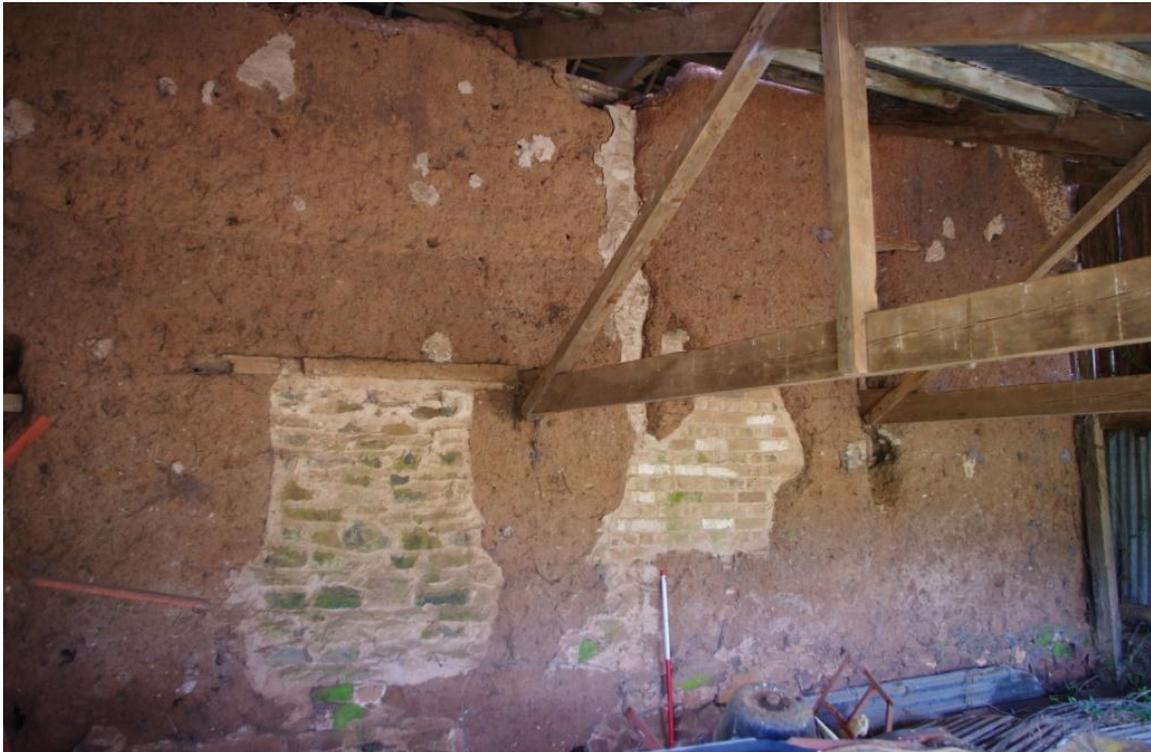
The survival of the external render prevents a thorough examination of the cob structure (further hampered by intermittent torrential downpours & bright sun wetting & drying the exposed elevations during the site visit), but there is potential evidence of banding within the principal elevation within the lean to, (4) where yellow culm clay overlays the local red clay (*Figure 17*), although being located in a sheltered and dry environment there could be other environmental factors to cause this potential colour change. The cob walls vary in thickness from between 520mm (approx' 20inches) to almost 900mm (35inches), the thinner walls suggest shuttering was used during construction, supported by the limited banding observed. The thicker walls may be earlier, suggesting that there may be multiple phases of construction within the cob walls.

Figure 17
B(4) Possible Banding Visible in the Principal Elevation (Looking South West).

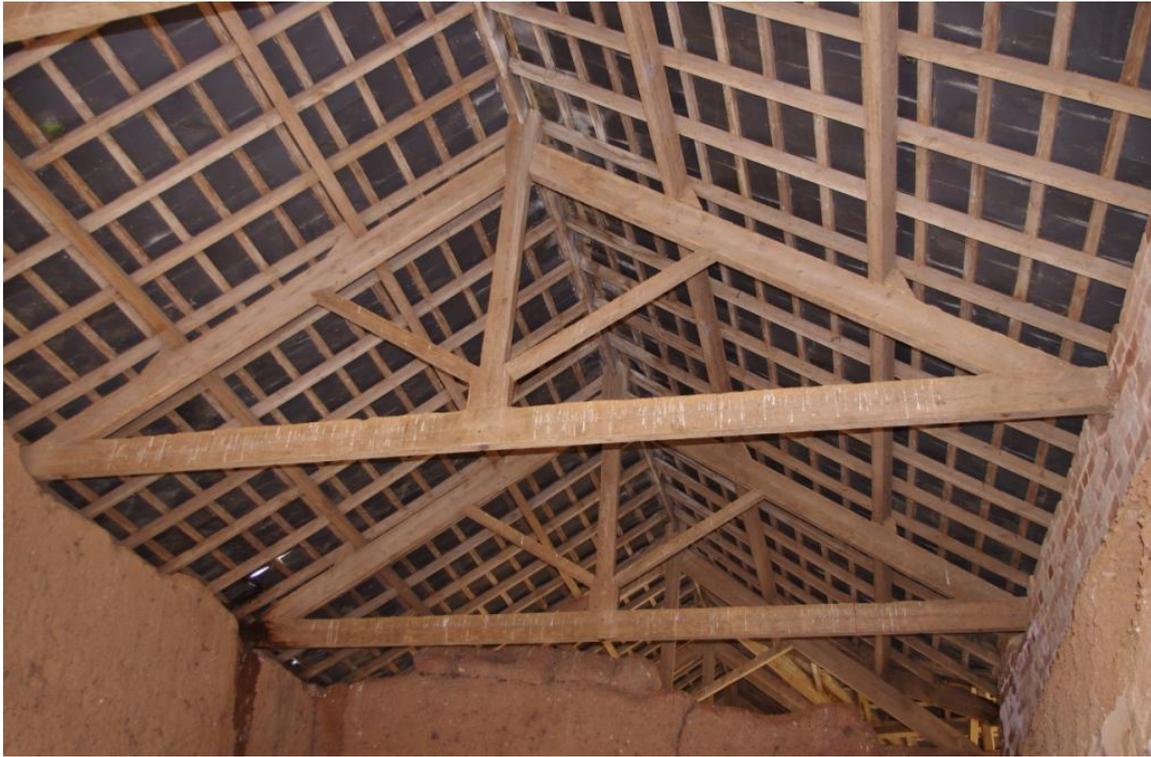
The roof is carried on eight King post trusses with raking struts, in deal. The trusses (*Figure 18*) are identical in design and appearance to those seen in building A(1) which suggests they may be contemporary, this however confuses the chronology established using cartographic sources which suggest A(1) is later. It is possible; therefore that B was re-roofed in the late 19th or early 20th century.

Figure 18
B(1) King Post Truss (Looking North – North East).

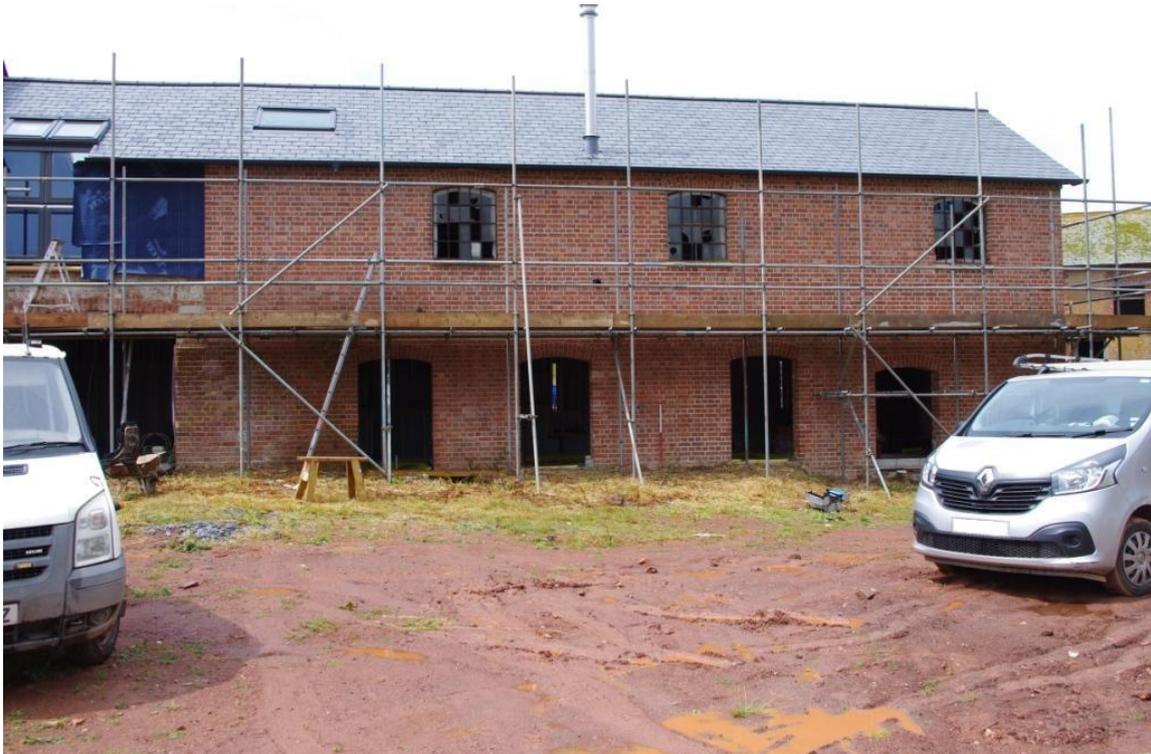
Conversion work on building C had commenced prior to the site visit, leaving nothing of historic or architectural significance within the interior. Externally, the “T” shaped building is clearly of two separate phases, the north – south range being brick built, while the east – west range is local rubble stone built. The brick range is constructed in English Bond (alternate courses of header and stretcher bricks), although a strong bond, it is an unusual choice for an agricultural building as it is difficult to lay and more expensive than other bonds due the number of bricks used. The range is well finished with cant brick window reveals and contrasting terracotta sills to the cast iron windows (*Figure 19*). The windows themselves are probably mid 19th century in date, suggesting a tentative date for the building as a whole. The range as a whole is peculiarly well finished for an agricultural building and in comparison to the previous buildings, suggesting that for a time at least the farm had some aspirations of grandeur.

Figure 19
C East Facing Elevation (Looking West).

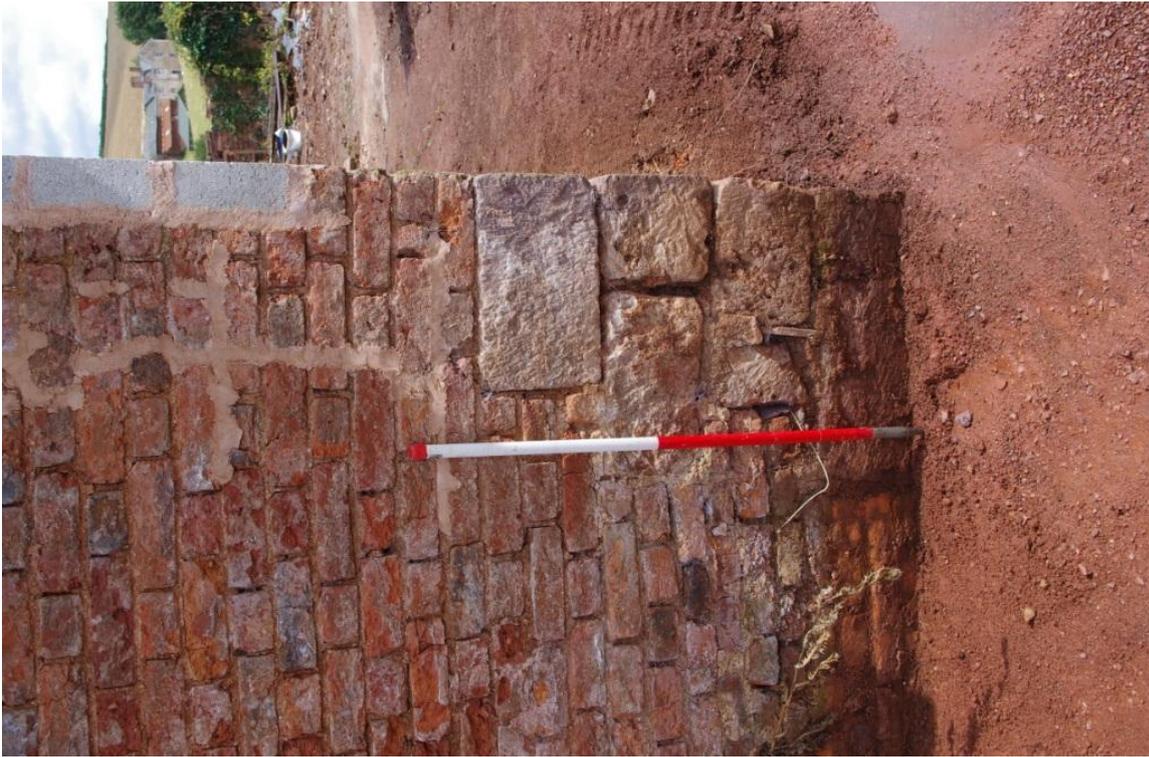
The east – west range is largely stone built, with some brick dressings and quoin work (*Figure 20*). It is likely that this range is the remnants of the original farmhouse seen on earlier maps, the only remaining evidence of which is the potential chimney breast on the west facing gable (*Figure 21*). The small, handmade bricks suggest the building may have pre-19th century origins, although not enough survives to speculate further.

Figure 20
C Quoins on South West Corner
(Looking East).

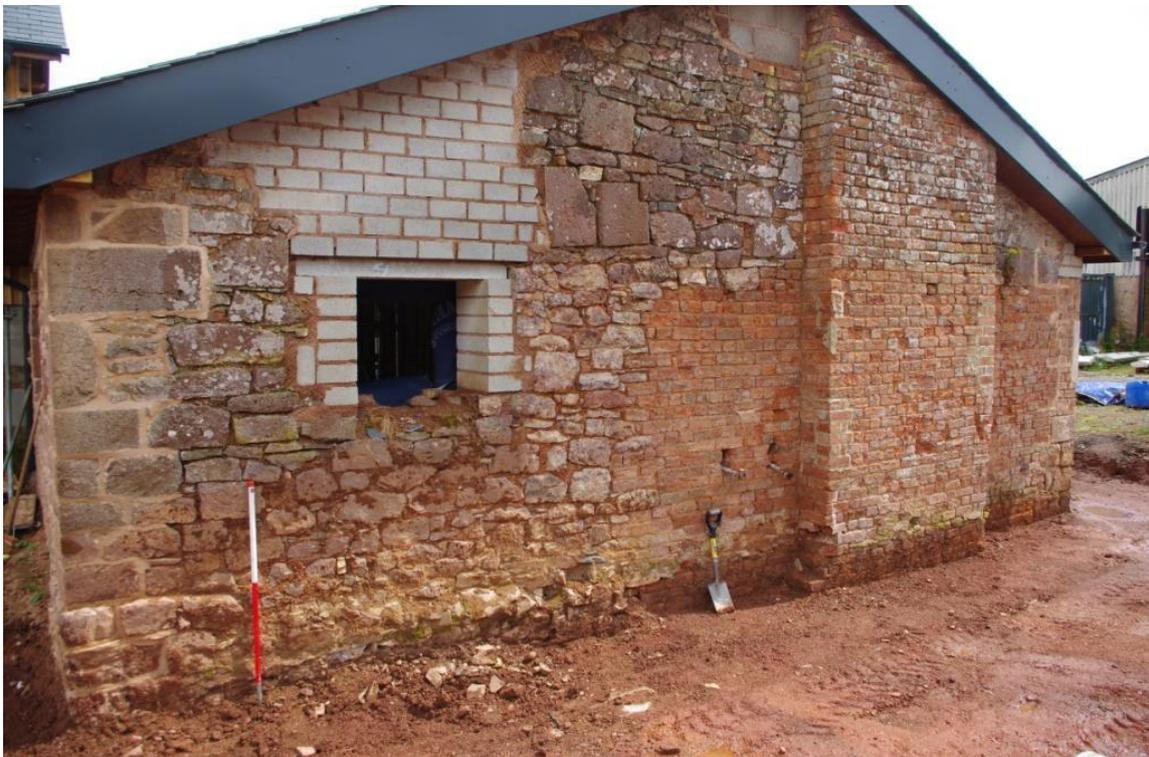
Figure 21
C West Facing Gable Showing Potential Chimney Breast (Looking East – South East).

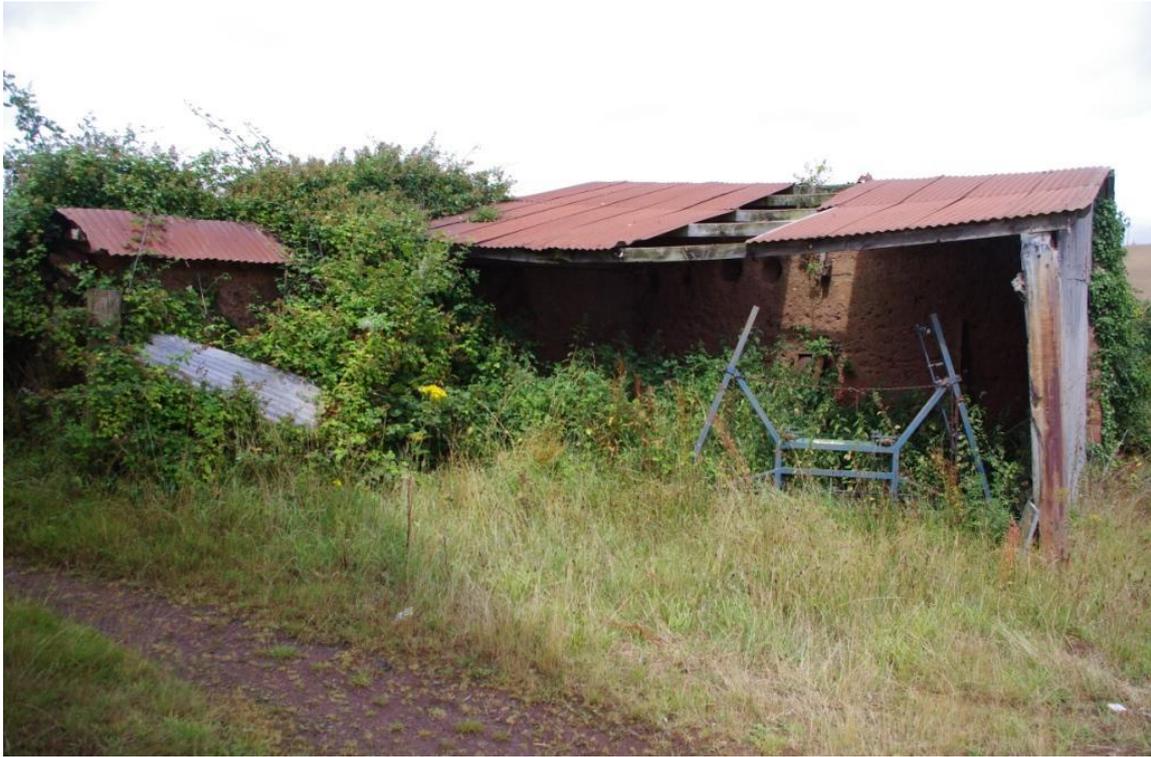
Figure 22
D General View (Looking North – North West).
