**A Photographic Survey  
14 - 16 Top Street  
Appleby Magna  
Leicestershire  
(NGR SK 53208 05582)**

**ABRS Project No 2019-TAML**

**Planning Permission 19/00623/LBC**

**A Photographic Survey of 14 – 16 Top Street (External Elevations Only), Appleby  
Magna, Leicestershire (NGR SK 53208 05582).**

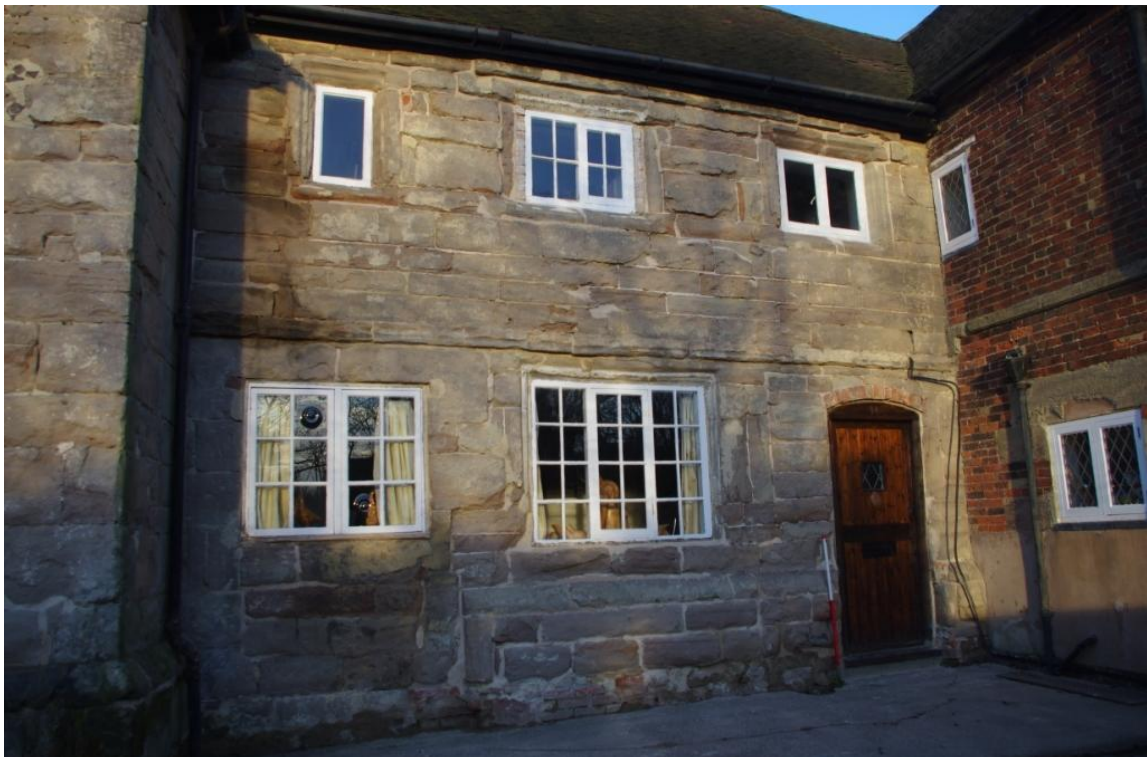
**Figure 4**  
No. 14 Principal Elevation (Looking North West).

these two principal elevation, the north east facing elevation of No. 16 was not, nor has been rendered (*Figure 6*). No. 14 revealed mullioned windows on the ground and first floor, unfortunately, there was no detail remaining to assist dating, but may have originally been ovolo or splay moulding. The continuous label moulding is equally damaged. There was alteration to the ground floor with a potentially blocked door to the south west and the current door potentially inserted into a window opening. There is apparently a straight joint between No. 14 and No. 16, suggesting the two are not contemporary, this is further supported by the lack of label moulding on No.16.

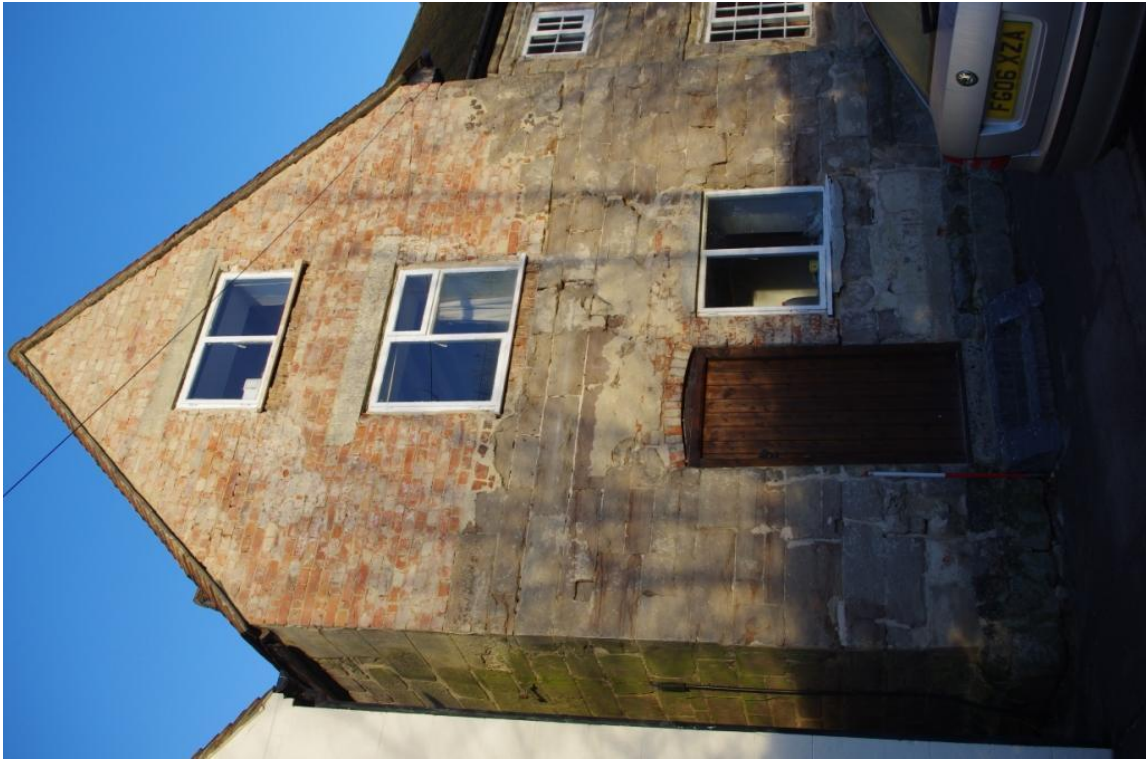
**Figure 5**  
No. 16 Principal Elevation (Looking  
North – North West).

No. 14 – 16 occupies the south westernmost extent of a terrace of four domestic buildings, historically the building has been identified as “two-thirds of an H-plan house” (Hayward, 2007), although the current building recording programme records no confirmation of this. The recorded external elevation does not include any dateable features, but the listing description (above) indicates a 17th century date. The building is a traditionally built in ashlar under a plain tile pitched roof with 20th century timber casement windows and timber doors (Figure 3). No. 14 is a two bay range fronting Top Street (Figure 4), No. 16 lies gable on to Top Street (Figure 5). The 20th century cement mortar render has been removed from

The principal elevation of No. 16 did not reveal any significant detail. The gable has undergone significant repair, the ground floor consists of poorly executed repair, now housing a 20th century door and casement window. The first and second floor is constructed in 20th century brick, the original structure having collapsed during a storm in 1962.
