**An Archaeological Standing Building Survey
31 & 33 High Street
Husbands Bosworth
Leicestershire**

ABRS Report No 2020-HHBL

Planning Application No 19/00160/FUL

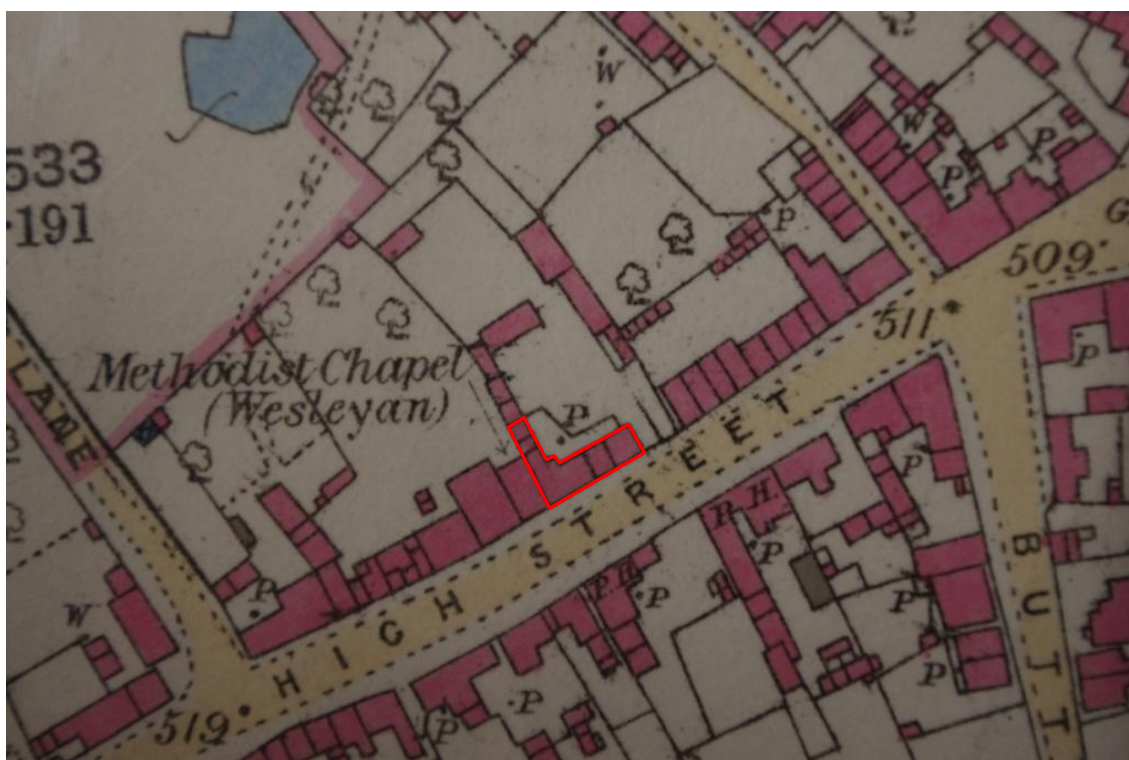
Figure 4
First Edition Ordnance Survey (1888).
(Sheet L.13)

The first edition Ordnance Survey showing Husbands Bosworth was published in 1888 (ROLLR Ref L.13 (*Figure 4*)), the map is the first large scale representation of Nos. 31 and 33. The buildings consist of an “L” shaped range fronting High Street, the frontage range appears to consist of three principal bays, with a range of smaller bays extending to the north west. This arrangement may suggest that the buildings were originally a village farm. Prior to the enclosures, farmhouses and their associated outbuildings occupied village plots.

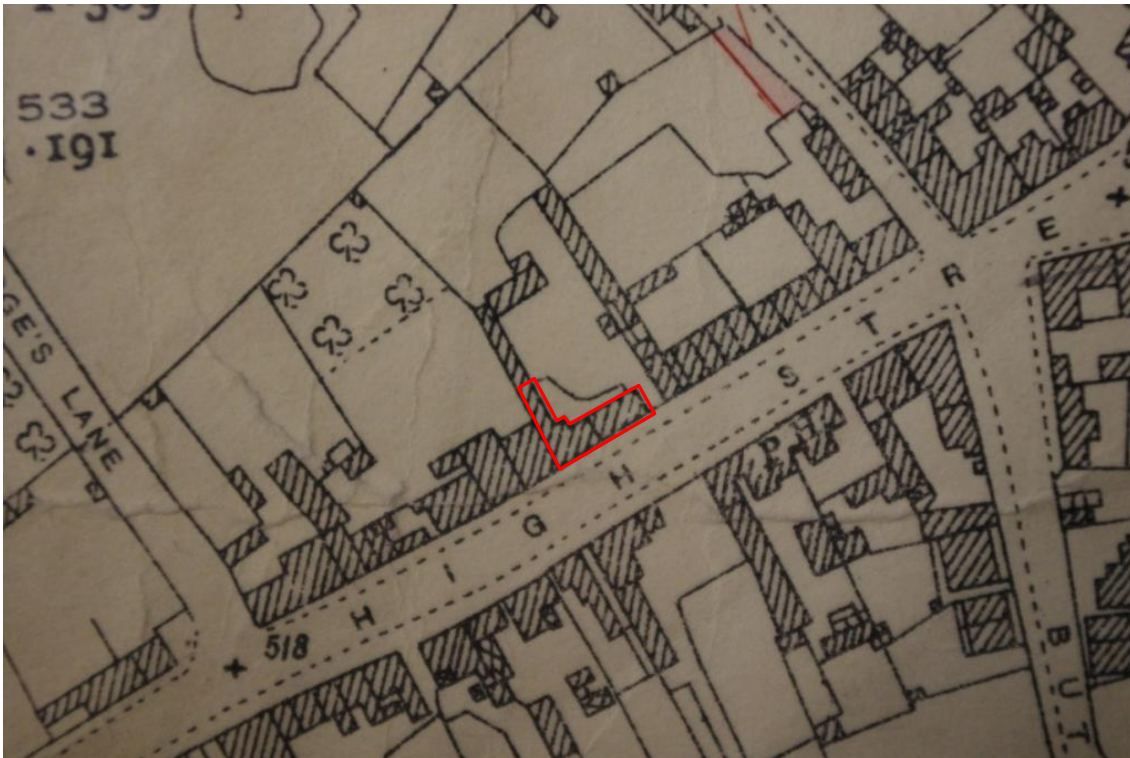
Figure 5
Second Edition Ordnance Survey (1929).
(Sheet L.13)

The next available edition of the Ordnance Survey is that published in 1929 (ROLLR Ref L.13 (*Figure 5*)), the first map to record a similar arrangement as that recorded in 1888, with the exception that the frontage range now appears to consist of two principal bays, not the three recorded in 1888, this suggests some degree of alteration has occurred. The rear outbuildings show no significant change.

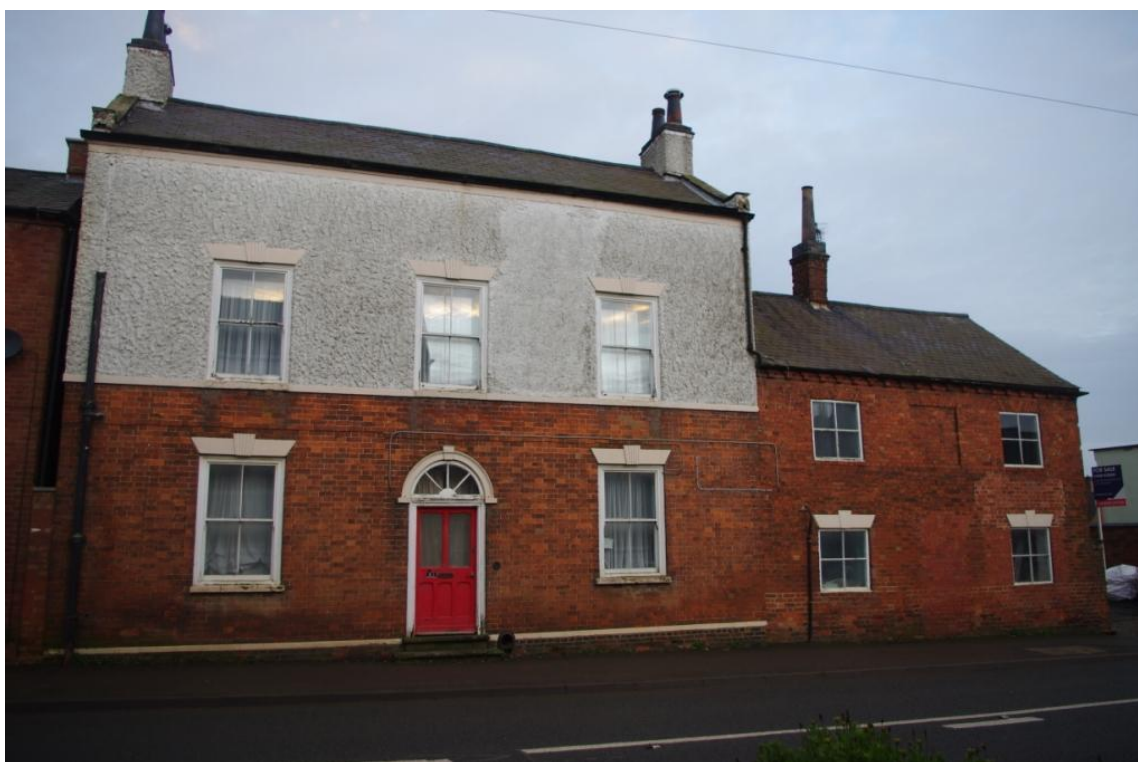
The building is approximately “L” shaped in plan and consists of five bays on the frontage range (*Figure 7*), three within No. 31 and two within No. 33, there are two bays on the projecting rear range, which abuts the westernmost end of No. 31, the northernmost being clearly modern and under a flat roof. The building is brick-built under pitched roofs clad in Welsh slate. There is a clear straight joint between Nos. 31 and 33, suggesting the two are not contemporary.

Figure 7
Principal Elevation, General View (No. 31 Left (Looking North)).

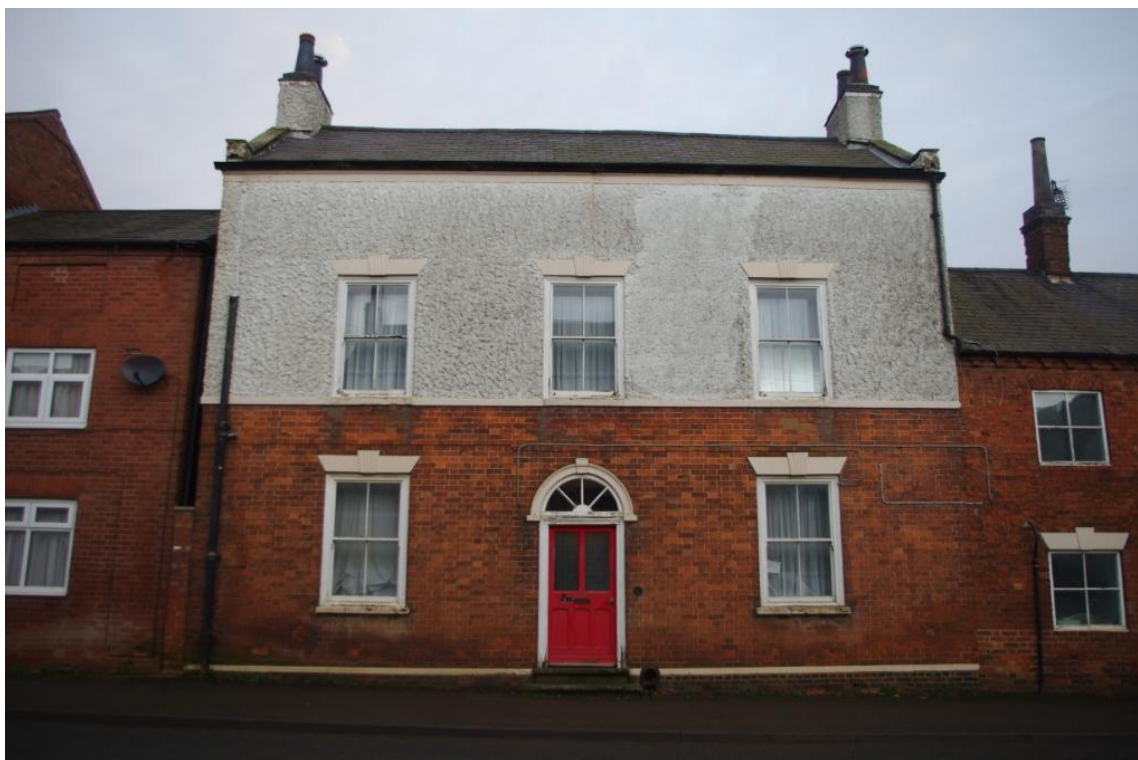
No. 31 is a three storey building (*Figure 8*), although there is no external evidence of the second floor. The upper reaches of the principal elevation, along with the gable chimneys are stucco rendered and there are parapet gables. The exposed brickwork is laid in a Flemish bond (alternating header and stretcher bricks in each course), this bond is considered more decorative, suggesting a building with aspirations. The bricks appear to be handmade and appear to be pre 19th century in date. The four light sash windows have exposed boxes, which suggest they may be original, dating to the early to mid 18th century. The windows are finished with rendered heads and keystones. The large rise between the first floor windows and eaves creates a rather uneven looking building, which may suggest the roof level has been altered at some point, the render, both on the principal elevation and on both gables however conceals any potential evidence of this. There is a central part-glazed timber door with a timber fanlight, again below a rendered doorhead. Fanlights became popular throughout the 18th century, the earliest examples being rectangular, only later did they become semicircular like this example. Timber was almost exclusively used in the early 18th century, which along with the exposed sash boxes may suggest a tentative date for the building.

Figure 8
No. 31 Principal Elevation, General View (Looking North – North West).

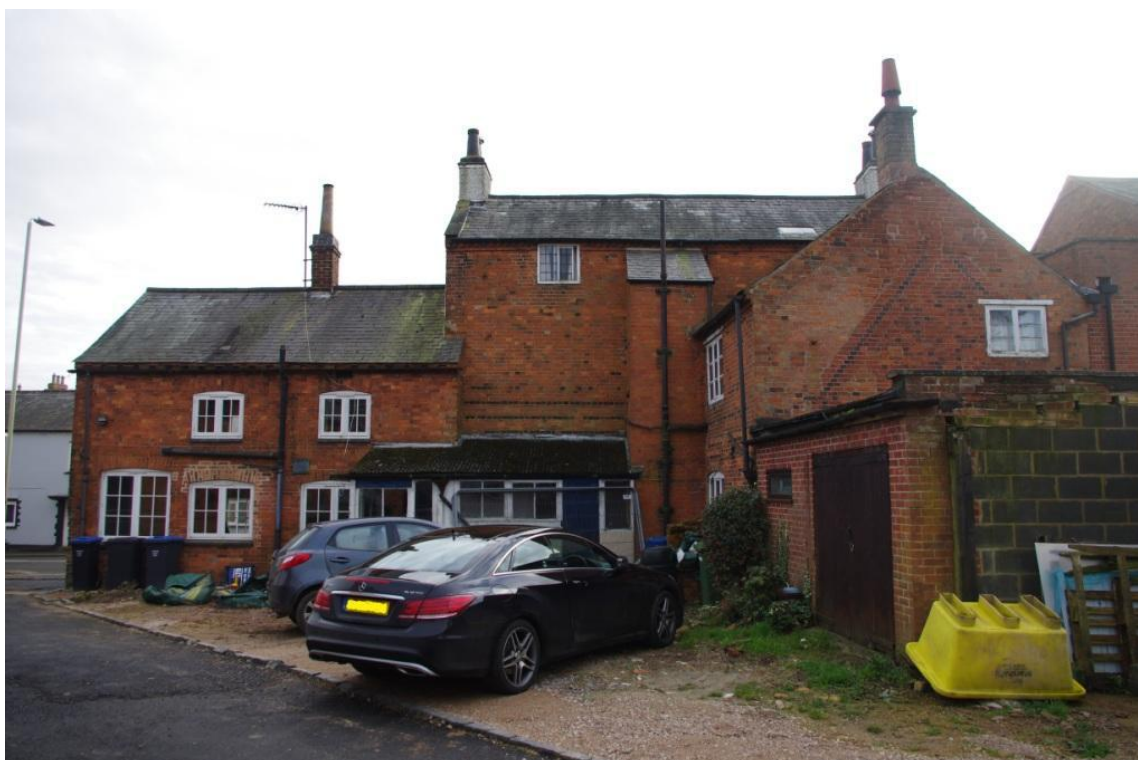
The rear elevation (*Figure 9*) with its exposed brickwork shows more evidence of the evolution of the building. There is a clear horizontal joint in the brickwork, confirming that the roof level has been altered and there is extensive use of flared headers, including three nearly full courses which may be a decorative feature. There are sawtooth corbels at eaves level and a single gable chimney to the north.

The Flemish bond brickwork continues on the rear elevation (*Figure 9*). There are a number of original window openings, all under flat cambered brick arches. The windows themselves are likely to be modern replacements.

Figure 9
Rear Elevation, General View (No. 31 Right) Looking South – South East).

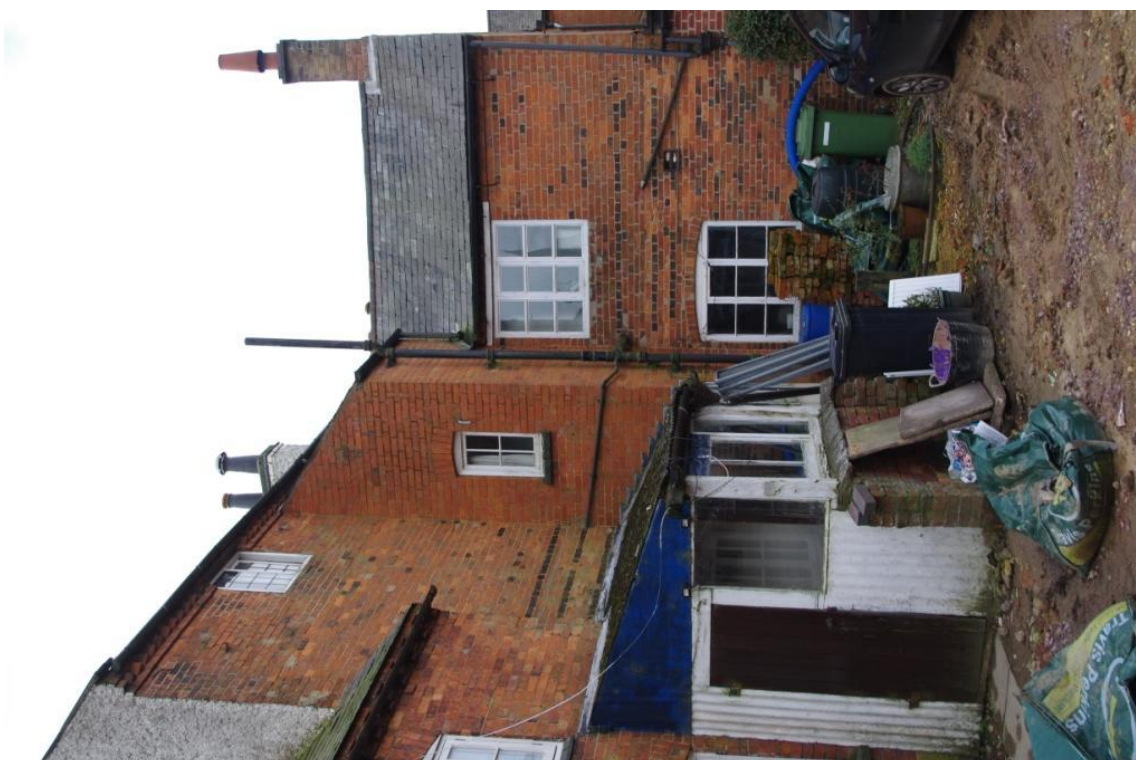
Figure 10
Rear Range (No. 31) Principal
Elevation (Looking South West).

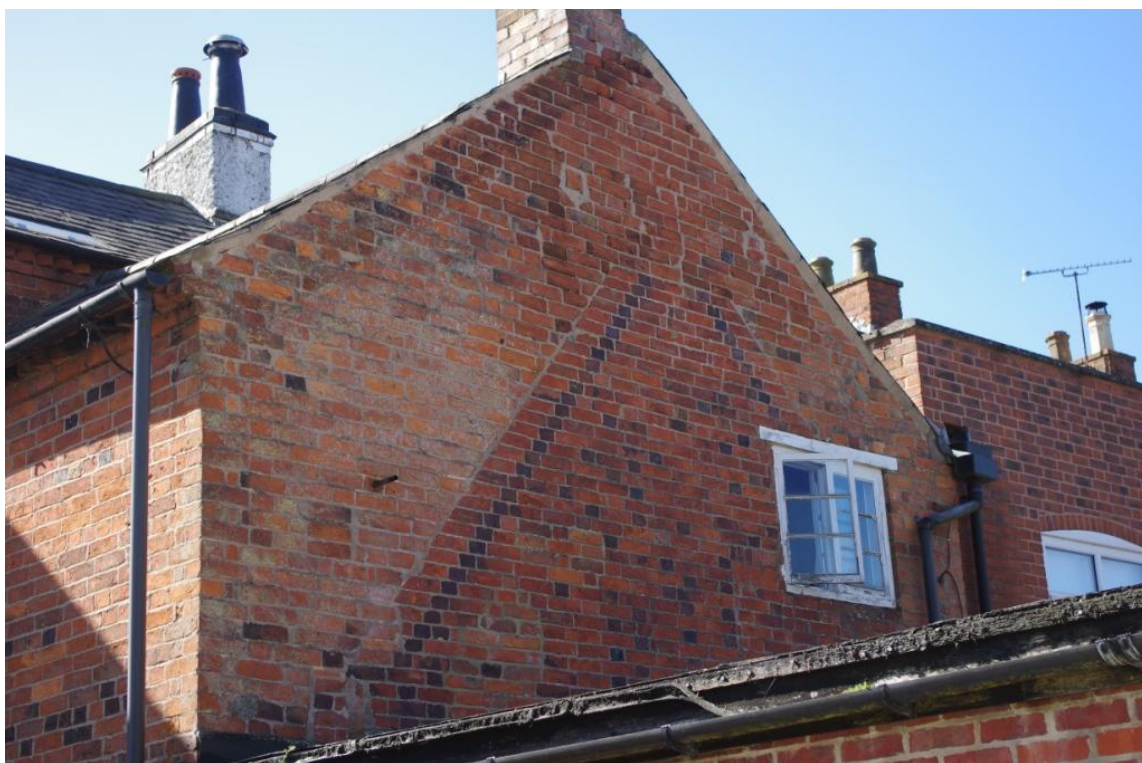
Figure 11
Rear Range (No. 31), North Facing Gable (Looking South).

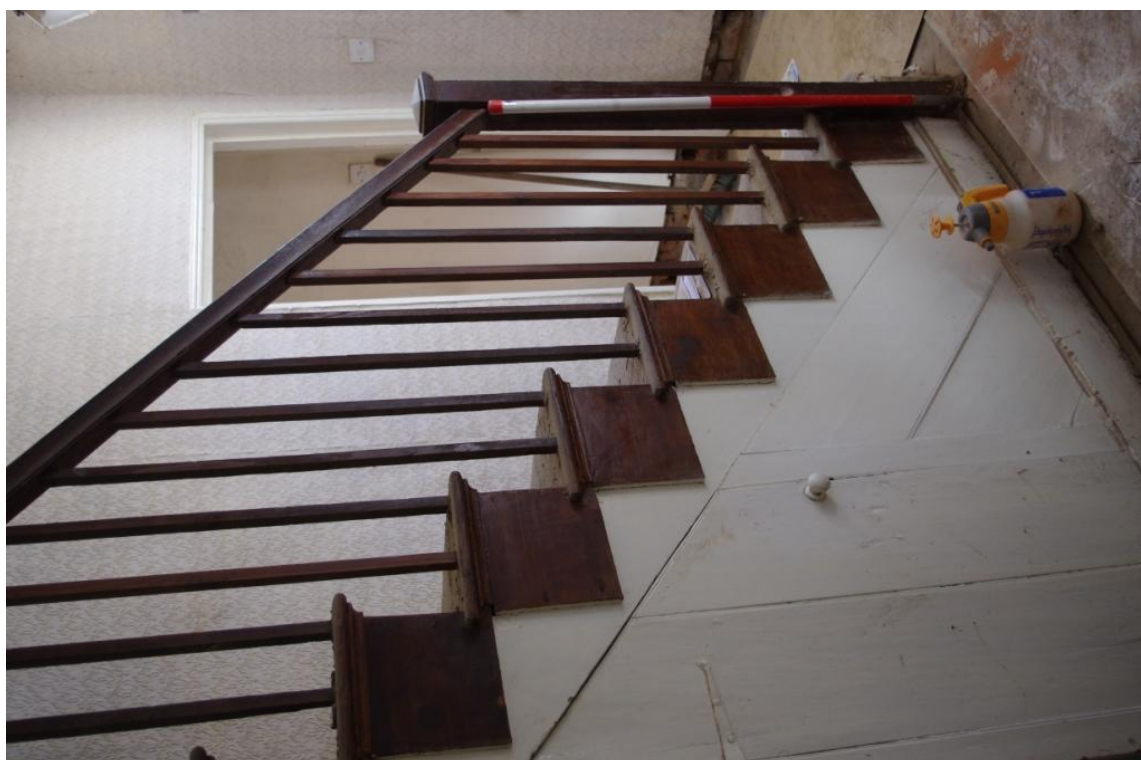
Figure 12
No. 31 Staircase (Looking South East).

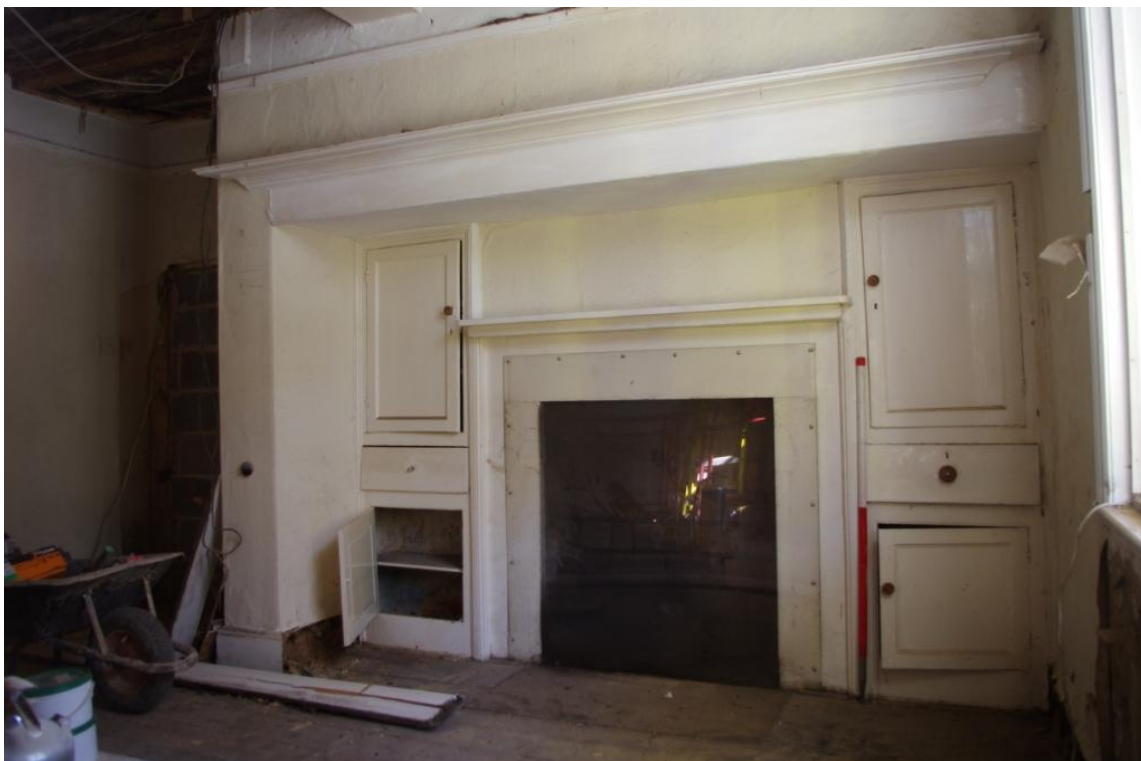
(3), to the east of the entrance hall houses a large gable fireplace (*Figure 13*). Sadly, the to be retained 19th century insert and alcove cupboards conceal any potential dating evidence, however the size of the opening would suggest an early date. There is a bridging beam; this is underdrawn, which again conceals any potential dating evidence. Following the removal of the ceiling the exposed ceiling structure recorded in August 2020 was white washed indicating that this was originally exposed, again suggesting an earlier date.

Figure 13
(3) Gable Fireplace (Looking North East).

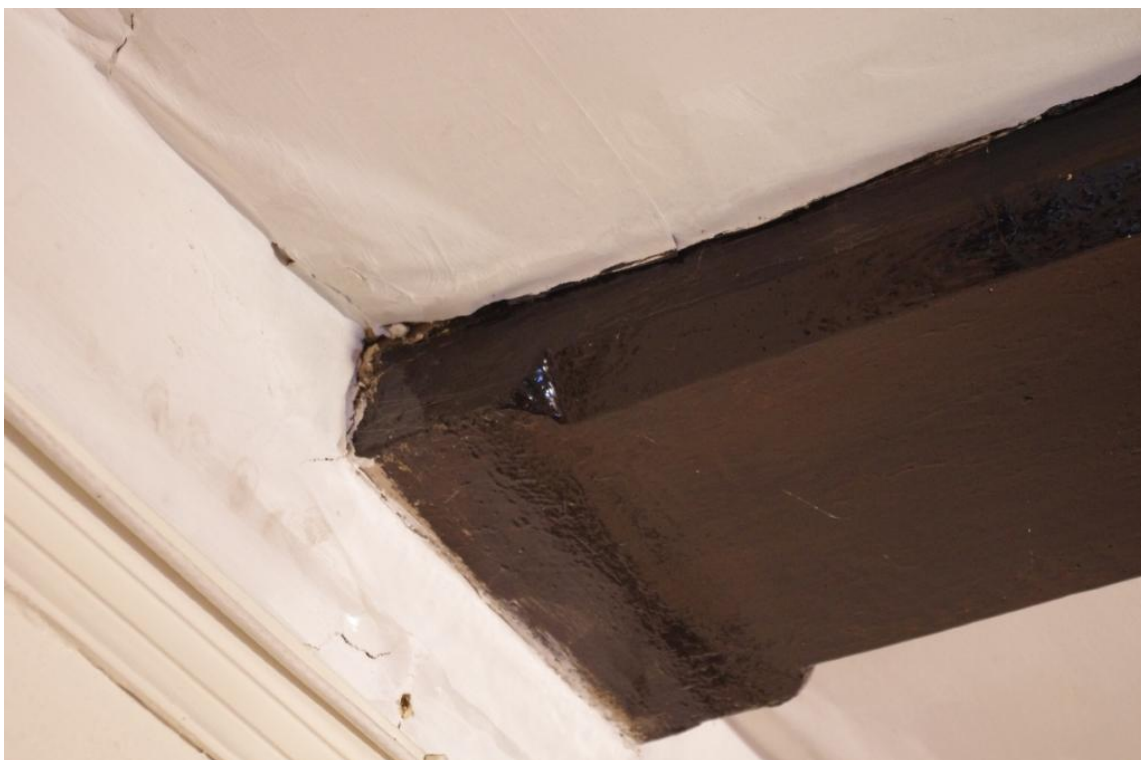
There is an exposed bridging beam in the westernmost bay, (4). The beam is chamfered and stopped. Stops began to fall out of fashion at the end of the 17th century in grand houses, but persisted in smaller houses well into the 18th century, this example (*Figure 14*) a scroll or lambs tongue, is identical to examples known to date to the 1740s, again supporting a mid 18th century date for the house. There is a gable fireplace in (4), it is significantly smaller than that seen in (3) and houses a modern insert.

Figure 14
(4), Chamfered & Stopped Bridging Beam (Looking East).

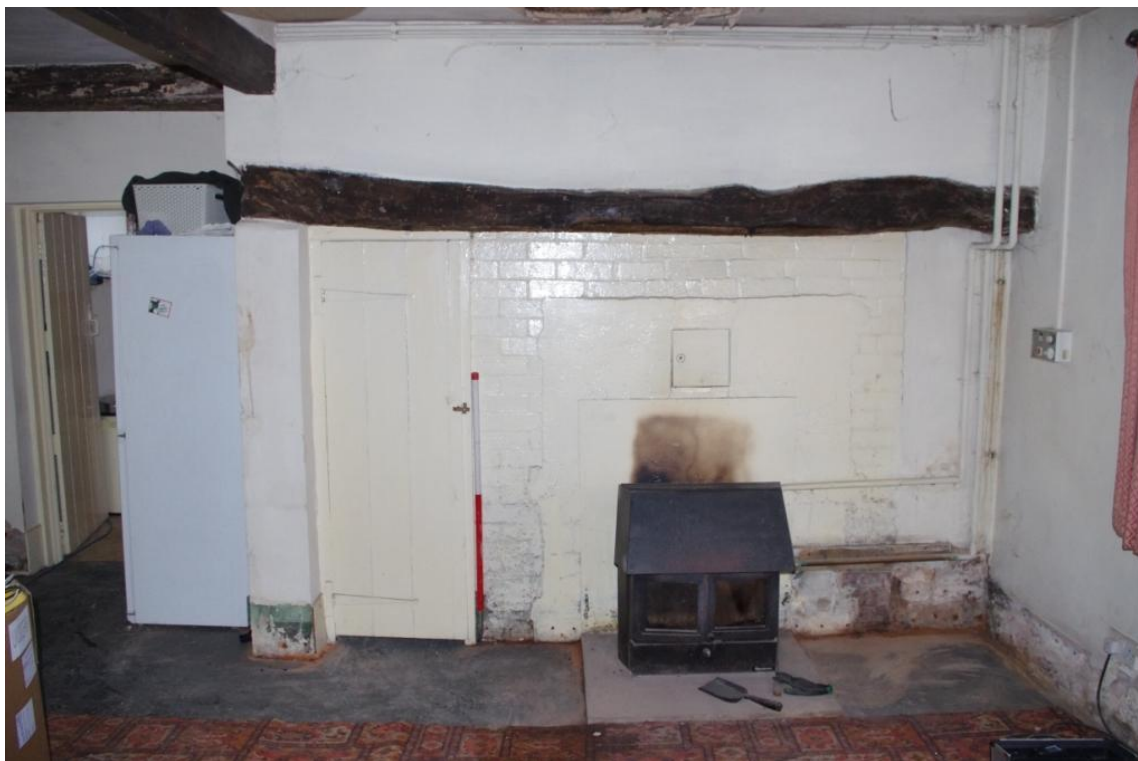
The rear range, (5) again houses a large gable fireplace (*Figure 15*); the infill again conceals any significant detail. Its presence, however confirms that the range originally had a domestic origin.

Figure 15
(5), Gable Fireplace (Looking North West).

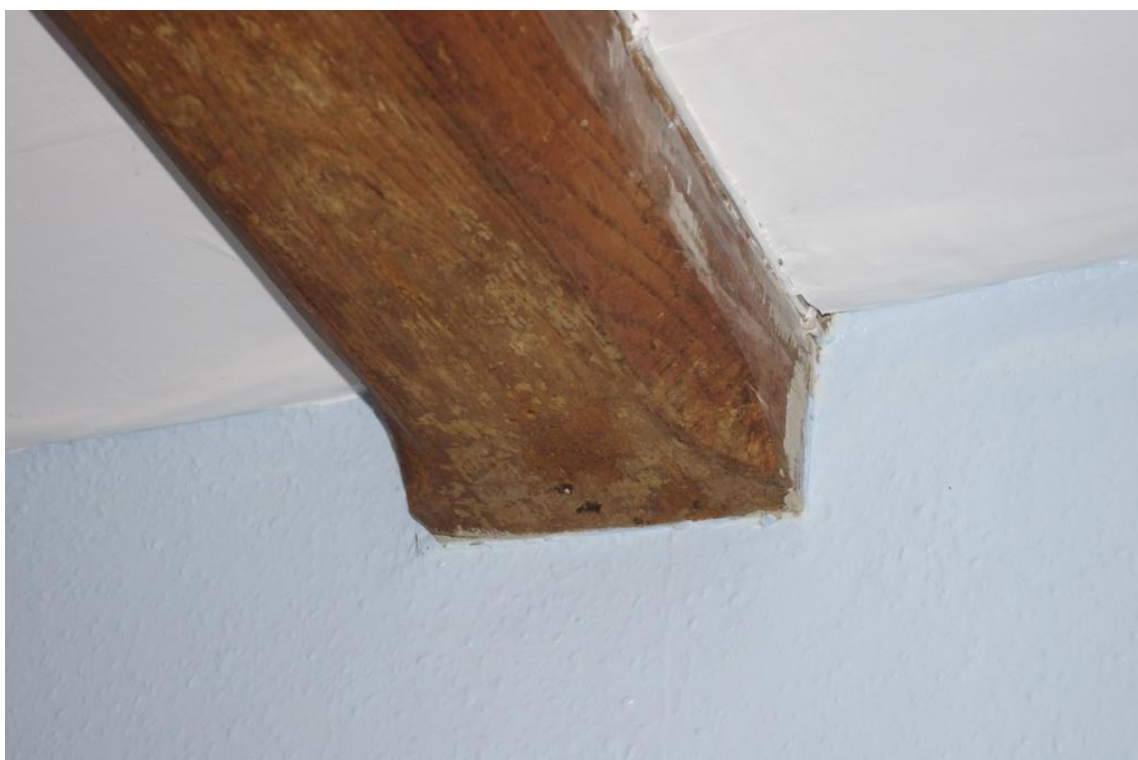
Figure 16
(8), Chamfered & Stopped Bridging Beam (Looking North East).

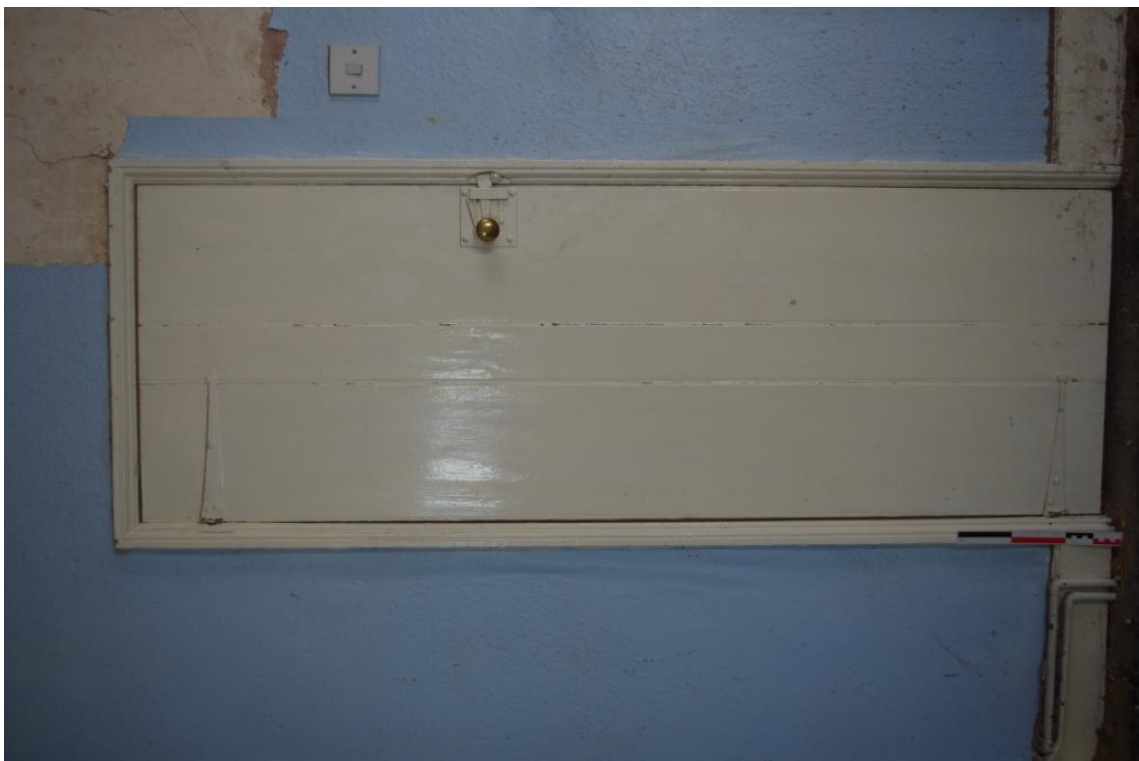
(8), the easternmost bay retains a number of wide floorboards which would suggest that these are, if not original, then early. There is also a plank and batten door in the northernmost alcove cupboard (*Figure 17*) with strap hinges, the strength of the taper would suggest an 18th century date.

Figure 17
(8) Plank Door with 18th Century Strap Hinges (Looking East – North East).

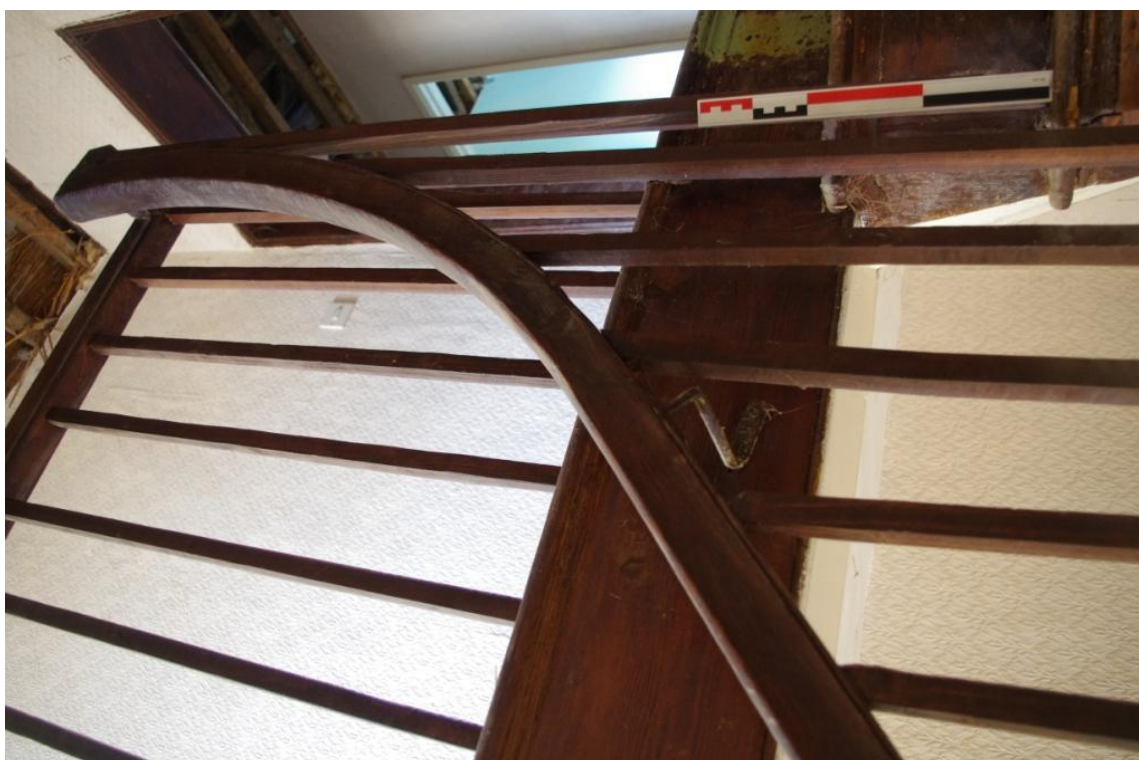
The stair as described on the ground floor continues with a ramped handrail (*Figure 18*), which again suggests a mid 18th century date.

Figure 18
Ramped Handrail on First Floor (Looking West).

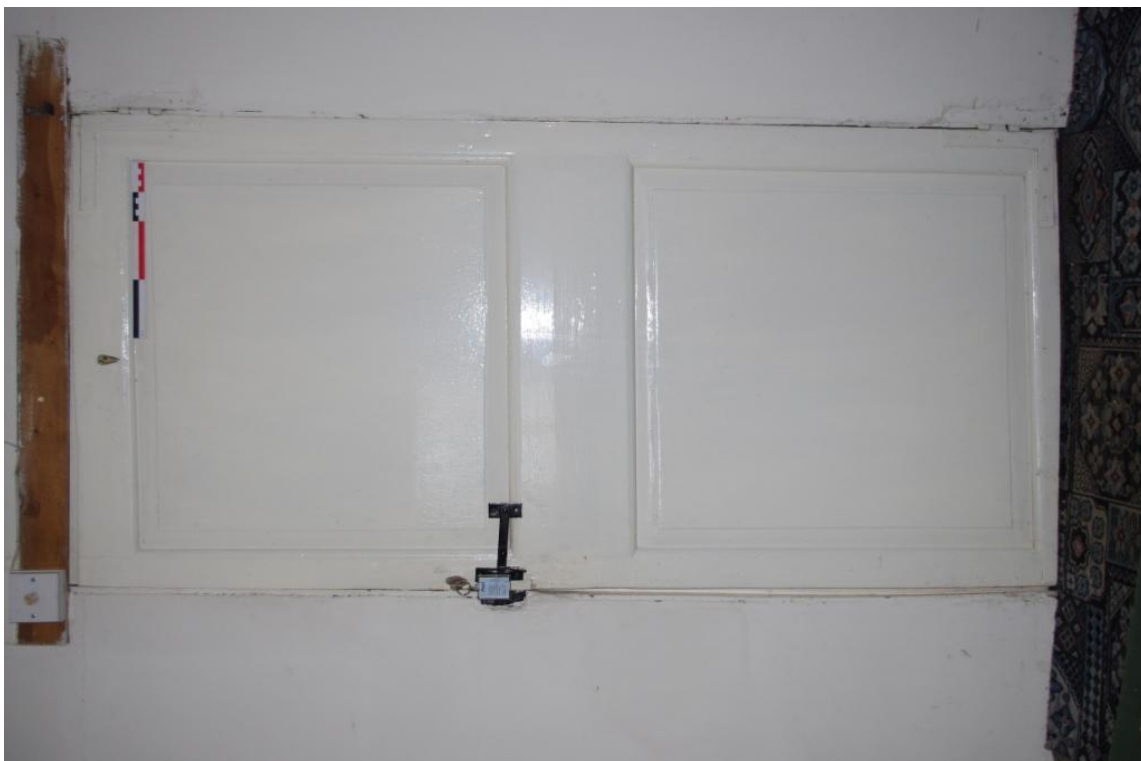
Interestingly, both rooms retain two panel doors hung on “L” and “H” hinges (*Figure 19*), such doors were the norm for superior rooms from the mid 17th century and persisted in lesser houses well into the 18th century. The hinges are of a similar early to mid 18th century date. However, external evidence would suggest that this second floor is later, so it is possible that these doors are either reused or the ground floor and first floor are earlier.

Figure 19
(11) 18th Century Two Panelled Door
(Looking South West).

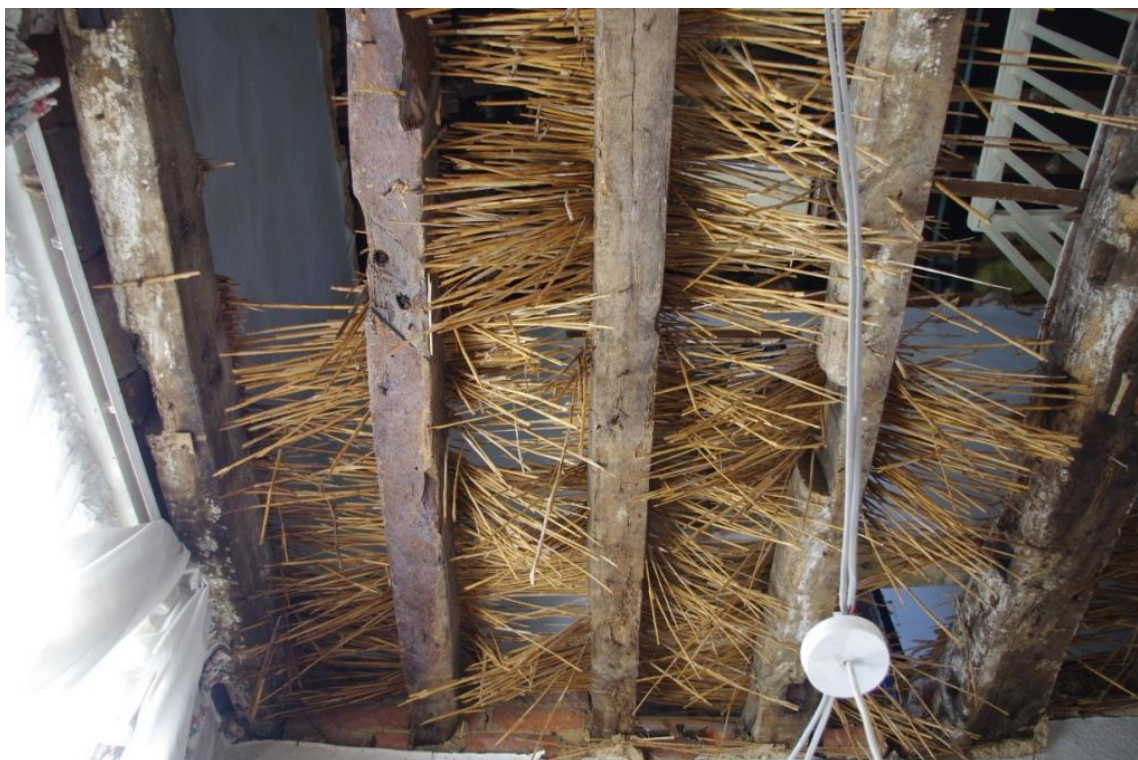
The floors are gypsum and water reed and where stripping out works revealed the joists, many are reused (*Figure 20*). The use of gypsum floors is common in Leicestershire between the 17th to 19th century, but there are examples known to date to the early 20th century.

Figure 20
(13), Exposed Water Reed Floor & Reused Joists (Looking South West).

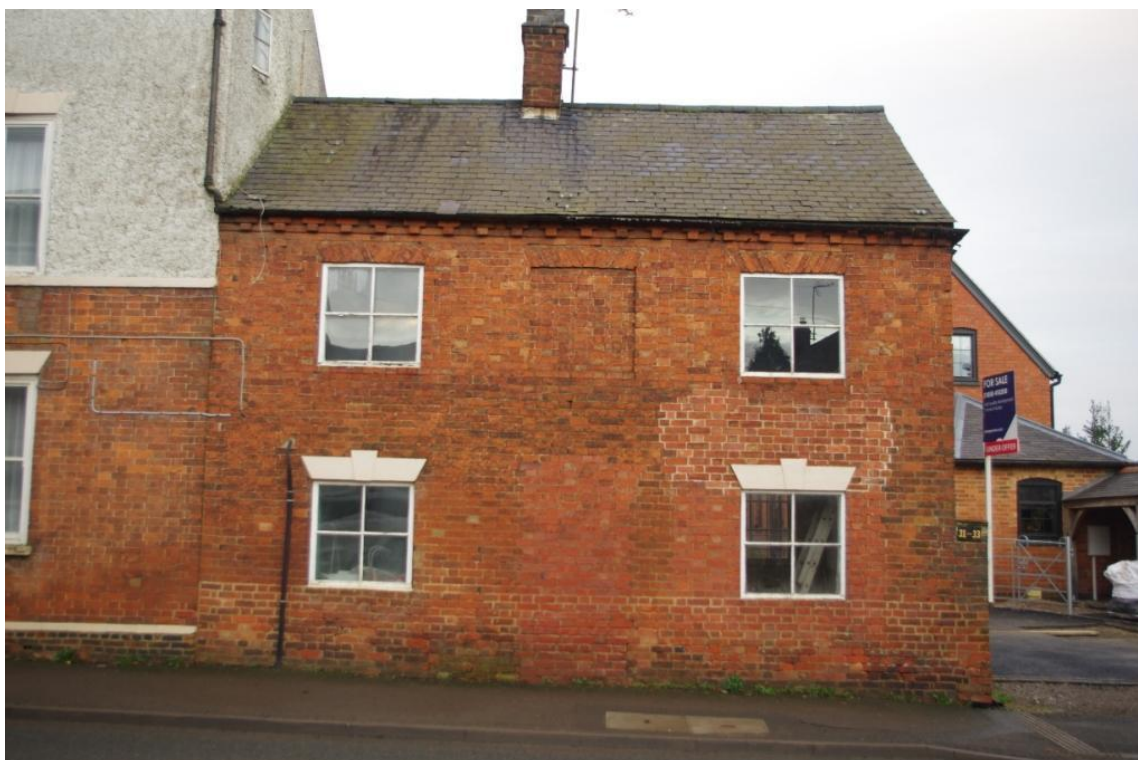
No. 33 lies to the east of No. 31, it is a two storey building under a Welsh slate roof (*Figure 21*). The bricks are again laid in a Flemish bond, flared header bricks are used on the east facing gable as a decorative flourish (*Figure 22*). There are four light casement windows on each floor and a blind window in the centre of the first floor as well as evidence of a blocked central door on the ground floor. The lack of any sills would suggest that the windows are

Figure 21
No. 33 Principal Elevation, General View (Looking North – North West).

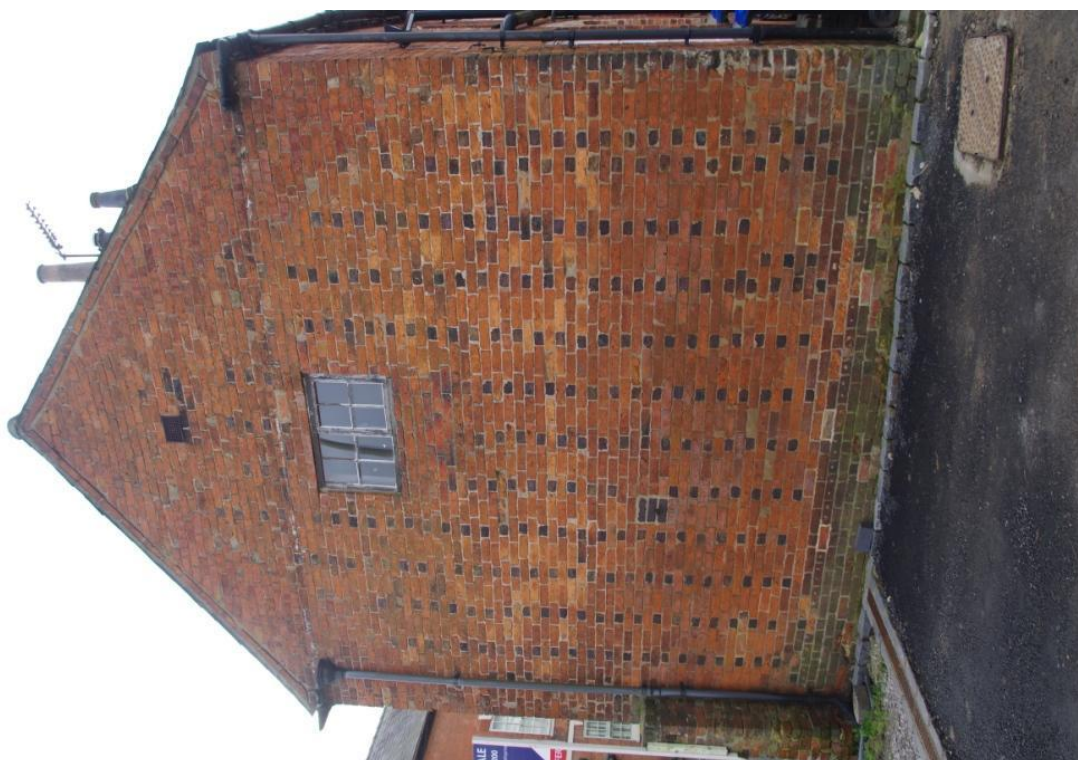
Figure 22
No. 33 East – North East Facing Gable
(Looking South West).

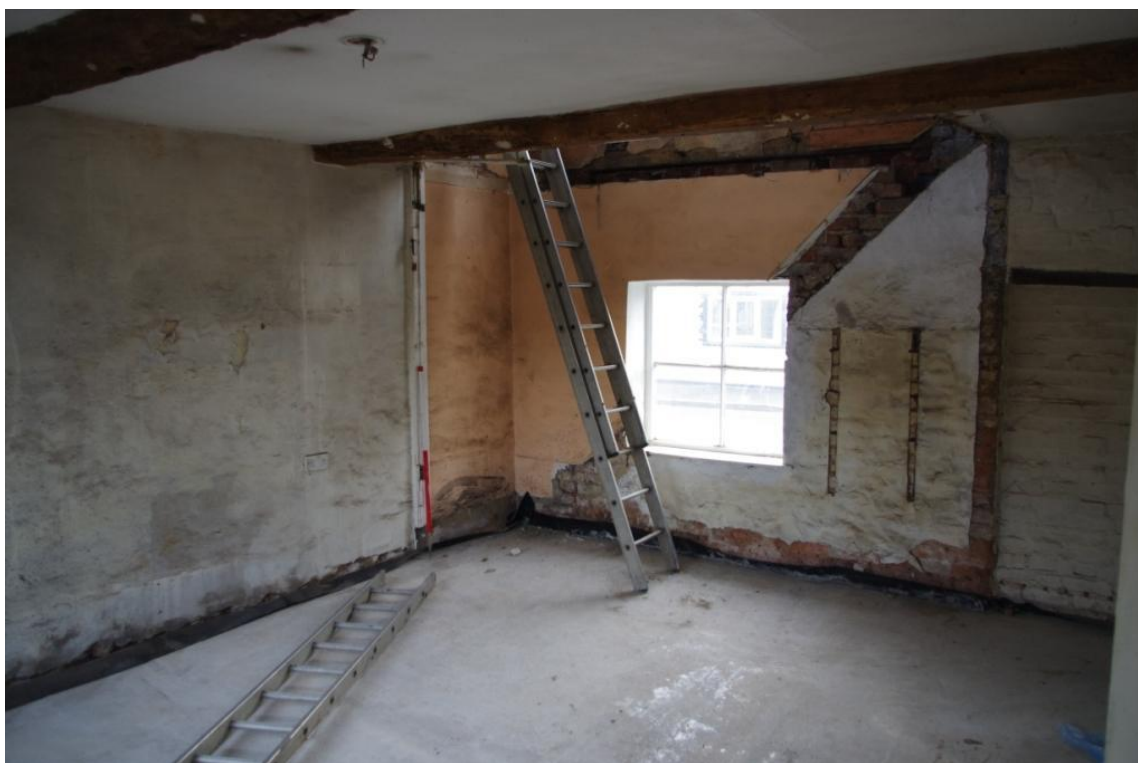
Figure 23
(1), Ghost Stringer Showing Location of Staircase on South Wall (Looking South East).

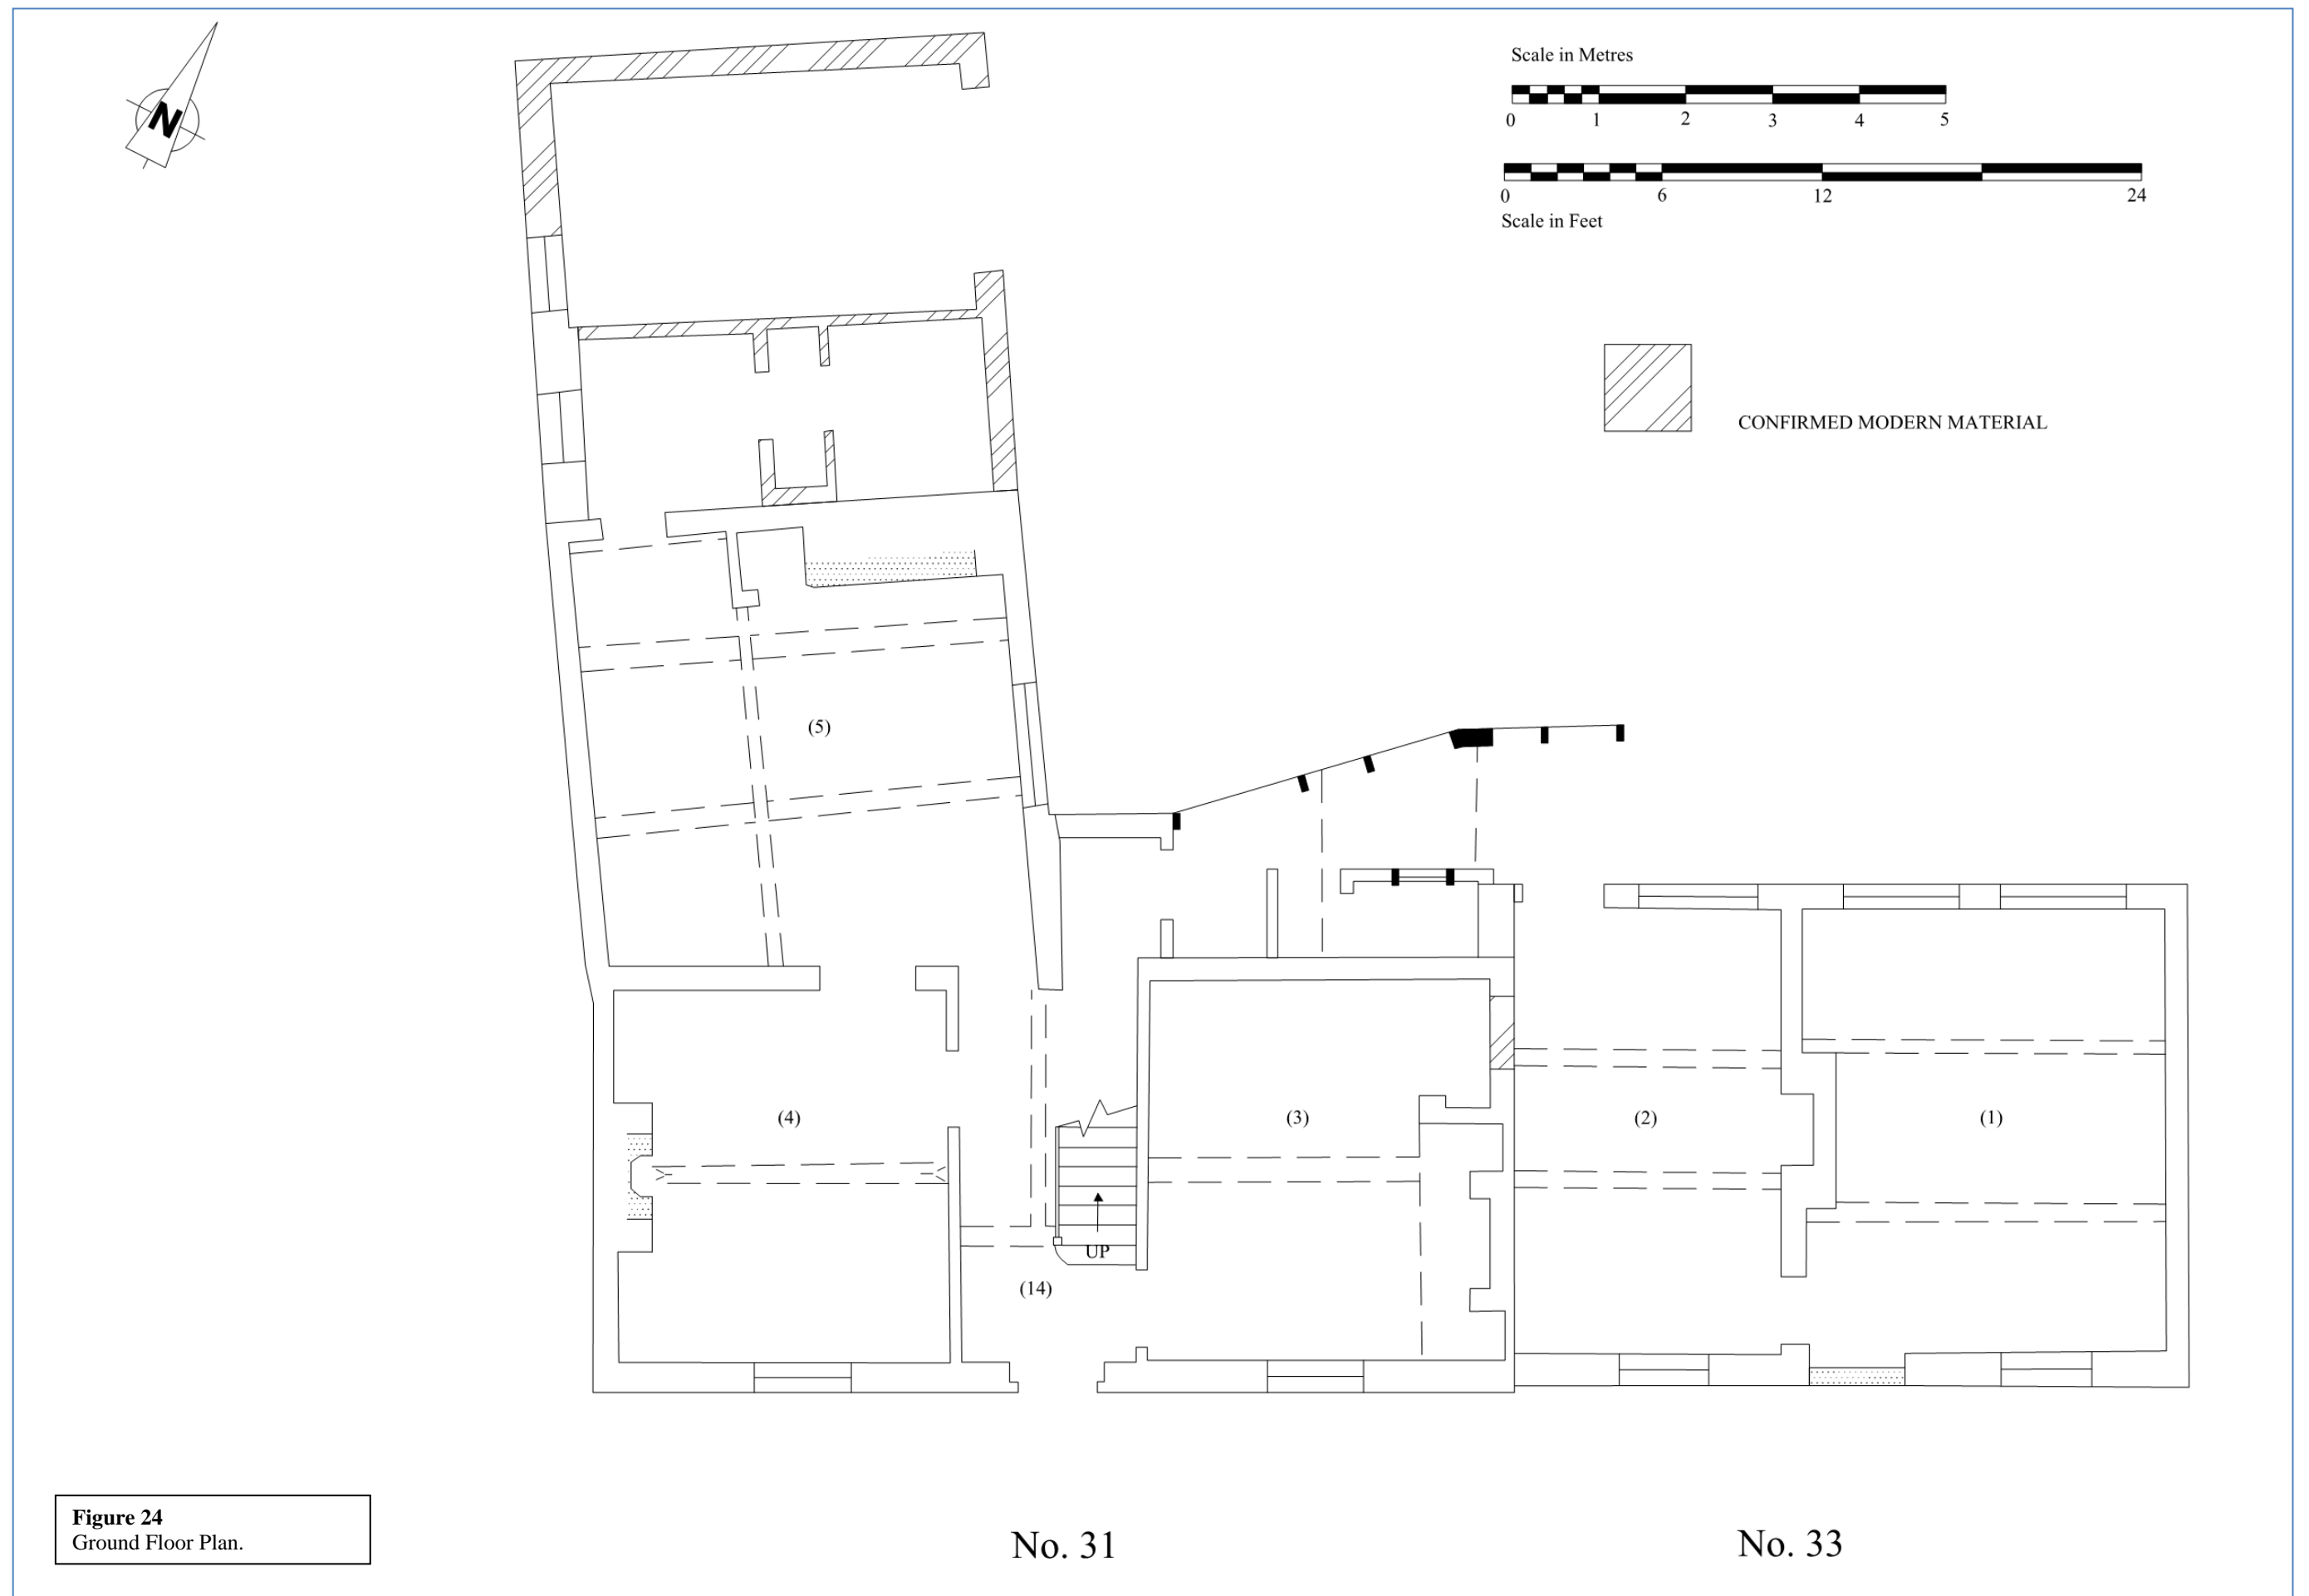
Figure 24
Ground Floor Plan.

The ground floor (*Figure 24*) consists of two bays off a central entrance hall in the frontage range and a single historic bay in the projecting range. The hall, (13) houses an apparently original straight flight stair with winder (*Figure 12*), the flat cap finial and rail appear to suggest a mid 18th century date, but the plain stick balusters and even plainer brackets are difficult to date and may suggest a later date. Victorian staircases are known to “mix and match” features and styles from various eras, it is possible that the staircase has been rebuilt or at least remodelled, but the few retained details would suggest a mid 18th century inspiration.

The interior of No. 33 (*Figure 24*) is divided into two bays, with an off-centre cross wall housing back to back fireplaces. To the south of the chimney is an opening between the two bays, it is unclear whether this opening is original or not. There is a ghost stringer on the southern wall of (1) indicating the location of the removed stair, the stair interrupts the ground floor window, so is unlikely to be original (*Figure 23*). The ceiling has been removed leaving only bridging beams in each bay, the southernmost beam in (2) is clearly reused.
