Fristling Hall, Stock, Essex. Watching brief on the works at Fristling Hall.
Surveyed during 2012. CBC 10/01780/FUL.

This reports records the watching brief carried out on selected ground works at Fristling Hall as part of the conversion of the farm buildings into dwellings. It details the sequences uncovered in the foundations of the buildings and the cable trenches excavated across the yard.

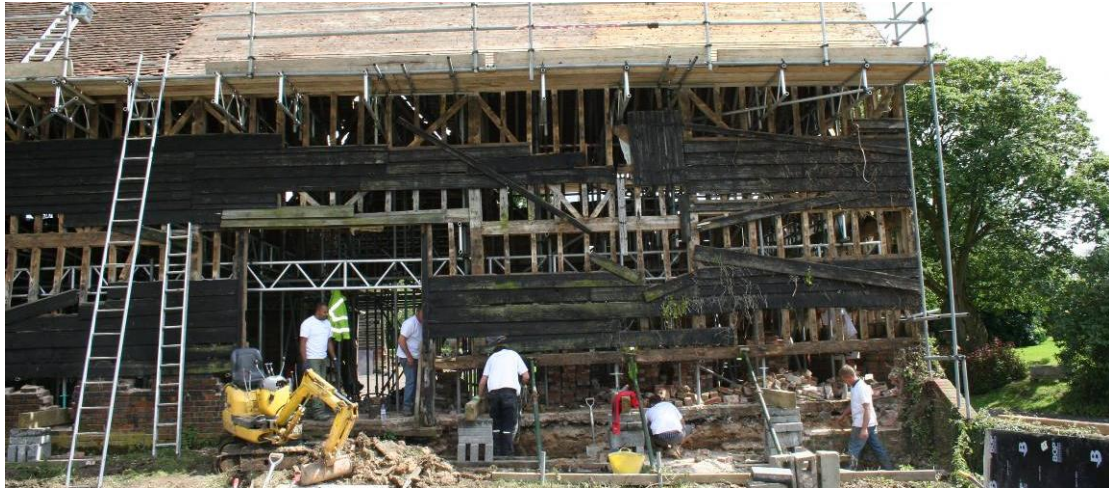
1. The north plinth of the Double Essex Barn.

The north plinth being removed prior to replacement. Looking S.

The brick plinth in the northern wall of the Essex Double Barn was removed because it was structurally unsound. Because the exterior levels had been reduced over the years this left a clean section through the floor of the Barn. It was apparent that the Barn was built directly onto the ground which is a mixture of interleaved London and Chalky Boulder Clays. The original beaten earth floor was lost where the interior had been scathed and then hardcore rubble dumped in for a concrete raft.

The construction trench for the plinth contained only desiccated clay and some roof tiles of the same type as removed from the Barn. The frame was stood on a continuous plinth of red, 65x110x220-225mm hand-made unfrosted bricks with creased and smooth faces, crisp arrises, and diagonal pressure lines. They were bedded with beige-white lime mortar in English bond. The quoins were finished with queen closers. All the viable bricks were reused.

It was noted that the studs of the timber-frame were numbered sequentially E-W using a bolster point. Each numeral was impressed on the outside face at the foot of each timber. All these features, already reported upon, reinforce the EC19th date of the Barn.

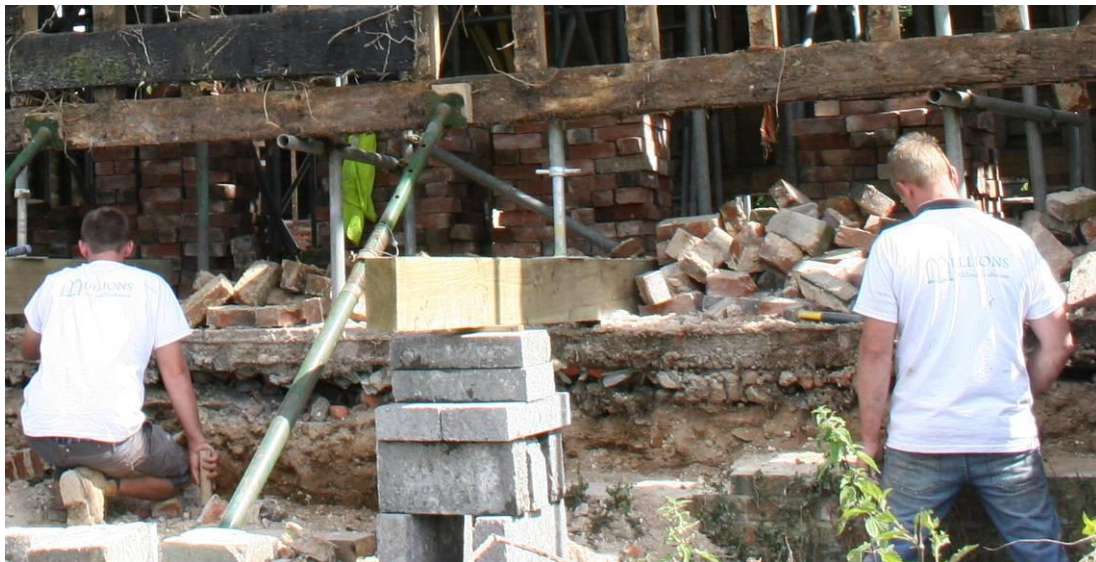
Section through the floor of the Double Essex Barn. Looking SE.

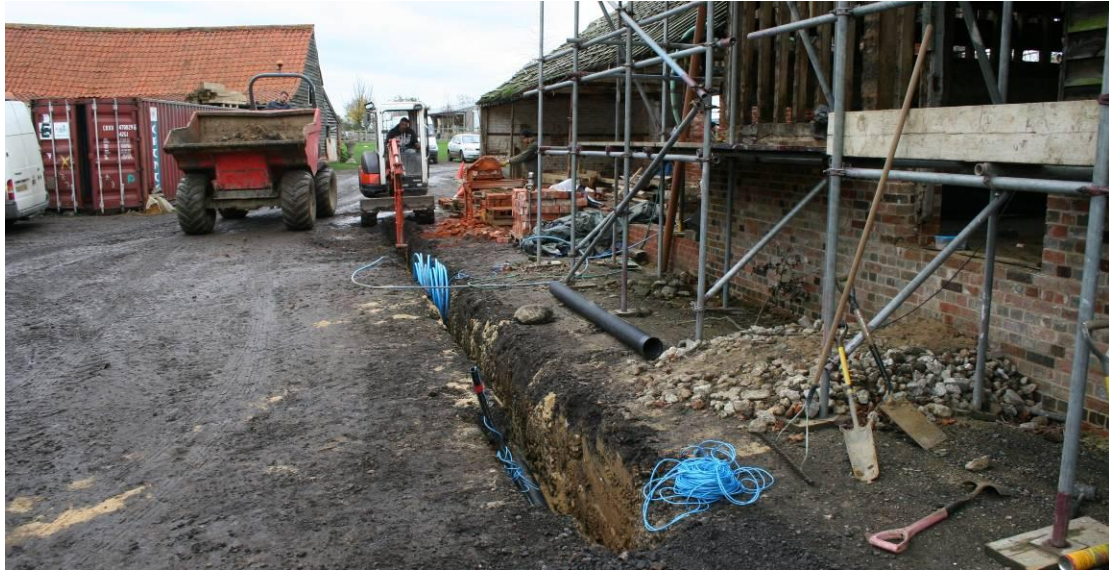
2. Water main and cable trench.

Open section of the water main trench. Looking E.

The water main trench consisted of a main branch passing E-W with spurs passing north toward the Double Essex Barn. Because of the logistics of cutting trenches across the main thoroughfare it was done in sections. Each section exhibited the same sequence. The trenches were 250 mm wide with 400mm junction points and 400mm deep.

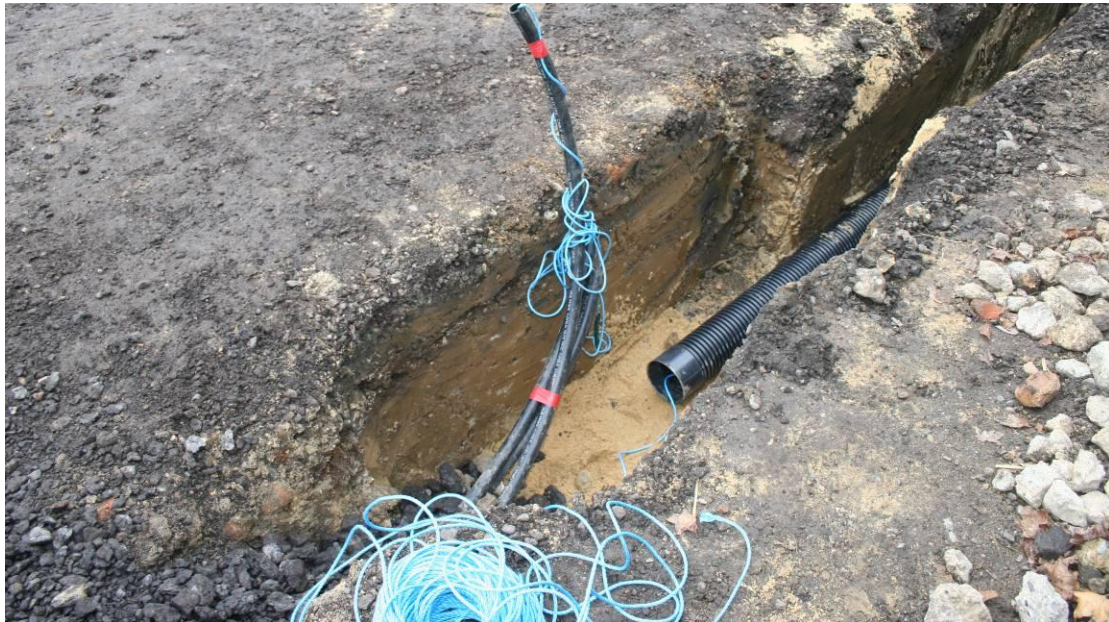
Representative section in the watermain trench. Conduit is 100mm in diameter. Looking NE.

The excavation was remarkable sterile of finds and archaeological horizons. It appeared the surface of the yard had been mechanically graded and then laid with compressed road chippings. Here and there were pockets of broken red brick used to fill earlier pot-holes. The local clay was compressed, un-aerated and undisturbed. There was no indication of previous structures or services trenches.

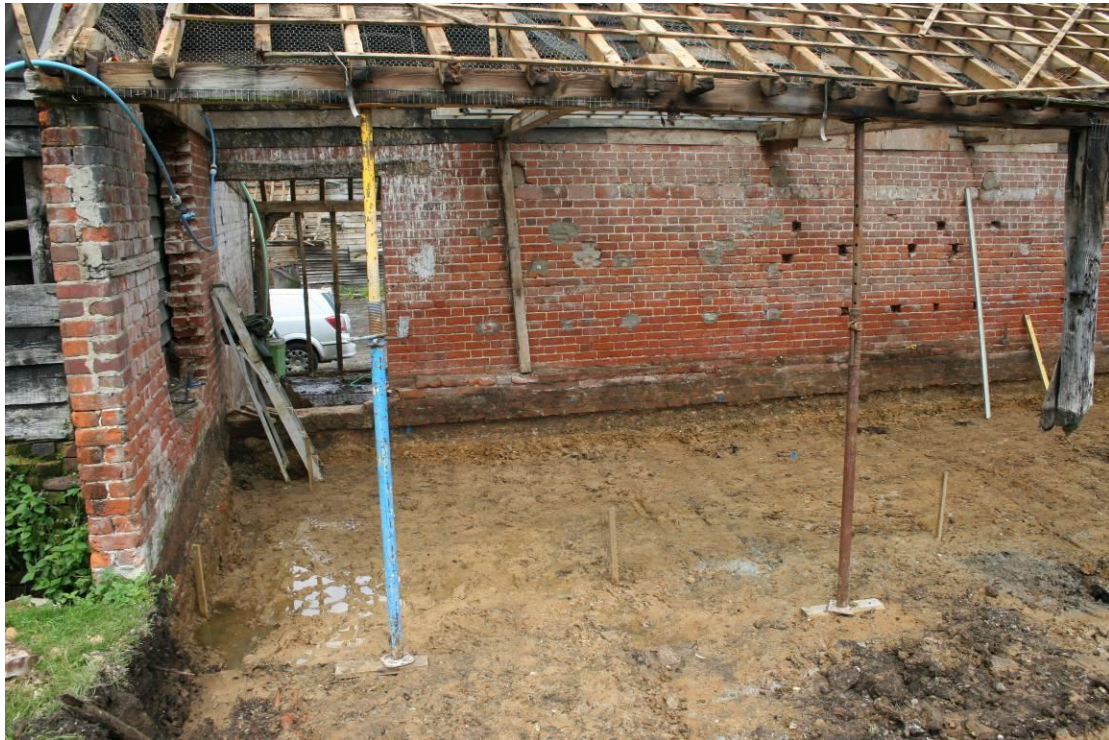
3. Ground stripping around the Granary and Stables.

Ground stripping within the Stables on the southern side.

The interior of the southern side of the stables was stripped of its earth surface down to the drainage layer of London clays and gravel lenses. The only feature uncovered was a line of C19th tubular field drains put in to drain the shelter. A builder's test pit against the foundations showed that the brickwork descended only two courses to a stepped pressure base placed upon 2ft exactly of rammed gravel hoggin. Curiously, the pressure base stepped inwards rather than becoming larger – a peculiar economy of bricks.

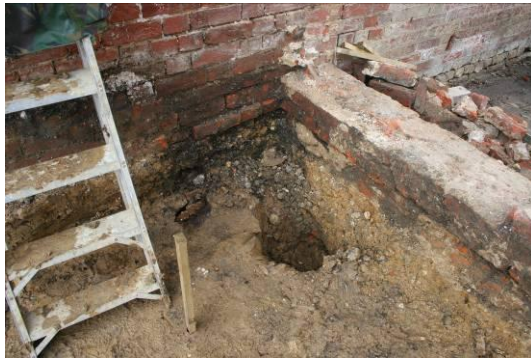
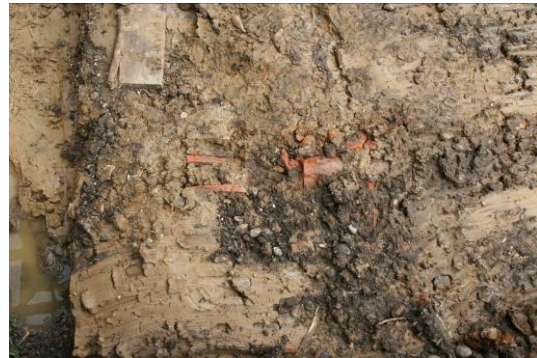
Builders test pit against the NE corner of the Stables. C19th tubular field drain.

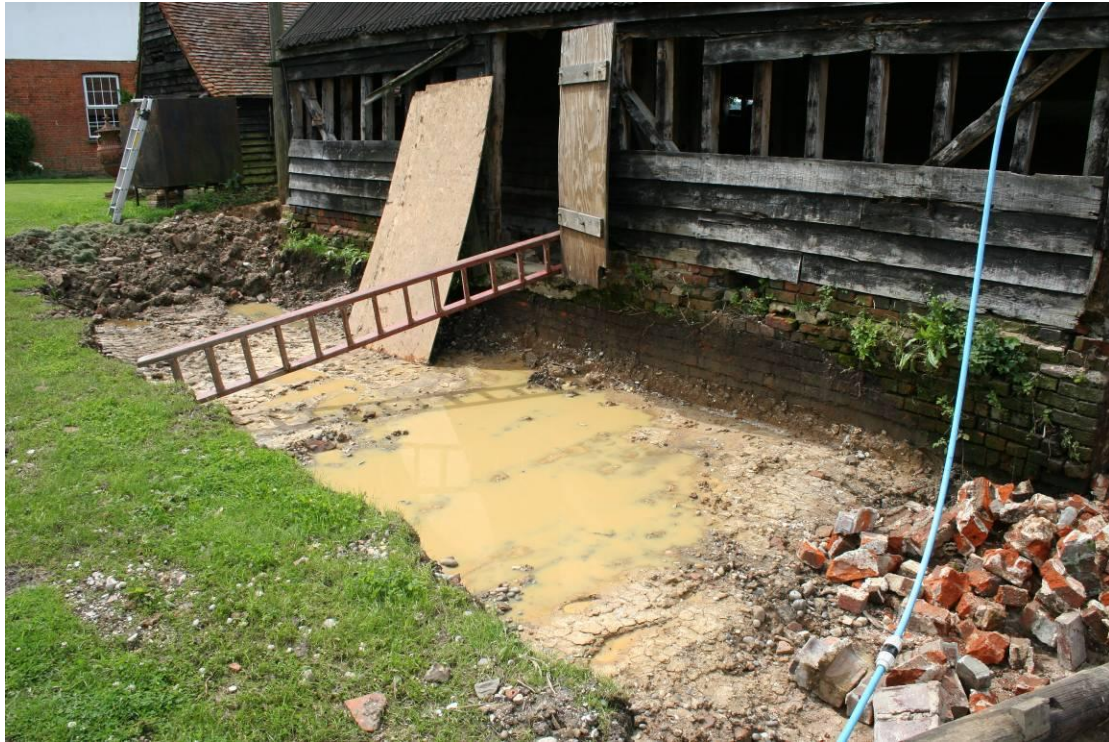
The south side of the Granary after the topsoil was removed.

Topsoil removed from around the Granary revealed an impervious layer of undisturbed clay. The soil above was interspersed with old and modern brickwork and appeared to have been ramped up for access.

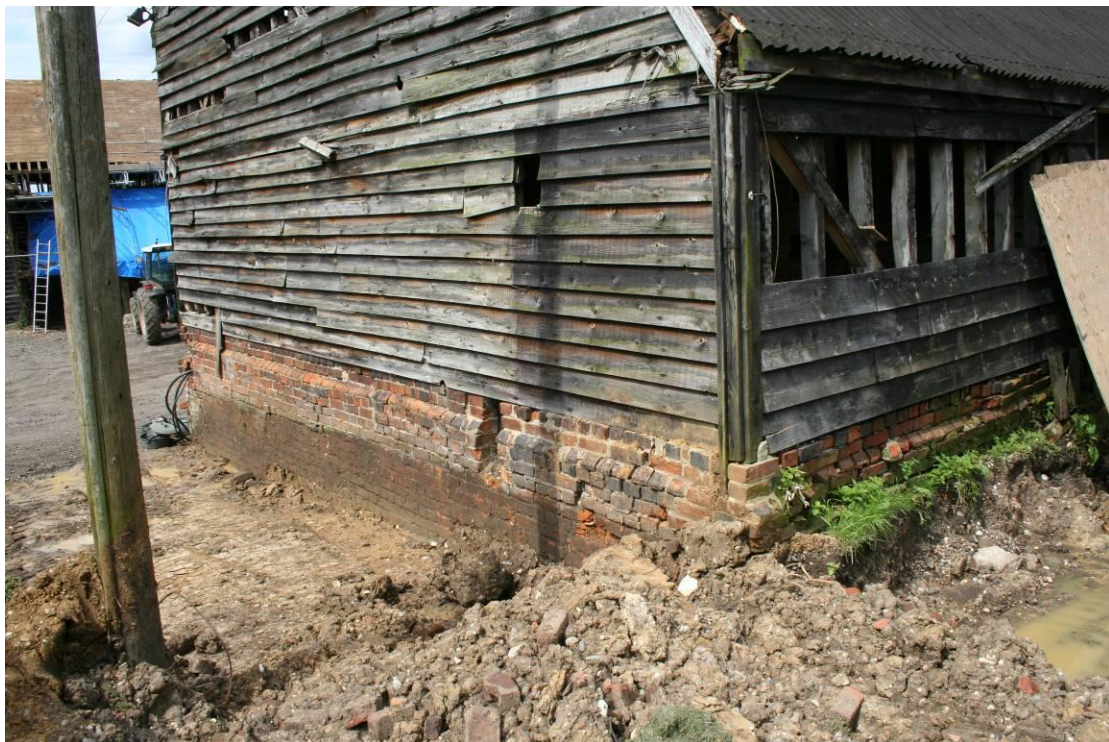
The western side of the Granary after machine stripping

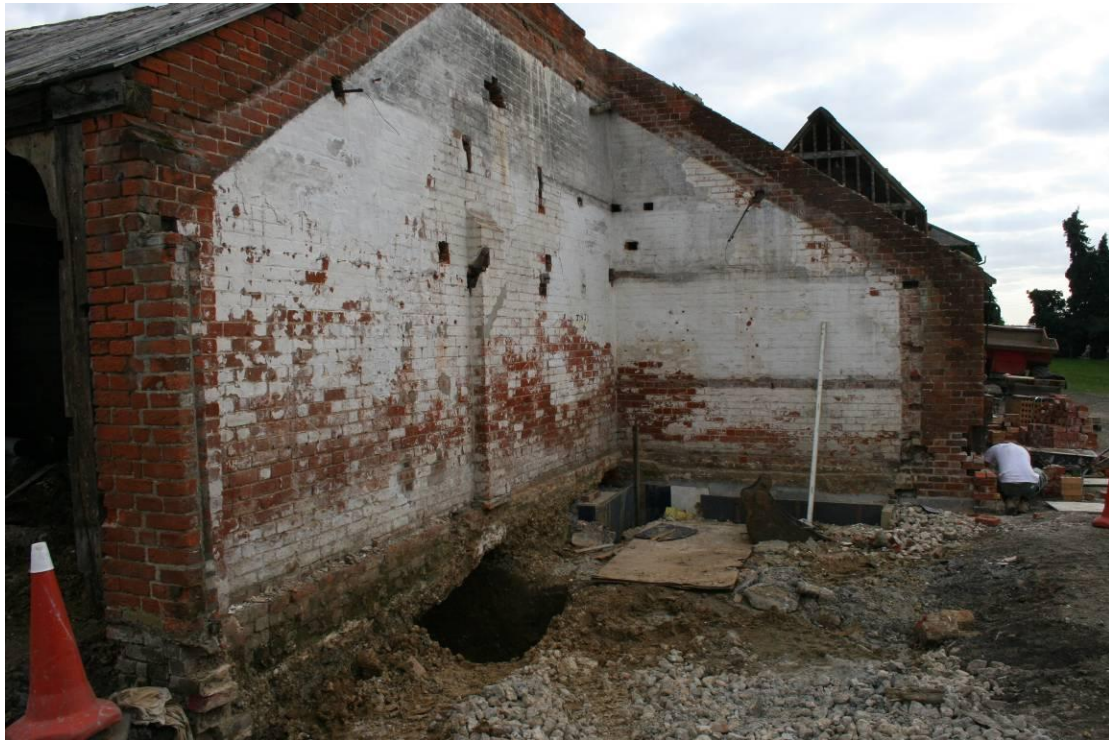
4. Underpinning in the Tack Room / Shelter.

Trenches cut for underpinning the Shelter walls. Looking W.

Trenches for underpinning revealed that the Chalky Boulder Clay was undisturbed. No archaeological features were discovered.

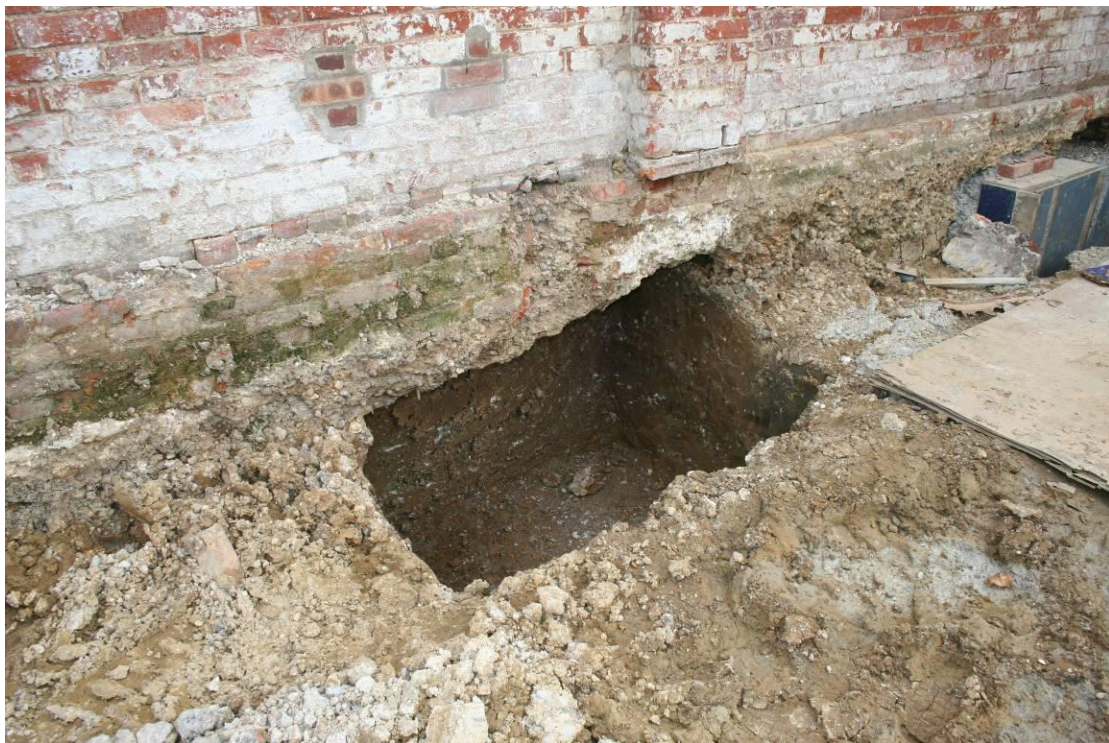
Underpinning trench. The trench is 1m deep and 2m long.
