Hill Farm, Southey Green, Sible Hedingham, Essex.
Description and analysis of granary and stables. Surveyed 28 09 2011.

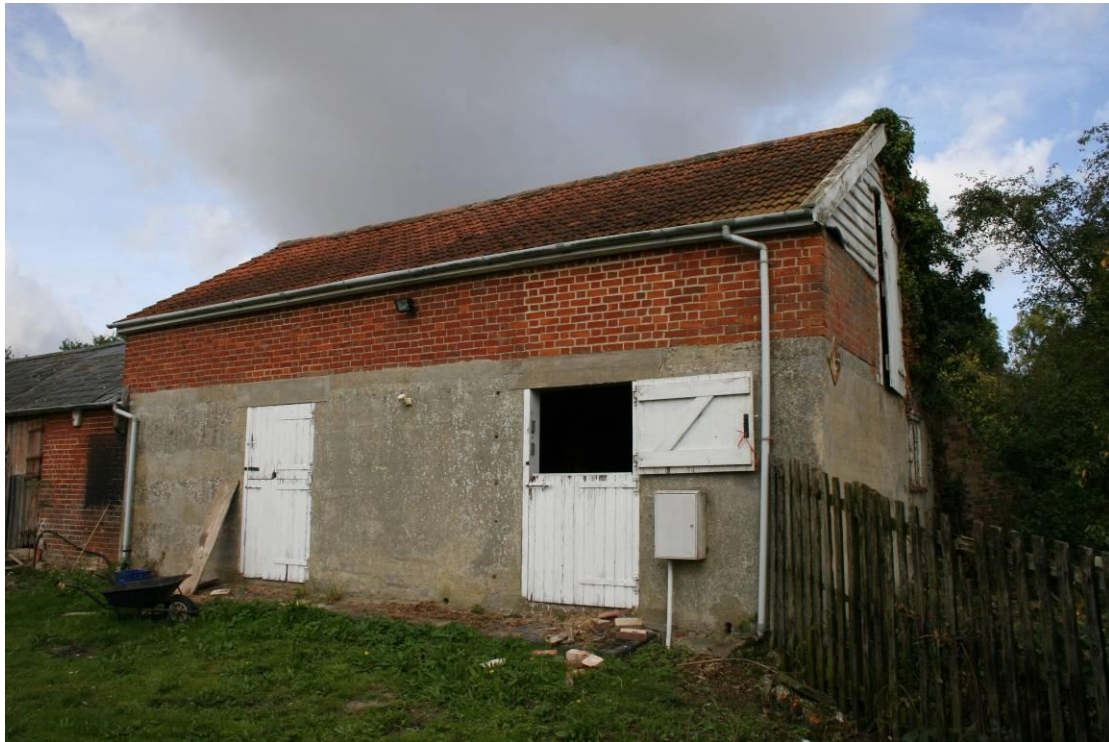
Oblique view of the south elevation of the Granary.

The Granary presents its main facade to the south into the farmyard. The lower storey is built of brick with a thick rendering of concrete with two reinforced concrete lintels over the stable doorways. The concrete extends around the eastern end of the building and represent a C20th remodelling of the lower wall.

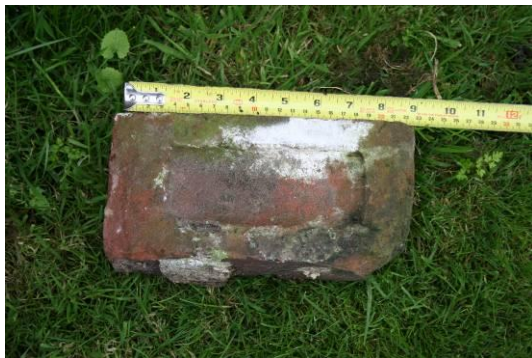
Loose brick from which the granary is made.

Above, there is exposed brickwork composed of red 65x110x225mm hard bricks with smooth, creased faces, sharp arrises set in hard white lime mortar in Flemish bond. A loose brick found in the garden shows they have broad shallow frogs but no makers stamp. The brickwork has queen closers at the quoins and all the visible openings. There is a section of repointed brickwork above the east stable door but no evidence of a window.

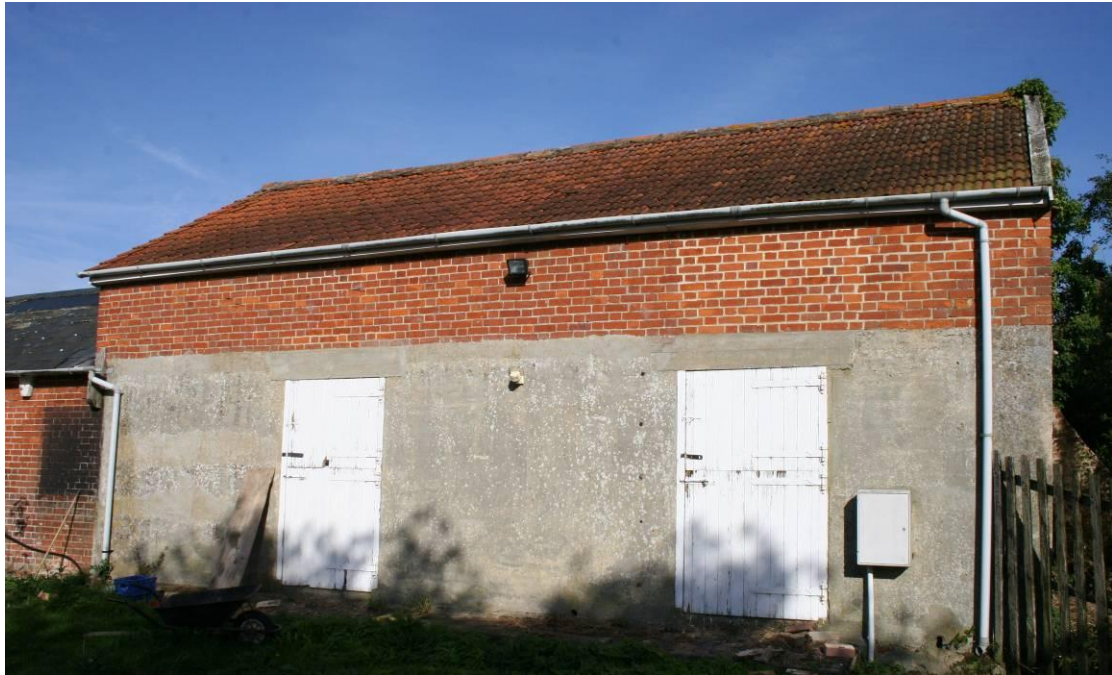
The building was refurbished in the LC20th.

The doors are LC20th split stable doors made of tongue and grooved softwood with gate and ledger construction with mild steel furniture and reversible hinges. The rainwater goods are grey plastic. The clay roof tiles are EC20th and inside it can be seen the roof was stripped in the LC20th and relaid. The barge boards appear recent as does the timber soffit which is a C20th feature.

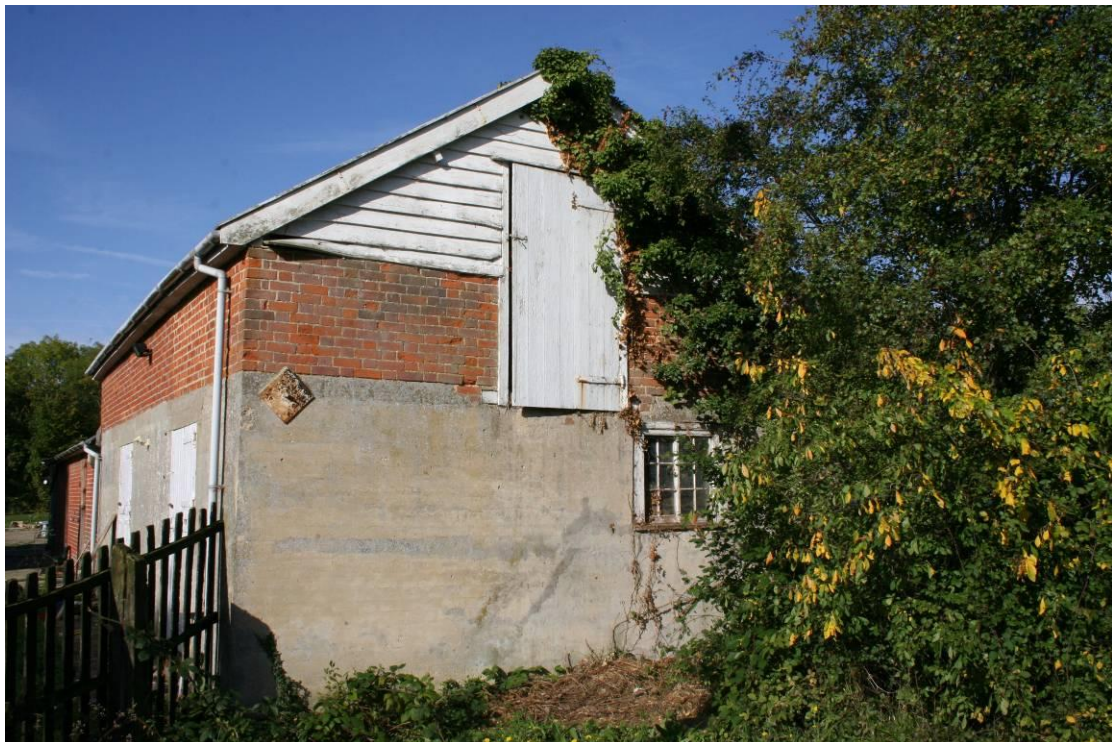
The Eastern Elevation.

The eastern elevation faces the road.

The eastern elevation presents itself to the road and has the gabled end of the Granary. The apex above the brickwork is clad with weather-boards painted white. Inside they can be seen to be circular sawn and fixed to 2x4in studs with French nails and so are C20th.

There is a central high level softwood door to the grain floor which is made of tongue and grooved vertical boards onto a gate and ledger frame. The fittings are mild steel. Crucially it is French nailed throughout and therefore C20th.

On the ground floor, awkwardly positioned to the north is a horizontally sliding sash window. Inside it can be seen it has been inserted into the wall and is a reused C19th frame now protected with battens on the inside.

There is a large square mild steel pattress plate near the southern edge just below the height of the floor. This retains a mild steel bar which connects to a series of brackets and rods that run the length of the building whose purpose is a little unclear. It seems most likely it is to prevent the floor joists from moving under the weight when the grain floor is loaded.

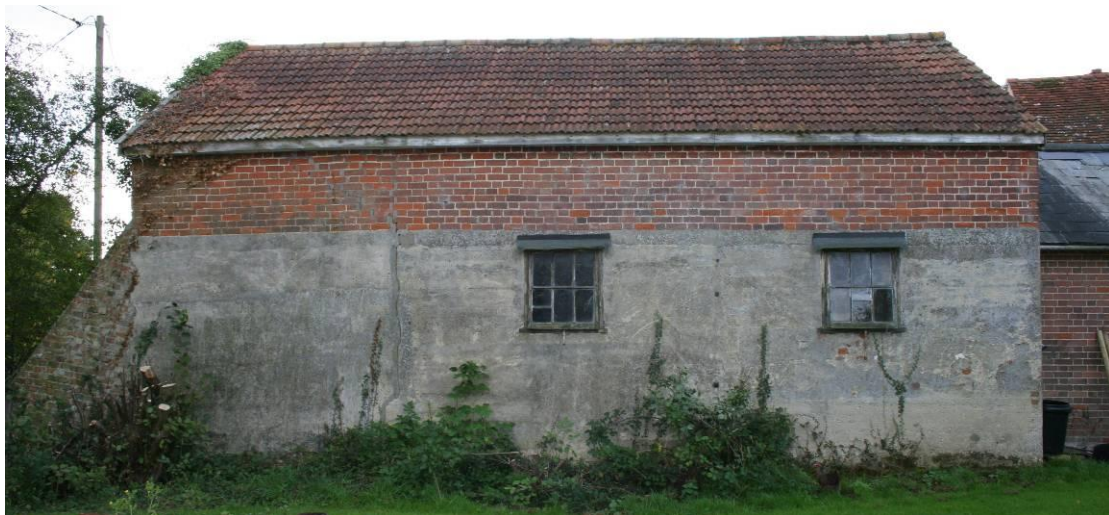
Northern Elevation

The rear elevation has been rendered with cement in sympathy with the front.

The northern elevation has two timber softwood top-hung 6 pane casements. The latch stays are cast metal and hinges are mild steel. There are asphalt lined pentice boards over the windows. The brickwork has been rendered with grey cement to the height of the pentice boards so it is not possible to tell if the windows have been inserted.

On the NE corner is a large brick buttress made from a variety of red bricks but there are also some Flettons built into it. There must have been a pronounced lean to the east at some point redressed in the C20th. Cracks in the walls have been filled with grey cement.

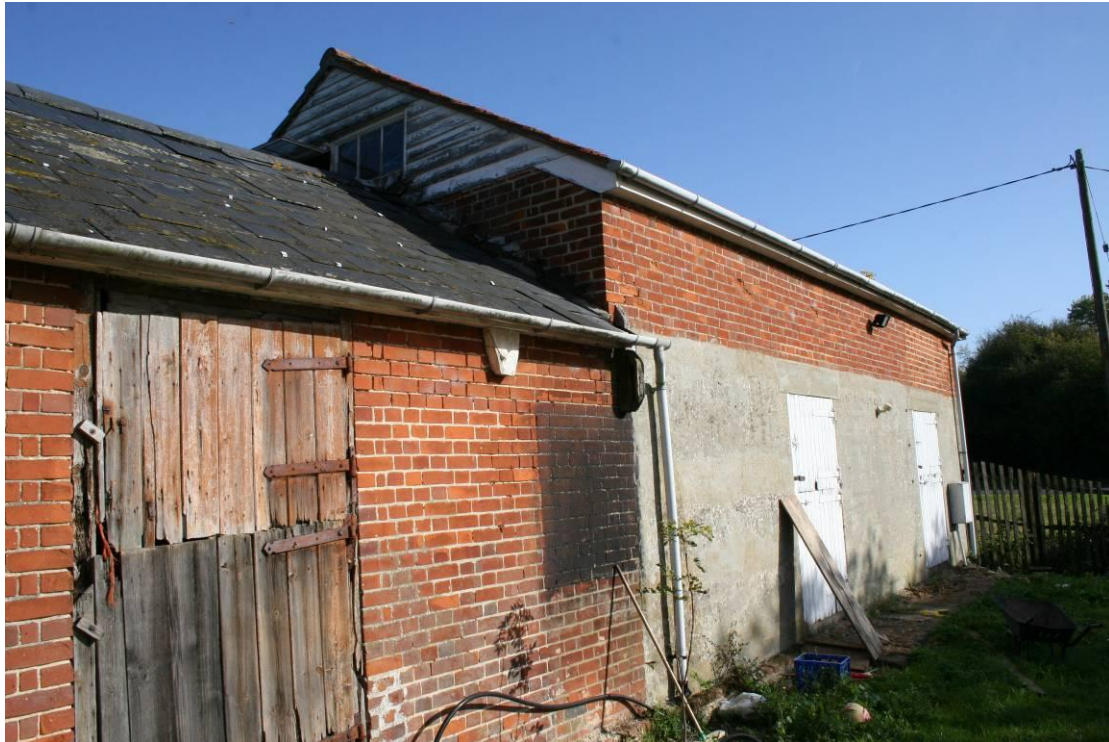
Western Elevation.

The western gable end of the Granary.

The western elevation is obscured on the ground floor by the Stable built up against it. Above the roof line can be seen weather-boarded studwork similar to the other gable end. There are two top-hung rolled steel casements which are Crittall style windows laid on their sides. Inside the buildings can be seen the solid brick wall which has an internal door between the Granary and the Stable and an external doorway that has been blocked and filled with shuttered concrete in the manner of the front facade that would have lead into the garden.

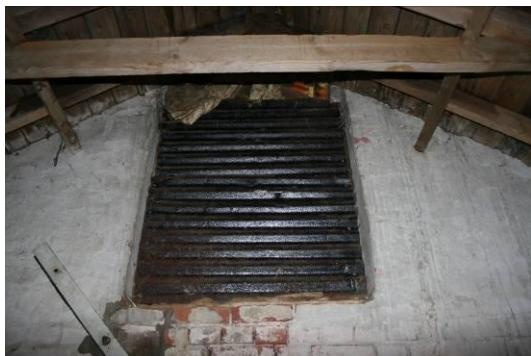
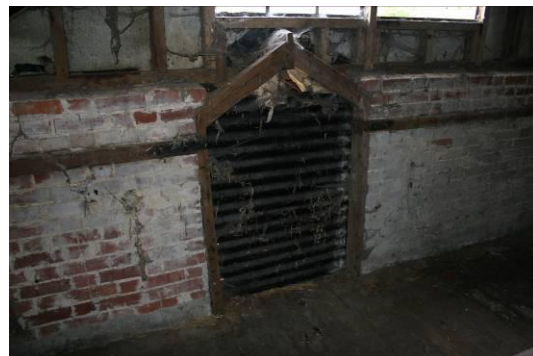
Hatch from the Granary floor into the Stable. Frame visible from the Granary floor.

There is also a hatch from the Granary floor into the Stable which has been blocked by a sheet of corrugated iron. The fact that it is centred on the Stable and its frame is incorporated into the ridge of the Stable indicates it was put in when the Stable was built. There are no closer bricks.

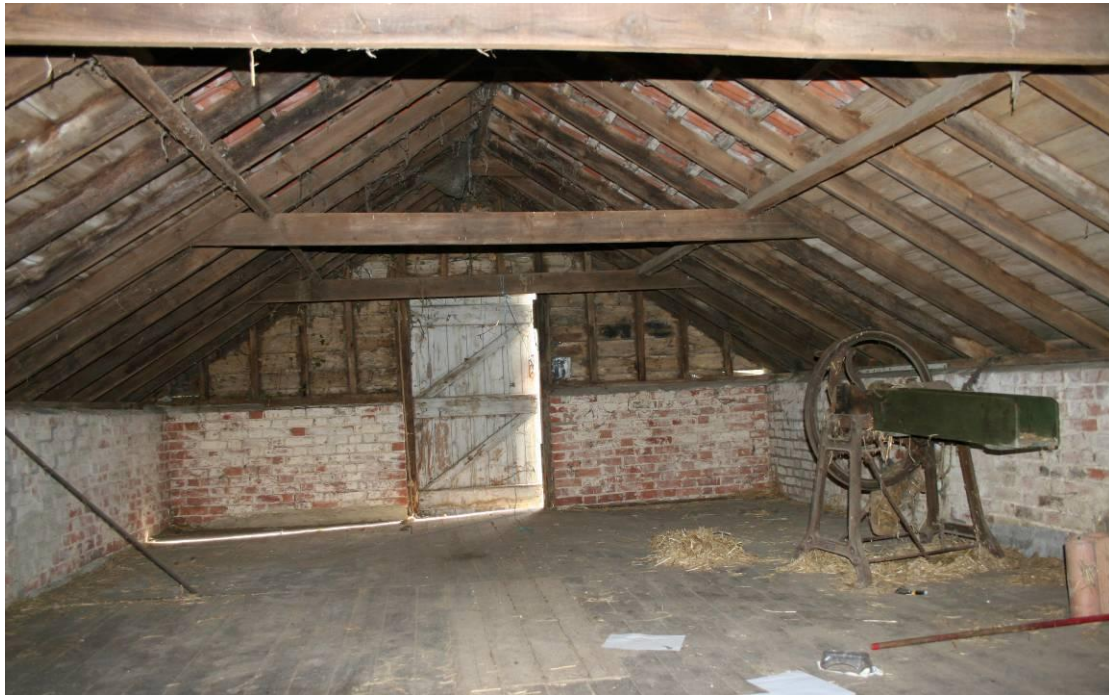
The Granary floor looking E. Note straw chopper from EC20th.

The Granary floor is a flat open space with a suspended timber floor boarded with 5in wide tongue and grooved softwood boards except in the NE corner where they are only 90mm wide. There are several hatches for chutes down into the rooms below and an open well for the loft ladder against the south wall. The western end is badly rotted and unsafe but otherwise it is dry and sound. There are various metal rods and bars nailed to the eaves plates that pass down onto the principal joists to support the floor. Typically a load of grain would weigh 30 tons.

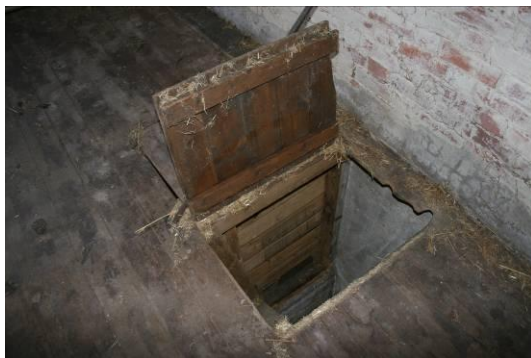
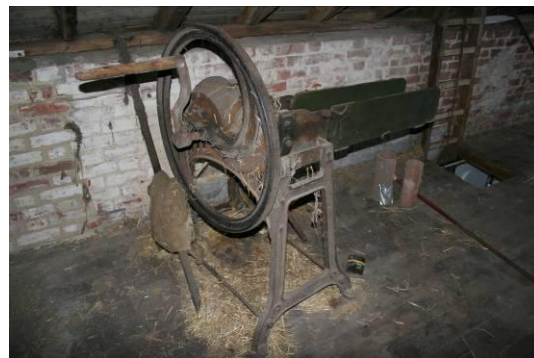
Grain floor hatches into stalls below. The Bentall Straw Chopper

The room is devoid of fixings except the ladder. There is a 'CDC Bentalls' straw chopper (or chaff cutter). These hand driven machines were still being used regularly up into the 1960's for cutting straw down for litter or animal feed. The cast iron frame is secured with hex head bolts dating it to the C20th.

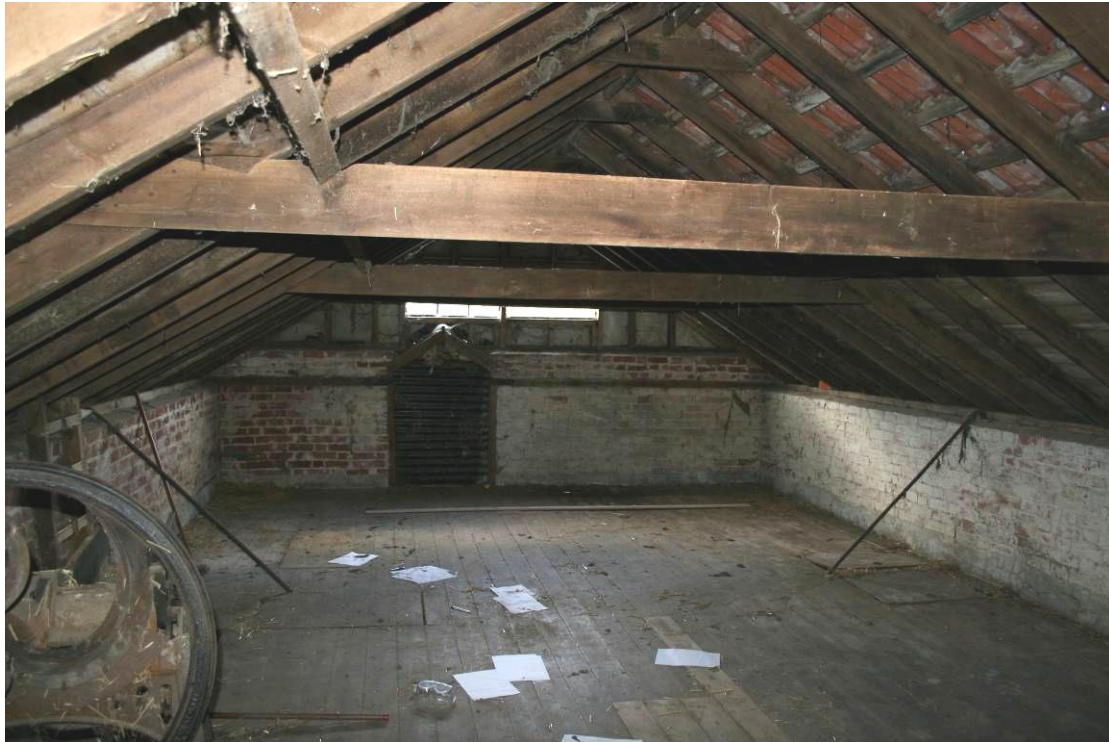
Clasped side purlin roof made of machined softwood.

The roof is a simple clasped side purlin construction made of machined soft wood all cut on an inch module. The rafters are 2x4in set at 2 in centres The four collared rafters are 3x4in and the collars are lapped and French nailed and there are gussets at the apex.

The purlins are 2x4in and the plain scarf is bolted and French nailed. The lower half of the roof is clad with plain 7in circular sawn boards. The north side has been rebattened with LC20th 30x50mm softwood marked 'DEM 226' in blue crayon. The few carpenter's marks are all pencil lines and in general indicate battens or struts tacked to the roof that have been since removed.

The tiles are EC20th clay nibbed tiles quite commonly seen in the village of Sible Hedingham.

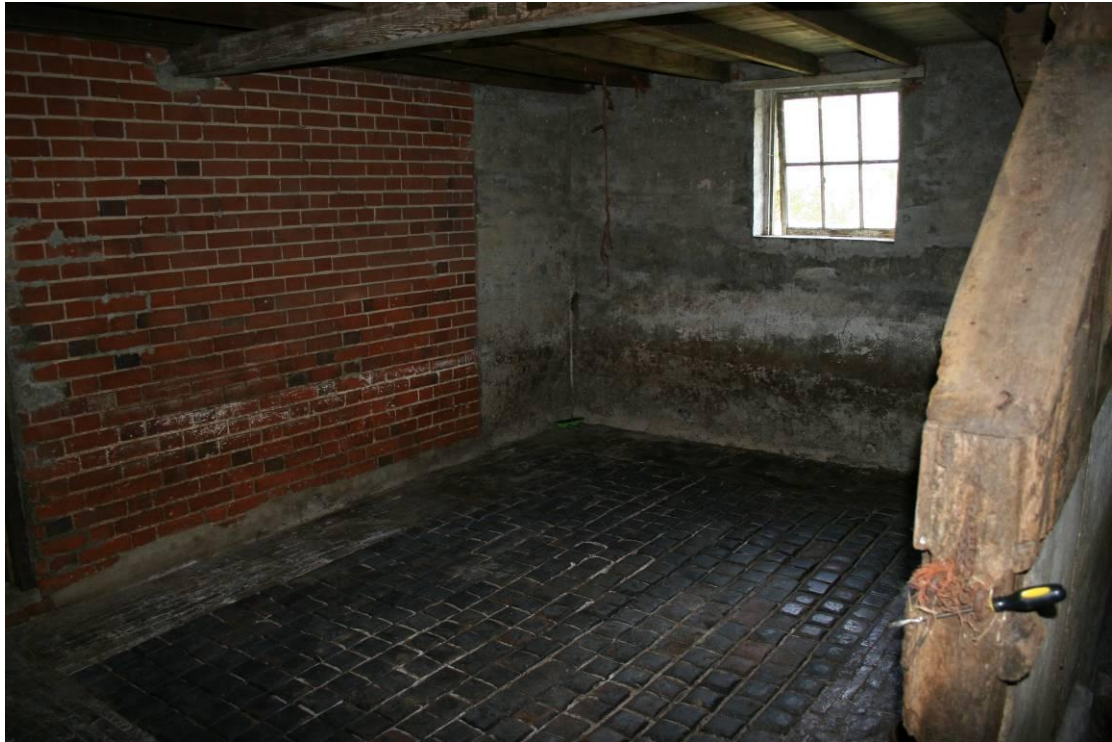
Stall 1 - note the blocked off doorway in the NW corner.

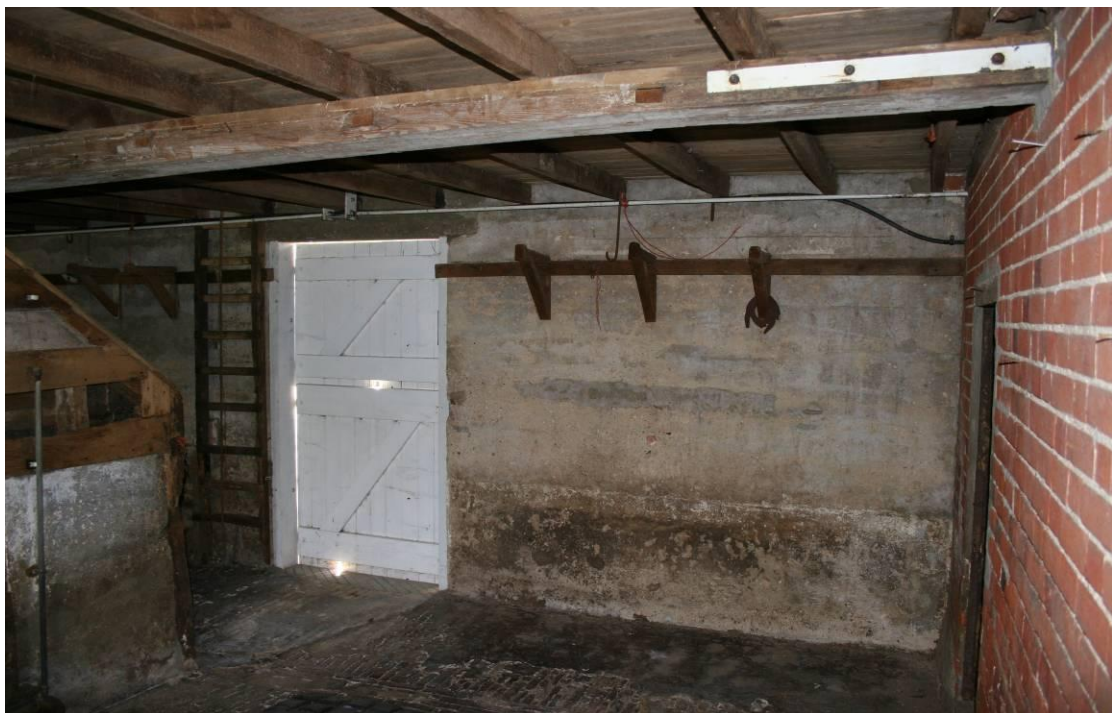
Stall 1. Looking SE. The spine beam has been reused and the mortices are pencil marked.

Stall one has few features but here the brick wall is exposed and seen to be of the same bricks as the rest of the building. There is an inserted doorway into the Stable with an EC20th door (see Stable description). There are three C20th harness trees made of sawn softwood, French nailed together. The 6x7in axial joist is reused and has pencil marked redundant mortices. A LC20th mild steel tie, matching the tie-rods, secures the western end.

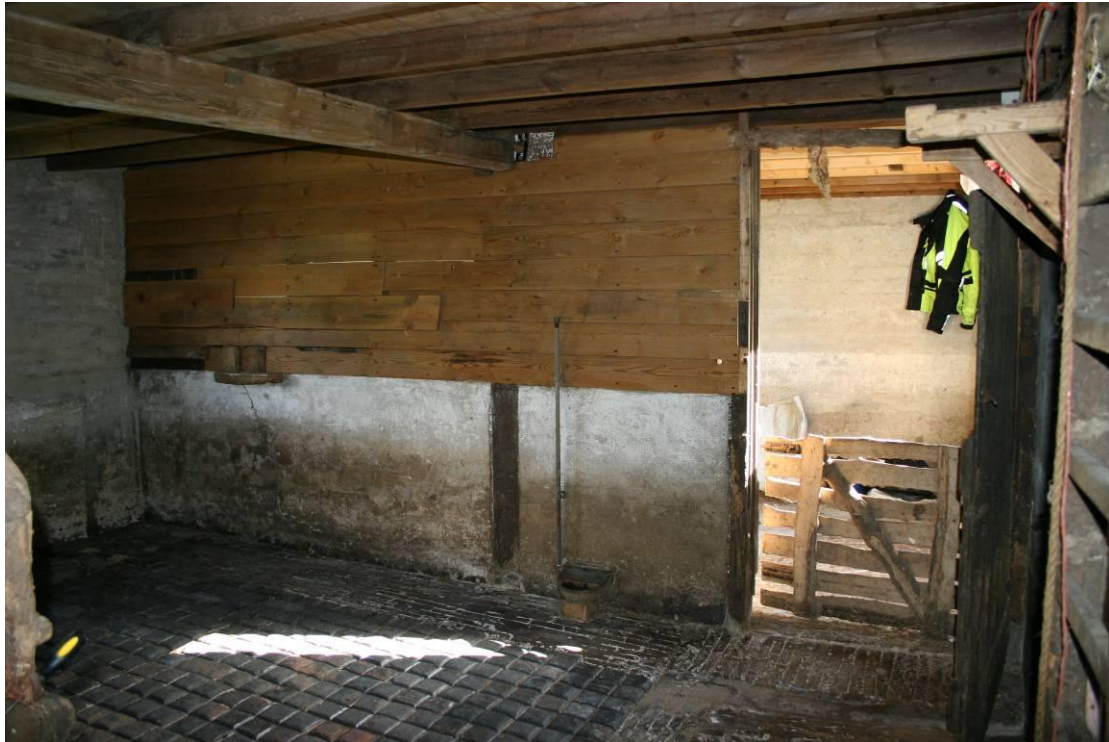
Stall 2 looking E. The partitions are rendered brickwork. Central post supports ceiling.

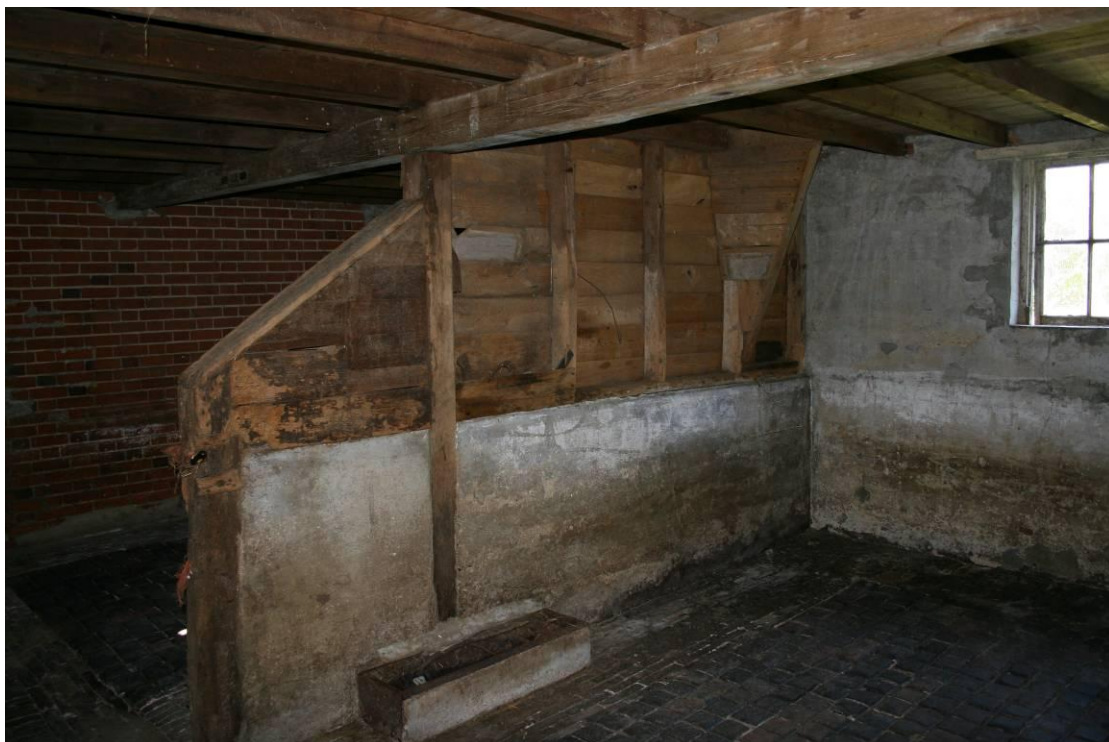
Stall 2 looking NW. Note grain chute at rear and pig trough.

Stall 2 retains a pig trough and water tray and there are two more C20th harness trees on the south wall. In the NW corner is part of a timber grain chute just below one of the trap doors in the granary floor. The partitions are made of 2x4in softwood studs French nailed to circular sawn weatherboards. The lower sections are cement rendered brickwork.

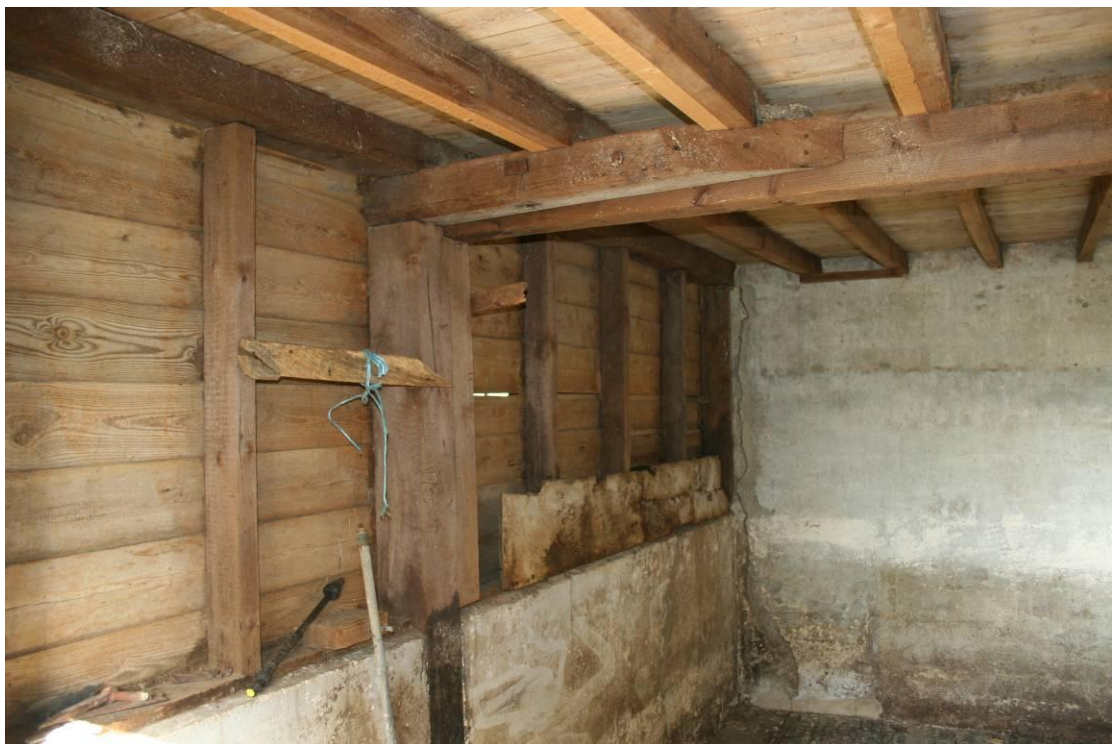
Stall 3. The spine beam wasn't quite long enough so it was nailed to another.

Stall 3 was used as a pig sty into the LC20th and it is known the pig used to look over the lower stable door. He was able to do this because the stall wasn't cleaned out leaving a stain almost to the height of the brick partition. The reused spine beam was not long enough for the building so it has been double up and nailed to a joist made of machined softwood.

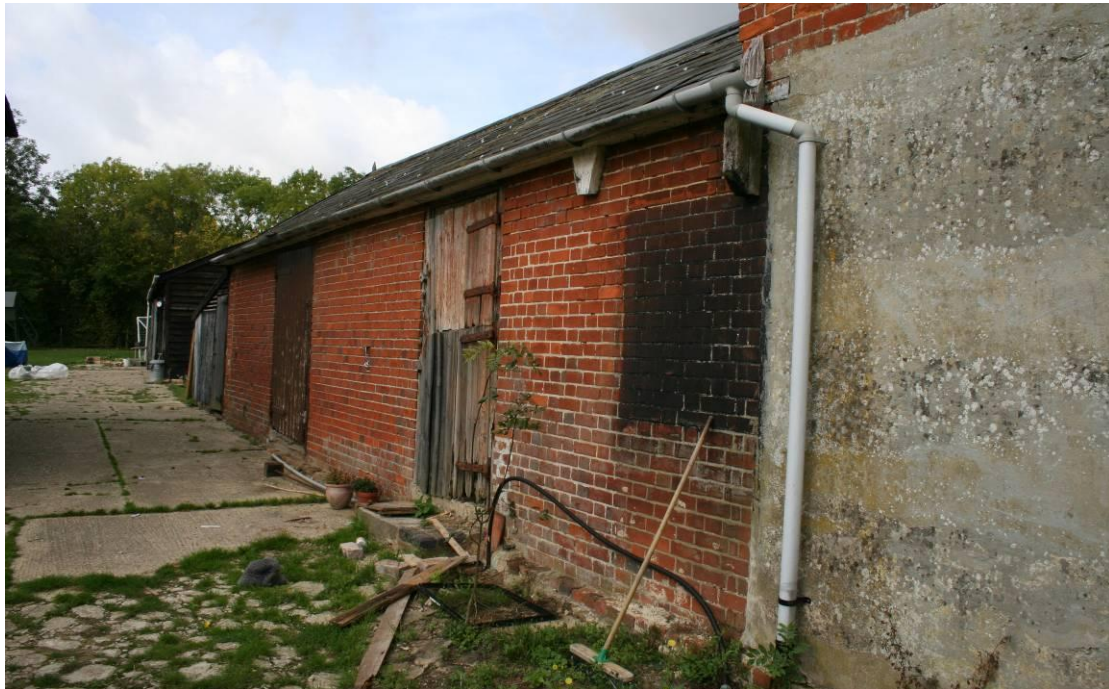
The Store and Stable is a single building divided with a rough studwork partition.

The southern elevation faces the farmhouse and like the Granary is the working side of the building - there is no rear access. The building is divided internally by a studwork partition to create a stable to the east and a large workshop or store to the west. The Stable has C20th split stable doors in poor condition hung on mild steel reversible hinges. The tongue and grooved boards are French nailed to horizontal ledgers.

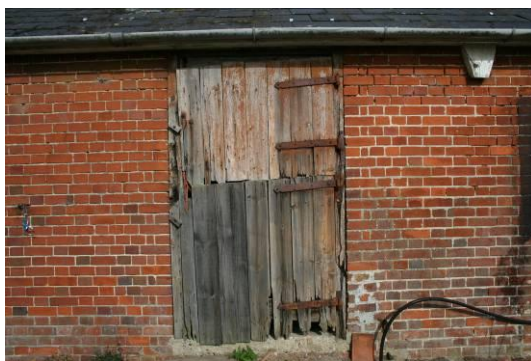
The Stable and Store doors are both C20th in character.

The Store has a 58in wide tongue and grooved, gate and ledger, softwood, French nailed door with mild steel fittings and a wood-stock lock box with a decayed mild steel lock. The machined door frame is of particular interest because it has 'Built June July 1904' written on it in pencil. At the eastern end there is a square patch of black paint on the wall denoting where a water tank used to stand to supply the animal water dispensers.

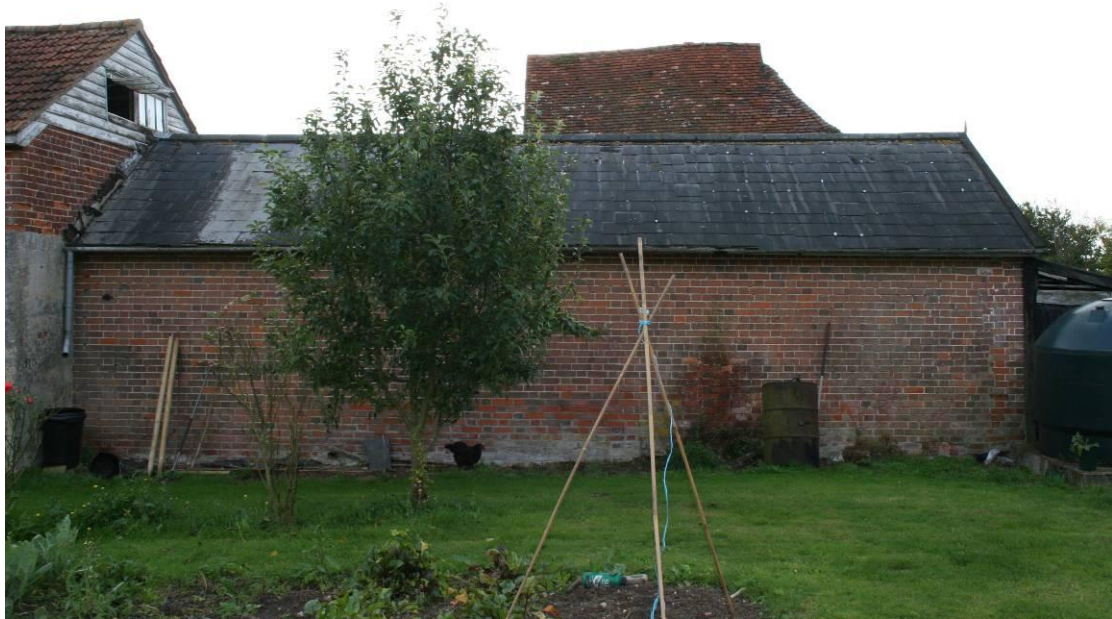
The rear of the building has no features.

The rear of the building has no windows or doorways. The roof is clad with 12x24in grey slates and the rainwater goods are grey plastic. The brickwork at the western end is disrupted near the quoins and although the wall is properly closed it looks as if originally the building was open or had a timber-framed wall at the western end.

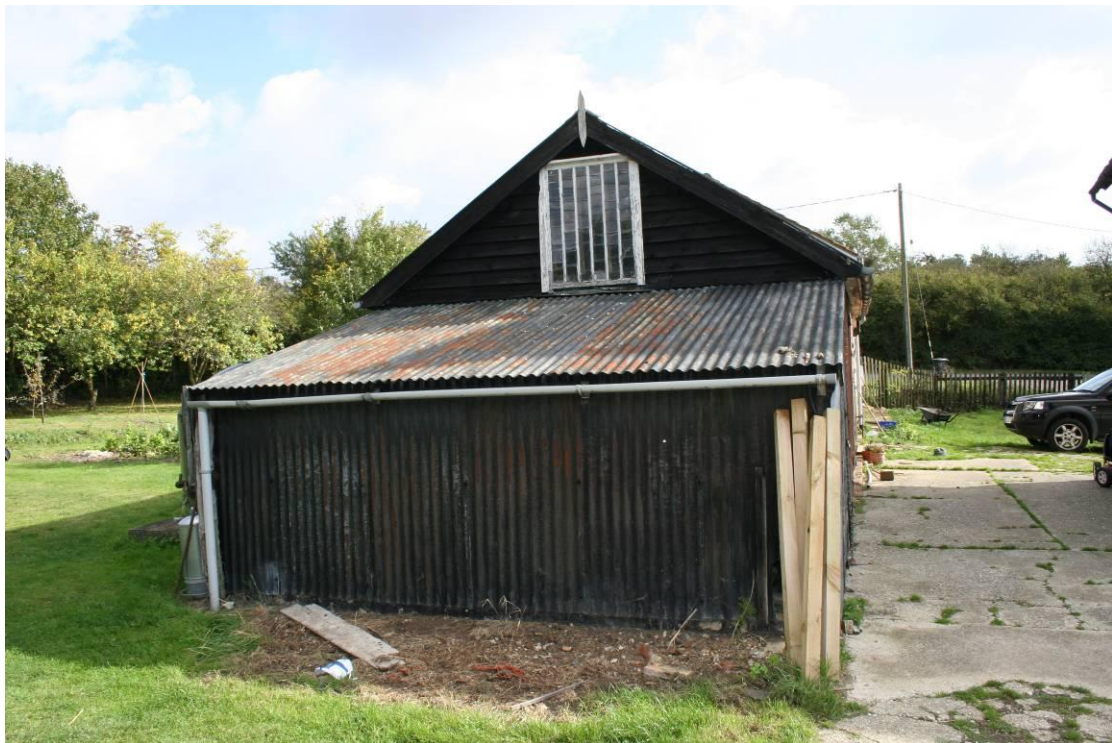
The western elevation of the Store and the Outshot.

The western elevation is largely obscured by the tin shack that is the Outshut. The lower wall, inside the Outshut has the exposed brick wall. Here and inside the Store it can be seen the bricks are reused with a random pattern of red and whitewashed bricks. This also explains the scars on both the end corners.

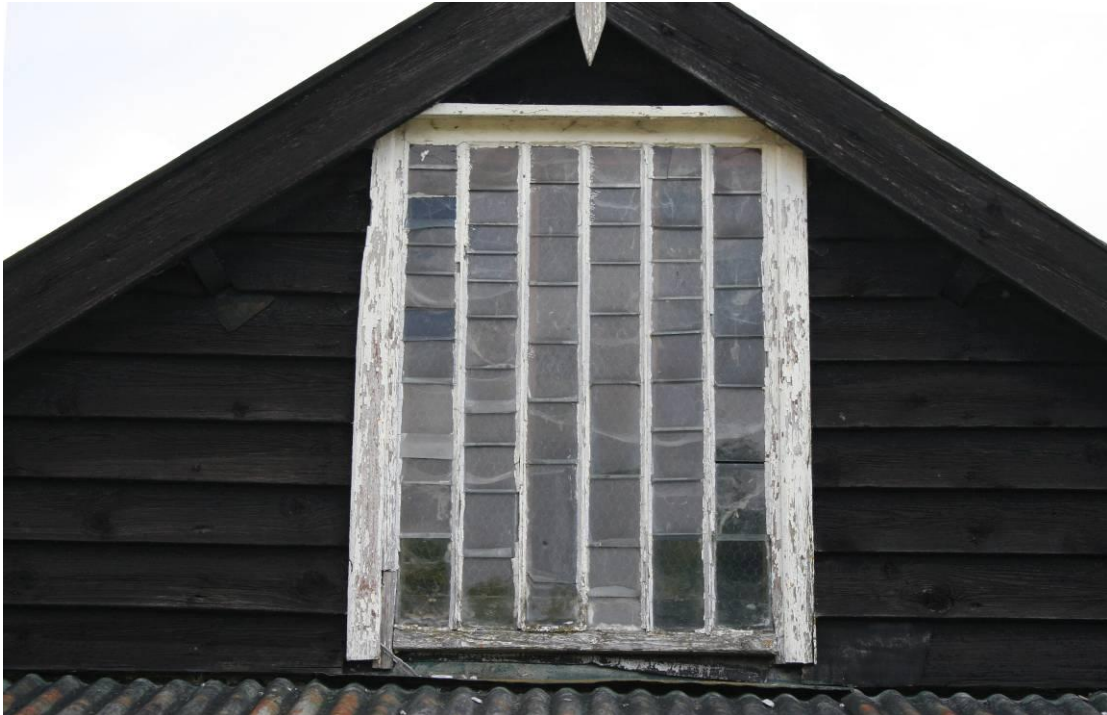
Unusual 'homemade' window with overlapping glass panes greenhouse style.

The upper wall is weather boarded with C20th French nailed band and circular sawn boards. There is a strange central window with full height mullions and no horizontal muntins. The window is glazed with strips of overlapping glass set in putty like a greenhouse. The shape of the opening suggests there was previously a hatch door here.

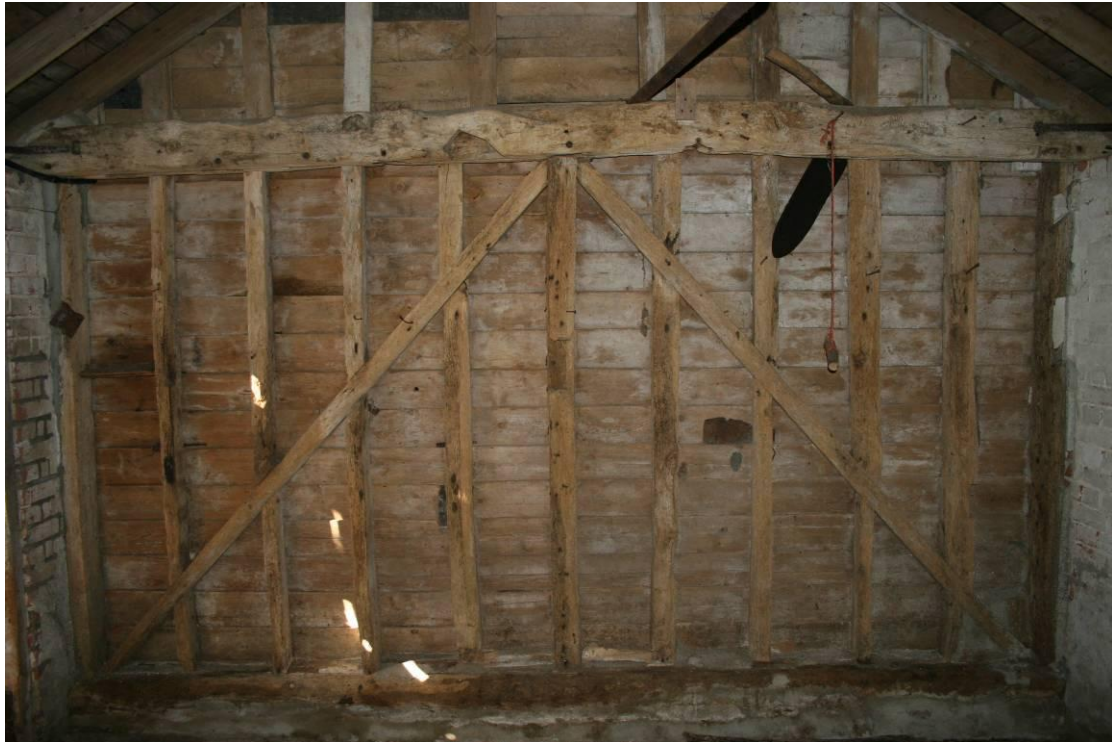
Although the Stable is a separate room from the Store it would be difficult to say with certainty when it came into being. This is because the body of the building is in solid brickwork while the internal partition is a rather shoddy timber-frame made from reused timbers nailed together in an unorthodox way.

The studs have been halved and nailed against the west side of the tie-beam (see photo following) rather than skew nailed or set into rebates as one might expect of C19th work. The conclusion must be that the design is EC20th, borne of necessity rather than design.

The partition between the Stable and the Store. EC20th interrupted studwork.

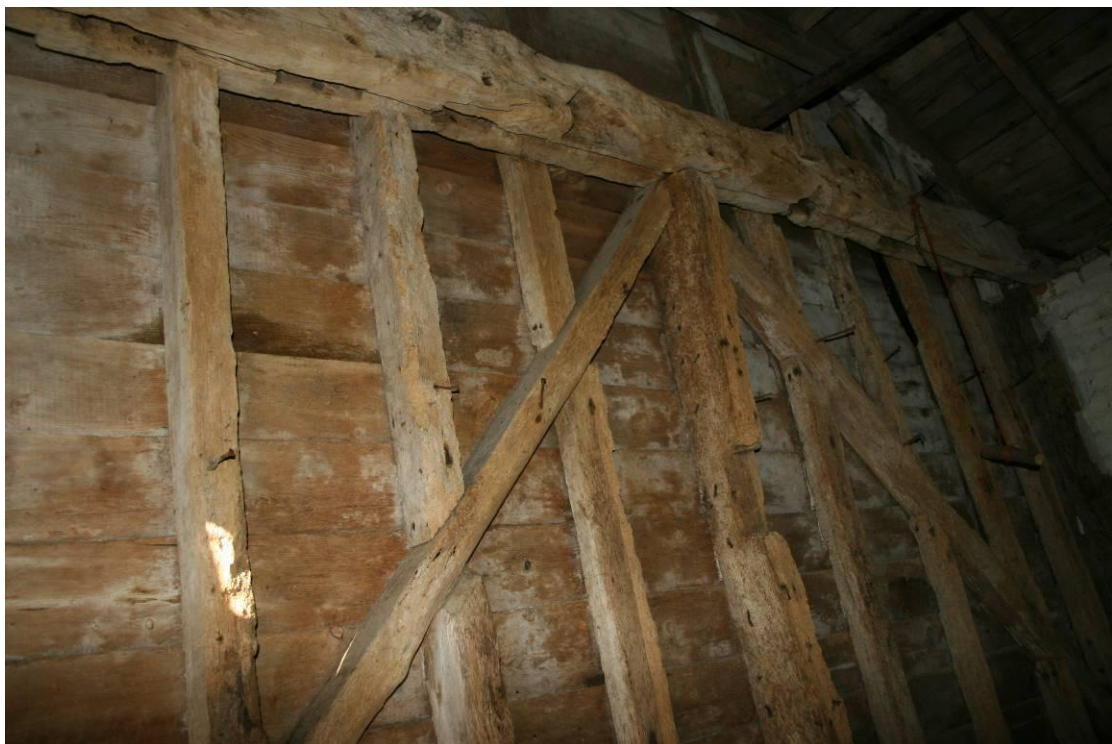
The tie-beam is from a very old building having redundant mortices, a wattle groove and a notched lap joint with refined entry for a missing brace. The weatherboards are bandsawn.

Interrupted studs pass behind the tie-beam. Note the notched lap joint near the central post.

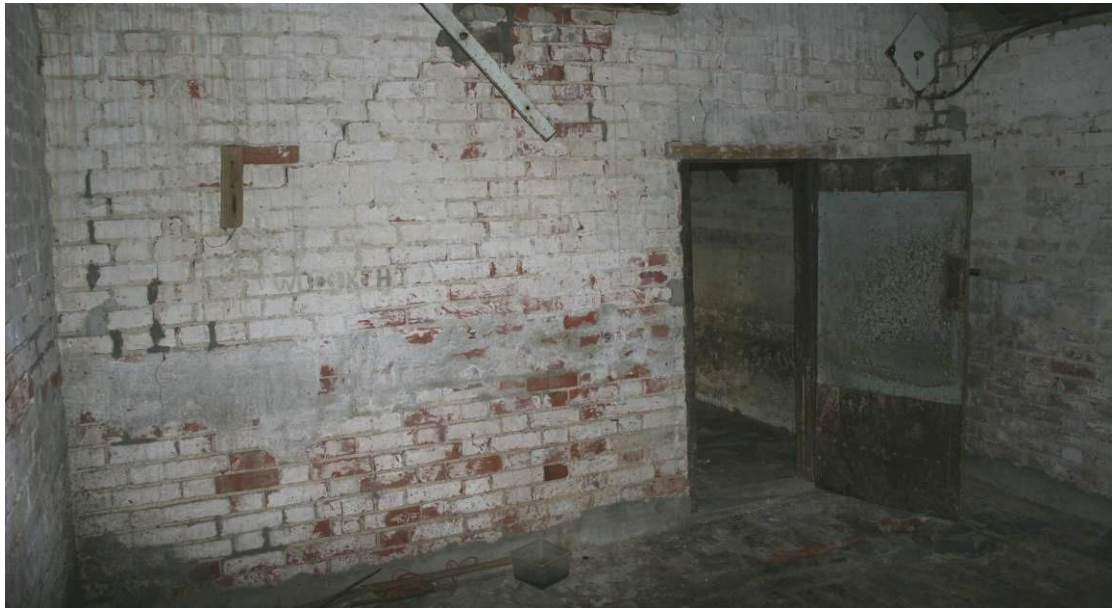
The Stable has a brick pavior floor. The doorway is inserted and C20th. Looking SE.

The Stable has a brick pavior floor very similar to Stall 3 of the Granary Stable but the bricks are larger at 50x11x210mm and there are no drainage gulleys. The room is connected to Stall 1 through an inserted doorway. The door is tongue and grooved softwood with horizontal ledgers, all French nailed with mild steel fittings and strap hinges. The eastern side has been plated with a galvanised iron sheet to prevent the animals from destroying it.

The walls have been whitewashed and lower down the brickwork has been rubbed to remove it by the animals kept inside.

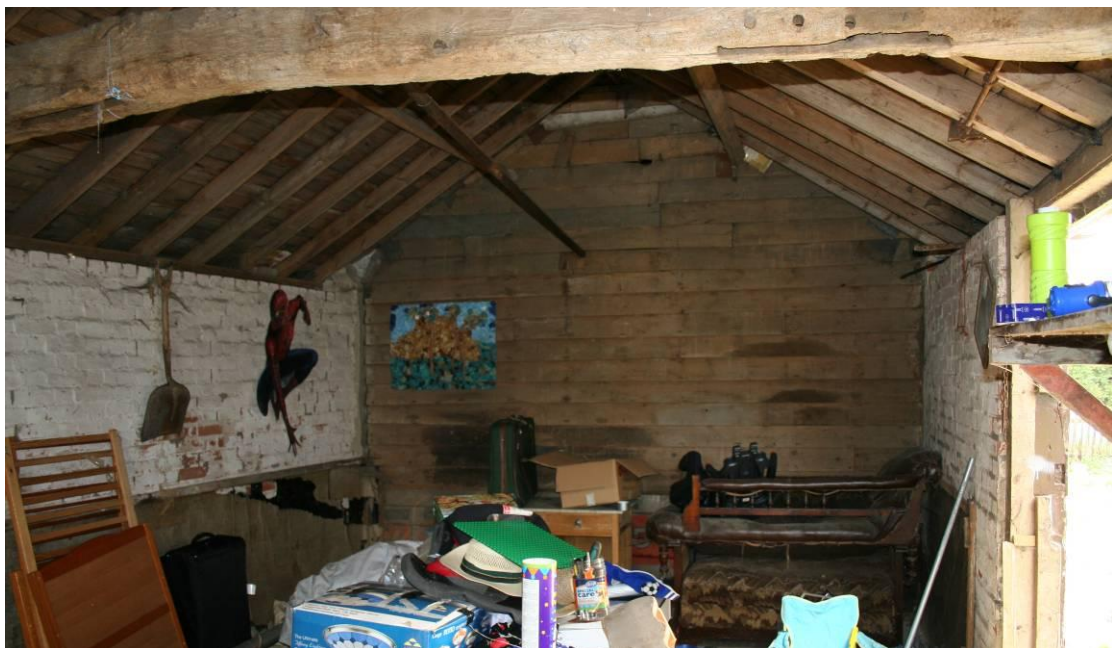
The timber partition wall visible in the Store. Note also the reused tie-beam. Looking E.

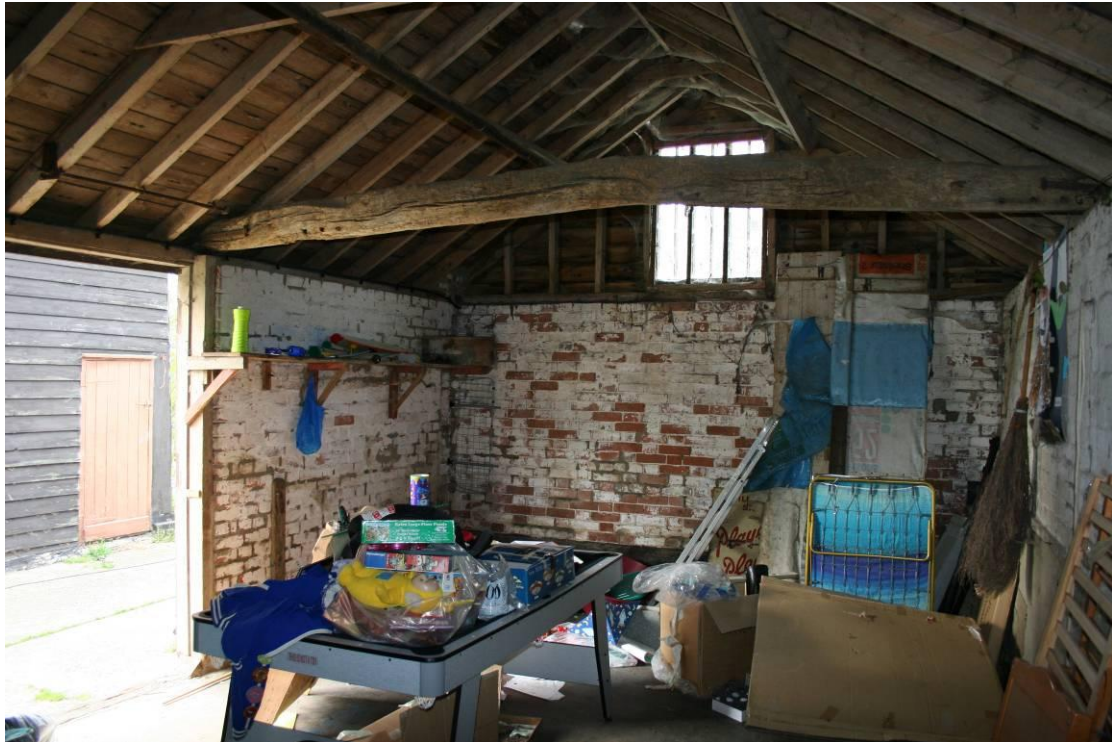
Inside the Store looking W. Machined timber roof. Reused bricks in the end wall.

The Store is a featureless room with a concrete floor. The walls were lined with an asphalt membrane which remains fixed to the north wall. Apparently this was to contain grain in large bins against the walls. There is a homemade shelf along the SW wall French nailed to the doorframe with the date 1973 written on it and the wall.

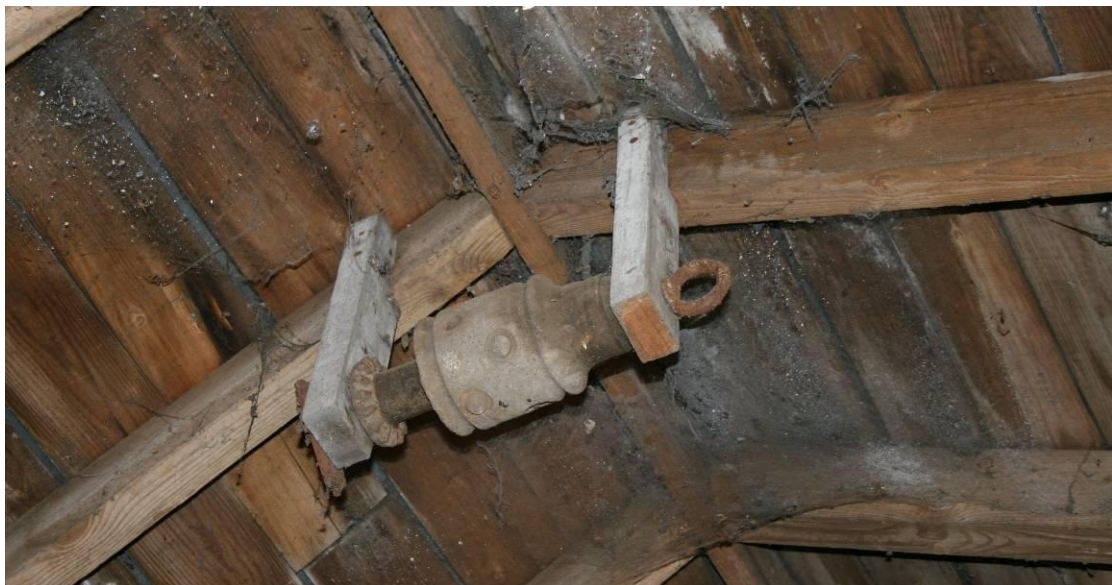
Pulley wheel and bevel drive hung in the roof.

At the eastern end of the Store there is a wooden pulley wheel with a bevel drive suspended from the rafters on two French nailed battens. The pulley appears to be a reused nave from the centre of a cartwheel with the spokes sawn off.

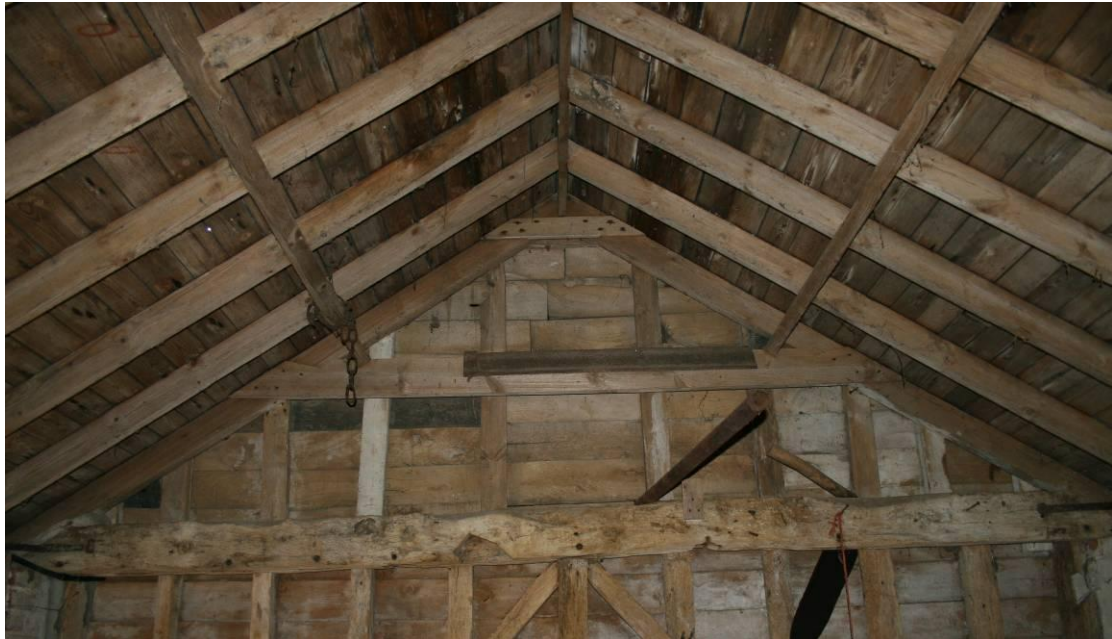
Roof structure in the Stable. Looking W.

The roof is a machine softwood side purlin design with a single lapped and nailed collar in the centre of the Store. The purlins are lodged in the end walls and the partition. The 2x4in rafters are set at 17in centres and the principal rafter is 3x4in. The tie-beams are reused ancient timbers. All the joints are pencil marked.
