Hill Farm, Southey Green, Sible Hedingham, Essex.
Description and analysis of granary and stables. Surveyed 28 09 2011.

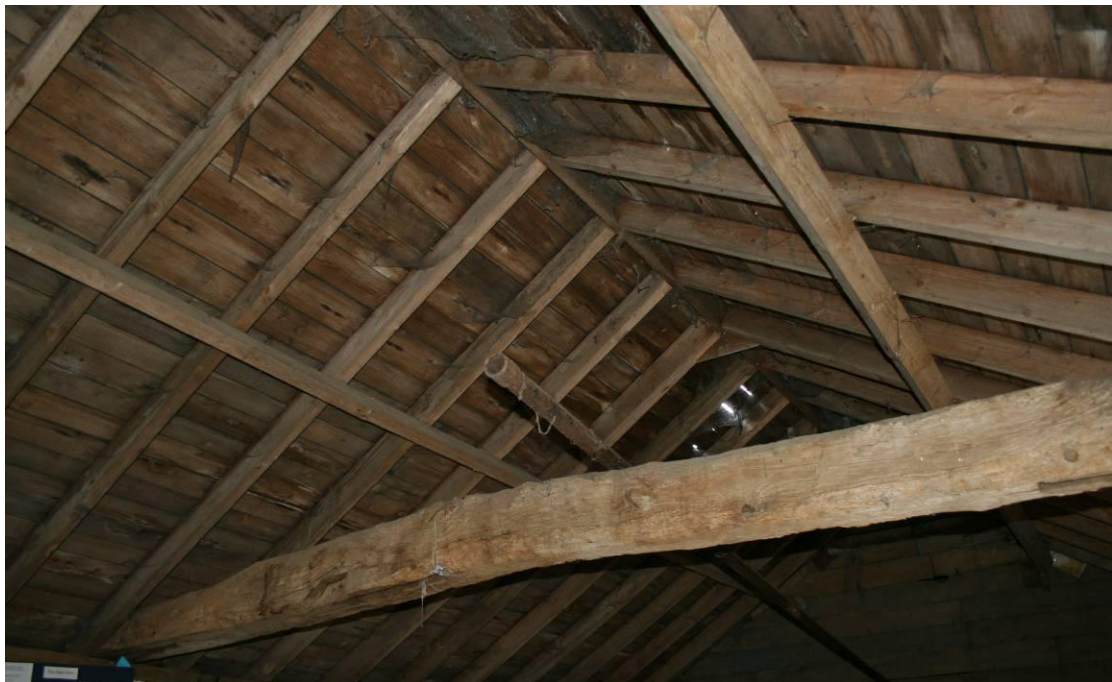
Roof structure in the Store. Looking NE.

The roof is a machine softwood side purlin design with a single lapped and nailed collar in the centre of the Store. The purlins are lodged in the end walls and the partition. The 2x4in rafters are set at 17in centres and the principal rafter is 3x4in. The tie-beams are reused ancient timbers. All the joints are pencil marked.

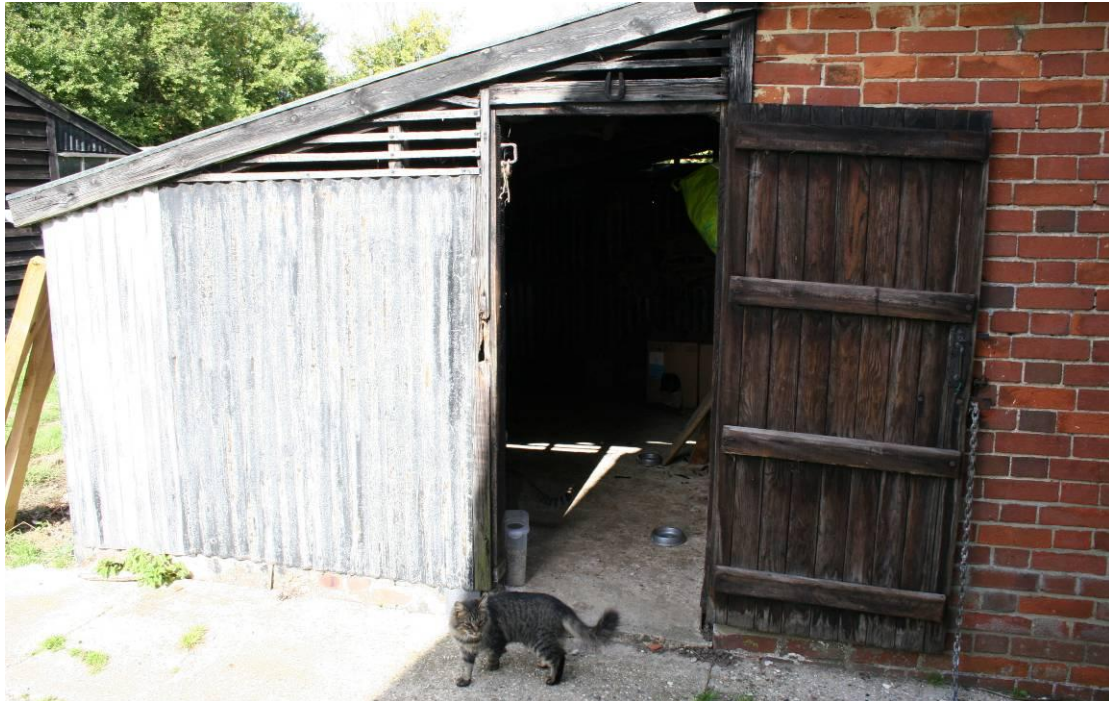
Southern elevation of the Outshut. Note donkey shoe over the door.

The Outshut is a makeshift shelter made of machined softwood clad with corrugated iron sheeting. The floor is concrete. The current door is a C20th softwood vertically boarded laedger door fastened with French nail and with C20th mild steel fittings. The frame indicates there once was split stable doors and nailed to the frame is a donkey horseshoe which may explain its original purpose. Now it is home to the farm cats.

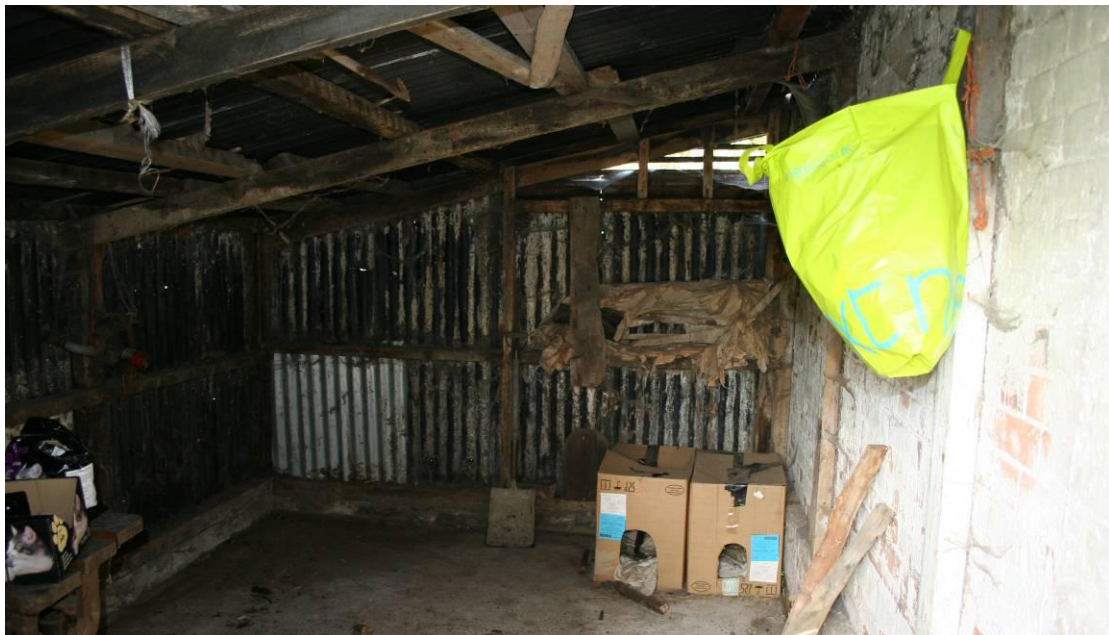
The interior is as inspiring as the exterior. Currently used as a cat's den.

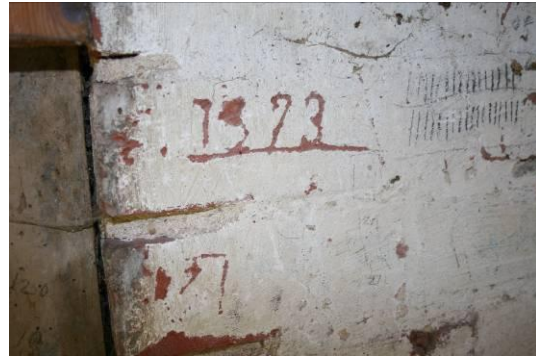
Pencil marks for the date of the building and the conversion to a LC20th grain store?

The two most important pieces of graffiti are in the Store. Written in pencil on the door frame is 'Built June July 1904'. Scratched on the wall beneath the shelf is '1973'. It is most likely these date the erection of the building and later the conversion to a grain store by lining it with asphalt sheets. A. Bonnet may have done this work.

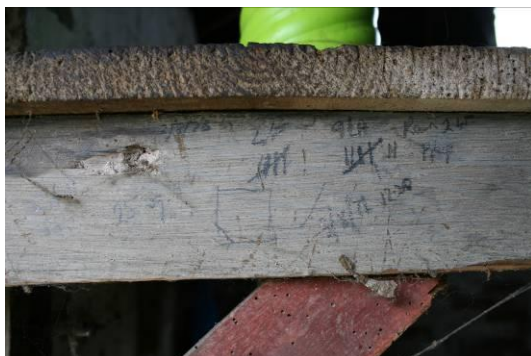
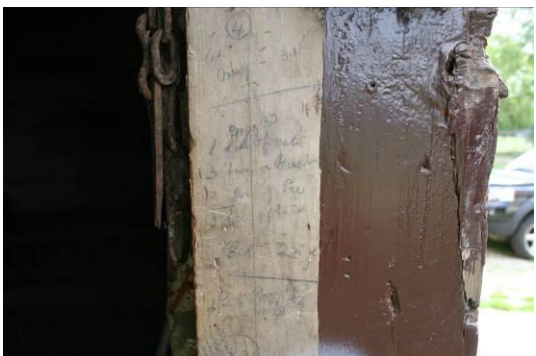
Tally marks with a date of 1978. Calculations show crop yields written for or by Bob Wright.

The graffiti is from two distinct periods. The earlier lists dating from 1904 onwards give details of produce such as '3 quarters wheat - 3 chickens - Crate weigh 17 1/2 lbs' and '1 sack of oats - 1 bus(hel) of Barley - 3 bus of peas - 3 bus of' The latter is either from or for 'Bob Wright. The more modern is largely tally marks with the date 3/8/1973 marked twice.

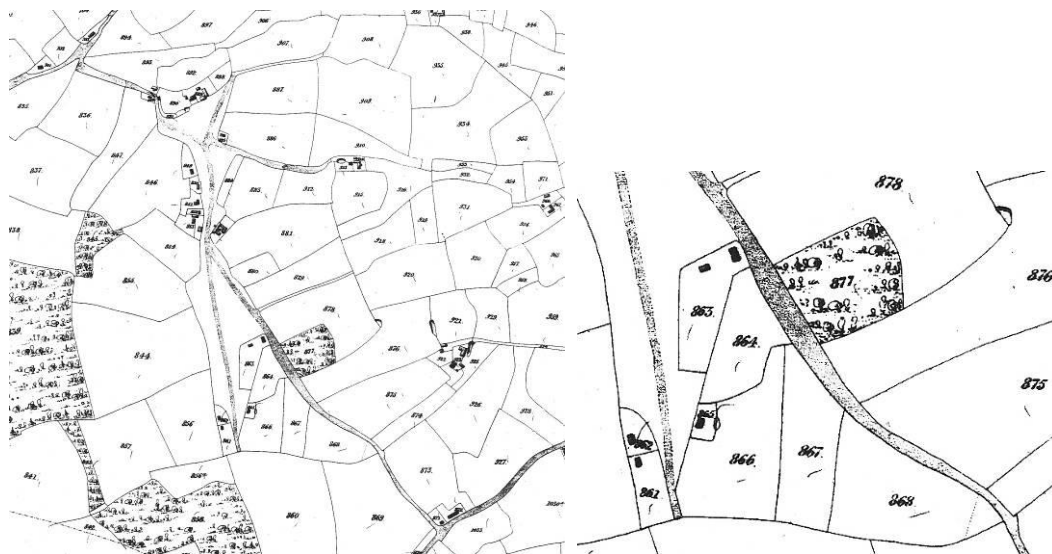
1840 Tithe Award Map for Sible Hedingham.

By the time of the 1840 Tithe Award the other roadside properties have vanished and a new copse (Light Foot Wood) grown up. Hill Farm is the sole remaining property and is identified as Plot 863 Brick Yard belonging to Daniel Smith and occupied by John Parish who is listed in White's Directory of Essex for 1848 as a Brick and Tile Maker. Only the house is shown and as a plain rectangle. There is another small building away from the road.
