SUMMARY SHEET

Site name/Address: Trefranck Farm, St Clether, Cornwall, PL15 8QN.	
Parish: St Clether	District: Launceston
NGR: SX 20360 84907.	Site Code: N/A
Type of Work: Historic Building Recording	Director/Team: Barry Hillman-Crouch
Date of Work: 28 12 2011	Size of Area Investigated: 100x100m
Location of Finds/Curating Museum: N/A	Funding source: Owner
Further Seasons Anticipated?: No	Related EHER Nos:
Final Report: Trefranck Farm, St Clether, Cornwall, PL15 8QN. Description and analysis of a stone built barn SW of the farmhouse. Surveyed 28 12 2011. Barry J Hillman-Crouch MStPA DipFA BSc HND.	
Periods Represented: C18th - C20th	
SUMMARY OF FIELDWORK RESULTS: Trefranck Farn Barn retains the plan and overall appearance of a building erected near the turn of the C19th. It was built as a granary and water mill. Only the stone shell is original and this has been altered significantly in the C19th and C20th with new openings. The water wheel was removed in the LC19th and a remote wheel installed in the field east of the Farmhouse to drive the Barn machinery. The granary floor dates to 1960 and a completely new roof was put on in 2002.

Trefranck Farm, St Clether, Cornwall, PL15 8QN.

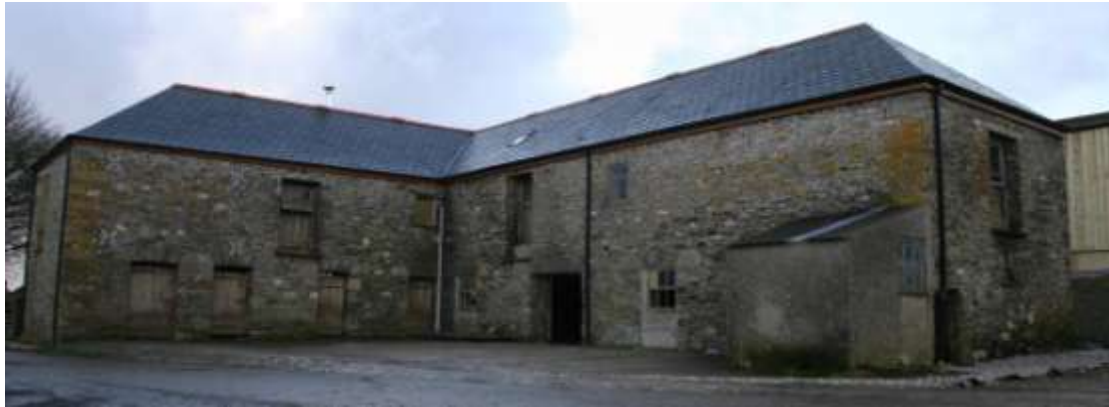
The Barn from the NE. White scale is 4m tall.

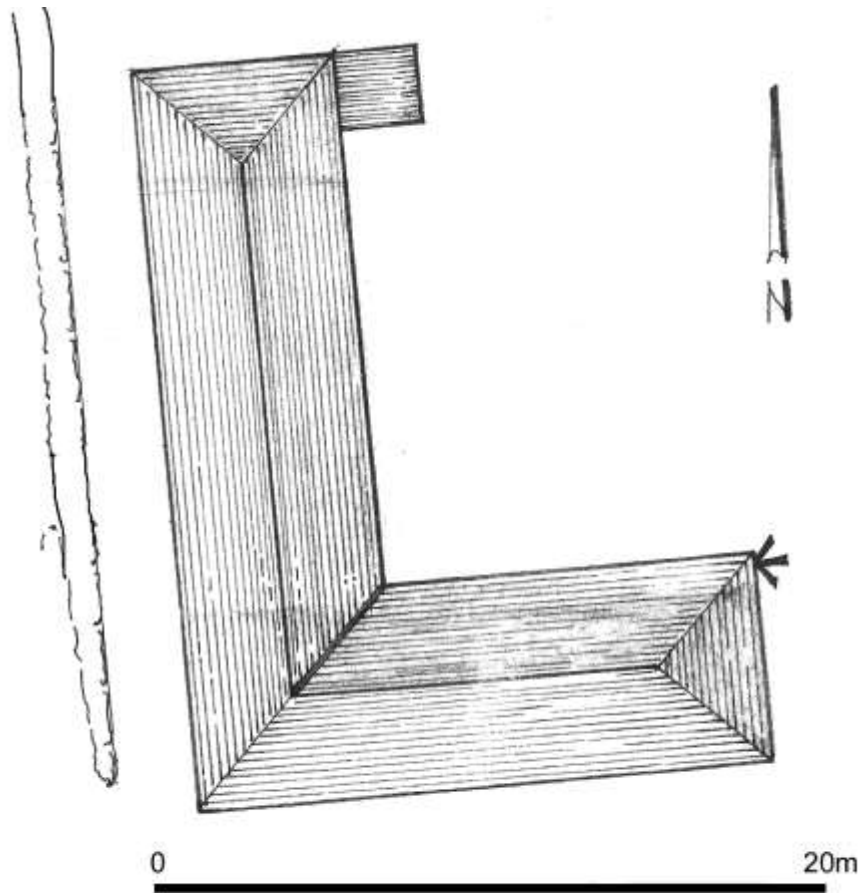
Roof plan of the Barn produced by Mr I Bray, 2010. There are no internal divisions.

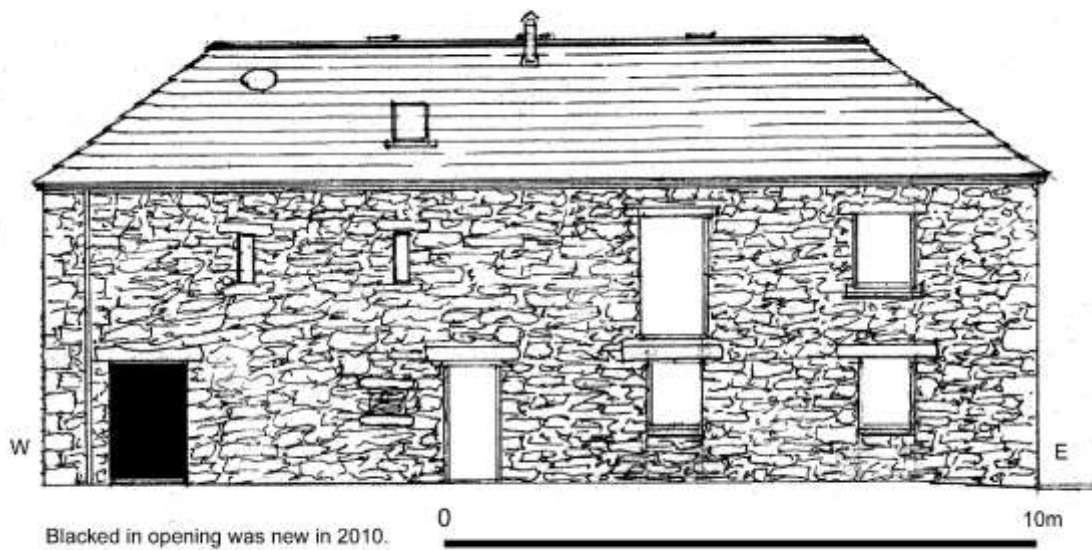
Southern elevation of the Barn. Mr I Bray, 2010.

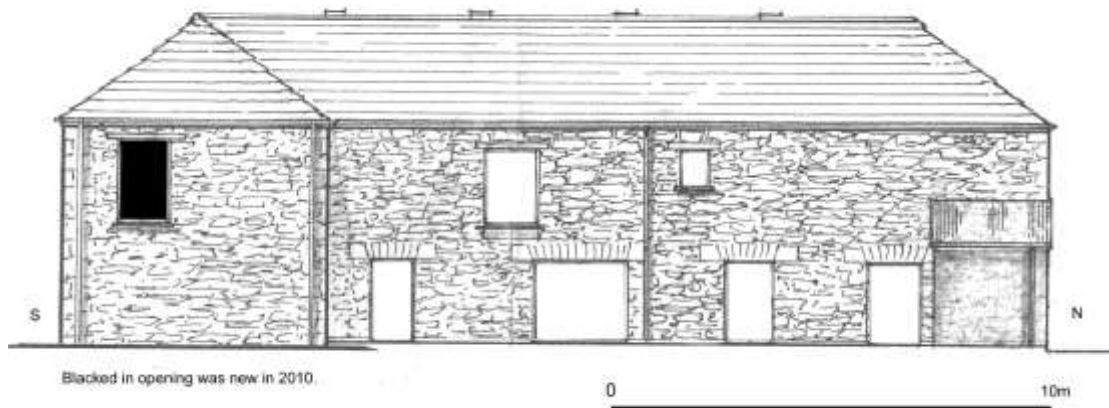
Eastern elevation of the Barn. Mr I Bray, 2010.

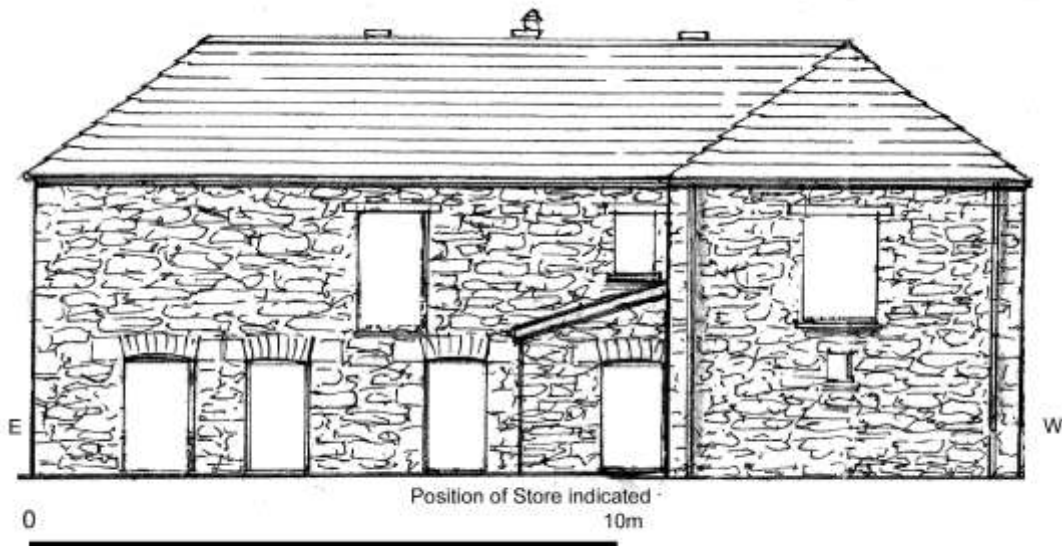
Northern elevation of the Barn. Mr I Bray, 2010.

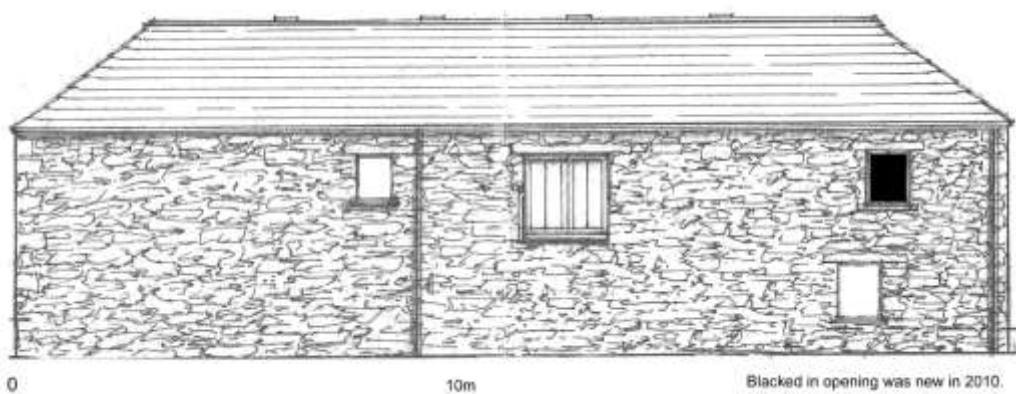
Western elevation of the Barn. Mr I Bray, 2010.

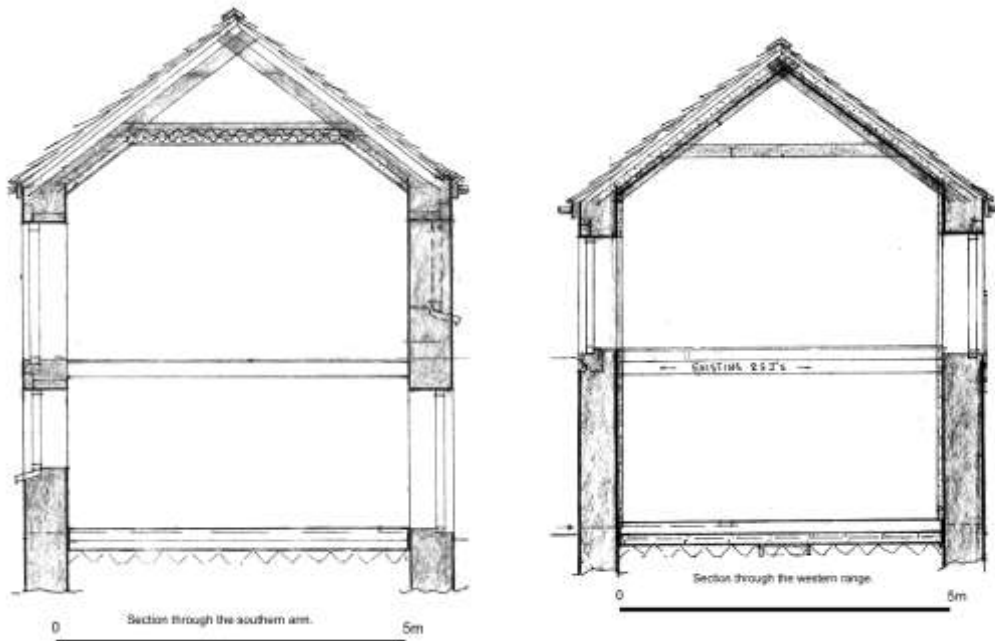
Sections through the southern arm and the western range positioned at the doorways.

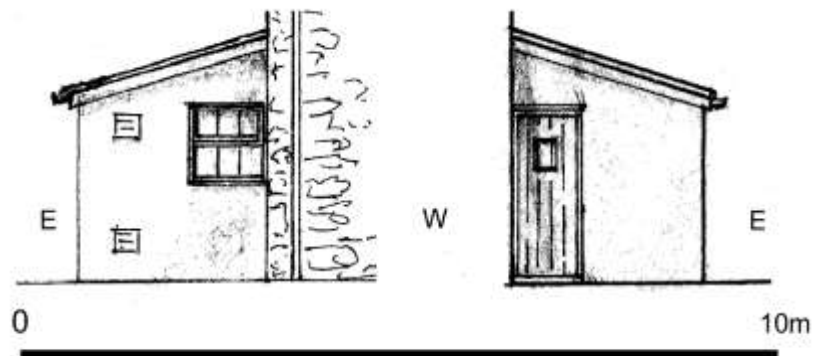
South (left) and north elevations of the blockwork store. 1960's. Mr I Bray, 2010.

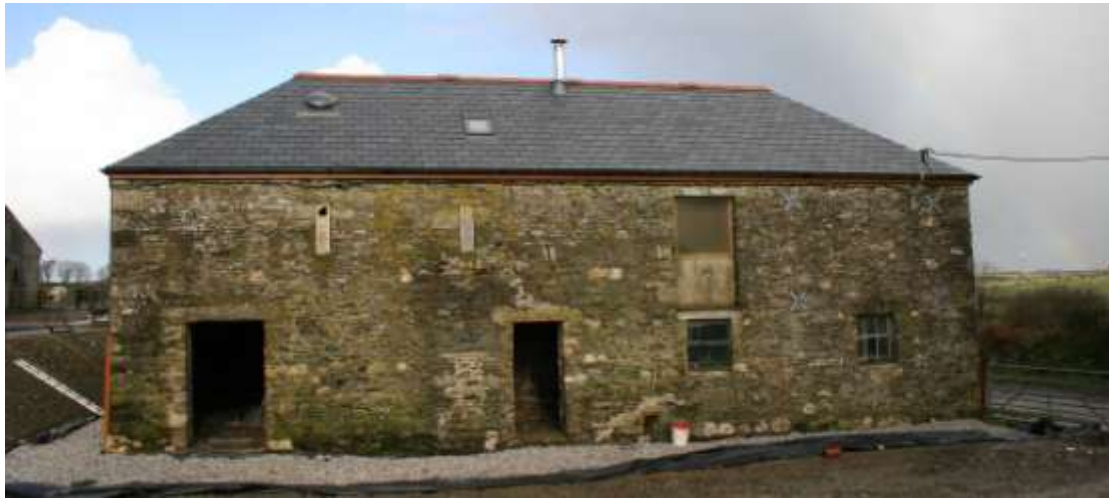
Southern Elevation.

The Barn has a new roof clad with modern grey slates with caly ridge tiles. There is a light pipe, Velux style rooflight and a flue for a multi-fuel boiler (not yet installed). Power is brought in by a cable from the SE corner. There is a fascia board with black plastic rainwater gutters and down pipe.

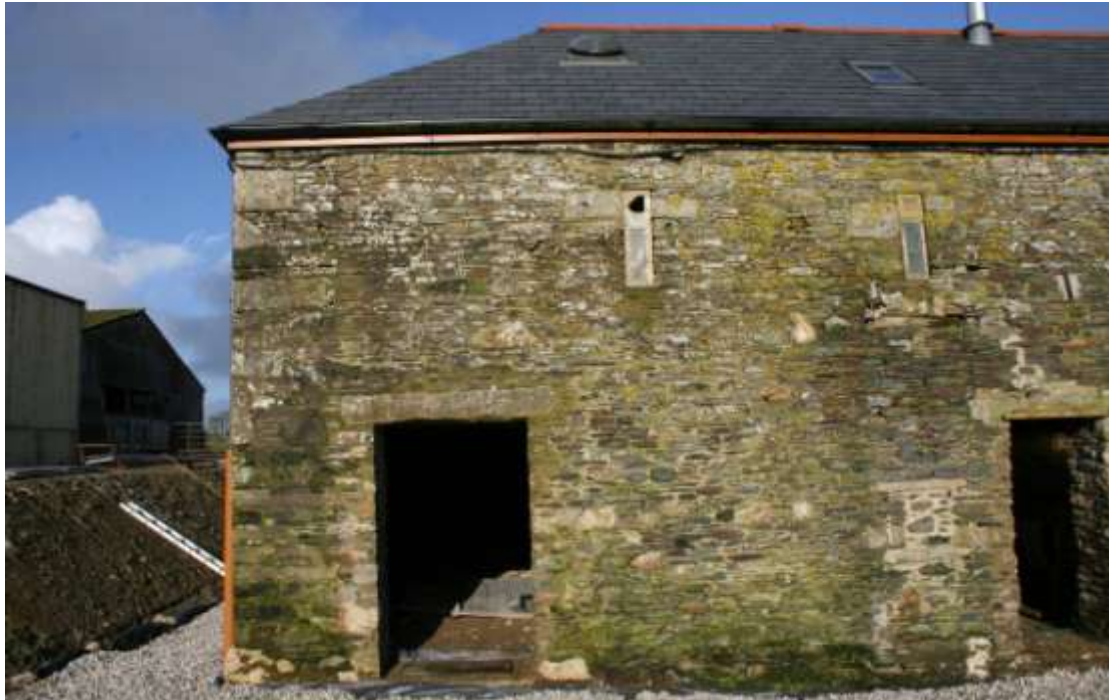
Detail of the western end of the southern elevation.

The walls are constructed of dressed stone known locally as Polyphant after the quarry from which it is mined. Polyphant Stone is a soft metamorphic rock type that is predominantly blue grey with green patches, and white and brown veins. The walls are dressed with granite quoins and lintels. There are also large blocks of white quartz.

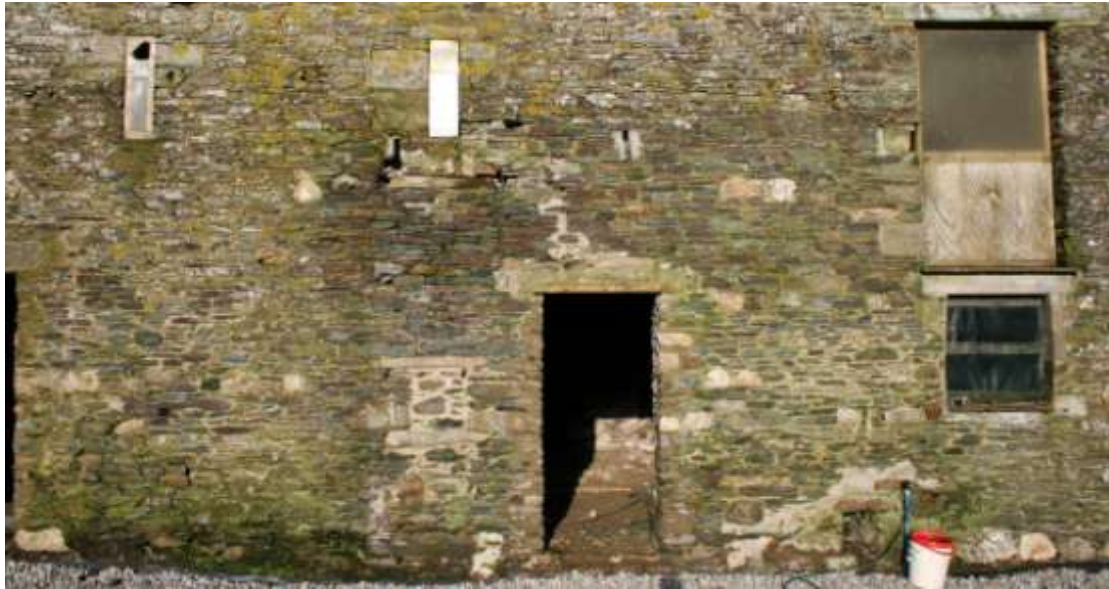
The central section of the south elevation. The wheel bearing housing has been bricked up.

There is a 48in (1.21m) wide inserted doorway to the west with a granite lintel. The central opening is an older insertion recently repaired with a timber lintel with fresh pointing. Above the door are sockets for joists and the stonework carries a shadow of an earlier lean-to structure. Also above are two slit windows with plastic panelled timber window frames.

To the east is a doorway to an upper floor (no longer in-situ) with a timber replacement lintel. The jambs are properly dressed and worn smooth with age. Below is a recently inserted window with a new timber lintel.

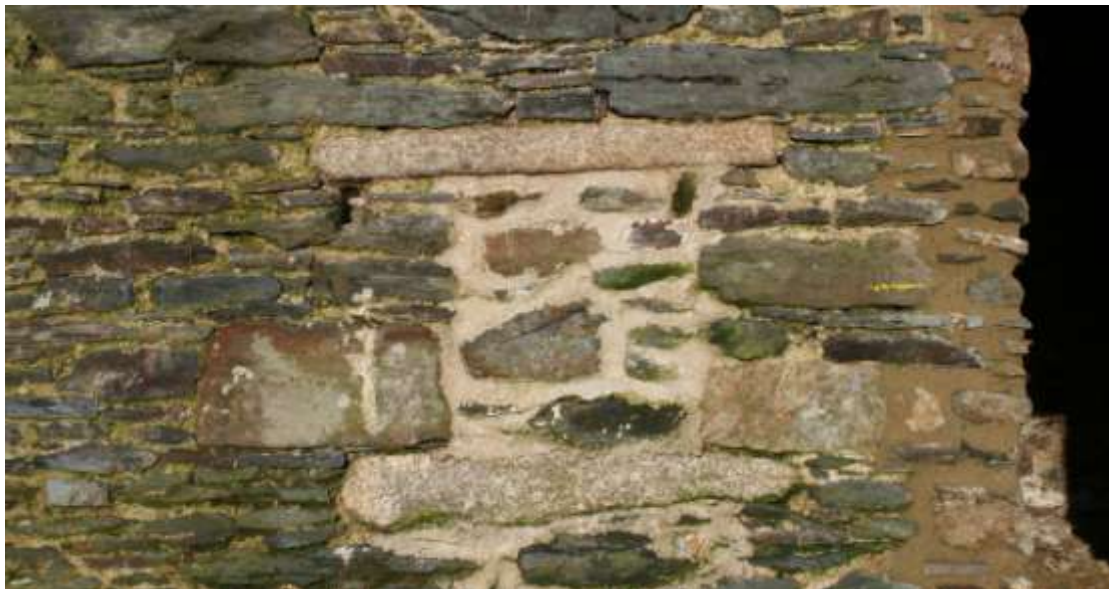
Blocked in bearing housing to the west of the central door. 16x24in (409x609mm).

Adjacent to the west of the central door is a small blocked up opening, 16x24in, (409x609mm), too low to be a window, dressed top and bottom with granite. This is most likely the housing for the main shaft of the water wheel that is known to have been here.

The stone built walls of the local Polyphant stone preserve the footprint of the barn as it was erected some time before the 1808 Ordnance Survey map. It was built as a granary and water mill with the wheel being fed from a leat supplied by a sluice in the pond to the west. The leat and pond have gone but the fabric retains the bearing housing for the wheel shaft which would have almost certainly been overshot.

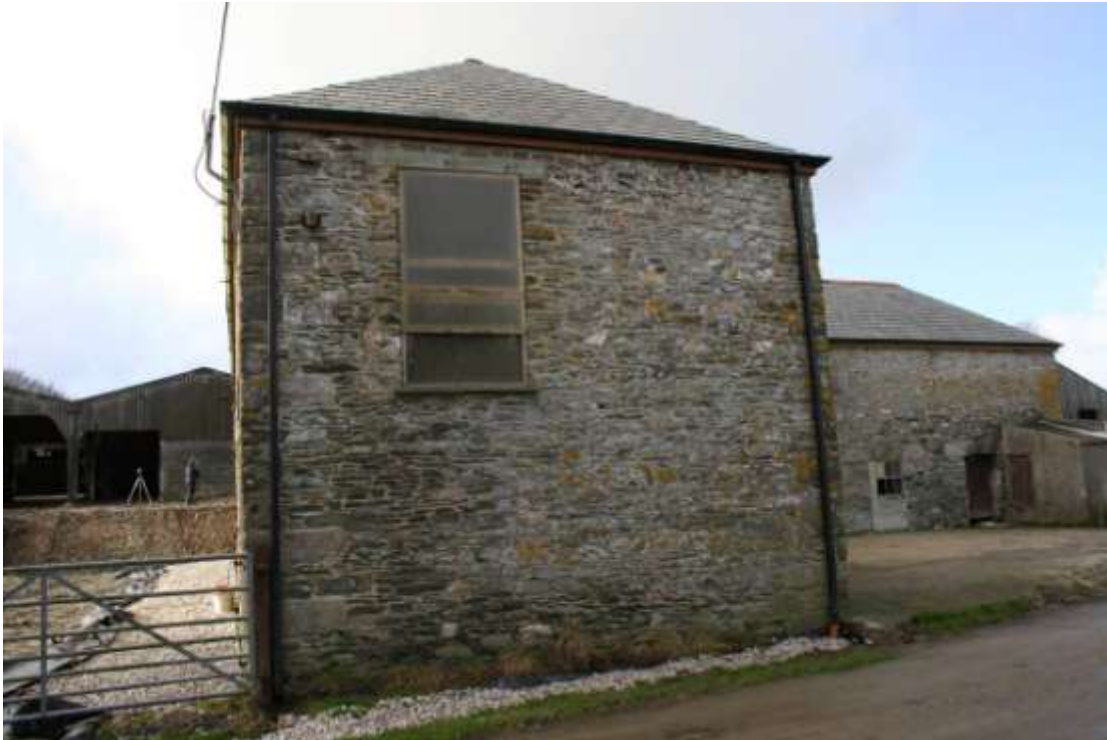
The eastern elevation of the southern arm. The doorway was inserted recently.

The elevation is divided between the southern arm of the L-shaped building and the western range. The southern arm has a fully hipped new roof. The wall has a recently inserted door sized opening. The quoins are dressed with huge stone blocks.

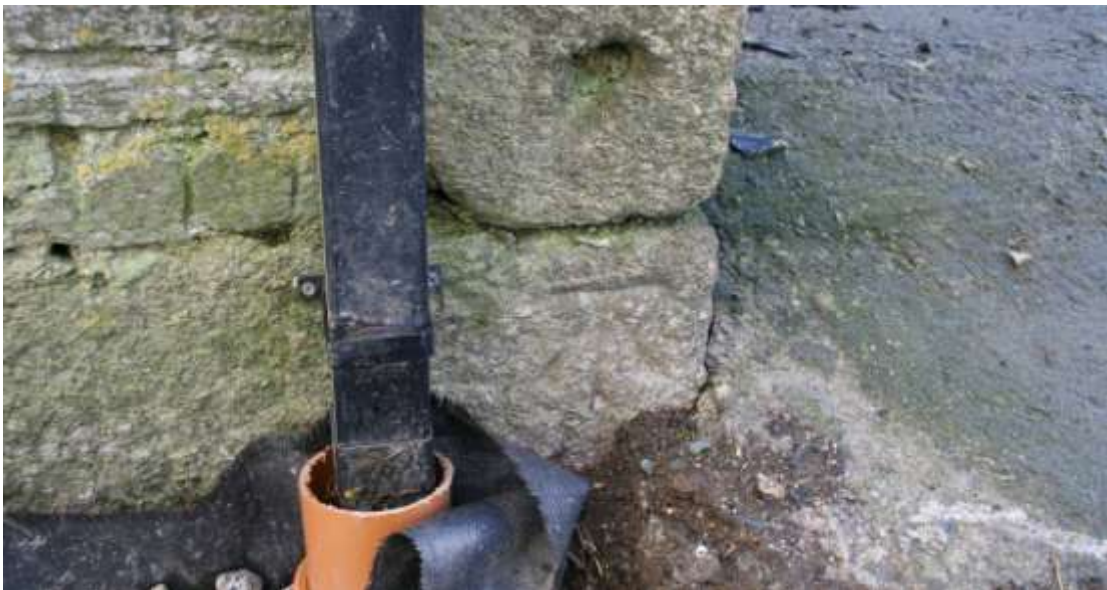
Ordnance Survey benchmark on the NE corner of the southern arm.

Of interest is the benchmark carved on the SW corner by the Ordnance Survey and shown on their maps.

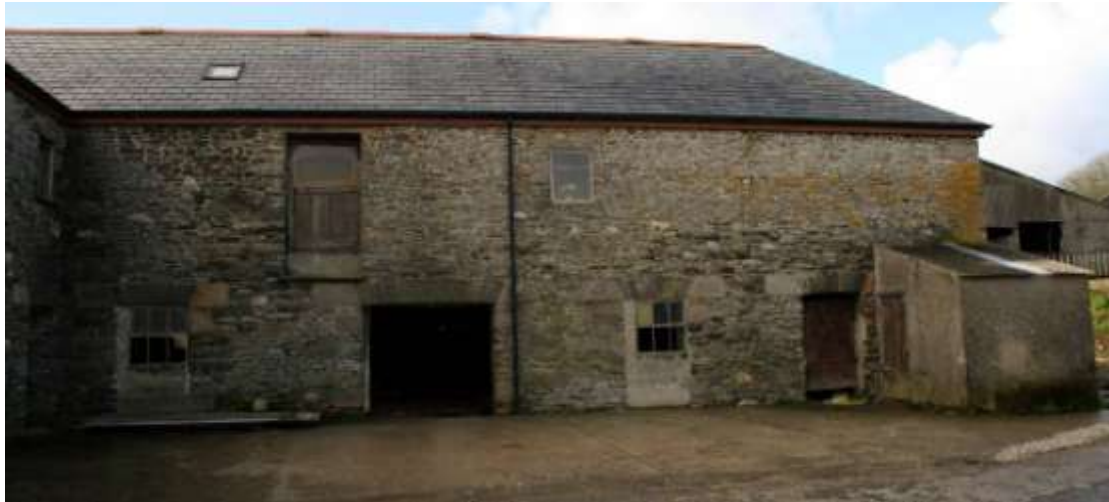
Southern elevation of the western range.

The southern elevation of the western range has a 6ft (1.83m) wide off-central opening with a granite block segmental gauged flat arch. There are three 36in wide doors with similar segmental heads. Large blocks of granite are set in the jambs and have lead filled sockets for the original pintles.

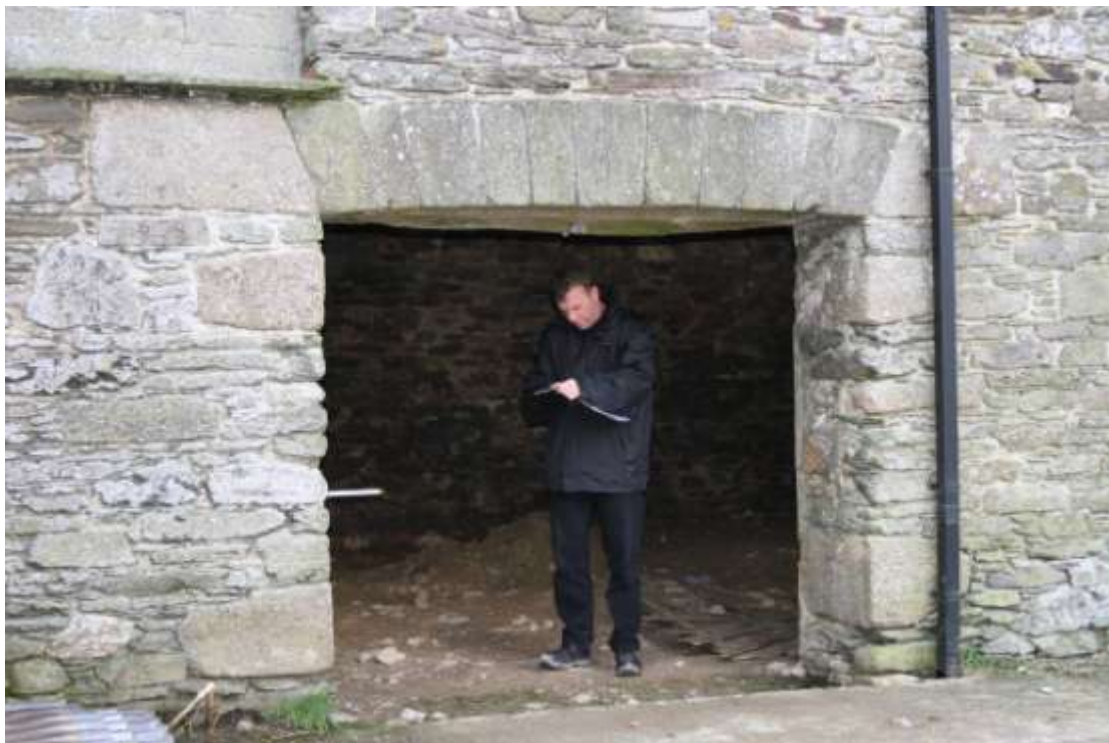
Detail of the main doorway. Figure (BJHC) is 6ft tall (1.83m).

While the doorways are faced with granite voussoirs, the 24in deep walls are supported with oak and elm timber lintels behind the facade. These bear the marks of a pit saw. The main door is a modern galvanised steel sliding door. The two adjacent doorways have been filled with blockwork and C20th rolled steel casements.

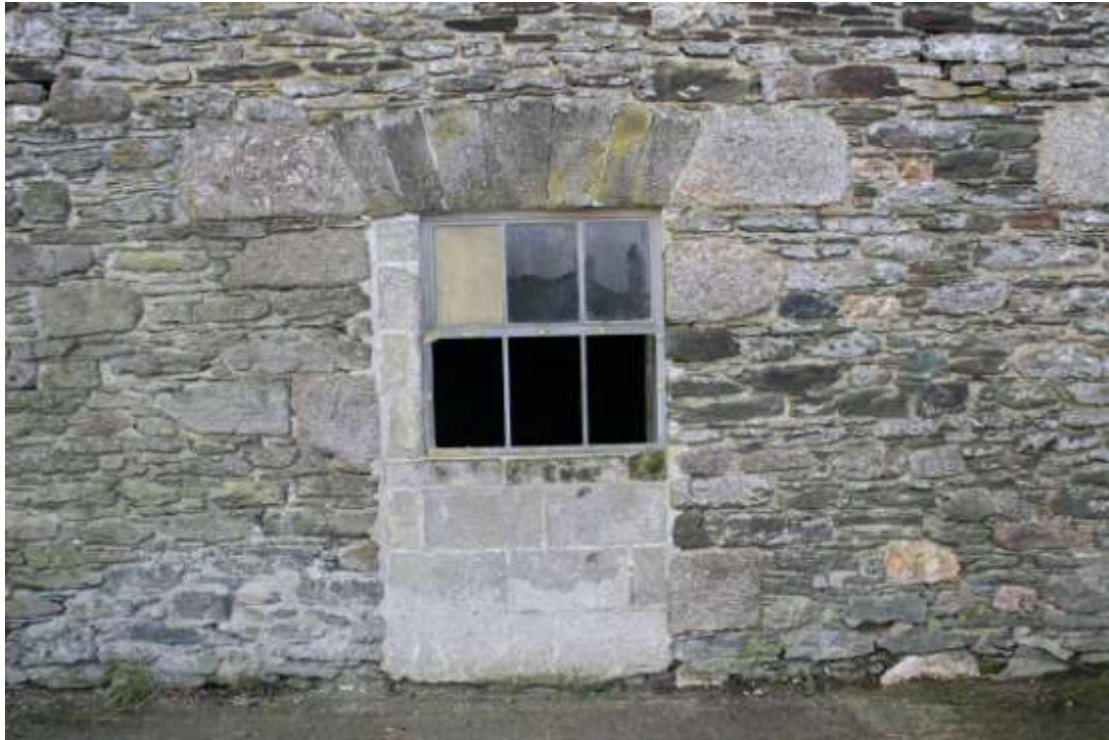
Blocked in doorway with C20th rolled steel casement.

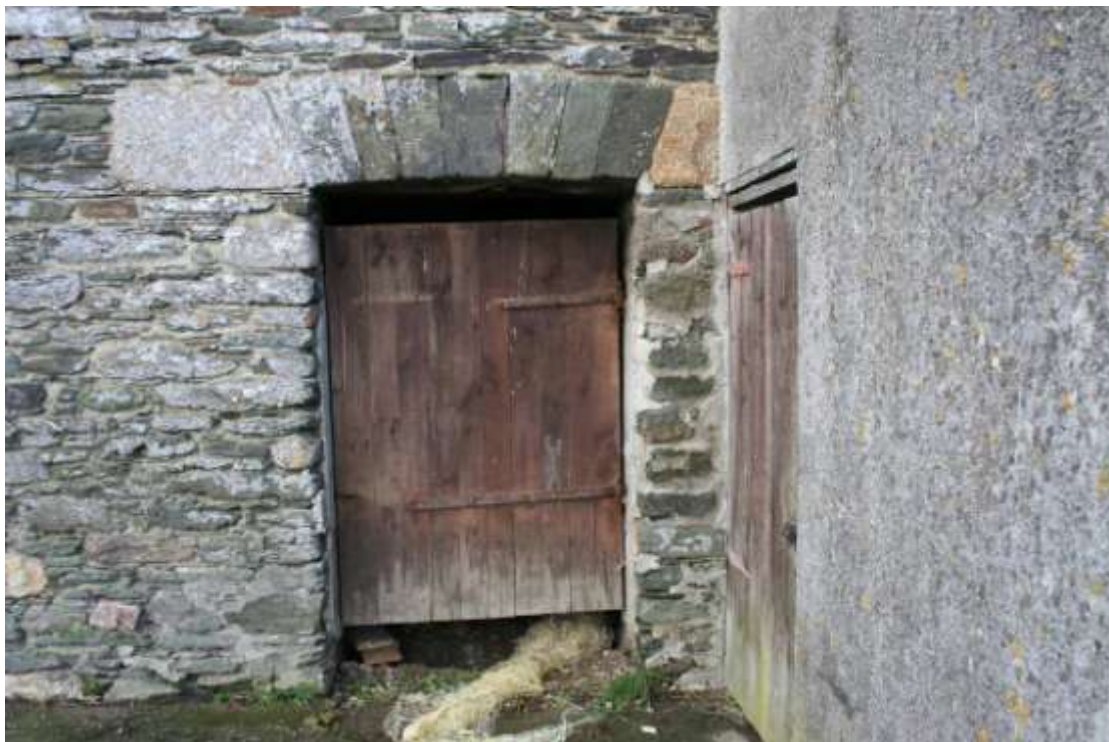
The northernmost door on the eastern elevation.

The northernmost doorway has a C20th vertically boarded gate and ledger softwood door hung on mild steel pintles which are not a pair. The door is identical in construction to that of the Store which is LC20th.

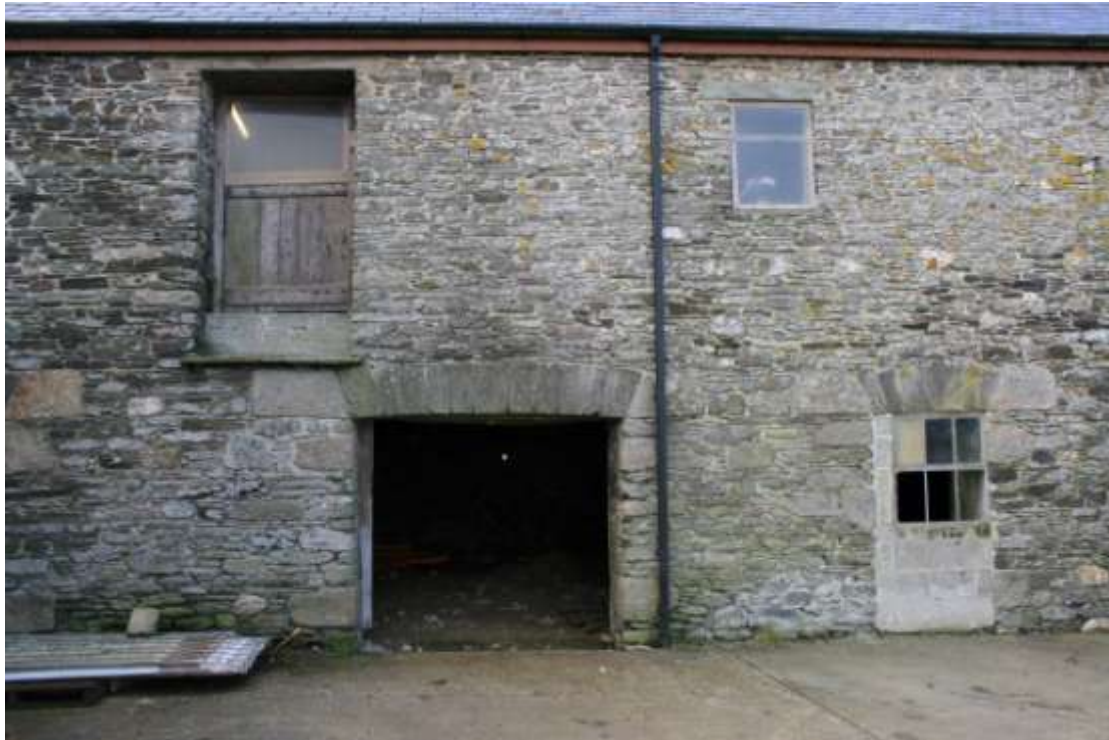
The doorway above is awkwardly inserted. The window is recent.

Above the main doorway there is a full height opening for a door to the granary floor. This has been reduced with blockwork and indicates the position of the new internal floor. The upper part of the door is made from a light frame and sheet plastic. While the lower section looks old it is fixed with French nails and has mild steel reversible hinges. It is also hung backwards with the ledgers facing out. The position of the doorway is awkward and appears inserted. It corresponds with the main doors to the upper floor on the other side of the building.

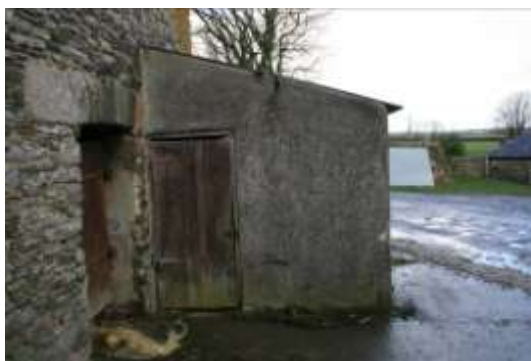
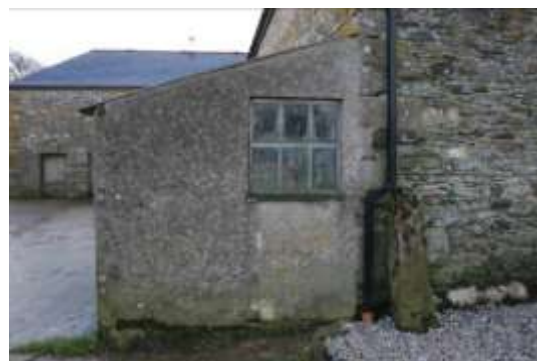
The Store from the south and north. Built of blockwork with a rolled steel casement.

The store is a C20th lean-to built of blockwork with a corrugated asbestos roof. It is rendered with hard cement.

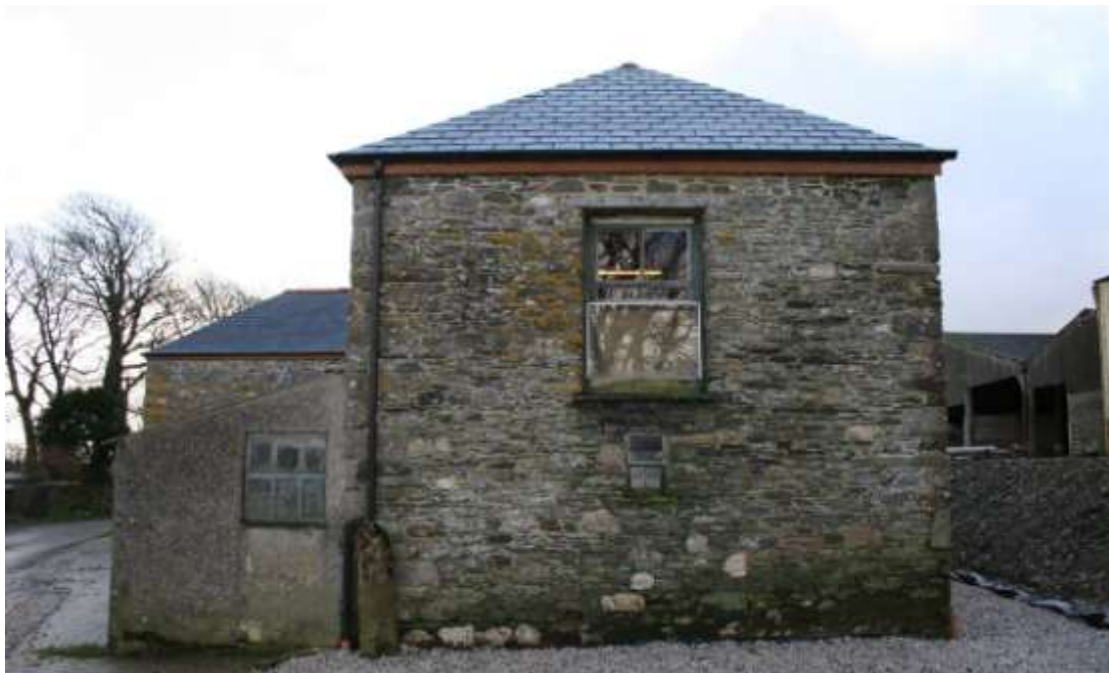
The north elevation of the western range.

In the north elevation there is a large central timber casement in very poor repair temporarily covered with a modern sheet of aluminium framed glass from a cabinet. The window is full height and the joinery matches that of the rear main door (west elevation). In fabric and form it is LC19th. On the ground floor there is a small original looking window with a granite lintel and large granite quoins.

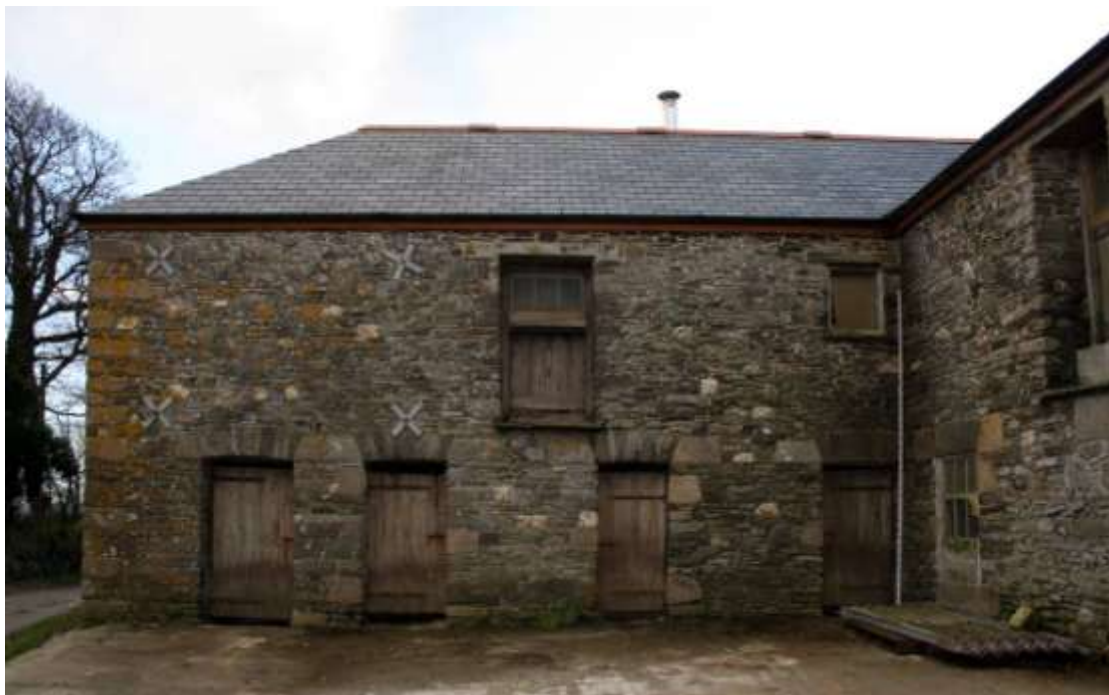
The northern elevation of the southern arm. The doorways vary in width.

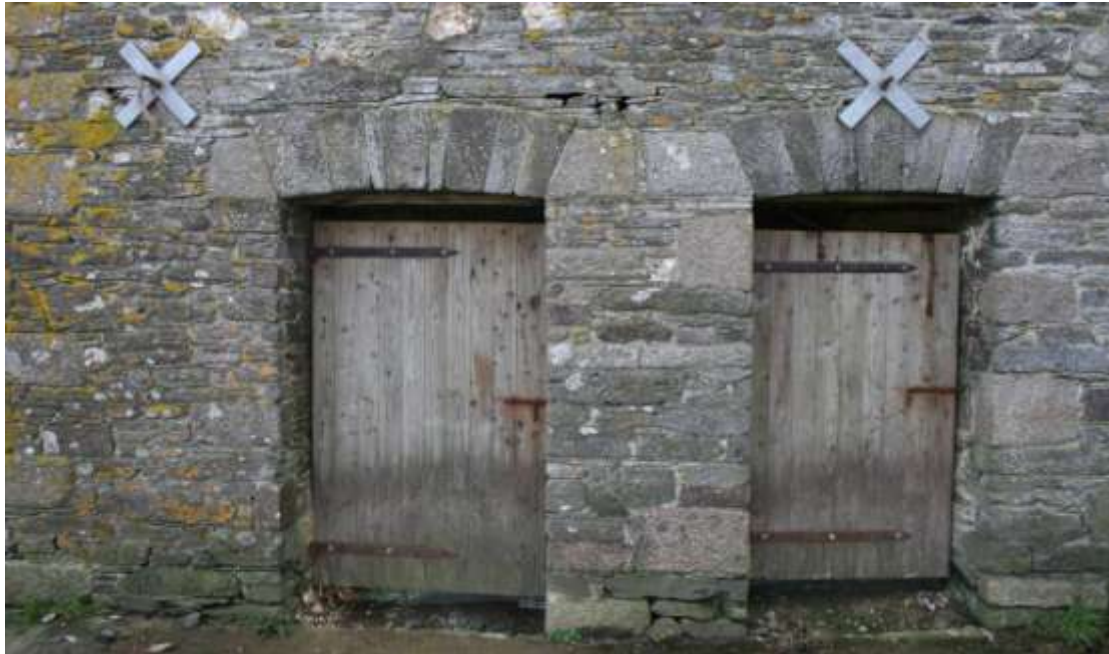
Detail of the doorways. Doors are LC20th.

There are four original doorways with segmental granite gauged voussoirs sprung off large chamfered granite blocks. The doorways are different widths - 36,42 and 48in wide (914, 1067 and 1219mm) indicating a hierarchy of use. The doors are modern vertically boarded softwood with mild steel pintle straps. There are galvanised steel pattress crosses connected to steel tie-rods put in last year to stabilise the building. There is no internal floor in this arm.

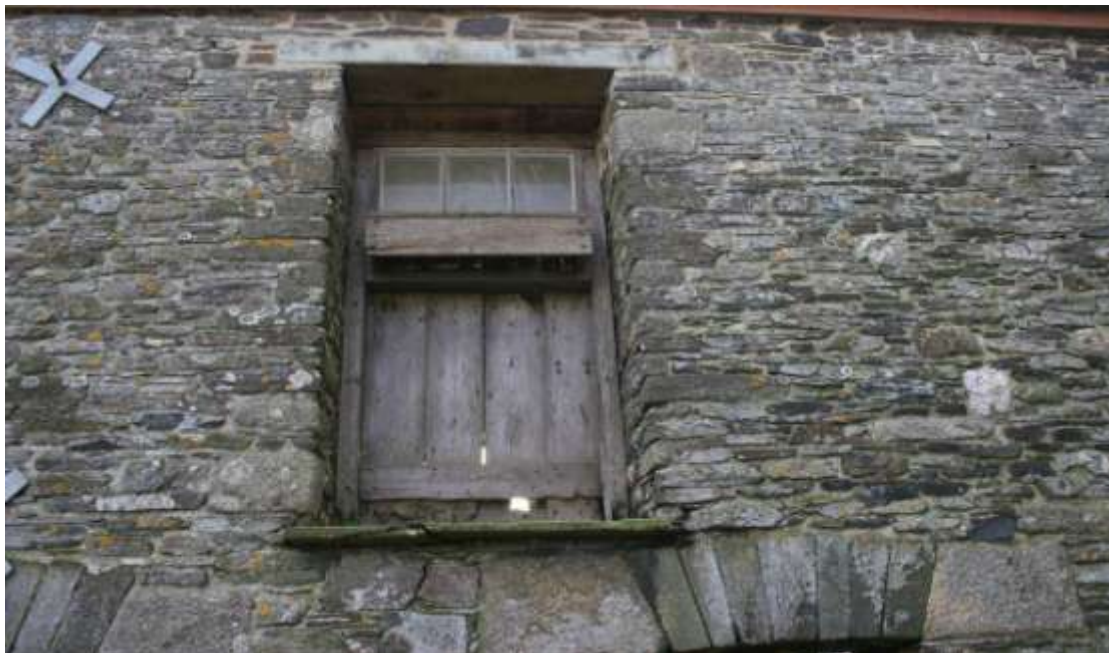
Detail of the upper doorway.

There is another awkwardly positioned upper doorway infilled with a modern makeshift frame and three light casement.

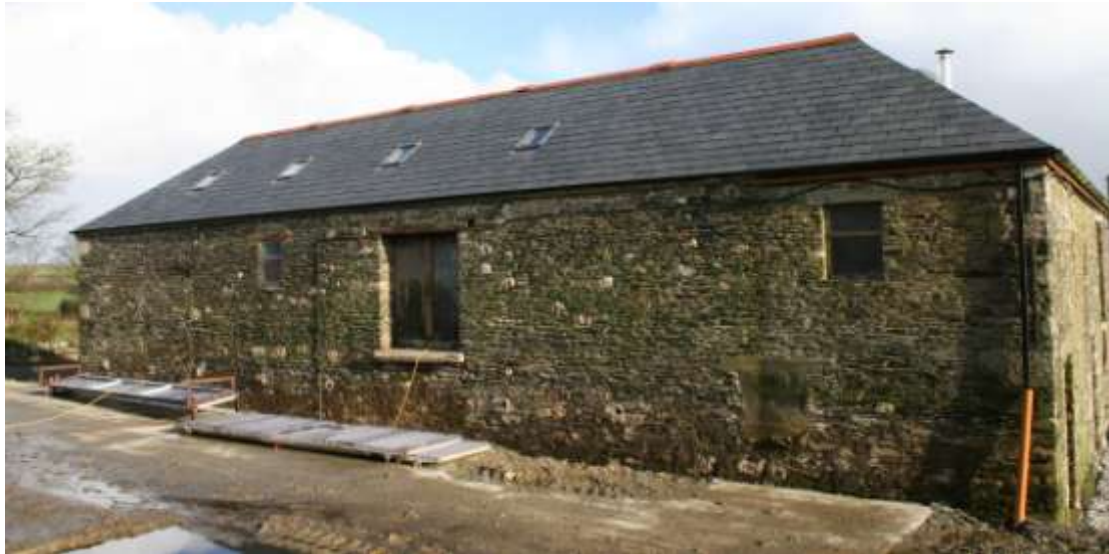
The ground has been excavated away from the west elevation to reveal a blocked window.

The western elevation has a large central double door with a timber lintel and a granite cill. The doorway has no granite quoins and is probably inserted. Until recently the ground level was just below the cill and the stain of the soil can be seen right across the building. Surprisingly there is a blocked window below the stain with a granite cill. The medium density blocks are C20th and show the level was raised in the C20th.

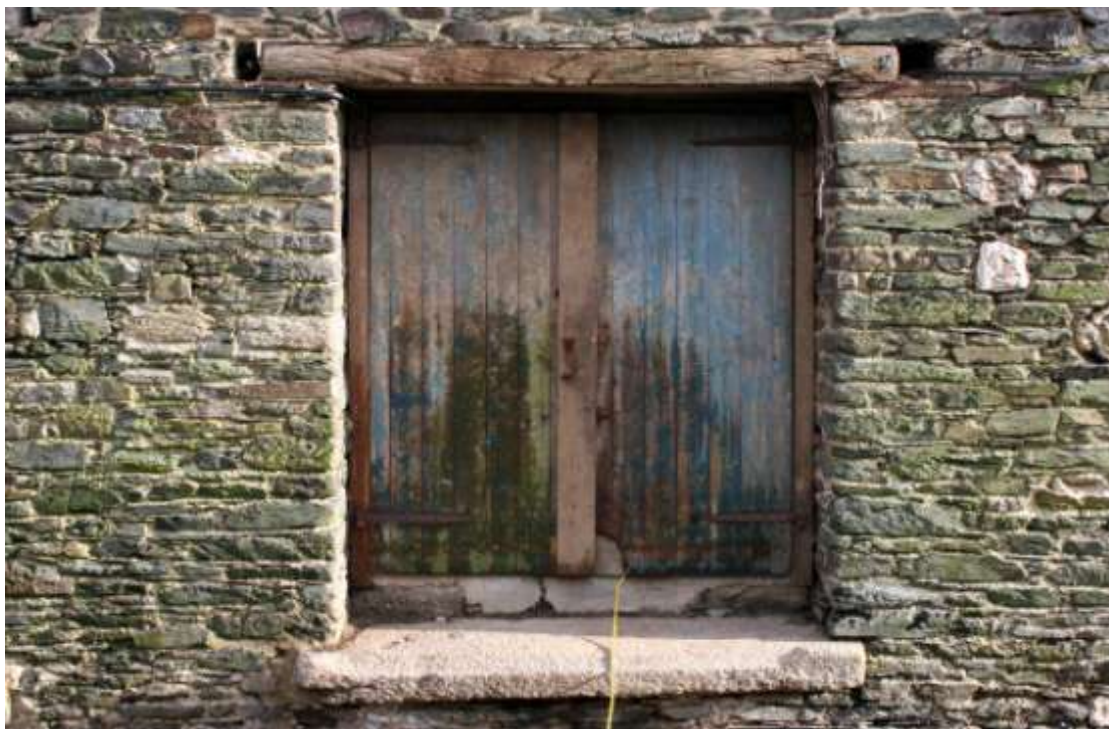
Detail of the central door. Note also the regular coursing of the stonework.

The coursing is very regular on this elevation and it can be seen that the building went up in 12in (305mm) lifts and was levelled with riven slates.

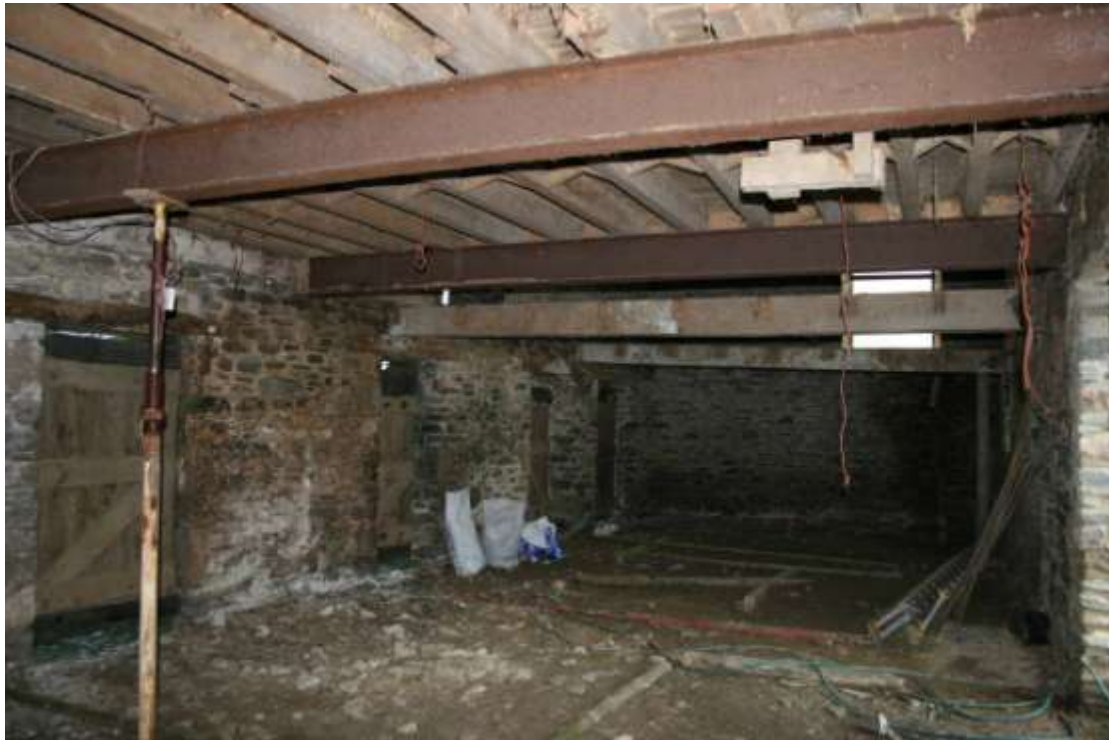
Standing in the SW corner looking E. Circa.1960 steel supported softwood floor.

In 1960 the granary floor was replaced using RSJ's and modern softwood. Lack of money at the time meant that not all the floor was replaced leaving an open section in the southern arm. The building was used as a Milking Parlour with blockwork partitions and stalls and contemporary machinery. There was a grain crushing machine in the SW corner fed by gravity from the first floor. The southern arm was used as stables. Poultry were also kept on the first floor.

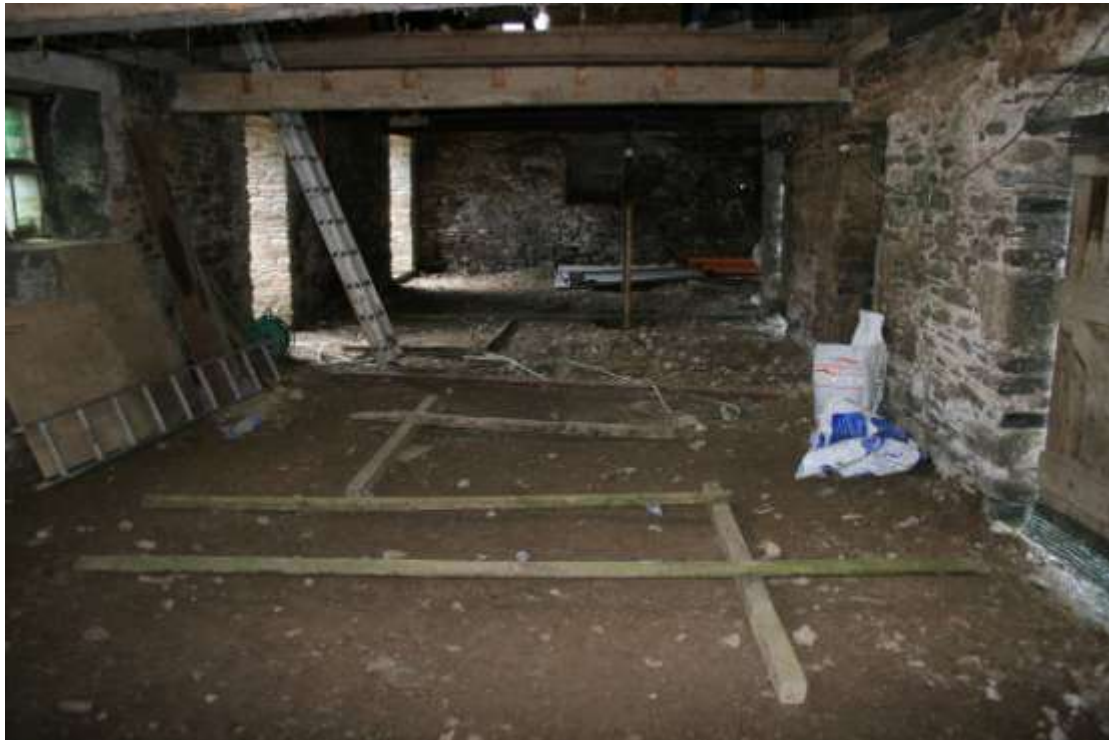
Looking W in the south arm back at the corner above.

Two older joists remain presently doing nothing. Both have pencil marked mortices for the removed joists dating the work to at least the Victorian era.

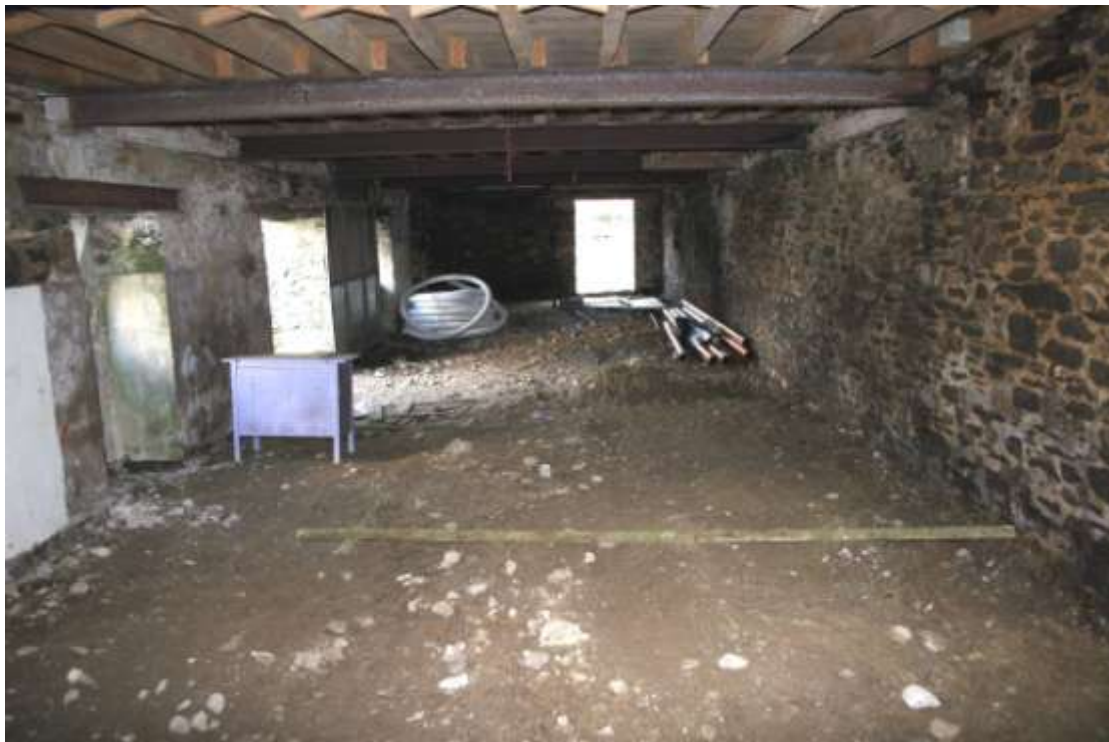
Looking S down the western range.

The building has been stripped of its Milking Parlour fittings and has only a rough earth floor mixed with local stone rubble. The granary floor is constructed of RSJ's marked 'Dorman Long & Company Ltd Middlesborough England' and 2x8in (51x 203mm) softwood joists with red merchant's marks R-P-L-A. There are similar RSJ's in the lintels of the narrow doorways. The floor is finished with tongue and groove boards and braced with diagonal noggins.

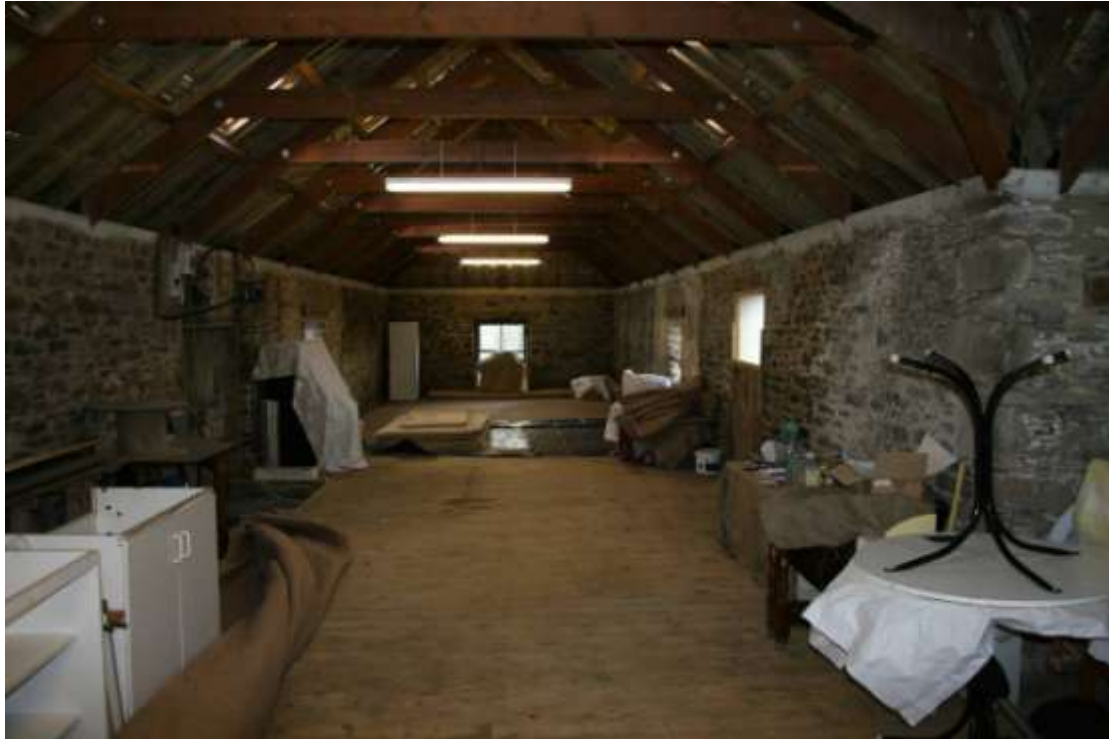
Standing in the SW corner looking N. Note modern roof and floor.
