SUMMARY SHEET

Site name/Address: Trefranck Farm, St Clether, Cornwall, PL15 8QN.	
Parish: St Clether	District: Launceston
NGR: SX 20360 84907.	Site Code: N/A
Type of Work: Historic Building Recording	Director/Team: Barry Hillman-Crouch
Date of Work: 28 12 2011	Size of Area Investigated: 100x100m
Location of Finds/Curating Museum: N/A	Funding source: Owner
Further Seasons Anticipated?: No	Related EHER Nos:
Final Report: Trefranck Farm, St Clether, Cornwall, PL15 8QN. Description and analysis of a stone built barn SW of the farmhouse. Surveyed 28 12 2011. Barry J Hillman-Crouch MStPA DipFA BSc HND.	
Periods Represented: C18th - C20th	
SUMMARY OF FIELDWORK RESULTS: Trefranck Farn Barn retains the plan and overall appearance of a building erected near the turn of the C19th. It was built as a granary and water mill. Only the stone shell is original and this has been altered significantly in the C19th and C20th with new openings. The water wheel was removed in the LC19th and a remote wheel installed in the field east of the Farmhouse to drive the Barn machinery. The granary floor dates to 1960 and a completely new roof was put on in 2002.

Trefranck Farm, St Clether, Cornwall, PL15 8QN.

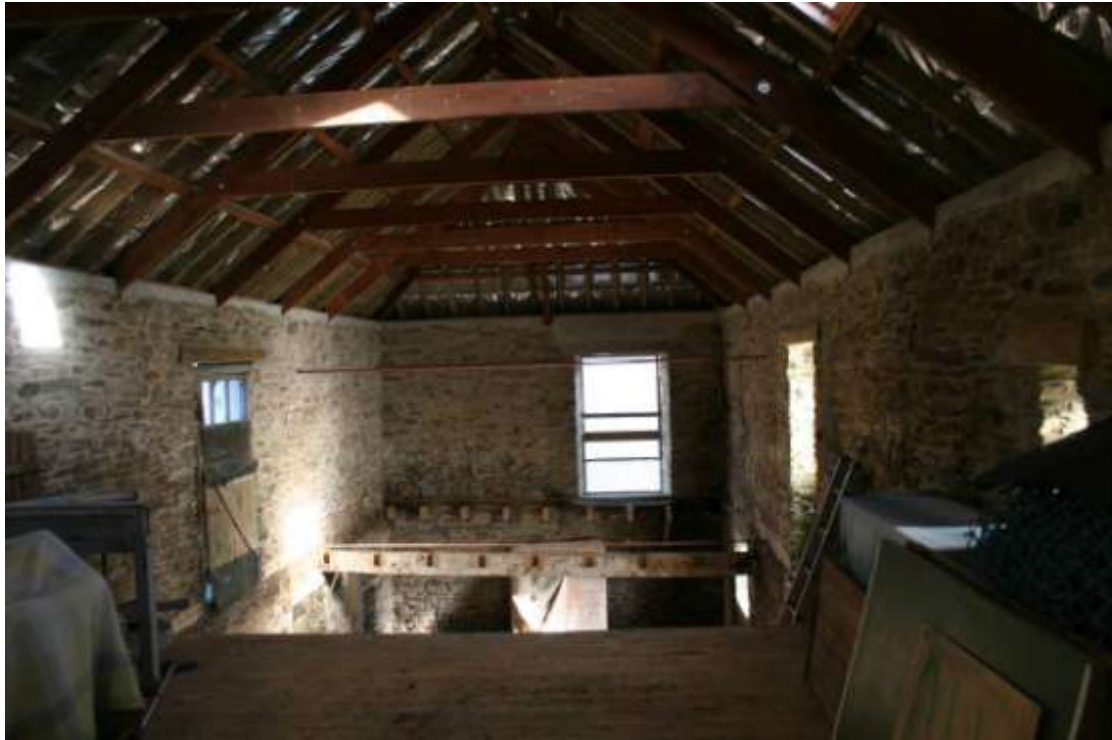
Standing in the SW corner looking E. This section lost its floor in 1960 due to budget limits.

In 1960 the granary floor was replaced using RSJ's and modern softwood. Lack of money at the time meant that not all the floor was replaced leaving an open section in the southern arm. The building was used as a Milking Parlour with blockwork partitions and stalls and contemporary machinery. There was a grain crushing machine in the SW corner fed by gravity from the first floor. The southern arm was used as stables. Poultry were also kept on the first floor.

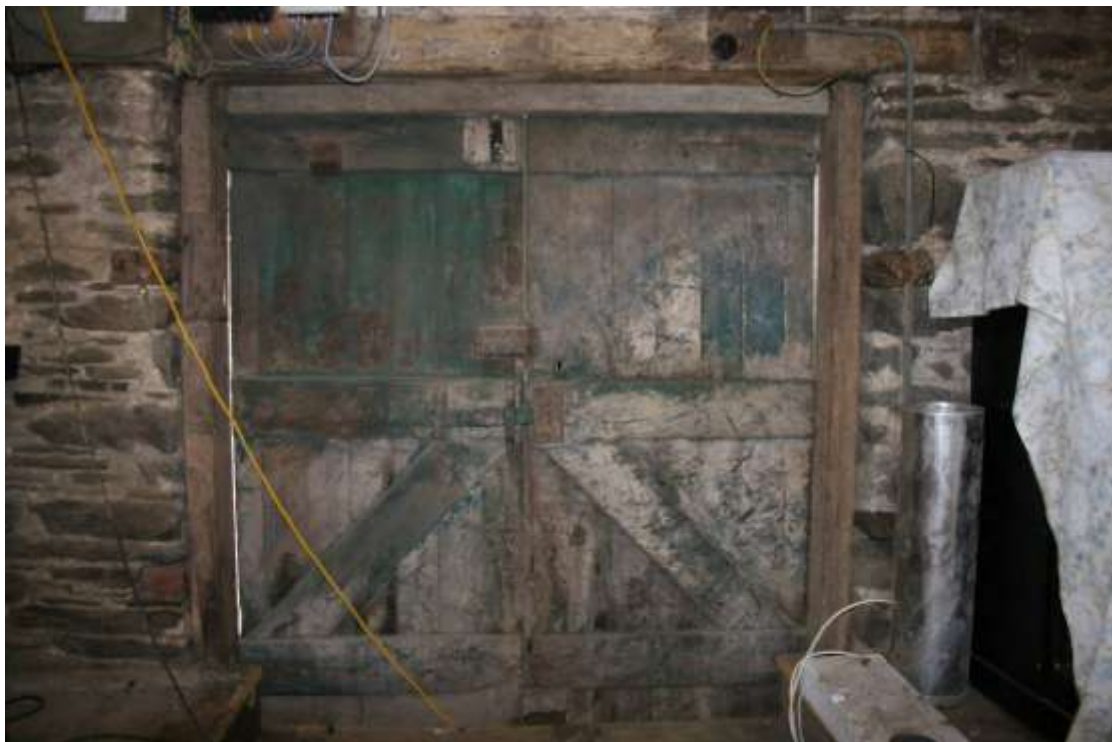
The main doors on the western side.

The only fixture of any age is the pair of main doors in the western wall. These are tongue and grooved, gate and ledger doors hung on mild steel pintles with a pressed steel lock box. The pattern is LC19th or Edwardian.

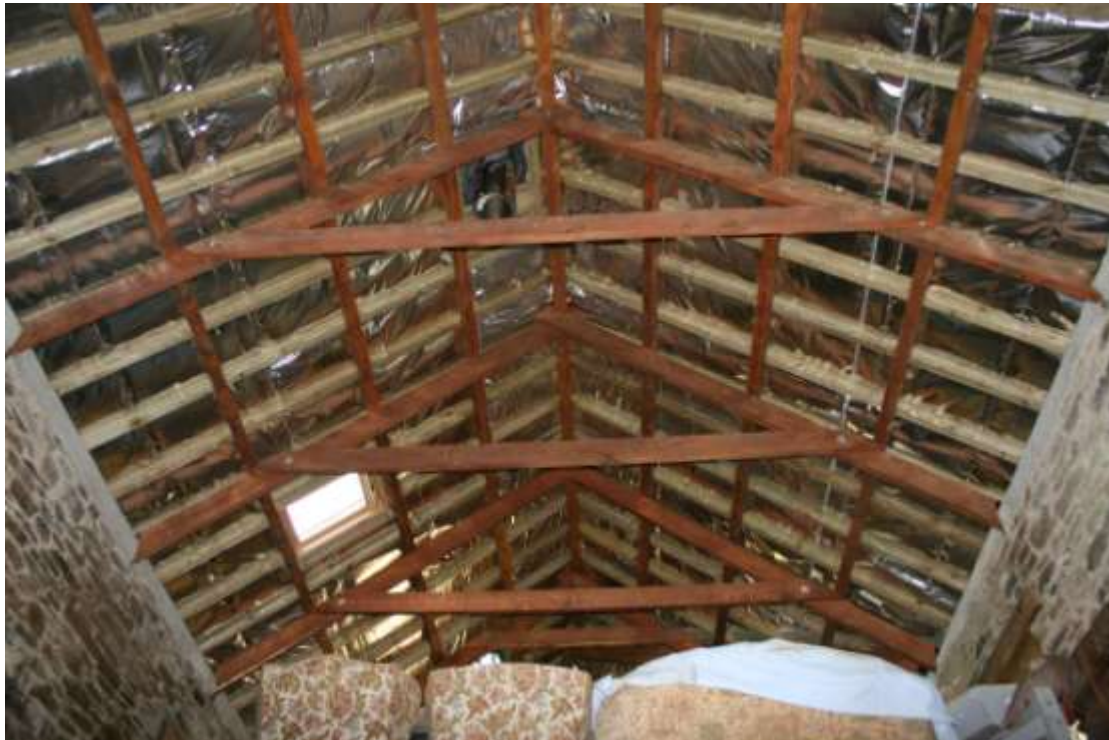
Roof over the south arm looking W. Velux roof light, stainless steel flue and light pipe.

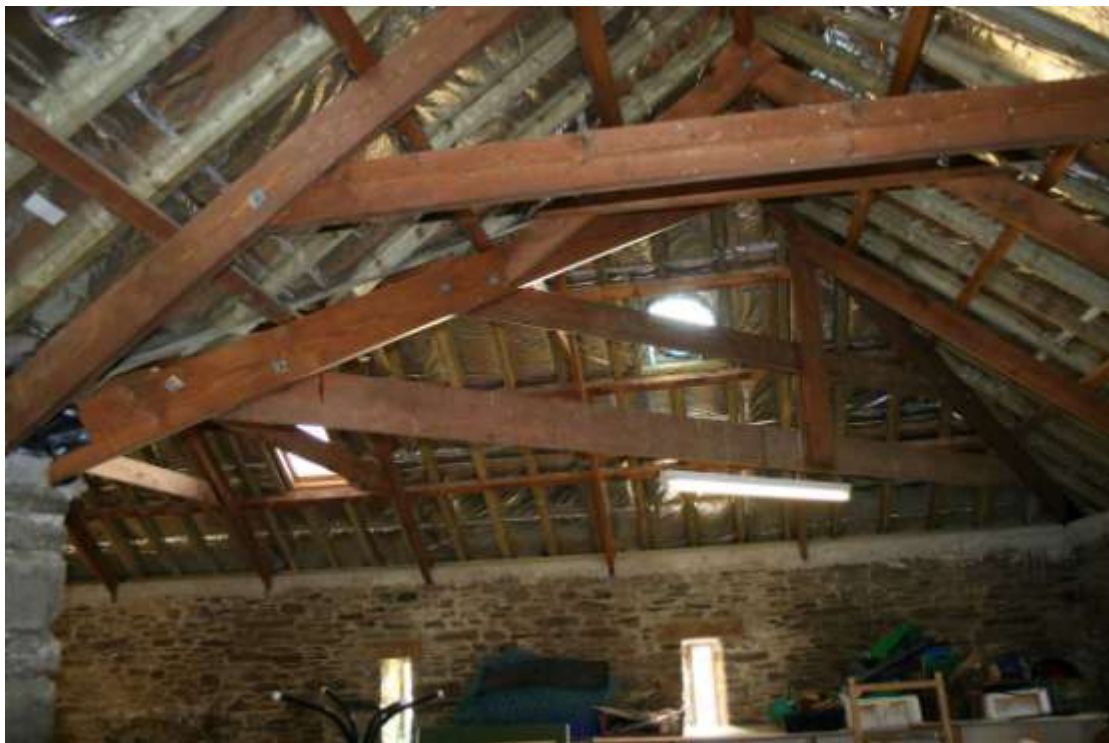
The junction of the roof in the SW corner looking S.

The roof is a bolted softwood construction in imitation of the original (seen in old photos). The dragon truss is quite inventive. Side purlin roof with lapped and bolted collars.
