Crown Inn, Crown Close, Sheering, Essex. CM22 7NX.
Heritage Statement for the Public House. Surveyed 31 01 2017.

The report forms a Heritage Statement outlining the historic importance of the building, identifying the historic features and examines the development of the building from its original inception. The building was Listed in 1984 and large scale alterations took place in 1985. In 1997 permission was given for an extension to the west which was never built.

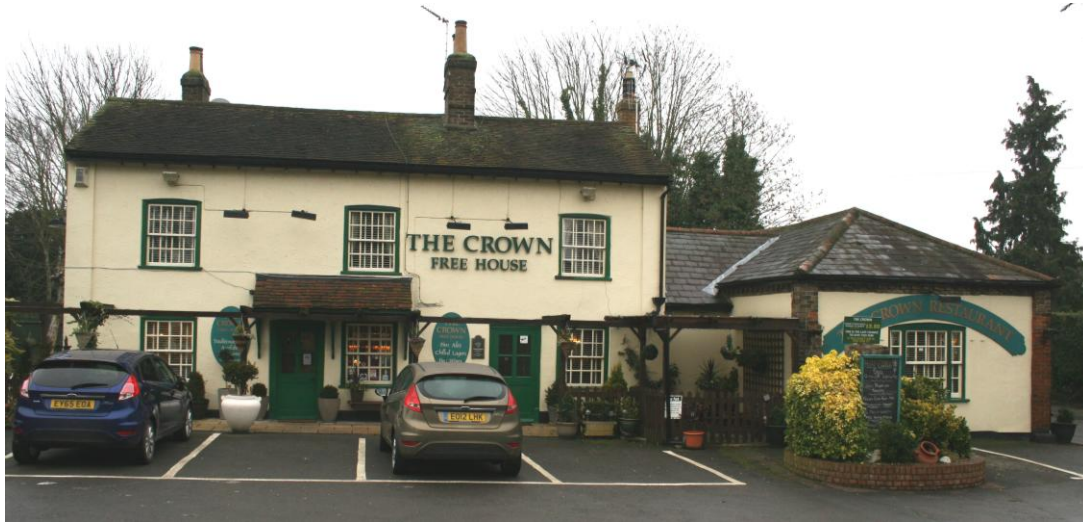
The south elevation is the front of the building. The former Stables has been conjoined.

The House is built of red bricks rendered over in hard cement. The roof has been retiled in plain clay tile and has an asphalt undercloak and repair timbers suggesting the original roof was repaired in the LC20th (1965-1985). The building is symmetrical about the 8/8 sash windows which are all modern replacements except that to the RHS of the right hand (eastern) entrance door which retains its fine astragals and some milled glass panes. The two front doors are C20th in design and fabric and it was noted that the opening for the right hand one is larger than the door itself.

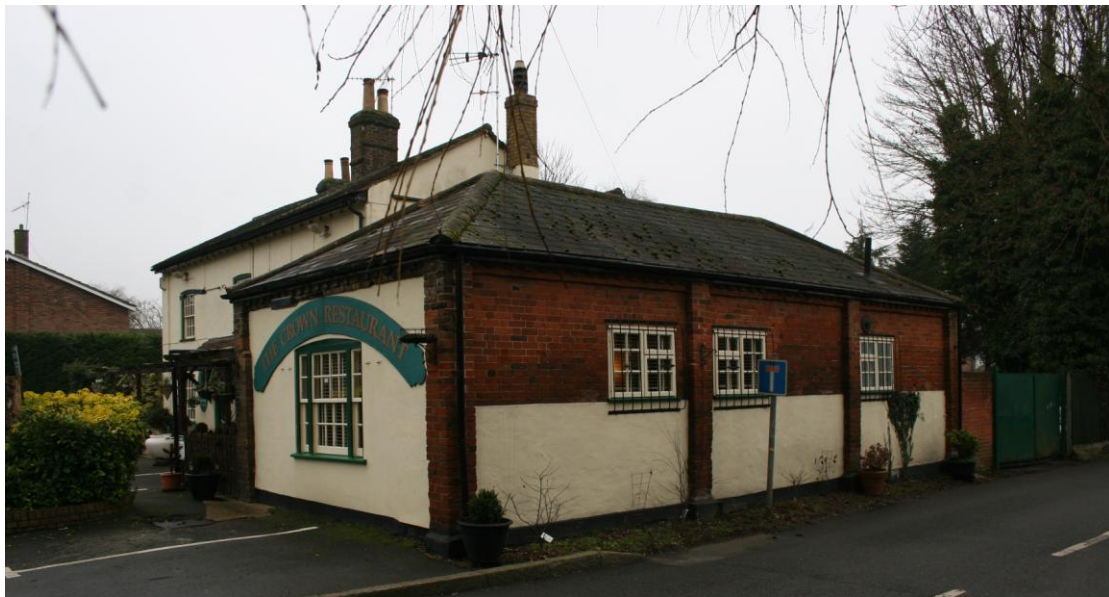
The former Stables seen from the SE.

The Stables was originally a separate building and has three bays of 60-65x115x230mm handmade bricks. This is not a standard size and suggests they were seconds which would also account for their varying colours. All the windows are LC20th and inserted. Historic photography shows that there was another building (Smithy) adjoined to the south end.

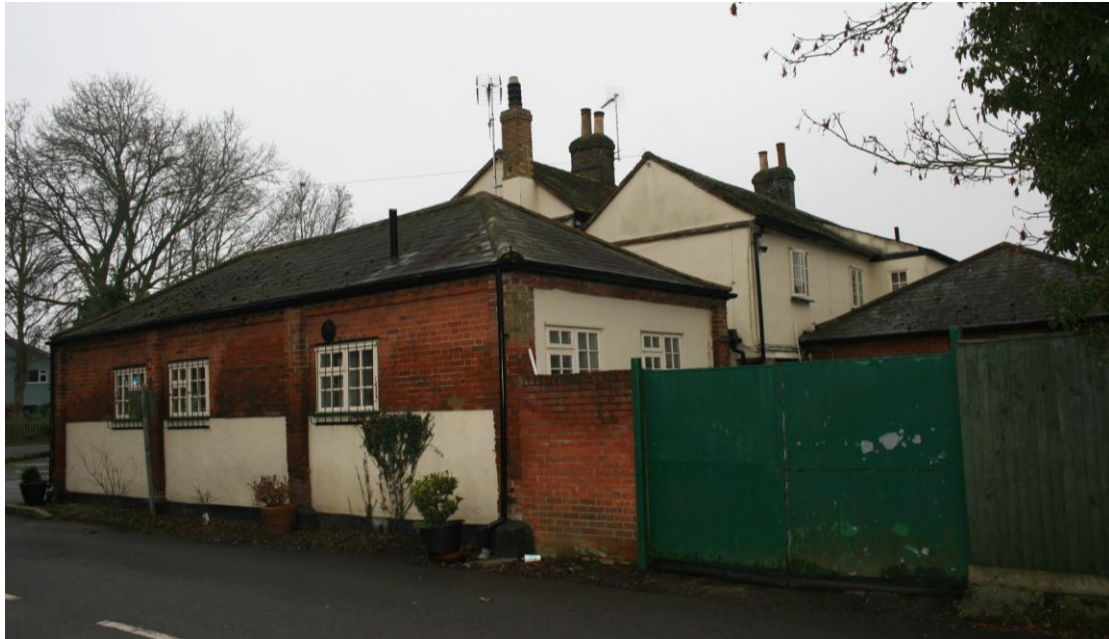
The eastern elevation and the rear of the House looking SW.

The Stables has a grey slate hipped roof at the correct slack pitch and panelled brick wall allowing for large openings. It has been converted, most likely in 1985 according to the planning records, to a dining room and suite of toilets. The rear of the House reveals it is a twin pile house with the rear pile being lower and narrower than the front. This would indicate it was built in two phases and would also account for the awkward disposition of the chimney stacks. The rear windows are 1930's in style and are the type manufactured by Rippers of Sible Hedingham. The aluminium fittings imply they are LC20th versions. Again the walls are rendered except for a section of London Stock style bricks forming a pillar on the corner of the House. Connecting the Stables and House is a flat-roofed structure of 1985.

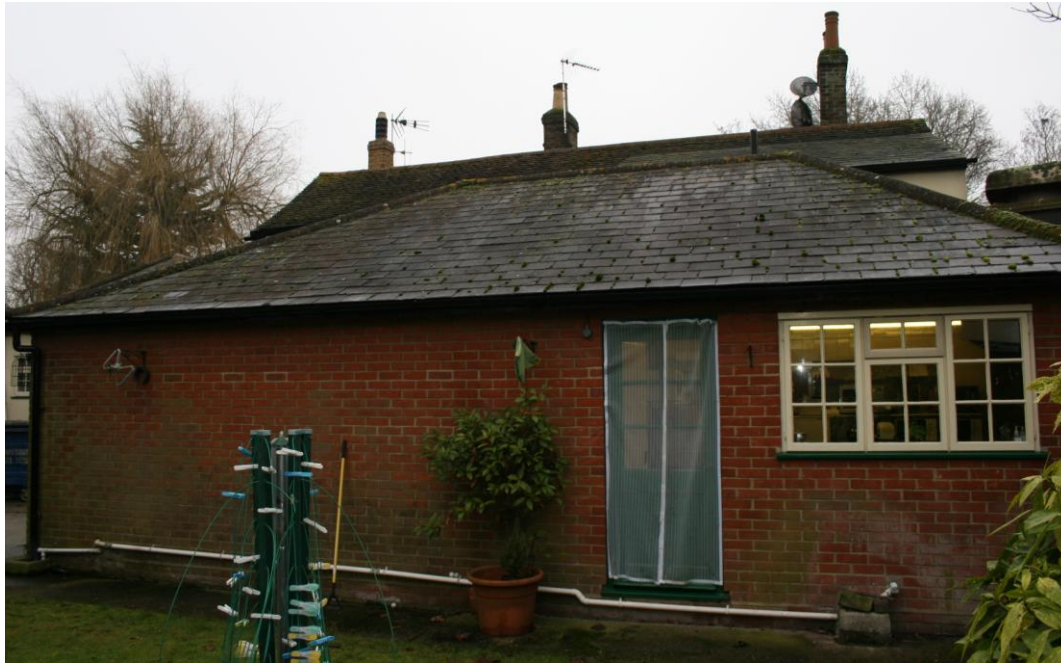
The Kitchen and Cellar. North elevation.

To the north is an adjoined LC20th building housing the Kitchen and the Cellar and stores. This is a brick and blockwork building and again the planning history implies it was built in 1985. All the visible fabric would concur with this. The broad hipped roof is finished with grey slates and the walls have 65x110x225mm machine made bricks.

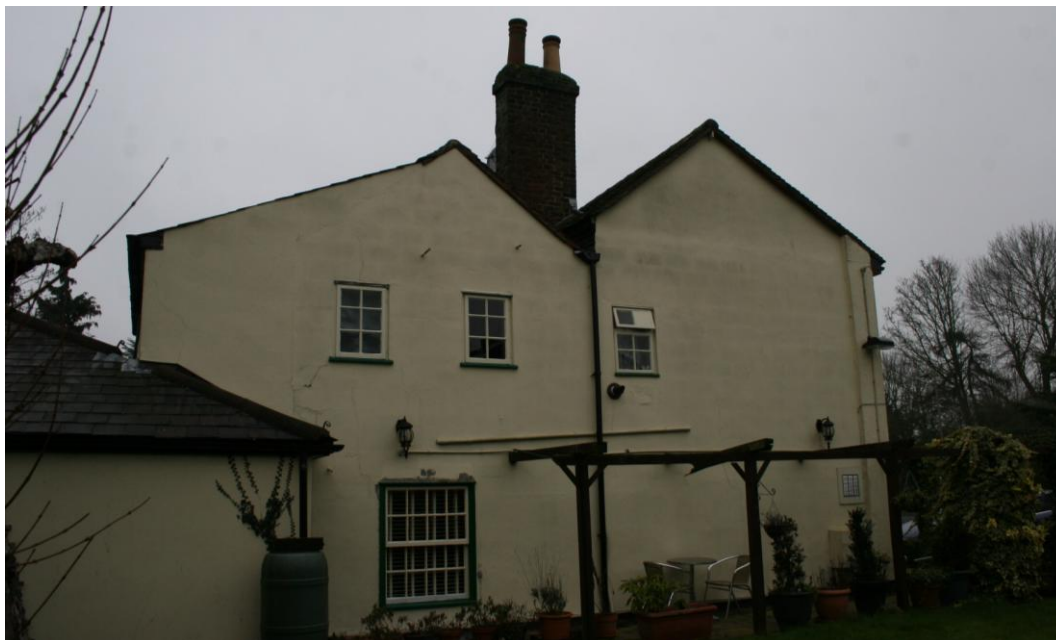
The western elevation.

The twin pile format can be easily seen in the western elevation. The rear pile has an added stair tower and the pitch of the rear roof has been altered to accommodate it. All the windows are LC20th replicas and it is likely that the large 8/8 pane sash shows where the Kitchen used to be.

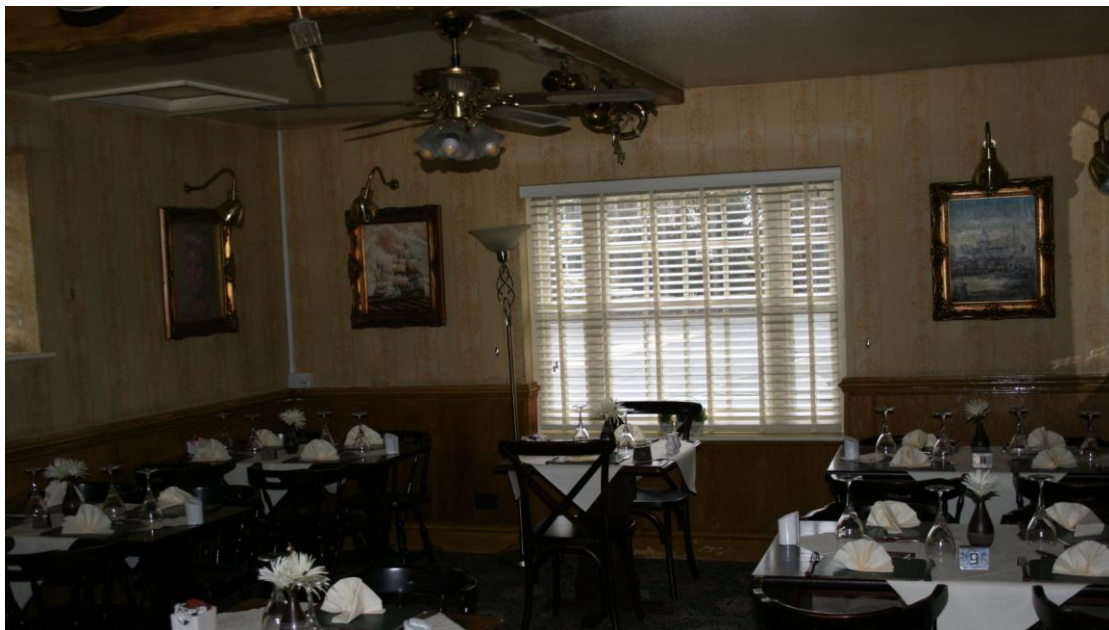
Looking E inside the Stables Dining Room.

Looking S inside the Stables Dining Room.

All the visible fabric in the Stable Dining Room is of 1985 or later. The ceiling is inserted (originally it would have been open to the apex) and the fake beams are secured with visible hex headed bolts.

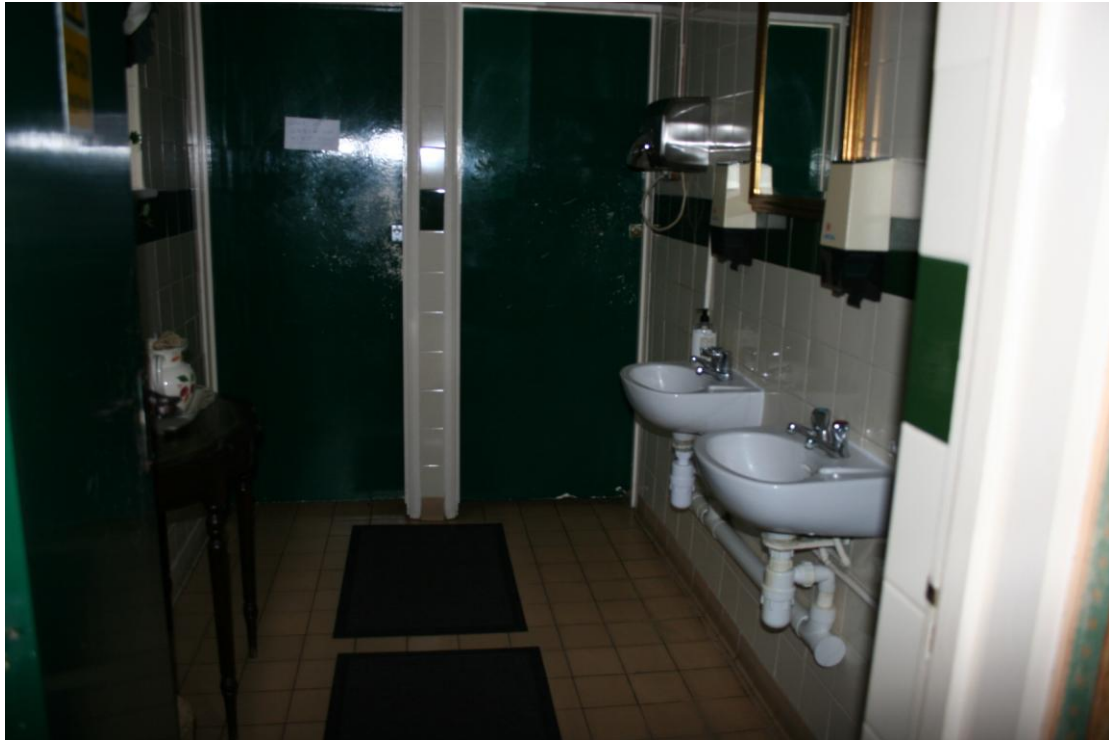
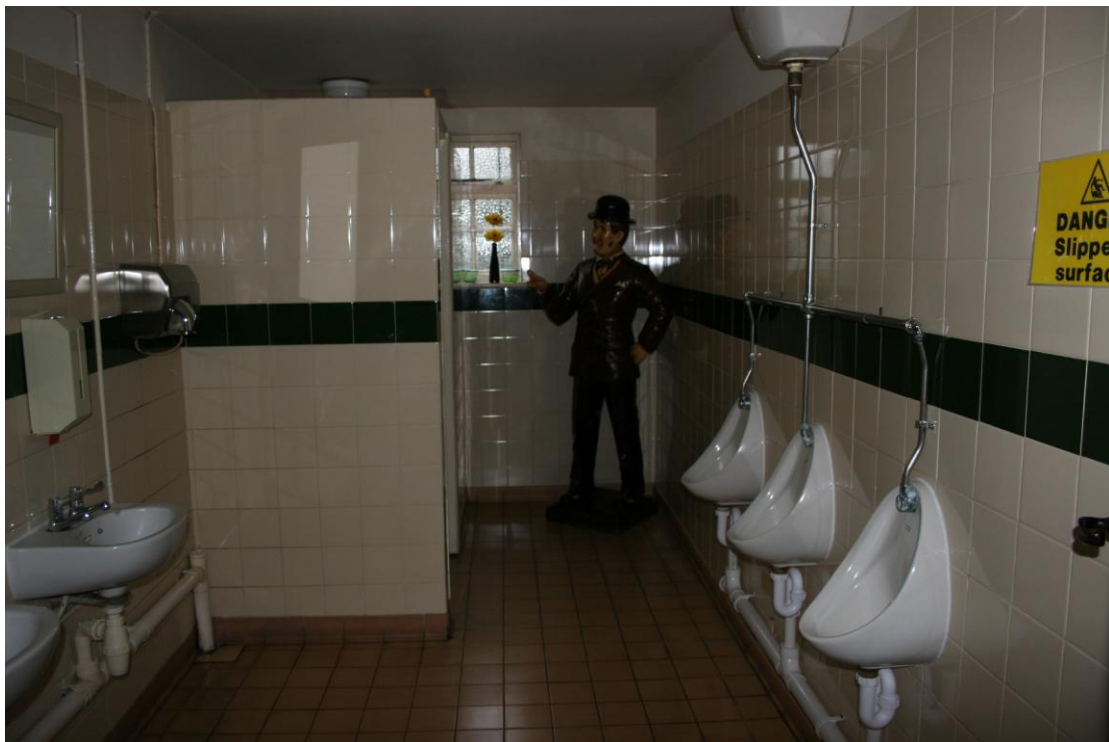
The Ladies WC.

The Gentlemen's WC.

The toilet facilities date to 1985 with later additions and there is no historic fabric on view.

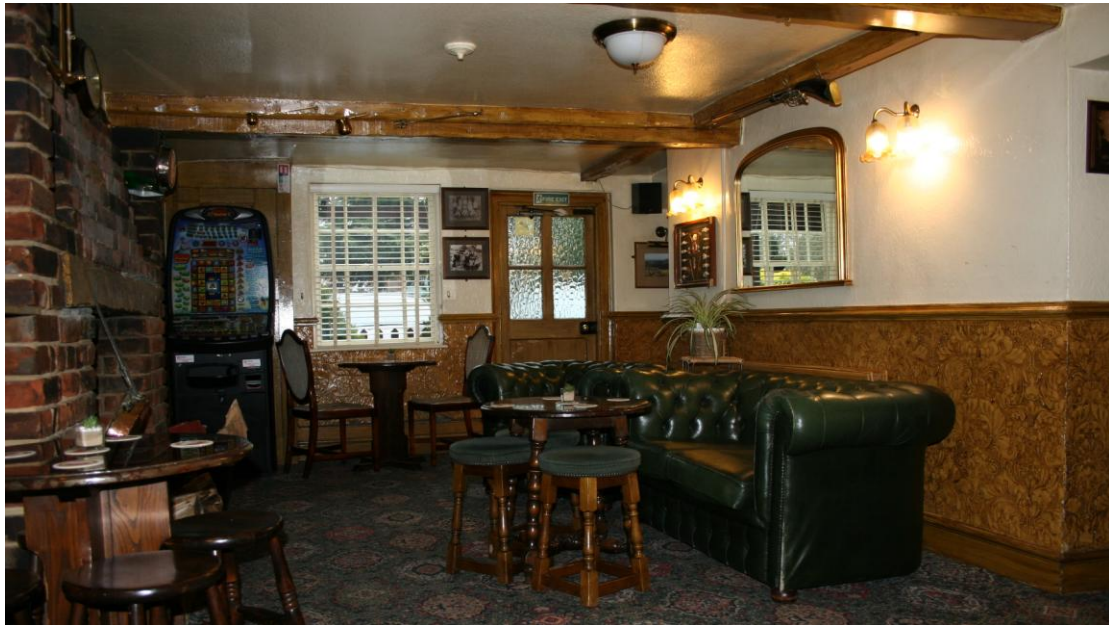
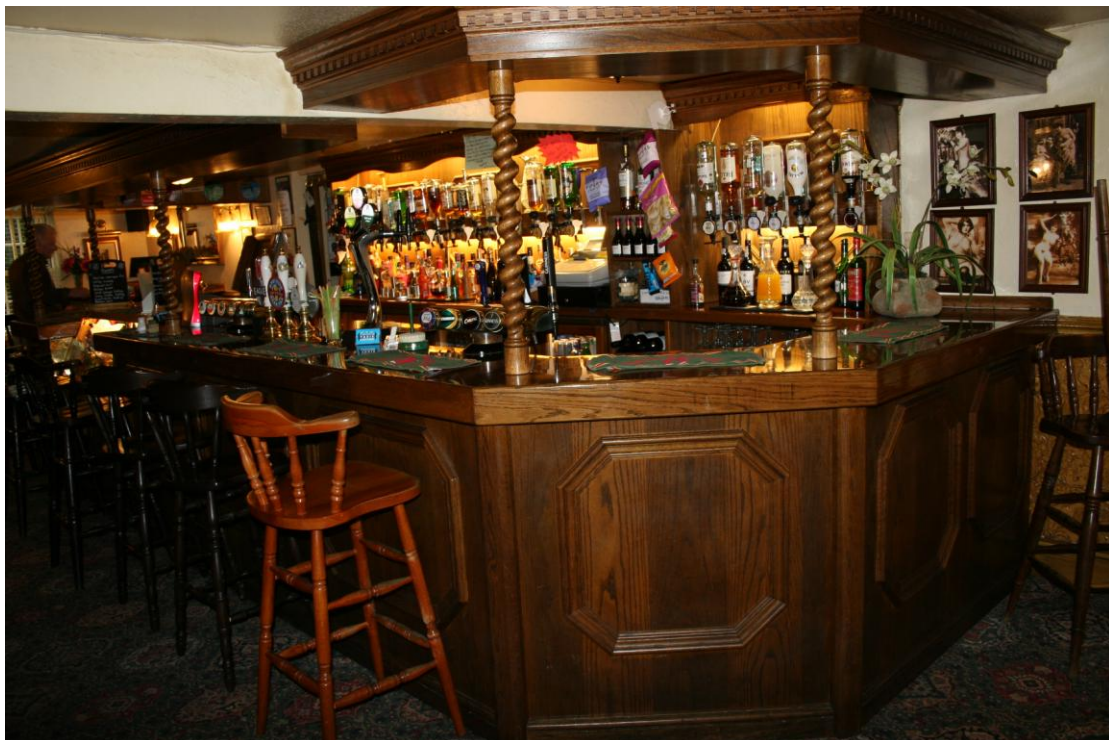
Looking S in the West Bar.

Looking WNW in the West Bar.

In common with many Public Houses the original walls have been removed between the rooms to create a larger open retail area. The openings are spanned by RSJ's hidden in timber boxes. The bar counter and backfitting serves all the retail areas and was put in by the current owner 23 years ago (1994) as an upgrade to one put in during 1985. There are no earlier fittings.

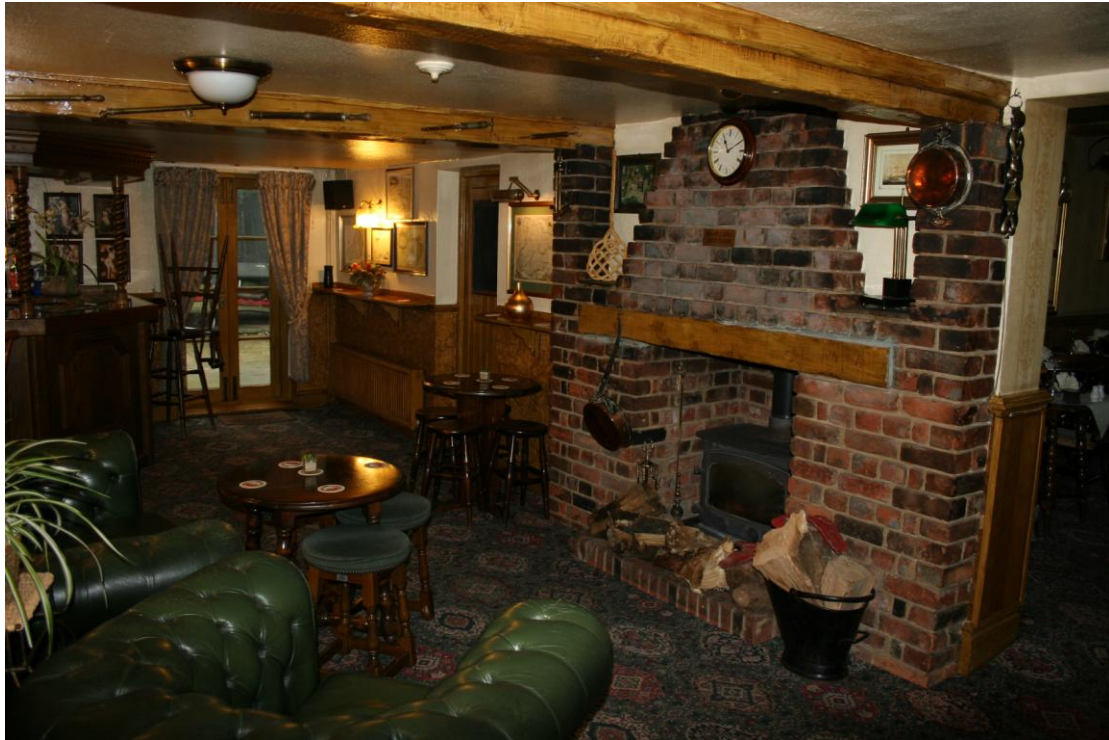
Looking NE at the fireplace in the West Bar.

The Bars can be defined by the ceiling beams and the positions of the fireplaces. None of the fireplaces have original surrounds or fires. That in the West Bar is a complete fantasy of 1985 and incorporates pillars supporting the RSJ's.

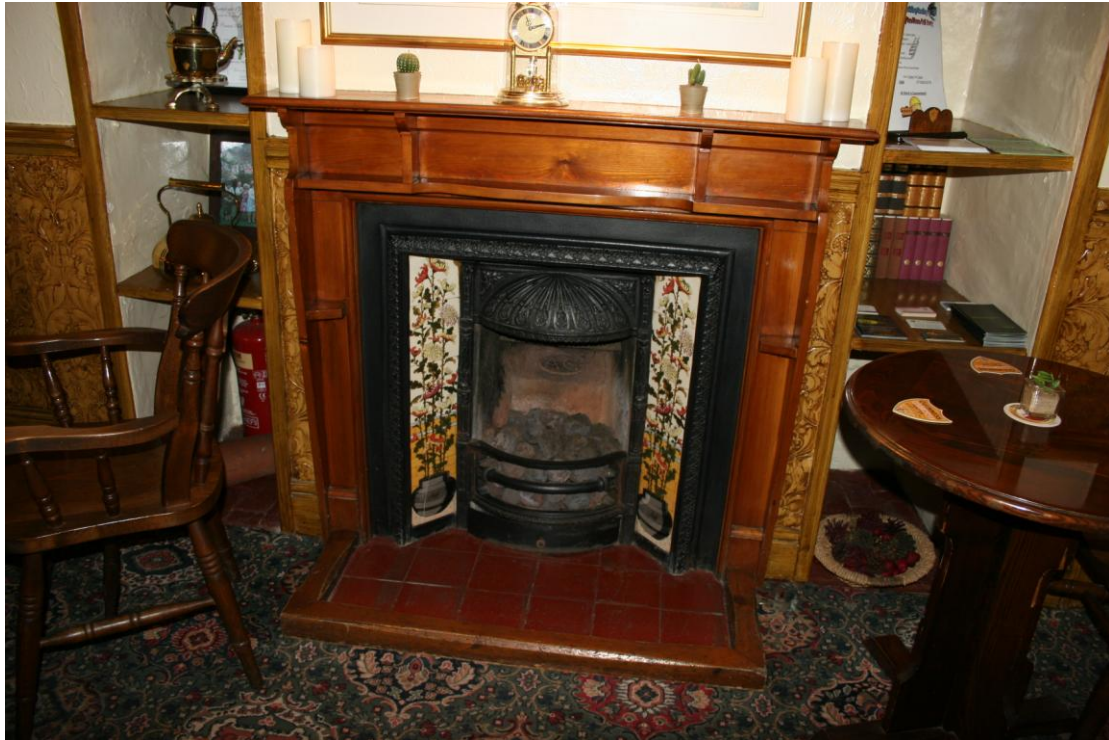
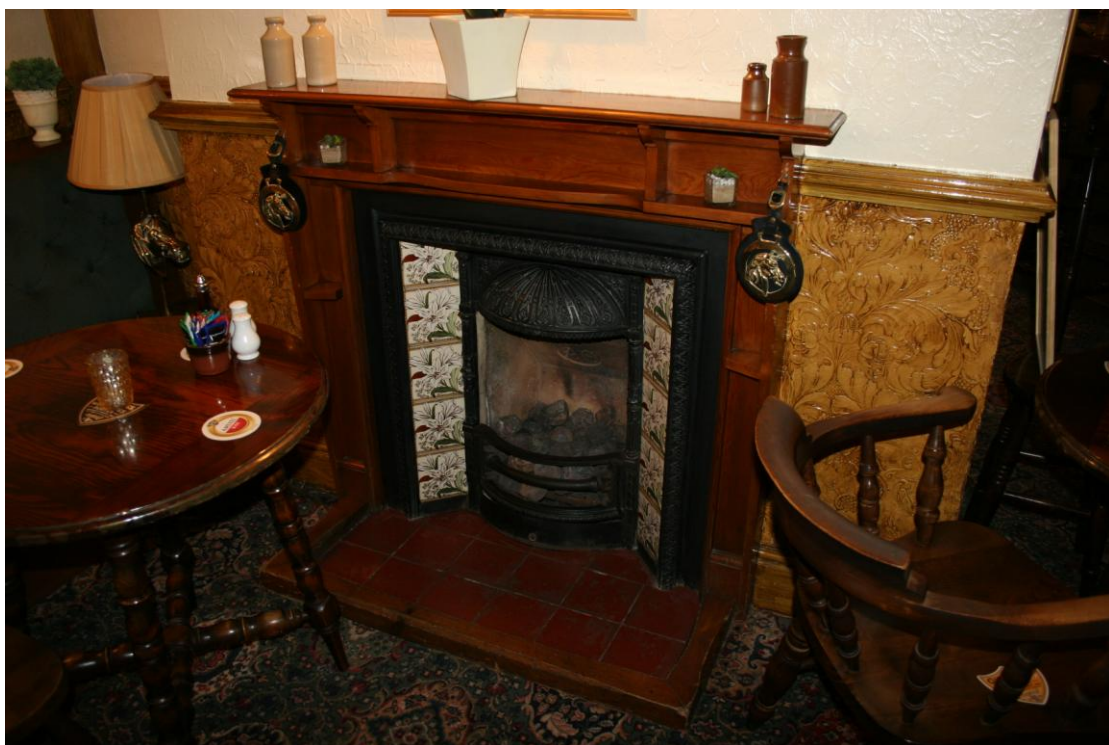
The fireplace in the Central Bar.

The fireplace in the Western Bar.

The other two fireplaces are LC20th copies of cast iron register grates with tiled cheeks and identical timber surrounds most reminiscent of the 1950's. They appear to be gas fires. The walls are decorated with heavily embossed anaglypta style paper in a tobacco stain brown and the timber has been painted and grained in a glossy caramel colour.

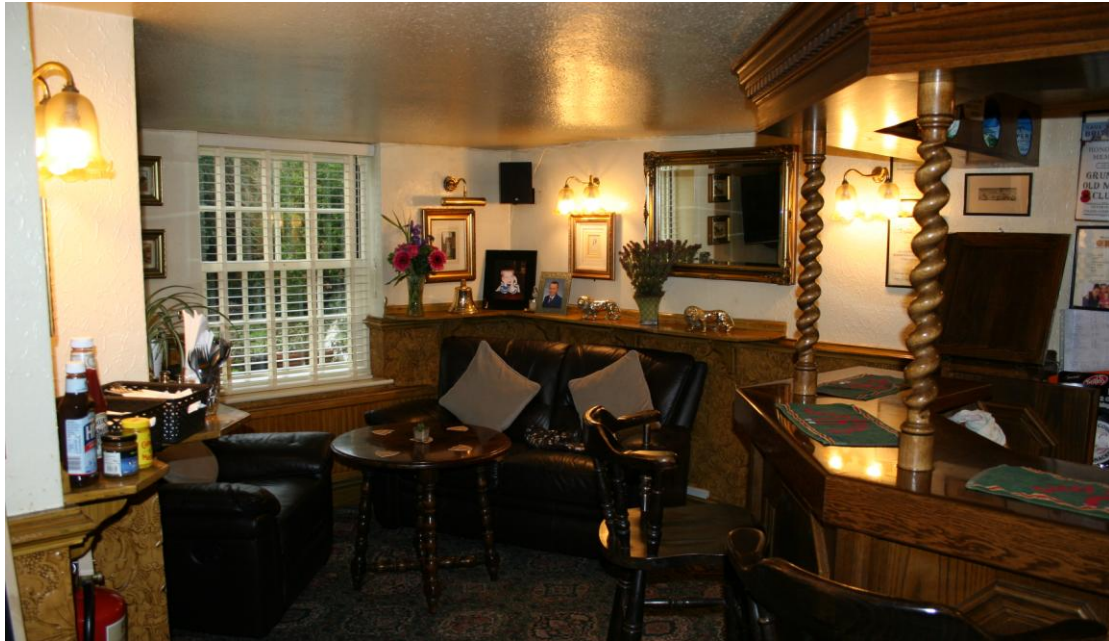
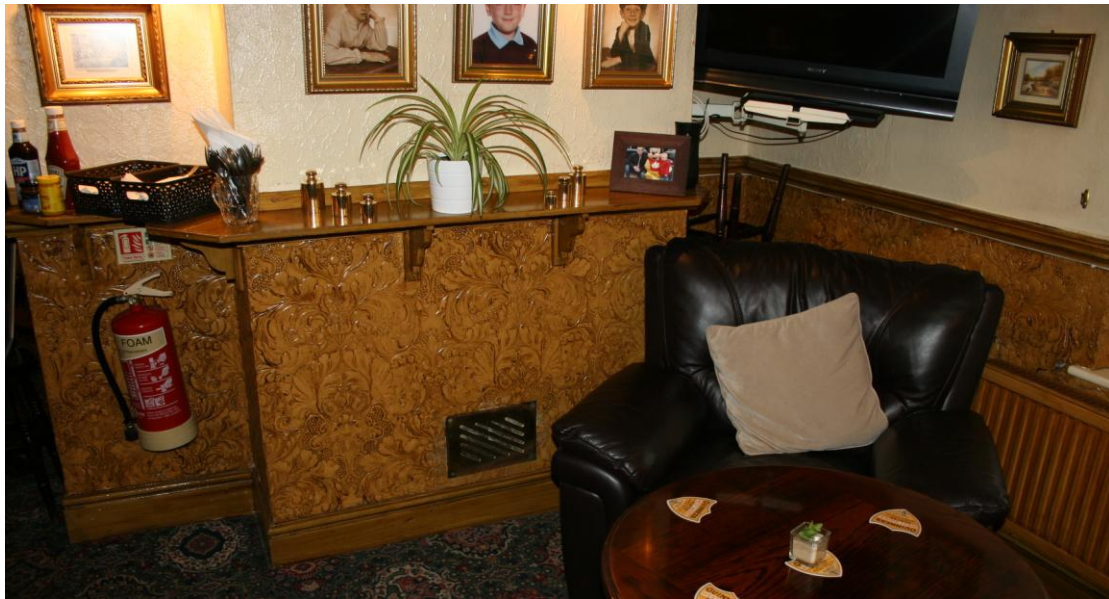
Looking NW into the Snug Area.

The blocked fireplace in the Snug.

The area to the west of the Bar Counter was originally divided off with its own fireplace. It has a large 8/8 sash which implies it was a work area such as a kitchen or scullery.

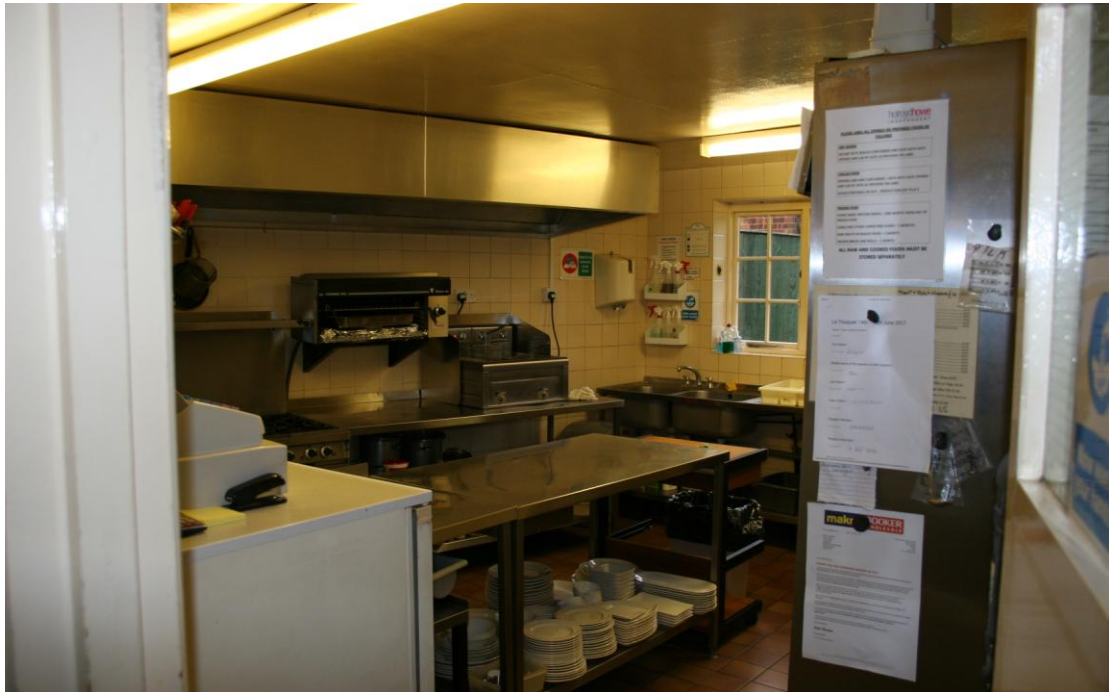
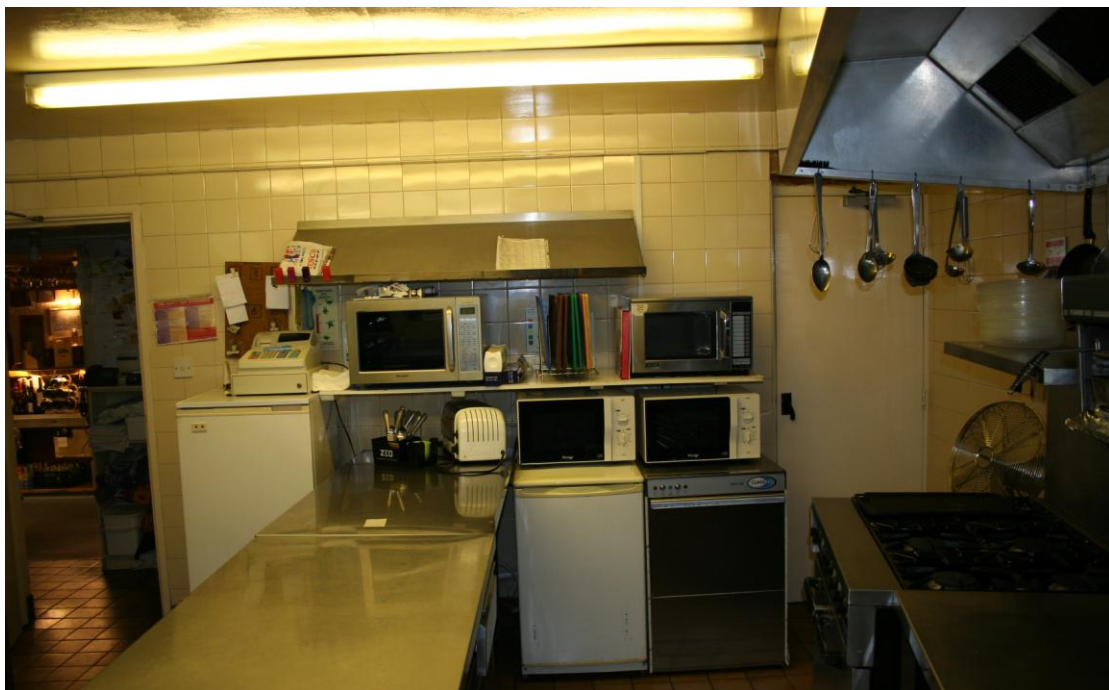
Looking NW in the Kitchen.

Looking S in the Kitchen.

The Kitchen and Store Rooms are situated in the rear extension and therefore nothing predates 1985. The blockwork construction can be seen in the Store Rooms, one of which contains the beer barrels and pumping equipment.

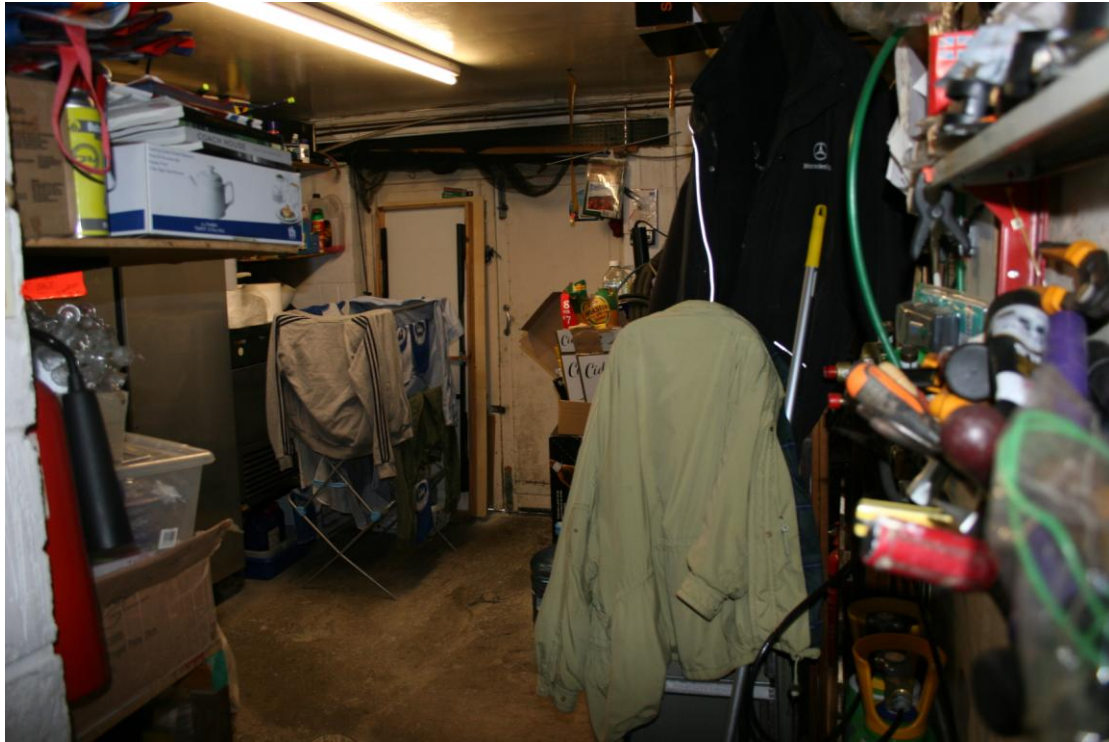
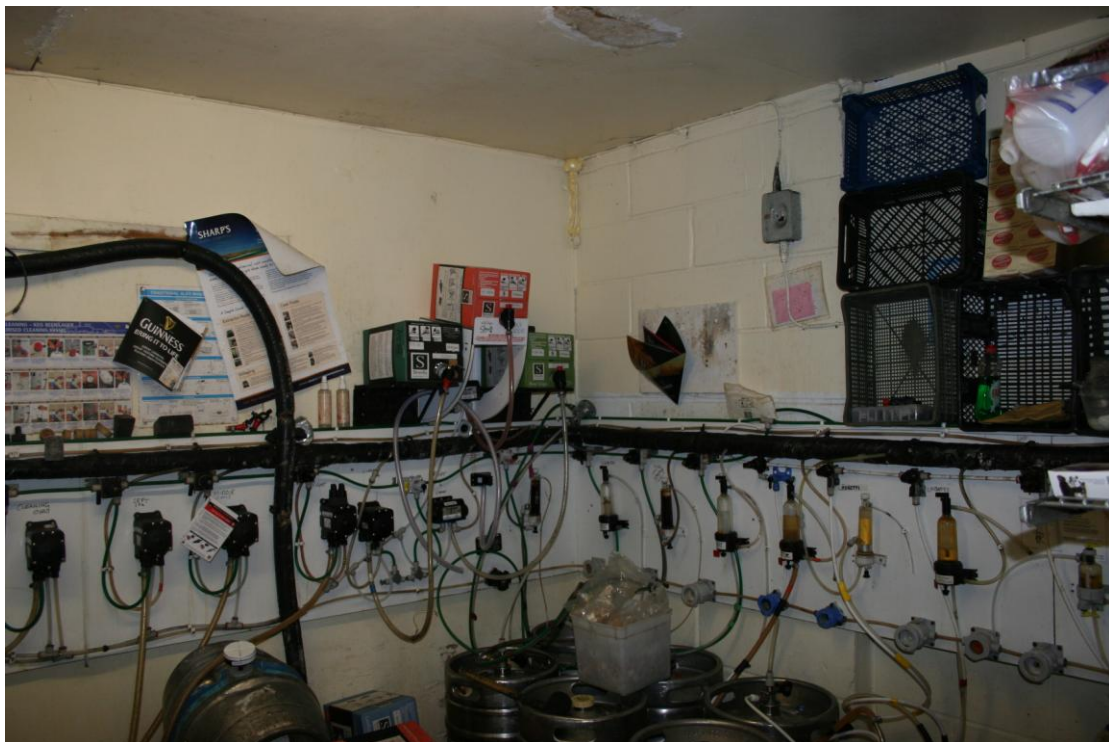
The North Store Room looking E.

The South Store room contains the beer barrels. The wall of the House has been rendered.

The North Store Room contains freezers and the cooler plant for the cellarge. The barrels are kept in the South Store Room. Here the wall of the House has been cement rendered.

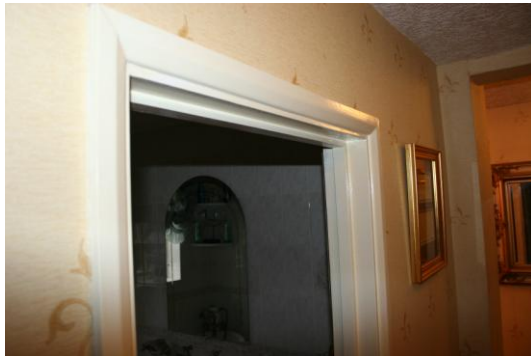
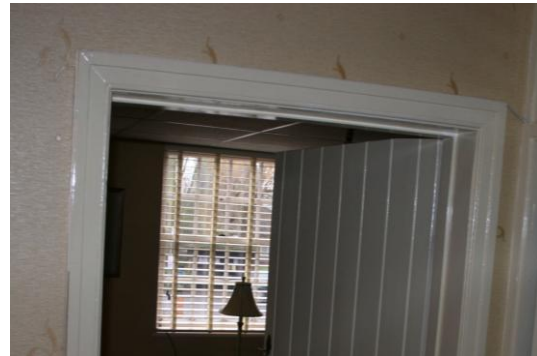
Inserted rooms have plain modern architraves while the originals have beaded doorcases.

The originality of the upper rooms can be determined by their doorframes. The original doorframes have beaded details that appear to be formed from applied rods rather than moulded and have full doorcases. The newer inserted rooms, the Bathroom, Office and Boiler Room each have plain modern architraves.

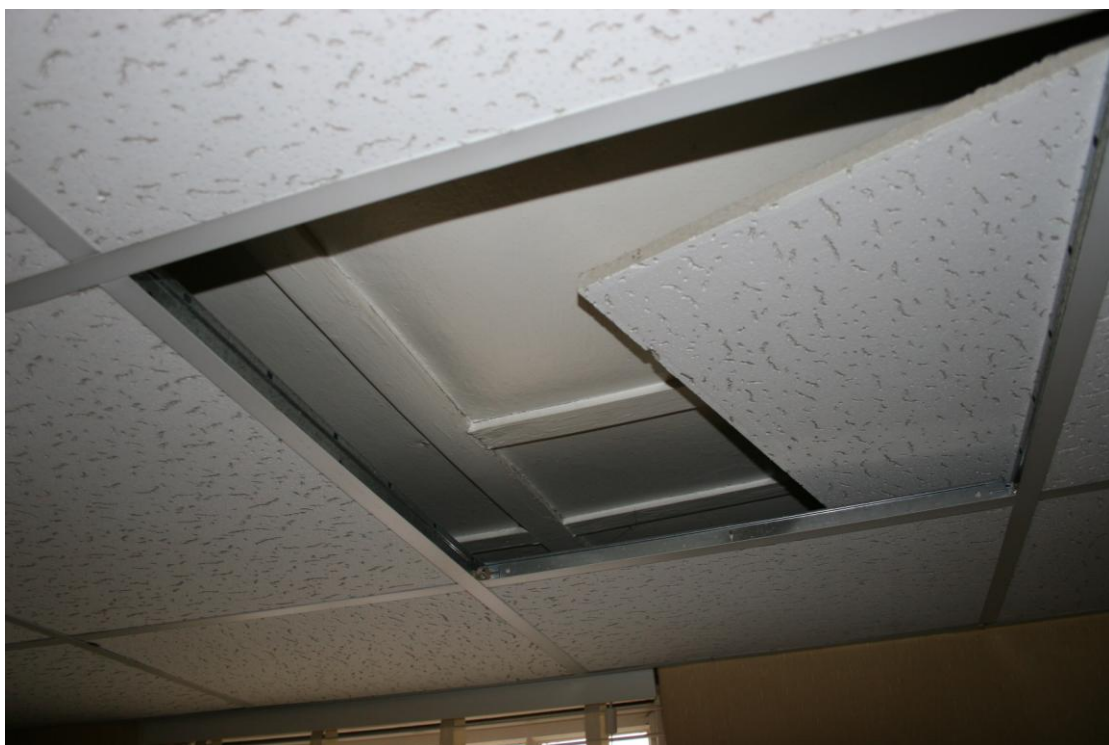
The suspended ceiling in the Kitchen hides a MC20th panelled ceiling.

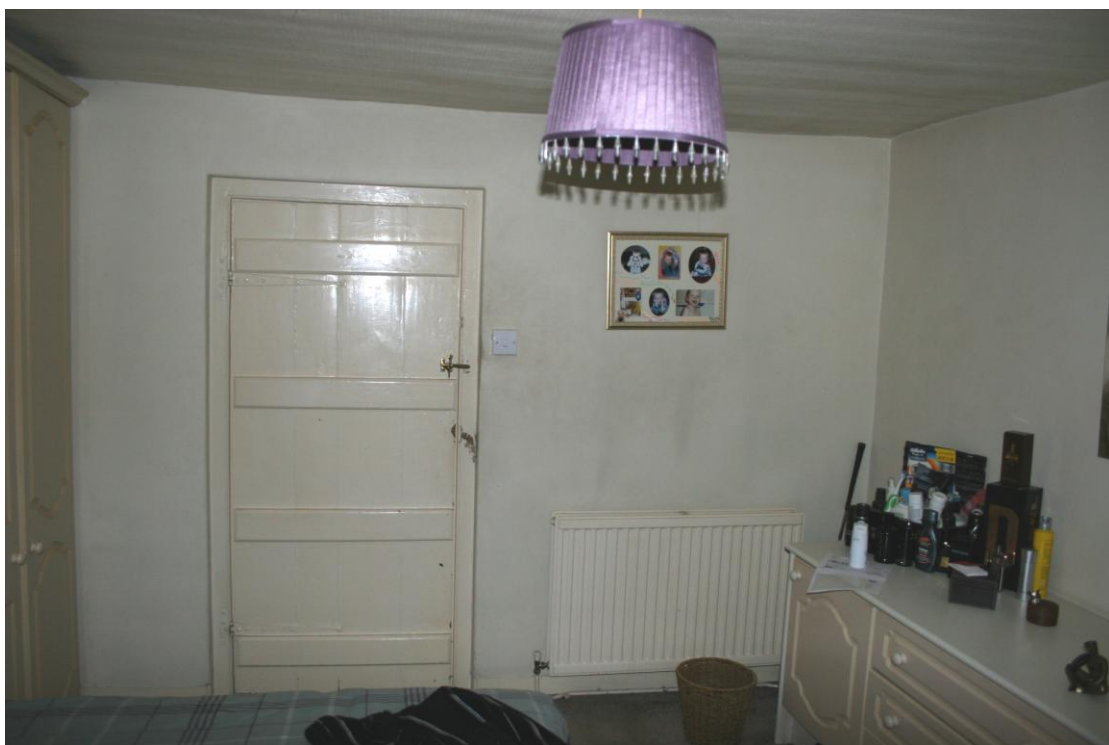
The EC19th boarded door in Bedroom 2. Looking S.

The boarded door in Bedroom 2 is the only hint of an early decorative scheme left in the building. The planked door has four horizontal ledgers nailed and clenched and is hung on two elegant wrought iron T-straps that are nailed to the door and the frame.

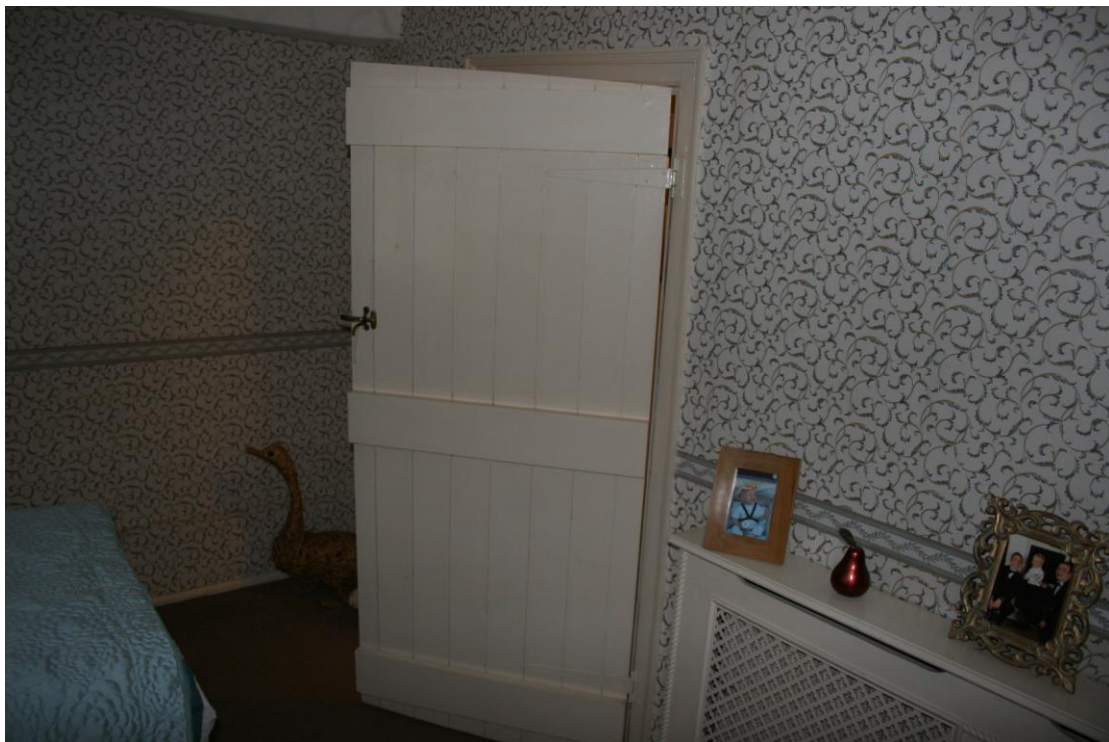
Looking NW in Bedroom 3. An example of a LC20th replica door in an original frame.

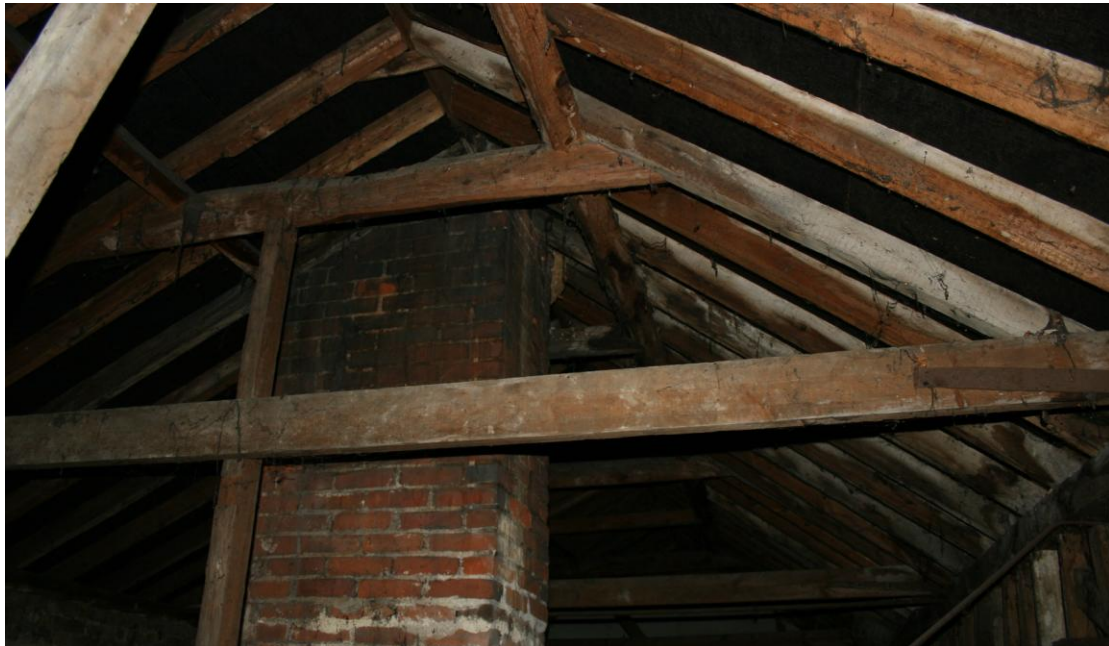
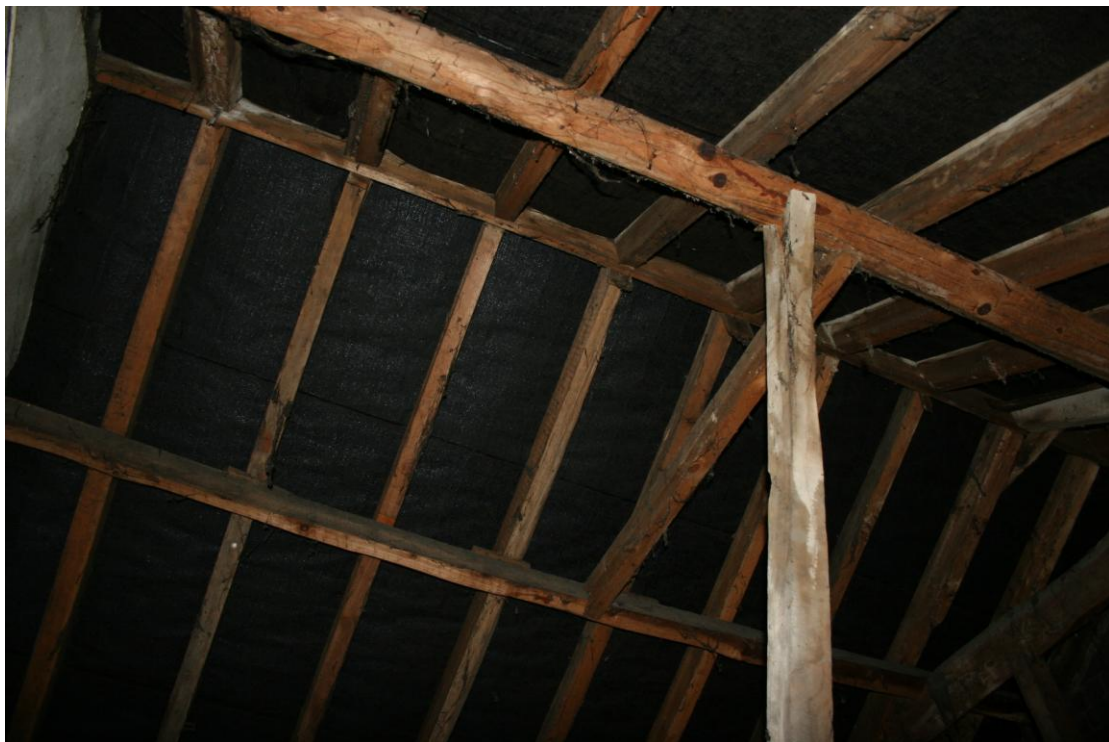
Looking W in the main front roof.

Looking SW in the main front roof.

The roof is a simple clasped side purlin roof constructed of pine rafters paired onto a ridge piece. The collars are side halved and nailed and there are inserted birdsmouthed struts. Plank tie-beams have been added to strengthen the spans and are secured with wrought iron ties. There is an asphalt undercloak in good condition which may have been part of the 1985 refit. The chimney is of EC19th red bricks.

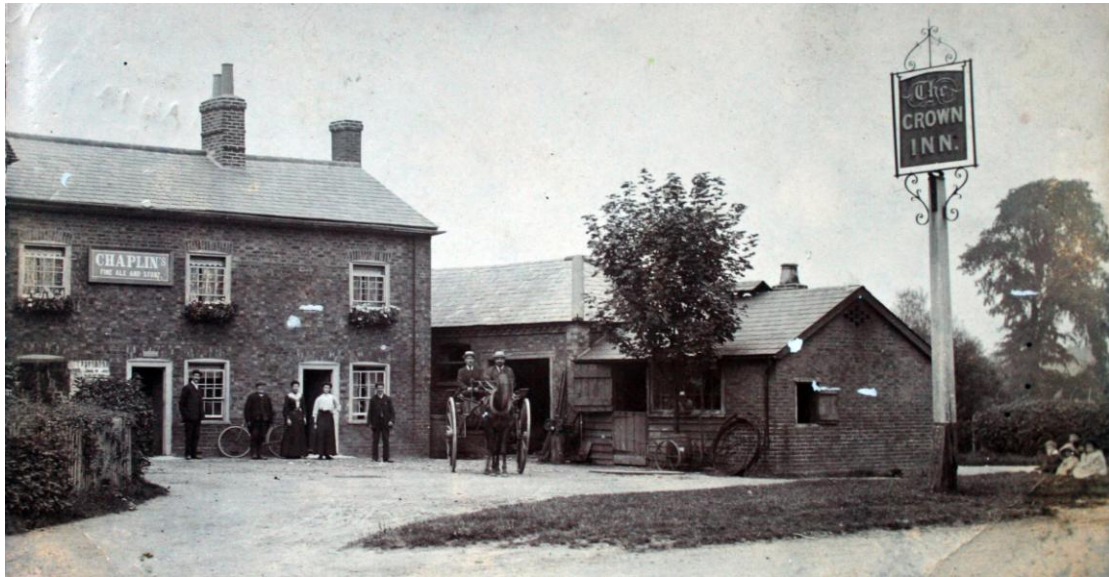
1908. The Crown Inn on a post card date stamped 1908.

The 1908 photograph shows the Stables and Smithy as separate to the House. Kelly's Directories of 1906 and 1908 show that the blacksmith was a Keith Young. He would have also been the landlord of the Crown. The small chimney for the forge can be seen next to a roof vent on the Smithy. The House is of exposed brickwork and has a grey slate roof.

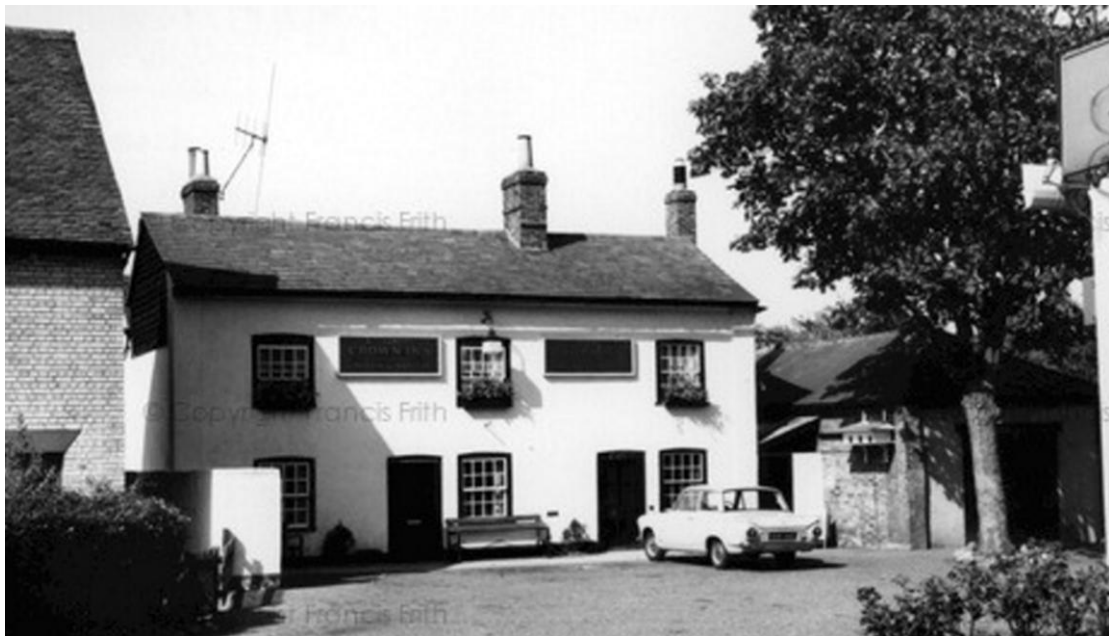
1960. The Crown Inn. Francis Frith Collection used under Fair Usage.

The 1960 photograph shows the Smithy has been removed and the Stable doors blocked up. There is a pair of garage doors. The gap between the buildings has a simple shelter and regulars remember this was the male WC. The roof now appears to have clay tiles.

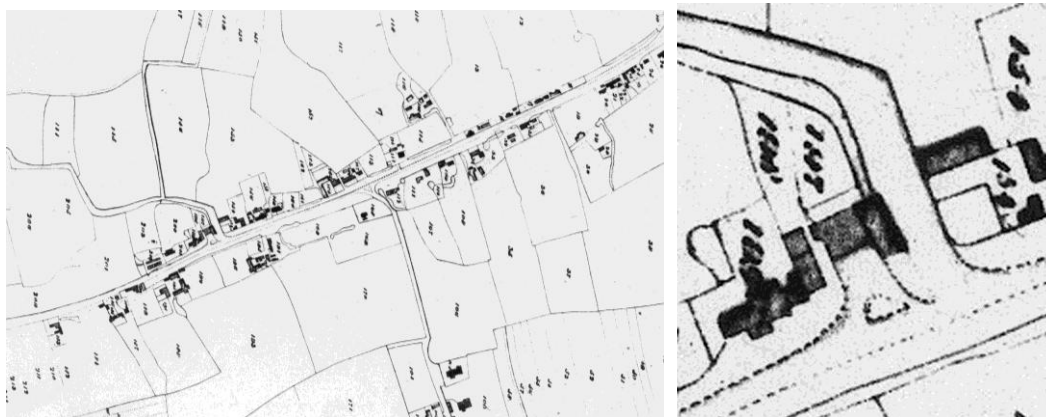
1839 Tithe Award Map of Sheering. The Crown is Plot 197.

The 1777 map of Essex shows a plot corresponding to that of the Crown but offers little detail. The 1839 Tithe Map shows the two buildings corresponding to the House and Stables as though conjoined. Plot 197 *Crown Public Hse, stables, gdn* was owned by Thomas Chaplin and occupied by John Garrett who is listed in Pigot's Directories of 1828, 1830 and 1839. By 1845 Charles Brown is listed as the victualler at the Crown in Pigot's Directory and in White's Directory of 1848 and the Census of 1851.

The 1839 map shows a small addition to the western elevation and it is likely this is an external staircase.
