Oak Cottage, Royston Road, Wendens Ambo, Essex. CB11 4JY.
Description and analysis of the Cottage and Stable. Surveyed 15 06 2016.

Scope of this Report

This report describes and analyses the two buildings to English Heritage Level 3 as outlined in Historic England. Understanding Historic Buildings – A guide to good recording practice. 2016. Page 22.

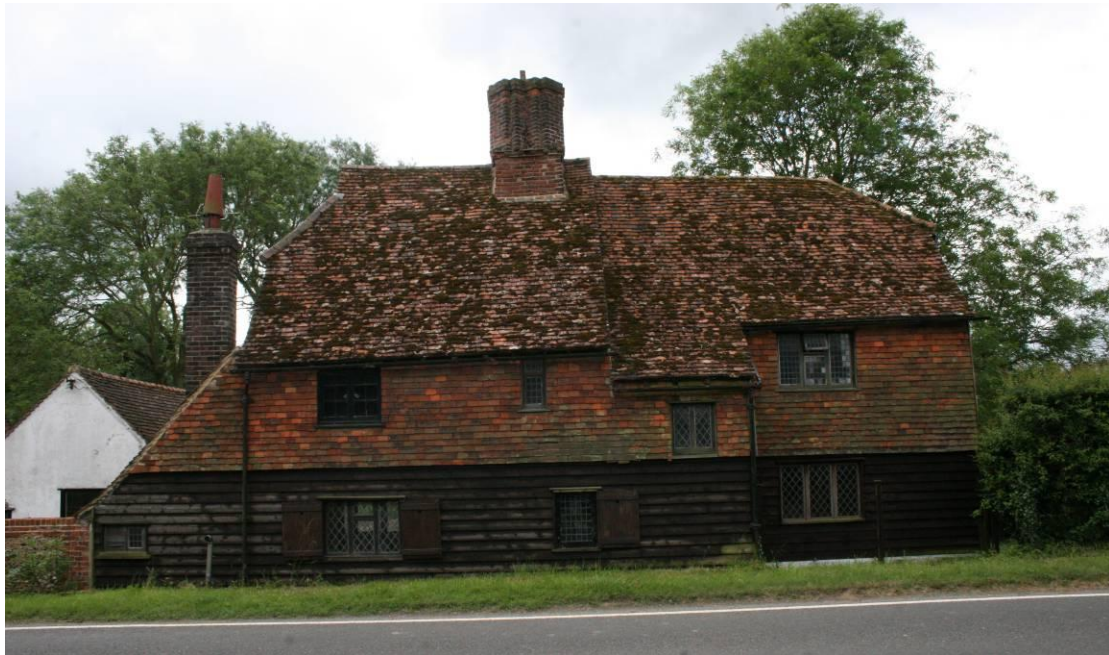
Oak Cottage. Northern Elevation.

The timber-framed House has two distinct historic parts. The building is divided by a large brick firestack built in two parts with later alterations. The diagonal shafts are C19th/C20th replacements. The eastern half of the roof steps off the lower western half and is wider. The eastern half has gablets with a half hip to the east and a plain gable to the west. Inside it can be seen that the eastern roof is a truncated offset butt purlin roof, the sawn off part being used to build the roof for the steeply pitched eastern extension.

The western roof has a half hip and gabled end and the roof is extended over a one and a half storey stair tower. All the roofs are clad with clay peg tiles. The building has been restyled in the 1950's with tile hung upper storey and weather-boarded ground floor. The leaded quarry glass casements are also believed to be installed in this period and are varying types. The previous owner was a collector of 'antiquities' and this explains the many types of doors and windows in the house.

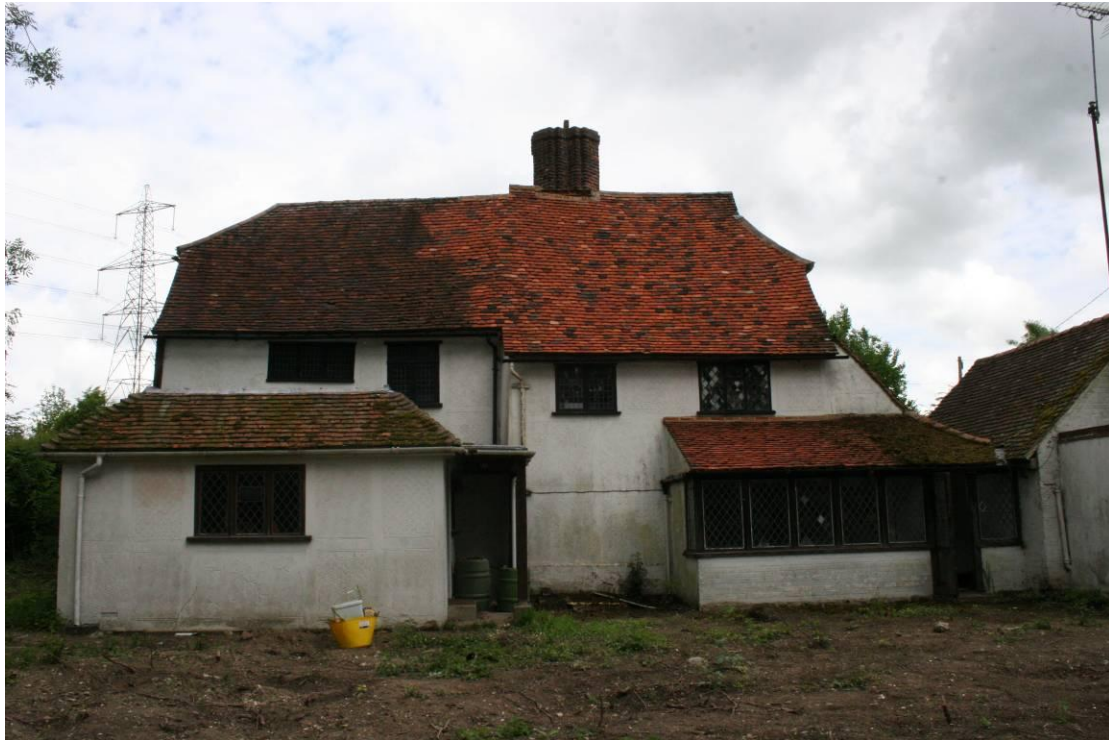
Oak Cottage. Southern Elevation. The roof is being cleaned by pressure washer.

The southern elevation is cement rendered on lath and EML (Expanded Metal Lath) and pargetted. There are two rather incongruous LC20th extensions (shown on the 1970 Ordnance Survey).

On the southern side the two roofs are more aligned and lack the large step. The eastern half is however taller and wider. The western half has a collared roof in near complete but reordered condition (indicated by the sequence of carpenter's marks).

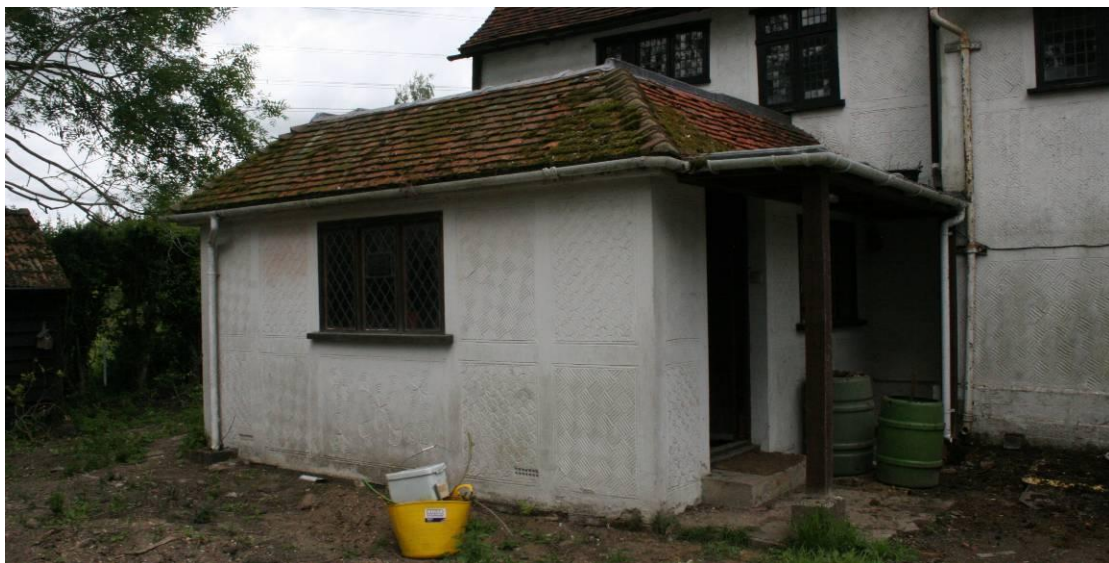
LC20th extension shares the same pargetting as the main building.

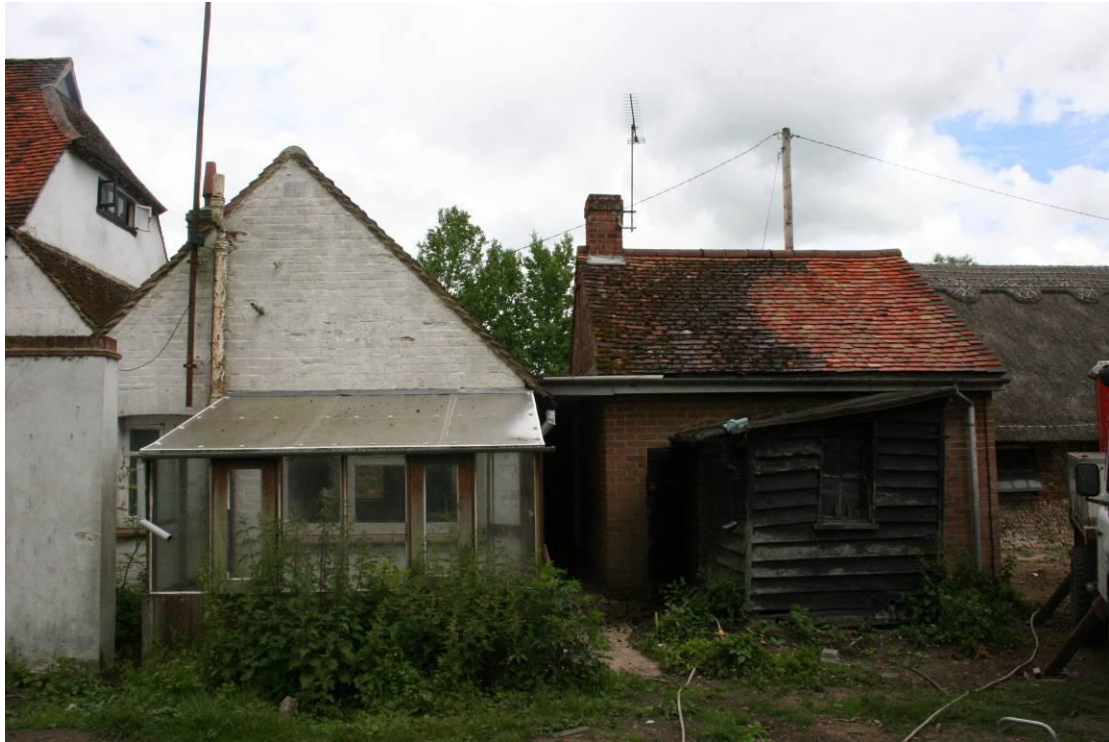
The southern elevation of the MC20th additions.

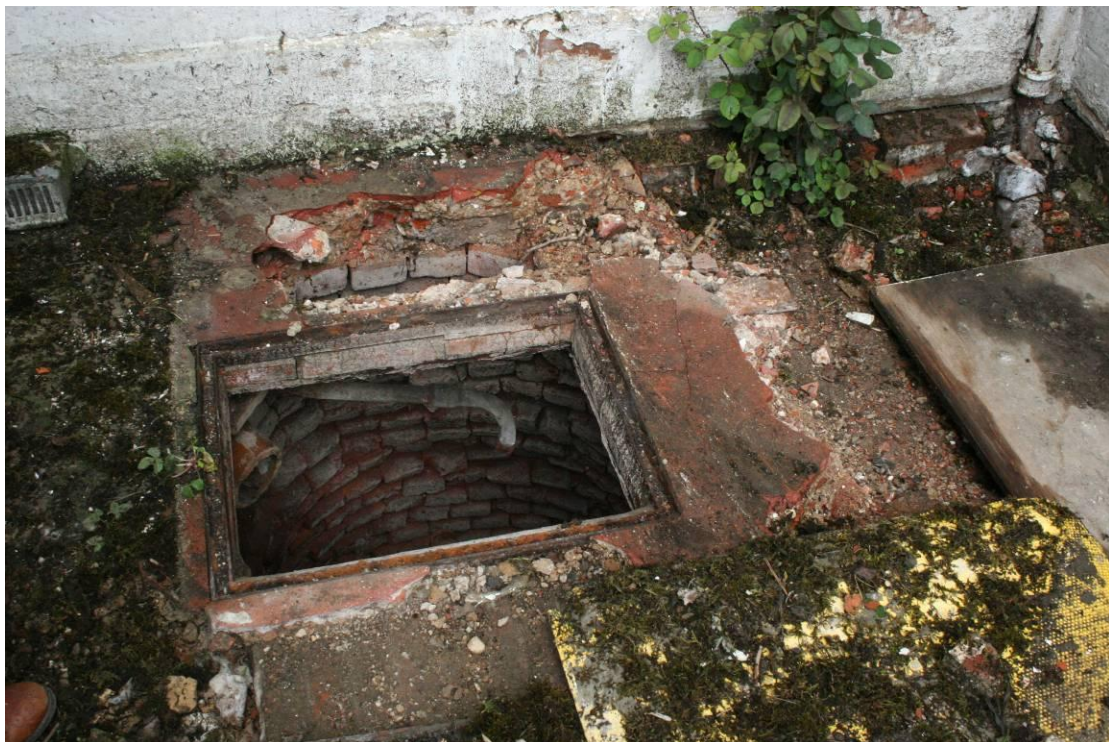
The 'Tudor' well at the back of the main house.

Of interest against the back wall of the main house is a deep well built of 2in thick Tudor style bricks. MC20th pipework implies it was still in use until the LC20th. It is approximately 4ft in diameter and the water level is at approximately 10ft down.

At the back of the house is a C16th brick well, 4ft in diameter and 10ft to the water.

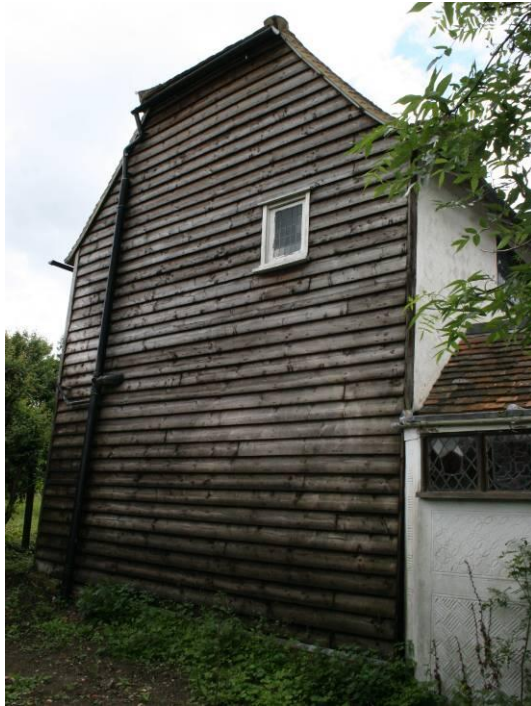
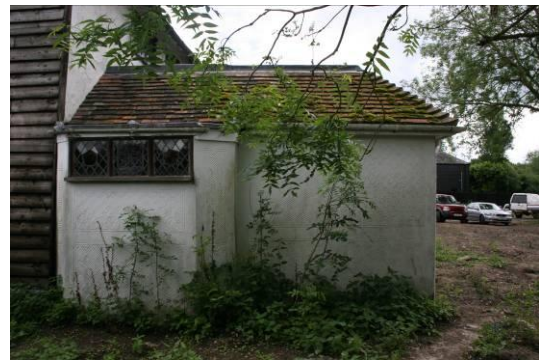
The western elevation.

The western elevation of the main house is clad with LC20th weather-boards characterised by bandsaw marks and fixed with French nails. To the rear (south) of the house is a LC20th extension under a clay tiled roof. Of interest is small flat roofed cubicle fitted with C20th casements with historic stained glass emblems and old glass. These were fitted by the previous owner who dealt in historic glass and left large stocks in the garage. The house was previously called Hawley Bishopp's – a famous C17th Venetian glass maker from London whose products are highly collectable.

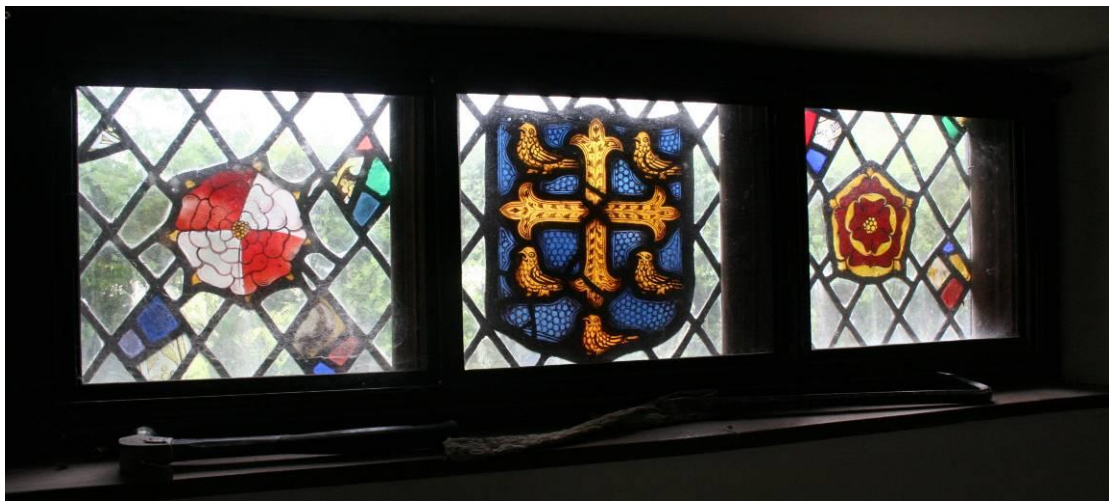
The stained glass in the extension.

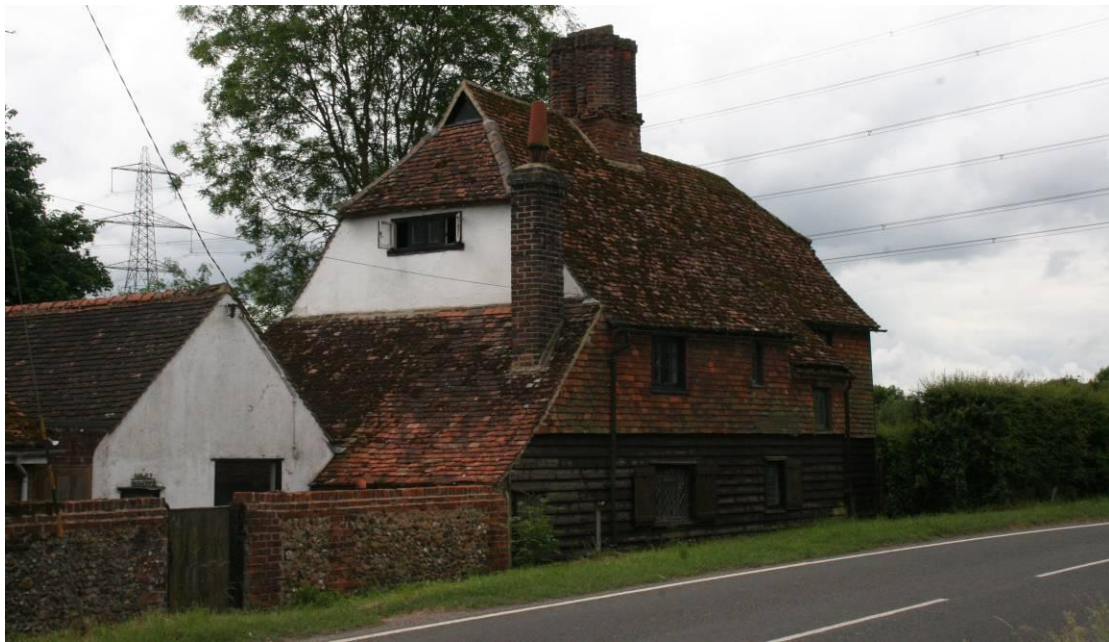
The western elevation.

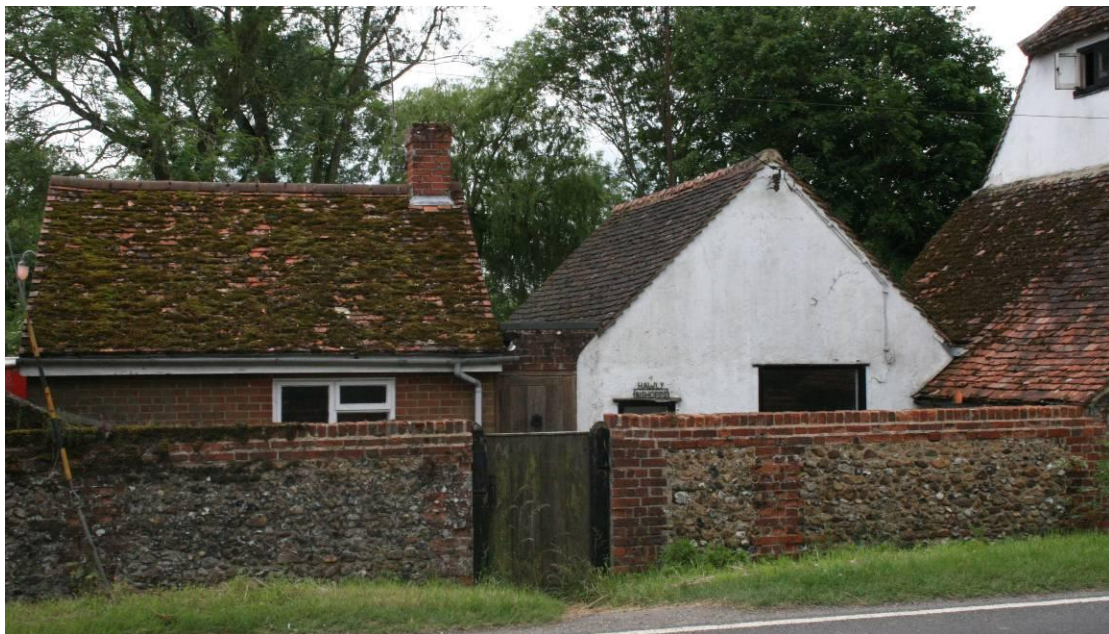
LC20th addition to the eastern elevation.

The eastern elevation has a single pitch lean-to falling from eaves height again clad with clay peg tiles. A narrow, tall MC20th chimney stack rises near the north end. Built against the lean-to is an independent MC20th single celled brick building used as a Kitchen. Part of its volume has been used to provide a downstairs bathroom. This appears on the 1970 OS along with another free-standing brick building set at right angles to the other. This appears to be a separate dwelling perhaps used as a granny annexe.

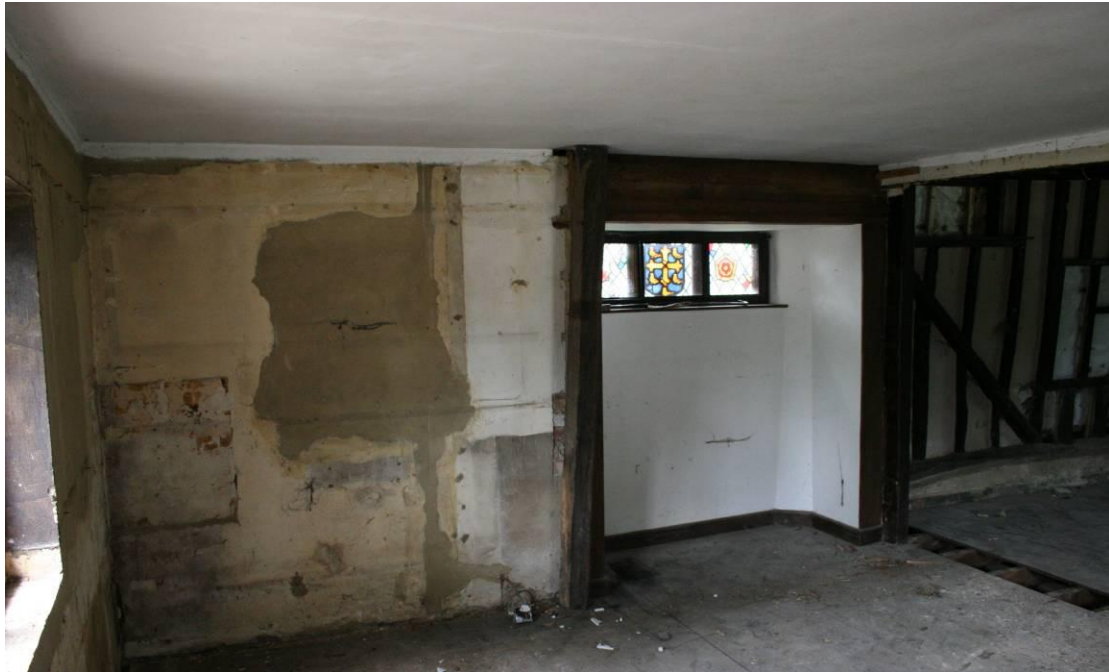
Looking W in the Study.

The Study is a MC20th room constructed of concrete rendered Fletton brickwork that was subsequently battened and panelled with a variety of C16th linen fold and fielded panels by the previous owner. The doors were also made from reused panels. The pre 1970's pargetting has been preserved on the back of the timber-framed house.

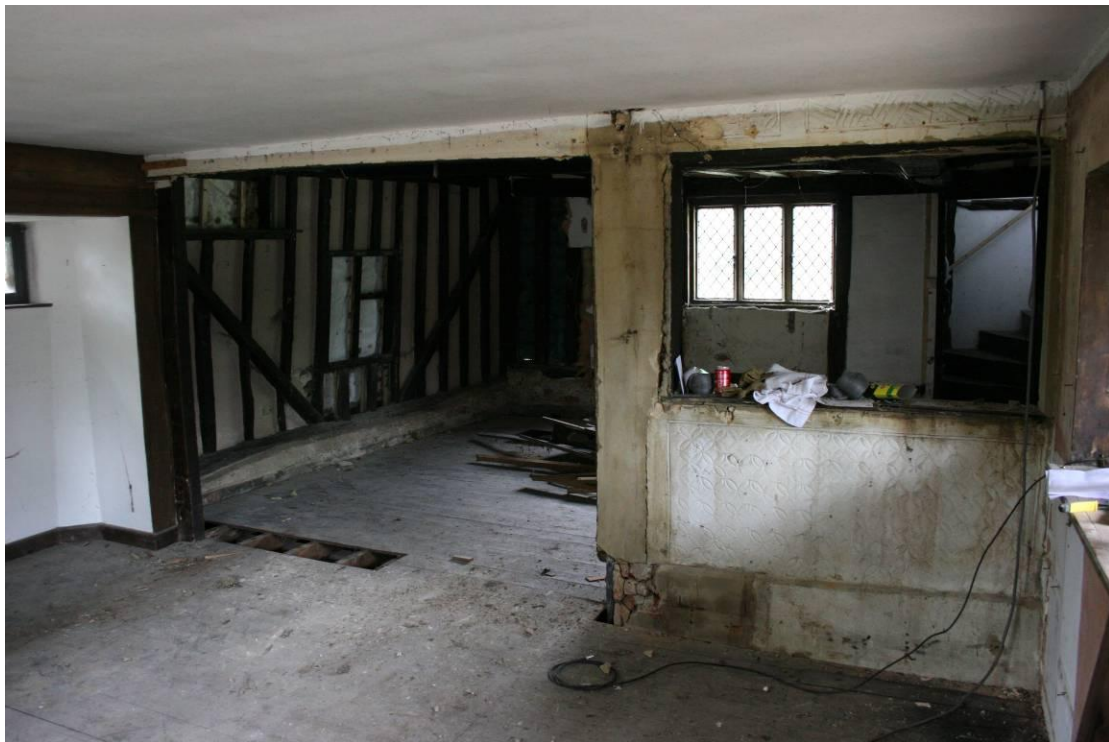
Looking NW into the Sitting Room. The former exterior wall is pargetted.

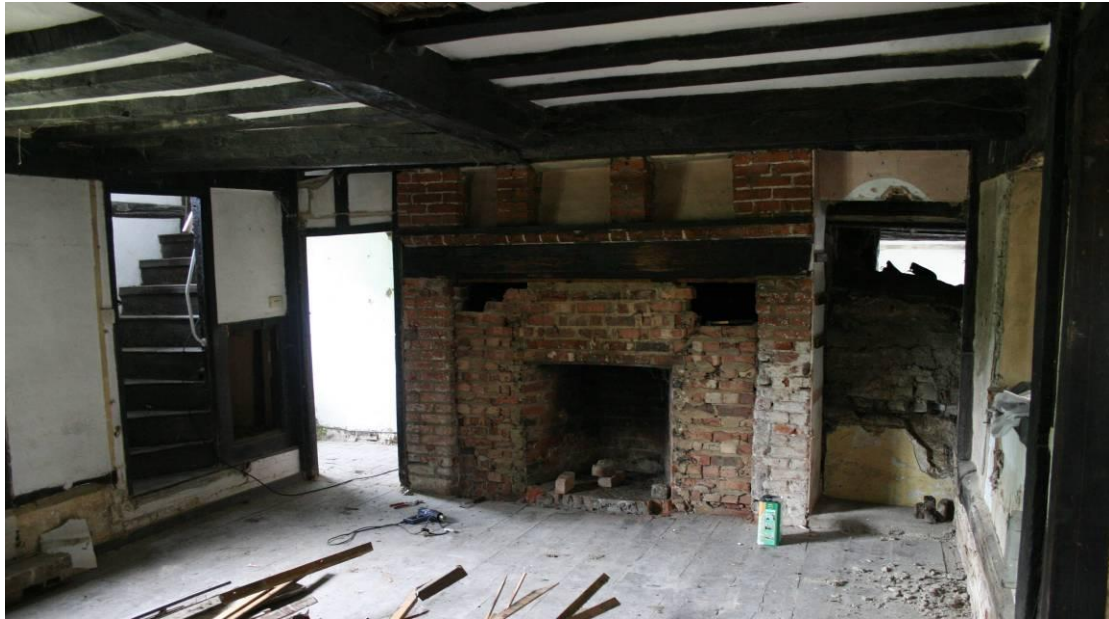
Looking E in the Sitting Room.

To the west of the firestack the timber-frame is of a C16th building with moulded transverse and axial beams and a collared roof in near complete condition (indicated by the sequence of carpenter's marks). The north and south walls contain some original studs but large sections have been removed for windows and openings. The western wall has been completely replaced with a M-LC18th style primary braced, interrupted nailed studwork wall. The frame has been raised on a much repaired brick plinth and the floors dug out.

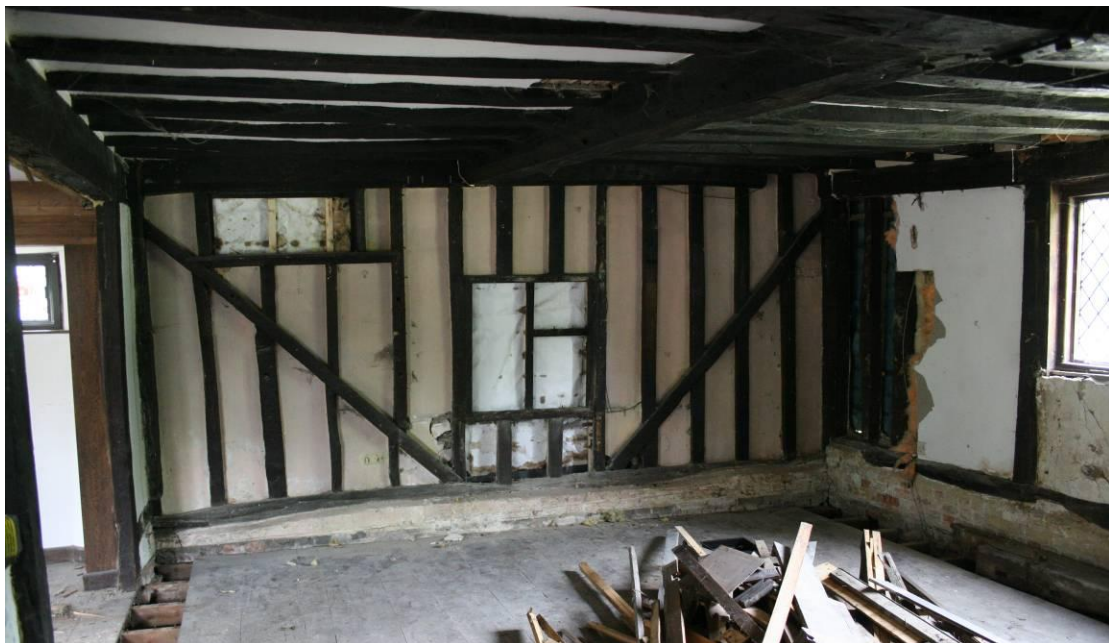
Looking W in the Sitting Room.

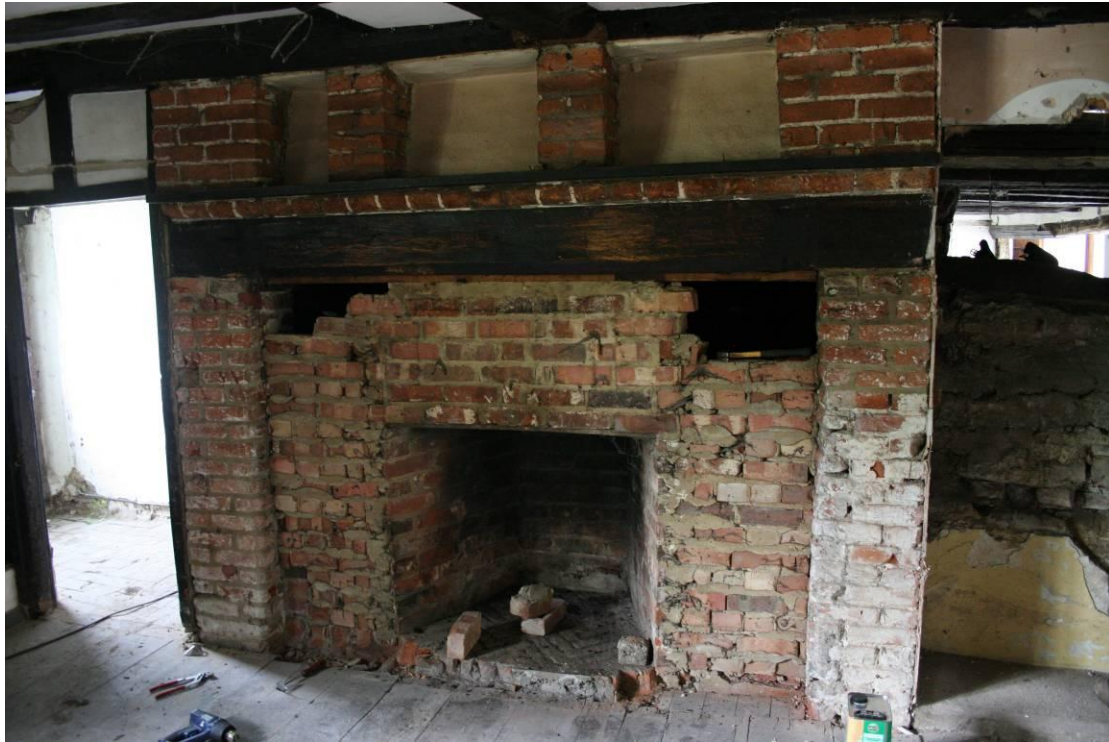
Detail of the fireplace in the Sitting Room.

The ground floor fireplace is built in exact measurements of feet (9ft wide with 5x7feet opening) with 2in Tudor style bricks of 50x110x230mm. The section above the bressummer has some piers of 60x110x220mm red bricks which have replaced the studwork of the earlier frame. The fireplace has been reduced in size with MC20th Flettons set in grey cement. To the RHS (south) is a poorly constructed brick dome bread oven which is operated from the other side and was previously panelled over with C19th studwork side nailed into rebates and lath and plastered over.

The western half of the building has a Tudor style brick firestack with a large 5x7ft inglenook fireplace on the ground floor and a more modest but appropriate fireplace on the second floor. The 50x110x230mm bricks are characteristic of the C16th when large scale brick production meant more modest and rural buildings could have firestacks built.

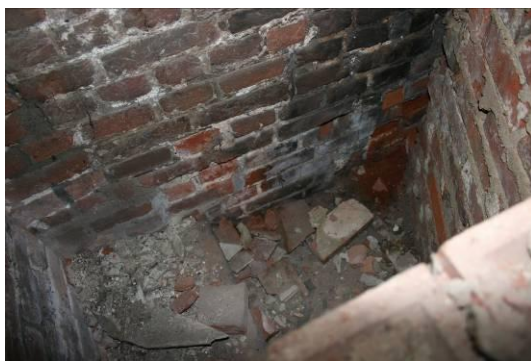
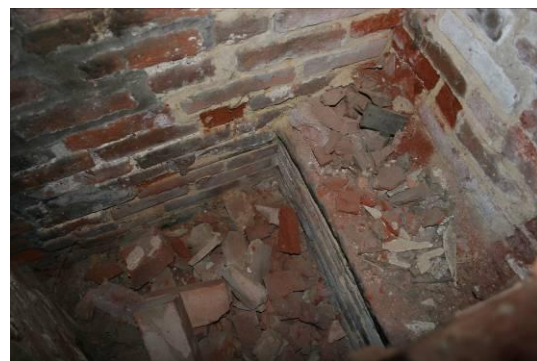
Looking down either side of the MC20th brickwork reveals inglenook seats.

Looking behind the inserted brickwork there are earlier inglenook seats with timber tops.

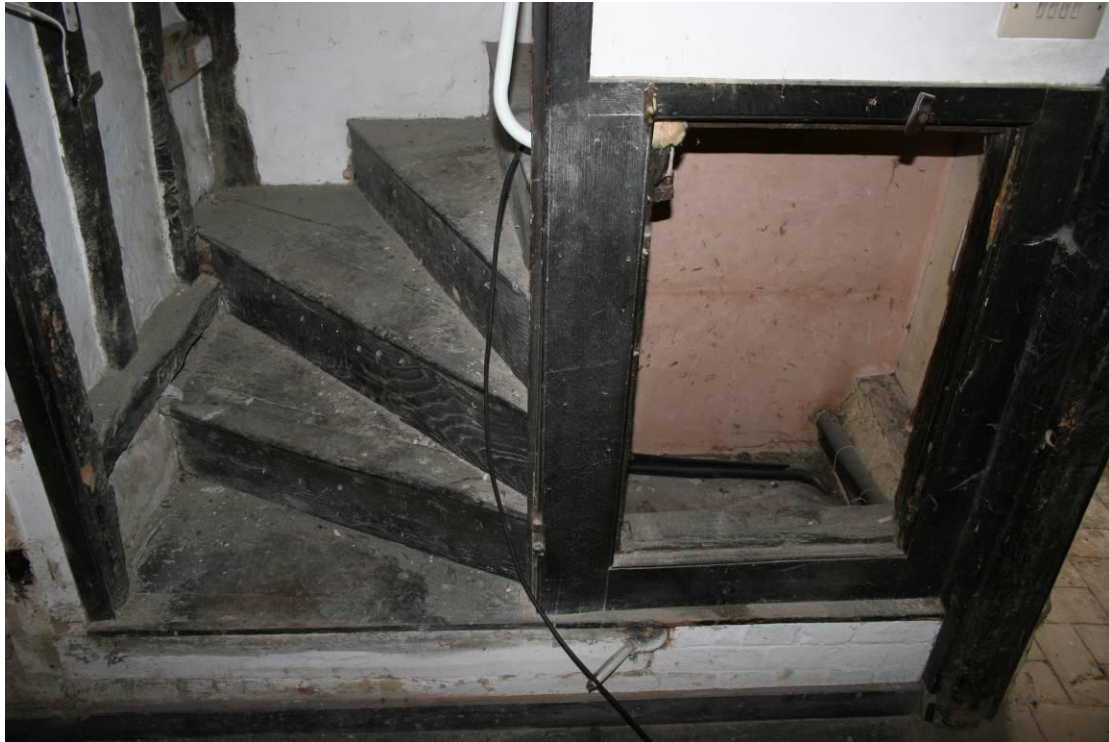
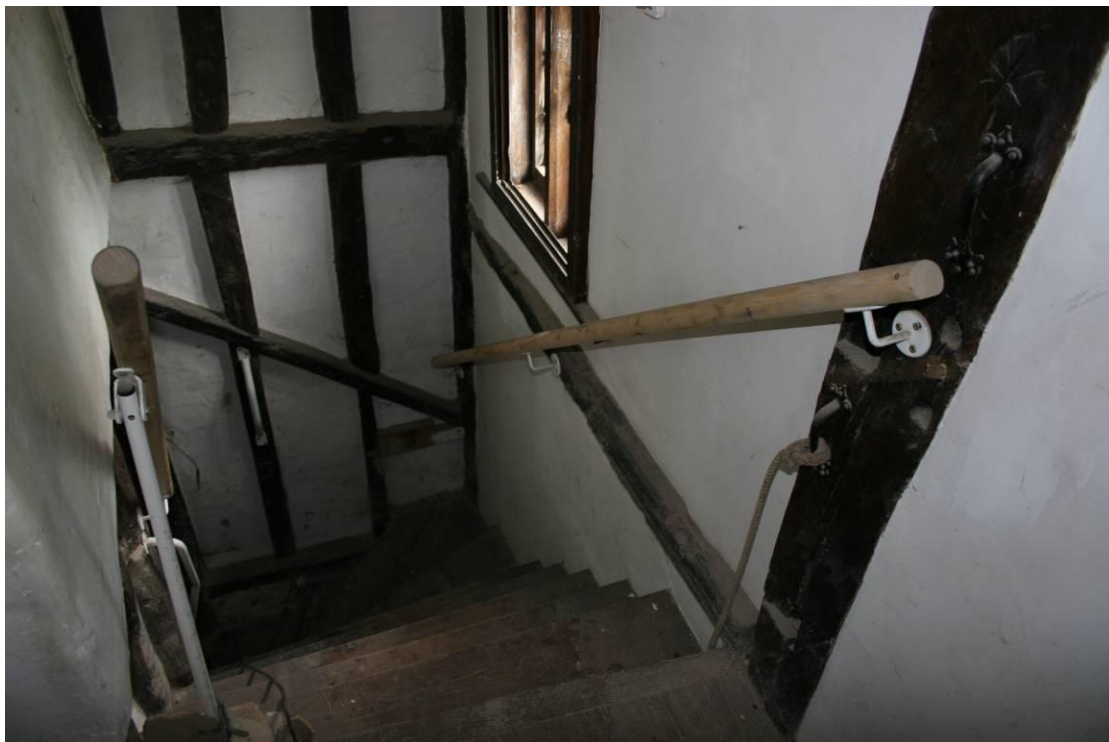
The base of the winder stair in the stair tower.

Looking down the stair tower

On the northern side is a stair-tower built of interrupted studwork in the style of the C18th which carries up into the roofspace. The hand-made treads and risers appear authentic and have been lath and plastered on the underside. The interior lath and plaster has been removed exposing the studwork in the style of the LC20th.

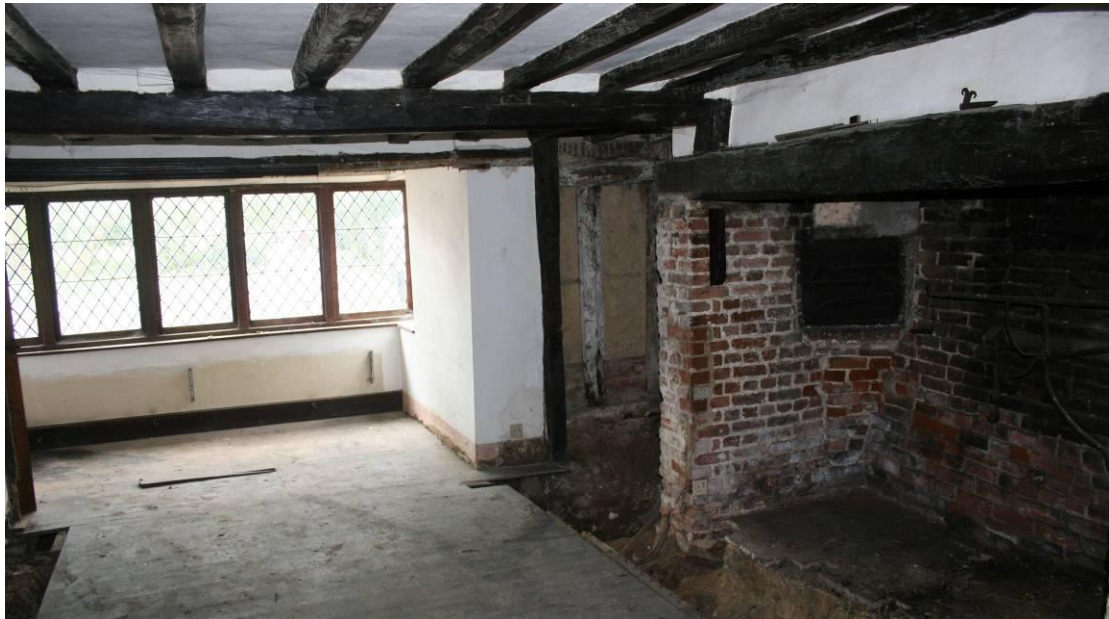
Looking S in the Living Room.

In the Living Room the firestack is built of 55x110x210mm Tudor style bricks with an inexact fireplace of 7ft6in x 5ft4in and is clearly a separate structure. The bressummer is 9ft9in and has a 9x8in section with a rough dressed chamfer. The floors have been excavated in the past to insert the MC20th suspended timber floor.

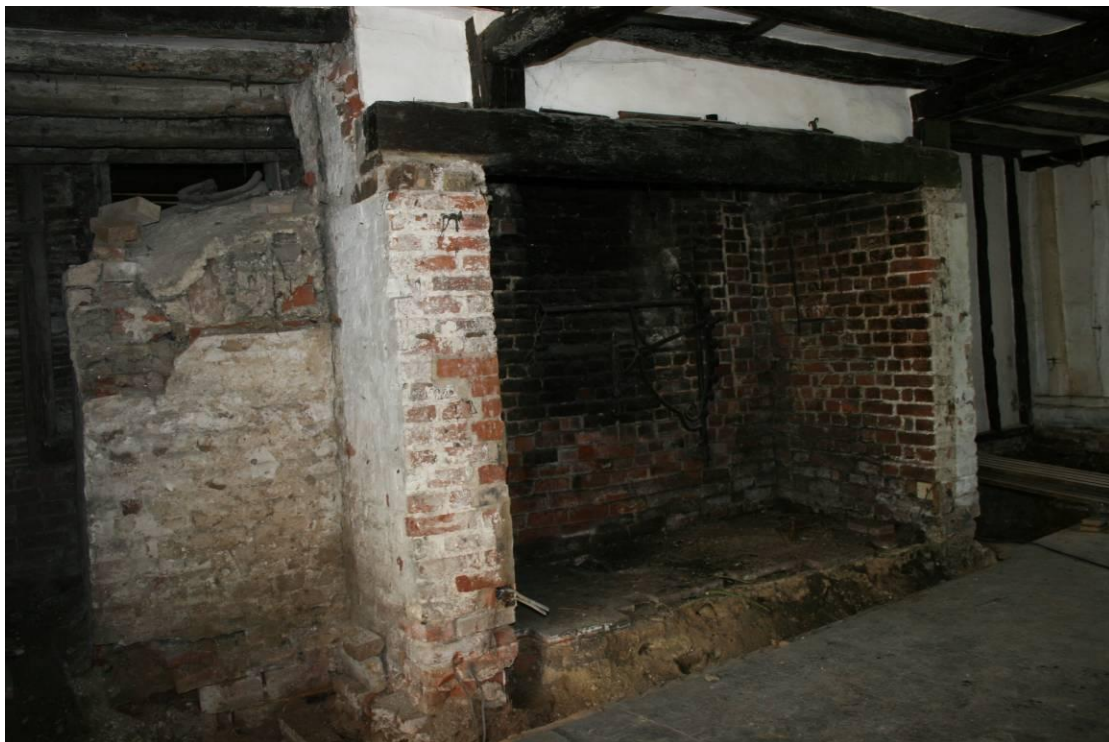
Looking W in the Living Room. The bread oven is to the LHS.

The second firestack was built up against the first using slightly larger 55x110x210mm and a similar sized but imprecise 5ft4inx7ft6in fireplace. An upstairs fireplace was not incorporated. The first floor frame has twin main joists and common joists with chamfers and cyma stops. The design of the frame would indicate that the room was built as a cross-wing in the C17th but the building has been later remodelled to have an inline, if somewhat stepped, roofline. The roof structure has a C17th offset butt purlin roof which has been severed and rotated and the offcuts used to build the Hallway in the next phase.

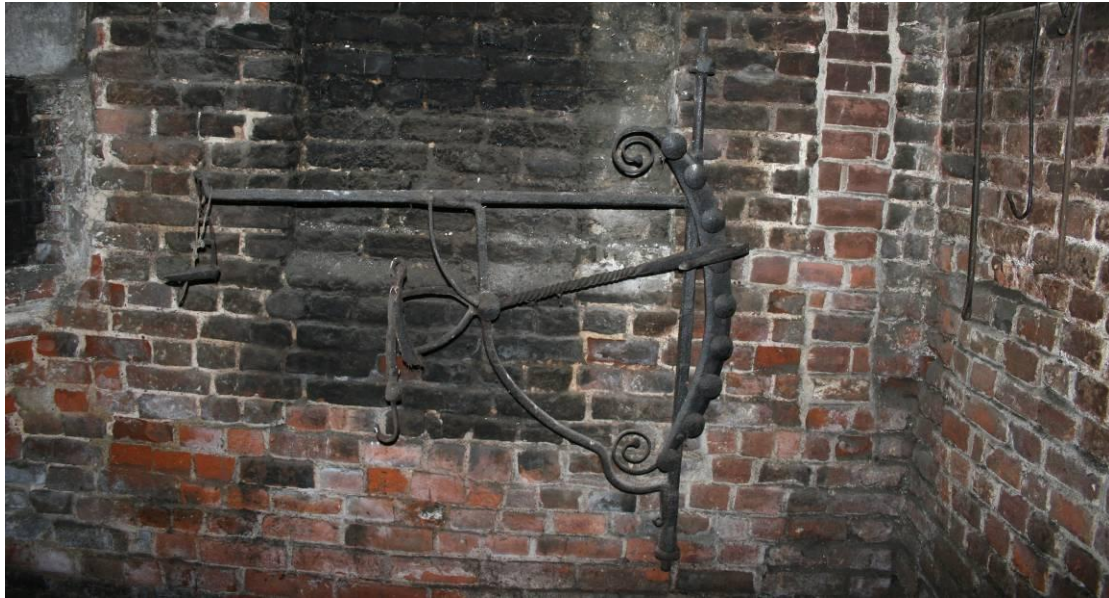
C18th fire crane.

The fireplace has an elegant wrought iron fire crane of Georgian characteristics having a butterfly adjustment nut. Earlier ones have rivets and pins. It is correctly housed in the brickwork. In the southern side is a cast iron door for the bread oven. This is an elegant component with hand wrought curved pintle hinges and a latch with a spooned terminal and spheres on the pinch handles.

Also in the inglenook is a Georgian firecrane, distinguished by its butterfly nut adjustment. While the firecrane is undoubtedly authentic it seems unlikely it would have remained in use while the bread oven was operating. It may have been folded back out of the way, or more likely is a feature added in the C20th by the antiquarian who lived in the house.

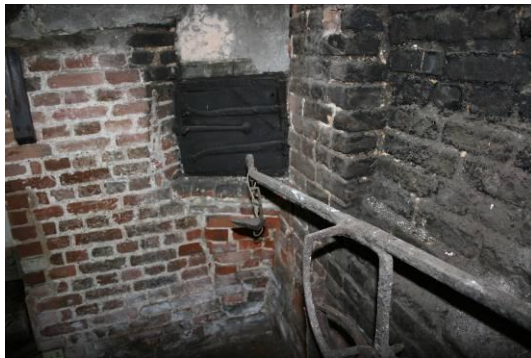
C.1800 oven door.

Bread ovens became popular additions in the first 30 years of the C19th built to similar designs using proprietary components. Often they can be built into existing firestacks to use the flues. In Oak Cottage, the bread oven door is within the inglenook implying there would also have been a range stove instead of an open fire (which would burn the cook). The bread oven itself has a well made cast iron door with wrought iron furniture. Tellingly the oven bricks are frogged, a feature that only becomes common at the very end of the C18th.

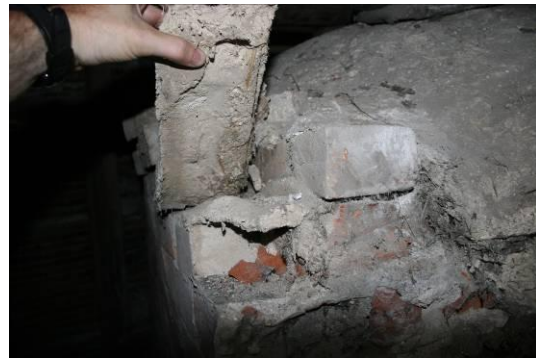
Frogged bricks in the bread oven dome.

The bread oven has a design typical of c.1800 -1820 and the loose bricks (still encased in the daubed insulation) have frogged bricks.

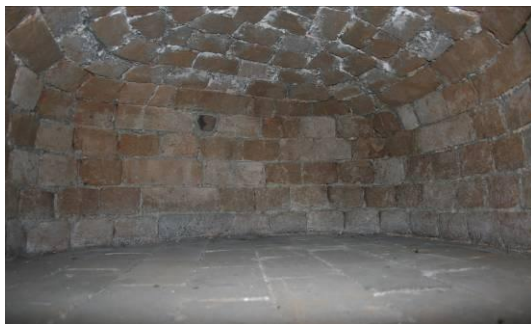
Domed interior of the bread oven.

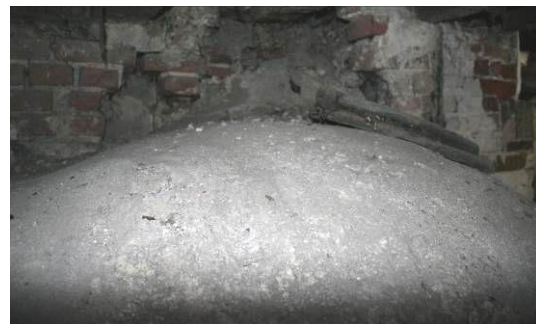
Daubed exterior of the domed oven.

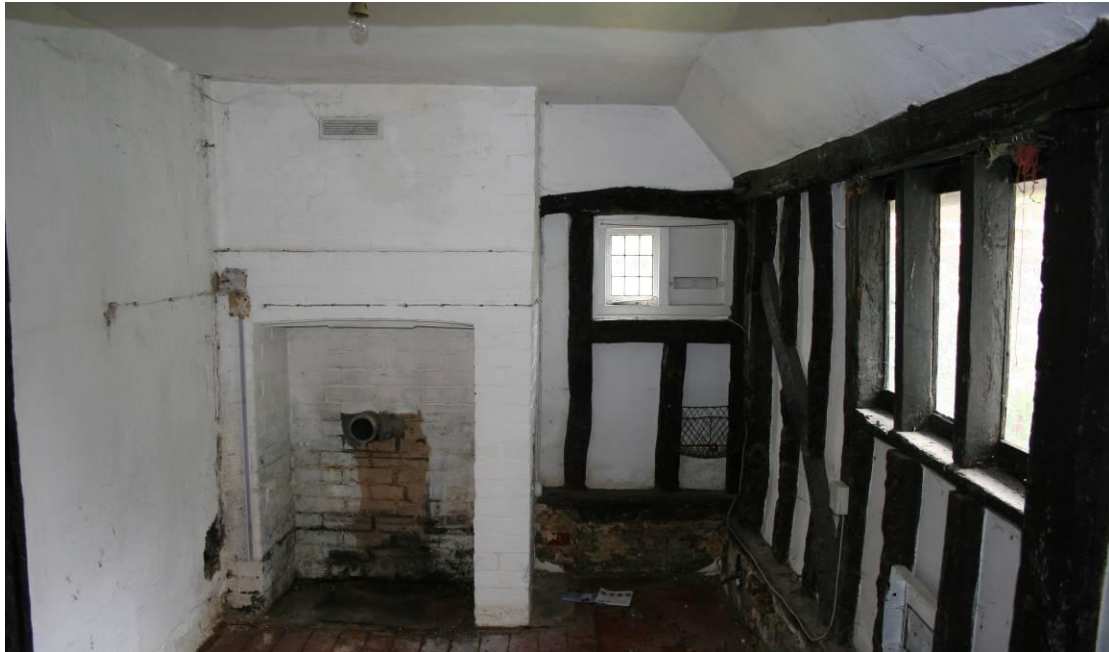
Looking N in the Hallway.

The Hallway is in the lean-to outshot on the east of the building. The exposed timber frame is of heavy section and scantling studwork cut for nailed interrupted studwork. There is a C20th chimney for a central heating boiler. The straight staircase is MC20th and the simple construction is exposed in the understairs closet.

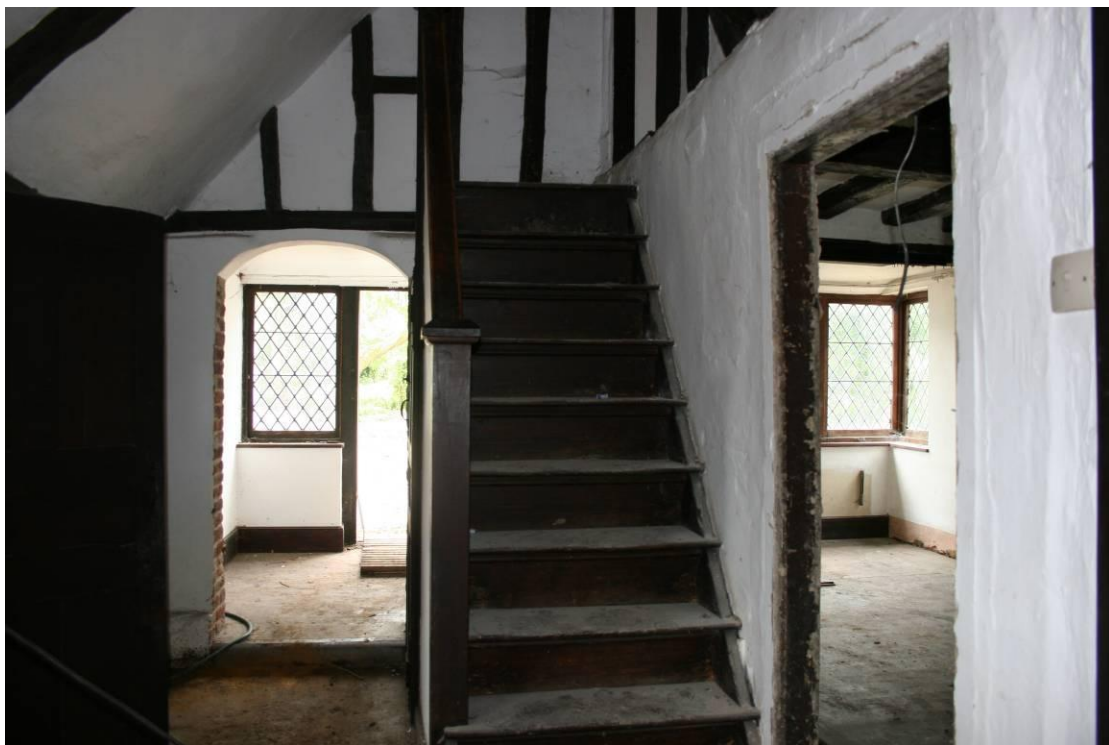
Looking S in the Hallway.

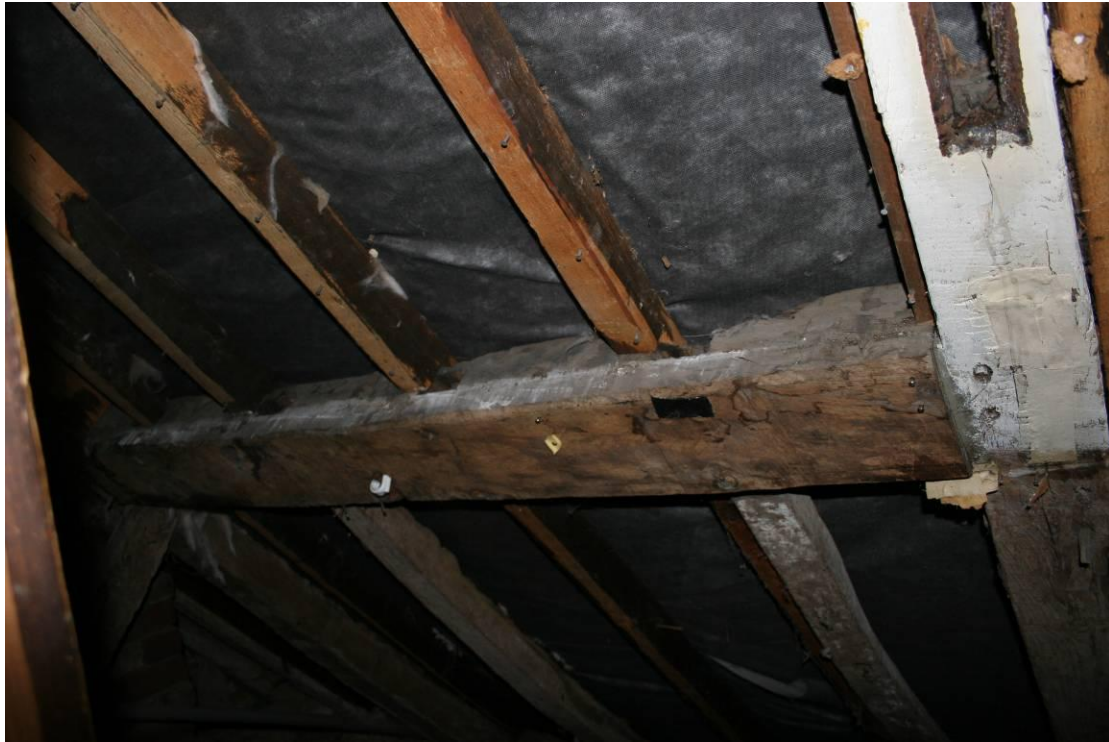
The roof above the Hallway

The roof structure of the Hallway is visible through a closet door in the room above. The main structure has been reused from a much older butt purlin roof with later narrow section 3in elm rafters and C20th 2x4in machined softwood rafters. The breathable membrane indicates the roof was retiled in the last 30 years.

The roof of the Hallway also has a cut down butt purlin roof of the same design and characteristics. The Hallway is a common Georgian feature, increasing the utility accommodation and providing for a grander staircase. The East Attic Room may also have been put in during this period but the original staircase has been removed and the lath and plaster stripped out so it may be later. The West Attic Room was never made habitable and the ceiling is insulated with daub.

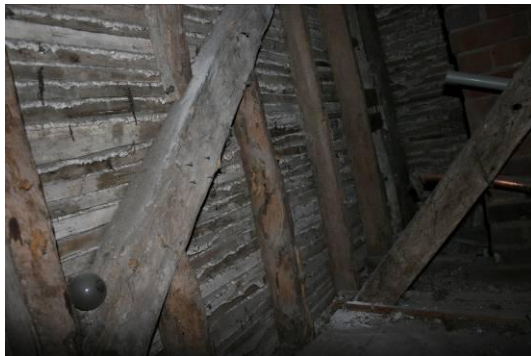
Looking N in the Hallway roof. Main frame.

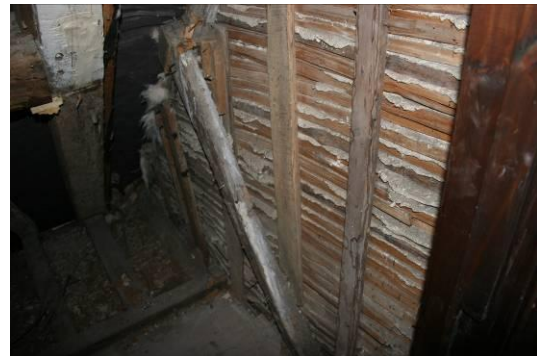
Looking SE at the stairwell wall.

Other details seen in the roof void show the grey cemented brickwork of the C20th chimney and the MC20th lath and plasterwork of the stairwell. Here the laths are of orange cedar and the studs are a variety of reused, machine cut timbers fixed across a raking strut. In contrast the wall of the main frame is of EC19th style nailed interrupted studwork with pitsawn finishes and rose-headed clout nails securing the interrupted studwork. The laths are riven chestnut and some of the studs are quarter poles.

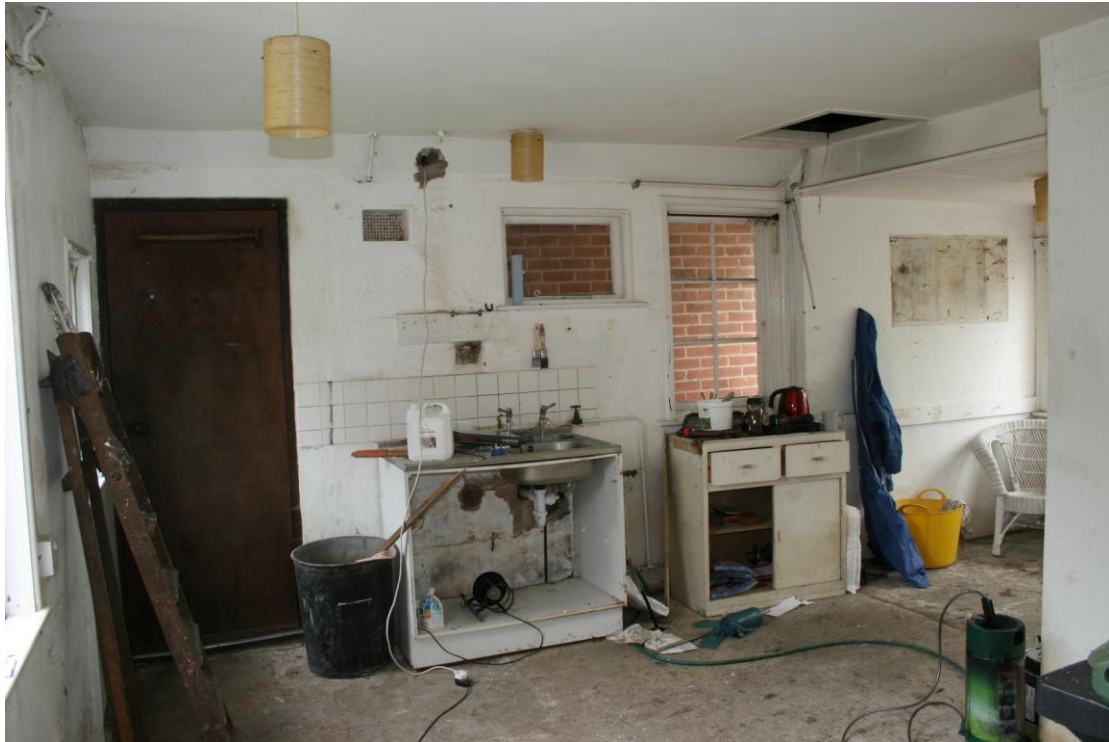
Looking E into the C20th Kitchen.

The Kitchen is a MC20th building built up against the eastern wall of the Hallway frame. The interior is plain and the floor is concrete. Some of the volume is taken up for a WC that is accessed from the Hallway. Of interest is a Victorian letterbox beside the Hallway door indicating this was once a front door. There is another in the northern end of the Hallway which is C20th and put there because it is nearest to the road for postal deliveries by van.

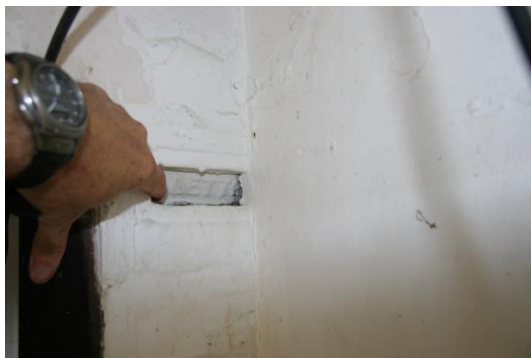
A Victorian letterbox has been part covered.

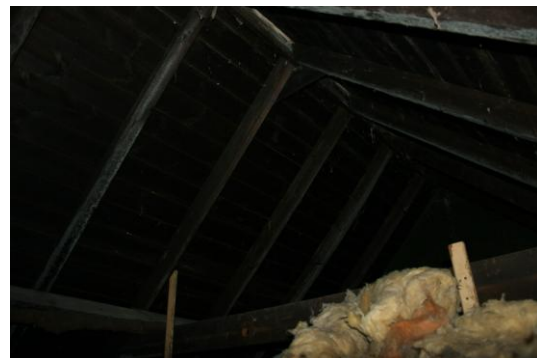
Fire damaged roof structure.

The simple structure of the roof is made of machined pine and is heavily blackened indicating a fire in the past.
