Oak Cottage, Royston Road, Wendens Ambo, Essex. CB11 4JY.
Description and analysis of the Cottage and Stable. Surveyed 15 06 2016.

Scope of this Report

This report describes and analyses the two buildings to English Heritage Level 3 as outlined in Historic England. Understanding Historic Buildings – A guide to good recording practice. 2016. Page 22.

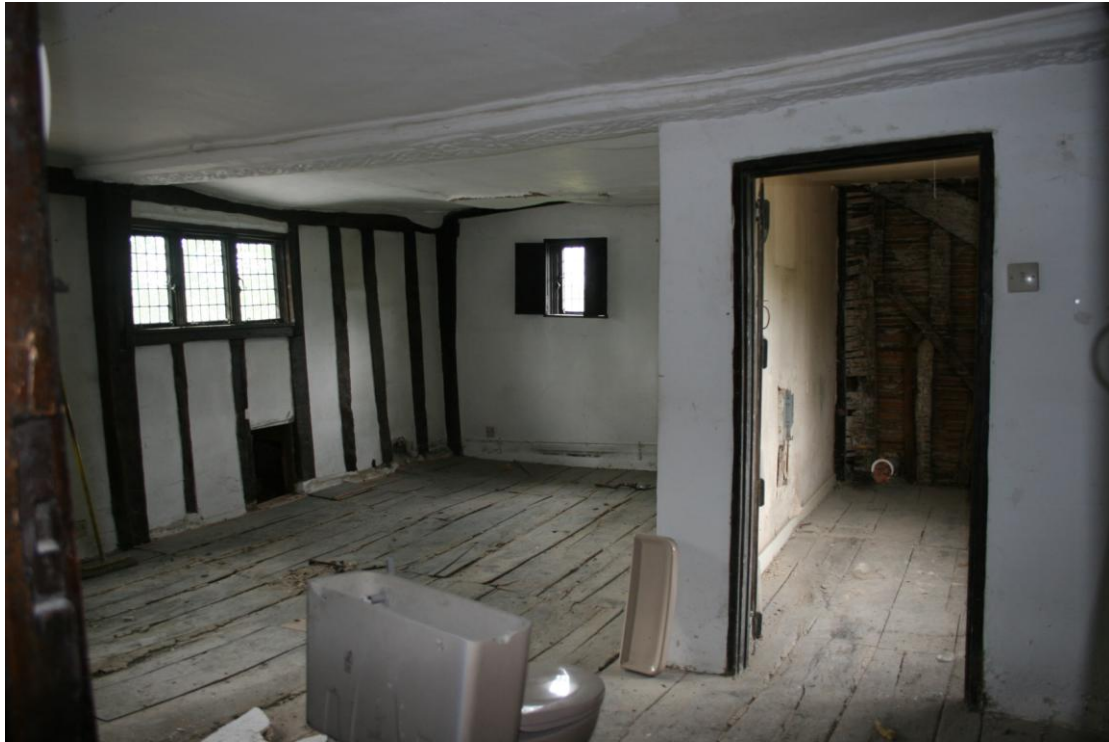
The West Bedroom looking SW from the landing.

The West Bedroom occupies the western half of the building and displays the heavy studded frame in the north and south walls and the interrupted stud frame in the western wall. The room has been divided with C20th studwork to create a bathroom and the partition clearly passes over the original 10-12in oak floorboards. Here also is seen a larger curved spandrel for the storey post to the tie-beam in the western wall. Much of the lath is cedar repairs.

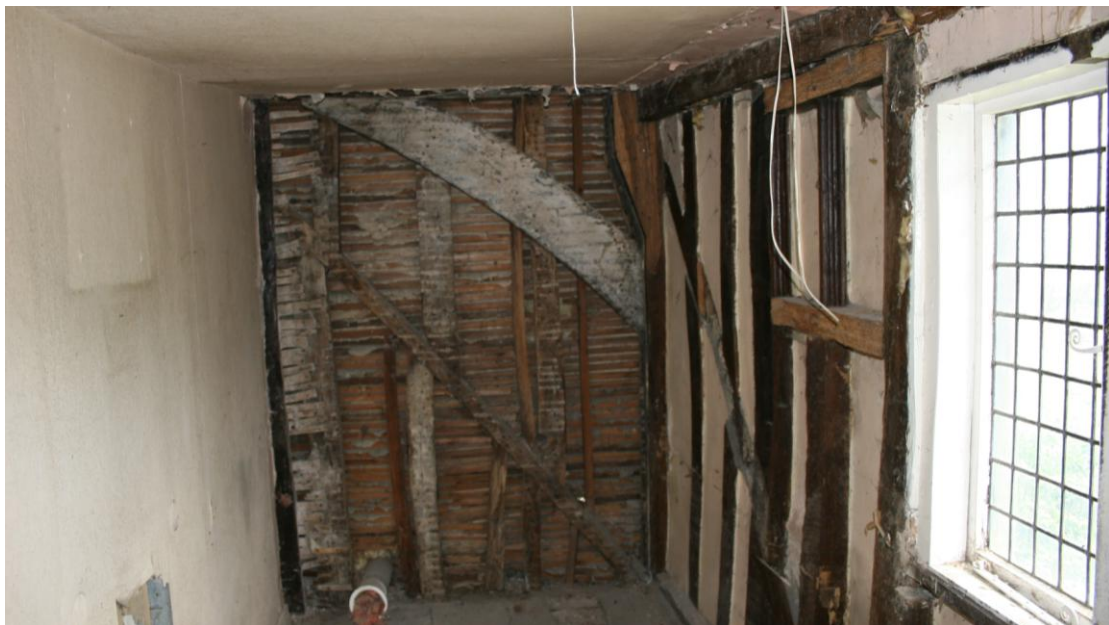
Bathroom inserted into the West Bedroom displaying curved spandrel in the studwork.

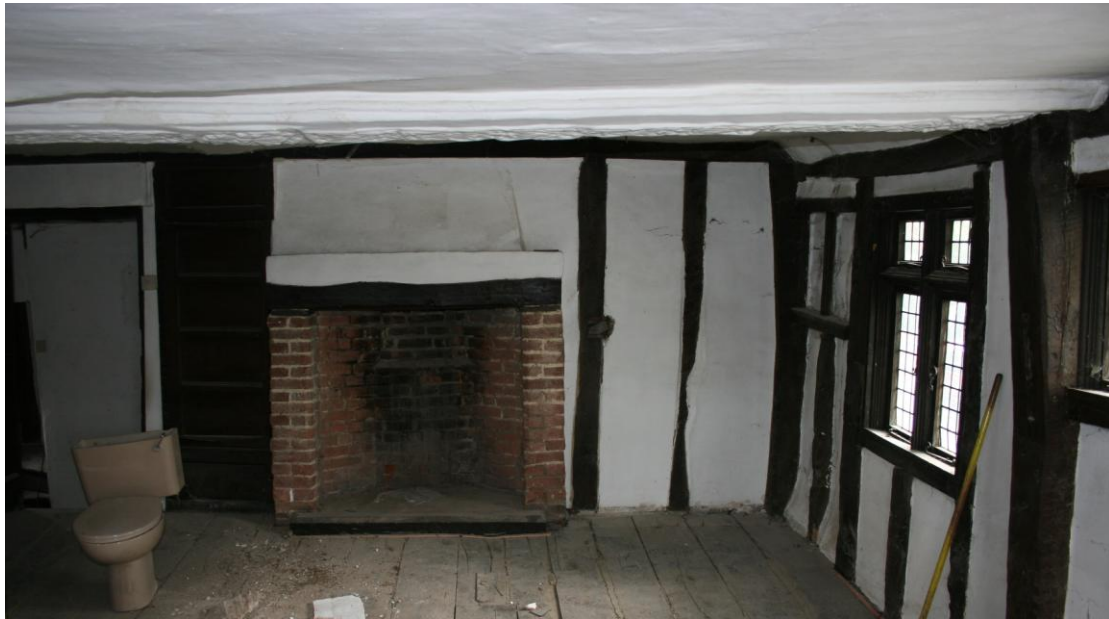
Looking E in the West Bedroom.

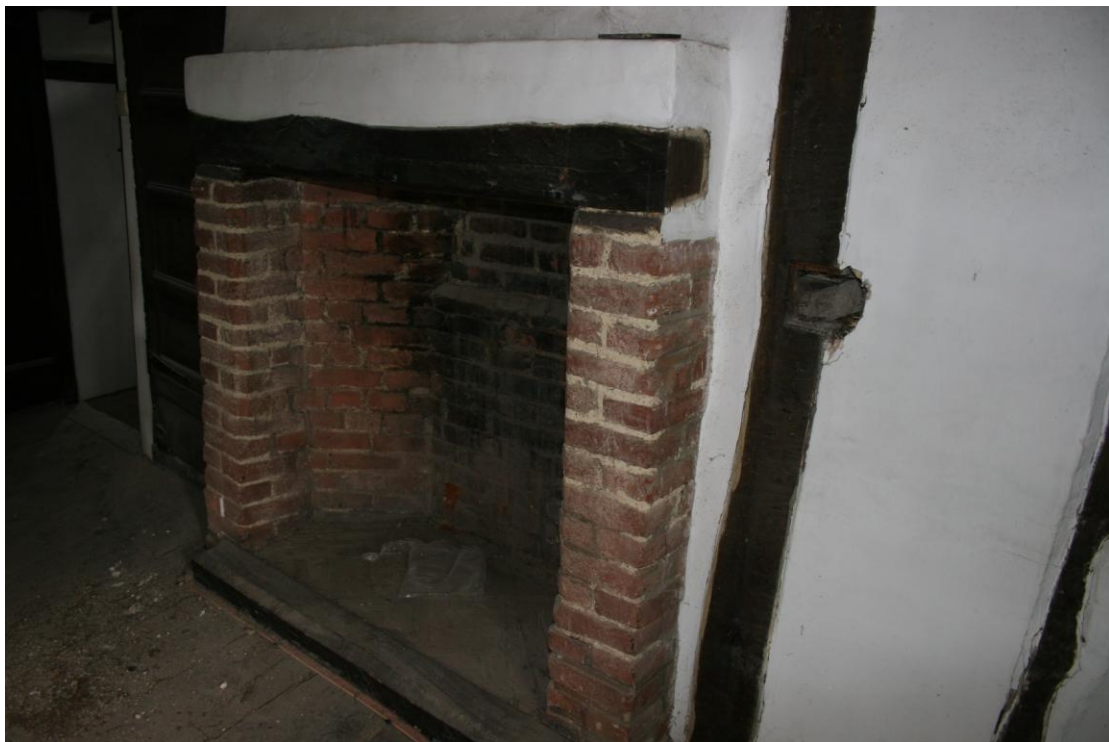
Detail of the fireplace.

The fireplace has Tudor style brickwork with an exposed bressummer. The back of the 3ft9inx3ft9in fireplace has been altered to accept a hobgrate fireplace with larger 60-65mm thick bricks which is a common MC18th or later feature. Despite a close inspection no apotropaic marks were found on any of the bressummers.

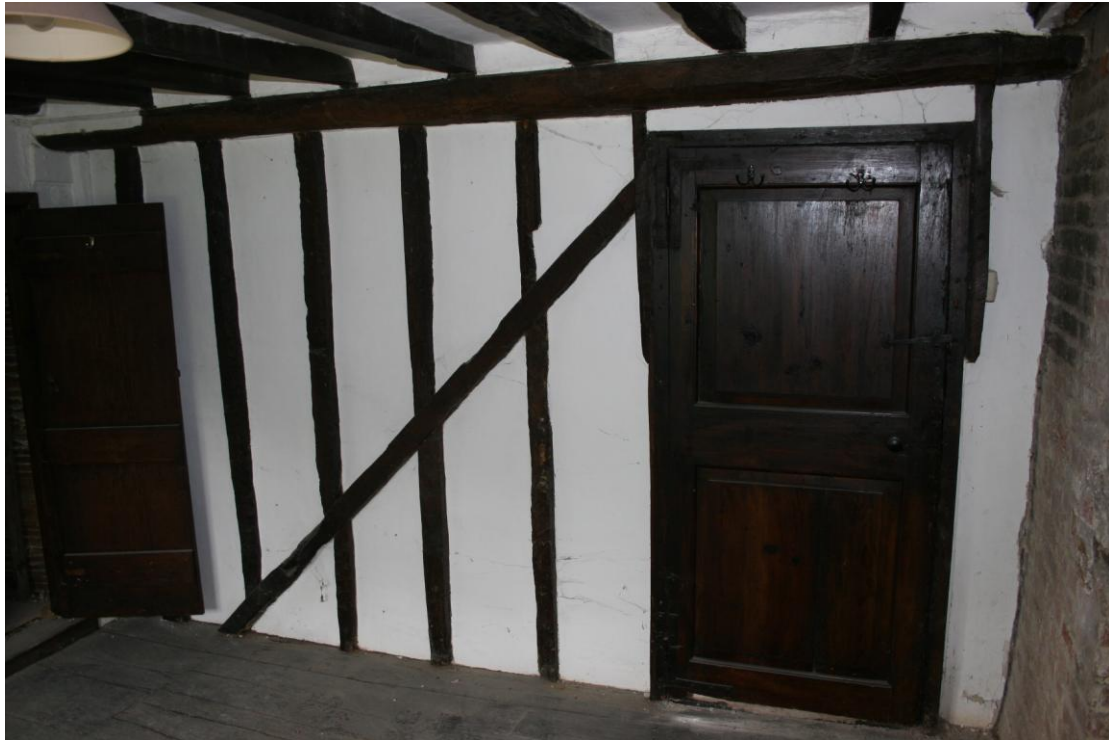
The dividing partition of the eastern side of the building.

The eastern side of the building has been divided by a EC19th style interrupted studwork partition. The landing also has a EC19th style partition which supported the attic stairs which have been entirely replaced with LC20th machined softwood. A former doorway was closed up with plasterboard.

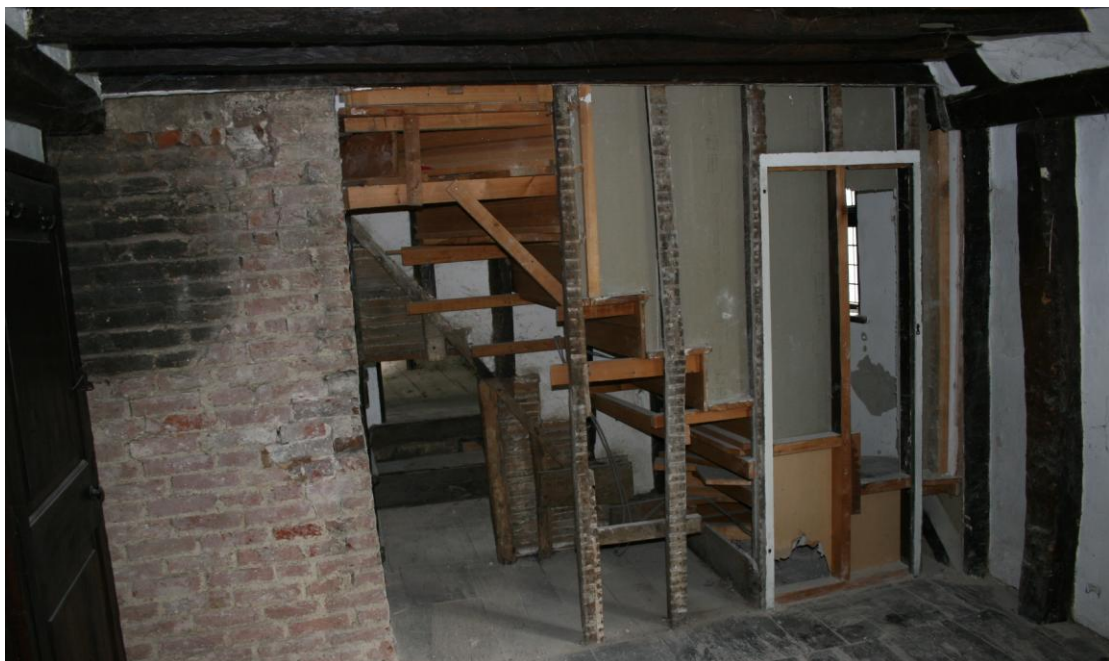
Looking W in the NE Bedroom.

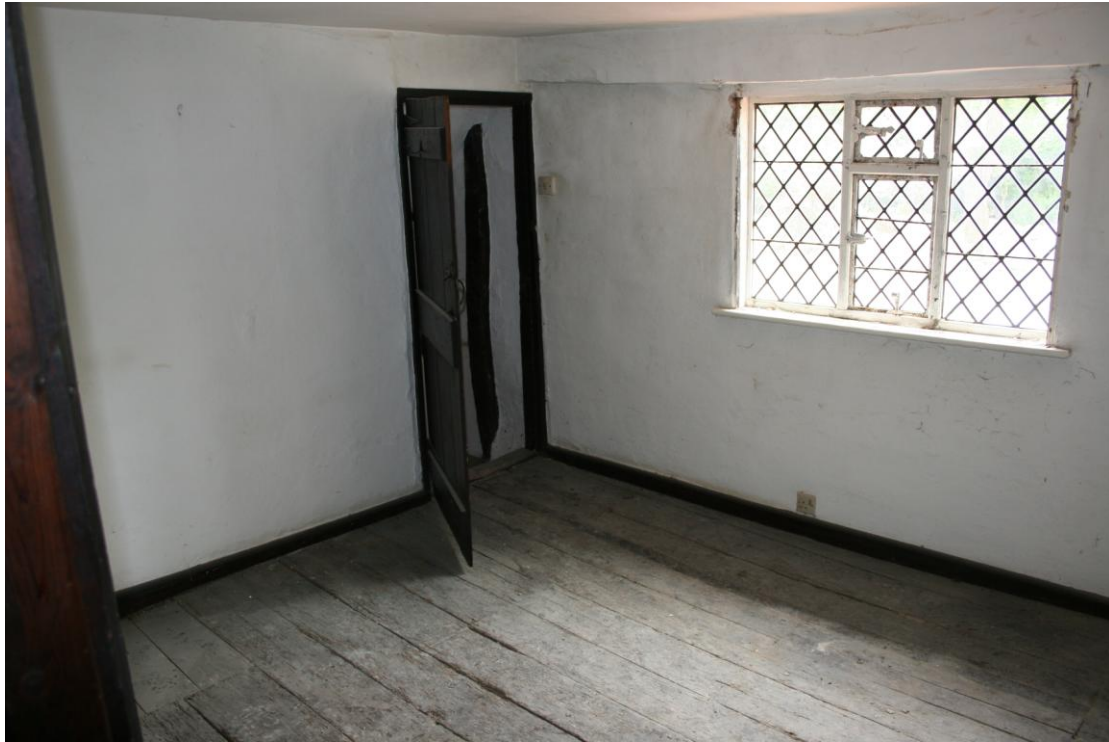
Looking SE towards the Hallway stairs in the SE Bedroom.

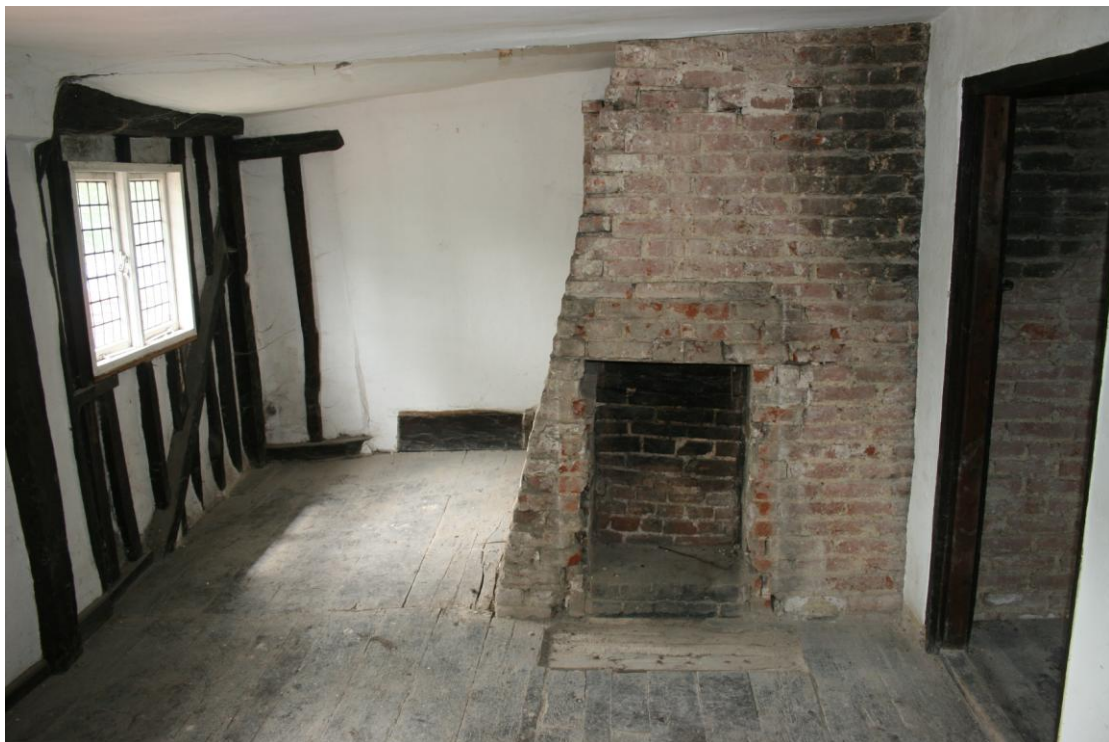
Looking W in the SE Bedroom. Note the inserted C19th fireplace.

Whereas the West Bedroom has a large C16th style fireplace on the eastern side there is only a small 2ftx2ft7in high inserted opening under an iron strap in the SE Bedroom. Here the narrow on edge joists seen in the NE Bedroom are hidden by lath and plaster. The wall frame is of C18th style interrupted studwork.

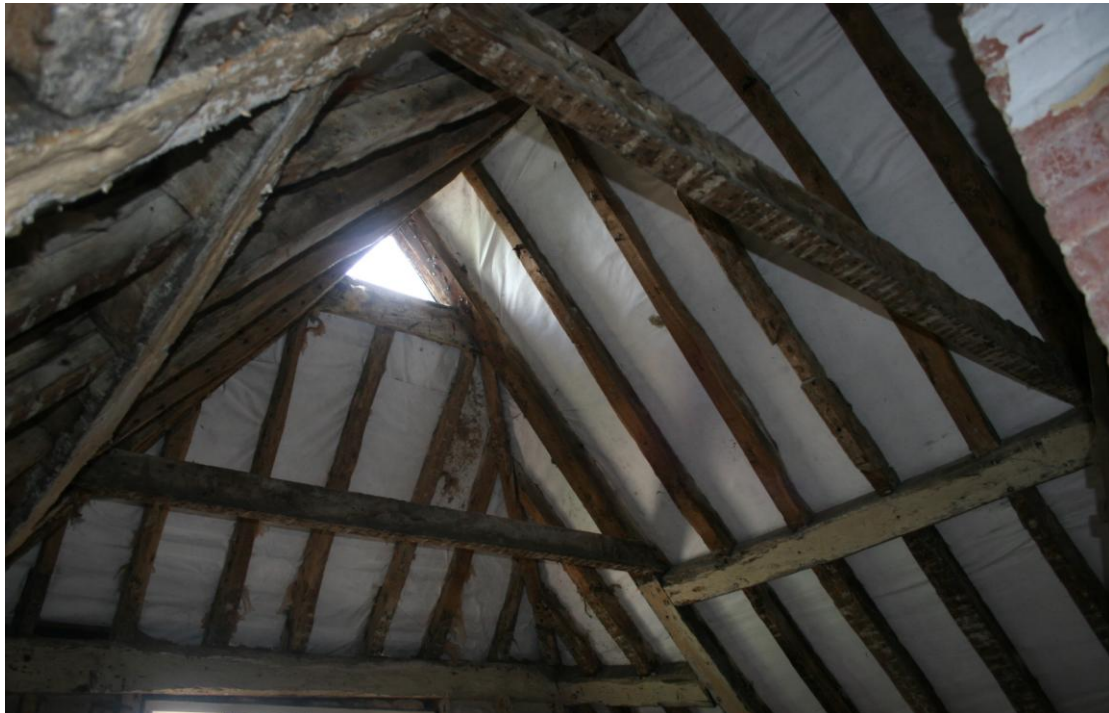
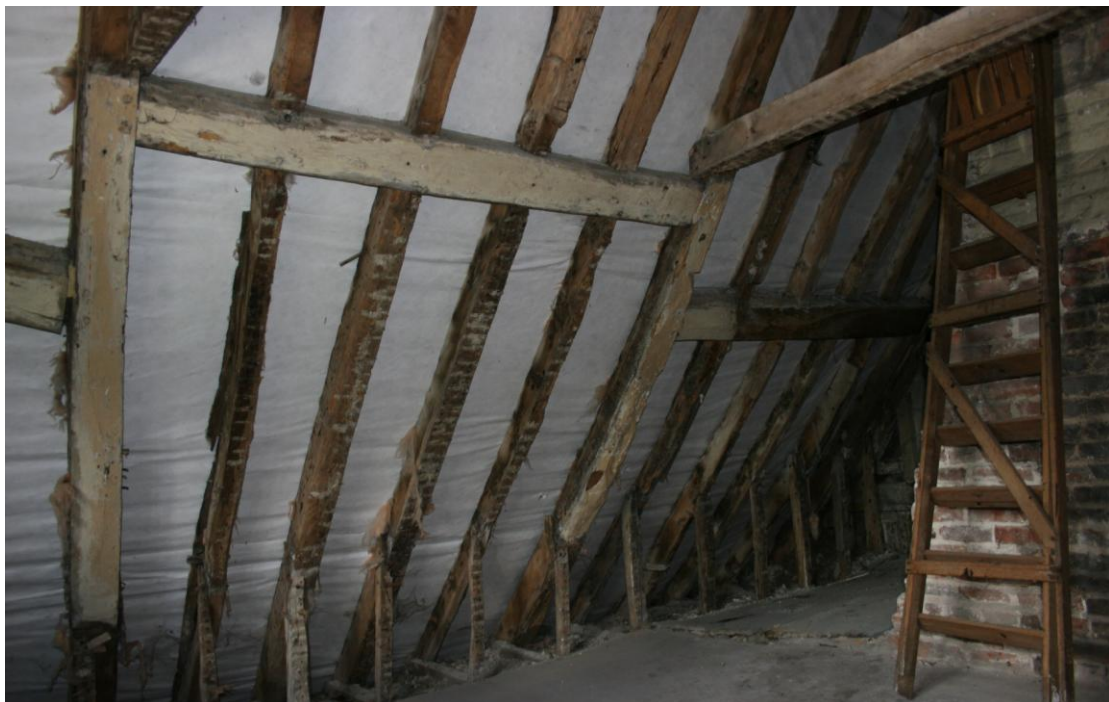
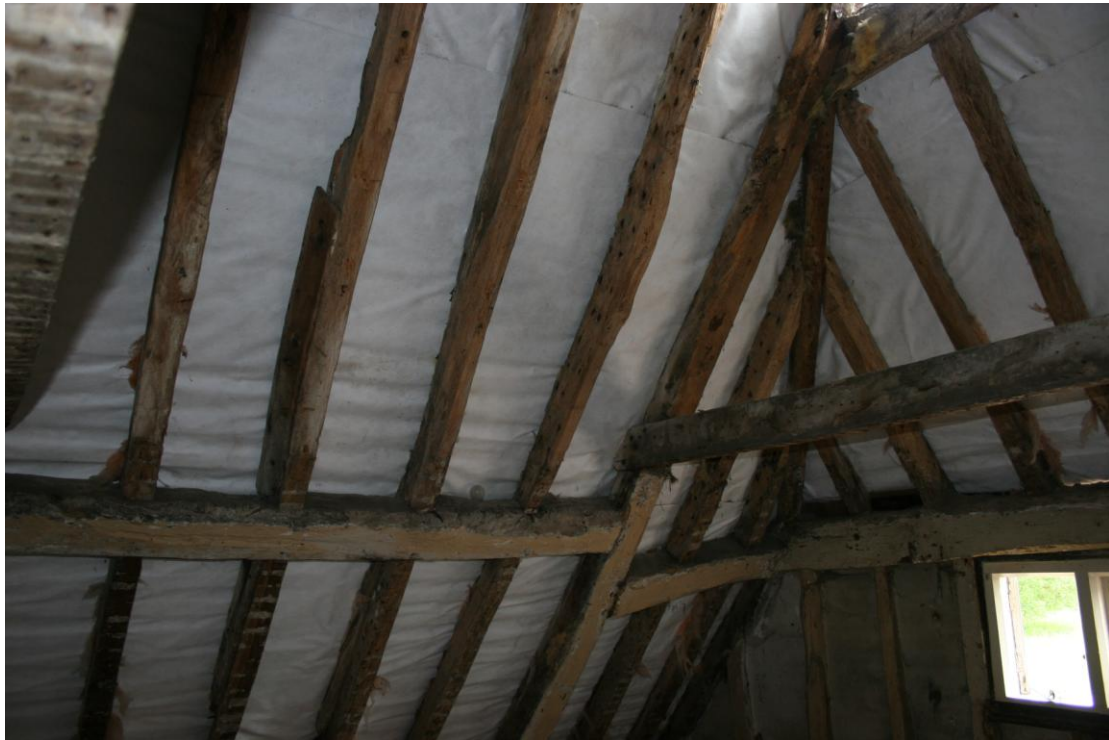
The roof structure of the Eastern Attic Room looking SE.

The offset butt purlin roof on the south side of the room.

The Eastern Attic Room reveals the structure of an EC17th style offset butt purlin roof. The heavy purlins are morticed into the side of the 5x5-6in principal rafters and offset to ensure strength at the terminals. The room was previously lath and plastered to the collars and limewashed.

The north side of the butt purlin roof.

The pitsawn paired rafters, which are morticed into the purlins, are largely reused and many have nails in their flanks from where they have been turned from being flat rafters to on their edges. The roof represents only part of the original frame and the purlins have been cut short at the hip end skewed upwards to reach the cambered tie-beam. The purlins at the western end are thicker at 8x5in rather than 6x5in. There are two side-nailed 6x3in collars and nail marks from where the ceiling joists have been removed. Small ashlar posts attached to each rafter are actually joist hangers and are side nailed in place to the slender 2.75-3x4in deep joists. No carpenter's marks were found.

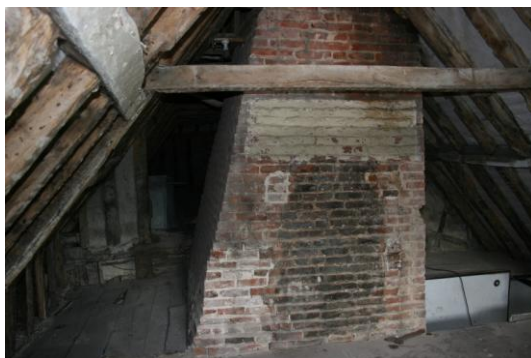
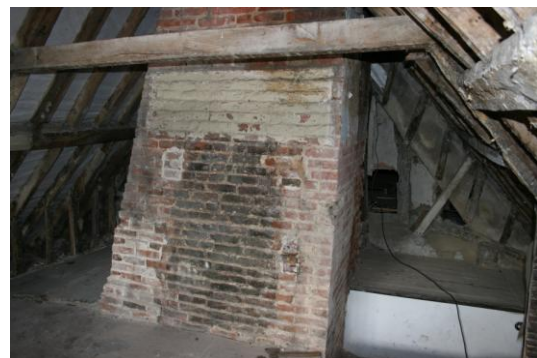
The firestack from two angles looking W.

The firestack appears to have had a fireplace that has been blocked up and there is a straight vertical joint on the northern (RHS) side. The bricks may be blackened due to a chimney fire which affected the thin skin more than the main body of the stack.

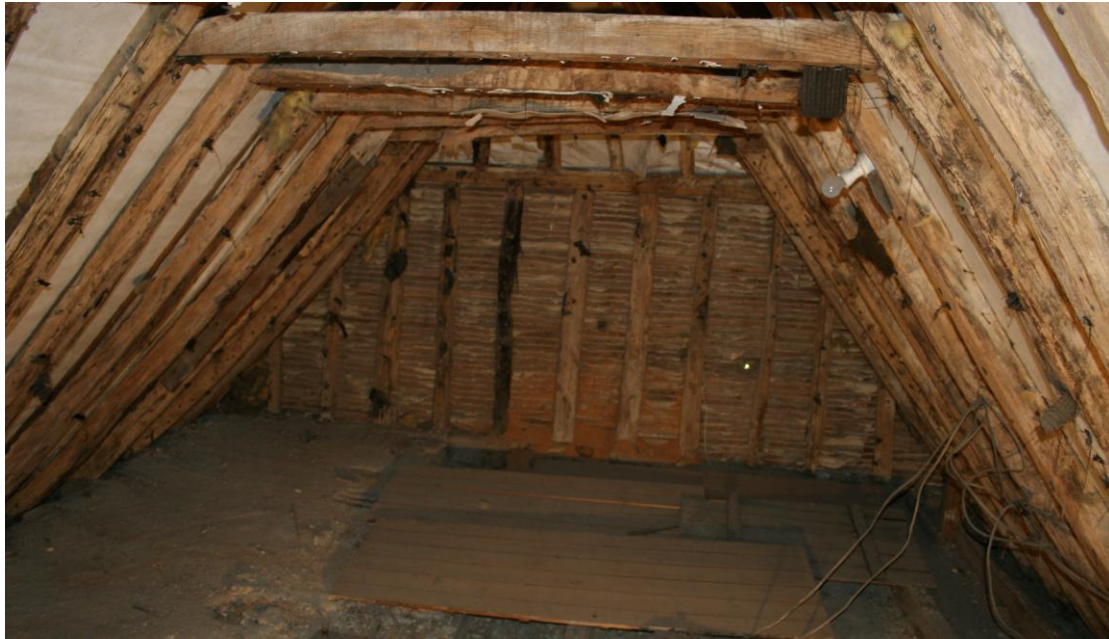
Looking W in the West Attic Room.

The West Attic Room has the exposed roof structure of a collared roof with paired 5x3in rafters numbered out of order at the apex and above the 5x4in collars with a race knife or thin blade. The roof has been reassembled from reused rafters showing lap joints for collars lower down the rafters. The collars are all renumbered using a chisel point at the lap joints. Some of the rafters and the studs in the western wall are sooted but most are clean.

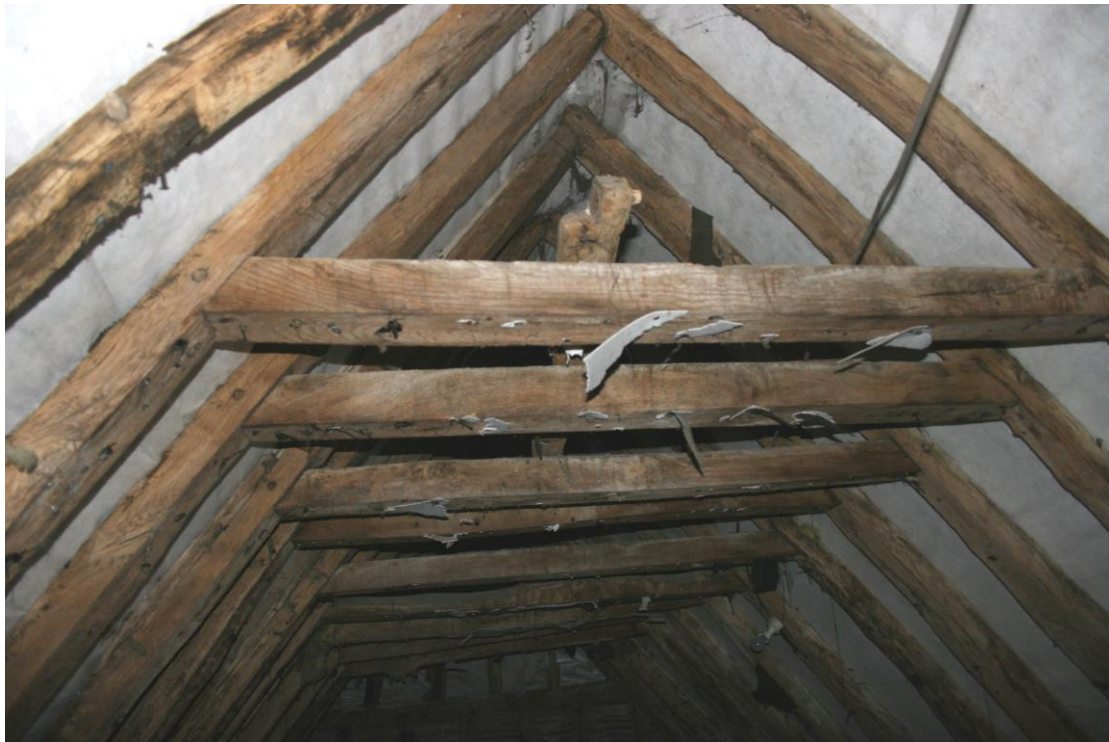
The collars of the paired rafters.

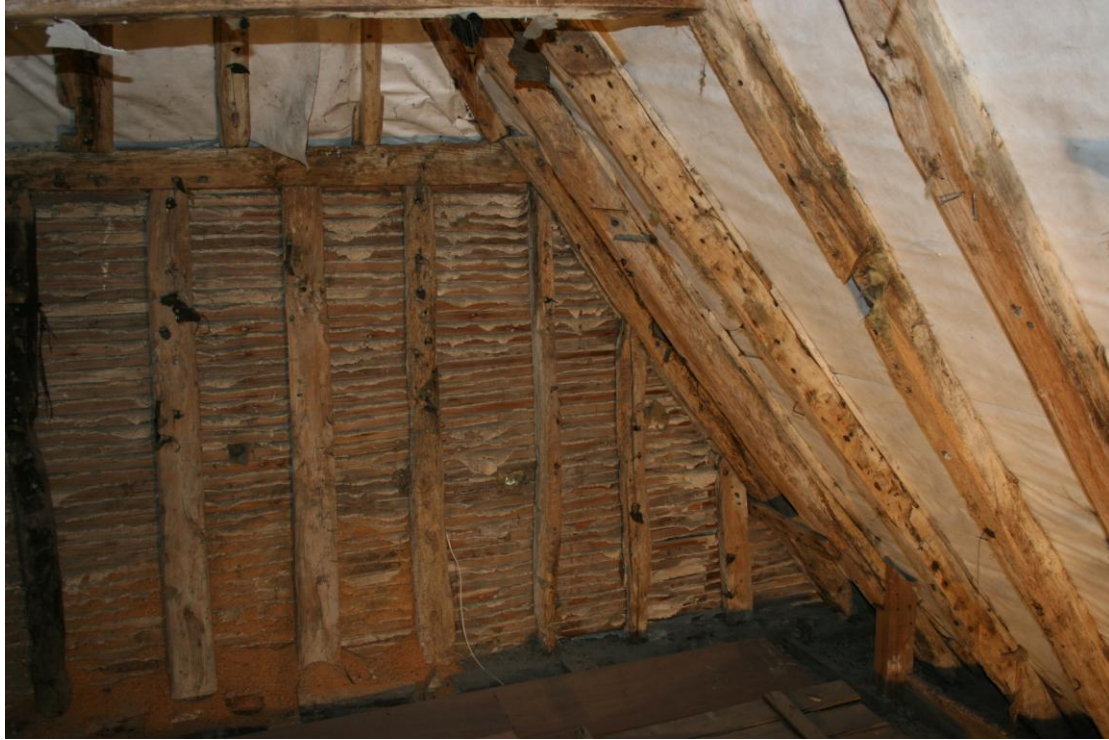
Reused rafters in the roof space. Looking NW.

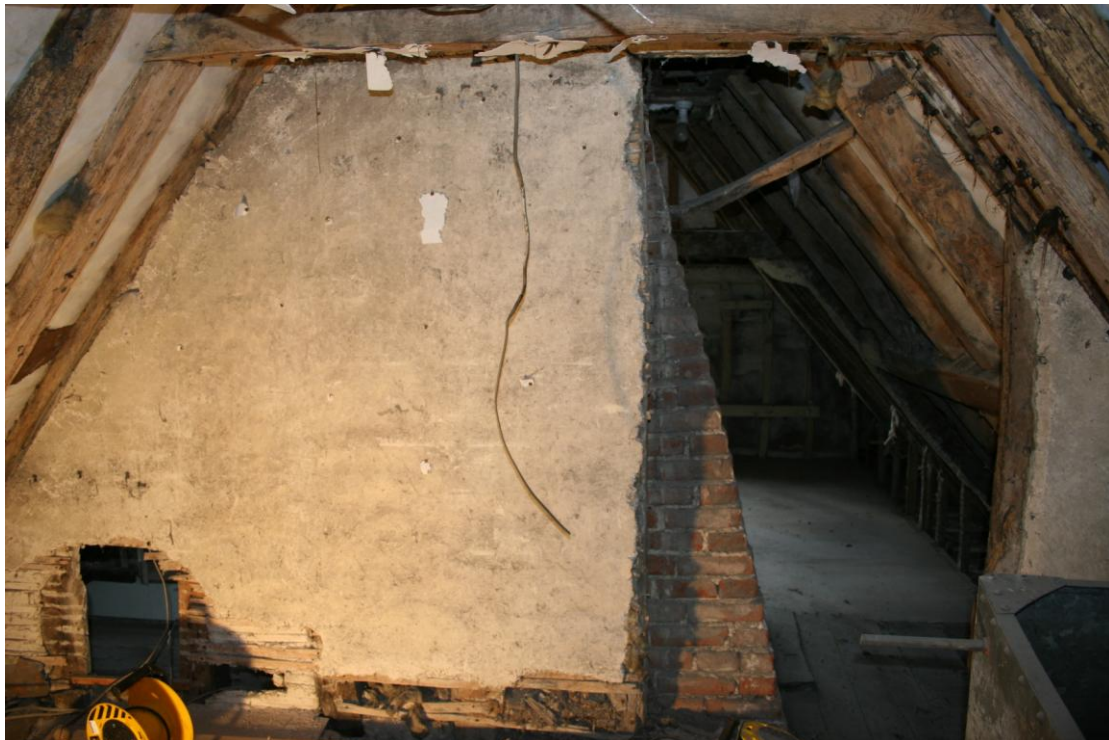
The room has been blanked off from the firestack. Looking E.

This space was not made habitable. There is no fireplace and the floor has no boarding and is insulated with daub over the widely spaced joists. The lath and plastered partition wall is EC19th in character. Of interest is a brass cam for a servant's bell fixed by the wall.

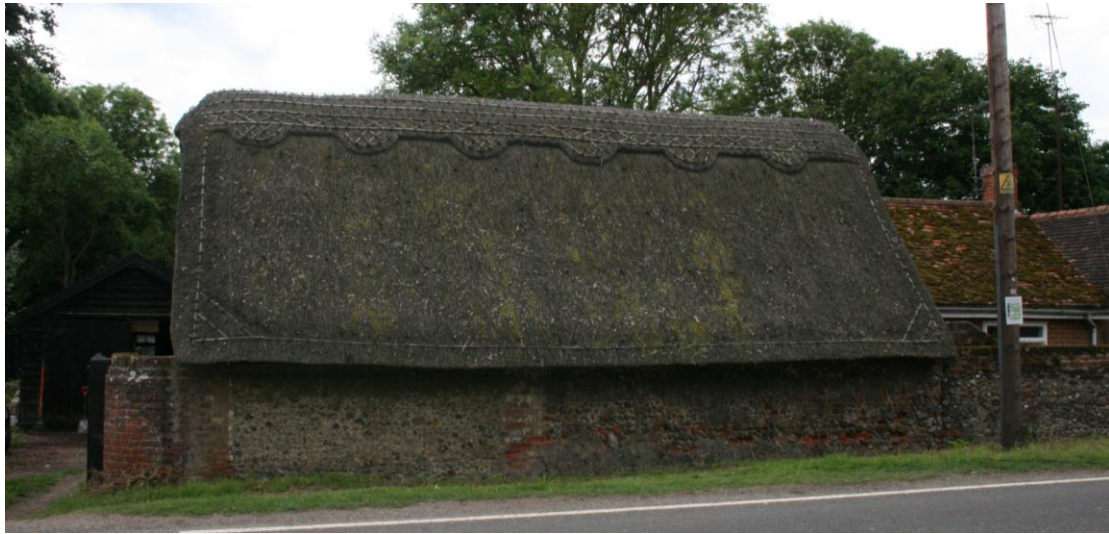
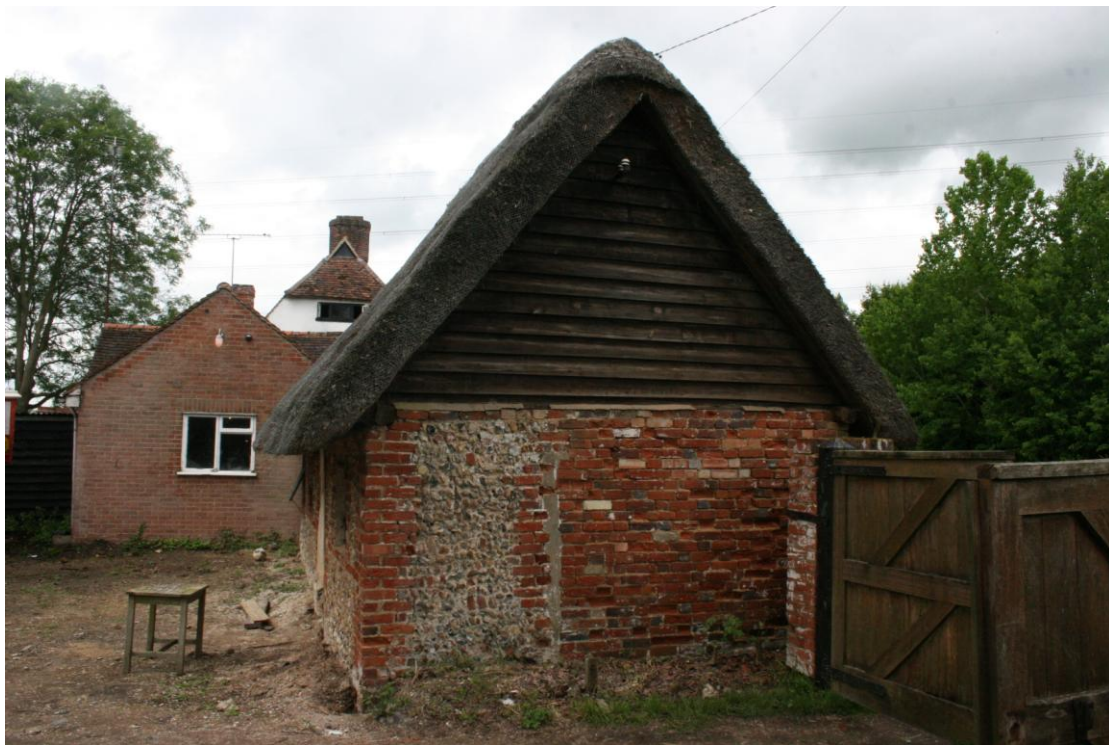
The northern elevation of the Stables.

The eastern elevation of the Stables.

The Stables is built from the remnants of a longer range of buildings that are outlined on the Ordnance Survey (1 to 10000 series) up until at least 1938 and are altered by 1960. This makes it easier to understand the piecemeal construction and many repairs. There are a variety of brick sizes and many are obviously reused but in the main they are 65x110x225mm. Many panels are rebuilt with brick and flint rubble.

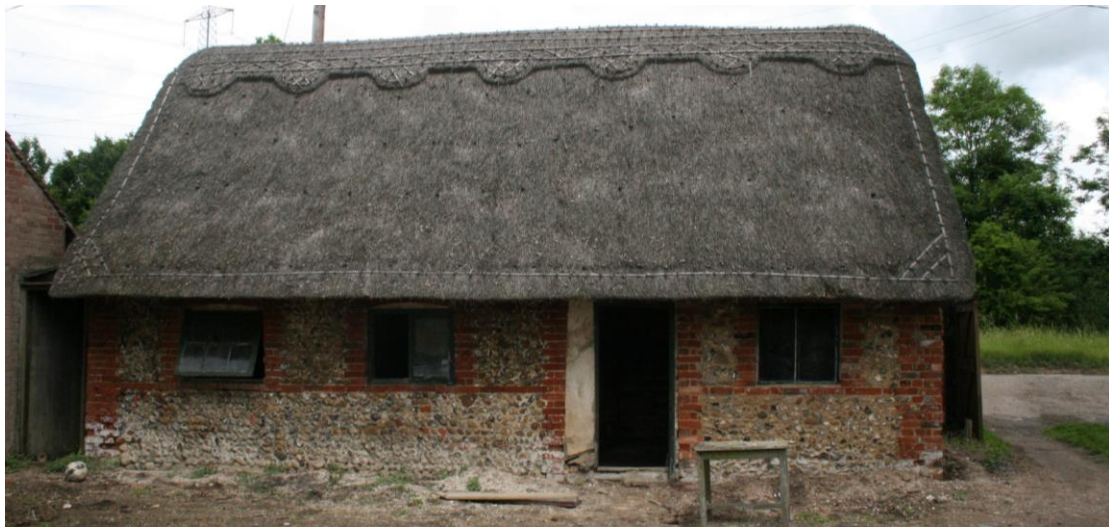
Southern elevation with new thatched roof.

The southern wall is executed in panels of flintwork outlined in red brick. There is a doorway with red brick quoins which has been reduced in width with a stud and diagonal lath and plasterwork. There are three windows under rough gauged brick arches. Two have plain casements while a third has a top hung 6 pane frame. The western wall is lath and cement rendered while the eastern is weather boarded with C20th boards fixed with French nails.

The roof has been recently thatched and inside has been largely rebuilt with recent graded softwood.

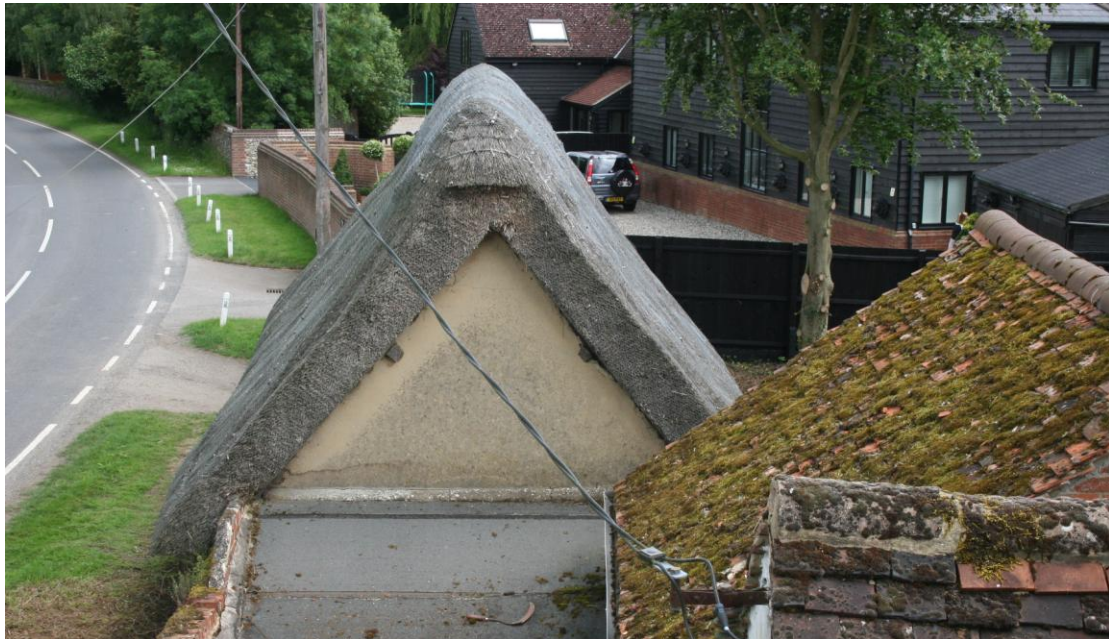
The western elevation seen from the house.

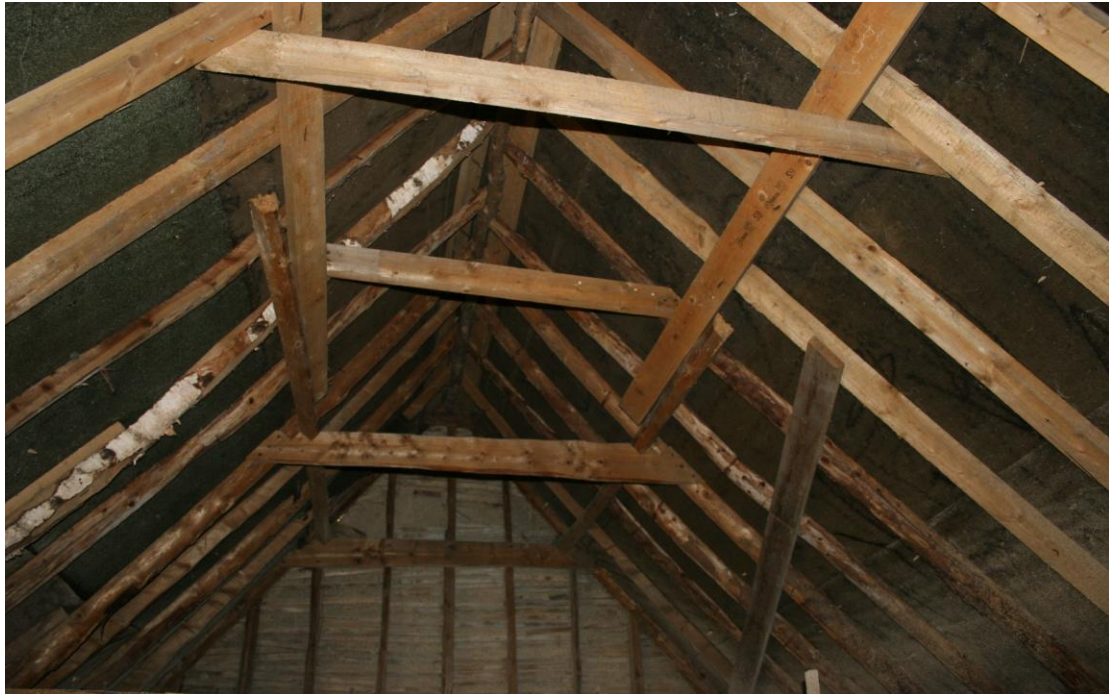
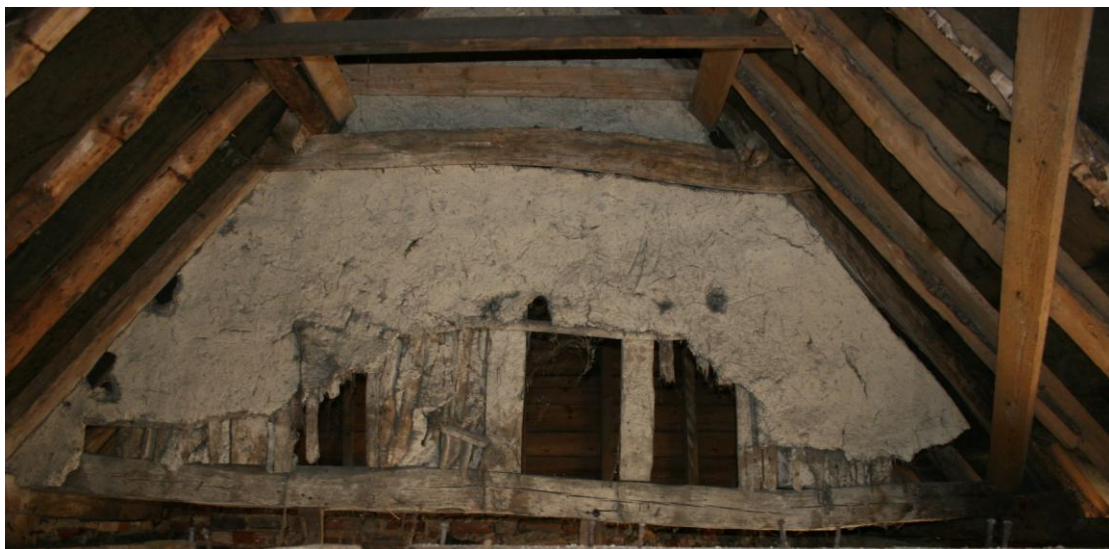
Looking W in the Stables.

Looking E in the Stables

The roof has been comprehensively rebuilt with machined softwood stamped GS 1691 – General Structural Licence No1691.(BS EN 14081). A variety of quarter poles have been retained including some from a silver birch. At the eastern end a panel of studwork with wattle and daub infill has been retained and marks the division between two roof designs.

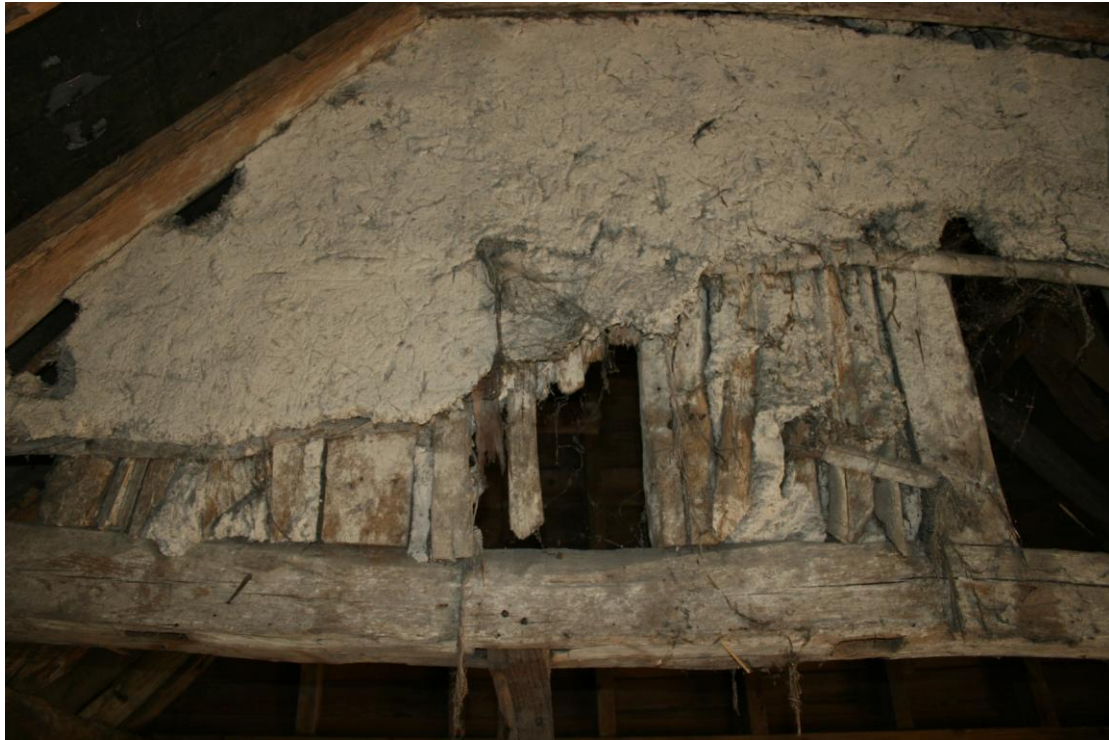
Detail of the wattle and daub panel. West side.

The wattle and daub panel has horizontal legers tied to vertical riven rods with hessian string. This feature dates the panel until after the 1820's when hessian began to be imported into England.

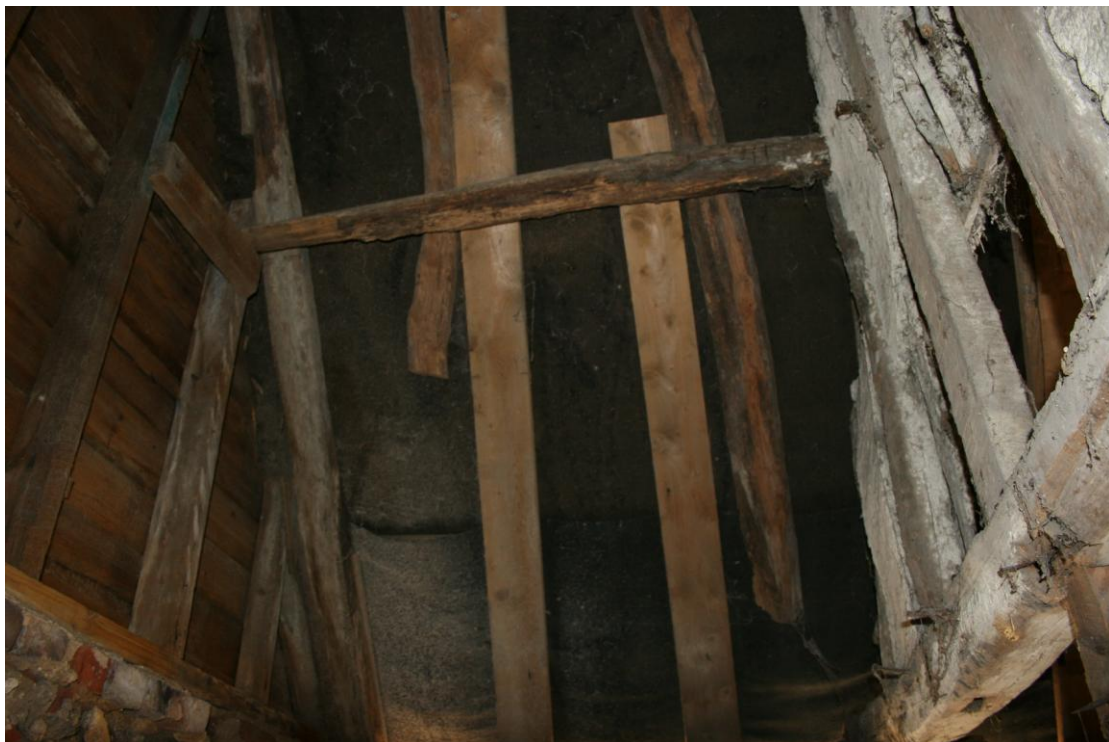
Change in the roof structure in the end bay. Looking S.

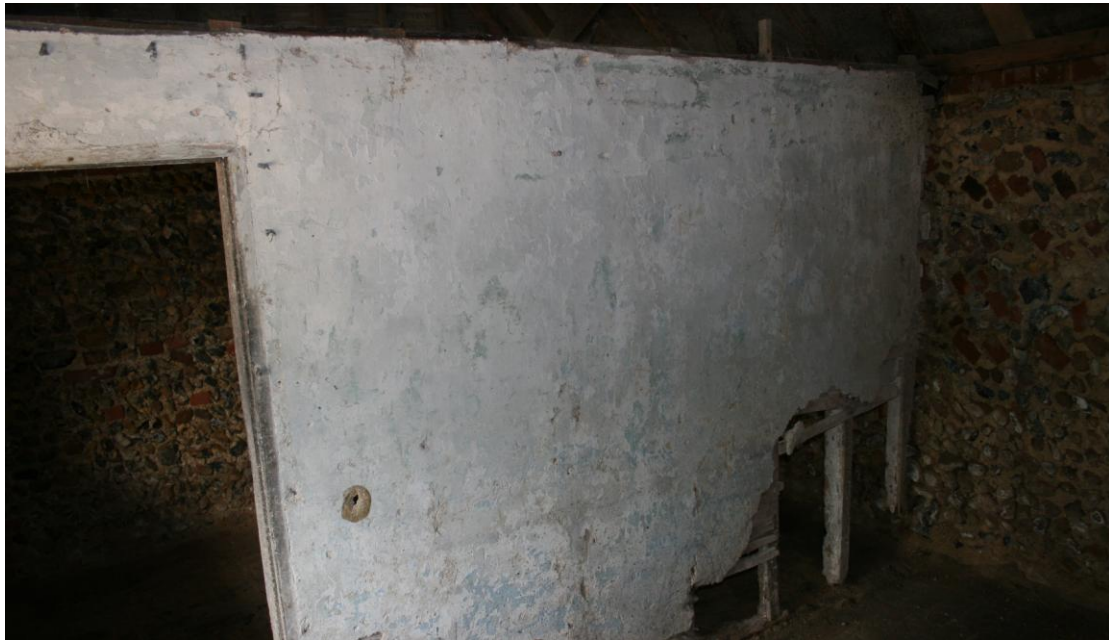
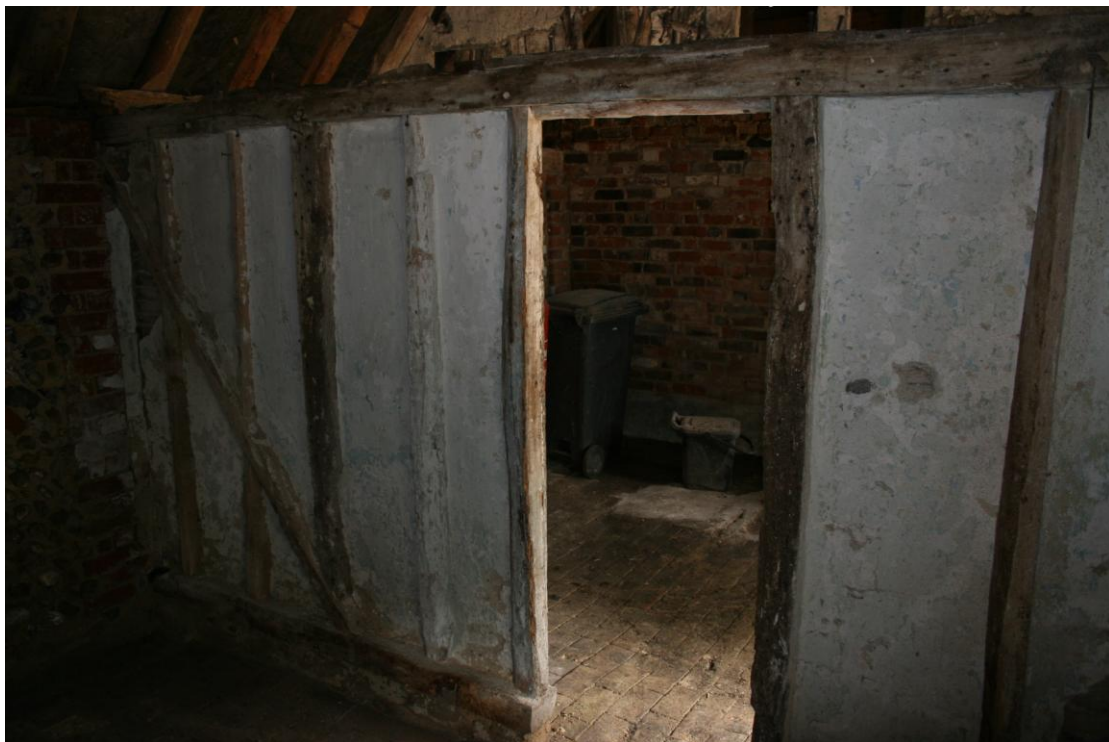
Lath and plastered partition wall between Bays 1 and 2.

Lath and plastered partition wall between Bays 2 and 3.

There are three bays divided by scantling studwork partition finished with lath and plaster on one side only. The work is more than likely MC20th and the panels do not connect with the walls, which are freshly repointed or the top-plate of the repaired roof. The wear on the brick paved floor indicates these were used as stables but no fixtures remain.

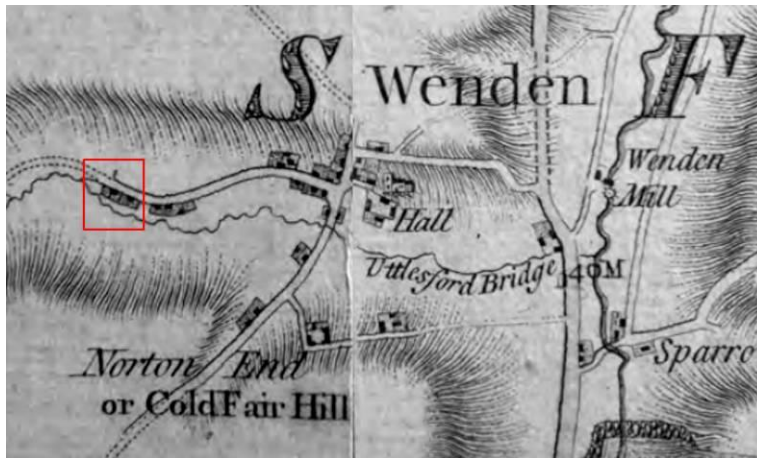
1777 Chapman and Andre's Map of Essex.

In 1777 the property is shown divided in two with an enclosure around both halves. A second property is to the east where the Stables is today. There is no Tithe Award Map for Wendens Ambo available.
