Little Mascalls, West Hanningfield Road, Chelmsford CM2 7SY.
Heritage Statement for part of the former farm site. 04 11 2016.

Location

This report investigates the historical evidence for a timber-frame barn that has been
demolished in order to inform a modern development on the site.

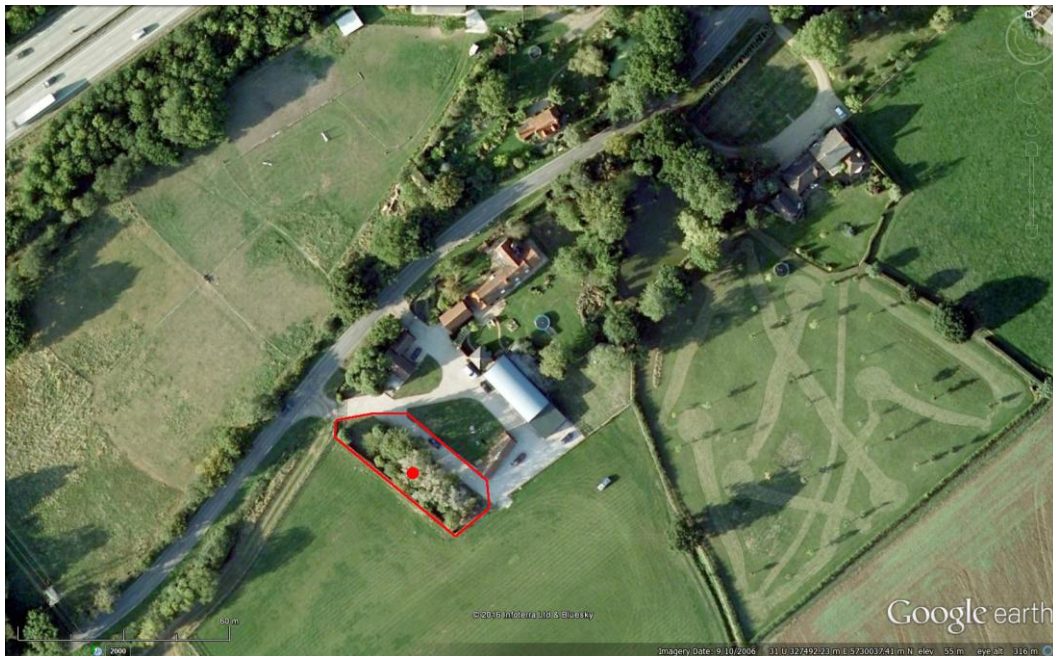
2013 Google earth. Detail of the site showing the building under study now under trees.

Little Mascalls, West Hanningfield Road, Chelmsford CM2 7SY. The site of a former barn, now under trees, is to the SW of the house. Centred on TL 732114 02485.

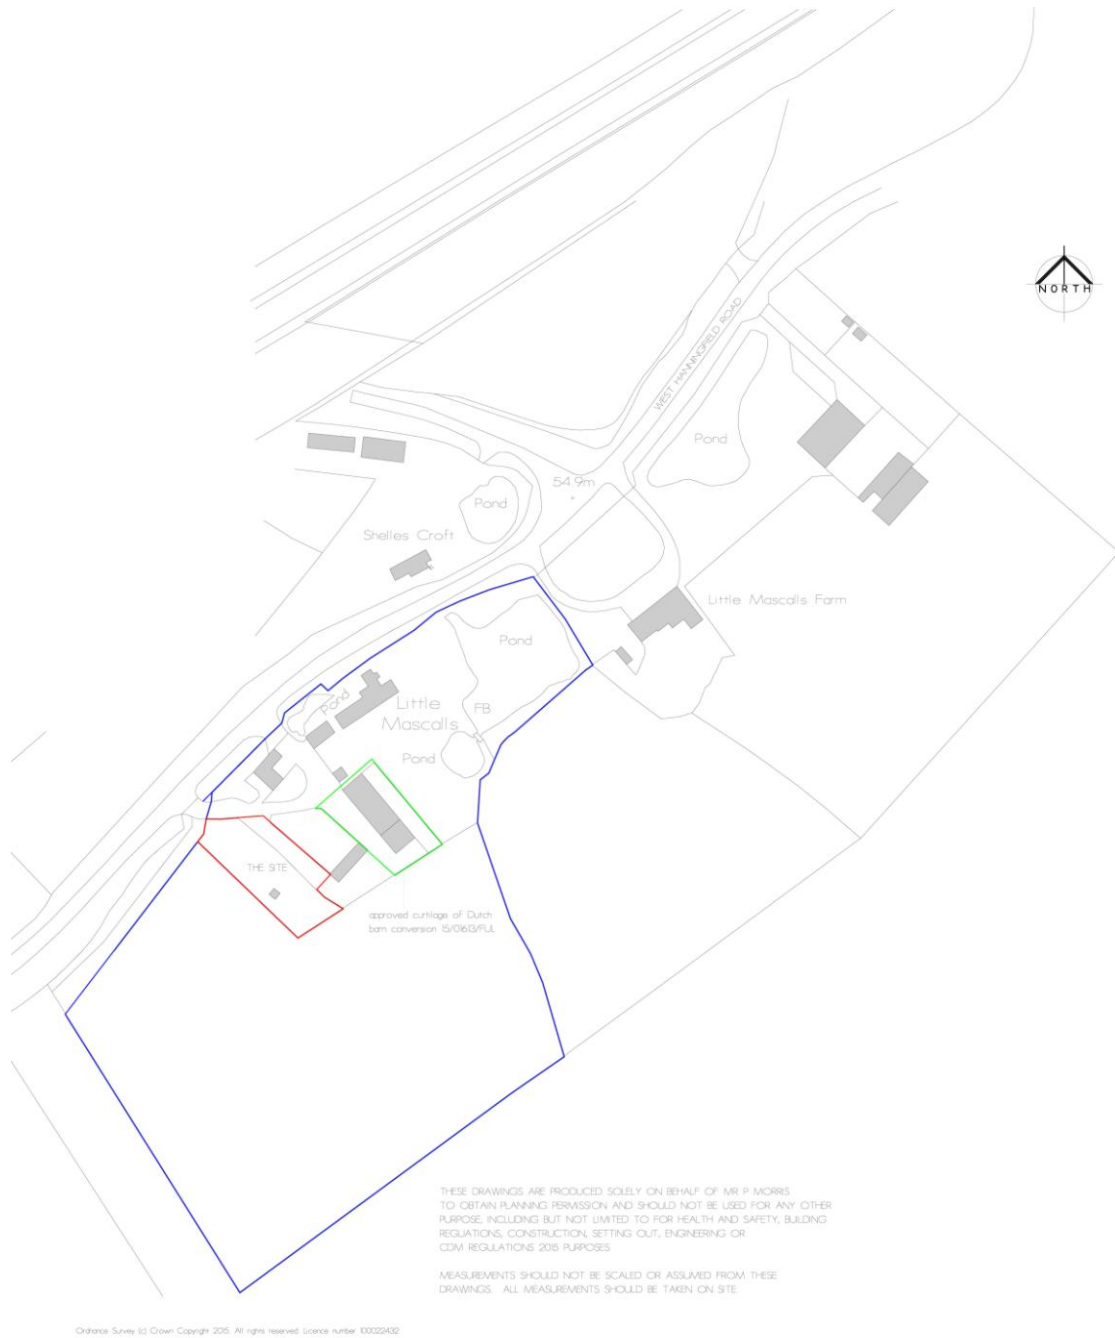
The Planning & Design Bureau Ltd	
Plan Title:	Site Location Plan
Site Address:	Land at Little Mascals, West Hanningfield Road, Great Baddow
Proposed:	Replace Dutch Barn (PP for Dwelling) with New Barn Dwelling
Plan No:	PDB/16/59/01
Scale:	1:250

2016. Site plan showing the site under study.

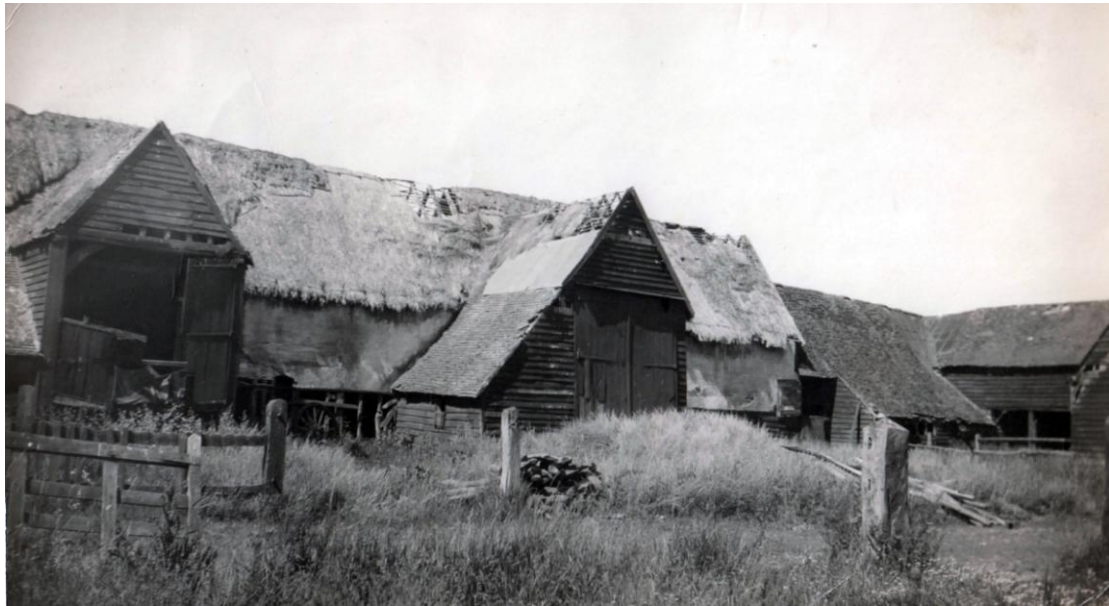
C20th photograph of the barns in a deteriorated state.

This photograph taken before the barns were renovated in the early 1970's offers some detail of the double Essex barn that was on the site. The roof can be seen to contain paired flat rafters and was clad with thatch fixed to riven laths. The flank walls are finished in large panels of lath and daub or lime plaster above runs of weather-boarding. The frame is revealed in the centre and has a mix of wide and narrow studs indicative of a c.1800 design.

The two porches are weather-boarded and have tall upper doors indicating they were built for threshing. The porches are two different sizes and this is often an indication that two barns have been conjoined to form a larger double barn. A weather-boarded outshot has been added to the northern porch (RHS) with a tiny window. There is another outshot parallel to the axis of the barn by the southern porch. Both outshots are under clay tiled roofs.

The buildings to the north (RHS) all have clay tiled roofs and are open fronted and railed with rustic poles to house animals. There is also a split stable door for a horse stall.

Photographic evidence suggests that an early barn with paired flat rafters was added to with a frame constructed of scantling. The most likely period for this to happen was during the period of the Napoleonic War.

The historic photography reveals that the barns were allowed to fall into disrepair in the post WW2 years until they were re-roofed before 1972. Many of the other buildings were demolished but new outshots were added to the barn and to the east a huge modern hay barn, often also used as cow byres, was erected.

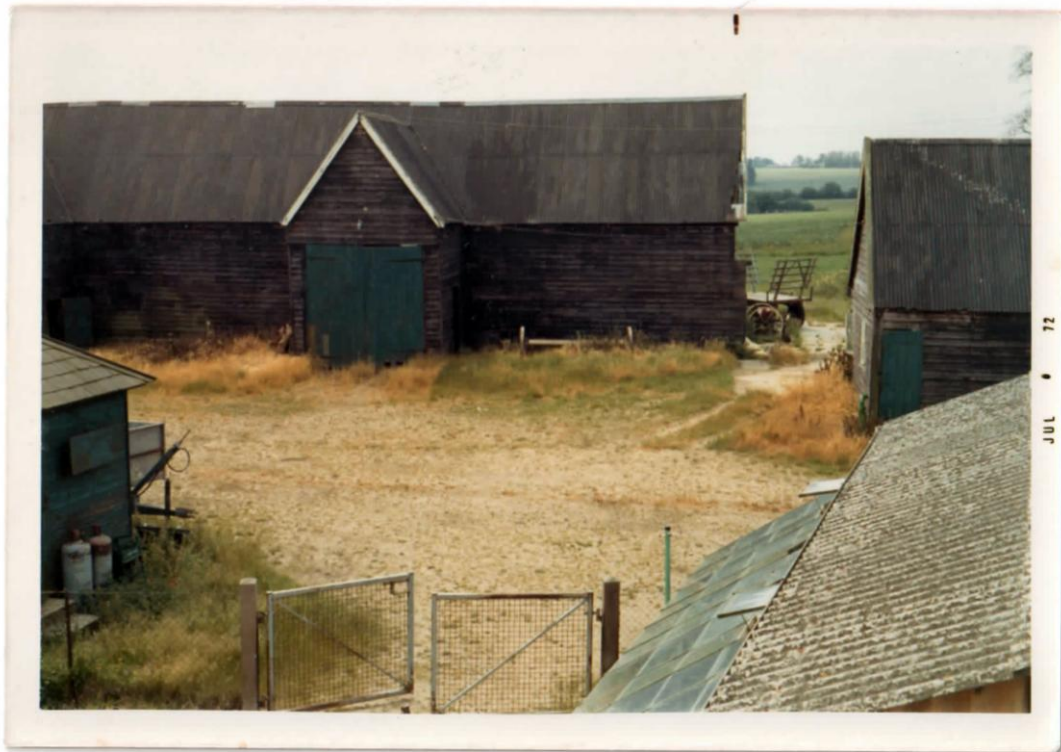
1972. Photograph showing the north end of the barn after remodelling.

Both photographs show the buildings as renovated in the LC20th. The upper one is dated to 1972 and the lower one is a common style of aerial photograph sold door to door in the later 1980's. The buildings have corrugated iron roofs and weather-boarded walls. The porches have garage style doors.

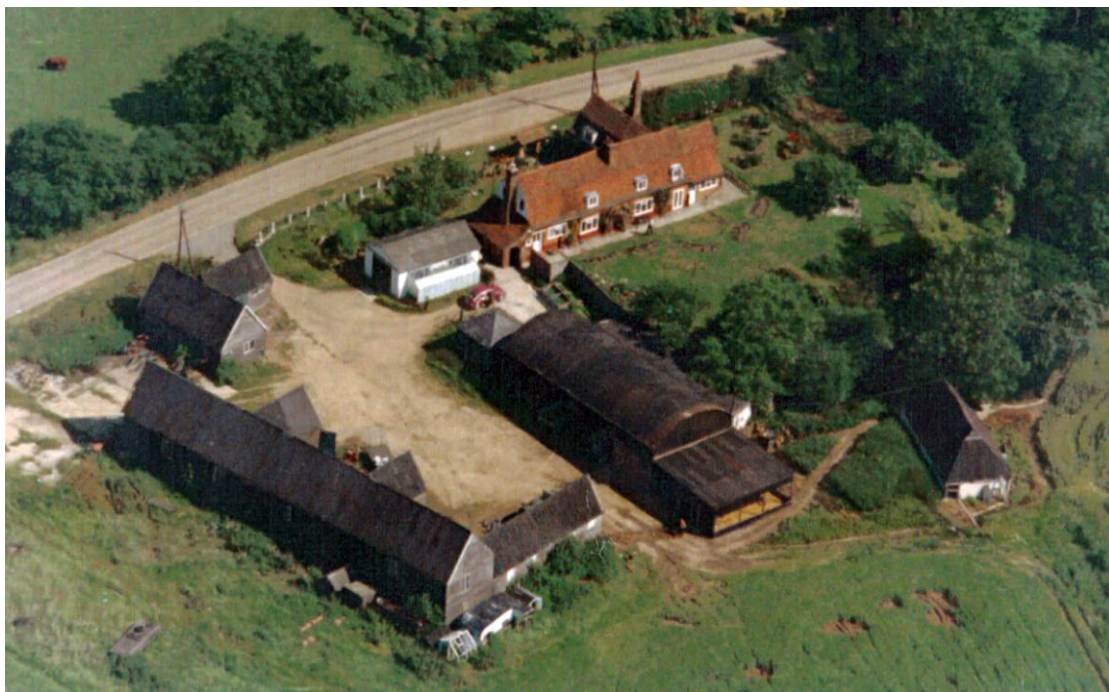
1980's. Aerial photograph from the SW showing the farm buildings.

The site represents a former Napoleonic War era barn added to an earlier timber-framed barn now only known from photographs. The buildings were lost before AD2000 having been photographed as complete in the late 1980's.

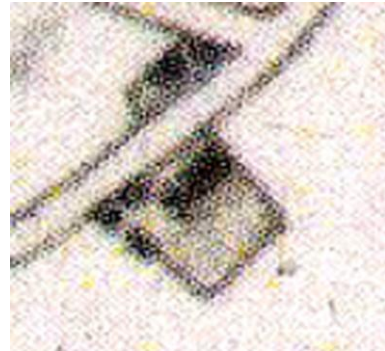
1777 Chapman and Andre's Map of Essex.

The 1777 map shows the site of Little Mascalls unnamed. Within the boundary is a large building corresponding to the farmhouse, two buildings near the road and another that corresponds with the northern half of the former barn. To the NE is 'Mascul'.

Map evidence suggests that a building on the site of the barn was extended to twice its size between Chapman and Andre's Map of 1777 and the Tithe Award map of 1838 being drawn.

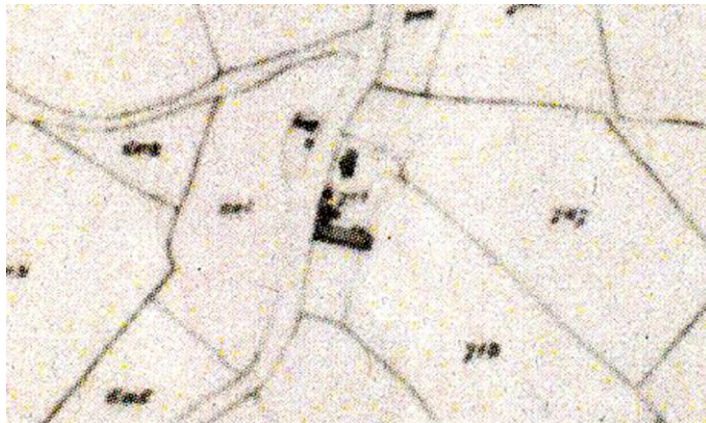
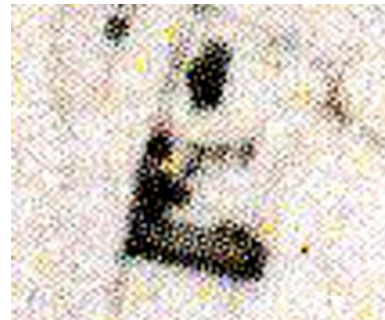
1838 Tithe Award Map for Great Baddow. ERO D/CT 13B.

The Tithe Award Map for Great Baddow shows the site has been developed with a larger building on the site of the barn, apparently with only one porch. The other buildings have been conjoined. The farmstead occupied Plot 714 Homestead and belonged to the Revd John Jefferies and was occupied by Charles Wilkinson who is listed in White's Directory of 1848 and 1863 as farmer at Little Maskells.

At Little Mascalls by 1838 we see a fully developed farmyard system fully corralled for animal husbandry. As Mingay says 'To house valuable stock, preserve its manure and promote greater efficiency in the working of the greater complexities of the system, new buildings in new configurations were required. Implements of unprecedented complexity and dedication to single tasks became increasingly common and steam power invaded, first the barn and eventually the field.'
