Wyndies Cottage and The Wyndies, Crow Street, Henham, CM22 6AH.
Historic analysis of the timber-framed house. Surveyed 09 08 2016.

Scope of this Report

This report describes and analyses the fabric of the buildings to English Heritage Level 3 as outlined in English Heritage. Understanding Historic Buildings – A guide to good recording practice. 2006. Page 14.

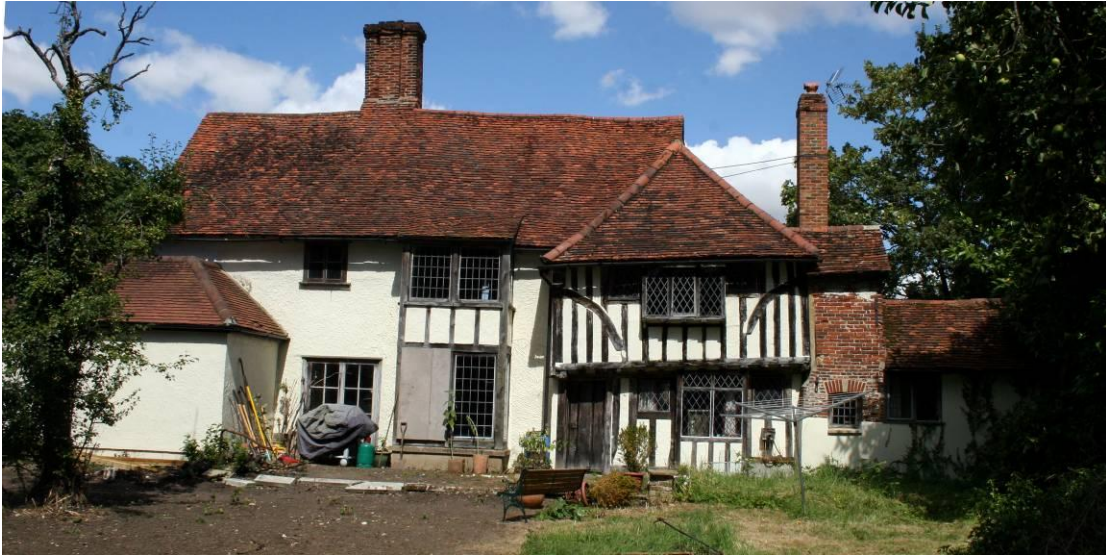
Southern elevation showing jettied cross-wing and raised hall roof.

The southern elevation has a close studded timber-framed jettied cross-wing with cranked display bracing under a fully hipped roof. There is a door corresponding to an undershot cross-passage. The original axe finished studs are 6in wide at 15in centres while later additions are 5in wide and bear machine marks.

There is an oriel window with side lights on the upper floor and off centre glazing on the ground floor. It is known that Mt Turner, Master Carpenter replaced all the windows in the 1930's and there is a photograph of him at work. Much of the internal outfitting can also be ascribed to him.

The main range has a full height bay window by Mr Turner in the position of the original hall window. The main range has been raised in height in order to insert a new floor and the roof height brought above the cross-wing. The original hall sits between the cross-wing and the central brick firestack which has rebuilt shafts.

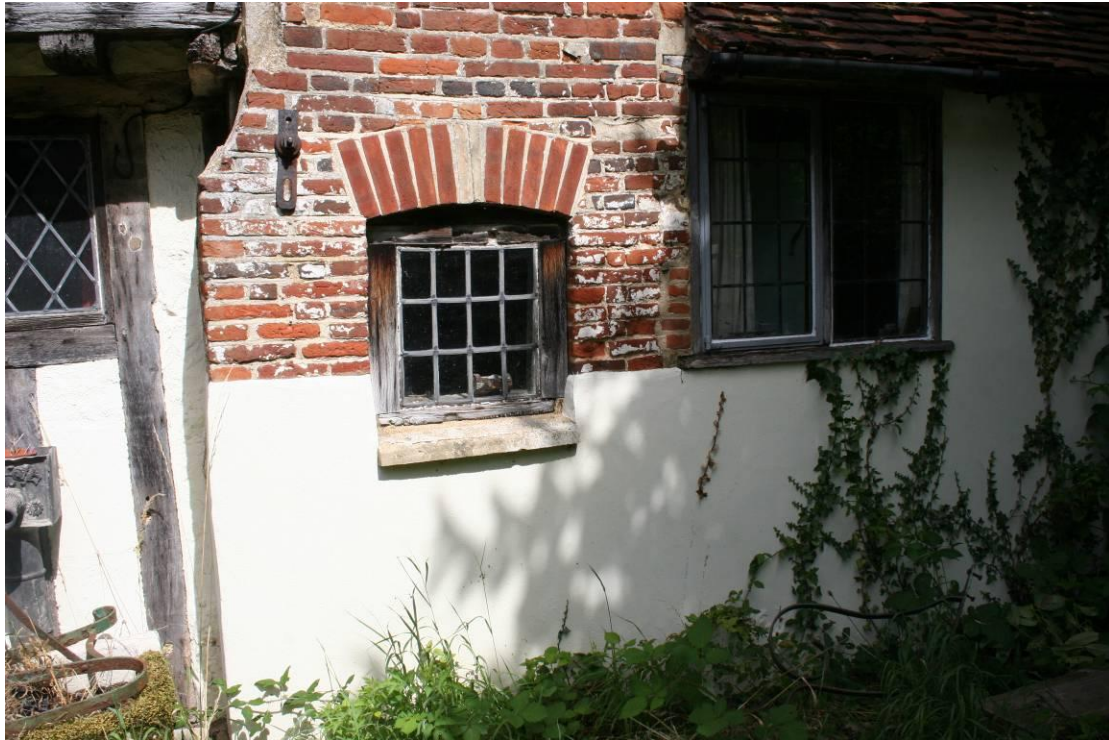
Base of the brick tower and Kitchen window.

Separating the cross-wing from the Kitchen is a tower built of a variety of bricks laid in peculiar type of stretcher bond by someone whose forte was not brickwork. It is believed that this was a stair tower in use until the Kitchen was added after WW2. (Owner –pers comm). It is secured with large bolts of the type seen elsewhere in Mr Turners work.

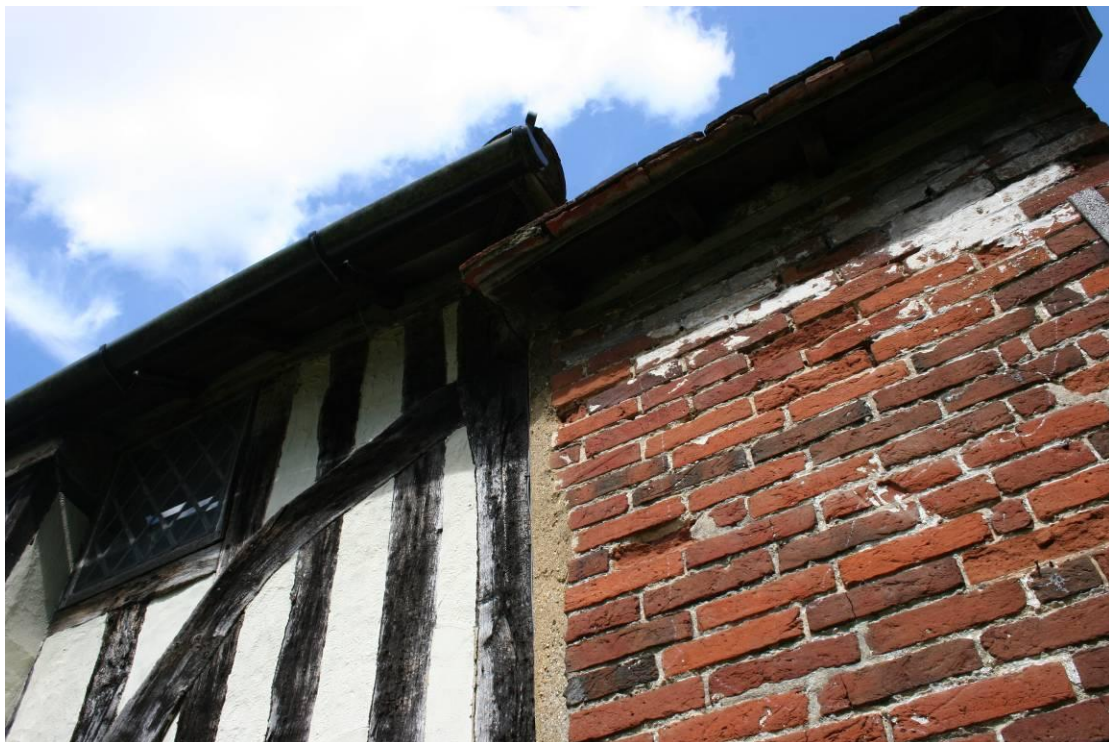
Detail of the brickwork of the brick tower.

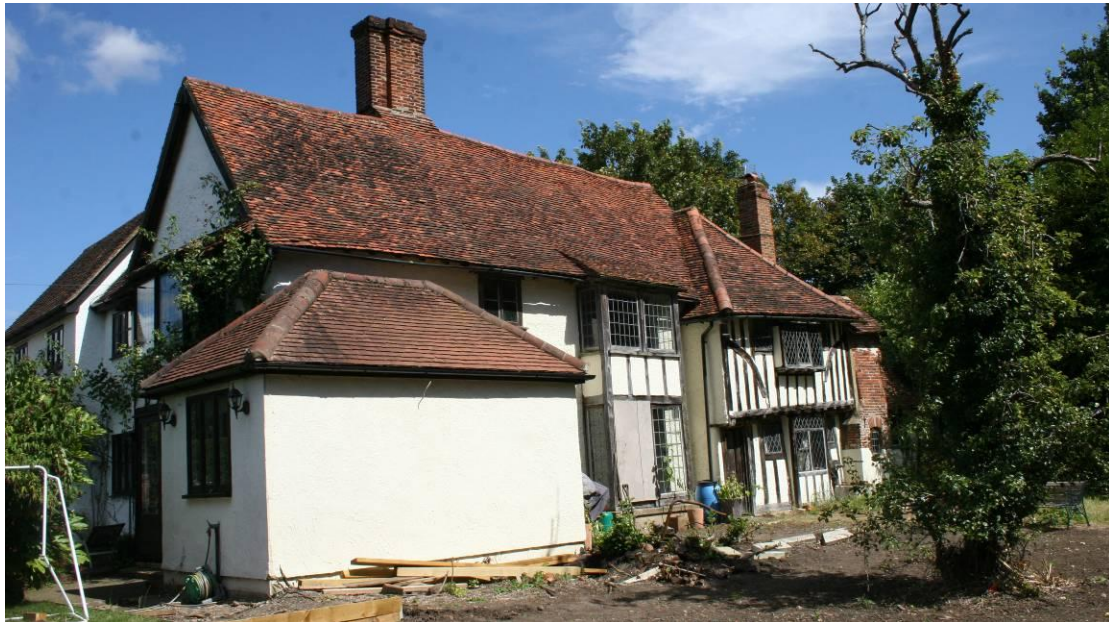
The west and south elevations.

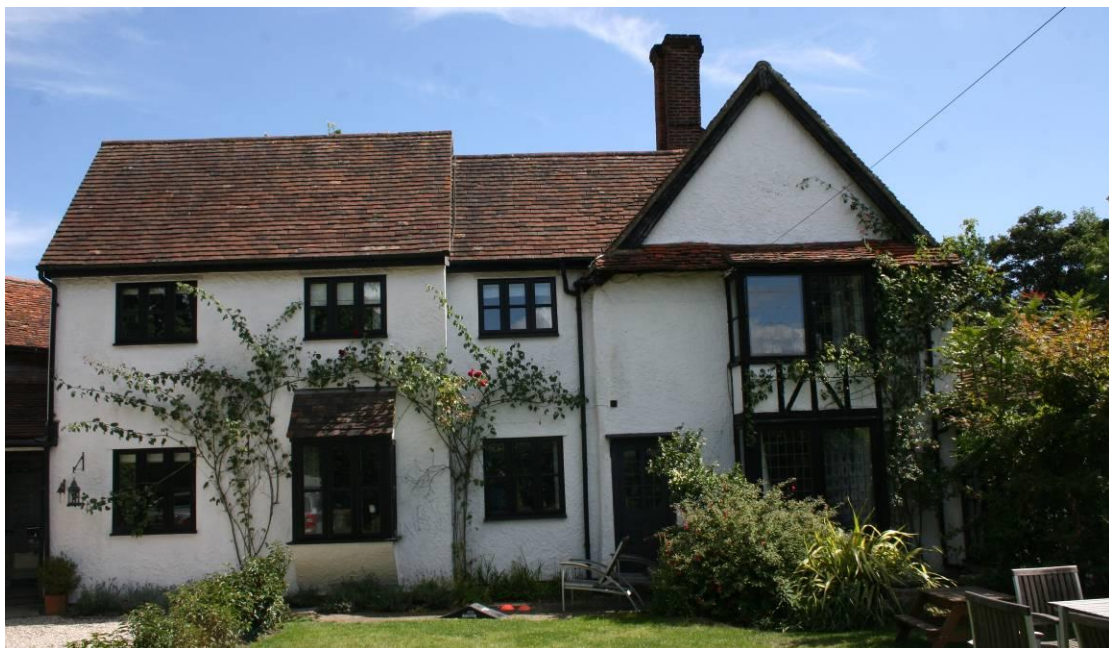
The south elevation.

The south elevation has the southern gable of the main range again outfitted with Mr Turner's full height bay windows. To the north (LHS) is a recent two storey connection and extension built in 1981. Historic photography shows a different form of extension has been removed. The windows are all double glazed and the roofs are clad with replica clay tiles over an asphalt membrane.

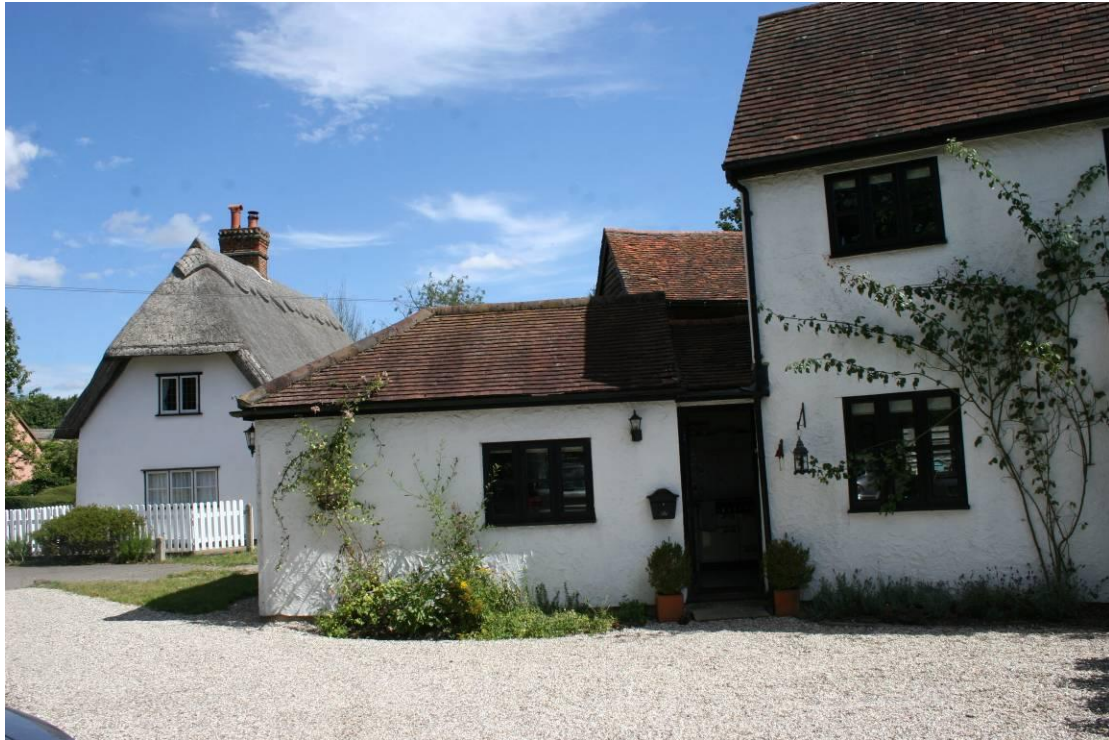
Southern elevation of the former garage.

The house has been further extended into a garage (built before 1978) and connected with a small lobby. The garage door has rather pointlessly been retained.

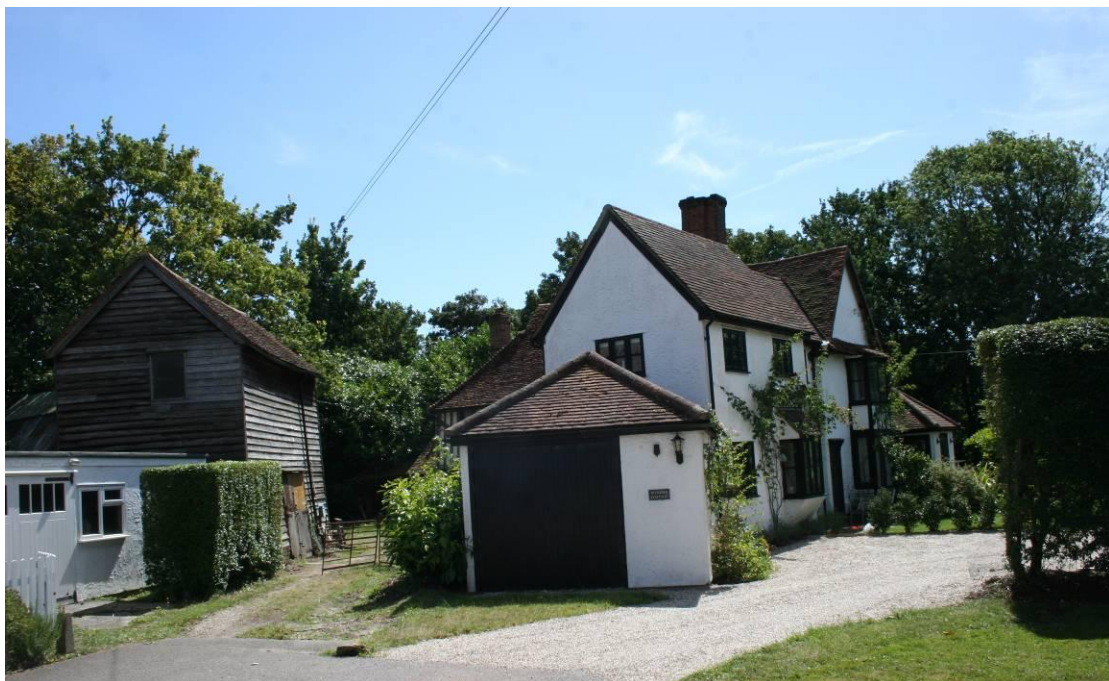
Northern elevation from the lane. To the RHS is the Stables.

The northern elevation shows that the cross-wing is jettied on both ends. Mr Turner has removed the upper oriel window (shown by its mortices) and added machined studwork to insert an internal partition forming a bedroom and landing. Examination of the close studding shows it has been lath and plastered over in the past.

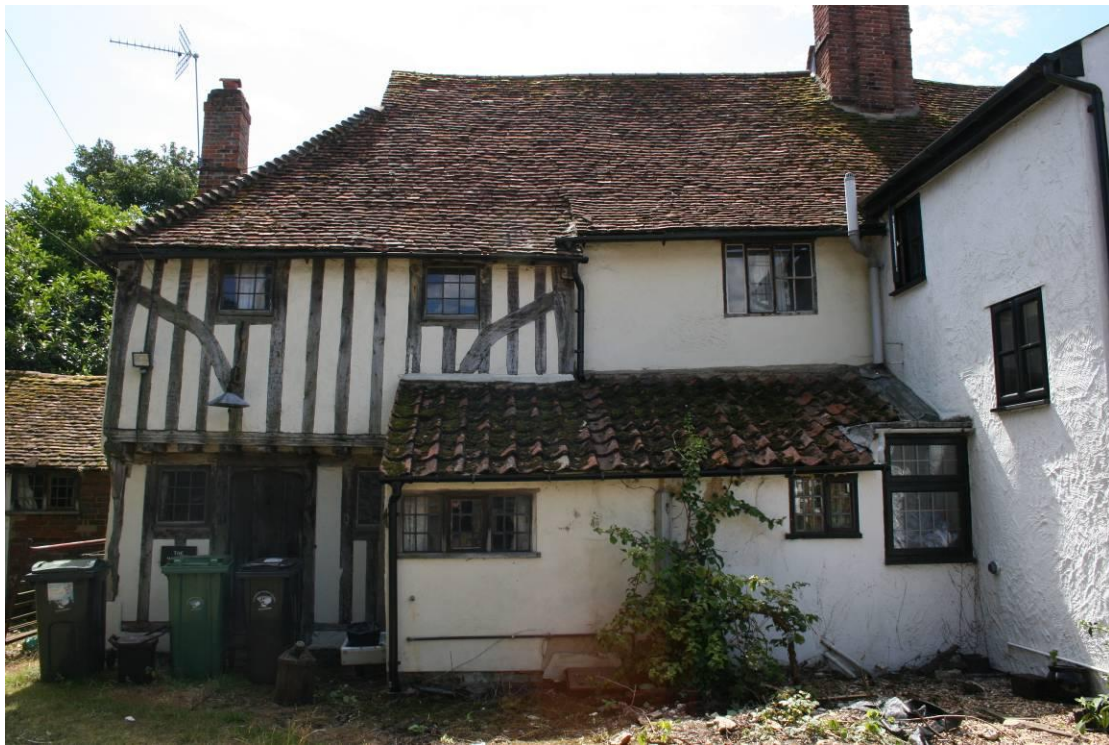
The northern elevation of the main range and cross-wing.

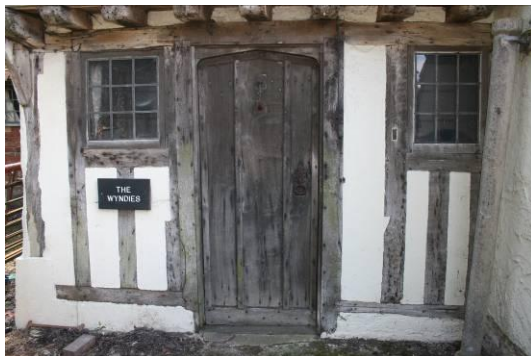
Mr Turner's front door.

The front door was also made by him and the original doorway to the undershot passage now passes into the ground floor bathroom. There is a pantiled single storey outshot which is divided between the properties (bathroom and utility room) with an eclectic mix of fenestration. On the first floor, a single C17th wrought iron casement has been retained.

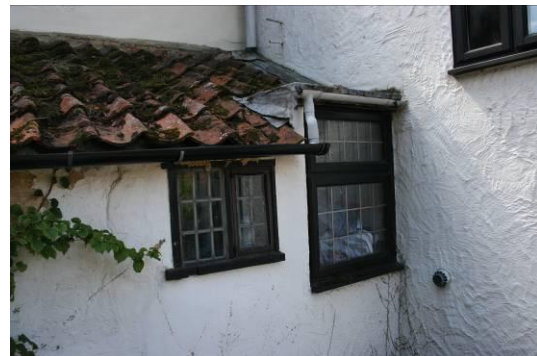
Historic and new glazing.

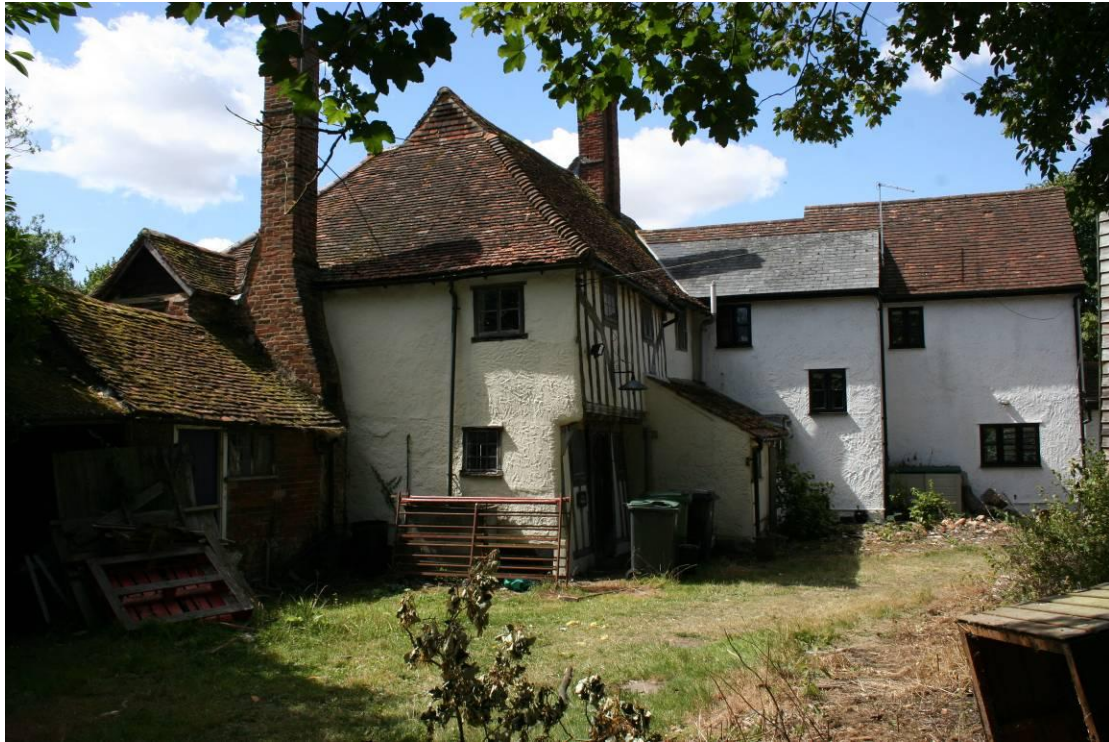
Eastern elevation.

A small kitchen has been added to the eastern end of the building with a two storey stair tower. Whilst looking old the construction is post 1920's using reclaimed bricks, machined roof timbers and period furniture and again can be attributed to Mr Turner.

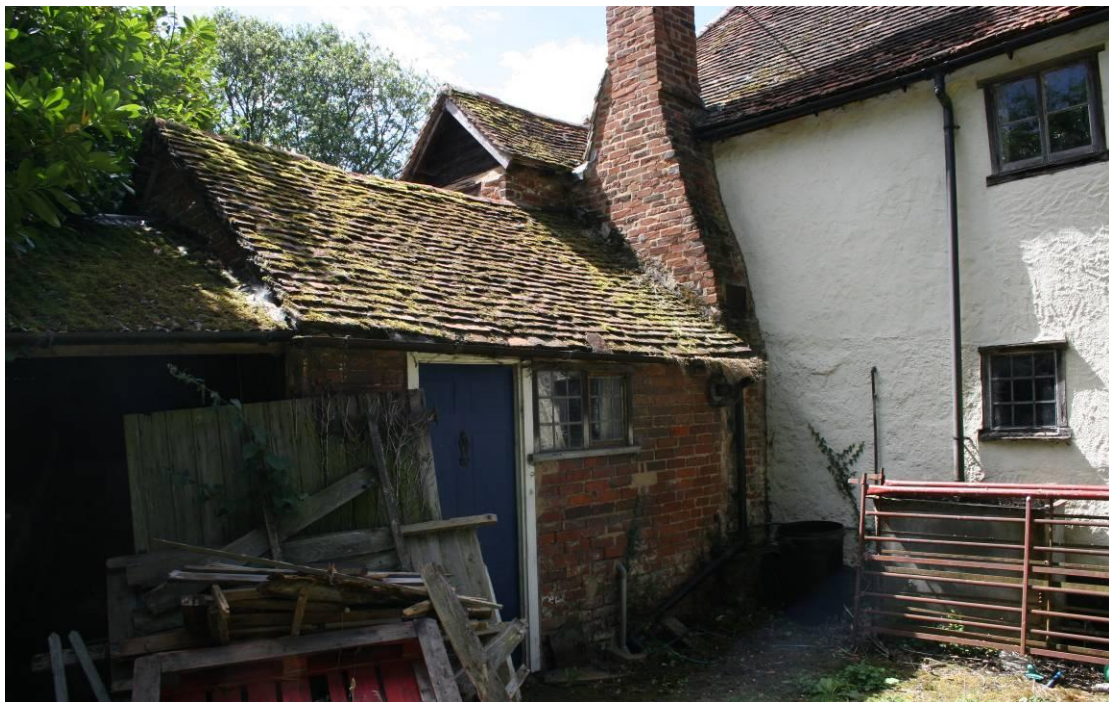
A small kitchen added to the eastern end.

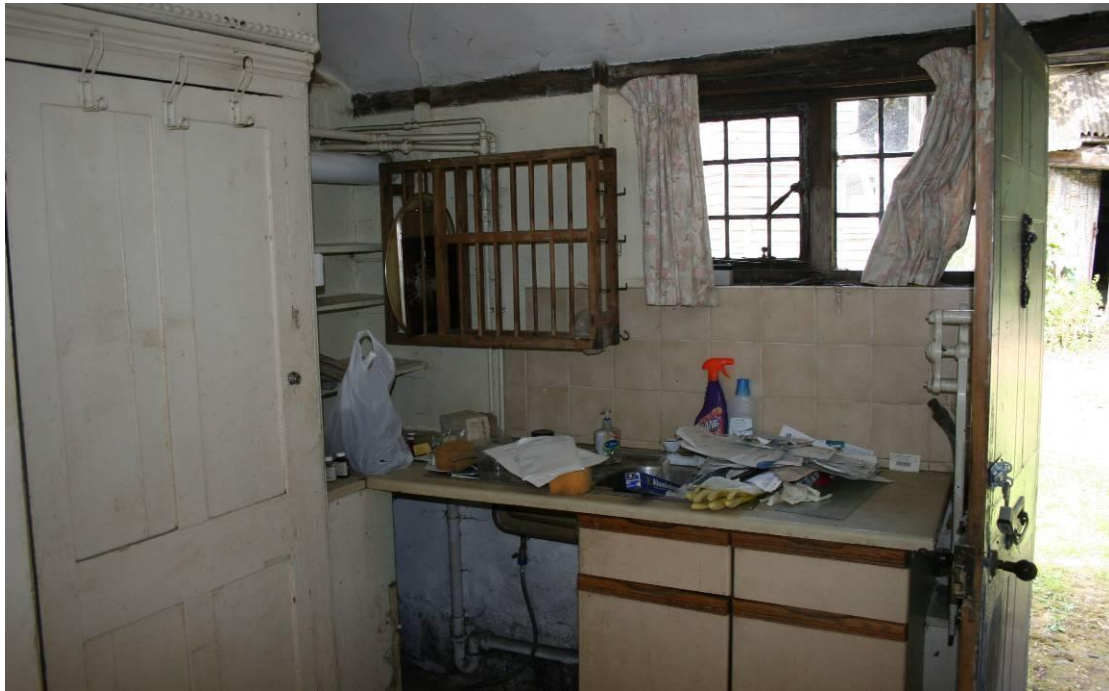
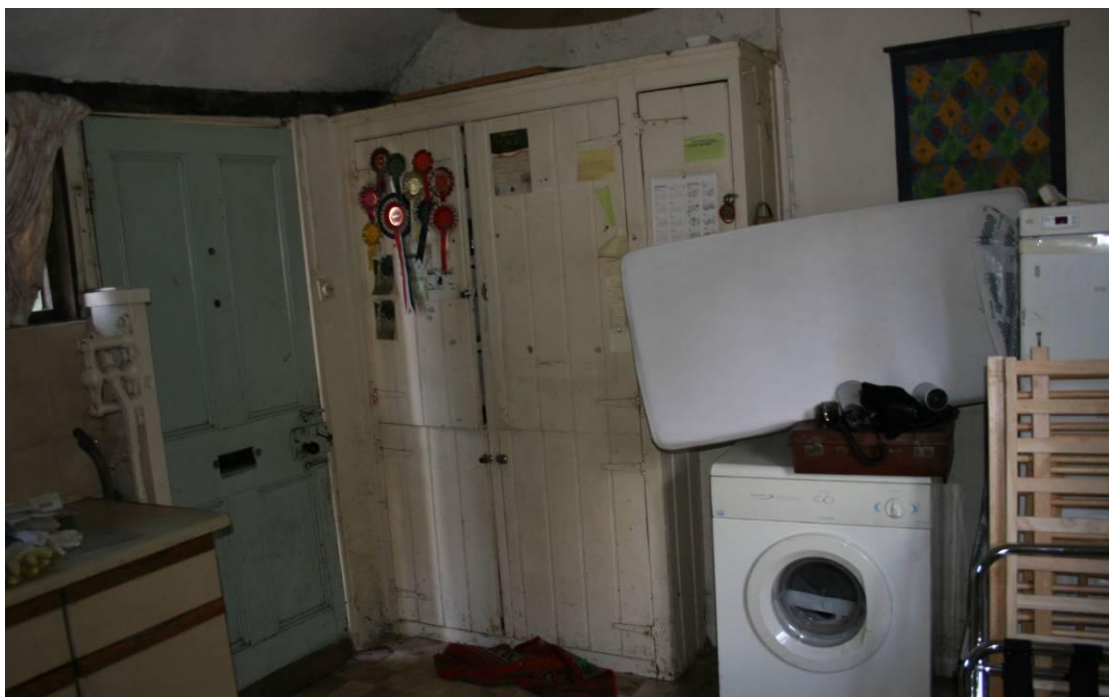
Kitchen looking NE.

Kitchen Looking NW.

The EC20th kitchen contains hand pump and period closets. The roof is made of machined softwood 2x4in rafters with narrow EC20th battens.

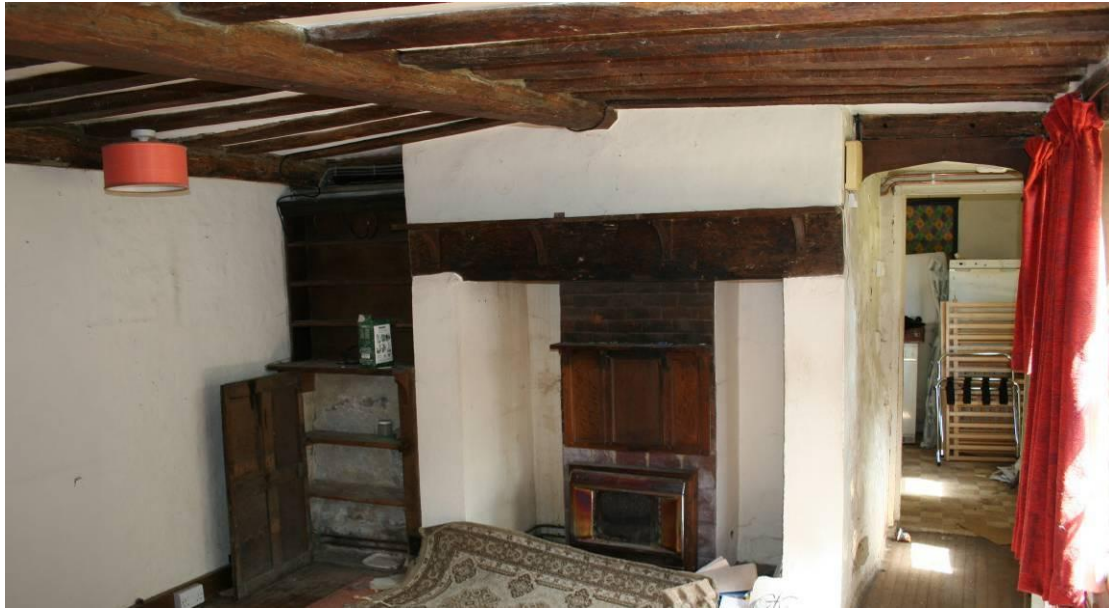
Living Room looking NE.

There is an exposed C16th floor with two axial main joists with 6in flat common joists foreing the cross-wing floor. A reused C17th strapwork exterior door has been used for the inserted C20th stairway. The fireplace was rebuilt in the 1930's with a replacement bressummer. The undershot passage screen has been removed s shown by empty mortices. The doorheads are fake. Other doors are clever replicas with C17th style wooden latches. The partition wall to form the hallway for front door is EC20th.

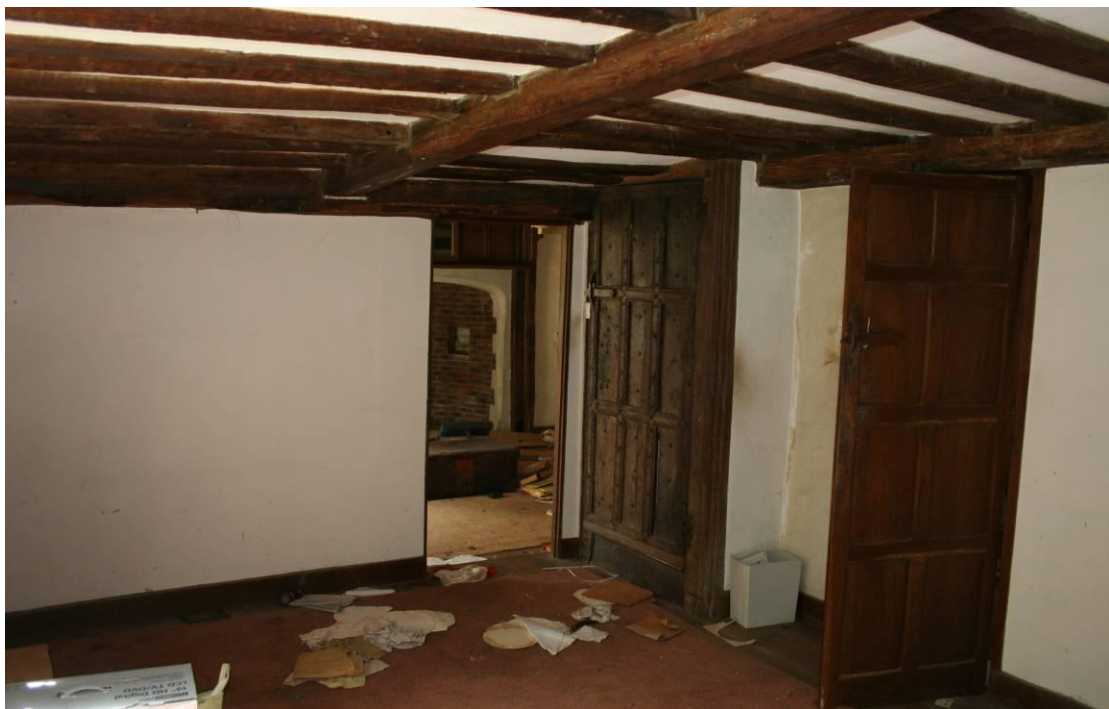
Living Room looking NE.

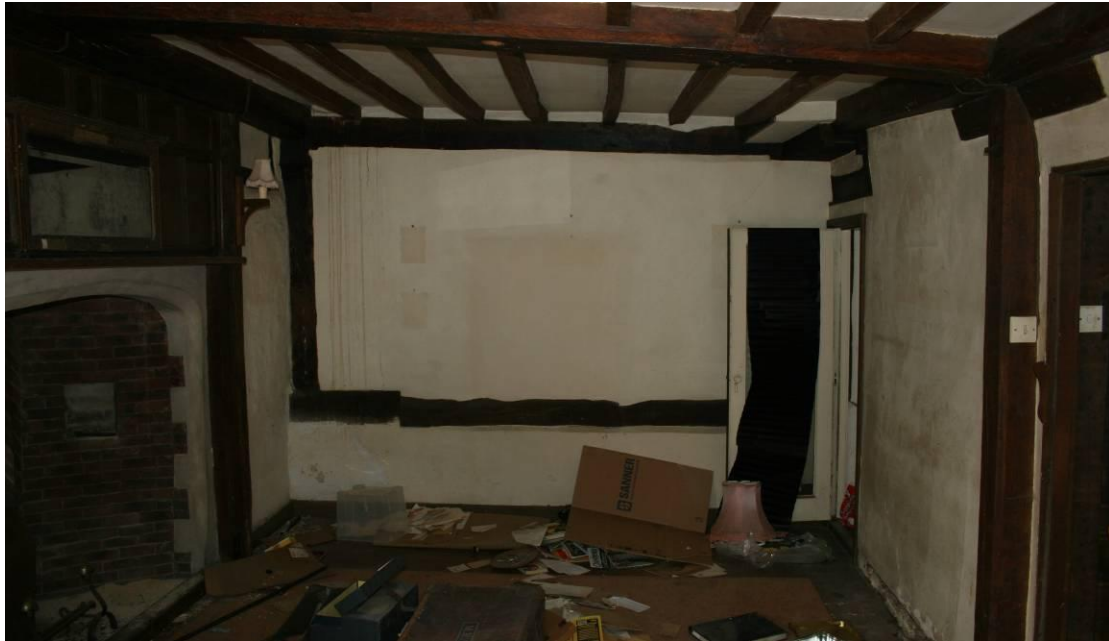
The Sitting Room looking N.

Apart from the timbers in the walls all the features on display are EC20th facsimiles. The partitions either side of the fireplace are either built or repaired by Mr Turner. Some older riven laths remain but have been reused on machined battens. A former doorhead (RHS) is a reused manger rail.

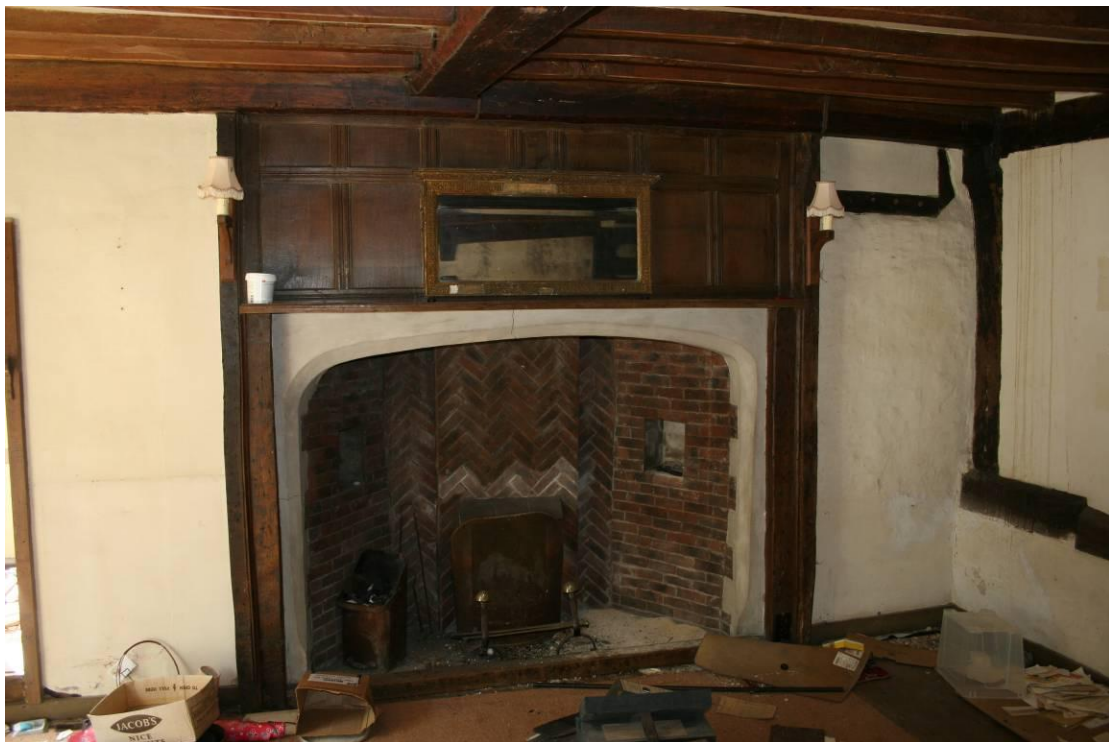
Replica fireplace and overmantel made of early panelling. The fireplace is tiled.

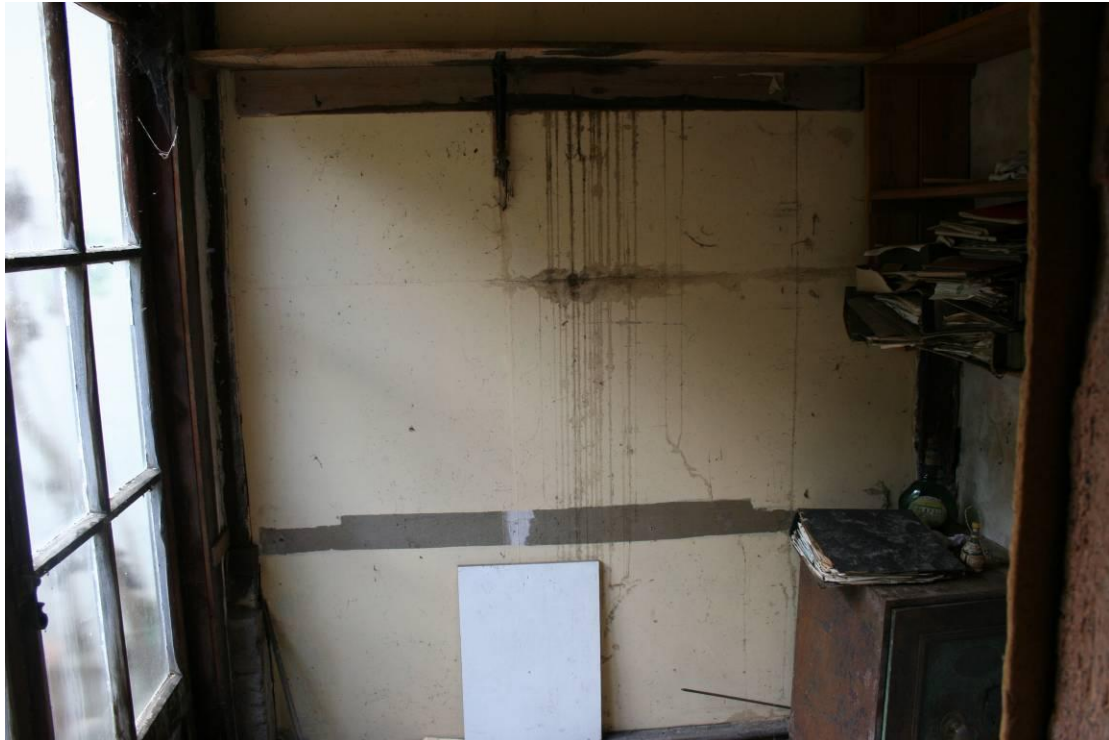
The alcove beside the fireplace has a plasterboard wall.

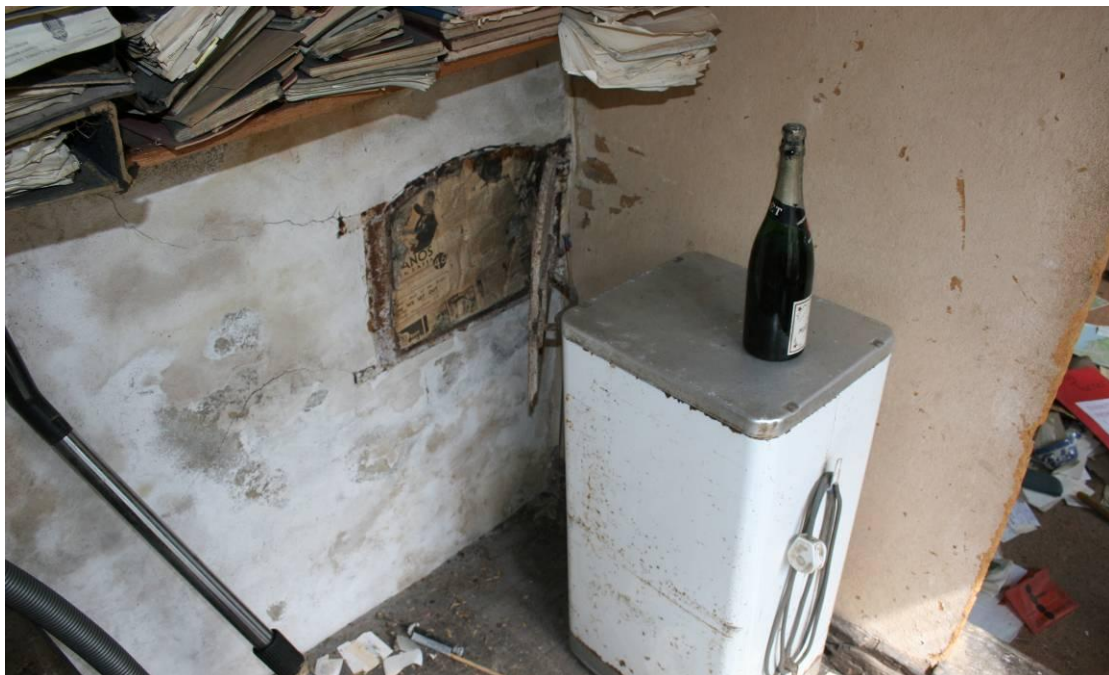
The bread oven door in the side of the firestack.

There is a EC20th bread oven door on the outside of the firestack which is very unusual as it means the oven would consume most of the fireplace. The aperture has been blocked with concrete and lined with a 1935 newspaper advertising Now We Set Out by Susan Ertz as Daily Mail Book of the Month. It seems more than likely that the bread oven was in the alcove (as is normal) and the oven door was put in position after it had been demolished. The wall was then rendered over to make good.

It is apparent he removed a bread oven from beside the main chimney stack, leaving the door as a feature and newspaper from 1935 to show when it was done. He rebuilt most of the fireplaces and surrounds to his own style, reusing old panels and timbers.

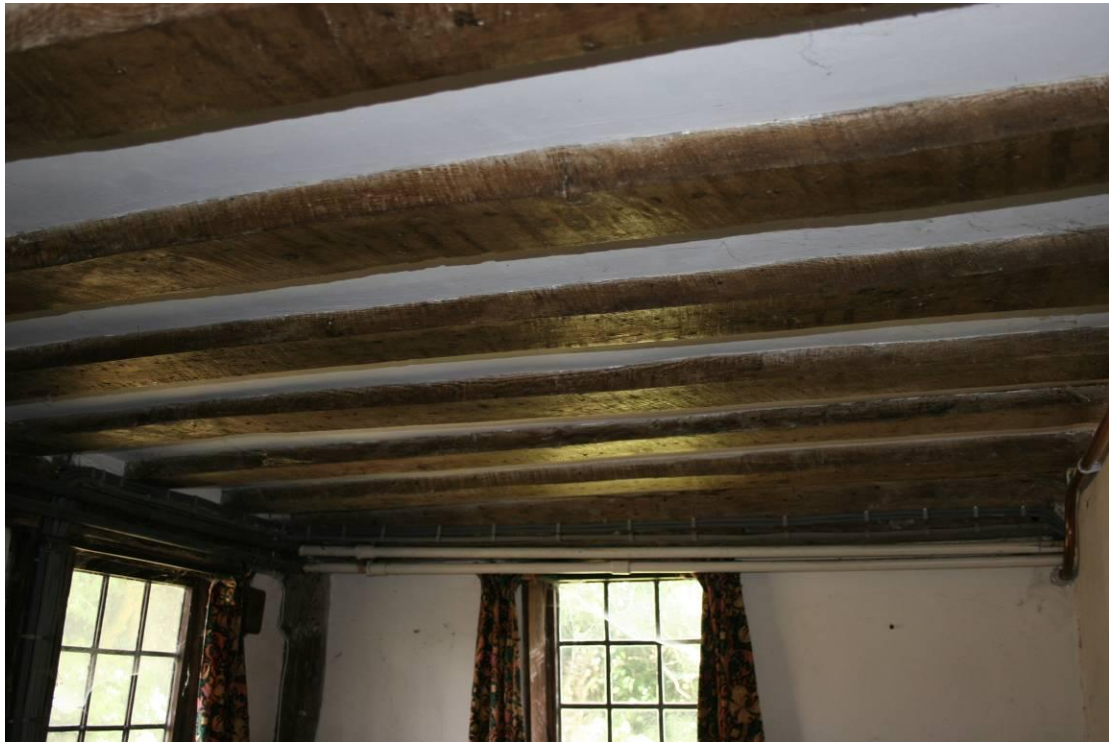
The framed floor in the Hallway.

The Hallway represents part of the cross-wing that has been divided off with a EC20th partition. The axe finished common joists form the cantilevers for the jetty. The staircase ascends in the position of the undershot cross-passage and can be ascribed to Mr Turner. The soffit, seen in the understairs closet is boarded with tongue and groove and the treads and risers are machined pine.

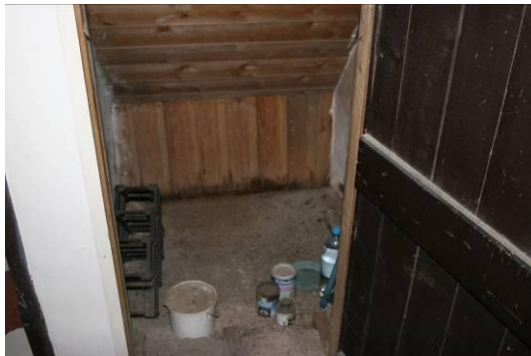
The underside of the staircase.

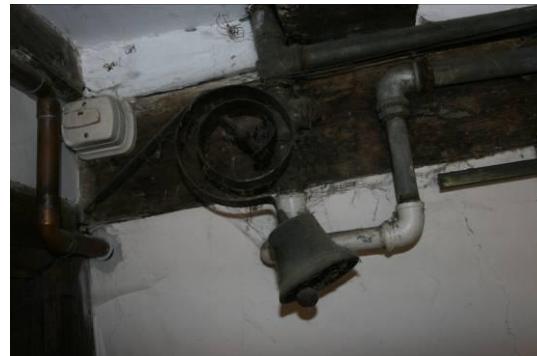
Reused C19th bell and pulley system.

Of interest is a C19th bell and pulley system reused for the front door bell.

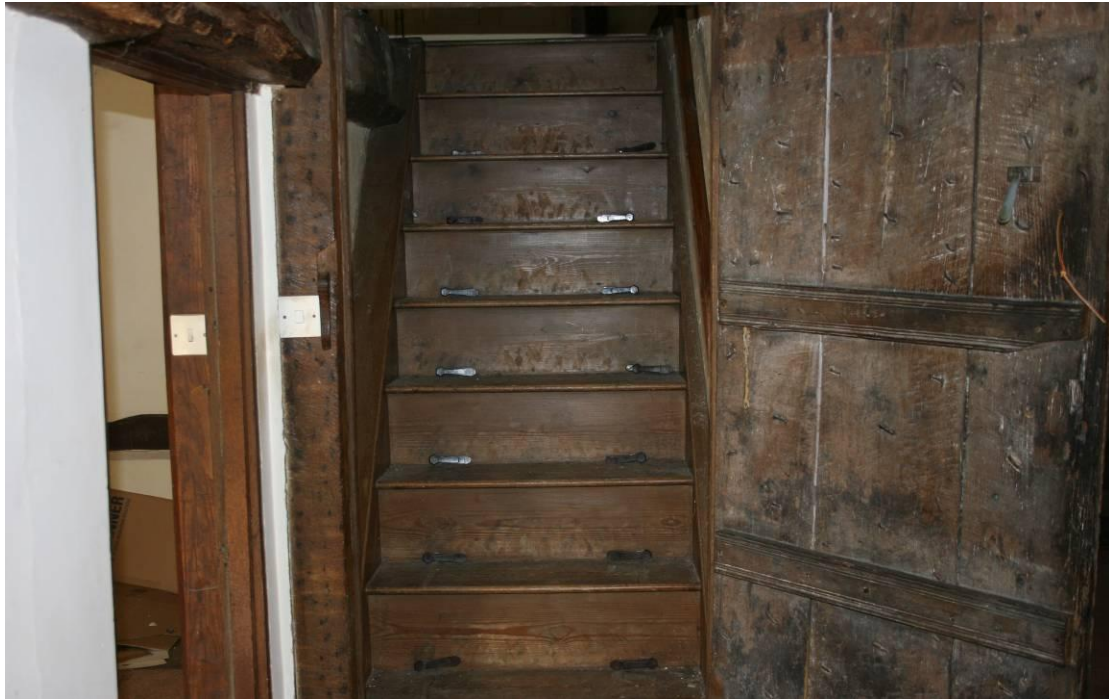
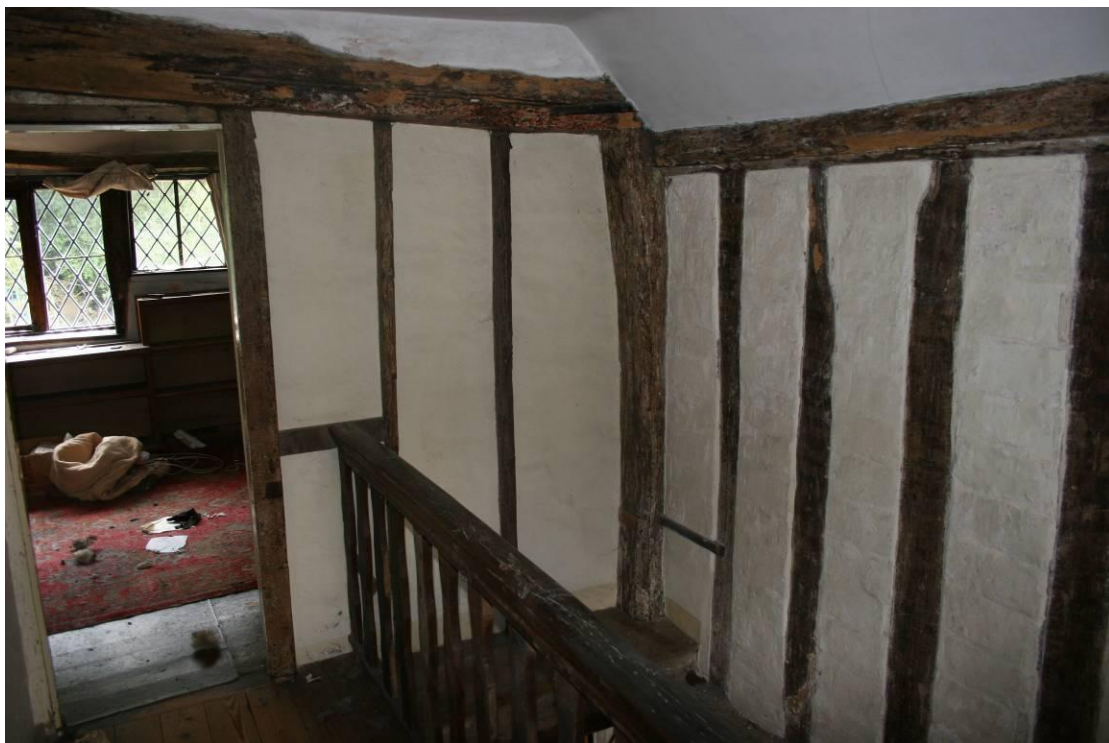
Detail of the EC20th staircase. Looking N.

Looking across the stairwell. Note the brick noggin the wall panels.

The staircase was built by Mr Turner who also fabricated the banister rail with a set of slender C17th style splat balusters. He sawed off one of the axial joists to insert the stairwell. The cross-wing walls have been brick nogged but this could have only been done after the lath and plaster was removed as they stand proud of the studwork. The narrower studwork and brick infill can also be attributed to Mr Turner.

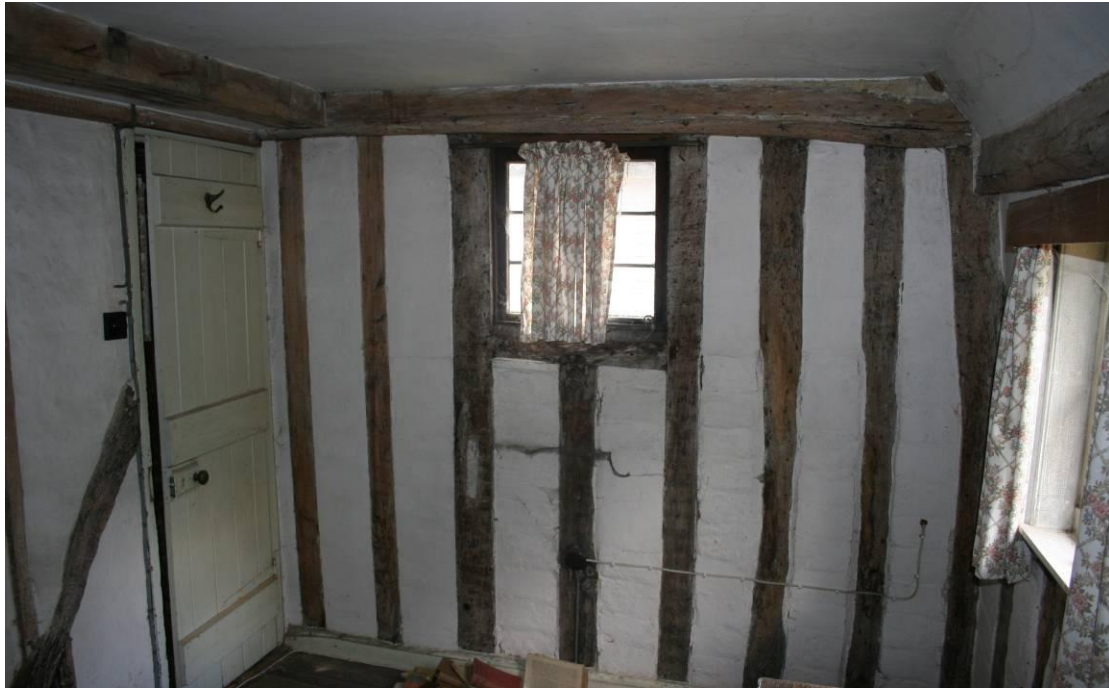
The cross-wing north bedroom looking N.

The cross-wing has been divided into two bedrooms and a landing by Mr Turner who has created faked interrupted studwork frames and panelled between the studs. Scantling studwork was never meant to be seen and many lack nail holes for lath and plaster. Empty mortices show the ceiling has been raised above the main joist.

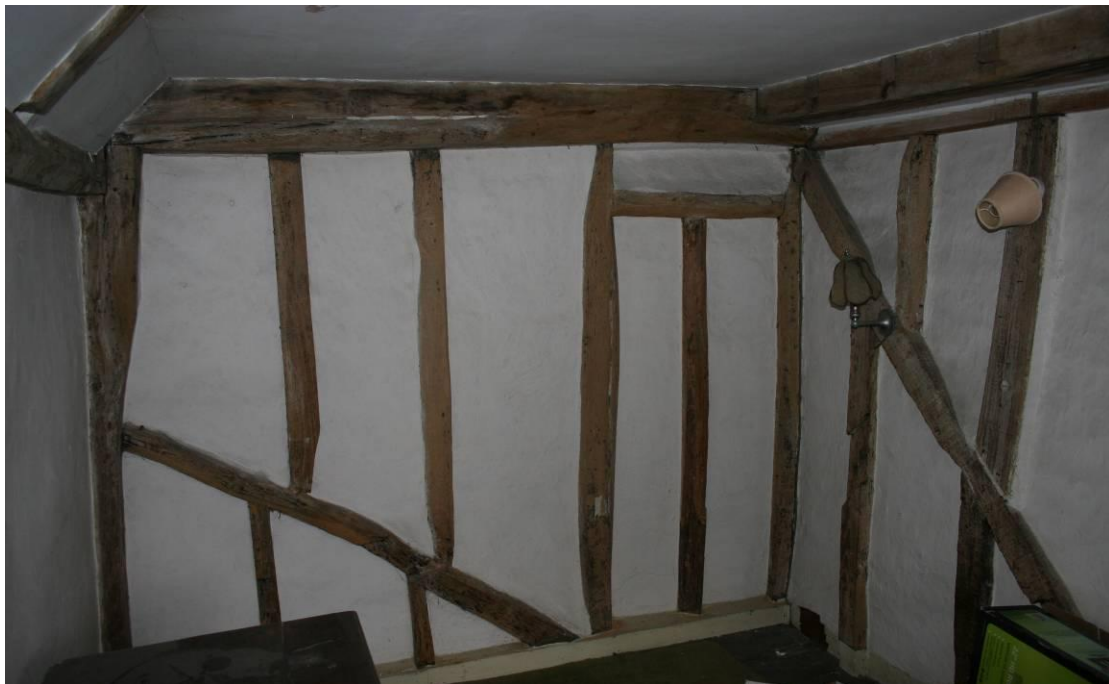
Cross-wing north bedroom looking SW. The wall framing is EC20th.

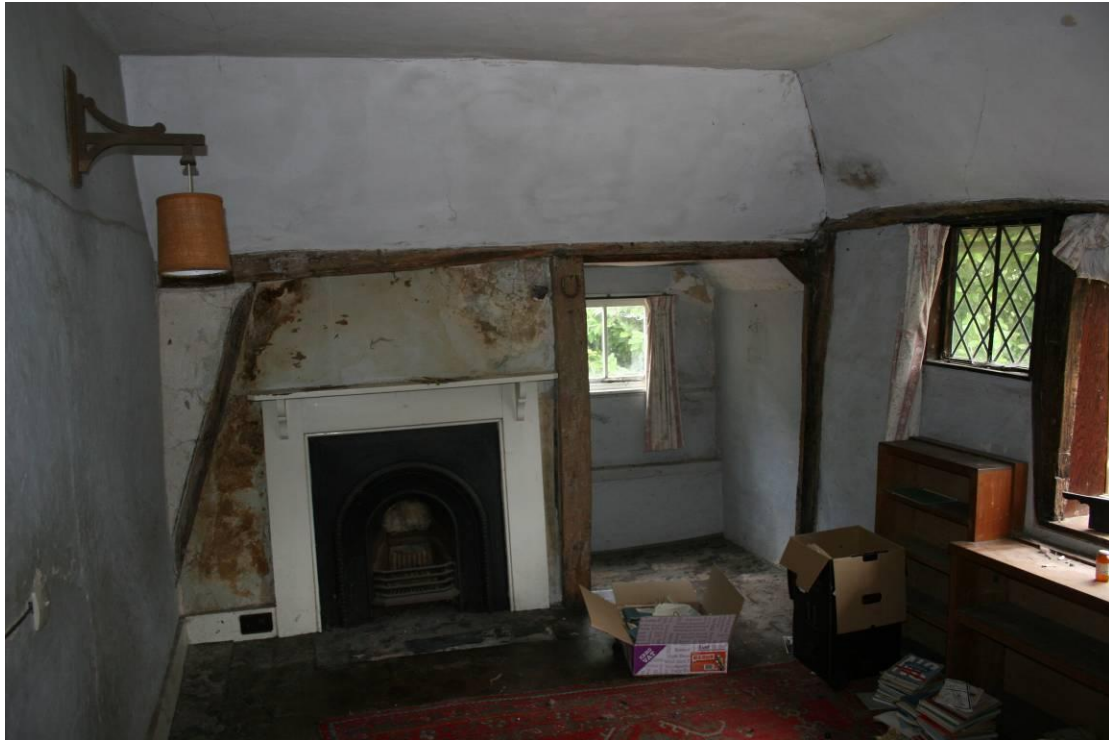
Looking E in the south cross-wing bedroom.

The south cross-wing bedroom has a C19th cast iron fireplace with a plain timber surround with mantel shelf. Beside it is a stair tower that was believed used until the Kitchen was built. Mr Turner was keen on bolting components together and there are a number in the stair tower implying he built it. This room has no exposed studwork.

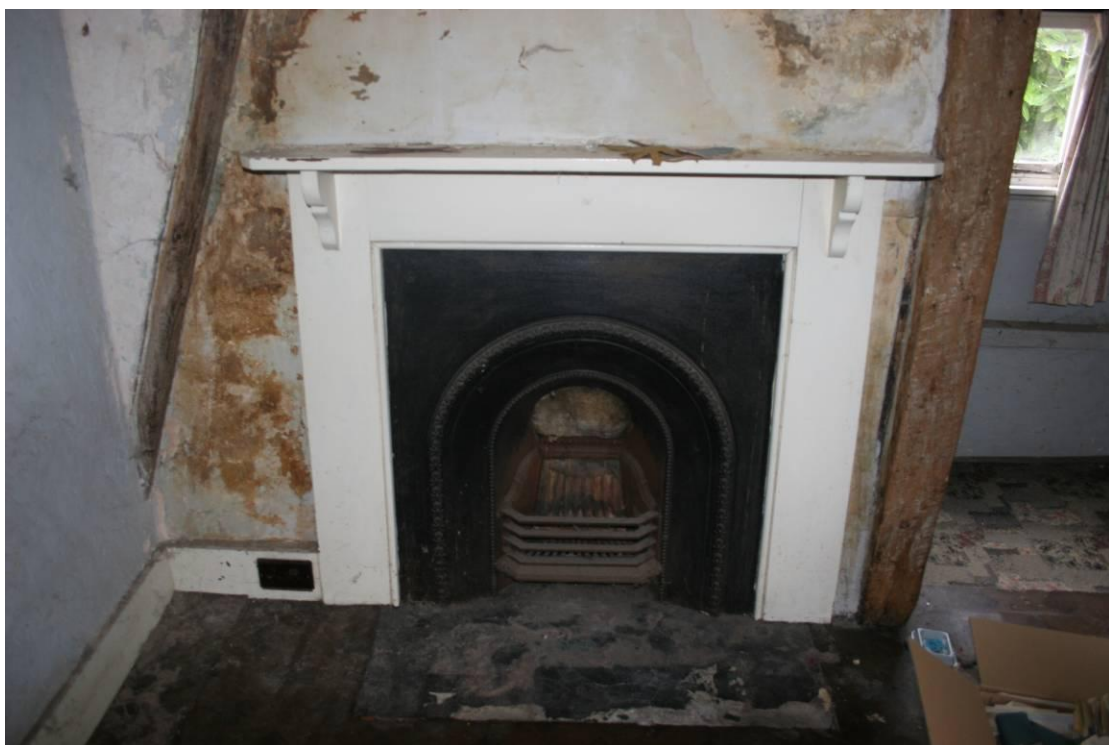
C19th cast iron fireplace with timber surround.

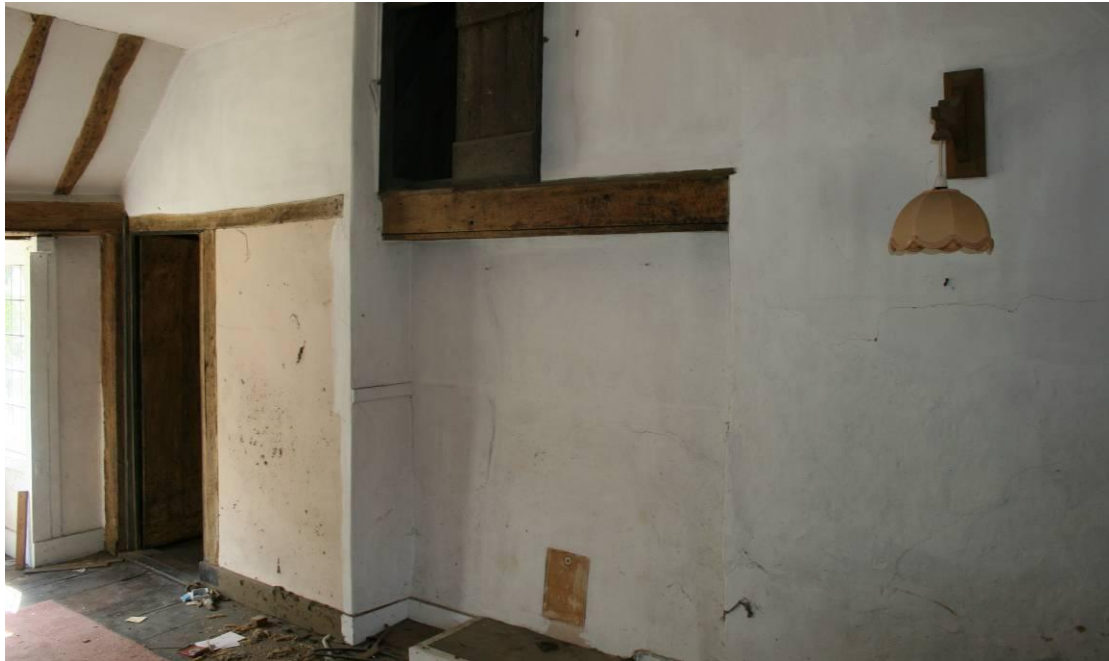
The fireplace in the main range bedroom. Looking SW.

The fireplace has been altered by Mr Turner but the original brickwork can be seen through a hatch door. The firestack is built in two parts of 2in thick 'Tudor' style bricks set in lime mortar. The partitions are skew nailed to the tie-beams and constructed of riven laths and reused timbers in such a way to indicate it is Mr Turner's work.
