Wyndies Cottage and The Wyndies, Crow Street, Henham, CM22 6AH.
Historic analysis of the timber-framed house. Surveyed 09 08 2016.

Scope of this Report

This report describes and analyses the fabric of the buildings to English Heritage Level 3 as outlined in English Heritage. Understanding Historic Buildings – A guide to good recording practice. 2006. Page 14.

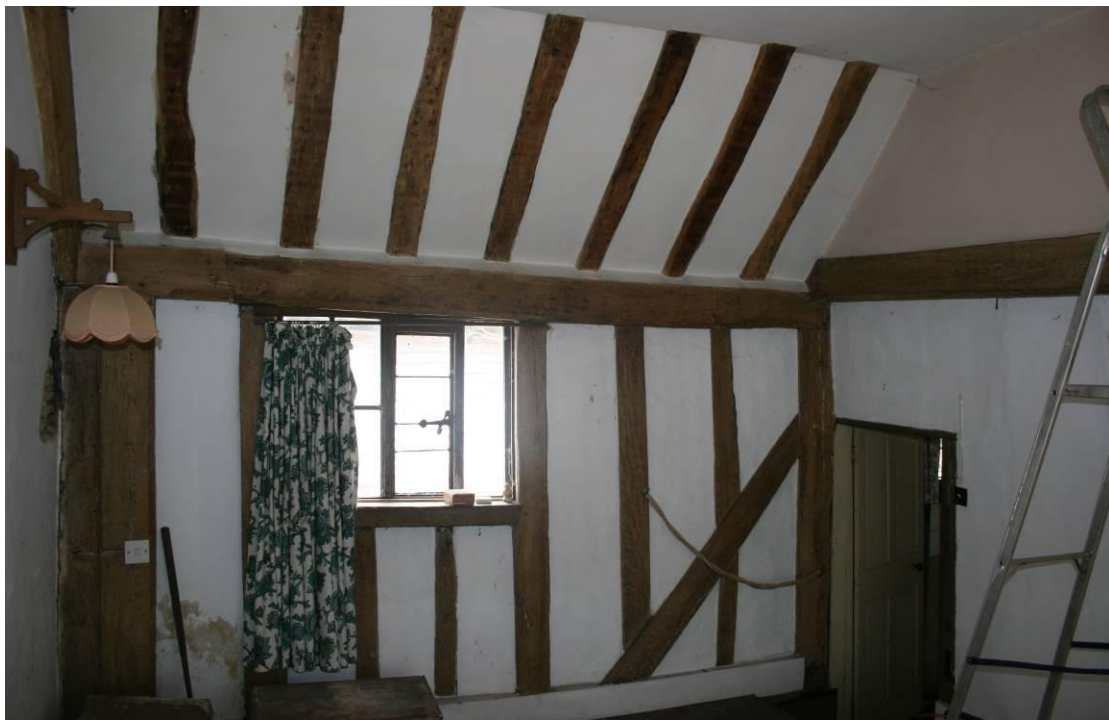
The exposed frame of the raised main range.

The Main Bedroom has the exposed frame of the raised range. The tie-beam is 3ft higher than the cross-wing top-plate. The 6-7in wide in rafters are laid on the flat and where lathed up to the flat ceiling. The north wall has a straight primary most likely added by Mr Turner as the studs are sawn through and nailed in place rather than curved and trenched as seen in the cross-wing.

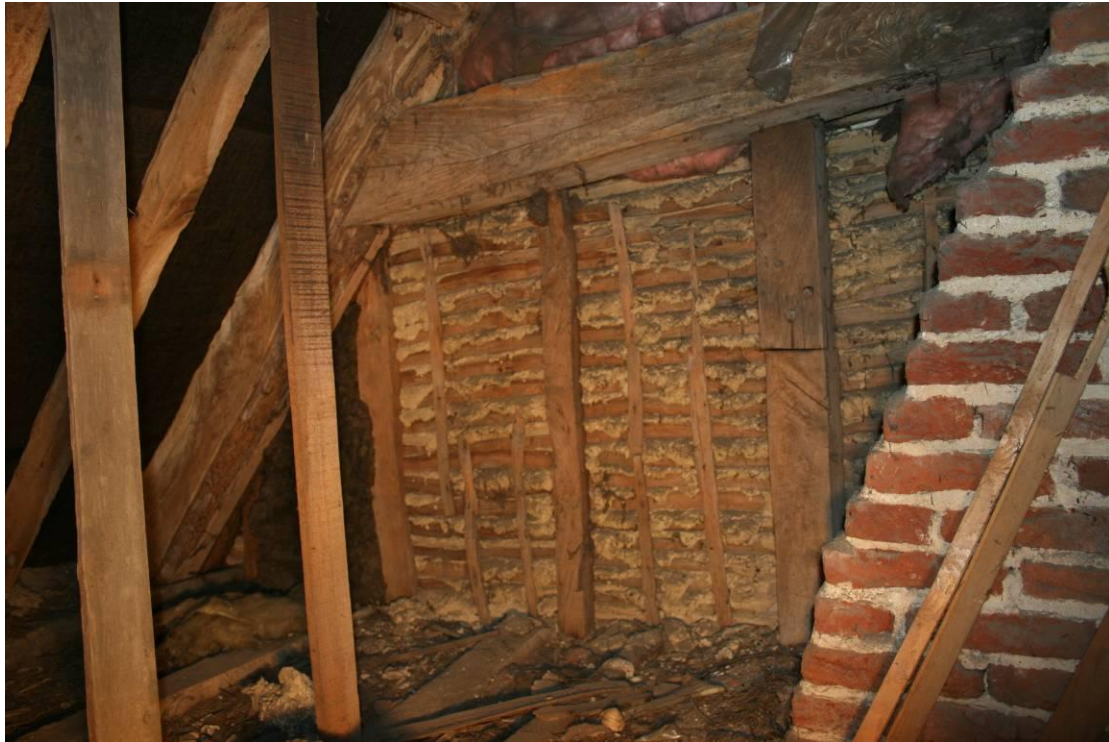
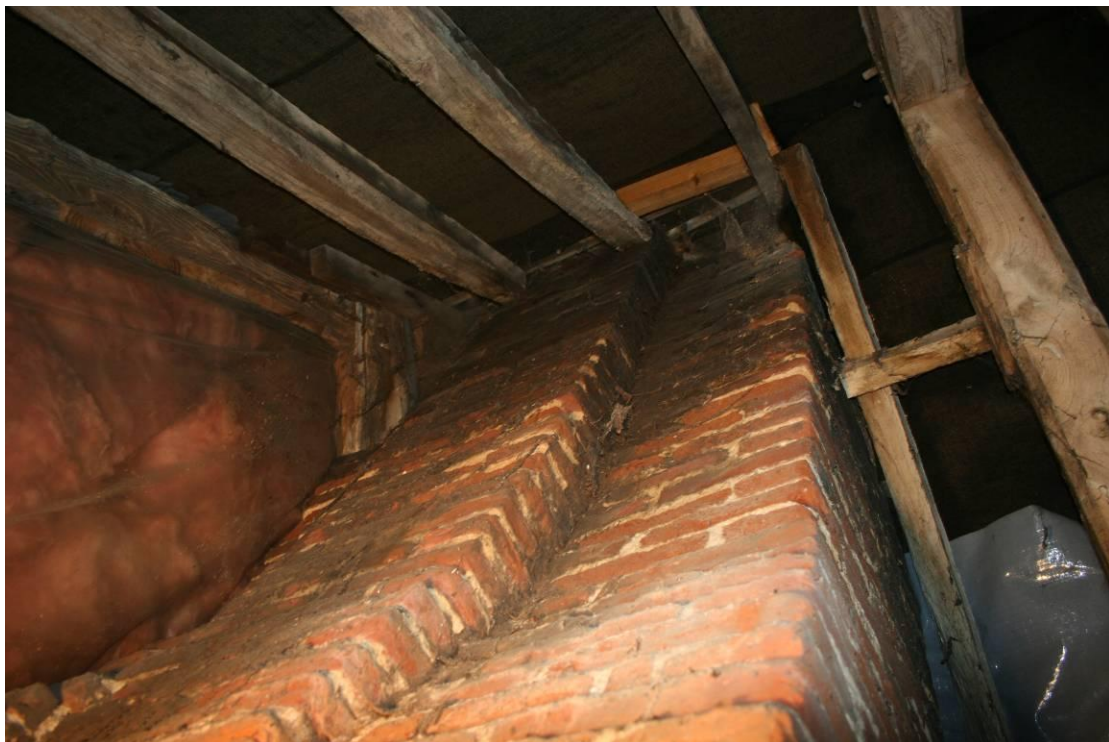
Looking SW the void above the fireplace. Note the nailed vertical laths and reused studs.

Looking up the firestack.

The fireplace has been altered by Mr Turner but the original brickwork can be seen through a hatch door. The firestack is built in two parts of 2in thick 'Tudor' style bricks set in lime mortar. The partitions are skew nailed to the tie-beams and constructed of riven laths and reused timbers in such a way to indicate it is Mr Turner's work.

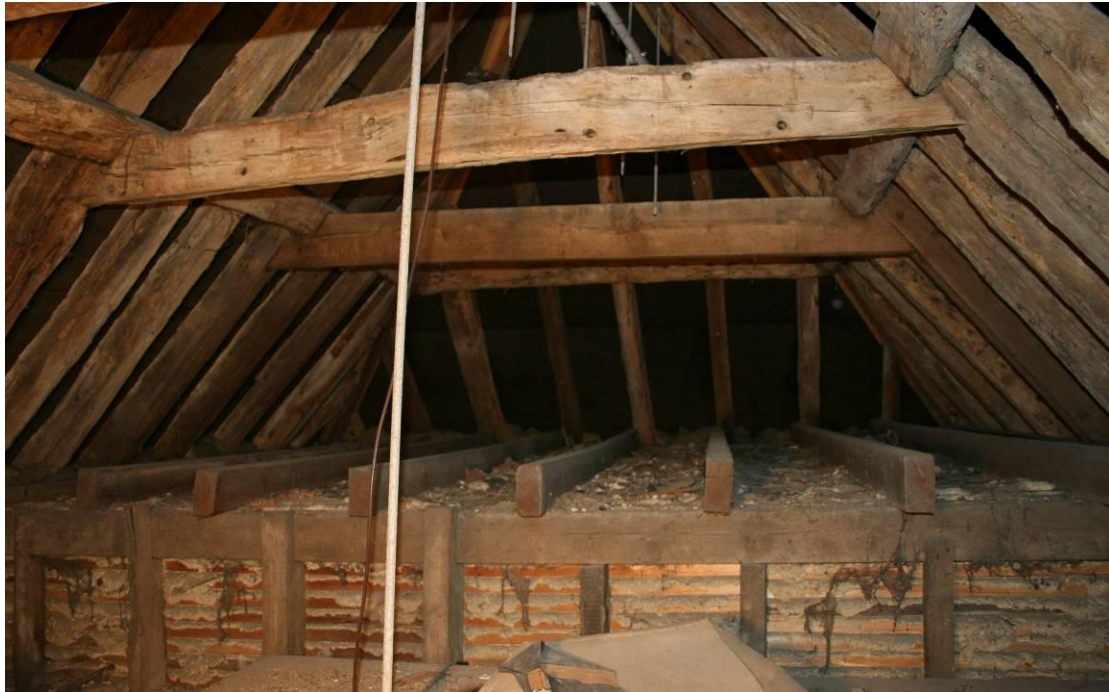
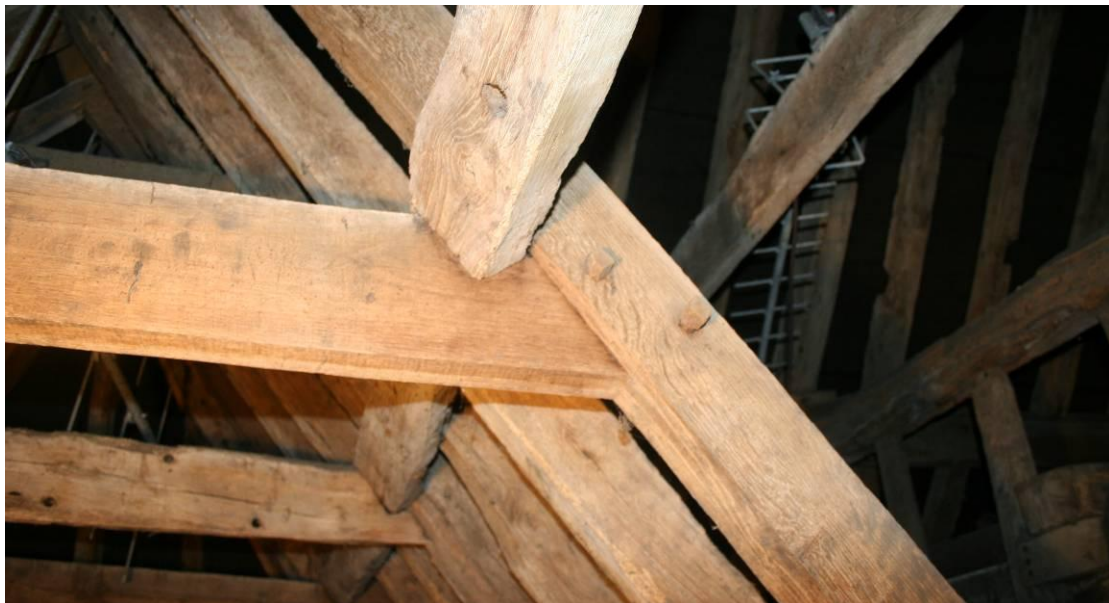
Looking S in the cross-wing roof across the ceiling of the south bedroom.

Detail of the clapsed side purlin.

The cross-wing has a simple clapsed side purlin roof with cambered collars and 3x6in paired rafters set on edge. Some of the rafters are reused from a collar purlin roof. The central collar has mortices for partition studwork and others have been replaced. No carpenter's marks were found.

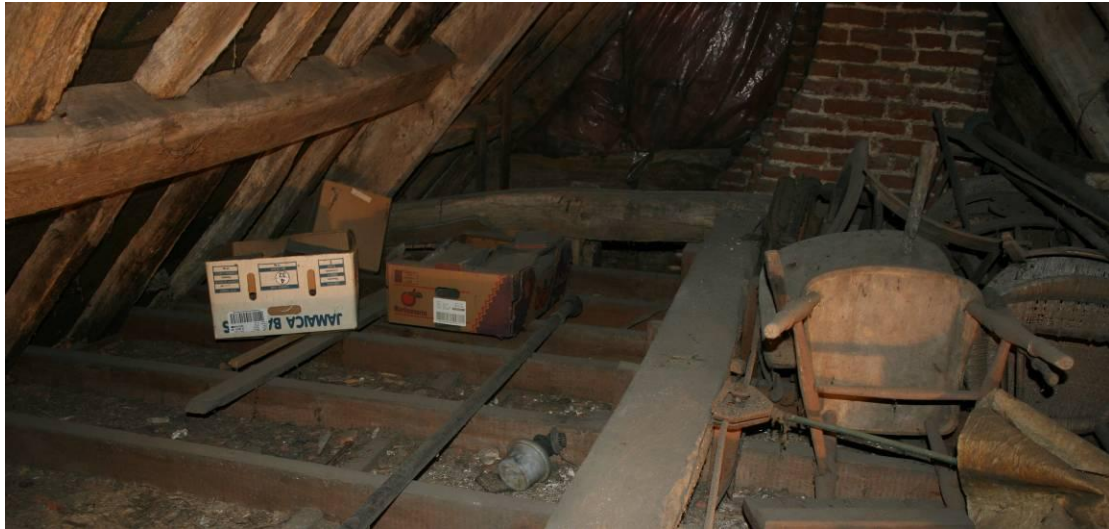
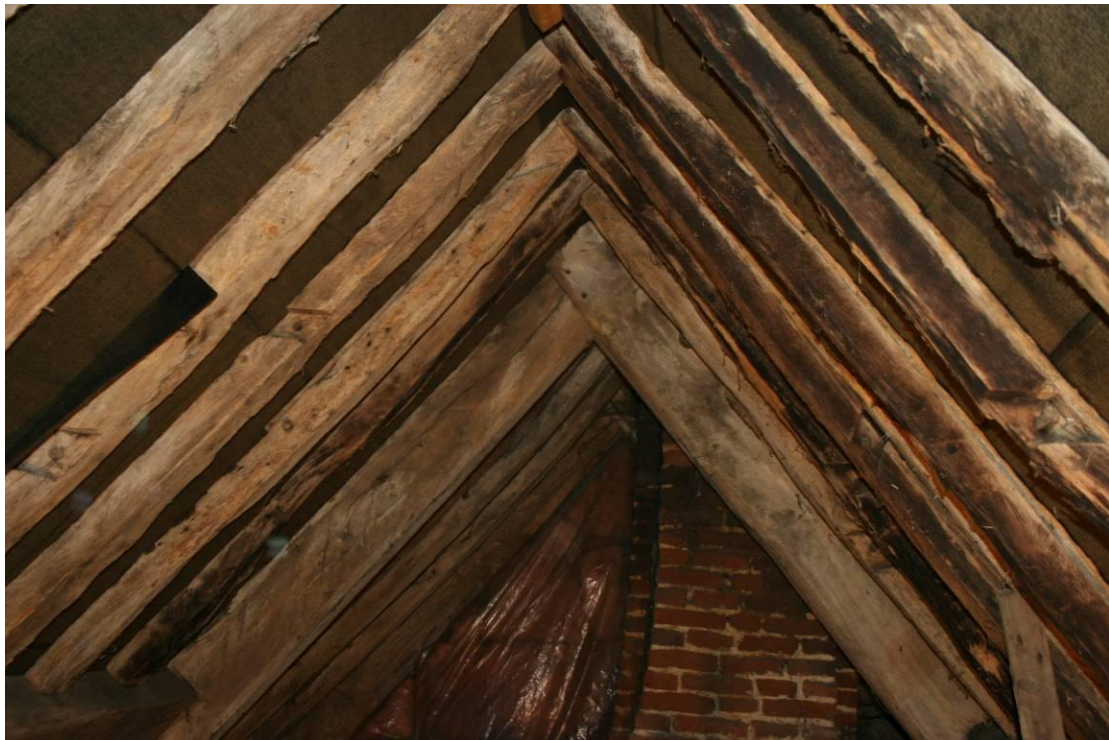
Looking W along the main range.

Reused sooted rafters from a hall roof.

The roof over the main range is a C17th style offset butt purlin roof with massive principal rafters set on edge housing the offset (or joggled) purlins. Most of the other paired rafters are reused from a collar purlin roof and are sooted from exposure to smoke. The lap joints for the collars are easy to see. The ceiling over the main bedroom is of C20th machined timber with a heavy old timber laid in the centre as a walking board. The tie-beams have pronounced cambers.

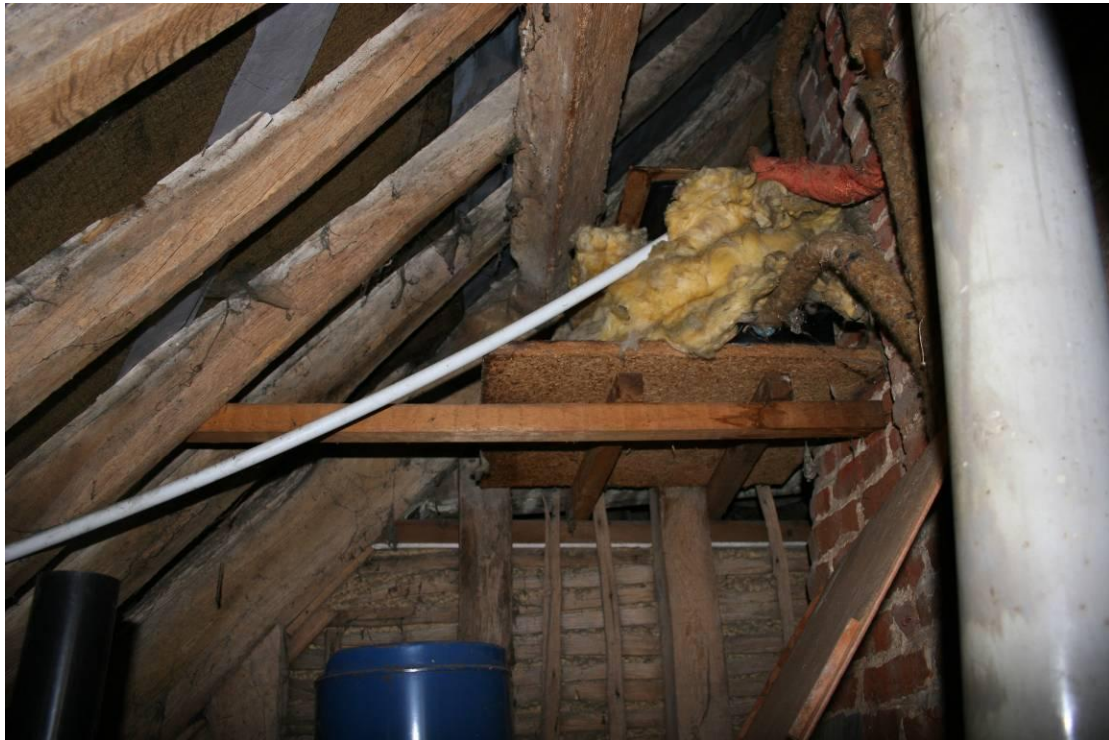
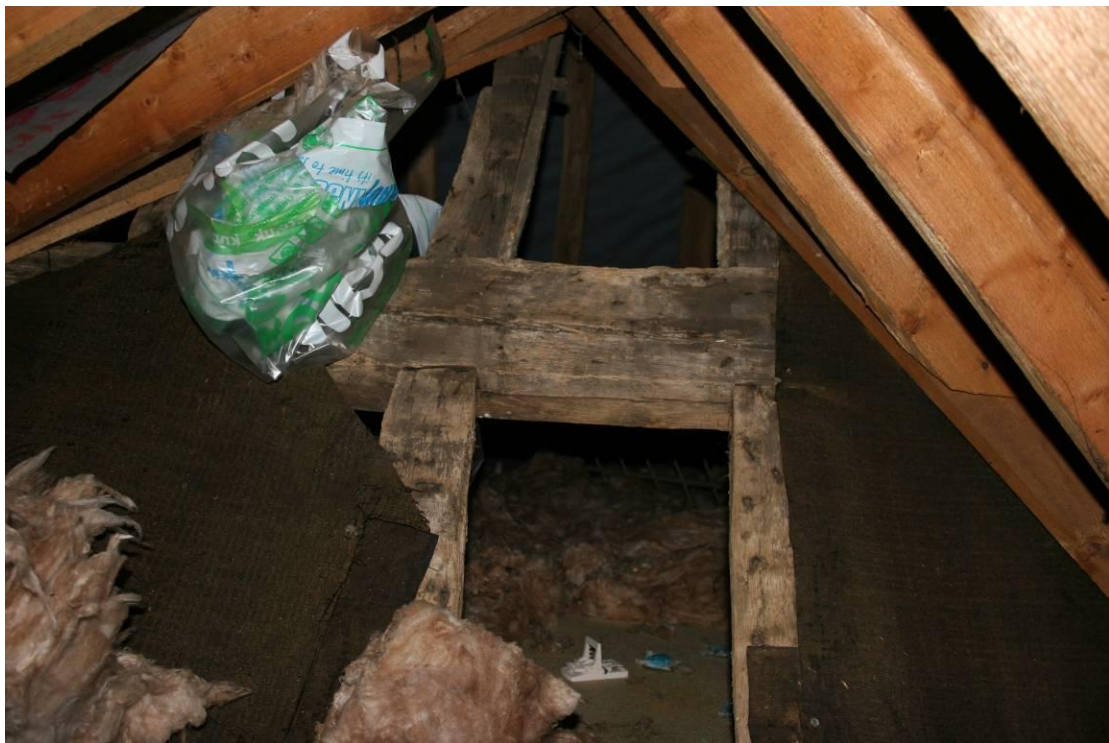
The offset butt purlin roof over the Master Bedroom in Wyndies Cottage.

Continuation of the butt purlin roof seen from the modern extension.

The butt purlin roof continues over the Master Bedroom of Wyndies Cottage. The extension roof is recent dating probably to 1981 (UTT/667/81/LB).

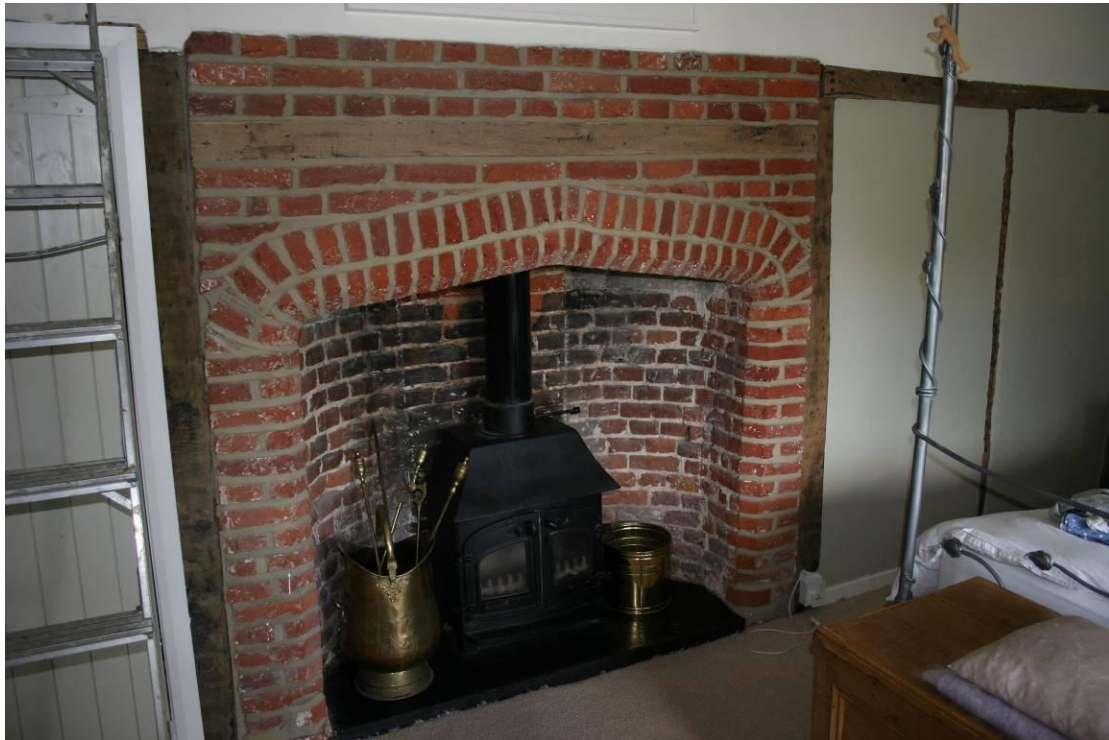
The exposed fireplace in the Master Bedroom.

Parts of the original frame are visible at ceiling height. The other timbers have been applied by Mr Turner who had a penchant for exposing the nail heads. There is a fine fireplace with a Tudor arch in 2in brickwork. The rear of the fireplace has been altered to accept a later hobgrate fireplace. The brickwork has been repointed with grey cement and a modern narrow bressummer inserted.

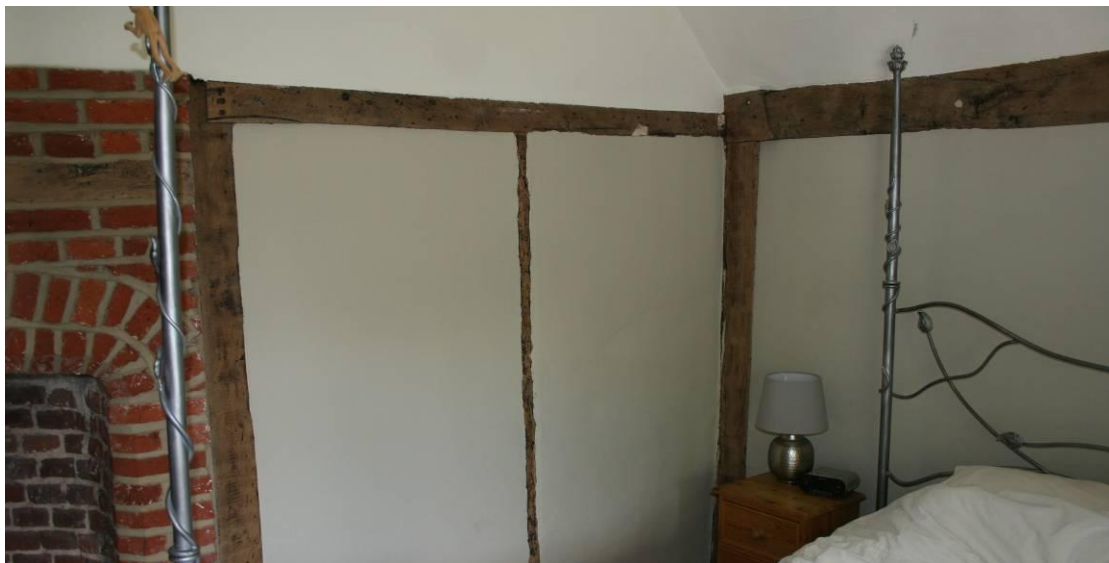
Original top-plate and partition wall by Mr Turner.

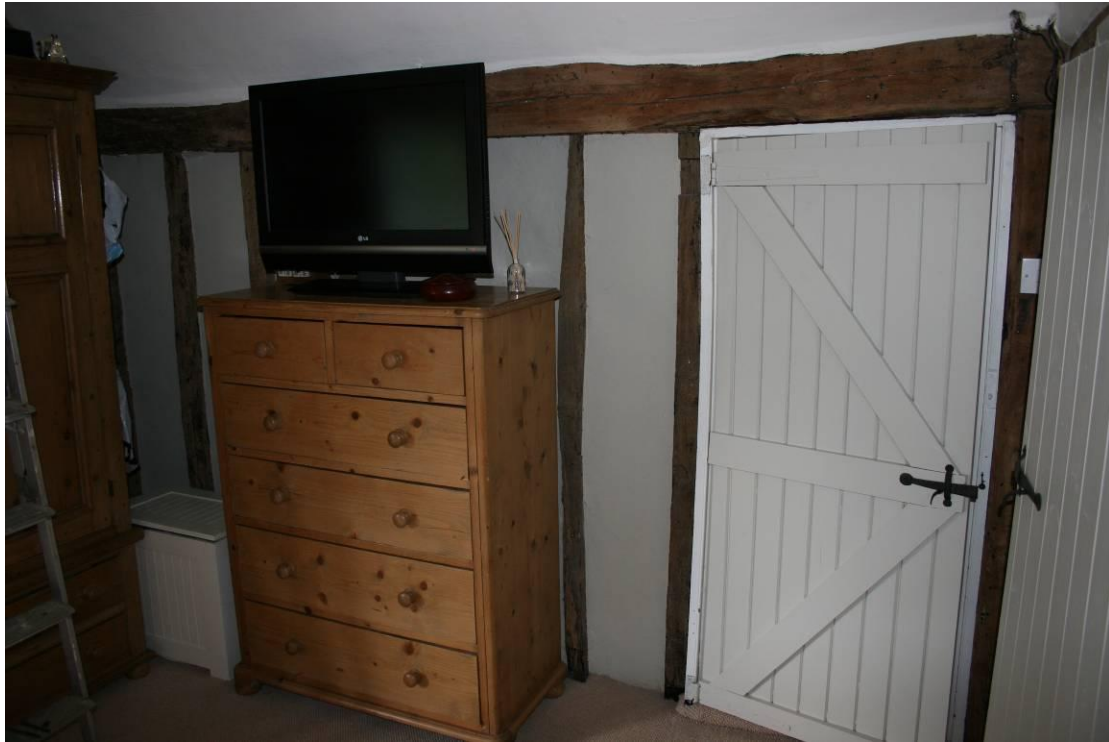
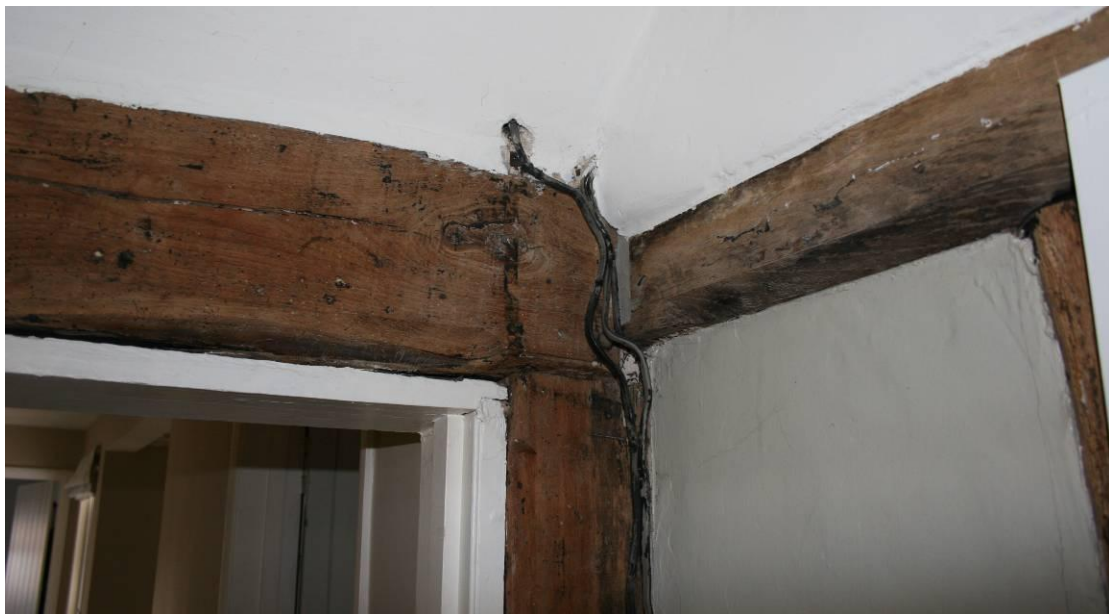
Wall common with the extension has some original studs.

Detail of the corner junction.

The original house has been extended to the north with a two storey LC20th extension. The party wall has a few original 6-7in wide studs and some inserted scantling probably attributable to Mr Turner. The junction over the doorway is interesting as it has three timbers each with different chamfers and stops.

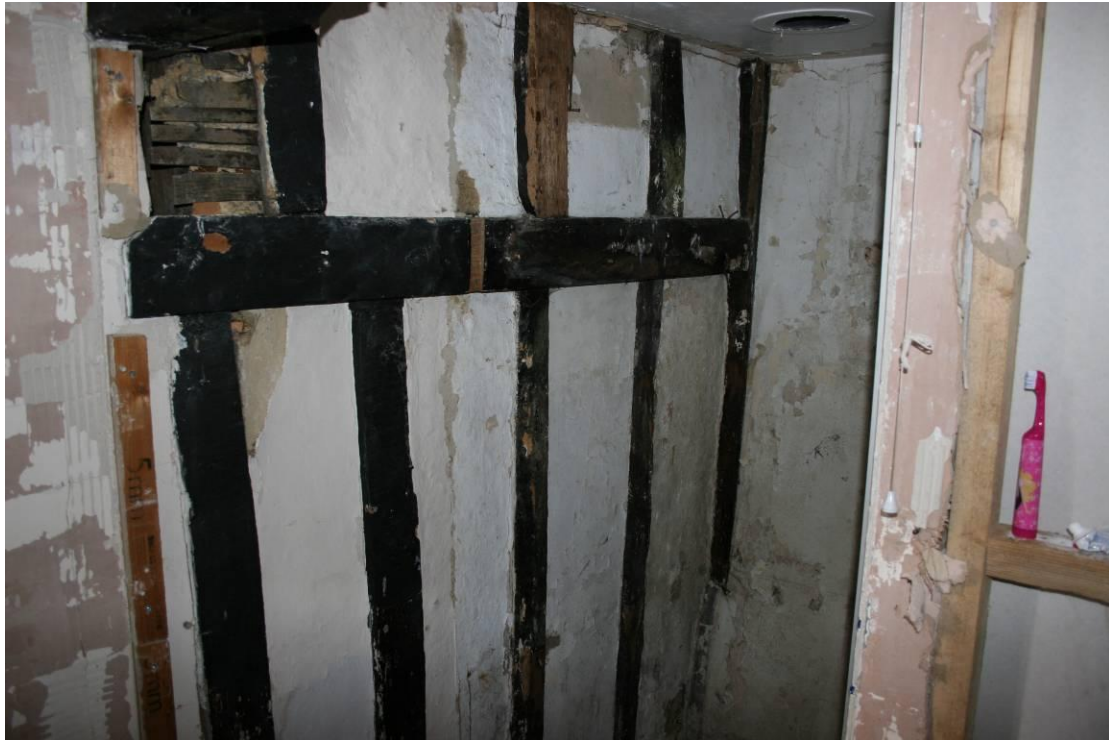
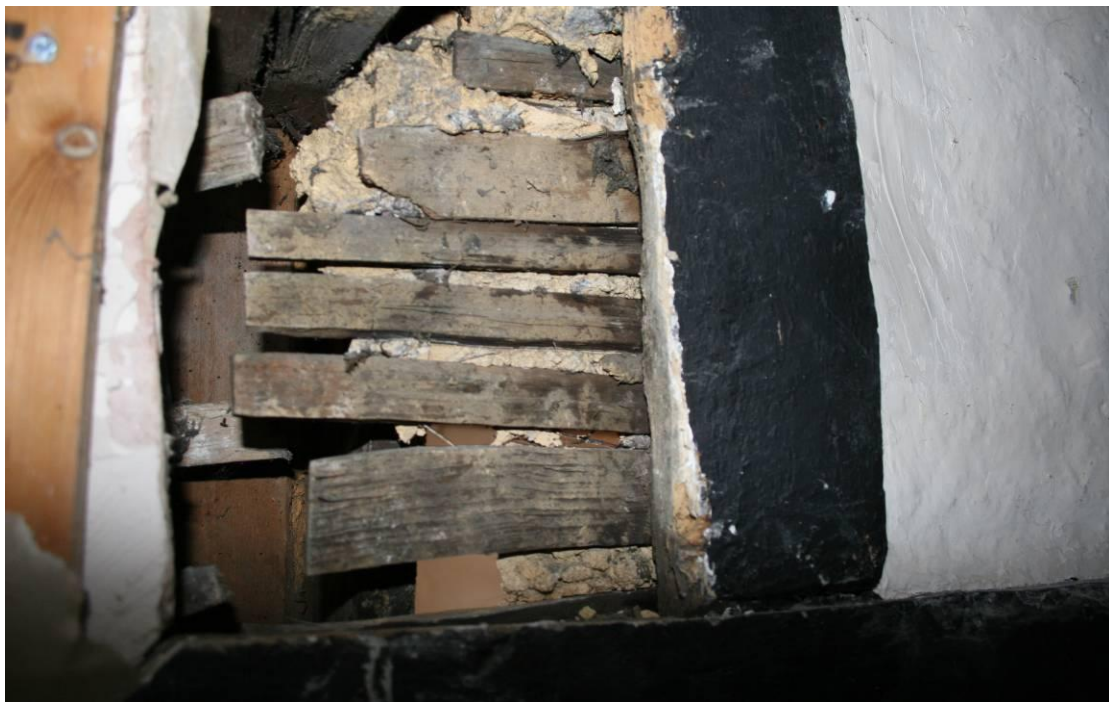
Studwork in the bathroom.

Detail of the lath and plaster.

There is a section of exposed studwork, previously hidden by a shower cubicle that has all the hallmarks of Mr Turner. The straight 5in studs are similar to those used in other repairs and the unorthodox design where the junctions are not actually connected other than by plasterwork is also his style. The riven laths may be reused but the render matches his other work. The top plate has been severed to make a doorway.

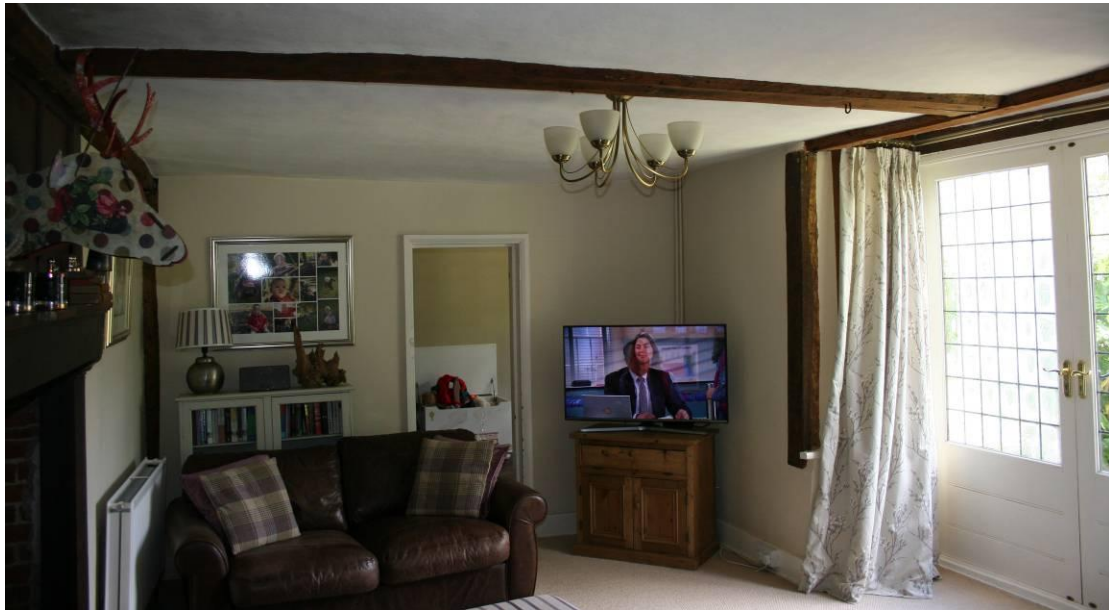
The Front Room looking S.

Parts of the timber frame are exposed and the ceiling appears lath and plastered. The brick fireplace has been altered again to accept a hobgrate fireplace and is made of 2in Tudor style bricks. The panelling and timber surround are of Mr Turner's style. The adjacent wall is plaster boarded.

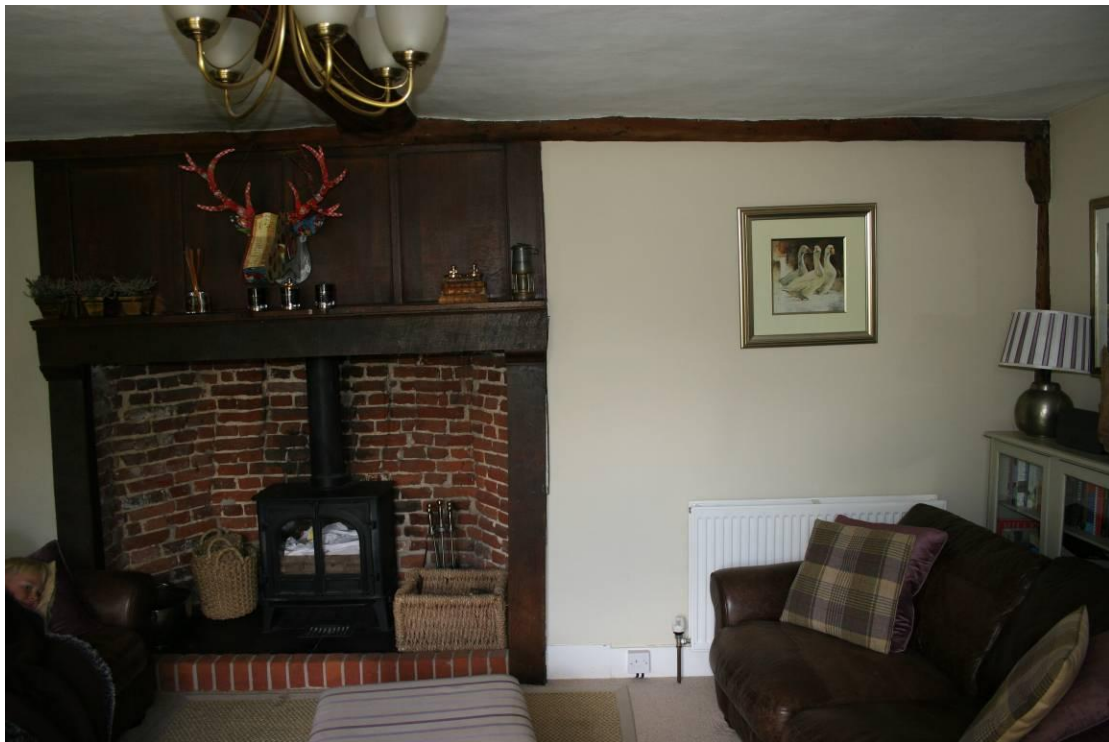
The fireplace in the Front Room.

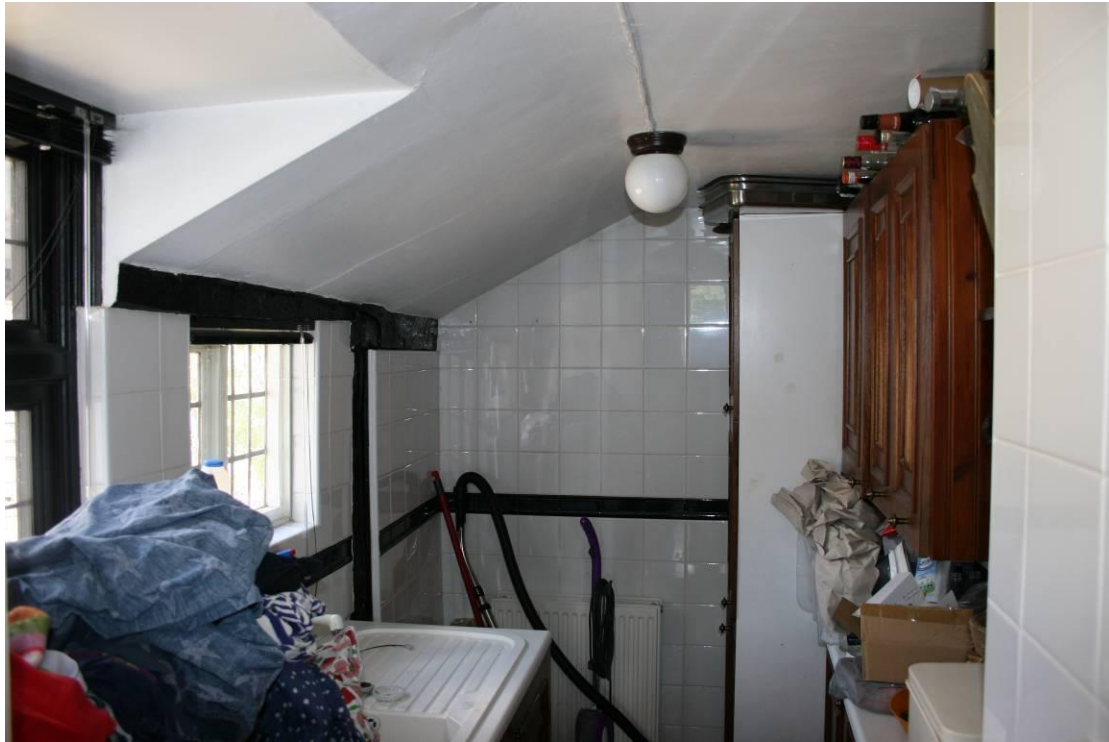
Looking E into the outshot.

The Outshot is decorated to modern standards with only the painted top-plate being revealed. The staircase is an entirely modern lightweight structure screwed together.

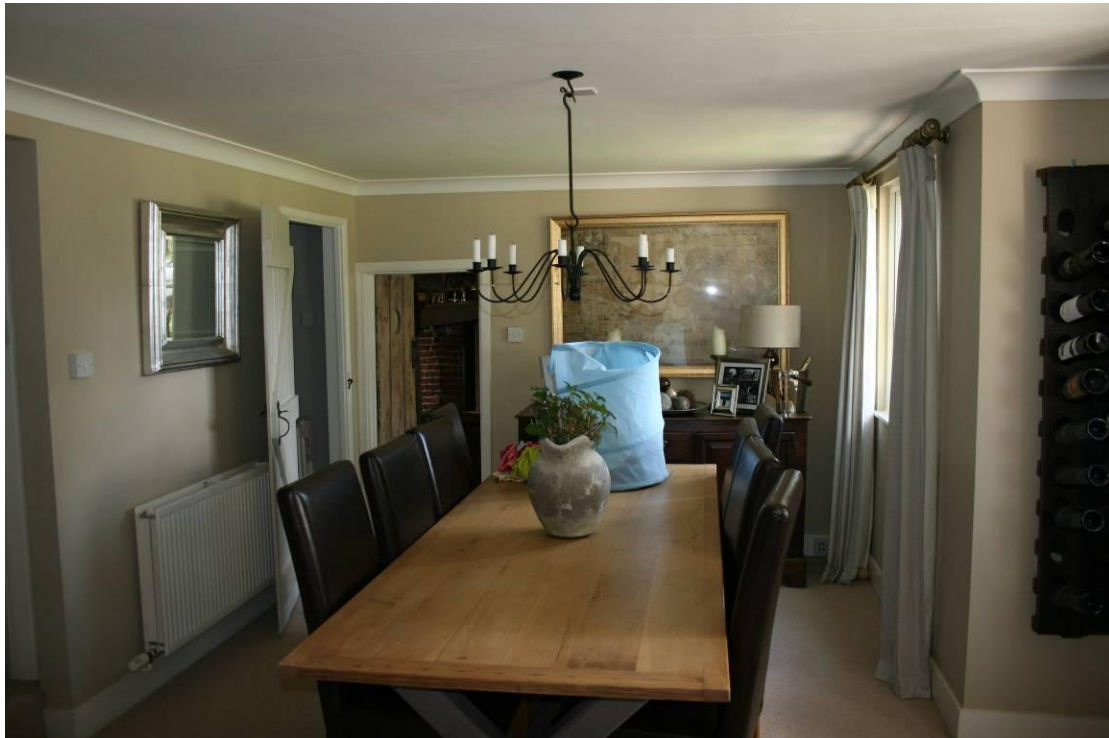
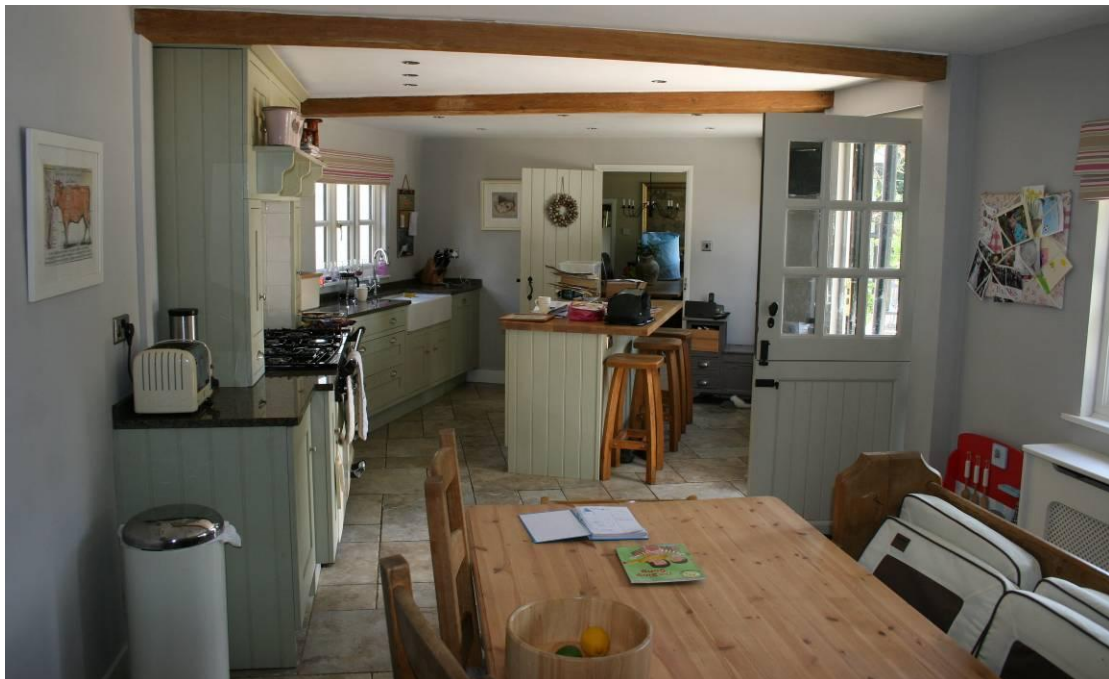
Looking W in the Dining Room.

Looking W in the Breakfast Room to the Kitchen.

The ground floor rooms are recently decorated and outfitted. The former garage was converted into a Breakfast Room and connected in 2004. (UTT/0061/04/LB). The lobby was filled in during 2009. (UTT/0151/09/LB).

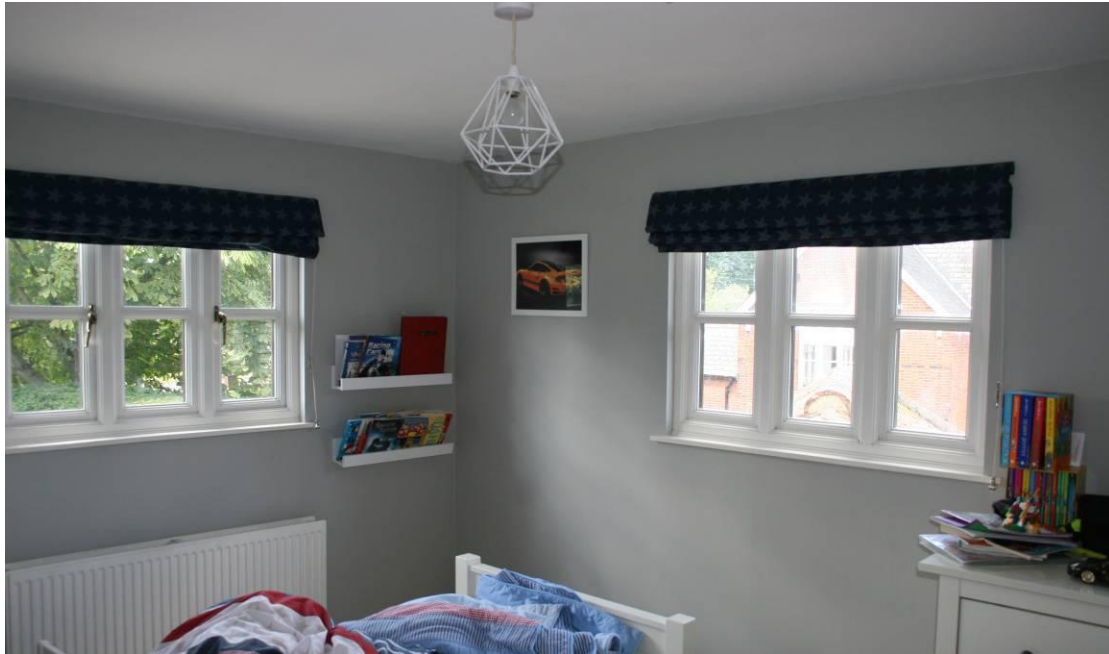
Northernmost Bedroom looking NW.

The upper floor is all recent with a machine cut roof with a cotton asphalt membrane and assumed built in 1981.

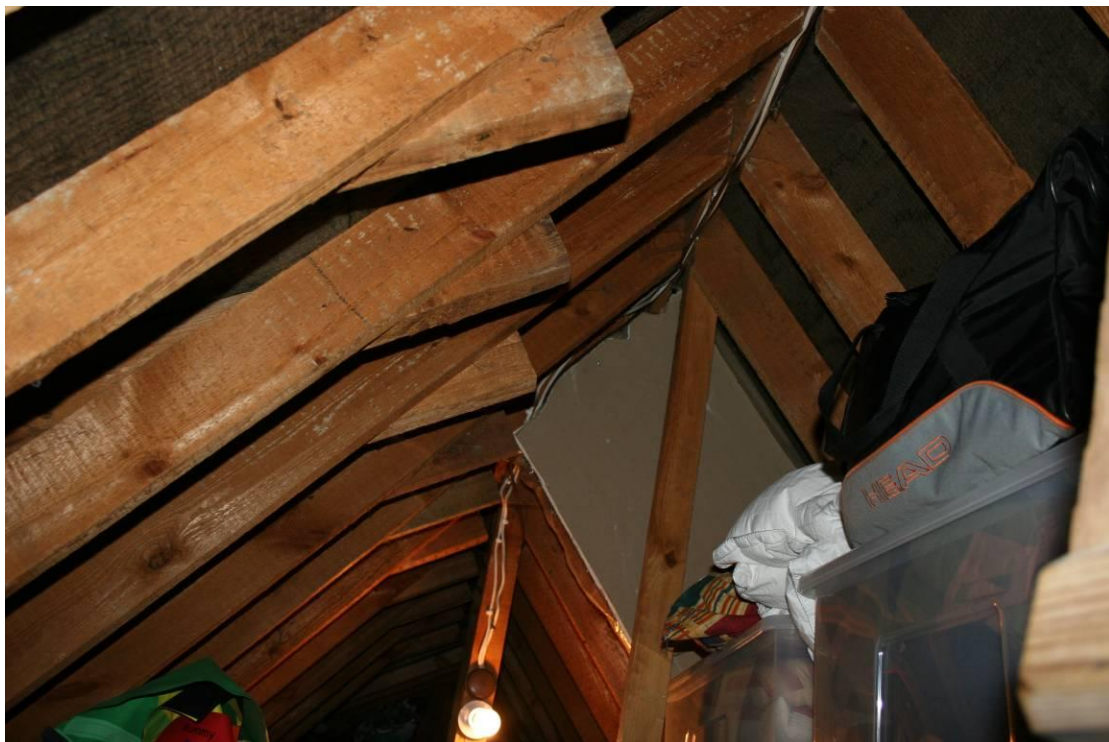
The modern roof structure above the bedroom.

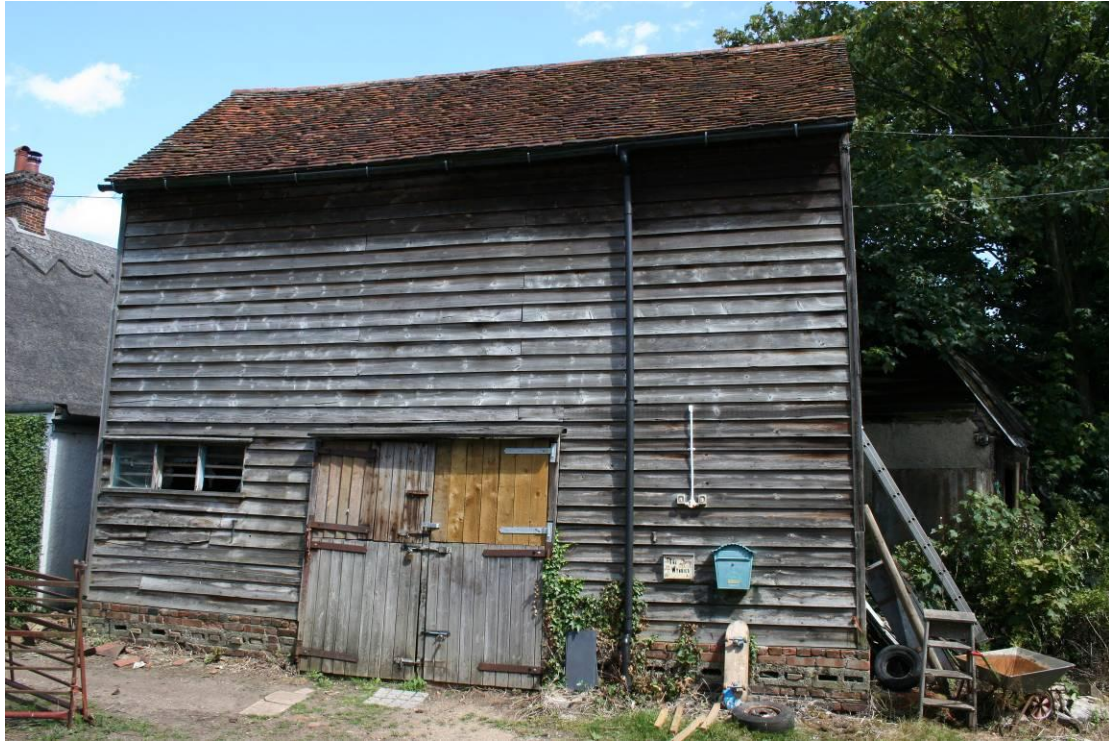
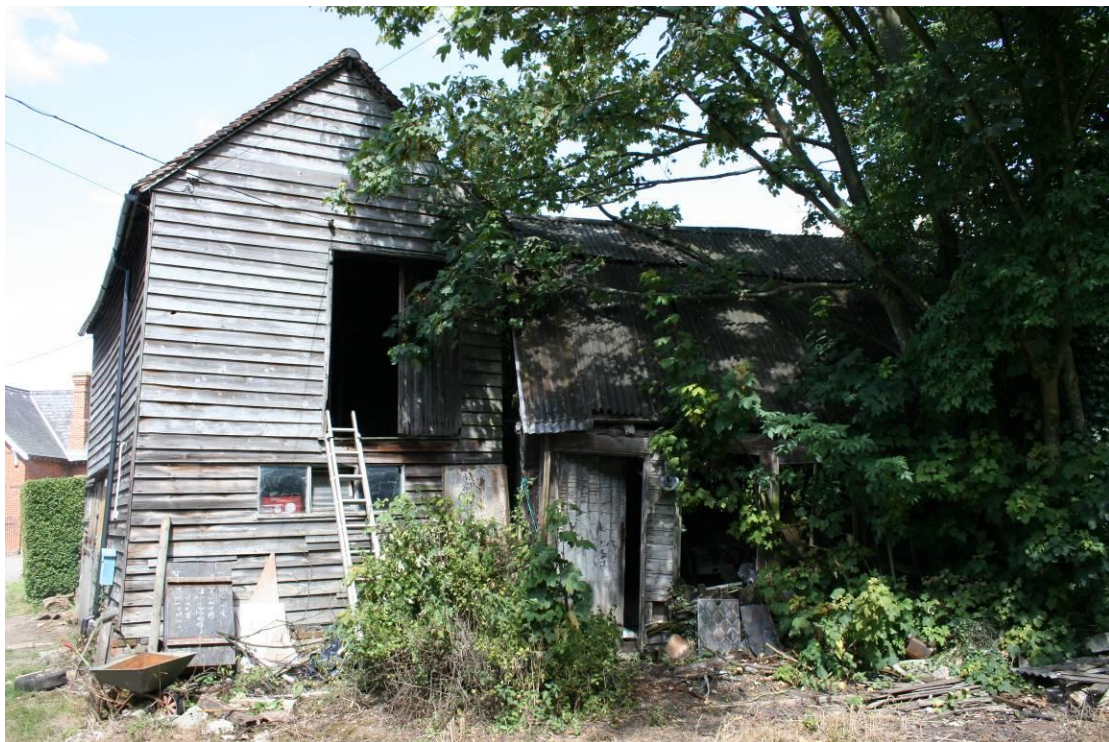
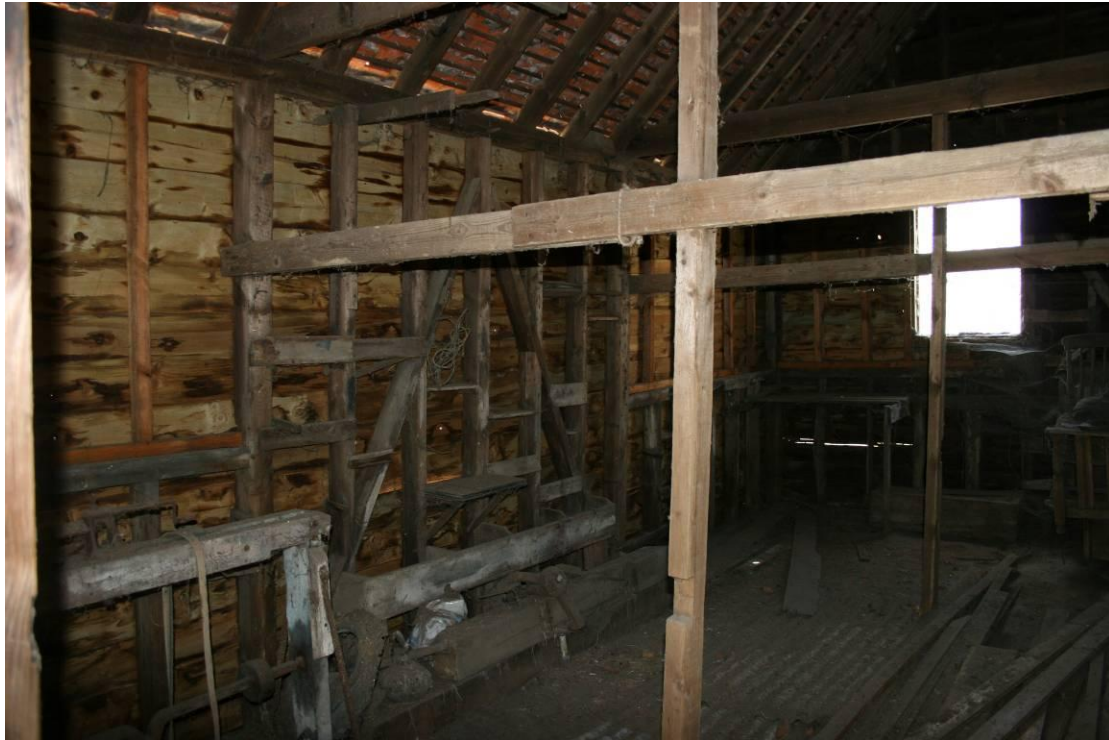
The Stables. Western elevation.

The Stables and Workshop. South Elevation.

The Stables upper floor was used as a woodworking workshop.

The Stables is timber-framed building made from machined cut 2x4in softwood that has been reboarded in the LC20th. The frame shows there were large windows on the upper floor and there is a treadle lathe and shelving from the former workshop. It is believed coffins were made here by Mr Turner.

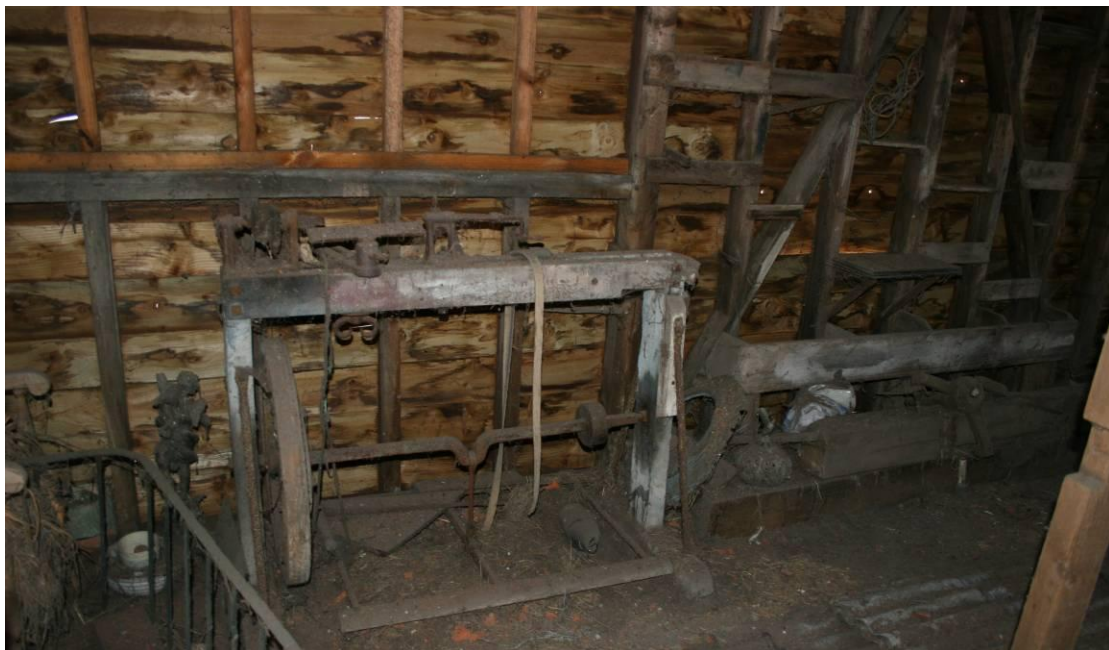
Treadle operated lathe.

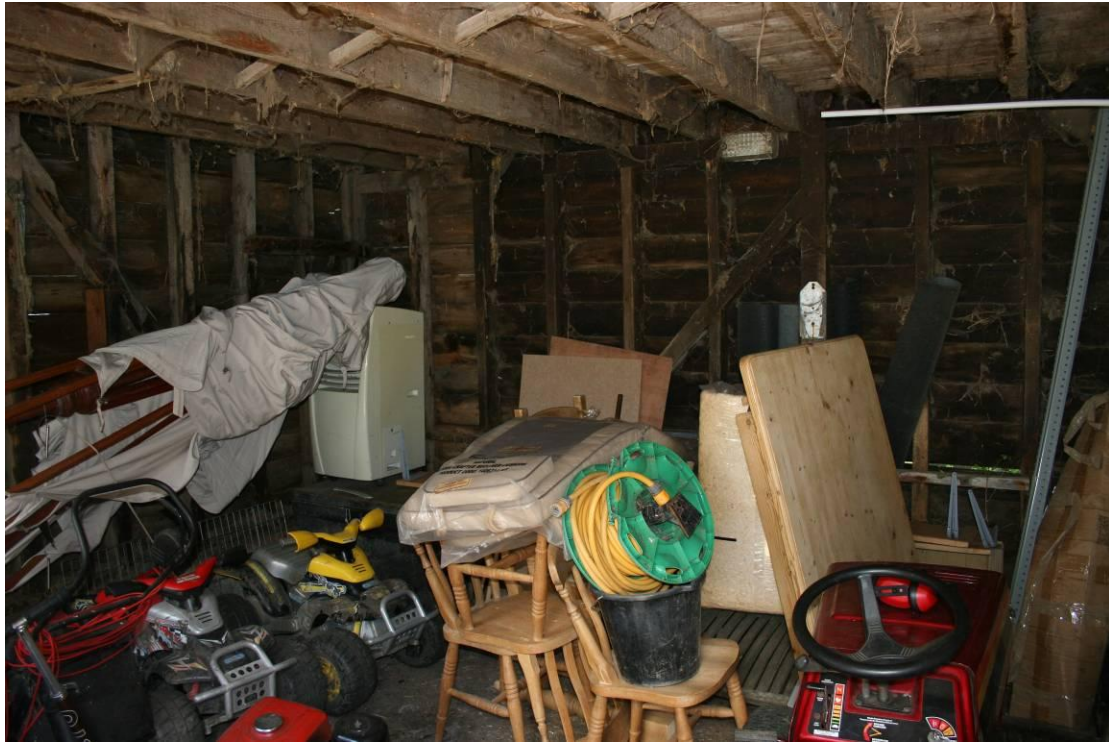
One of the ground floor rooms.

Although the building is called the Stables there is little to betray its former use. The dividing wall on the ground floor has circular and straight sawn kickboards. A galvanised tethering ring remains but it is known that Ms Gillian Turner was a keen horsewoman and the building may have been used to shelter her horses.
