Wyndies Cottage and The Wyndies, Crow Street, Henham, CM22 6AH.
Historic analysis of the timber-framed house. Surveyed 09 08 2016.

Scope of this Report

This report describes and analyses the fabric of the buildings to English Heritage Level 3 as outlined in English Heritage. Understanding Historic Buildings – A guide to good recording practice. 2006. Page 14.

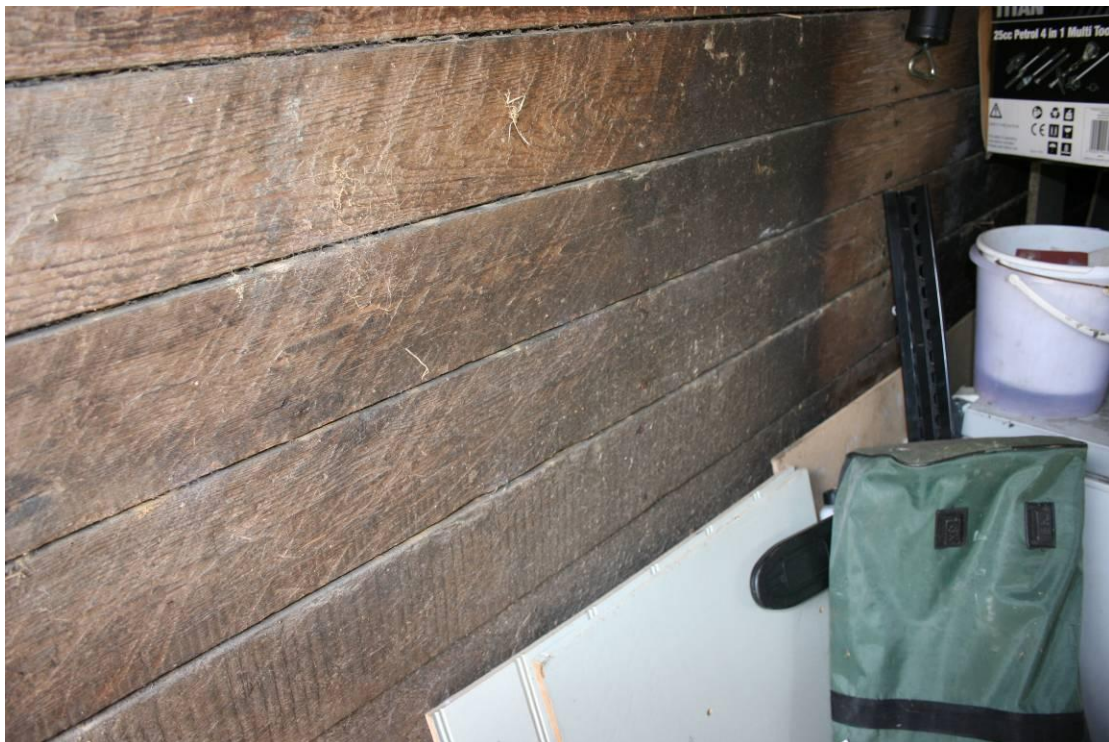
Detail of the machine cut kickboards.

Although the building is called the Stables there is little to betray its former use. The dividing wall on the ground floor has circular and straight sawn kickboards. A galvanised tethering ring remains but it is known that Ms Gillian Turner was a keen horsewoman and the building may have been used to shelter her horses.

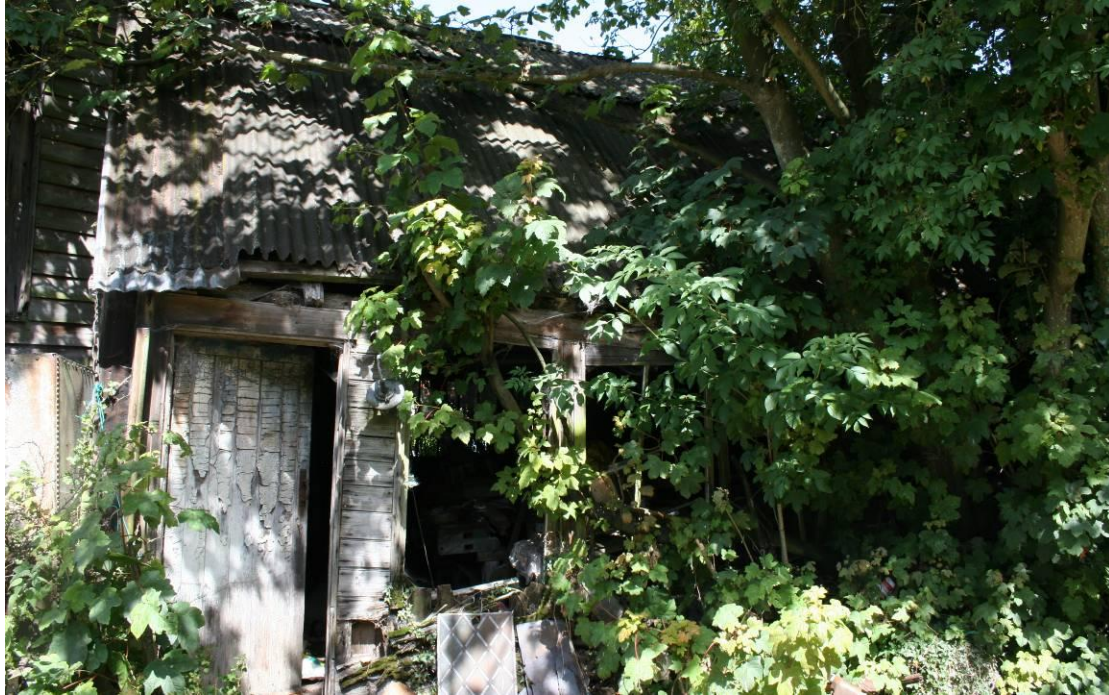
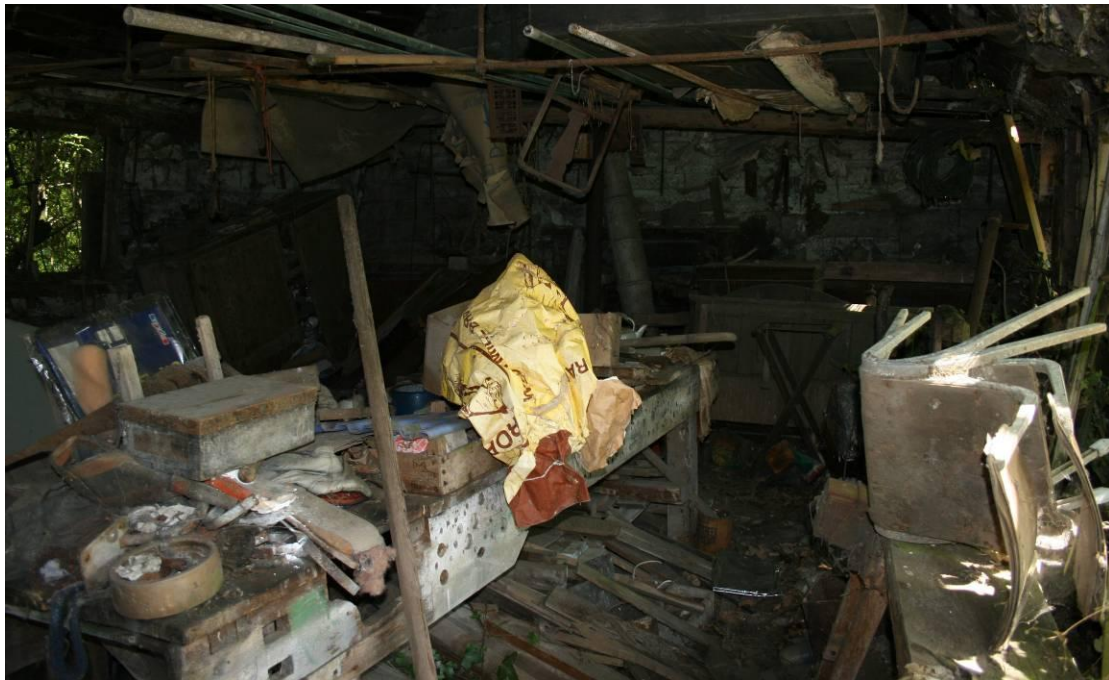
The Workshop is in parlous condition.

The Workshop is in danger of collapsing.

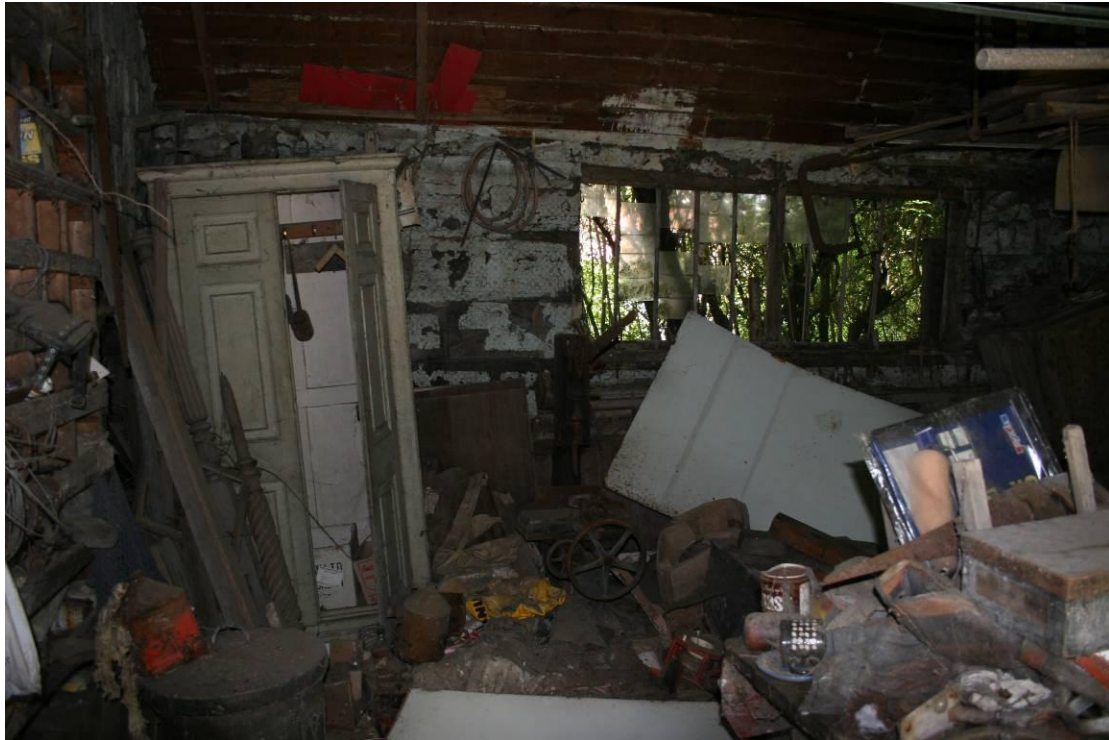
Inside the Workshop looking N.

Looking E inside the Workshop.

The Workshop is boarded with tongue and groove on the walls and ceiling. It has a C19th scantling frame with nailed interrupted studwork that can be seen in the tin shelter on the eastern end. The roof has also been clad with corrugated tin sheets. Parts of the external walls have been lath and plastered. There are very large pane windows, all but destroyed.

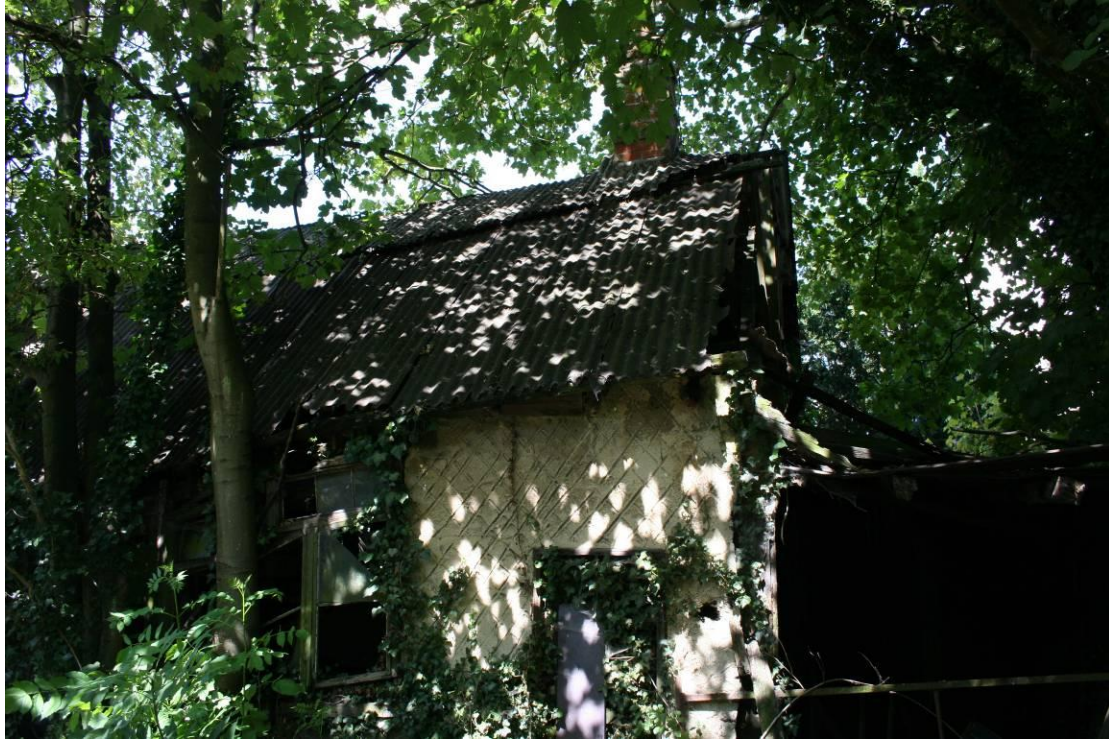
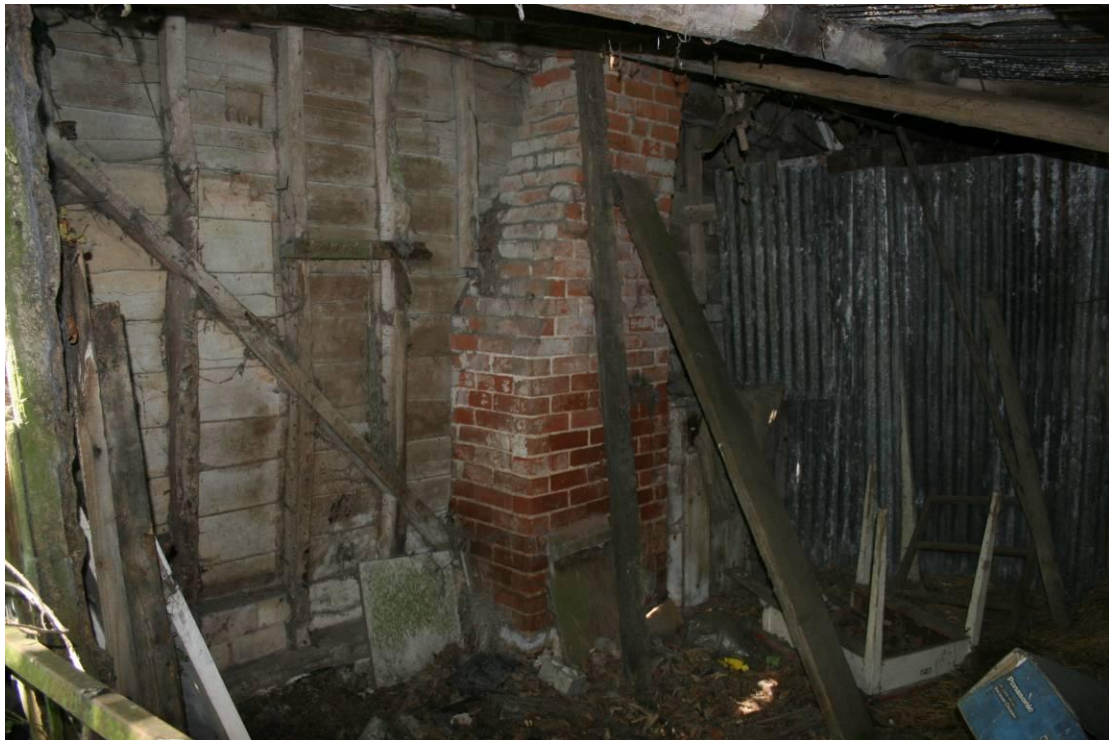
The eastern end of the Workshop.

C19th chimney and nailed interrupted studwork seen in the tin shelter.

There is a C19th brick chimney on the eastern end of the Workshop.

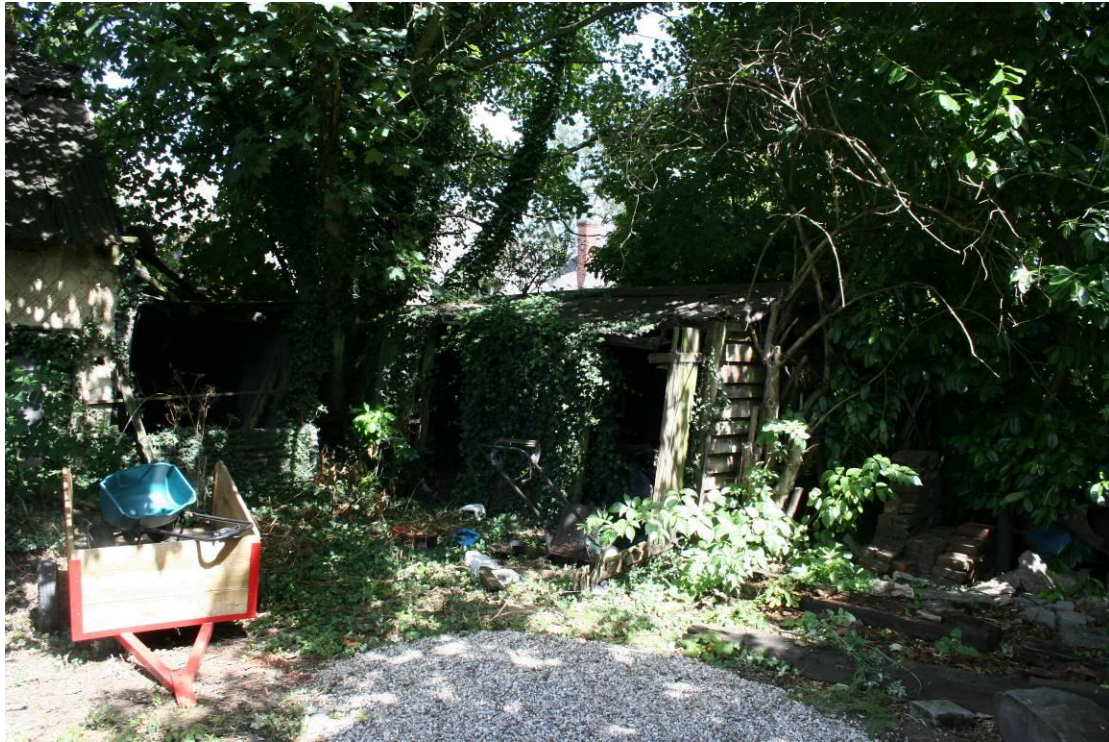
Store buildings. Looking NE.

Interior of the northern store.

A pair of ramshackle store buildings is made of offcuts of machined timber, quarter poles and corrugated tin to store logs, coal and garden equipment. The southern wall is weather-boarded.

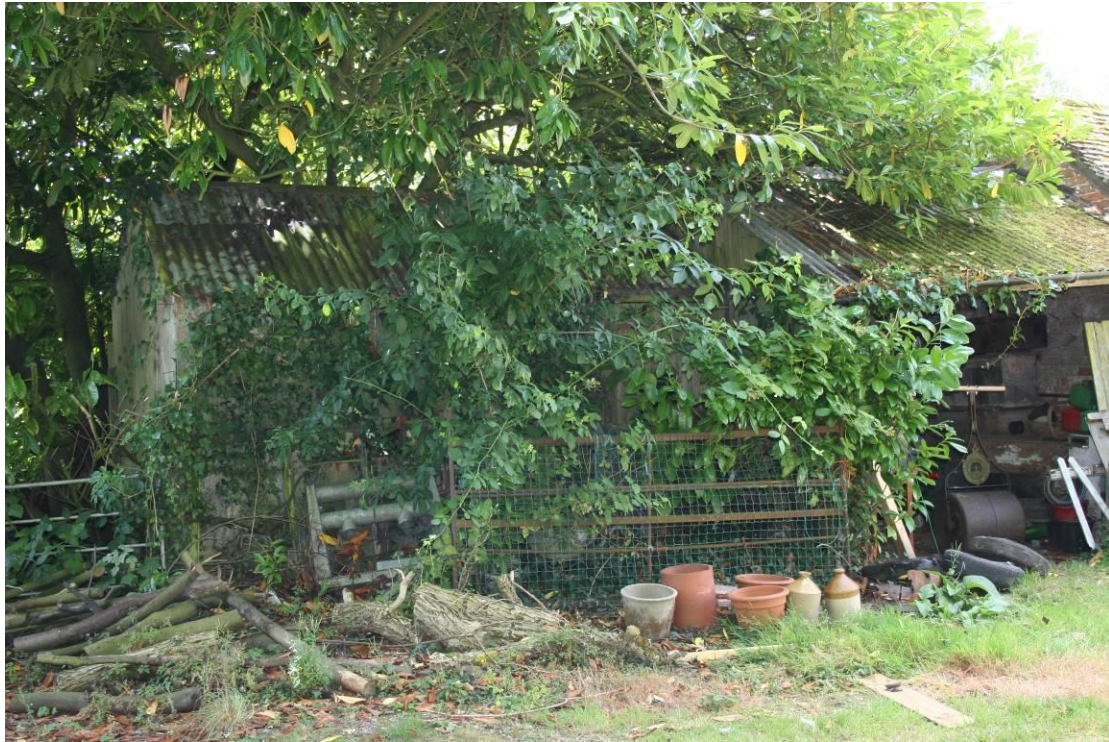
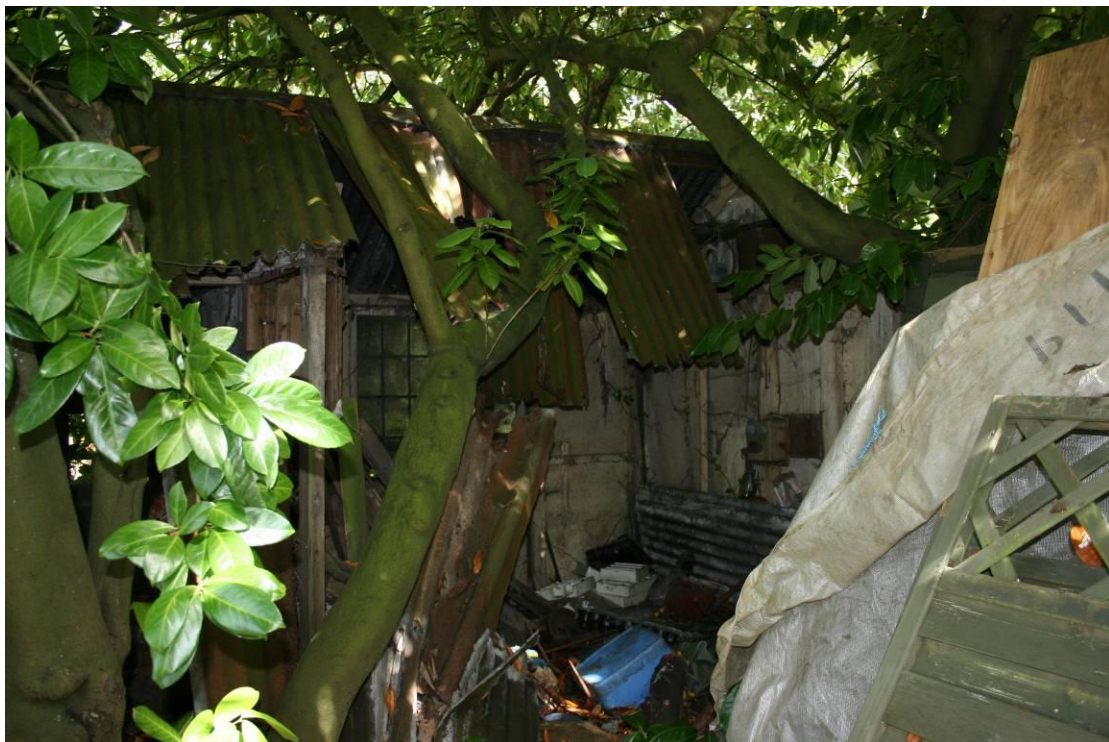
Garden buildings. Looking S.

Interior of the garden buildings.

There are two tumbledown garden buildings east of the Kitchen poorly built in the same fashion as the Stores. There is one of Mr Turner's trademark windows so it can be assumed he erected these little utility buildings.

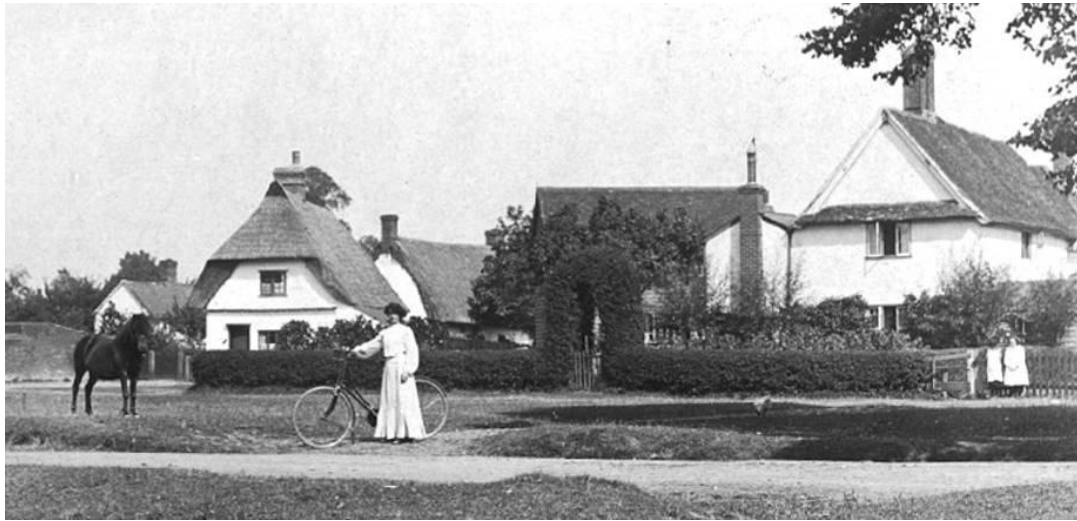
1907. Wyndies. Note the two storey extension.

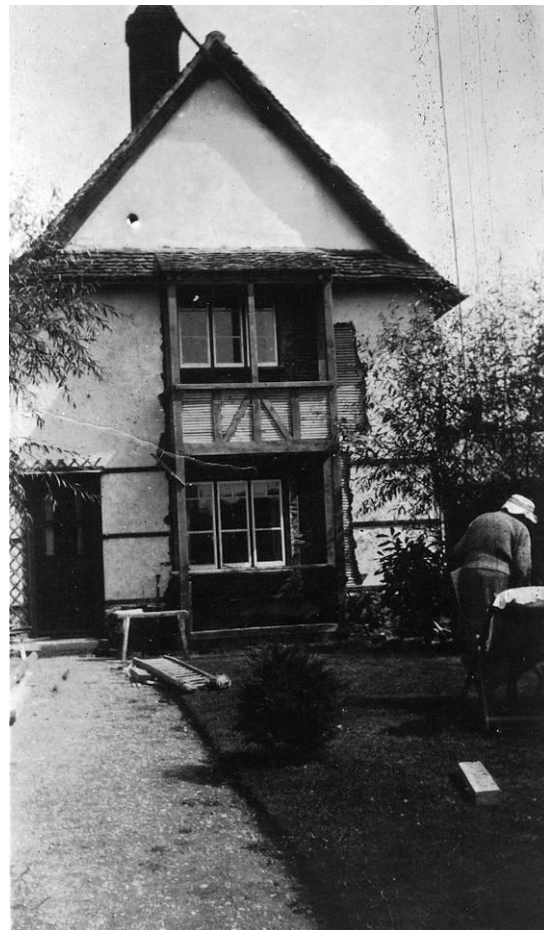
Mr Turner building the bay windows. 1930's.

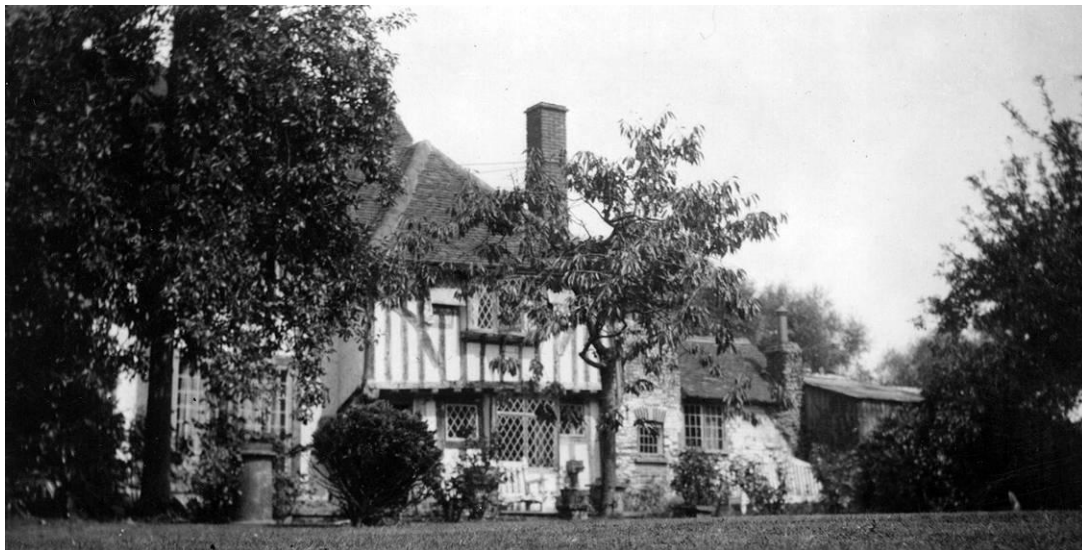
1930's. The south elevation with Mr Turner's windows.

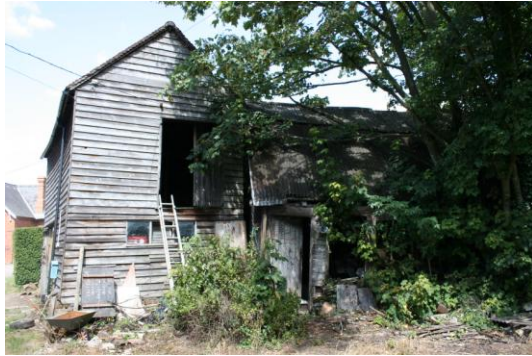
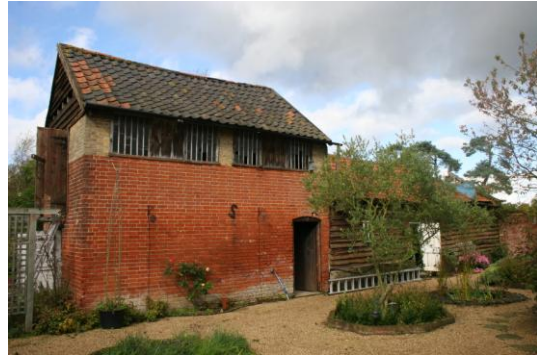
The Stables and Workshop at Wyndies compared to the same at Chapel Farm, Bredfield.

The Stables is a two storey timber framed building constructed of machine cut soft wood on a 2x4in module. The upper part of the building had large windows implying it was built as a workshop. It would have had an external staircase, probably with a platform but this has been lost. A Victorian treadle lath is still in place as are various shelves and parts bins and it is commonly known that coffins were built here. In this case the timber would have been seasoned in the Workshop building and the complex can be compared to other coffin makers and carpenter's workshop around the area that adopted this formula. The Stables at Wyndies would have been built near to 1877 when it was first mapped.

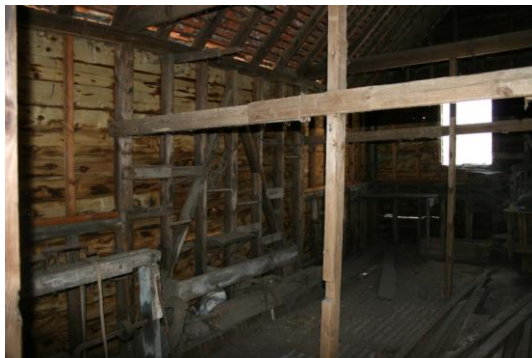
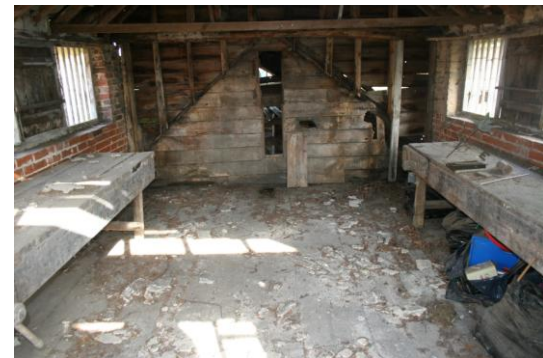
The upper floor of the Stables at Wyndies compared to the coffin makers at Chapel Farm
