NOTTINGHAM 1973
FISHER GATE

SITE NOTEBOOK 17

{OVEN/KILN H (477)

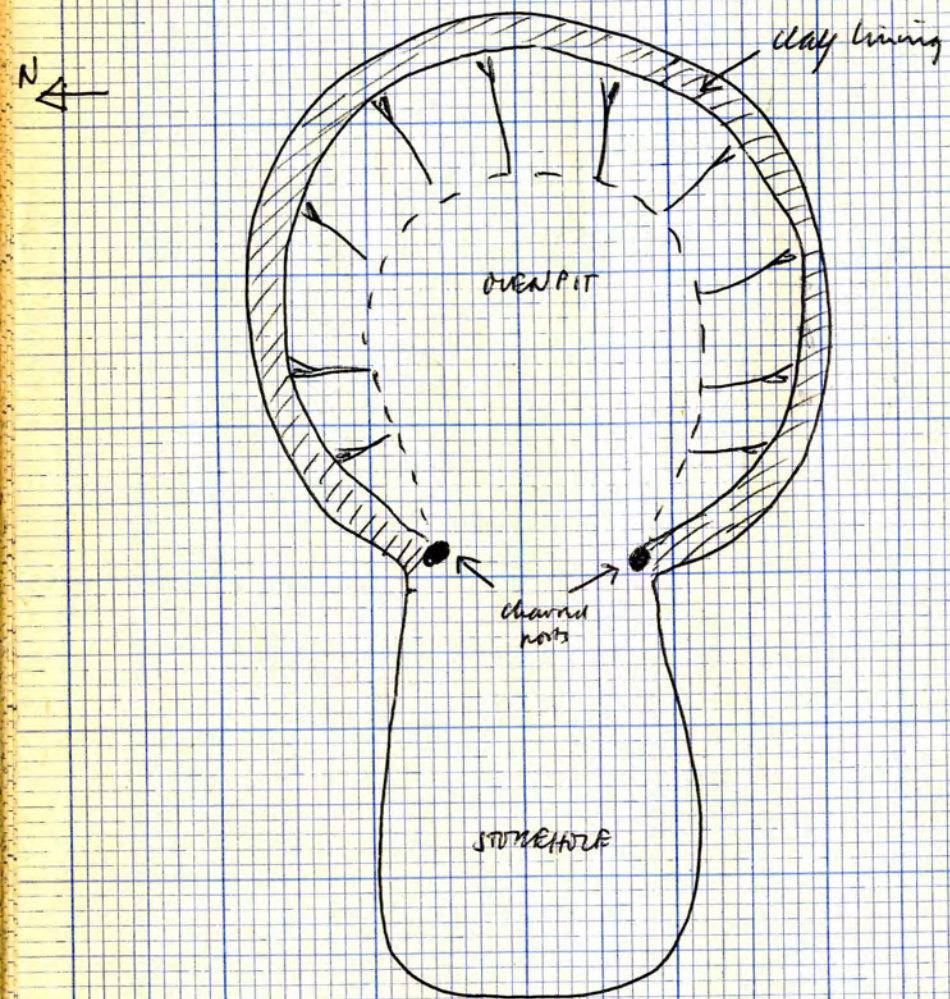
Sketch plan

The oven-pit is smoothly lined with red clay. This lining is on the sides but NOT on the bottom. It terminates at the remains of two charred wood posts, at the junction of the oven-pit and structure.

sketches). The addition in sketches are accounted for by the fact that, because of later features, the oven survives to varying different heights.

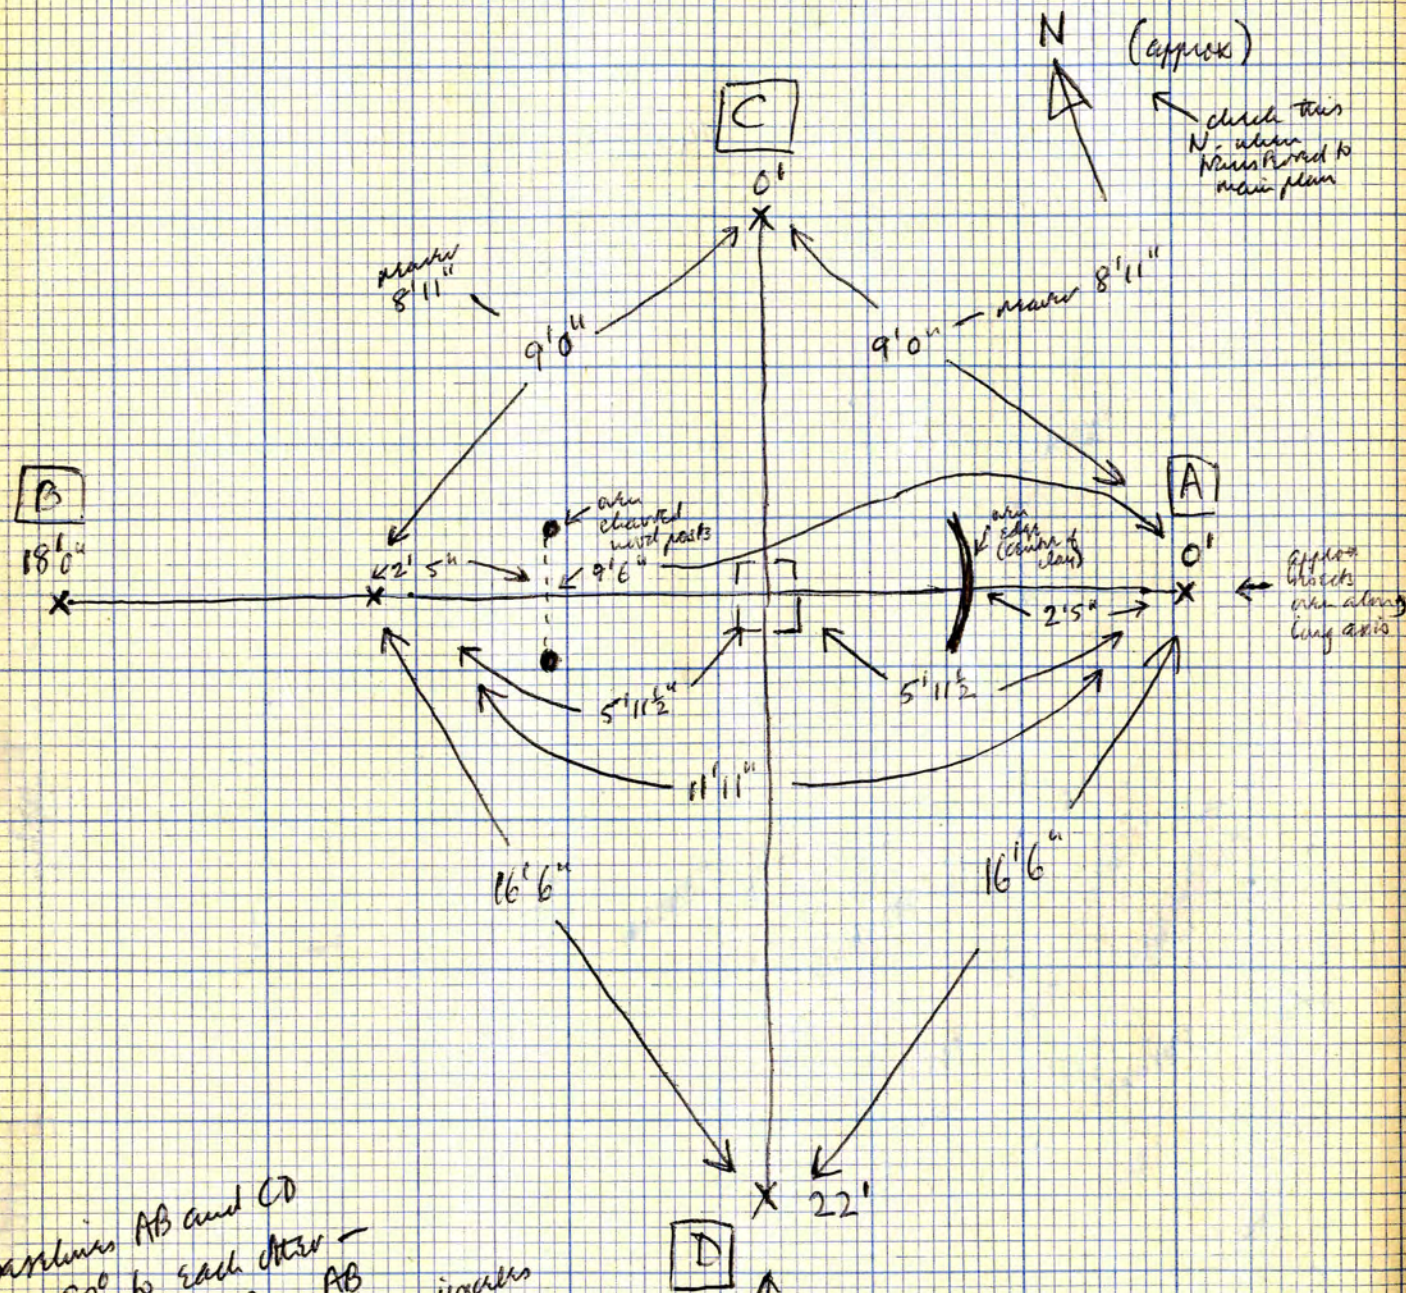
Baselines AB and CD at 90° to each other - CD laid out from AB by triangulating ~~from~~ ~~isoclines~~ isoclines. CD crosses AB 5' 11 1/2" from A

baskets are put 1/2 way between posts and East end.

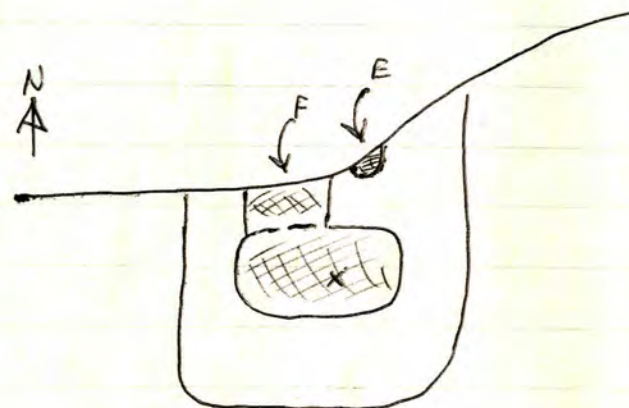
Sketch plan diagram.

* Seems to me more likely there were 3 posts here. white soil-marks for E + F (the wicker) and for a third post - possibly for arching the flue.

Post X would be the third post.

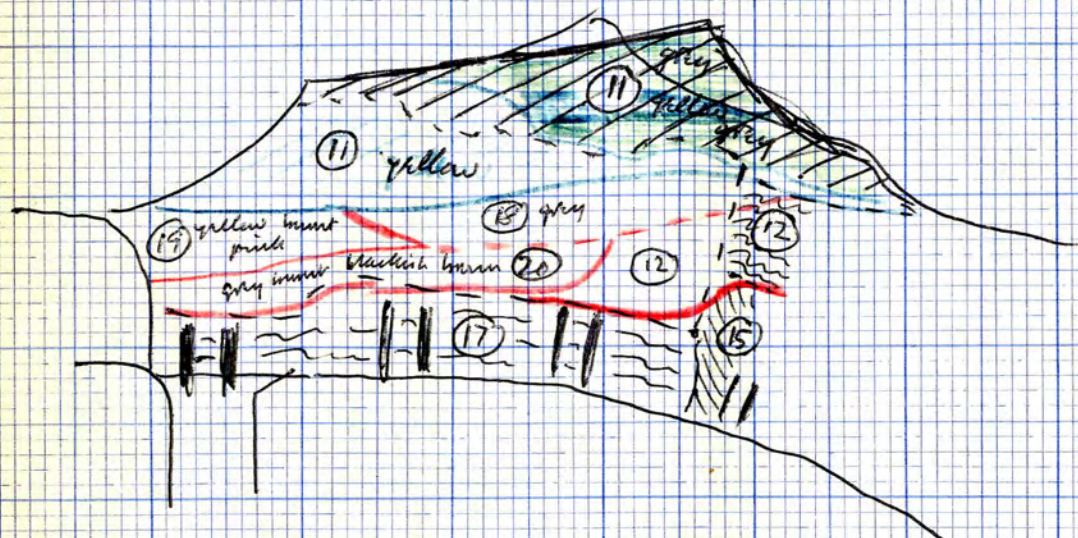
Layers of (165) showing after removal of undercoat.

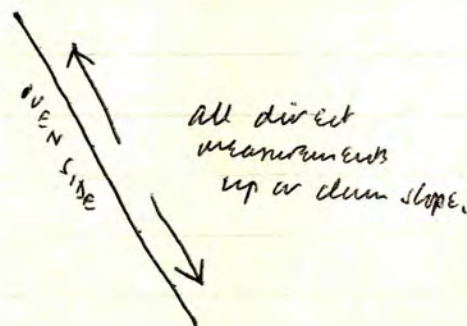
The sketch is a fairly accurate representation of the sides of the urn with wires and salt marks, ascending from the bottom. In situ, the wires & salt marks are not vertical but on the urn's sloping sides.

If this "sketch" (a drawing) were cut out and "upped" it should fit fairly neatly into the urn plan - both at scale of $1'' = 1'0''$

On this drawing therefore -

- A. All horizontal measurements are correct.
- B. All the "vertical" measurements are direct measurements up the slope of the run sides, from top or bottom

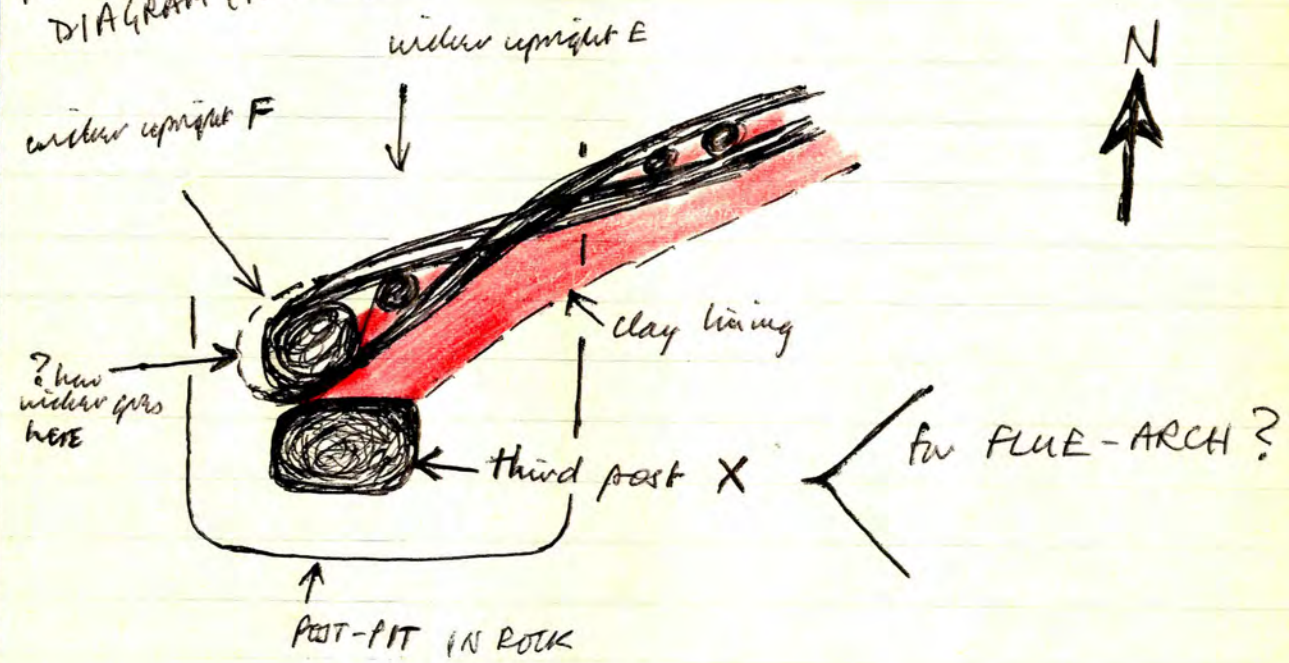
RECONSTRUCTION DIAGRAM (PLAN VIEW)

This means there must have been THREE posts in this post pit — two belonging to the wickerwork (uprights E and F) and the third an extra post

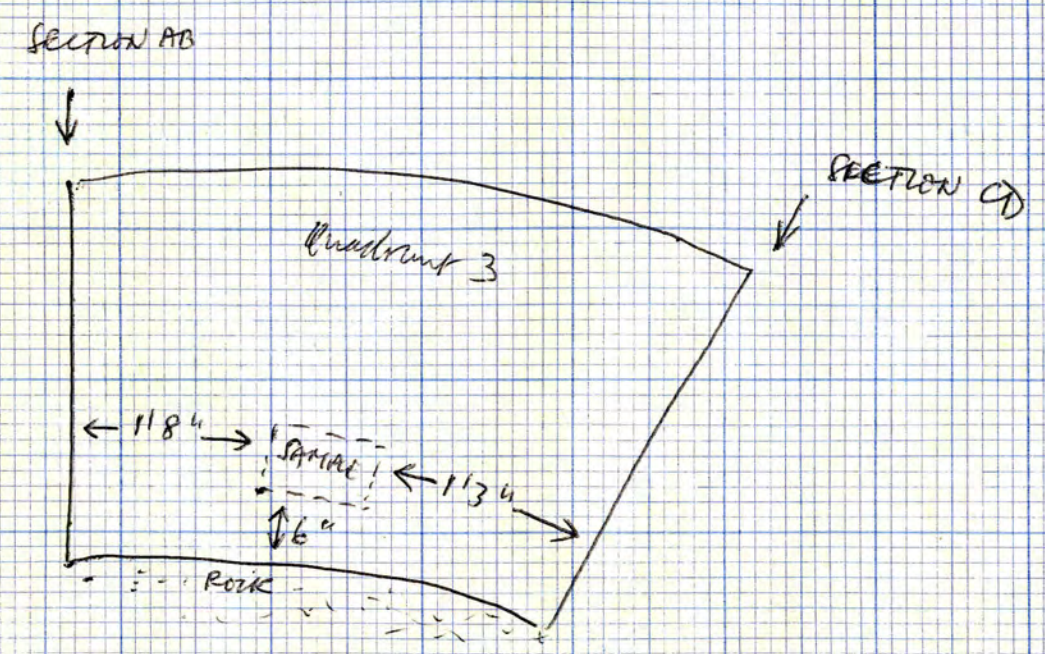
Sketch of position of clay sample (168A)

(168) slightly exaggerated on
section CD to show wickmark
irregularities.

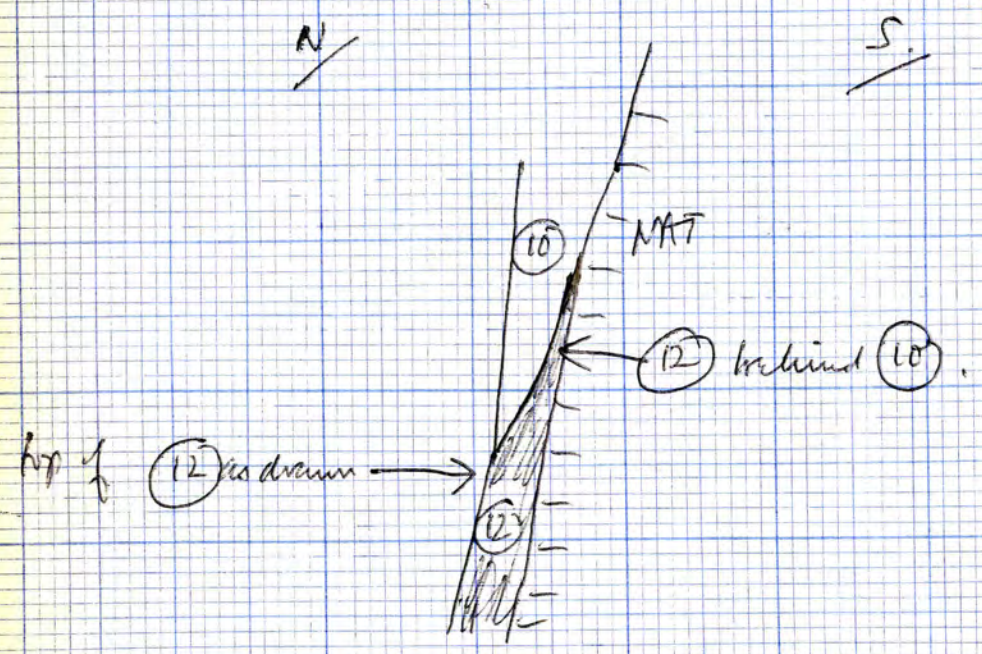
See previous notes on (165) of quadrants 1+2. This south side is much less "parallel" and predominantly redeposited materials except for one main grey blob. Layers as follows (nos. apply to sketch only as they're all (181))

* (12) goes up behind yellow layer (10) for about 8" to 1'0"

- ① Yellow grey sand from b/s
- ② Dark grey sandy with red clay + ch. cl. pebbles
- ③ Clean yellow sand from b/s
- ④ Yellow sandy ~~with~~ from b/s with mixture of red-brown soil - some red clay pebbles.
- ⑤ Dark grey sandy with red clay pebbles
- ⑥ Mixture of yellow sand from b/s and mid-grey sandy. Some dark grey sandy lumps.
- ⑦ Coarse yellow sand from b/s with pale lumps of b/s.
- ⑧ Yellow sand from b/s mainly mixed with dark grey sandy
- ⑨ Clean coarse yellow sand from b/s with small lumps of orange rot.
- ⑩ Coarse lumpy redeposited rats. - mixed orange + yellow.
- ⑪ Clean coarse but comparatively fine yellow sand from b/s
- * ⑫ Grassy dark grey sandy with ch. cl. pebbles - redeposited pit-fill.
- ⑬ Fine dirty yellow grey sand with horizontal b/s/thin layers of dark grey sand.
- ⑭ Fine slightly greyish yellow sand from b/s (poured in?)
- ⑮ PIT predating area. Goes behind ④/⑤/⑥/⑩
