Grove Farm, Kirkbride

Historic Building Record

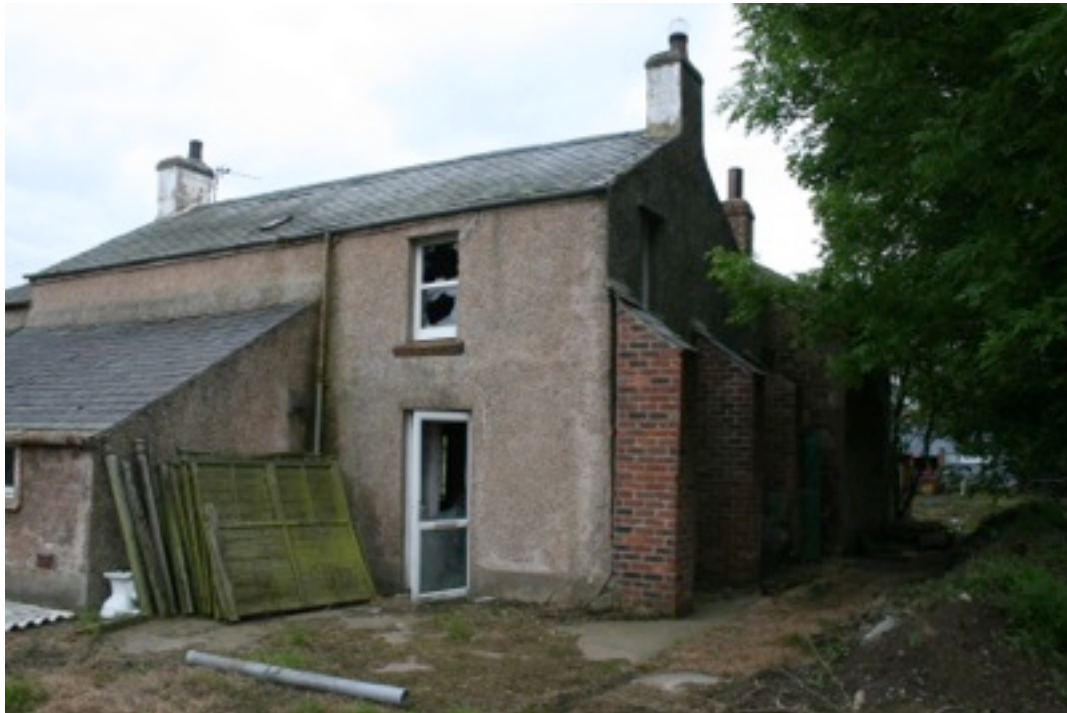
Plate 1. North West Elevation of House

The house is two storey, rectangular on plan and has two gables. The external walls are clay dabbins with some brick to the first floor. The roof is pitched and covered with blue slates, probably welsh, with a blue clayware ridge. There are two chimneys at the gables with rendered stacks, capping and clay pots. The external walls are finished with a roughcast coating. The window frames and doors are modern PVCU. On the west gable there are three brick buttresses of more recent date. Internally the ground floor has two main rooms and a hall. On the first floor there are four bedrooms, landings and two staircases. The ground floor is constructed of solid concrete. The first floor is of timber suspended construction and all the internal surfaces of the external walls on both floors are plastered. The ceilings to the ground floor hall and all the first floor rooms are also plastered or plasterboard and skimmed. The ceilings to the two ground floor main rooms are timber board, joists and beams as there is no applied finish to these ceilings. The thin partition walls on both floors are timber stud with a plasterboard, hardboard or vertical timber boarded finish. Internal doors are modern flush type. The staircases are fabricated from timber treads and risers let into timber strings.

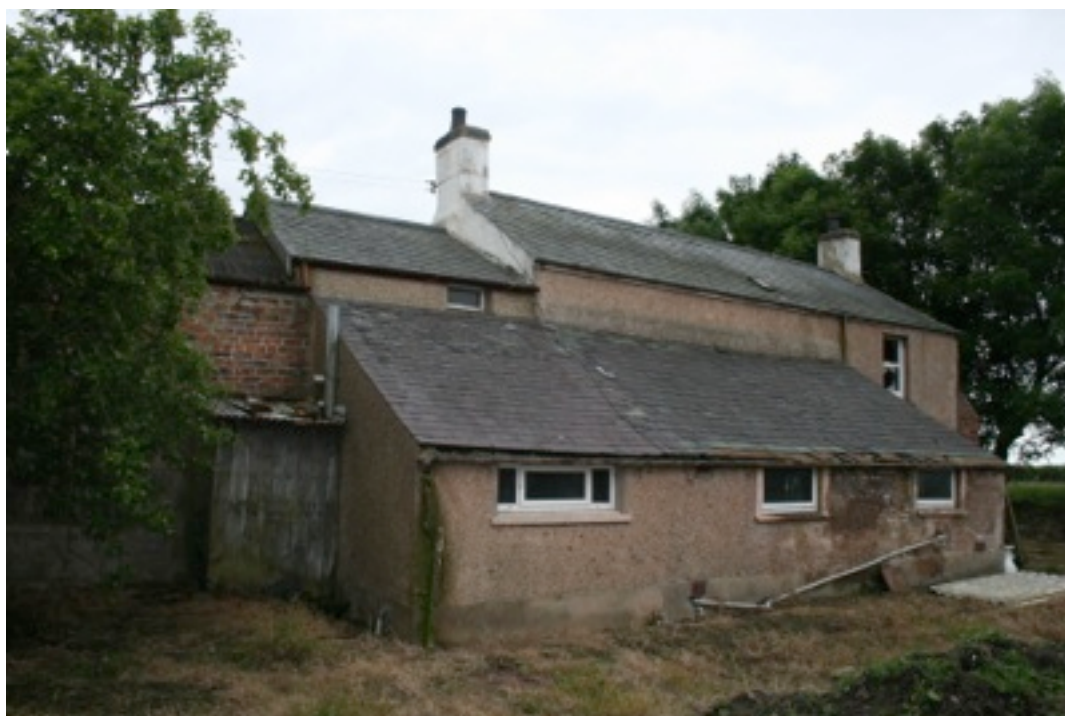
Plate 2. North Elevation of House

Attached to the north of the house is a single storey extension. This has a mono-pitched roof covered with blue slates with some sandstone at the eaves course. There is an apparent join

in the roof slope indicating that the extension has itself been extended (See Plate 2). The external walls appear to be a mixture of brick and stone finished externally with roughcast. The interior comprises two rooms. The floors are solid concrete, the wall finishes internally are plaster and the ceiling is lath and plaster and plasterboard and skim. The three window frames on the north elevation are more recent and the openings appear to have been modified at some time.

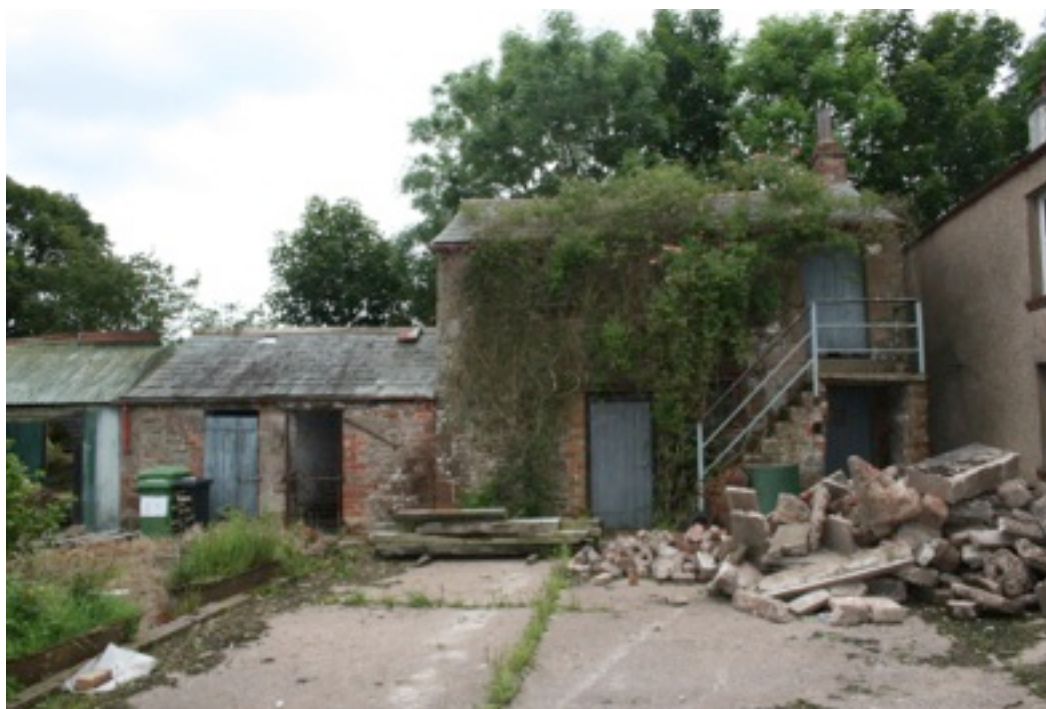
Plate 3. Small Detached Building

Despite not being required for inclusion in the historical recording it is desirable to give a brief description of the small detached building to the south of the farmhouse (See Plate 3). As Grove Farm was a working farm the small building to the south of the house would have had an important function. This building is two storey with a single storey addition. The external walls are mostly constructed of stone with some brick and some of the quoins are dressed stone ashlar. It has pitched roofs covered with slates and the trusses to the two storey part are rough tie beam type. The single storey roof has heavy timber purlins supporting the roof. The first floor is suspended timber and the ground floors are solid. There is a chimney stack on the two storey part built in brick serving a former fireplace, now built up, on the ground floor. The first floor is accessed from an external stone staircase which is supported on brick walls and the stone treads are not built into the main walls of the building. Doors are timber boarded and there are window frames in stone surrounds on the ground and first floor; one on the first floor is blocked up. The single storey addition appears to have been used for farm animals.

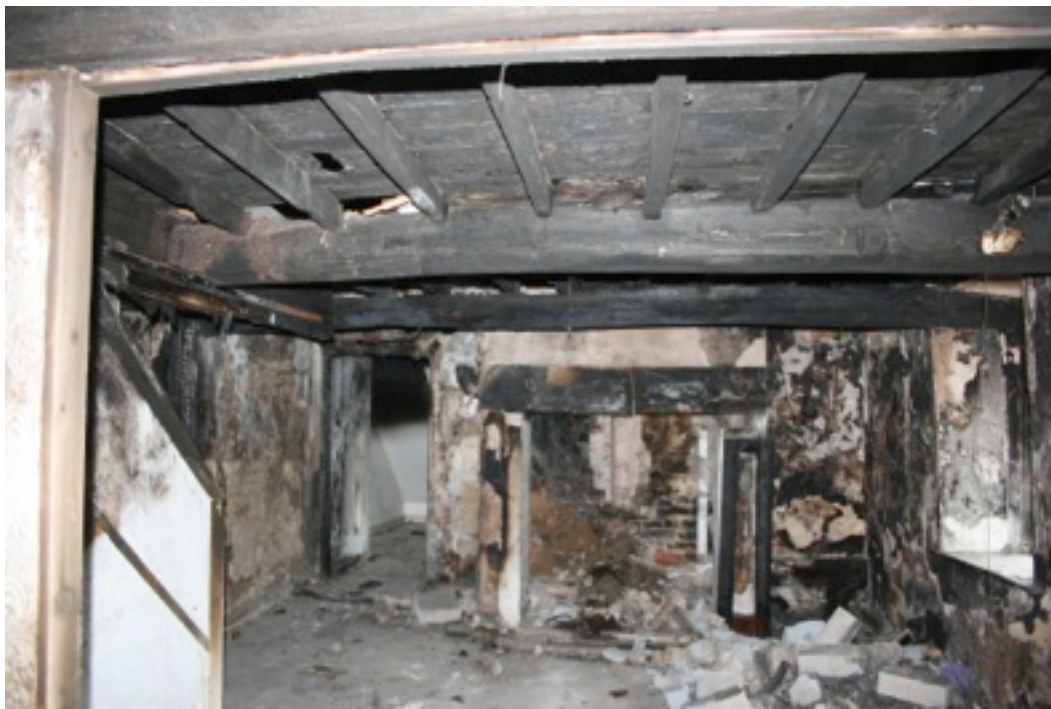
Plate 4. Main Fireplace

Looking at a design for a farmhouse and the similarities with Grove Farm. Brunskill describes a typical two unit house with a room that contains the principal or only hearth which was where cooking, eating and general domestic tasks were carried out.⁴² Off this room there was another smaller room, the parlour, which was the bedroom.⁴³ Brunskill goes on to discuss the upper storey. Above the ground floor rooms was a continuous loft which was gradually given taller side walls until it became a full height room and divided up into bedrooms.⁴⁴ Most early houses were open to the roof but eventually most were given a loft accessed by a ladder.⁴⁵ From the mid eighteenth century the more prosperous farmhouses acquired an upper storey.⁴⁶ Plate 4 shows the remains of the fireplace in the larger main ground floor room at Grove Farm. Plate 8 shows the smaller ground floor room, probably the parlour, and the staircase leading up to the first floor.

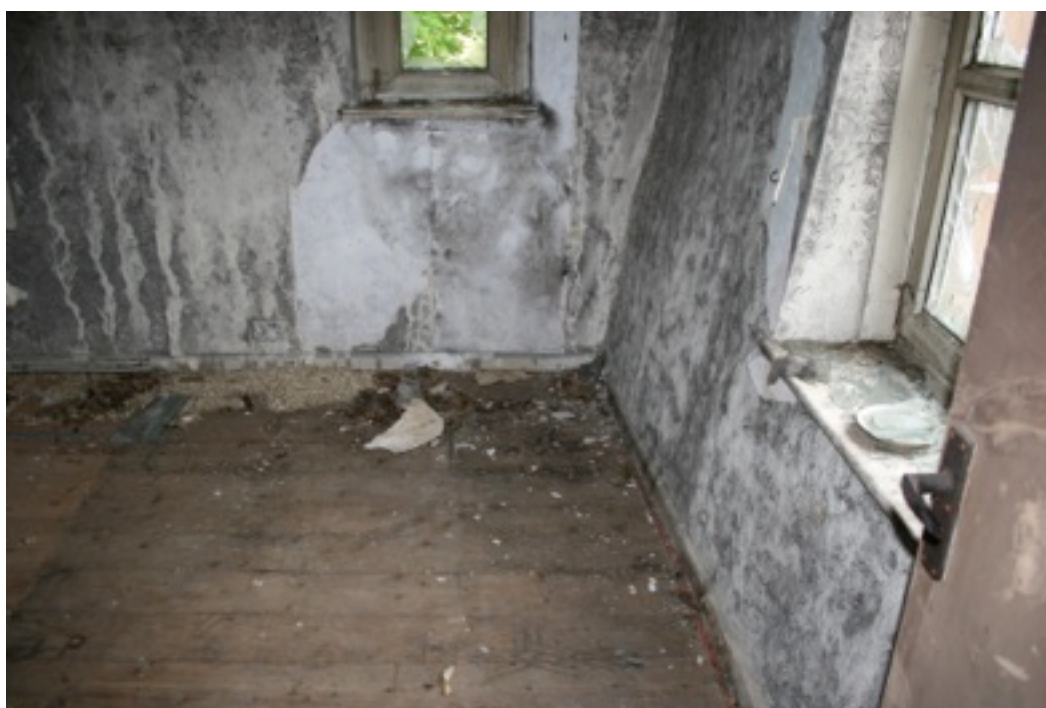
Plate 5. First Floor Bedroom

Today any evidence of a cross passage has been engulfed in a more recent conversion to provide a first floor bedroom. To achieve this, part of the barn roof has been heightened and a staircase installed leading from a ground floor hall which was no doubt the former cross passage. This conversion also provides access into the rudimentary WC on the ground floor at the rear.

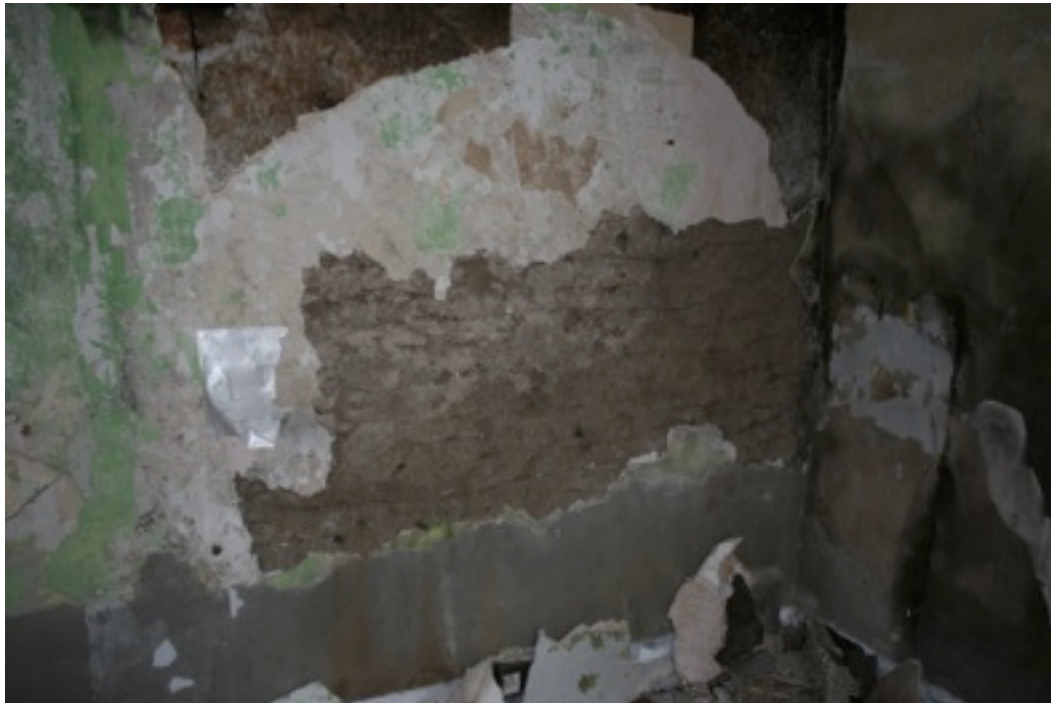
Plate 6. Clay Dabbins Wall

On the first floor the two gables are constructed differently. The west gable above first floor level appears to be built entirely of brick. The east gable seems to be constructed of clay dabbins with straw in the mix probably for most of the gable. In this gable at the entrance to the kitchen, oak beams span over the door opening to support the clay above. On the south elevation near paving level there is a stone plinth at the base of the wall about 500mm high on which the clay dabbins is built. The method of construction for the clay dabbins appears to have involved building the clay up in layers approximately 75mm thick with a layer of straw between the layers (See Plate 6).

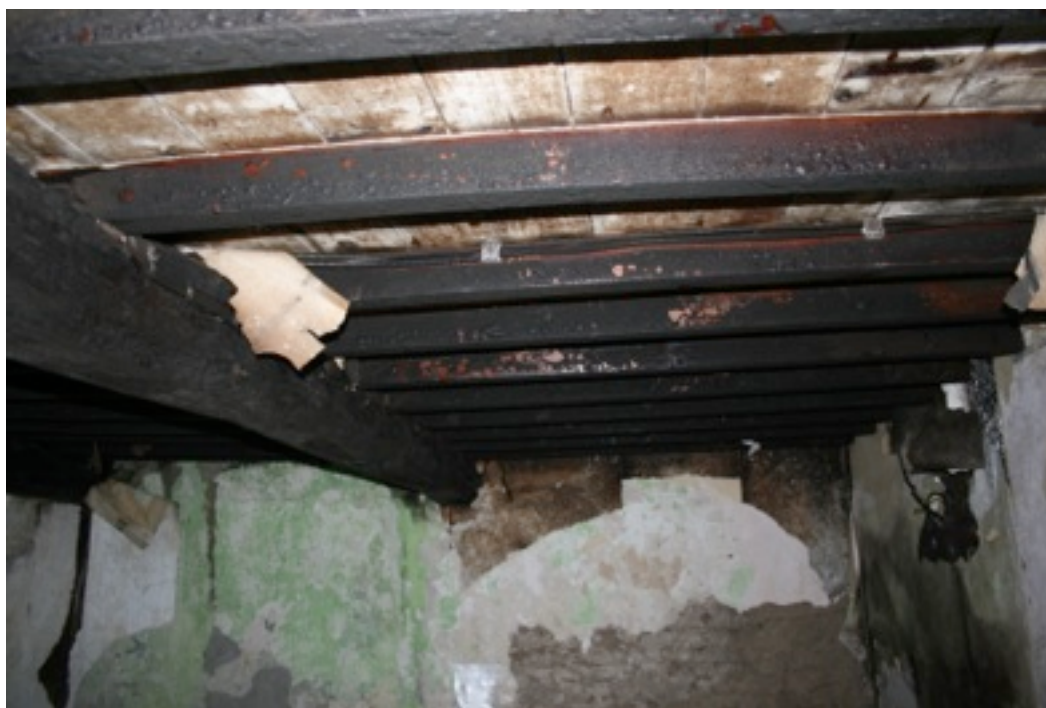
Plate 7. First Floor Construction

The first floor construction comprises oak beams averaging 230mm deep and 200mm wide and fixed at approximately 1800mm centres. These beams support 90mm x 55mm joists positioned at approximately 360mm centres. These carry softwood tongue and groove floor boards approximately 160mm wide. The ceilings to the first floor have a sloping corner at the junction with the wall. Details of the floor construction is shown in Plates 4, 7 and 8.

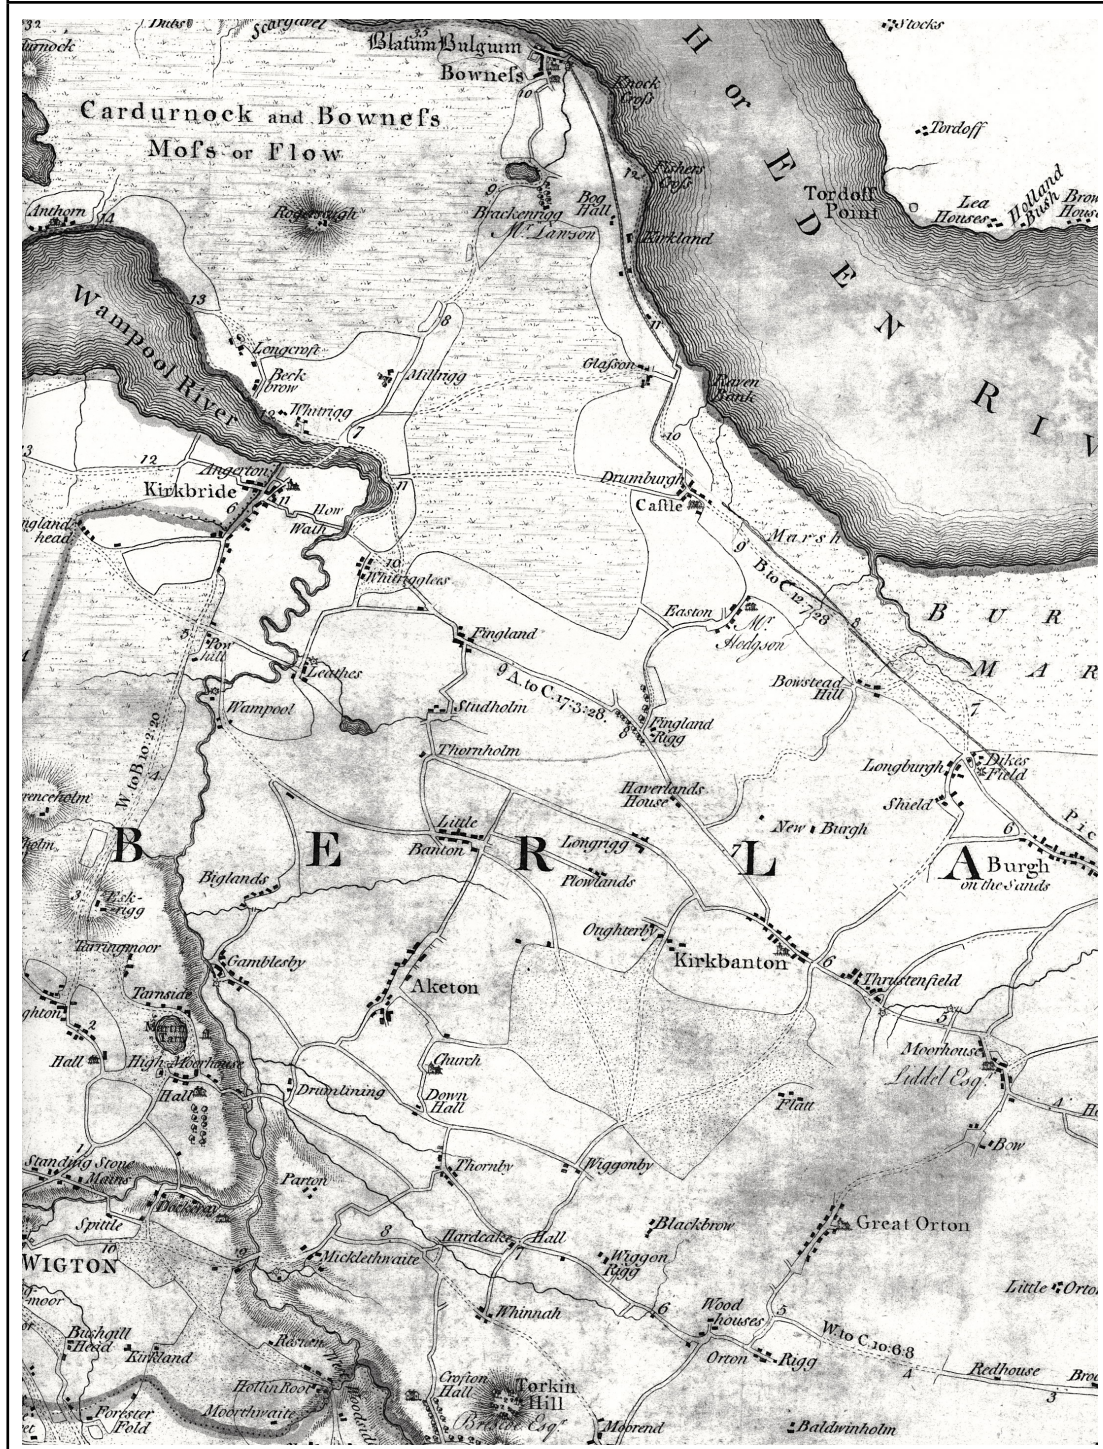
Hodkinson and Donald's Map

From the historic maps it is evident that Grove Farm has been a farmstead for some years. The Hodkinson and Donald Map of 1770 ³² shows a settlement at Whitrigglees but no fine detail. The 1868 6" to 1 mile map³³ gives a good layout of the whole of Whitrigglees. This map was surveyed in 1866 and shows the layout of the farmstead at Grove Farm largely as it is today. The Ordnance Survey Sheets of 1900 ³⁴ and 1924 ³⁵ again show the farmstead layout largely as seen today. The exception is the range of buildings shown on the maps to the east of the farmstead which today appear to have been replaced with more recent structures.
