Penton Mill

Historic Building Record

Date of Report: 20 February 2011

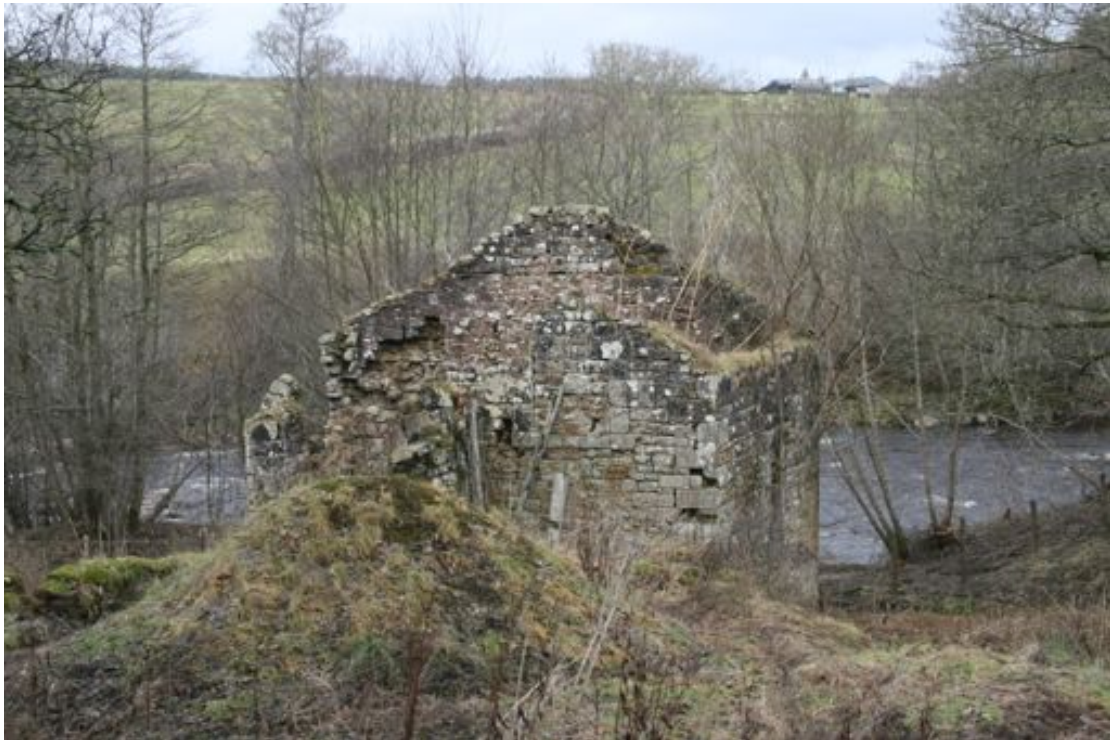
Photo 1. Penton Mill. South Elevation.

Penton Mill is located to the northern fringe of the B6318 close to the bridge over Liddel Water and close to the English/Scottish border. Presently there is a ruin on the site showing a plan form of three rooms with parts of their external walls surviving up to roof level. Other external walls survive only at low level and some sections are missing. There is no evidence of roof covering material or roof timbers to be found on the site. There is evidence of a mill race to the north and east of the Mill.

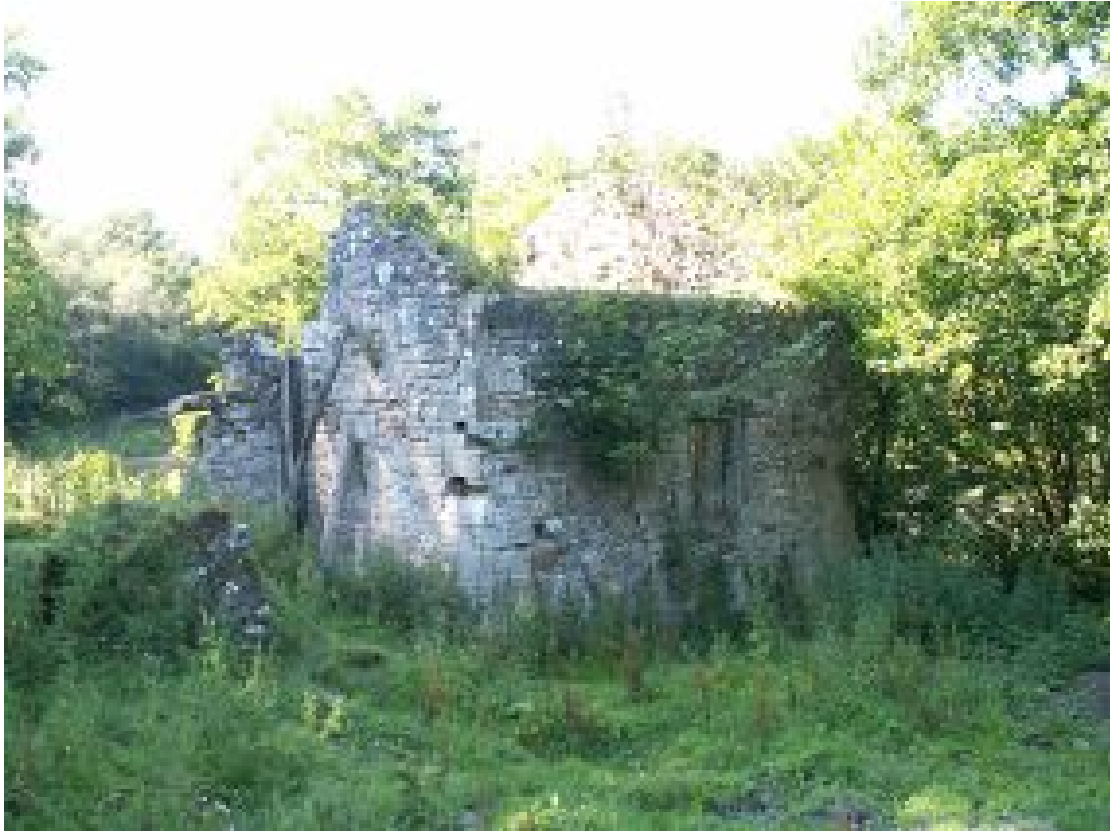
Photo 2. Penton Mill. South-east Elevation.

Penton Mill is located along the B6318, in an area of low elevation, along the meandering watercourse close to Liddel Water. There are no other buildings in the vicinity of the Mill. It is now a ruin having only some parts of the external walls surviving up to roof level, the remaining walls being small vestiges at low level, or missing altogether. However, a rectangular plan form showing three rooms is still discernible, these rooms being built in succession making a three roomed elongated plan form. The most northern room has substantial parts of its external walls and gable intact; the remaining two rooms heading south have less external wall surviving. The immediate area around the buildings is very overgrown with grass, moss, ferns and trees. In the past sections of external wall have collapsed resulting in piles of stones within the rooms, now covered with vegetation. There is no evidence on the site of roof covering material. Some decaying timbers are strewn around the building but their condition is such that their original use is uncertain. There is evidence of a mill race to the north east of the Mill but this is full of organic debris and soil.

The external walls are constructed of stone random rubble with some parts built with dressed ashlar stone all bedded in lime mortar. The stone is buff coloured sandstone and there are

some areas of red sandstone. Walls are generally about 500mm thick, the inside built of random rubble, the core of which is rubble filled.

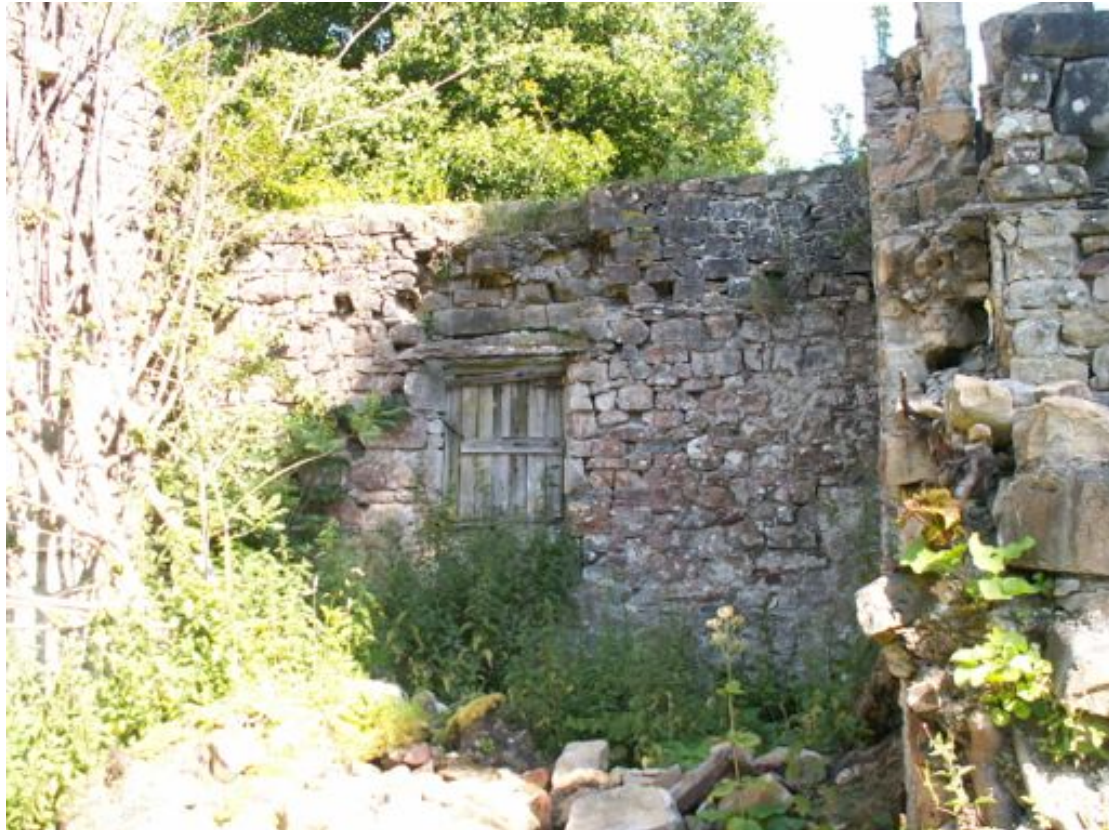
Photo 3. Penton Mill. Inside of east facing wall showing boarded up window.

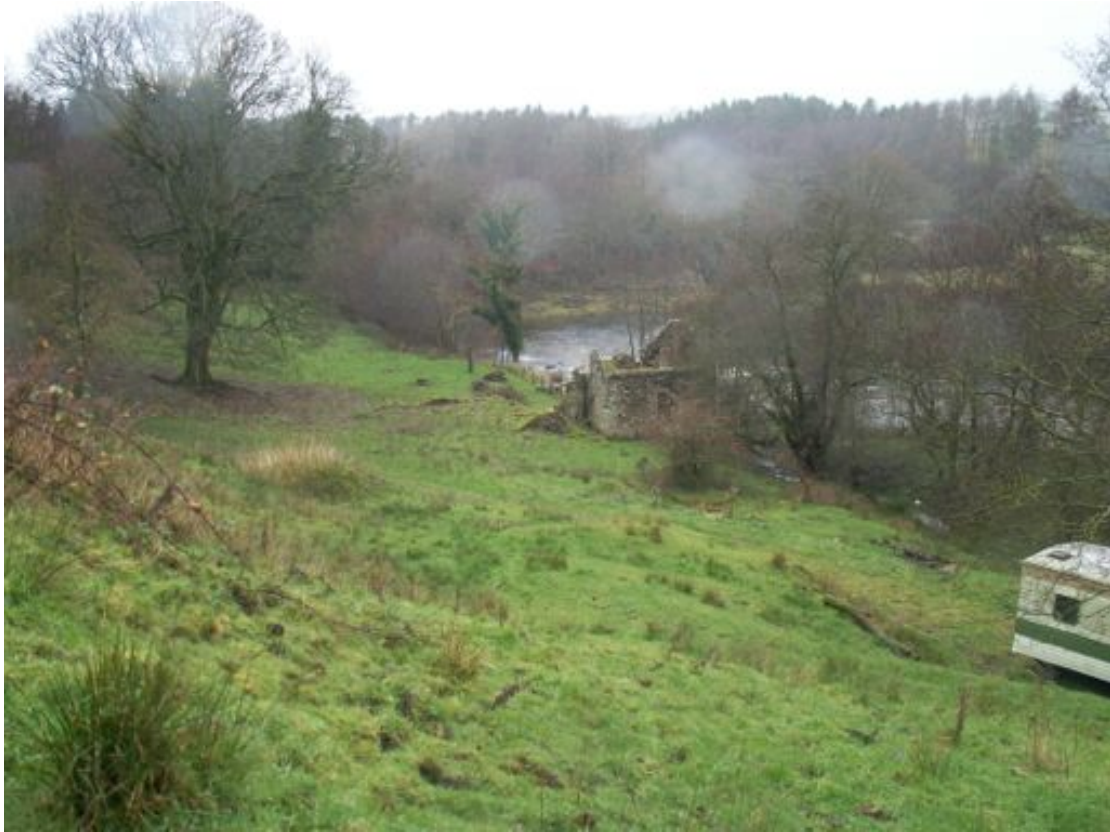
The Mill is built at the bottom of a site that slopes sharply towards the river. The vegetation on this site is long grass and trees. The surrounding area is mainly farmland. There is an access track giving partial access to the Mill from the B6318.

Photo 4. Penton Mill. Showing topography.

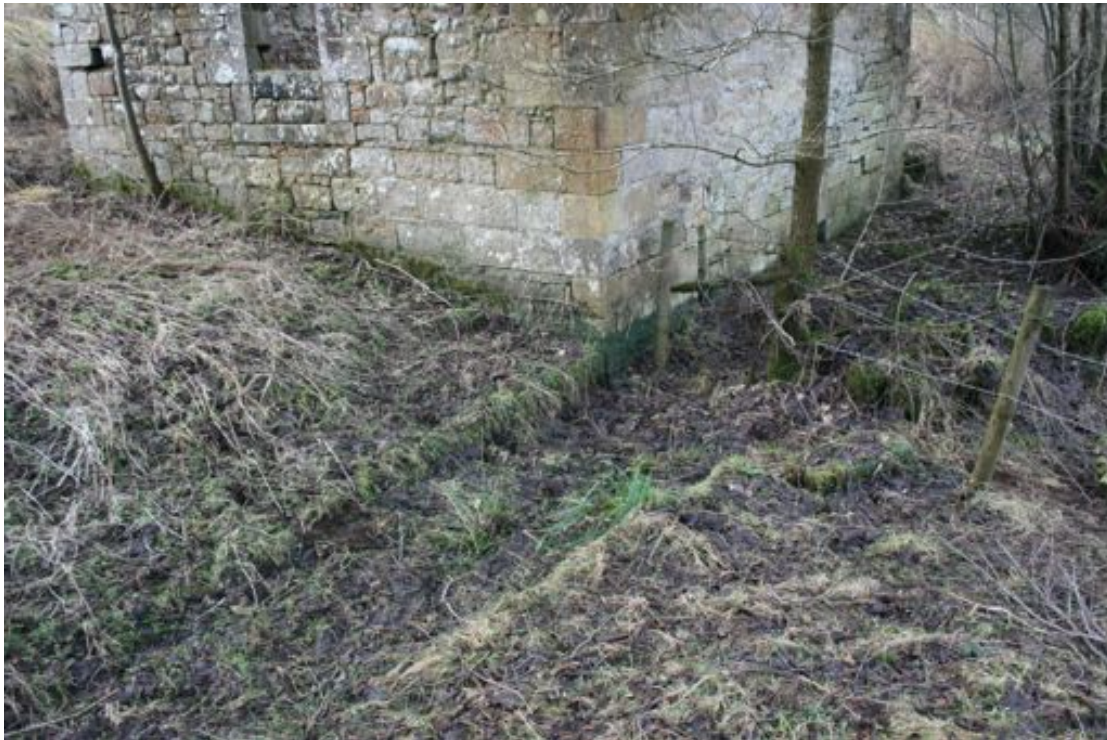
Photo 5. Penton Mill Signs of the mill race and the bypass just before the wire fence on the right of the picture.

Today the Liddel river has a good continual flow of water running from east to west past the Mill, which would have supplied the mill race. A depression in the landscape appears to indicate that the mill race left the river and entered the site on the east providing water for the head race. It then continued as a tail race past the north mill gable and back down to the river. Just off the north-east corner of the gable a further depression would indicate the position of a bypass. The 1868 and 1901 Ordnance Survey Maps^{52,53} confirm the mill race left the river to the east of the Mill at the edge of the weir. Site observation at this point shows

a loose formation of stones in the river forming a bank and allowing the water to be channelled off to the race. The OS Maps also show the bypass and tail race. Close to the bypass location it was possible to see the stone walls that formed the side of the race; at this point the race measuring 1400mm wide. The race is now full of earth therefore the depth of the race or the existence of a wheel pit below the waterwheel, could not be ascertained.

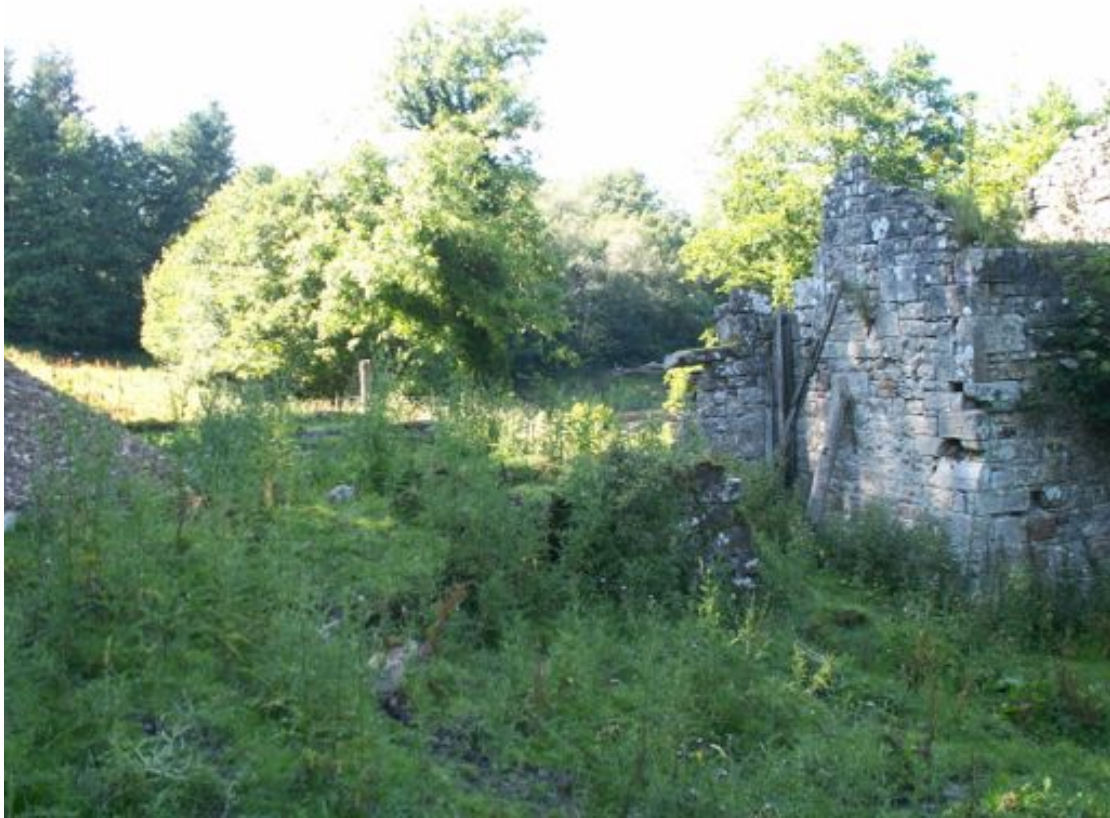
Of the three rooms remaining, it is likely that the centre room housed the kiln. Externally to the south-east of the Mill there is what appears to be a formation of earth behind a stone retaining wall. This may have been an elevated access to an external door possibly once located in the eastern external wall. Carts would be brought down the track from the road, pass along the elevated access and discharge their load onto the kiln floor.

Photo 6. Penton Mill. Stone retaining wall in centre of picture concealed by vegetation.

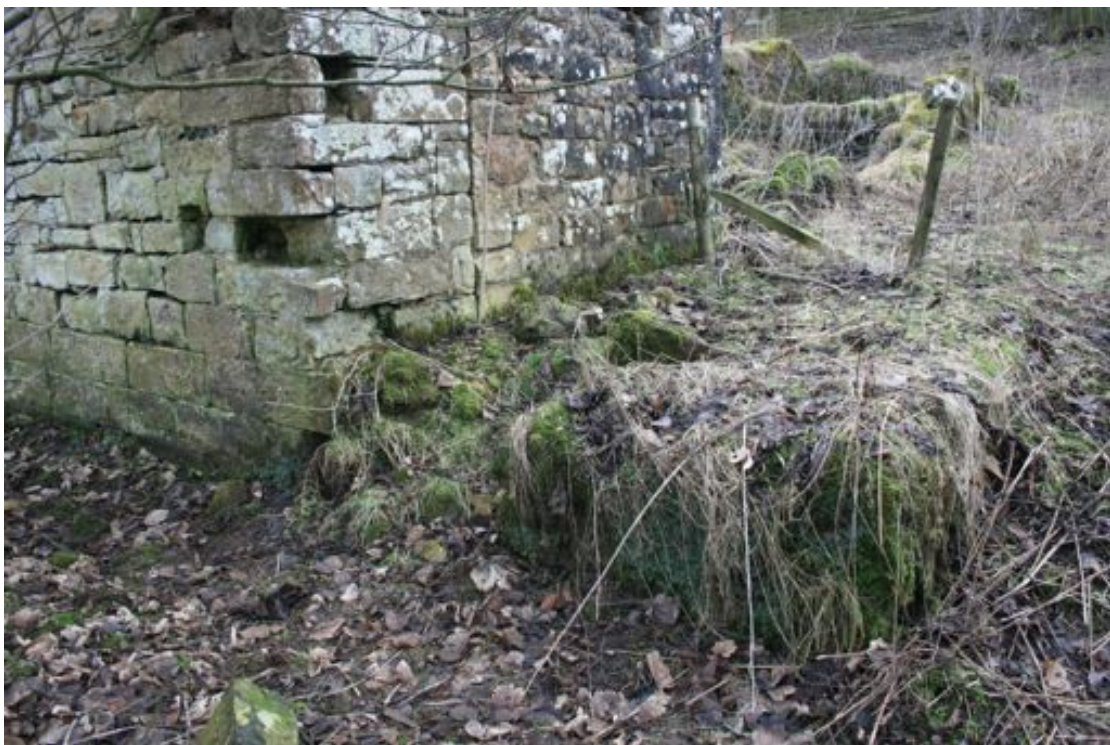
One further structure is located on the north west corner of the Mill. Only vestiges of external walls remain but if it was a room then it would probably have been used for storage.

Photo 7. Penton Mill. Structure to north-west corner of Mill.

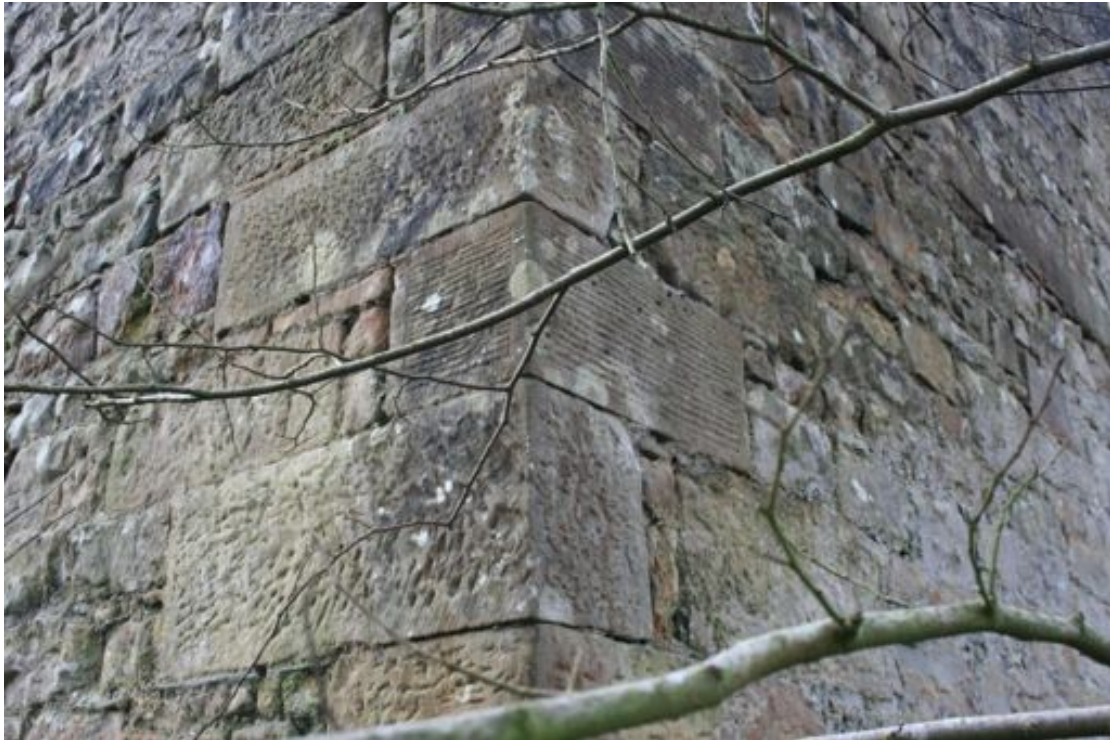
The stonework to most of this elevation is random rubble with squared quoin stones to the two corners. The gable peak is roughly formed. To the lower walls there is some fine ashlar walling. On the north east quoin the tooling to one quoin stone is different from that of the remainder. These features suggest that there has been some rebuilding of this wall.

Photo 8. Penton Mill. Tooling to quoin stone.

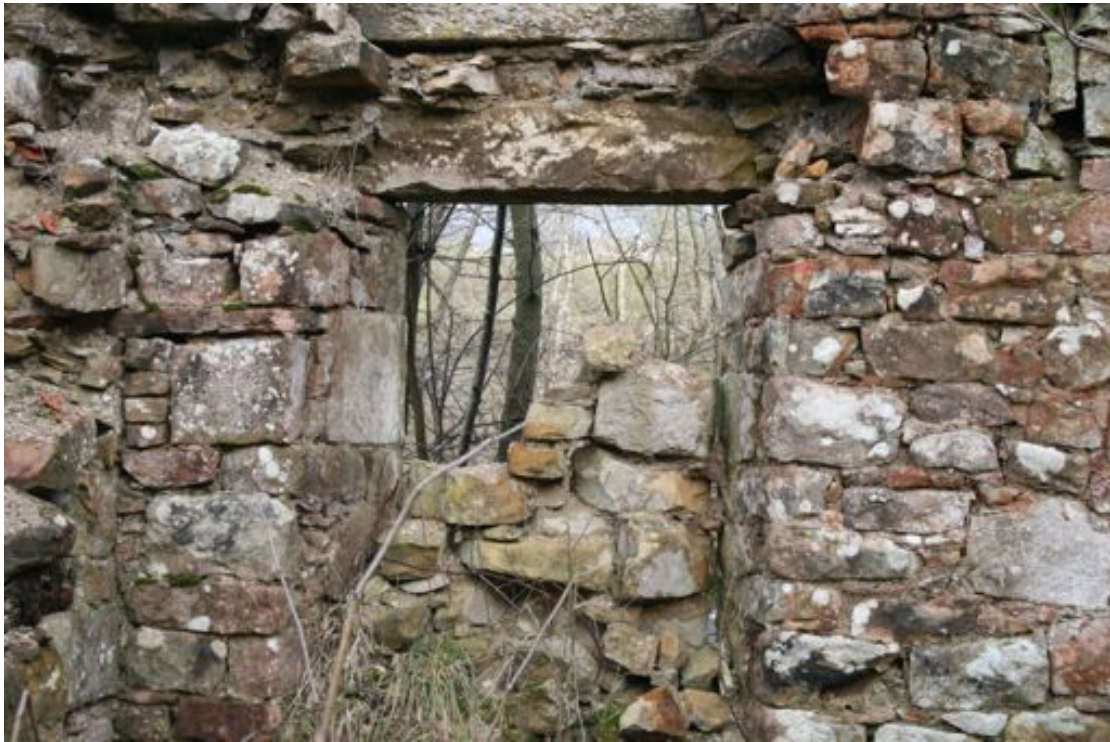
There are two windows in this gable set at about 2000mm above ground level. They both have stone cills and stone lintels. The north eastern one is 1300mm high by 820mm wide. It has been built up with stone but in two vertical sections, one 300mm wide and the other 520mm wide, suggesting that partial building up had been deliberate and for a purpose. Internally there are the remains of a timber lintel. The north western window is 1320mm high by 850mm wide, is now partially built up but some of this stonework has collapsed. A section of wall internally above the window has also collapsed. Also noted on this north western window, the window reveals are squint.

Photo 9. Penton Mill. View of north-western window from inside.

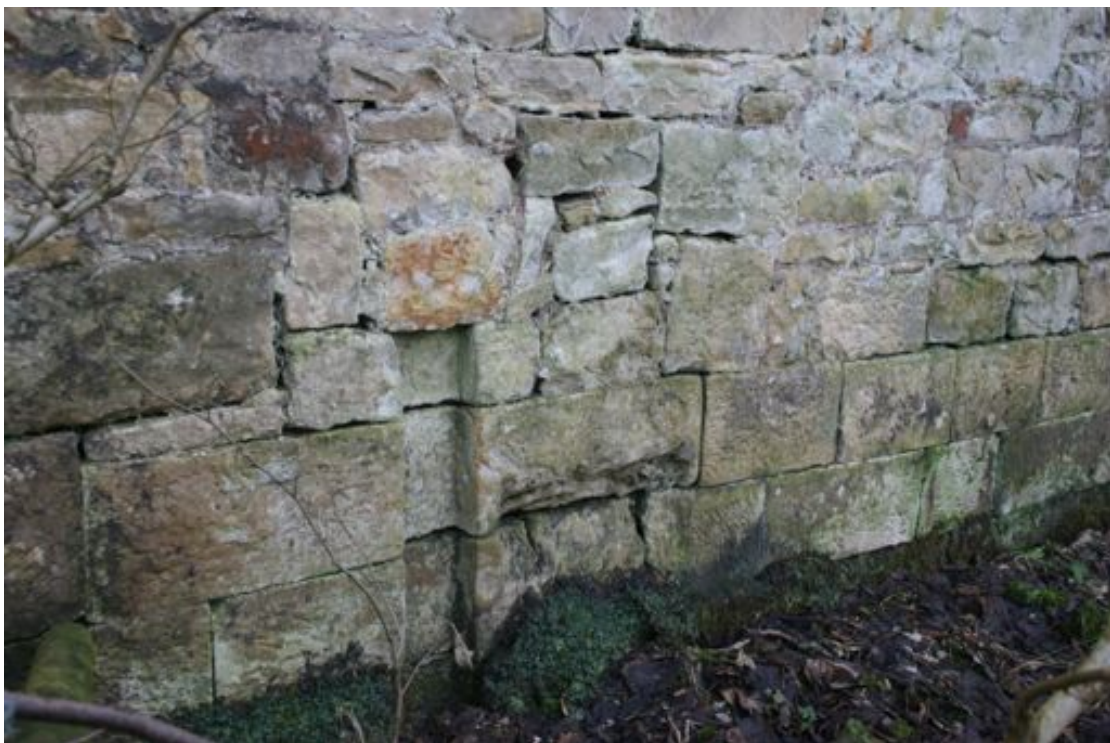
Photo 10. Penton Mill. Features in north gable wall.

At low level towards the north-east corner of the gable wall is a vertical aperture 170mm wide by 800mm high by about 70mm deep. This is positioned 1600mm from the north east corner of the wall. Immediately to the right of it and just visible on the photograph is a depression at

ground level 500mm wide by 400mm high and 70mm deep, cut into the ashlar stonework. It is possible that these features were used for regulating the water flow to the waterwheel.

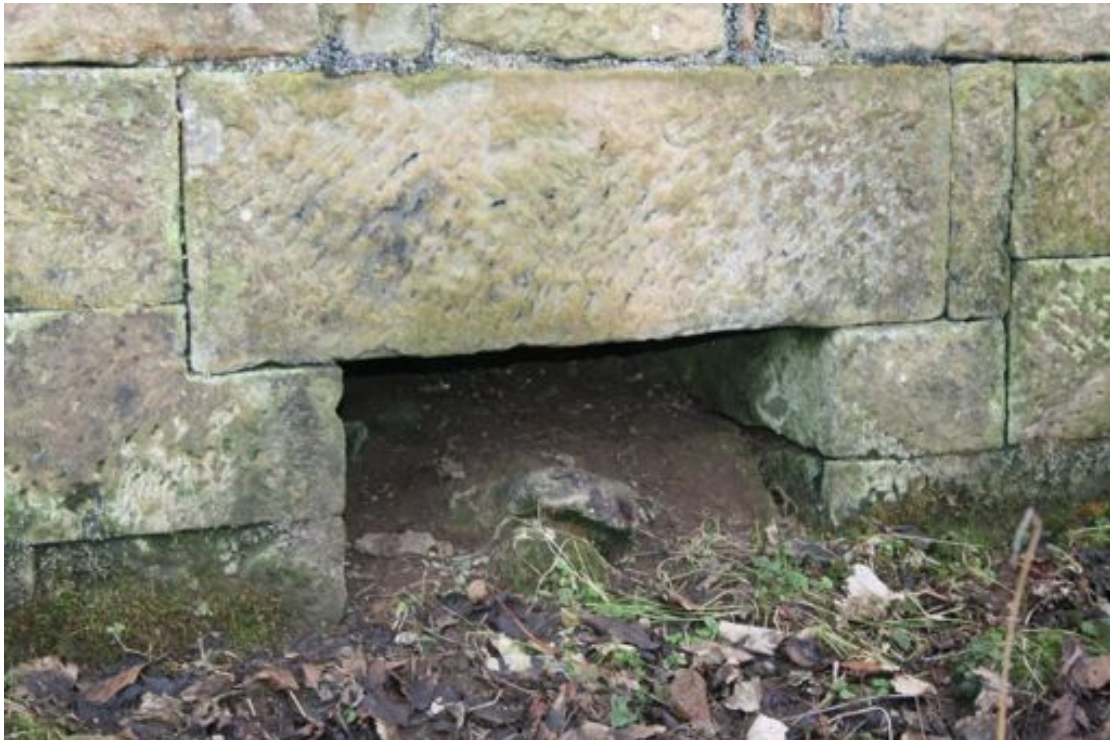
Slightly off centre of the gable and at ground level is a square opening passing through the full thickness of the wall. It is 680mm wide by 300mm high and has a substantial stone lintel over the opening. The opening is positioned 3300mm from the north west corner of the gable. It was probably formed as the axle hole for the waterwheel shaft to pass through. Its position slightly off-centre of the gable wall might suggest that the millstones were positioned towards the eastern end of the room.

Photo 11. Penton Mill. Axle Hole in gable. Note the quality of the low level stonework.

No traces of the waterwheel survive but the relationship of the axle hole to the head race suggests probably an undershot wheel was fitted.

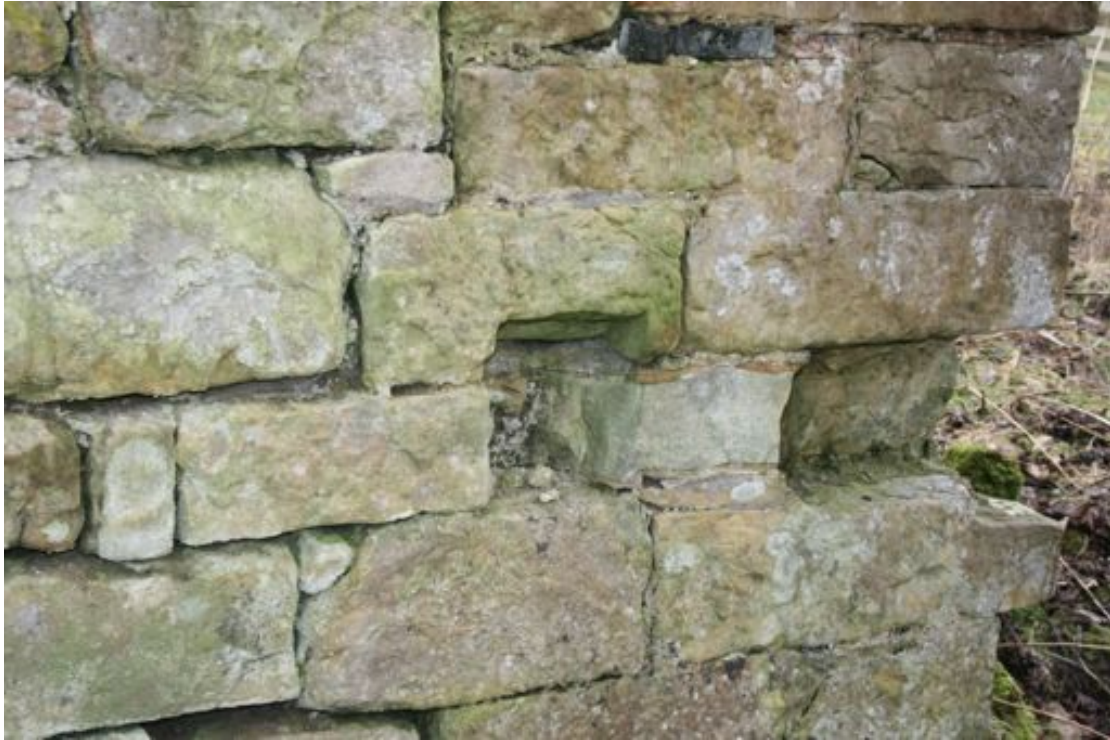
Close to the north west corner is a square hole formed in the stonework. It is 220mm high by 200mm wide and 100mm deep. It is positioned at 1100mm above ground level and 700mm from the corner of the wall. It is not known what its purpose was.

Photo 12. Penton Mill. Square hole in wall.

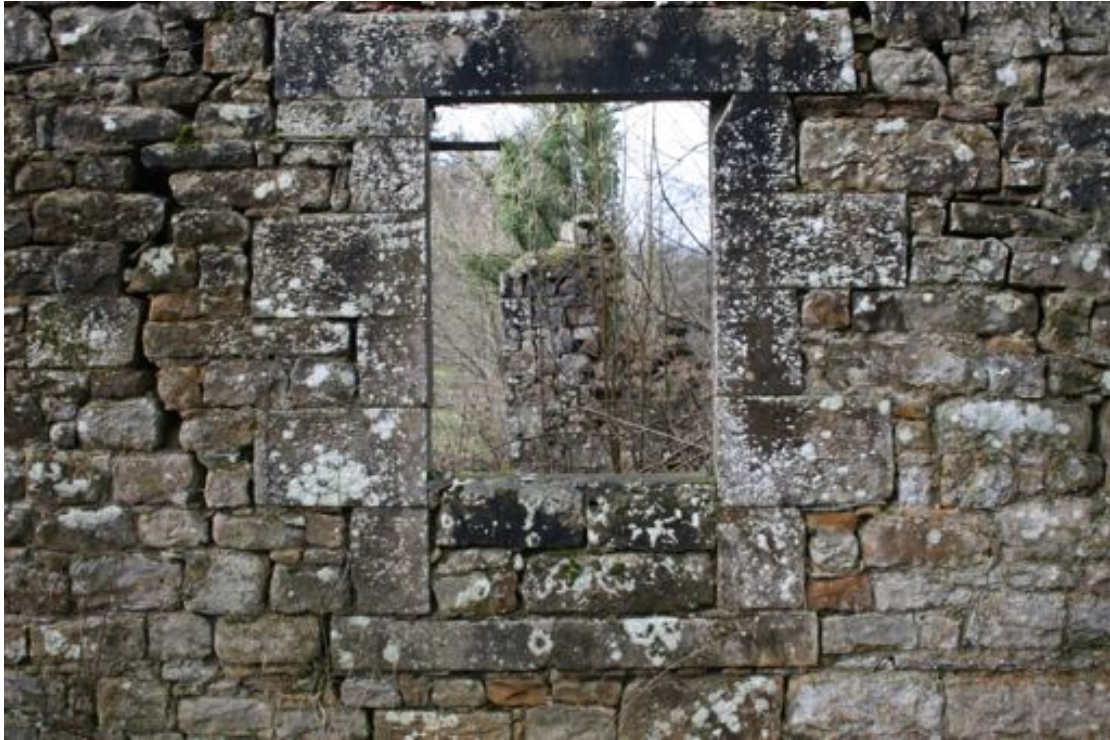
The east wall of the northern room is of random stone rubble, the quoin stones on the southern corner being of irregular form. The eaves are roughly formed at the top of the wall. The wall contains one window with a stone cill and stone lintel and has squared stone dressings to the reveals. It is 1670mm high and 920mm wide but is also partly built up with stone. Below this window are two small holes formed in the stonework approximately 20mm diameter each. The dressings have different detailing from the window on the north gable and the stone surface is tooled. The reveals are squint but also recessed, presumably for the window frame. The lintel is also recessed on its back edge and there are the remains of a timber lintel above the opening.

Photo 13. Penton Mill. External view of window east elevation.

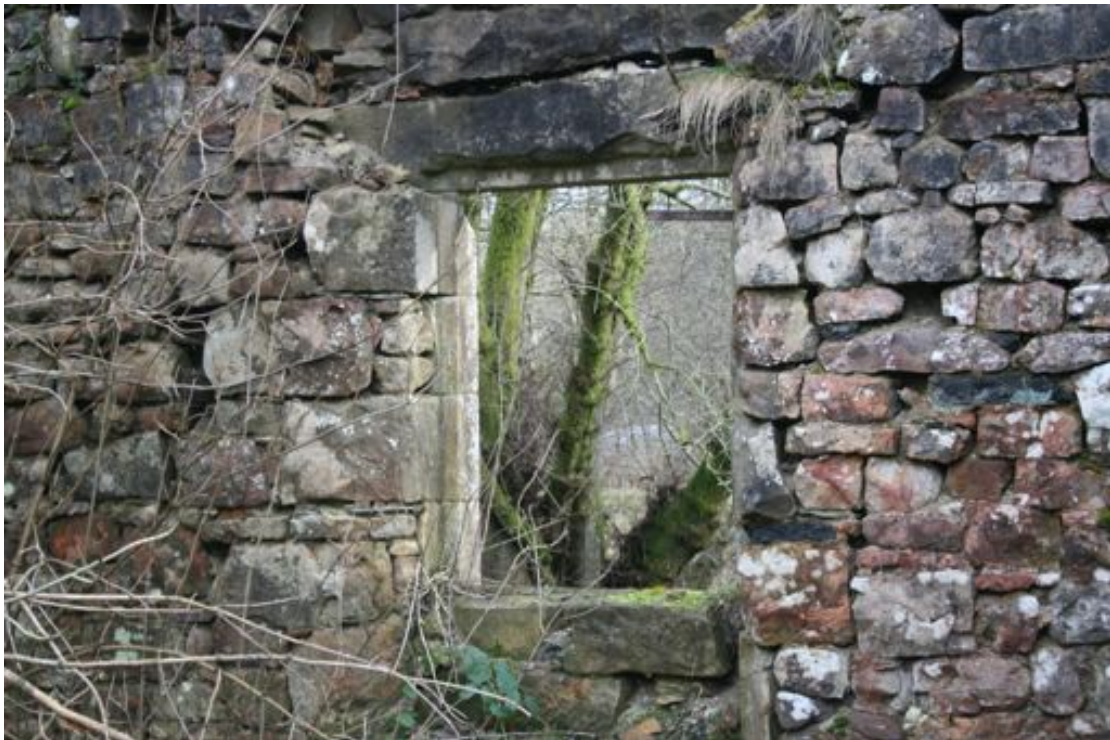
Photo 14. Penton Mill. View of east facing window from inside.

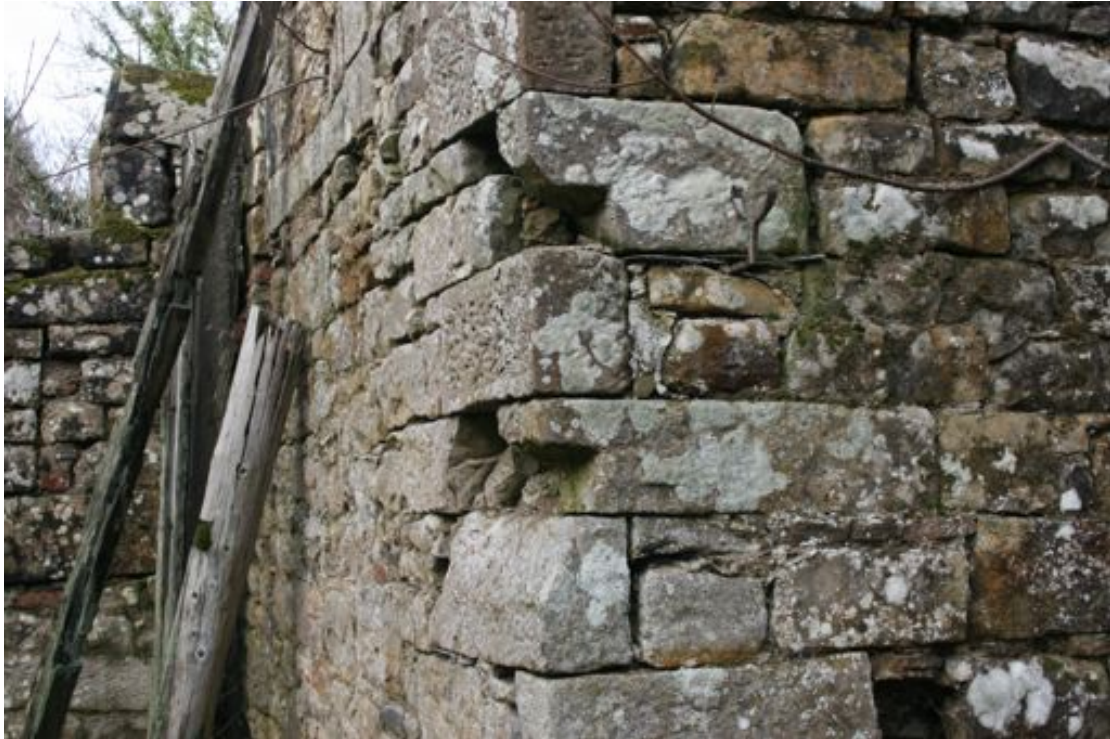
At the southern corner of the wall is an angular depression cut into the wall that is almost certain to be a skewback for an arch over an opening. This is set at about 1650mm above ground level and is about 250mm girth. Approximately 300mm above the skewback is an

opening formed in the corner with an old wrought iron gutter bracket alongside it. It is likely that a stone arch sprang from this skewback to the stone retaining wall opposite and supported a narrow wall above, which probably carried either a roof or a platform, hence, the need for a gutter bracket.

Photo 15. Penton Mill. Southern corner of east wall to northern room. Arch skewback.

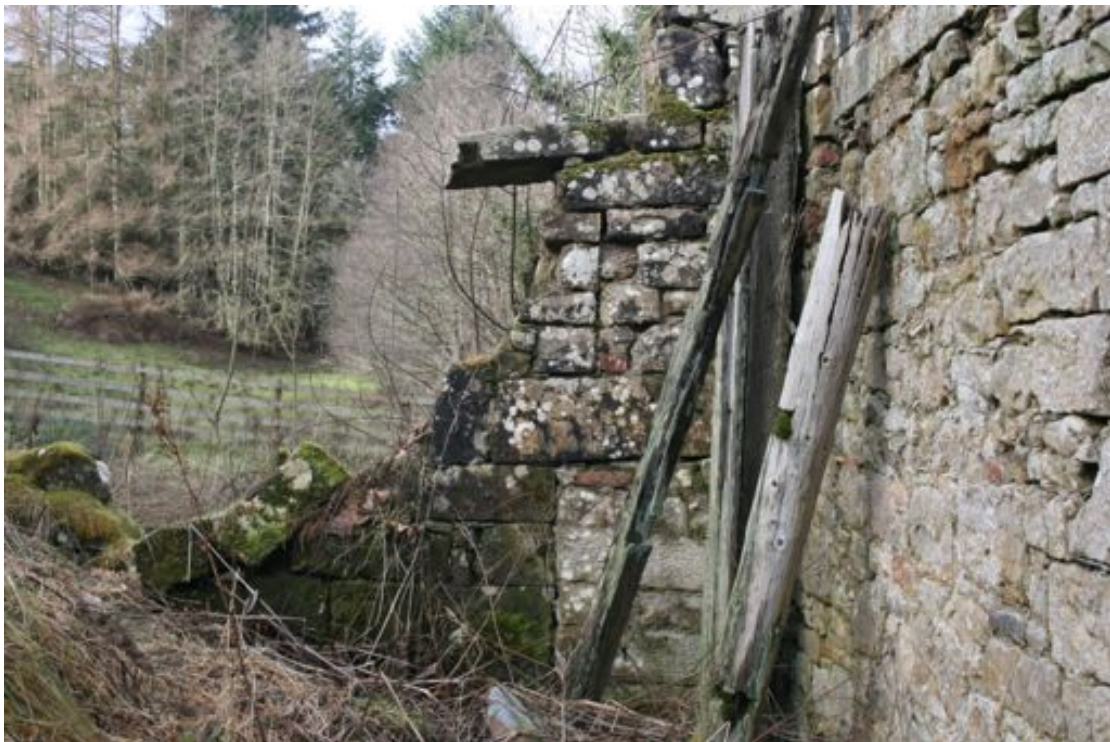
Photo 16. Penton Mill. East wall of centre room.

Little survives of the east wall to the centre room. Two openings built up with stone, each with a stone lintel can be seen with the remains of a stone cill at the top. The lower opening could have been to serve the kiln. The upper opening could have been access to the kiln floor.

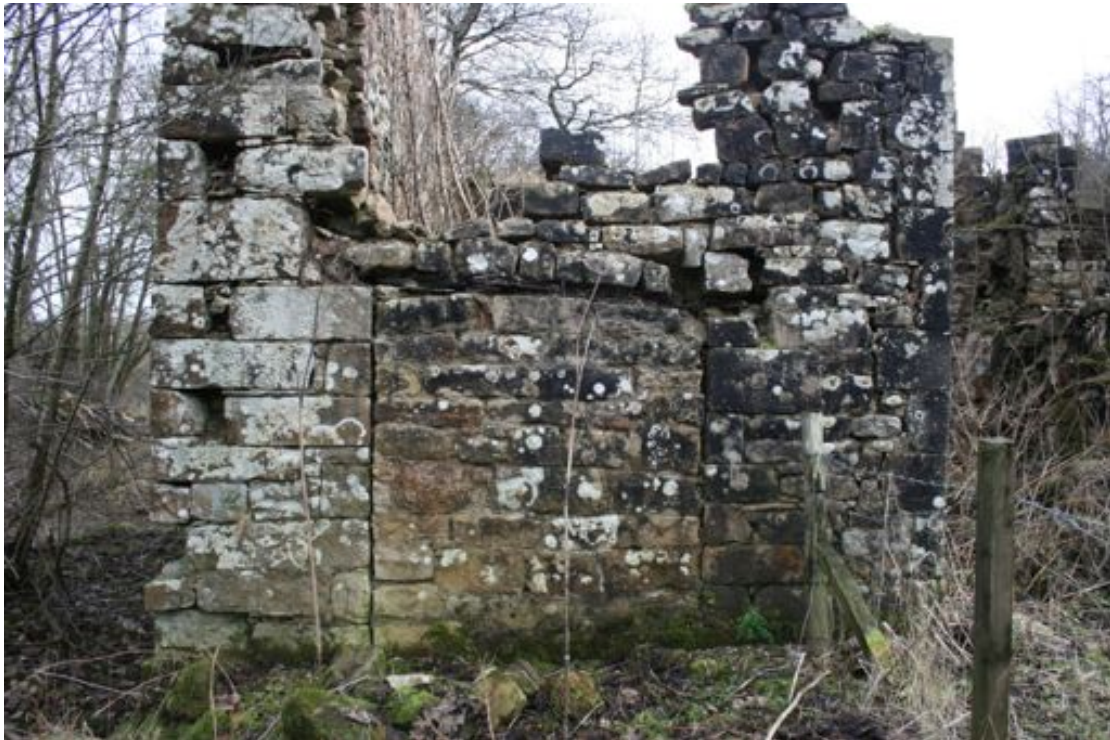
The west facing wall of the north room has lost much of its upper masonry. In this wall is a former doorway, positioned approximately in the centre of the wall, 1530mm wide by 1040mm high. The opening has a slightly curved door head formed by a decaying piece of timber lintel with a crude stone arch above it. There is also a further decayed timber lintel on the inside of this opening. Towards the north corner of the wall at about 1500mm above ground level is a wrought iron gutter bracket fitted into the wall.

Photo 17. Penton Mill. Former doorway on west elevation.
