ARCHAEOLOGICAL OBSERVATION & RECORDING REPORT:
THISTLEDOWN COTTAGE
CHURCH ROAD
MAULDEN
BEDFORDSHIRE

on behalf of Aragon Land and Planning Ltd

KDK:047/MCR/2

November 2014

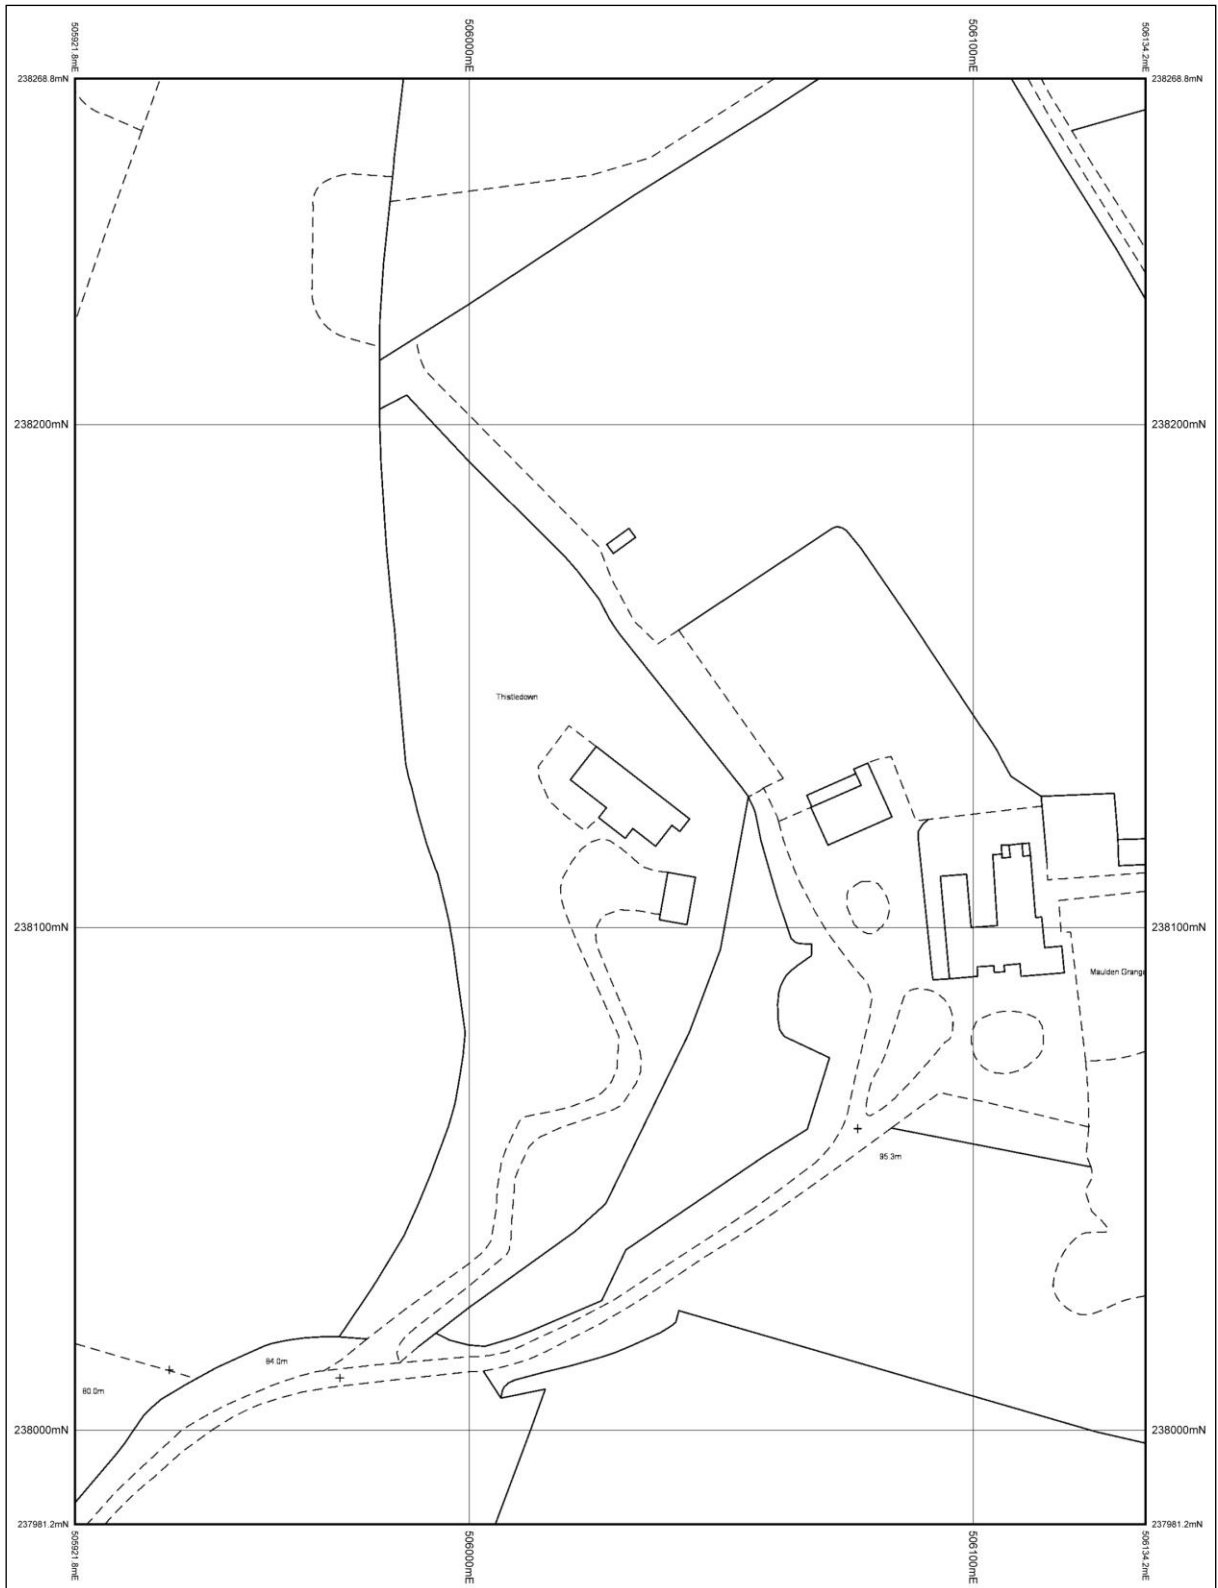
Figure 2: Site location (scale 1: 1250)

The site as a whole is irregular in shape and bounded by fields on all sides except the east, where Maulden Grange and its associated grounds are located. It is accessed by a narrow track to the south off Church Lane (Fig. 2).

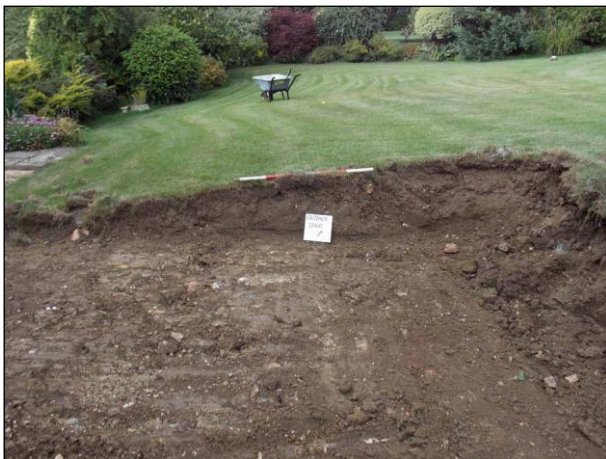
Plate 3: Ground reduction, facing NM

The groundworks consisted of a combination of ground reduction, footings trenches and the excavation of a soakaway. To the rear of the house the ground was reduced by up to x m cutting into the slope of the garden, through the topsoil and into the underlying clay (Plates 3-4). This was the largest single area of excavation covering approximately x sq. m.

A total of x m of foundation trenches were excavated with widths varying from c. 0.60m-0.90m, and up to 1.66m in depth. The stratigraphy found across the impacted area is relatively homogeneous (Plates 3-6) and comprises shallow topsoil varying between 0.12-0.21m, modern made-ground c. 0.19-0.62m in depth, overlying a sandy, gault clay natural geology. The foundations in the northwest part of the rear extension consisted of piles 0.22m in diameter and 4-4.8m in depth, joined by a ring-beam which was excavated c. 1.20m into the clay.
