ARCHAEOLOGICAL OBSERVATION & RECORDING REPORT:

ST EDMUND'S CHURCH DOWNHAM MARKET NORFOLK

KDK: 034/DMC/2

January 2015

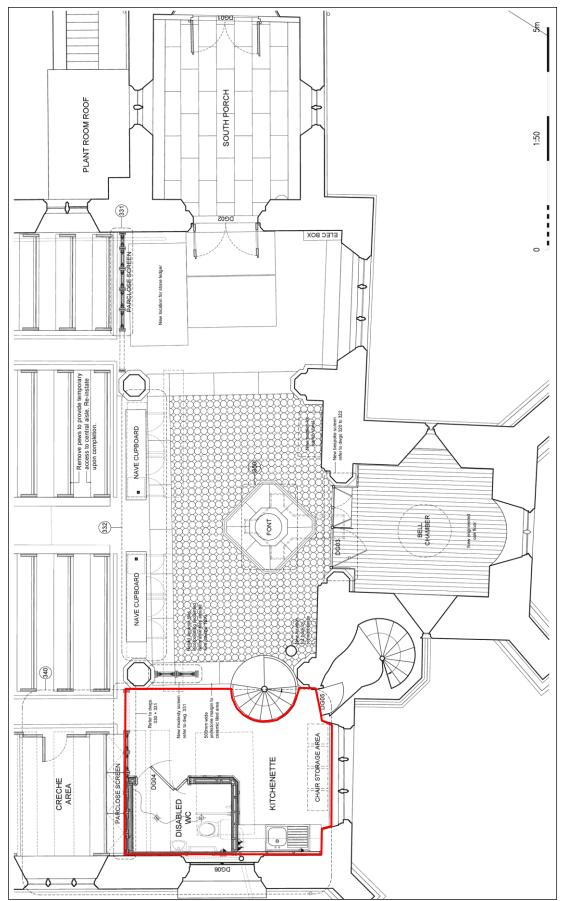
Figure 3: Internal alterations highlighted (scale as shown)

The development comprised alterations to the church's interior including the installation of a WC, kitchenette and associated external drainage works (Fig. 3).

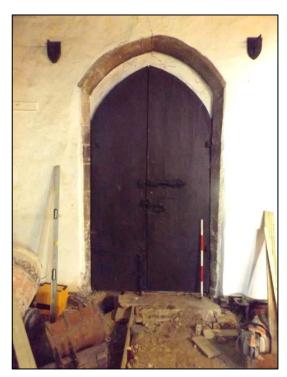
Plate 1: Ground reduction at NW corner of inside church, looking N (1m scale)

The northwest corner of the church was altered to accommodate a new WC and kitchenette. The area measured 16.36 sq. m. The floor tiles and a stone ledger (laid into the floor) were removed and the ground reduced by 0.1m. A light whitish/grey compacted lime mortar material and a loose sandy material were revealed. The stone ledger removed from this area was re-set closer to the south porch.

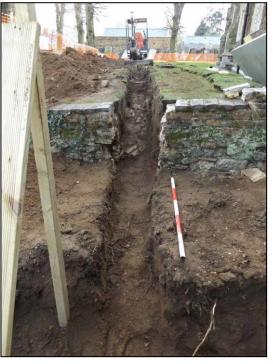
Plate 8: Drainage trench, looking E (1m scale)

A drainage trench was excavated along the northern side of the church to connect into existing services (Plate 7-9).

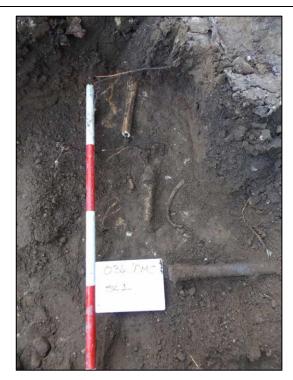
Plate 11: SK1, looking E (1m scale)

SK1: An adult female, found 0.3m (spine) BGL (below ground level). The skeleton had been partially disturbed and extended beyond the limit of excavation. As a result only fragments of the skull, the vertebra column, ribs and part of the left side of the pelvis were present. No pathology was observed (Plate 11).

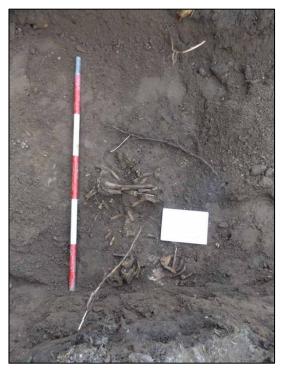
Plate 12: SK2, looking W (1m scale)

SK2: A mature adult male, found 0.48m BGL (mandible), and 0.52m BGL (pelvis). The skeleton had been partially disturbed exposing only the mandible, left and right clavicles, vertebra column and ribs, and fragment of the left side of the pelvis. The surviving teeth were heavily worn indicating a more mature individual. No pathology was observed (Plate 12).

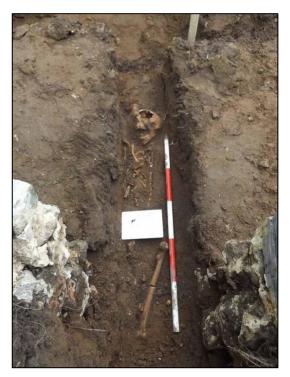
Plate 13: SK 3, looking W (1m scale)

SK3: A young adult male, found 0.17m BGL (skull) and 0.9m BGL (femur). The skeleton had been partially disturbed exposing only the skull and mandible, vertebra column, right ribs, right scapula and clavicle, part of the right pelvis and although unarticulated the right and left femur. The third molars of the individual had not erupted and little wear was present on the second molars pointing to a younger adult. Slight to moderate levels of calculus (mineralised plaque) were present on both the upper and lower teeth across the lingual side (Plate 13).

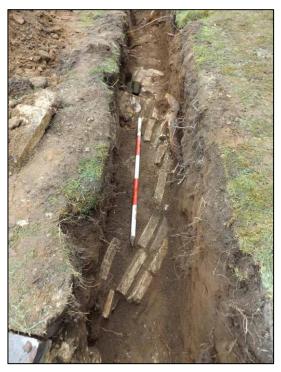
Plate 14: Brick vault (102), looking E (1m scale)

Brick Vault (102): A brick vaulted structure orientated E-W that extended beyond the limit of excavation. The area as a whole measured 2.25m long and ranged between 0.55-0.65m BGL. It was constructed with light pinkish beige bricks bonded with a light greyish white lime mortar. The bricks were un-frogged and measured 235mm long, 120mm wide and 50mm deep. Part of the vaulted roof had begun to collapse revealing an inner chamber filled with cemetery soil and fragments of brick with no sign of a coffin or skeleton being observed (Plate 14-16).

The works also exposed a brick built burial vault that had partially collapsed exposing the inside of a vaulted chamber. The chamber contained cemetery soil and brick, with no evidence of a coffin or skeleton. The feature was constructed with un-frogged bricks pointing to a pre late 18th century date.

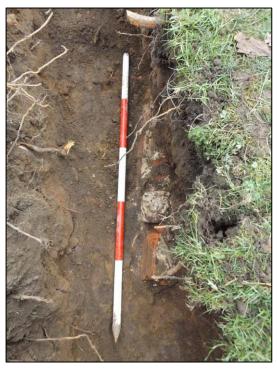
Plate 17: Brick wall (103), looking E (1m scale)

Red Brick Wall (103): Towards the eastern end of the drainage trench the remains of a wall were exposed that extended beyond the limit of excavation. The wall was orientated E-W, and constructed of red bricks bonded with a light greyish white lime mortar. The bricks measured 150mm long and 65mm deep, and were un-frogged. The wall measured 0.74m in length and was found at 0.43m BGL; it was thought to be part of a grave (Plate 17).

The remains of a red brick wall were also found, orientated E-W that was thought to be part of a grave. Finally three footstones were also found dating to the 18th and 19th centuries.

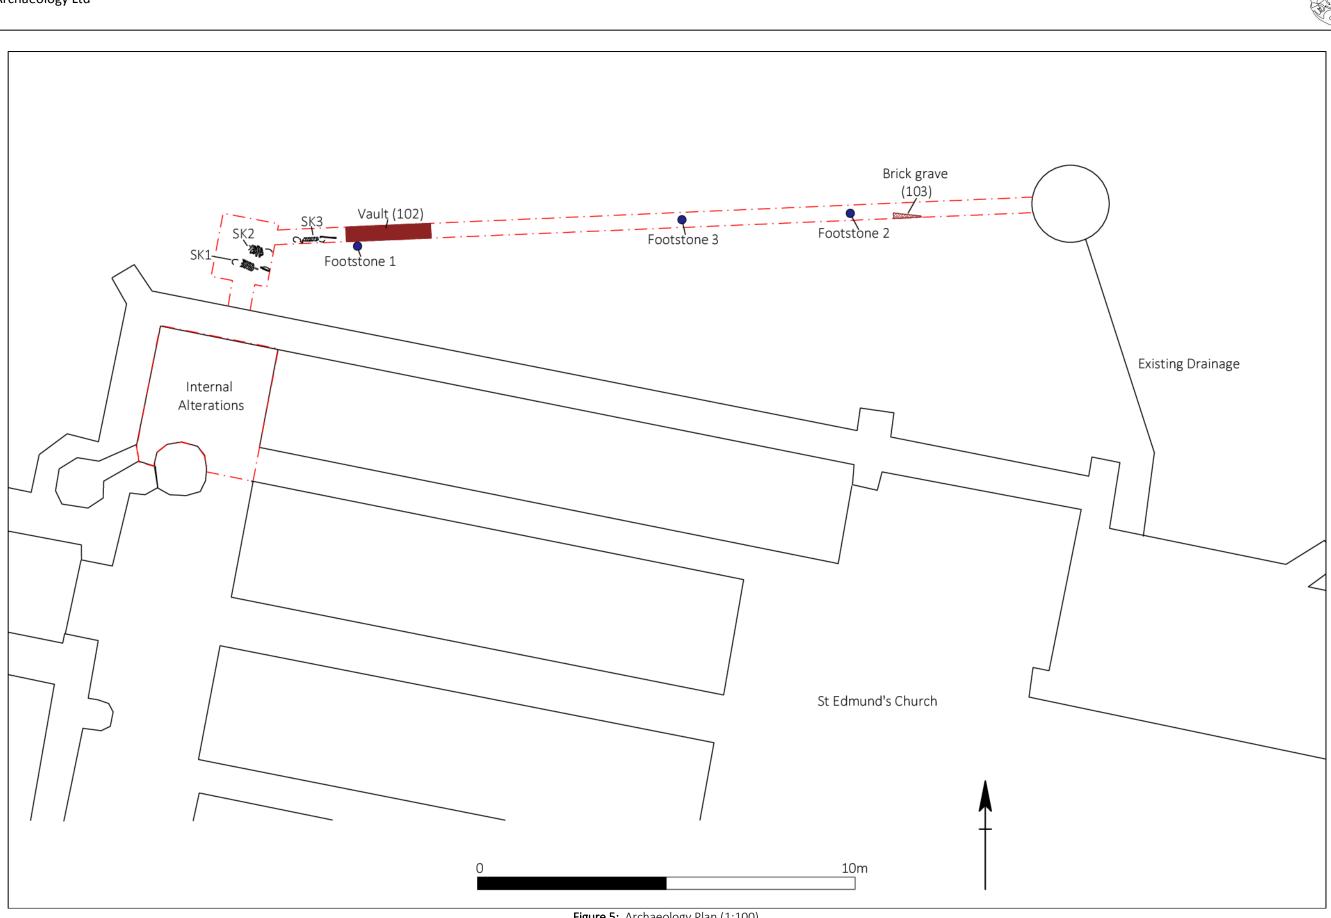
Figure 5: Archaeology Plan (1:100)

Footstones: Three limestone footstones were found during the excavation of the drainage trench (Fig. 5). Footstone 1 measured 590mm long and 300mm wide and 55mm deep and had an incised inscription which read 'R G 18??'; Footstone 2 measured 530mm long and 300 wide and 60mm deep and had an incised inscription which read 'R W 1792'; Footstone 3 measured 430mm long and 250mm wide and 55mm deep and had no inscription.

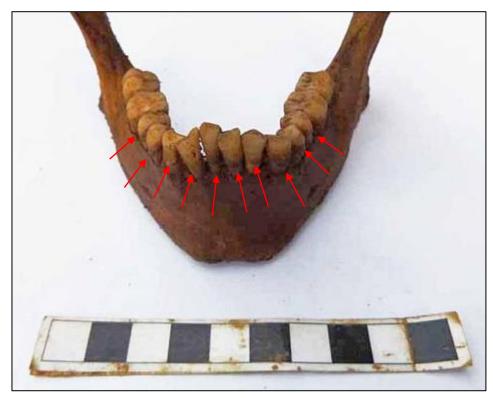
Plate 18: SK3, dental calculus (scale 100mm)

pathology assessment. SK3, a young adult male, was the only skeleton to reveal pathological changes. Dental pathology was noted in the form of slight-moderate levels of calculus (mineralised plaque) on both the upper and lower teeth across the lingual side. The build-up of mineralised plaque was indicative of poorer dental hygiene (Plate 18).
