ARCHAEOLOGICAL BUILDING RECORDING AND OBSERVATION & RECORDING REPORT:

WHITE COTTAGE
ST MARY'S LANE
HERTINGFORDBURY
HERTFORDSHIRE

on behalf of Marc Hawley

KDK: 087/HWC/2.2

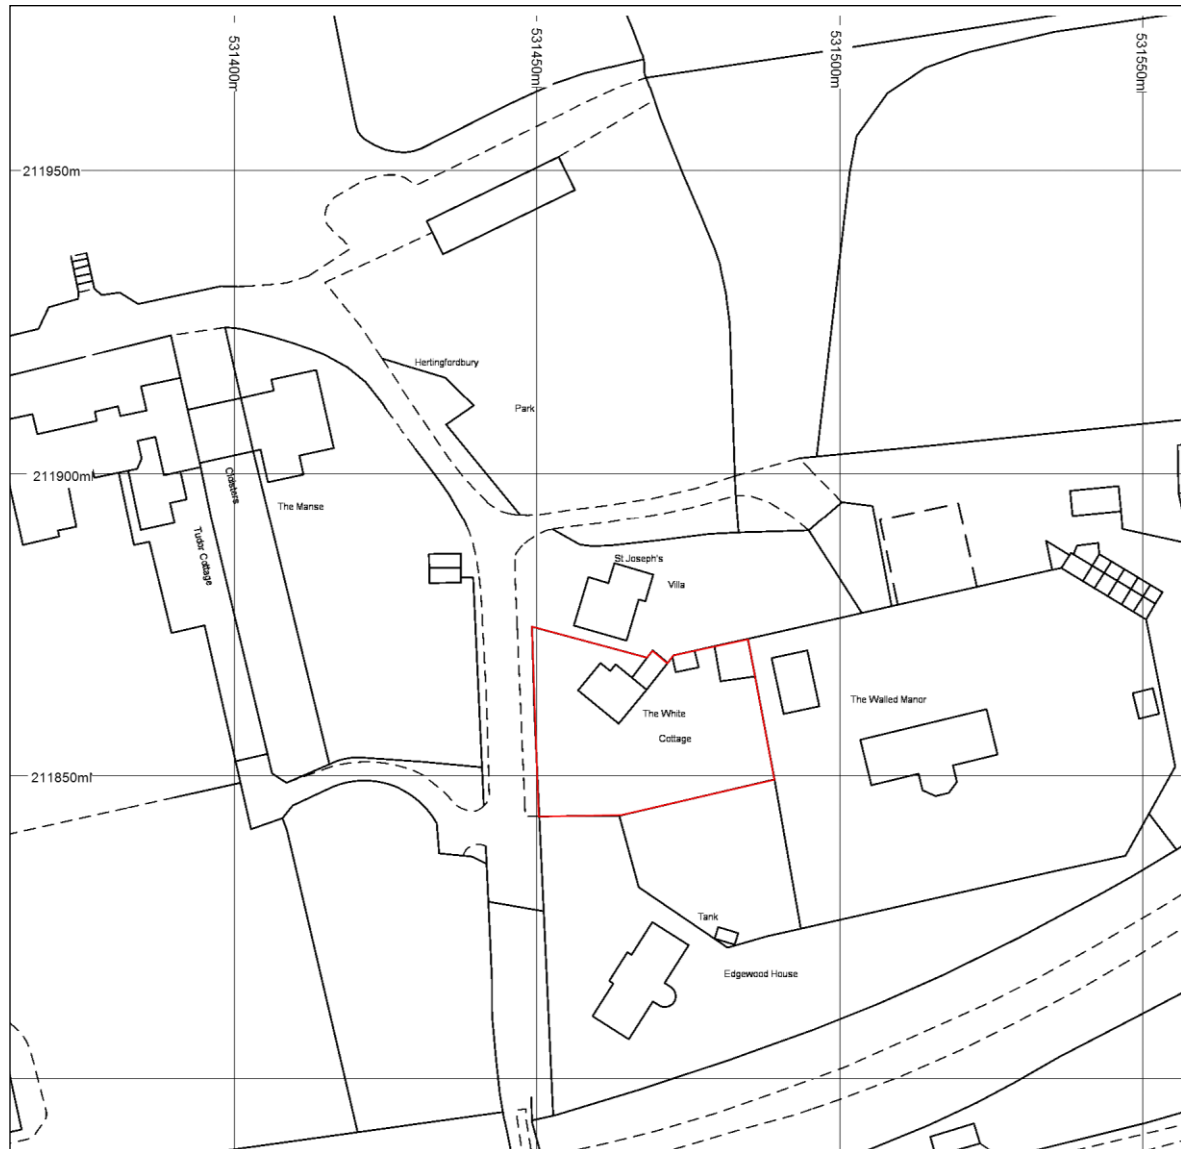
Figure 2: Site location (scale 1: 1250)

The development site is the middle plot of three on the eastern frontage of St Mary's Lane. The L-shaped building appears to incorporate part of the associated plot's northern boundary wall, which also projects southwards in part of an octagonal form. The otherwise detached dwelling is surrounded by gardens with a gravel drive/ access at the west (Fig. 2).

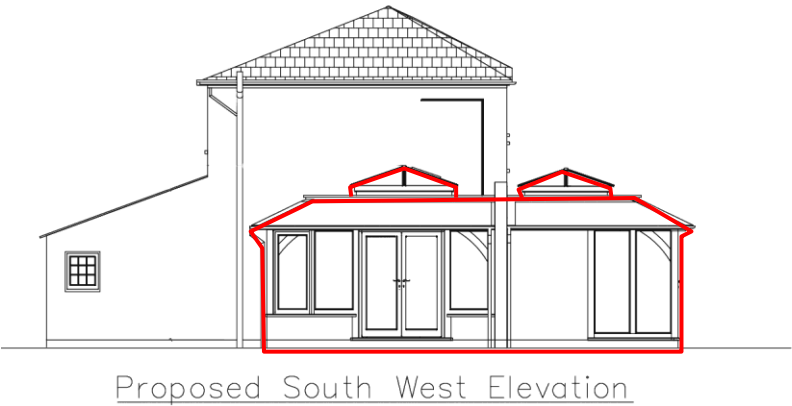
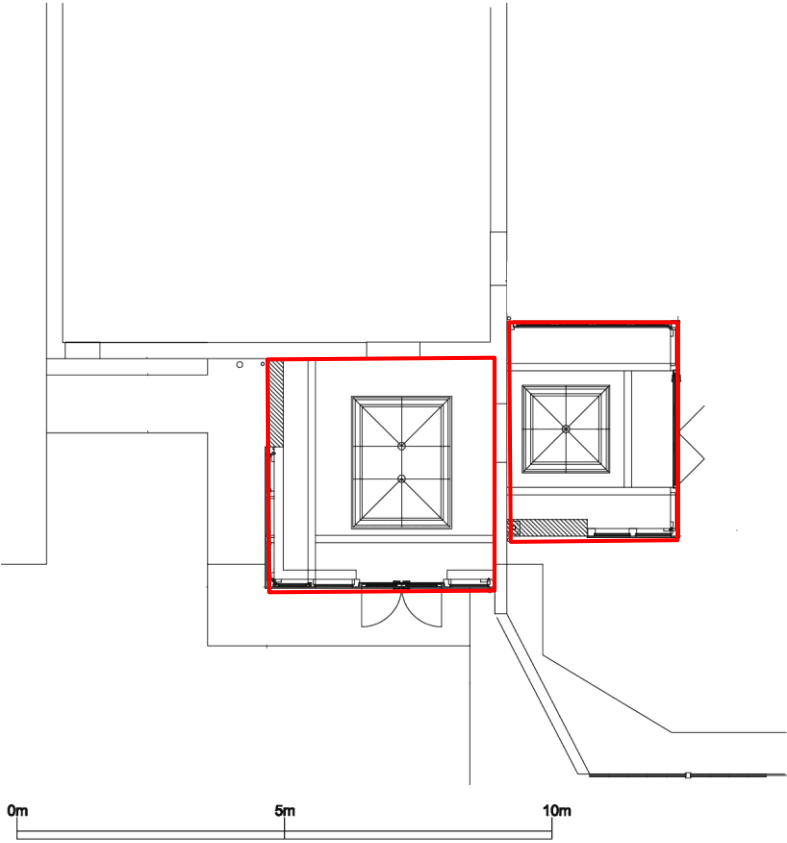
The development entailed the construction a single storey, double garden room attached to the main building, with one room on either side of the projecting wall at the southern side of the existing property (Fig. 3). Access between the two rooms will utilise an existing opening in the wall.

Figure 3: Development highlighted (scale as shown)

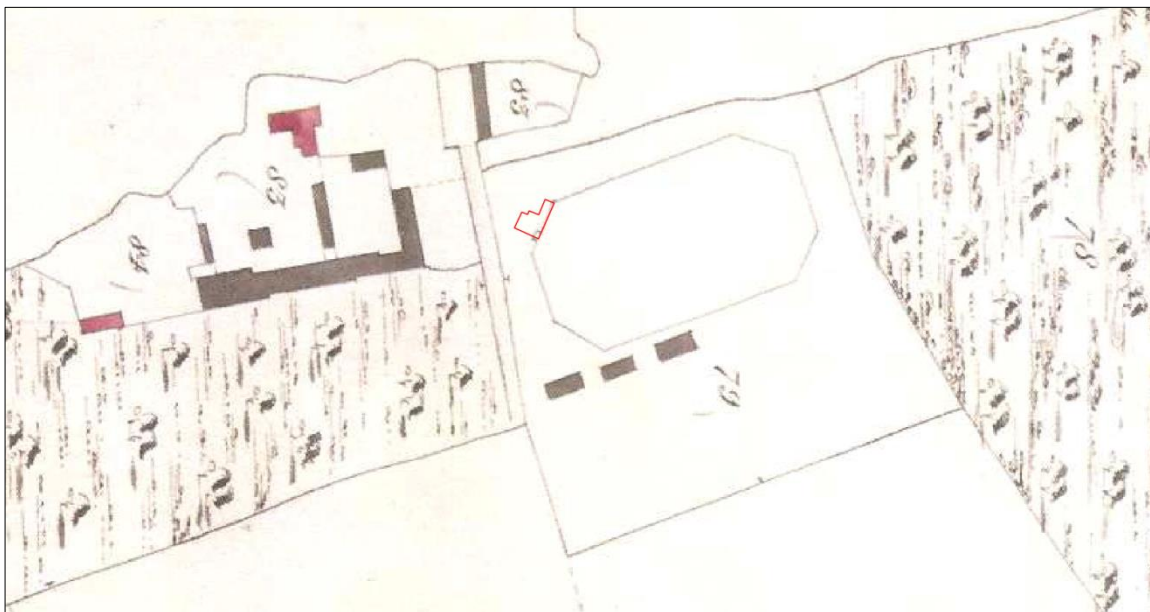
Figure 7: Extract of 1838 Tithe map (scale c. 1:2500)

The White Cottage was not yet built when the Tithe Map was produced in 1838 (Fig. 7), but it is clearly shown on the first edition Ordnance Survey map of 1880 (Fig. 8) as is a rectangular building on the northwest return wall replacing the earlier structure. In this and subsequent Ordnance Survey maps the cottage is depicted without the bread oven at the northern end of the west wall, although this is clearly an integral part of the original build and is finally shown on the 1973 edition (Figs. 9-11)

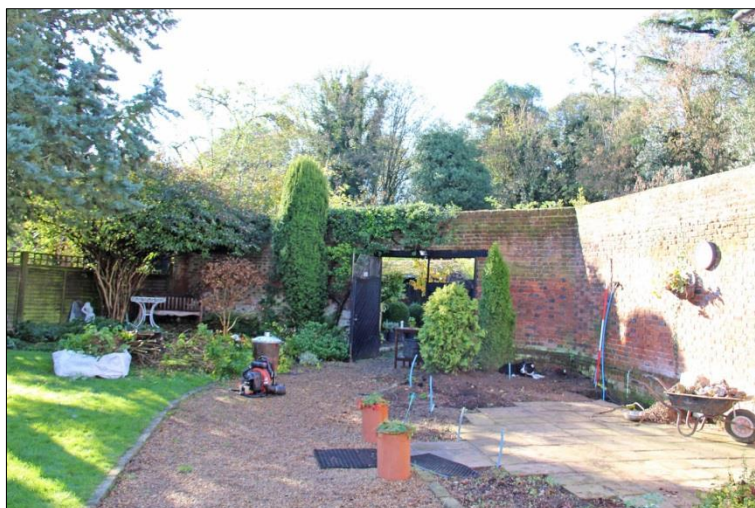
The garden wall (Plate 1) is built of handmade red bricks measuring approximately 23 x 10.5 x 6.5 cm with some burnt headers set in Flemish bond using lime mortar. The bricks are well made, well puddled, with few inclusions and the mortar beds are very regular. There are many nail and possibly bee holes, but no other features were noted other than the odd horizontal skintling, which would suggest a later 18th century date for the wall (Plate 2). The wall is offset c.45cm above the ground, a feature which continues along the length of the house. There are two gates piercing the wall to the south of the house. The first is a modern double gate and the second an original postern gate within strengthened walling and under an arch (Plate 1). To the rear of the garden is a more recent tower that has been crenellated by the present owner (Plate 3).

Plate 1: Southwest corner of the garden wall and double gates (19)

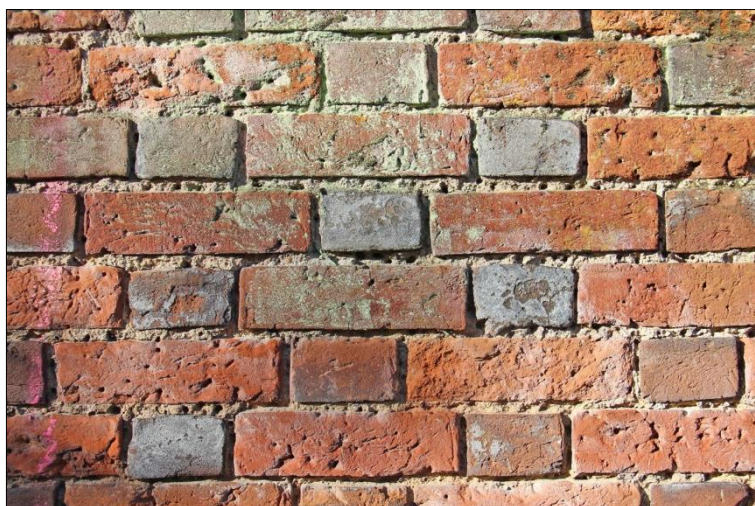
Plate 2: Garden wall detail (30)

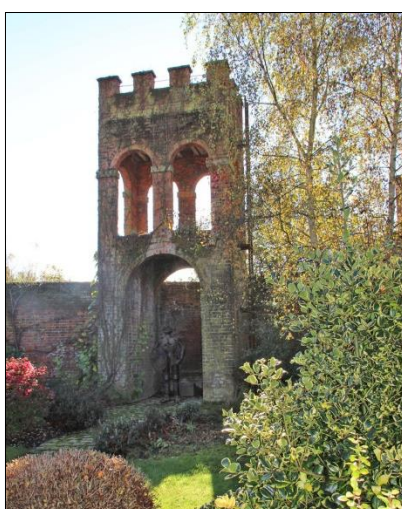
Plate 3: Crenallated former water tower (21)

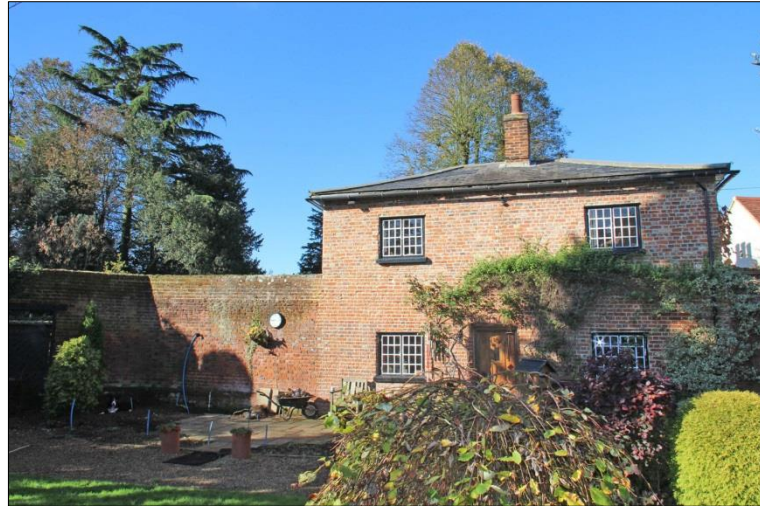
The garden wall runs seamlessly into east wall of the cottage (Plate 4), suggesting it was incorporated in the new construction, which is supported by the lack of queen closers to either side of the ground floor windows. Queen closers are present on the first floor, both alongside the window reveals and also at the southern end of the wall; the brickwork at the northern end of the wall where queen closers would have been apparent was obscured by a downpipe. The bricks are scarred as a result of removing render and appear to be slightly smaller in height and depth as they measure approximately 23 x 10 x 6cm, although this is no doubt due to the recent repointing (Plate 5). The remaining elevations are painted white.

Plate 4: Rear elevation of the cottage (17)

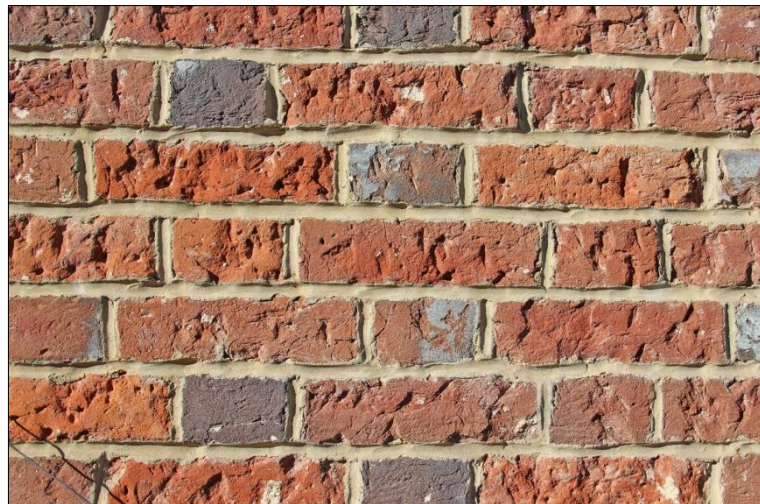
Plate 5: Detail of brickwork in the rear cottage elevation (29)

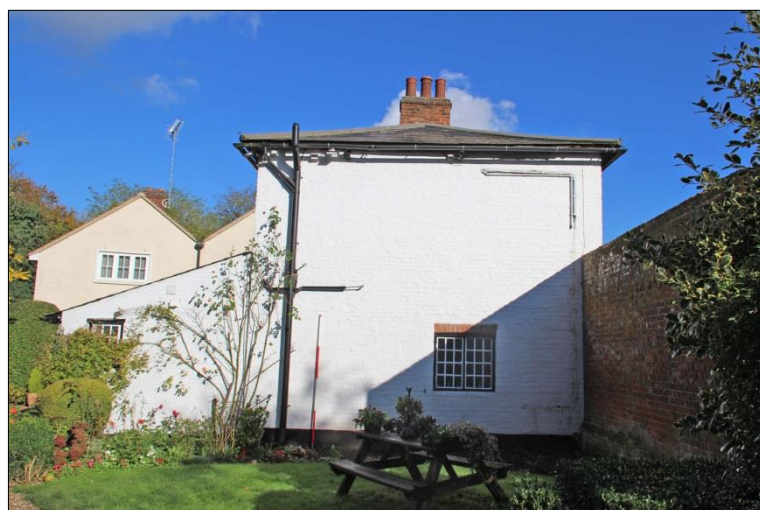
The south wall has a 2-light timber and metal casement under a soldier arch with no sill. There is a small partially obscured timber window in lean-to to the west (Plate 6).

Plate 6: South elevation (23)

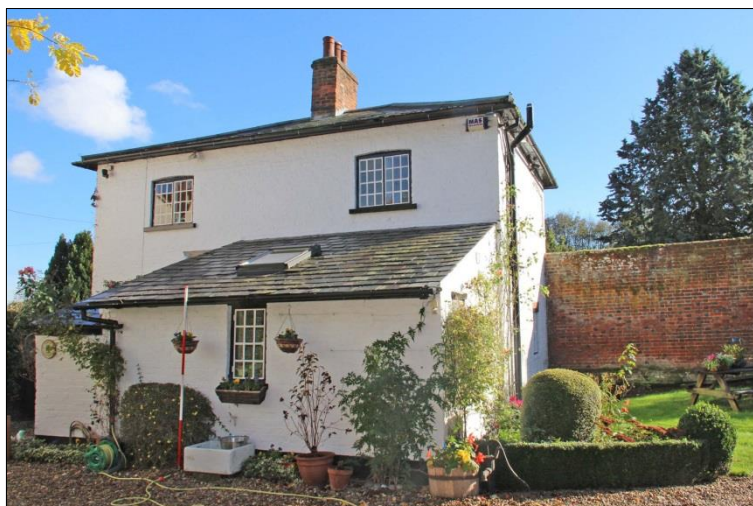
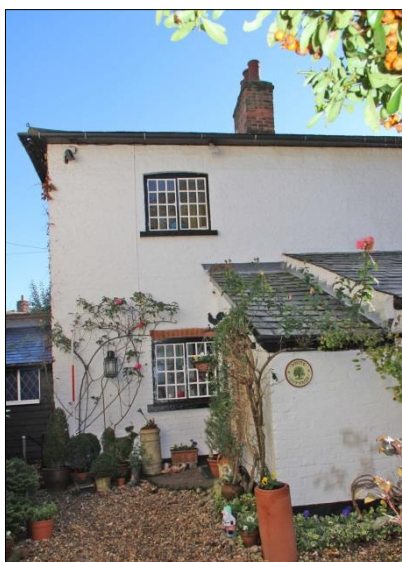
The west elevation comprises a lean-to extension with a bread oven at its northern end, which now houses the front door (Plates 7-8). There is a 2 light timber and metal casement to north of bread oven and a single casement window to kitchen at ground floor level. The first floor has two 2-light timber and metal casements under straight arches with timber sills.

Plate 7: West elevation (26)

Plate 8: West elevation detailing showing former bread oven (27)

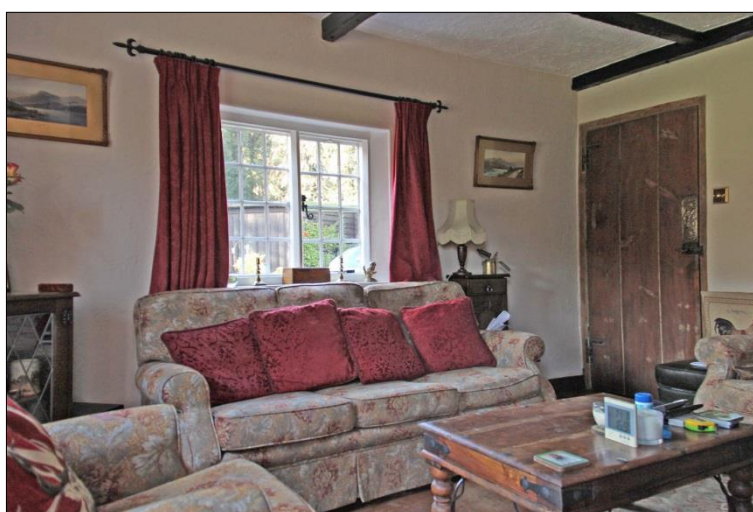
Plate 9: Living room looking northwest (1)

The living room (Plates 9-12) has exposed timbers in the ceiling, all of which are scored and have wooden pegs and ties (Plate 13). A number of apparent carpenter's marks and initials are incised into the timbers, but these are modern. There is a 2-light timber and metal casement windows with rectangular leaded lights, scroll catch and handle in the west and south walls (Plate 9). Both have straight a chamfer on the central million. There is a plank and batten door in the north and west walls; the northern one is modern but is hung on L and H-shaped hinges. The historic door in the west wall is hung on L-hinges. Both doors have 18th century door handles that the present owner imported from elsewhere (Plate 14). In the west wall is a wood burning stove in a brick built fire place with rebuilt brick hearth, herring bone brick back and timber lintel that is scored and incised with the numbers XII and VI (Plate 15). These marks are also modern. The timber floor boards are up to 50cm wide, and appear to be elm.

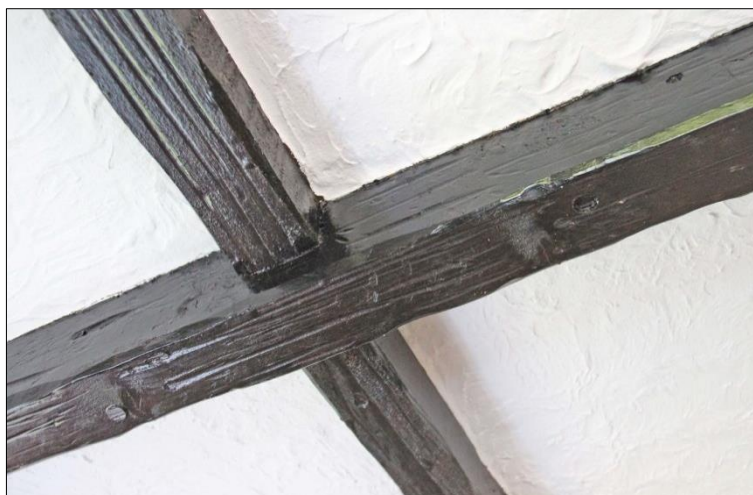
Plate 13: Detail of ceiling timbers (7)

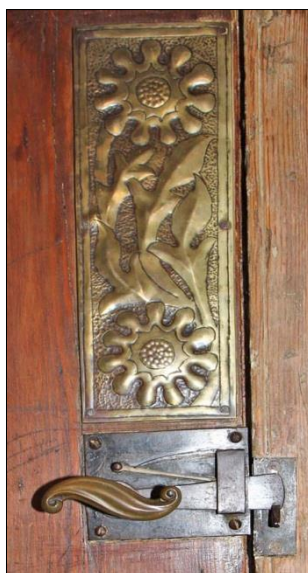
Plate 14: 18th century door catch and finger plate (15)

The interior has been extensively renovated with features, such as the 18th century door furniture, imported that are in keeping with the traditional cottage style of the house. As a result of these later additions, including the graffiti in the woodwork, a detailed narrative of the interior is inappropriate to the chronological narrative of the interior.

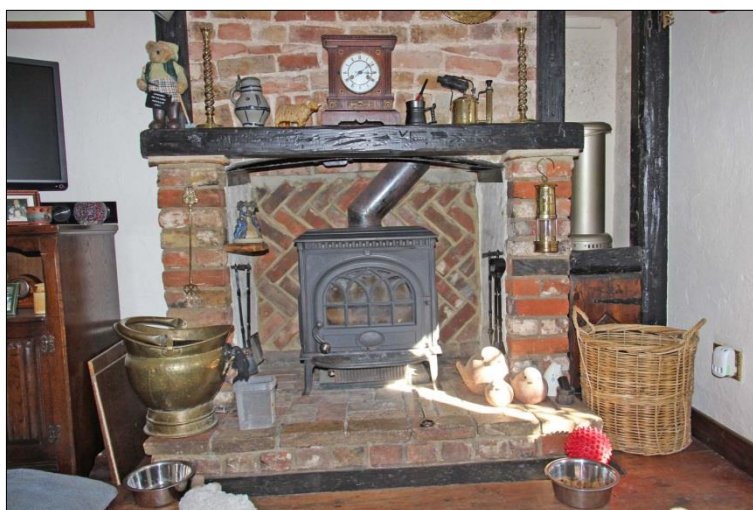
Plate 15: Fireplace detail (13)

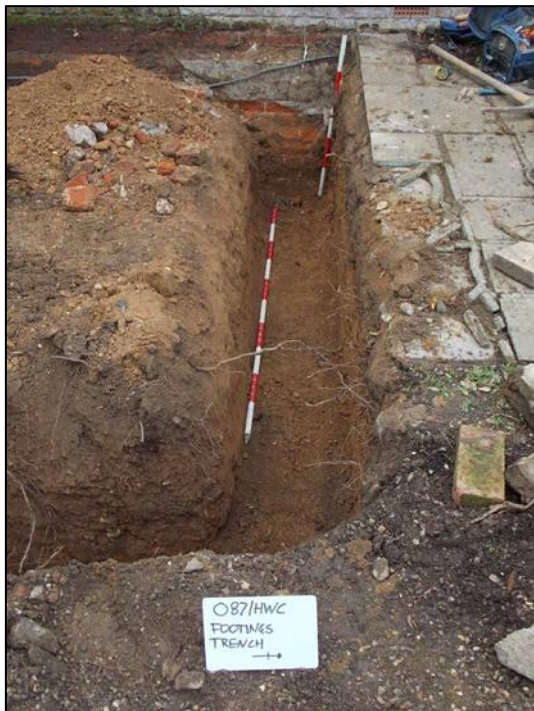
The footing trench for the new eastern garden room was mechanically excavated with a tracked mini-digger fitted with a 0.45m wide toothless ditching bucket. The area measured 82.49 sq. m, and the trench was 0.45m wide and 0.6m deep (Plate 16).

The trench stratigraphy comprised 0.5m of made-ground, which was mixed silty clay, topsoil and redeposited natural, overlying the sandy clay geology.

Plate 16: Footing trench, looking W

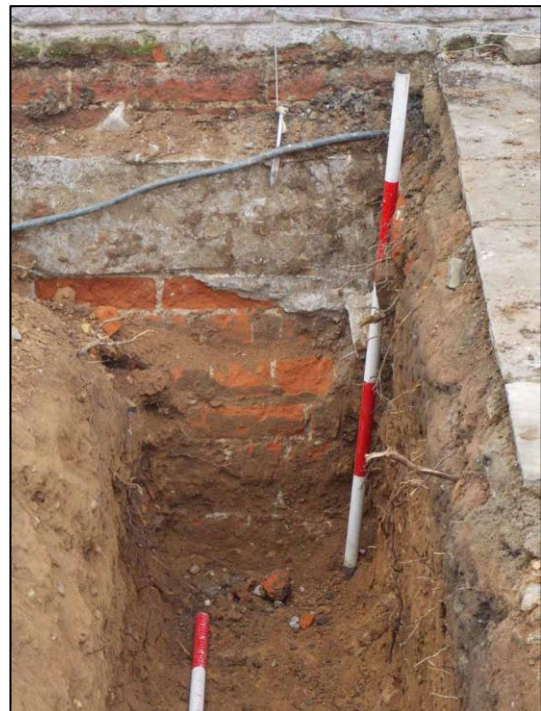
The cottage foundations were partly revealed consisting of the same building material as the rest of the cottage; red bricks bonded with lime mortar (Plate 17).

Plate 17: White cottage foundations, looking W
