KDK ARCHAEOLOGY LTD

## Archaeological Observation and Recording Report

Land Adjacent to 47 Towcester Road  
Old Stratford  
Northamptonshire

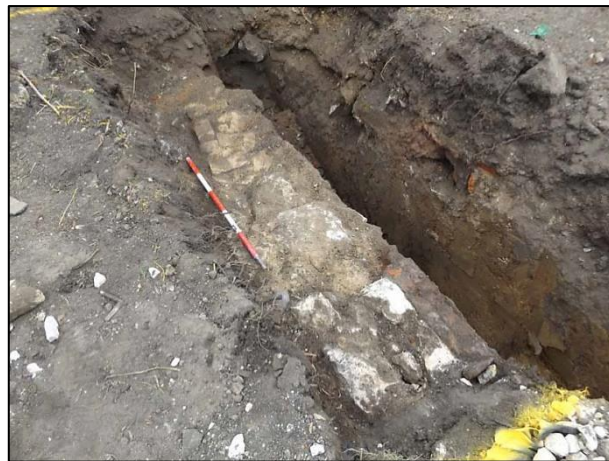
**Plate 5:** Footing trench, stone wall [108] & brick wall [110], looking south (1m scale)

**Stone Wall [108]** (Plate 5): was situated towards the eastern end of the footing trench, orientated northwest-southeast. The wall was constructed of roughly dressed, small-medium stones bonded with lime mortar (109). Brick surface [106] was found butting up to the wall to the west, and brick wall [110] was found butting up to the wall to the southeast.

**Brick Wall [110]** (Plate 5): was found at the eastern end of the footing trench, orientated northwest-southeast. The wall was constructed of un-frogged red bricks bonded with a lime mortar (111). The wall butted up to stone wall [108] to the northwest.

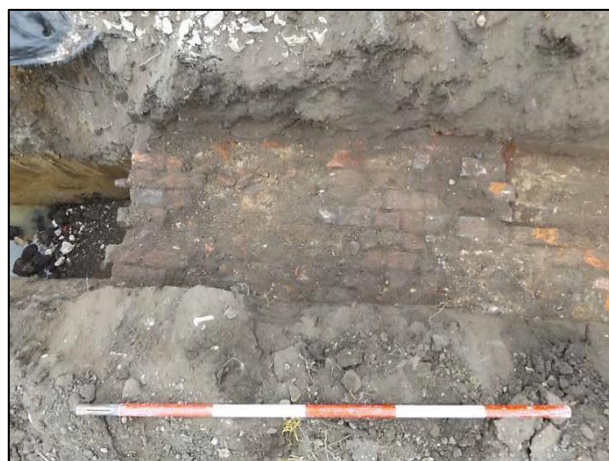
**Plate 6:** Footing trench, brick surface [106], looking north-east (1m scale)

**Brick Surface [106]** (Plate 6): was found towards the northwest end of the footing trench and ground reduction. It was constructed of a single course of un-frogged red bricks laid out in a stretcher bond and set into a layer of lime mortar (107).

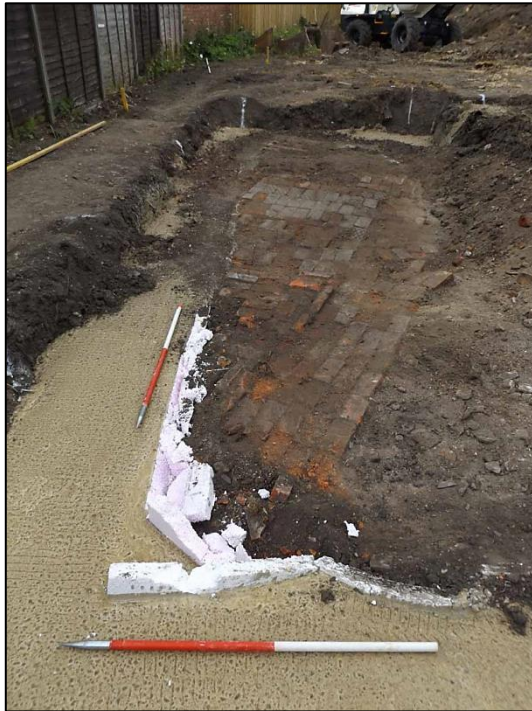
**Plate 7:** Ground reduction, brick surface [112], looking south-west (2 x 1m scale)

**Brick Surface [112]** (Plate 7): was exposed at the southern end of footing trench and ground reduction. It was orientated northeast-southwest and constructed of a single course of un-frogged red bricks with no bonding material. A number of frogged, stable bricks inscribed with the words 'Doulton' on were also found within the surface. The bricks were thought to have been manufactured by Henry Doulton and Co, pipe maker and brick agents of High Street, Lambeth, London established in 1846 ([http://www.gracesguide.co.uk/Henry\\_Doulton\\_and\\_Co](http://www.gracesguide.co.uk/Henry_Doulton_and_Co)).

When overlying the archaeology with the 1884 OS map the majority of features found cannot be specifically married up to the buildings shown in the OS map, however, brick surface [112] may possibly be the floor of the rectangular building depicted on the OS map and brick surface [106] may be part of an outside yard area adjacent to the building shown towards the north-west corner of the site (Figure 7).

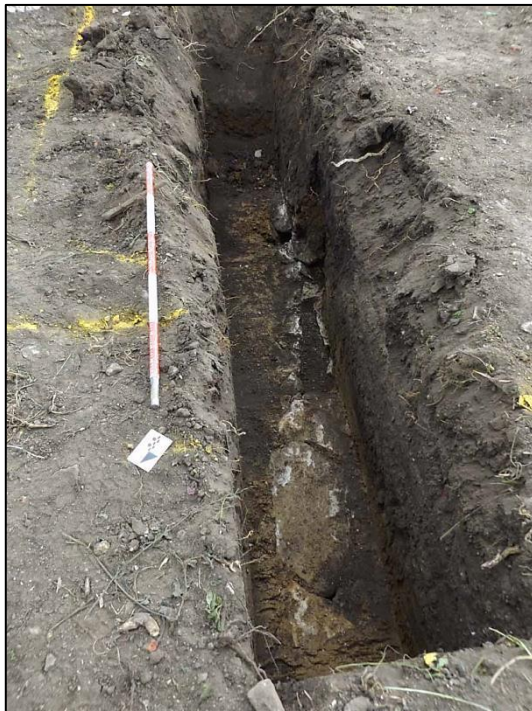
**Plate 8:** Footing trench, stone drain [105], looking south-east (1m scale)

**Stone Drain [105]** (Plate 8): was found towards the northern corner of the footing trench, orientated north-south. It was constructed of un-mortared, roughly dressed, medium stones with finds of post-medieval pottery of white ceramic and willow-pattern (not retained).

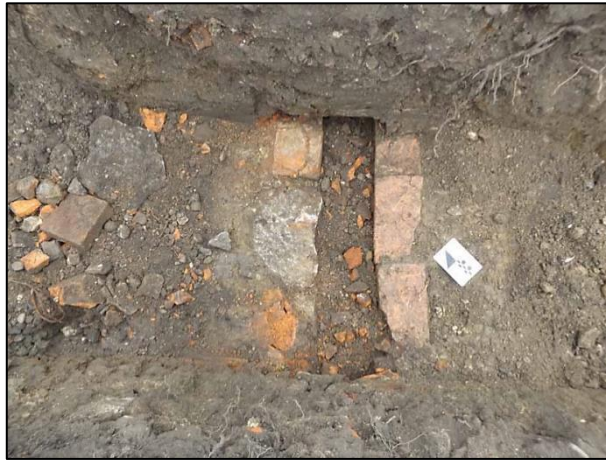
**Plate 9:** Footing trench, brick & stone drain [116], looking north-east (50mm)

**Brick & Stone Drain [116]** (Plate 9): was found at the southwest end of the footing trench, orientated northeast-southwest. It consisted of four un-frogged red brick courses and roughly dressed stone bonded with a lime mortar (117).

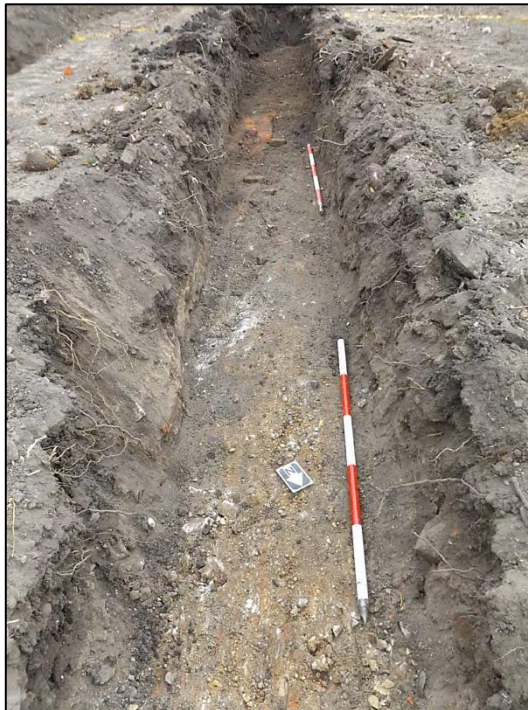
**Plate 10:** Footing trench, stony deposit (113), looking south-west (2x1m scale)

**Stony deposit (113)** (Plate 10 & 11): was found both underlying and beyond brick surface [112], consisting of a concentration of small sub-angular stones that may have formed a surface or a base layer for partly overlying brick surface [112].

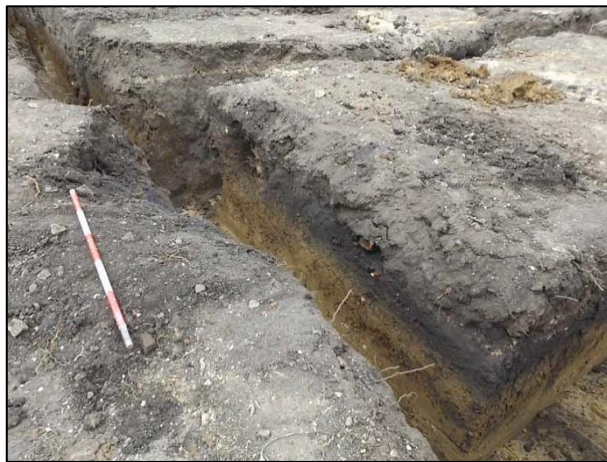
**Plate 12:** Footing trench, burnt deposit (120), looking east (1m scale)

**Burnt deposit (120)** (Plate 12): was situated at the western corner of the footing trench/ground reduction area containing frequent charcoal flecks and CBM. A continuation of this deposit was also observed in service trench 4, (401).

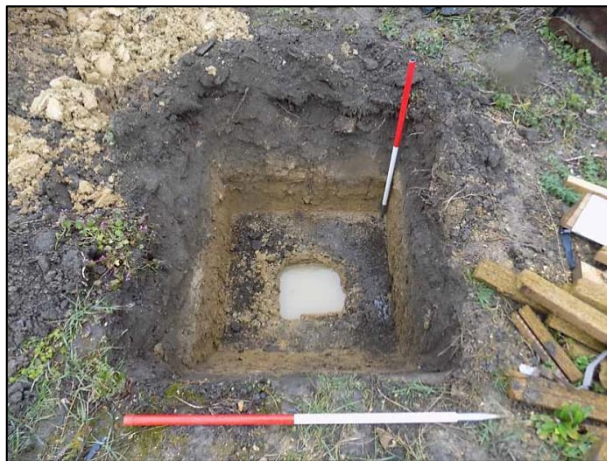
**Plate 13:** Services, soakaway, looking north-east (2x1m scale)

A soakaway percolation pit was excavated to investigate the depth of the water table and to ensure appropriate drainage. A pit 1.40 x 1.20 x 1m was excavated with a smaller 0.30 x 0.30 x 0.25m square dug in the centre. The water table was hit at 1.20 metres and drainage was not sufficient for the installation of a soakaway. As a result, the soakaway was relocated to the front of the house near to the property boundary an area which had been previously disturbed by the building of the road and vegetation. The trench leading to the soakaway was also cut

through the disturbed ground and therefore was not monitored. No archaeological finds or features were encountered from the percolation pit.

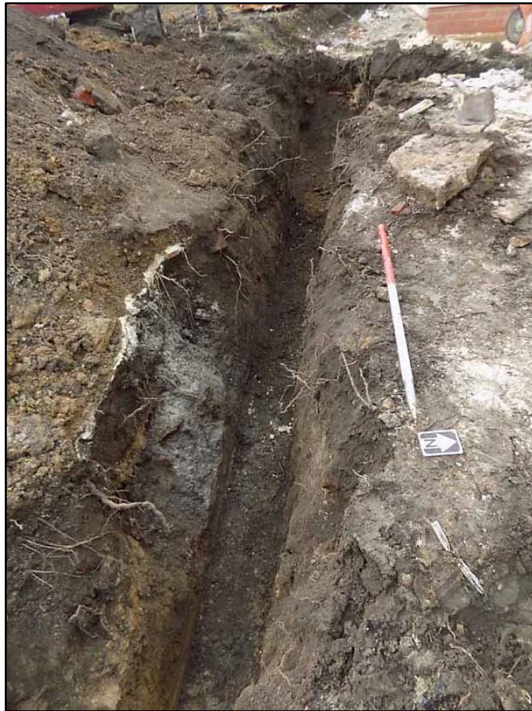
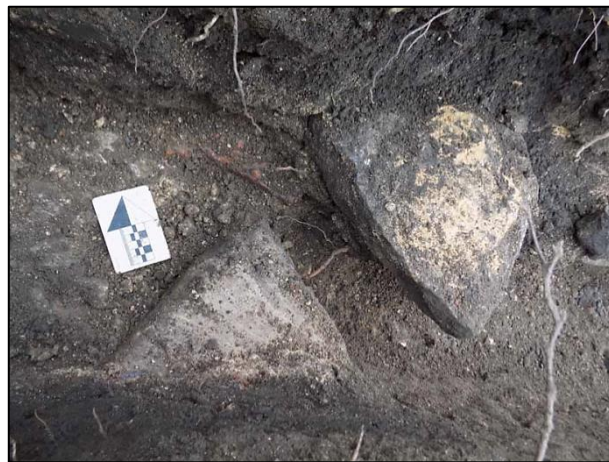
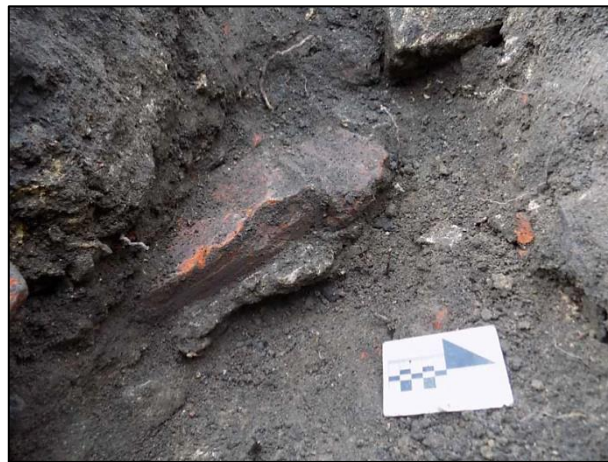
Trench 2 was 5.20m long, 0.40m wide and >1.24m deep. A large square pit measuring 1.50 x 1.20 x 1m was cut in order to install a manhole. Service Trench 2 led west southwest from this pit for 5.20m before turning north into Trench 3. Towards the centre of the trench a section of stone wall (**202**) was observed which consisted of two large roughly dressed stones and a double course of smaller stone bricks which were obscured by the northern baulk. The largest of the stones measured 0.50 x 0.41m in size and was 0.09m in depth. Mortar was visible on the top and bottom of the larger stones but none was visible in the space between them. The precise orientation of this wall is unclear but it is likely that it ran in an east-west orientation. The stones sat on stony deposit (**203**) which contained a high concentration of degraded mortar and red brick. Dateable finds included; modern glass and pottery as well as part of the stem of a clay pipe (finds not retained). This context may be associated with the stony deposit (**113**) found in the footing trench/ground reduction part of the site. To the west-southwest of the trench the highly fragmented base of brick wall (**204**) was discovered. Two bricks were mortared together on a cement base which was 0.05m deep. The bricks were a single course high and ran in a south-east orientation. They were very degraded and bonded together with cement mortar. On the larger of the two bricks, which measured 0.12m wide by 0.06m deep, horizontal skintling was visible.

**Plate 15:** Services, trench 2, looking west (1m scale)

**Plate 16:** Services, trench 2, stone wall [202], looking north-east (50mm scale)

**Plate 17:** Services, trench 2, brick wall [204], looking west (50mm scale)

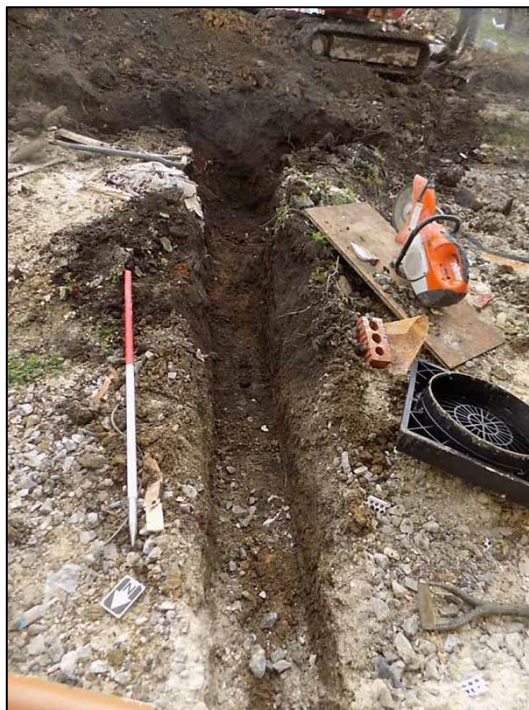
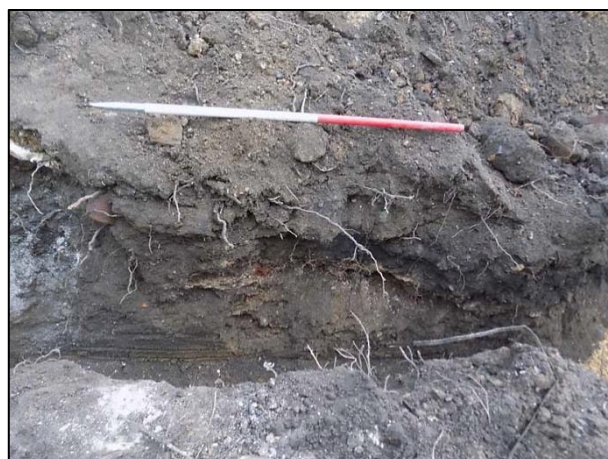
Trench 3 was 4.60m long, 0.40m wide and >1.24m deep. It was located to the southwest of the property and was orientated north-south. Wall (**204**) continued into this trench and a steel water pipe was discovered beneath it which ran in a south-southwest – north-northeast direction. Modern deposit (**301**) which contains backfill from the house foundation ground reduction was located to the northeast of the trench.

**Plate 18:** Services, trench 3, looking south-west (1m scale)

**Plate 19:** Services, trench 3 stratigraphy, looking south-west (1m scale)

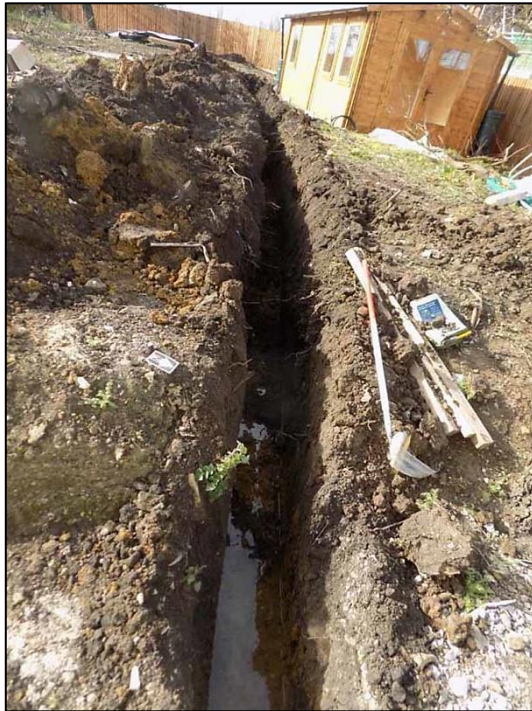
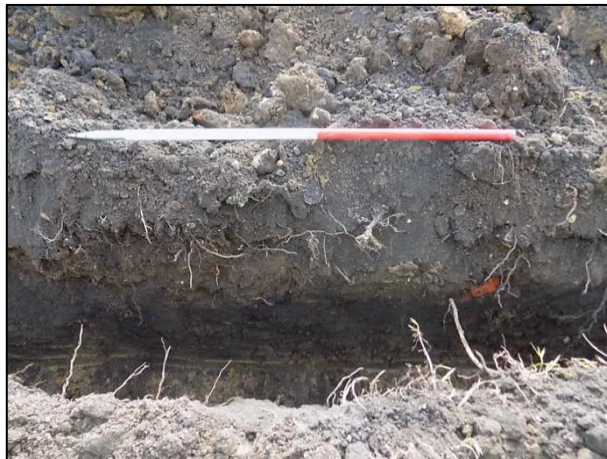
Trench 4 was 18m long, 0.50m wide and 0.90m deep and ran in a southwest direction from the main dwelling to an out building. The stratigraphy of Trench 4 comprised 0.30m topsoil (**400**), 0.32m burnt deposit (**401**), which was thought to be the same deposit as seen within the footing trench/ground reduction part of the site, context (**120**), and >0.26m natural (**402**). No archaeological finds or features were observed from within this trench.

Plate 20: Services, trench 4, looking south-west (1m scale)

Plate 21: Services, trench 4 stratigraphy, looking south (1m scale)
