KDK ARCHAEOLOGY LTD

Historic Building Recording and Archaeological Observation and Recording Report

44 Station Road
Long Marston
Hertfordshire

July 2016

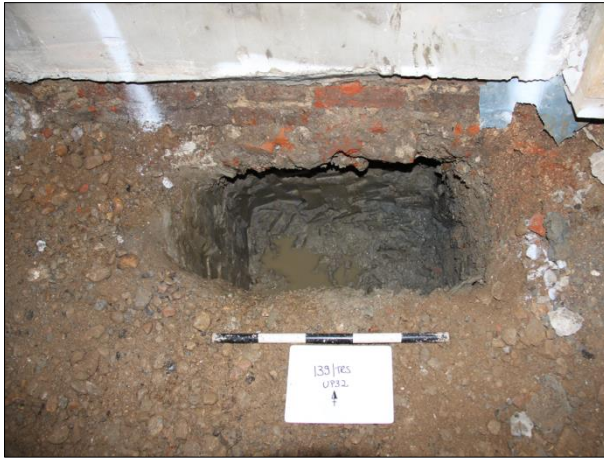
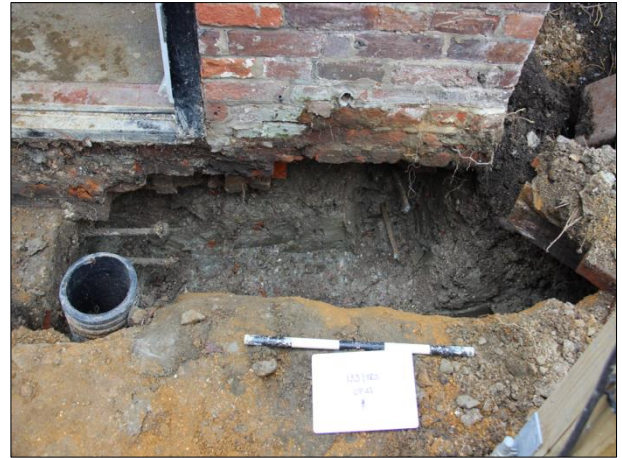
The natural clay was reached in the trench and all of the pits at a depth of 30-40cm below ground level. The overlying deposits tended to be fairly homogenous (Plates 1-2) with the exception of alternate gravel and clay layers in Trench 1 (Plate 3), the adjacent pit (No. 37), and the shingle and gravel deposits in the former open passage in the north of the house (Plate 4).

Plate 1: Pit 32 stratigraphy

Plate 2: Pit 47 stratigraphy

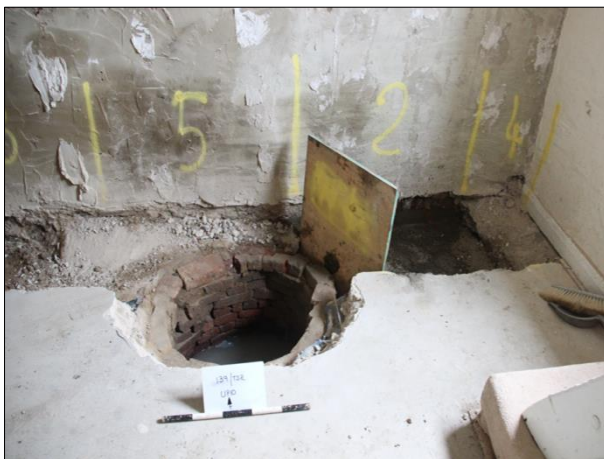
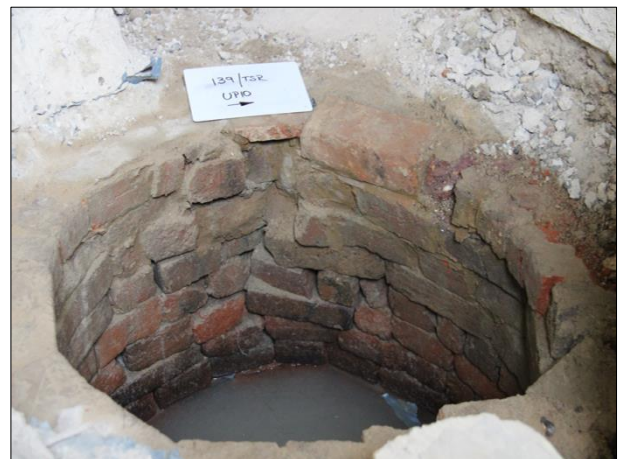
A red brick well was discovered beneath a concrete slab in Room G2 at the eastern end of the house (Plates 5-6). It was 0.86m in diameter and had been constructed of both frogged bricks, measuring 210 x 100 x 60mm (8¼ x 4 x 2¾ inches), and unfrogged bricks that were poorly puddled with some spanish, measuring 230 x 100 x 60mm (9 x 4 x 2¾ inches). Although the lower courses were not mortared, the upper three courses were set in cement mortar. The well was thought to date to the 18th century with 19th century repairs and had been constructed when this room was still an open passage between number 44 and the adjoining property.

Plate 5: Well looking north

Plate 6: Well, detail of the brickwork

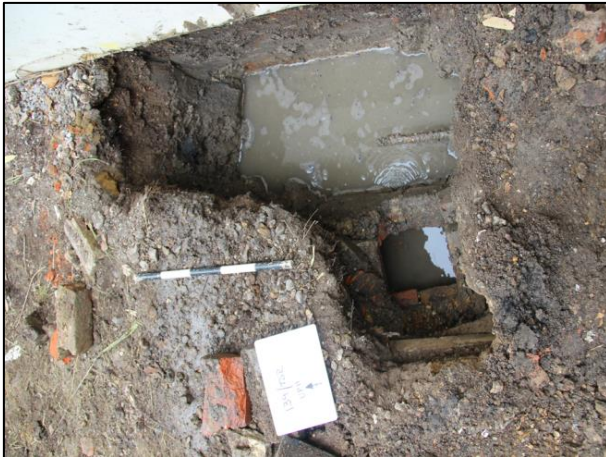
Plate 7: Culvert, facing east

A brick culvert was found running parallel to the rear wall of the house at a distance of 0.45m (Plates 7). It was most fully explored alongside the southern end of the house where the walls of the culvert were made of two courses of hand-made red bricks with some spanish, similar to those in the footings. It was barrel roofed with purple/brown bricks measuring 215 x 100 x 60mm (8½ x 4 x 2¾ inches). The base of the culvert was waterfilled and covered by clay. The bricks used in the culvert and the house wall appear to be very similar and of possible 18th century date, which would suggest that they were part of the century building programme.

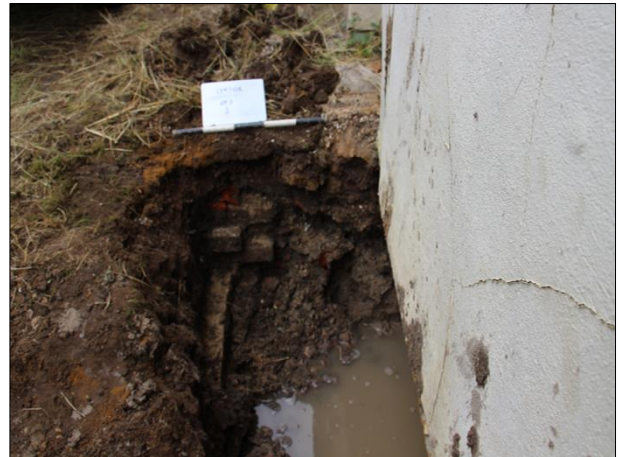
Plate 8: Culvert, facing north

Although not fully exposed, a 40cm length of bricks, 2 courses high, was also observed alongside the northern end of the west wall of the house. The bricks were well puddled and without spanish and appeared to be 19th century. Whether this is a later extension of the culvert is unclear (Plate 8).

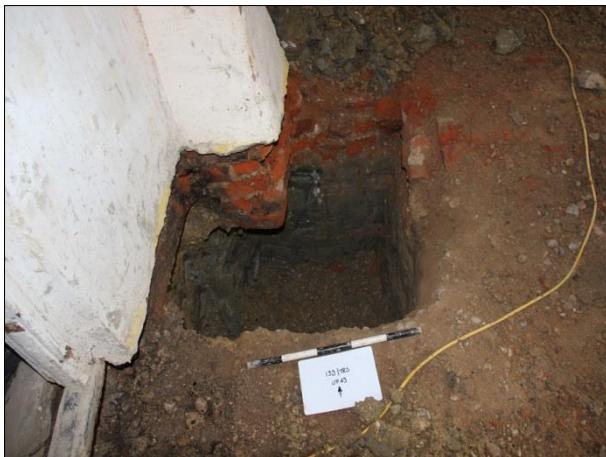
Plate 9: Remains of earlier north wall in Room G3

A small section of a brick walling, 3 courses high was exposed in Room G3 to the south of the door to G2. This would have been the north wall of the rear of the house before it was extended in the 20th century (Plate 9).

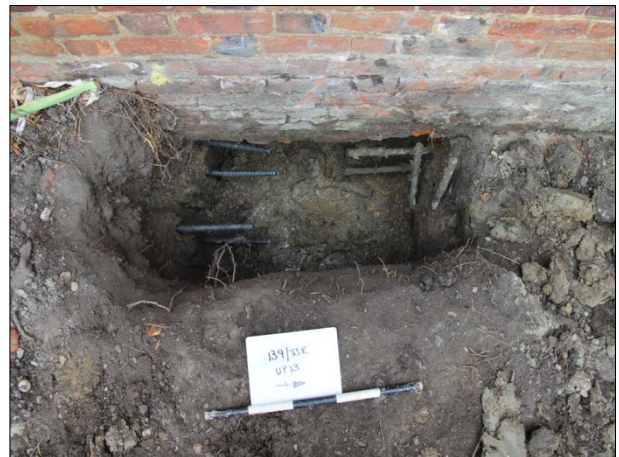
Plate 10: Brickwork in the eastern external wall

Although the east wall had been extensively rebuilt, the original footings were revealed below the modern wall and appeared to be up to 30cm below external ground level (Plate 10). In contrast the rear wall was up to 75cm deep (Plate 11) and the internal walls only 7-8cm below ground level (Plate 12). The bricks used in the west wall of G8 were hand made red bonded in lime mortar and of probable 18th century date.

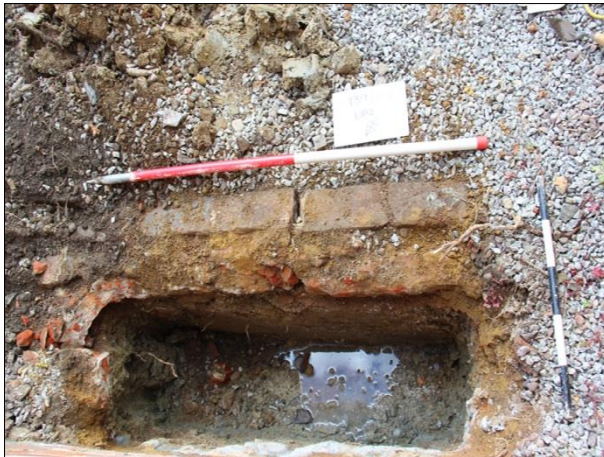
Plate 13: Garden feature or chimney stack alongside eastern external wall

A brick feature of uncertain function was revealed on the outside of the northern end of the east wall (Plate 13). The bricks were possibly 18th century in that they were poorly puddled with spanish but set in cement mortar. As such it could have been a garden feature or possibly the remains of the chimney stack for the fireplace that is recorded as having been in Room G2.

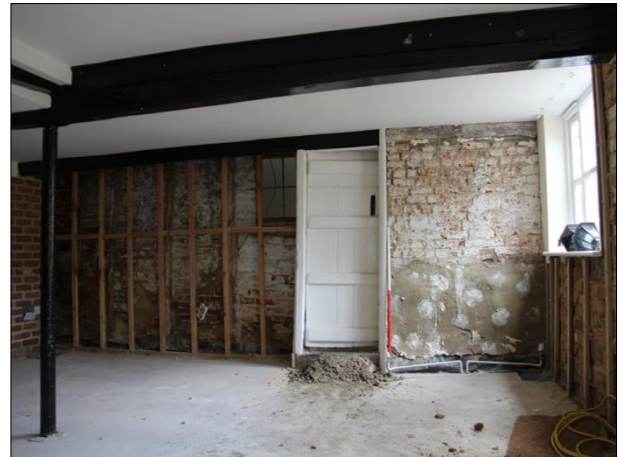
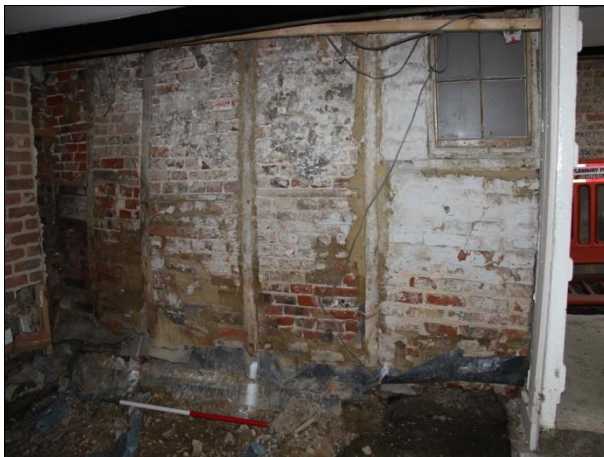
The north wall of Room G1, formerly the northern extent of the house, was fully exposed, revealing studwork with brick infill except at the western end where there were timber inserts (Plate 14). The bases of the studs were rotten and no longer supported by a base plate. Remains of lath and plaster still survived. The bricks used to infill the framework were partially painted handmade reds that measured approximately 22 x 6 cm (8½ x 2¼in). Tiles had been used to pack the top of the central section of brickwork.

The doorframe which had previously been flush with the wall, had later been added to in order to accommodate modern wall finishes. An early 19th century timber was exposed window to the west of the door.

Plate 14: North wall of Room G1

Plate 15: Studwork and window in the north wall of G1

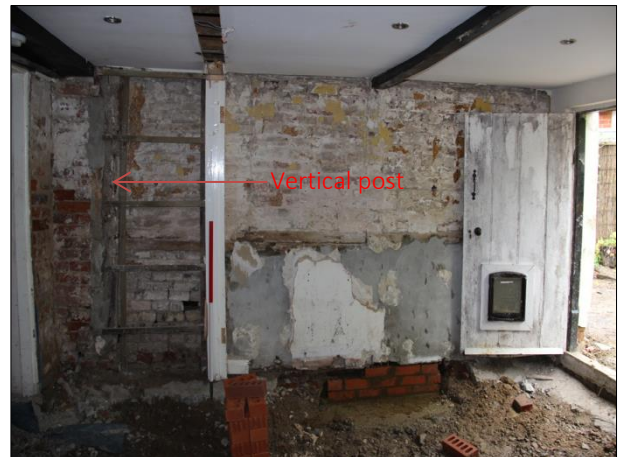
Plate 16: Partition wall between Rooms G6 & G8

The wall between G6 and G8 in the southwest corner of the building was fully exposed, revealing a 12cm wide timber post with pegs on its eastern side and bonding timbers to west (Plate 16). Traces of wallpaper survived on the brick infill and behind a timber frame that had been added later (Plate 17). The post, which was located 35cm from the main east-west range, may well be part of an earlier crosswing, now subsumed by the rebuilding of Room G8 in the 18th century.

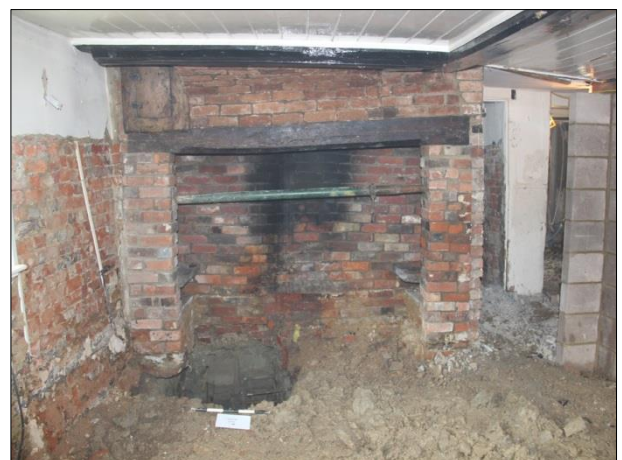
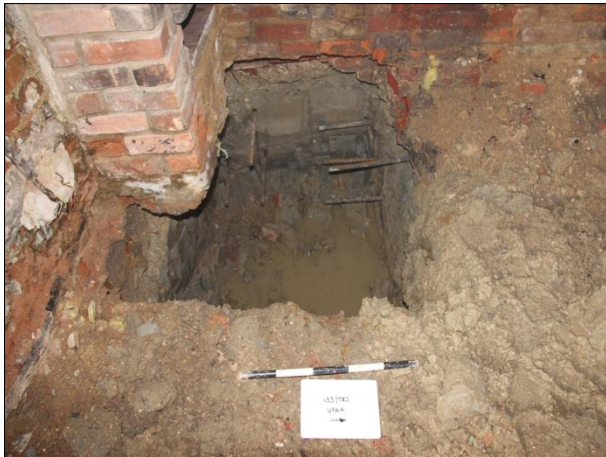
Despite its appearance, comparison of the brickwork in the south wall of Room G7 and that used in the fireplace would suggest that the fireplace is a later insertion and has been subject to repair work since then (Plates 18-19).

Plate 18: Fireplace in Room G7

Plate 19: Room G7 fireplace detail of bricks

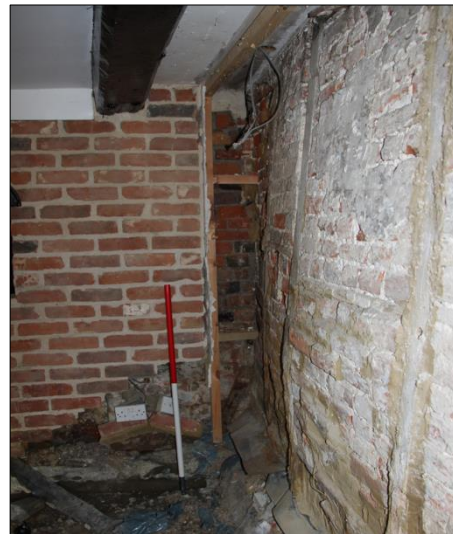
Plate 20: Rebuilt oven with earlier brickwork behind

Considerable rebuilding or repair work is also evident in the footings of the oven in Room G3 which were seen to consist of cement encased flint fragments. The original brickwork was also revealed behind the modern reconstruction in Room G1 (Plate 20).

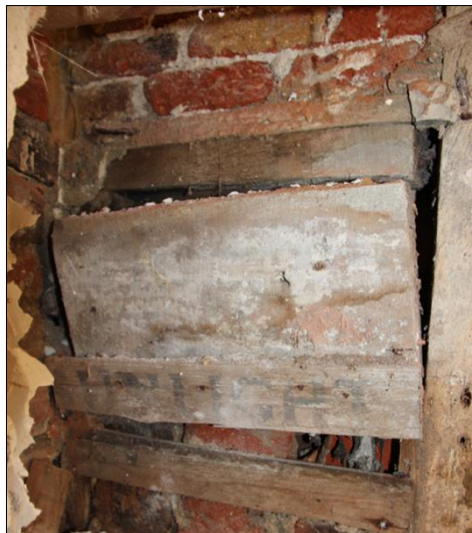
Plate 21: Wooden packing in the north wall of Room G1

More unusual discoveries included packing in the north wall of Room G1 made from the side of a wooden box (Plate 21) and a bullet ridden metal shop sign found in one of the underpinning pits to the west of the house.
