KDK ARCHAEOLOGY LTD

Archaeological Evaluation Report

The Castle
147 Kentish Town Road
Camden
London

January 2016

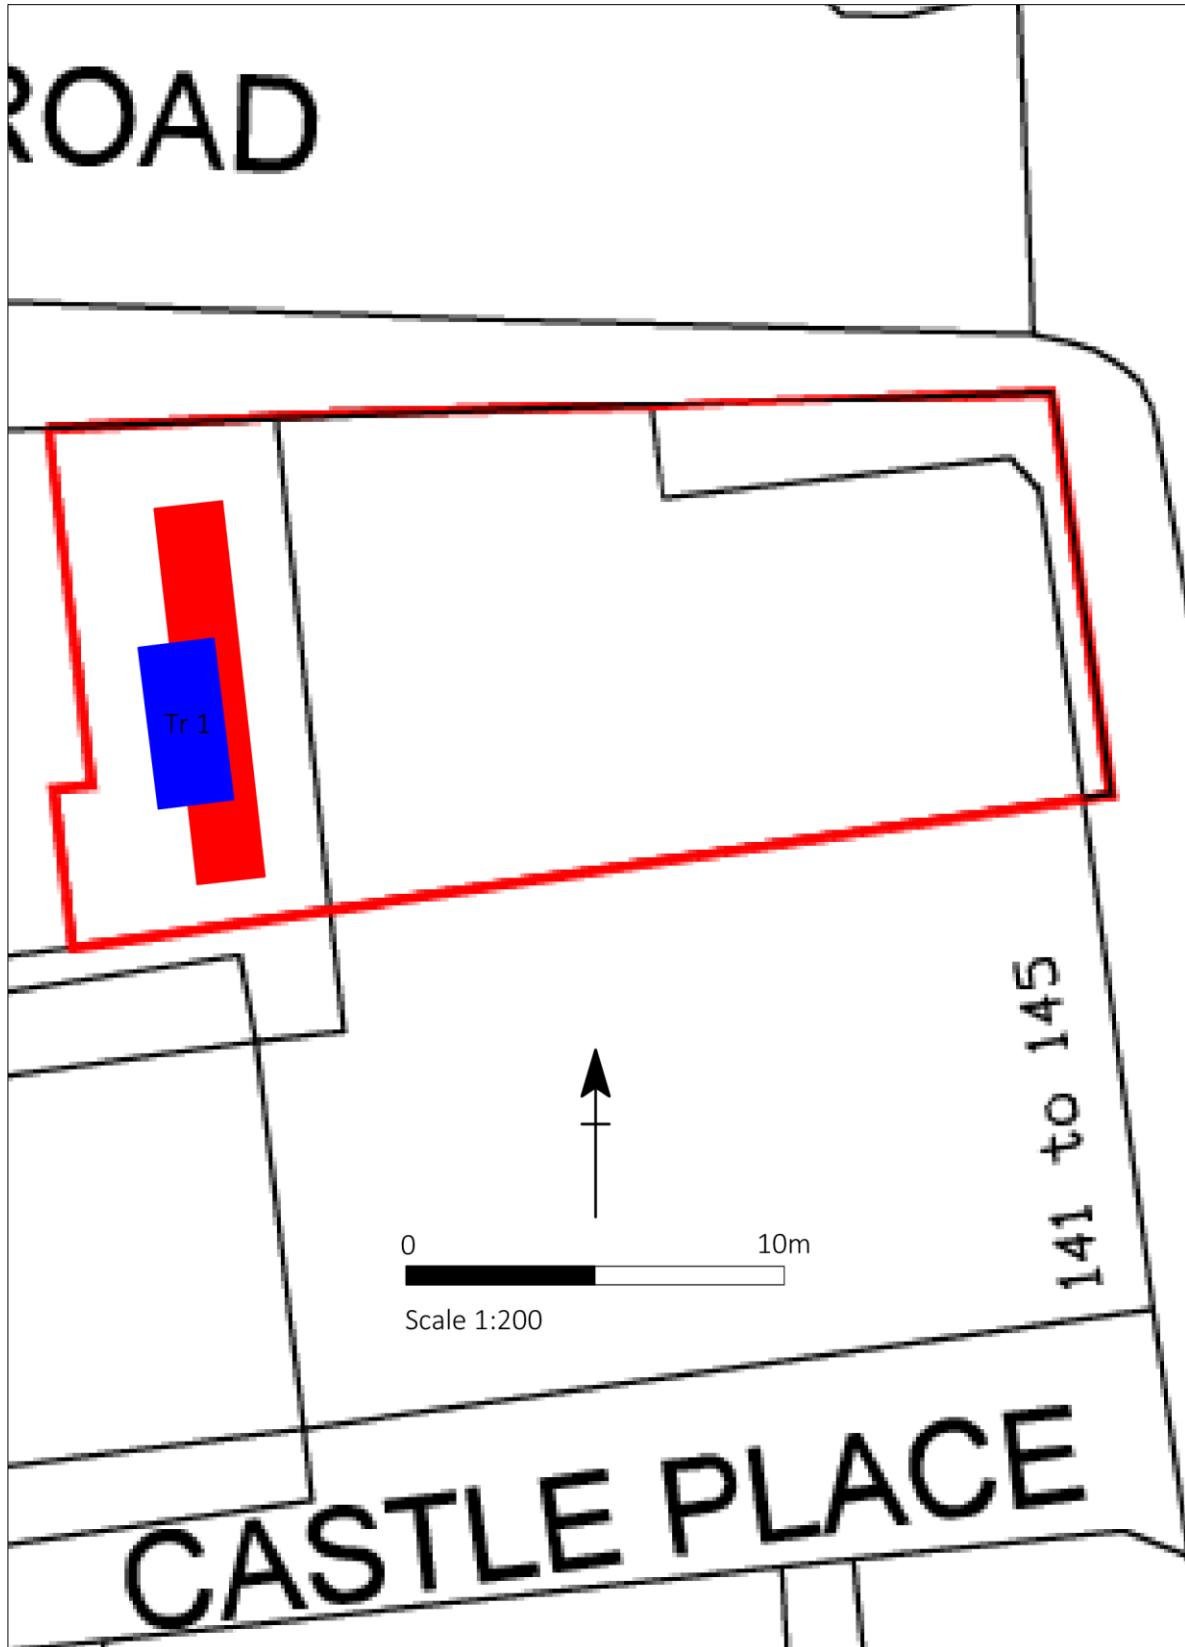
Figure 4: Trench location plan, with proposed in red, and actual in blue (scale 1:200)

- Excavation of one evaluation trench measuring 4.3 x 2m situated within the less disturbed area of the site (Fig. 4)
- The Archaeological Advisor was consulted on the archaeological remains identified in the evaluation trench for determination of further investigations

Due to the confined space, location of services, and presence of debris within the area, the trench dimensions were reduced from 10 x 1.8m down to 4.3m x 2m.

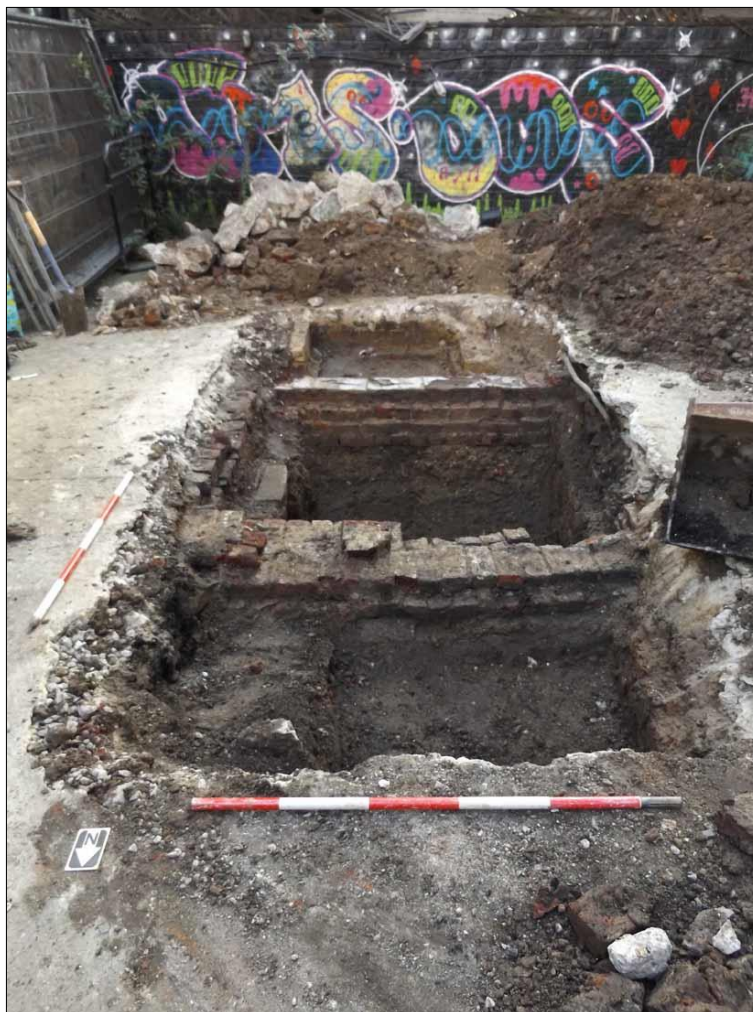
Plate 1: Trench 1, facing south, with 1m scales

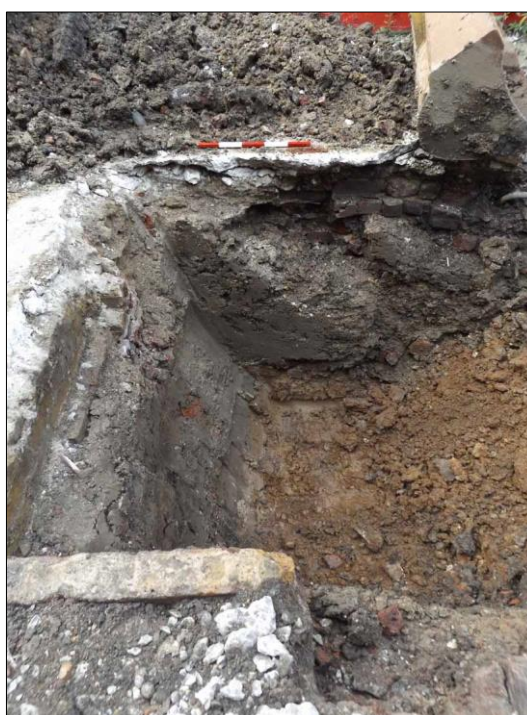
The general trench stratigraphy comprised 0.16m of concrete (100), overlying 0.2m deep of made-ground (101), overlying 0.94m deep of made-ground (114), underlying which was the natural strata (109).

Plate 2: Site stratigraphy, facing west, with 0.5m scale

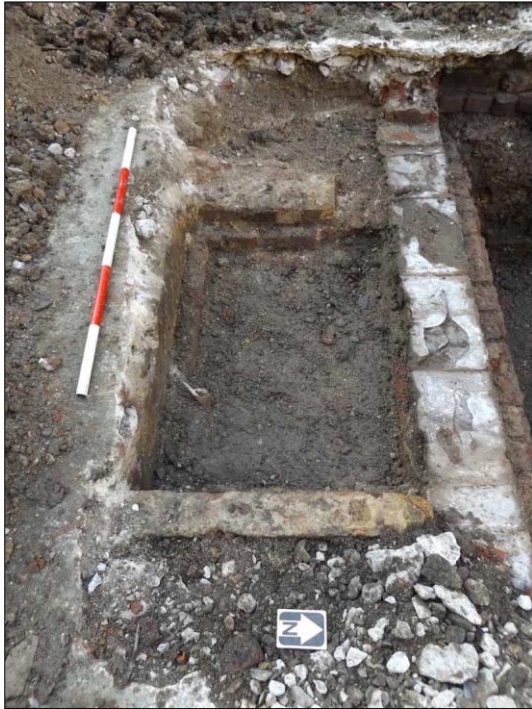
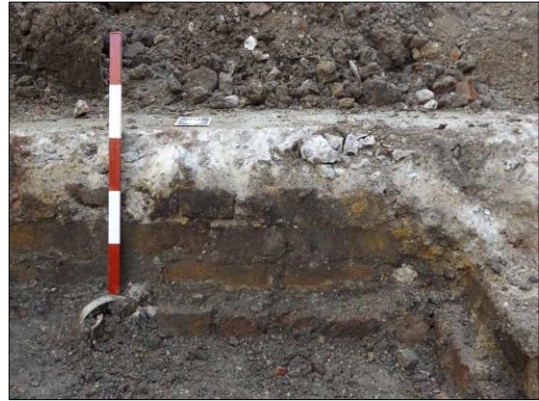
Wall [102] found at the southern end of the trench, 'U'-shaped in plan consisting of four courses constructed of yellow bricks with a shallow frog laid down in a stretcher bond and bonded with grey white cement mortar (103). The foundation butted a further foundation brick wall [104].

Plate 3: Brick wall [102], facing west, with 1m scale

Plate 4: Brick wall [102], facing south, with 1m scale

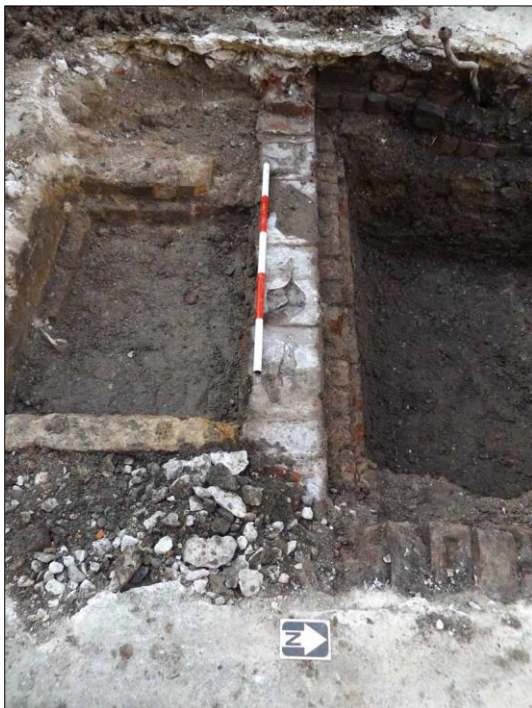
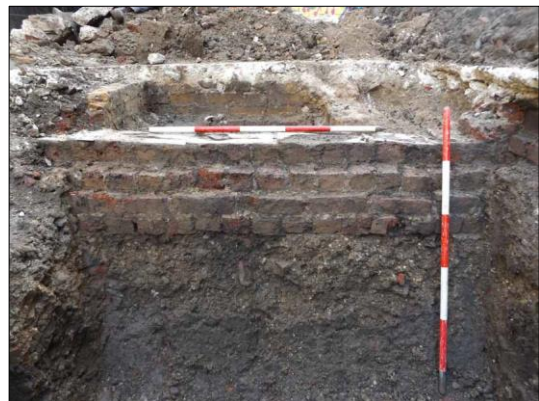
Wall [104] found towards the southern end of the trench, orientated east to west consisting of four courses of red bricks with a shallow frog. The two lower courses were laid down in stretcher bond and the two upper courses were header bond. A layer of slate was bonded to the uppermost course, acting as a damp-proof coursing. The foundation was bonded with beige, sandy, lime mortar (105). It was butted by foundation wall [102] to the south and foundation wall [106] to the north at the western end. To the north at the eastern end, foundation wall [108] partially covered [104].

Plate 5: Brick wall [104], facing west, with 1m scale

Plate 6: Brick wall [104], facing south, with 1m scale

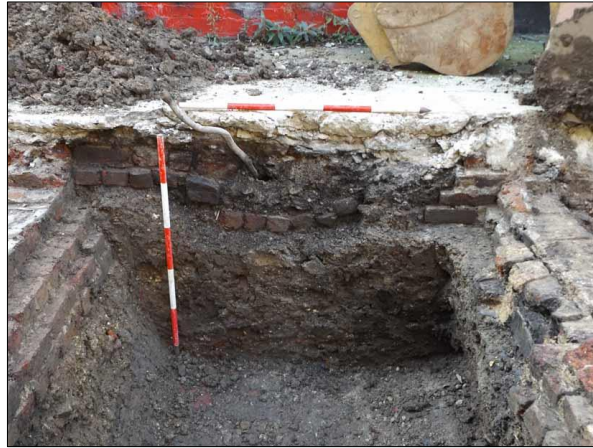
Wall [106] was seen in the west section of the trench, orientated north to south. Two courses were found constructed of red bricks with a shallow frog and laid down in a header bond and bonded with beige, sandy, lime mortar (107). Towards the northern end of the wall the brickwork respects a lead pipe. The foundation butts foundation wall [104] to the south.

Plate 7: Brick wall [106], facing west,
with 1m scales

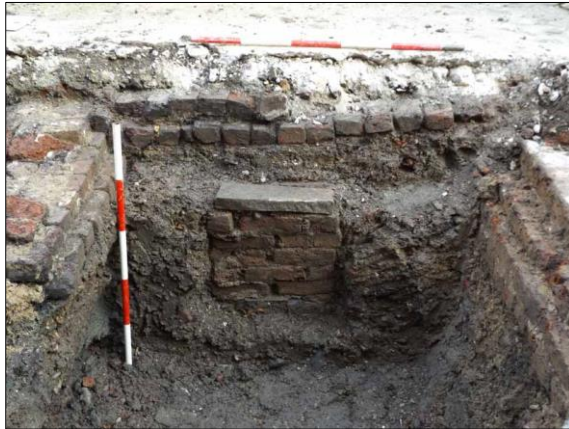
Wall [108] was found in the east section of the trench, orientated north to south. It consisting of two brick courses constructed of red bricks with a shallow frog, laid down in a header bond with no mortar. At the walls southern end it partly overlay wall [104], whilst at its northern end it partly overlay wall [112]. A possible inspection chamber [110] was also found underlying wall [108].

Possible inspection chamber [110] was rectangular in section and seen in the east side of the trench. It consisted of five courses of red bricks laid down in a stretcher bond and bonded with beige lime mortar (111), at the base of which was a layer of slate for damp-proof coursing. The structure was capped with a possible limestone slab that had been broken. The structure may have also acted as a step as opposed to an inspection chamber. The structure was also found underlying wall [108].

Plate 8: Brick wall [108] and possible inspection
chamber [110], facing east, with 1m scales

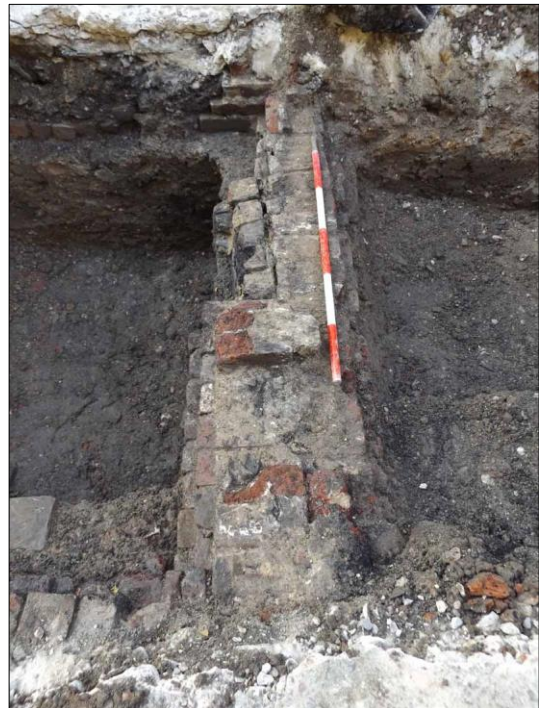
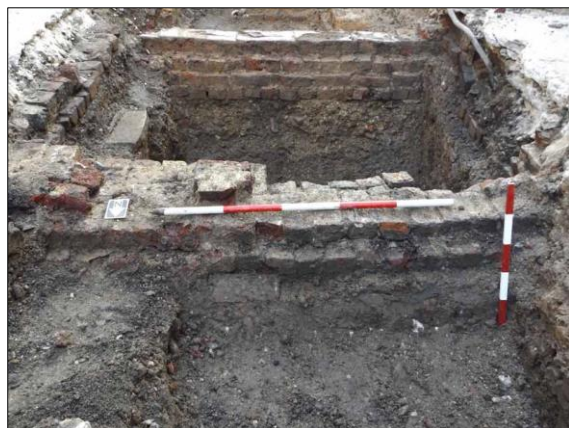
Wall [112] was situated towards the northern end of the trench, orientated east to west. It was constructed of three courses of red bricks with a shallow frog laid down in a header bond. The majority of the wall was bonded with a beige sandy lime mortar, aside from at the western end, which consisted of grey white cement interpreted as a later retouching. The wall was overlaid by wall [108] to the south at its eastern end.

Plate 10: Brick wall [112], facing west,
with 1m scale

Plate 9: Brick wall [112], facing south,
With 0.5m and 1m scale

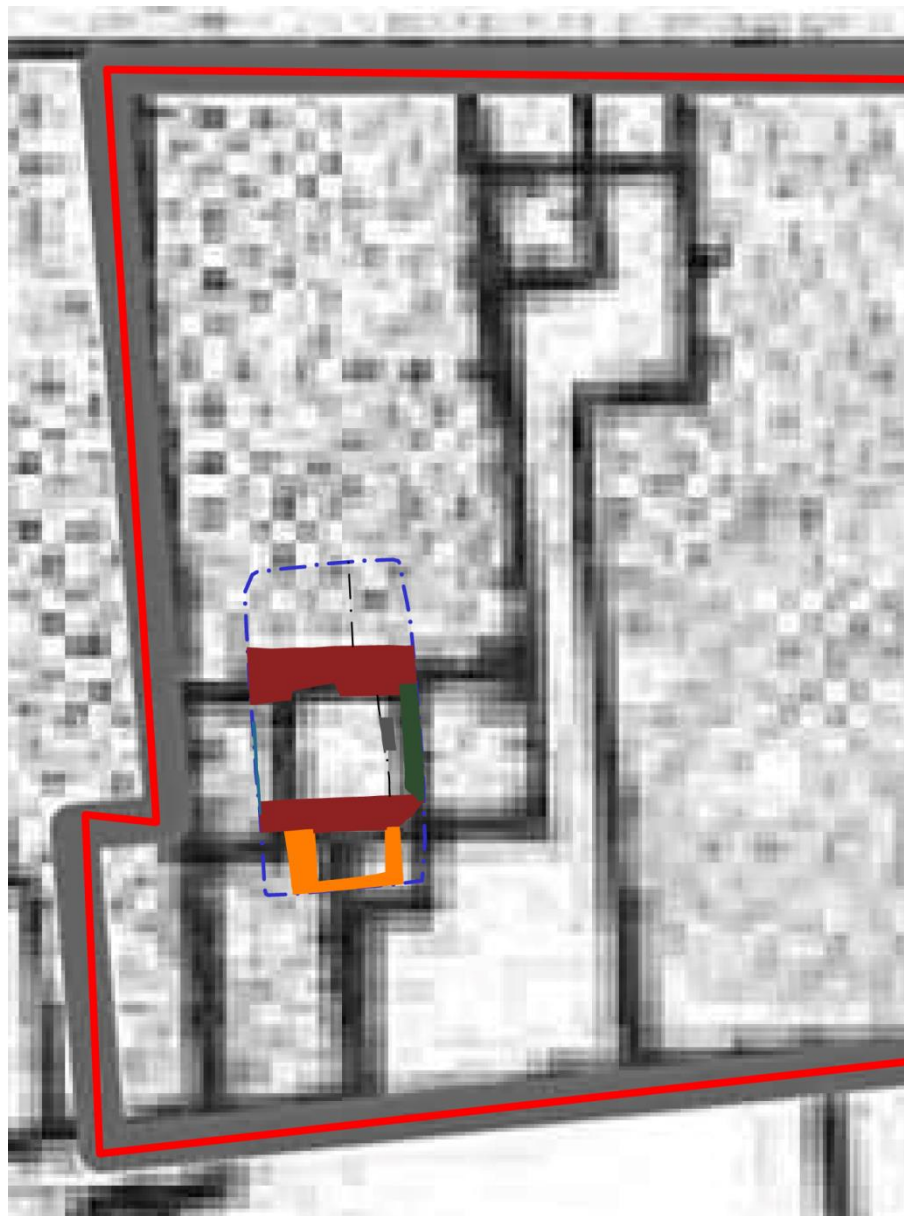
Figure 10: Archaeology overlay on the 1894 OS map (scale 1:100)

Overlaying the archaeology found in the evaluation with 1894 OS map indicates that the brick foundations are indeed the residential property that once stood to rear of the site, that was demolished after 1969 (Figure 10).
