Archaeological Evaluation Report

Church of St Mary and All Saints
Main Street
Fotheringhay
Northamptonshire

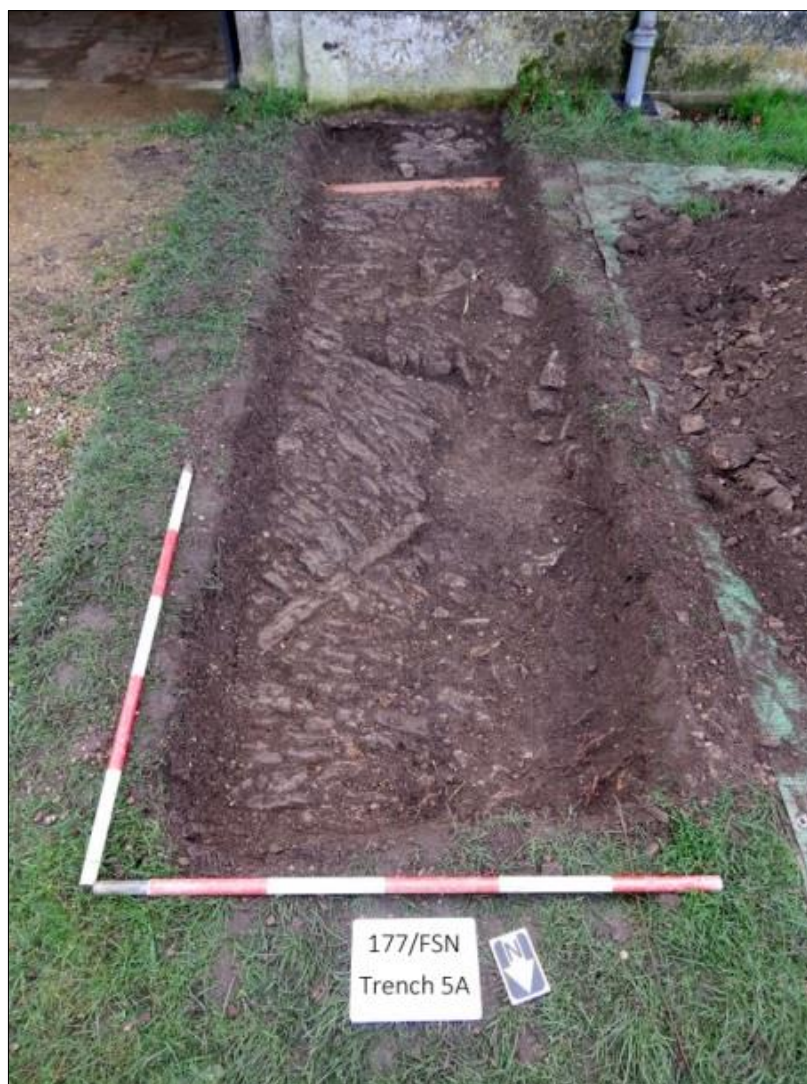
Plate 1: Trench 5A, facing south-west, with 1m scales

Trench 5A was orientated north to south and positioned parallel to the existing gravel pathway to the north of the church (Fig. 7). The trench was 3.5m long, 1m wide and 0.2m deep (Fig. 8, Plate 1). The contexts observed in this trench are as follows:

Surfaces (502) and (503) had both been cut by modern services, however it is clear from their close proximity and composition that they were the same surface (Fig. 8, Plate 1). Probing by hand with a metal rod showed a high probability that the surface extends a further 4m to the north of the trench. A single fragment of ceramic building material and an iron nail were found within the matrix of (502).

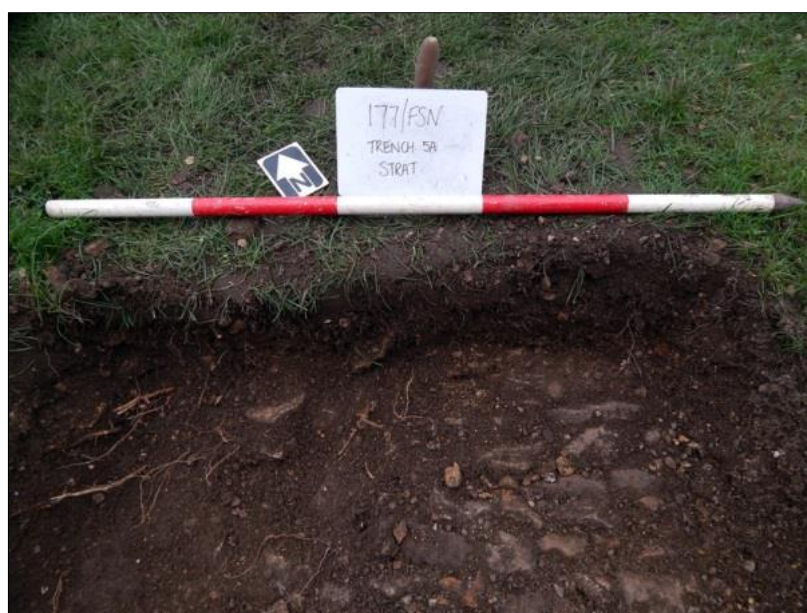
Plate 2: Trench 5A stratigraphy, south-west facing section, with 1m scale

The stratigraphy of the trench comprised 0.05m of topsoil (500) above a stony layer (501) 0.15m in depth, beneath which was stone surface (Fig. 9, Plate 2). Although layer (501) may have been deliberately laid to cover the stone surface, it could also have been produced naturally by soil movement from the surrounding higher cemetery ground.

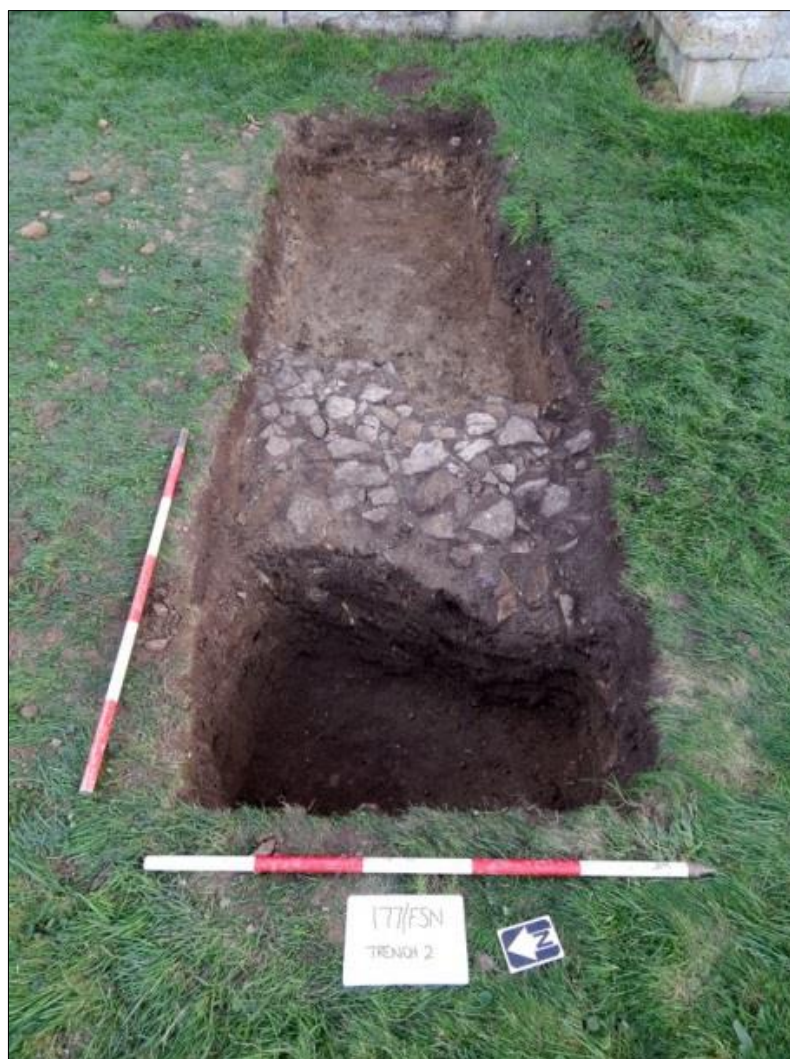
Plate 3: Trench 2, facing east south-east, with 1m scales

Trench 2 was orientated east to west on the north-east corner of the church, perpendicular to Trench 5A (Fig. 7). The trench was 3.5m long, 1m wide, and a maximum of 0.7m deep (Fig. 10, Plate 3). The contexts observed in this trench are as follows:

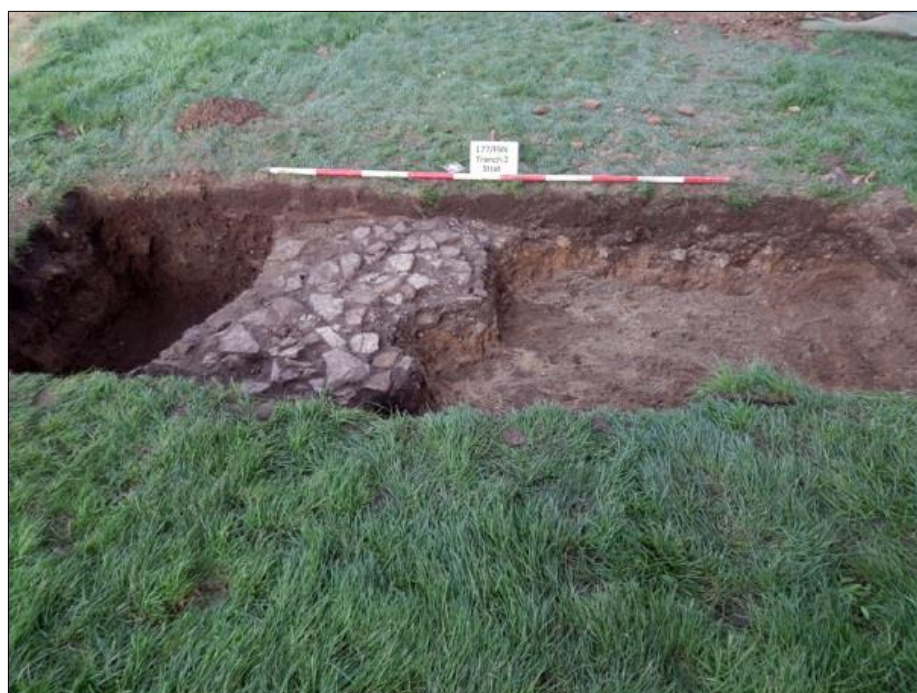
Plate 4: Trench 2 stratigraphy, south-west facing section, with 2m scale

The stratigraphy at the west end of this trench comprised 0.15m of topsoil (200) overlying cemetery soil (203) (Fig. 11, Plate 4). The cemetery soil continued beyond the edges of the trench to the north, south and west, and also underlay the wall foundation (202) but did not continue beyond (202) to the east. A moderate amount of human charnel remains, pottery, and clay pipe was discovered in (202).

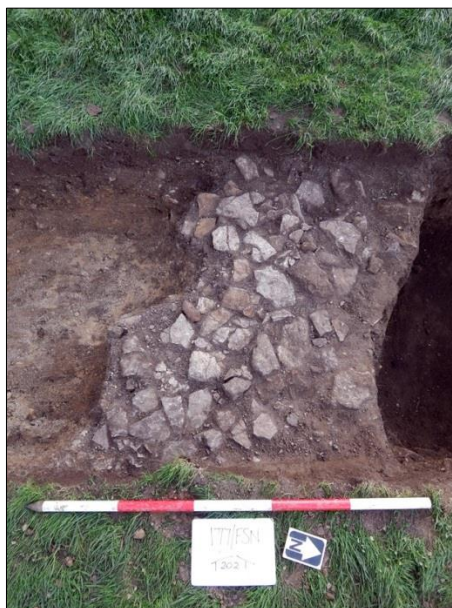
Plate 5: Wall [202], facing south-west, with 1m scale

A stone feature (202), which may have been a footpath or a wall foundation, was observed at the western end of the trench (Fig. 10, Plate 5). There were no finds within this feature. Probing by hand with a metal rod indicated the feature may extend on the same alignment to the north and south of the trench.

To the southwest of the path was a stone feature (202), which ran parallel to but on a slightly different alignment from the west wall of the church. The location and composition of the feature as well as the lack of burials to the east of it would suggest that this was a wall, possibly a retaining wall for the burial ground or a building that has since been demolished. However, an illustration of the church from 1850 depicts a path in much the same location, which, if the drawing is accurate, could provide an alternative function for this feature. Probing indicated the feature extended some way north and south of the trench, but the GPR survey may provide further information on the size and function of the feature.

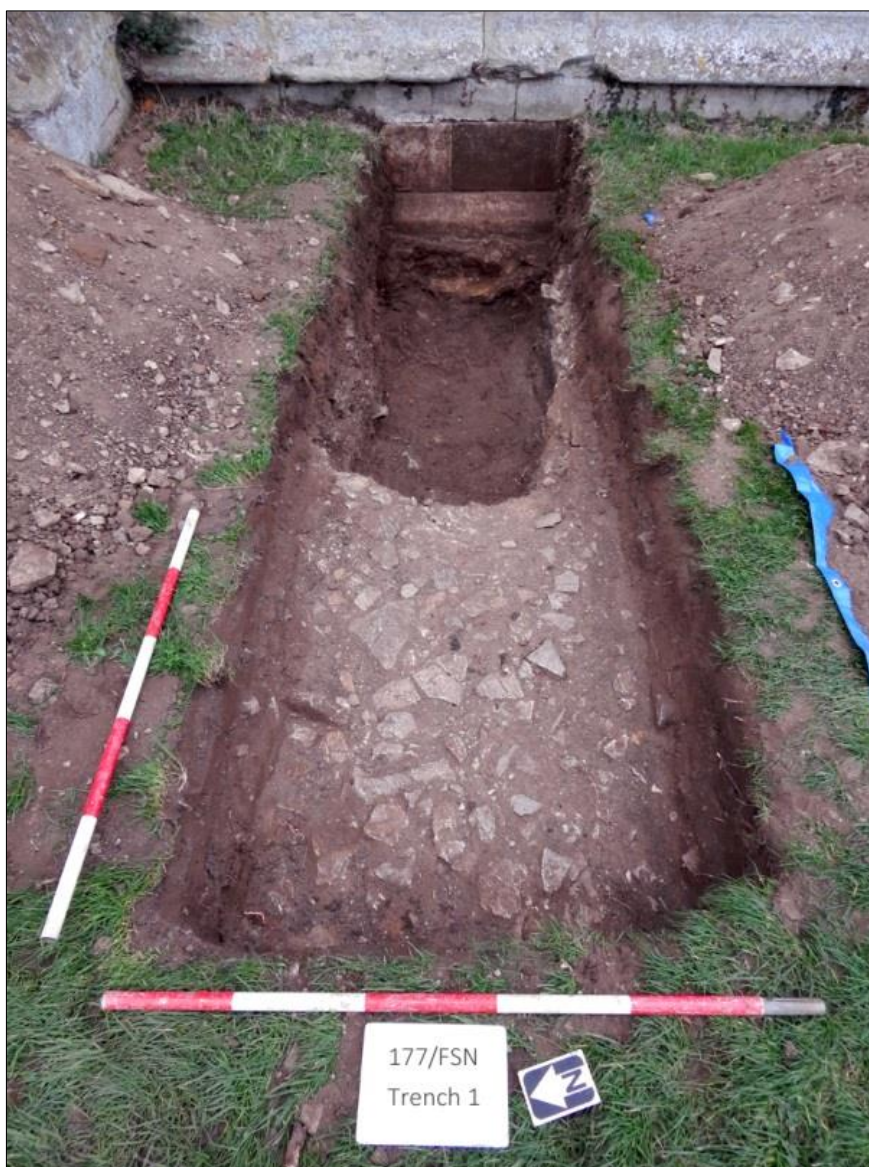
Plate 6: Trench 1, facing east south-east, with 1m scales

Trench 1 was orientated east to west, parallel to Trench 2. It was positioned perpendicular to the church wall at the south-western corner of the building (Fig. 7). The trench was 3.5m long, 1m wide and a maximum of 0.8m deep (Fig. 12, Plate 6). The contexts observed in this trench are as follows:

Surface (103), which appeared to have been a demolition layer, had also been truncated (Fig. 12, Plate 6). As there were no finds, this cannot be accurately dated.

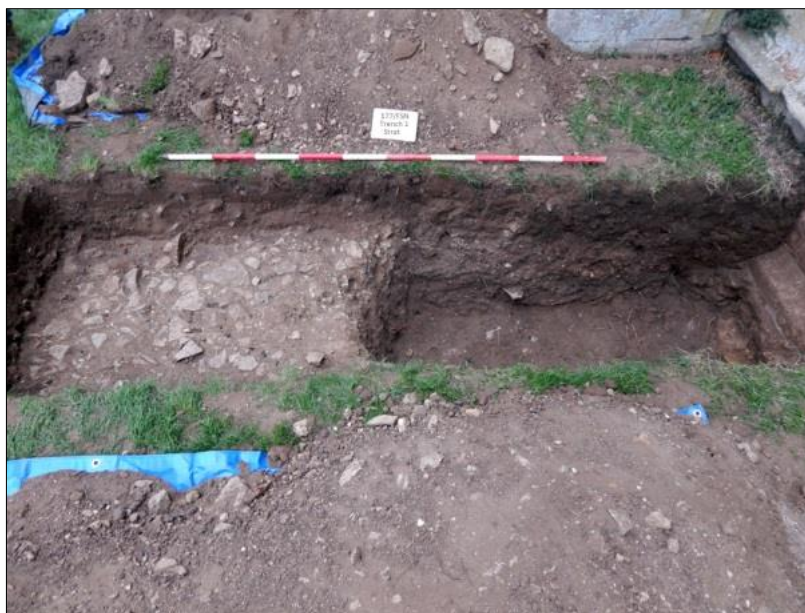
Plate 7: Trench 1 stratigraphy, south-west facing section, with 2m scale

The stratigraphy of this trench comprised 0.26m of topsoil (100) above a stony layer (101), 0.34m deep, which overlay cemetery soil (105) (Fig. 13, Plate 7). Layer (101) was most likely formed in a similar manner to (501) in Trench 5A. This layer contained a small amount of adult, and a moderate amount of subadult human charnel remains. The cemetery soil (105) was the same in composition as (203), and finds from this layer included a moderate amount of adult and subadult human charnel remains, CBM, oyster shell, glass and clay pipe.

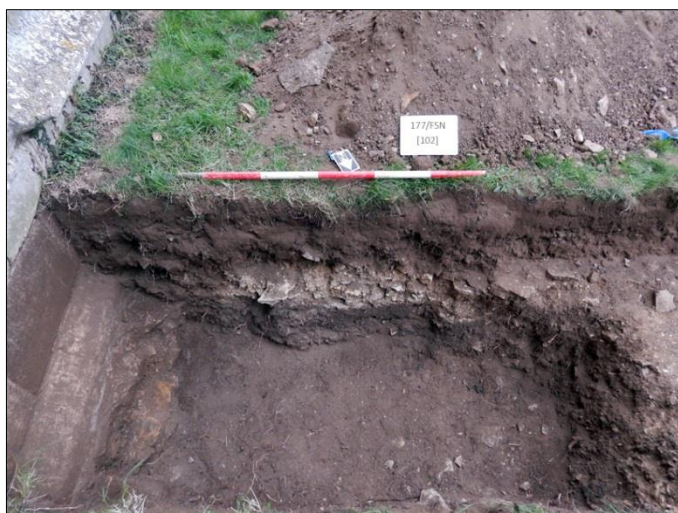
Plate 8: Surface [102], north-east facing section, with 1m scale

Surface (102), which was rectangular with straight edges, underlay surface (103), and was most likely a demolition layer or a path rather than a wall due to the loose nature of the

structure and its positioning in relation to the extant church wall (Fig. 13, Plate 8). It was, however, only observed in the north facing trench section having been cut, presumably for burial purposes. No datable finds were recovered.

Stone deposits were found to the south of wall (202) in Trench 1, which appear to have been the result of two separate events. A possible path (102) was revealed in the southern trench section, above which was a more loosely arranged assemblage of rubble stone (103) extending westwards that appeared to have been the result of demolition. Again, it is hoped that the extent, and possibly function, of these features will be discernible in the GPR survey.

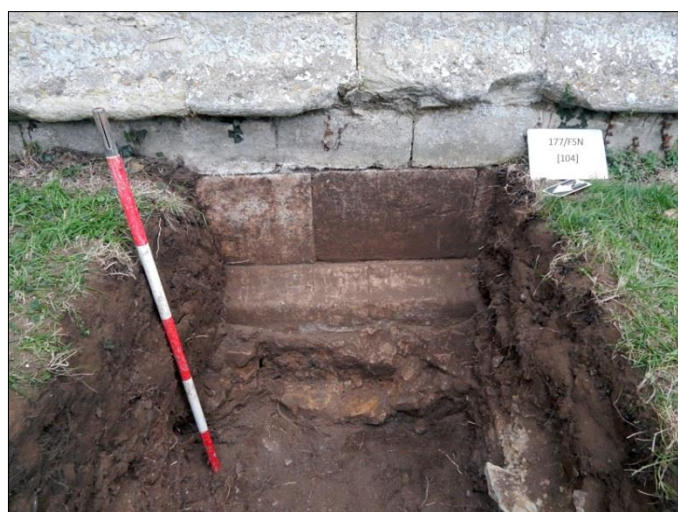
Plate 9: Foundation [104], facing east south-east, with 1m scale

The church foundations (104) were revealed at the eastern end of the trench (Fig. 12, Plate 9) and consisted of rubble stone footings beneath the corbelled basal course of the dressed stone wall. The base of the wall had been completely obscured by soil that had built up since the wall was first constructed in the 15th century.

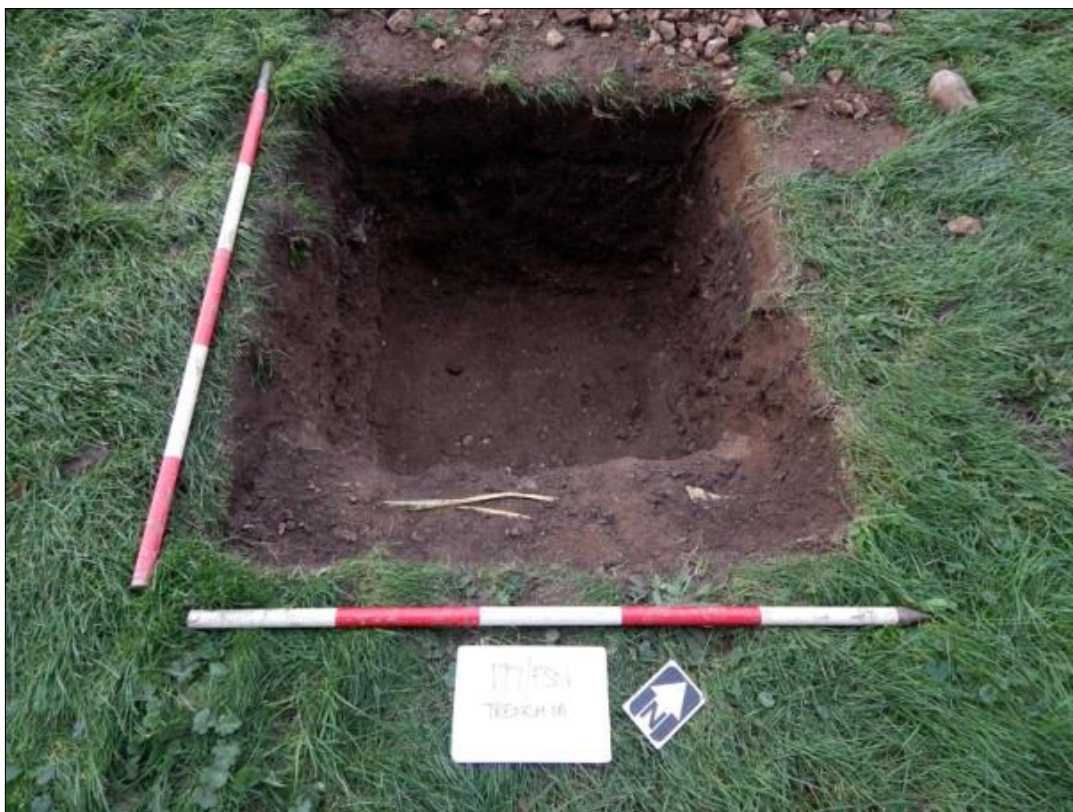
Plate 10: Trench 1A, facing north-west, with 1m scales

Trench 1A was located to the west of the west door and measured 1m² with a maximum depth of 0.65m (Figs. 7 & 14, Plate 10). The contexts represented in this trench comprised:

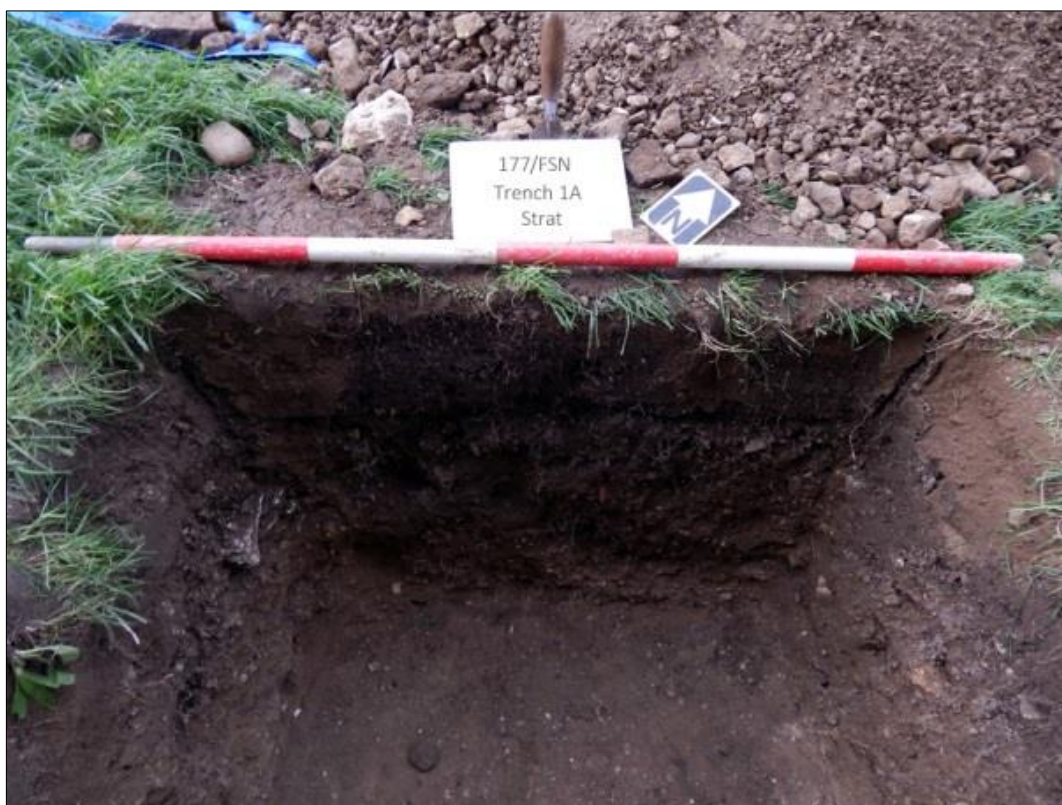
Plate 11: Stratigraphy of Trench 1A, south-east facing section, with 1m scale

The stratigraphy of this trench comprised 0.19m of topsoil (106) overlying cemetery soil (107) (Fig. 11, Plate 11). Finds in (107) included a small amount of adult human charnel remains, iron objects and animal bone. There was a modern service cutting through the southern part of the trench.
