KDK ARCHAEOLOGY LTD

## Historic Building Observation and Recording Report

44 High Street  
Kings Langley  
Hertfordshire

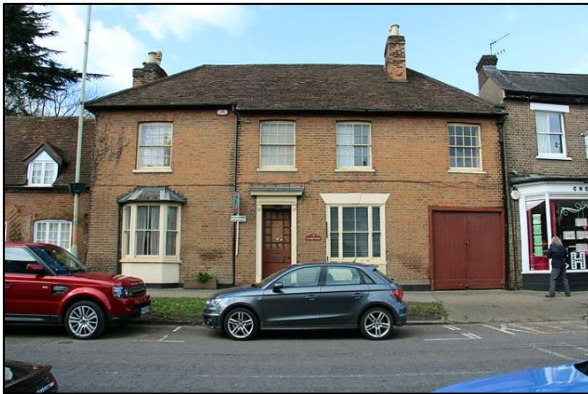
44 High Street is a 2-storey brick encased building set directly onto the street frontage (Plate 1). A covered access to the north of the front elevation leads to the garden, where two new houses are under construction as part of the overall development of the site. At the southern end of Number 44 is a 19<sup>th</sup> century coach house/stable (Plate 2), the upper floor of which has been incorporated into the living space of the house.

**Plate 1:** Front elevation

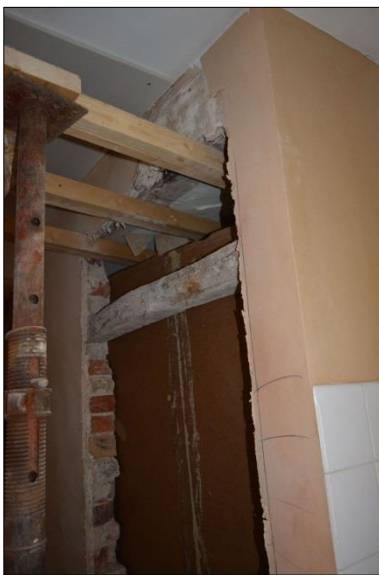
The internal walls were breached in Rooms G3, G5 and F5, revealing the brickwork beneath the plaster. The bricks were fairly uniform in appearance, although only a few were evident in each opening. They appeared to be handmade with some Spanish and probably dated from the 18<sup>th</sup> or early 19<sup>th</sup> century. The bricks in the west wall of G3 could be measured and were found to be c. 22 x 10 x 6cm (8 $\frac{5}{8}$  x 4 x 2 $\frac{3}{8}$  inches). These were set in lime mortar, whereas the bricks in the east wall of G5 and the west wall of F5 were set in cement based mortar. What may have been a bonding beam was also exposed in F5 (Plate 3).

**Plate 3:** Bonding beam and exposed brickwork in Room F5

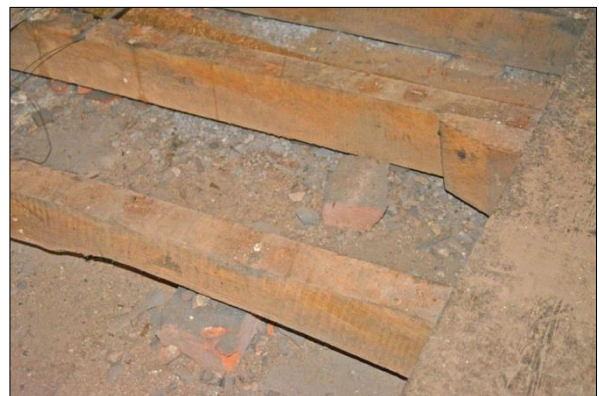
A selection of floorboards was removed in Rooms G2, F1, F3, F7 and F12 in order to assess the condition of the underlying joists. The joists in Room G2 to the south of the main entrance were aligned east-west and were 5.5-6cm wide, 12cm high and 36-43cm apart (centred measurement). The saw cuts were well spaced but even, and likely to have been made by machine. The floor below appeared to be cement (Plates 4-5).

**Plate 4:** Joists in Room G2

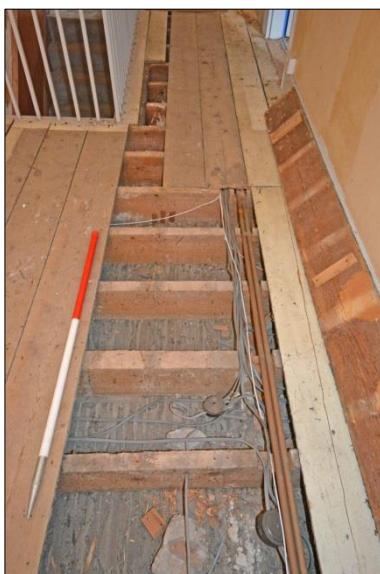
**Plate 5:** Joists in the landing (F1)

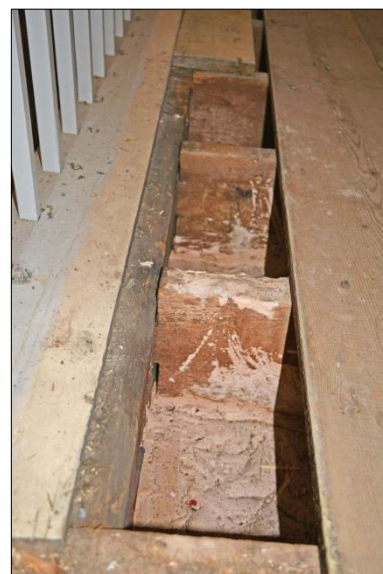
The floor joists on the first floor, which were all aligned north-south, were fairly uniform throughout, measuring between 4.5 and 8cm, 19-20cm high and c. 30cm apart. Only in the landing (F1) was it possible to see how the joists were tenoned into a major timber (Plates 5-6). A central tenon of equal length to the shoulders on either side was used.

**Plate 6:** Detail of central tenons

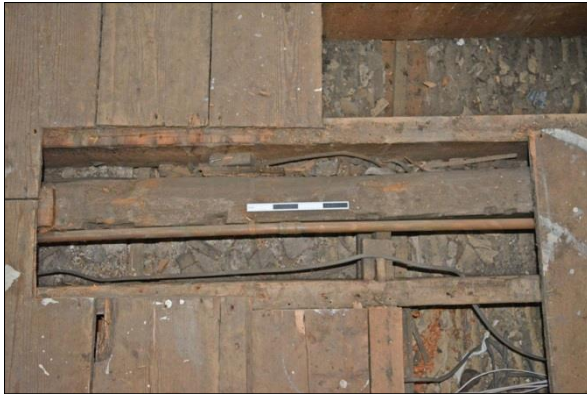
A re-used timber was exposed in Room F2, closely set between two other joists (Plate 7). Redundant mortices were apparent on the upper face, but not entirely exposed, as a copper pipe had been set alongside the timber. Both in this room and in Room F7, where there were two closely spaced joists, a timber was aligned at 45 degrees to the joists that terminated with a tusk tenon. The joists in Room F7 also had diagonal bracing in the exposed area, which was to the east of the tusk tenon (Plate 8). It was not possible to see whether this bracing extended beyond the tusk tenon.

**Plate 7:** Re-used timber used as a joist in Room F2

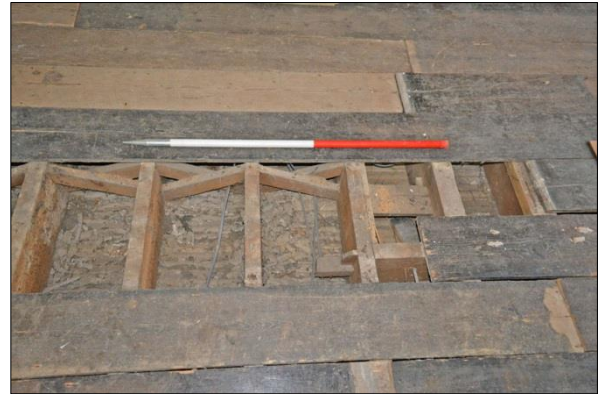
**Plate 8:** Diagonal bracing and tusk tenon in Room F7

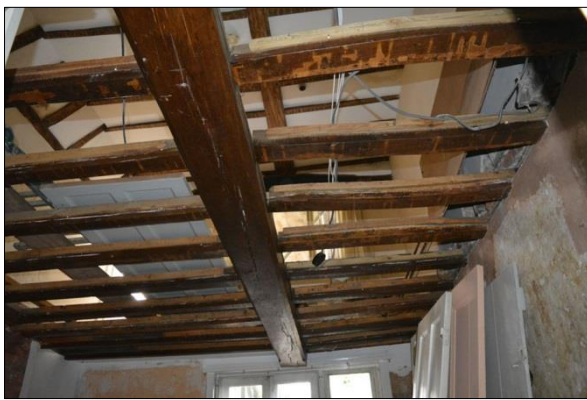
The beam and floor joists in Room F8 were completely exposed (Plates 9 & 10), revealing the date 1981 carved into the upper face of the beam. Machine made tool marks were observed on the eastern end of the beam, although the western end appeared to have been more crudely handled. Both beam and joists are later insertions; machine made tool marks were also evident on their untreated surfaces.

**Plate 9:** Fully exposed joists in Room F8 from below

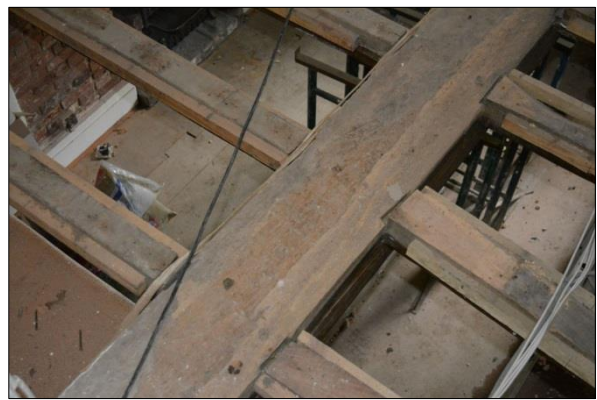
**Plate 10:** Fully exposed joists in Room F8 from above

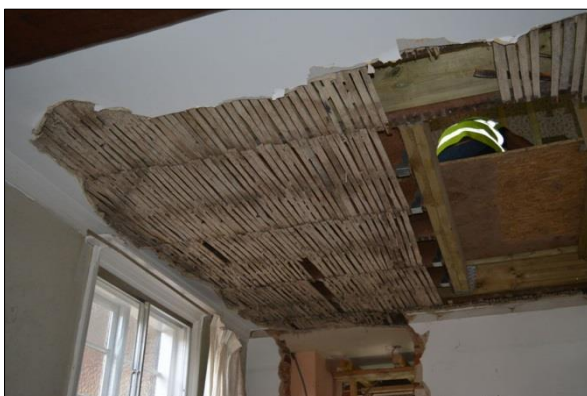
Where exposed, the ceilings in the building were lath and plaster (Plate 11).

**Plate 11:** Lath & plaster ceiling in Room G5

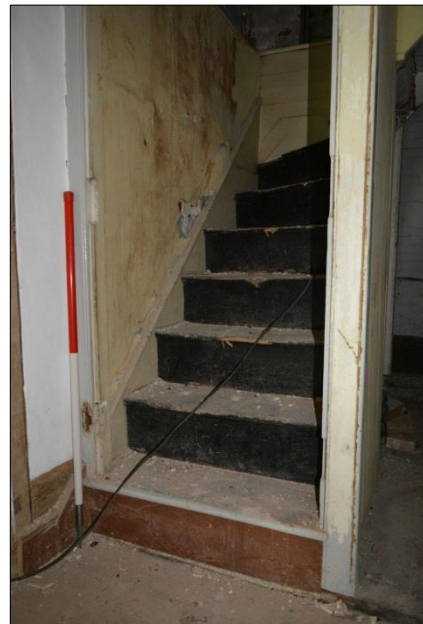
The rear staircase, which was an enclosed timber structure of 10 treads, was opened up for re-use (Plates 12-13).

**Plate 12:** Rear staircase

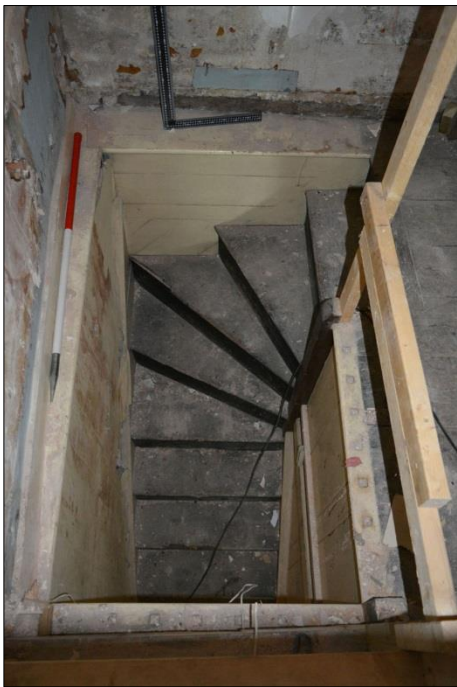
**Plate 13:** Rear staircase from above

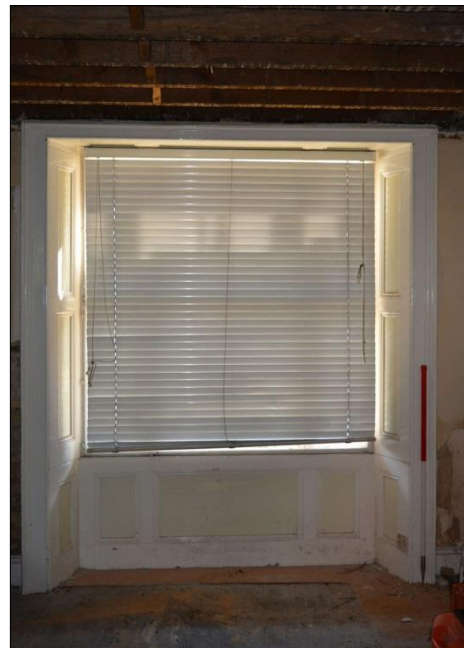
The cork tiles were removed in the kitchen (Room G2) revealing c.22-23cm wide timber boards, aligned east to west. No other architectural or structural details of note were observed (Plate 14).

**Plate 14:** View to east in the kitchen (Room G3)

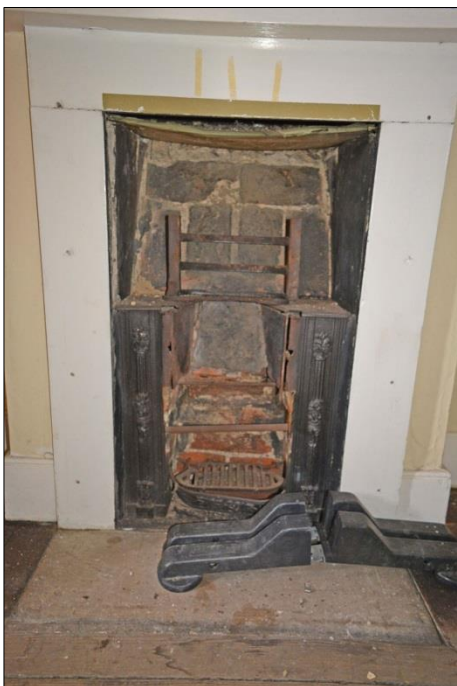
The timber surround to the fireplace, which had a cast iron grate with acanthus leaf motif and a stone hearth, was removed (Plate 15).

**Plate 15:** Fireplace in Room F3

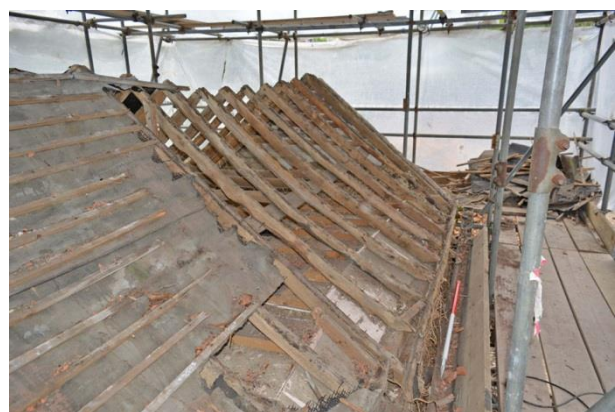
The roof was a simple A-frame without a ridge post or board (Plate 16). The rafters, of which one or two were waney edged, were between 4 and 7cm wide and roughly 30cm apart. A few collars had survived at the western end as well as a section of purlin on the west end of the north side of the roof. Some lath and plaster was also evident at the base of the roof. The eastern gable end was covered with lath and plaster (Plate 17) whereas that to the west was of brick (Plate 18). These and the tiebeams were all that remained of the original roof. The new trusses were to be visually tied into the older fabric by means of king posts on the original tie beams.

**Plate 16:** View of the stable roof from the southwest

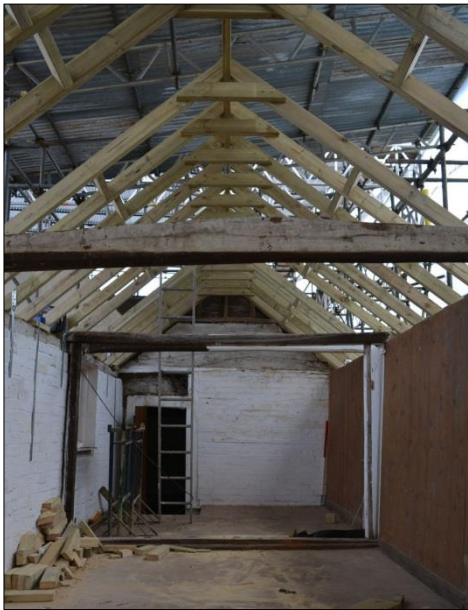
**Plate 17:** Eastern end of the stable

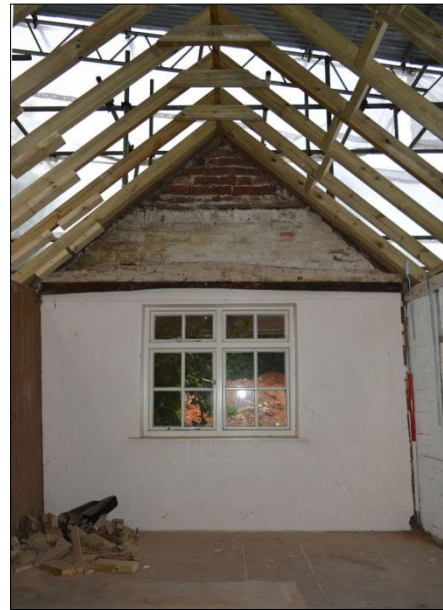
**Plate 18:** Western end of the stable

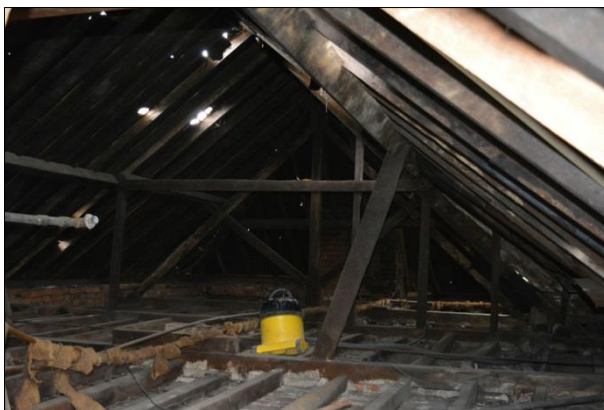
The roof over the main range consisted of a king post truss at the southern end, to the north of which was a queen post truss. Elsewhere raking braces with birds mouth joints supported the purlins (Plate 19). At the northern end of the roof space was a chimney breast built of a mixture of brick types, possibly dating from the 18<sup>th</sup> century (Plate 20). Twentieth century work on the three roofs over the main house was evident in the battens and roofing felt. Some of the roof tiles were also modern (R. Cain pers. comm.).

**Plate 19:** Roof over the main range looking south

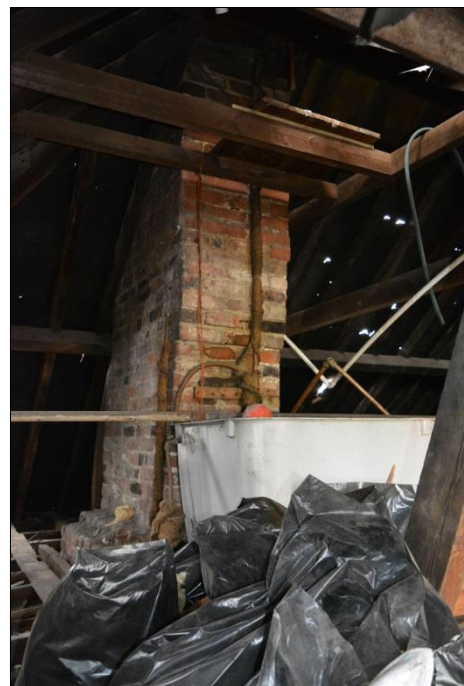
The scaffolding allowed detailed photographs to be taken of the chimney stacks, which were all built of different brick types and in different styles. The chimney stack over Room F7 was 19<sup>th</sup> century and built of gault bricks (Plate 21). The red brick stack serving rooms G6 and F8 appears to be of 18<sup>th</sup> century bricks and that serving rooms G2/F12 of earlier, Tudor sized bricks (Plates 22 & 23).

**Plate 20:** Chimney at the northern end of the main range

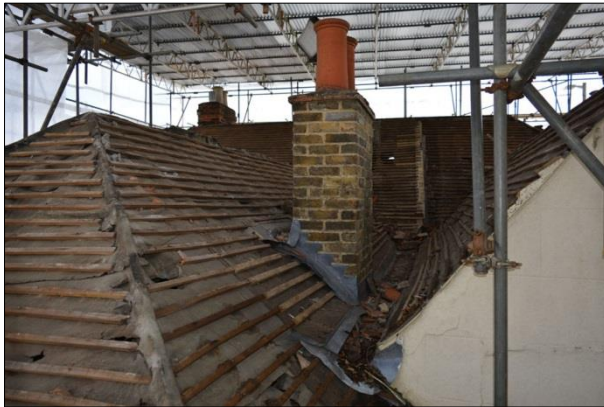
**Plate 21:** Roof over northern extensions looking east

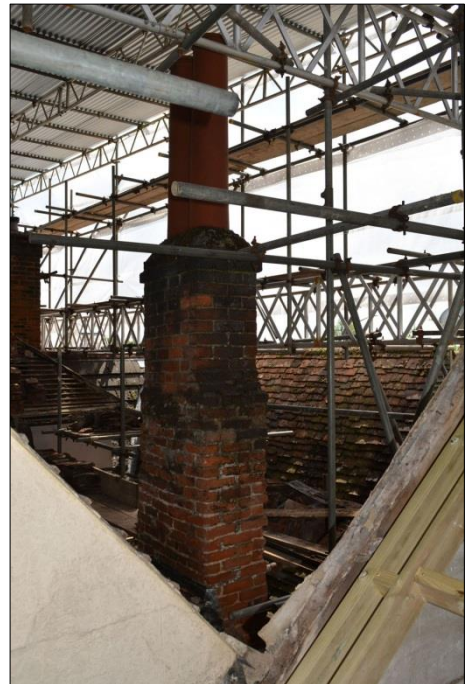
**Plate 22:** Chimney stack for G6/F8

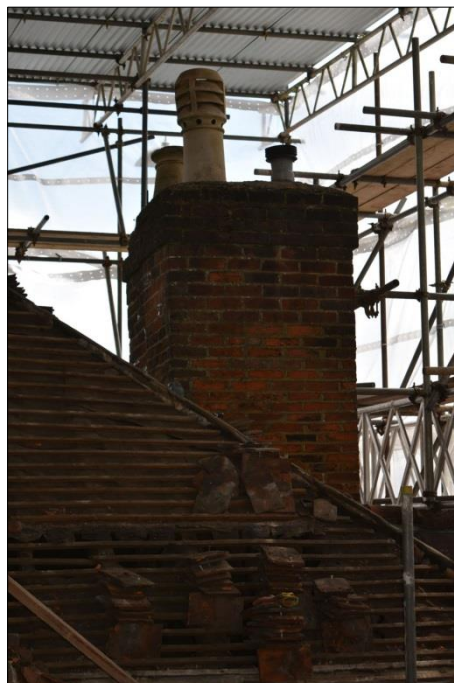
**Plate 23:** Chimney at southern end of main range
