## Historic Building Recording

Villa Farm

New Road

Great Barford

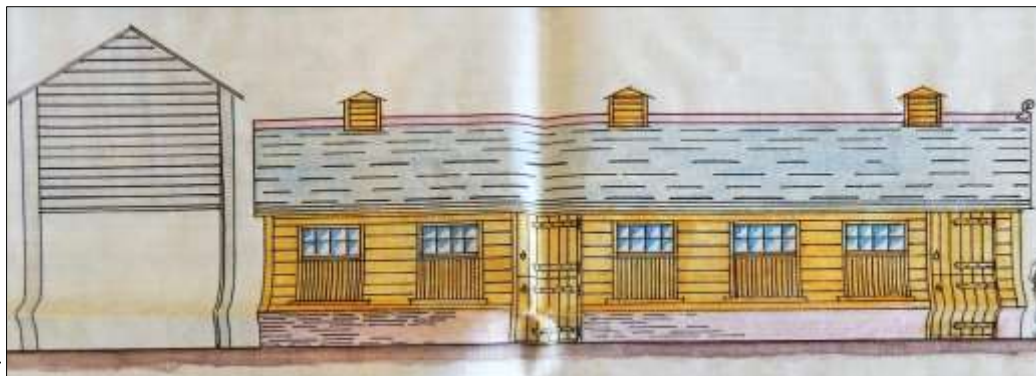
The farm was clearly being redeveloped around the time Thomas took over the tenancy. A set of plans produced by Wilstead architect T. Finding in 1912, depicts a new stable and cow shed alongside the already extant onion shed (RDBP 1/214).

Figure 11: Exterior of development from 1912 drawings (scale 1:100)

Figure 12: Plan of development from 1912 drawings (scale 1:100)

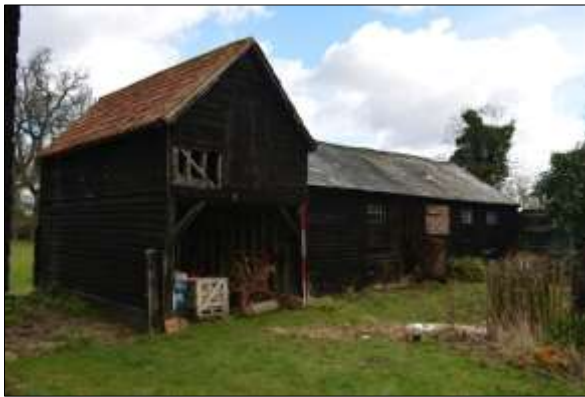
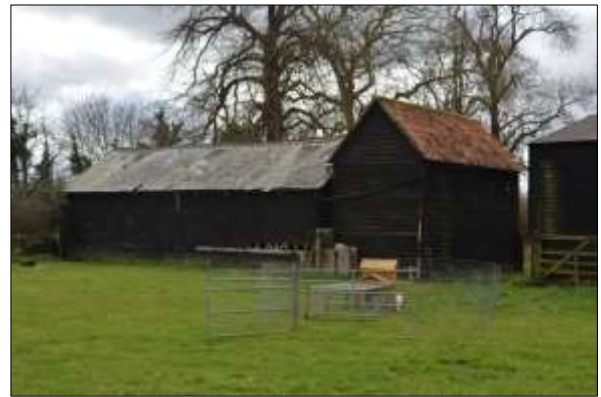
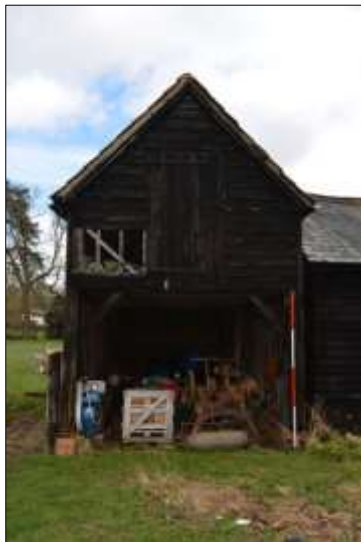
The Onion Shed is a 2-bay, 2-storey weatherboarded structure, set on 34.5cm high brick supporting dwarf wall under a clay tiled roof (Plates 1-3). The bricks, which measure 22.5 x 10 x 6.5cm (8 $\frac{7}{8}$  x 4 x 2 $\frac{1}{2}$  inches) are set in Flemish bond with lime mortar. Although painted black, they appear to be handmade red bricks. Horizontal skintlings are evident on some of them, which would suggest that they were made between the end of the 18<sup>th</sup> century and the large scale mechanization of brick making in the mid – late 19<sup>th</sup> century. Within the weatherboarding are fixed vents some 2.65m above ground level, on all but the south elevation. The south elevation is open fronted at ground floor level, above which is a door with long strap hinges on pintles (Plate 3).

**Plate 1:** Onion Shed & Cowshed/Stable from the southwest

**Plate 2:** Onion Shed & Cowshed/Stable from the northwest

**Plate 3:** Onion Shed: south elevation

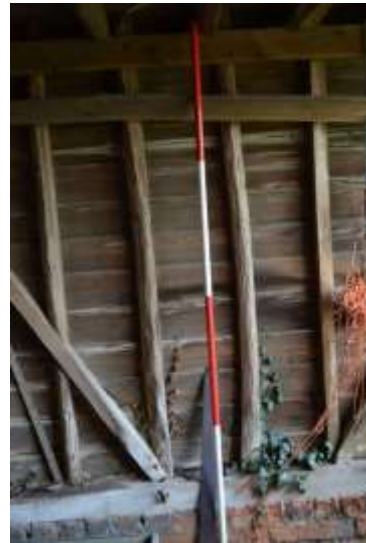
Internally, the brick supporting dwarf wall is some 28cm high and unpainted. The timber framing has primary bracing with both machine cut studs and studs that have either been quartered or halved (e.g. Plate 7). The machine cut studs vary in width from 5cm in the east wall to 7-8.5cm in the north. The sole plates are also variably sized, from 8cm in the north wall to 10cm in the east. Re-used timbers, such as the braces in the southern bay and a vertical post that was adzed on the eastern face, are present in the west elevation (Plate 8).

**Plate 8:** Onion Shed: adzed studs in the east wall

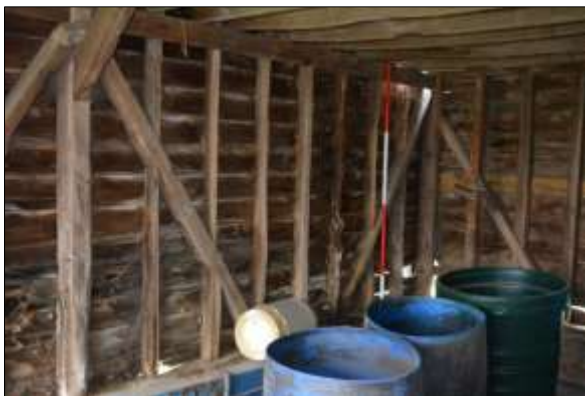
The joists at the northern end of the structure are made from poles (Plate 9), but elsewhere they are halved timbers. The loft floor above is made of timber slats, approximately 4cm wide, set 2cm apart to form vents. However, at the front of the loft are some boards giving a 40cm wide solid floor to allow safer access into the vented loft space.

**Plate 9:** Onion Shed: northwest corner

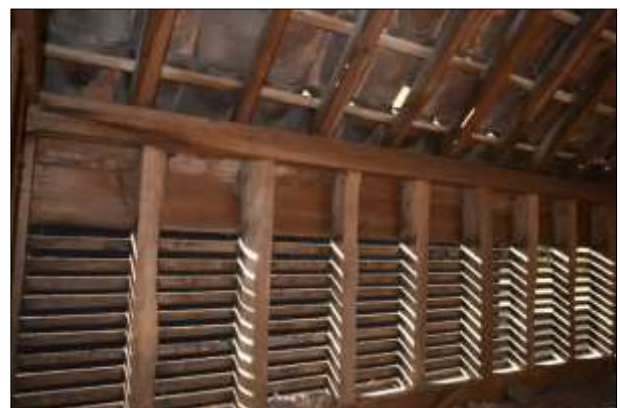
The studs at first floor level are 8cm wide and set 35-40cm apart, and the distance from the floor to the top of the wallplate is just 1.12m (Plate 12). Immediately below the wallplate is a board, some 22cm deep, below which are 4cm side louvres also set 2cm apart. There is primary bracing to either side of the door but not on the opposite wall.

**Plate 12:** Onion Loft: louvre detail

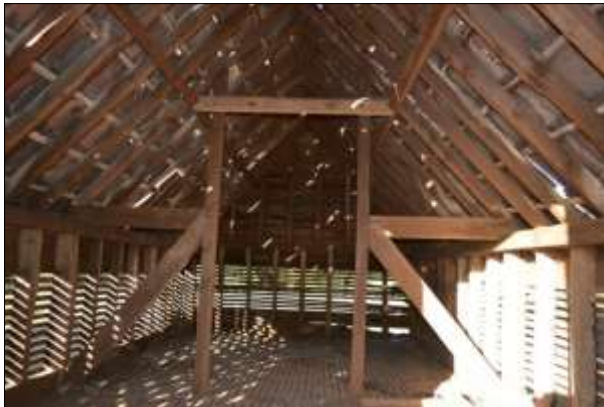
The building has a queen post roof with diagonal bracing and birds mouth joints that support the purlins to either side (Plate 13). The rafters are 3-6cm wide and set 28-30cm apart. The timbers are all softwood.

**Plate 13:** Onion Loft: queen post truss

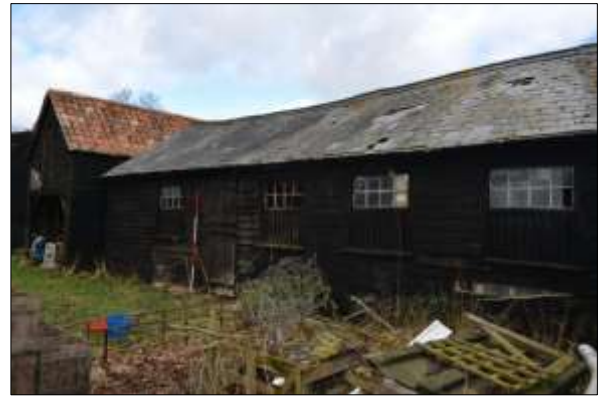
This is a 4-bay timber structure built to provide a single stable in the easternmost bay whilst the remainder was used as a cowshed. Like the Onion Shed, it is weatherboarded and sits on a brick supporting dwarf wall but has a slate roof rather than a tiled one. The only openings are in the south elevation, where there are two ledged and braced stable doors and four timber windows with 8 panes above hit and miss vents (Plate 14).

**Plate 14:** Cowshed: from the southeast

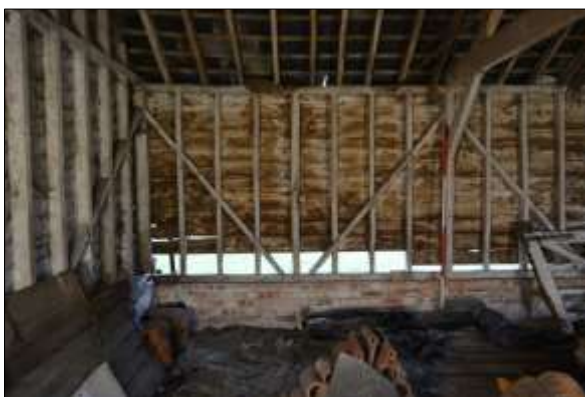
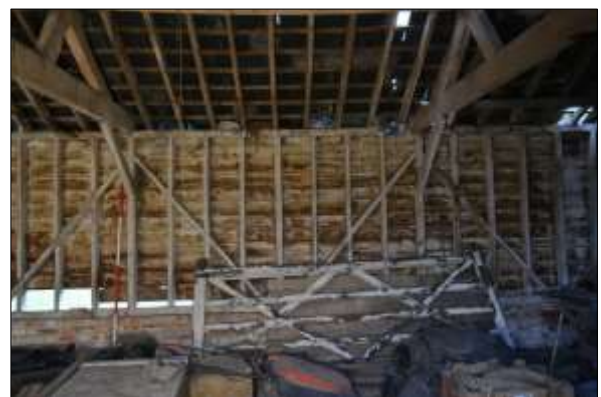
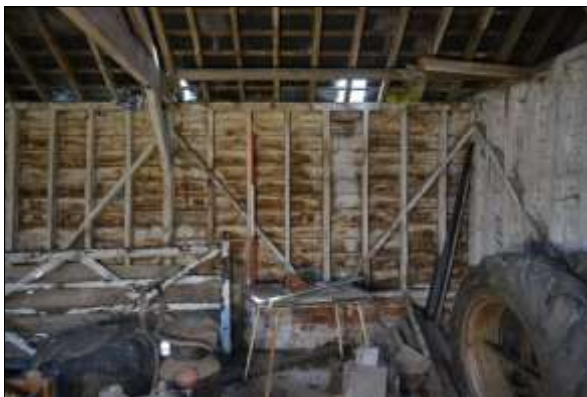
The timber frames have primary bracing, with studs that are 5cm wide and posts and sole plates that are 7 or 8cm (Plates 17-19). There are two edge-halved scarf joints in the northern wallplate in the cowshed, with the possibility of another in the stable. The supporting dwarf wall, on which the partition rests between the cowshed and the stable, is 49cm high and built of Fletton bricks in Stretcher Bond using cement mortar. The timber frame above, which also has primary bracing, is weatherboarded on the eastern face. The east wall of the stable is again built predominantly of red bricks with some Flettons.

**Plate 17:** Cowshed: Bay 2, north wall

**Plate 18:** Cowshed: Bay 3, north wall

Plate 19: Cowshed: east wall

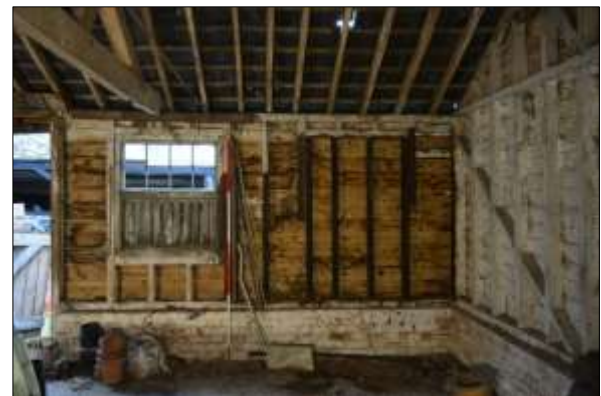
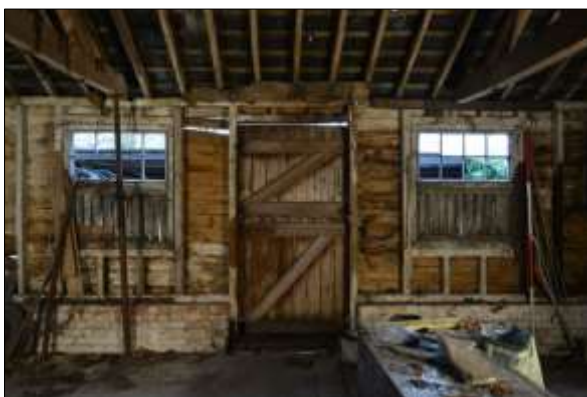
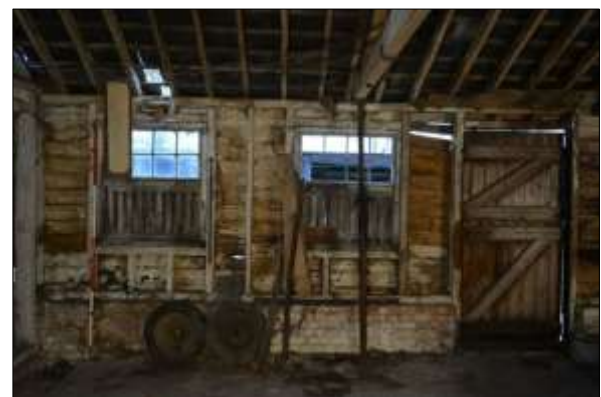
The floor of the cowshed is concrete, but stops some 3cm short of the north wall. A 37cm wide gully runs along the south wall (Plates 22-24) and returns at the eastern end. The gully in the stable (Plates 25-29), which is also aligned east-west, is considerably smaller at 18cm in width. There is no evidence for feeding troughs in either part of the building, although this may exist along the north wall of the Stable, which is obscured.

Plate 22: Cowshed: Bay 1, south wall

Plate 23: Cowshed: Bay 2, south wall

Plate 24: Cowshed: Bay 3, south wall

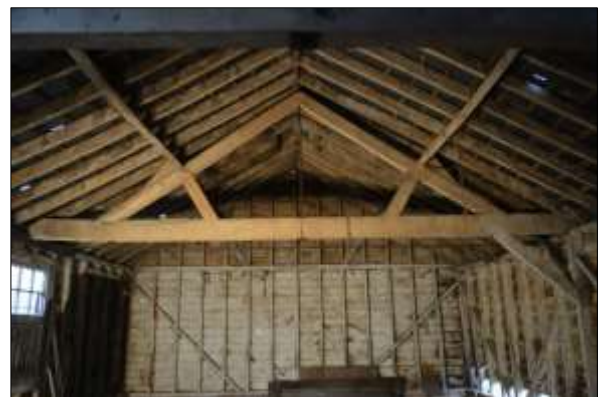
The roof has trenched purlins with cleats and raking queen post trusses with metal rods forming the central upright (Plate 30). Missing slates at regular intervals suggest the former presence of louvres or roof vents of some form.

Plate 30: Roof truss
