Historic Building Recording, Historic Building Watching Brief and Archaeological Watching Brief

Wilstone Great Farm Stables

New Road

Wilstone

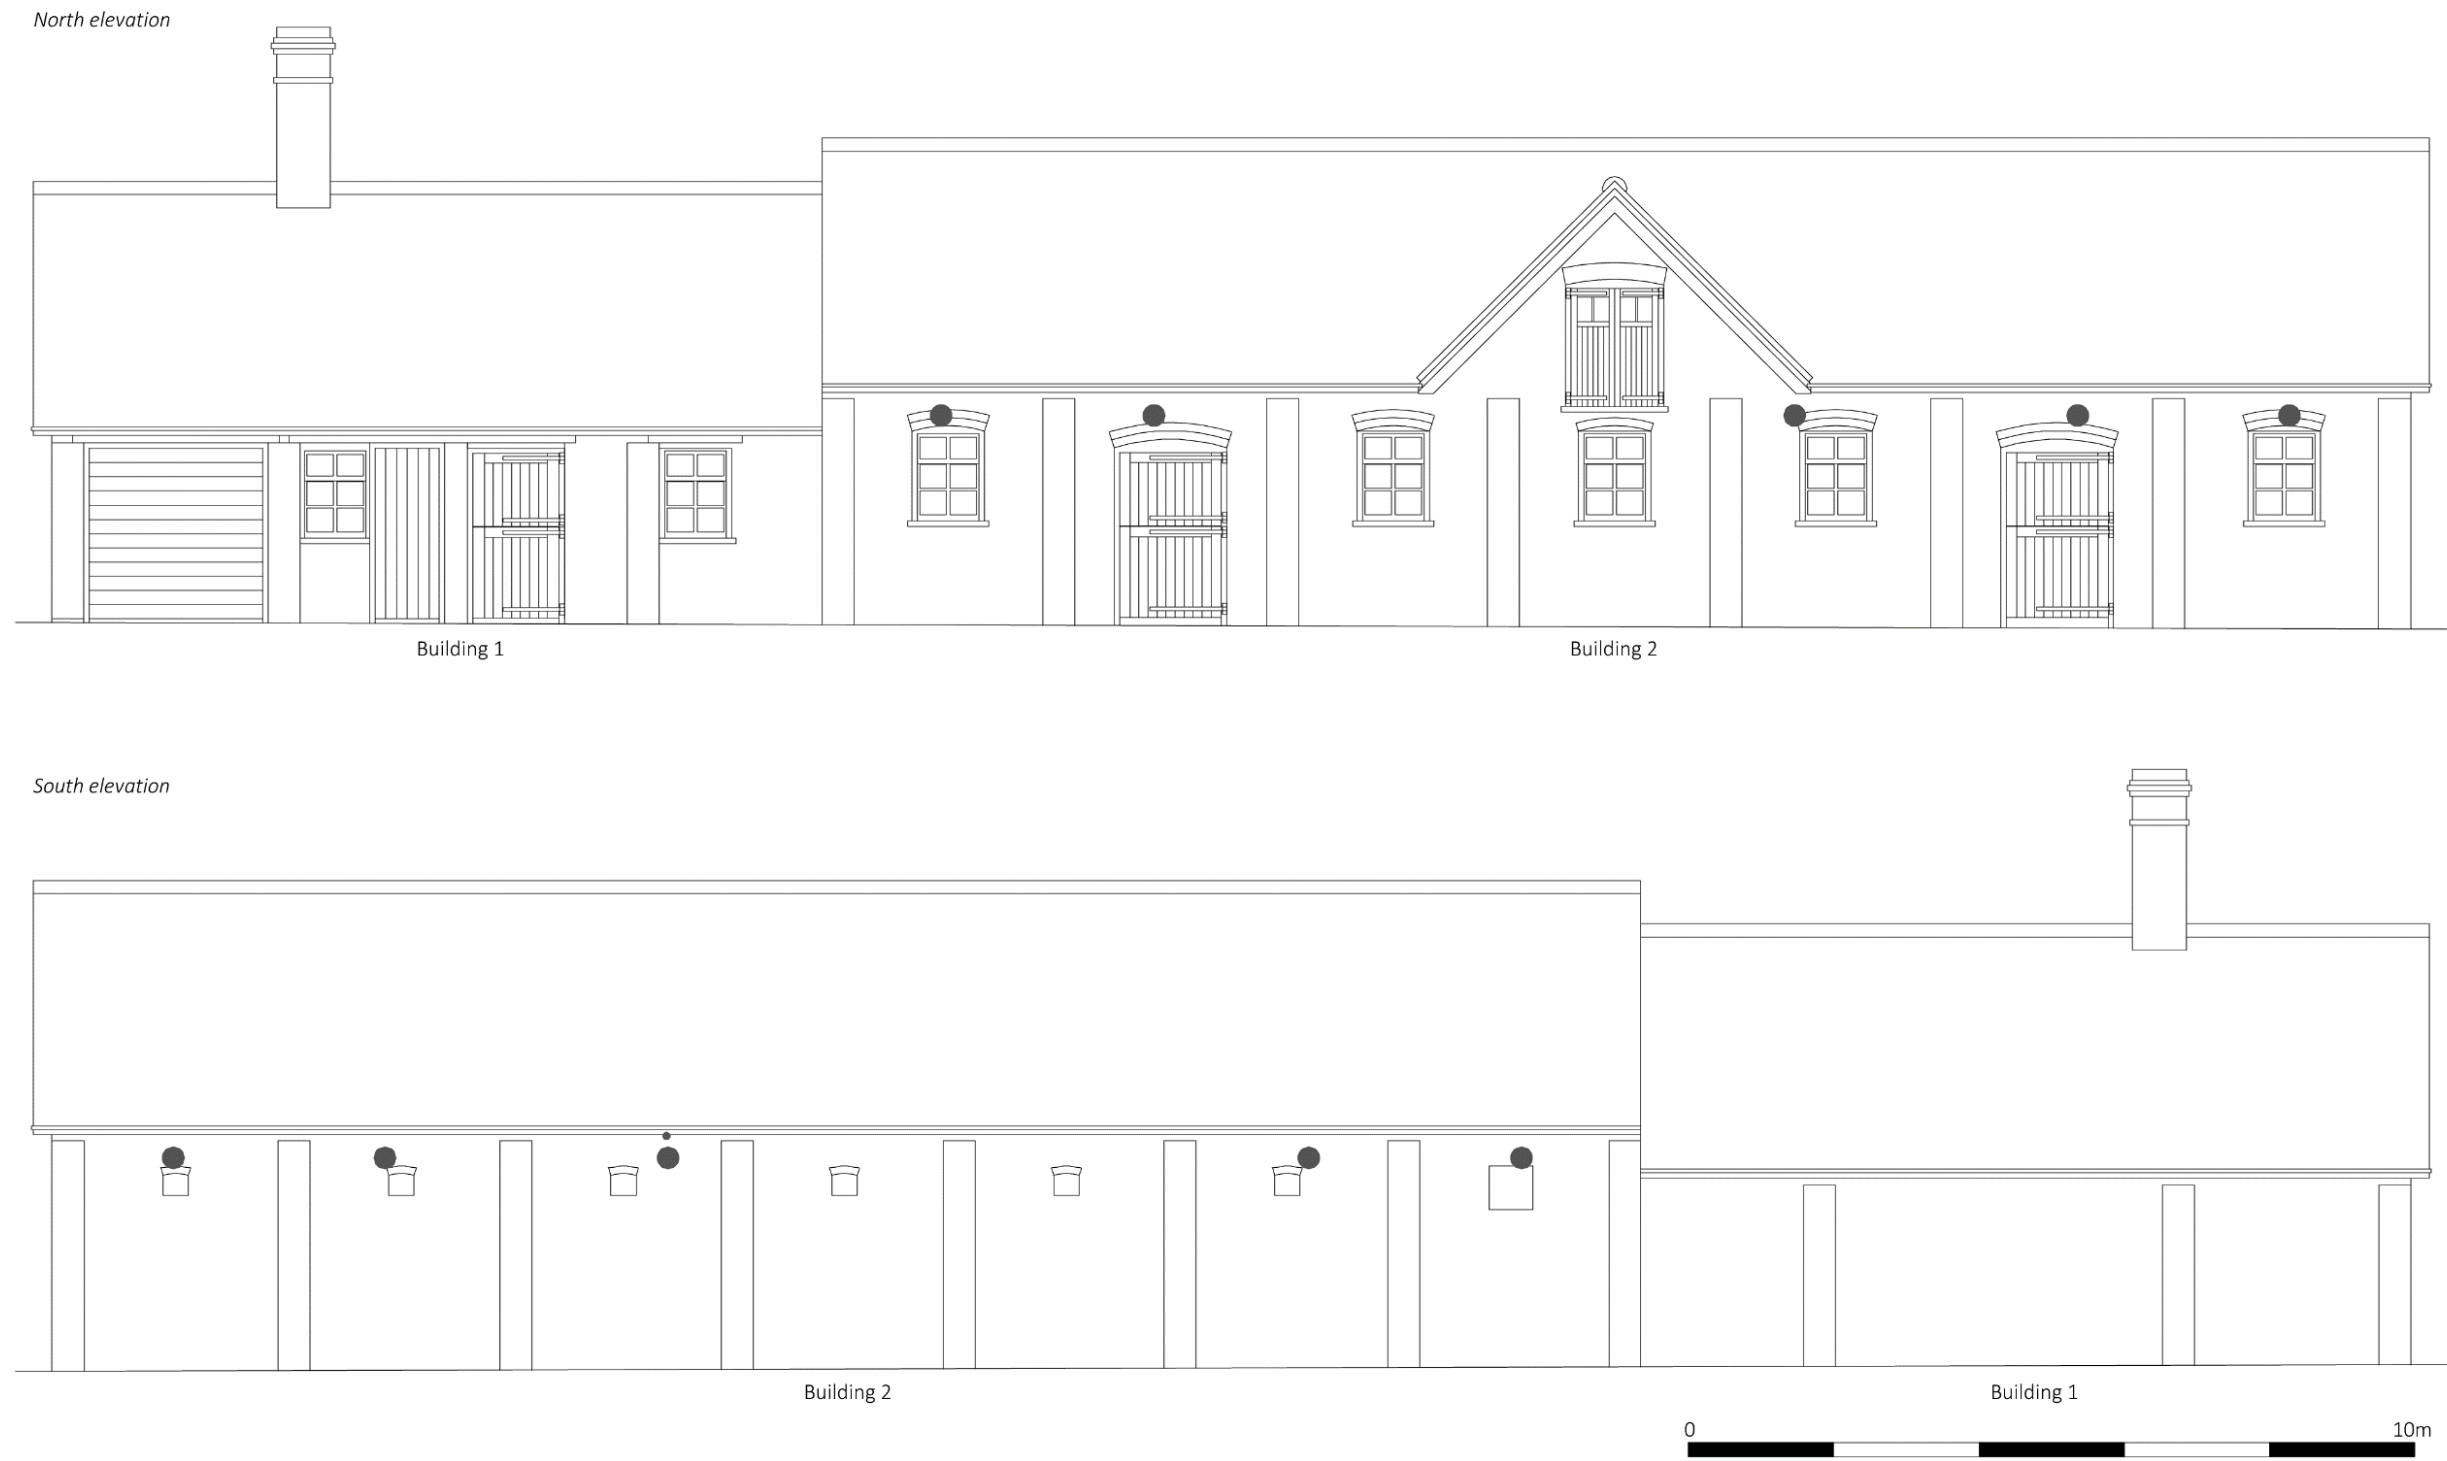
Figure 6: Northwest and southeast elevations (scale 1:100)

The north elevation of Building 2 has a centrally located gable with double hayloft doors, a stable door at ground floor level to east and west and 5 timber windows, all of 6 lights with the upper lights top hung (Shots 1-2 & 4). The openings all have segmental relieving arches and a timber sill. A brick buttress is located between each opening. There are five large iron ties above some of the openings and the smaller ones c.0.20m above ground level.

Building 1 is similar in its overall construction, and has a stable door to the right opening into former tack room, a modern garage door at the eastern end that have replaced timber doors hung on pintles (Shots 1&3). Between the two is a single timber door opening into an office. Both this and the tack room are lit by timber windows similar to those in Building 1.

The south elevation of both buildings has brick-built buttresses at regular intervals, with a single light window beneath the eaves in Building 2 (Shots 7-9). These, like the window in the north elevation of Building 1 have single relieving arches and a brick sill. There is a timber air vent at the eastern end of Building 2 directly above the window. There are no window or other features on the south elevation of Building 1.

The garage (Room 1) was largely inaccessible during the survey, but the walls were of painted brickwork and the ceiling was exposed (Shot 11). The office to the west (Room F2) had matchboard panelling to all the walls and a herring bone parquet floor. The ceiling was of plasterboard and painted. A top hung window and plank and batten door were located in the north wall and a brick fireplace with an iron grate, stone hearth and concrete surround were to the east (Shots 12-14). The walls in Room G3 were painted brickwork and the floor was also of bricks. A stable door and top hung timber window were located in the north wall and a

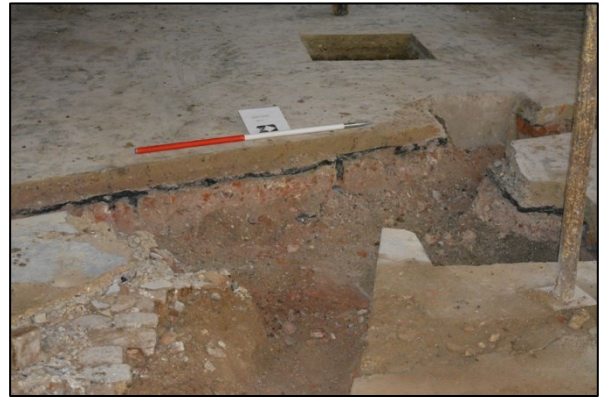
Plate 26: Brick footings in Service Trench 1

A layer of bitumen lay directly over the brick rubble to the west of the north-south aligned wall in Pad 4, and was also noted to the south of an east-west aligned footing in Service Tr 1 (Plates 26-27). It was apparently where the horse fodder was formerly kept.

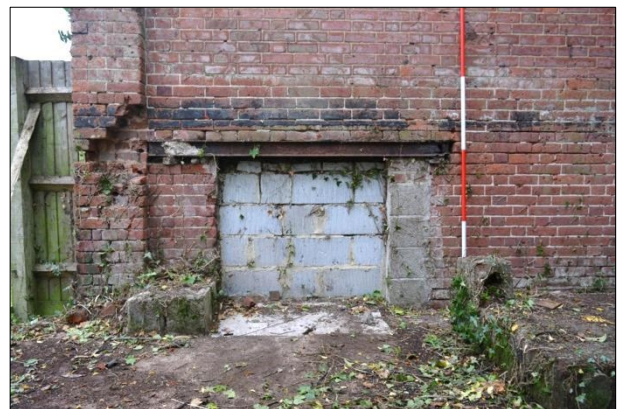
The west elevation has a modern PVC 2-light casement window at first floor level, angle buttresses and a section of blockwork under a steel lintel at the northern end where the opening to the grain silo once was (Shot 5). The opening is 1.51m wide and 1.39m high (Shot 6).

Shot 6: West elevation, bricked up opening

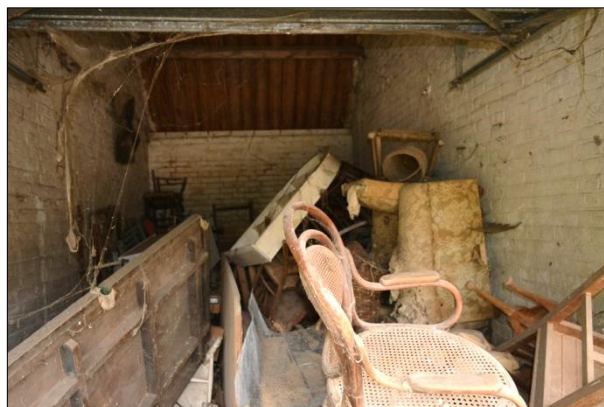
Shot 11: Room 1 looking east

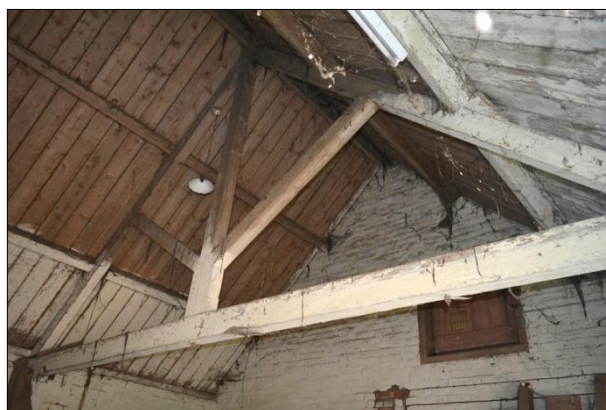
hayloft door in the west wall. The roof was exposed and had king posts with raking queen struts supporting trenched purlins with cleats. The underside of the roof was boarded (Shots 15-17).

Shot 17: Room 3 roof detail

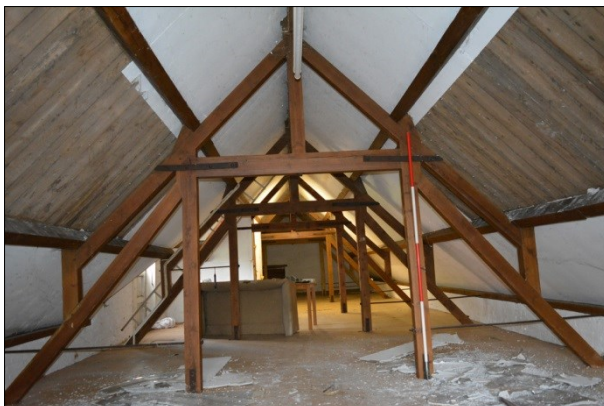
The building had a queen post roof with a king post above the collar and double trenched purlins with cleats (Shots 3-31). The rafters, which terminate just beneath the upper purlin, are supplemented by braces running parallel to them between the queen post and the wall plate. The ceiling consisted of plasterboard over timber boards. Trait de Jupiter scarf joints were present throughout the structure (Shot 32).

Shot 31: First floor roof structure

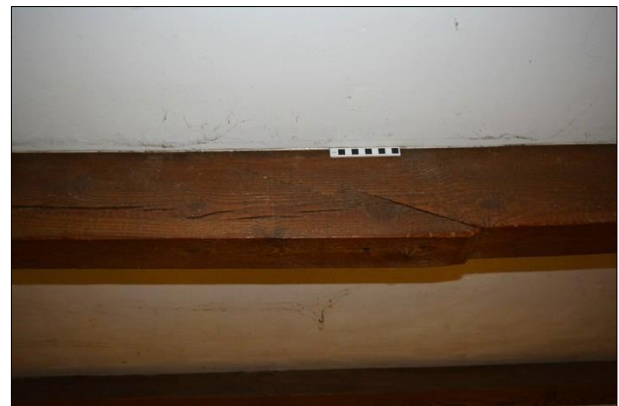
Shot 32: Detail of Trait de Jupiter scarf joint
