Archaeological Observation and Recording Report

St Swithun's Church

Great Chishill

Cambridgeshire

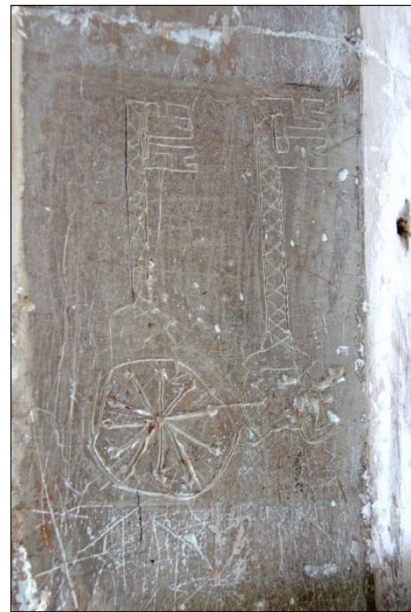
Plate 12: Graffiti depiction of two keys on south arcade column

Inside the church, the Early English origins of the nave are clear to see, characterised by the substantial two-centred arches on octagonal column bases in the south arcade. The tower arch and chancel arch are also two-centred in the Early English style but are noticeably offset to the south, demonstrating the past widening of the nave and the 15th century extension of the north aisle. The timber nave roof also dates to the 15th century and consists of tie beams supported on wall posts with curved braces and spandrel traceries springing from stone corbels. Also of note is the varying graffiti of unknown ages present on the arcade columns, which includes a compass and an image of two keys.

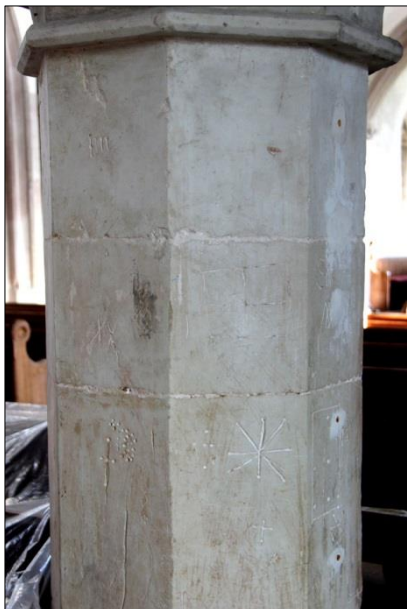
Plate 13: Various graffiti to south aisle column, including compass and crosses

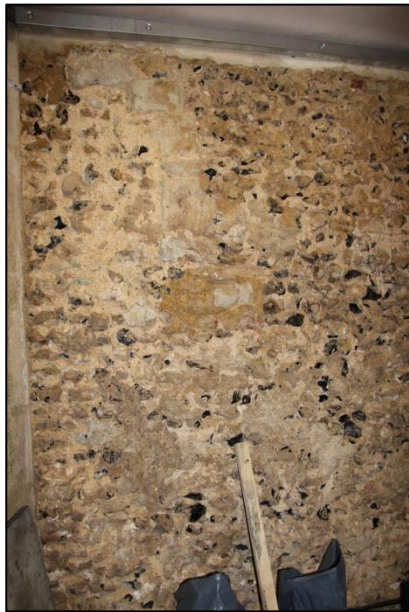
Plate 15: Tower: internal flint wall, view north

Examination of the tower during the works and following the removal of the interior plaster revealed the flint rubble walls as expected. Also present were put-log holes marked by a layer of tiles above or alternatively blocked with flint rubble. These would have been used to support the scaffolding as the tower was being constructed. The tower floor was also recorded before extensive works took place. The items of interest included two memorial ledger slabs and a brass plate in the shape of a heraldic shield, the shield is halved vertically (party per pale) with a blank field to the left and a single chevron to the right. The plate is 14cm long by 11cm wide. The floor ledgers are transcribed as follows, as accurately as possible:

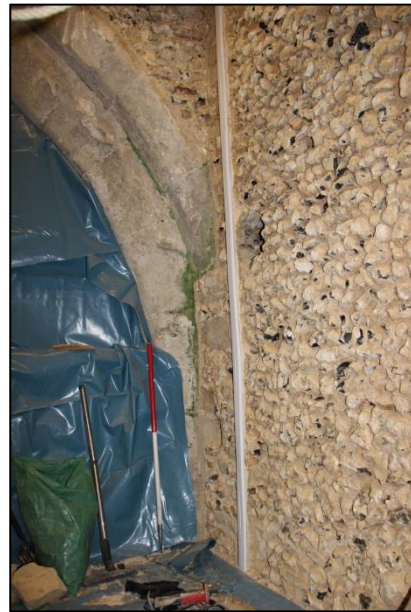
Plate 16: Tower: internal flint wall, view southeast

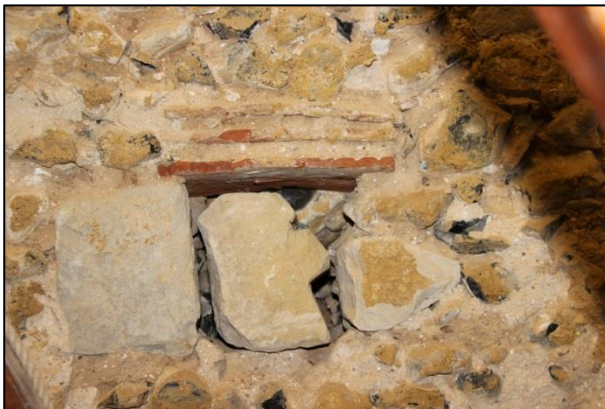
Plate 17: Tower: put-log hole, view north

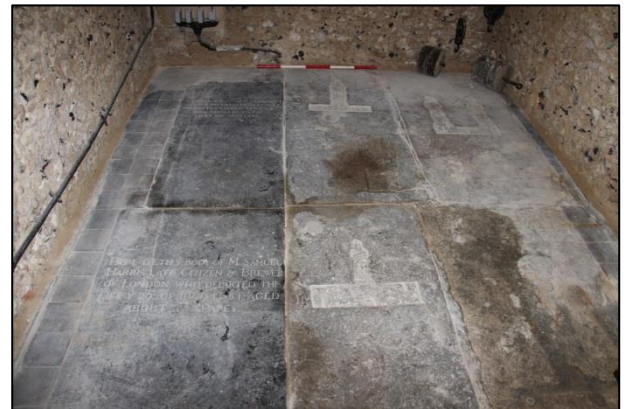
Plate 18: Tower floor: overview, view west

The four other flagstones in the tower floor may also have been ledgers or bore brass plates in the past, but these have been removed leaving only impression in the stone. The ledgers themselves appear to be composed of limestone. The outside edges of the floor have been filled with square quarry tiles.

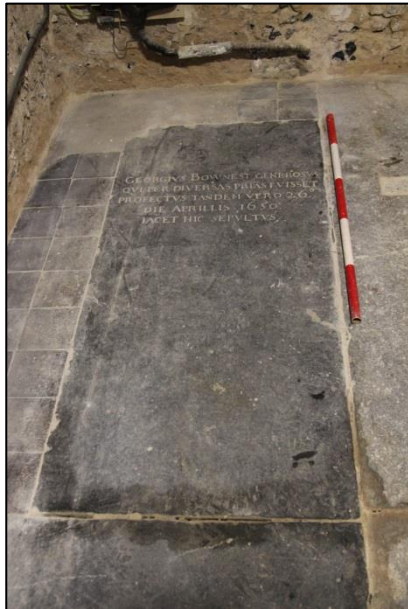
Ledger 1:

GEORGIVS BOWNEST GENEROSVS
QVI PER DIVERSAS PRIAS FVISSET
PROFECTVS TANDEM VERO 26.^o
DIE APRILLIS 1650
IACET HIC SEPVLTVS

Plate 19: Tower floor: Ledger 1, view west

Assuming that *prias* is an error and in fact is intended to be *prius*, meaning ‘previously’ or ‘earlier’, this may be translated as:

GEORGE BOWNEST GENTLEMAN
WHO DURING EARLIER TIMES MIGHT HAVE BEEN
ADVANCED, BUT PASSED ON THE 26TH
DAY OF APRIL 1650
HERE LIES BURIED

Alternatively, *prias* may be an abbreviation for *provincias* meaning ‘provinces’ or ‘countries’, but this renders the translation as:

GEORGE BOWNEST GENTLEMAN
WHO THROUGH DIVERSE PROVINCES MIGHT HAVE BEEN [or HAD BEEN?]
HAVING SET OUT AT LAST [DEPARTED LIFE] VERILY ON THE 26TH
DAY OF APRIL 1650
HERE LIES BURIED

However, the use of the pluperfect subjunctive in *fuisset* is inconsistent with the rest of the text, which may be an error and may have originally been intended as simple pluperfect. (Howarth 2018 pers. comm.)

A search of the names inscribed on the floor ledgers reveals that the wills of both men are held at the National Archives at Kew. The entry for George Bownest [PROB 11/212/191] indicates that he was a ‘Gentleman of Upper Clushall, Essex’, which may relate to the nearby village of Chrishall approximately 2.4km (1.49 miles) to the northeast. The other catalogue entry [PROB 11/367/177] lists ‘Samuell [sic] Harris’ as a ‘Brewer of London’, matching the inscription on Ledger 2. Their ledgers indicate that both were likely local men of some importance.

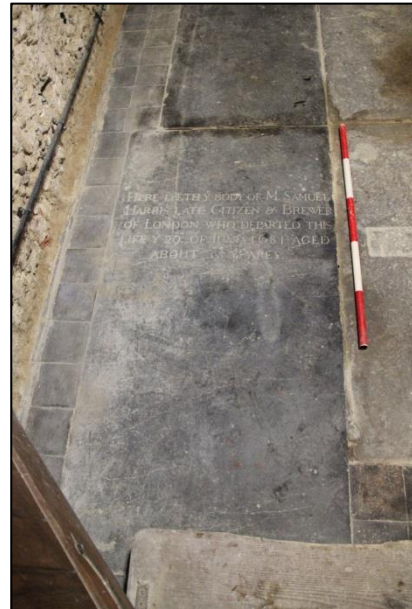
Ledger 2:

HERE LYETH Y^E BODY OF M^R SAMUEL
HARRIS LATE CITIZEN & BREWER
OF LONDON WHO DEPARTED THIS
LIFE Y^E 29TH OF JUNE 1681 AGED
ABOUT 58 YEARES

Plate 20: Tower floor: Ledger 2, view west

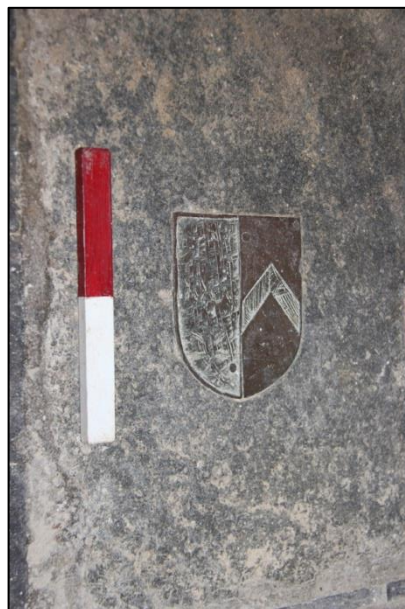
Plate 21: Tower floor: brass plate, view west

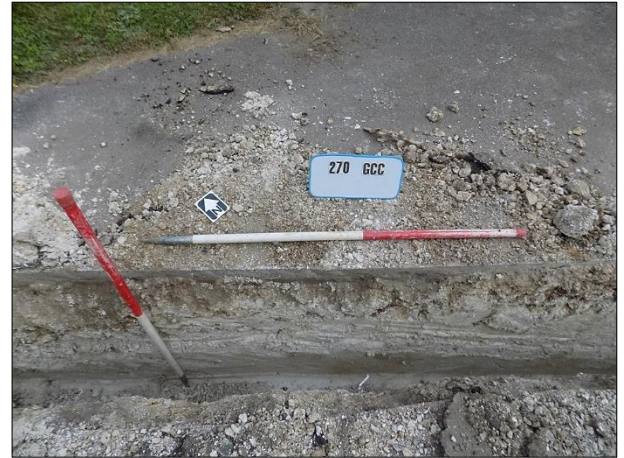
Initially manhole was excavated next to the front gate at the eastern end of the site which measured 1.8m in length, 0.87m in width and 0.8m in depth. The main service trench, which measured 0.25m in width and up to 0.85m in depth, was excavated from the manhole through the churchyard pathway. In this part of the site the tarmac was 0.1m in depth and lay directly over the natural chalk.

Plate 23: General stratigraphy of man-hole and service trench underlying church pathway, view NE

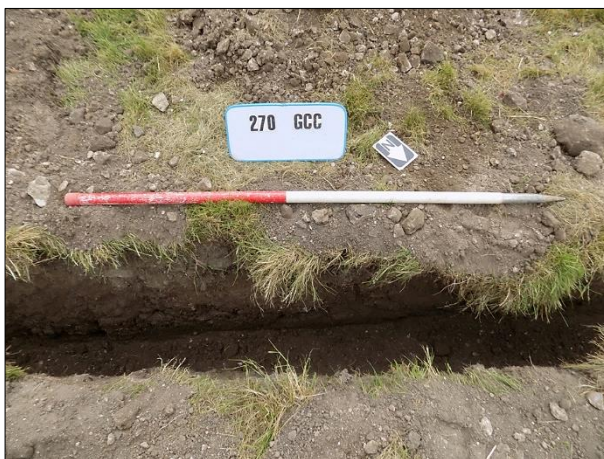
The general stratigraphy observed throughout the churchyard consisted of 0.2m of topsoil consisting of dark brown, loose clayey silt with occasional sub-angular stones/chalk less than 20mm in size overlying cemetery soil. This was over 0.40m in depth and consisted of mid brown, soft/friable silty clay with moderate sub-angular stones/flint/chalk less than 50mm in size and occasional fragments of ceramic building material (CBM) and disarticulated human bone (Fig 8).

Plate 28: General stratigraphy of service trench through churchyard, view SW

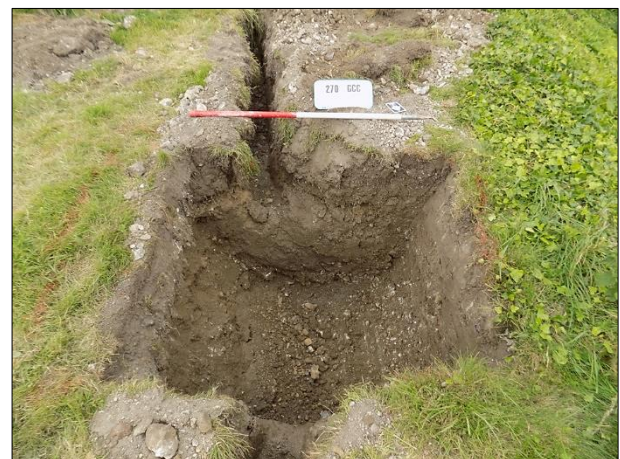
A trench to accommodate the new pump was also integrated into the main service trench. This trench was excavated at the rear of the church tower and measured 1m in length, 1m in width and 1m in depth. The general site stratigraphy was observed, and the natural chalk was not breached.

Plate 29: Pump trench, view SW

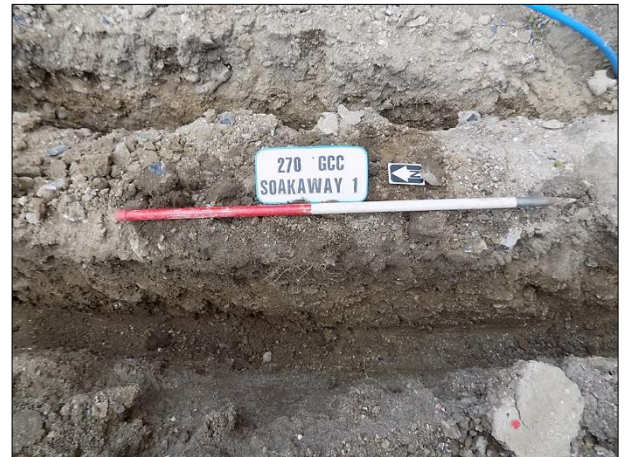
Two soakaways were also excavated with associated pipe trenches. Soakaway 1 was located to the rear of the church tower whilst Soakaway 2 was excavated to the front of it. Soakaway 1 was 1m³, and its associated pipe trench measured 5m in length, 0.25m in width and 0.6m in depth. Soakaway 2 was 1.3m long, 1m wide and 1m deep, and its associated pipe trench measured 6.5m in length, 0.25m in width and 0.6m in depth. For both of the soakaways the general site stratigraphy was observed with a further deposit noted underlying the topsoil. This further deposit was 0.15m in depth and consisted of light-mid brownish yellow, friable silty clay with frequent sub-angular stones/chalk/flint less than 50mm in size.

Plate 31: General stratigraphy of pipe trench for Soakaway 1, view E

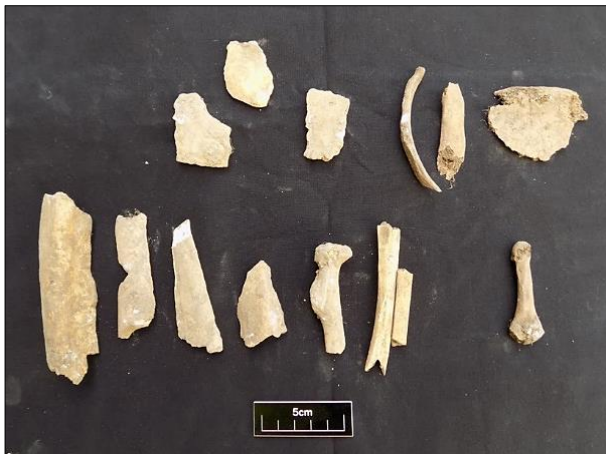
A small amount of disarticulated human bone fragments was found in the main service trench, in the area along the northern side of the site. The disarticulated remains, were collected and recorded following the methods outlined in Buikstra and Uberlaker 1997. They were examined and described and the MNI (minimum number of individuals) was calculated by determining the most frequently represented skeletal elements for each age/sex class that are presented in Table 1 below.

The minimum number of individuals amounted to 2 (MNI=2). The remains included a fragment of a mandible (lower jaw), a complete left clavicle (collar bone) and a fragment of left humerus (upper arm). The development of these bones indicated that this individual was prenatal aged between 30-32 weeks (Fazekas and Kosa 1978 taken from Scharfer, Black and Scheuer 2009). This was based from the length of the clavicle being 33.5mm. It was thought that they likely came from the same person as they were found in the same area. The remaining disarticulated remains were adult with no signs of pathology noted.

Plate 36: Disarticulated human remains

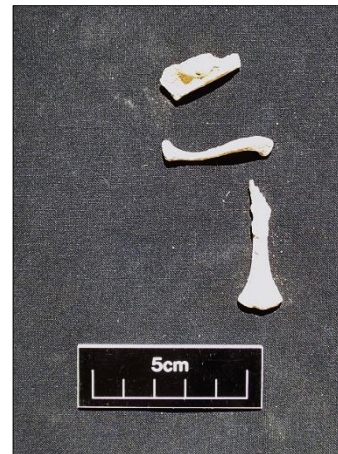
Plate 37: Infant human remains

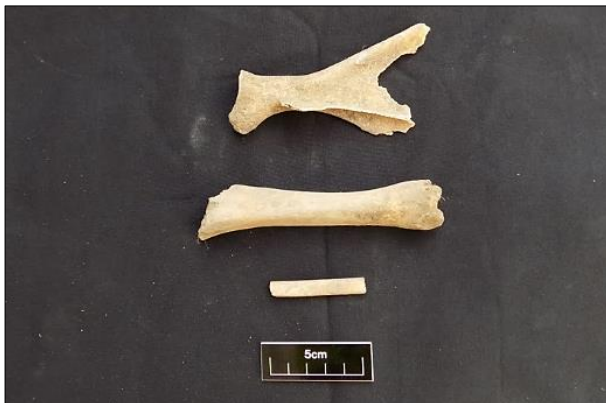
Three fragments of animal bone were also observed in the main service trench; a fragment of scapula, tibia and an unidentified fragment.

Plate 38: Animal bone remains

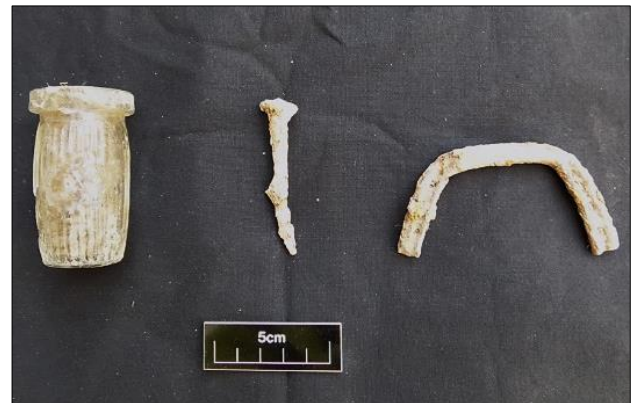
A number of metal objects were also observed. What was thought to have been a horse shoe was found in the main service trench. It measured 90mm in length and 45mm in height, either side of the horseshoe three holes were drilled. A nail was also found in the pipe trench for Soakaway 2. This nail had a round head which measured 17mm in width whilst the entire nail measured 67mm in length. Two pins were also found in the pipe trench for Soakaway 2. They consisted of a round head that measured 20mm in width with a twisted shaft, the entire length of which measured 66mm. Also, during the excavation of this trench, a twisted metal bar was found that continued beyond the limit of excavation and was able to stay in-situ. The bar was reminiscent of metal railing which can often be found surrounding grave monuments.

Finally, a glass jar with the words 'Shippams' on its side and the words 'Founded 1750' on its base was also observed. The company Shippams are widely known for producing food pastes and spreads, and the jar was thought to have been of a 20th century date.

Plate 39: Metal finds and glass jar
