KDK ARCHAEOLOGY LTD

Historic Building Recording

Woolston Farm Barn

Haultwick

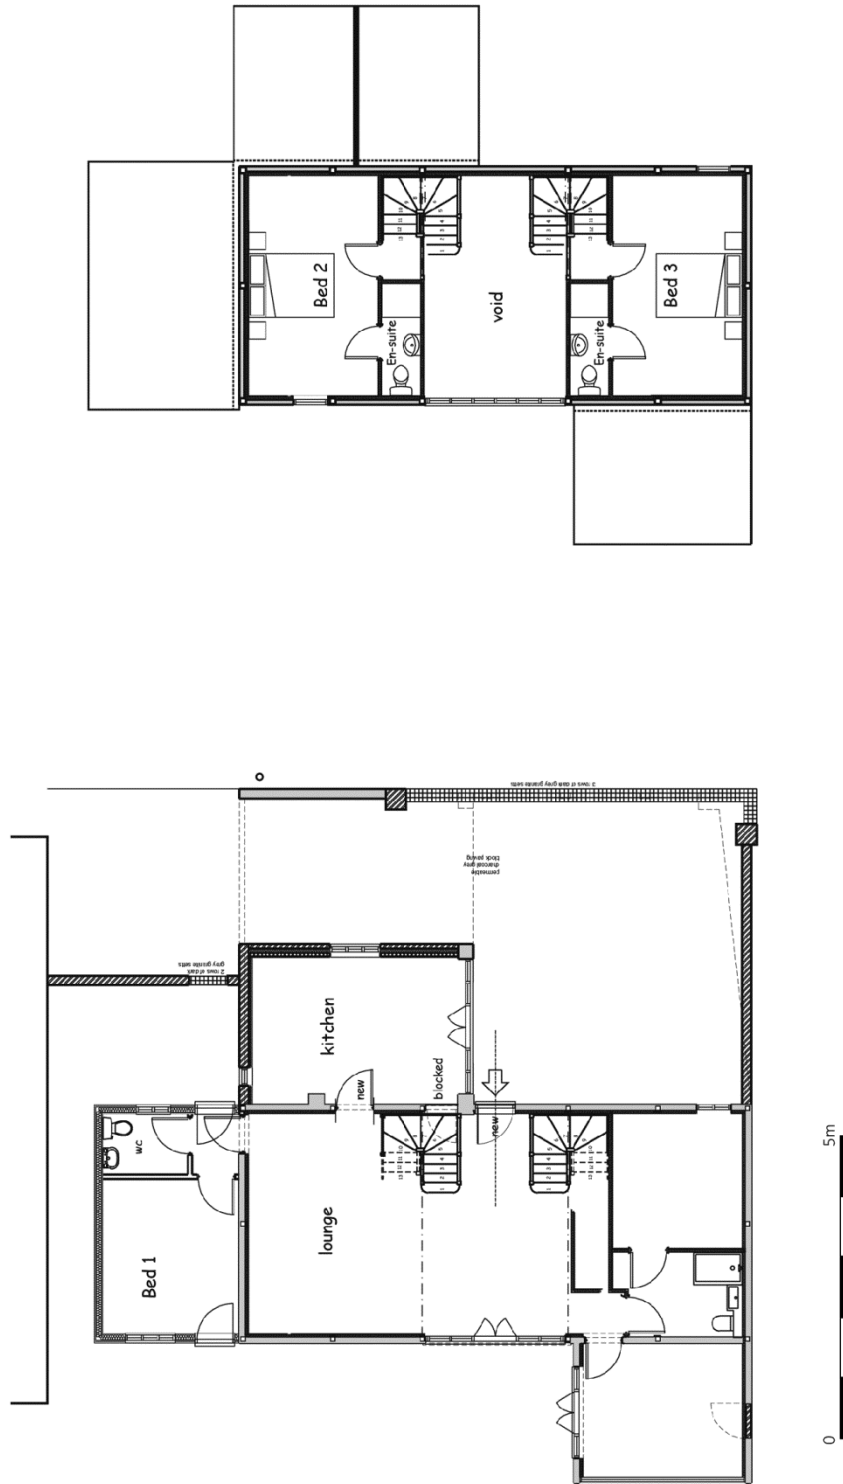
Figure 3: Development plan (scale 1:125)

The development comprises the conversion and extension of the existing barn to a residential dwelling, and the demolition of a car-port (Fig. 3).

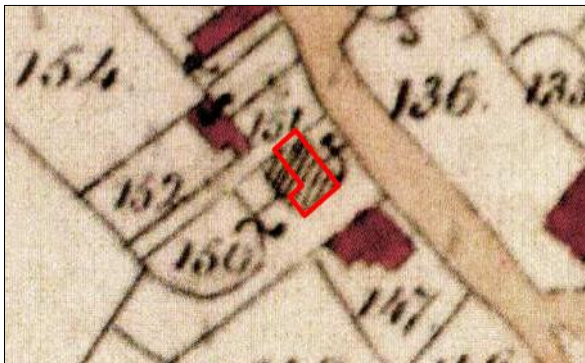
Figure 4: Tithe map 1840 (scale 1:1250)

The earliest cartographic depiction of the property now known as Woolston Farm is to be found in the Tithe Map dating to 1840 (Fig. 4). The farmhouse is shown, as is a large outbuilding to the northwest in the location of the barn. This building seemingly had a wider footprint than the current barn and therefore is likely to have been a separate earlier structure. This earlier outbuilding is also present in the 1st Edition Ordnance Survey map of 1878 (Fig. 5) along with adjoining outbuildings including stables to the southwest and the predecessor of the garage to the northeast. The 2nd Edition map of 1898 (Fig. 6) is the first to show a footprint that fits with the current footprint of the barn, including the workshop to the southwest. It should be noted, however, that the lines marking the divisions of the outbuildings do not match the outline of the barn. Without the overlay of the modern

The current farmhouse has been present on the site since at least 1840 and is shown on the Tithe map with an earlier outbuilding. This structure survived until at least 1878, when the farm was known as 'Kirby's'. By 1898, however, the original structure was likely demolished and the barn that exists today was constructed. The building is depicted on all subsequent Ordnance Survey maps as a continuous structure with a range running perpendicular to the southwest of the main barn and then abutting other structures, most likely stables. This range is no longer present, probably having been demolished and replaced with a steel barn since 1974. However, there is no structural evidence in the current barn to suggest a range previously attached to the southwest elevation. While the possibility should not be excluded that the structure was altered, the disparity could also be attributed to the inaccurate marking of structural divisions in the historic Ordnance Survey maps.

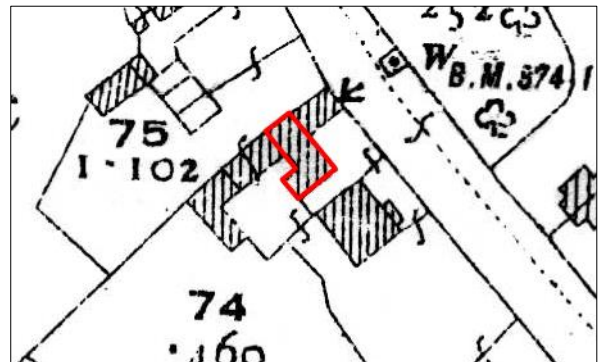
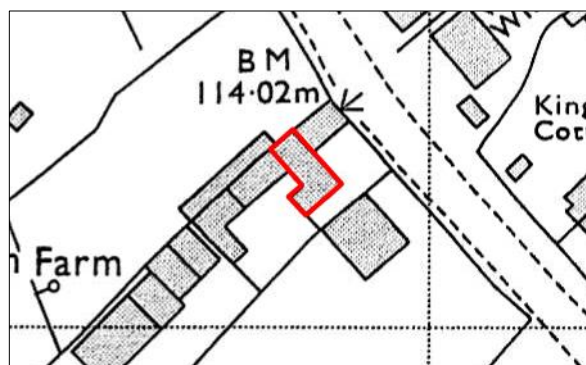
There is little change to the editions of 1923 or 1974 (Figs. 7 and 8), which still show a disparity between the marked divisions of the buildings and the current footprint of the barn. The presence of the 19th century outbuildings to the southwest did not change until after 1974, when the structure between the barn and the L-plan building to the far southwest must have been demolished and replaced with the steel barn present today. The lack of a marked division between the barn and the now demolished structure could be attributed to an oversight in the historic maps.

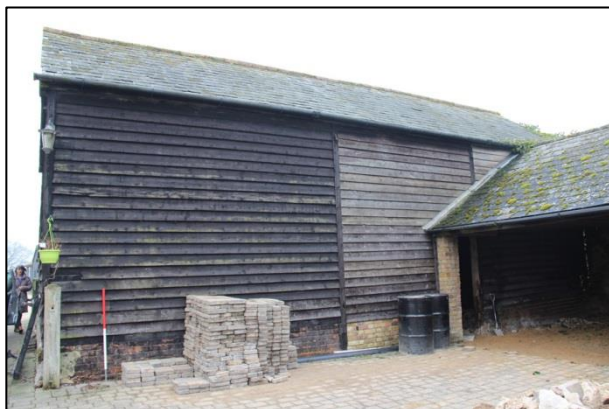
Plate 1: East elevation

The structure comprises a three bay timber barn with a lean to workshop to the west and a brick built car port to the east. The exterior of the barn is mainly weather boarded above a 19th century red brick supporting dwarf wall of between six and seven courses. These bricks measure 22 x 7 x 10cm (8 $\frac{3}{4}$ x 3 $\frac{3}{4}$ x 4 $\frac{1}{4}$ "") and are arranged in Flemish bond with lime mortar. In places the bricks have been covered in cement render. Later repairs using modern Fletton brick are visible inside the barn where the render has not been applied. Some replacement gault bricks are also present on the exterior of the eastern dwarf wall. These replacement bricks are associated with works undertaken during the construction of the car port. The gault bricks measure 22 x 7 x 11cm (8 $\frac{3}{4}$ x 3 $\frac{3}{4}$ x 4 $\frac{1}{4}$ ""). These same bricks have also been used in the supporting plinths and the rear wall of the car port. A door has also been installed within the car port allowing access to the main barn. Access to the barn can also be gained via the workshop and through modern timber sliding doors on the west elevation. The workshop also has single wooden door to the south.

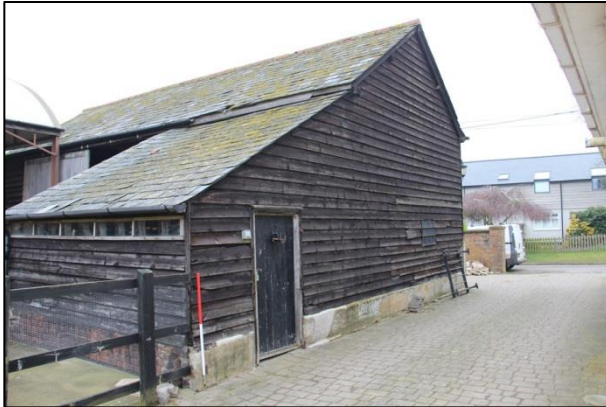
Plate 9: South elevation, facing northeast

A few small alterations are evident from the exterior of the barn, including a small weather boarded hatch that has been installed in the south elevation of the main barn. Modern glass has been installed below the roof to the west elevation of the workshop and a small hollow drain has been added at ground level on the same elevation. To facilitate the drain several bricks have been removed to create a hollow and thick mortar and offcuts of brick have been roughly replaced either side of the void.

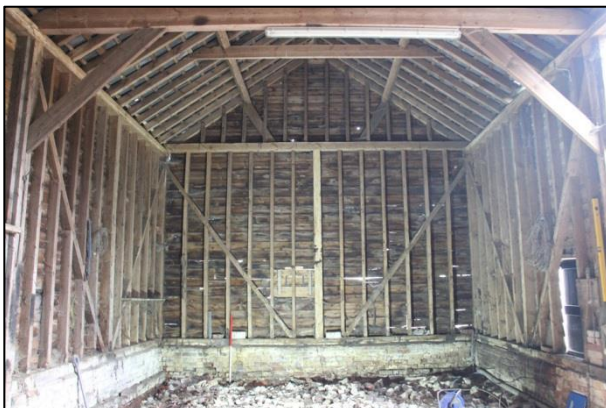
Plate 11: South wall

The timber frame construction of the barn is fully exposed on the interior of the building. The timberwork sits on a supporting dwarf wall which shows signs of modern repair work in places and in the north elevation the brickwork is stepped. Original timbers remain in Bays 1 and 3, the walls have primary bracing. Modern timbers have been used in the east elevation and the presence of the modern brick dwarf wall below would suggest that Bay 2 was rebuilt completely in modern times, most likely when the car port was constructed. At the same time, a door was installed in the eastern elevation linking the car port to the main barn. Opposite, on the west elevation, Bay 2 contains a large modern sliding door providing access to the external areas. Additional openings have been cut into the west elevation for access to the workshop and the north elevation for access to the barn exterior.

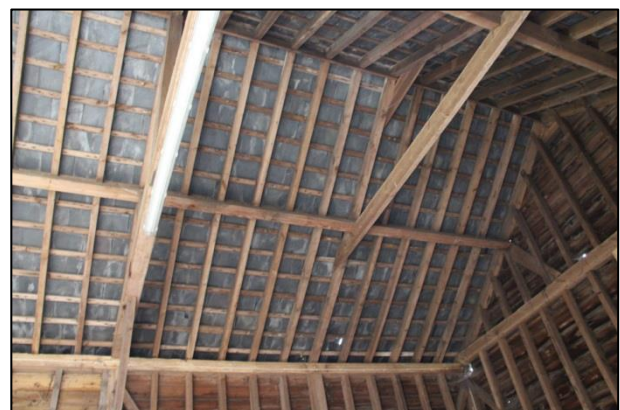
Plate 18: Barn roof detail, facing southeast

The clasped purlin roof has two king post trusses with raking queen struts. There are collar beams running across the centre of Bays 1 and 3. The purlins appear to be quite recent as are the rafters and roof tiles. Modern light fittings have been added to the truss beams.

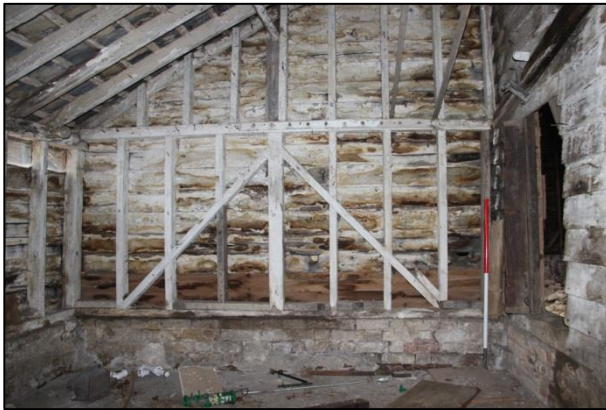
Plate 25: Workshop , north wall

The workshop is a three-sided timber framed structure with a brick supporting dwarf wall, attached to the west elevation of the main barn. The plinth wall consists of red brick of a similar type found in the wall of the barn. The east elevation comprises the external weather boards and dwarf wall belonging to the main barn. This has been painted white in places and an opening has been cut into the northeast corner to allow access to the main barn area. Some 20th century Fletton brick repair work set in cement mortar is visible below the opening. There is a single timber door in the south elevation. The timberwork to the north and west consists of primary bracing and all of the timbers are machine cut.

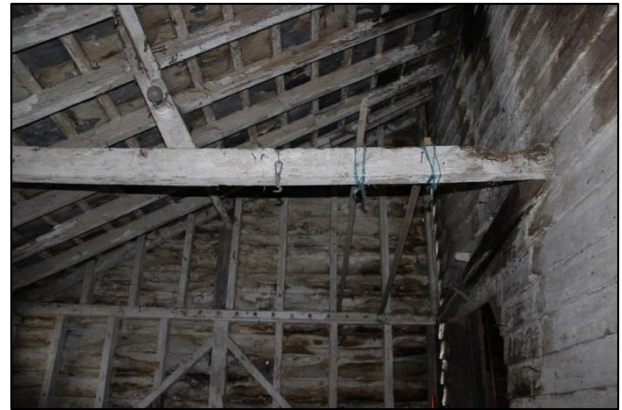
Plate 26: Workshop interior roof detail, facing northwest

The mono-pitched, clasped purlin roof is supported by a single beam with a raking post. The slate tiles are visible above the machine cut rafters. The floor is concrete.
