KDK ARCHAEOLOGY LTD

Heritage Asset Impact Assessment and Archaeological Evaluation Report

65 High Street
Ridgmont
Bedfordshire

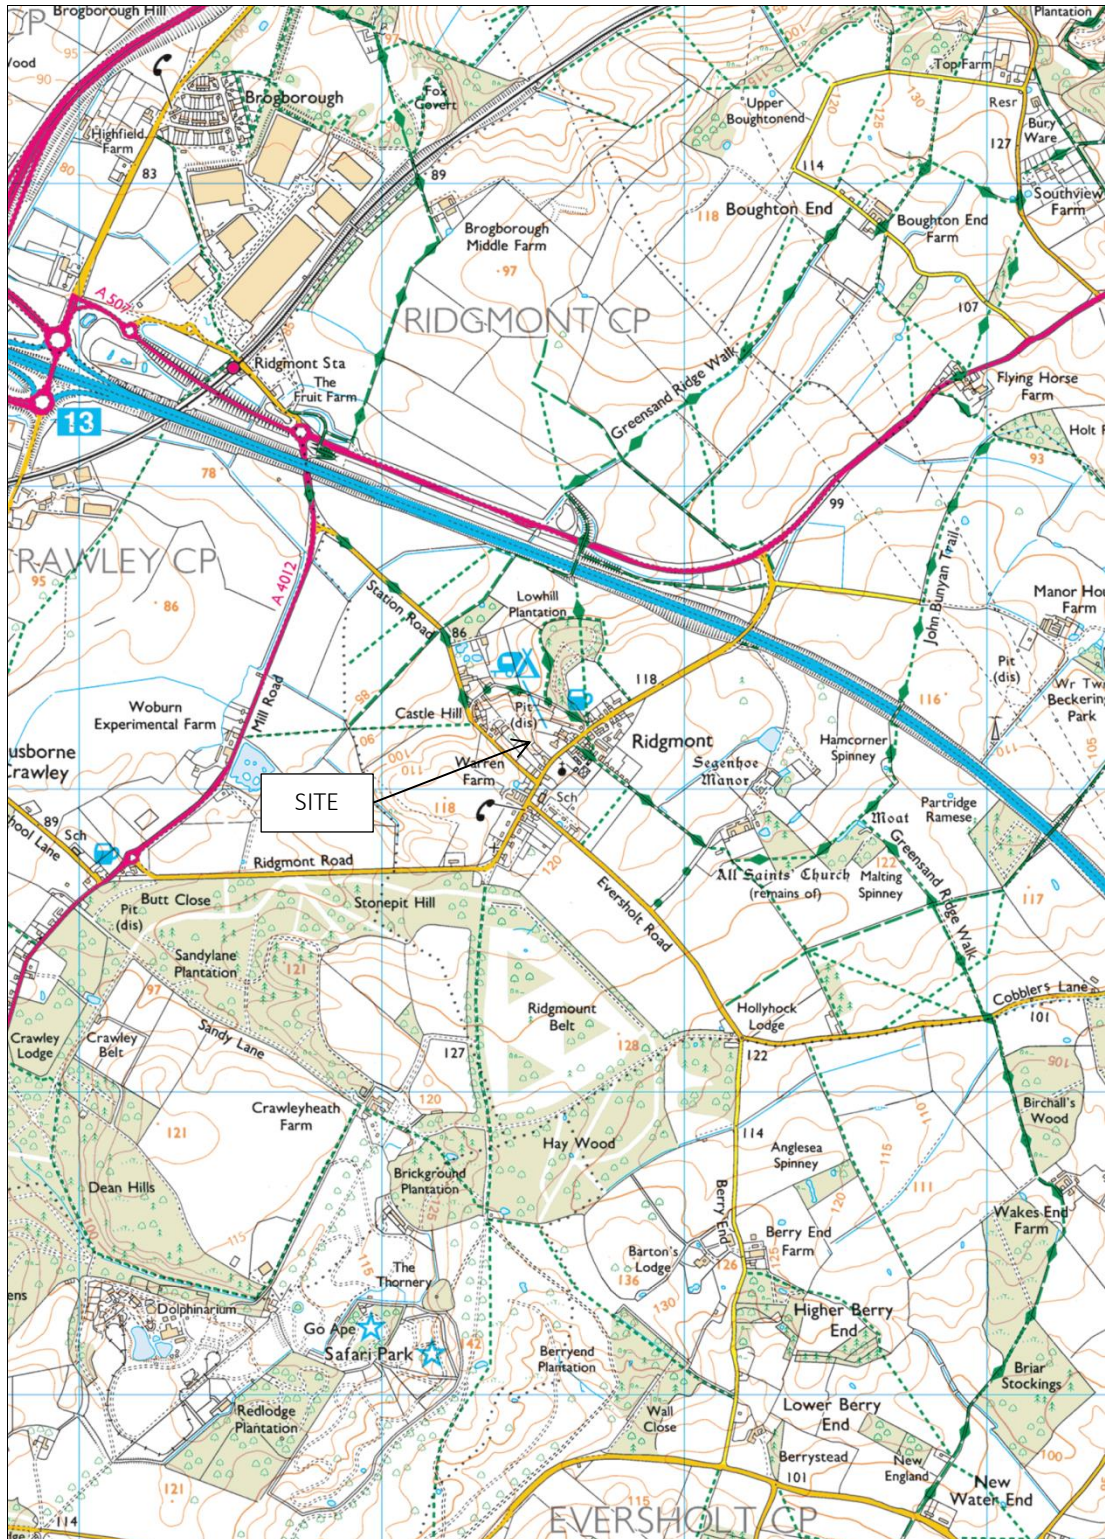
Figure 1: General location (scale 1:25,000)

The site is located within the village and civil parish of Ridgmont, in the administrative district of Central Bedfordshire, at National Grid Reference (NGR) SP 97561 36121 (Fig. 1). It is located in the Ridgmont Conservation Area.

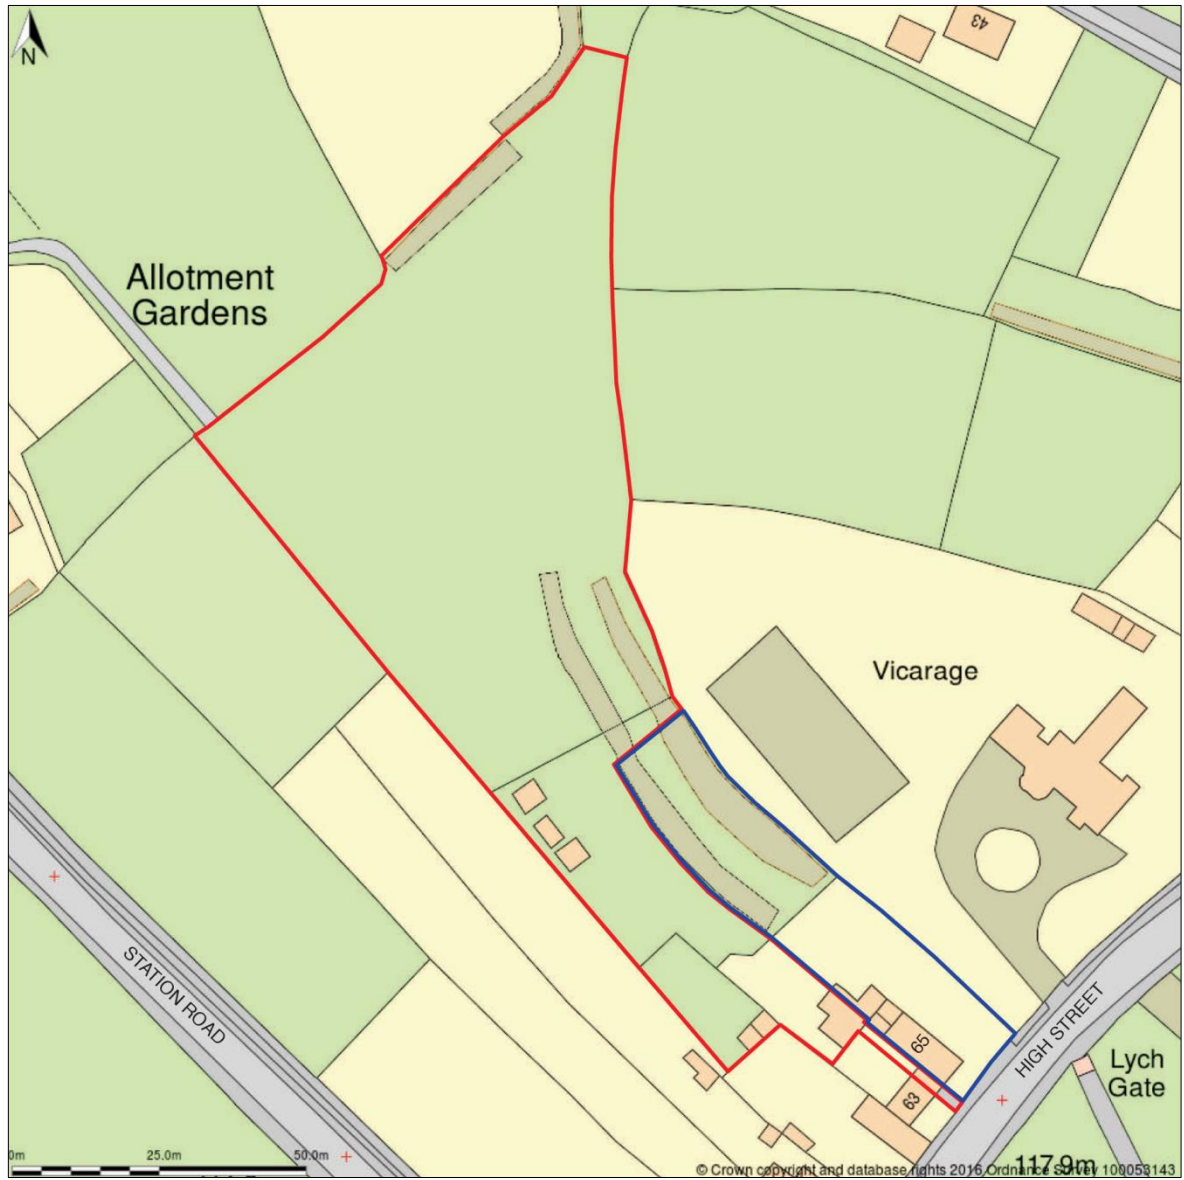
Figure 2: Site location (scale as shown)

The site is roughly rectangular in shape, and is bounded to the north-east and north-west by a treeline separating it from the adjoining property (the Vicarage). The south-western boundary is formed by the High Street, and the south-eastern boundary is formed by 63 High Street, which directly joins the development area (Fig. 2).

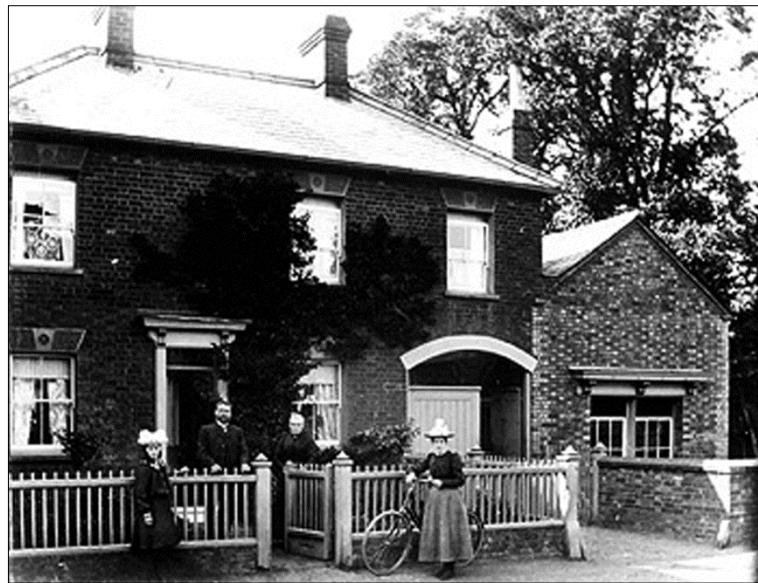
Plate 1: Nos. 63 and 65 High Street around 1900
(<http://bedsarchives.bedford.gov.uk/CommunityArchives/Ridgmont/63And65HighStreetRidgmont.aspx>)

No. 65 High Street was probably purpose built as a shop. According to the Bedfordshire Archives Community Archives, a 1925 assessment in Ridgmont found that the two properties belonged to Harry James, a butcher who lived at No. 63 and ran his shop in No. 65. To the rear of the property 'stood a licensed slaughterhouse, a timber and slate stable, a store, a corrugated iron piggery and a timber and corrugated iron garage'. The shop measured 17 feet 9 inches by 12 feet 9 inches (DVI/C54/81 as cited in <http://bedsarchives.bedford.gov.uk/CommunityArchives/Ridgmont/63And65HighStreetRidgmont.aspx>). There was a butcher shop in this location until the mid-1970s (*ibid*). Photographs from the early 20th century indicate that 65 High Street was built in the 19th century (Plate 1). One of the earlier outbuildings was a 2-storey structure which had a sun room on the upper floor when it demolished some 10 years ago (Plate 10).

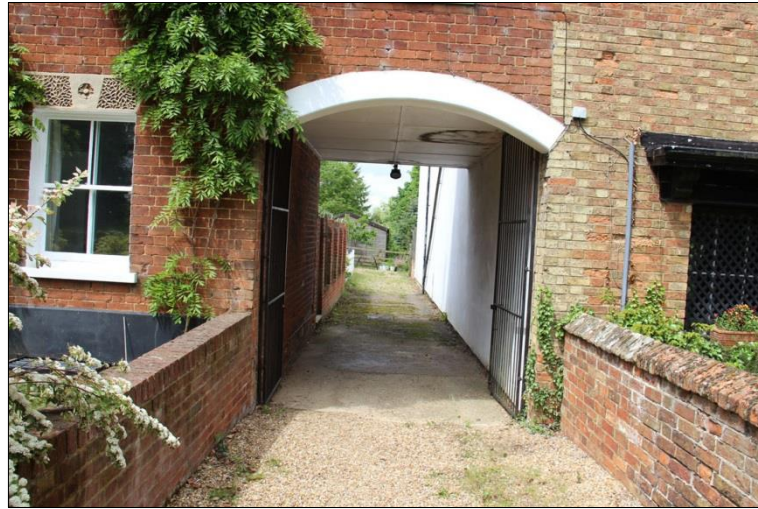
Plate 5: Carriageway and access to the proposed development site

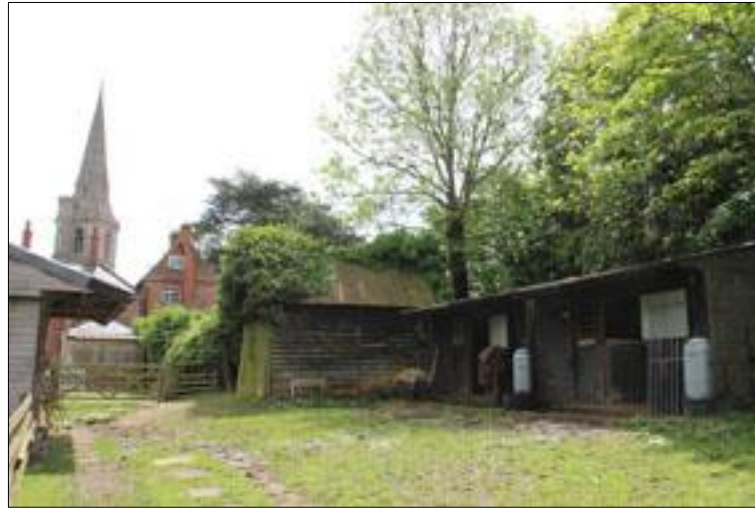
Plate 8: Timber outbuilding and stables in the southwest corner of the proposed developments site

There is a small post-medieval timber framed outbuilding on a brick supporting dwarf wall in the southwest corner of the proposed development site. This was not fully accessible during the survey, but it appears to be a rudimentary structure of little architectural or historical interest. To the north and west of this are timber built stables.

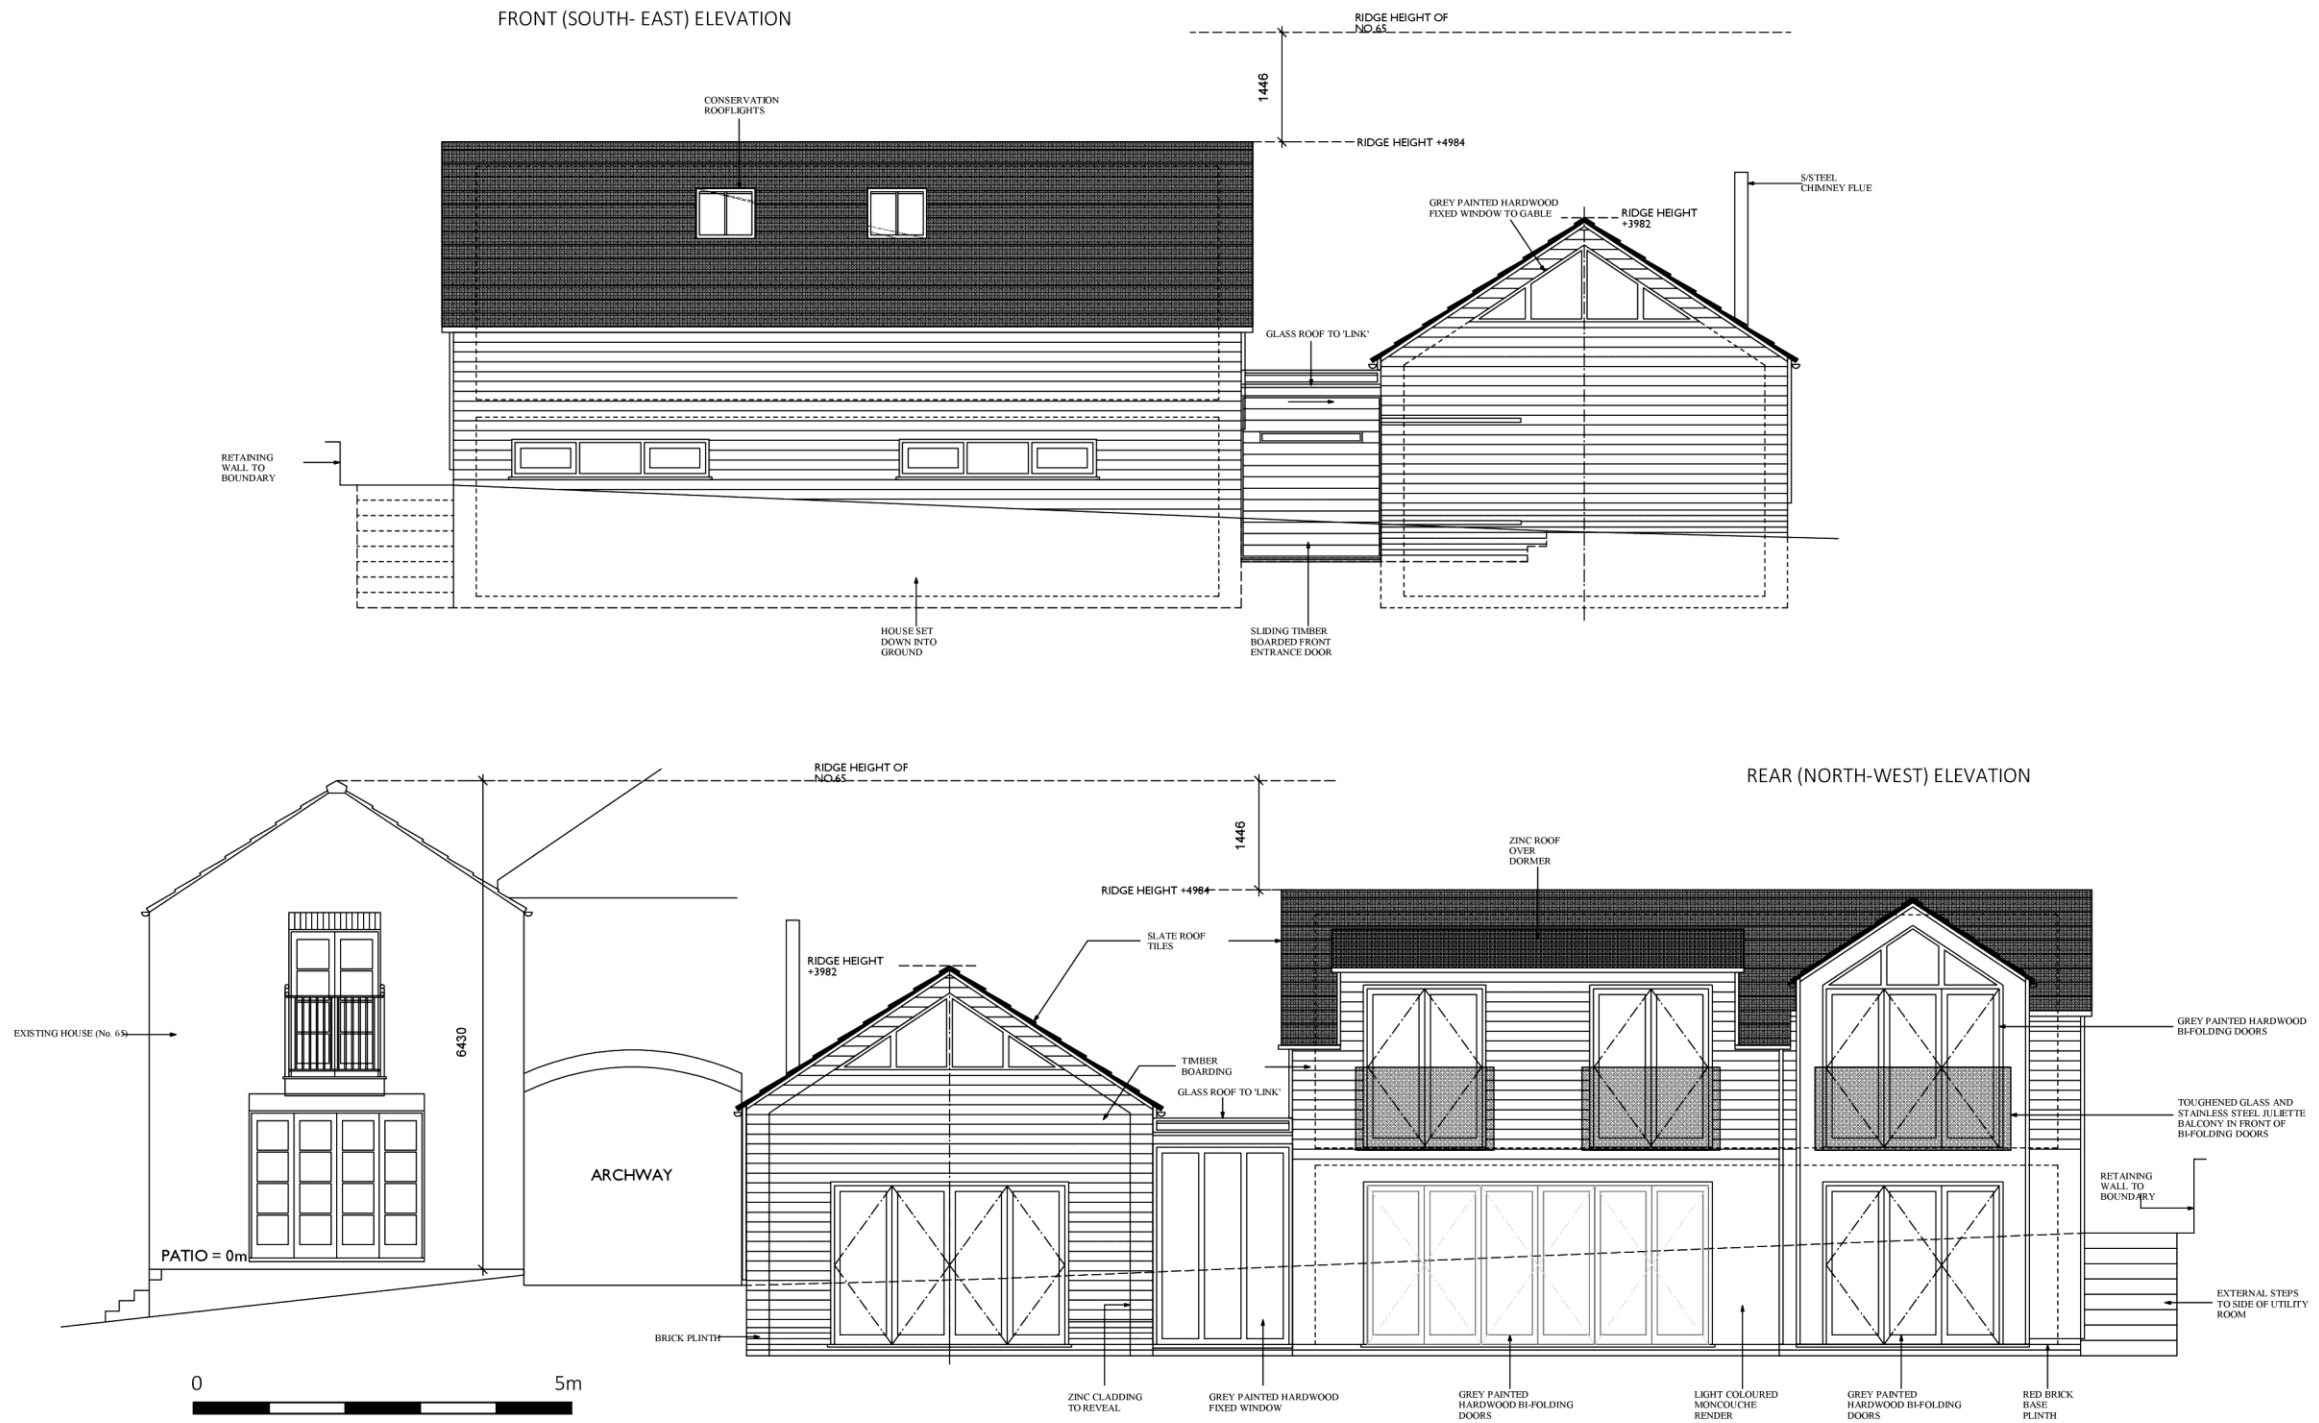
Figure 8: Proposed front and rear elevations (scale 1:100)

The application is for the proposed erection of a single detached dwelling (Fig. 3).

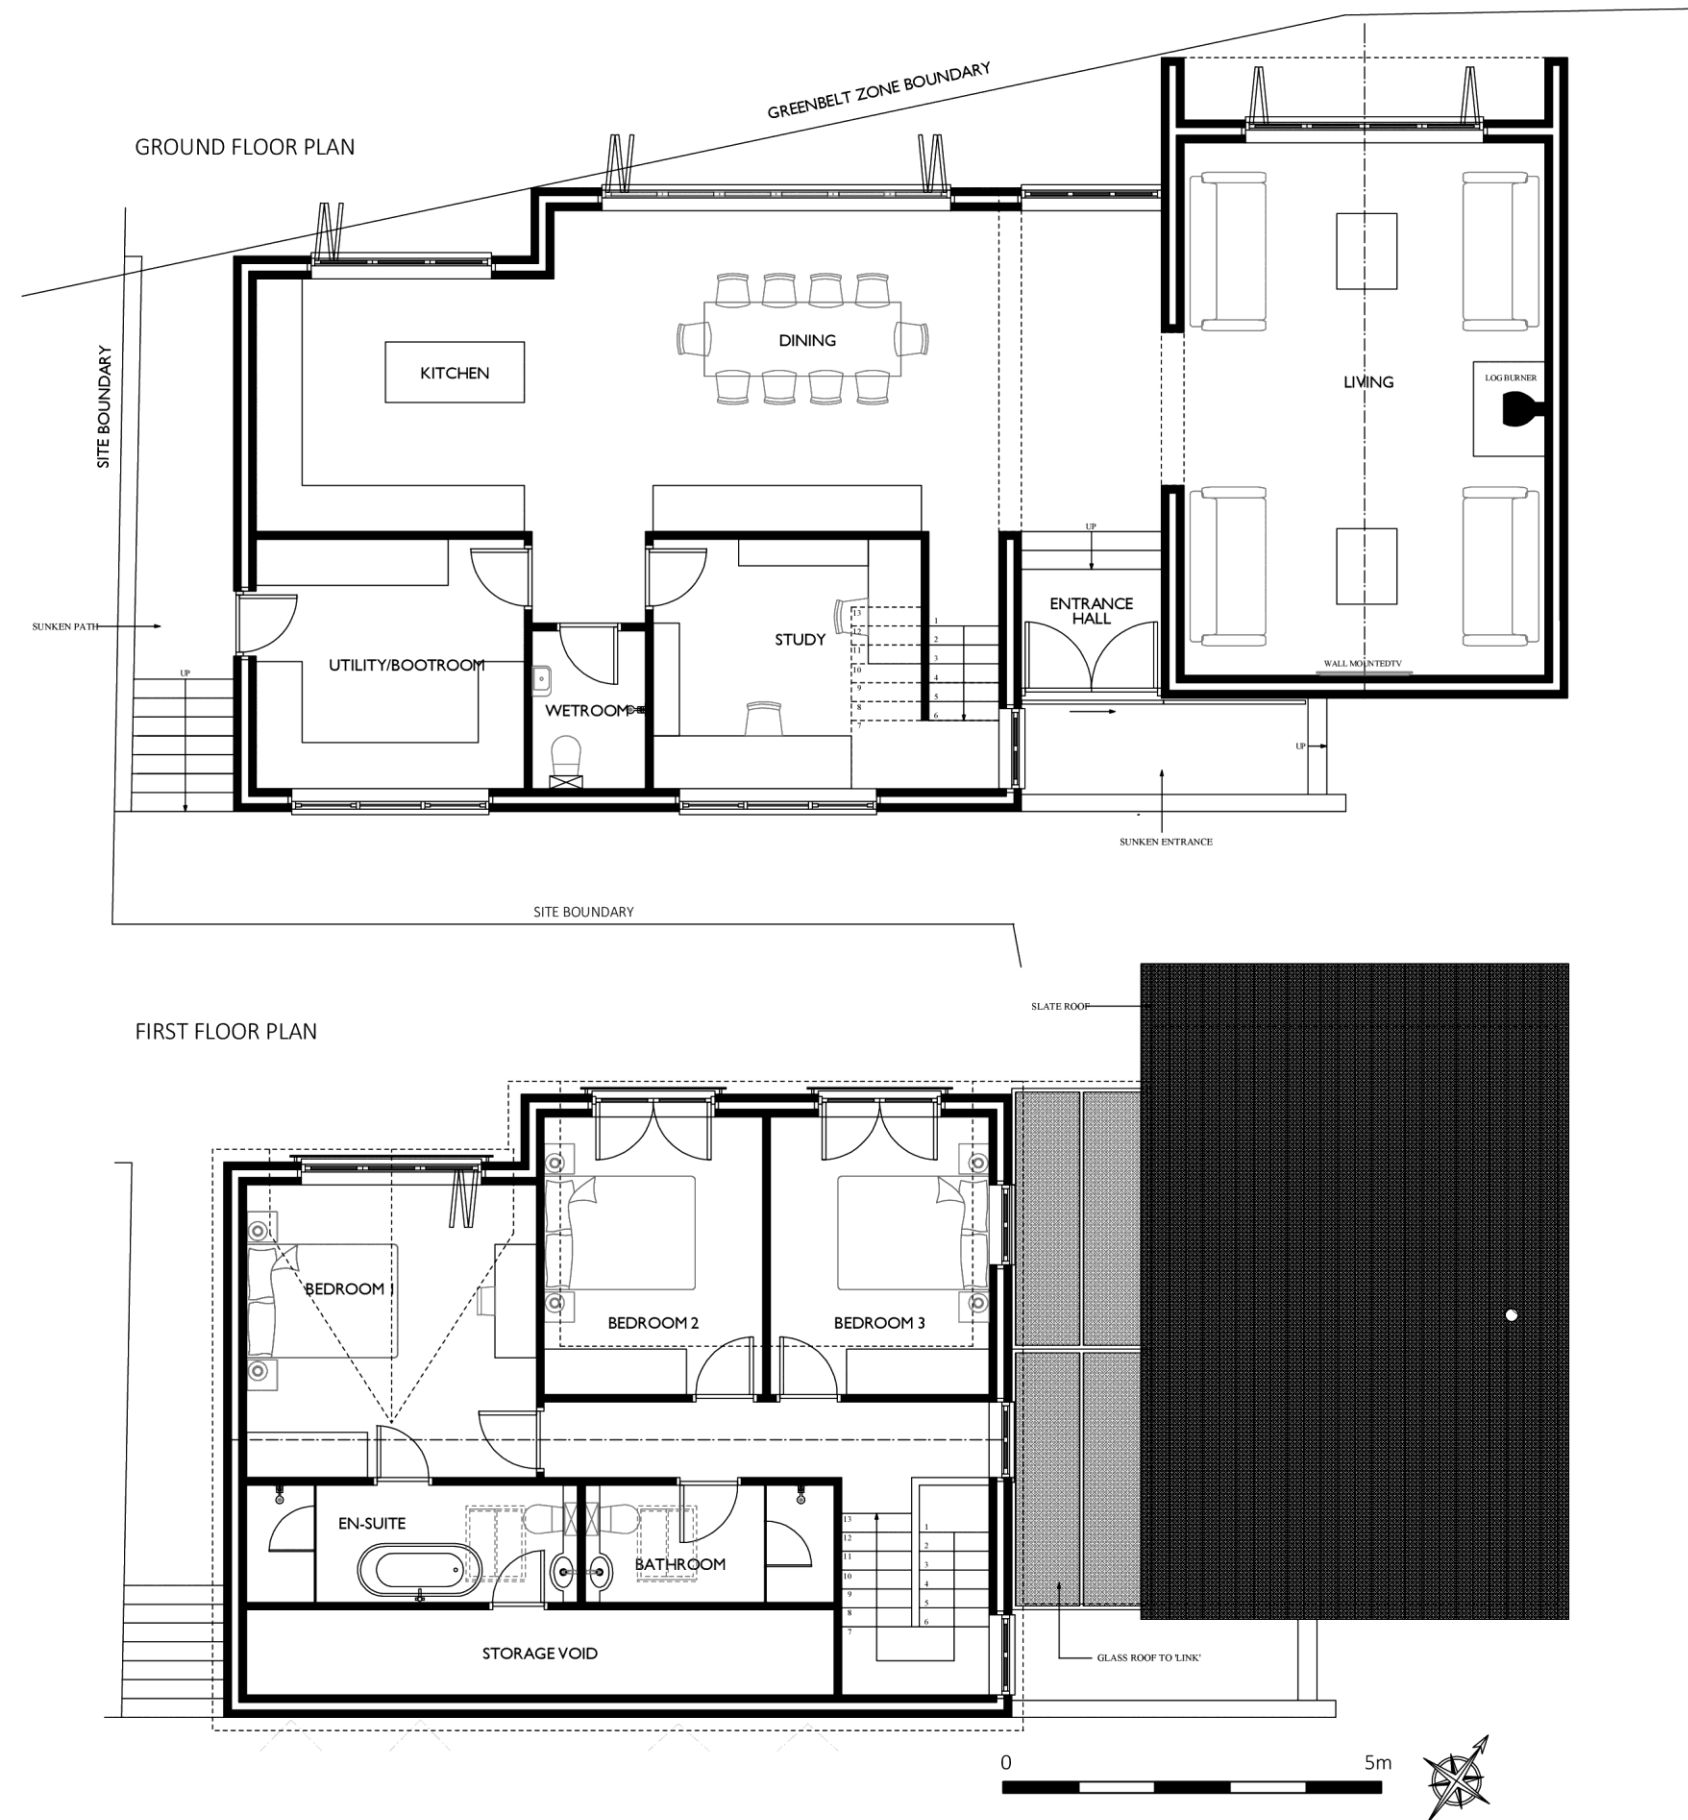
Figure 10: Proposed floor plans (scale 1:100)

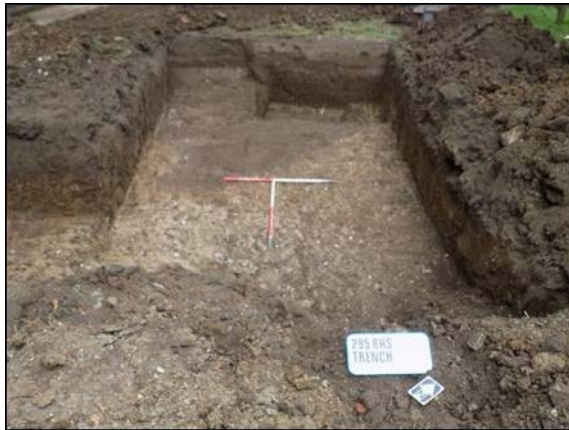
Plate 11: View of trench, facing WNW

A single L-shaped trench was excavated using a 2 tonne tracked excavator fitted with a 1.2 metre wide toothless bucket (Plates 10 & 11).

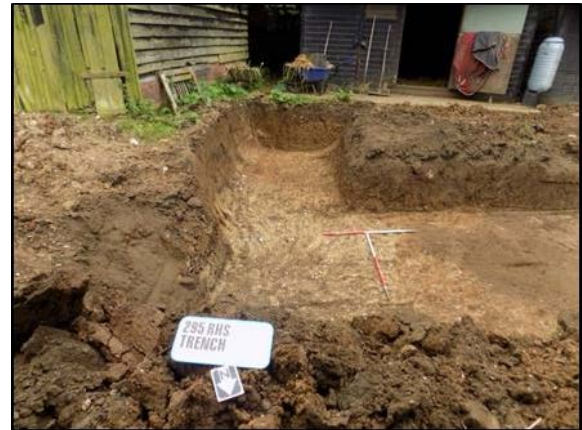
Plate 12: View of trench, facing SSW

The main part of the trench was orientated west-northwest to east-southeast, with a perpendicular area extending to the south-southwest. The longest side measured 6.05m and the widest side measured 5.77m, with the south-southwest extension forming 1.9m of the main length and 2.41m of the main width. The trench was excavated to a depth of 0.85m, with an exploratory sondage in the north-northwest corner measuring 1.22m deep. It contained two archaeological features.

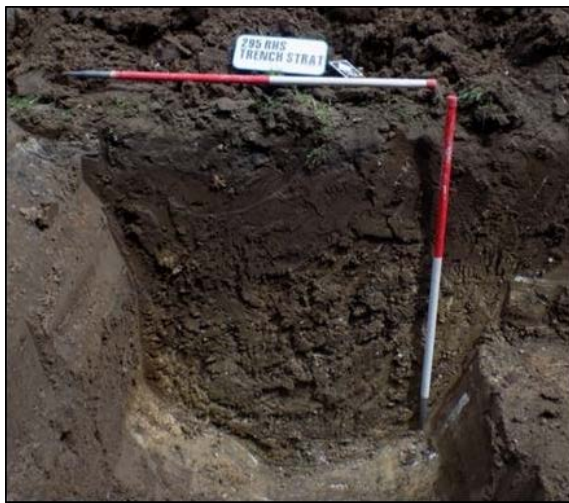
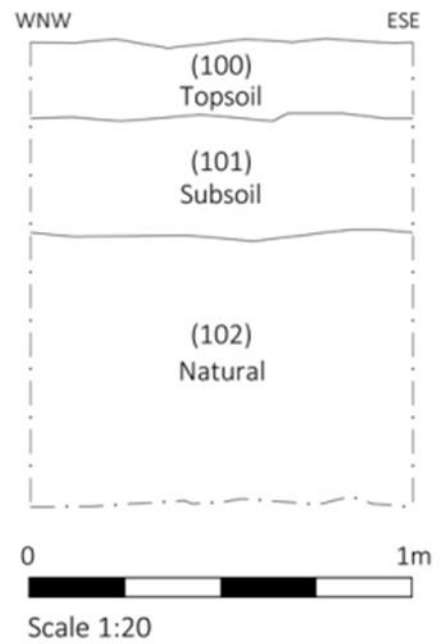
Figure 11: Diagram of trench stratigraphy

The stratigraphy appeared to be fairly uniform throughout the trench; a thin layer of topsoil comprised of soft clay was found on the surface above slightly deeper silty clay subsoil. The natural geology beneath was sandy clay with chalk inclusions (Plate 12; Figure 11).

Plate 13: Trench stratigraphy, facing NNE

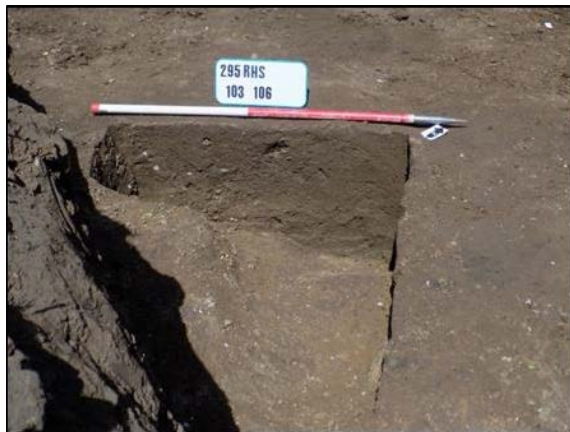
Plate 14: Ditch terminus [103] and pit [106], facing NW

There were two archaeological features at the west-northwest end of the trench, a small ditch terminus [103] (Plates 13-15; Figures 12 & 13) and a large sub-rectangular pit [106/108] (Plates 13-16; Figures 12 & 13). The ditch [103] was 0.84m wide, 0.15m deep, at least 0.55m in length and orientated approximately southeast to northwest. It contained a single sandy clay fill (104), which may be re-deposited natural soil as a result of tumbling or sedimentation. This would be consistent with the theory that the ditch had a drainage related purpose. The fill contained a small amount of animal bone and pieces of brick or tile, presumably from the surrounding buildings.

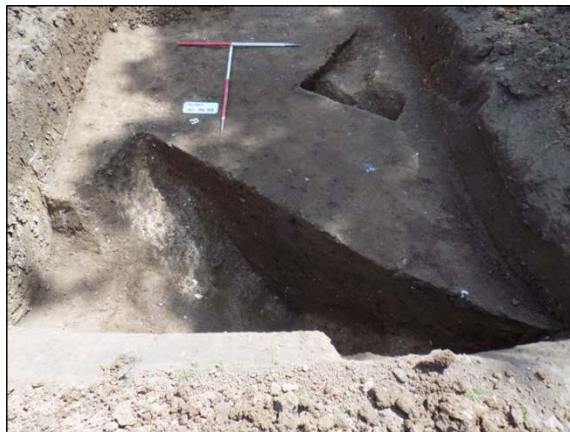
Plate 16: Overview of features [103] and [106/108], facing ESE

This ditch was cut by the large pit [106/108] that, with the entire extent of the feature within the trench taken into account, measured 3.53m in length and 3.14m in width; at its deepest point it measured 1.32m. Both slots of the pit contained two fills, (105) and (107) for the smaller slot, and (109) and (110) for the larger. (105) and (110), the lower fills of the two slots, both consisted of a loose sandy clay, likely caused by tumble, and should probably be considered the same deposit, though this cannot be proven. (107) and (109) were the upper fills of the two slots and were made up of silty clayey sand. They are more likely to have been deposited by deliberate backfill and, as with the lower fills of the slots, were probably deposited in the same event. The upper fill of the larger slot (109) contained a fair amount of animal bone, CBM and pottery, which appeared to be post-medieval. This animal bone was a mixture of cow, sheep/goat and even the lower jaw of a cat. Both (107) and (109) contained fragments of medieval Hertfordshire Greyware, as well as (109) containing some post-medieval pottery and CBM. This mixture of finds means that the pit [106/108] must be medieval or later in date, though it is most likely later with some residual medieval material finding its way into the feature. It is pre-dated by the ditch [103], but this feature is certainly not earlier than the medieval period.

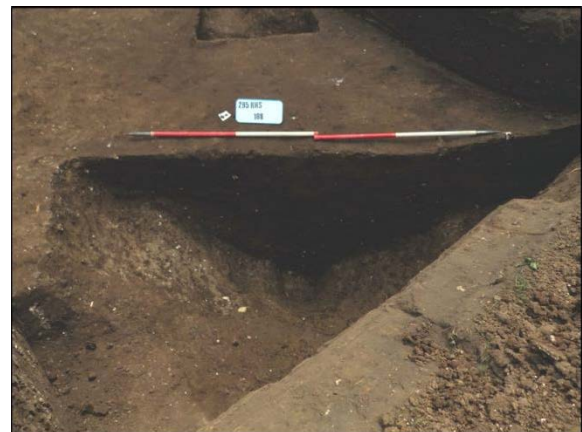
Plate 17: Large pit [106/108], facing SE

The ditch was cut by the much larger feature [106/108], a substantial pit more than 3m wide and cut more than 1.3m into the natural soil (100). Its fill was flecked consistently with chalk in much the same way that is found in the natural soil, though the fill was much darker in colour, suggesting that much of this pit was back-filled with a mixture of natural soil and topsoil at some point after it was excavated. It seems unlikely that it was ever used as a pond or sump as there is no clear evidence of water-lain deposits or silting, but whether this was a rubbish pit or an extraction pit is unclear, particularly as its full shape cannot be seen in plan.
