**Historic Building Recording (EMK1308)  
&  
Archaeological Watching Brief (EMK1309)**

100 High Street  
Olney  
Buckinghamshire

August 2017

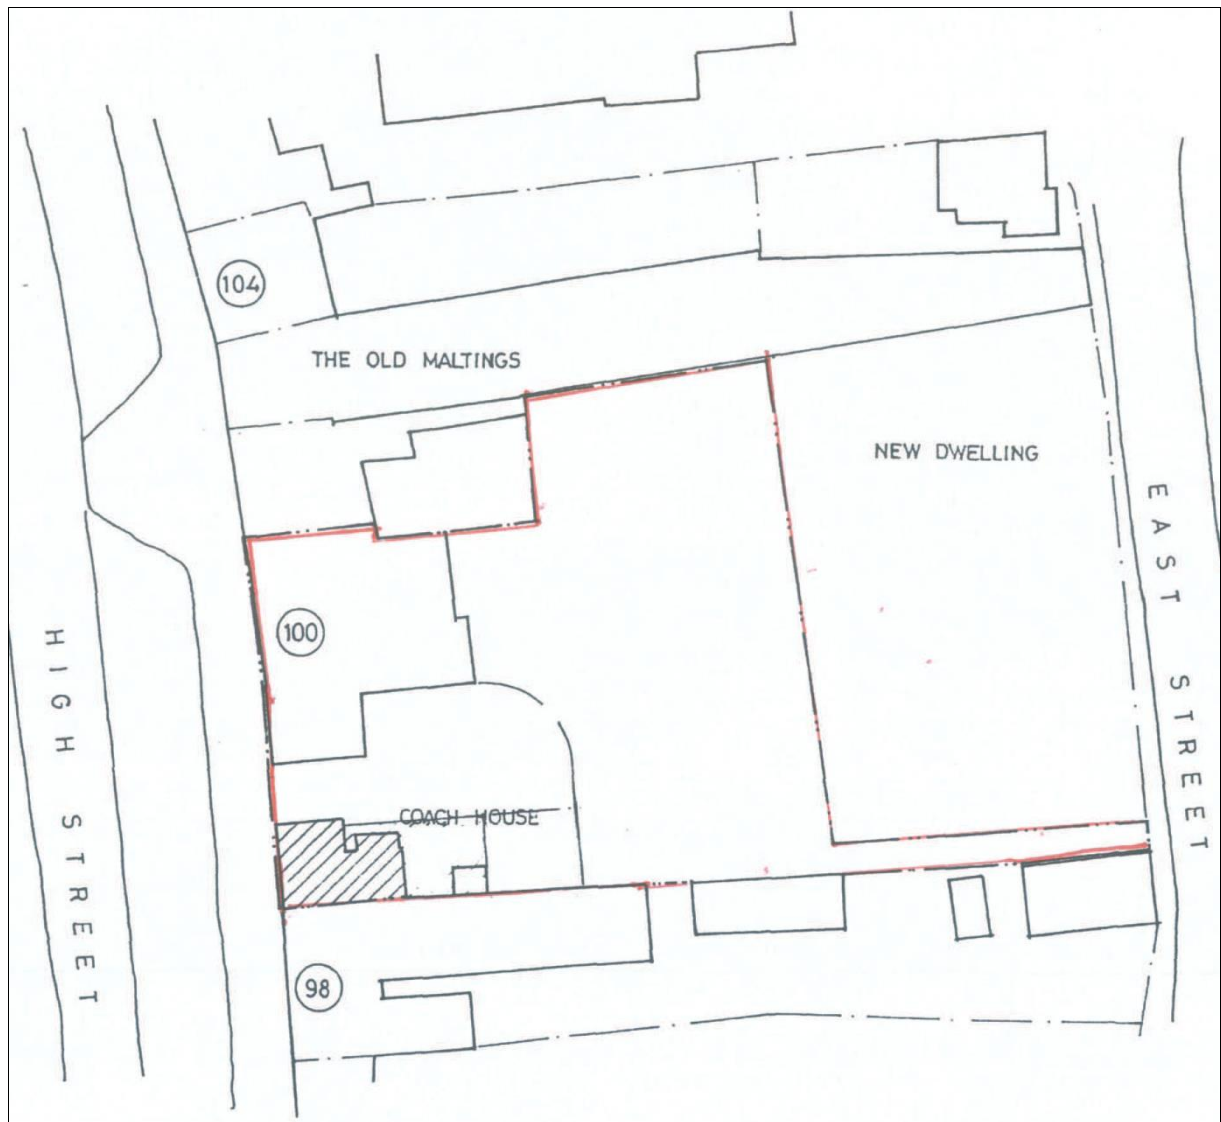
**Figure 2:** Site location (scale 1:500)

The site slopes gently to the east, with the area adjacent to the existing dwelling and coach house being predominantly level. It is bounded on all sides by adjoining properties, and lies at approximately 51m AOD (Fig. 2).

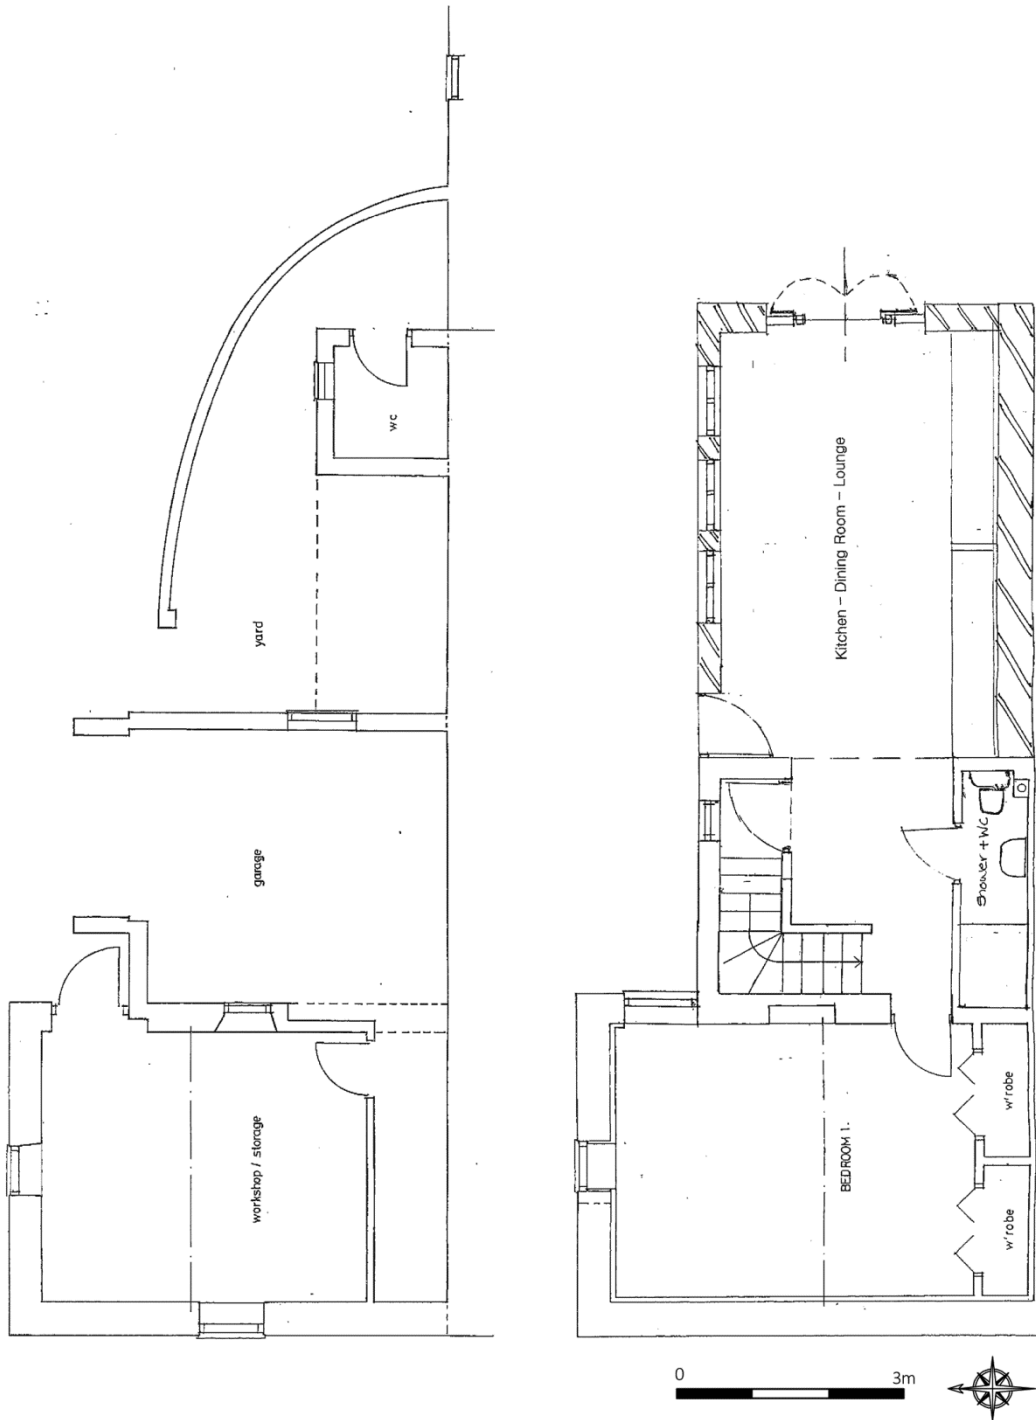
Figure 3: Existing and proposed ground floor plans (scale 1:100)

The proposed development consists of a partial two-storey and partial one-storey rear extension to the Coach House, as well as internal alterations to convert it into a residential annexe (Fig. 3).

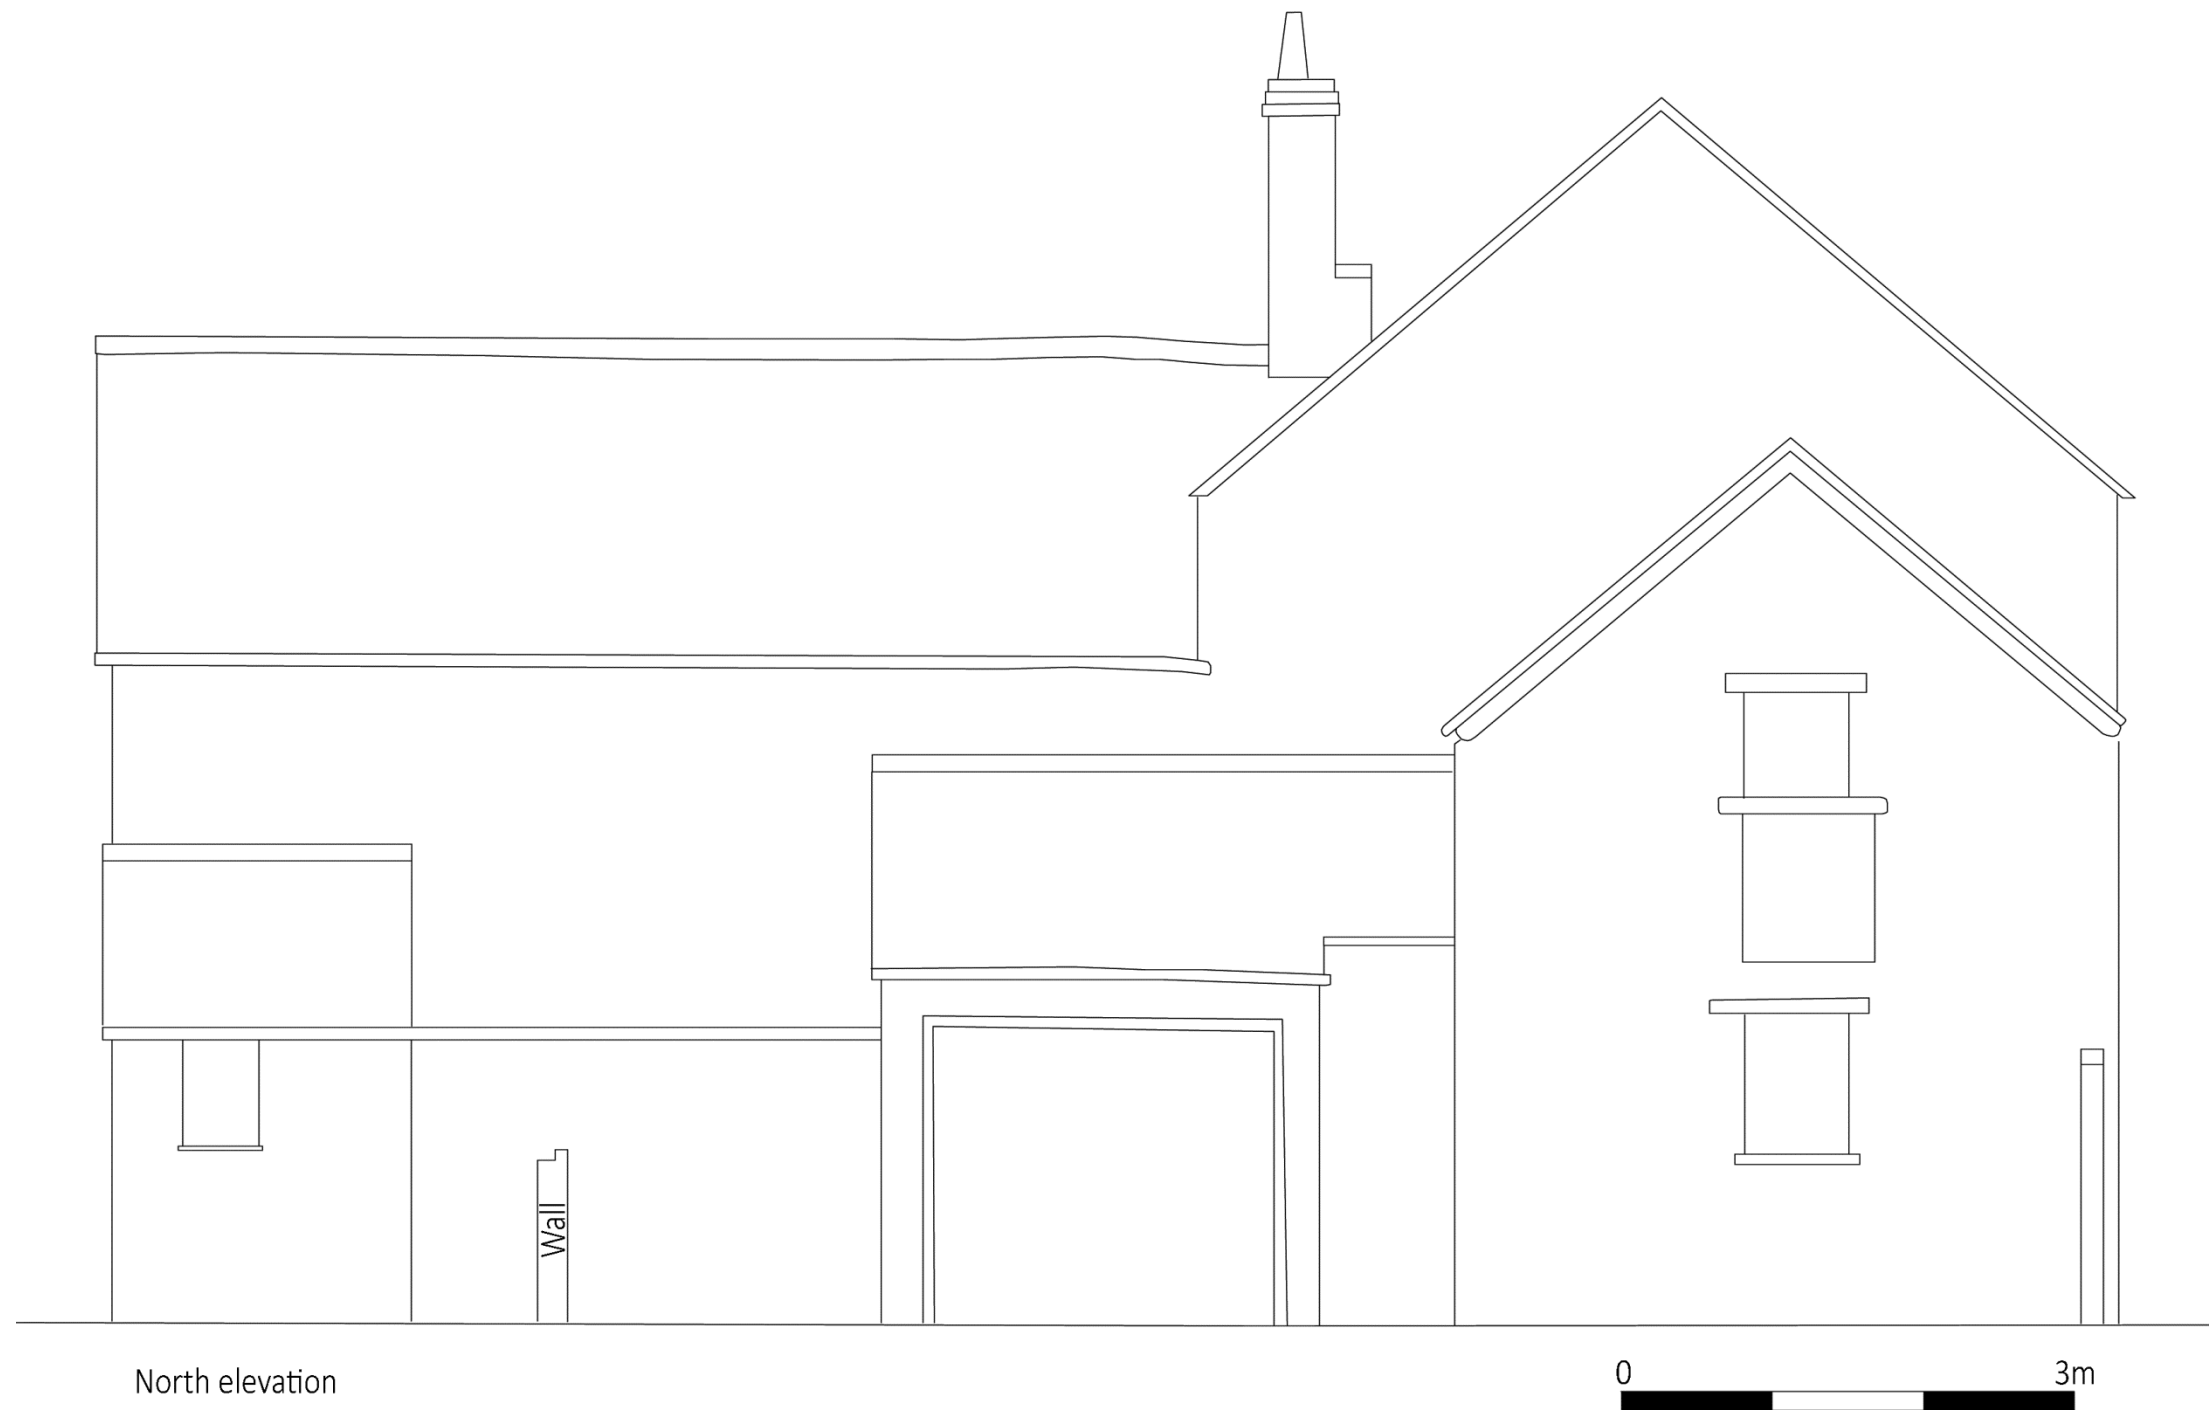
Figure 6: North elevation (scale 1:50)

The stonework in the north elevation is not as well coursed and made of smaller roughly dressed stone pieces. A patch of cement render survives that was incised to imitate ashlar stonework. There are two, vertically aligned timber windows with a hayloft door in between. All the openings and the eastern corner of the building have brick dressings. The upper window, which lights the mezzanine floor, has a single fixed light and the ground floor window is a 2-light casement. Both have timber lintels and whereas the lower window has a tiled sill, the upper window utilises the timber lintel of the hayloft door as a sill.

The hayloft door has long strap hinges with rounded ends that were popular in the 18<sup>th</sup> century.

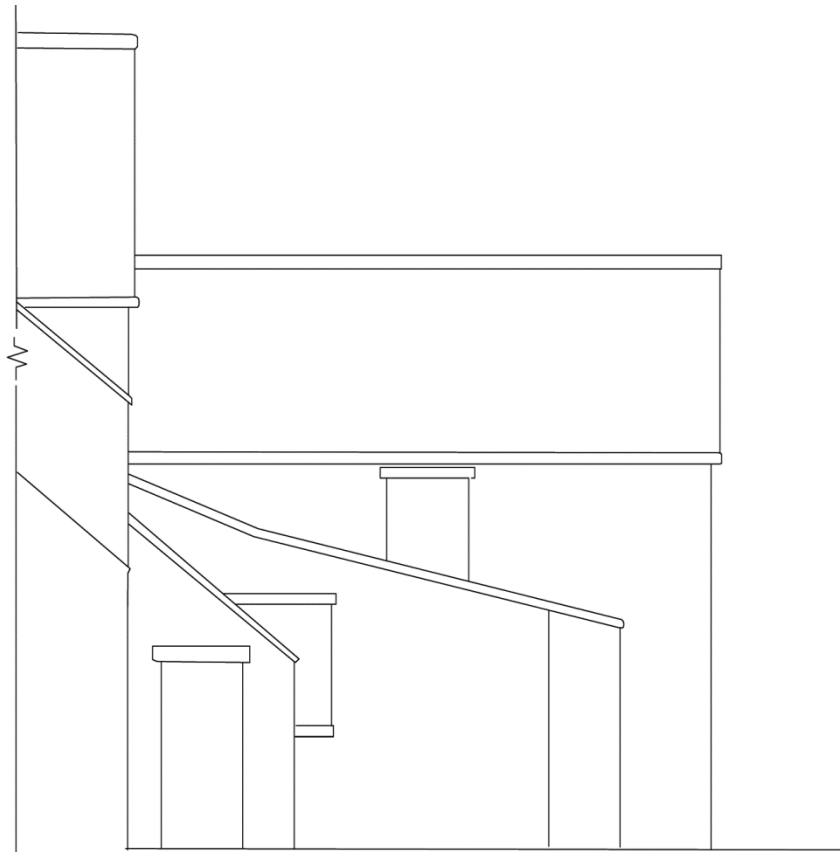
East elevation

A window in the east wall has been bricked up, but like the others has a timber lintel. Much of the stonework on this elevation is partially obscured by surviving render.

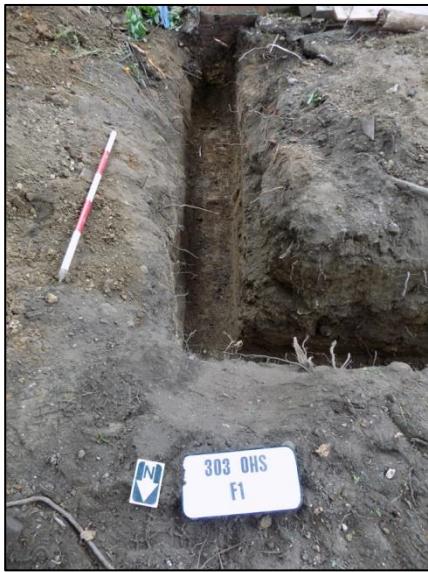
Plate 1: Footing 1

Footing trenches were dug to the depth of 1.2 metres as required using a 1 tonne machine fitted with a 0.45m toothed bucket and by hand where the digger could not reach (Figs. 8-9 ; Plates 1 -3).

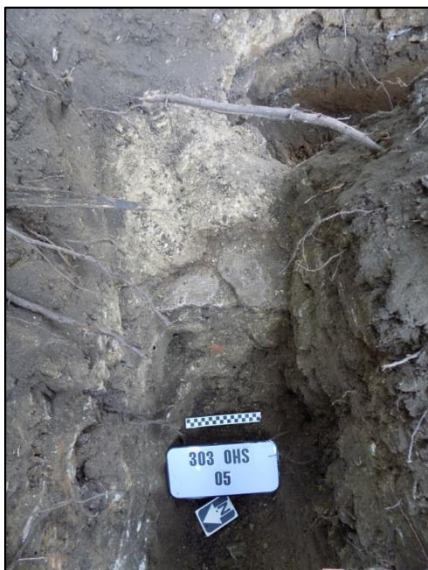
Plate 4: Wall (05)

**Wall (05)** was located in the northeast corner of the trench (Figs. 9-11; Plate 4-6). Only a small section of the wall was observed; however, more could be seen in the northern baulk. There was evidence that some demolition had taken place as many limestone pieces were observed from the made ground. Unlike with (05), these did not appear to form a structure but occurred randomly within the fill. Wall (05) appeared to be constructed of the same material that had been used to construct the earlier part of the house; however, the limestone pieces were narrower in comparison. The mortar appeared similar but has become very friable. This feature was probably the base of a boundary wall. A piece of post-medieval pottery was recovered from within the stonework, but not retained (Plate 6).

During the Observation and Recording exercise, only a small area of the site was excavated and the ground observed showed signs of disturbance in the late post-medieval period. The foundations of a red brick wall which had recently been demolished still remained in situ and an earlier limestone wall, which appeared to be the crumbling remains of a boundary wall was also noted. Pottery was recovered from within the stonework signifying a post-medieval date.

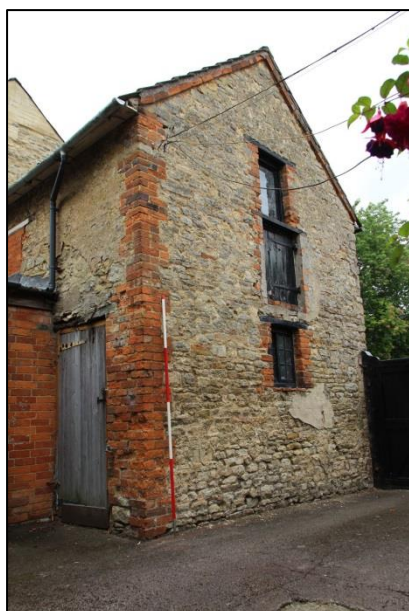
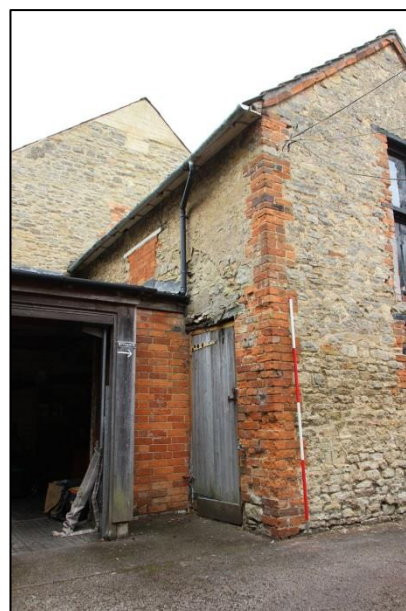
<b>Project No/code:</b> 303/OHS	<b>Project:</b> 100 High Street, Olney, Buckinghamshire	<b>Elevation:</b> North
<b>Doors:</b> Hay loft door with long strap hinges and rounded ends		
<b>Windows GF:</b> 2 light timber casement under timber lintel with a tiled sill		
<b>Windows FF:</b> Single light fixed timber windowsill timber lintel and utilising timber lintel of thrush loft door as a sill		
<b>Walling material:</b> Roughly coursed stone walking with Rick quoins and dressings. The wall had once been rendered with cement render most of which has been removed. Bricks are handmade reds with horizontal skintlings		
<b>Other Architectural Features:</b> Roof tiles with modern tiles		
<b>Recorder:</b> KK		<b>Survey date:</b> 02.08.17

Plate 8: Shot 1. North elevation

Plate 9: Shot 2. North elevation, door detail

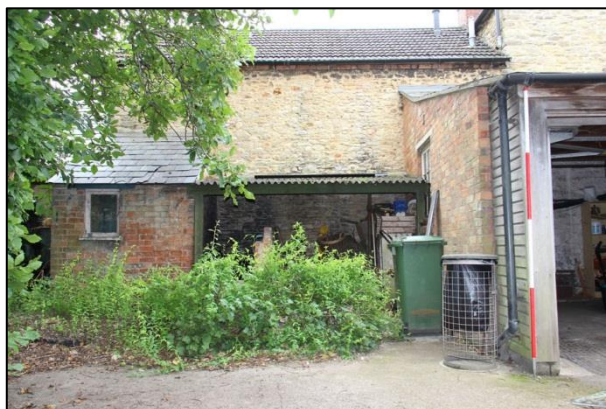
**Plate 12:** Shot 5. Wood store to east of garage

#### 4.5 **Open fronted store** (Figs. 4, 6 & 7, Plates 12)

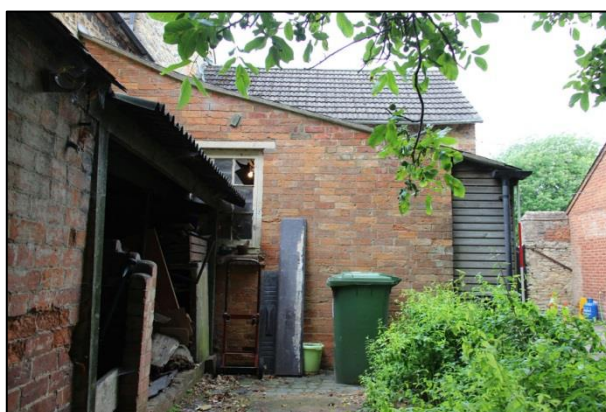
**Plate 13:** Shot 6. East elevation

<b>Project No/code:</b> 303/OHS	<b>Project:</b> 100 High Street, Olney, Buckinghamshire	<b>Elevation:</b> East
<b>Doors:</b> Ledge and braced door- 20th century replacement		
<b>Windows GF:</b> None		
<b>Windows FF:</b> Blocked window under timber lintel		
<b>Walling material:</b> As north wall. More render has survived here and this side is of lesser quality not having lines incised to imitate ashlar		
<b>Other Architectural Features:</b> None		
<b>Elevation:</b> Garage east		
<b>Doors:</b> None		
<b>Windows GF:</b> Timber window with bull nosed brick will and under timber lintel		
<b>Windows FF:</b> N/A		
<b>Walling material:</b> Red bricks with horizontal skintlings set in quasi Flemish bond in lime mortar. Northern end is timber built. Queen closers to wall and window		
<b>Other Architectural Features:</b> Slate roof		
<b>Recorder:</b> KK		<b>Survey date:</b> 02.08.17

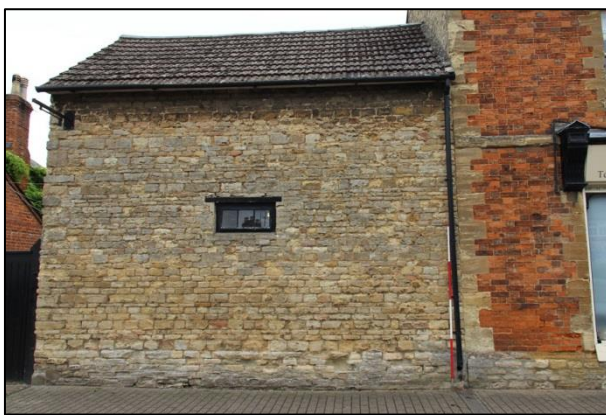
**Plate 14:** Shot 7. West elevation

<b>Project No/code:</b> 303/OHS	<b>Project:</b> 100 High Street, Olney, Buckinghamshire	<b>Elevation:</b> West
<b>Doors:</b> None		
<b>Windows GF:</b> Top hung timber window		
<b>Windows FF:</b> None		
<b>Walling material:</b> Well coursed roughly dressed limestone with some Totternhoe clunch set in lime mortar		
<b>Other Architectural Features:</b> Pole for street sign at northern corner		
<b>Recorder:</b> KK	<b>Survey date:</b> 02.08.17

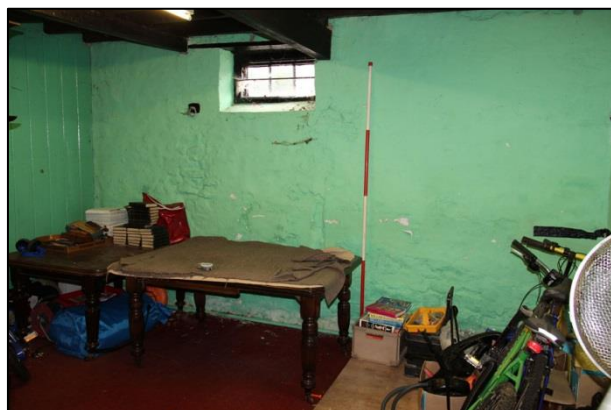
Plate 18: Shot 11. G1, West wall

<b>Project No/code:</b> 303/OHS	<b>Project:</b> 100 High Street, Olney, Buckinghamshire		<b>Room no:</b> G1
<b>Location:</b> Western end		<b>Function:</b> Workshop	
<b>Dimensions (m):</b>	Length: 3.69	Width:4.40	Height:
<b>Wall form &amp; decor:</b> Painted brick and plastered stone to north, east and west. Tongue and groove panelling to south			
<b>Ceiling / roof structure:</b> Plyboard above machine cut and manually converted joists			
<b>Windows:</b> Single light top hung timber window to west. 2 light timber window to North. Single light window to east			
<b>Doors:</b> replacement ledge and braced door at northern end of east wall			
<b>Floor:</b> carpet over concrete			
<b>Fireplace:</b> None			
<b>Staircase:</b> None			
<b>Other architectural details:</b> Opening to upper level in North East corner. Only access to upper floor is by unsecured ladder. Photos taken from ladder as precautionary matter

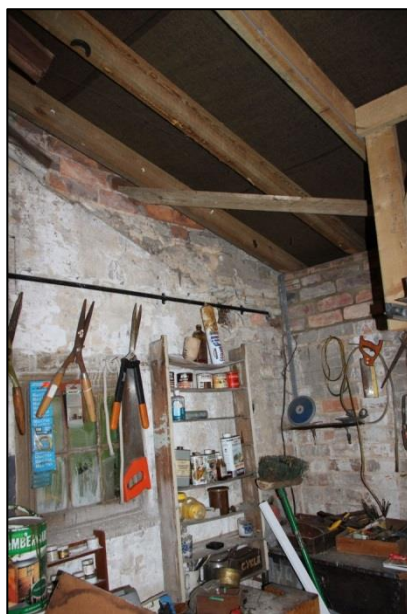
Plate 34: Shot 34. G2, northwest corner showing garage heightening

The garage is a brick built structure under a mono pitched roof covered in slate tiles that was added to the east of the workshop. The bricks are similar to those used for the dressings on the workshop, which would suggest that this was added in the 19<sup>th</sup> century. It has subsequently been extended twice; initially in brick and then again in timber when an up and over garage door was added in the late 20<sup>th</sup> century. The floor is made of bricks measuring 23.5 X 13cm in the main body of the garage as well as the passage to the rear of the workshop. Stable bricks have been used in the extension to the north.

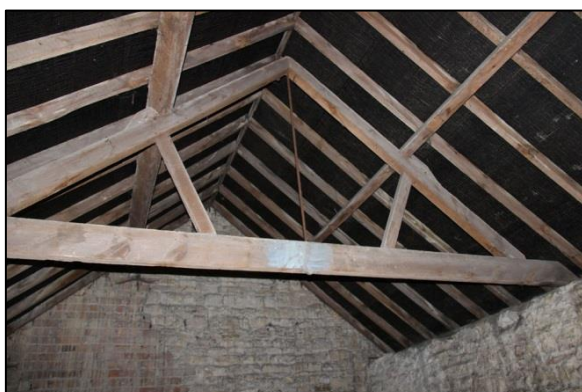
**Plate 35:** Shot 17. F1, Roof detail

The walls here have been left unpainted and a large area in the south wall, which is the north elevation of the adjoining house, has been rebuilt in brick. This is also partially evident outside. The workshop has a clasped purlin roof with raking queen posts and cleats.
