KDK ARCHAEOLOGY LTD

## Historic Building Recording and Archaeological Observation and Recording Report

The Old Maltings

Biggleswade

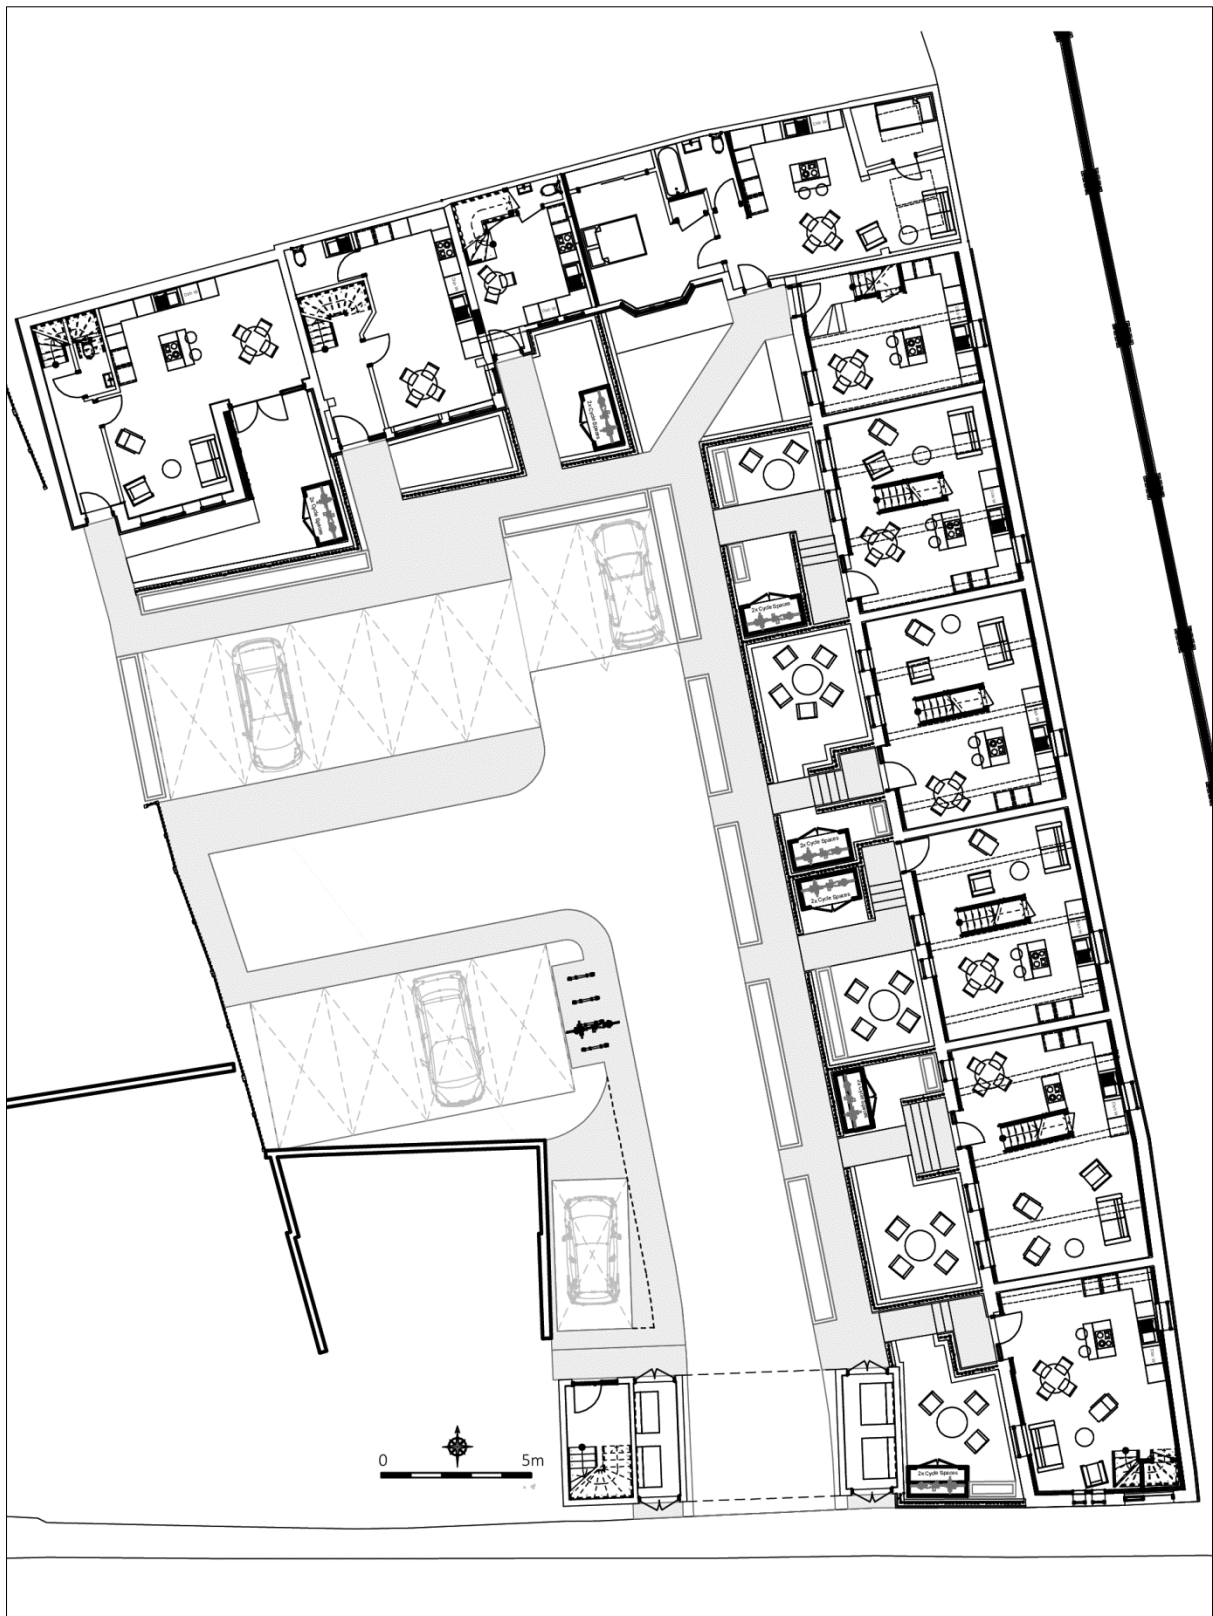
Figure 3: Development plan (scale 1:250)

The development comprises the conversion of the former maltings and Brewmaster's House into residential units, with the demolition and re-building of the timber building and the construction of a new dwelling to the west of the Brewmaster's House (Fig. 3).

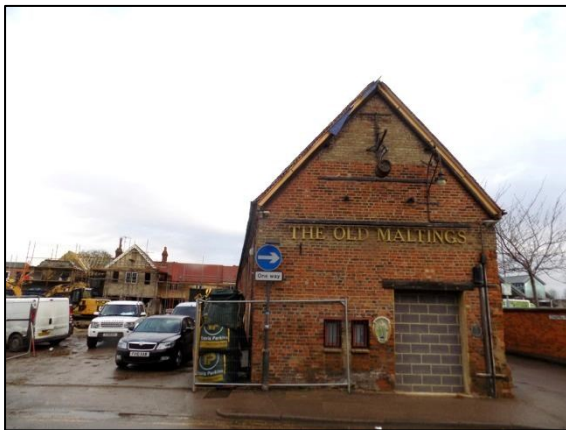
**Plate 1:** Old Maltings south elevation

The brickwork in the Old Maltings provides clear evidence for repair, rebuild and extension on all three exposed elevations, most particularly on those facing south and east. The south elevation, which stands directly on Church Street, had been refaced using red bricks with horizontal skintlings and white bricks above (Plate 1). Skintlings are the raised section of brick left behind from the way the bricks were stacked whilst being dried before being fired. The stacking method changed some time in the late 18<sup>th</sup>/early 19<sup>th</sup> century, so the diagonal skintlings that had been the norm until this time changed to being horizontal. Diagonal skintlings are prevalent in the other two elevations despite the different bricks types used and the variation in bonding techniques. The eastern elevation is primarily in English bond, with the exception of the northernmost section, which is set in Flemish bond. The west elevation has less variation in brick types, but the bond is also less regular. What is clear in the west elevation was the rebuild at the northern end.

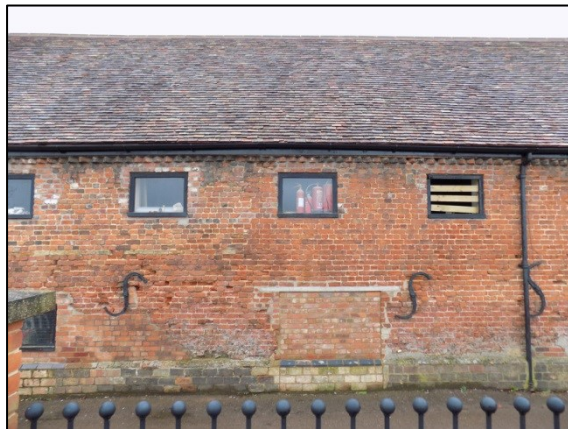
Plate 9: Old Maltings west elevation- north end moving north

Later alterations to the building included the addition of a plinth to the east elevation, the re-ordering/replacement of doors and a programme of refenestration. In addition, the door within the west elevation towards the northern end of the maltings had been bricked up (Plate 9)

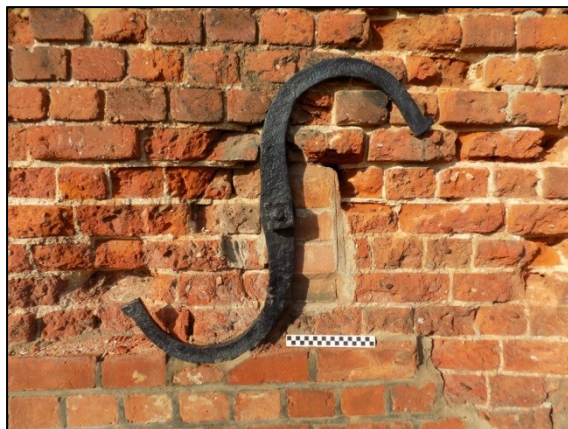
Plate 11: S Anchor plate

Figure 9: S anchor plate (scale 1:10)

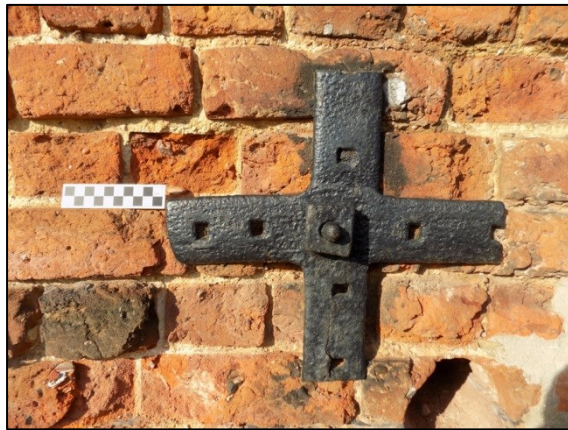
**Plate 12:** Cross anchor plate

**Figure 10:** Cross anchor plate (scale 1:10)

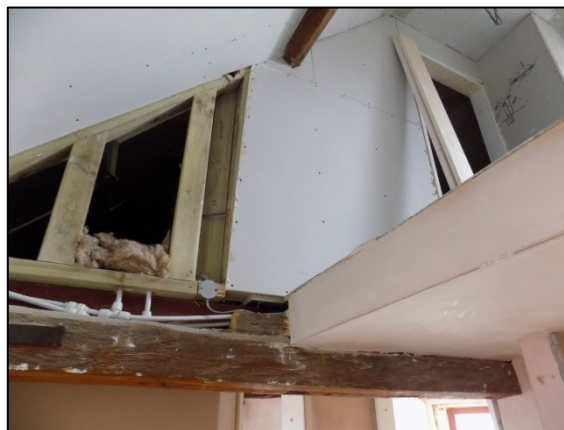
During the survey, the first floor was inaccessible, but the reconfiguration of the upper floor when the building was converted from use as a malting was evident in the new mortices in one of the tiebeams visible from the ground floor. The floor joists were chamfered and all appeared to be original. Iron ties had been added for structural reasons to some, just as ties have been added to the main structure of the building.

**Plate 13:** Tiebeam with newly added upper floor, looking northeast

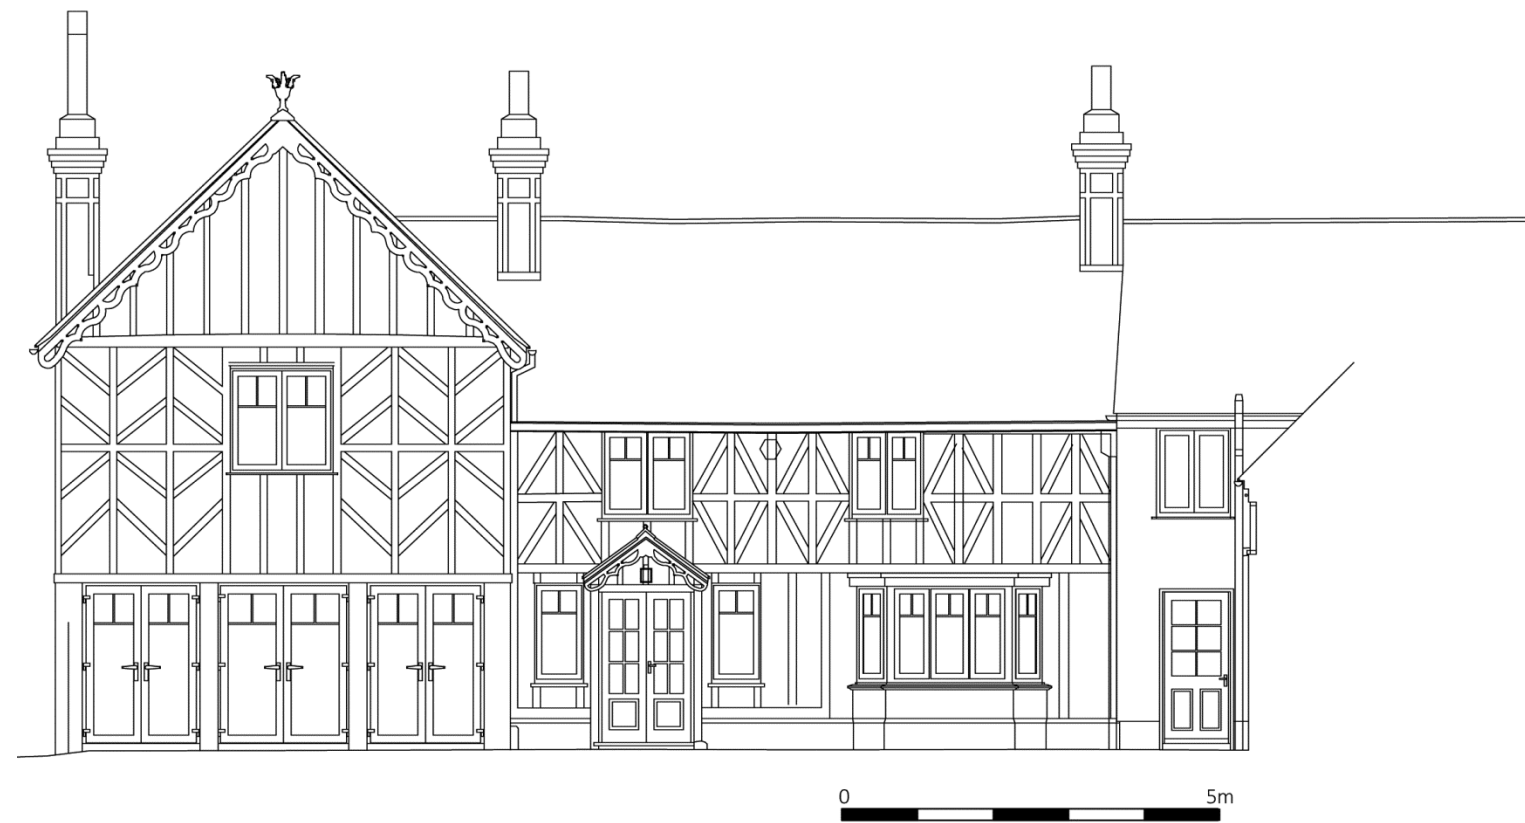
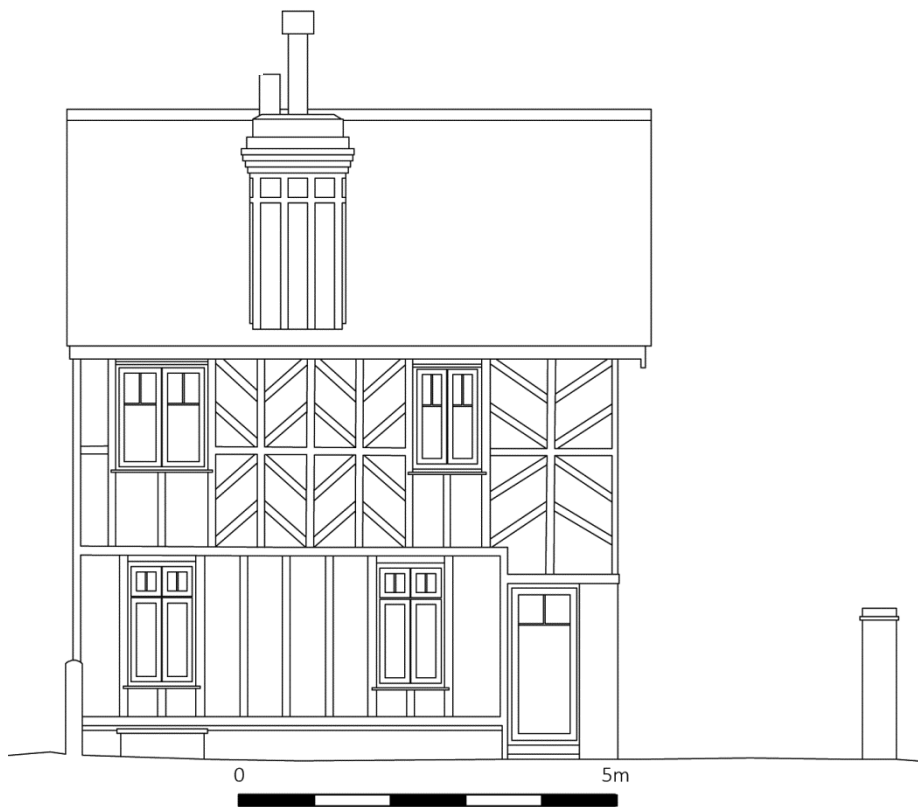
The Brewmaster's House is a late 19<sup>th</sup> century structure that was extended in the early 20<sup>th</sup> century. The eastern part of the building was weatherboarded and located directly to the north of the Old Malting. The central range and west wing were rendered with decorative timber applications. The wing had a decorative barge board and finial to the clay tiled roof, which appeared to have been rebuilt across the entire house. The central range had a chimney at either end of the ridge and a third chimney was located on the western side of the west wing.

The building had been refenestrated and modernised throughout, although some of the original features such as the 6-panelled timber front door, some of the fireplaces and skirting boards survived. The entrance hall (G1) had a tiled fireplace and hearth within a timber surround and bronze hood to the west, a modern staircase to the north and the original staircase with brick steps to the cellar behind the modern stud wall. The door to the cellar at the top of the stairs had ventilation holes in the lower panels; the door at the bottom of the stairs had been dismantled prior to the survey. The north wall was rendered and painted, but the south wall was simple painted brick. The ceiling and skirting boards are modern, as is the UPVC window to the west.

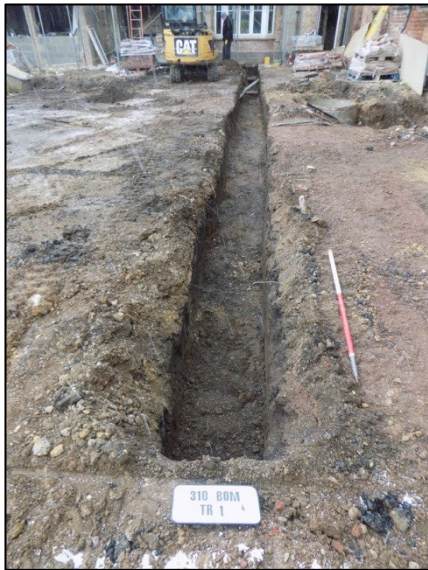
Plate 14: Wall Footing 1 looking north

Several wall foundation and service trenches were dug within the courtyard to the west of the Old Maltings using a 3 tonne machine fitted with a 0.45m toothless ditching bucket (Fig. 16; Plates 14, 15 & 19). These were 0.50m in width and reached a depth of 0.60m, occasionally exposing the natural geology beneath. Further foundation trenches were excavated in the southern part of the site, where a small gatehouse was to be erected. These footings were dug to a depth of 1.20m (Fig. 16; Plates 17-18). Towards the centre of the site a large area was excavated for a soakaway (Area 1), which measured 6.40 x 7m (Fig. 16; Plates 20-21). This was dug with a 13 tonne machine fitted with a 1.80m toothless ditching bucket. Initially, this area was excavated down to a depth of 0.75m before being reduced further to the required depth of 2m.

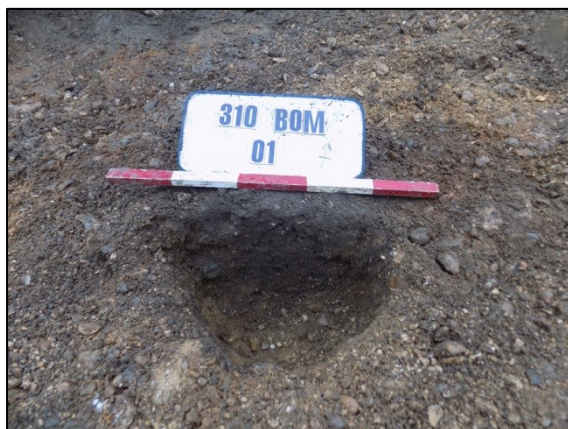
<i>Context no.</i>	<i>Type</i>	<i>Dimensions (max)</i>	<i>Description</i>
01	Cut	L: 0.44m W: 0.44m D: 0.23m	Square u-shaped posthole with sheer sides found towards the northern part of the stripped area. Contained a single backfill (02)
02	Fill	L: 0.44m W: 0.44m D: 0.23m	Fill of [01]. Mid greyish brown very loose slightly silty clay. Contained occasional flecks of chalk and sub-angular and rounded stones. Contained CBM including red brick, animal bone and a bit of an iron object (probably nail).
03	Cut	L: unknown W: 1.64m D: 0.91m	Cut of Pit. Obscured in plan by baulk to the north, steep in section. Contained an irregular base which steps down to the east. Contained fill (04)
04	Fill	L: unknown W: 1.64m D: 0.91m	Fill of pit [03]. Mid brown very loose slightly silty clay. Contained occasional flecks of charcoal and sub-angular stones. Contained CBM including red brick, and animal bone including the mandible of a pig. Cut by [05] and [07]

Figure 17: Plan and south facing section of Posthole [01] (scale 1:10)

All other ground reduction and excavation was undertaken under archaeological supervision. The investigation exposed several thick layers of made ground, which would indicate that this area had been heavily truncated, most likely in modern times. Nonetheless, several features still survived that cut the natural geology including several possible pits and a posthole, which were observed in the large soakaway area. The finds recovered from these features would suggest that they are post-medieval rubbish pits, but it is unclear whether they were directly associated with the maltings. The function of the posthole is unclear, as no similar features were exposed nearby.

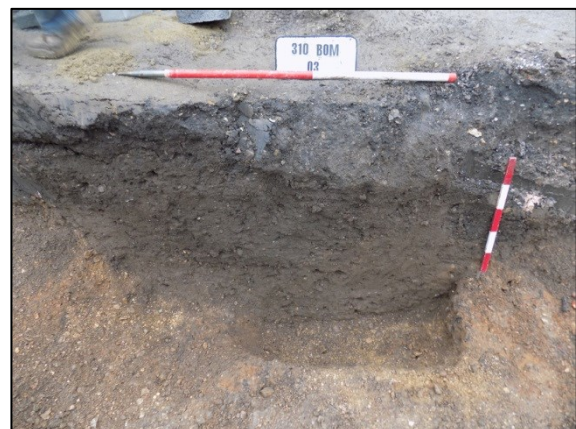
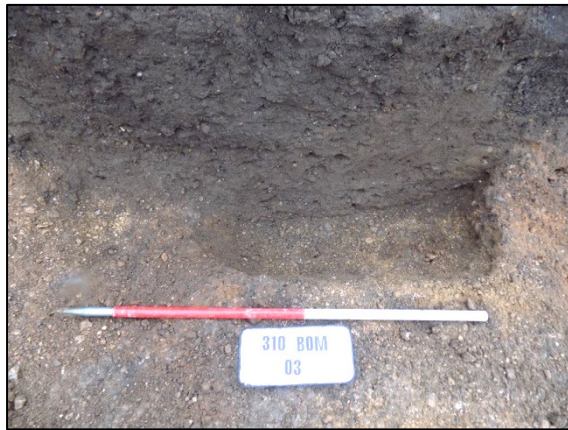
05	Cut	L: unknown W: 1.22m D: 0.65m	Possible pit [05] which could be seen in the baulk to the north. Contained late post-med/modern material. Cut through fill of pit [03]
06	Fill	L: unknown W: 1.22m D: 0.65m	Fill of possible pit [05]. Dark greyish brown very loose slightly silty clay. Contained occasional flecks of charcoal and sub-angular stones. Contained CBM including red tile, and a square headed masonry nail. Also some burnt material, possible brick or mortar. Thin lens of gravel at the base of the pit
07	Truncation	L: >7m W:>6.40m D: >0.72m	Appeared to be an area of truncation containing made ground which covered the majority of the site. Site topography steps down in the eastern side of the site which has subsequently been built up, probably in the modern period

Figure 18: Plan of Pit [03] (scale 1:20)

Figure 19: South facing section of Pits [03], [05] and [07] (scale 1:20)

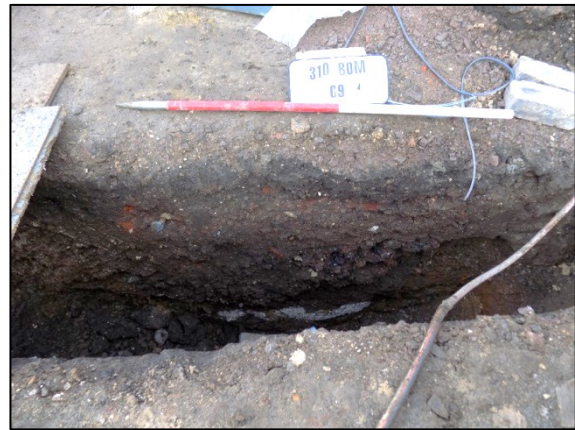
degraded CBM and a large layer of chalk at its base in south facing baulk only. Due to the depth and width of the trench, access to the feature was limited.

Figure 20: South southeast facing section of possible Pit [09] (scale 1:20)

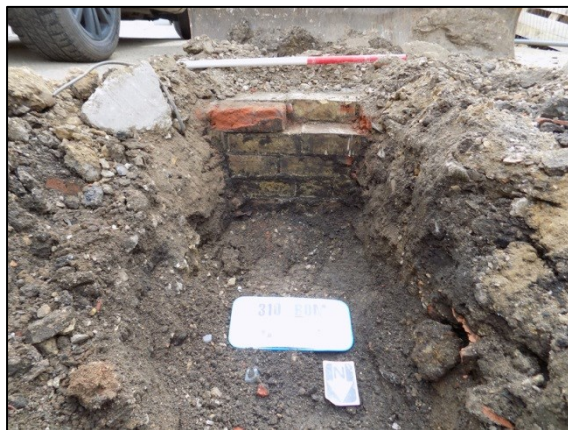
Plate 27: Wall [013] looking south

Brick wall [13] was exposed at the south end of the site in Service Trench 2 (Fig. 16; Plate 27). It was 0.23m wide and at least 0.38m high (it continued below the limit of excavation). Five courses were exposed, laid in a stretcher bond set in a cement mortar, indicating that the wall was modern but older bricks had been used. The bricks had no frog and varied between orange and yellow. Each measured 230x110x70mm (9 1/8 x 4 1/4 x 2 3/4").

12	Natural	-	Natural geology. A mixed orange and yellow stony gravelly sand containing a high proportion of small to medium sized stones
13	Masonry	L:>0.50 W:0.23 D: >0.38	Brick wall [013] was observed at the southern end of the site. Each brick measured 230x110x70mm (LxWxD). The wall measured >0.38m high (as it continued beyond the limit of excavation) and 0.23m wide. Cement mortar.
14	Masonry	L: W: 0.23 D: 0.39	Part of the foundation for the old barn. Fletton bricks 210x115x650mm in size. The base of the bricks were frogged. 5-6 coursed including a lower course of headers. The upper courses were regular but did not appear to conform to a particular pattern. Bonded with a firm white stony mortar
15	Masonry	W:0.75 D: >0.11	Possible brick service (i.e. Inspection chamber) or the lip of a well at the southern end of the site in the southern baulk of Building foundation 3. A single rowlock course of red brick. No visible mortar. Bricks measured 110x6.5mm (WxD). The bricks were sitting on a stony greyish brown matrix and had made ground above.

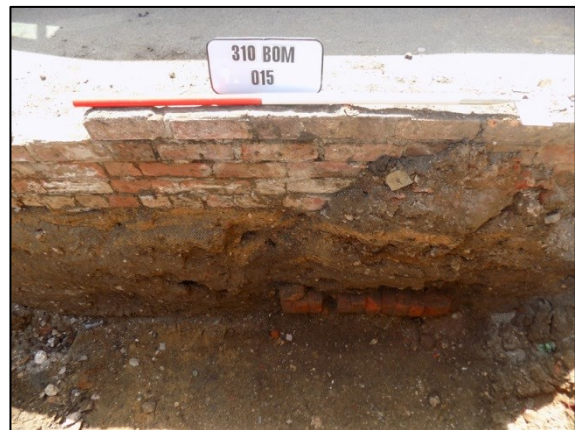
A wall (014) was also observed along the southern site boundary (Fig. 16; Plate 28). It had been part of the foundation of the barn that was demolished in 2017/2018 and was made of Fletton bricks that measured 210x115x650mm (8 1/4 x 5 7/8 x 2 1/4"). The base of the foundations comprised a course of headers with an additional 3-4 courses of bricks above. These upper courses were regular but did not appear to conform to a particular pattern. The wall was bonded with a firm white stony mortar. Below wall [014] was part of a post-medieval/ modern brick structure [015] (Fig. 16; Plates 28-29). This feature could only be seen in the baulk section, so its true function could not be ascertained. It is possible that these bricks form part of an Inspection chamber or the lip of a well. It comprised a single header course, which was set on end, measuring at least 0.11m height and 0.75m in width. The bricks were 110 x 6.5mm (4 1/4 x 2 1/2") and were placed on a stony greyish brown matrix. Above [015] and below [014] was a layer of made ground, (17).

Plate 28: Brick feature [15] beneath barn foundation [014] looking south

Brick walls were found in several of the service trenches. Remnants of the recently demolished barn overlying a single course of unassociated brickwork were present at the southern boundary of the site. The brick wall revealed to the northeast of this appears to be the remains of the rectangular building recorded on the 1838 Tithe Map.

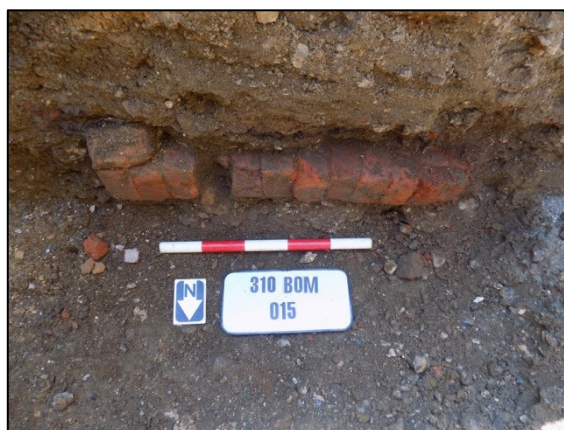
Plate 29: Brick feature [15] looking south
